2015 Earthquake Damage Mapping

Sankhu

October 2015

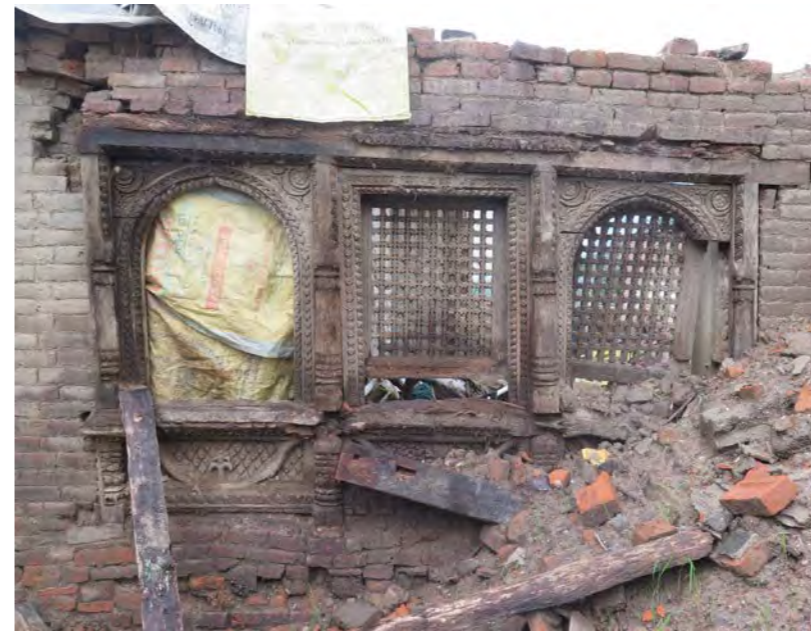
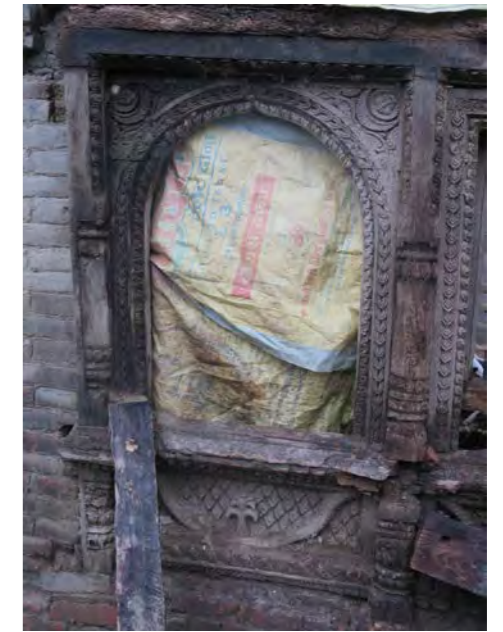
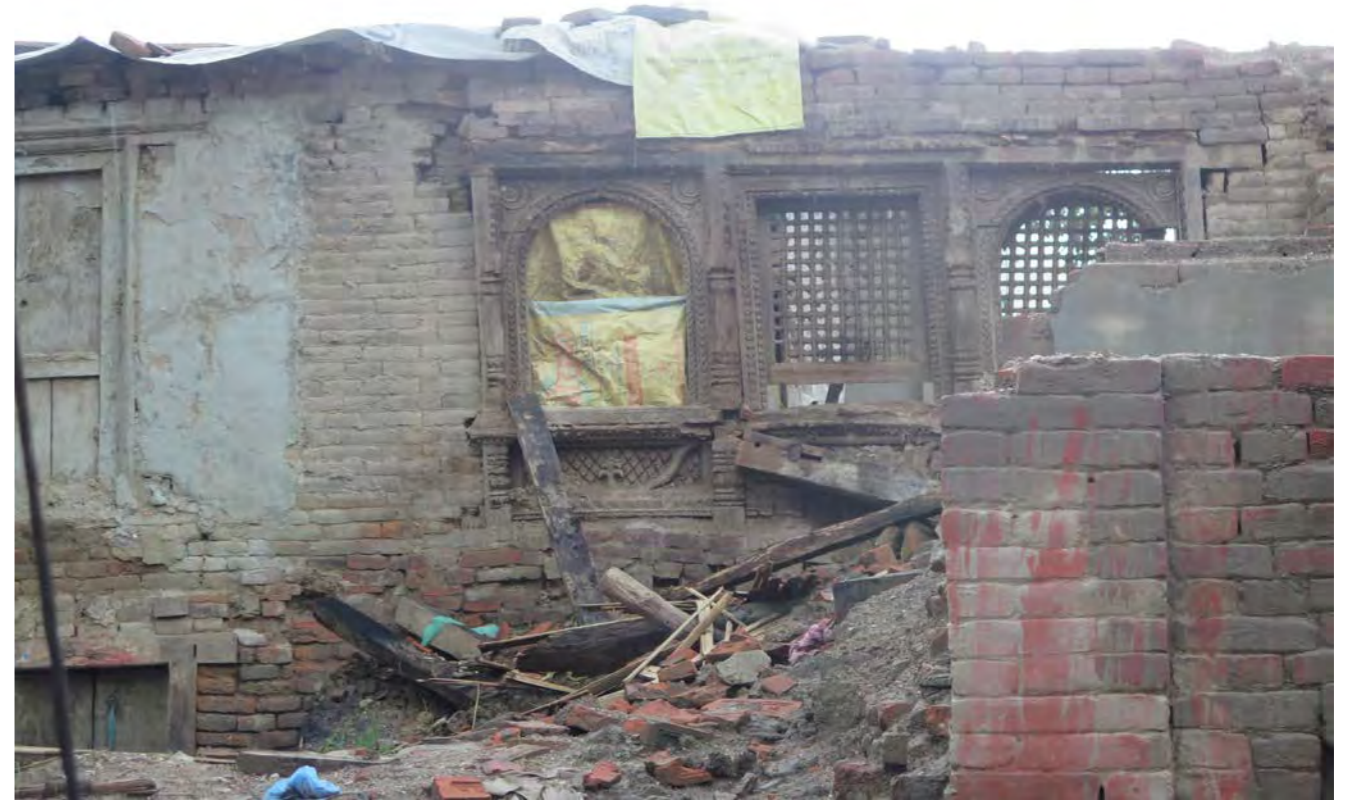
NUMBER	CONTACT	STOREY NO. RELATIVE POSITION	STRUCTURAL SYSTEM	PROBLEMS DESCRIPTION	DANGER	CONDITION	
i32	Hari Bhakta Shrestha	G+3	B+UnB	2 Floors collapsed. Covered by rubbles	⚠️ ☒	R ++

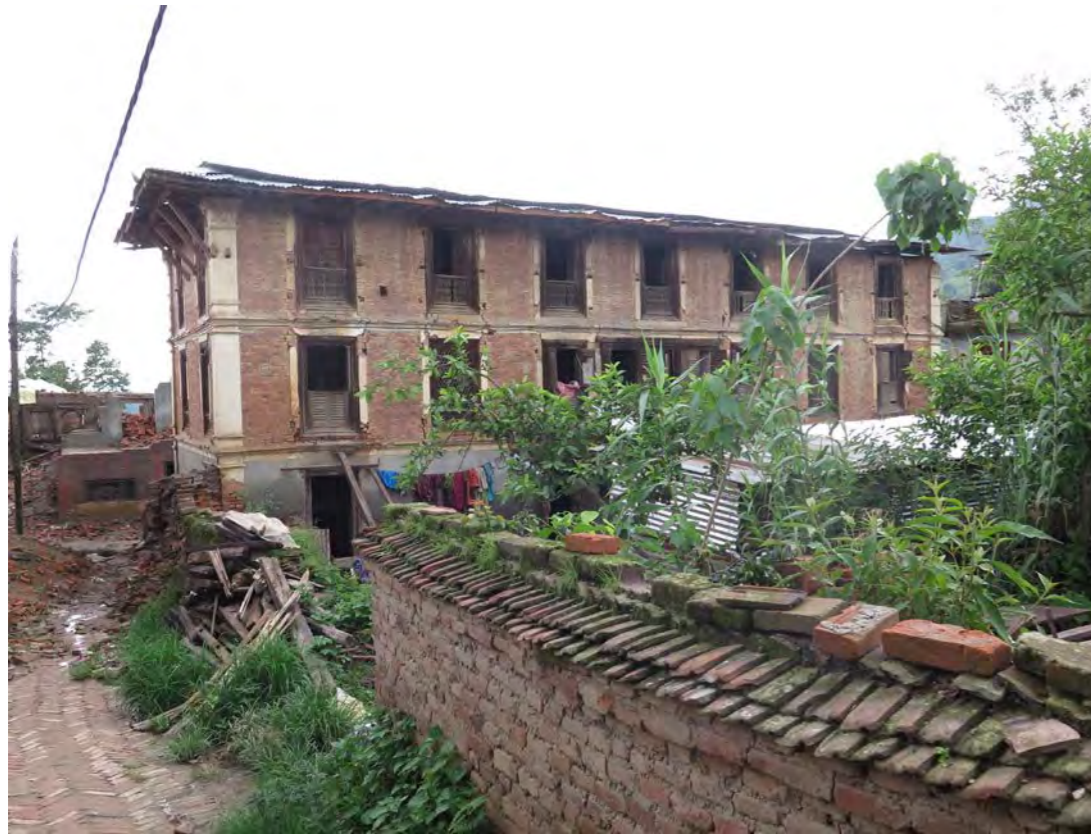
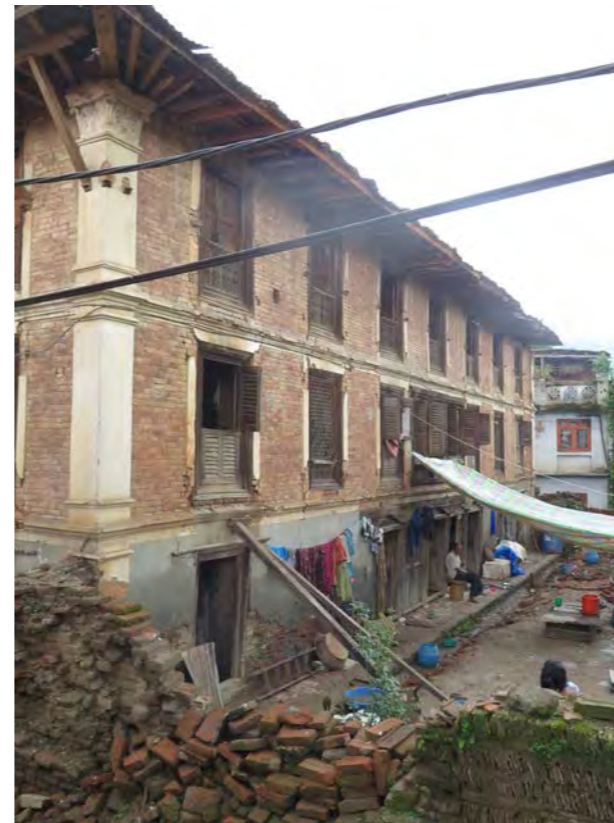
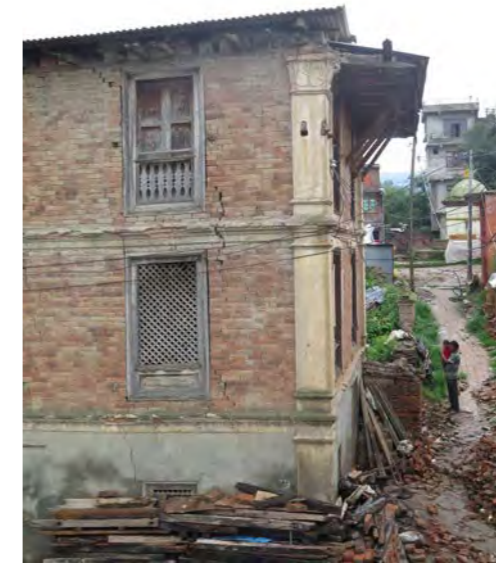
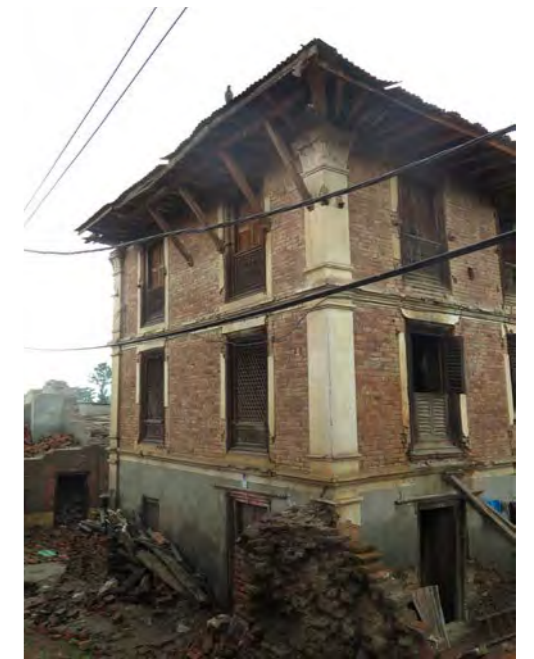
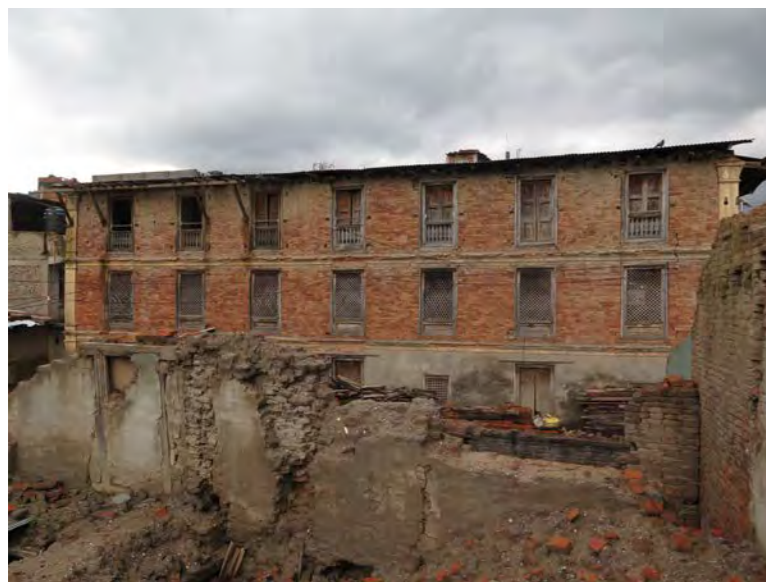
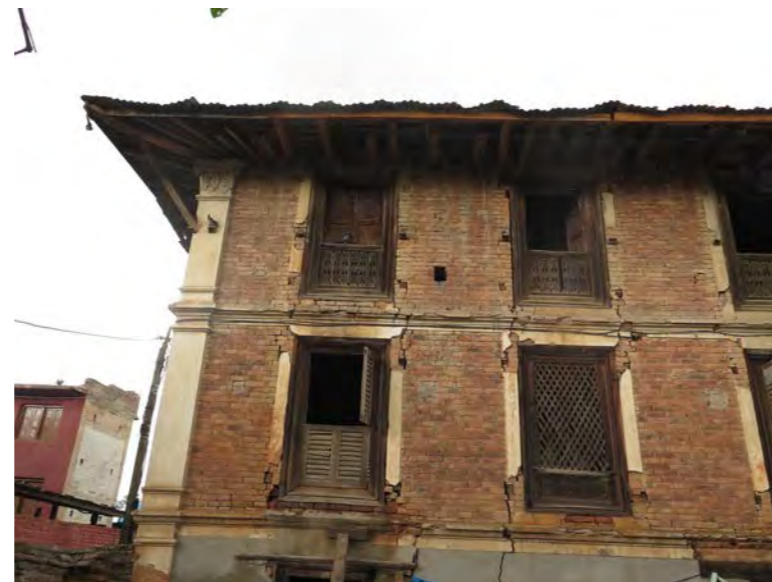
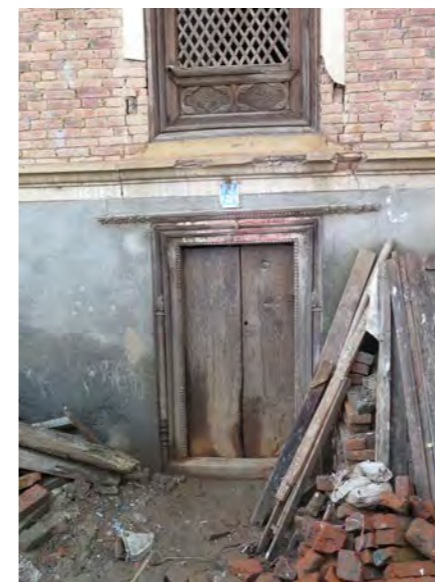
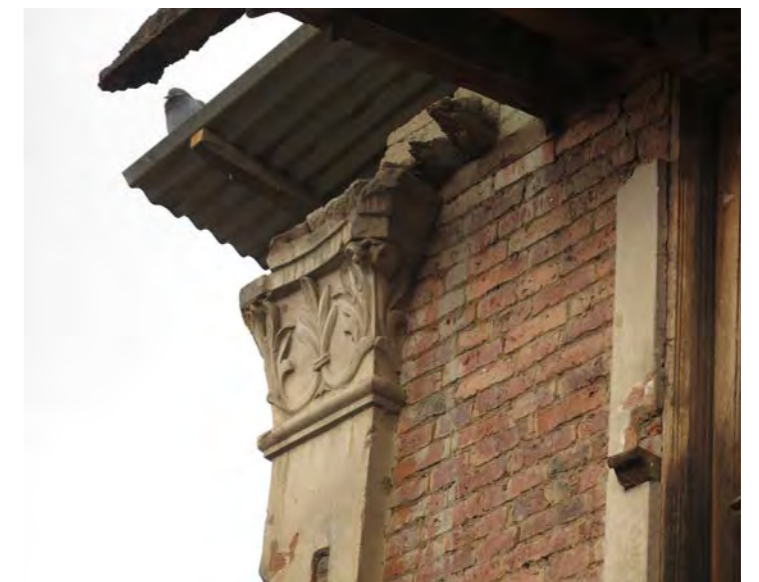
i53, i54, i55

NUMBER	CONTACT	STOREY NO. RELATIVE POSITION	STRUCTURAL SYSTEM	PROBLEMS DESCRIPTION	DANGER	CONDITION
i53/i54	Birendra Shrestha/ Amrit Shrestha (9849383881)	G+4/ G+5	UnB + B	2 floors demolished. Major cracks >5cm on east side. Long vertical crack on North side. North wall seperating. Bricks displacement on North east corner. East wall buldging.		Beautiful Pilasters W +
i55	Ishwor Shrestha	G+6	UnB + B	4 floors demolished. Major cracks >5cm on east side. Long vertical crack on North side. North wall seperating. Bricks displacement on North east corner. East wall buldging.		Beautiful Pilasters W +

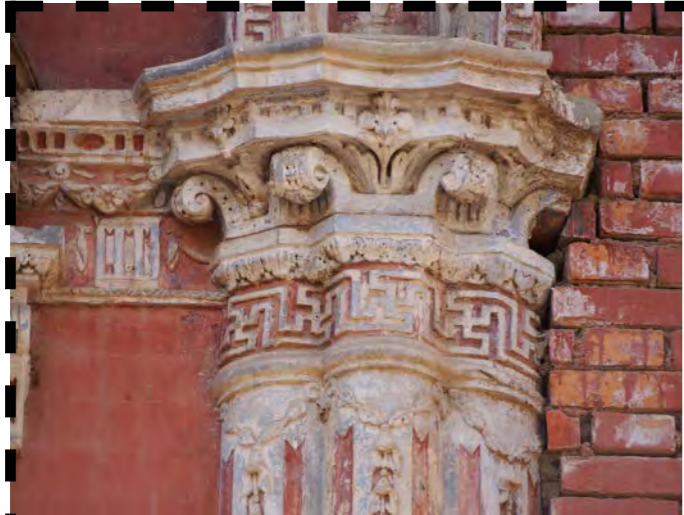
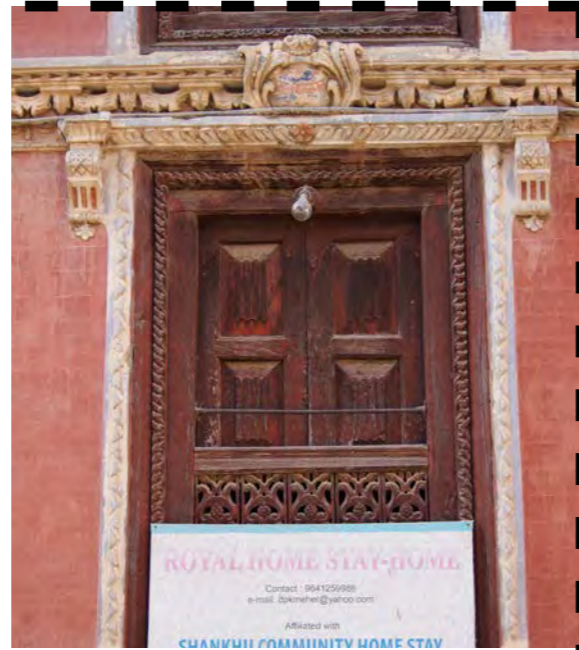
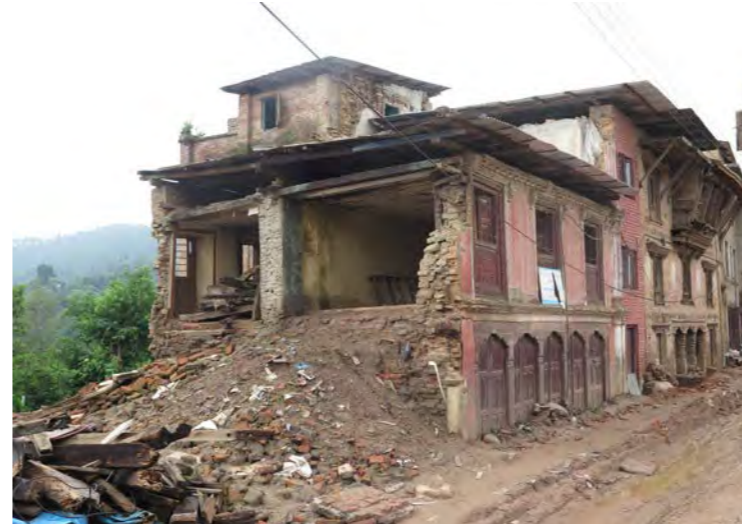
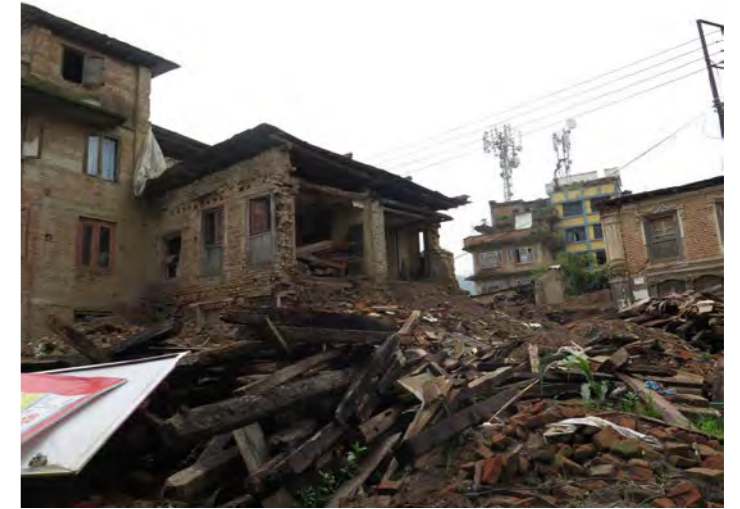
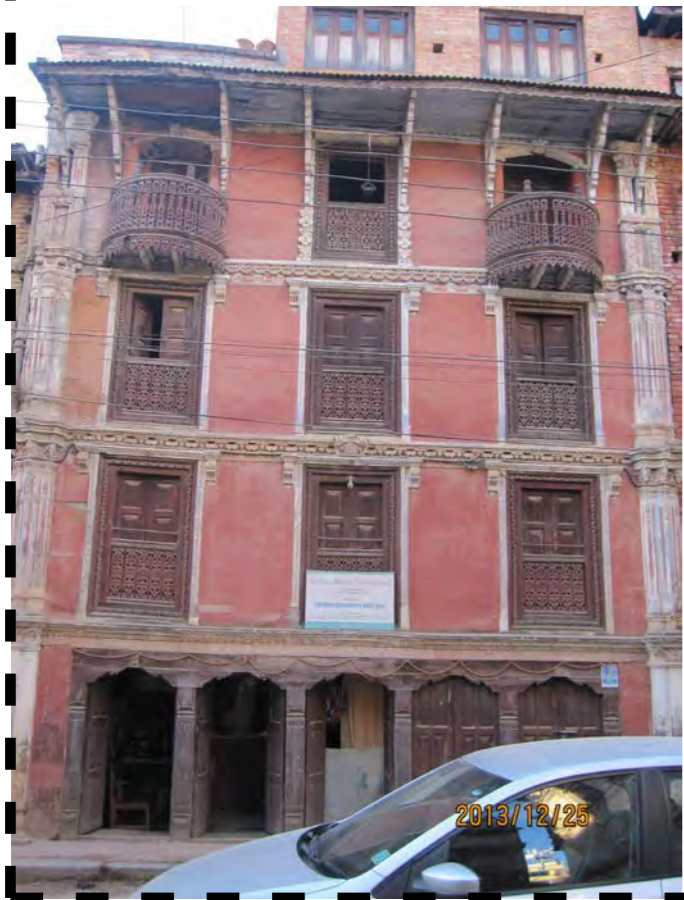
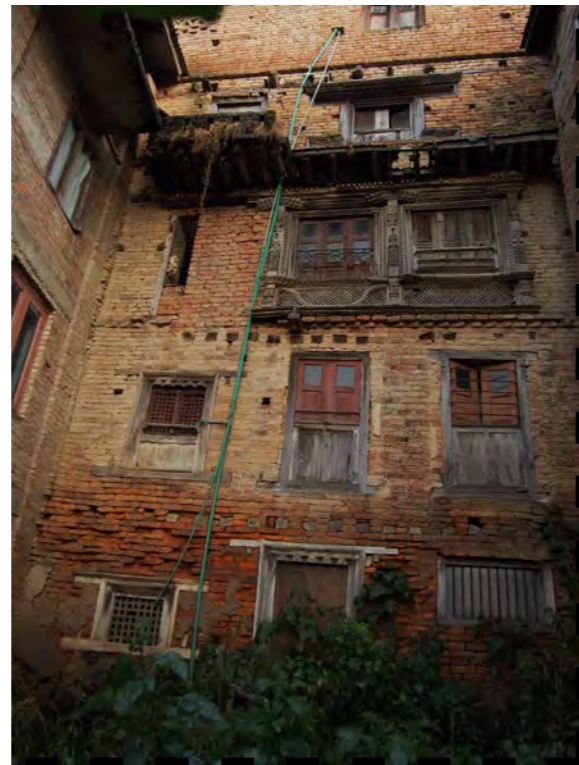
NUMBER	CONTACT	STOREY NO. RELATIVE POSITION	STRUCTURAL SYSTEM	PROBLEMS DESCRIPTION	DANGER	CONDITION	
i68	Daiba Meher Shrestha	G+3	B	2 floors collapsed. South wall demolished.	1/2 ☒	Good stucco work ++

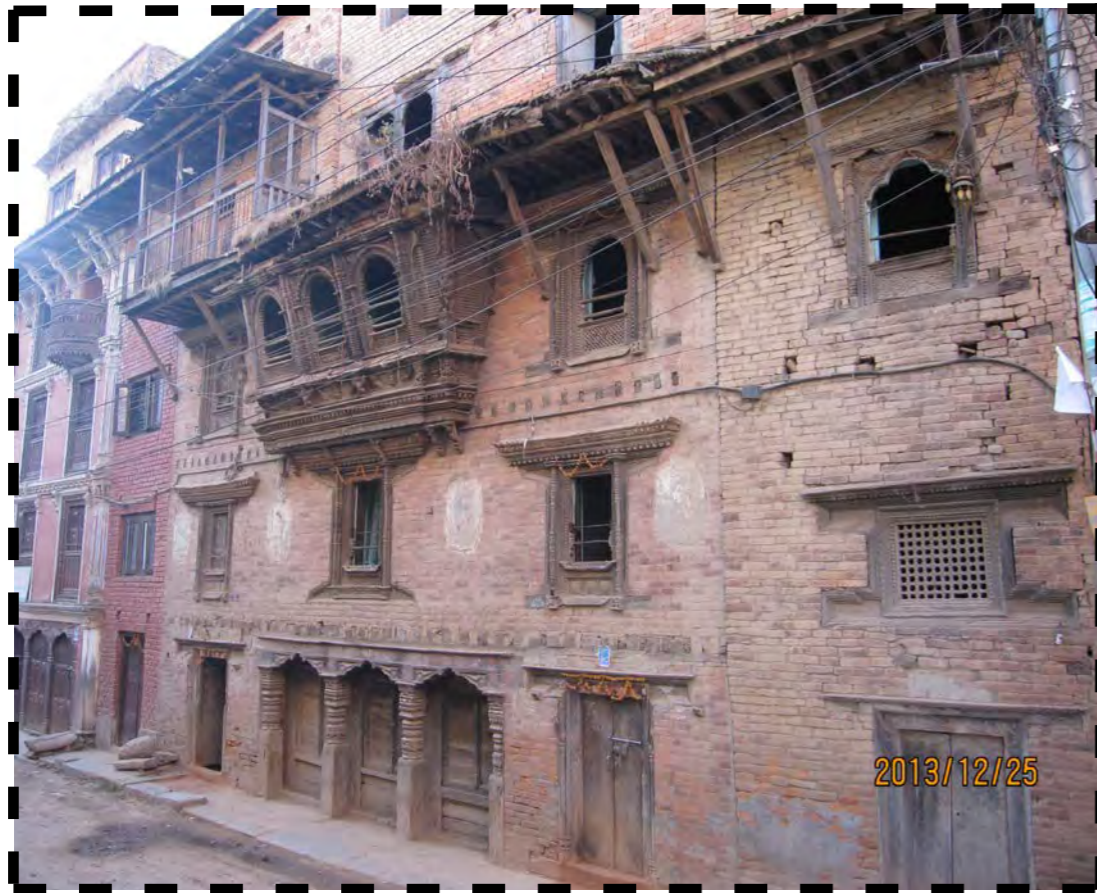
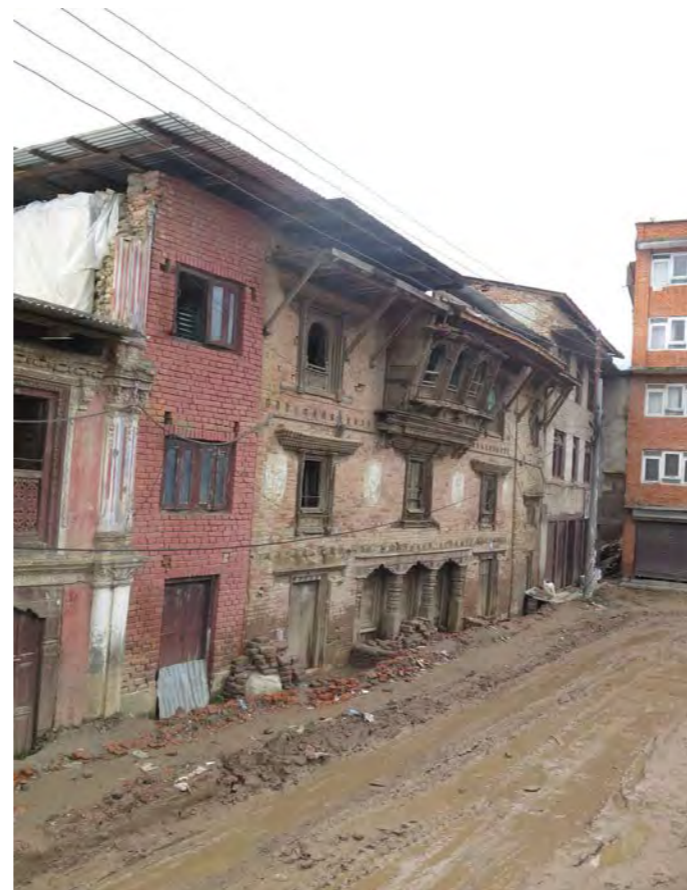
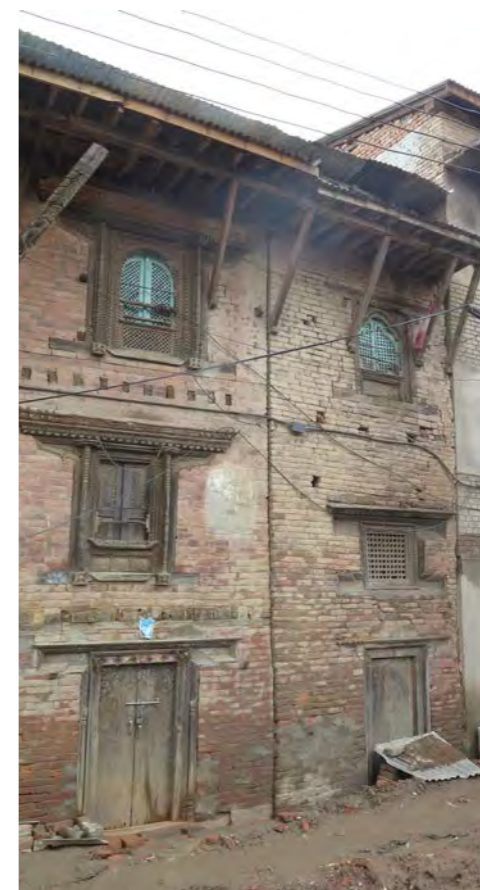
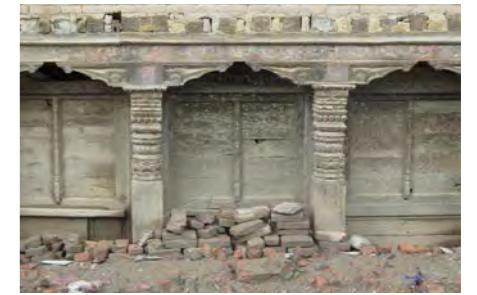
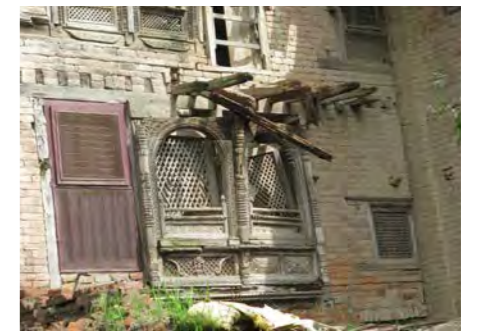
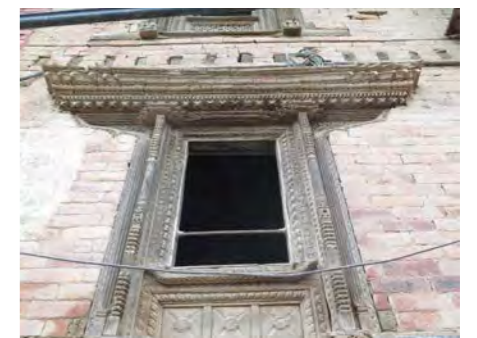
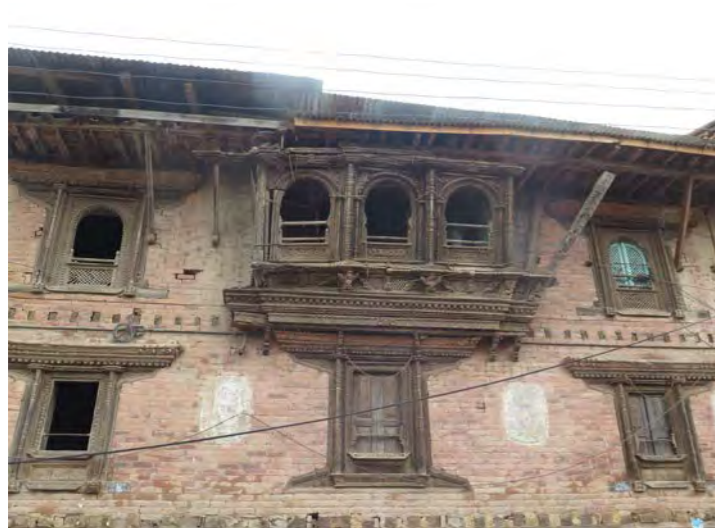
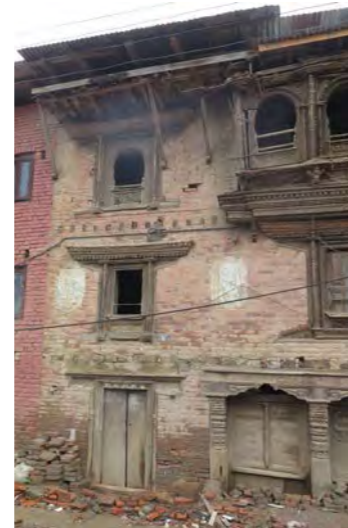
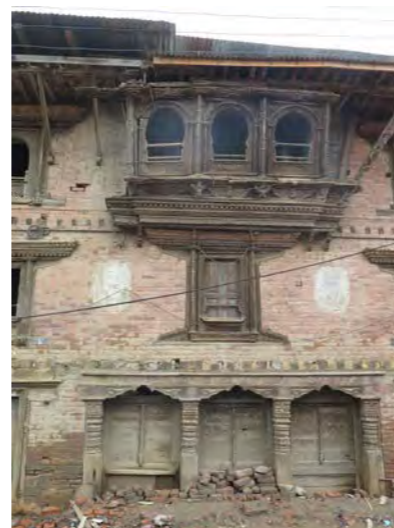
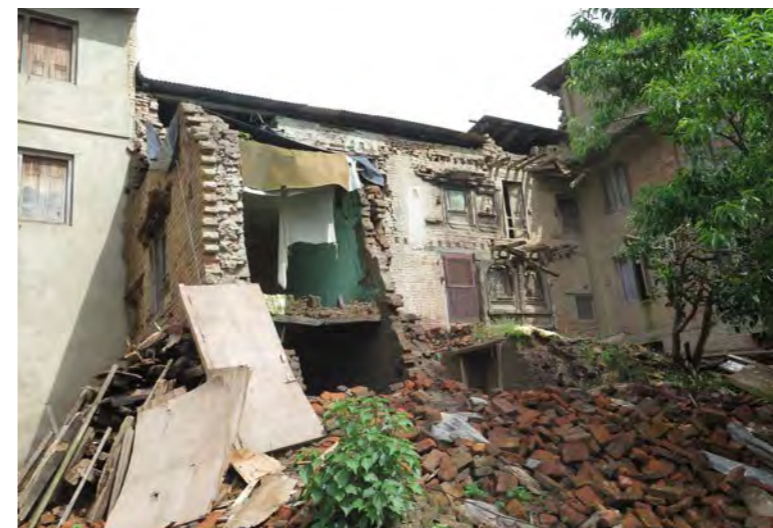
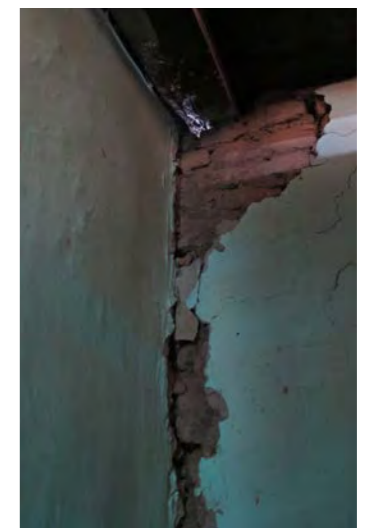
i71, i72, i73

NUMBER	CONTACT	STOREY NO. RELATIVE POSITION	STRUCTURAL SYSTEM	PROBLEMS DESCRIPTION	DANGER	CONDITION	
i71	Laxman Bahadur Shrestha, Rabin Bahadur Shrestha	G+4	B	Major cracks all over	⚠	W ++	
i72/i73	Sangeeta Shrestha (9841343176)	G+4	B	Diagonal cracks all over. Windows in delected condition/ 1 floor collapsed. West part collapsed.	⚠	W ++

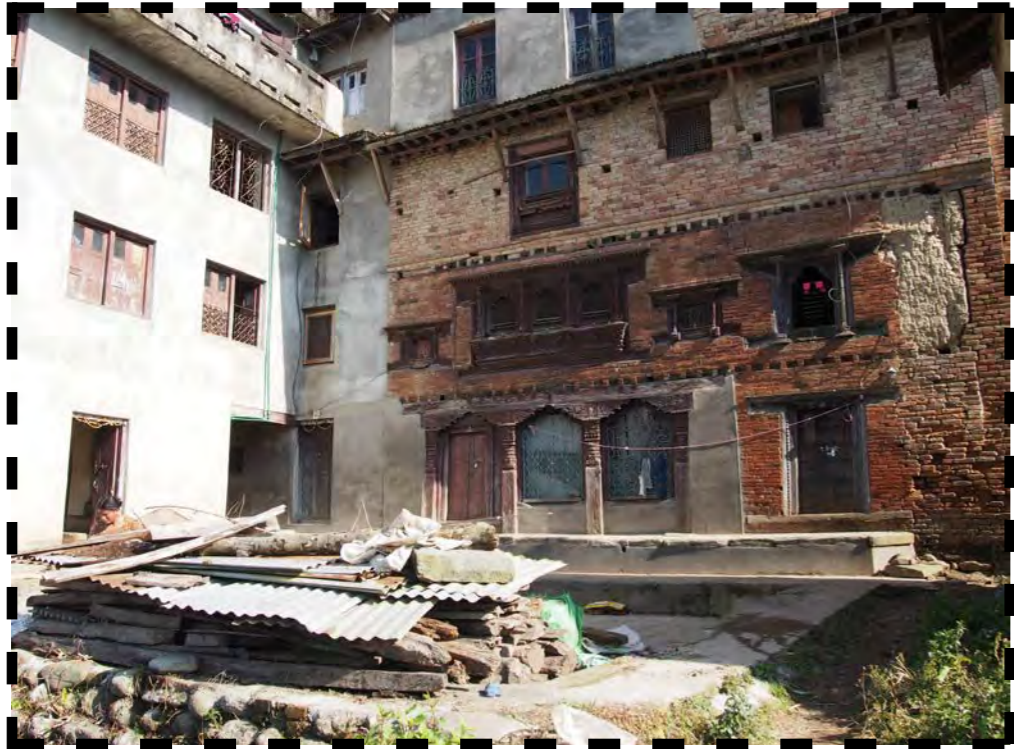
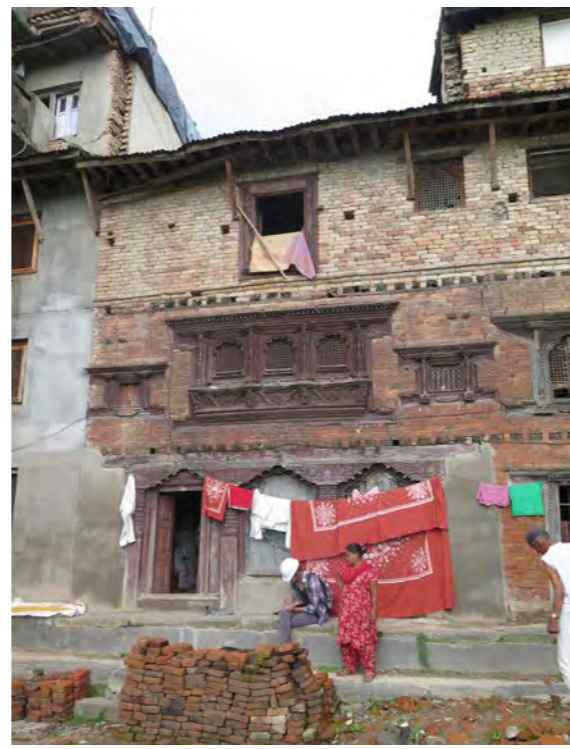
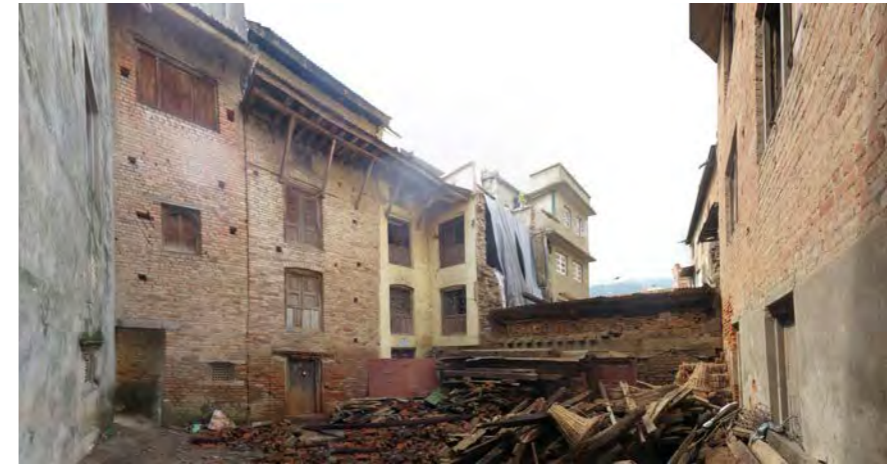
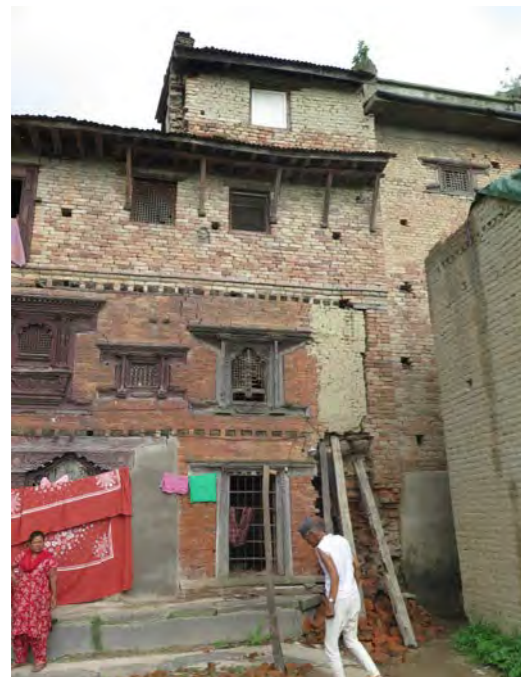
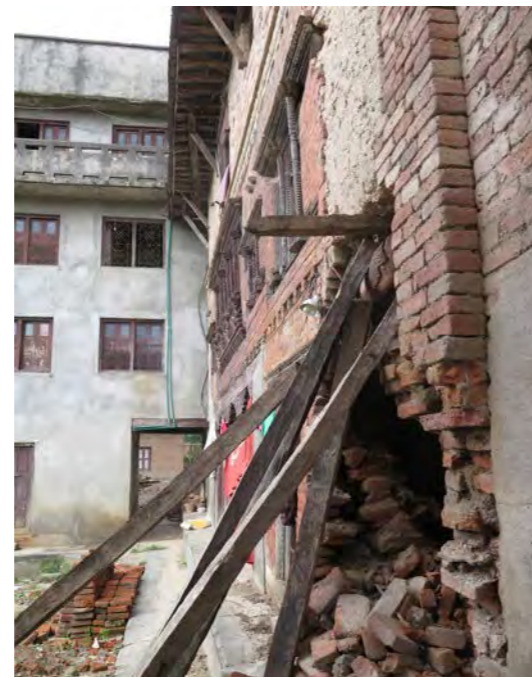
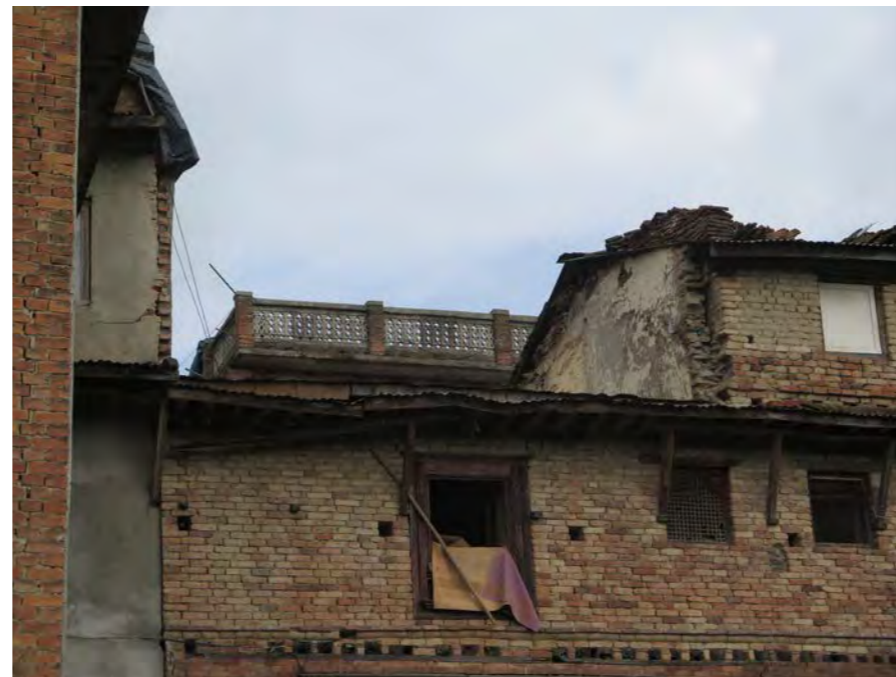
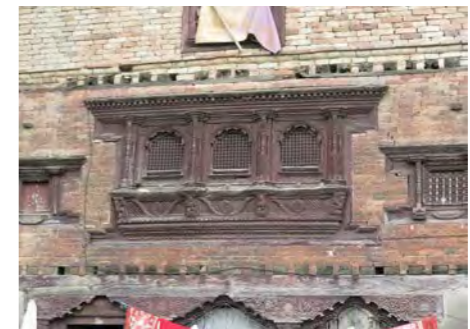
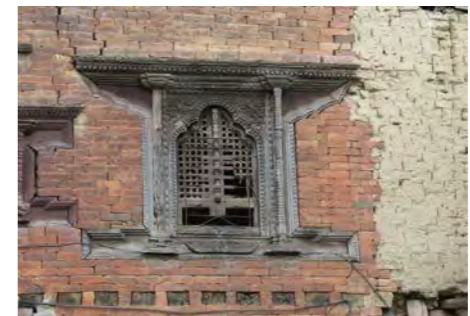
i79, i80

NUMBER	CONTACT	STOREY NO. RELATIVE POSITION	STRUCTURAL SYSTEM	PROBLEMS DESCRIPTION	DANGER	CONDITION
i79	Madhav Narayan Shrestha	G+3	B	South west end collapsed. West wall has idol carved in stone.		++
i80	Narayan Das Shrestha	G+3	B	1 floor collapsed. East part collapsed.		++

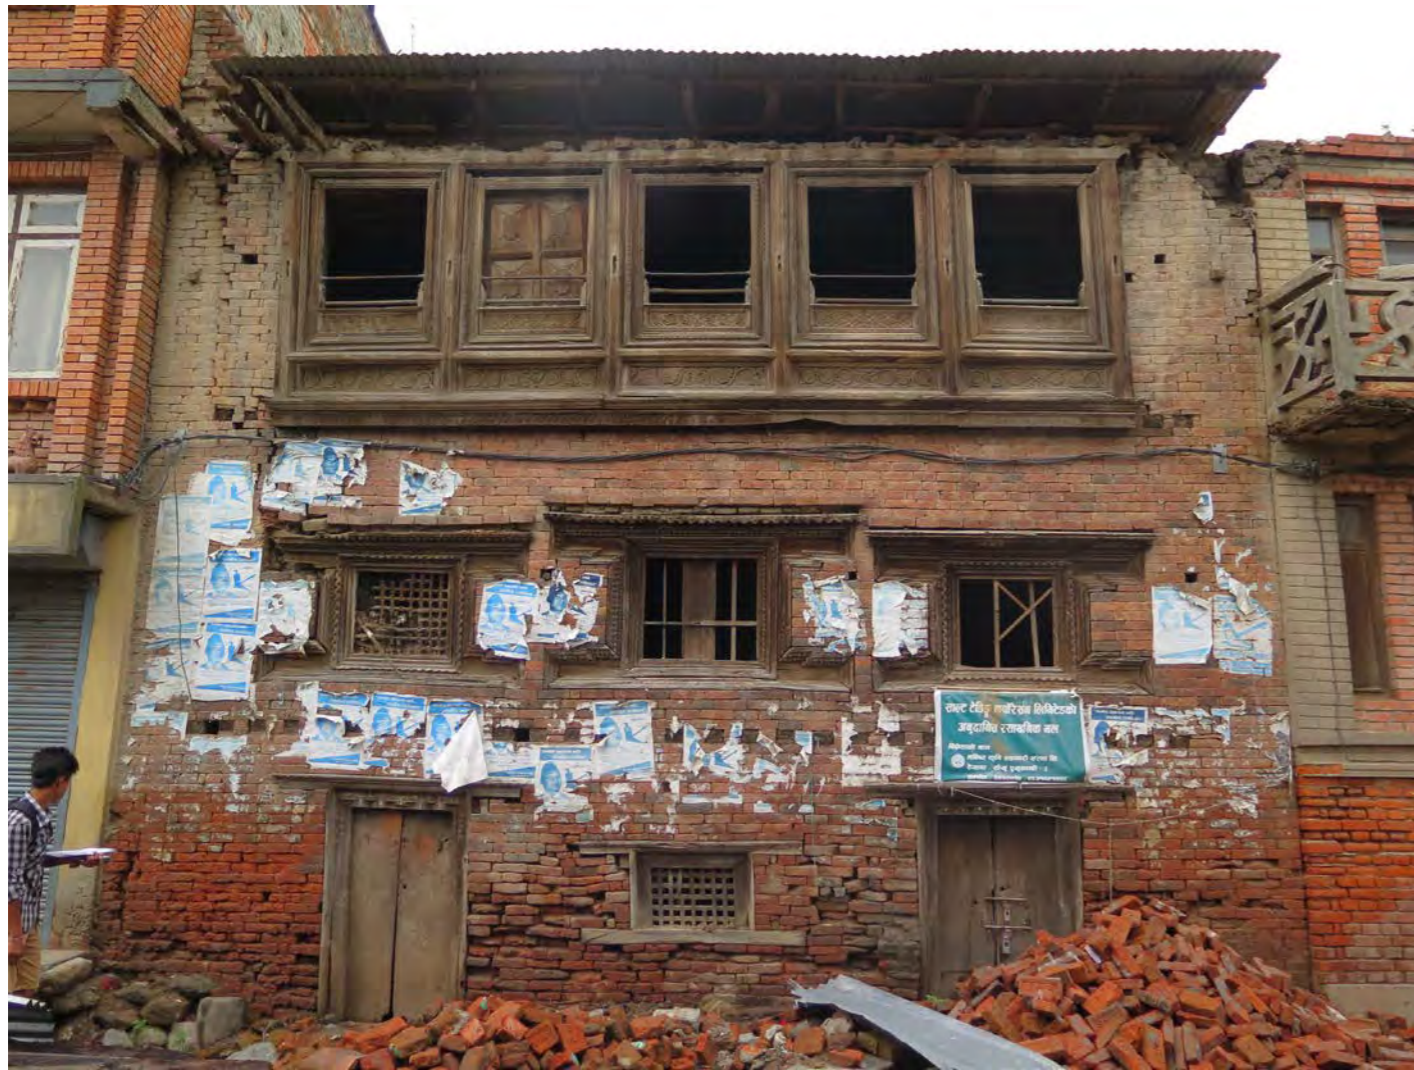
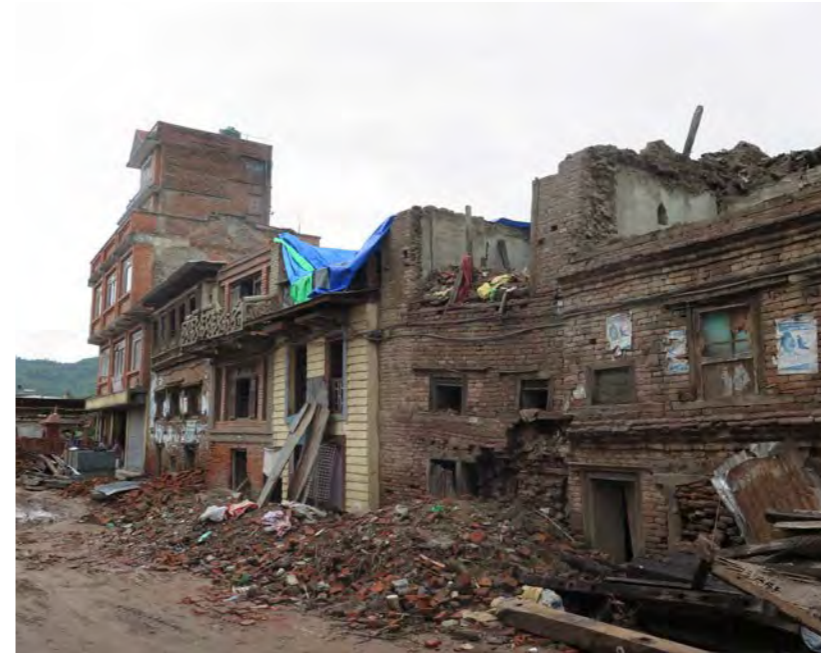
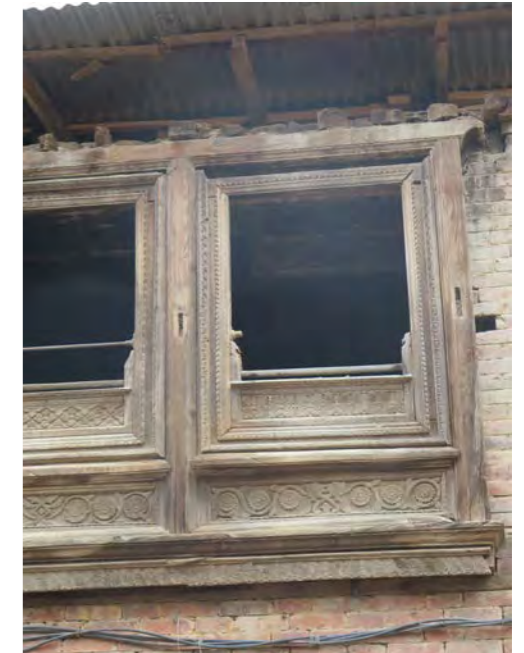
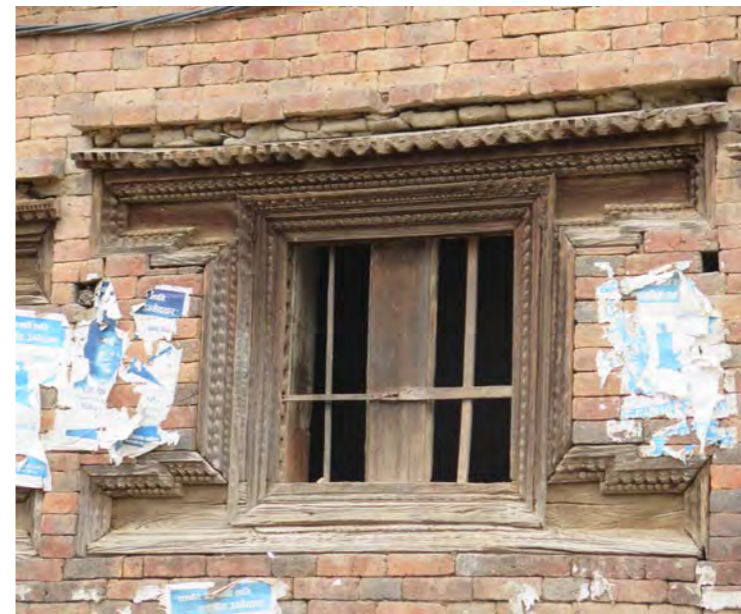
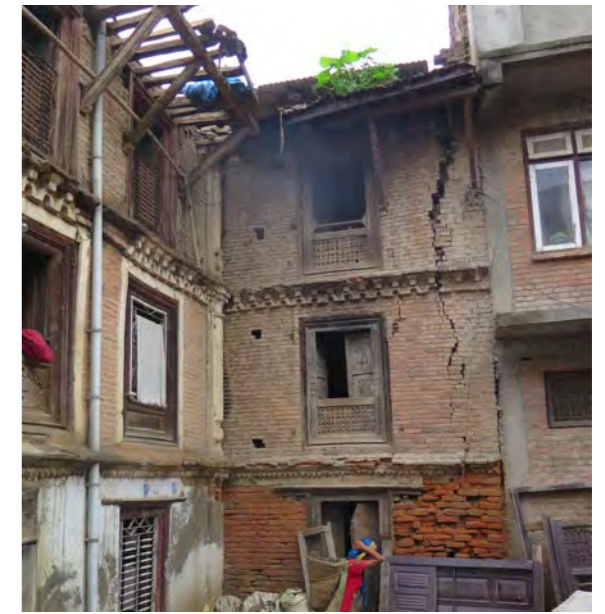
NUMBER	CONTACT	STOREY NO. RELATIVE POSITION	STRUCTURAL SYSTEM	PROBLEMS DESCRIPTION	DANGER	CONDITION	
i99	Madhav Narayan Shrestha	G+3	B	1 floor demolished. East wall rising damp and tilting. Vertical crack on south east and south west corner >15cm	1/2 ☒	++

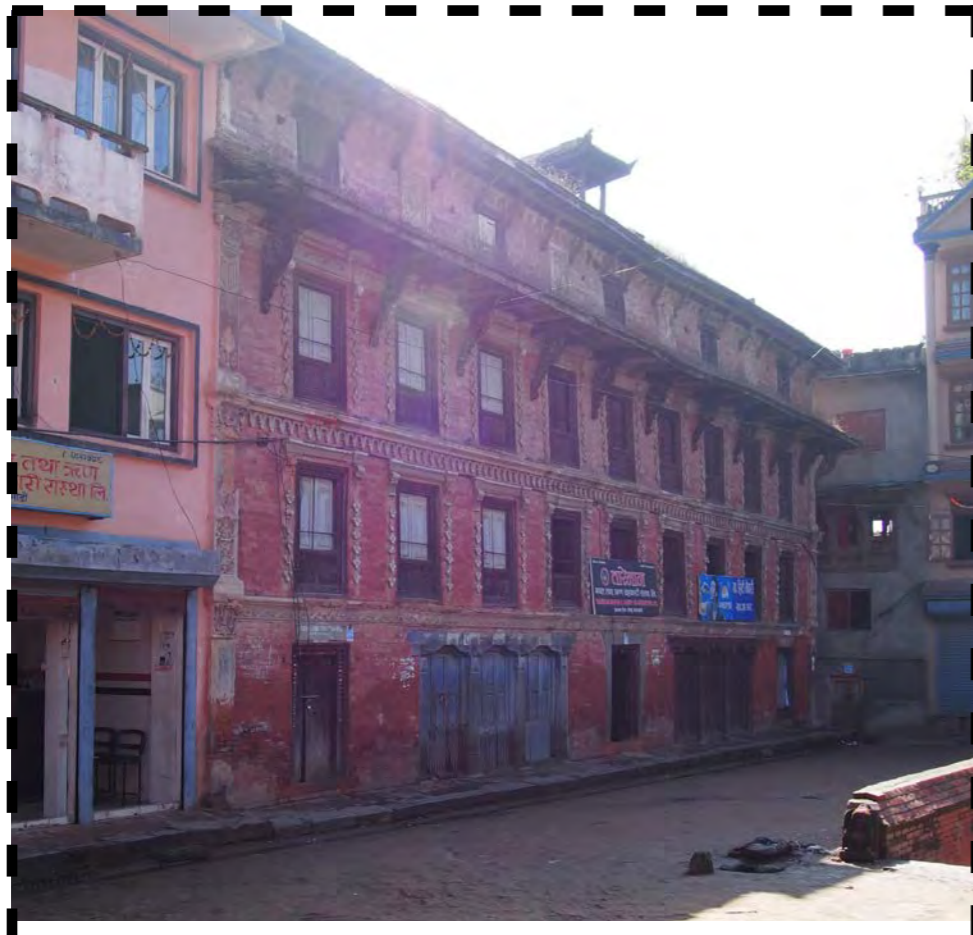
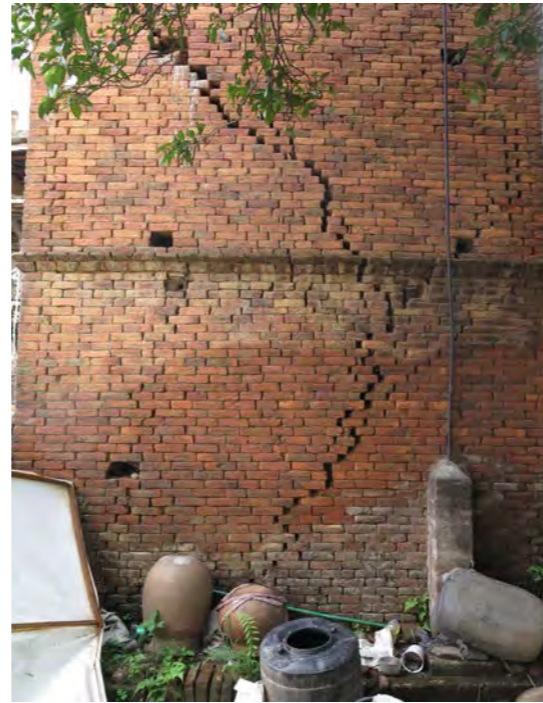
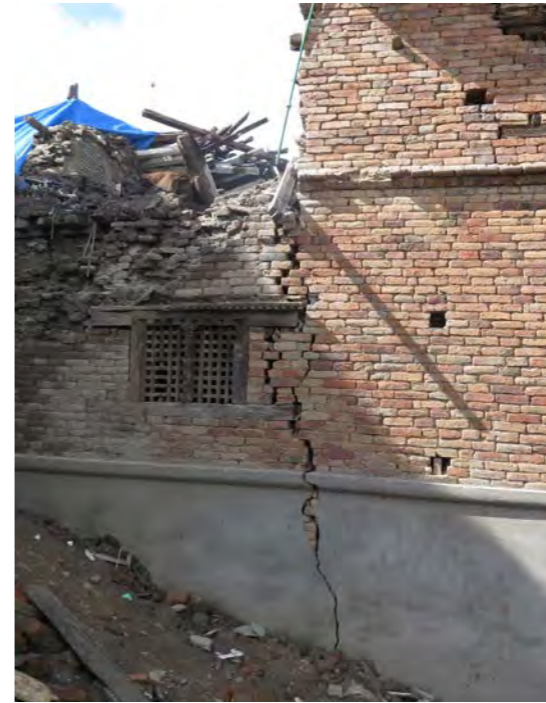
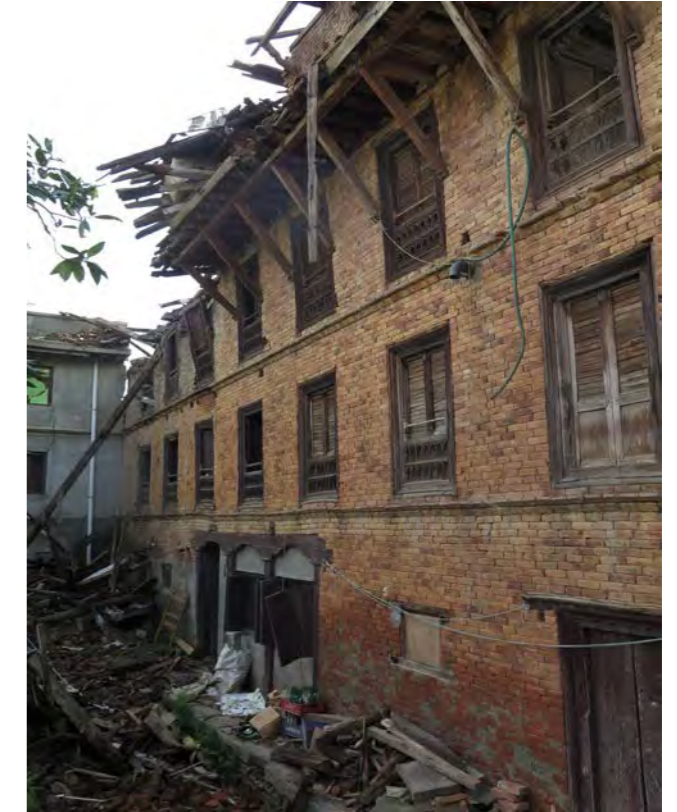
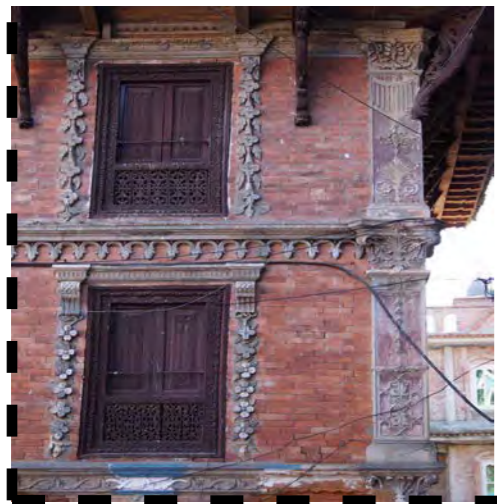
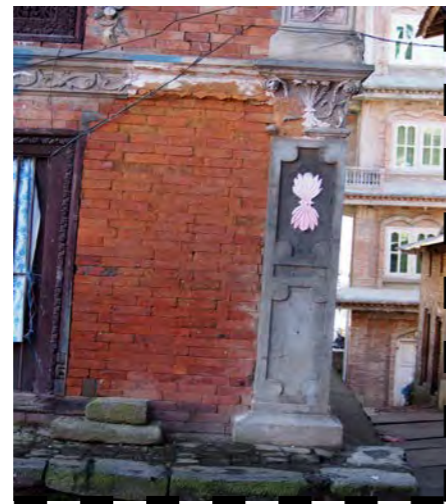
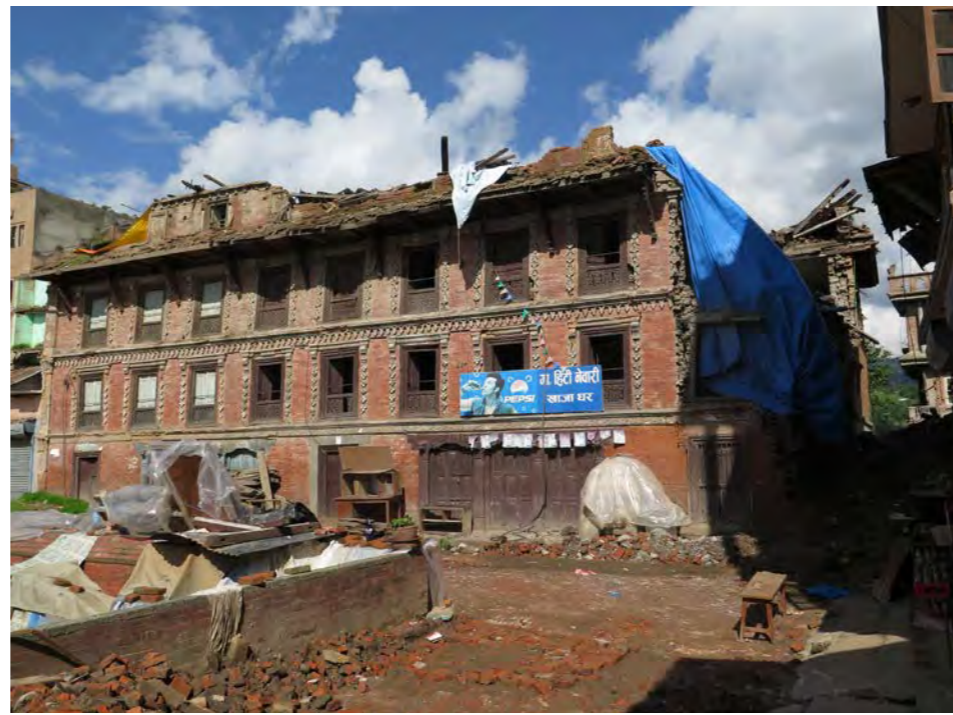
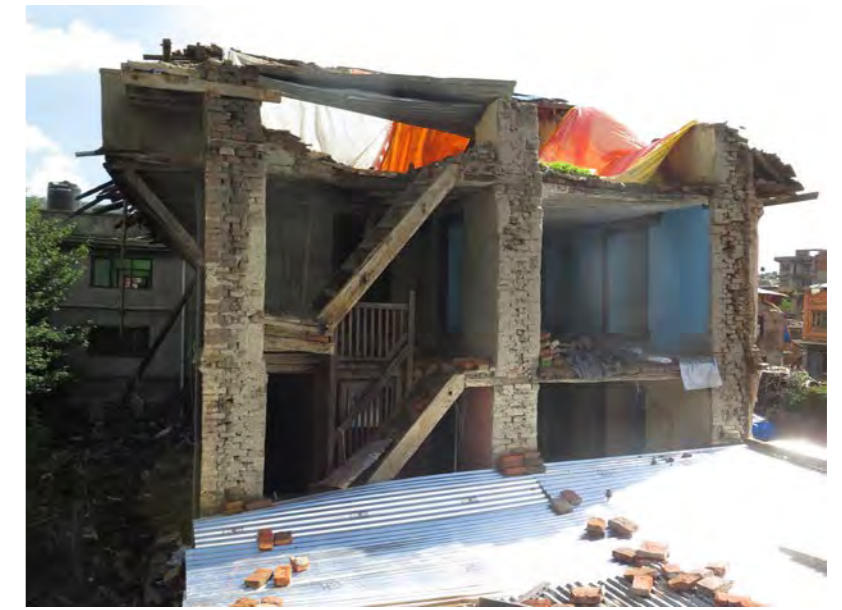
NUMBER	CONTACT	STOREY NO. RELATIVE POSITION	STRUCTURAL SYSTEM	PROBLEMS DESCRIPTION	DANGER	CONDITION	
j02	Bidya Pikha Shrestha	G+4	B	2 floors collapsed. South part totally collapsed till ground floor.	⚠️ 1/2 ❌	++
