2015 Earthquake Damage Mapping

Sankhu

October 2015

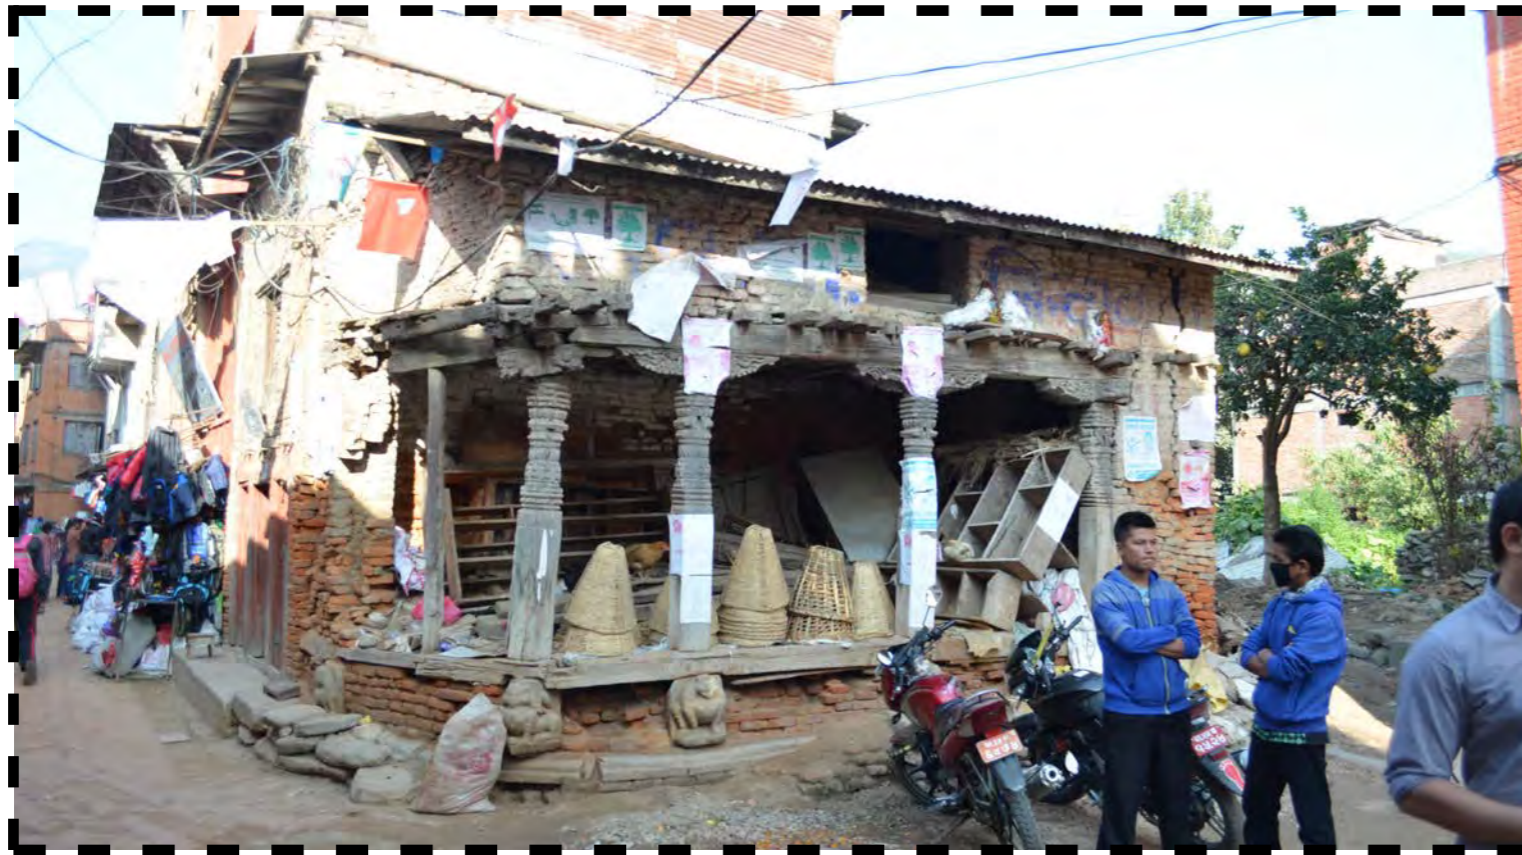
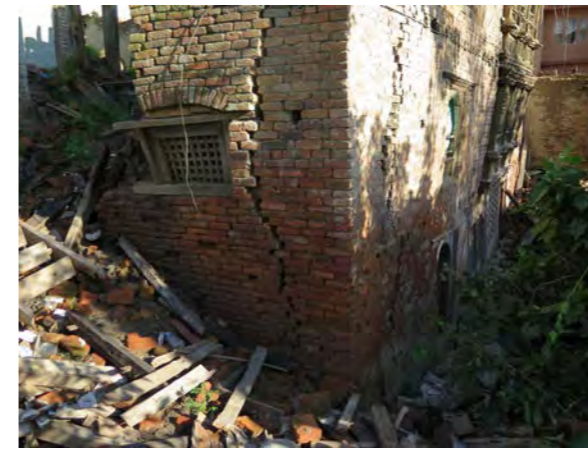
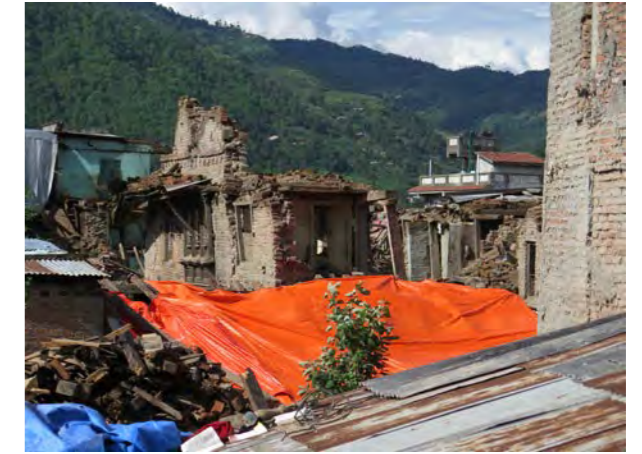
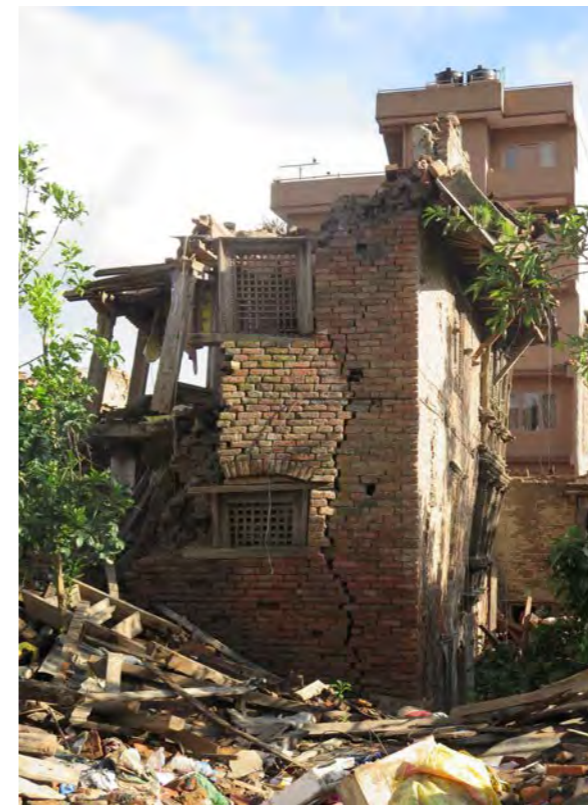
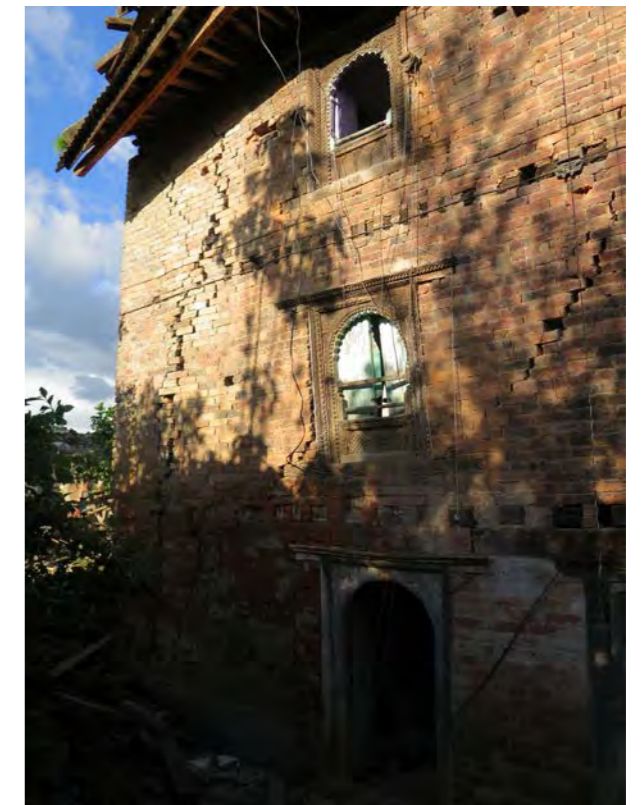
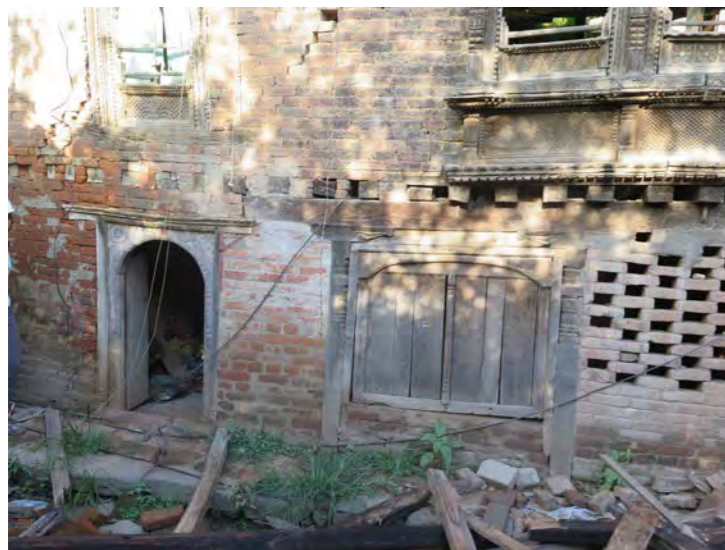
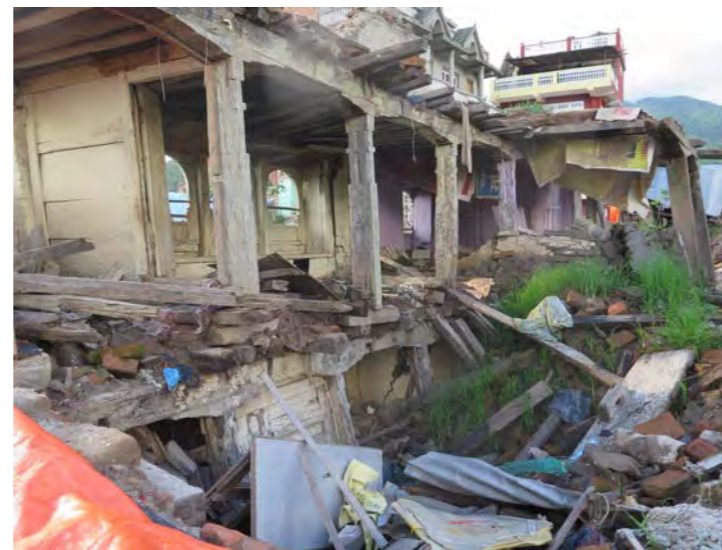
j15, j17

NUMBER	CONTACT	STOREY NO. RELATIVE POSITION	STRUCTURAL SYSTEM	PROBLEMS DESCRIPTION	DANGER	CONDITION
j15	Hari Banta Lal Shrestha	G+4	B	West wall going to fall. Vertical crack on north east corner. Covered by rubbles		W ++
j17	Nanu Shrestha	G+2 (CH)	B	Bricks of south wall falling		RW ++

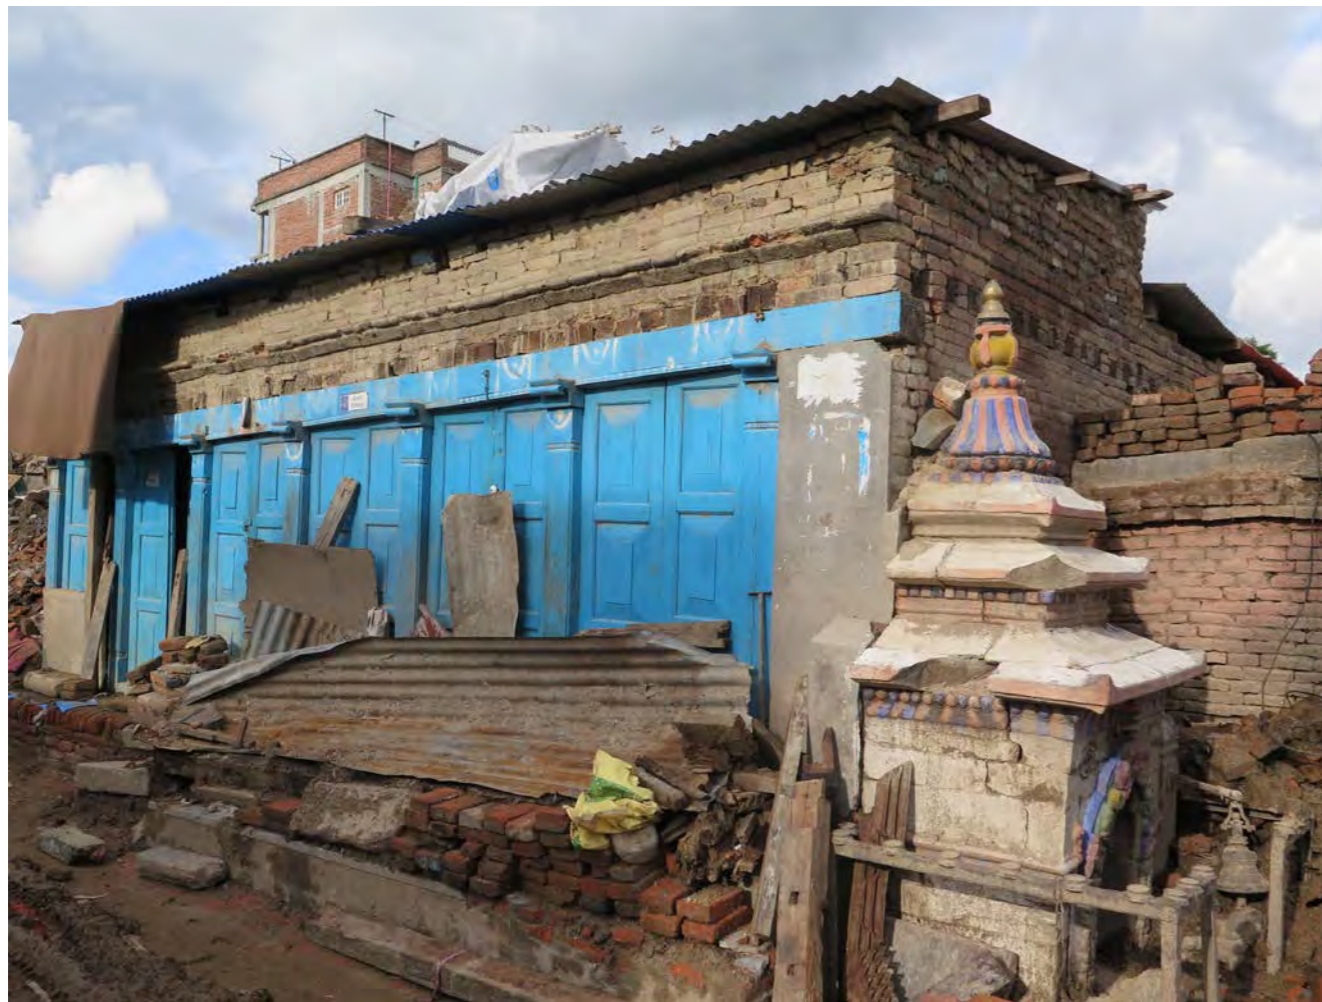
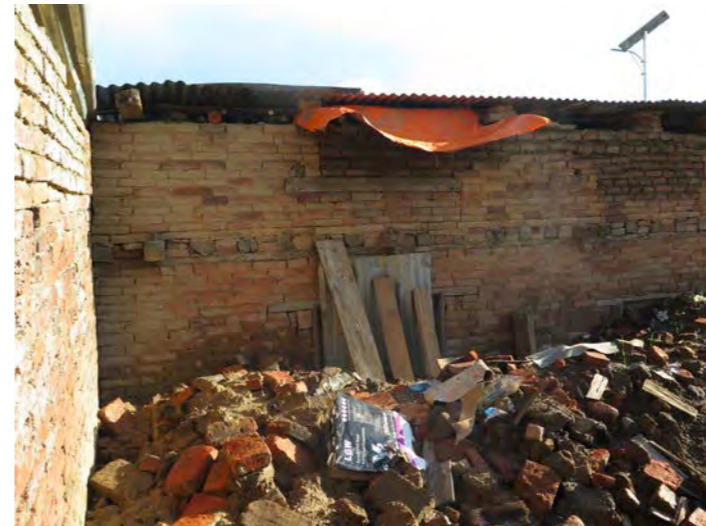
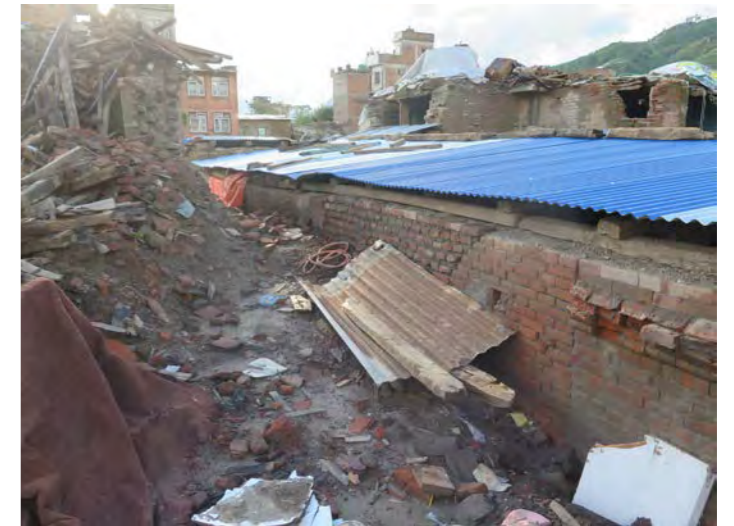
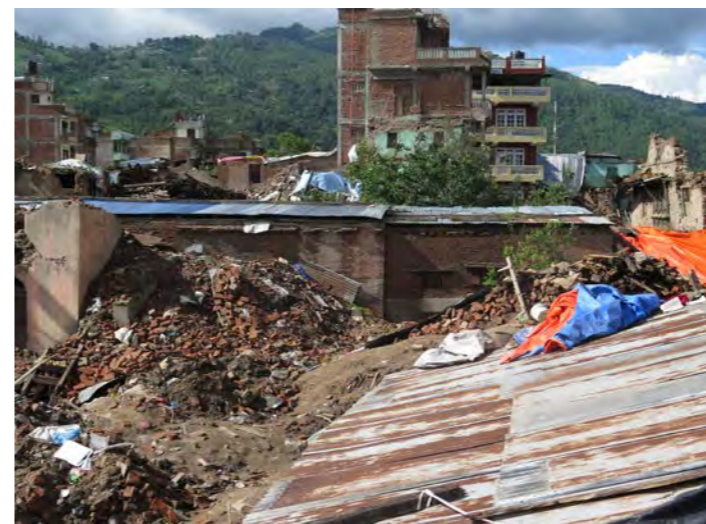
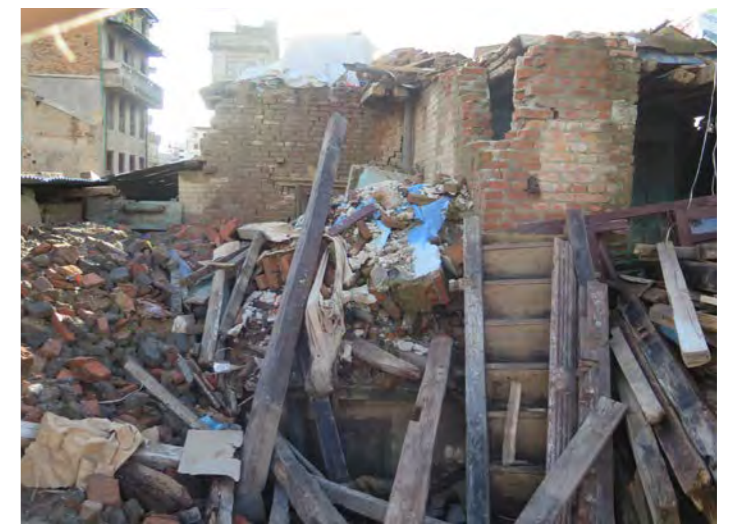
NUMBER	CONTACT	STOREY NO. RELATIVE POSITION	STRUCTURAL SYSTEM	PROBLEMS DESCRIPTION	DANGER	CONDITION
j21	Bihar Lal Bashi	G+4	B	3 floors collapsed		Biggest Ga Jhya ++

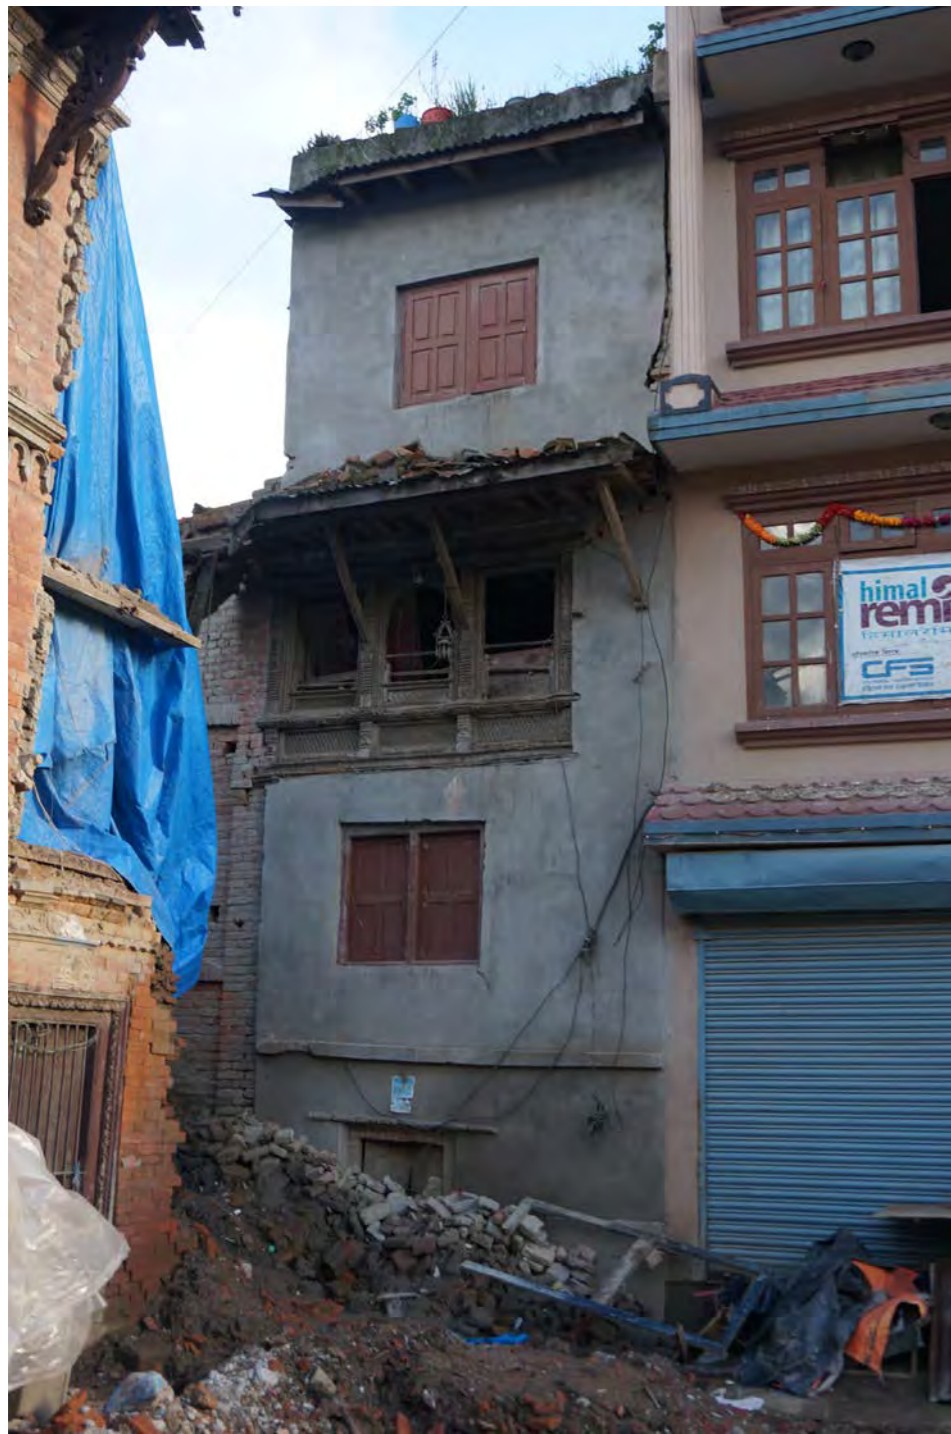
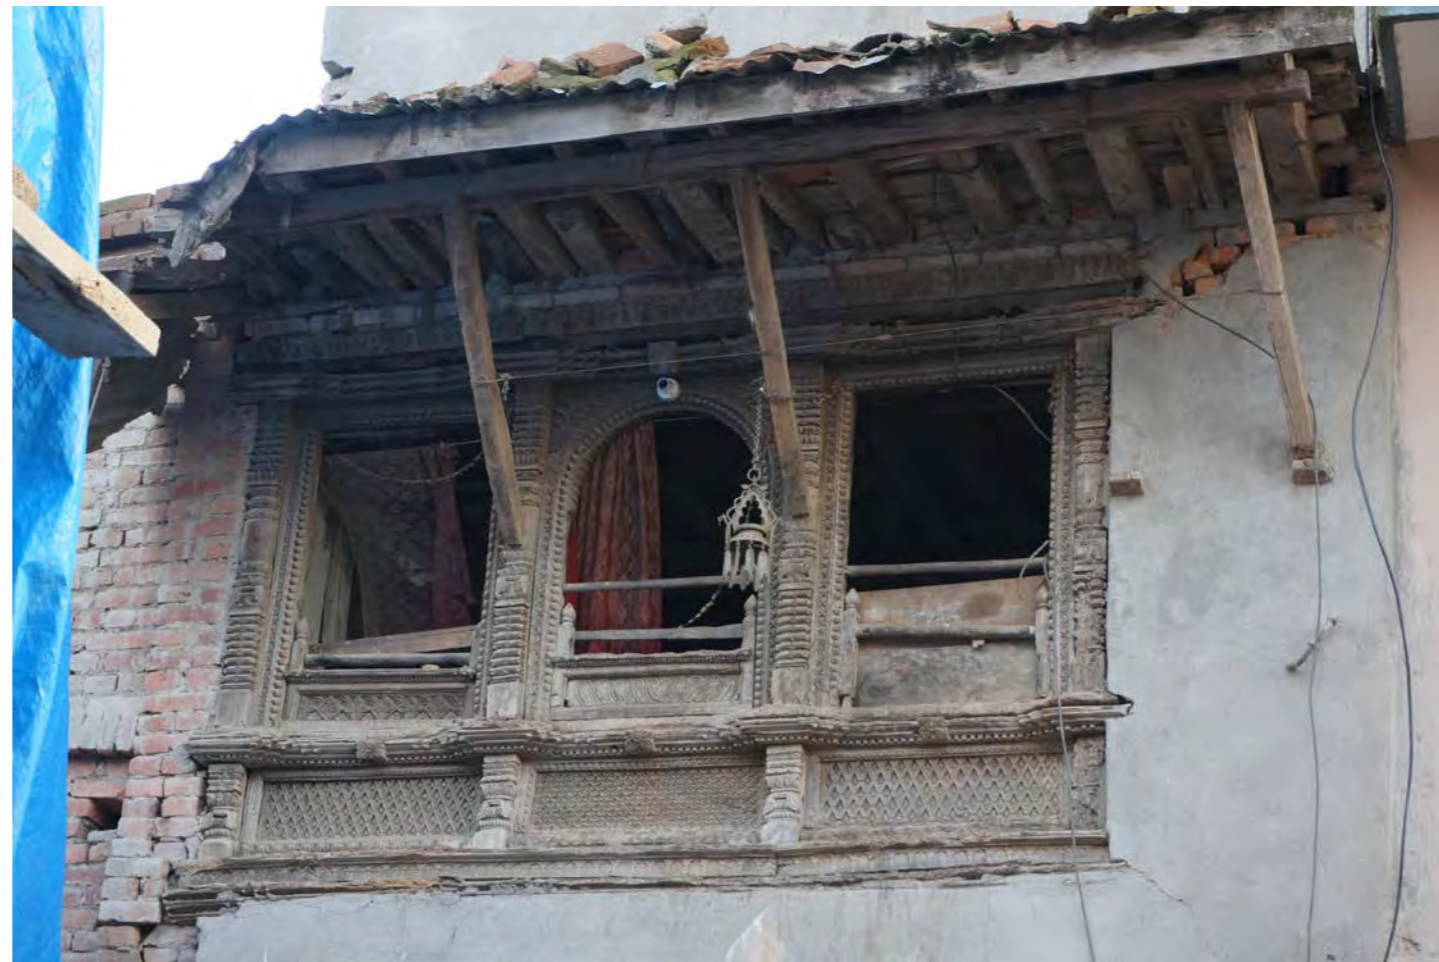
NUMBER	CONTACT	STOREY NO. RELATIVE POSITION	STRUCTURAL SYSTEM	PROBLEMS DESCRIPTION	DANGER	CONDITION
k86	Rajit Singh	G+3	B	“W-façade on top level demolished Walls tilting on all sides”		W++

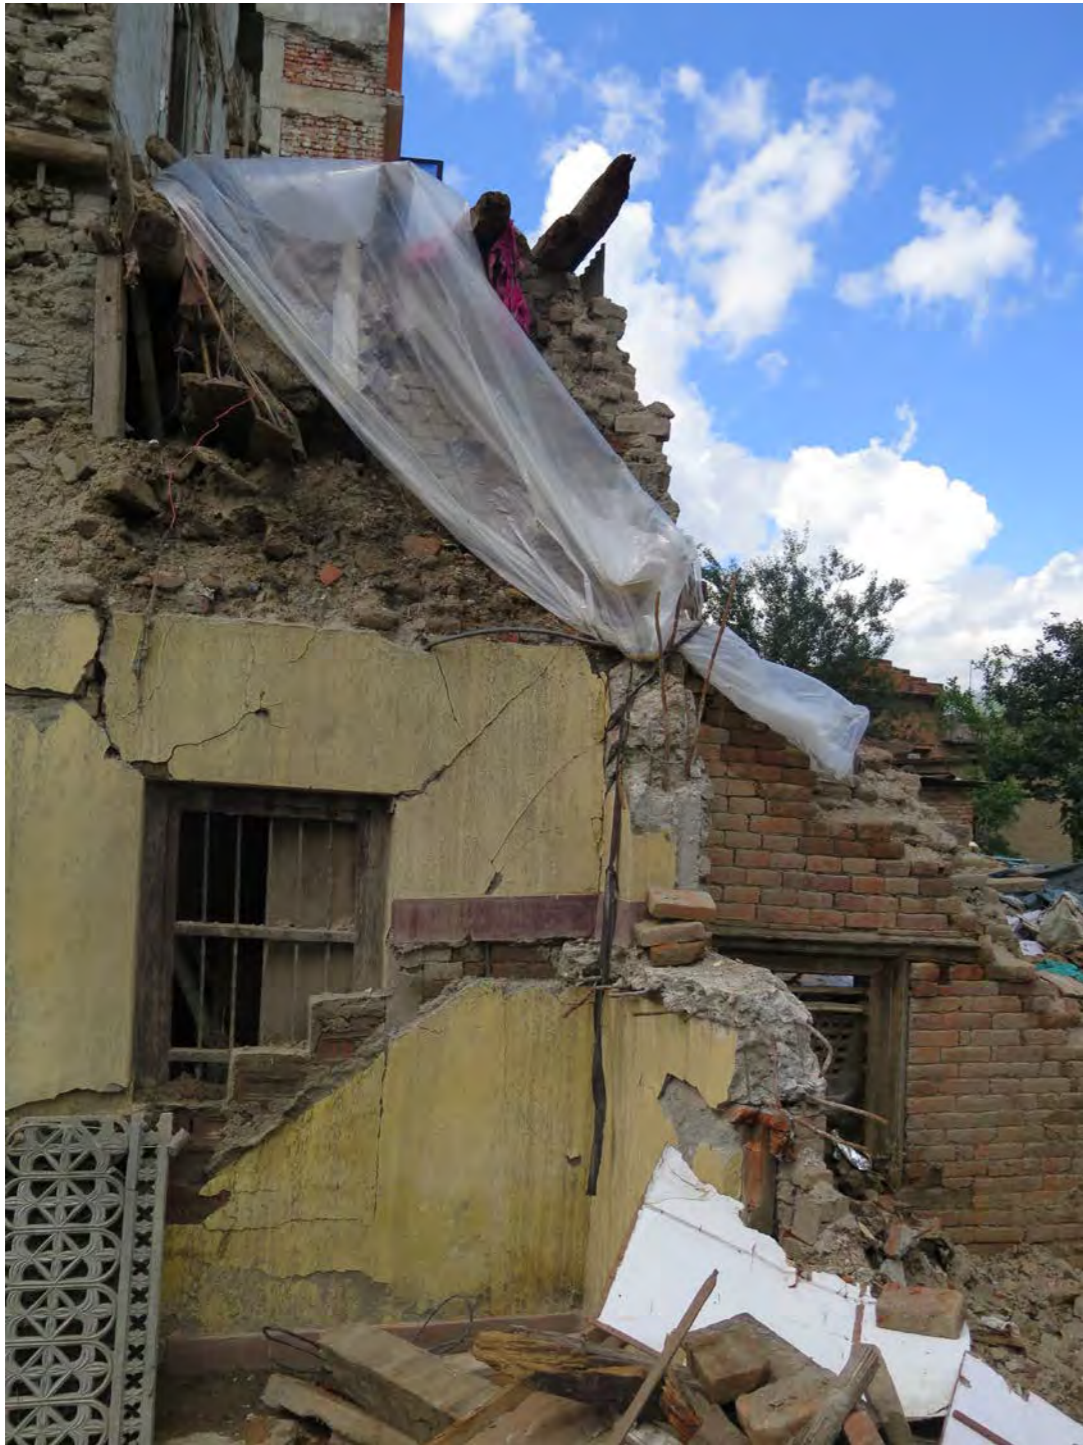
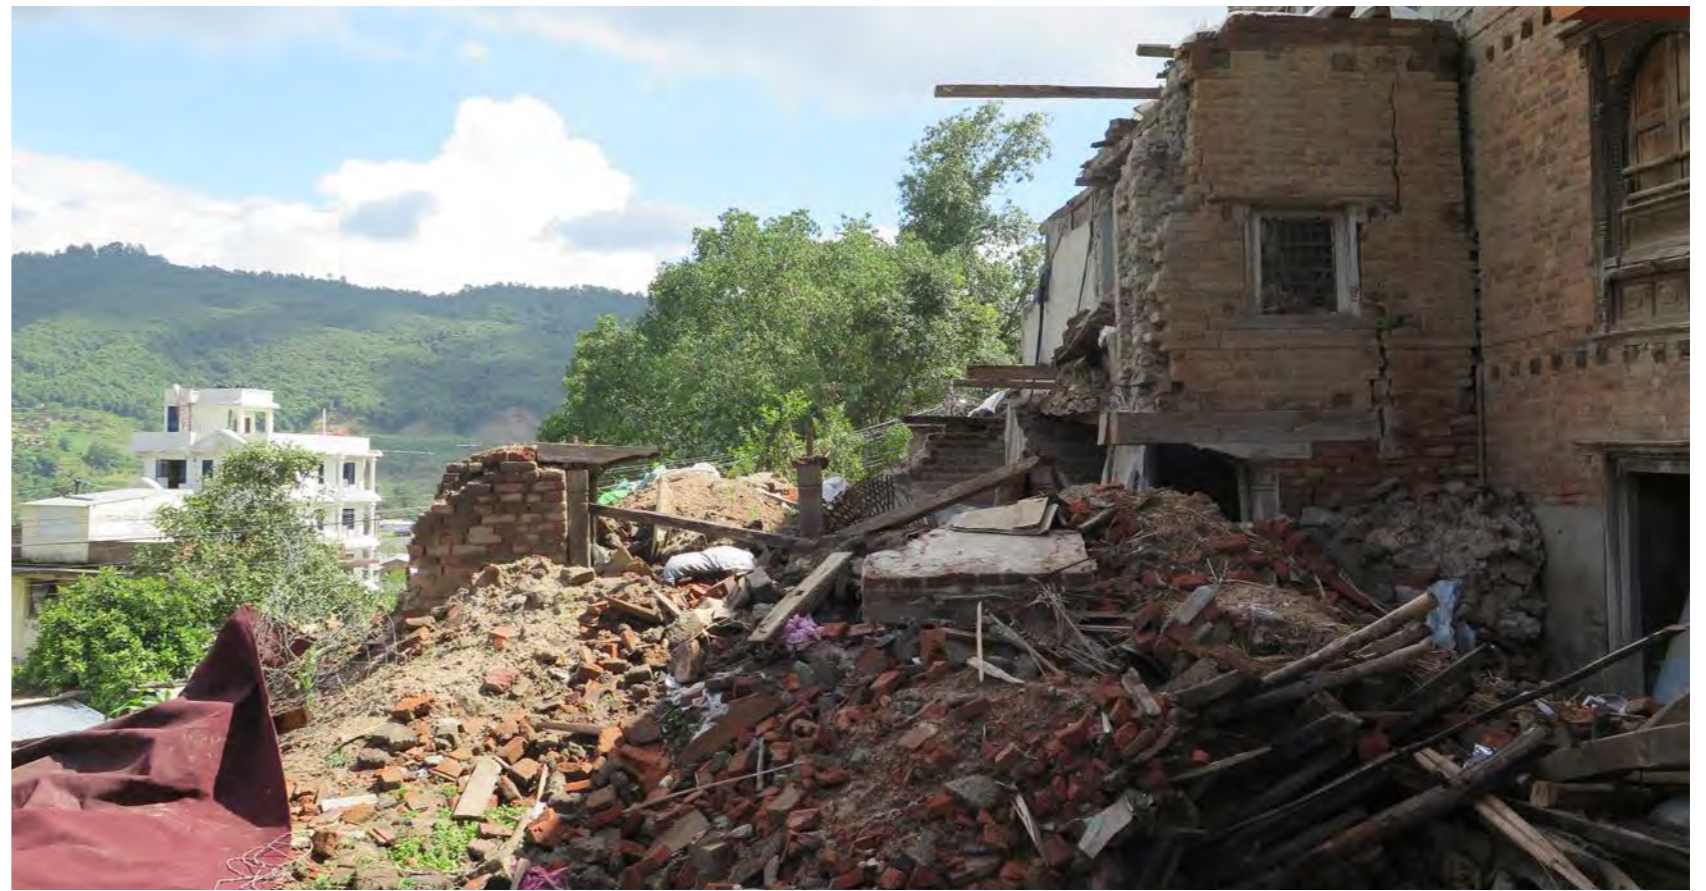
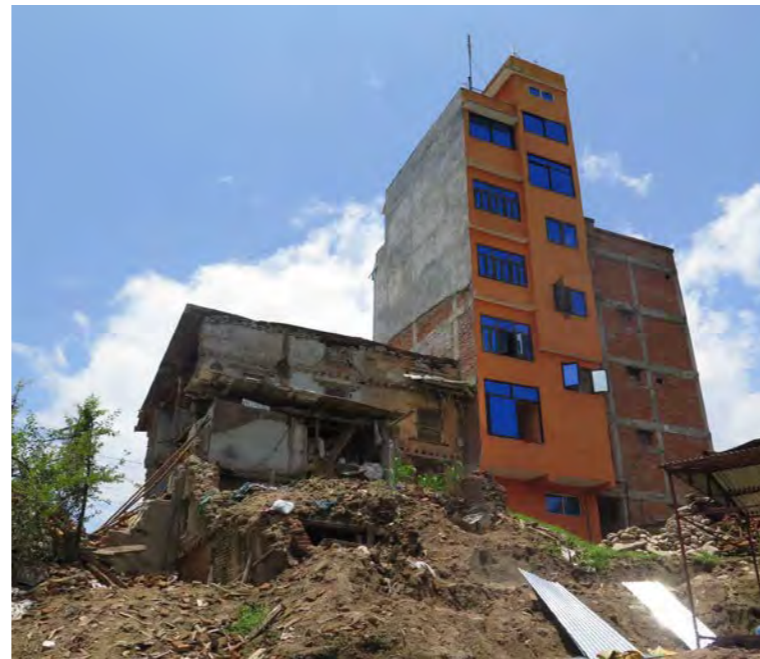
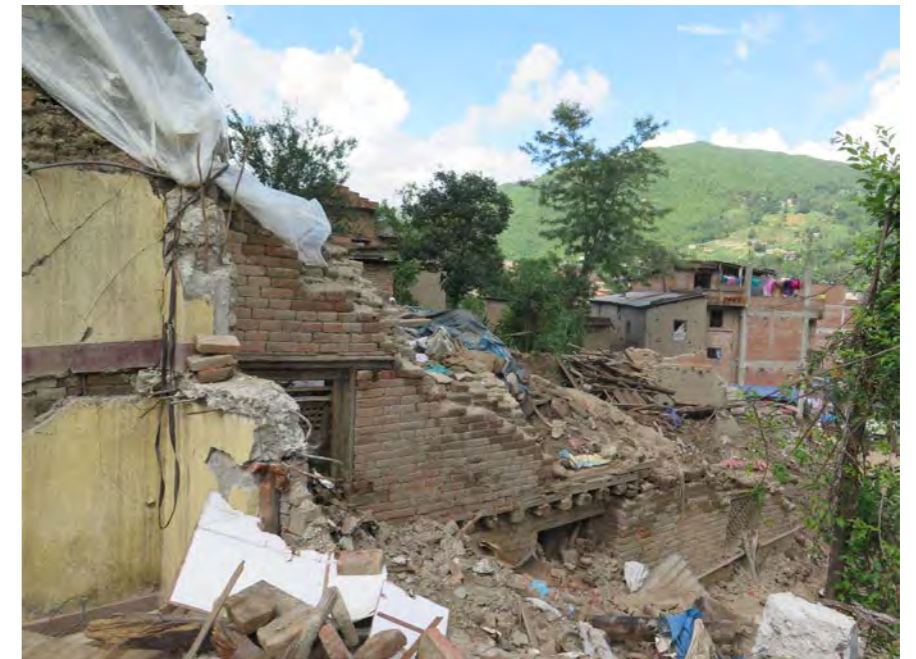
NUMBER	NAME	ESTABLISHED DATE (A.D.)	TYPOLOGY	GENERAL DESCRIPTION	PROBLEMS DESCRIPTION	DANGER/ DESTROY
103	Narendra Raj Shrestha (9860014492)	G+3	B+UnB	Southern side collapsed	⚠️ 1/3 ☒	R ++

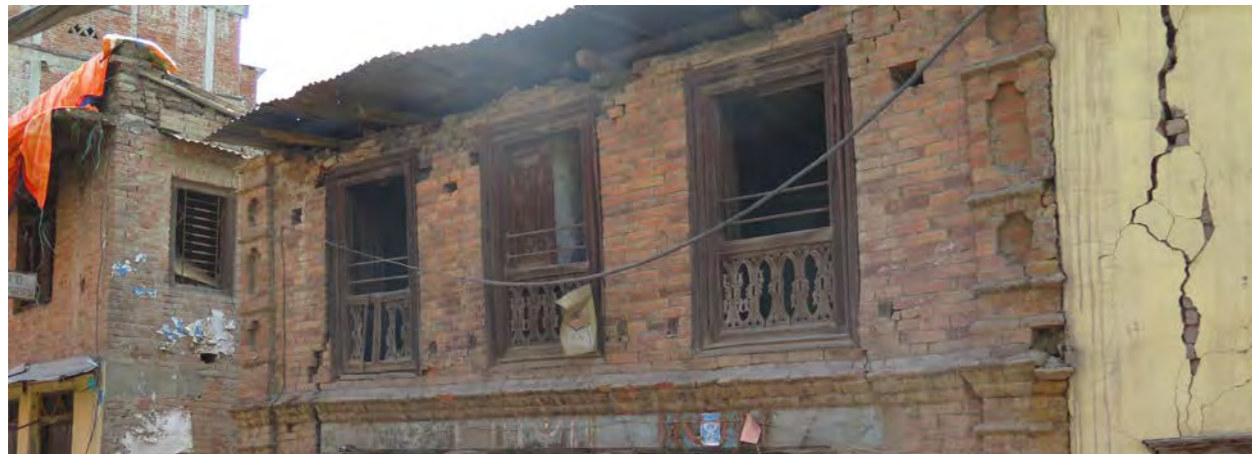
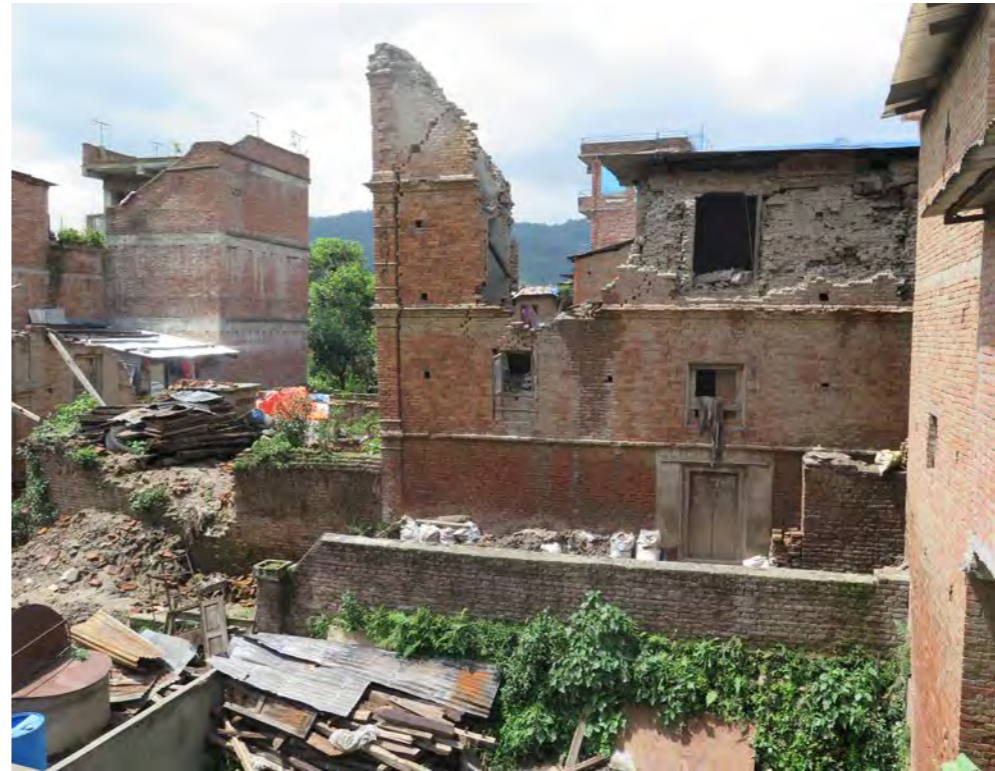
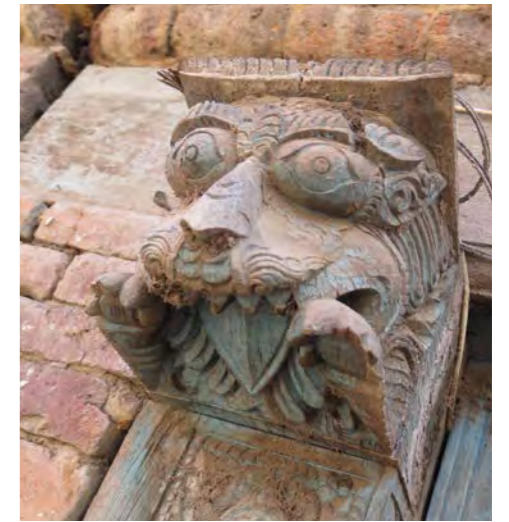
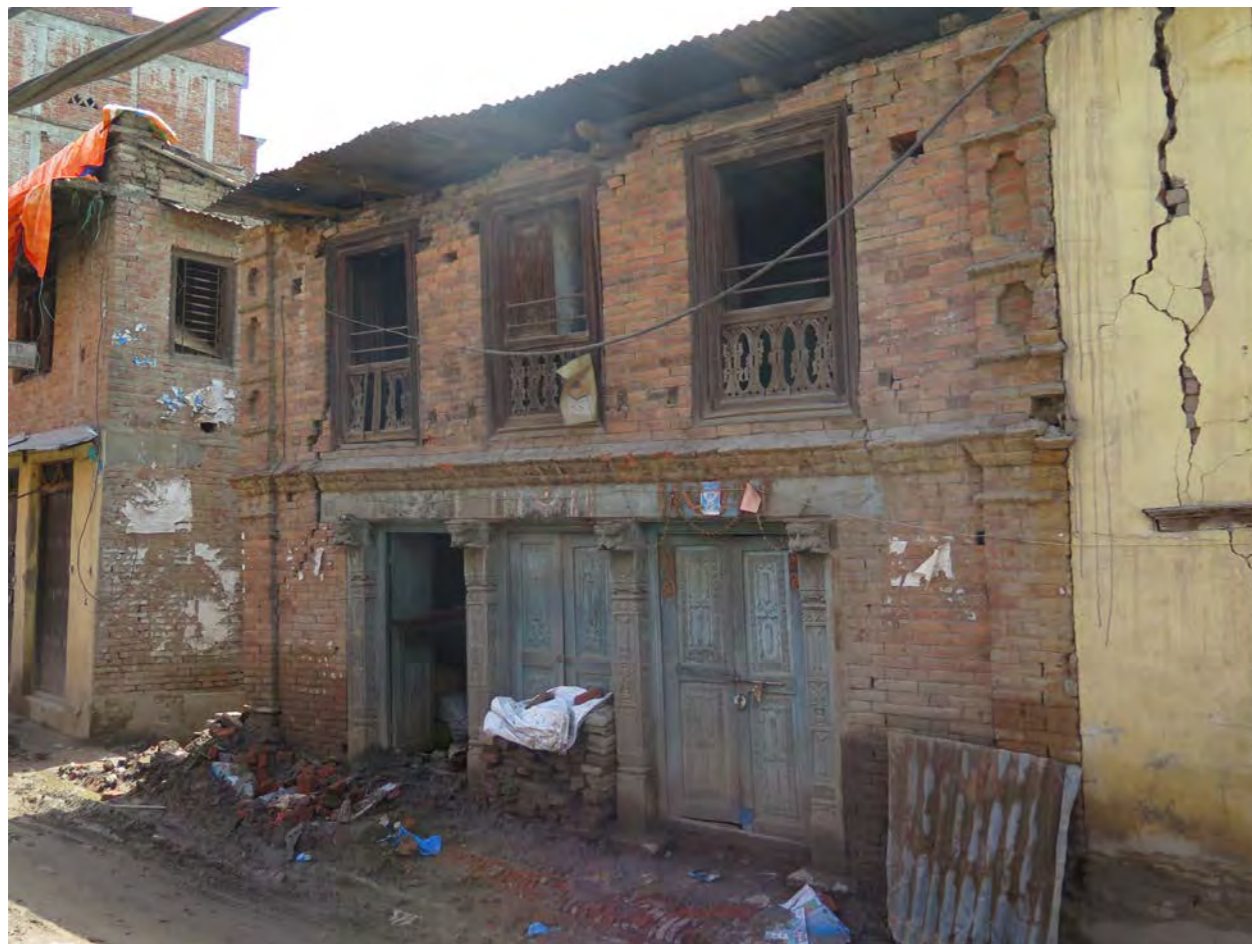
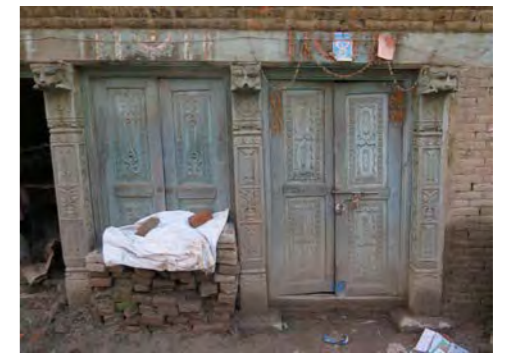
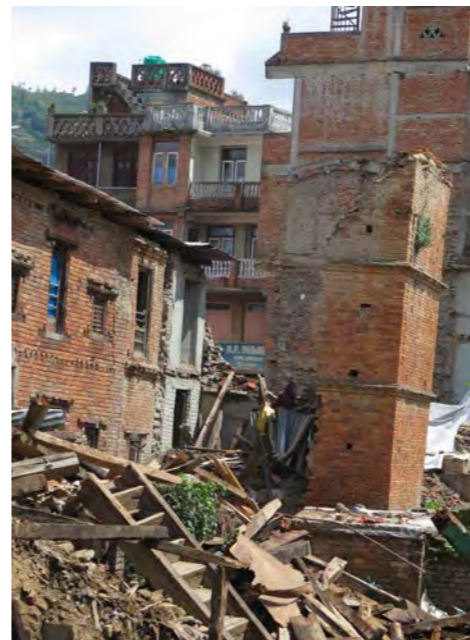
NUMBER	NAME	DATE A.D.	TYOLOGY	GENERAL DESCRIPTION	PROBLEMS DESCRIPTION	DANGER/ DESTROY
127	Jagana Devi Rajbhandari (9841693577)	G+3.6	B	Collapsed upto first floor. Northern wall totally collapsed. Rising damp on North wall, eastern wall going to fall.		W ++

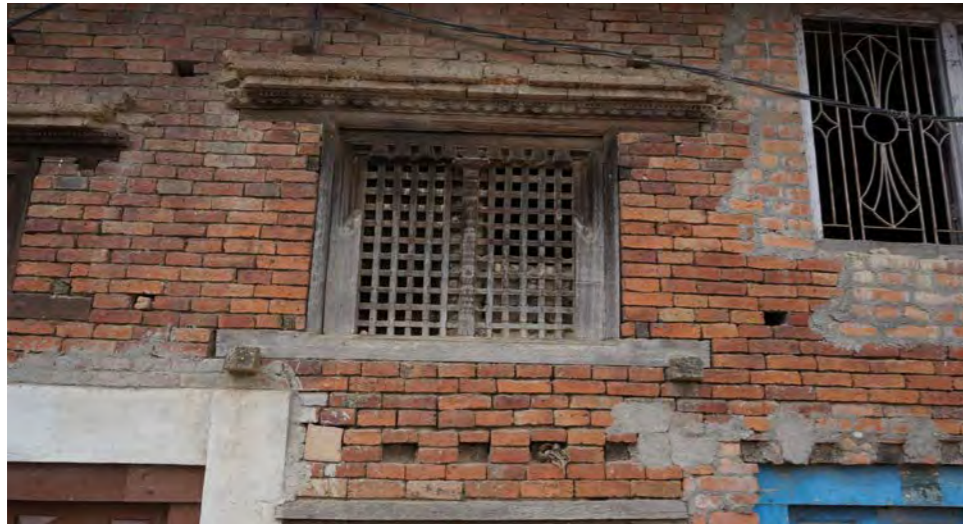
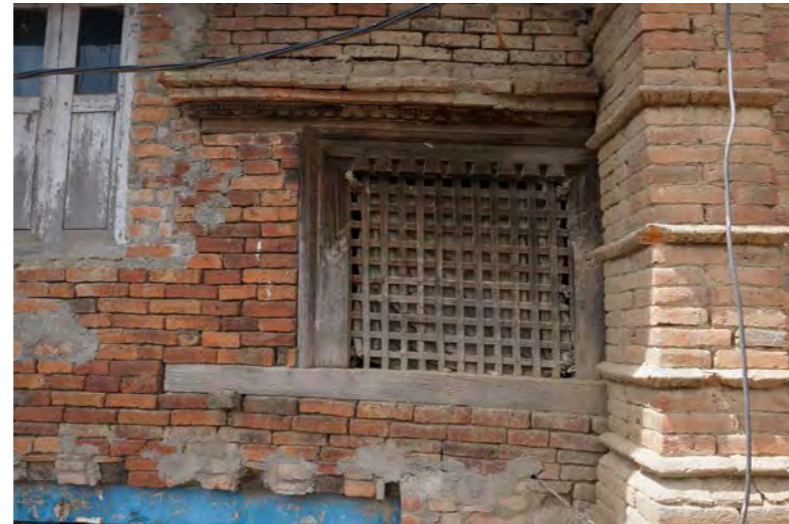
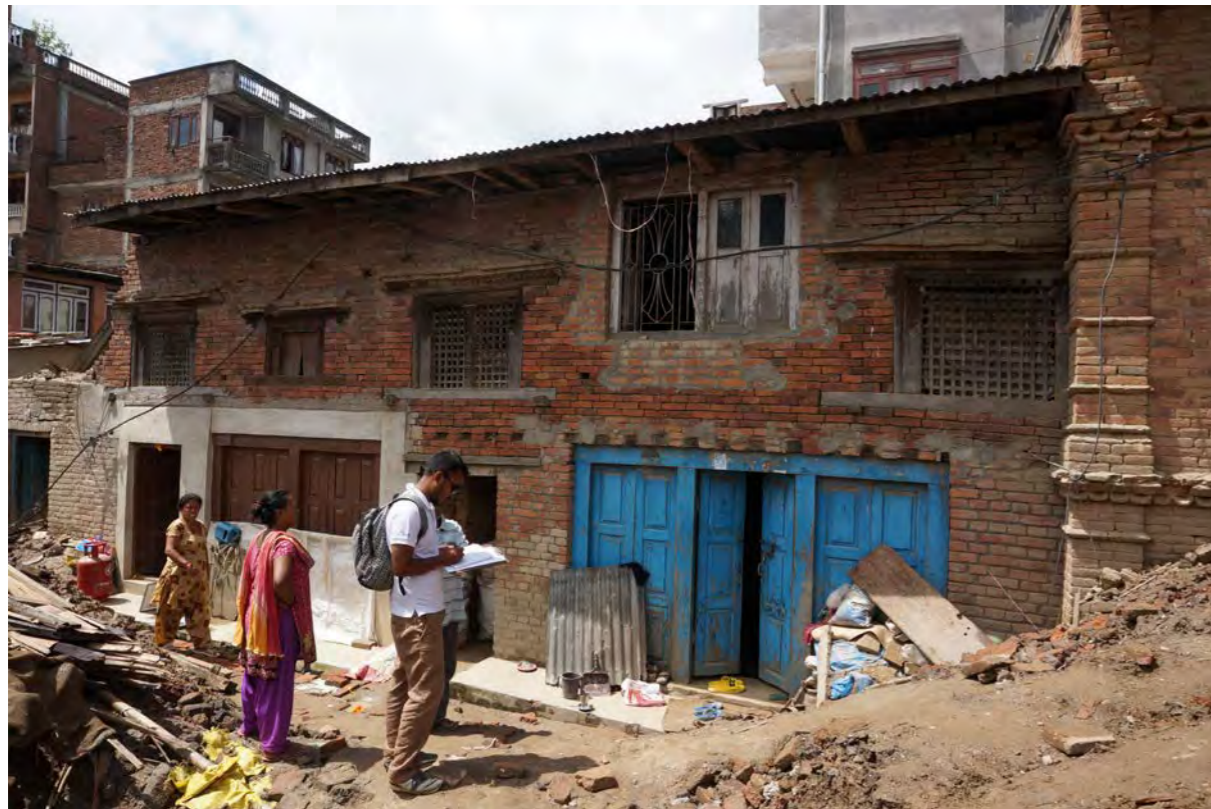
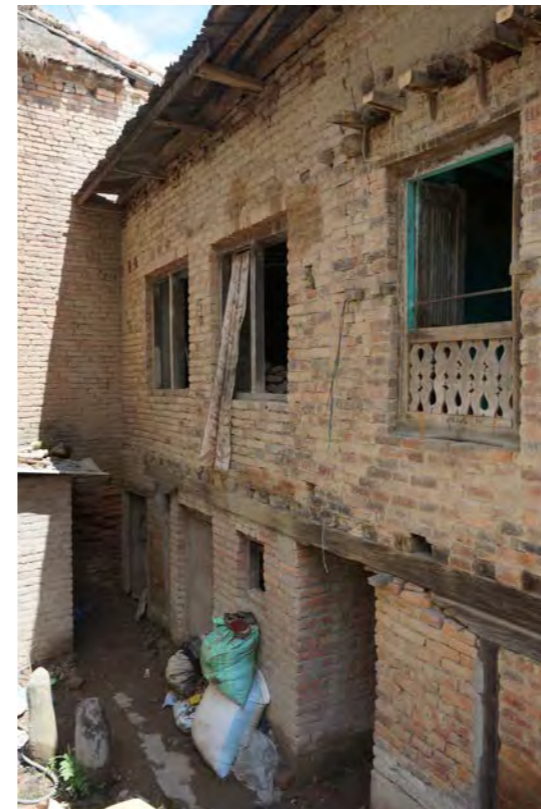
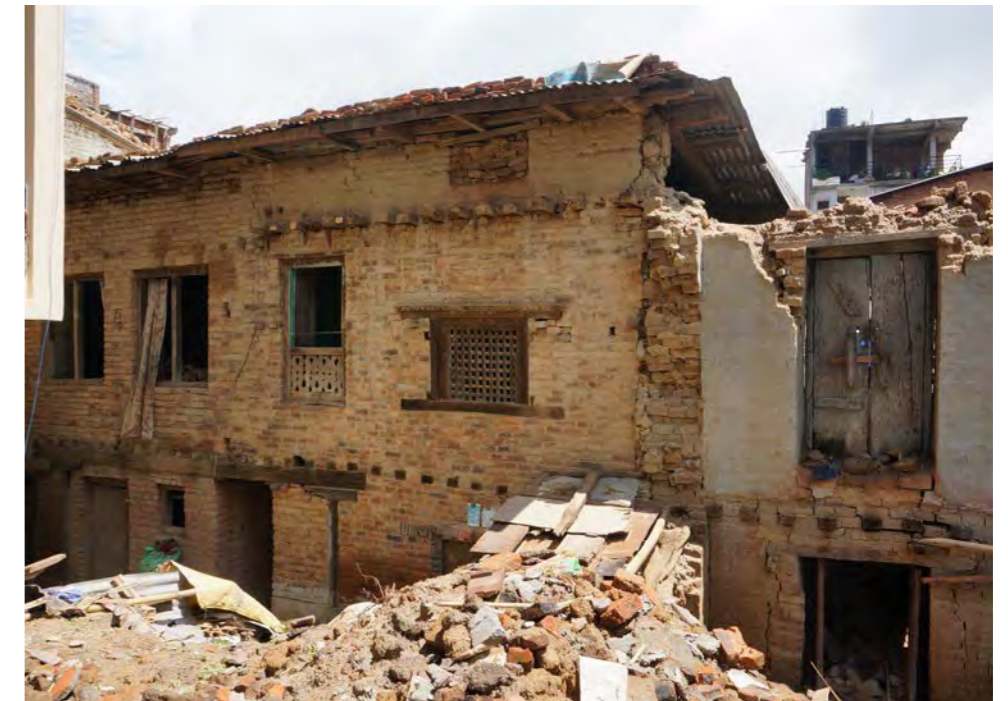
a8, a9

NUMBER	CONTACT	STOREY NO. RELATIVE POSITION	STRUCTURAL SYSTEM	PROBLEMS DESCRIPTION	DANGER	CONDITION
a08	Ramesh Shrestha	G+2	B	“Top storey is demolished New metal sheet covering on remaining part”		+ W!
a09	“Bekulal Shrestha 9849447106”	G+3	B	“Top storey is demolished New metal sheet covering on remaining part”		+ W!

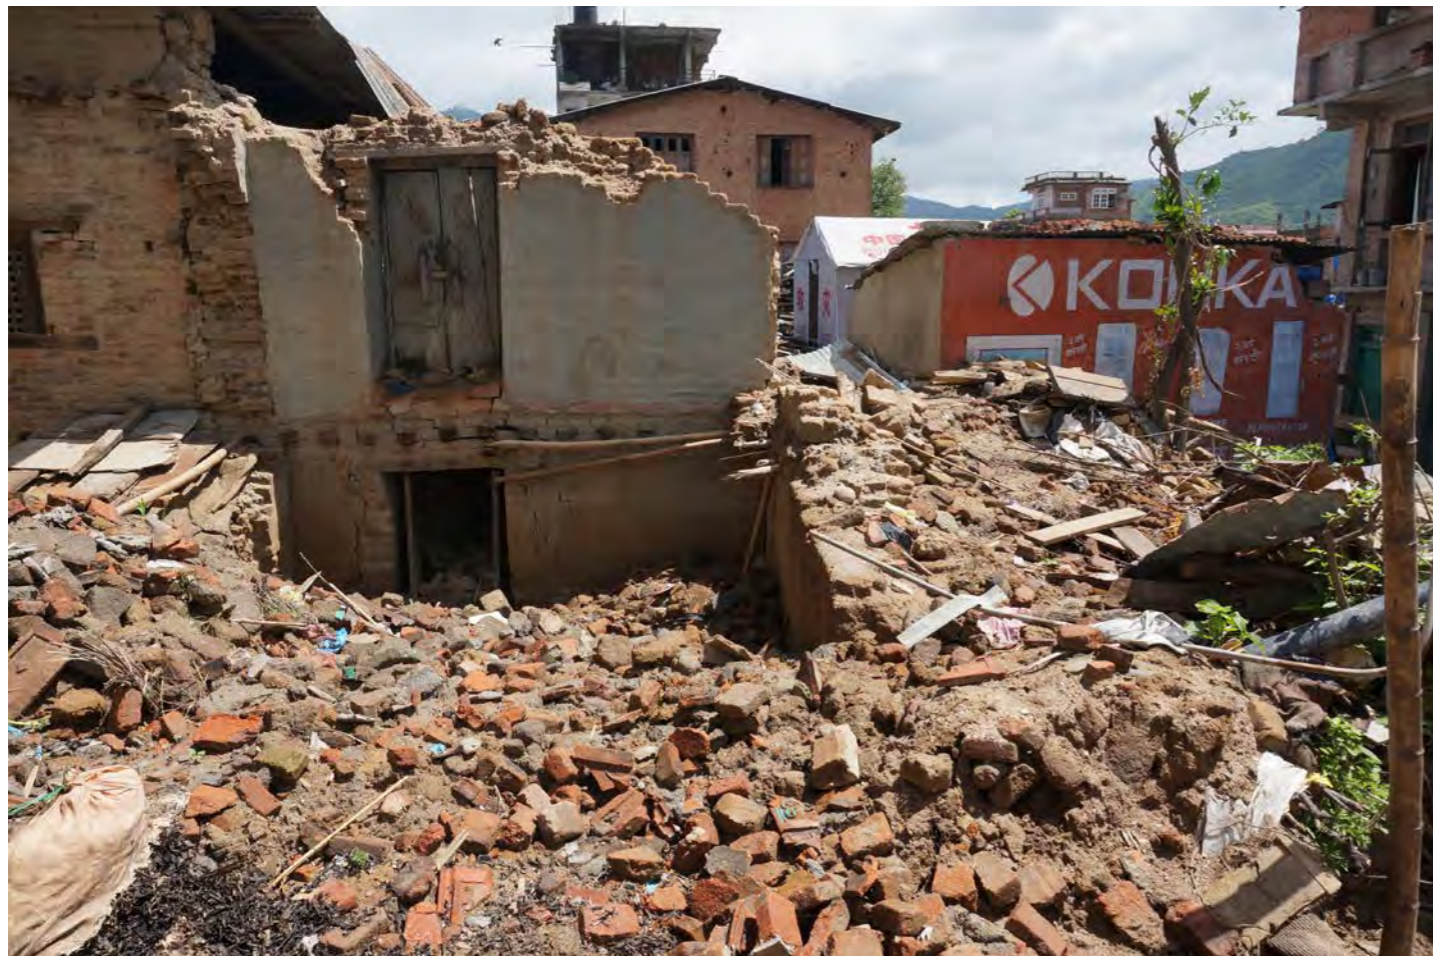
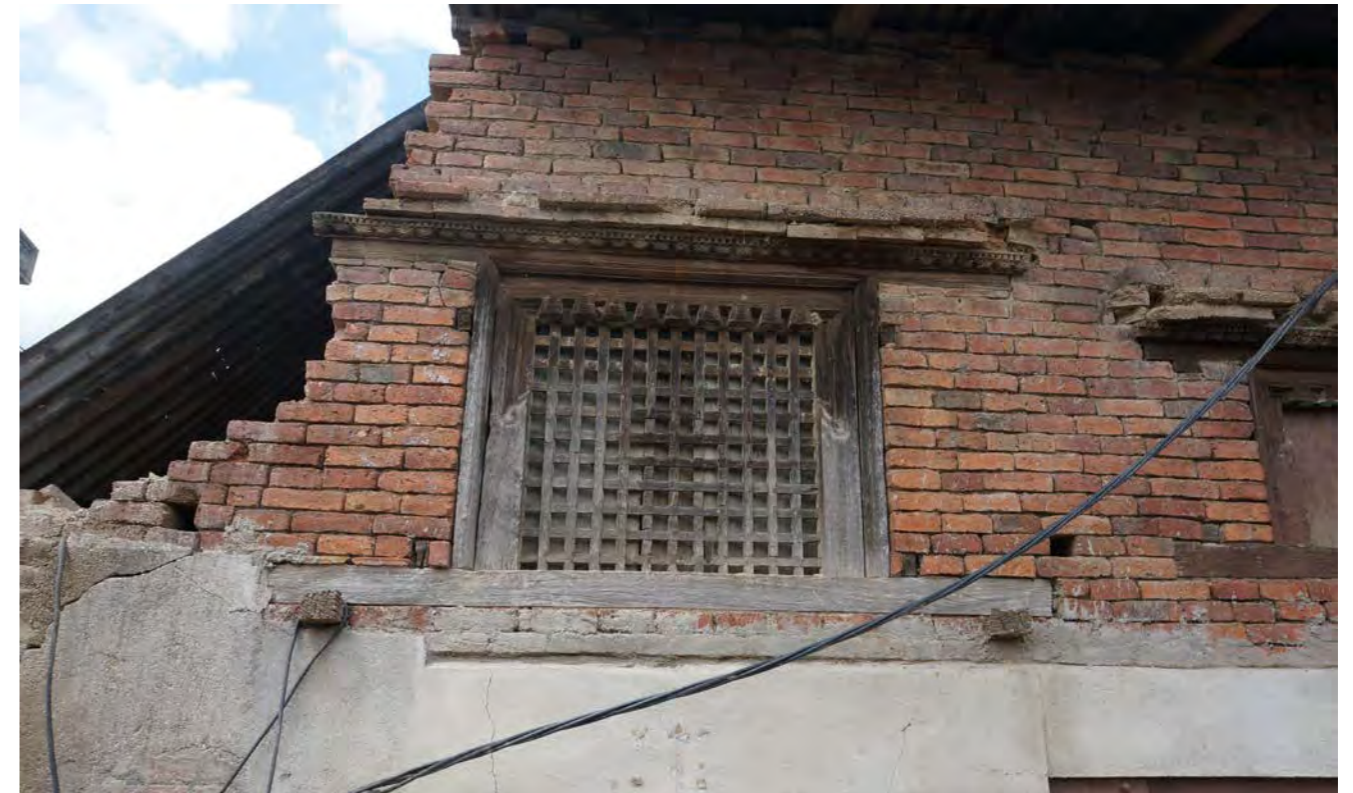
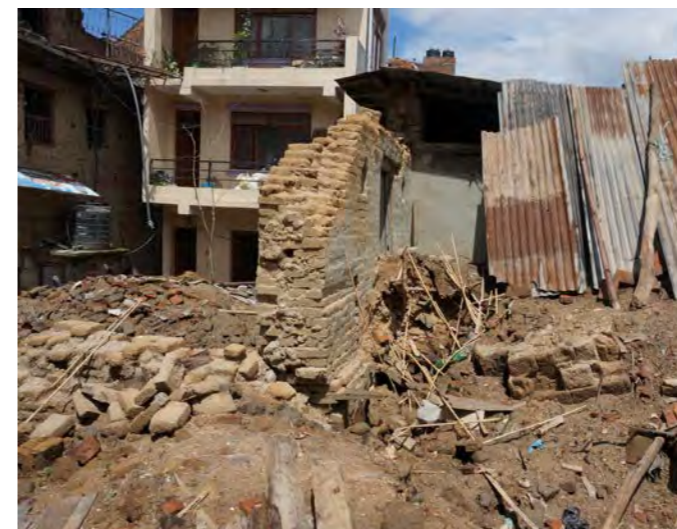
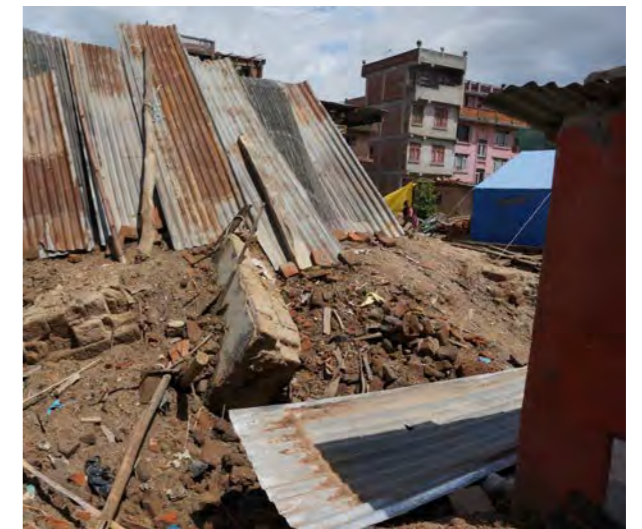
NUMBER	CONTACT	STOREY NO. RELATIVE POSITION	STRUCTURAL SYSTEM	PROBLEMS DESCRIPTION	DANGER	CONDITION
a10	Tejlal Shrestha	G+4	B	Totally collapsed		+ W!
