2015 Earthquake Damage Mapping

Sankhu

October 2015

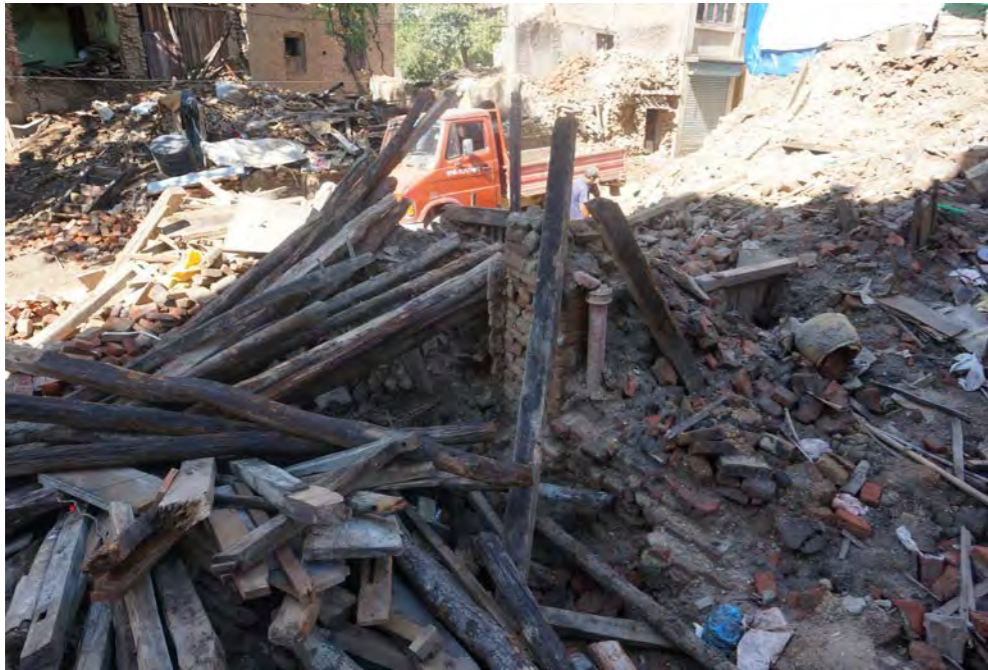
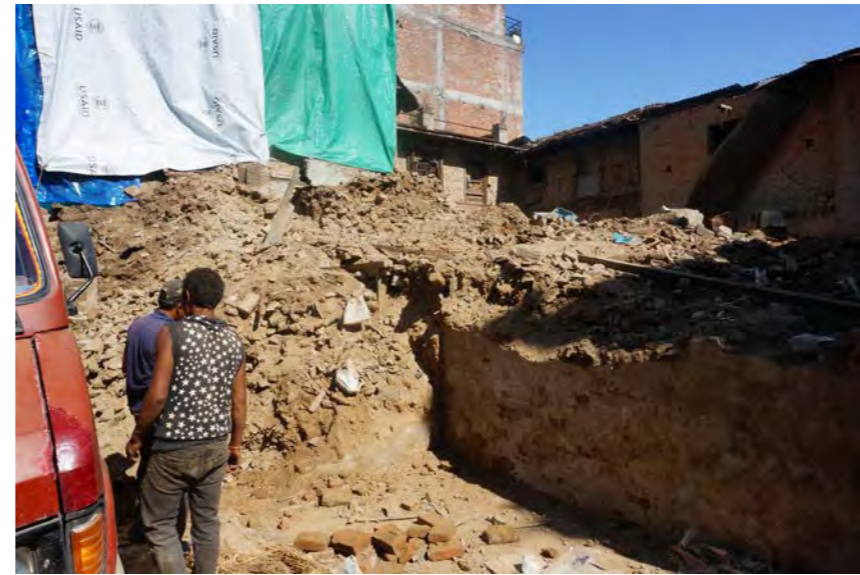
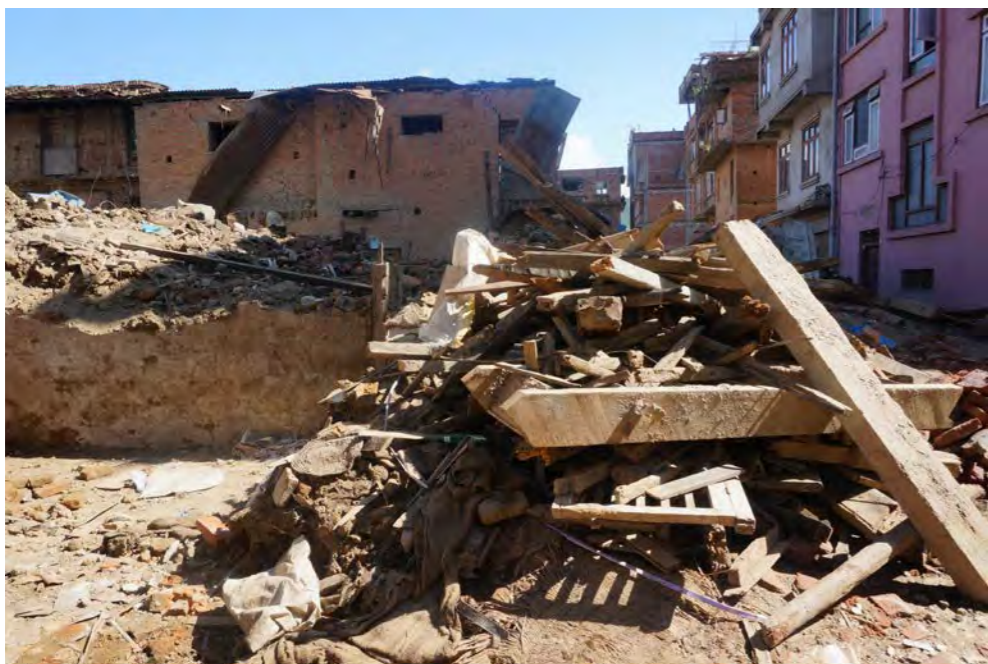
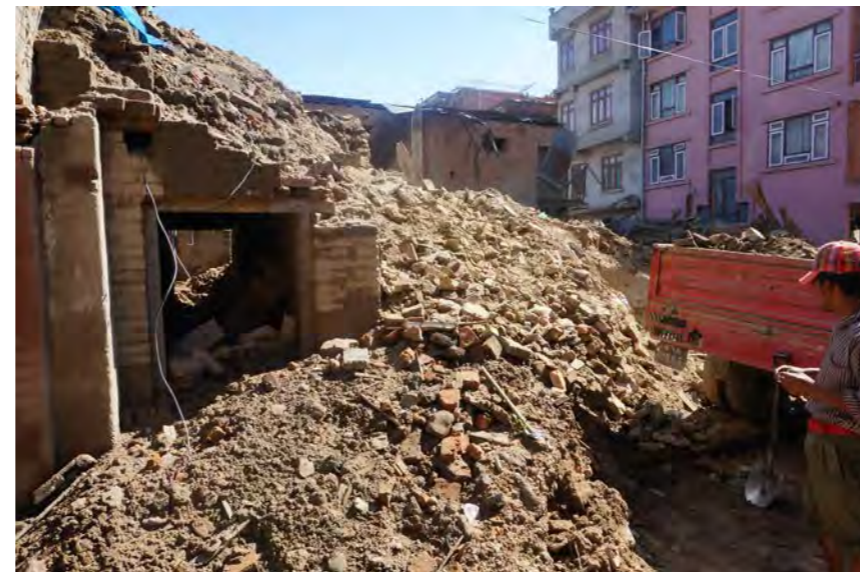
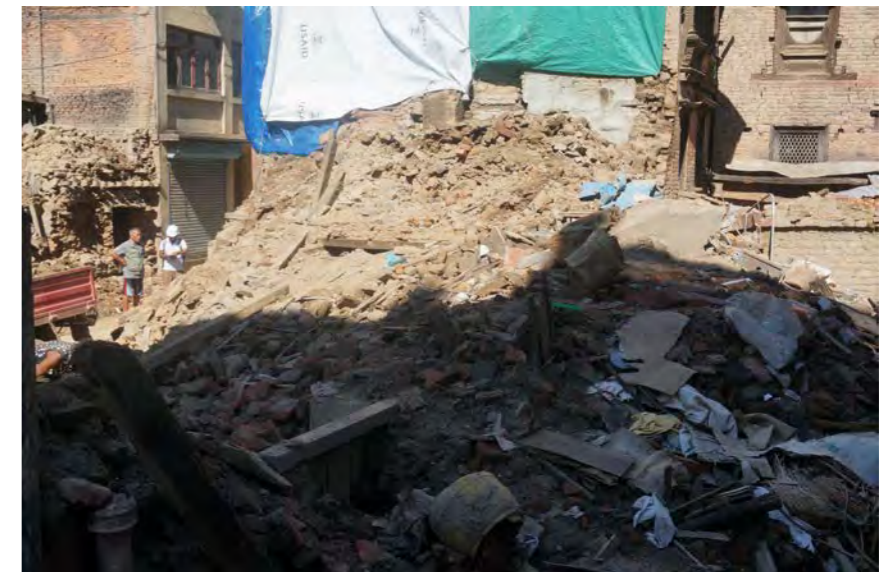
a27, a28

NUMBER	CONTACT	STOREY NO. RELATIVE POSITION	STRUCTURAL SYSTEM	PROBLEMS DESCRIPTION	DANGER	CONDITION
a27	“Gauri Narayan Shrestha 9841016666”	G+3	B	“Totally collapsed (some remainings of window stored in 35 by owners; still needs salvaging of other window parts from debris)”		“P! (in 35) R!”
a28	“Ram Bhakta Shrestha (refer 27: father of Gauri)”	G+2	B	“Totally collapsed (some remainings of window stored in 35 by owners; still needs salvaging of other window parts from debris)”		“P! (in 35) R!”

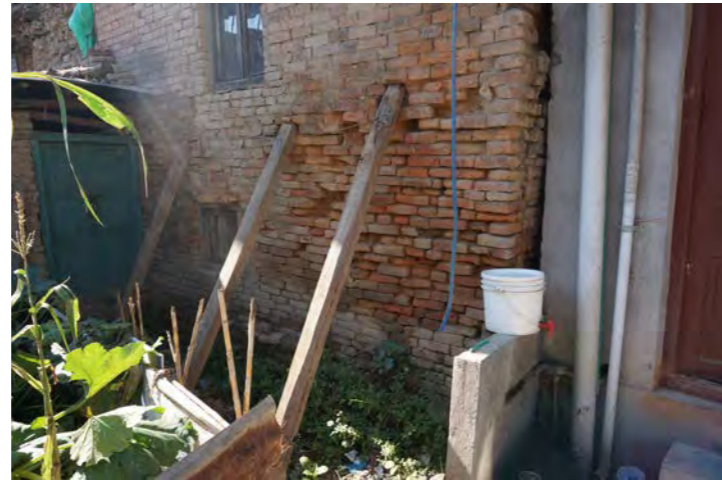
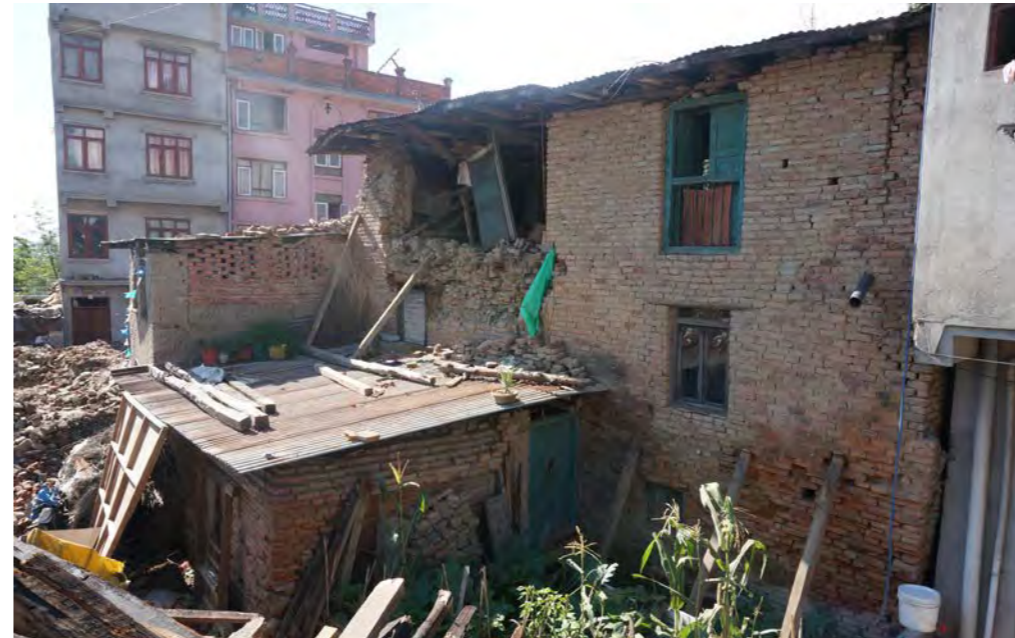
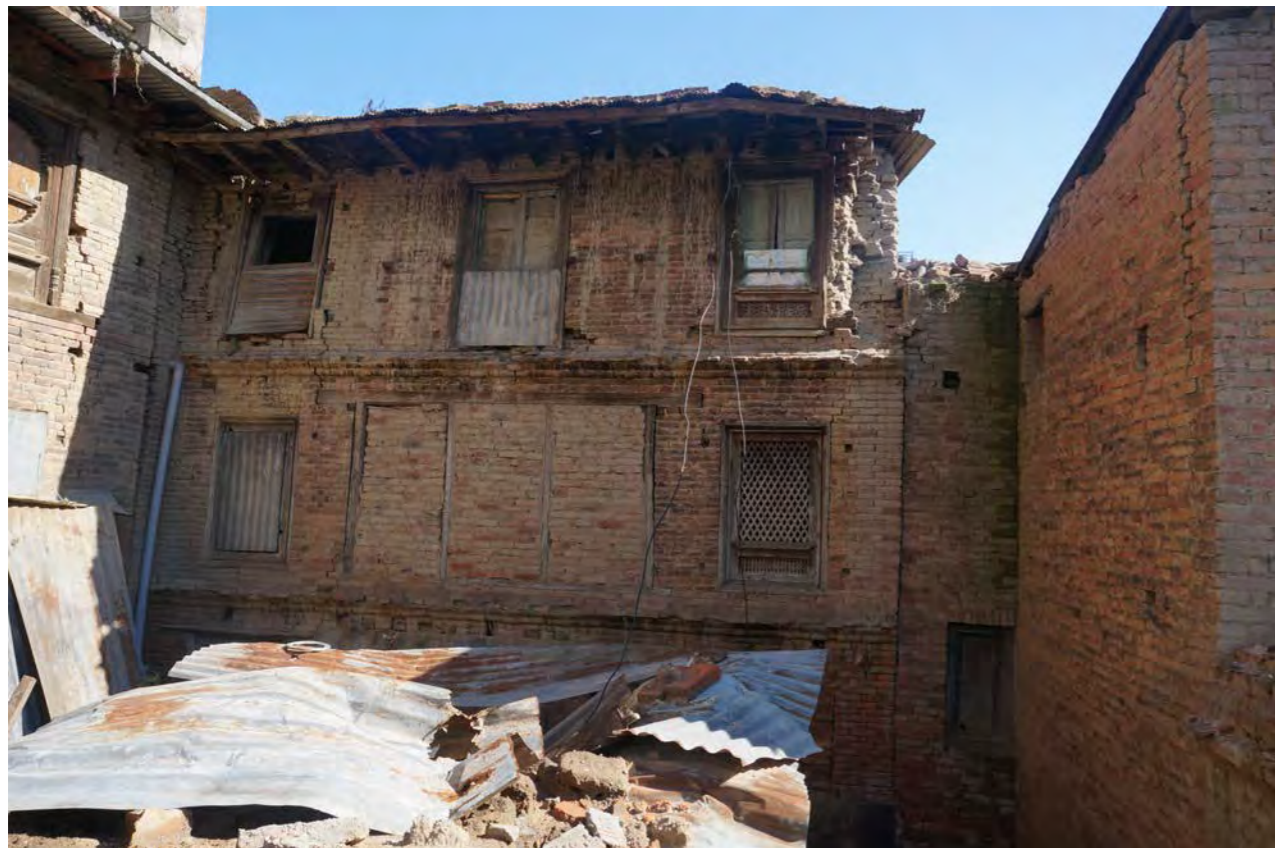
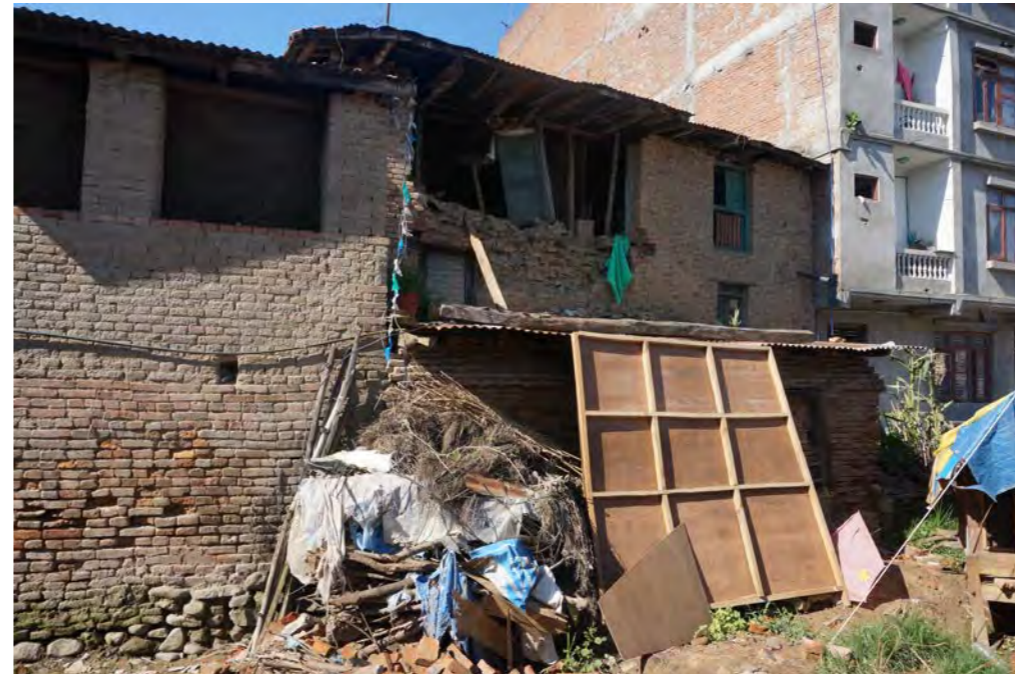
NUMBER	CONTACT	STOREY NO. RELATIVE POSITION	STRUCTURAL SYSTEM	PROBLEMS DESCRIPTION	DANGER	CONDITION
a33	“Basanta Lal Shrestha 9849764998”	G+4	B	“Critically damaged Major cracks with S-wall façade collapsed Needs dismantle before reconstruction”	1/3 ☒	+

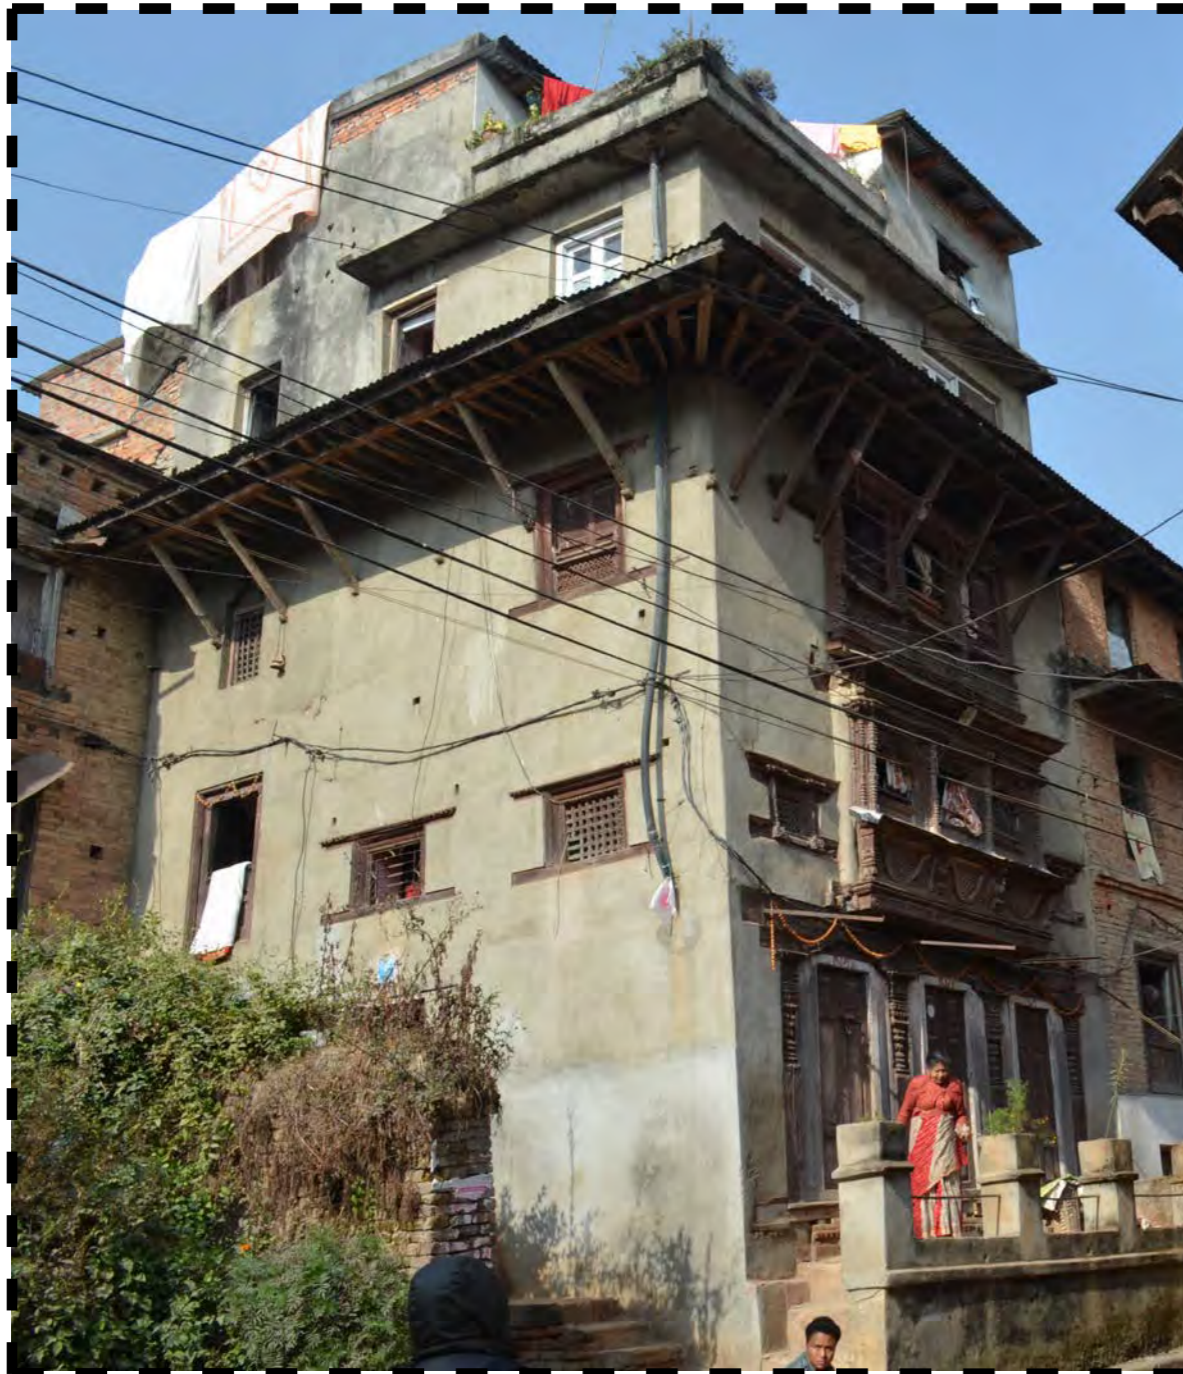
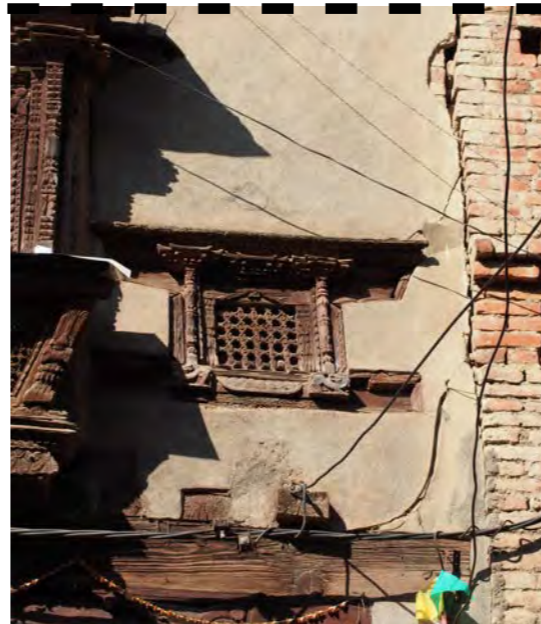
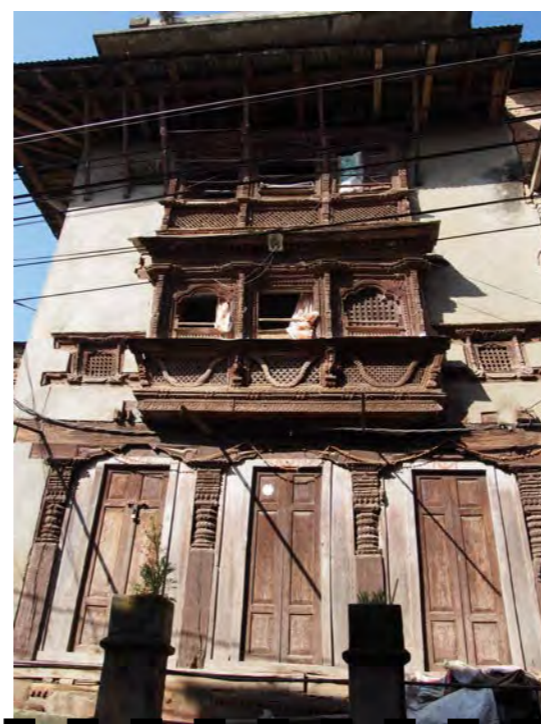
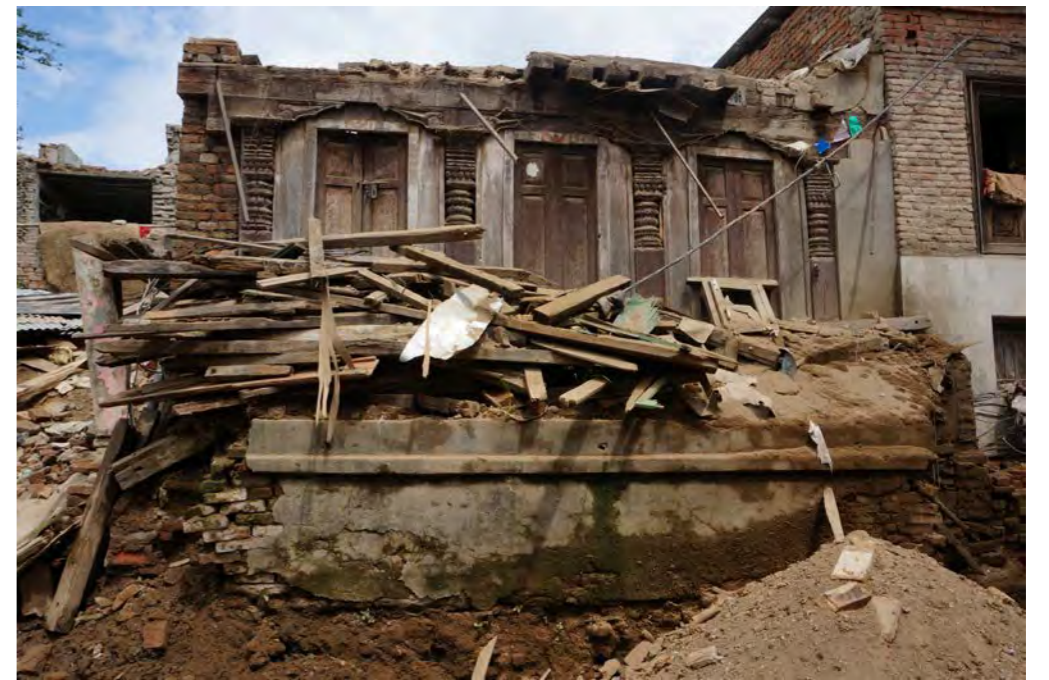
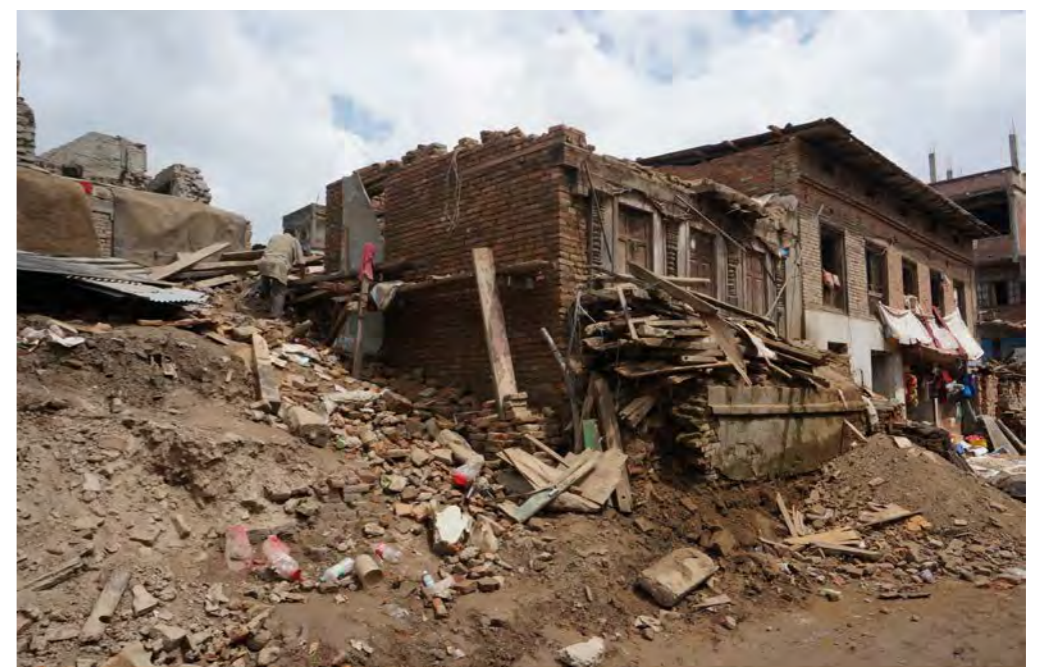
NUMBER	CONTACT	STOREY NO. RELATIVE POSITION	STRUCTURAL SYSTEM	PROBLEMS DESCRIPTION	DANGER	CONDITION
c66	Purna Bahadur Ranjit 9841420523	G+3	UnB + B	“Under constructed house after Earthquake for storage pupose Contains some old artefacts and windows”		Artefacts pro- tected by Youth Club

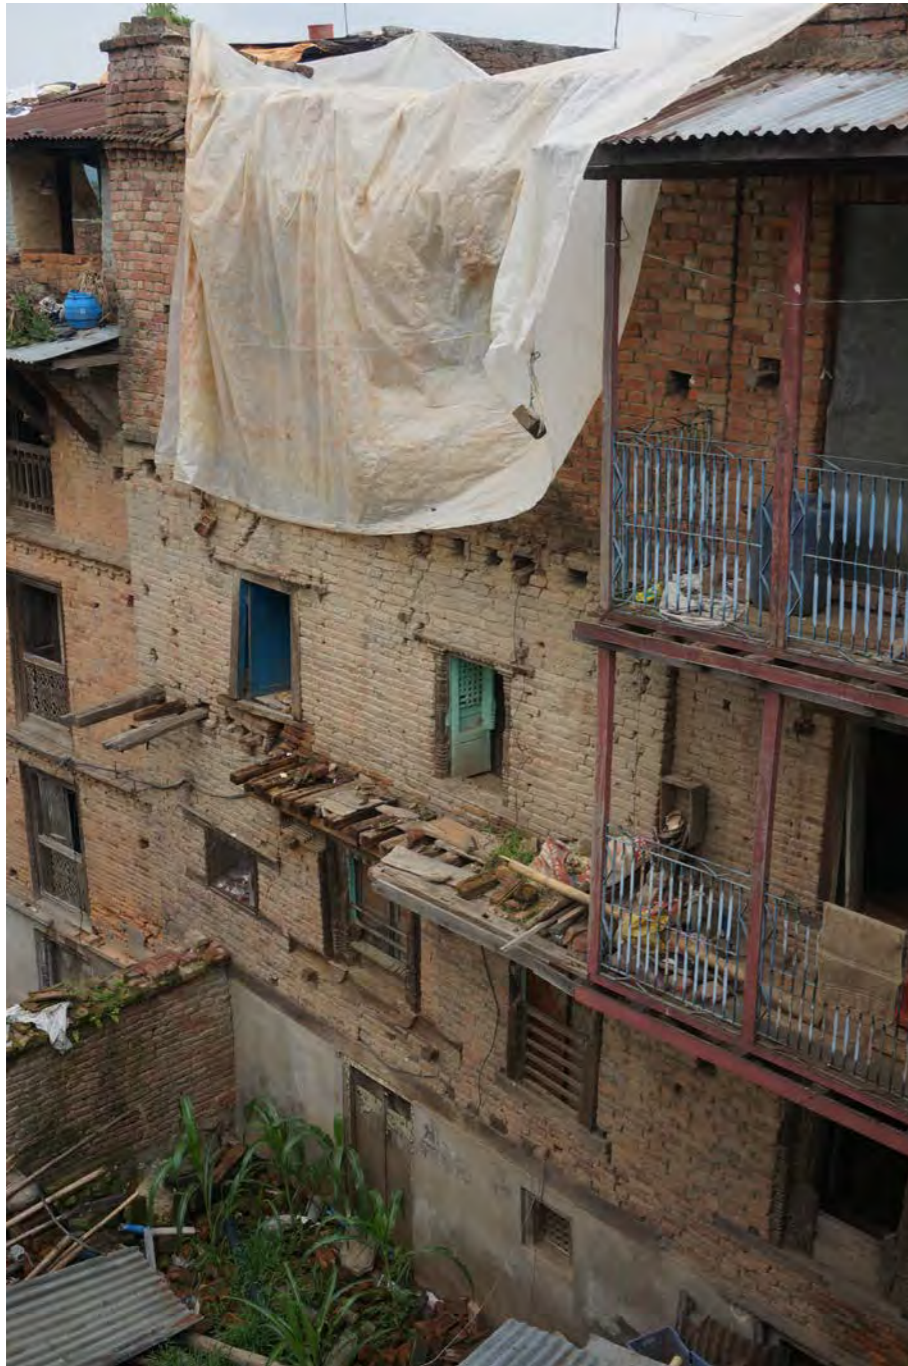
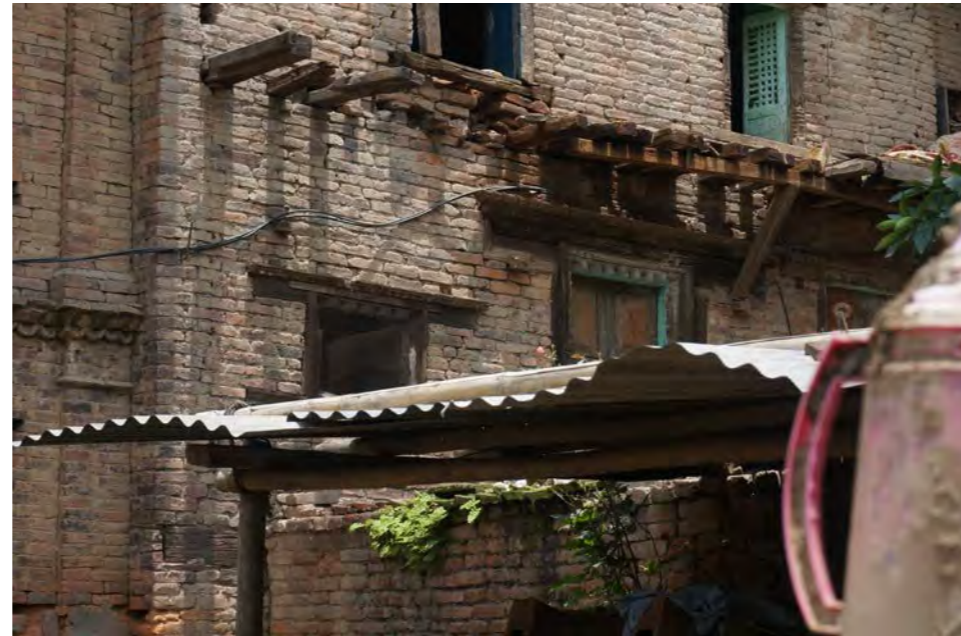
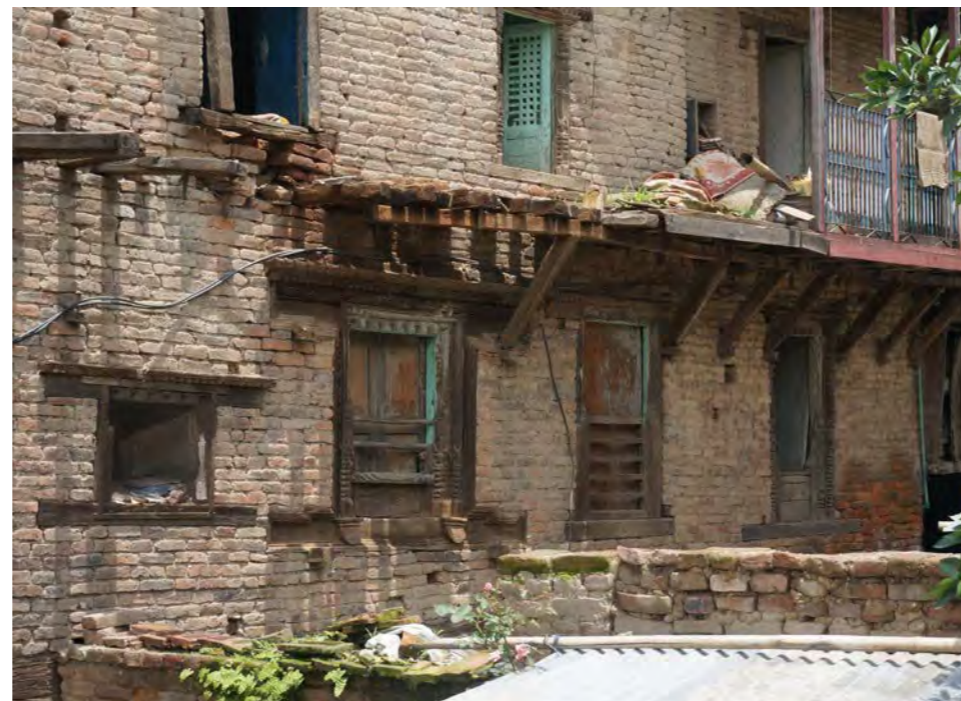
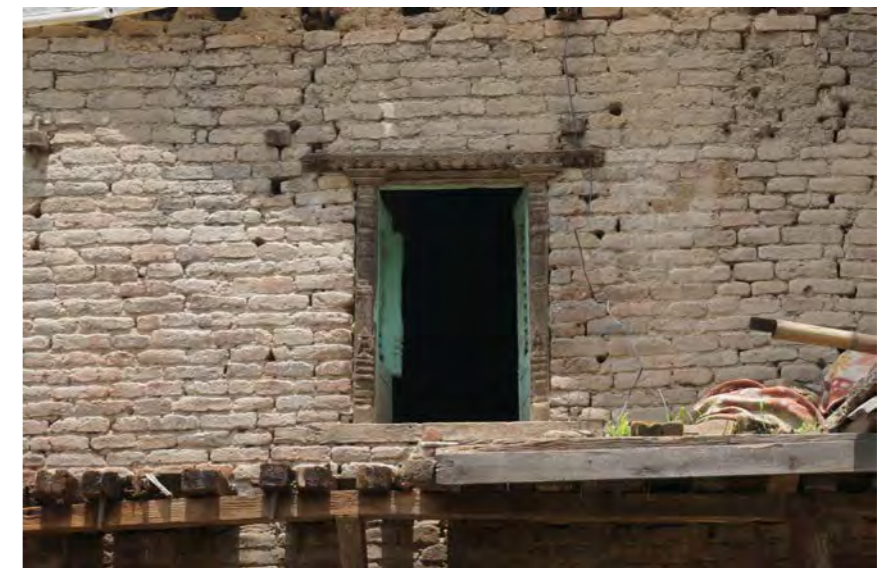
NUMBER	CONTACT	STOREY NO. RELATIVE POSITION	STRUCTURAL SYSTEM	PROBLEMS DESCRIPTION	DANGER	CONDITION
c142	Nanda Lal Shrestha	G+3	UnB + B	“Severely Damaged Needs total reconstruction”

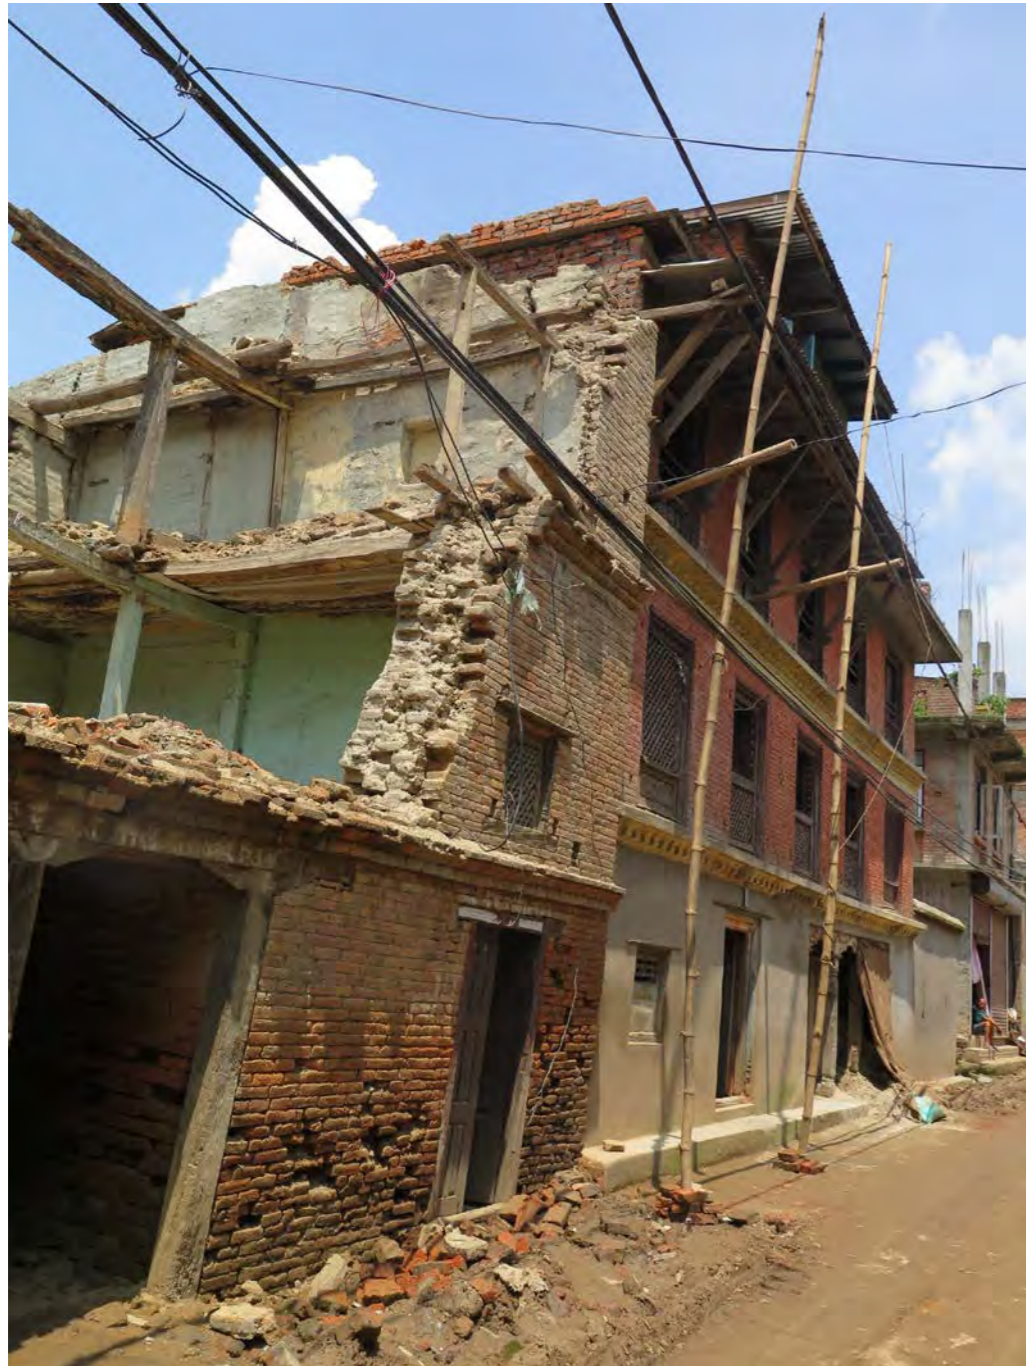
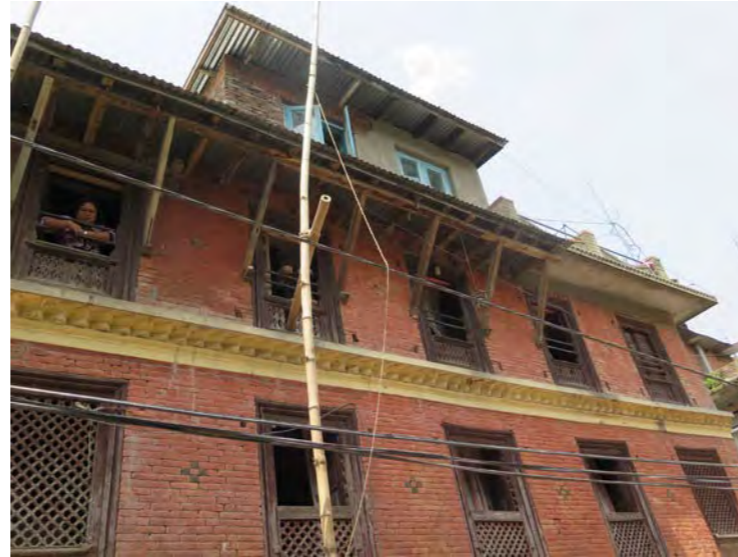
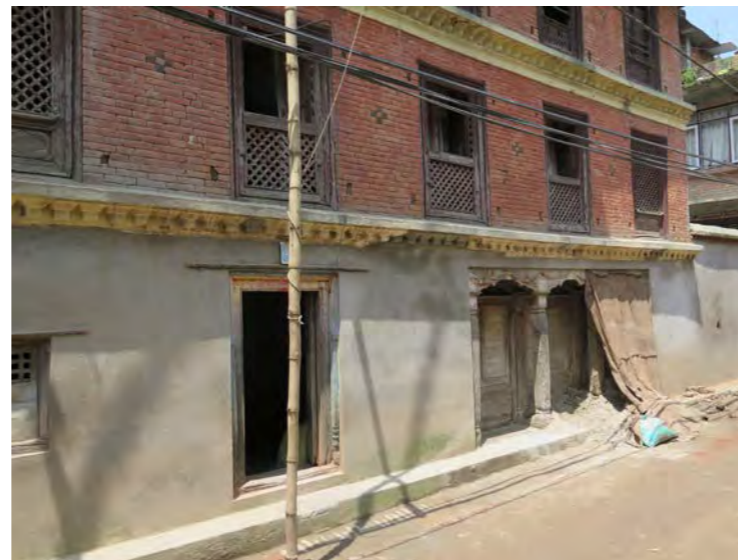
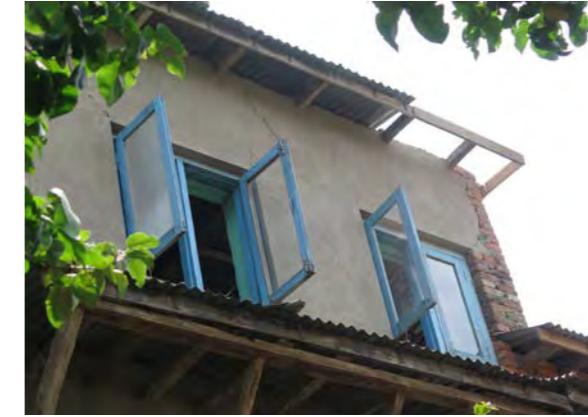
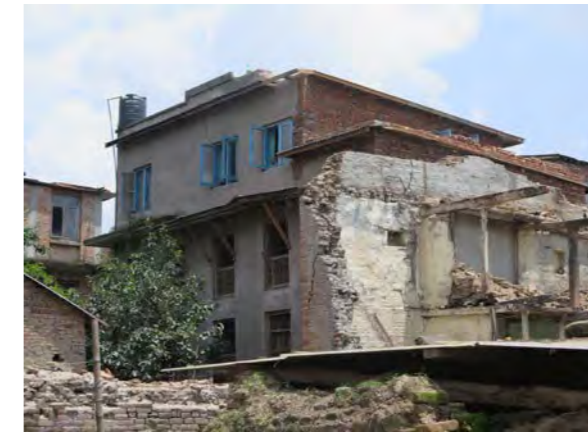
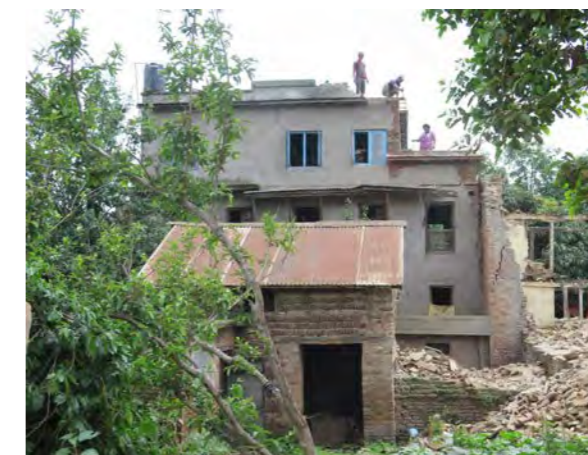
NUMBER	CONTACT	STOREY NO. RELATIVE POSITION	STRUCTURAL SYSTEM	PROBLEMS DESCRIPTION	DANGER	CONDITION
d11	Bisweshwor Das Shrestha (4451063, 9841362895)	G+3	B	Top floor east part collapsed. East wall totally collapsed. Major vertical cracks on many walls.

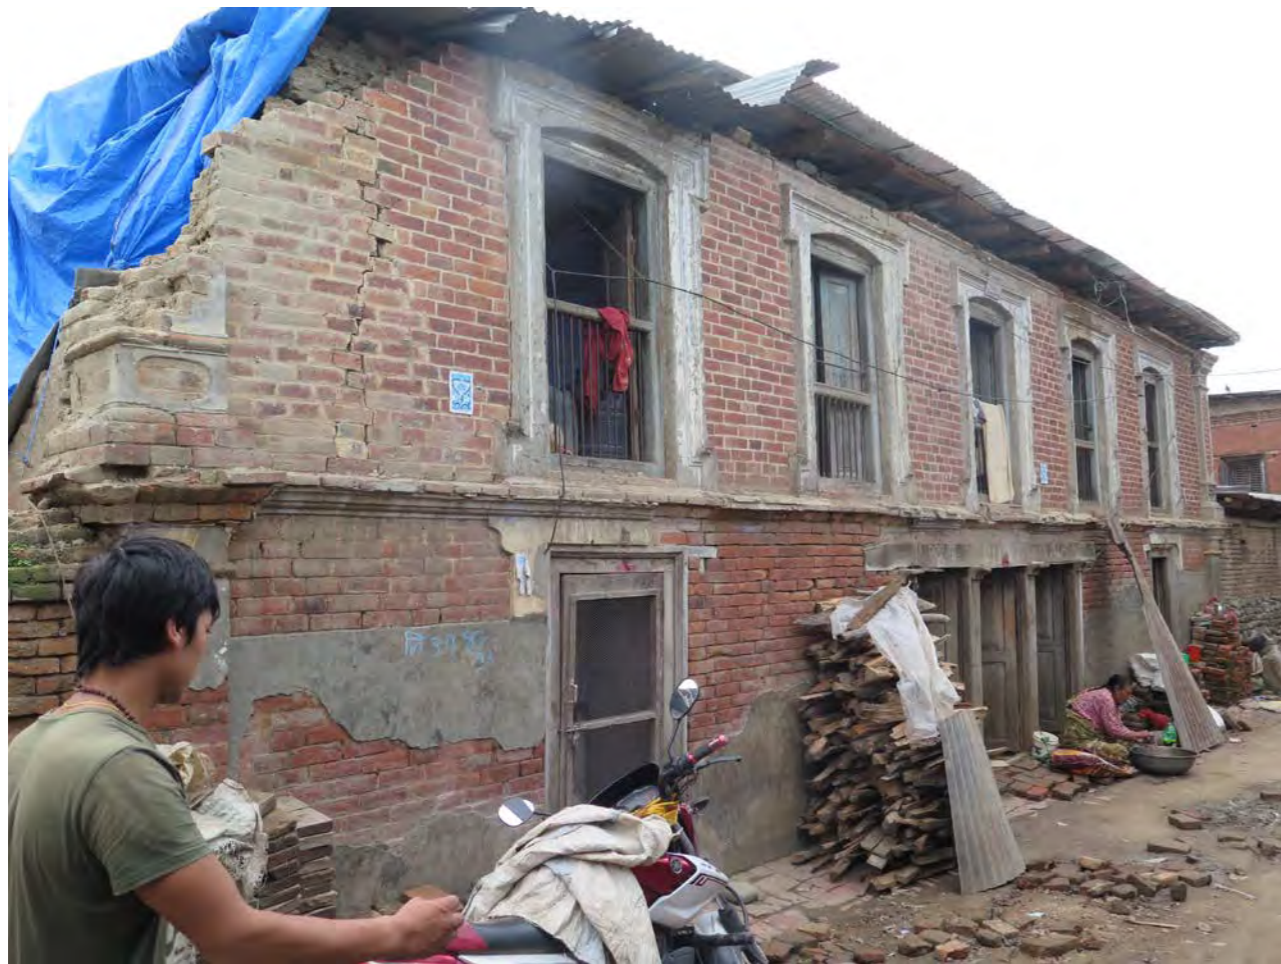
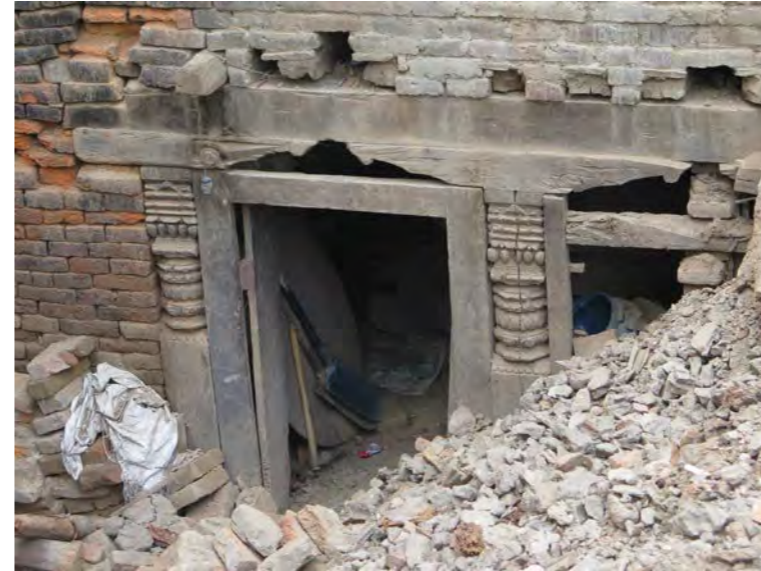
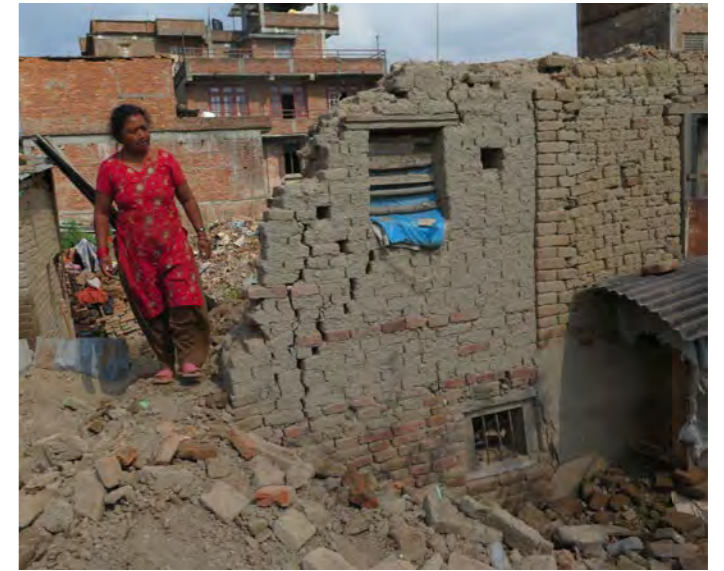
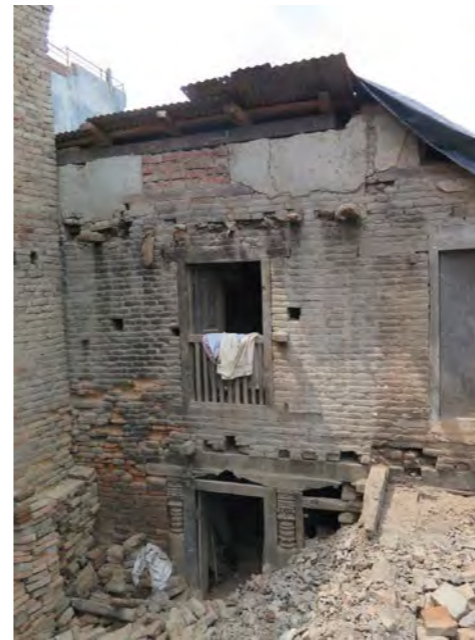
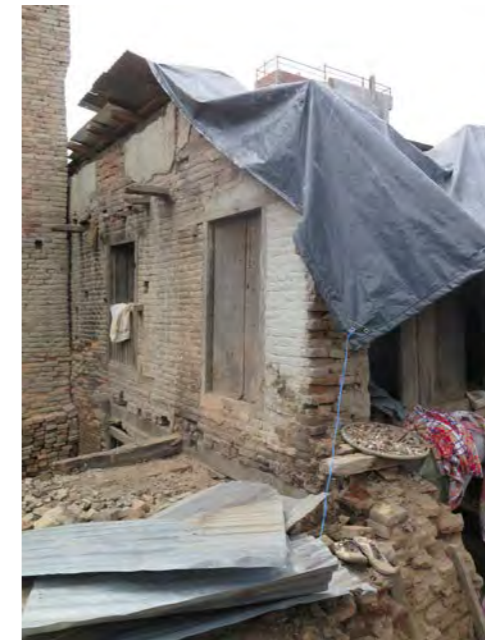
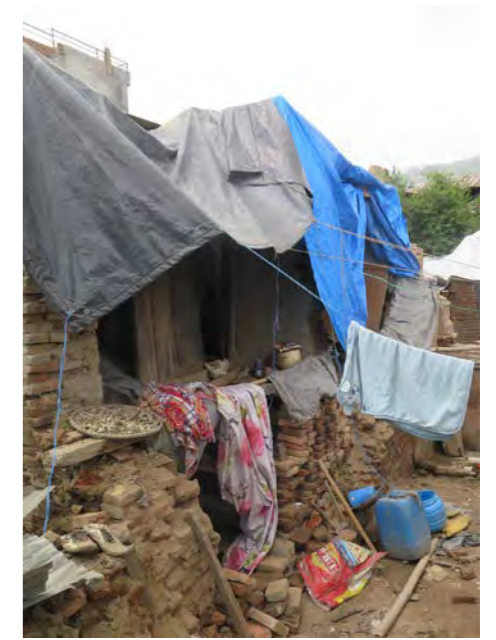
NUMBER	CONTACT	STOREY NO. RELATIVE POSITION	STRUCTURAL SYSTEM	PROBLEMS DESCRIPTION	DANGER	CONDITION
d15	Narayan Devi Shrestha (9841035712)	G+4 (EH)	B	Ground subsided. East wall totally collapsed. 3 floors collapsed. Diagonal cracks all over. Rising Damp.	⚠️ ☒

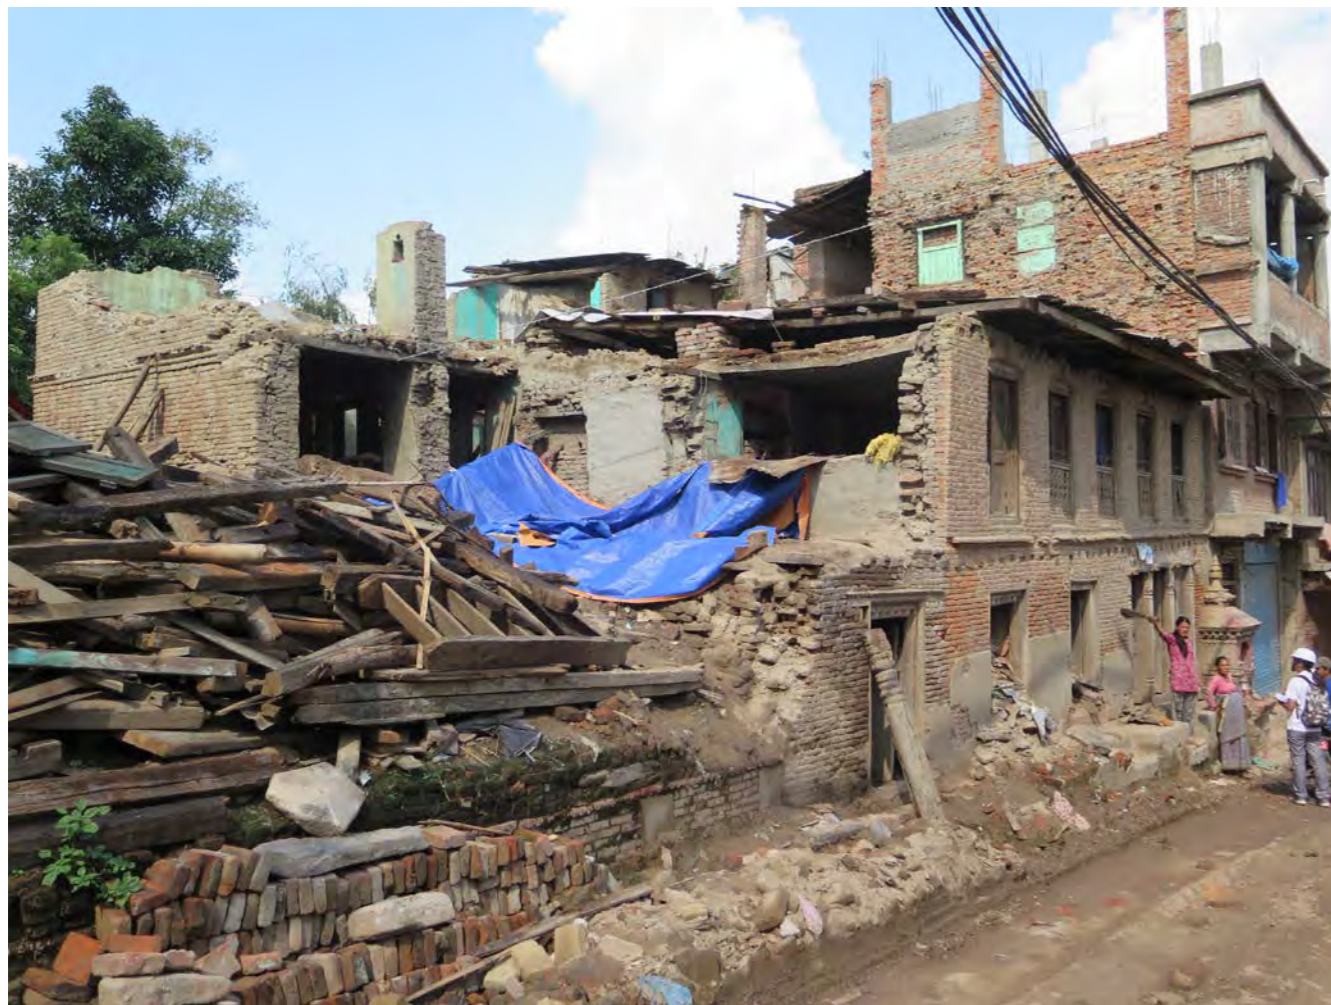
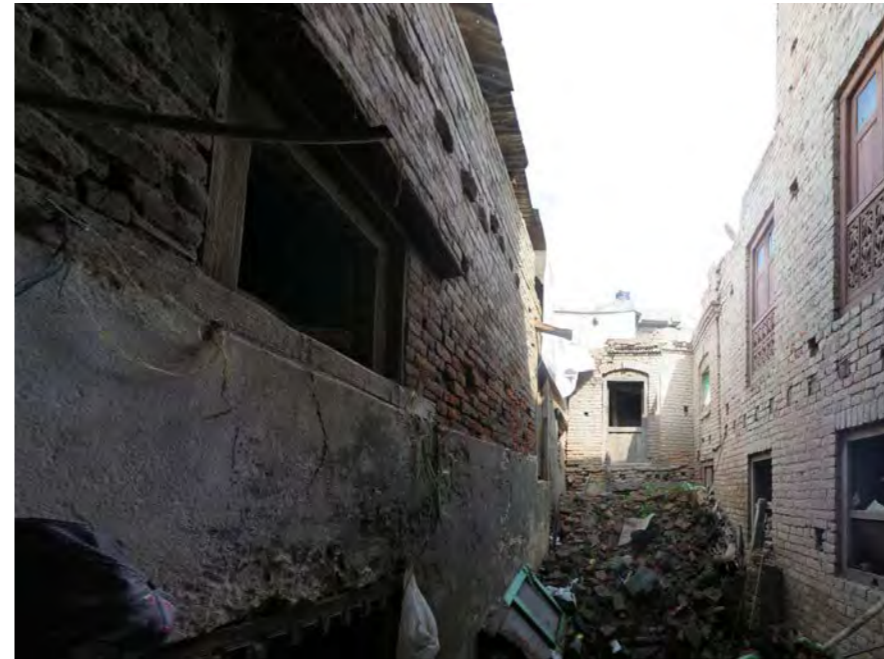
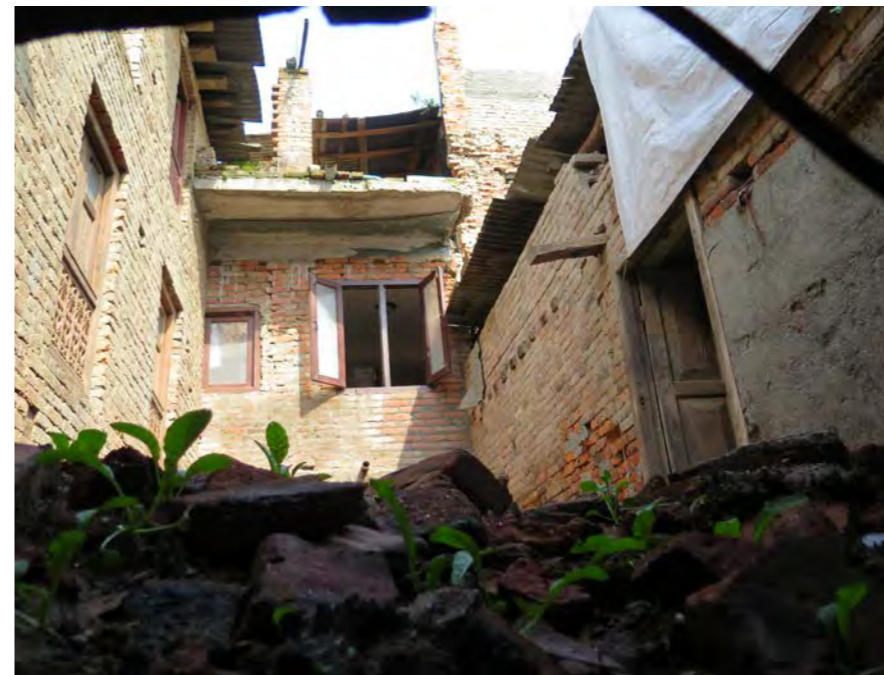
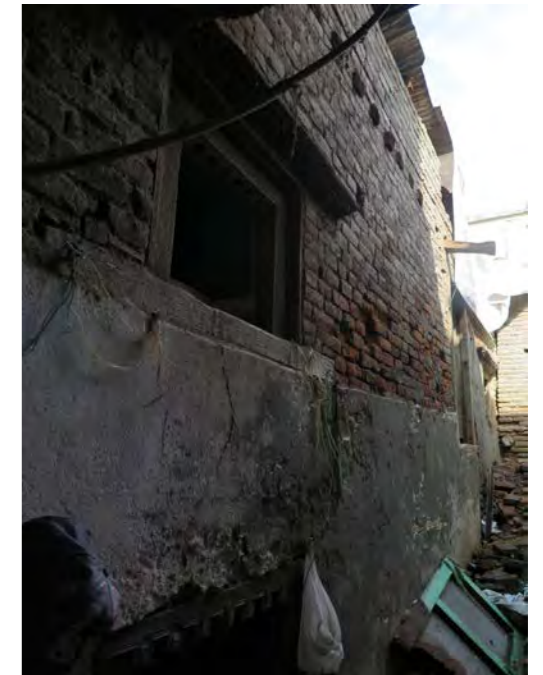
d44, d46

NUMBER	CONTACT	STOREY NO. RELATIVE POSITION	STRUCTURAL SYSTEM	PROBLEMS DESCRIPTION	DANGER	CONDITION
d44	Badri Man Dongol	G+4	B	2 floors collapsed. Filled with rubbles. Rising damp		
d46	Gobinda Man Dongol	G+4	B	2 floors collapsed. Rising damp.
