2015 Earthquake Damage Mapping

Sankhu

October 2015

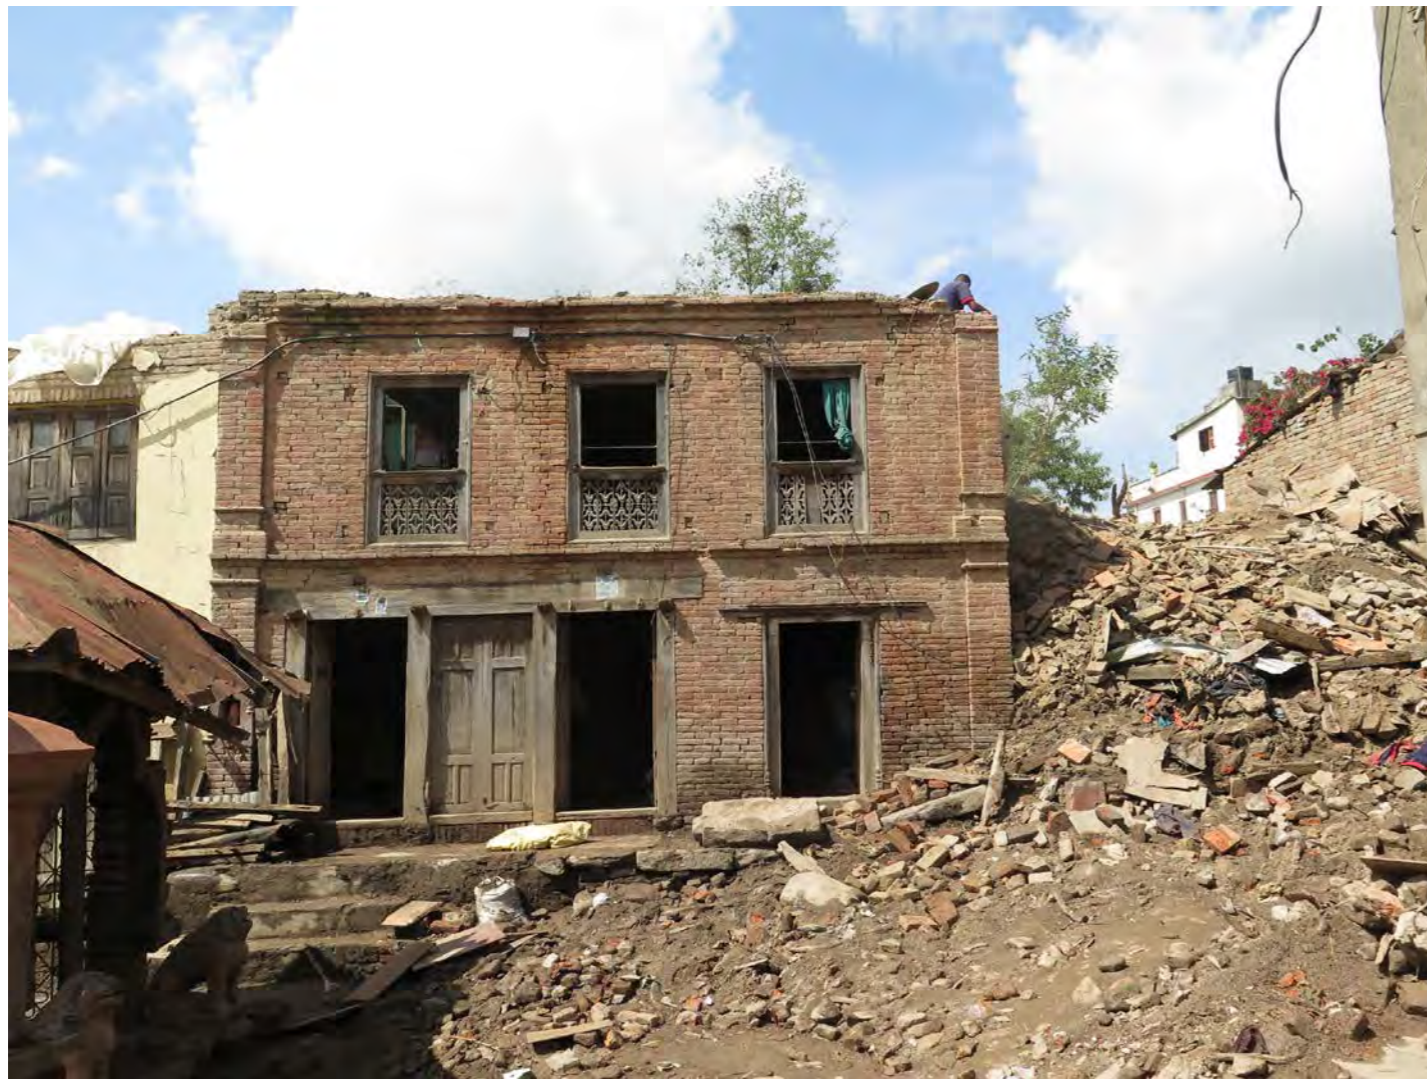
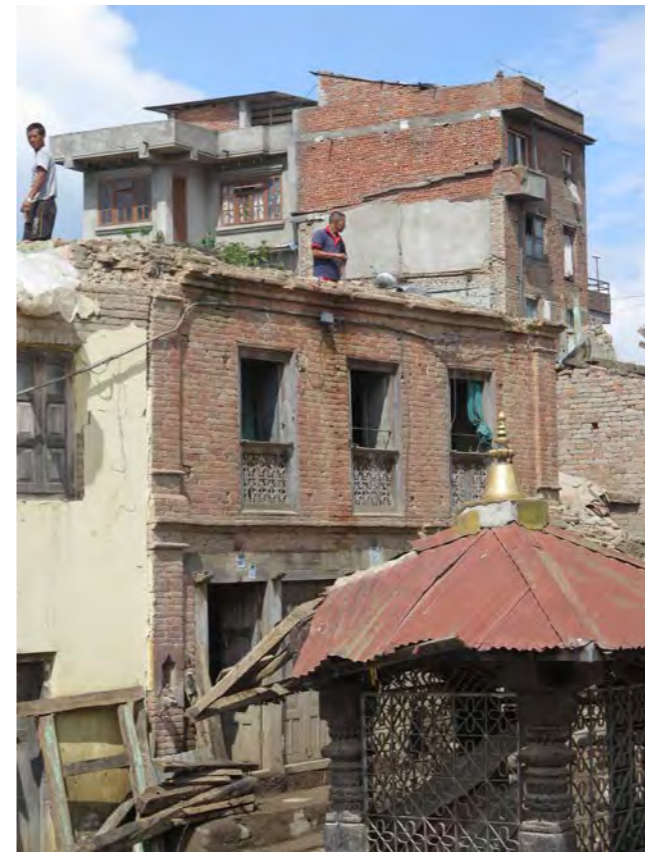
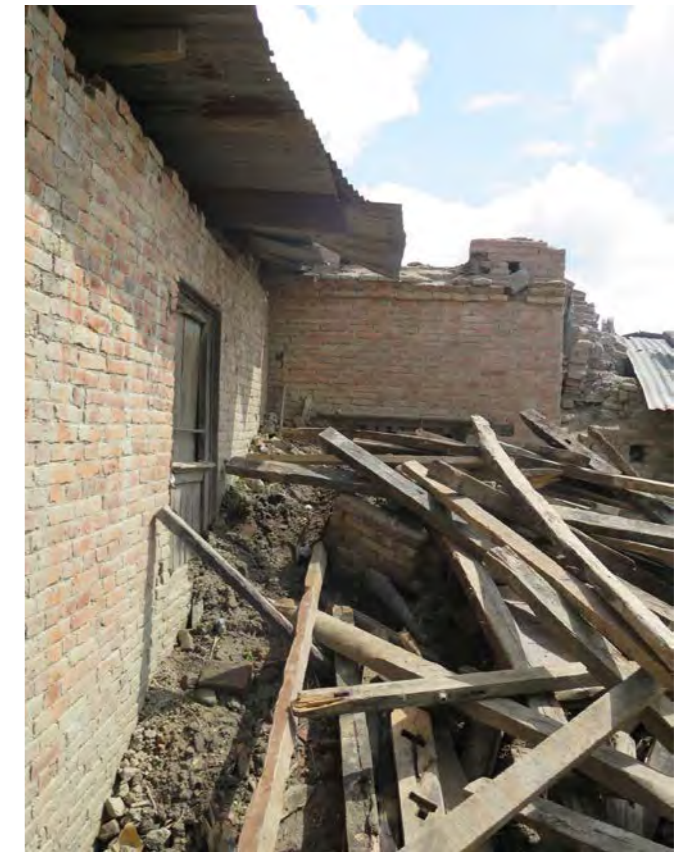
NUMBER	CONTACT	STOREY NO. RELATIVE POSITION	STRUCTURAL SYSTEM	PROBLEMS DESCRIPTION	DANGER	CONDITION	
d59	Chandra Shova Ranjit (9841245285)	G+3	B	2 floors collapsed	1/2 ☒	P + But not properly stored

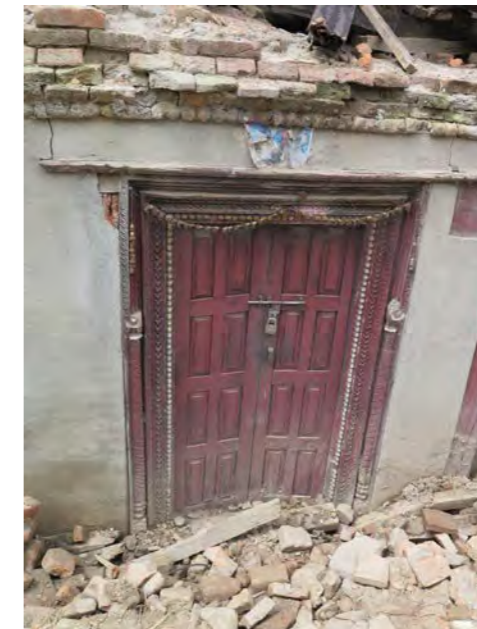
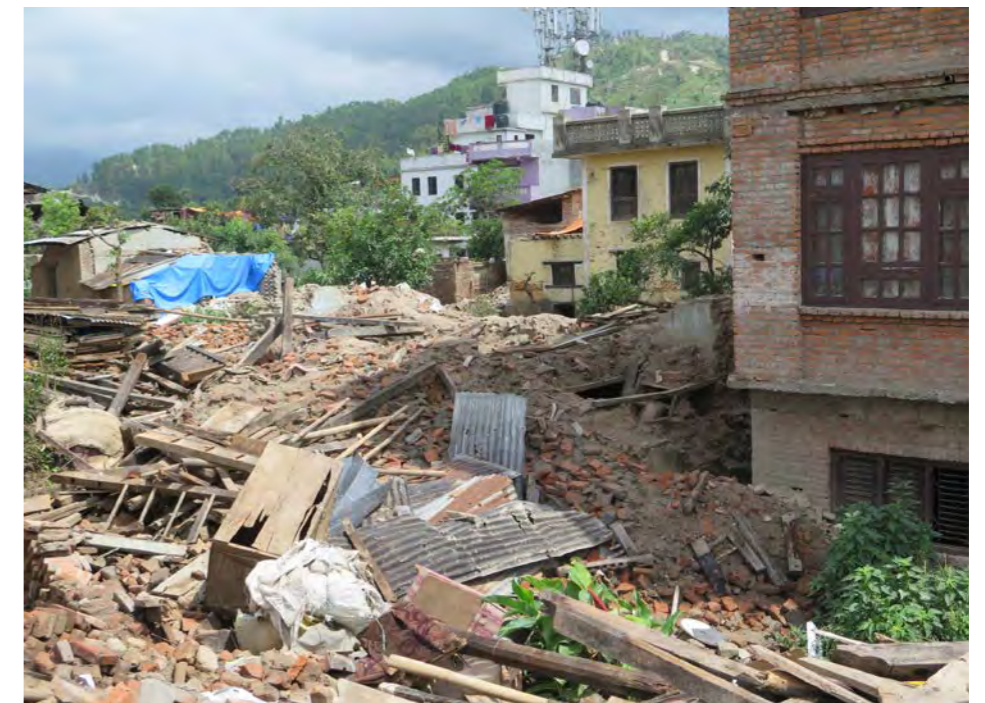
NUMBER	CONTACT	STOREY NO. RELATIVE POSITION	STRUCTURAL SYSTEM	PROBLEMS DESCRIPTION	DANGER	CONDITION	
d68	Ishwor Shrestha (9841954869)	G+3	B	Collapsed upto ground floor. Ground floor under rubbles.		+

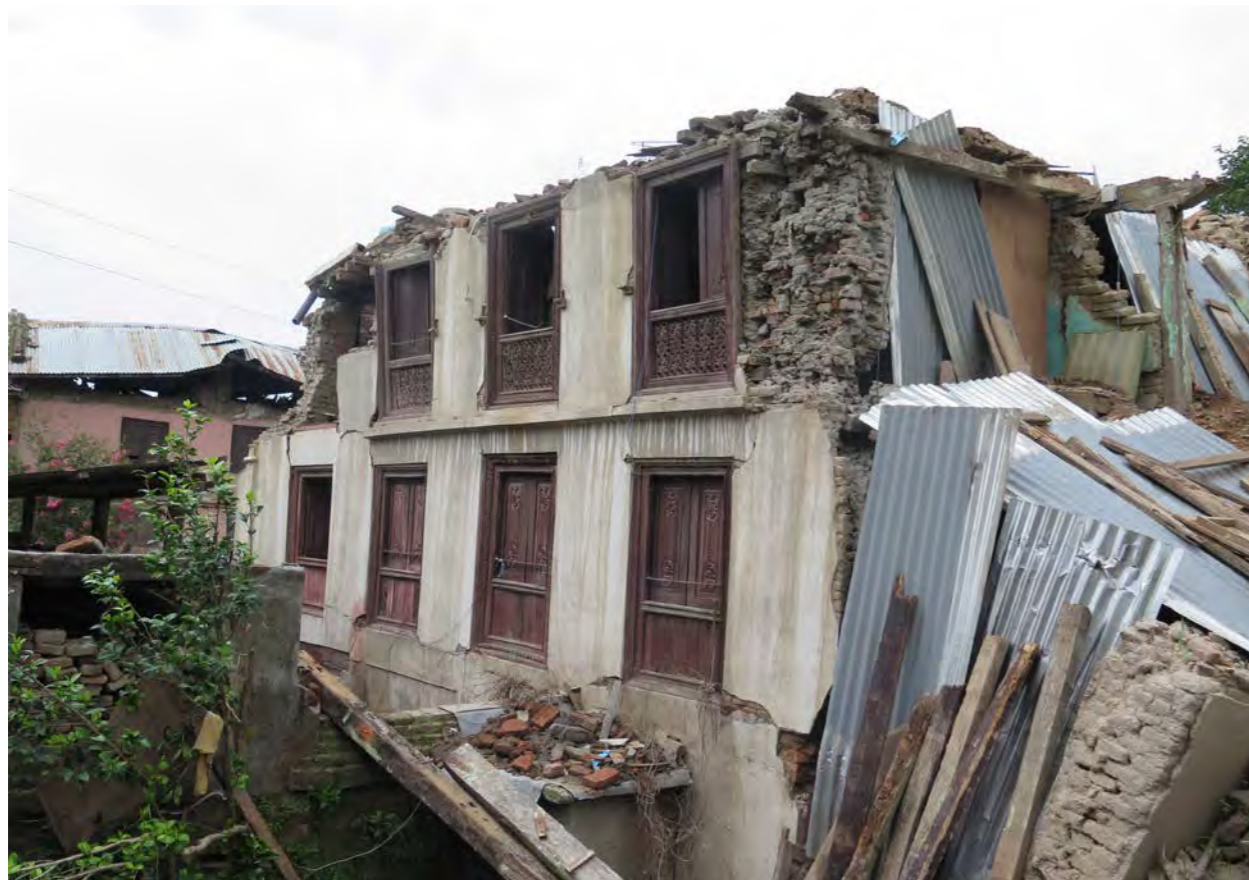
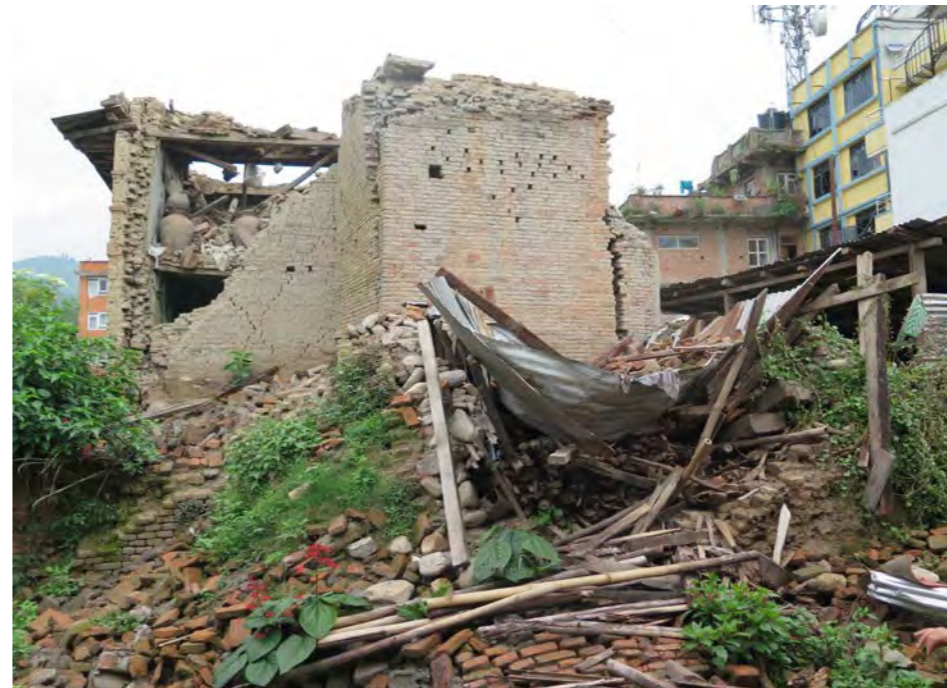
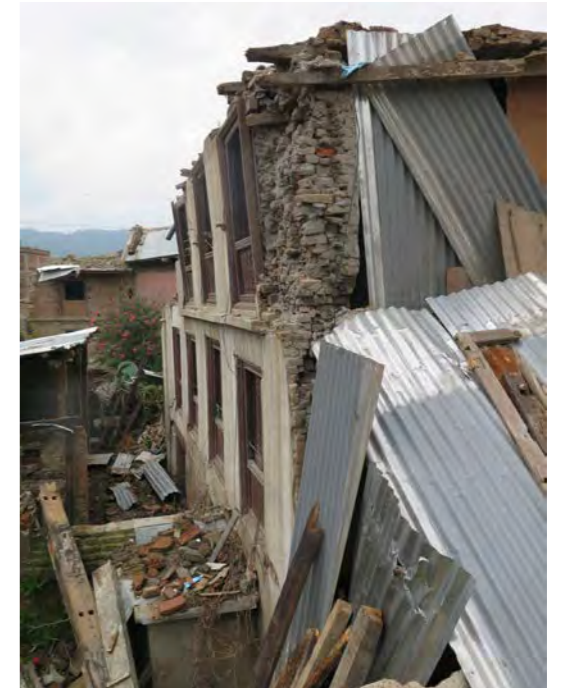
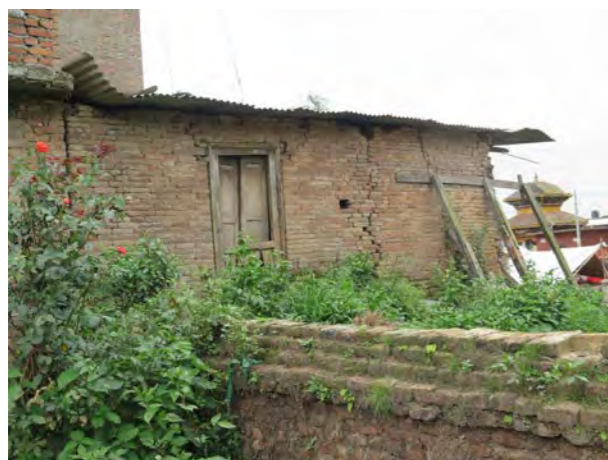
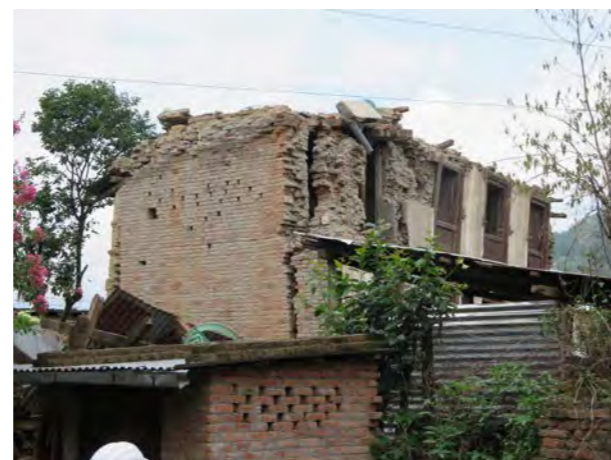
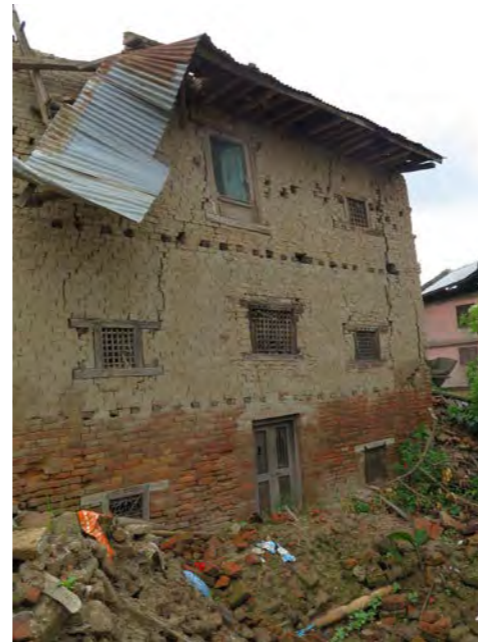
NUMBER	CONTACT	STOREY NO. RELATIVE POSITION	STRUCTURAL SYSTEM	PROBLEMS DESCRIPTION	DANGER	CONDITION
e03	Ram Prashad Shrestha	G+3 (CH)	B+UnB	2 floors collapsed. Vertical crack on south east wall.	⚠️ 1/2 ☒	+

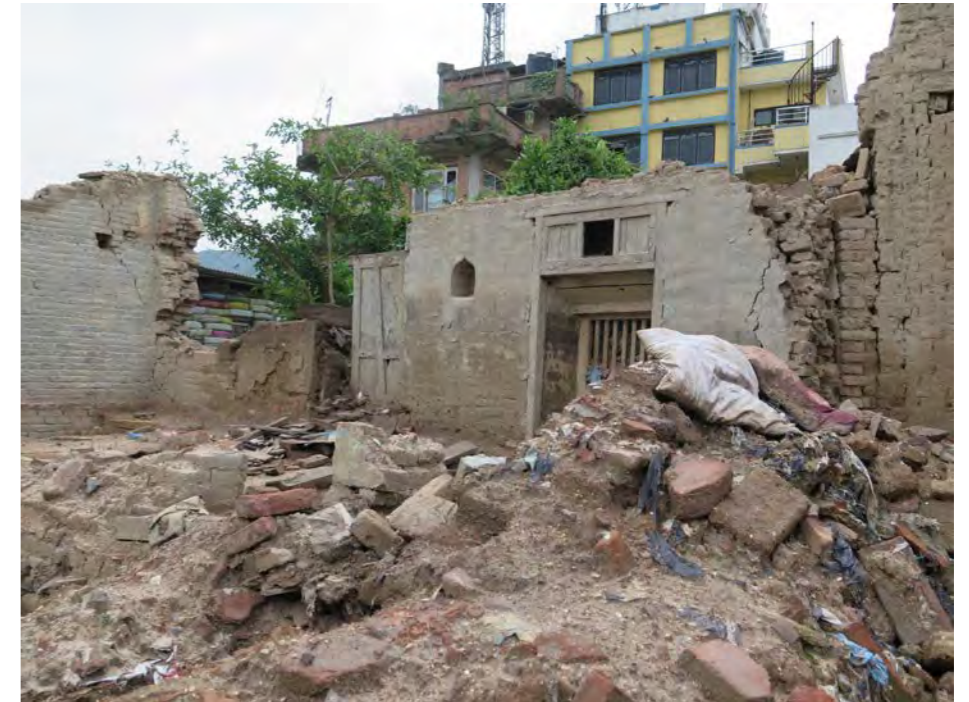
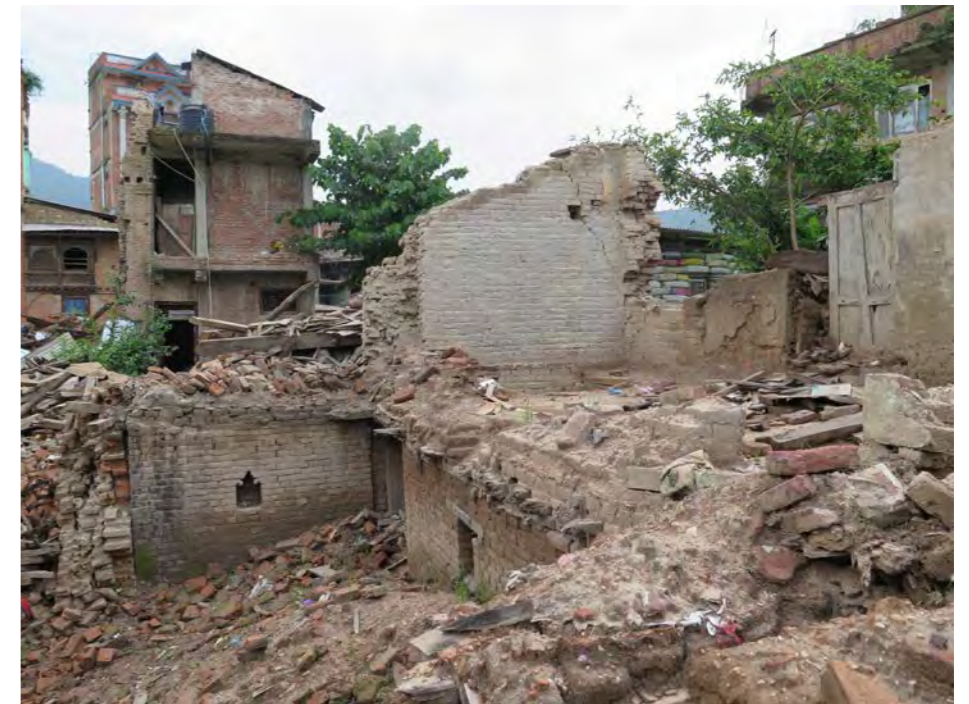
NUMBER	CONTACT	STOREY NO. RELATIVE POSITION	STRUCTURAL SYSTEM	PROBLEMS DESCRIPTION	DANGER	CONDITION
e04	Hridya Chandra Shrestha	G+3 (EH)	B+UnB	2 floors collapsed	⊗	+

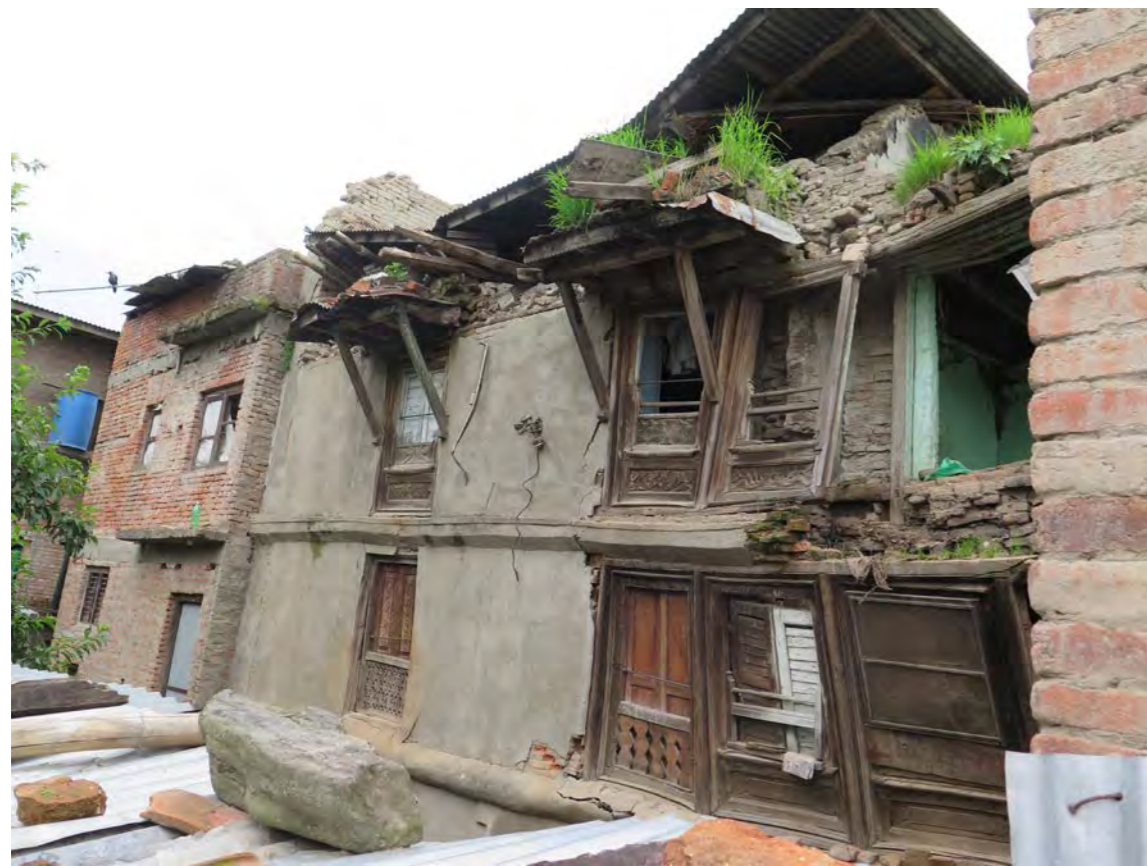
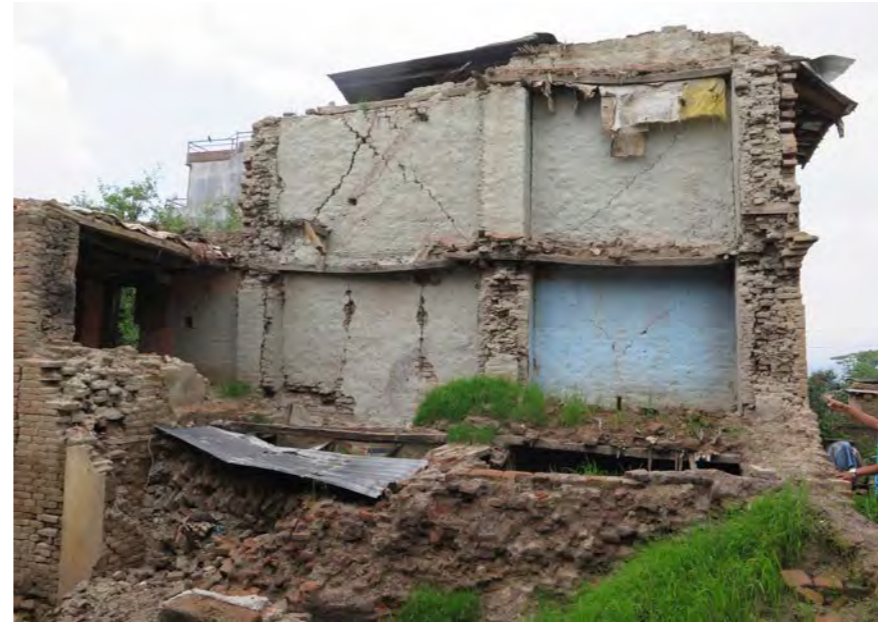
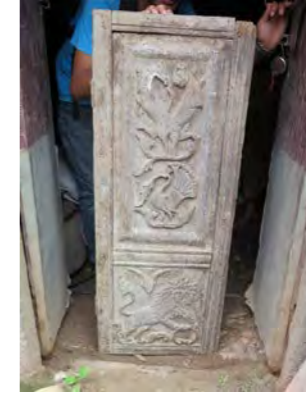
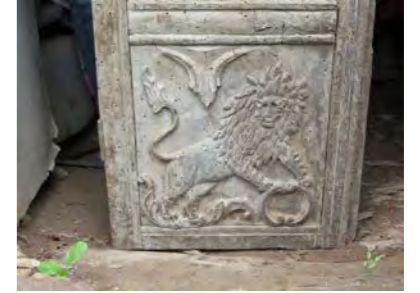
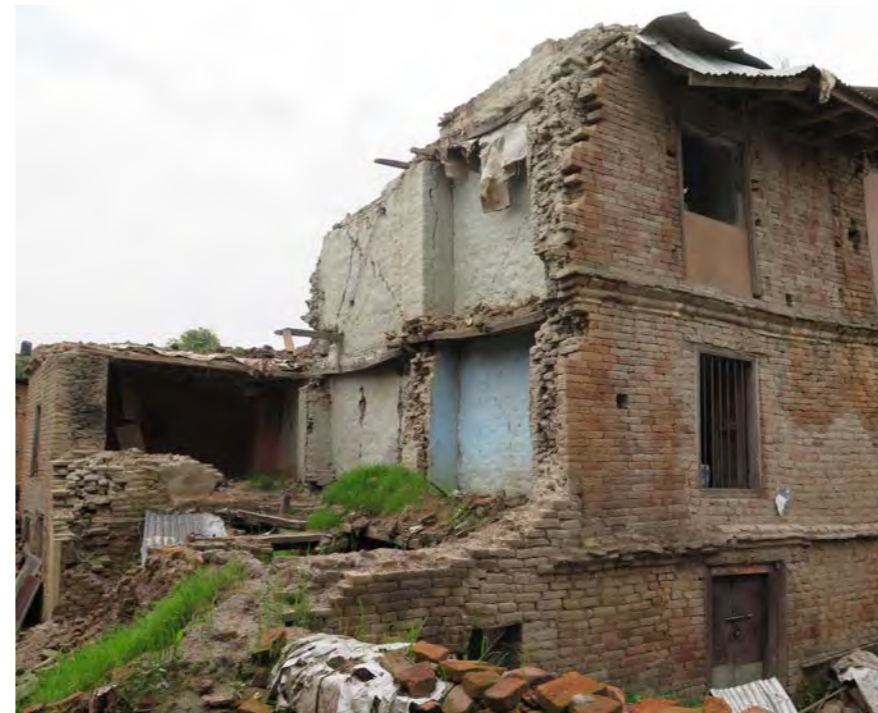
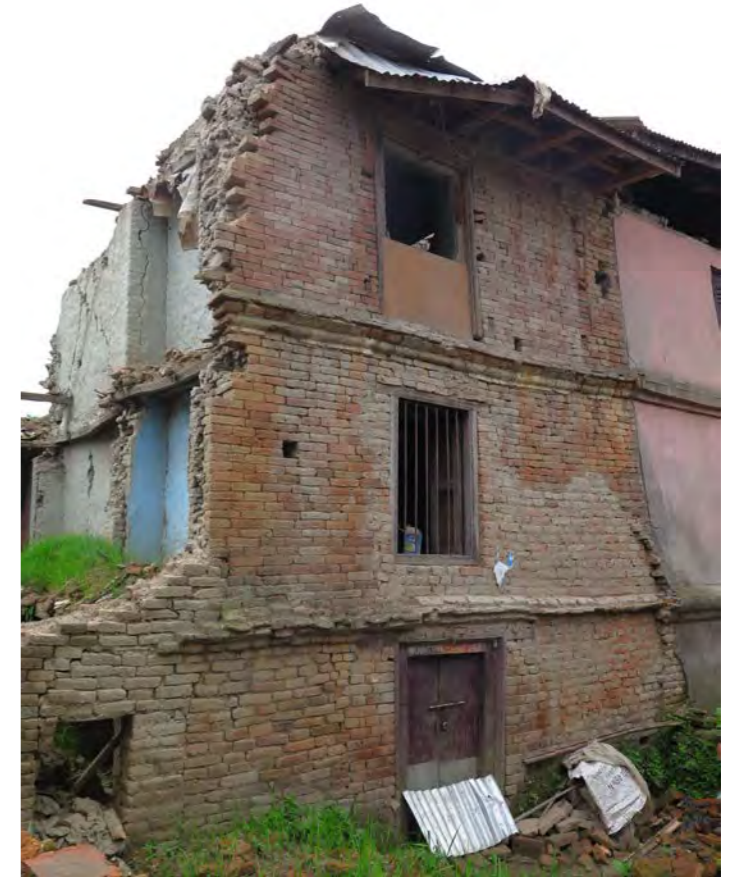
NUMBER	CONTACT	STOREY NO. RELATIVE POSITION	STRUCTURAL SYSTEM	PROBLEMS DESCRIPTION	DANGER	CONDITION	
e10	Durga Narayan Shrestha	G+4	B+UnB	2 floors collapsed. North part collapsed	1/2

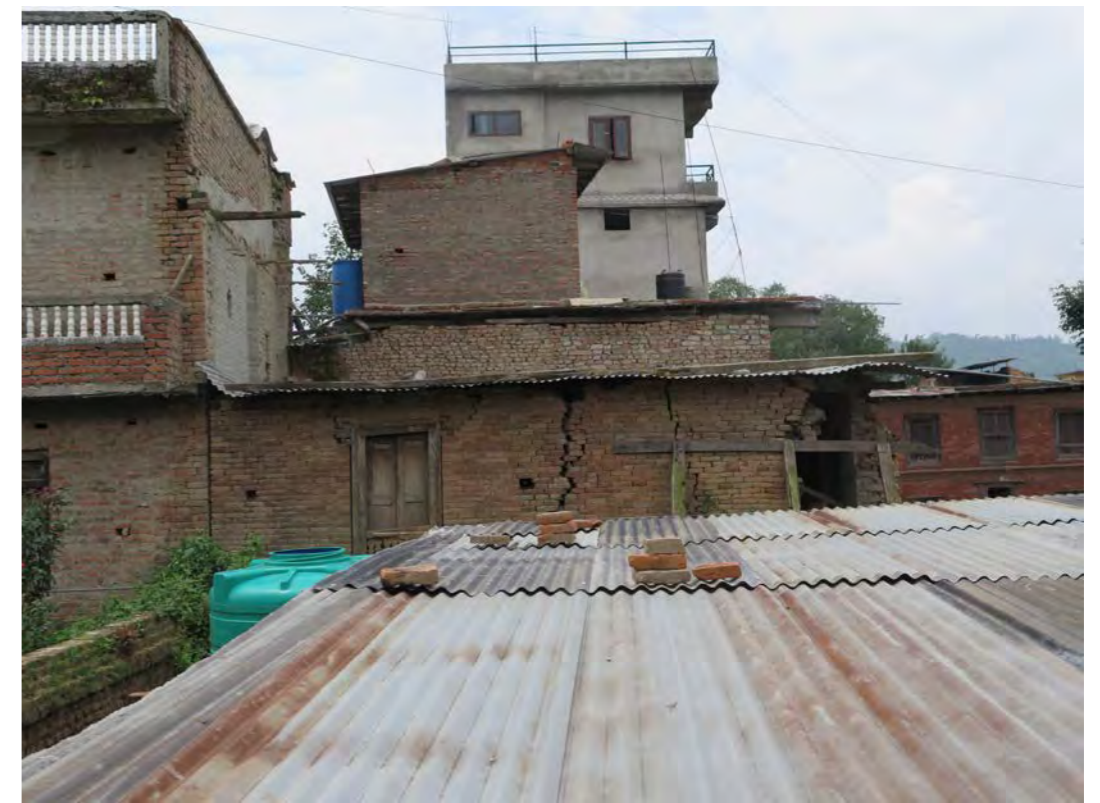
NUMBER	CONTACT	STOREY NO. RELATIVE POSITION	STRUCTURAL SYSTEM	PROBLEMS DESCRIPTION	DANGER	CONDITION	
e13	Gagan Bahadur Ranjit	G+4	B	Demolished to G+1 for reconstruction before earthquake. West wall collapsed. Vertical cracks on north wall.		+

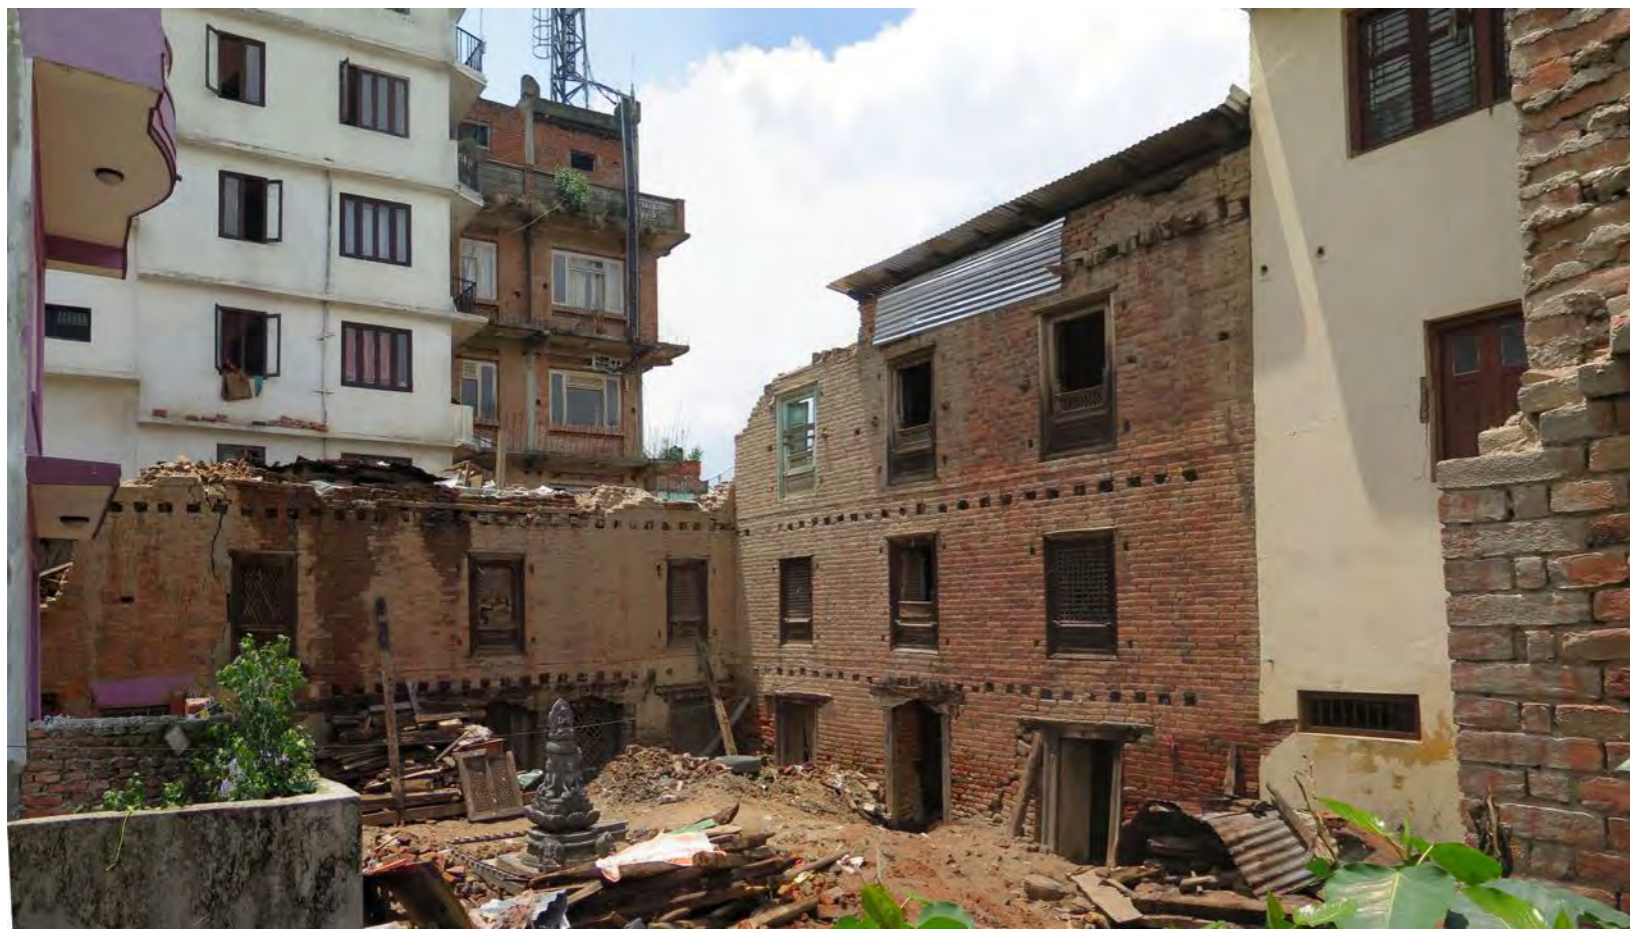
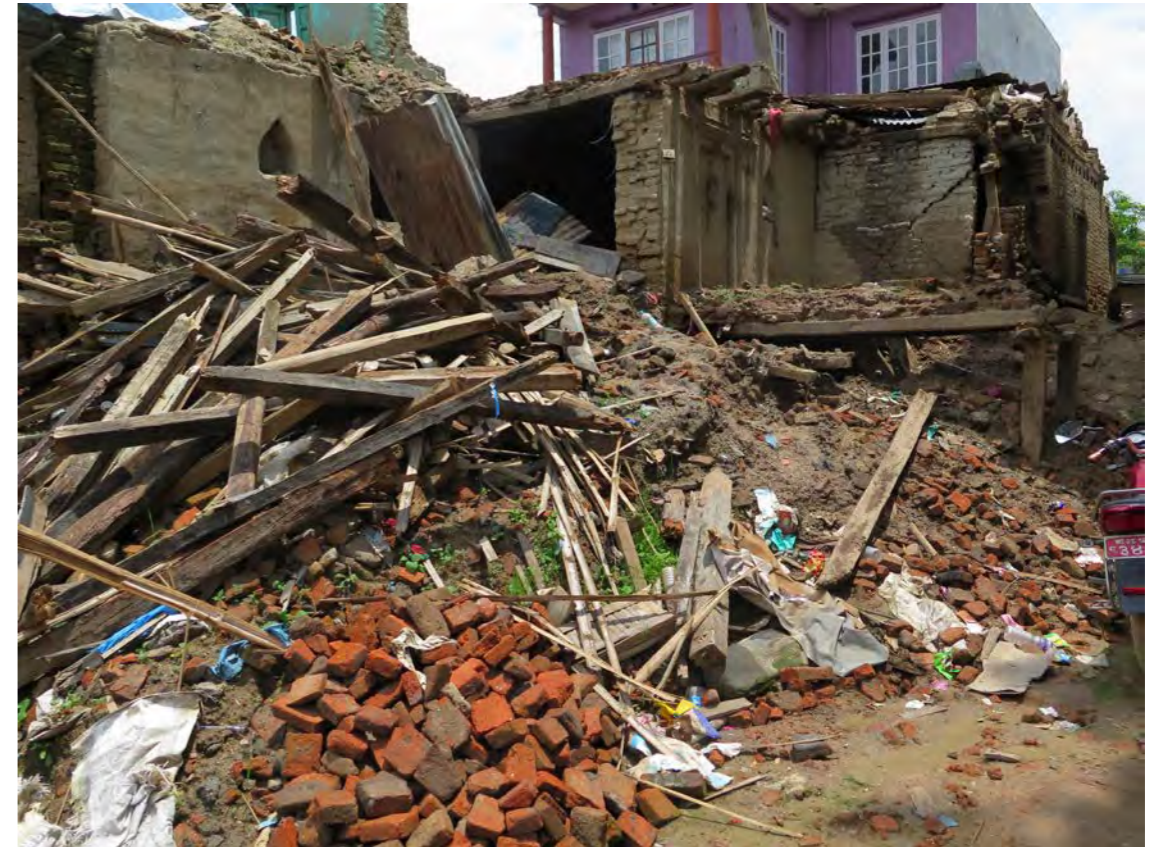
NUMBER	CONTACT	STOREY NO. RELATIVE POSITION	STRUCTURAL SYSTEM	PROBLEMS DESCRIPTION	DANGER	CONDITION	
e28	Ratna Kamal Baidya	G+3	B	Totally collapsed		R+

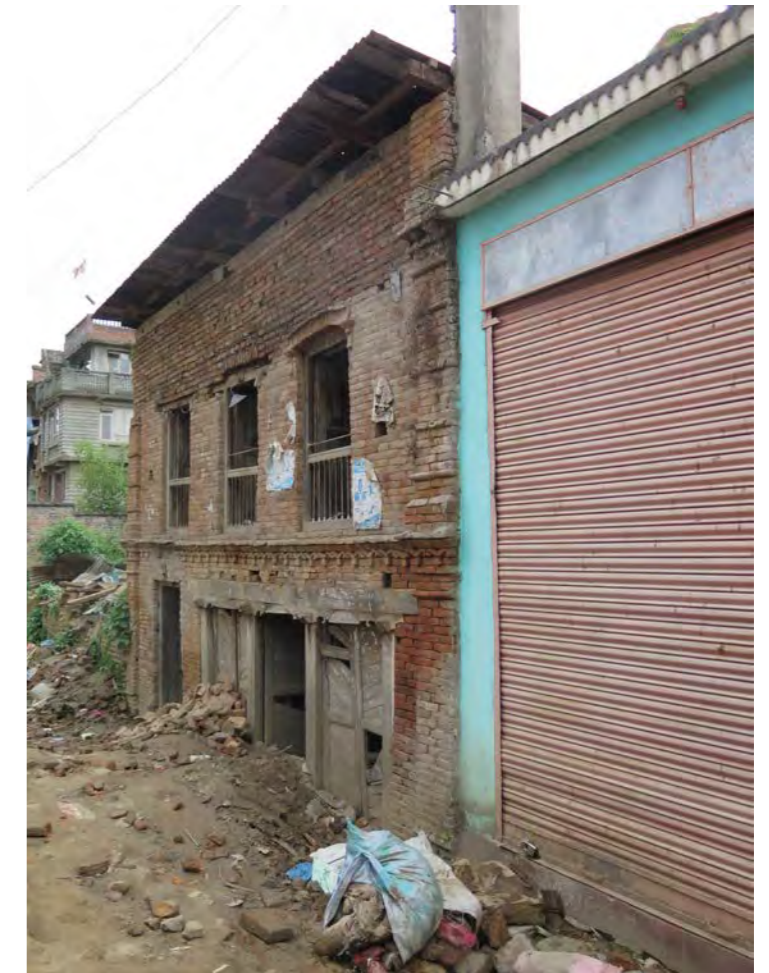
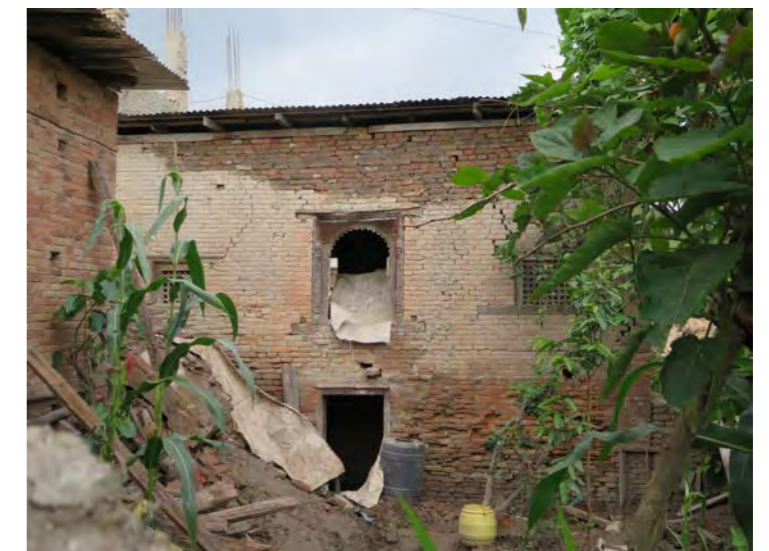
NUMBER	CONTACT	STOREY NO. RELATIVE POSITION	STRUCTURAL SYSTEM	PROBLEMS DESCRIPTION	DANGER	CONDITION
e36	Jhamak Shrestha	G+3 (EH)	B	2 floors collapsed. Vertical crack on North west and south east corner. North wall buldging. Ground floor doors damaged. Rising damp.

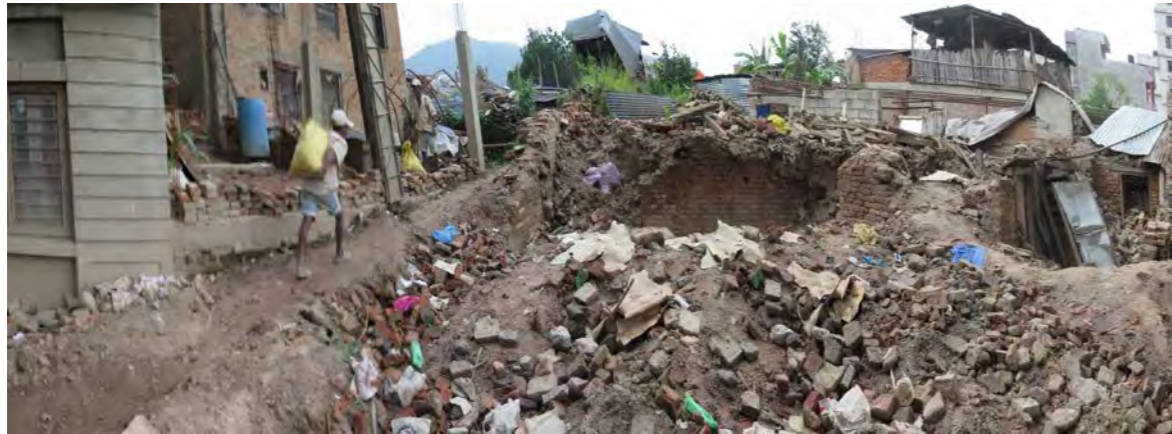
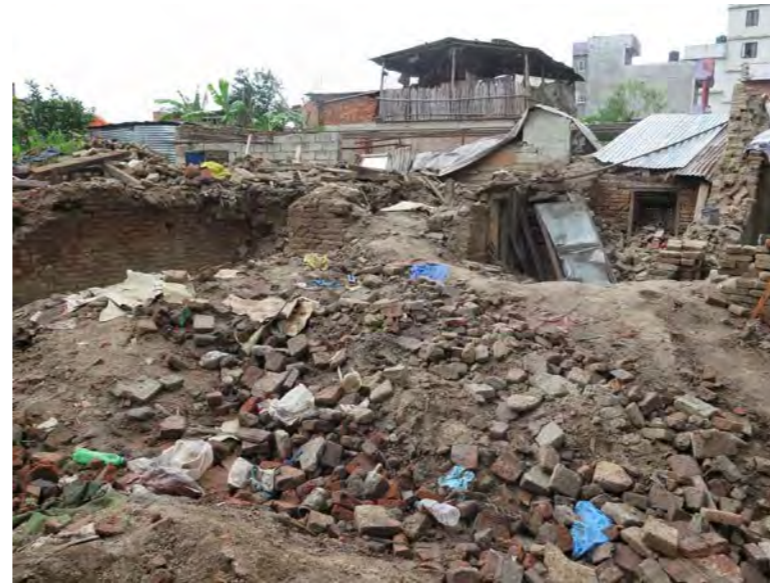
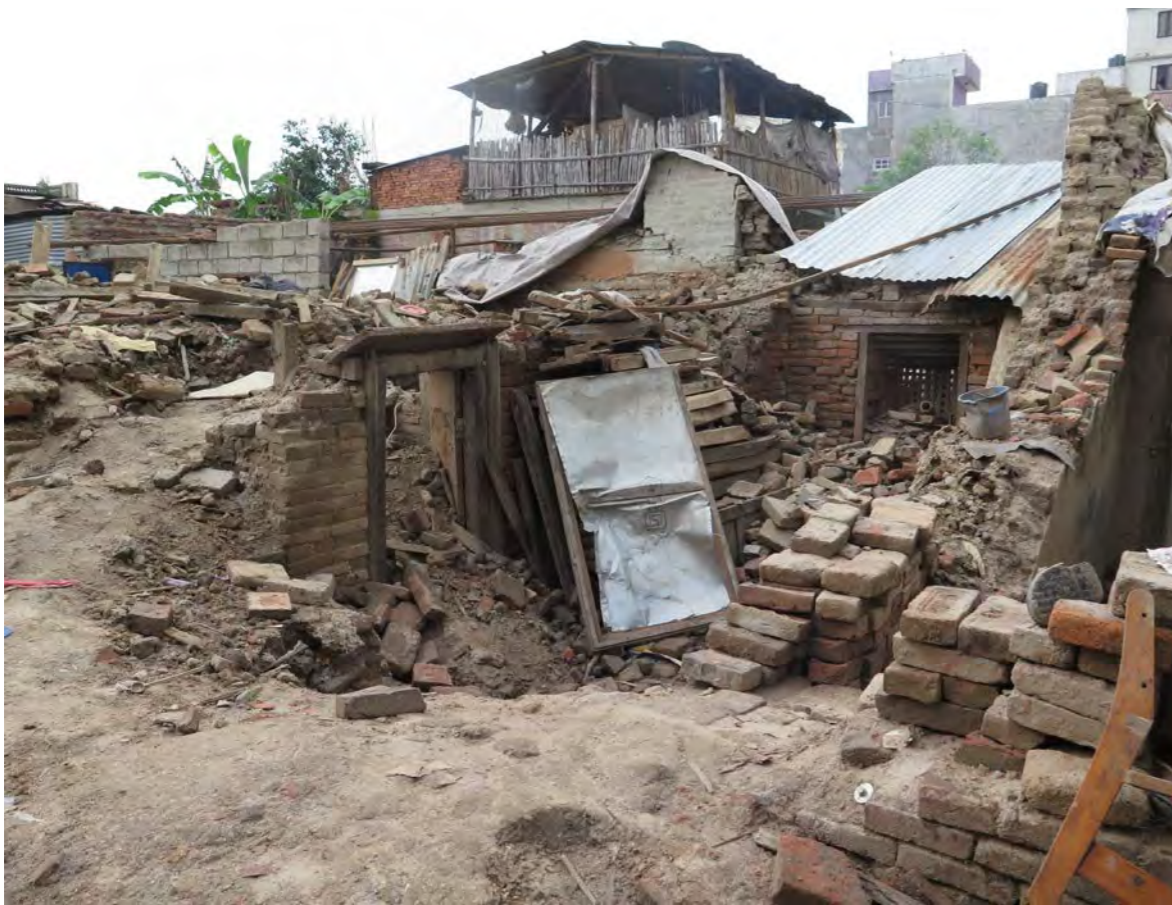
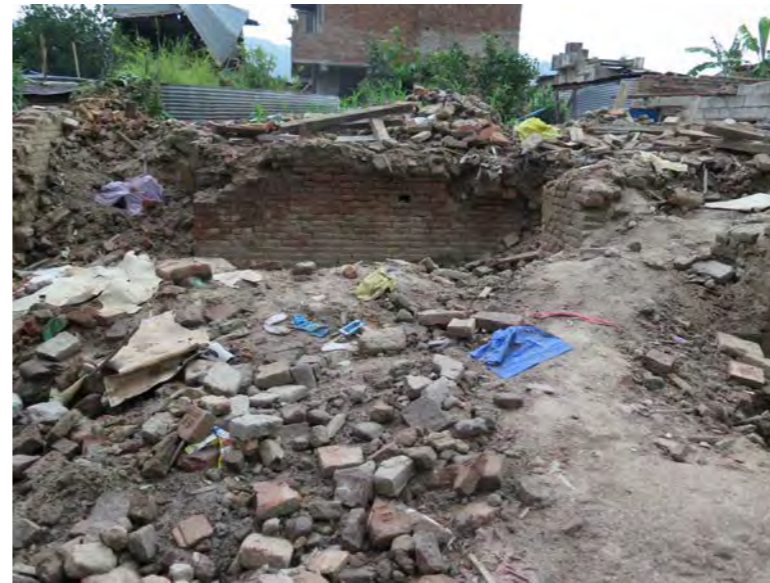
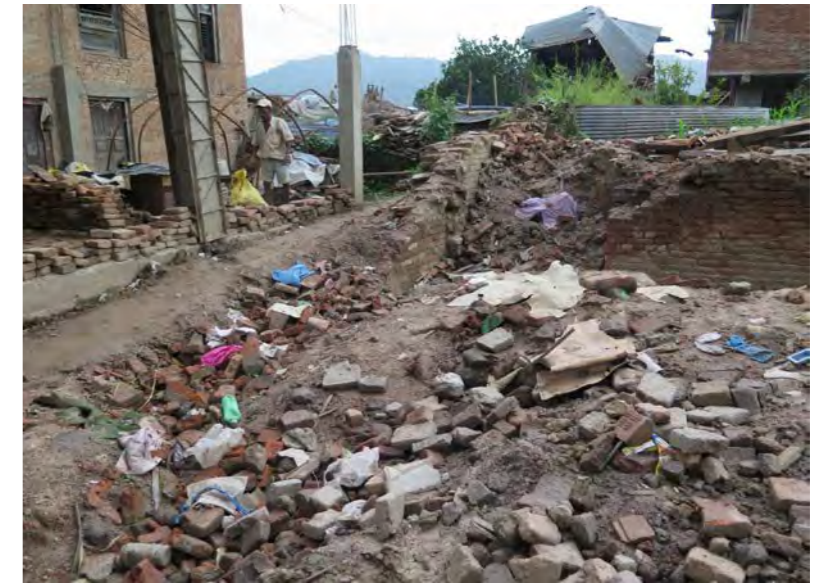
NUMBER	CONTACT	STOREY NO. RELATIVE POSITION	STRUCTURAL SYSTEM	PROBLEMS DESCRIPTION	DANGER	CONDITION	
e38	Bhim Bahadur Shrestha	G+4	B	Totally collapsed	⊗	+

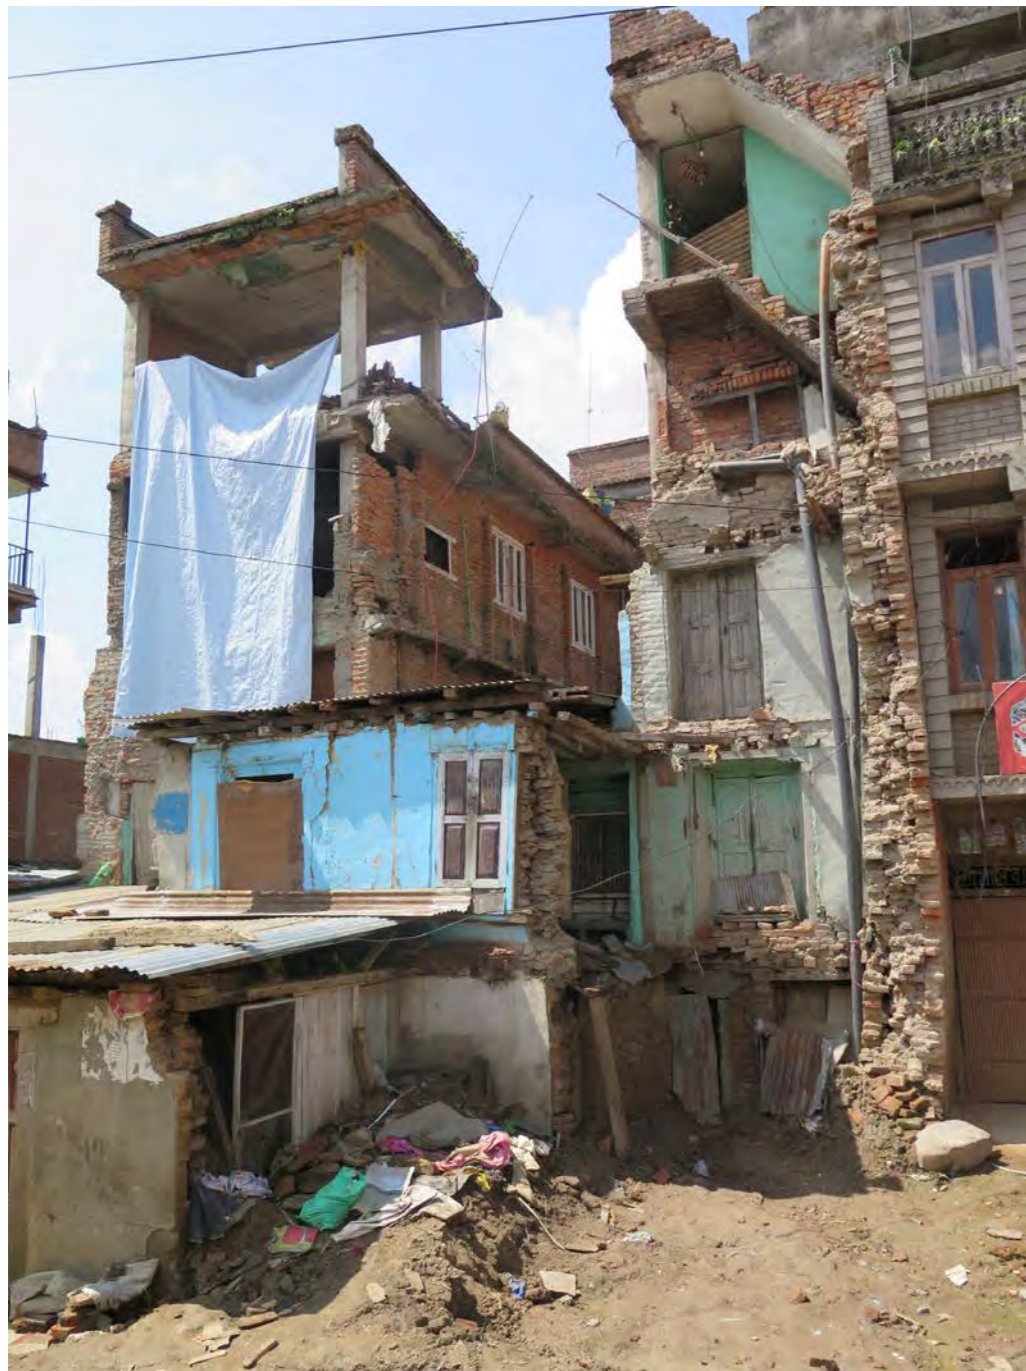
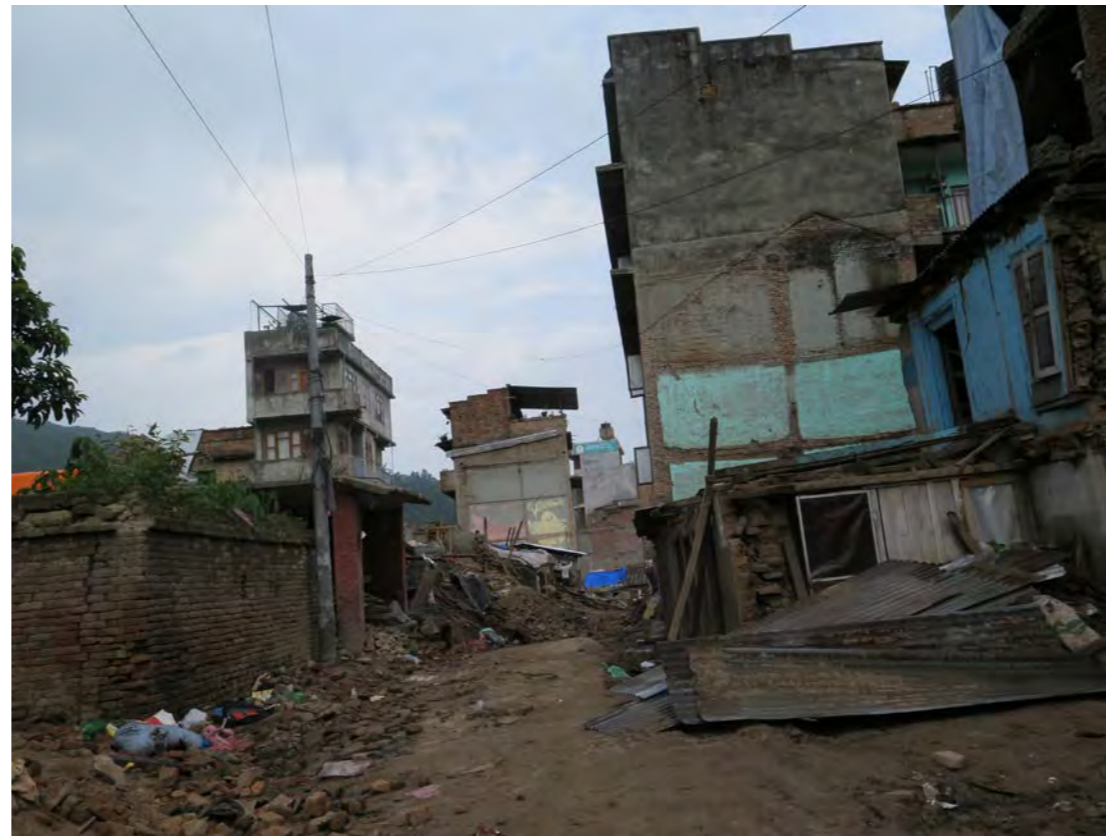
NUMBER	CONTACT	STOREY NO. RELATIVE POSITION	STRUCTURAL SYSTEM	PROBLEMS DESCRIPTION	DANGER	CONDITION
e42	Prakash Man Shrestha (9841496235)	G+4	B	Totally collapsed	⊗	+
