2015 Earthquake Damage Mapping

Sankhu

October 2015

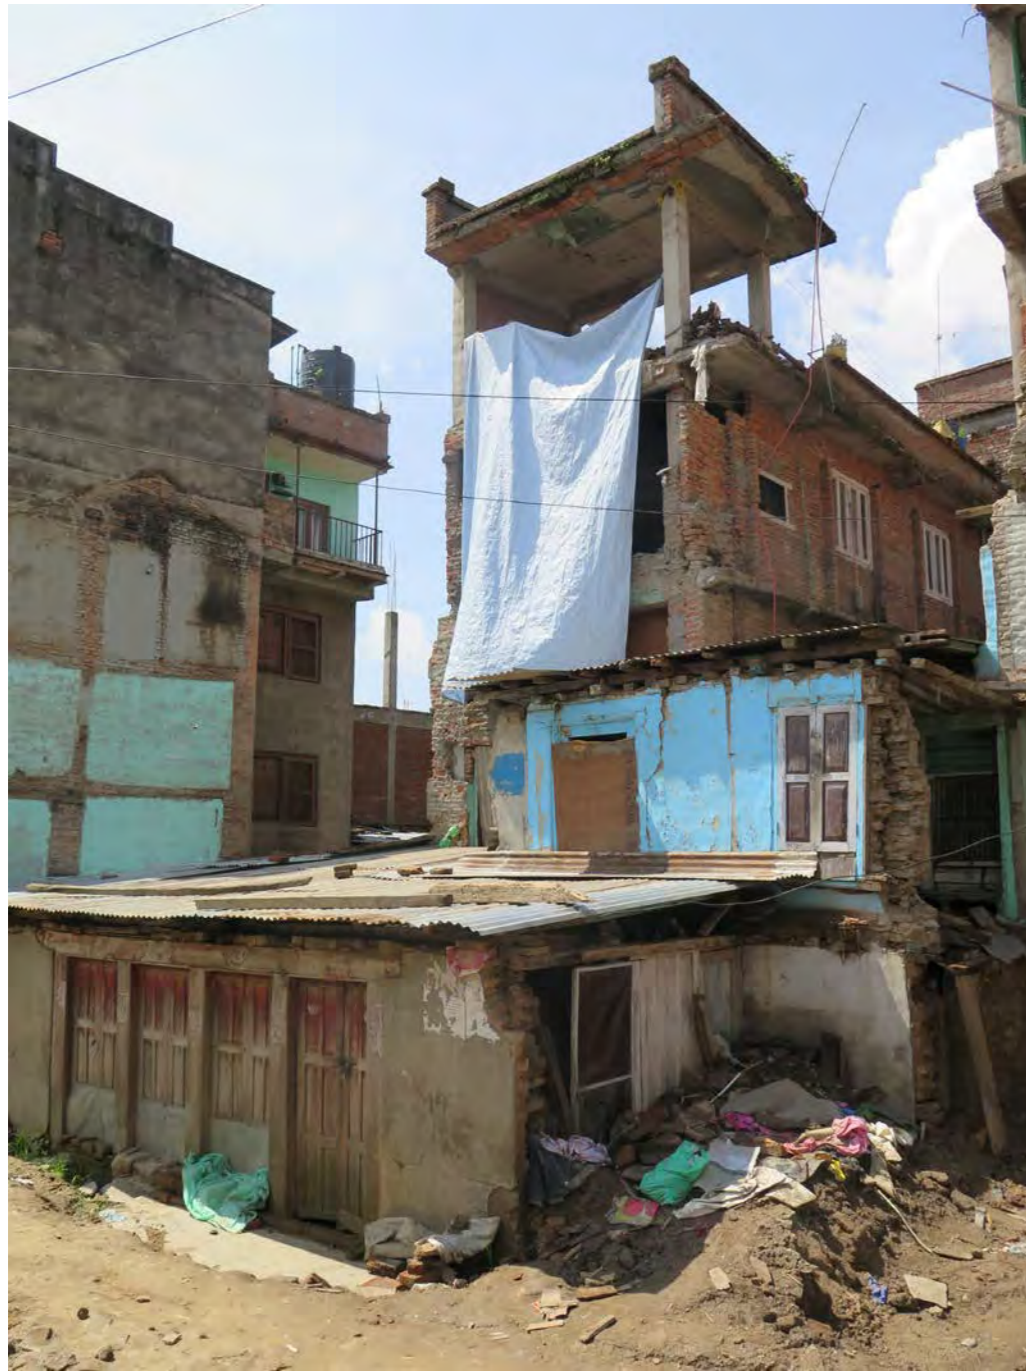
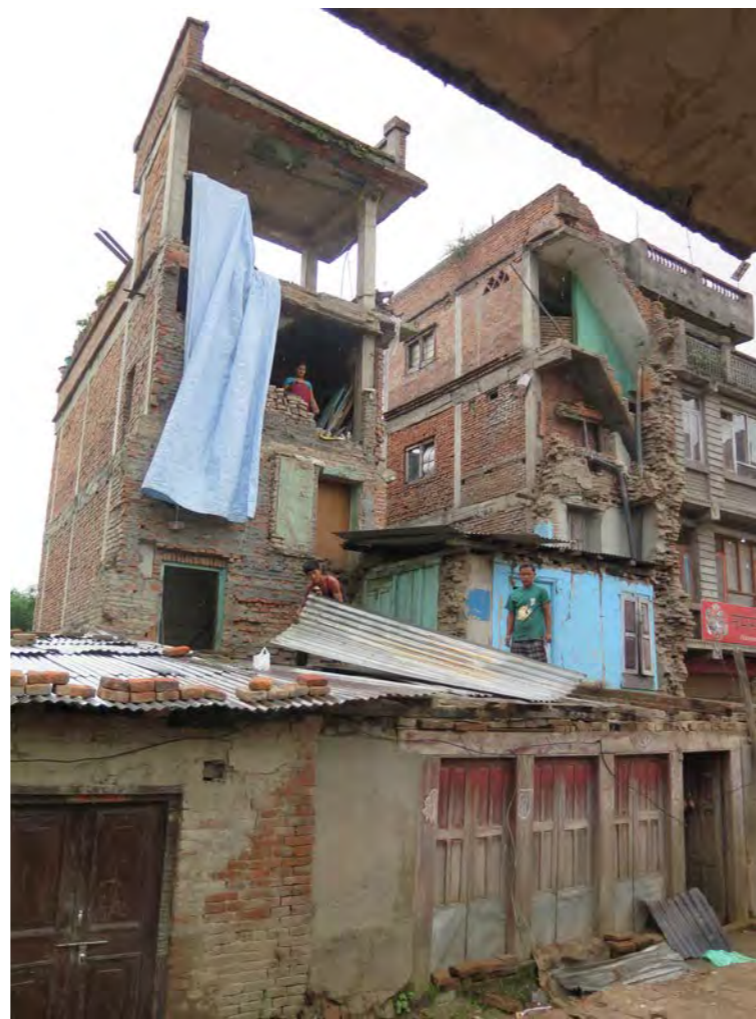
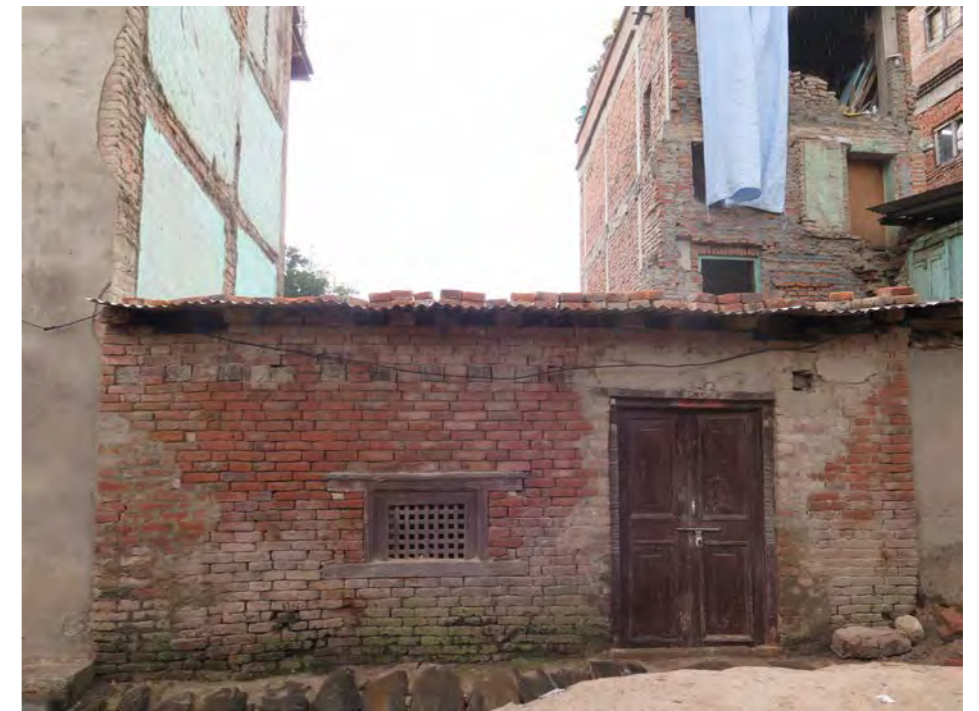
e43, e45

NUMBER	CONTACT	STOREY NO. RELATIVE POSITION	STRUCTURAL SYSTEM	PROBLEMS DESCRIPTION	DANGER	CONDITION
e43	Sanjay Shrestha	G+4	B	2 floors collapsed. Remaining in deleptated condition.	⊗	+
e45	Nati Kaji Shrestha	G+3	B	3 floors collapsed. Rising damp.	⊗	+

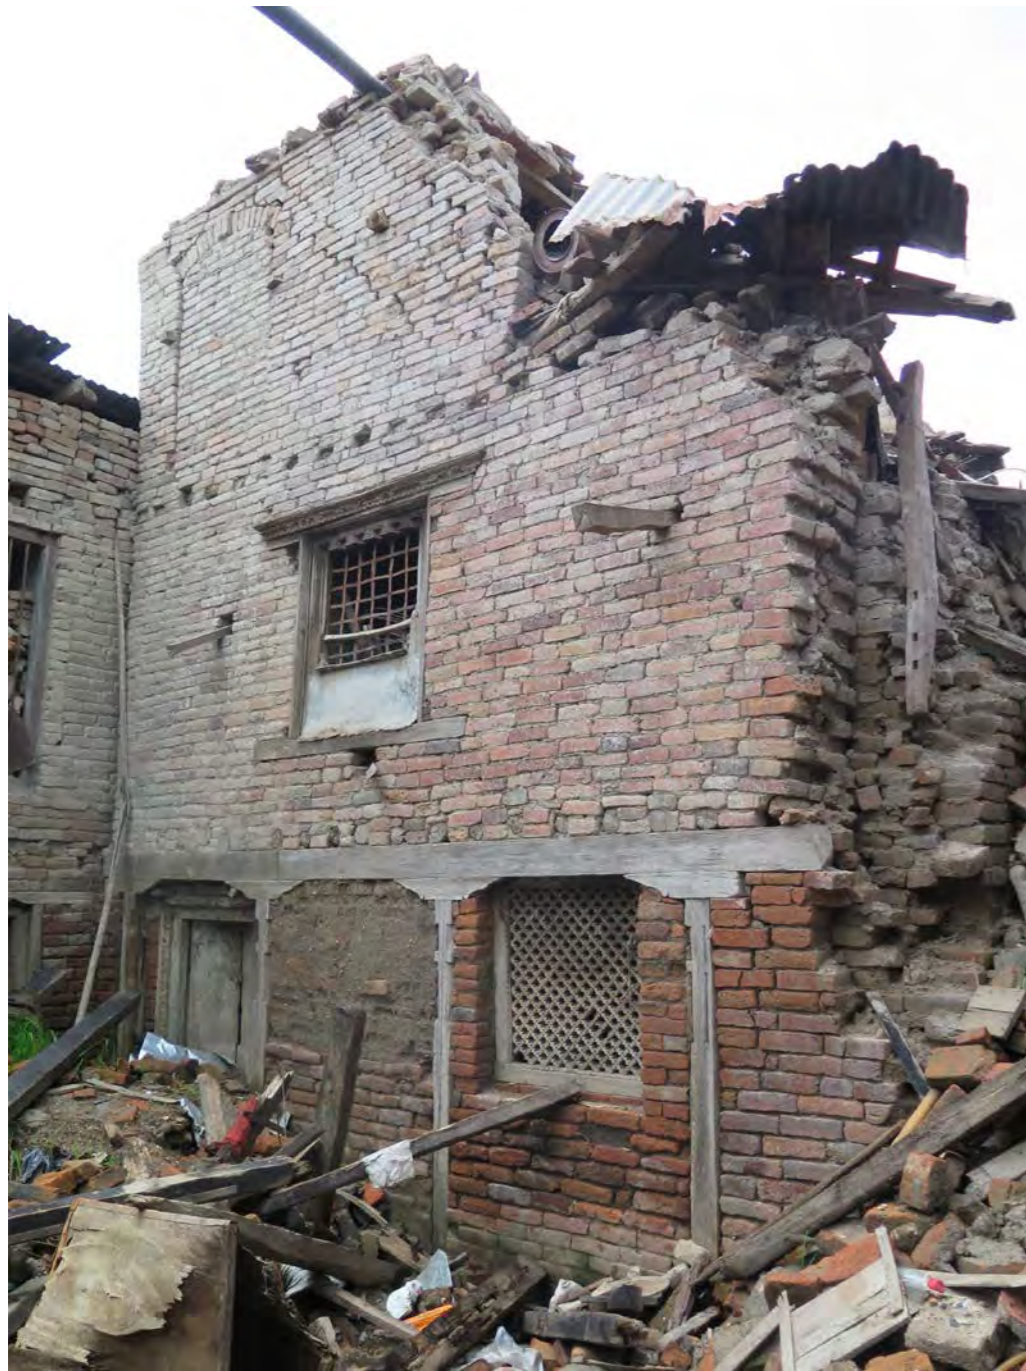
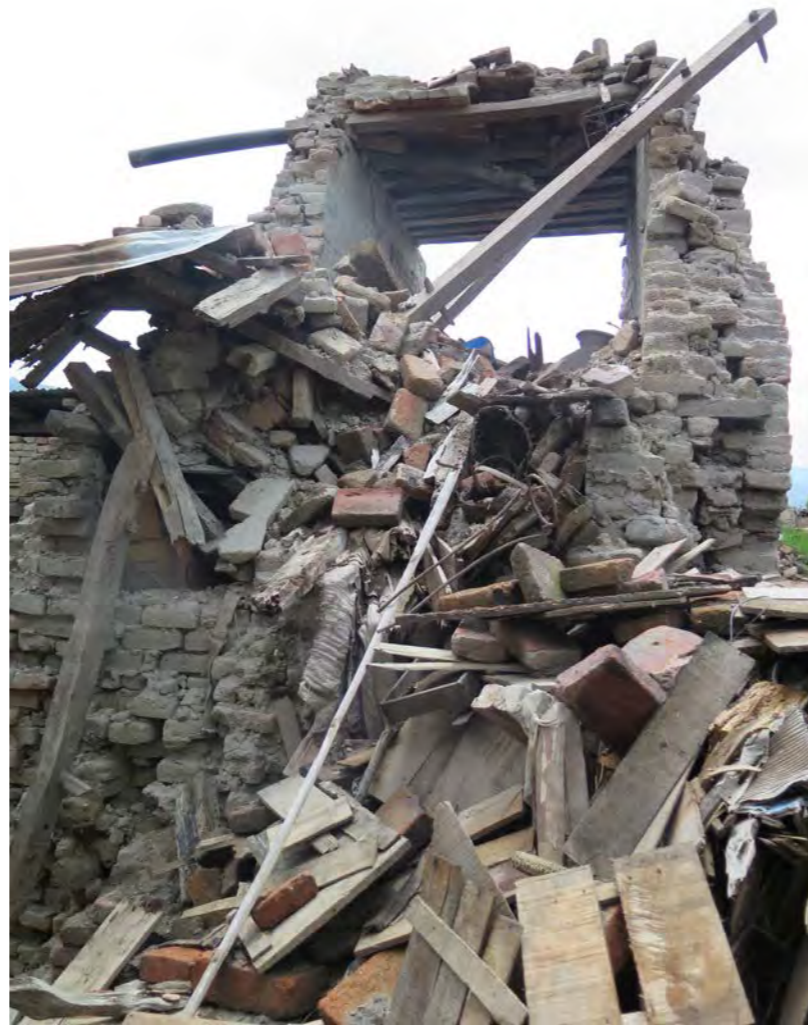
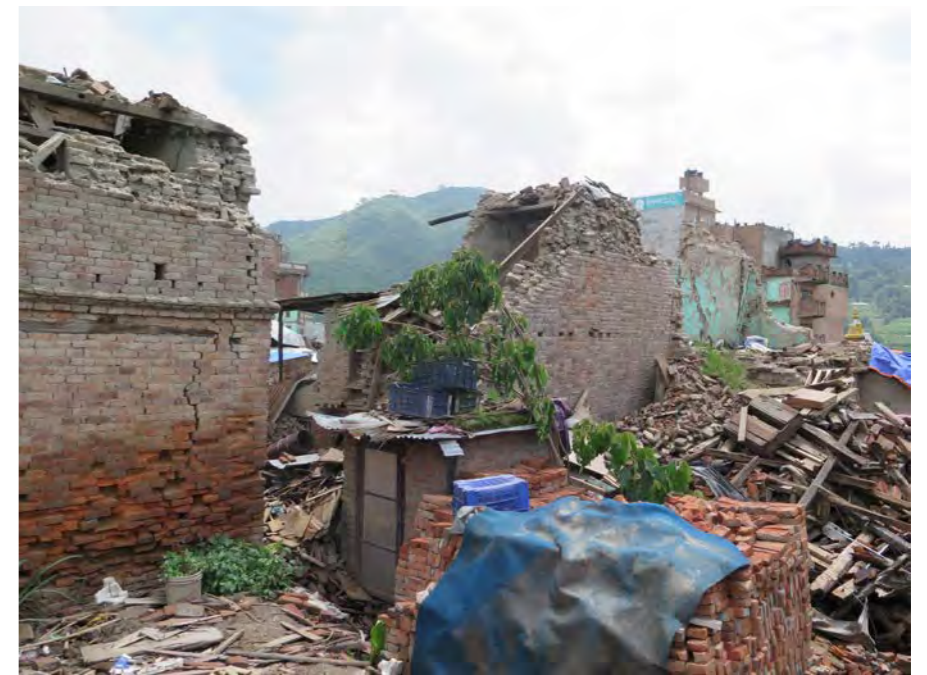
NUMBER	CONTACT	STOREY NO. RELATIVE POSITION	STRUCTURAL SYSTEM	PROBLEMS DESCRIPTION	DANGER	CONDITION
e61	Bishnu Malla	G+3 (EH)	B	East part totally collapsed. Western part upto 1 floor collapsed.	⚠️ 1/2 ❌	R+

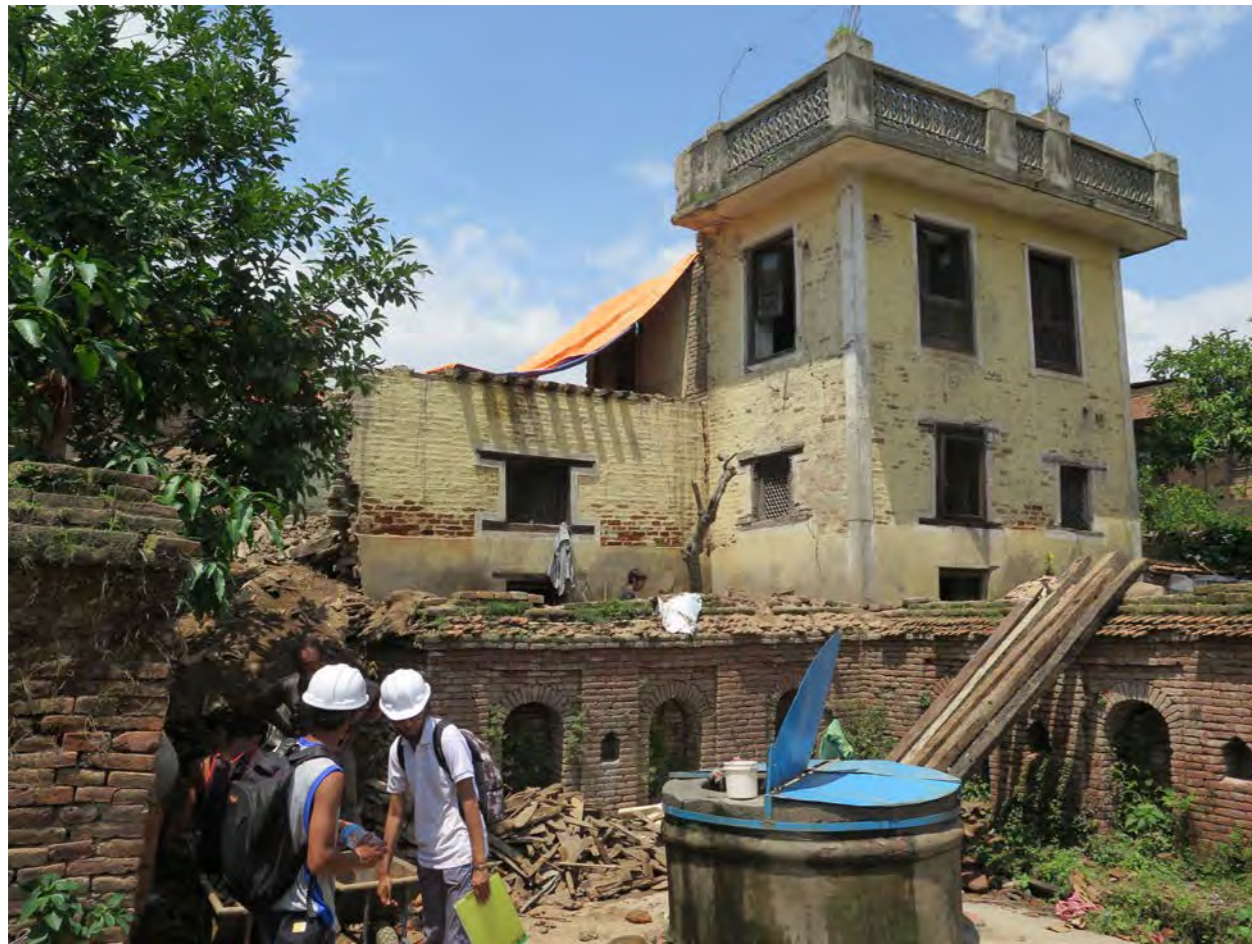
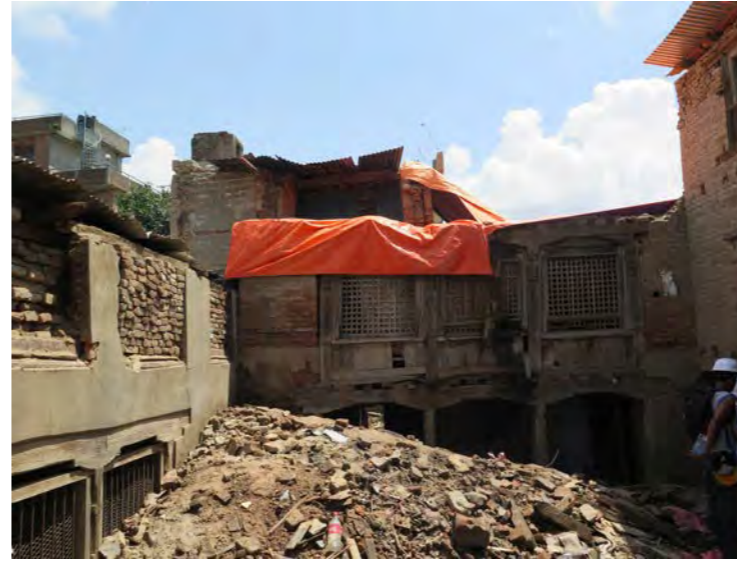
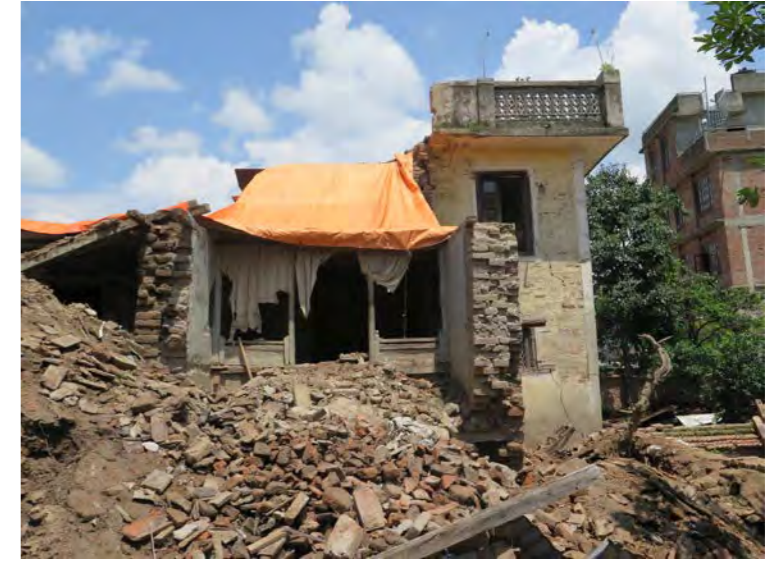
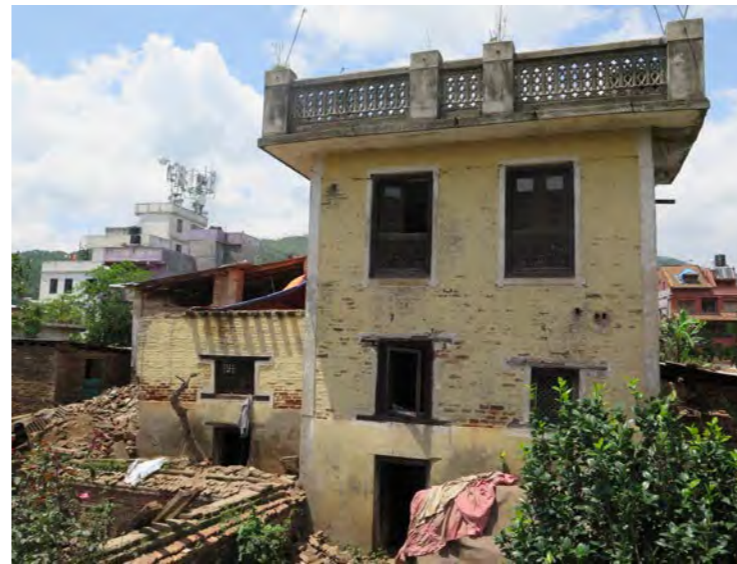
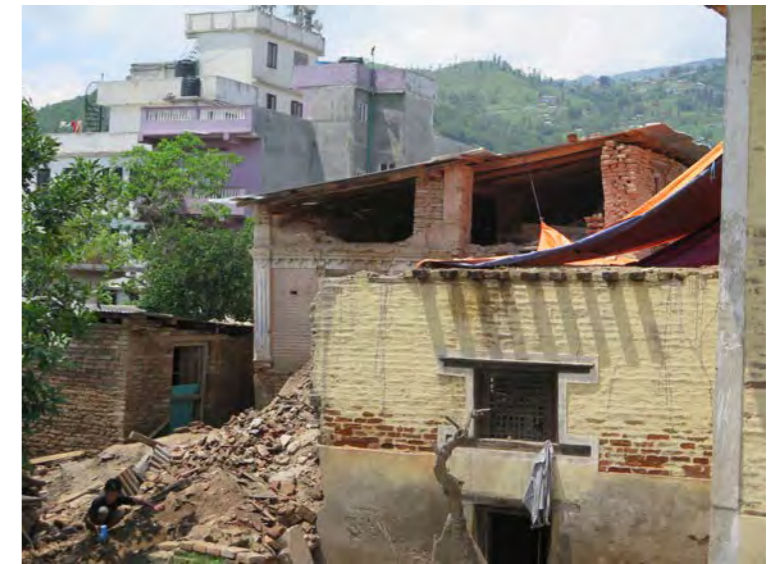
NUMBER	CONTACT	STOREY NO. RELATIVE POSITION	STRUCTURAL SYSTEM	PROBLEMS DESCRIPTION	DANGER	CONDITION	
e93	Umesh Man Shrestha (9841230004)	G+3	B+C Roof	1 floor collapsed in North. East wall collapsed till ground	⚠ 1/2 ☒	+

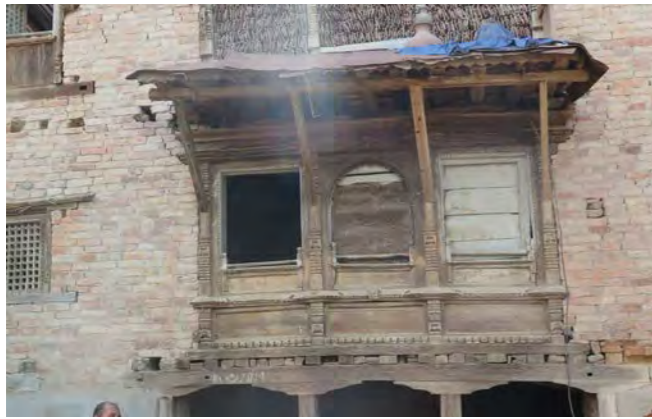
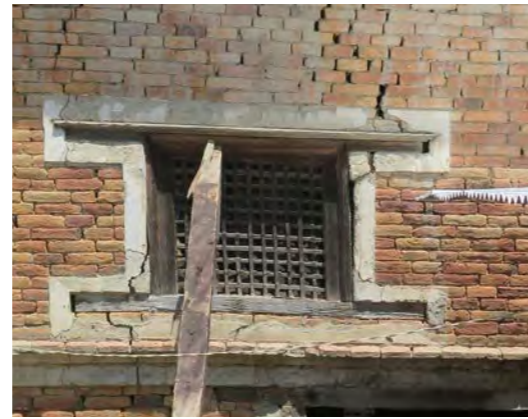
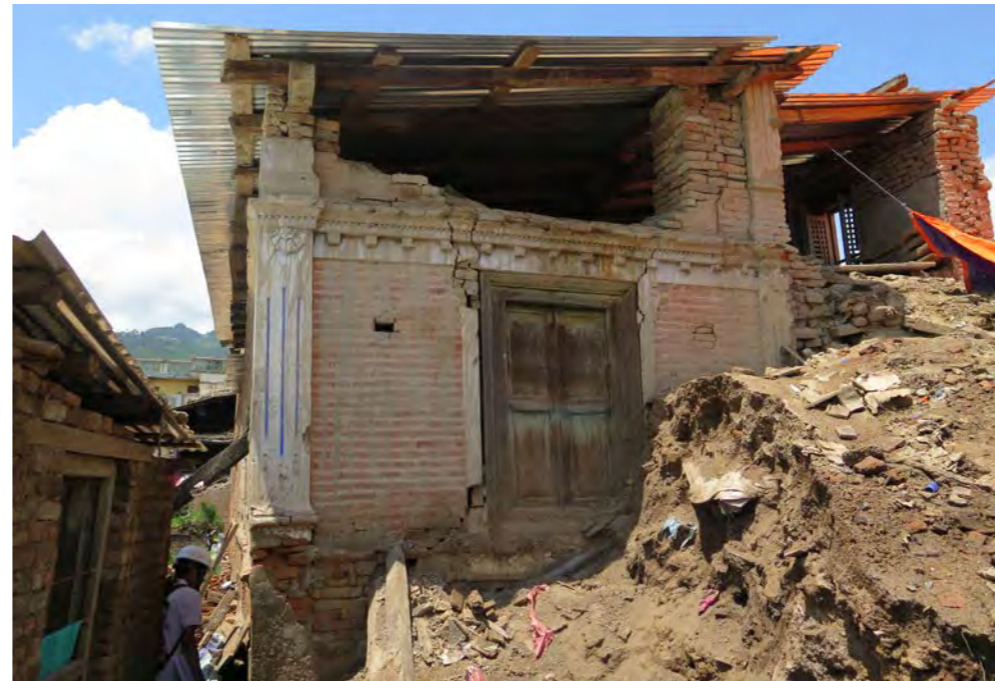
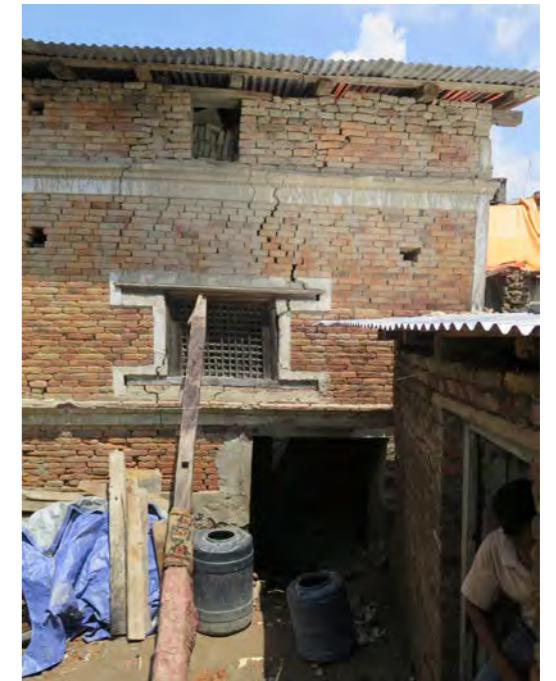
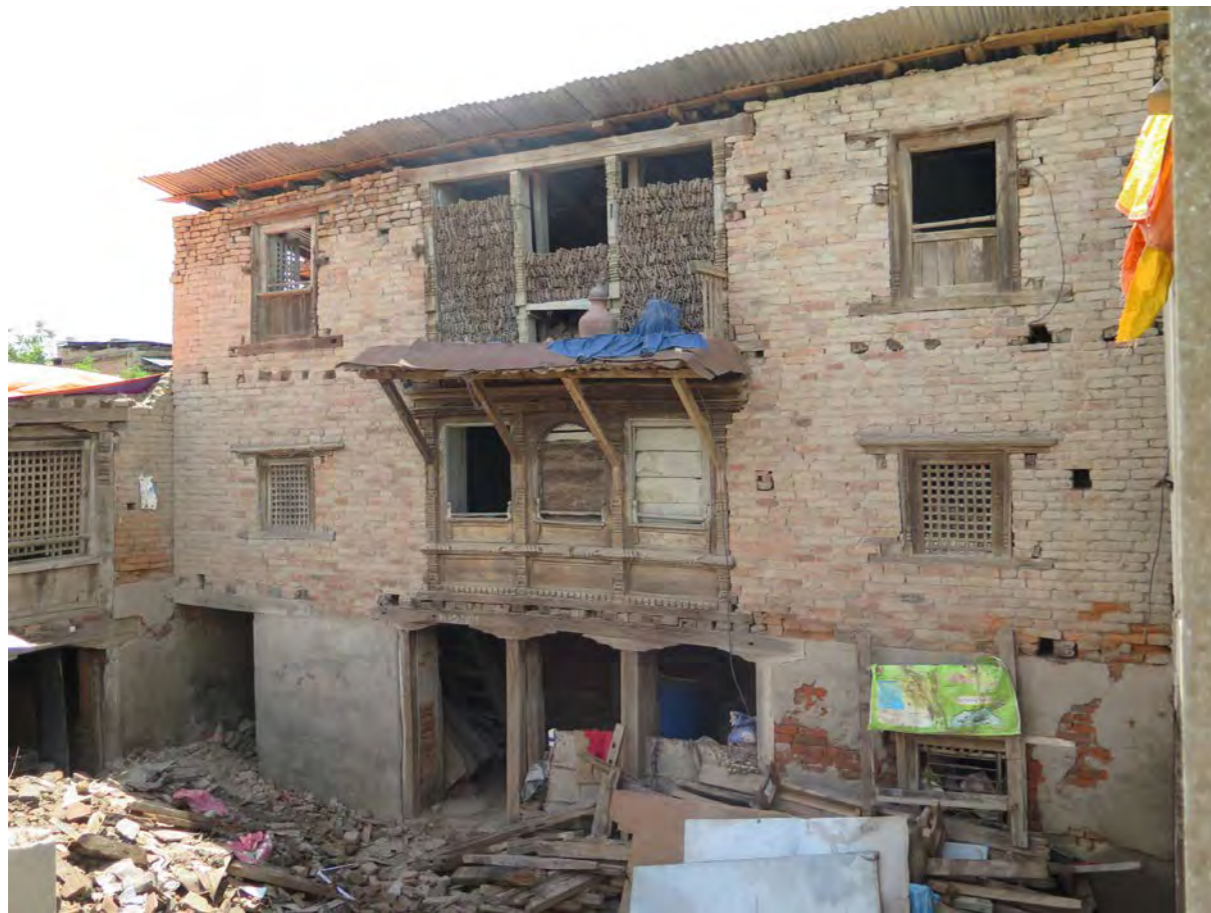
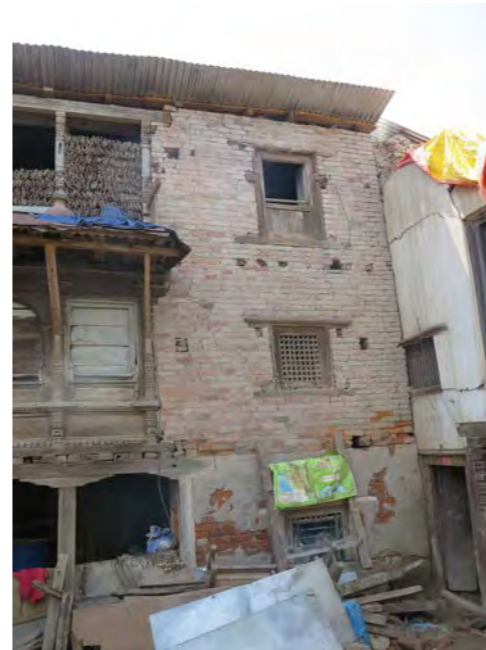
NUMBER	CONTACT	STOREY NO. RELATIVE POSITION	STRUCTURAL SYSTEM	PROBLEMS DESCRIPTION	DANGER	CONDITION	
e94	Kamal Shrestha	G+3	B	1 floor collapsed. Minor cracks on north wall. Rising damp on ground floor to great extent. Building tilting to North. Vertical cracks on west	1/2	W +

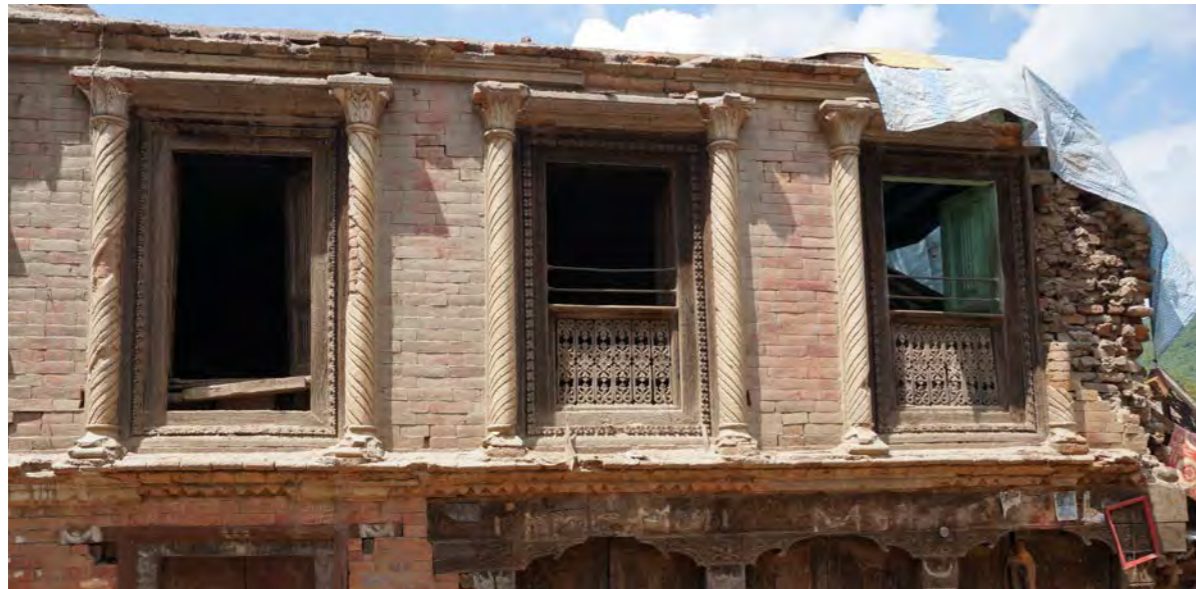
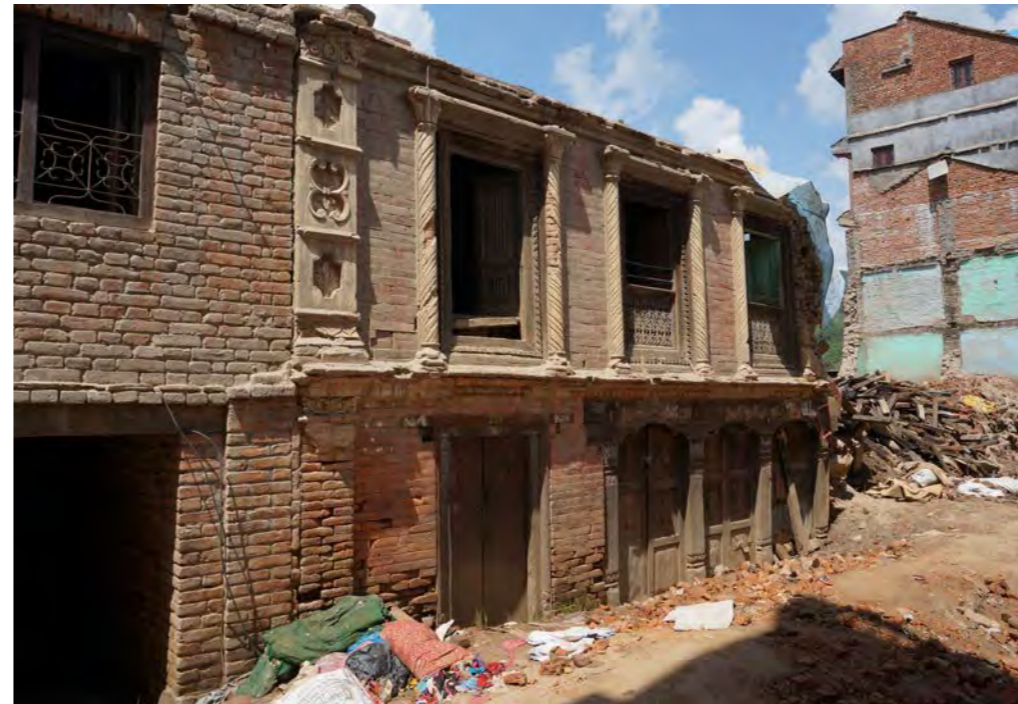
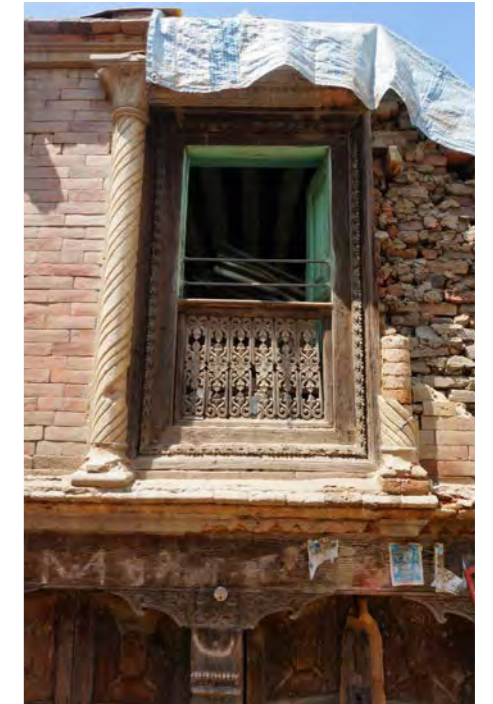
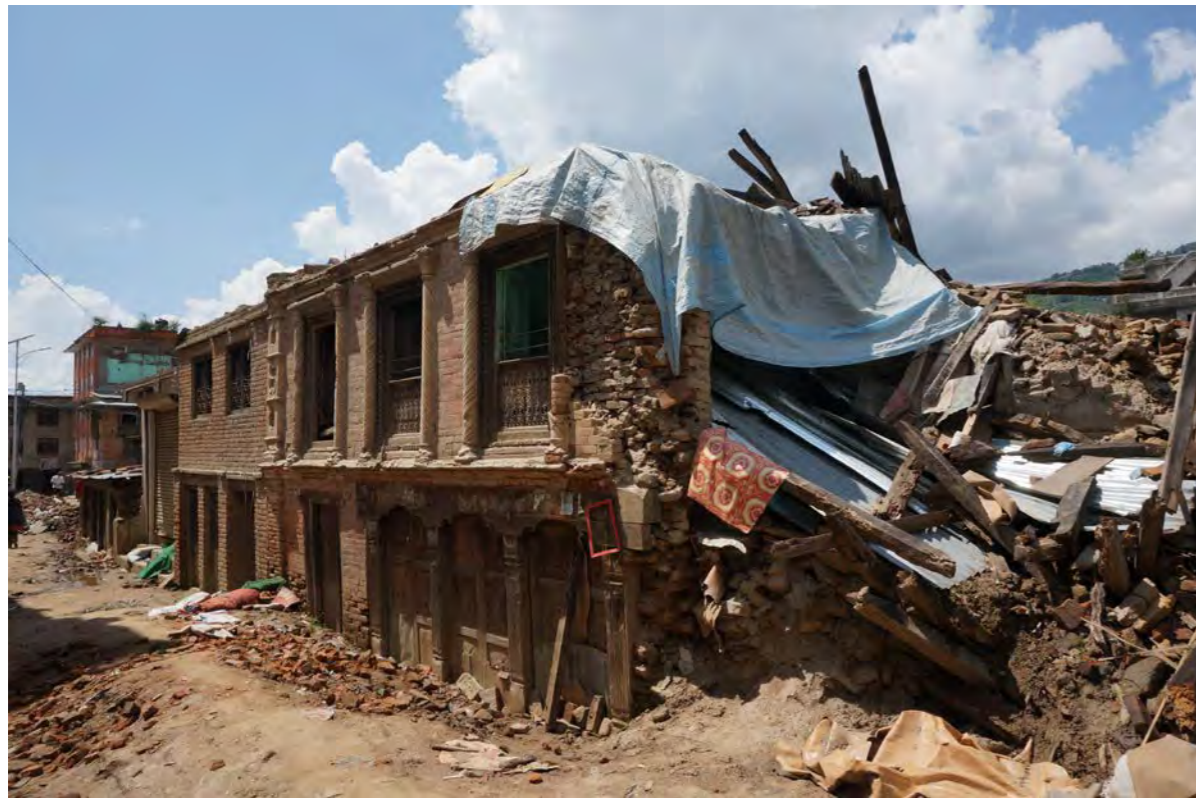
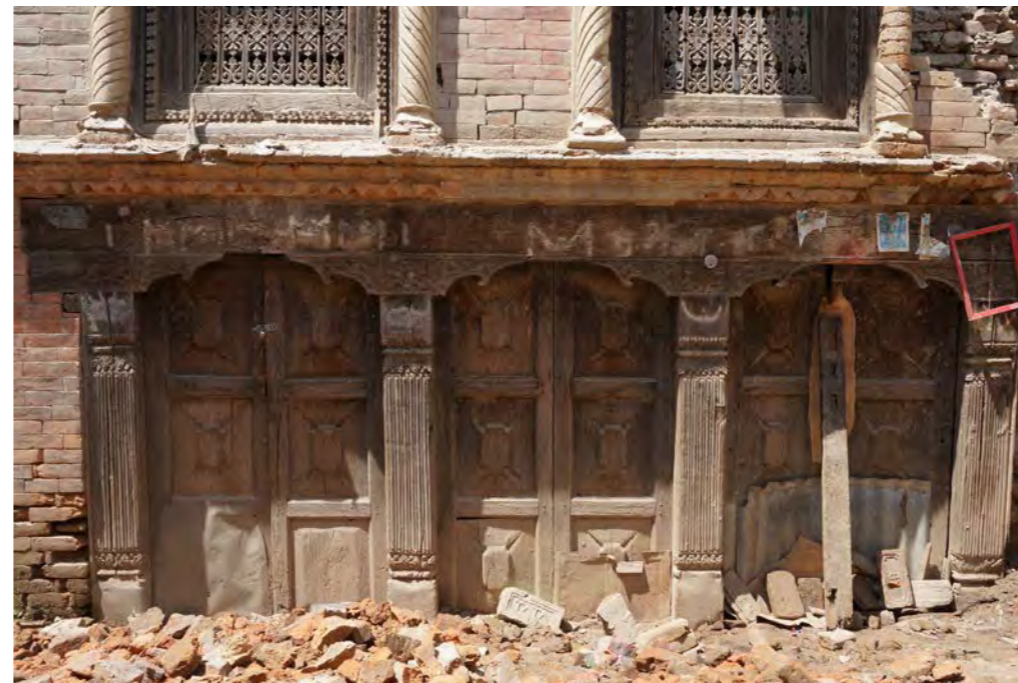
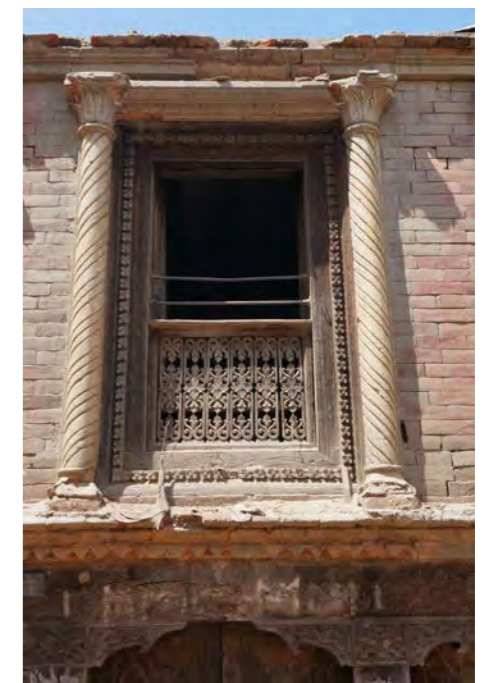
NUMBER	CONTACT	STOREY NO. RELATIVE POSITION	STRUCTURAL SYSTEM	PROBLEMS DESCRIPTION	DANGER	CONDITION
f19	Hari Narayan Napit	G+3	UnB + B	Totally Collapsed		+

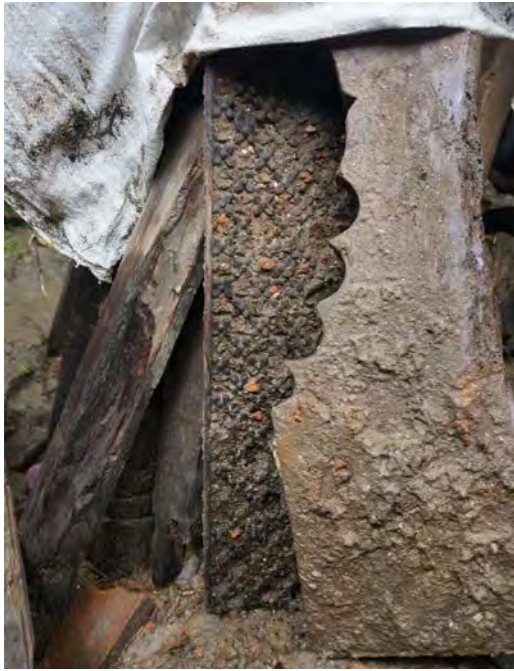
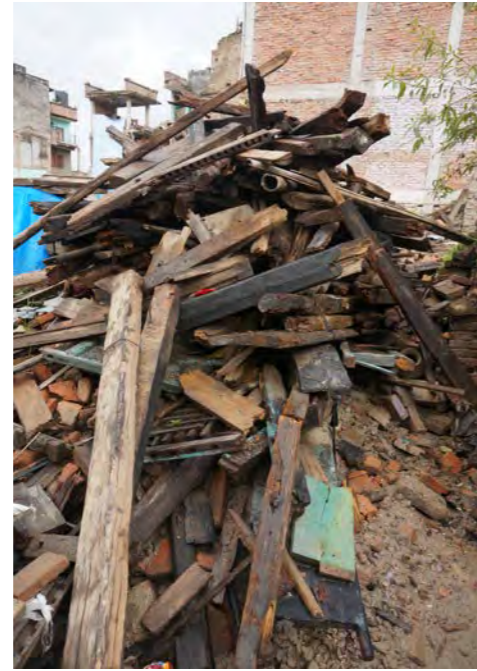
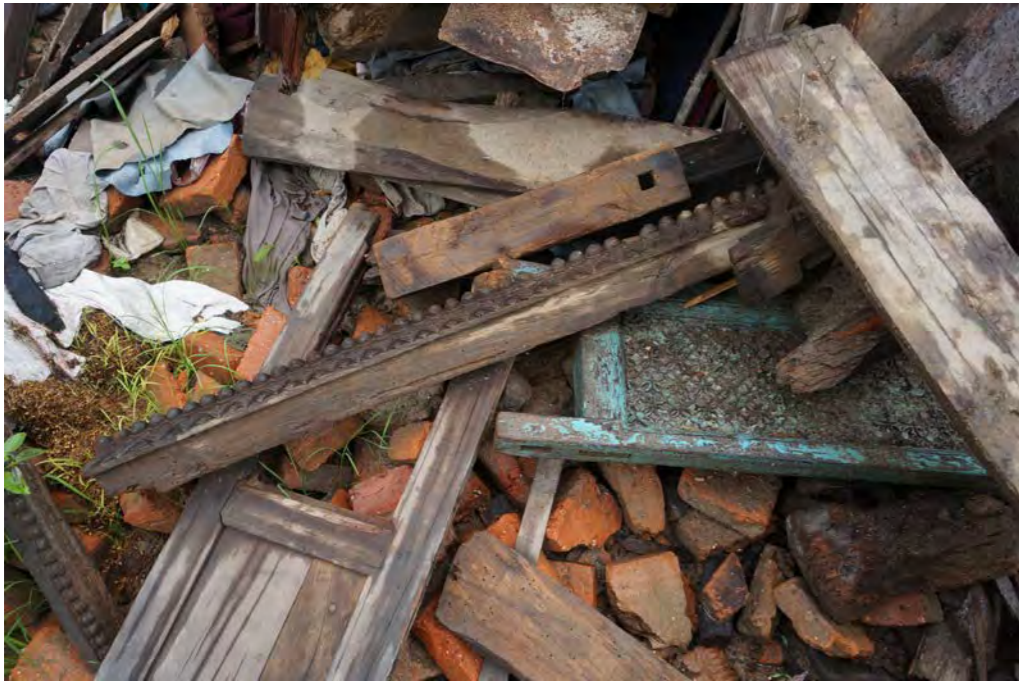
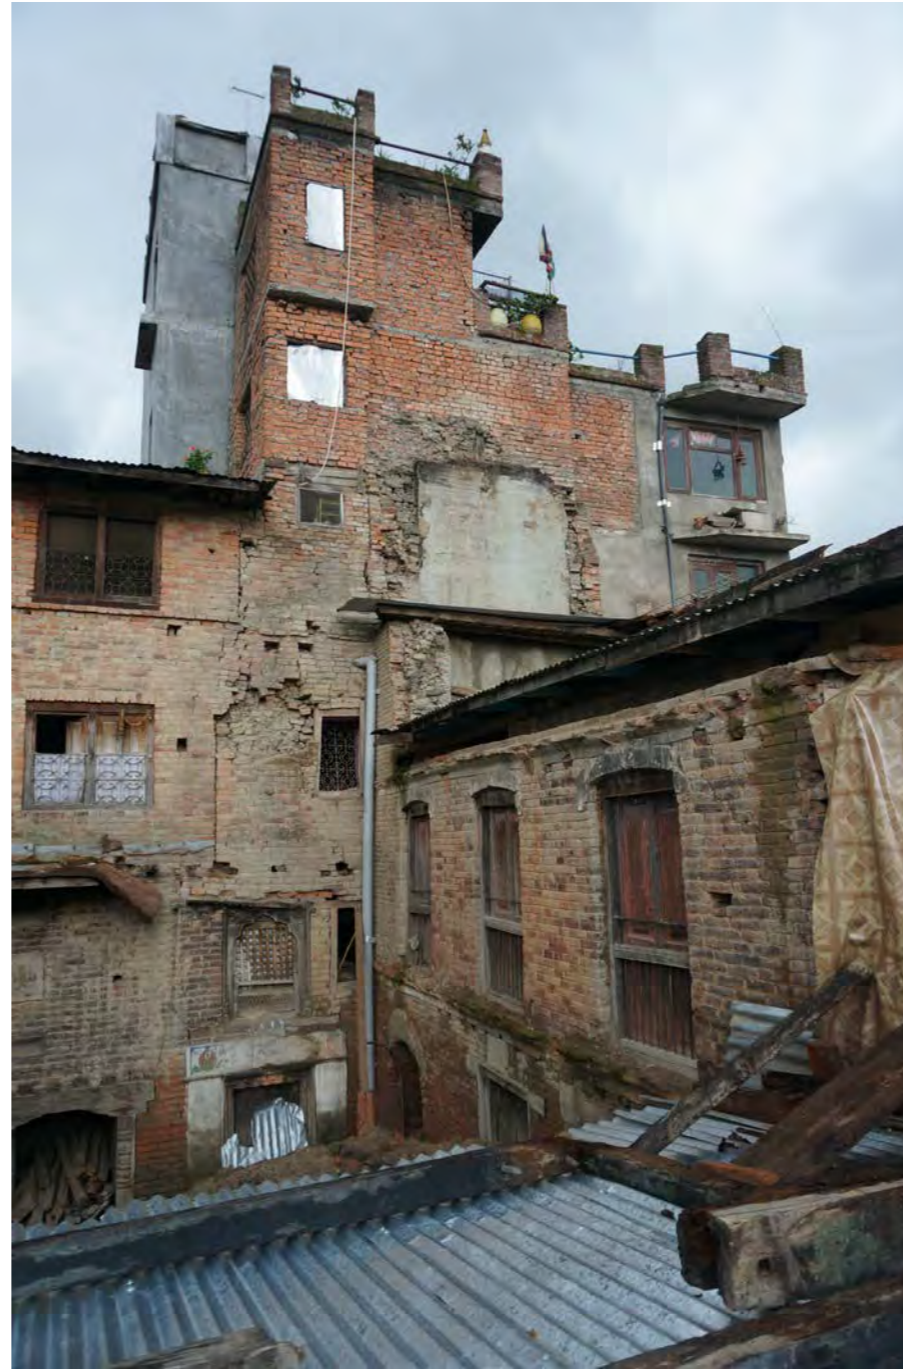
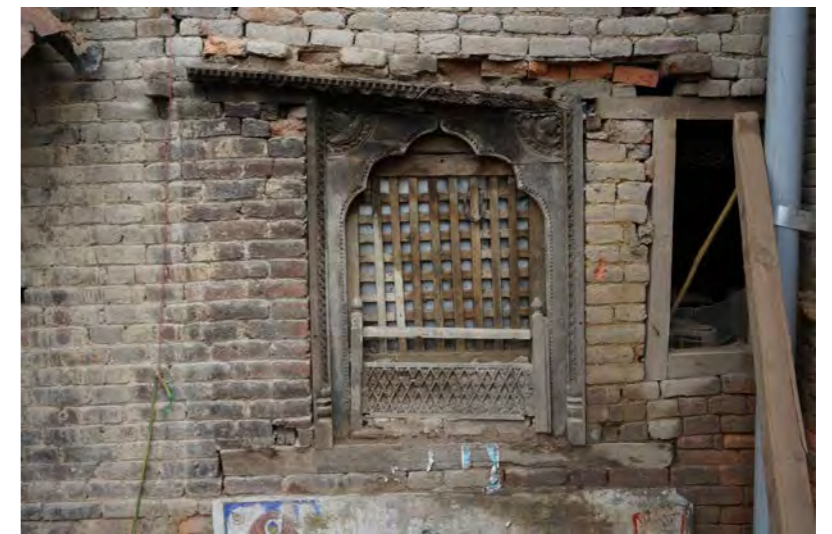
f27, f44

NUMBER	CONTACT	STOREY NO. RELATIVE POSITION	STRUCTURAL SYSTEM	PROBLEMS DESCRIPTION	DANGER	CONDITION
f27	Jagadish Man Shrestha	G+4	UnB + B	Totally Collapsed		+R!
f44	"Lawan Bajracharya 9841737189"	G+5(EL-2)	UnB + B	"Hybrid Structure with concrete on top and front parts Old wall on E-façade is collapsed"		+W! (Damaged wall)

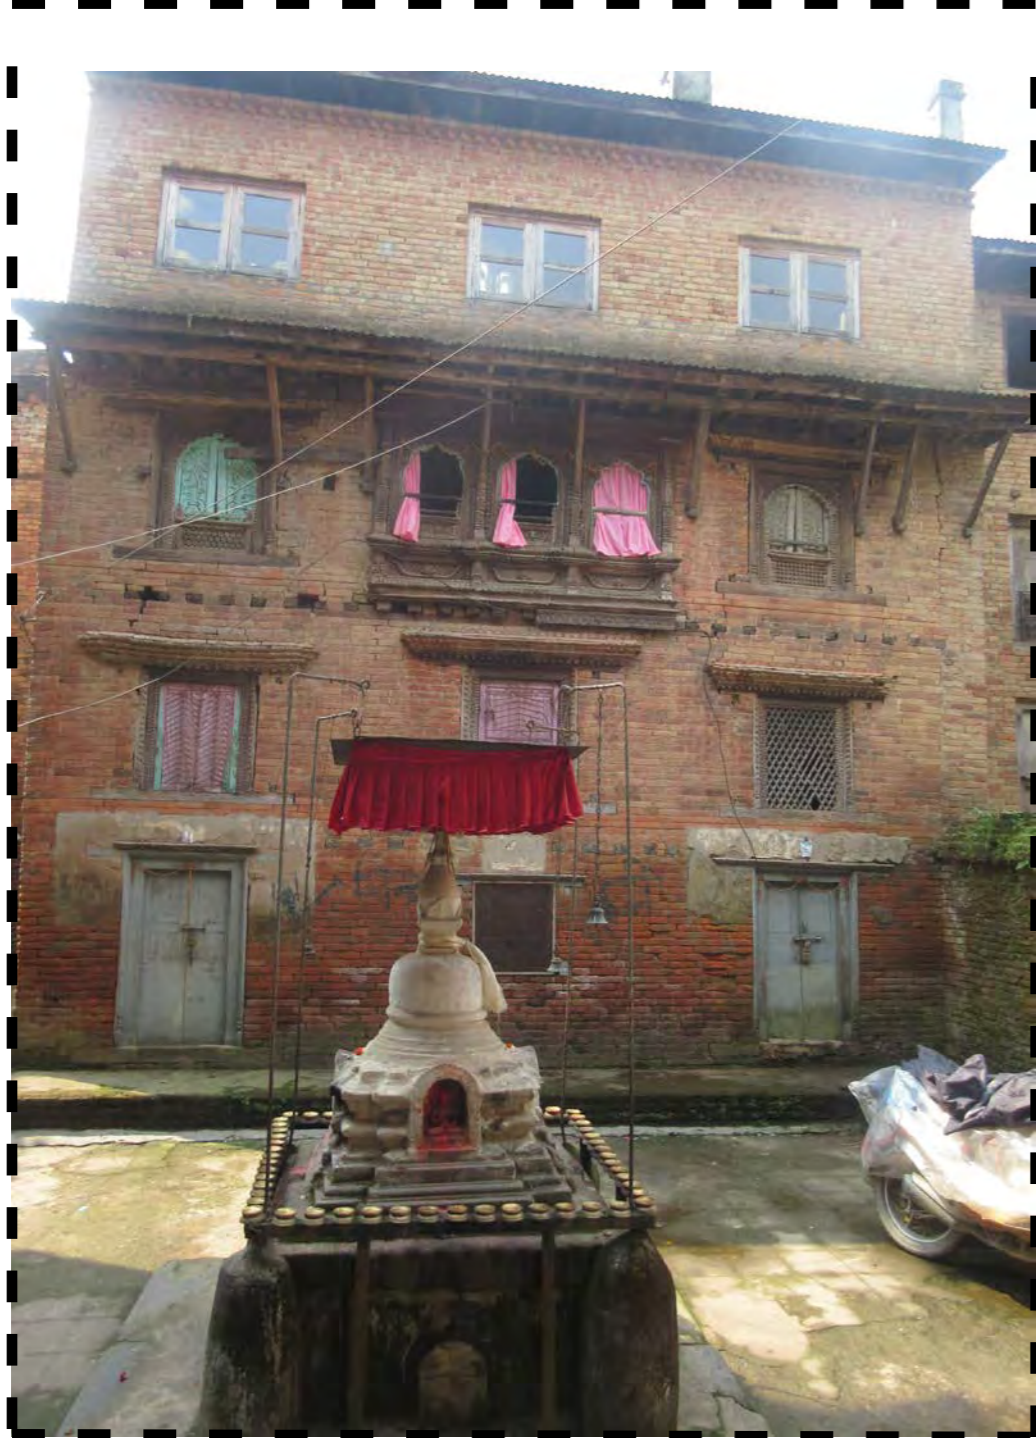
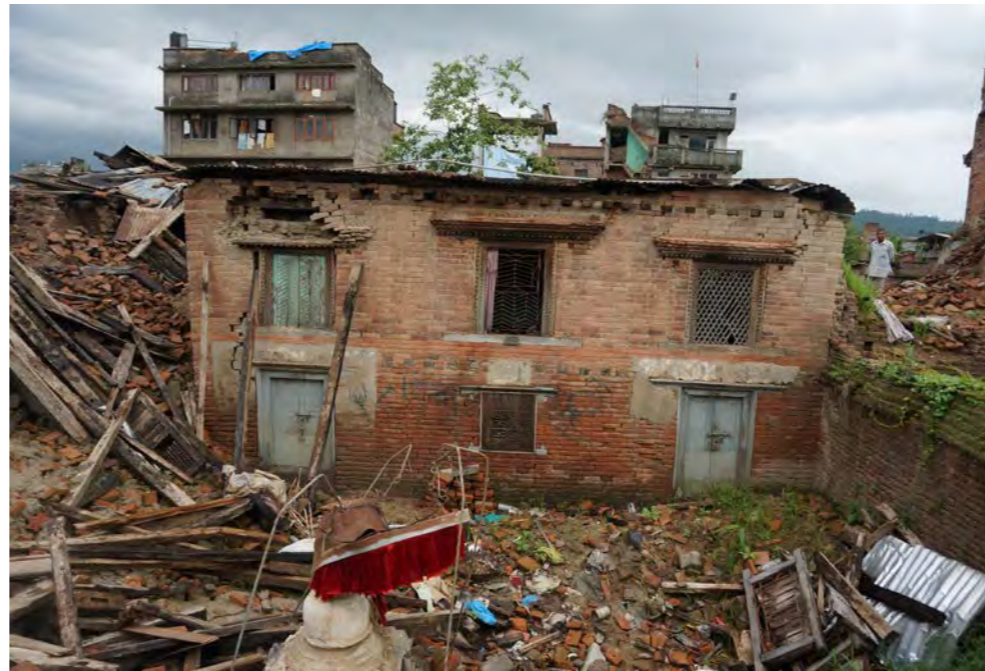
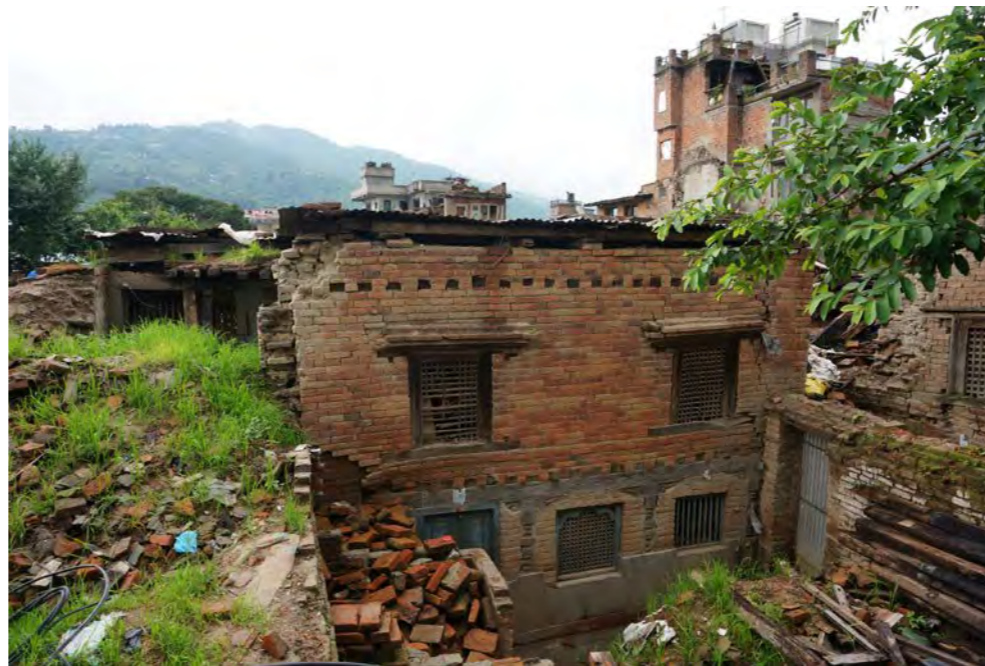
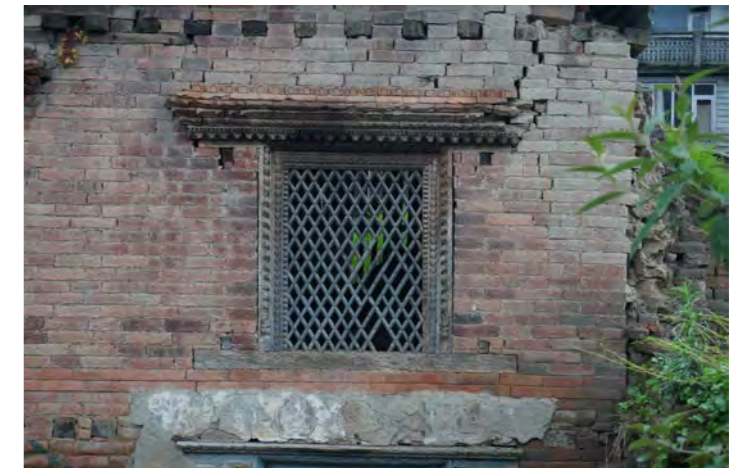
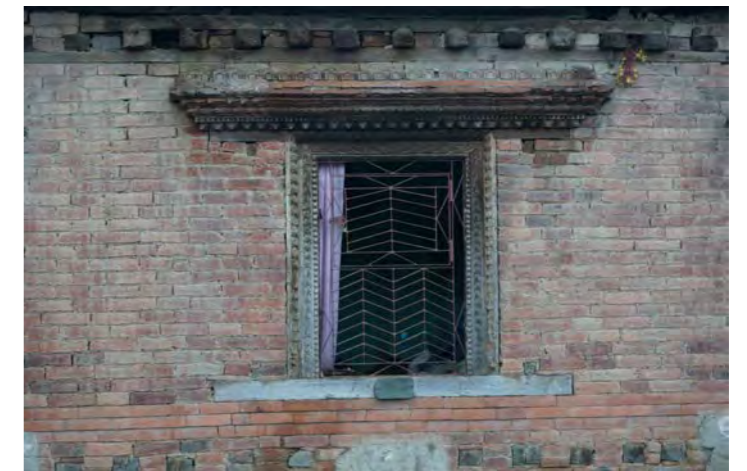
NUMBER	CONTACT	STOREY NO. RELATIVE POSITION	STRUCTURAL SYSTEM	PROBLEMS DESCRIPTION	DANGER	CONDITION	
f31	"Suraj Bajra 9841917788"	G+4	UnB + B	"Totally Collapsed Lower two floor remaining in critical state"		+P!
