2015 Earthquake Damage Mapping

Sankhu

October 2015

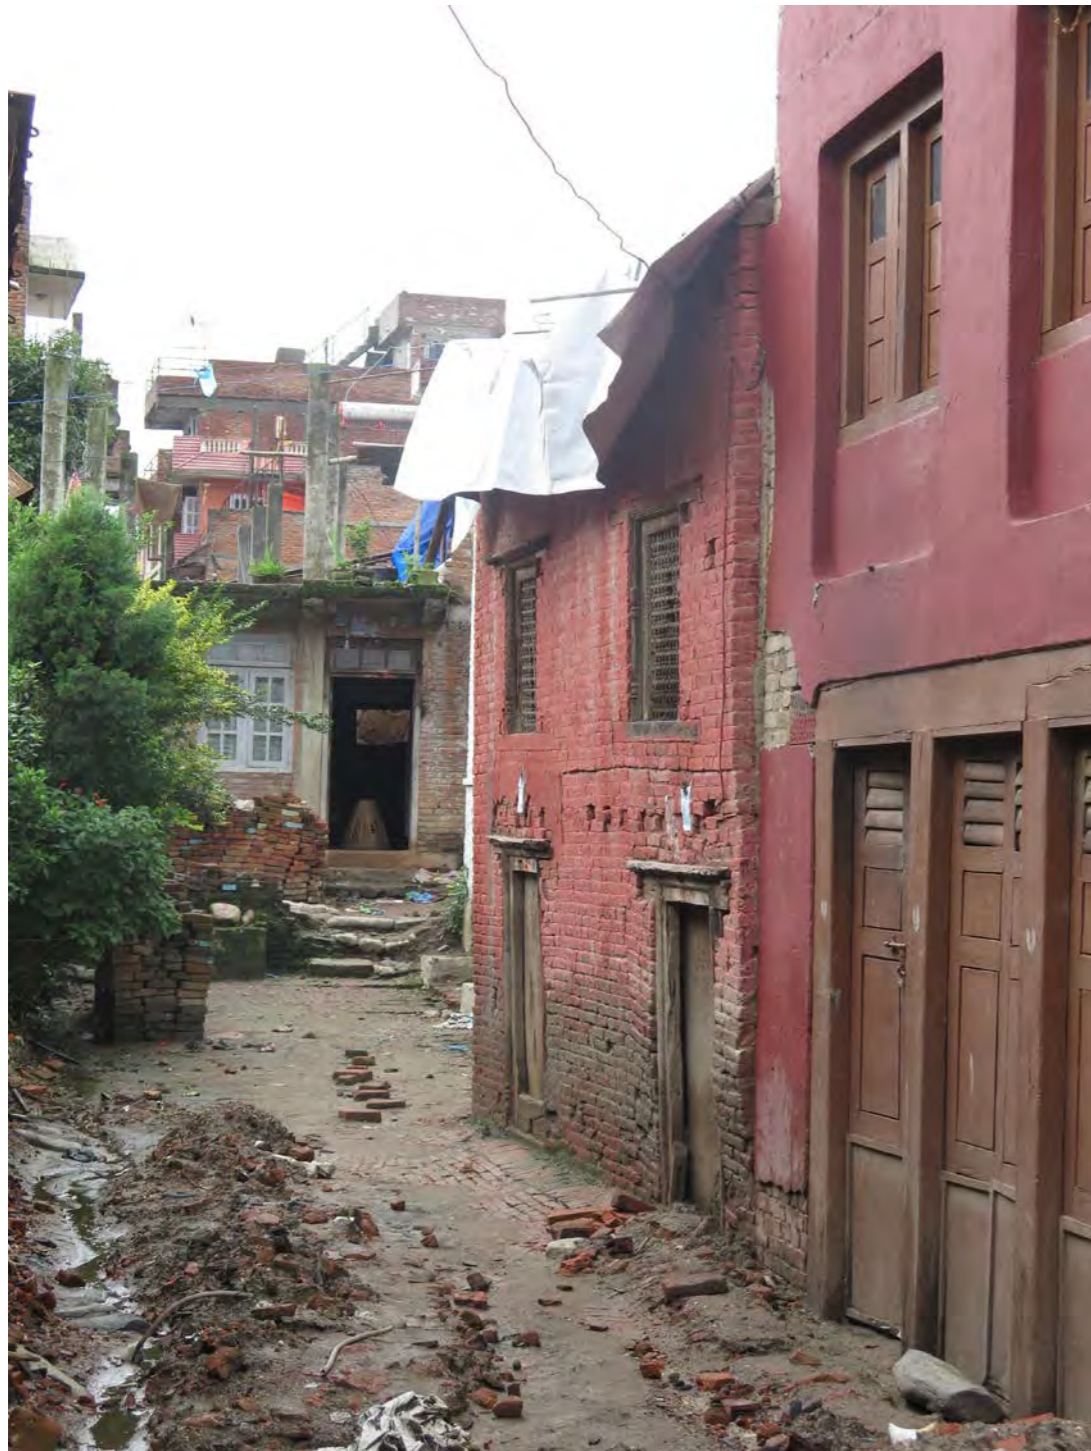
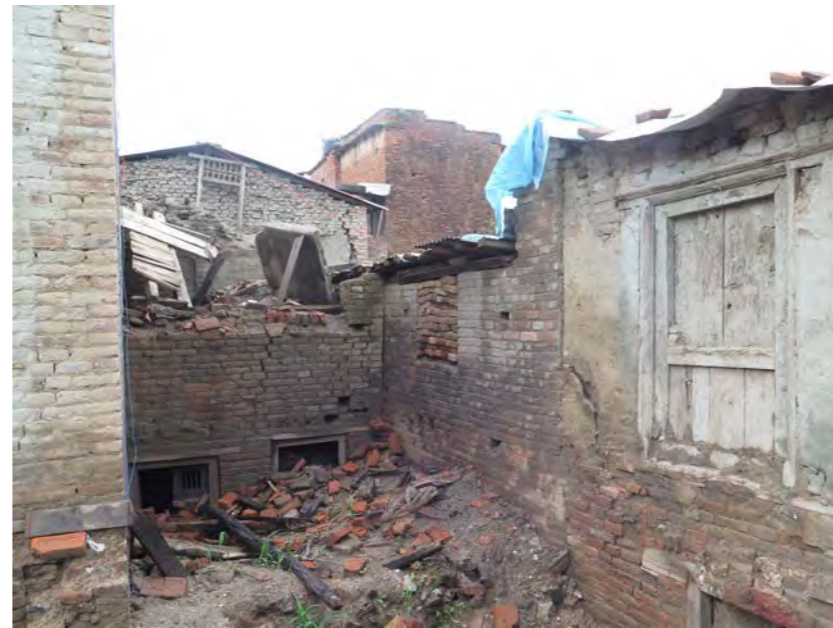
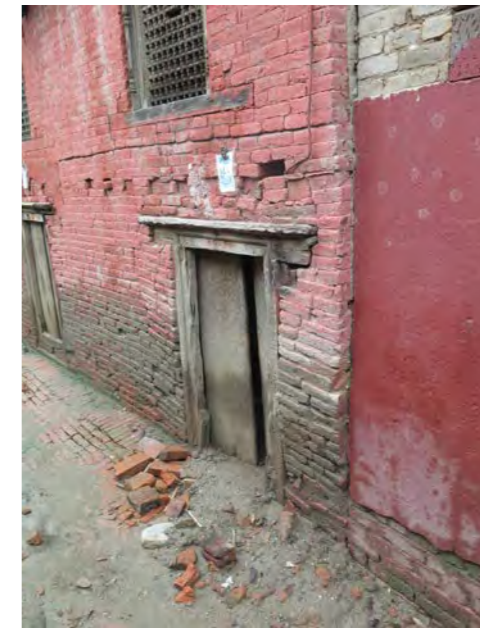
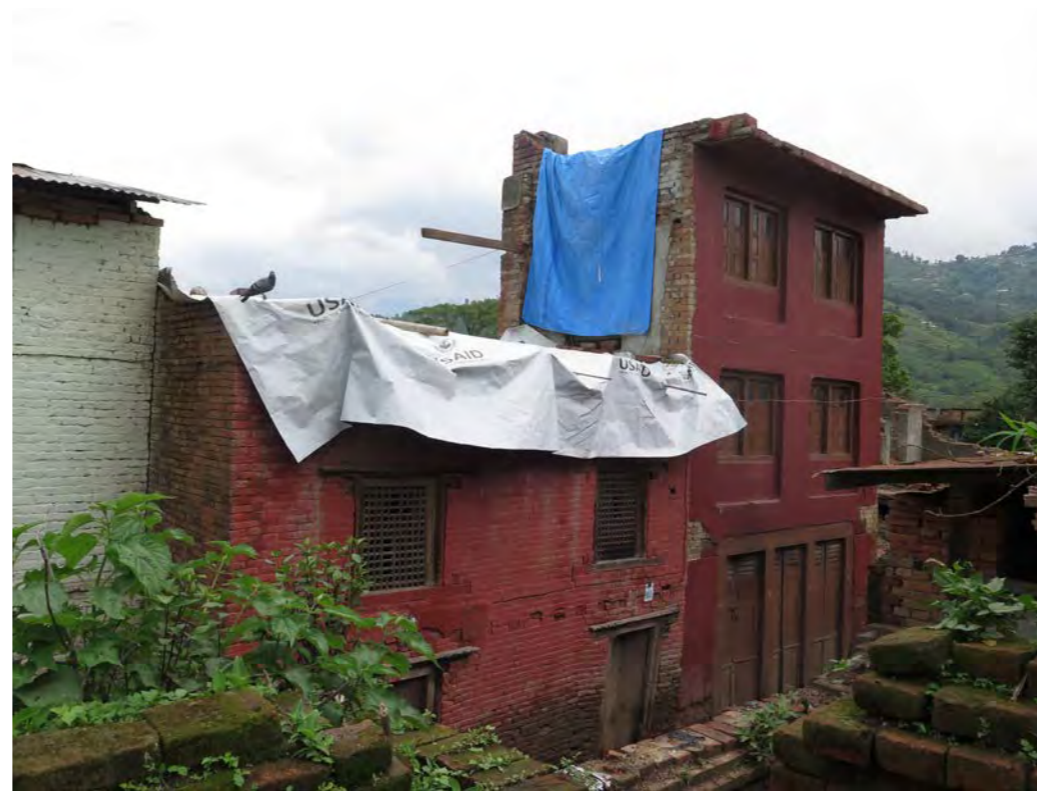
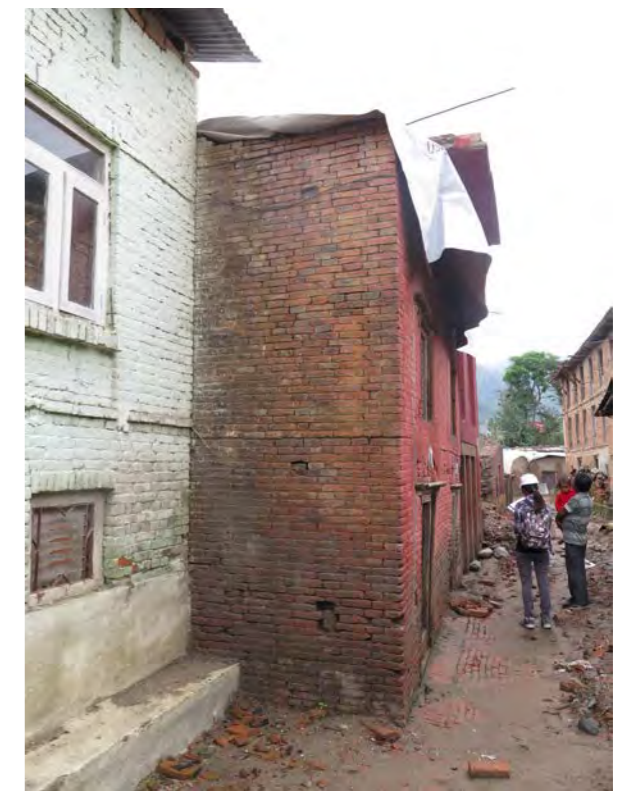
NUMBER	CONTACT	STOREY NO. RELATIVE POSITION	STRUCTURAL SYSTEM	PROBLEMS DESCRIPTION	DANGER	CONDITION	
i36	Krishna Bhakta Shrestha (4450664)	G+3	B	East wall buldging		W +

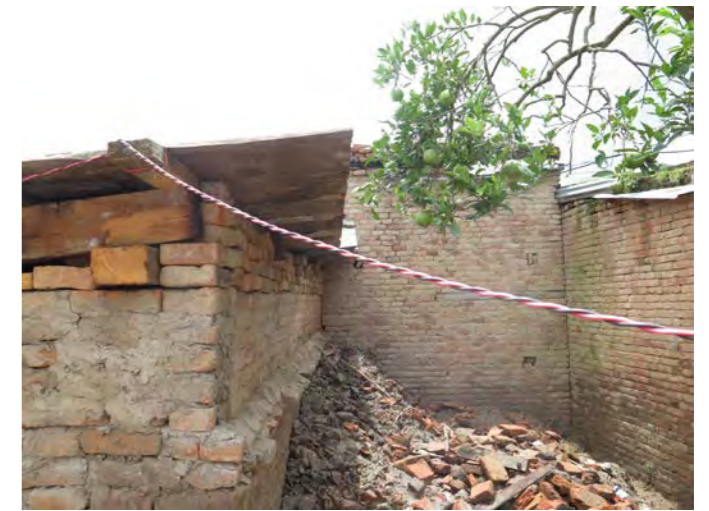
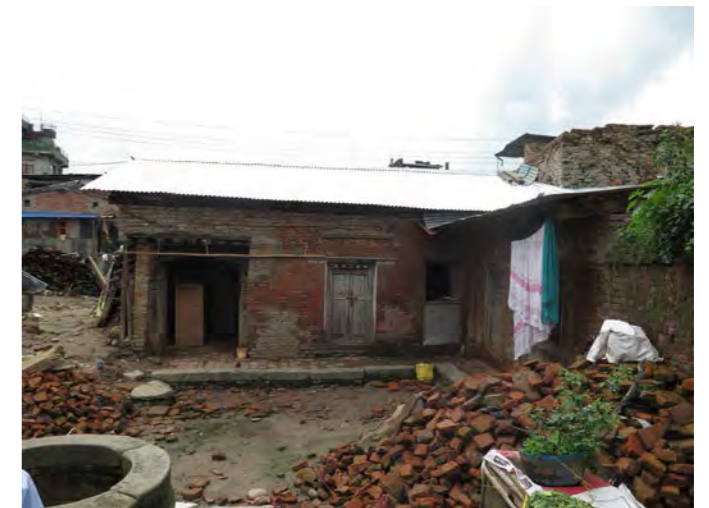
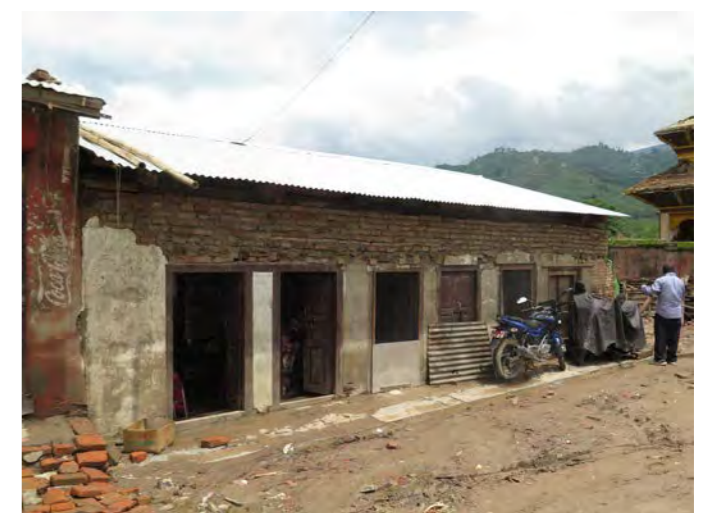
NUMBER	CONTACT	STOREY NO. RELATIVE POSITION	STRUCTURAL SYSTEM	PROBLEMS DESCRIPTION	DANGER	CONDITION
i50	Surendra Joshi (9841014240)	G+4	B	4 floors collapsed		Pukhulachi Nhu Chhen +

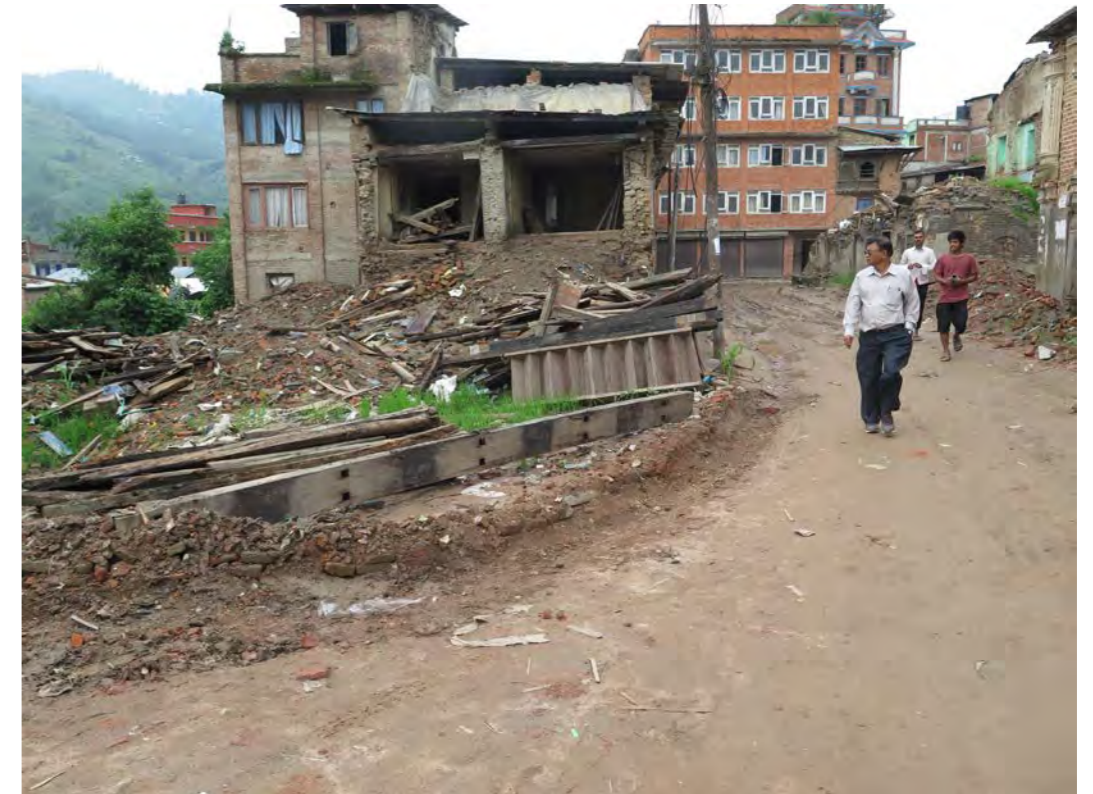
i63, i64

NUMBER	CONTACT	STOREY NO. (SI) RELATIVE POSITION	STRUCTURAL SYSTEM	PROBLEMS DESCRIPTION	DANGER	CONDITION
i63	Gobinda Bahadur Shrestha (9851008099)	G+1	B	Totally collapsed	⊗	R +
i64	Krishna Bahadur Shrestha (9843791039)	G+4	B	Totally collapsed	⊗	R + Jhya lost

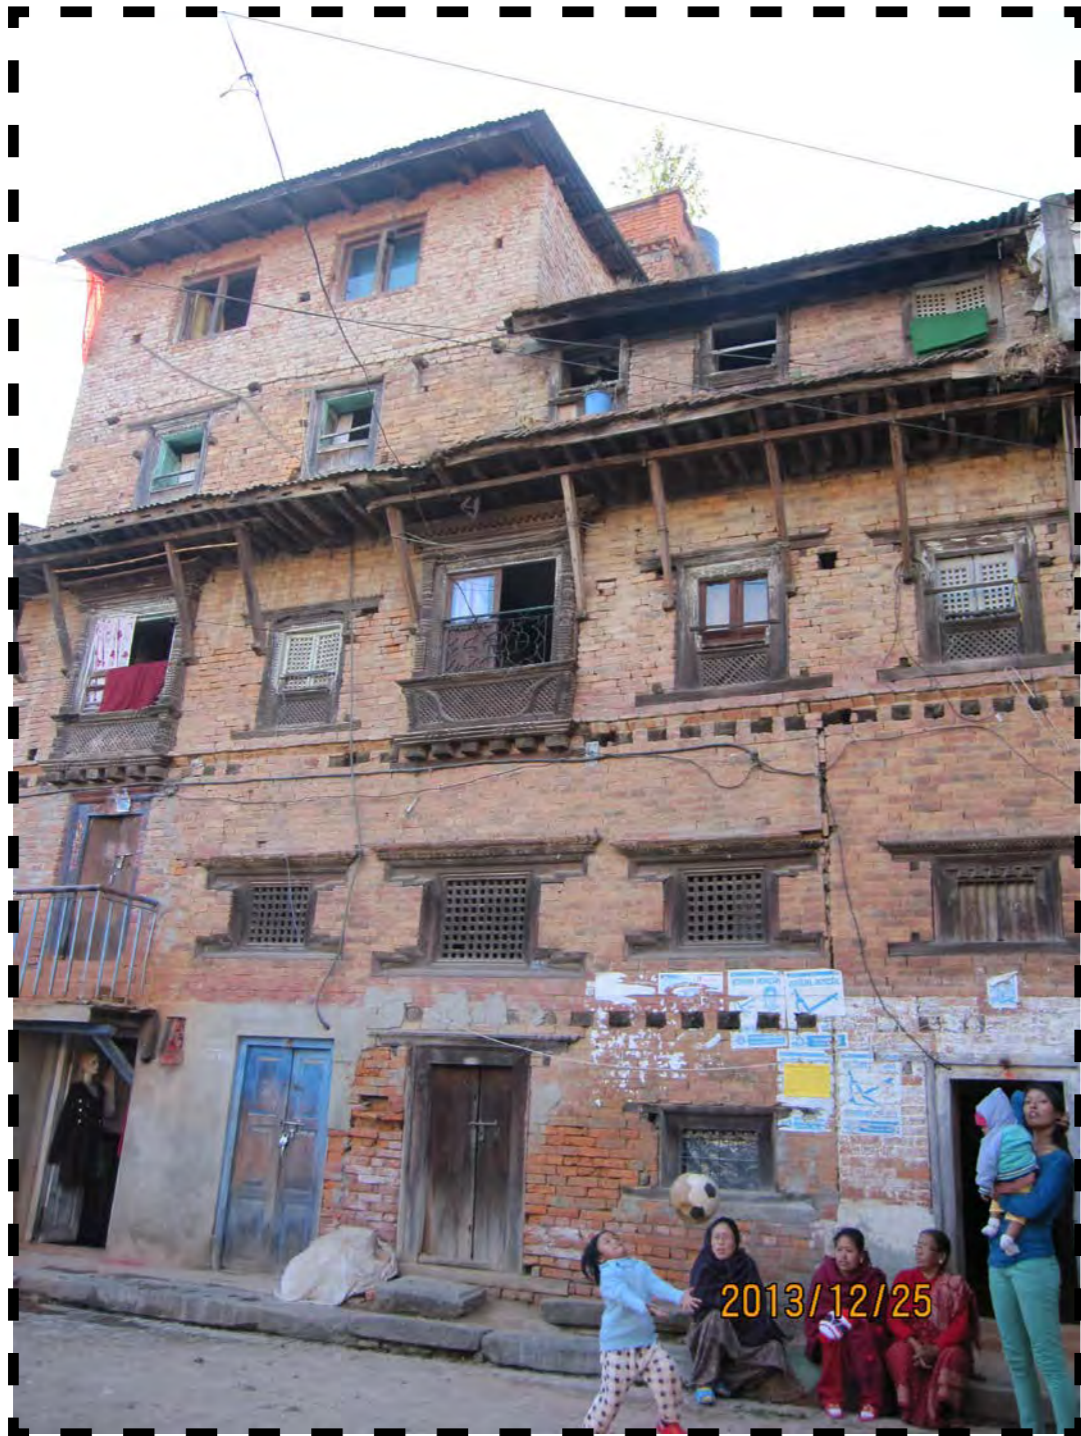
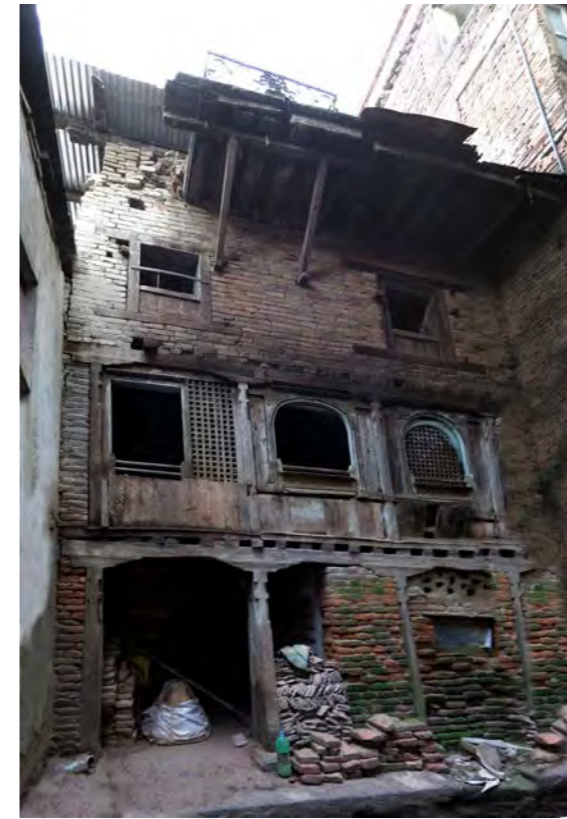
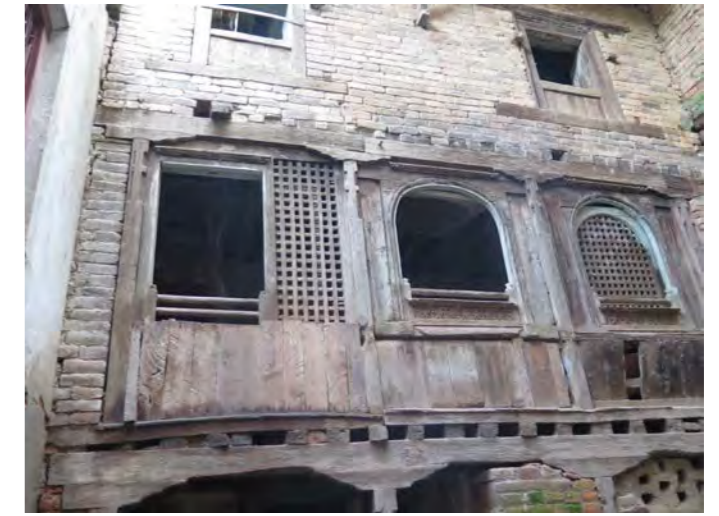
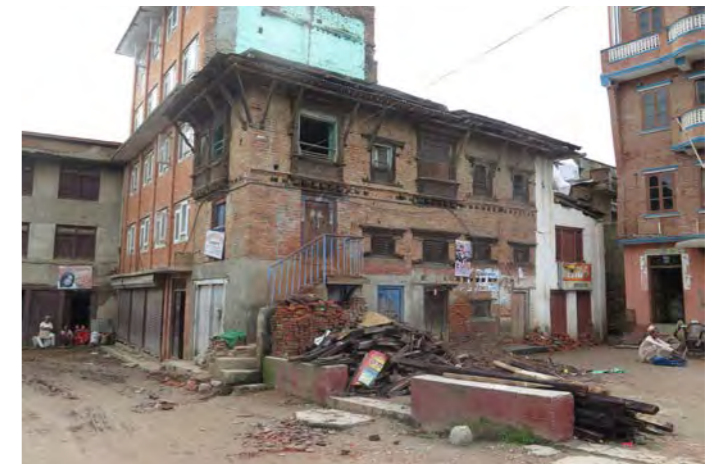
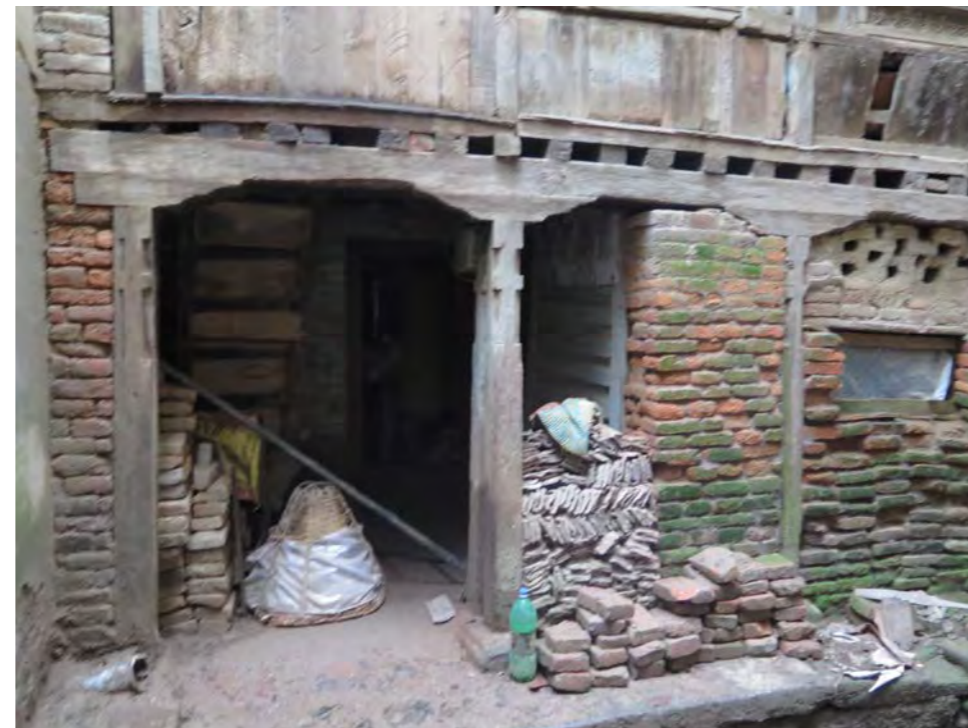
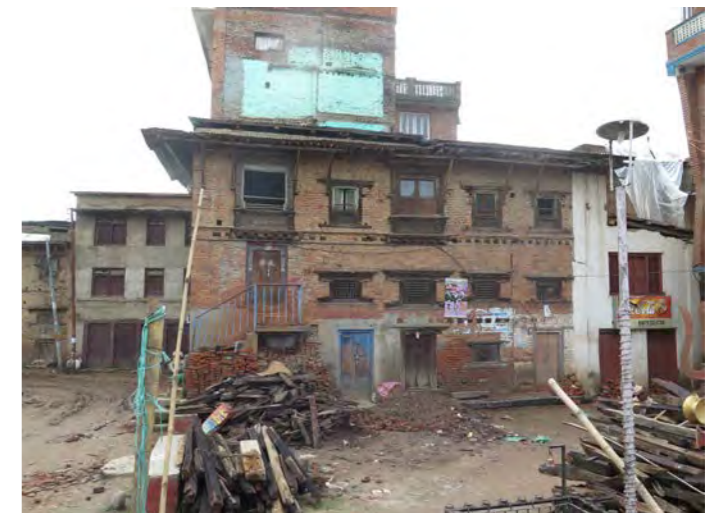
i96, i97

NUMBER	CONTACT	STOREY NO. RELATIVE POSITION	STRUCTURAL SYSTEM	PROBLEMS DESCRIPTION	DANGER	CONDITION
i96	Laxmi Narayan Shreshta	G+3	B	3 floors collapsed. North east corner at top floor falling. Rising damp. Delipated east wall.		+
i97	Jagat Ram Shrestha (9841670581)	G+4 (CH)	B	2 floors collapsed. Vertical crack on south wall.		+

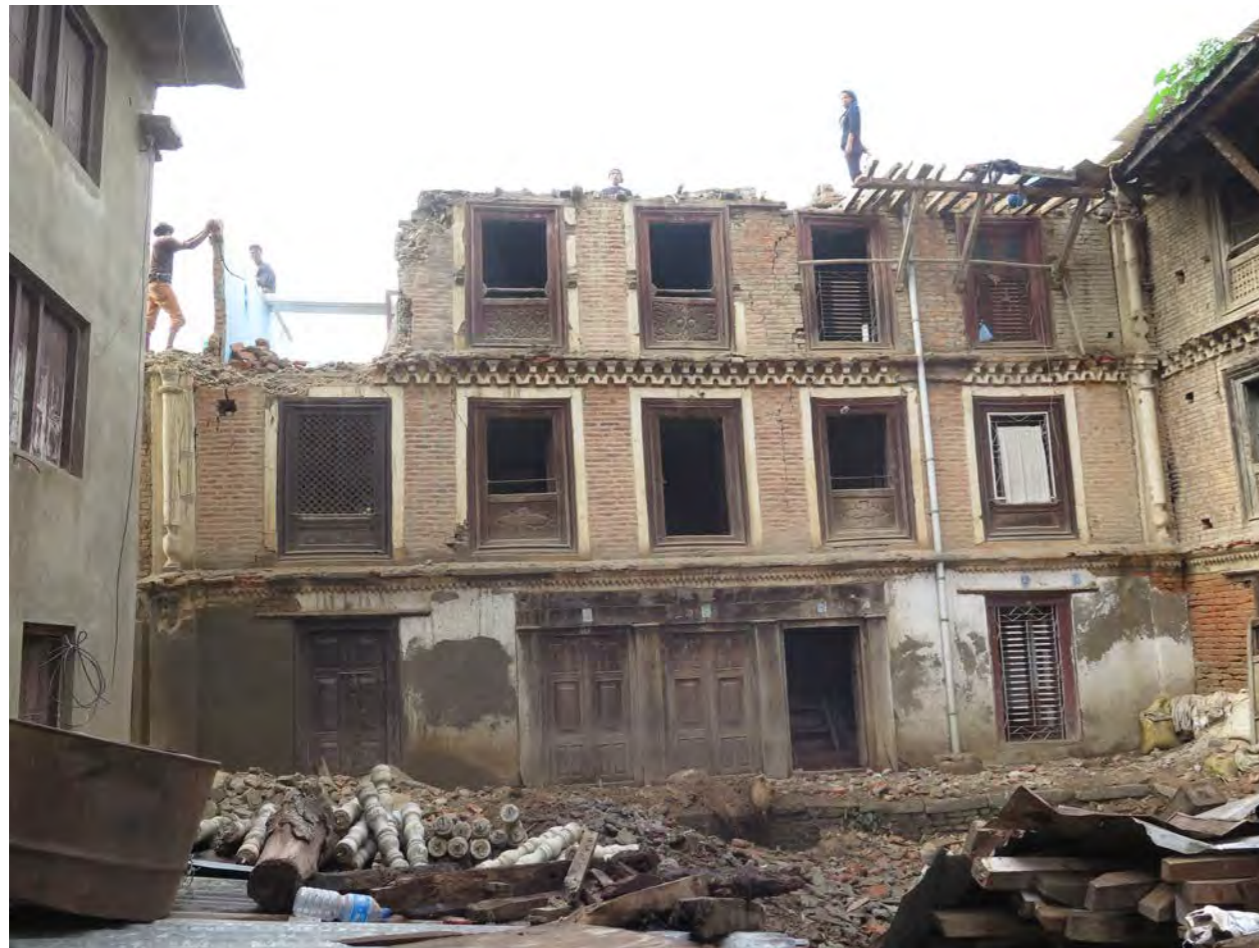
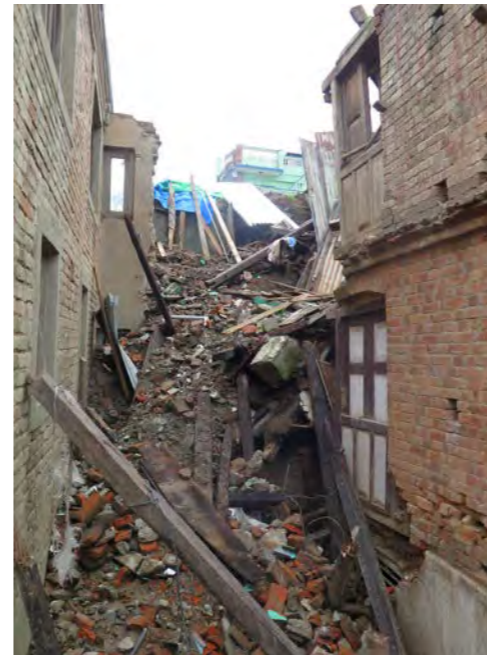
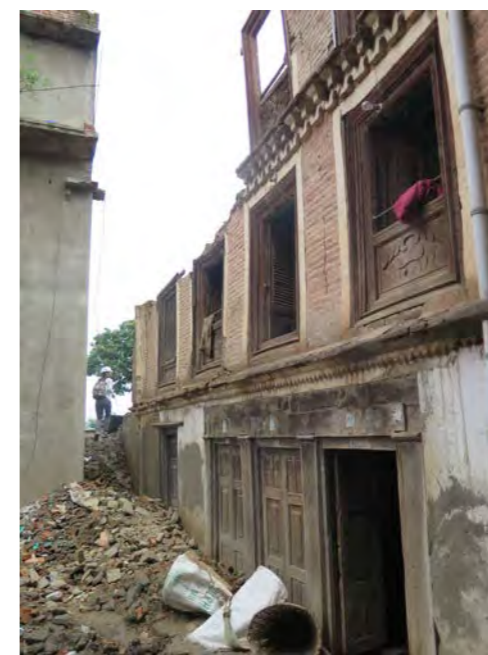
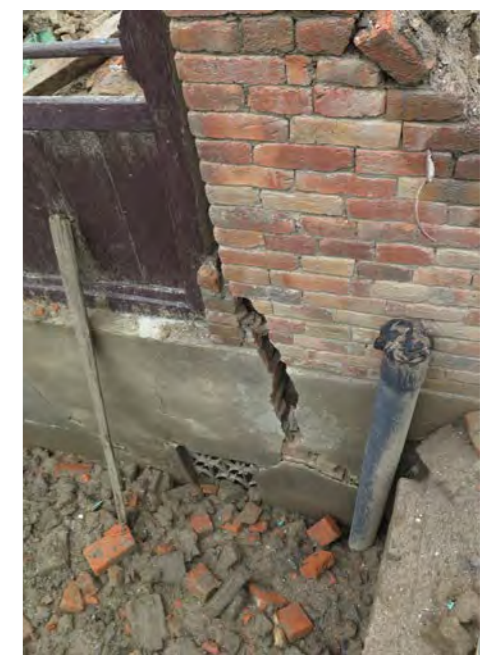
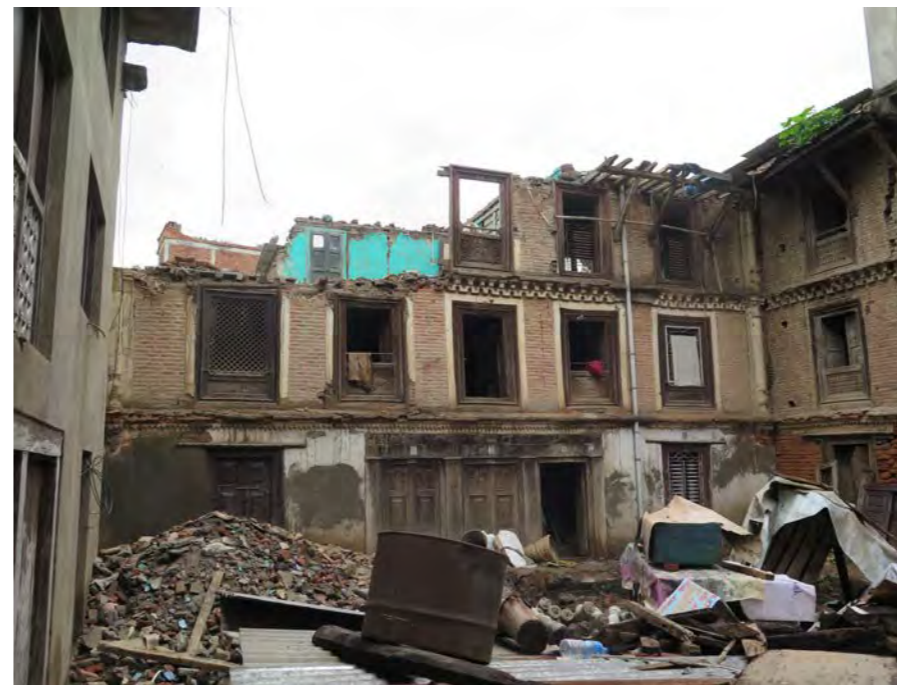
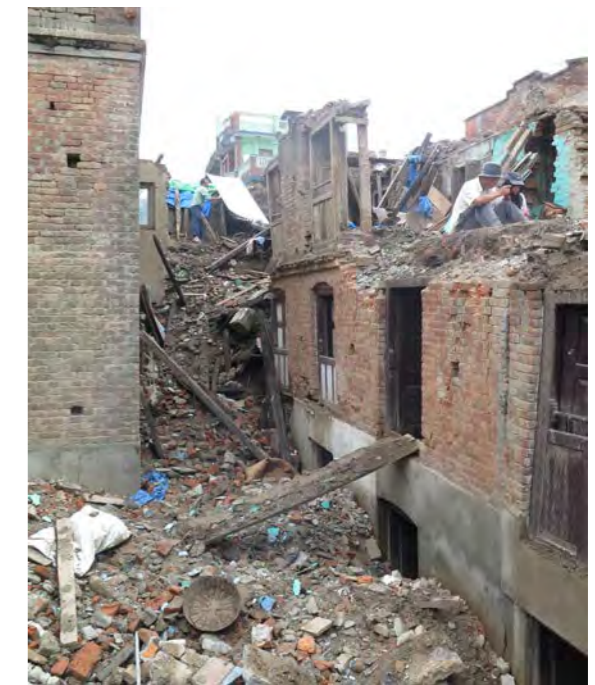
i100, i101

NUMBER	CONTACT	STOREY NO. RELATIVE POSITION	STRUCTURAL SYSTEM	PROBLEMS DESCRIPTION	DANGER	CONDITION
i100	Radhika Shrestha	G+3	B	2 Floors collapsed. Ground floor bricks falling. Vertical cracks on south wall.	⚠️ ⊗	+
i101	Ram Krishna Shrestha	G+4 (1EL)	B	3 floor demolished. Ground floor filled with rubbles. Vertical crack on south wall.	⚠️ ⊗	+

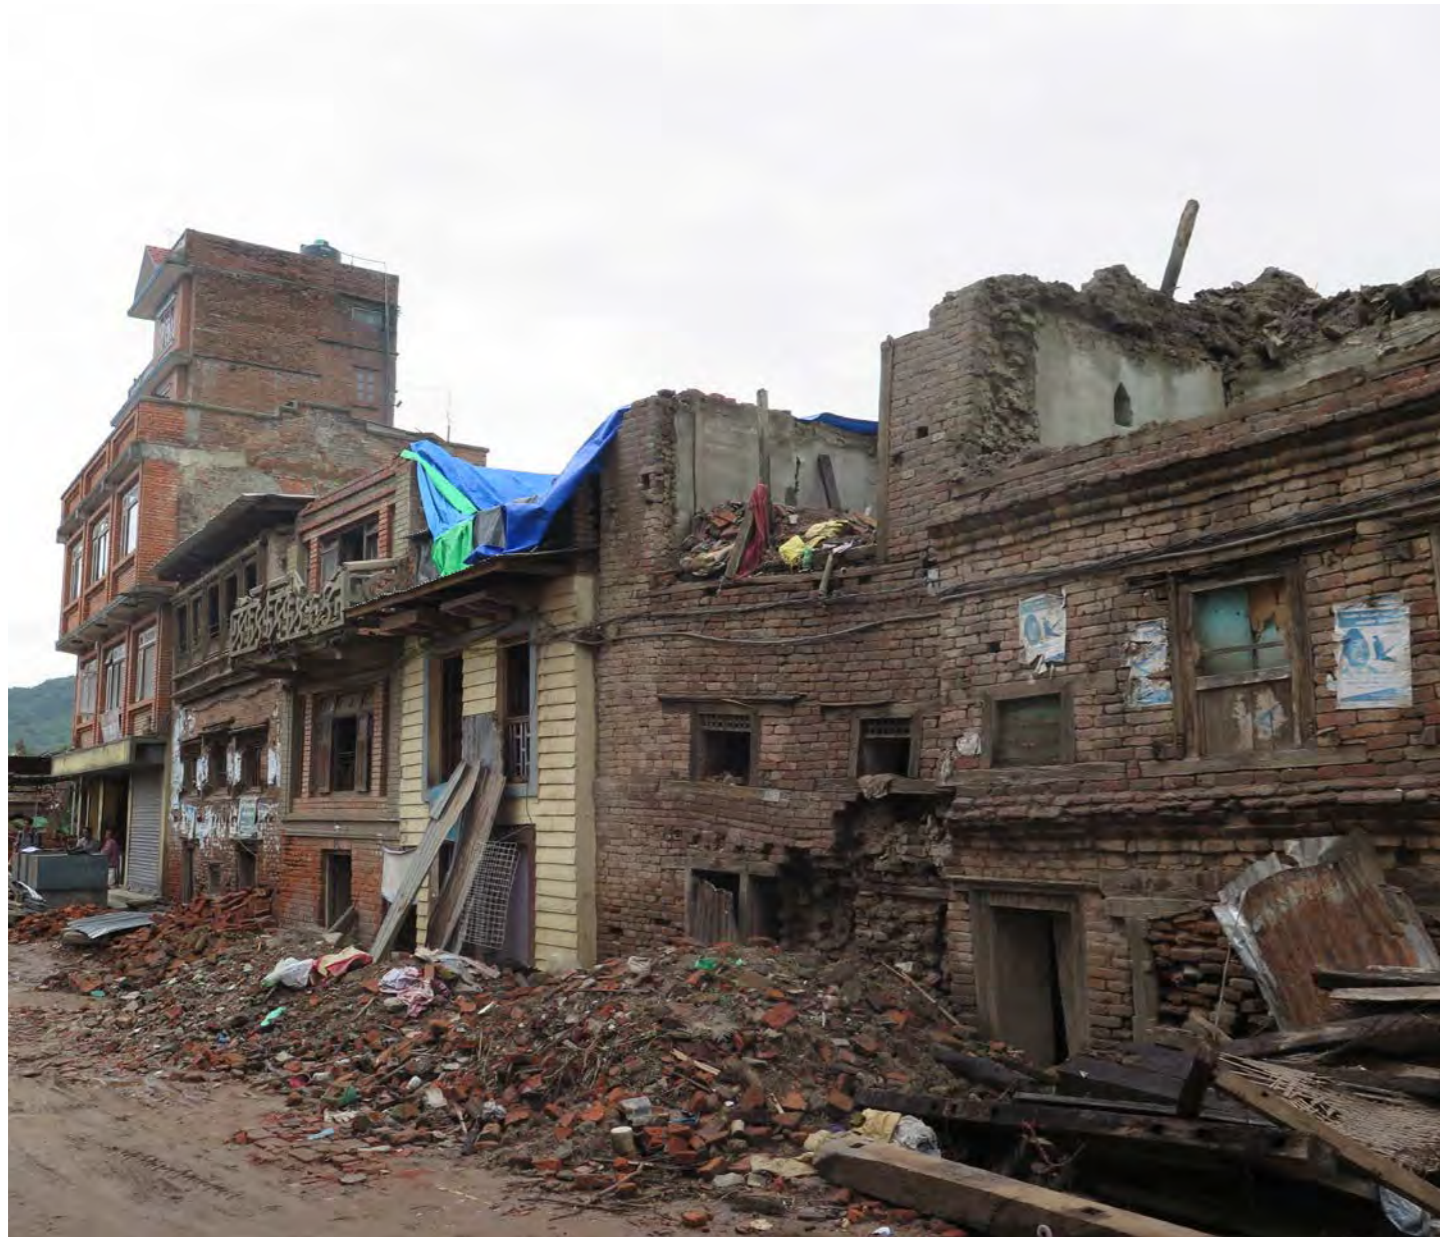
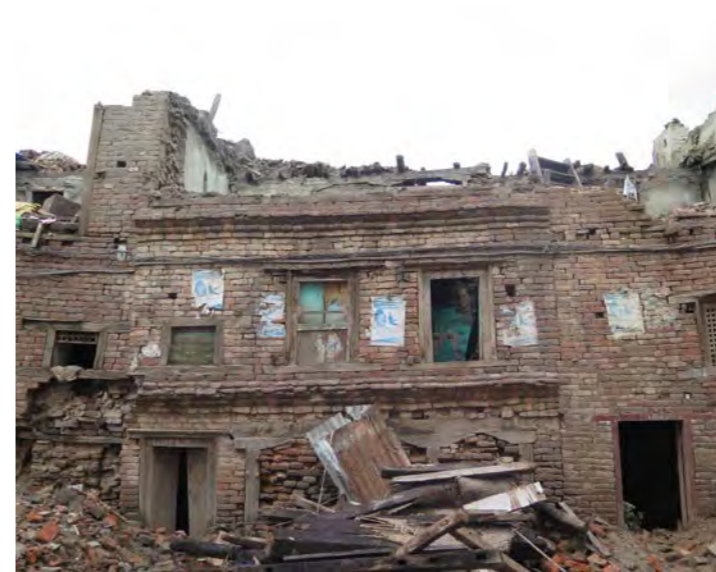
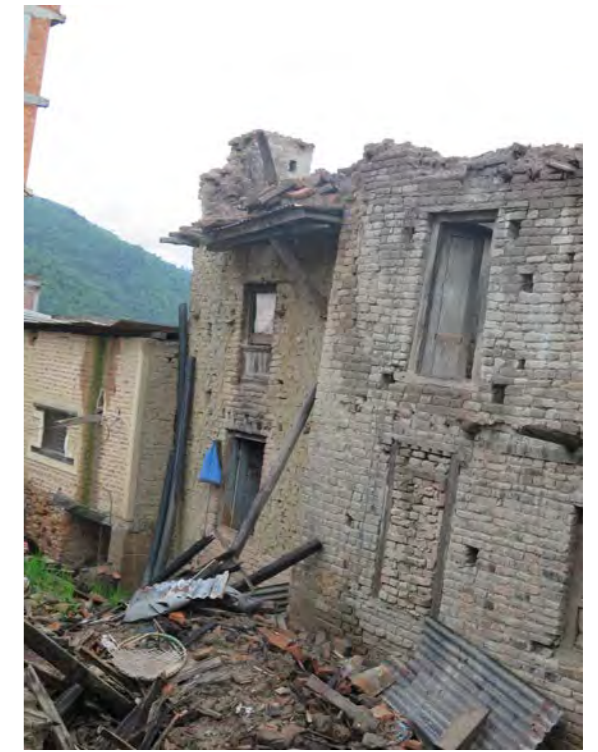
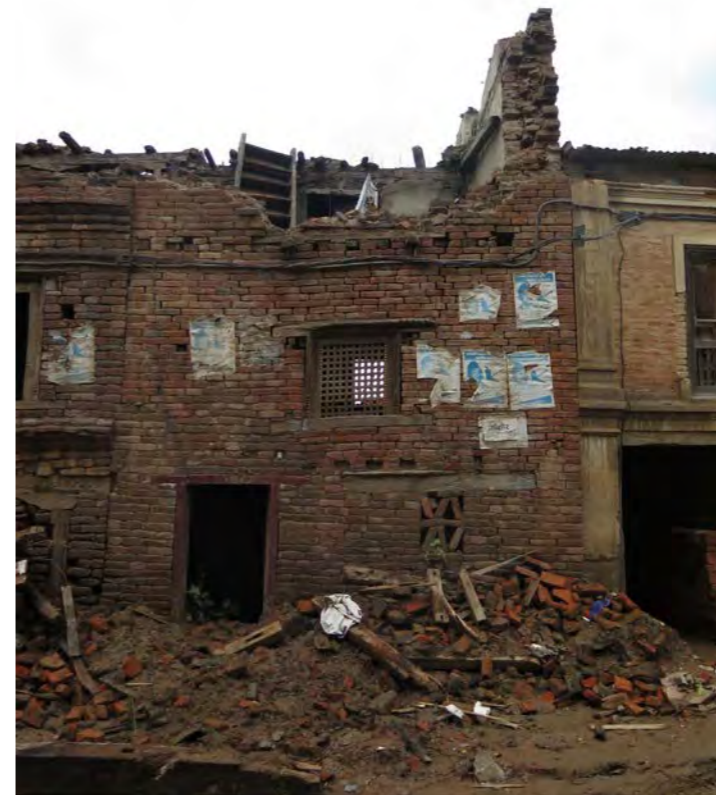
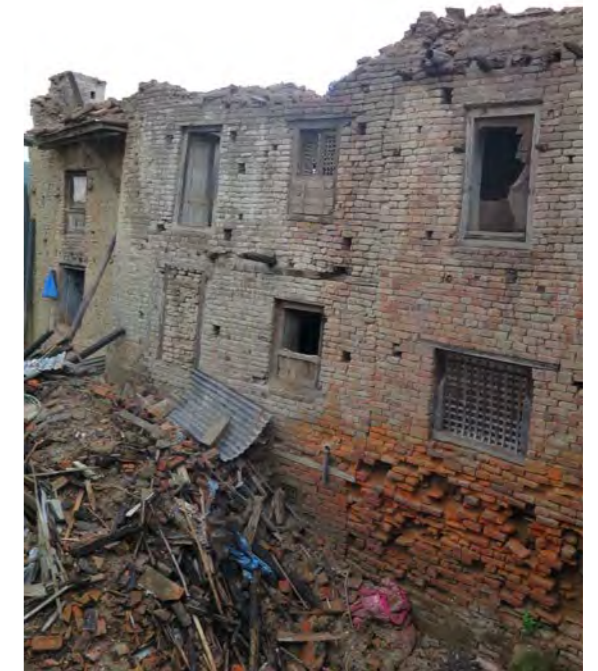
i105, i106

NUMBER	CONTACT	STOREY NO. RELATIVE POSITION	STRUCTURAL SYSTEM	PROBLEMS DESCRIPTION	DANGER	CONDITION	
i105	Mijendra Kaji Shrestha	G+3	B	2 floors collapsed. West wall buldging. Bricks not aligned. Rising damp.		+	
i106	Mijendra Kaji Shrestha	G+3	B	2 Floors collapsed. In very delipated condition		+

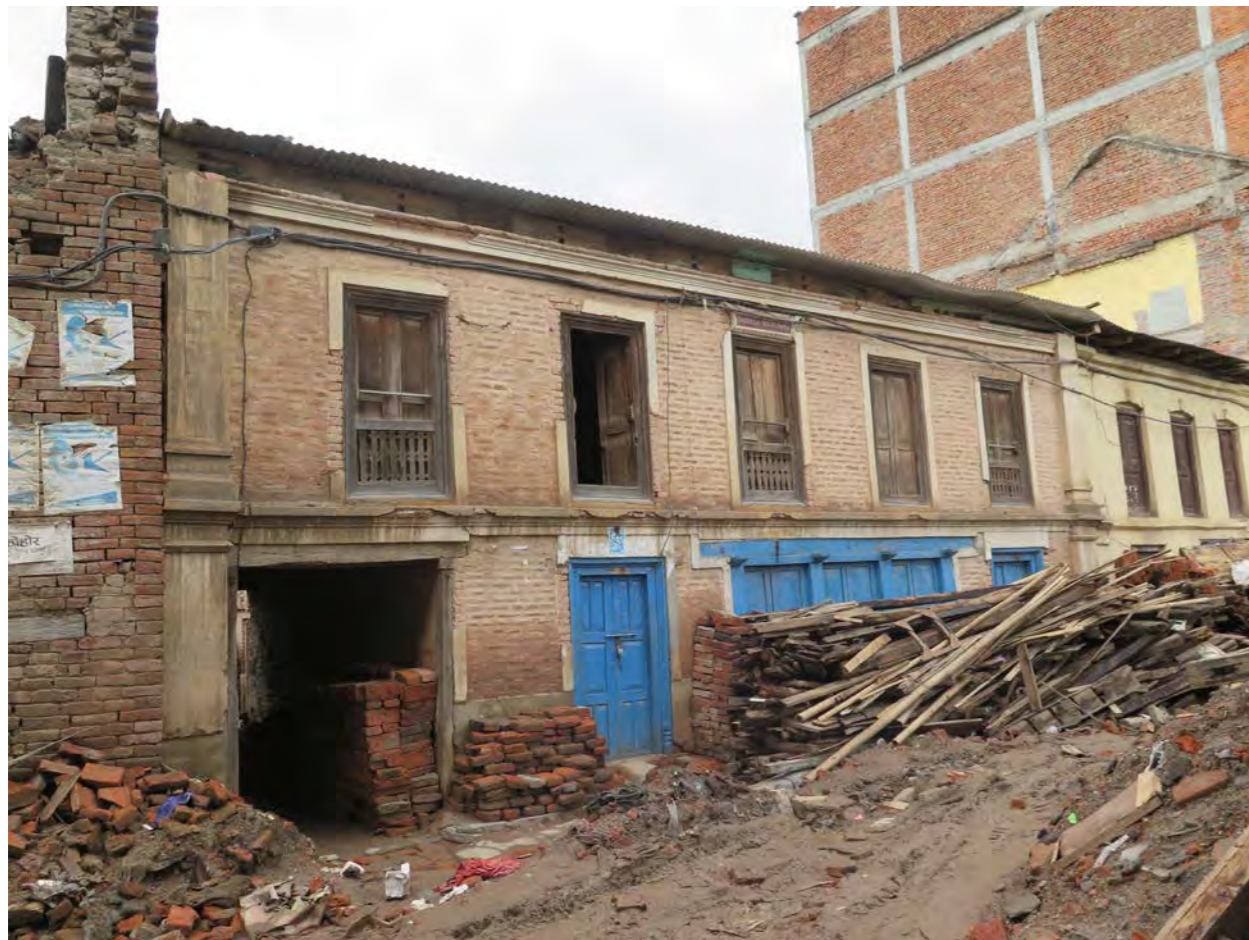
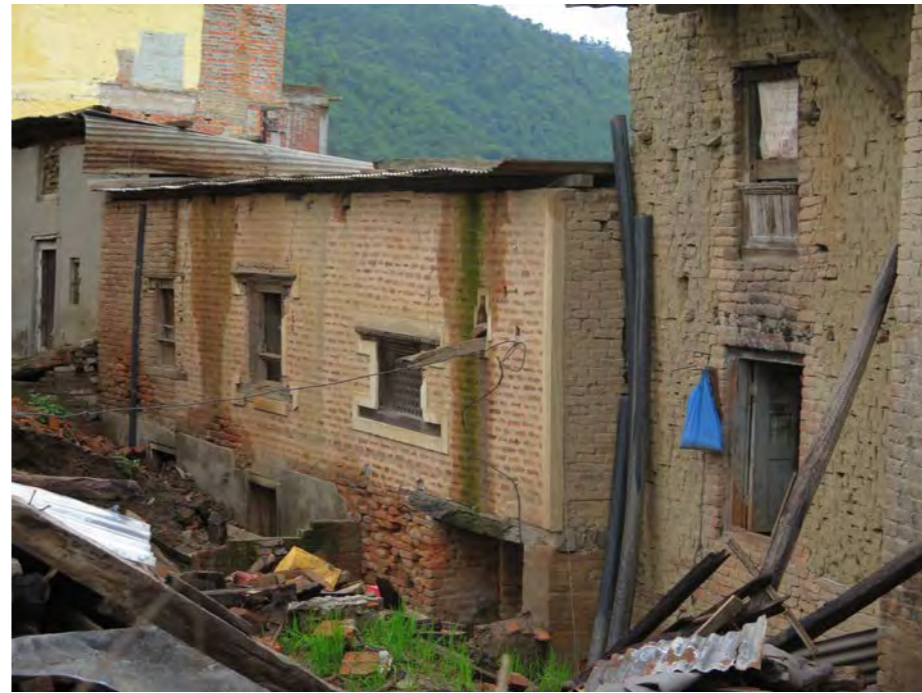
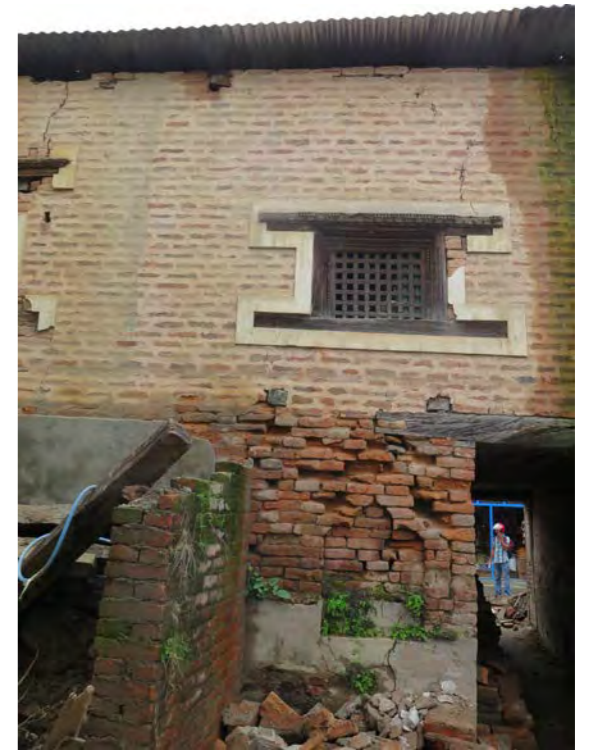
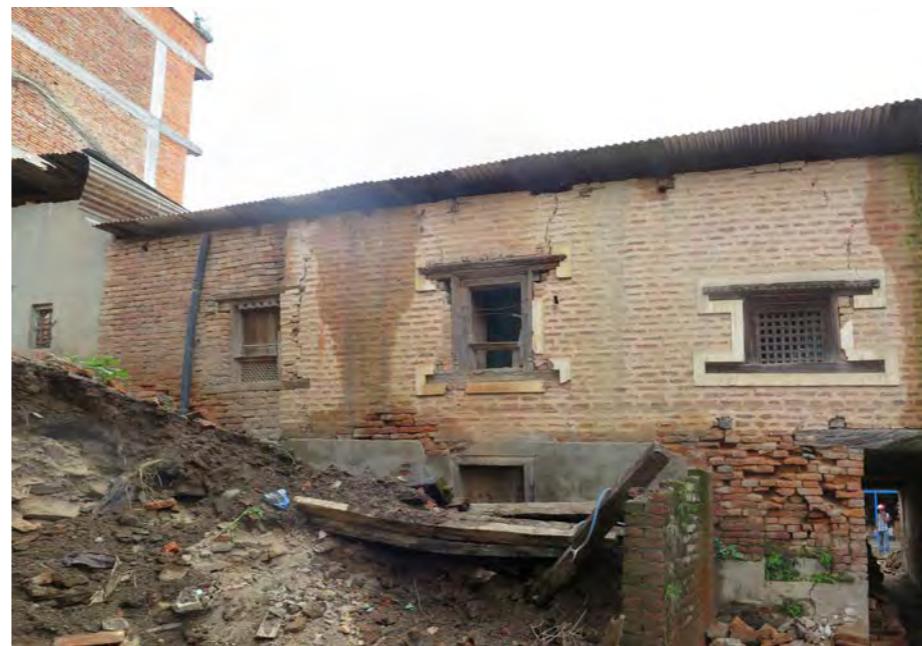
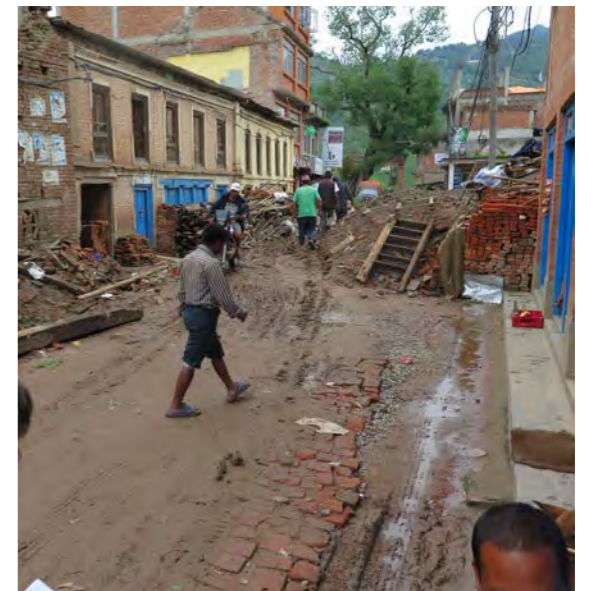
NUMBER	CONTACT	STOREY NO. RELATIVE POSITION	STRUCTURAL SYSTEM	PROBLEMS DESCRIPTION	DANGER	CONDITION
i107	Babu Raja Shrestha	G+4	B	3 floors collapsed. Rising damp on east wall.	1/2 ☒	+

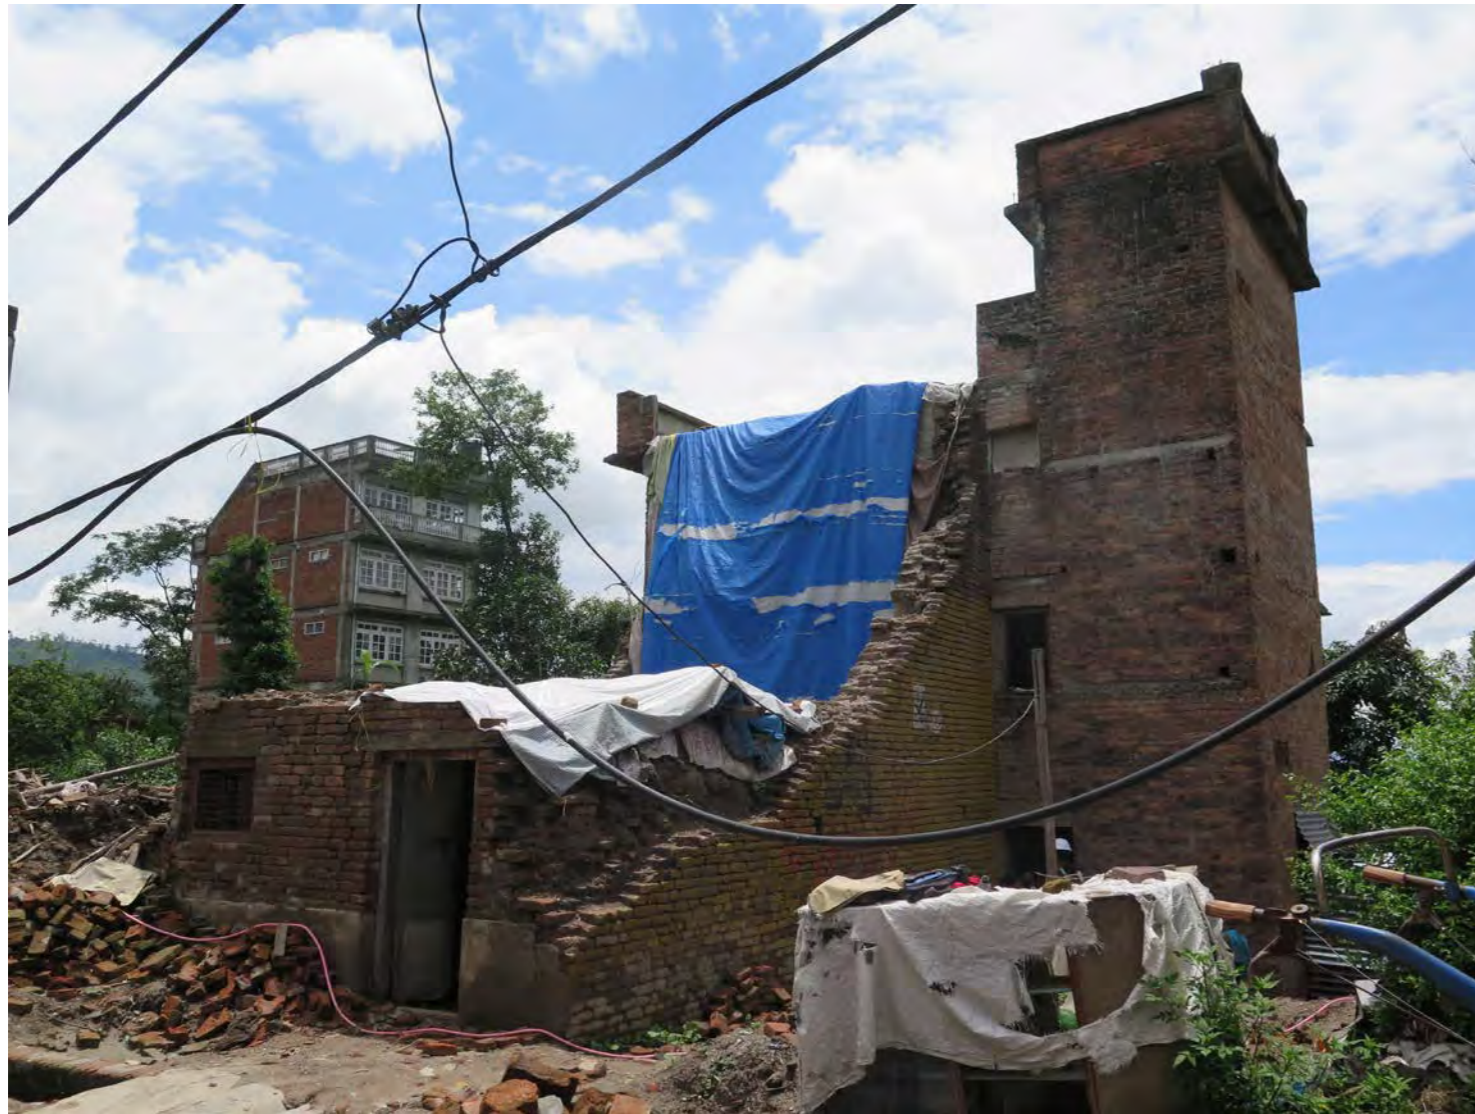
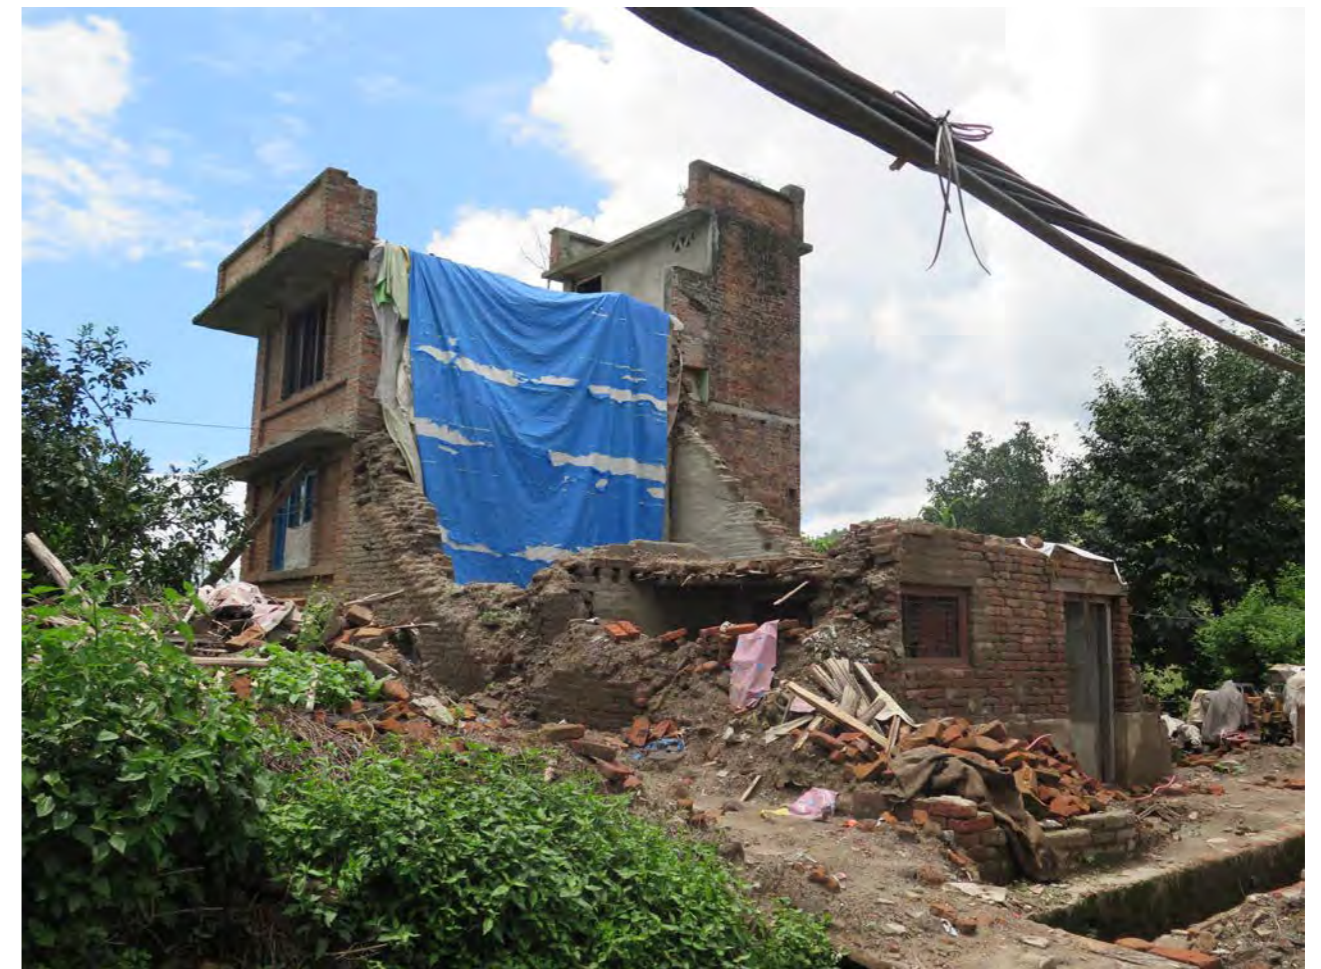
NUMBER	CONTACT	STOREY NO. RELATIVE POSITION	STRUCTURAL SYSTEM	PROBLEMS DESCRIPTION	DANGER	CONDITION	
i131	Asha Maru Kapali (9803449329)	G+2	B	Totally collapsed		stone lion on base of south east corner +
