2015 Earthquake Damage Mapping

Sankhu

October 2015

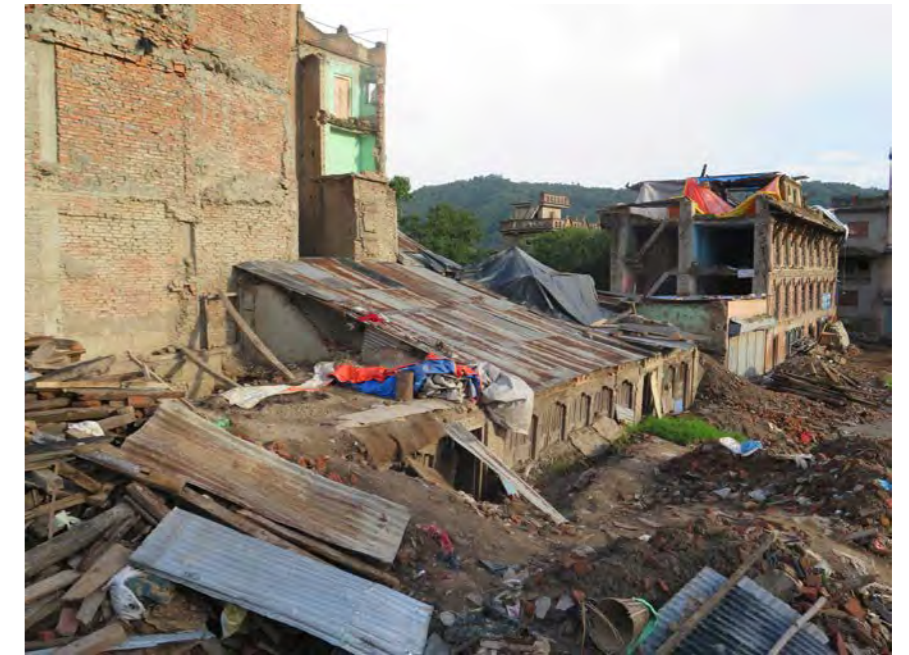
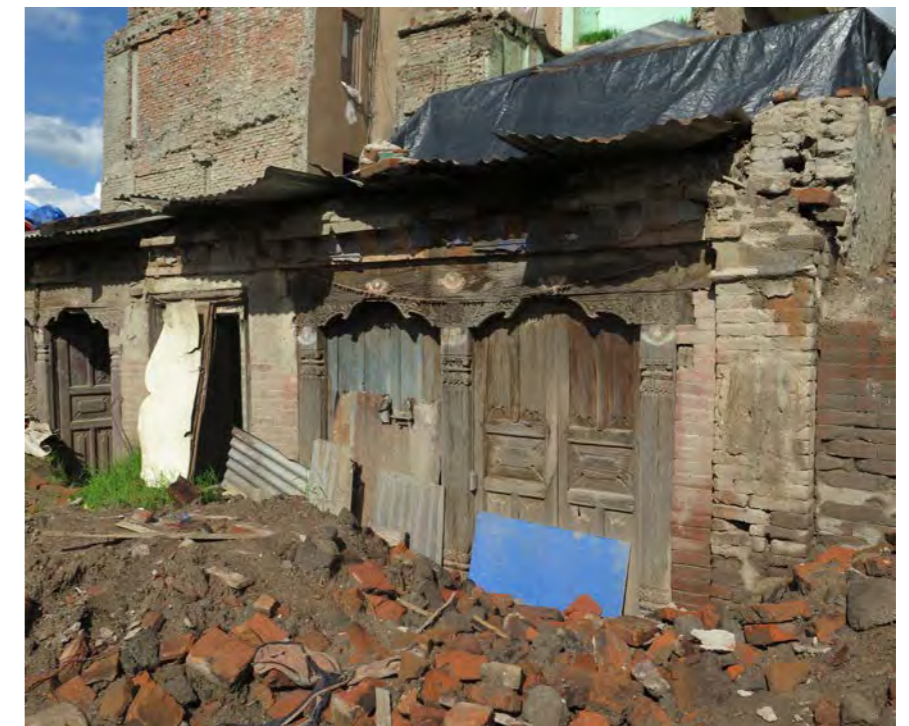
NUMBER	CONTACT	STOREY NO. RELATIVE POSITION	STRUCTURAL SYSTEM	PROBLEMS DESCRIPTION	DANGER	CONDITION
j05	Ashok Lal Shrestha (9841492326)	G+4	B	4 floors collapsed. Ground floor very degraded.	⊗	P +

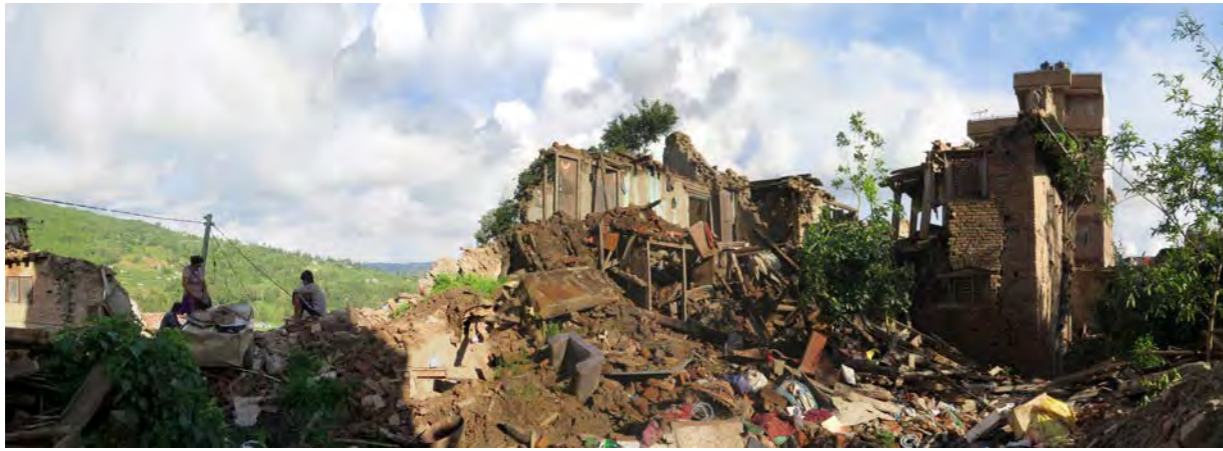
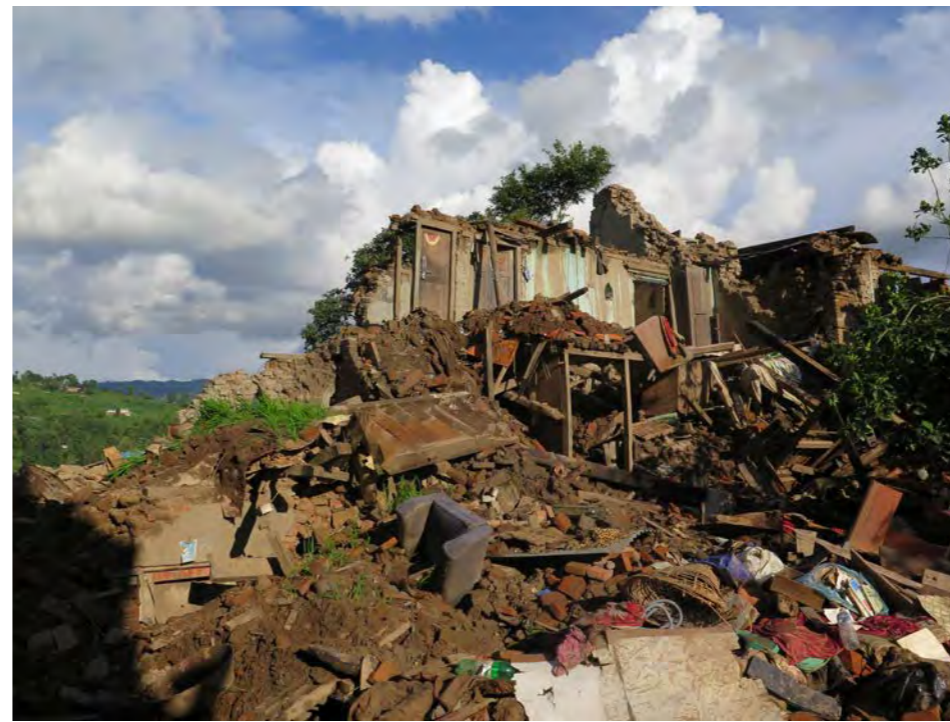
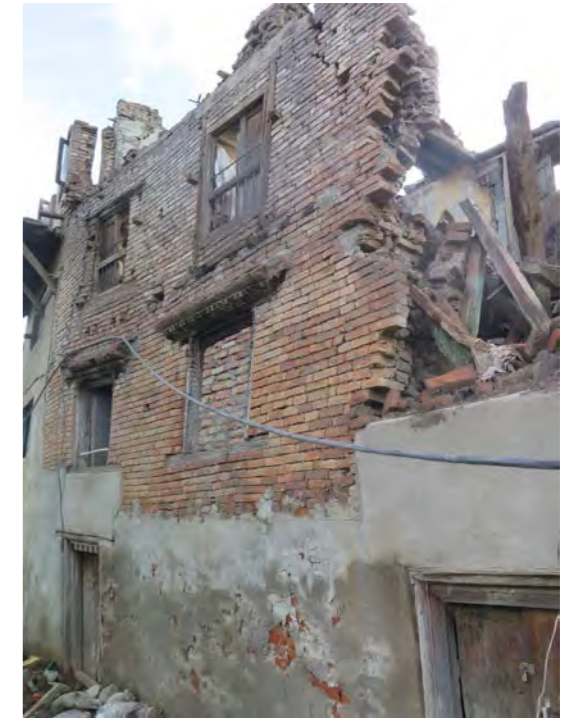
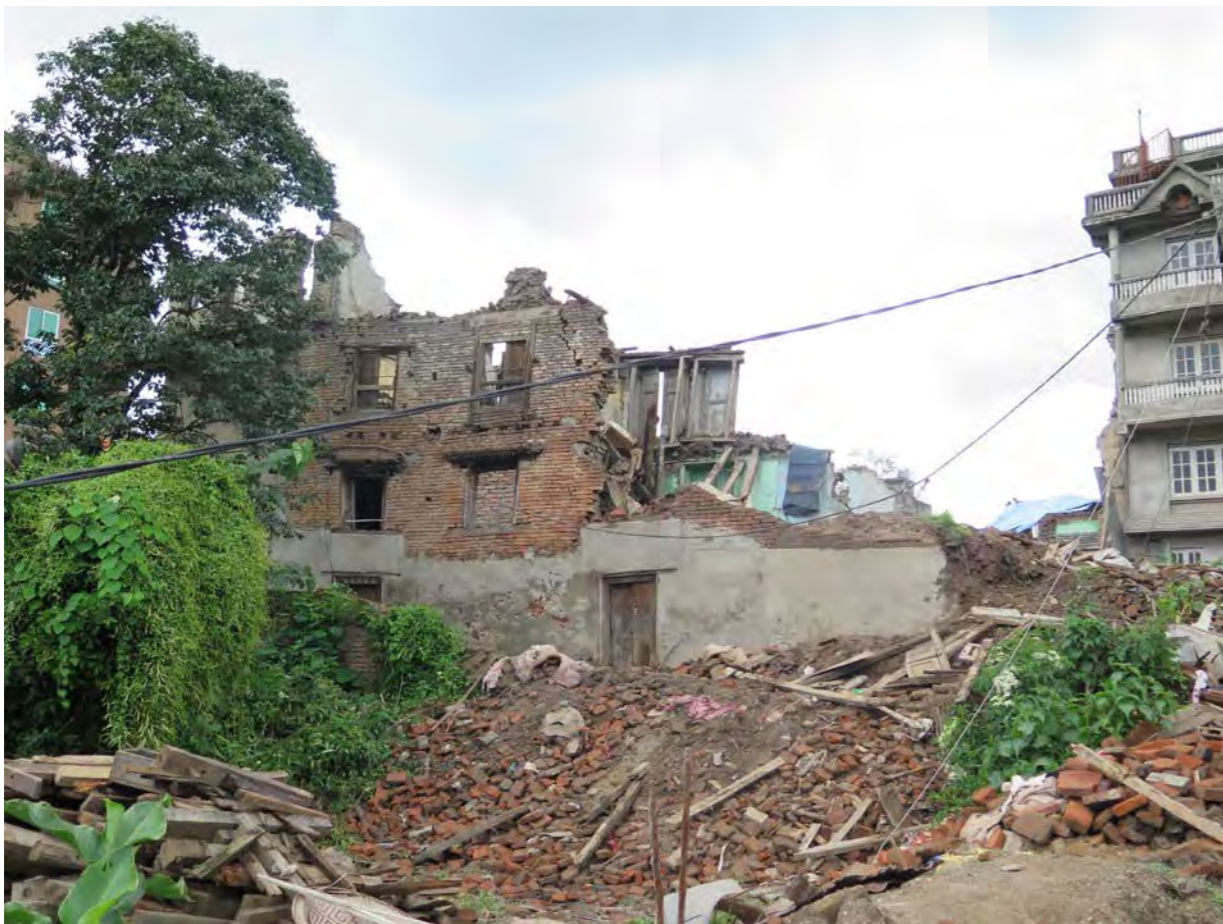
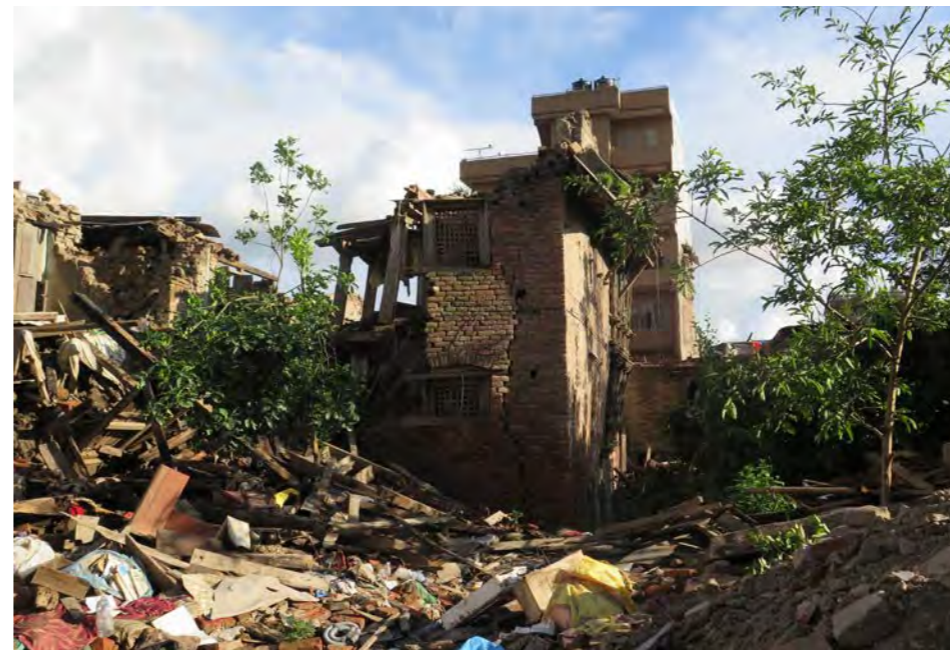
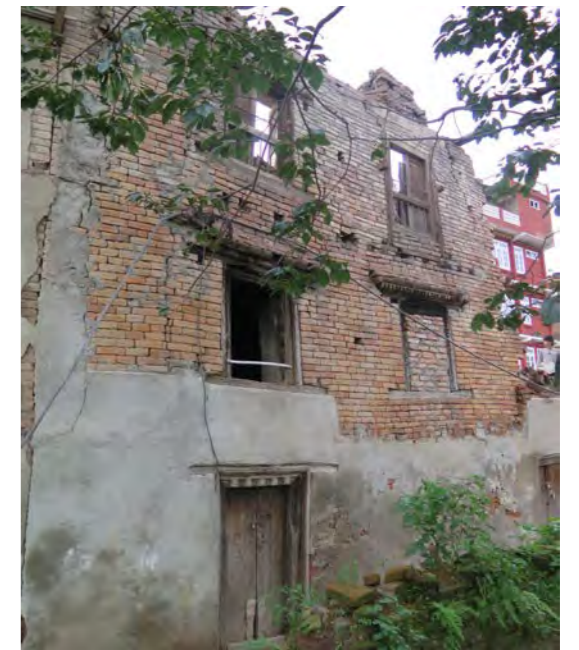
NUMBER	CONTACT	STOREY NO. RELATIVE POSITION	STRUCTURAL SYSTEM	PROBLEMS DESCRIPTION	DANGER	CONDITION	
j13	Ram Krishna Shrestha (98412633551)	G+4	B	Totally collapsed	⊗	+

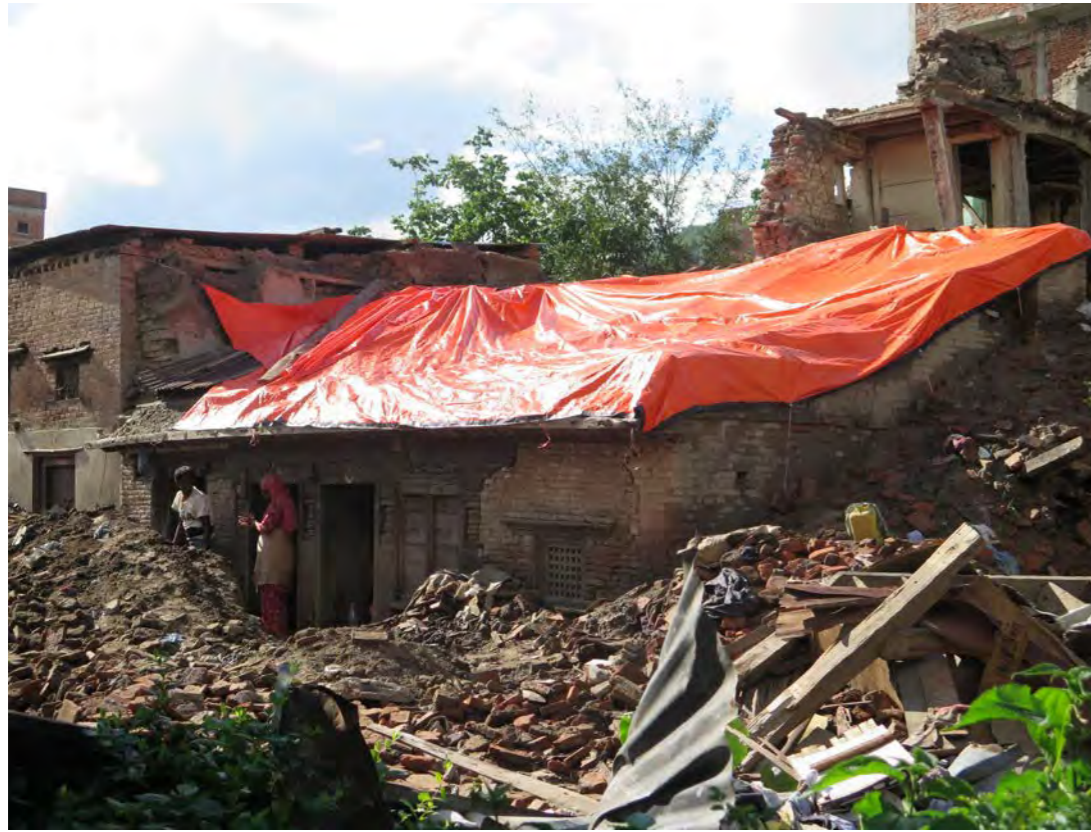
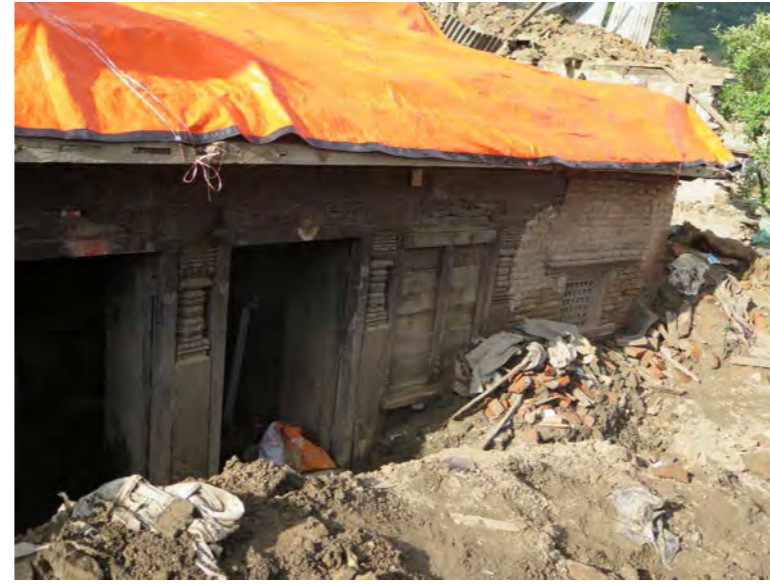
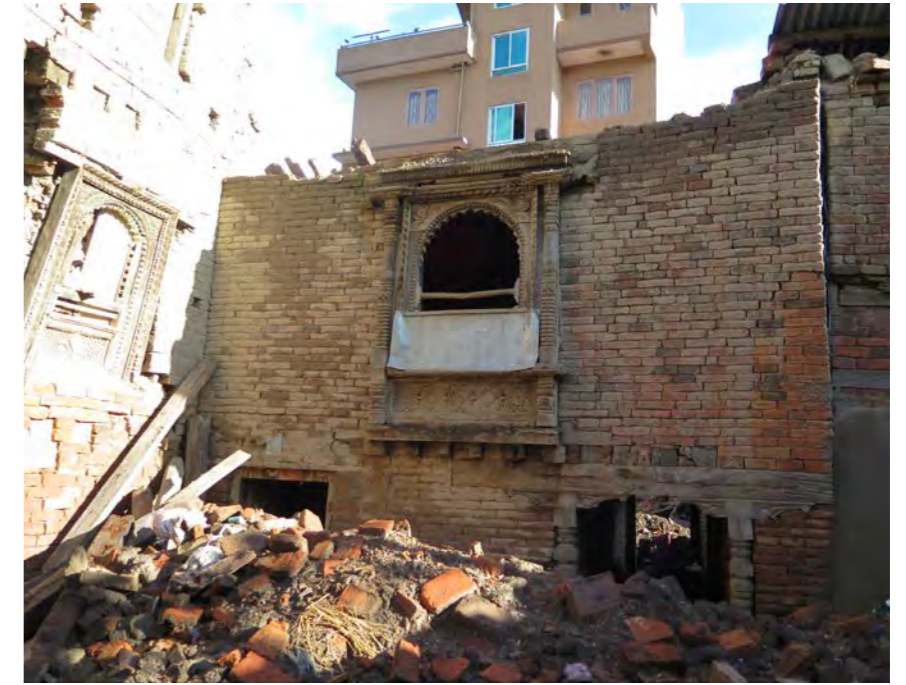
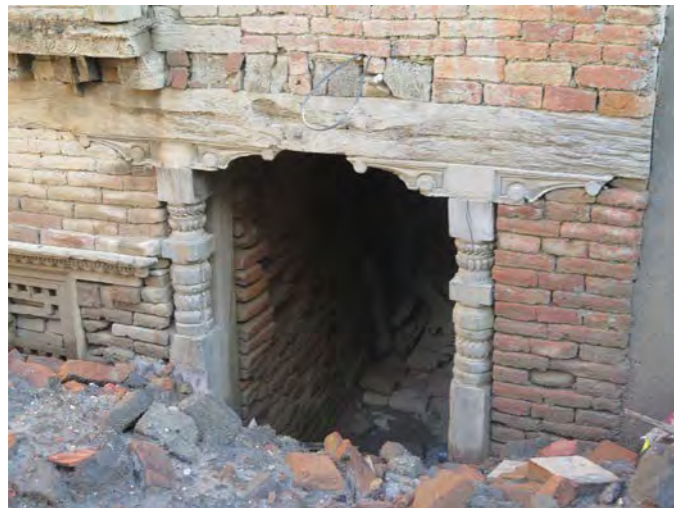
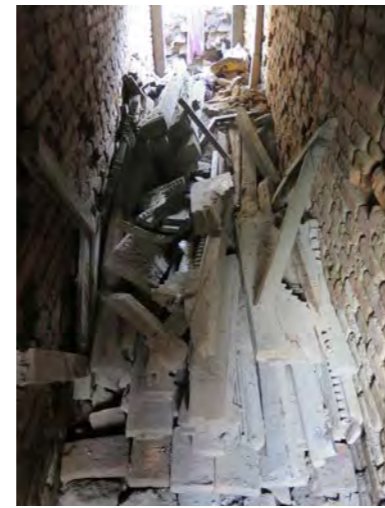
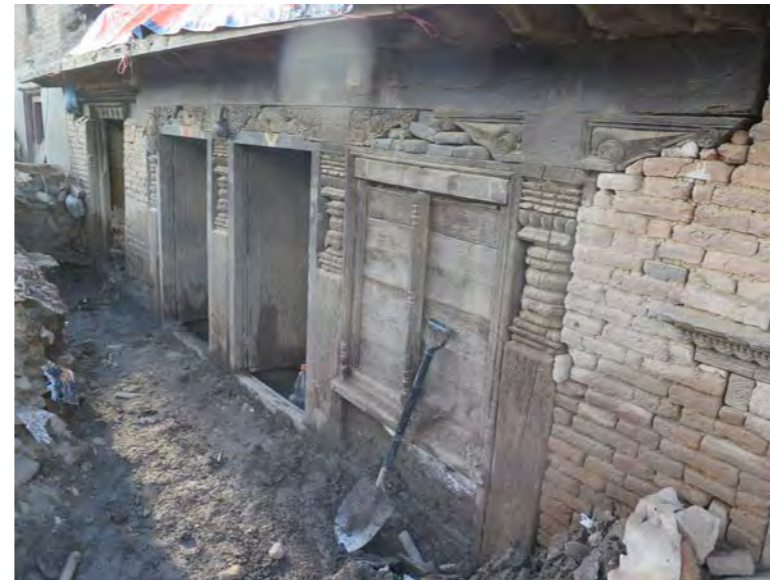
NUMBER	CONTACT	STOREY NO. RELATIVE POSITION	STRUCTURAL SYSTEM	PROBLEMS DESCRIPTION	DANGER	CONDITION	
j19	Gayatri Shrestha (9841404085)	G+4	B	Only North wall of ground floor remaining.	⊗	W R P +

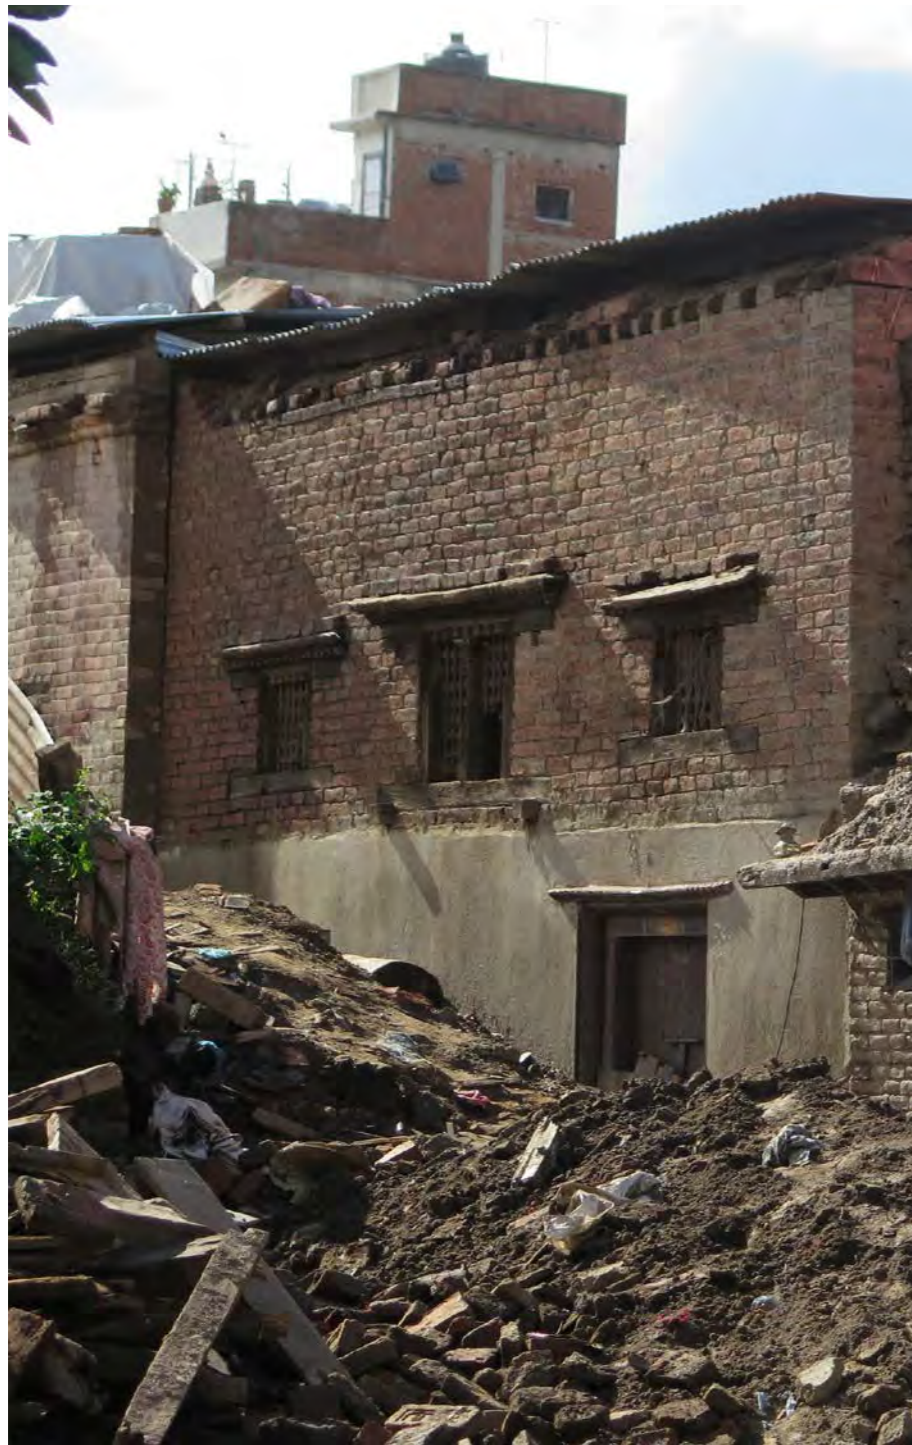
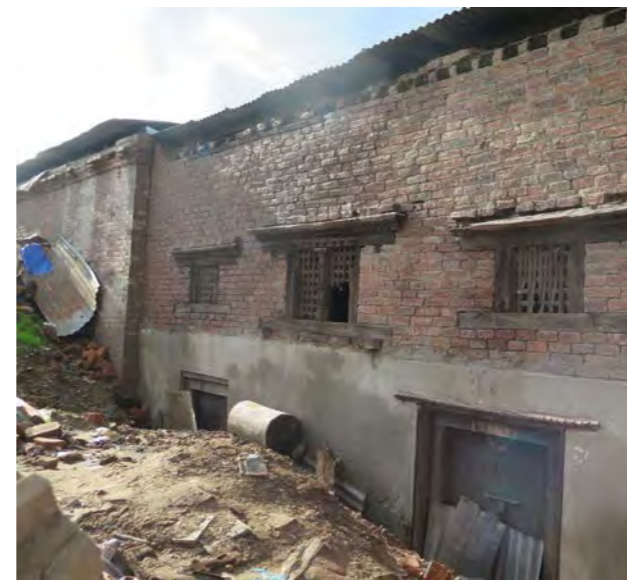
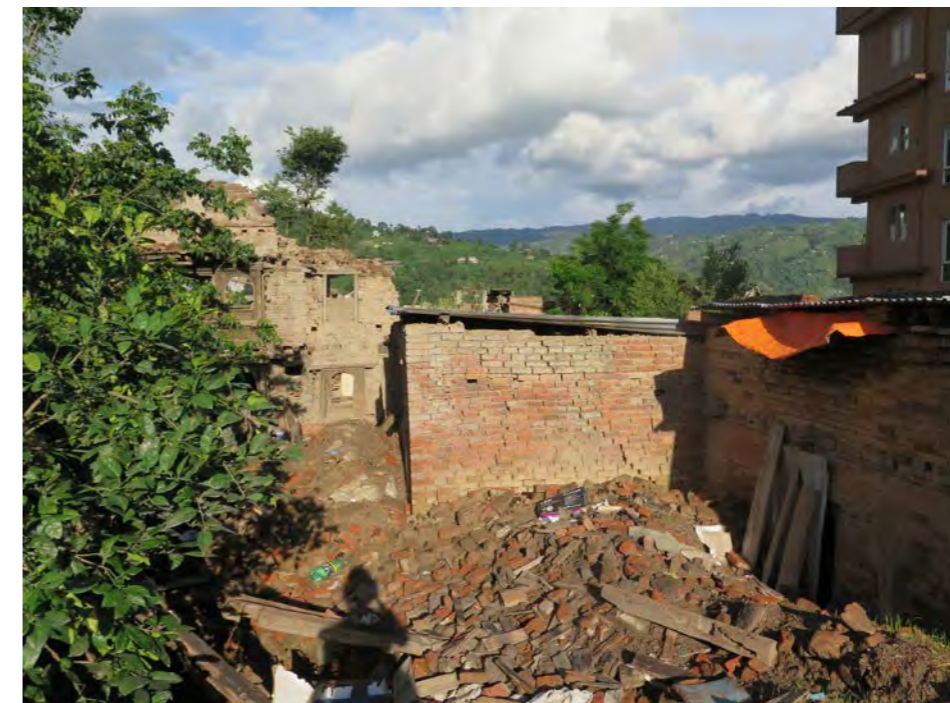
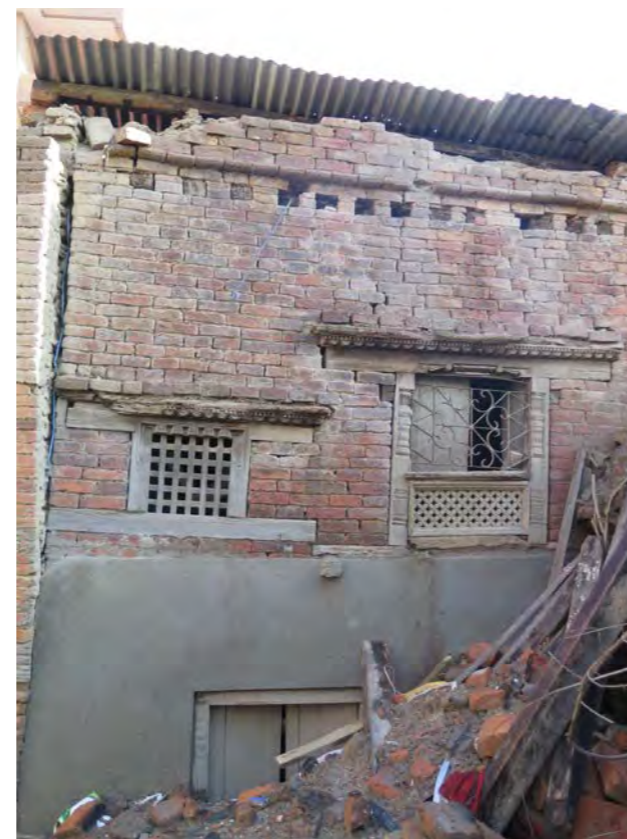
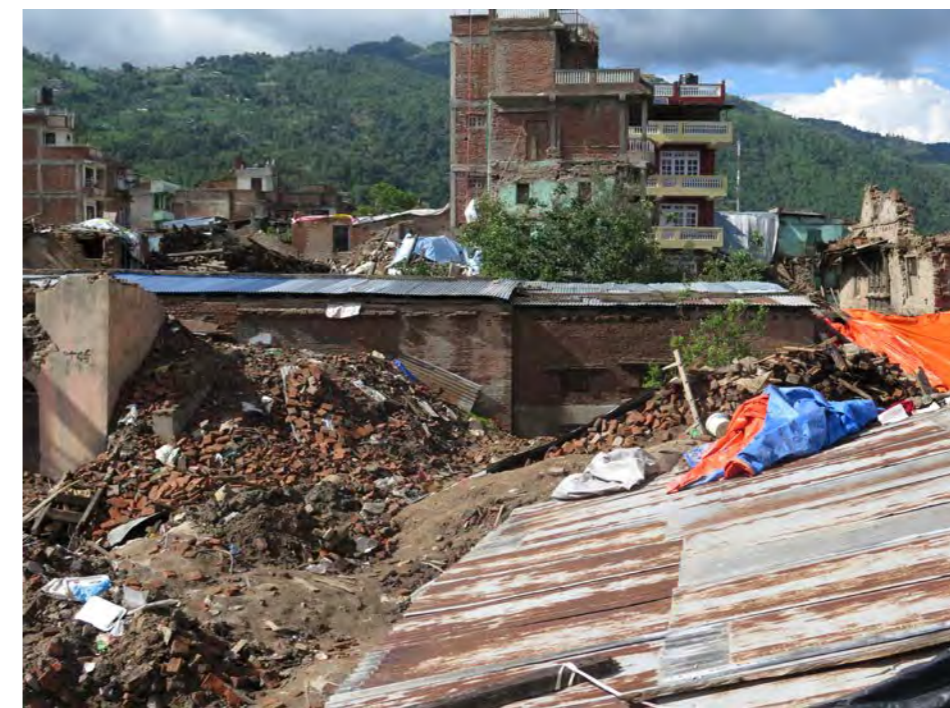
NUMBER	CONTACT	STOREY NO. RELATIVE POSITION	STRUCTURAL SYSTEM	PROBLEMS DESCRIPTION	DANGER	CONDITION
j20	Jamuna Shrestha, Ram Krishna Shrestha	G+4	B	3 floors collapsed. Major cracks on ground floor.	⊗	+

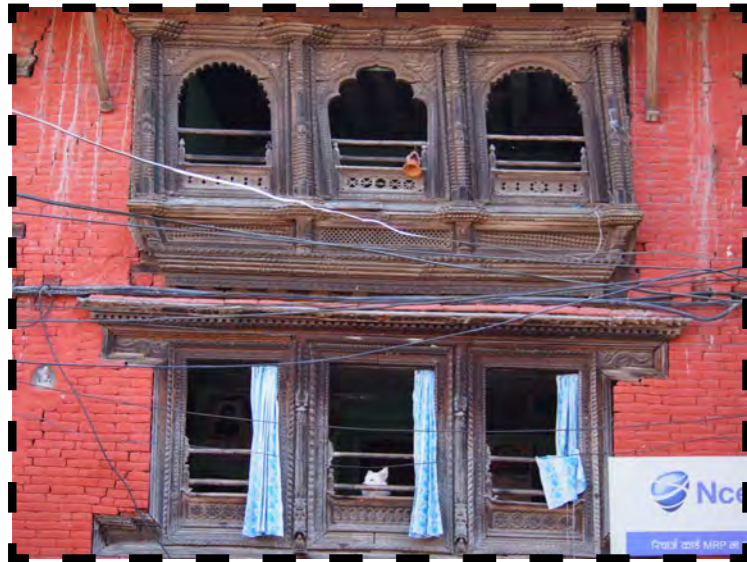
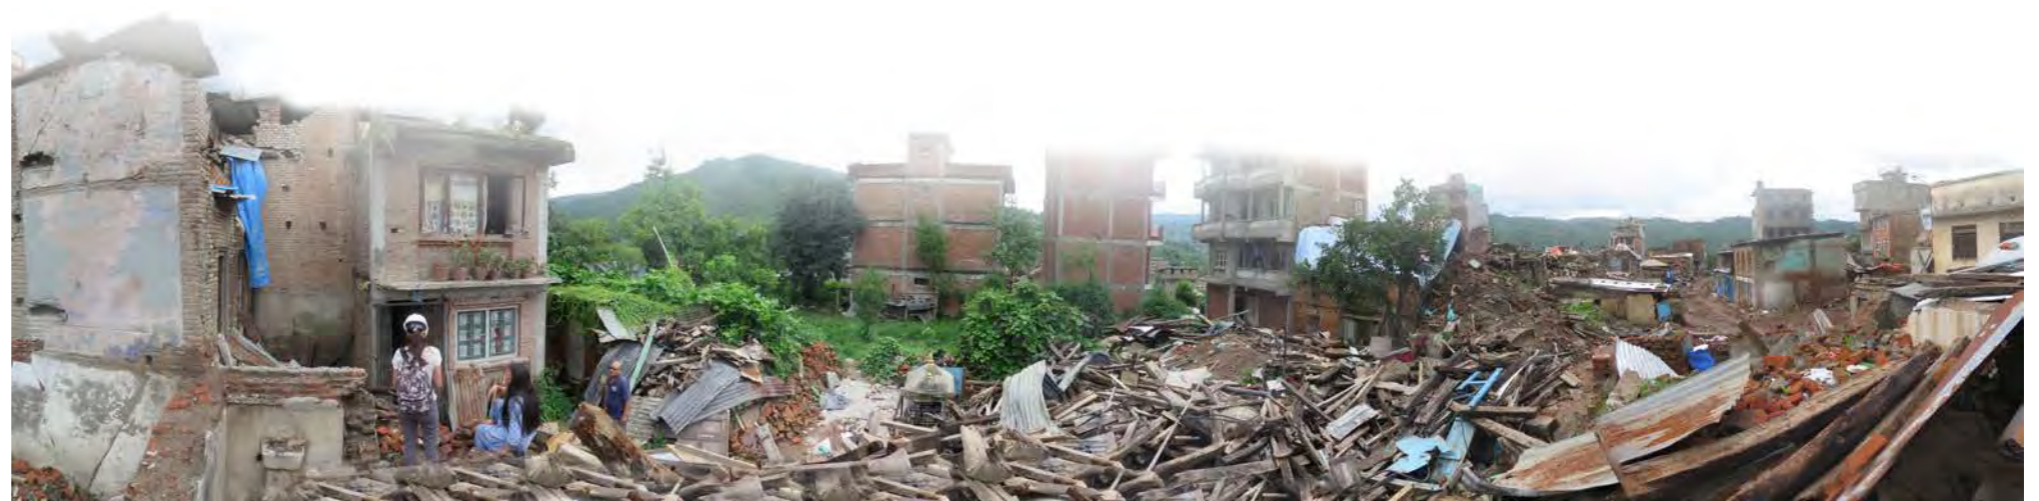
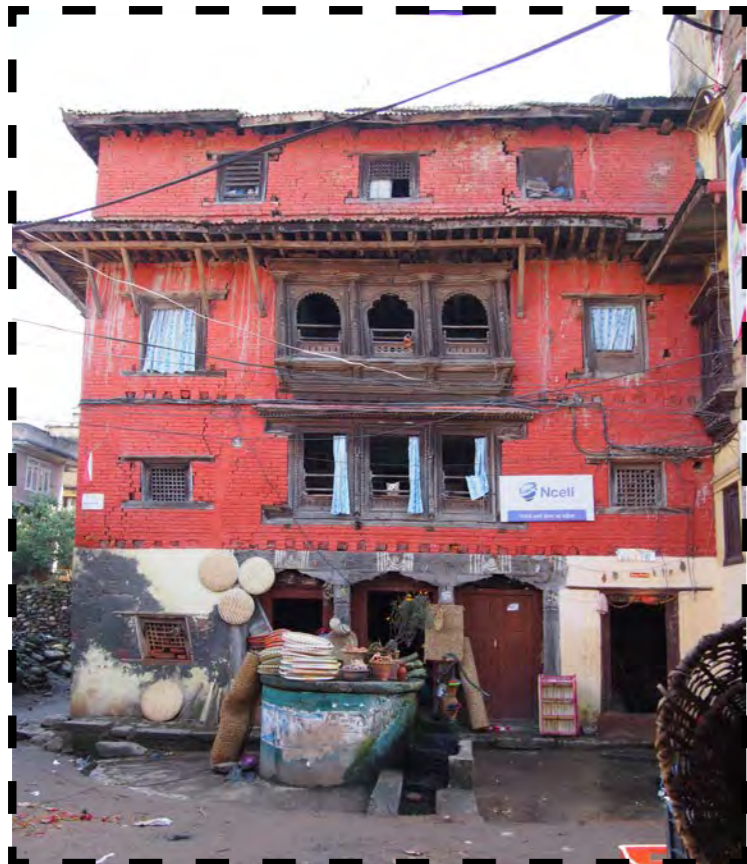
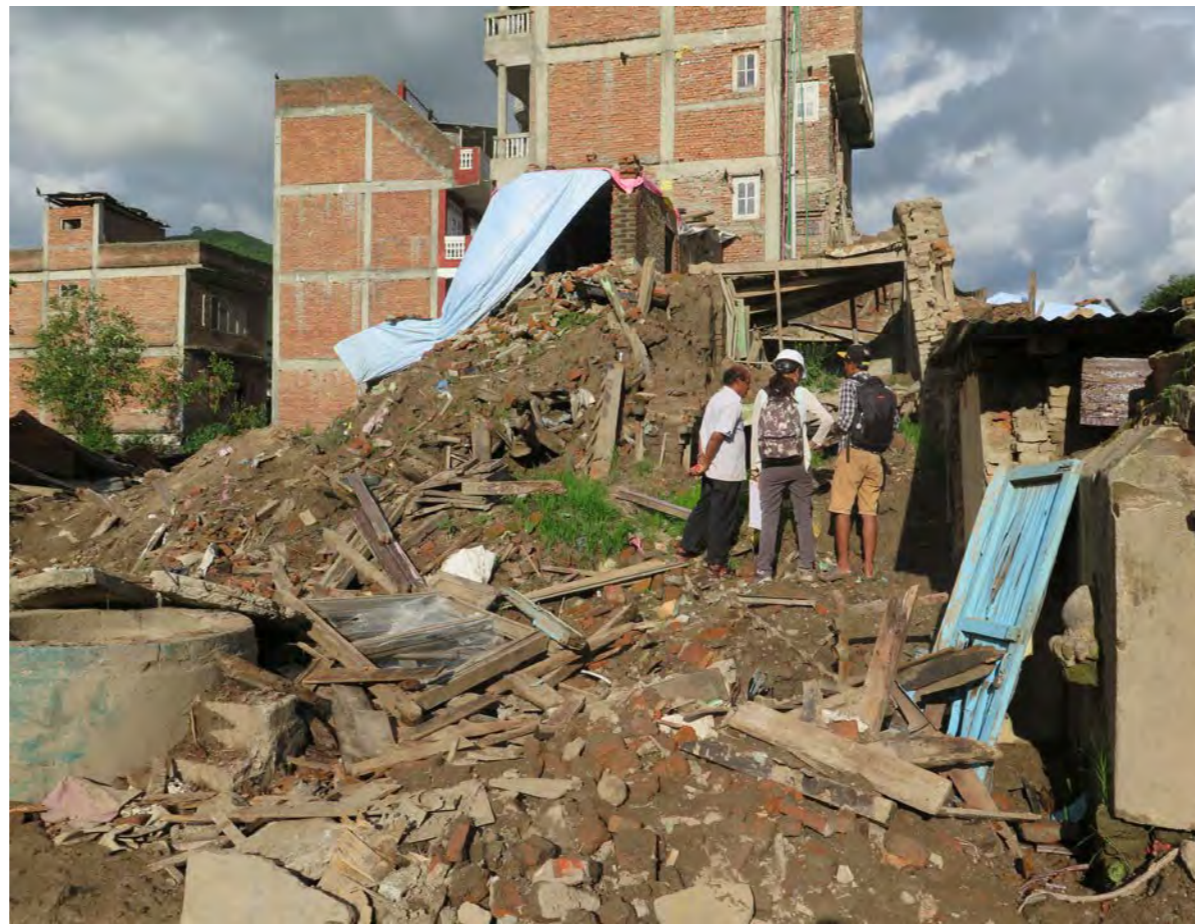
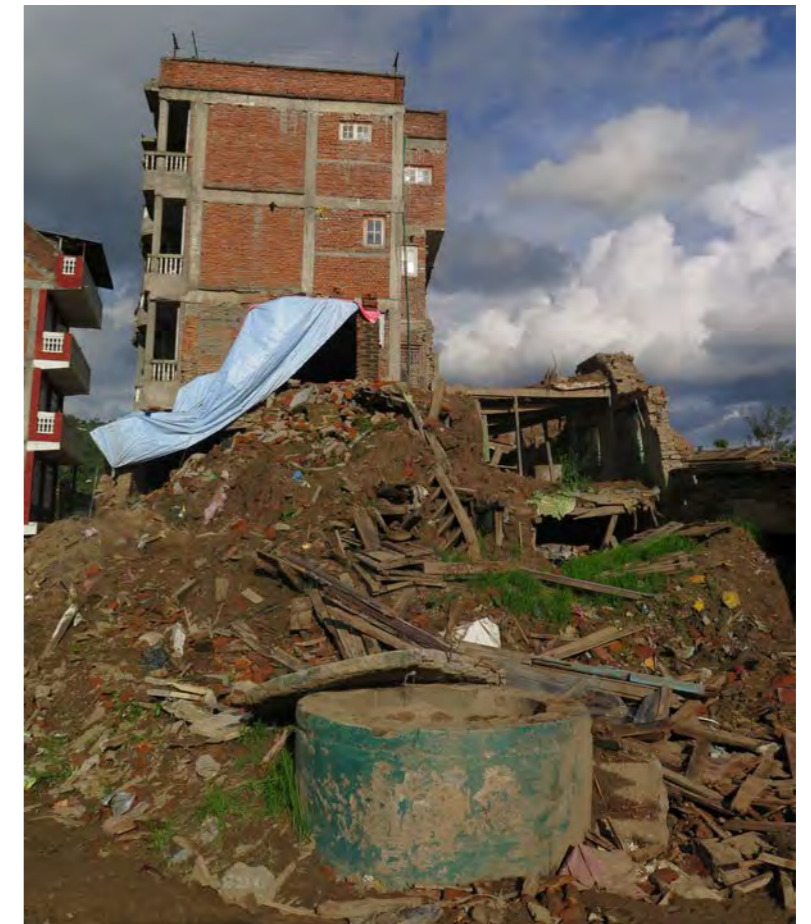
NUMBER	CONTACT	STOREY NO. RELATIVE POSITION	STRUCTURAL SYSTEM	PROBLEMS DESCRIPTION	DANGER	CONDITION	
j25	Leeza Shrestha, Krishna Shrestha,	G+4	B	Totally collapsed	⊗	+

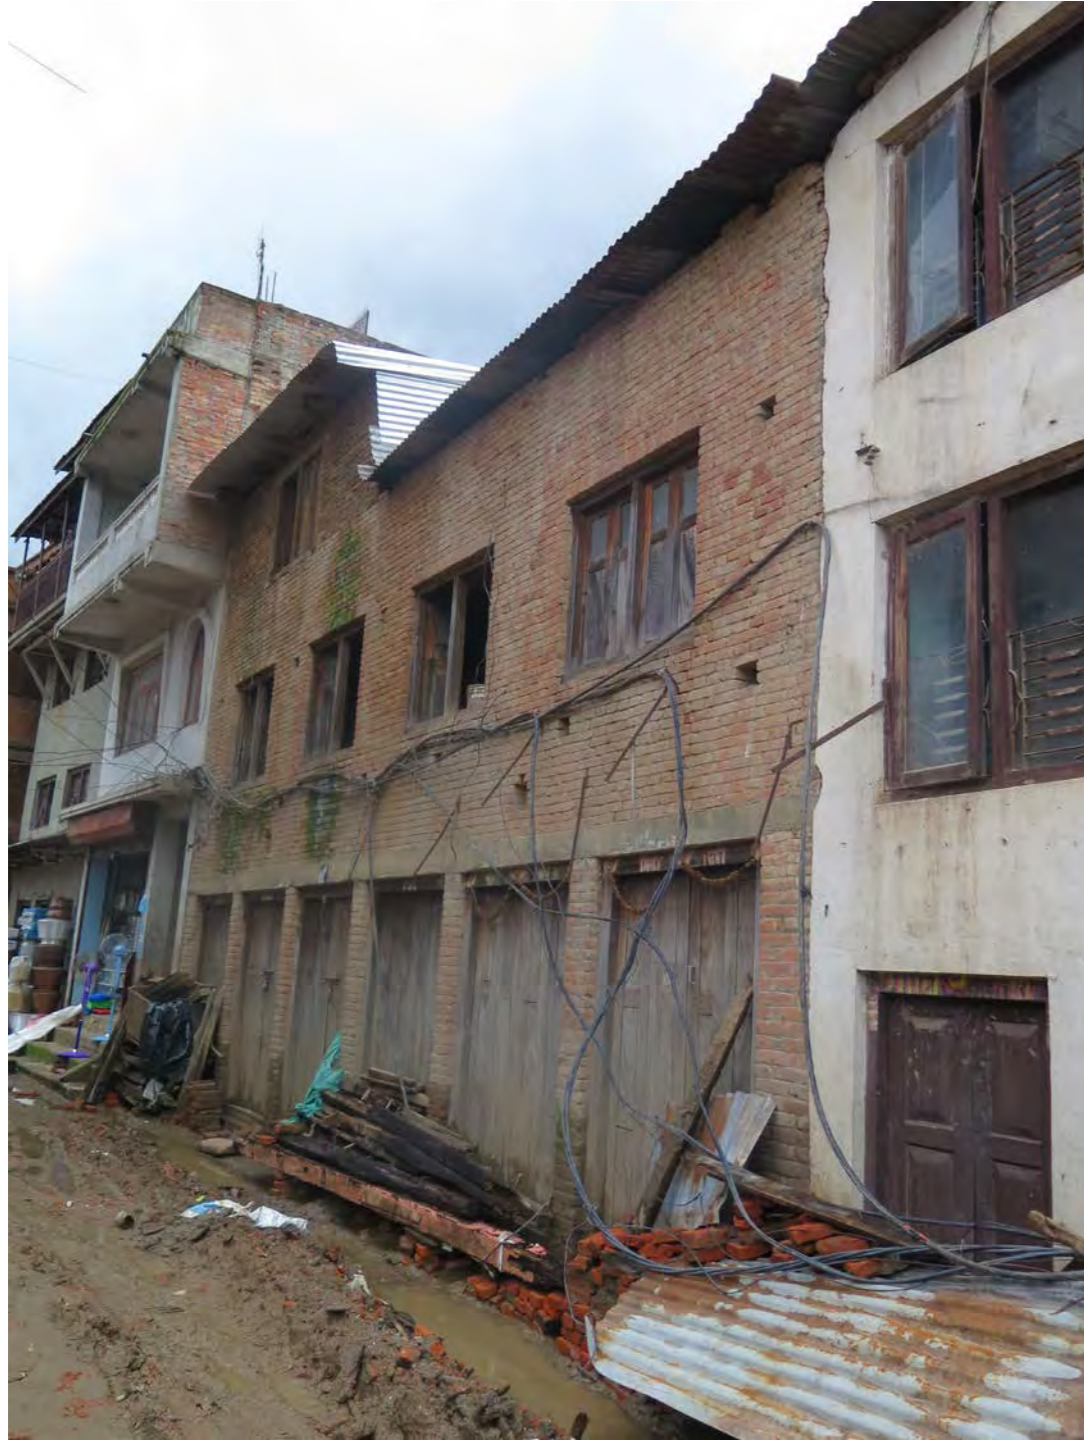
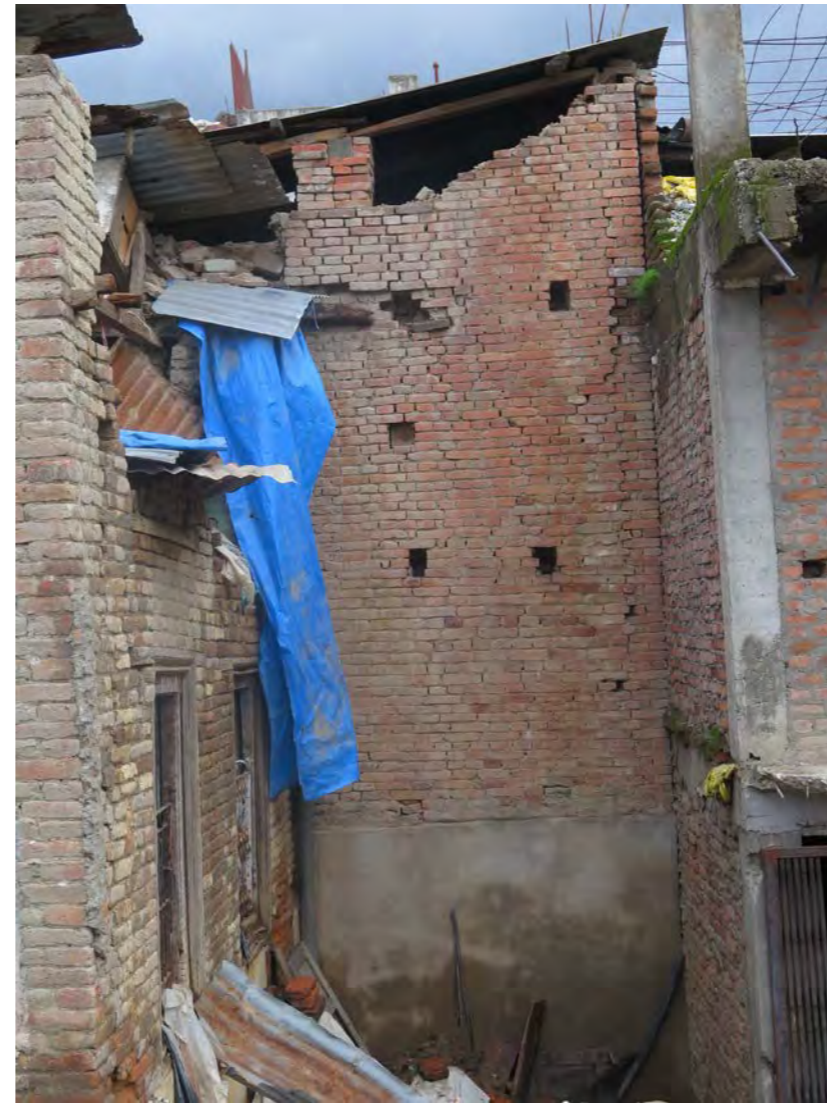
j34, j35

NUMBER	CONTACT	STOREY NO. RELATIVE POSITION	STRUCTURAL SYSTEM	PROBLEMS DESCRIPTION	DANGER	CONDITION	
j34	Sulochana Shrestha	G+3	B	2 floors collapsed. Dalins on first floor are falling. East wall heavily damaged.	⚠	+	
j35	Purna Bhakta Shrestha	G+3	B	2 floors collapsed. Second floor reconstructed. Vertical crack on north west corner in ground floor.	⚠	+

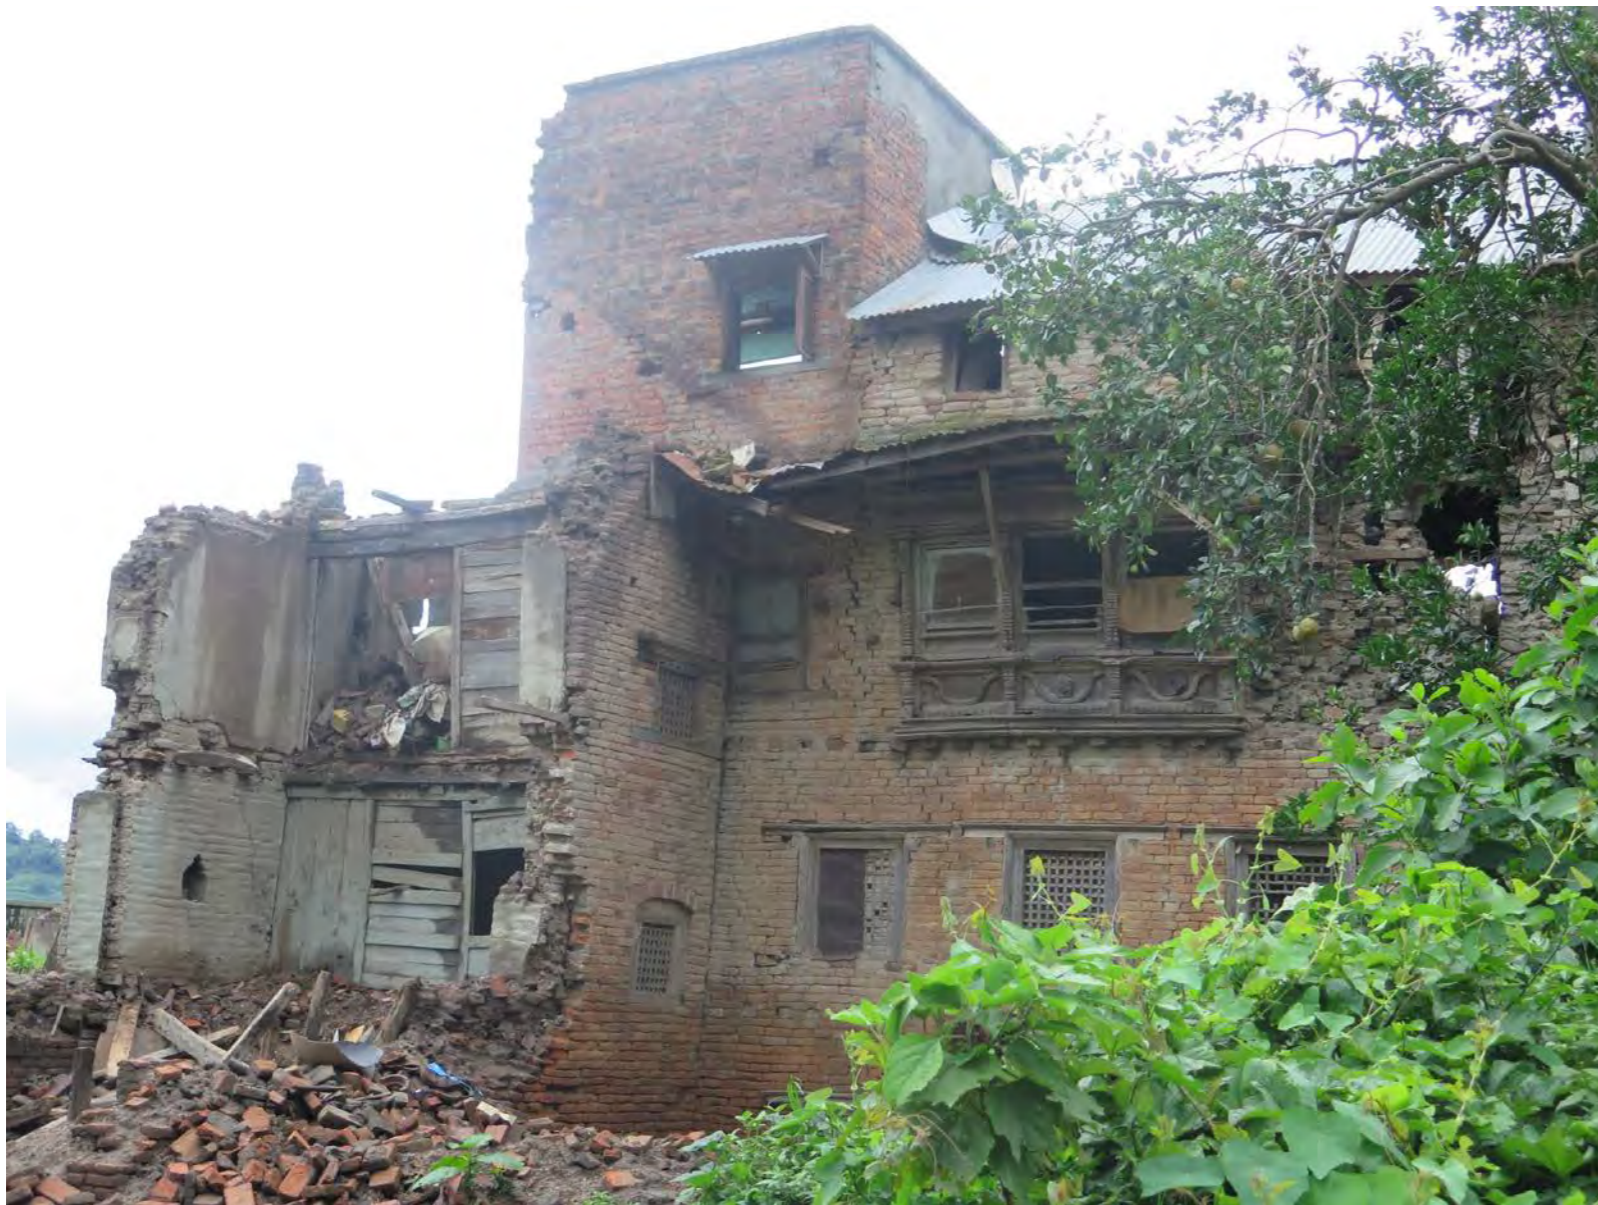
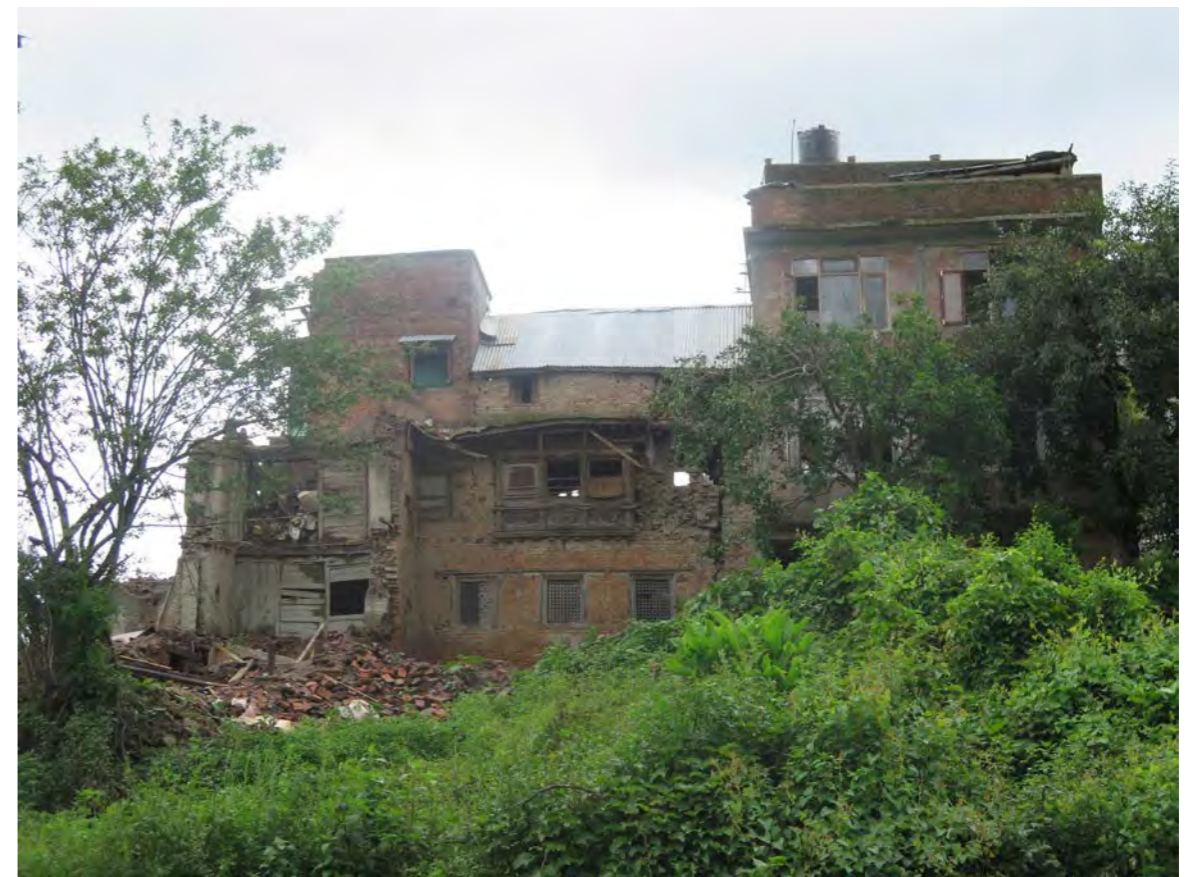
NUMBER	CONTACT	STOREY NO. RELATIVE POSITION	STRUCTURAL SYSTEM	PROBLEMS DESCRIPTION	DANGER	CONDITION	
j52	Ram Shrestha	G+3	B	South part collapsed	⚠️ ❌	W +
