2015 Earthquake Damage Mapping

Sankhu

October 2015

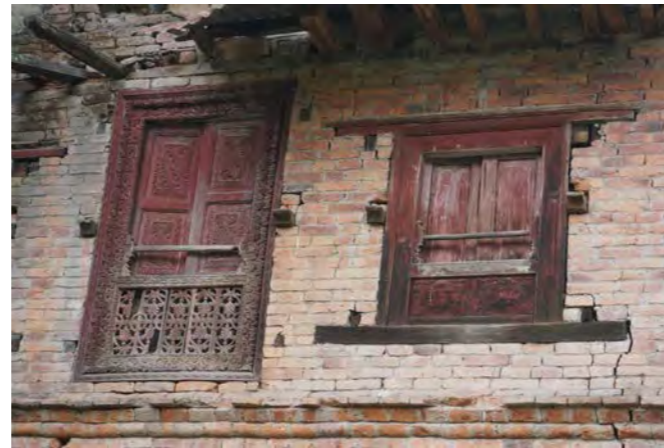
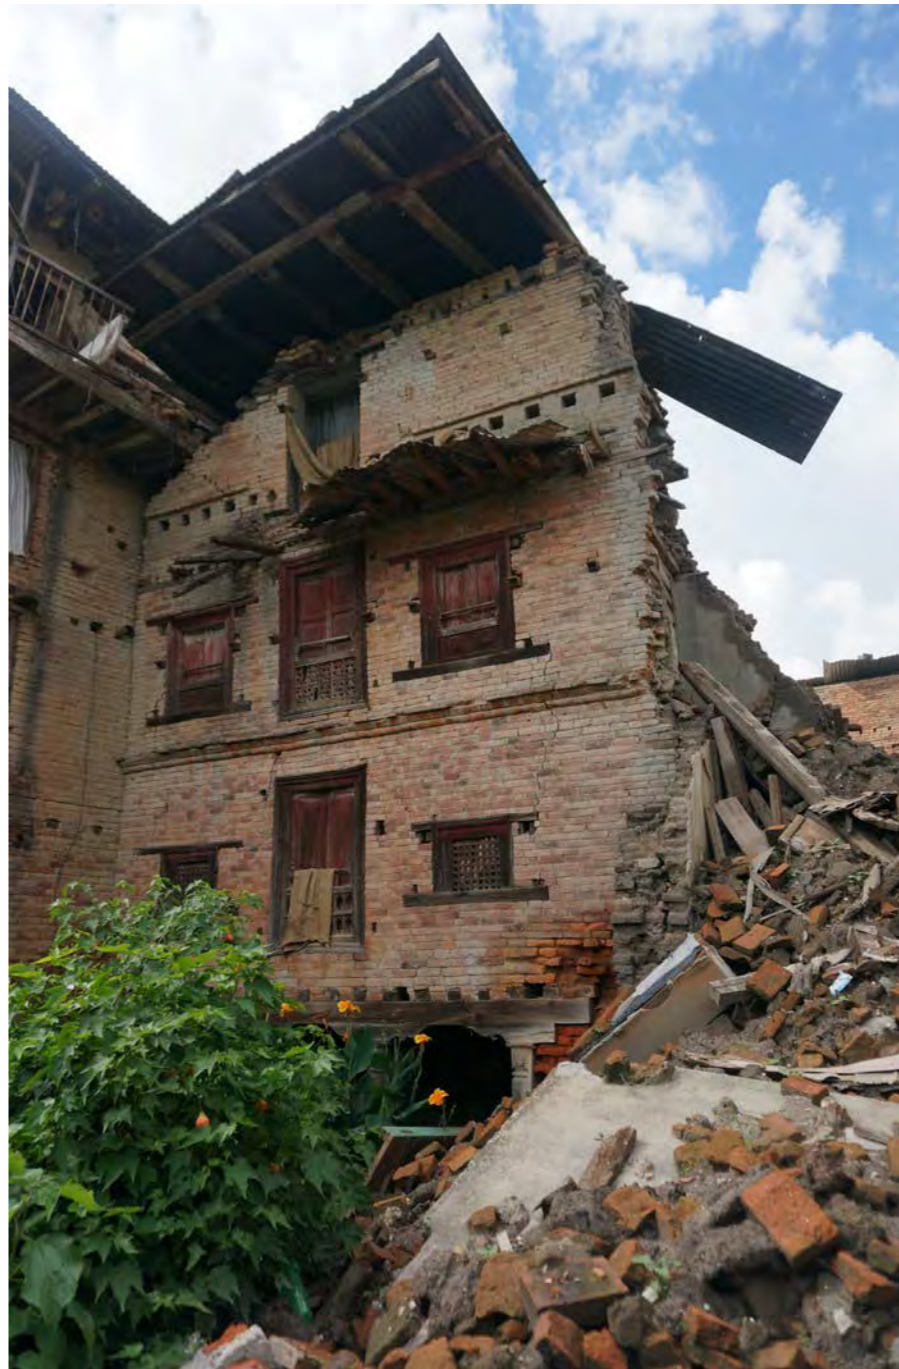
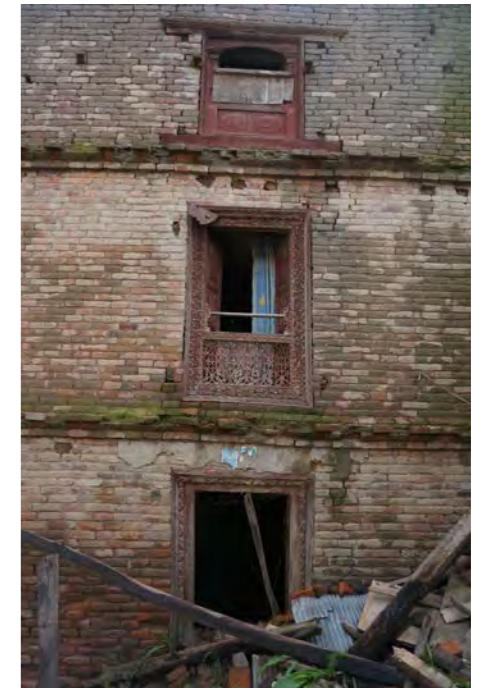
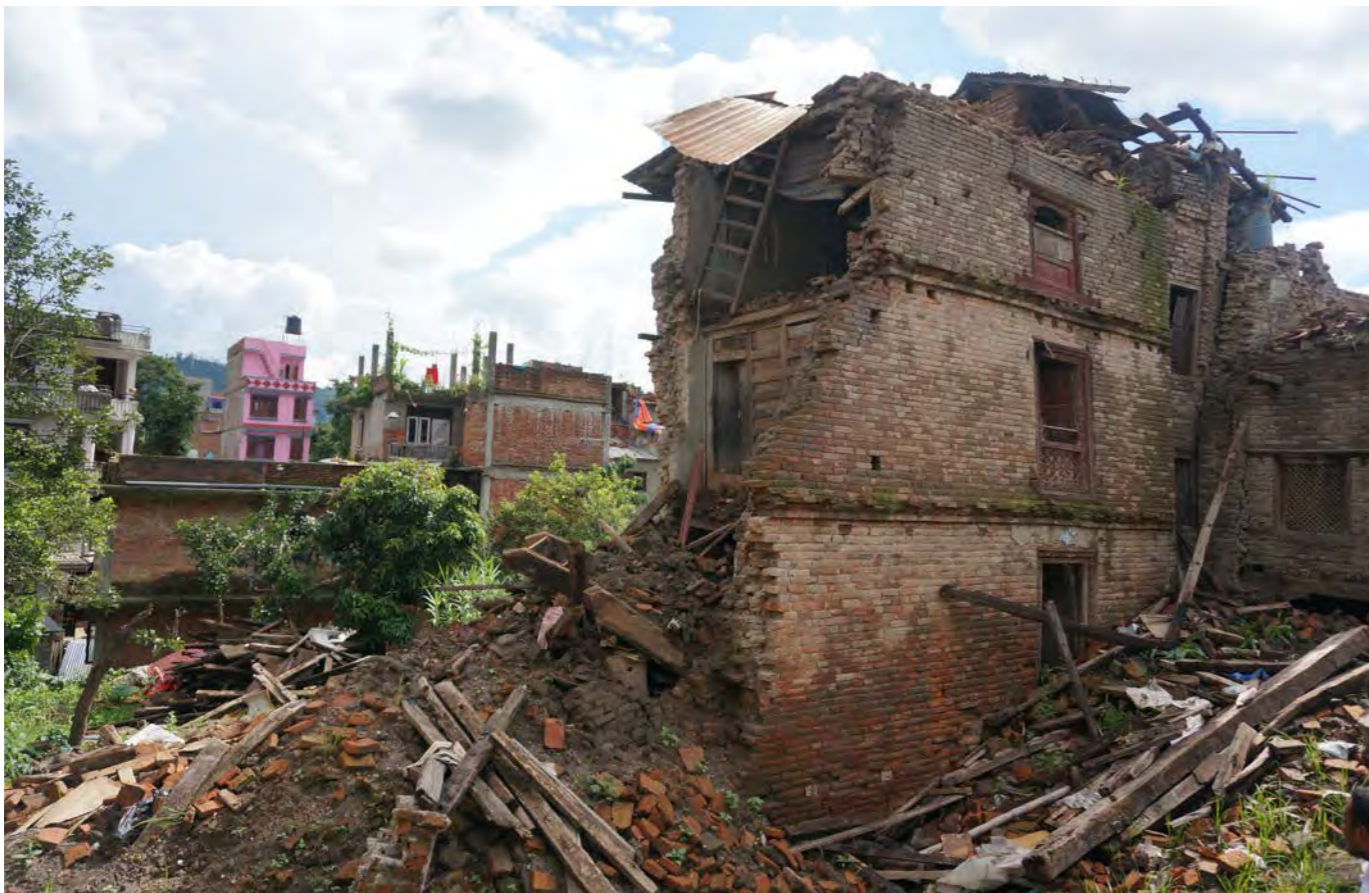
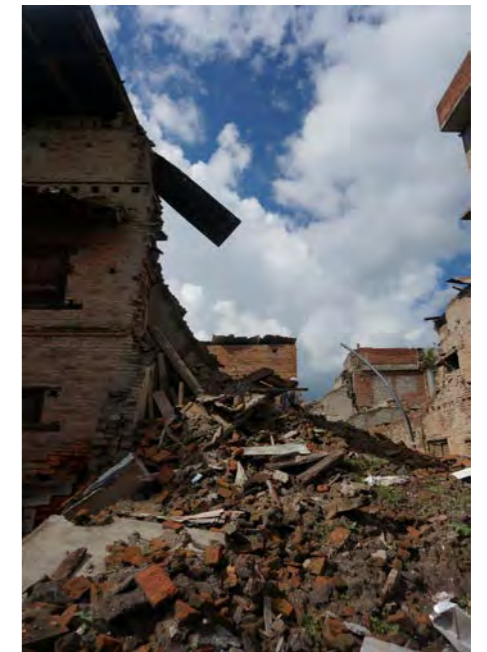
NUMBER	CONTACT	STOREY NO. RELATIVE POSITION	STRUCTURAL SYSTEM	PROBLEMS DESCRIPTION	DANGER	CONDITION	
k18	Bekha Ram Shrestha	G+3	UnB + B	Totally Collapsed		+W!

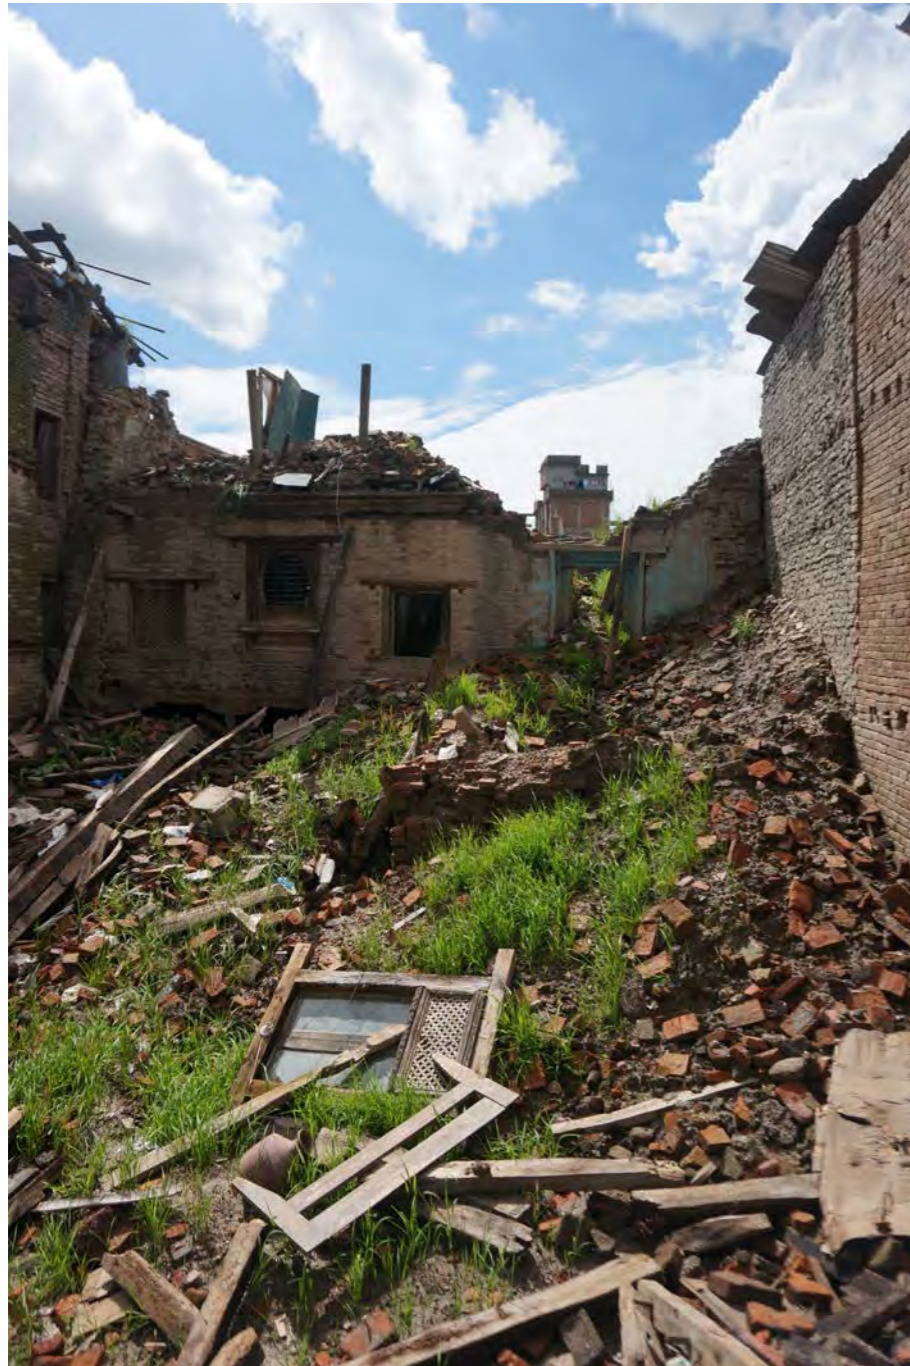
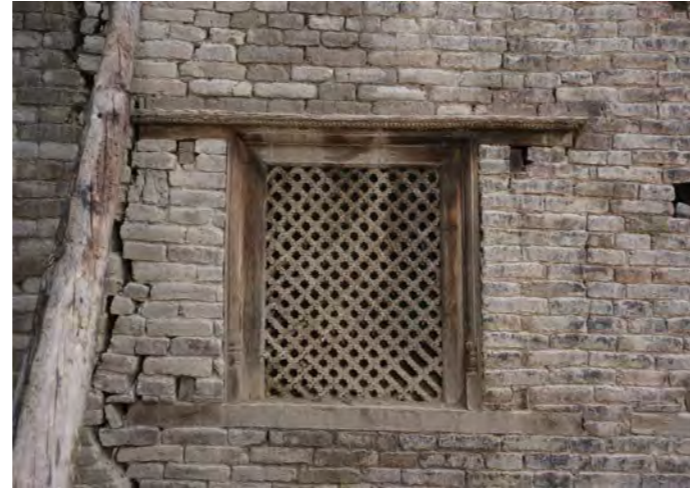
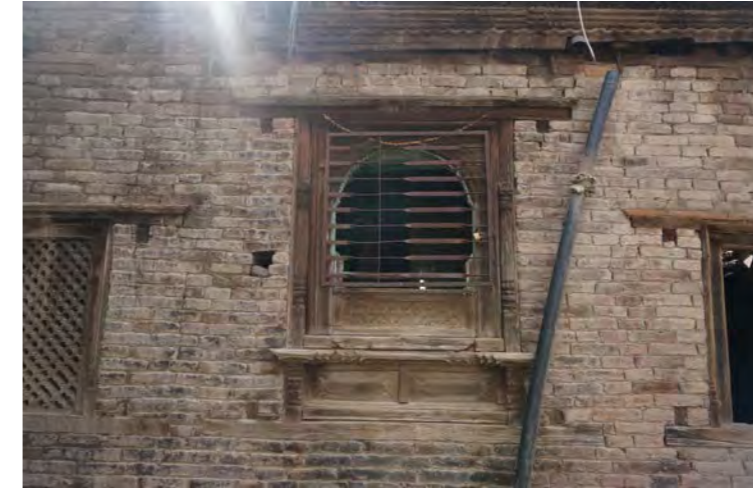
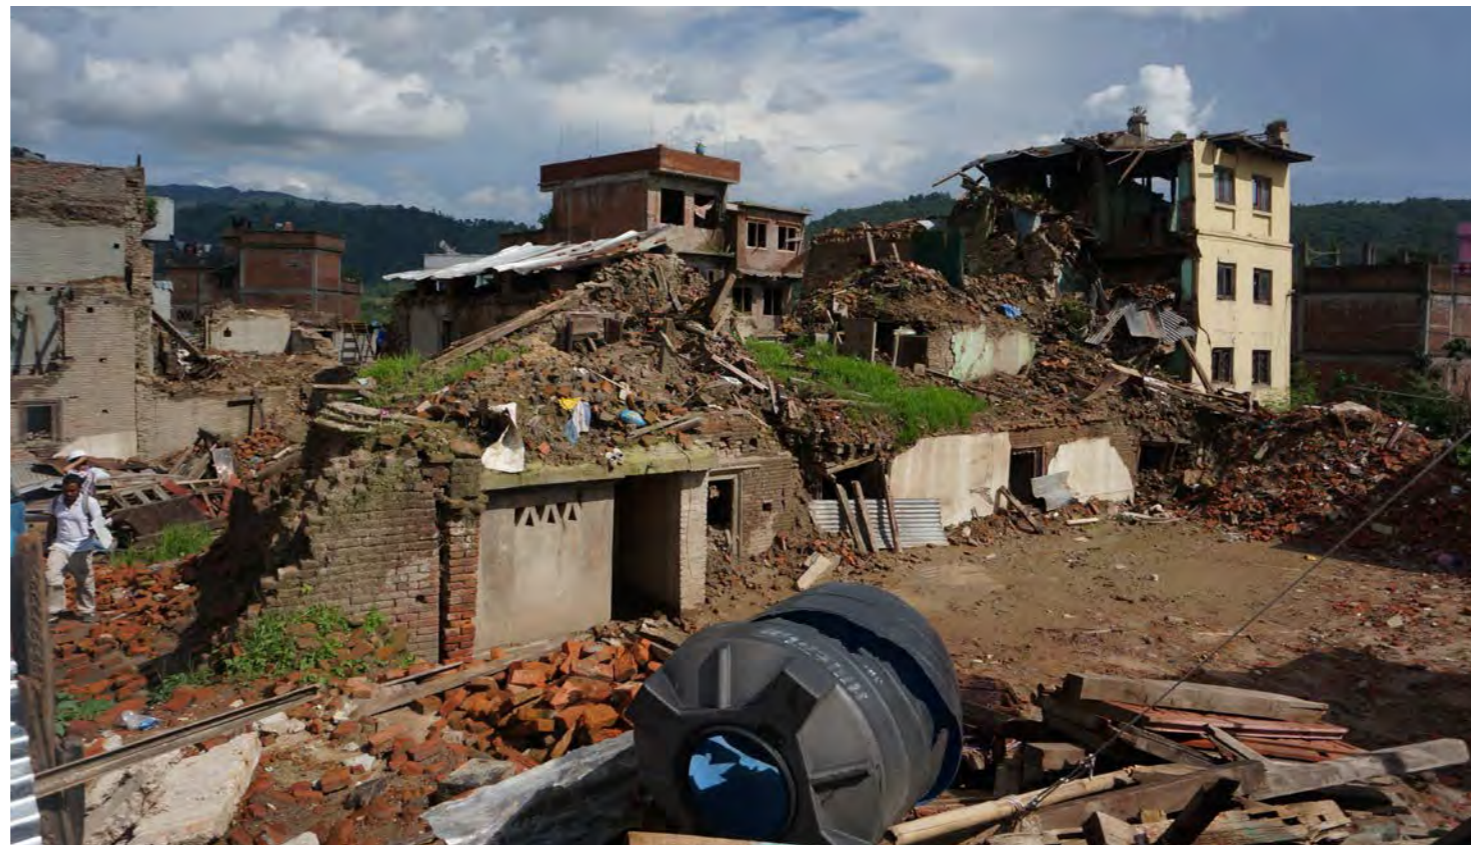
k22, k23

NUMBER	CONTACT	STOREY NO.	STRUCTURAL SYSTEM	PROBLEMS DESCRIPTION	DANGER	CONDITION
k22	Purushottam Shrestha	G+2	UnB + B	Totally Collapsed		+
k23	“Surya Bhakta Shrestha 9841655347”	G+2	UnB + B	Totally Collapsed		+

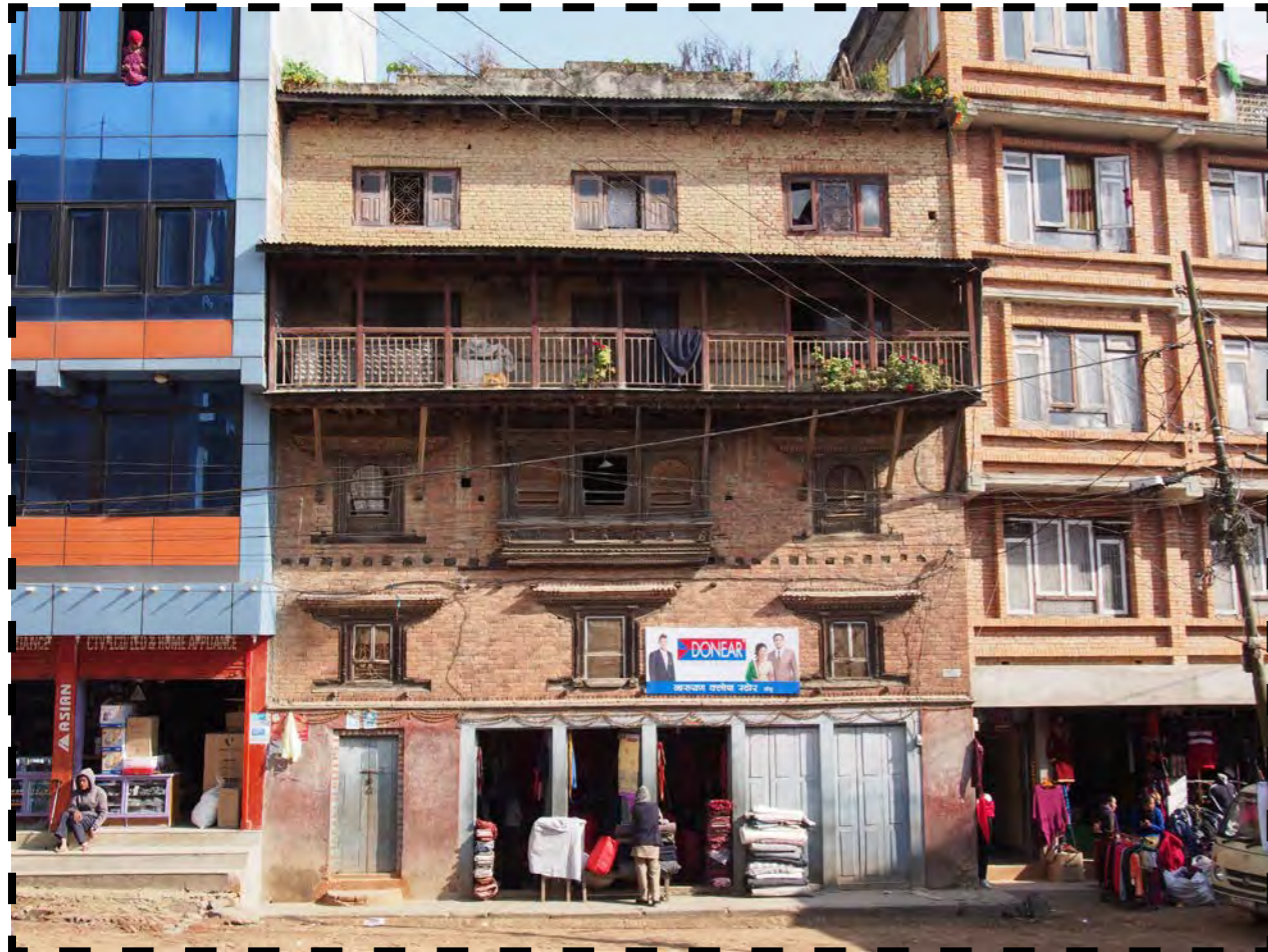
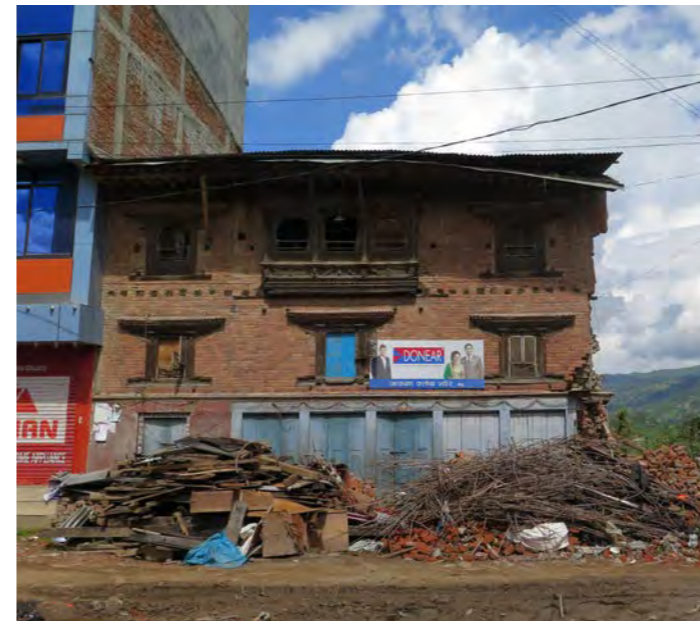
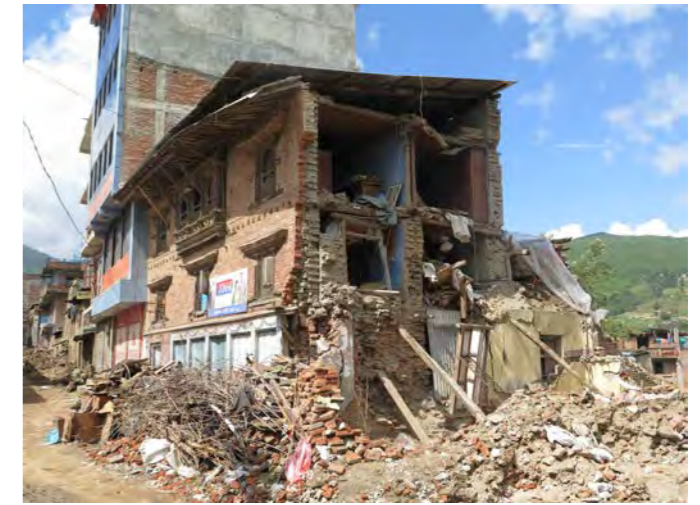
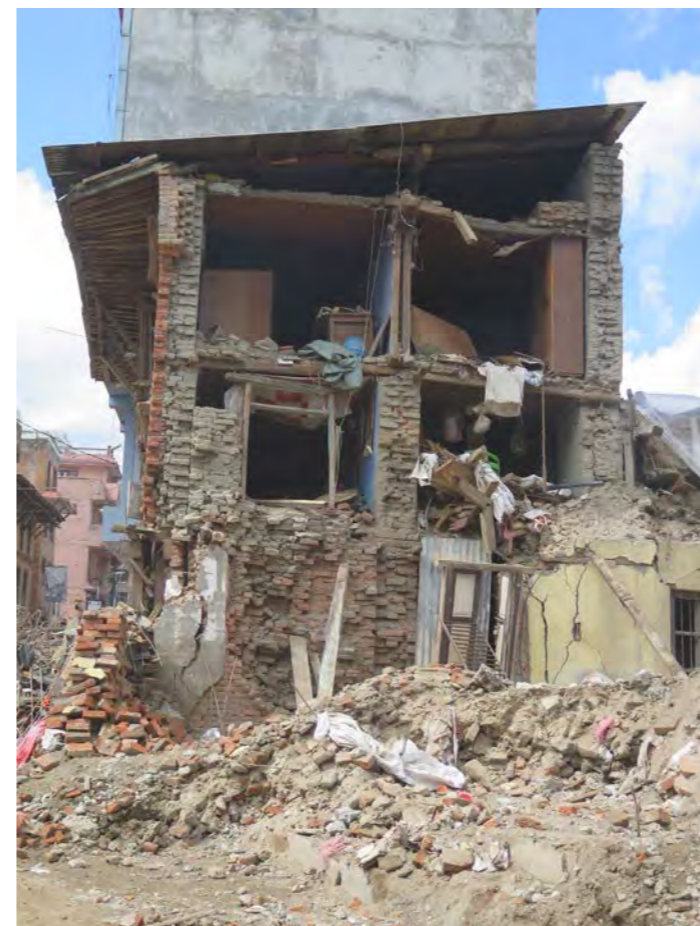
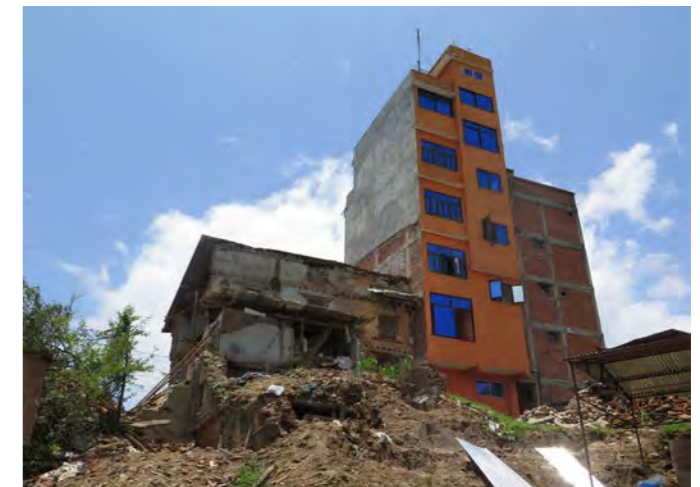
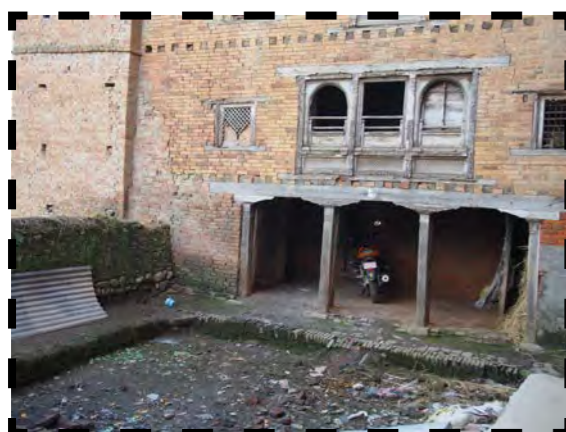
NUMBER	CONTACT	STOREY NO. RELATIVE POSITION	STRUCTURAL SYSTEM	PROBLEMS DESCRIPTION	DANGER	CONDITION	
102	Narendra Raj Shrestha (9860014492)	G+3	B+UnB	Completely collapsed	3/4 ☒	+

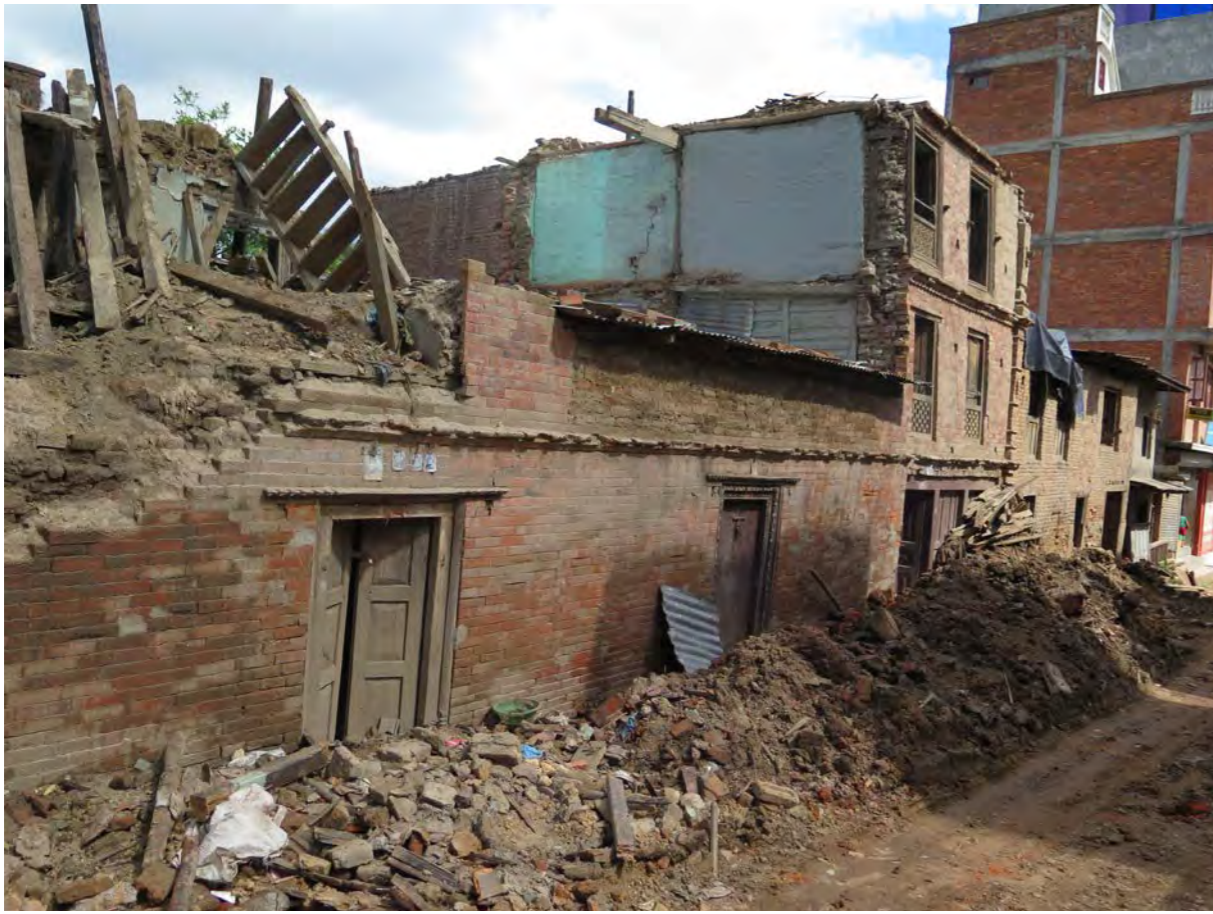
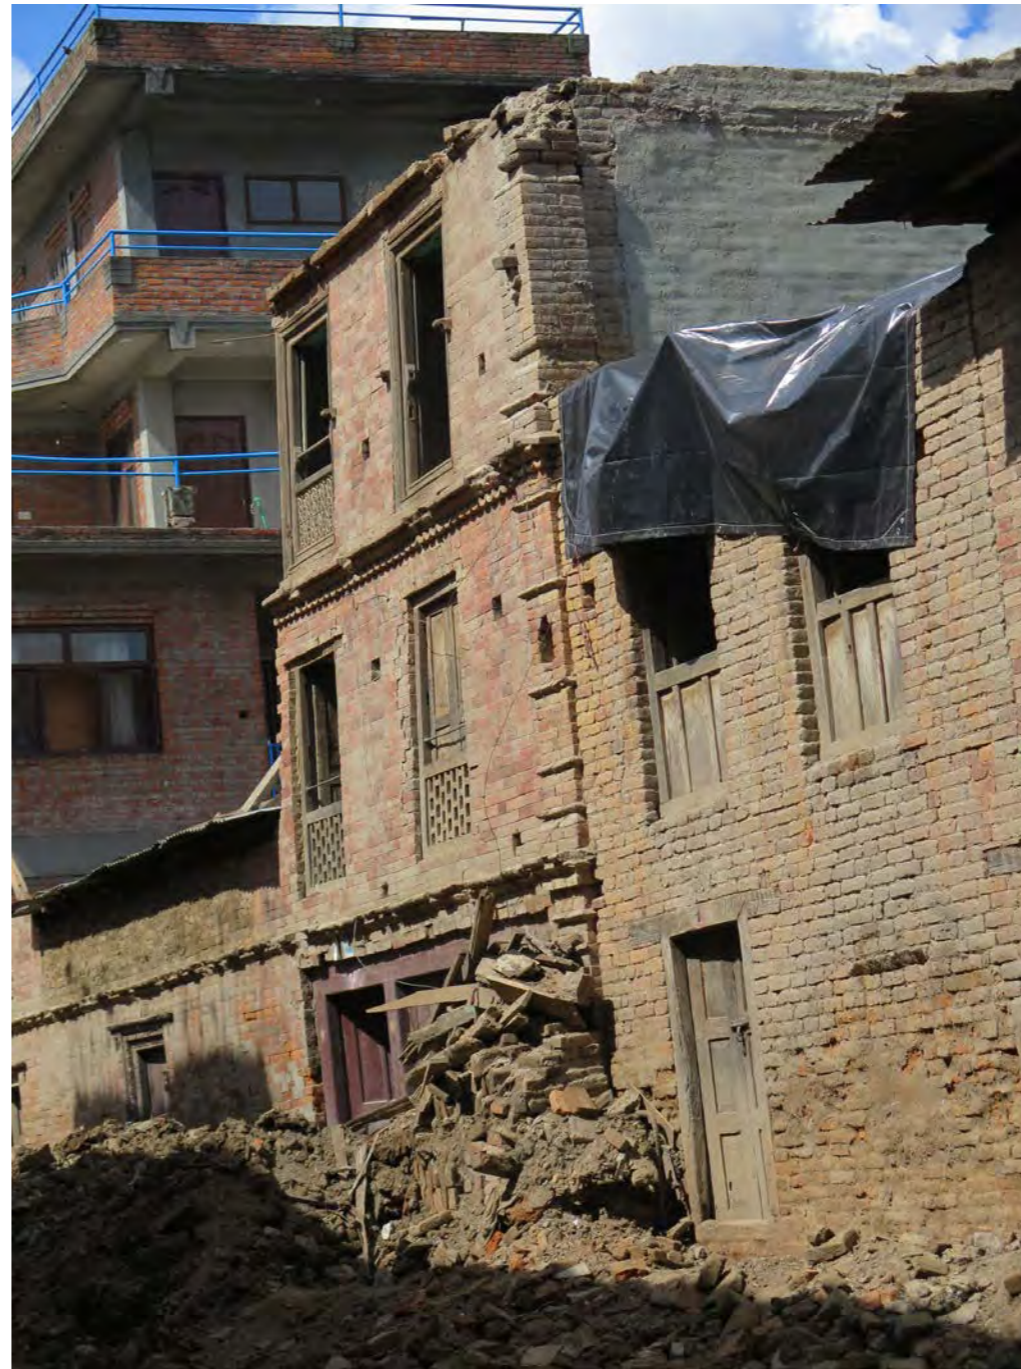
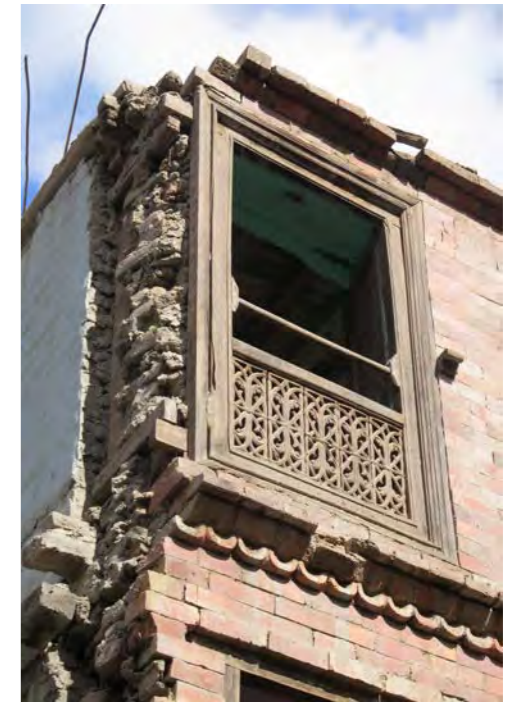
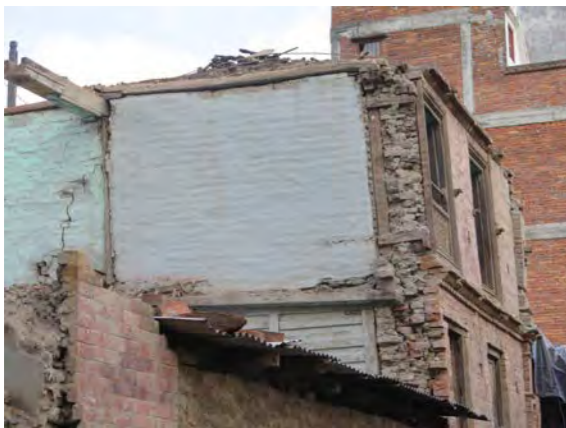
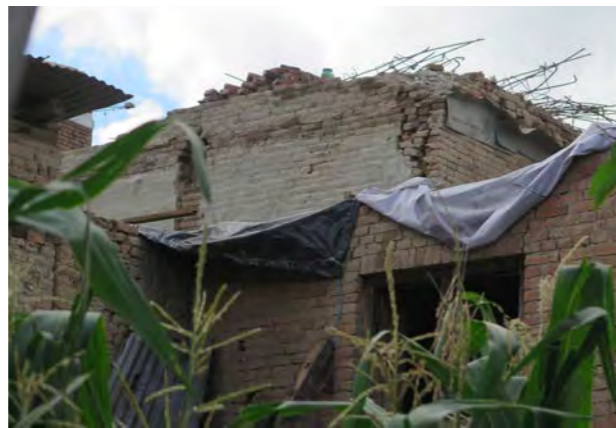
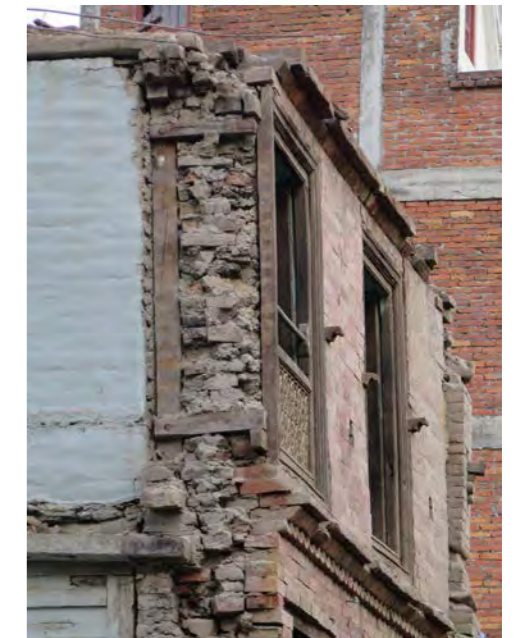
NUMBER	CONTACT	STOREY NO. RELATIVE POSITION	STRUCTURAL SYSTEM	PROBLEMS DESCRIPTION	DANGER	CONDITION
I11	Shyam Krishna Shrestha	G+3 (1EL)	B	roof of second floor collapsed. Concrete over elevation collapsed. Western wall bulging	⚠️ 1/2 ❌	+

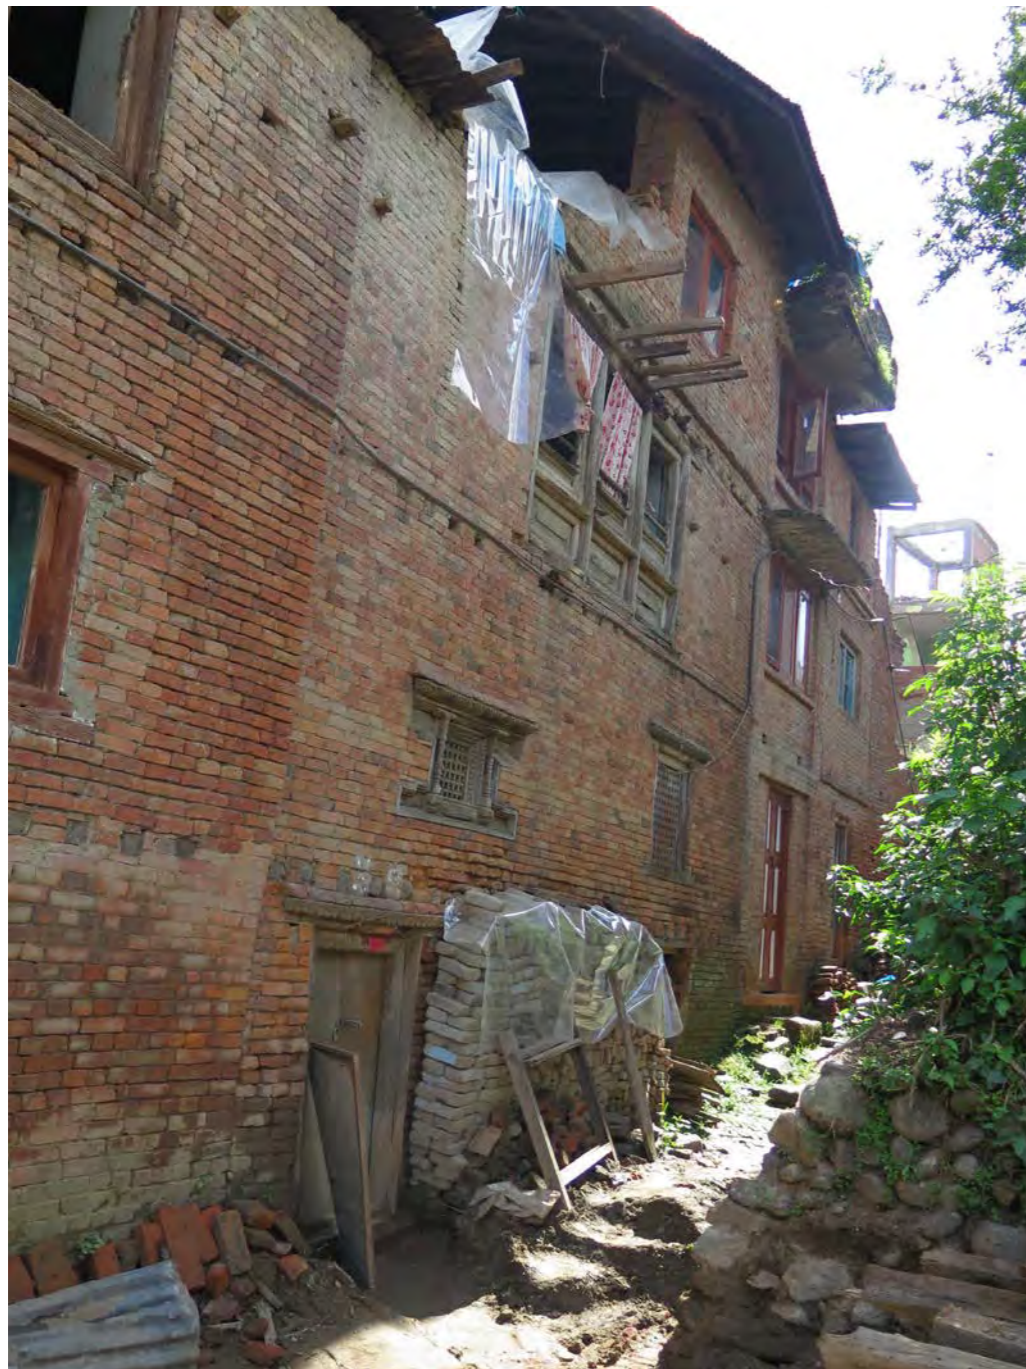
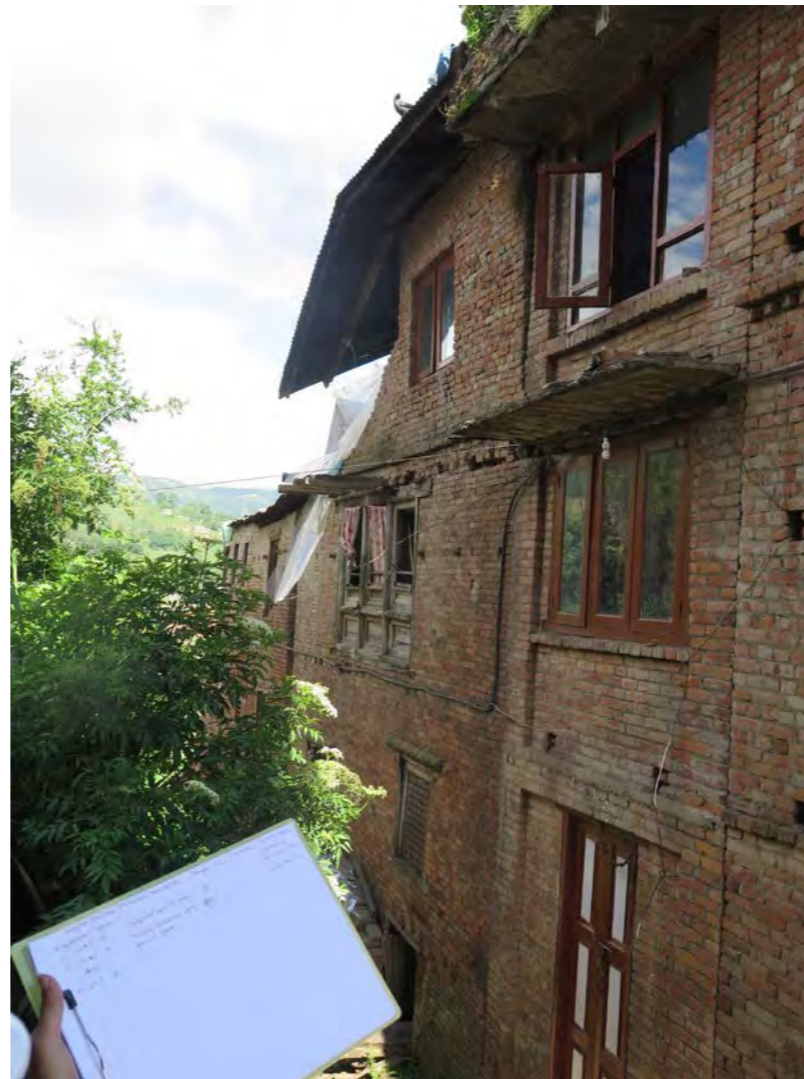
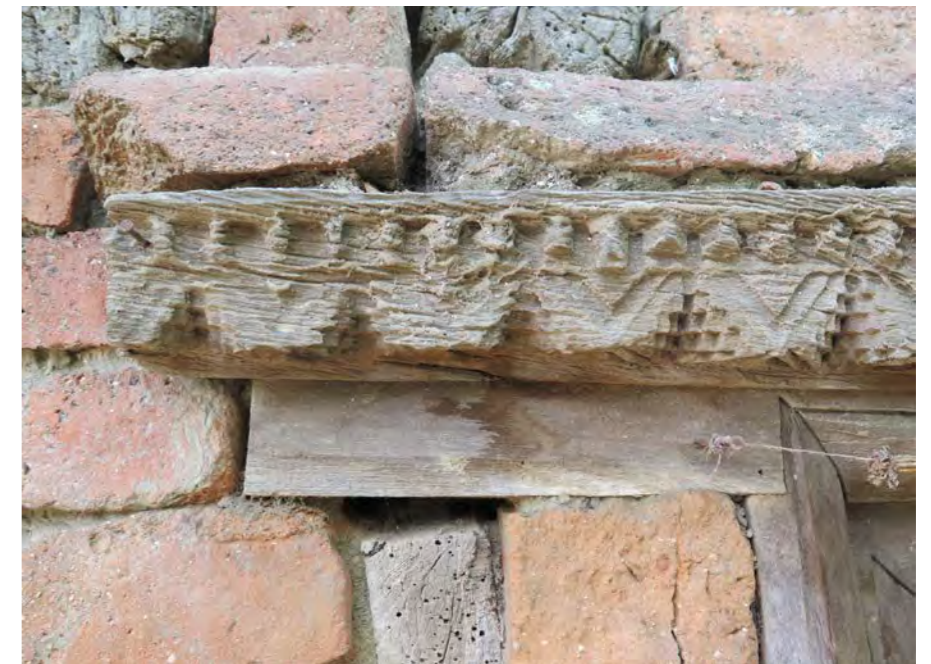
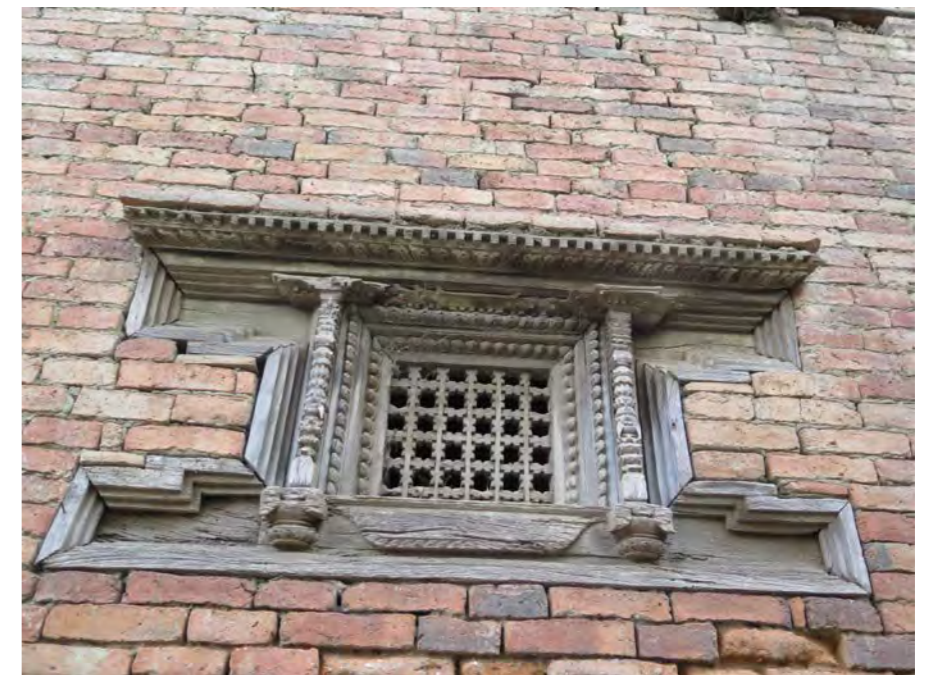
NUMBER	CONTACT	STOREY NO. RELATIVE POSITION	STRUCTURAL SYSTEM	PROBLEMS DESCRIPTION	DANGER	CONDITION
I16	Manga Lal Shrestha	G+3	B	Eastern side third floor half collapsed	1/3 ☒	+

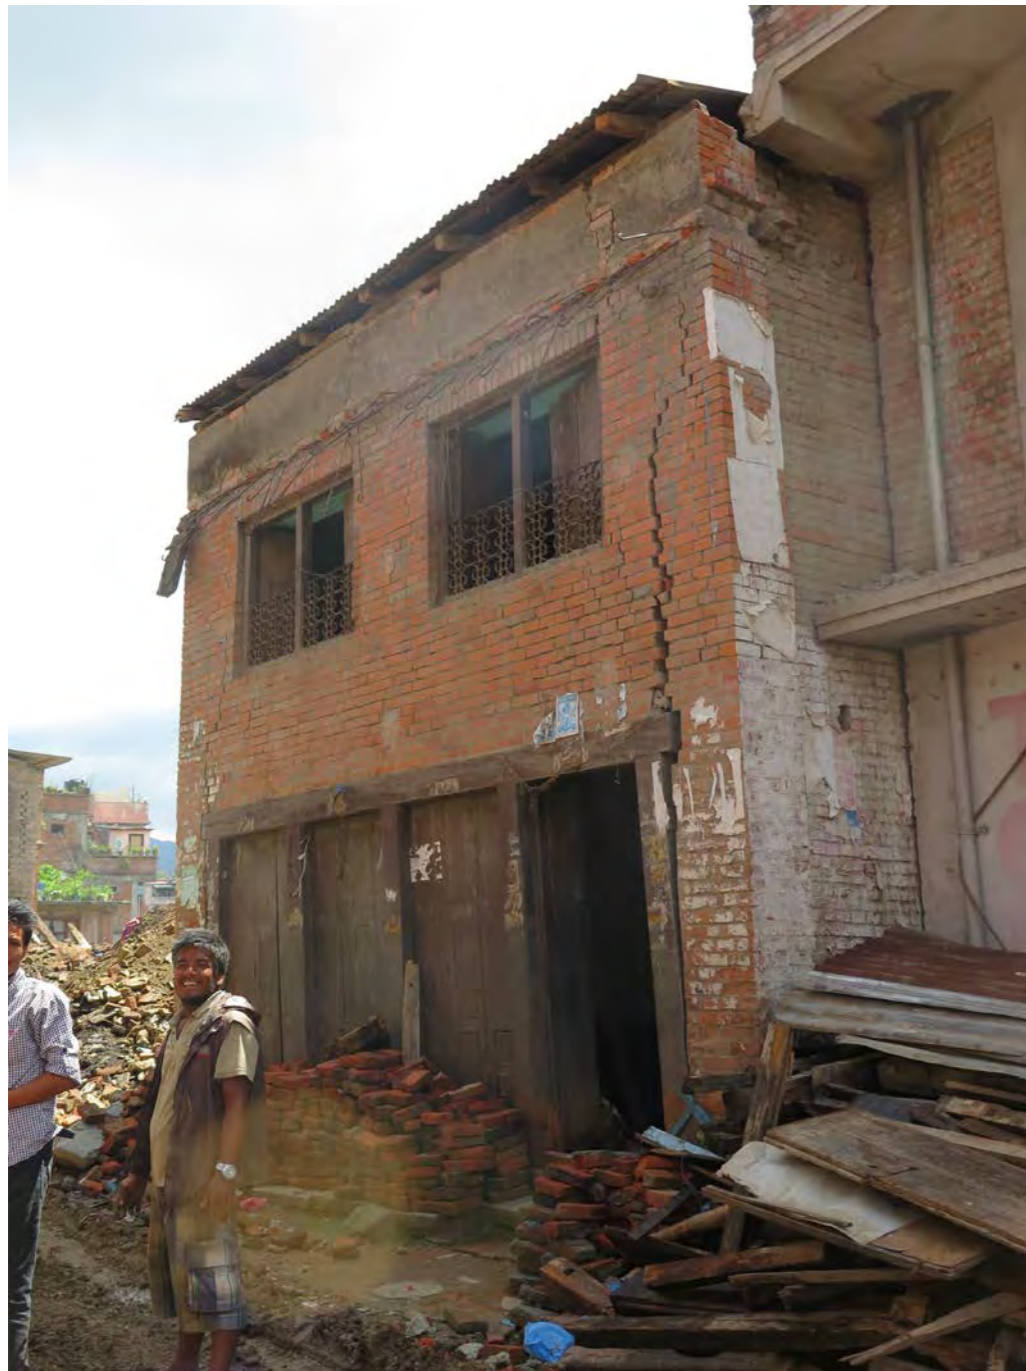
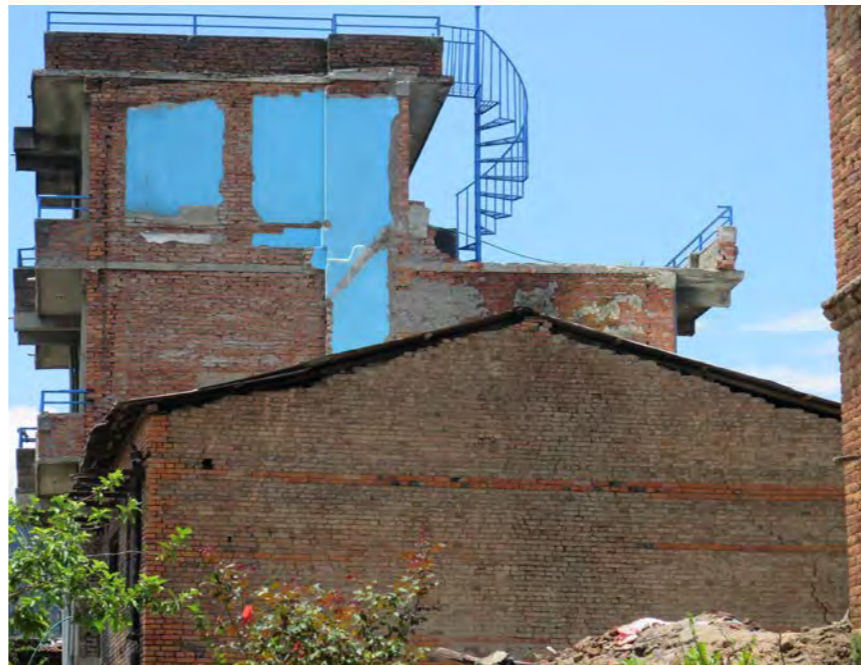
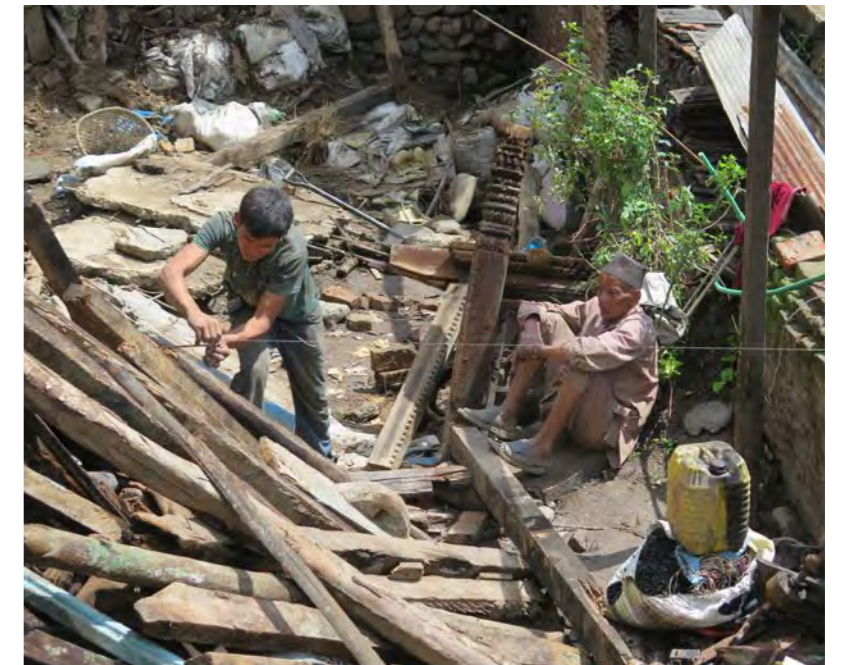
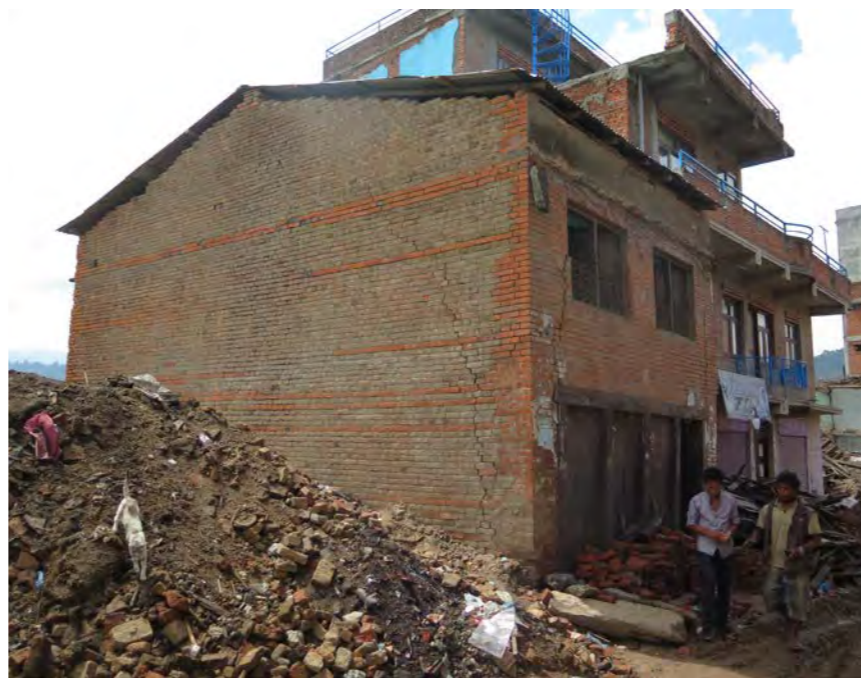
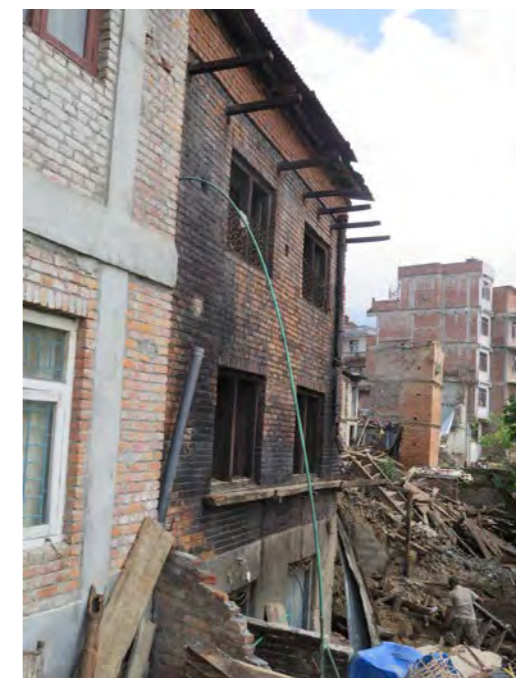
NUMBER	CONTACT	STOREY NO. RELATIVE POSITION	STRUCTURAL SYSTEM	PROBLEMS DESCRIPTION	DANGER	CONDITION	
I23	Prem Bahadur Shrestha (9841631331)	G+5 (3EL)	B	Top three floors collapsed. Western wall bulding.	1/2	R +

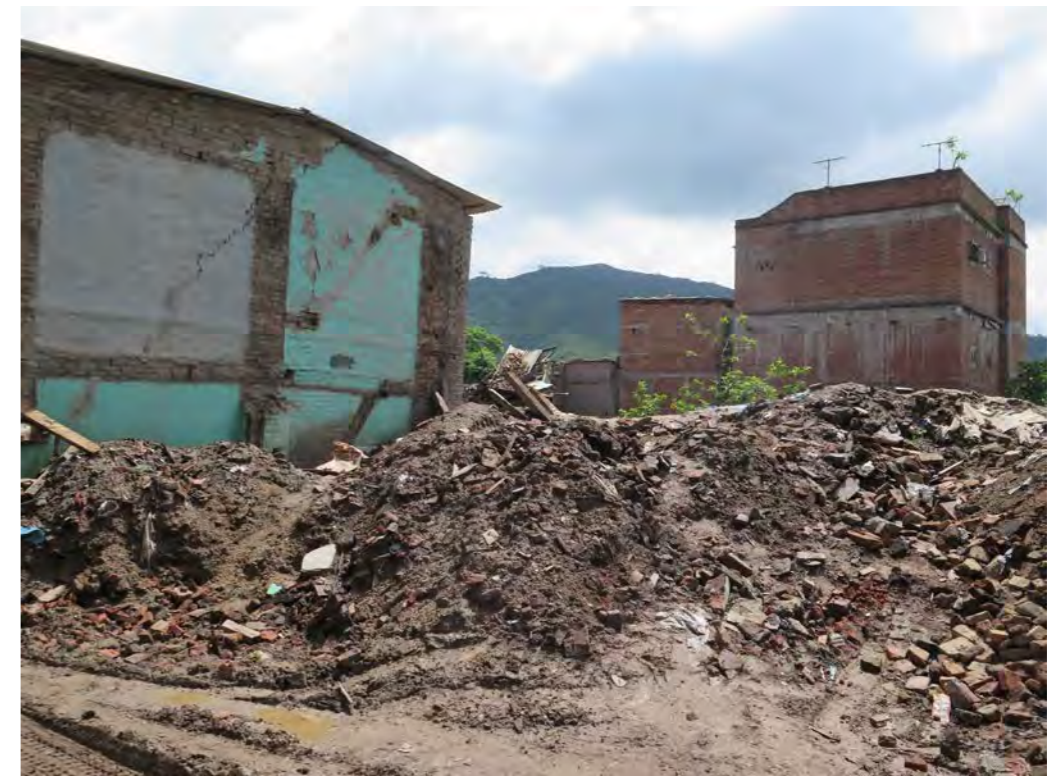
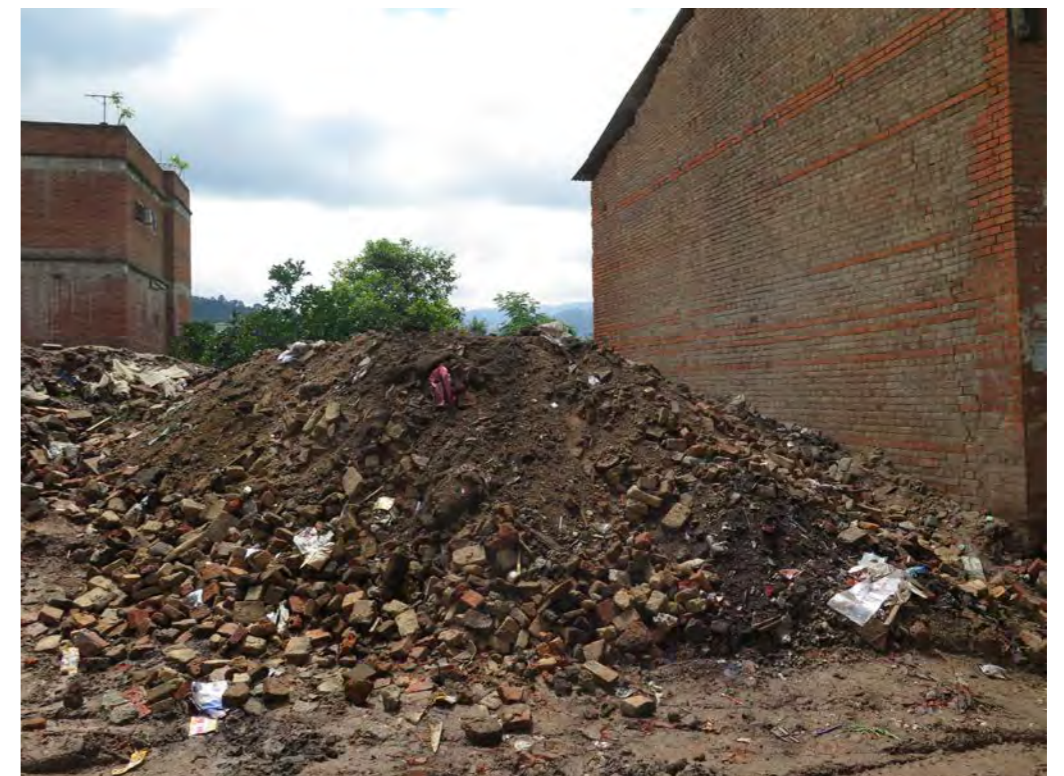
I24, I25

NUMBER	CONTACT	STOREY NO. RELATIVE POSITION	STRUCTURAL SYSTEM	PROBLEMS DESCRIPTION	DANGER	CONDITION
I24	Bhakti Das Shrestha (9841239782)	G+4 (1EL)	B	Totally collapsed	⊗	
I25	Madan Shrestha (9841176507)	G+4	B	Totally collapsed	1/2 ⊗
