2015 Earthquake Damage Mapping

Sankhu

October 2015

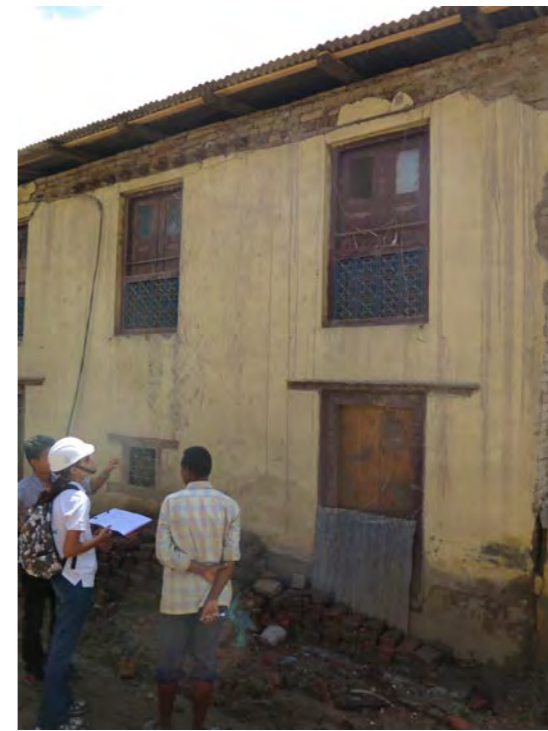
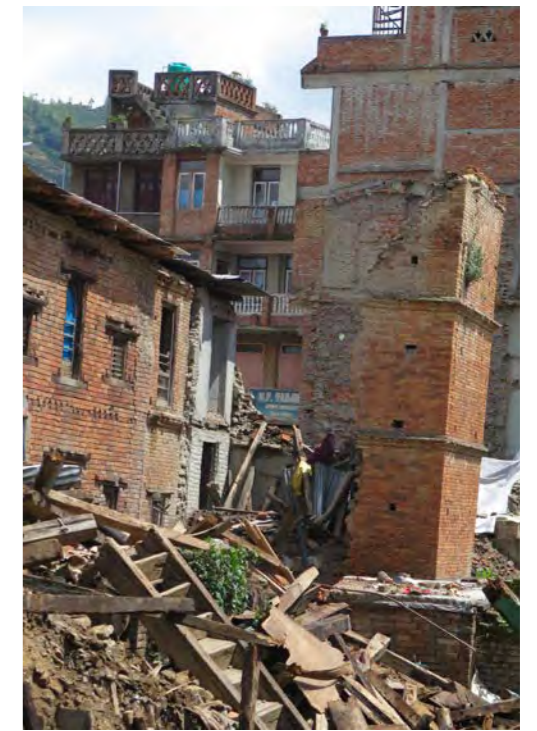
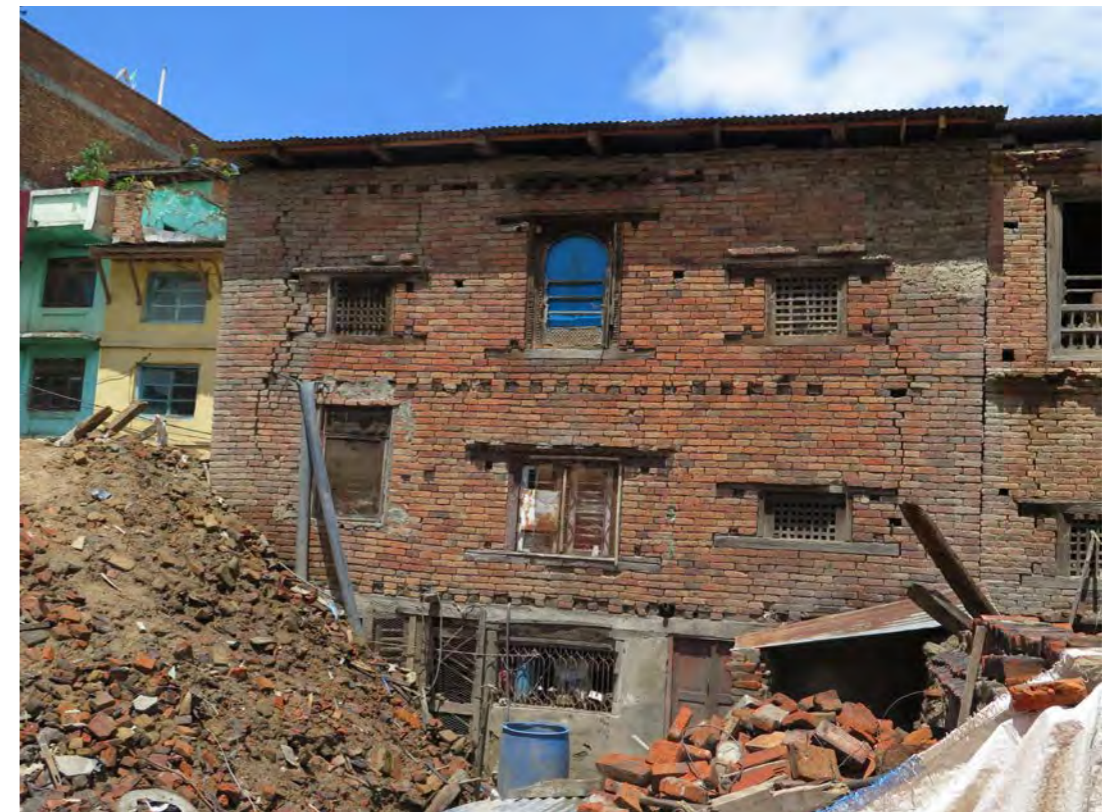
NUMBER	CONTACT	STOREY NO. RELATIVE POSITION	STRUCTURAL SYSTEM	PROBLEMS DESCRIPTION	DANGER	CONDITION
I26	Sumsher Raj Rajbhandari	G+3.5	B	top floor demolished. South eastern end bulding	1/2 ⊗	+

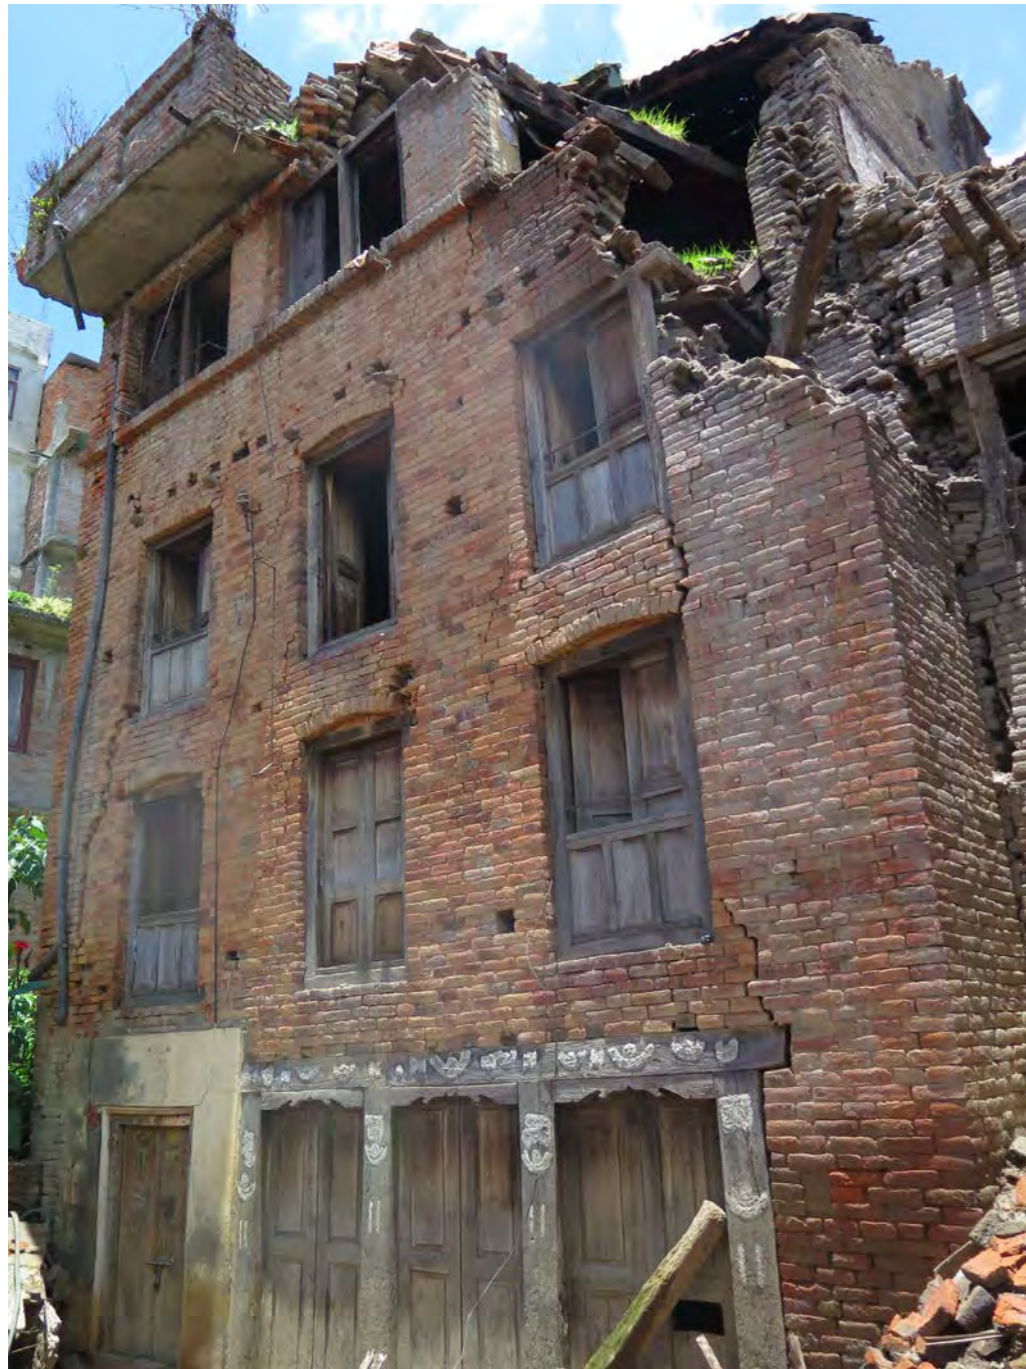
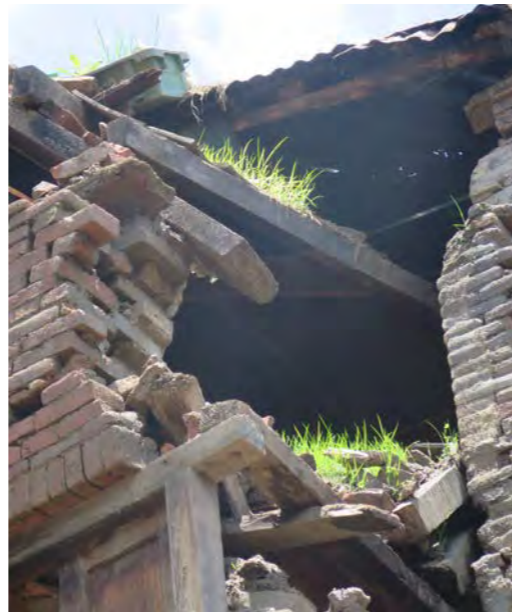
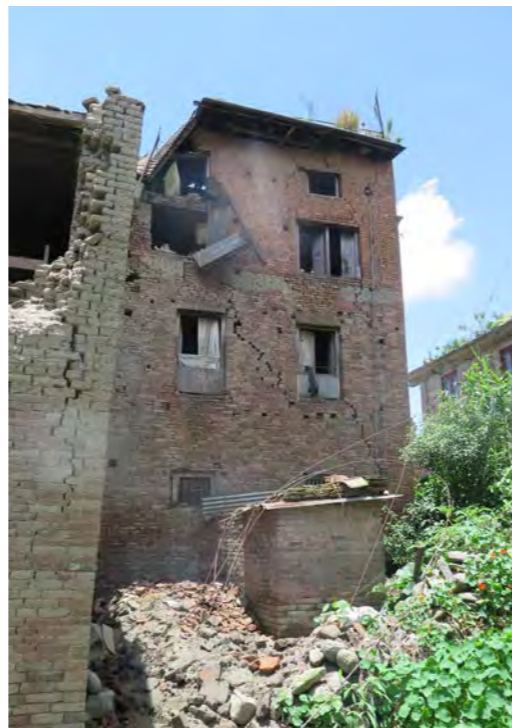
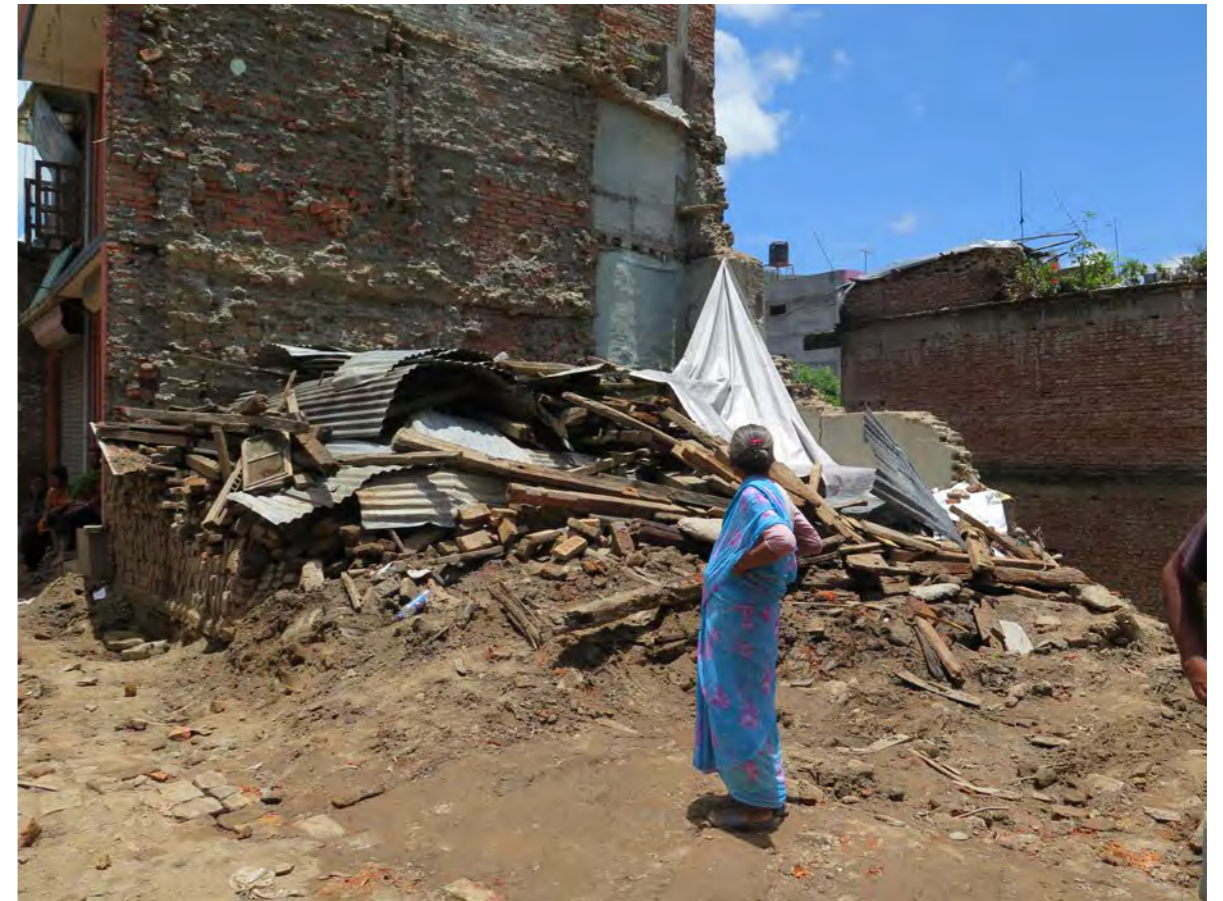
I41, I44

NUMBER	CONTACT	STOREY NO. RELATIVE POSITION	STRUCTURAL SYSTEM	PROBLEMS DESCRIPTION	DANGER	CONDITION	
I41	Surja Narayan Shrestha	G+3 (1EL) (EH)	B	Large cracks on Northern side. South eastern corner collapsed. Major cracks all over	⚠️ 1/2 ❌	+	
I44	Bakhar Bahadur Shrestha	G+3.5	B	Totally collapsed	❌	+

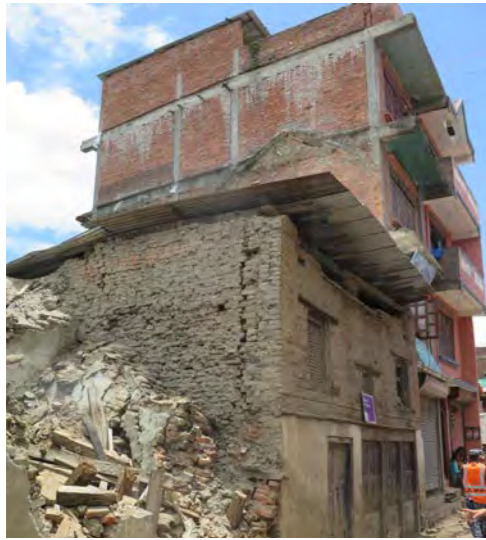
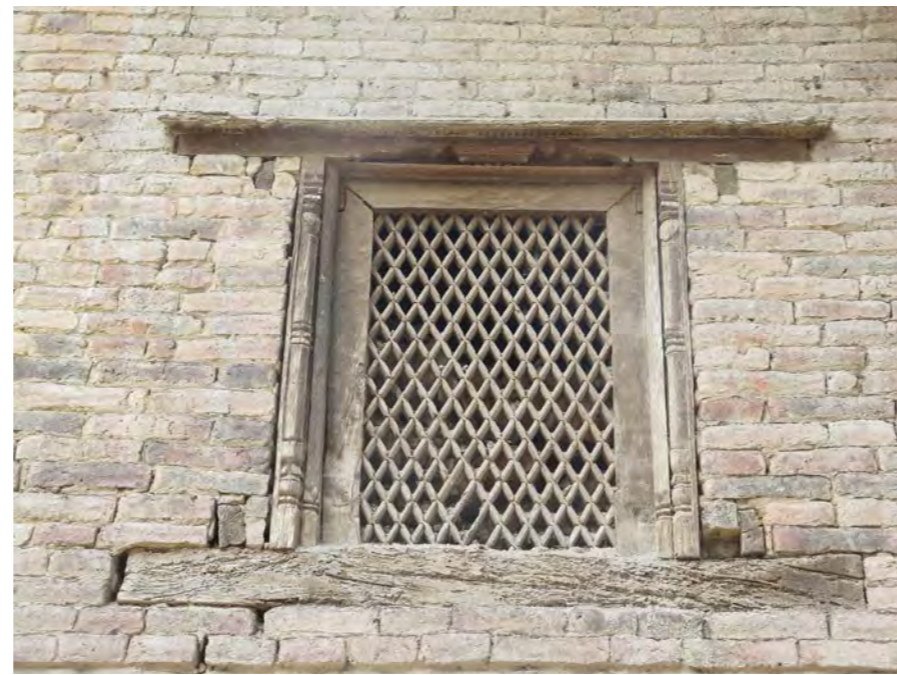
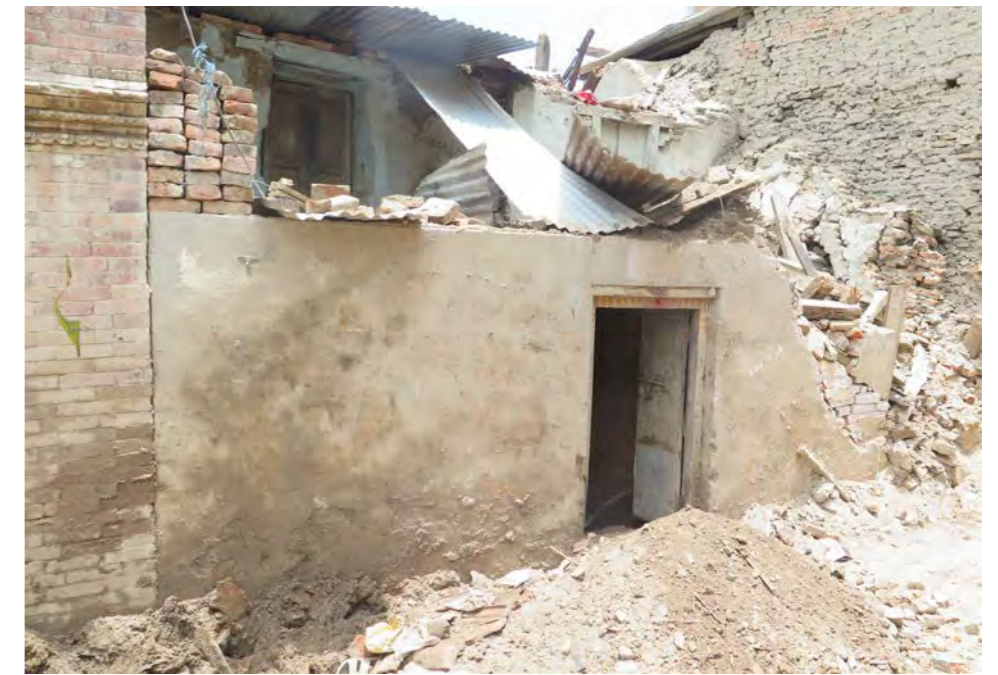
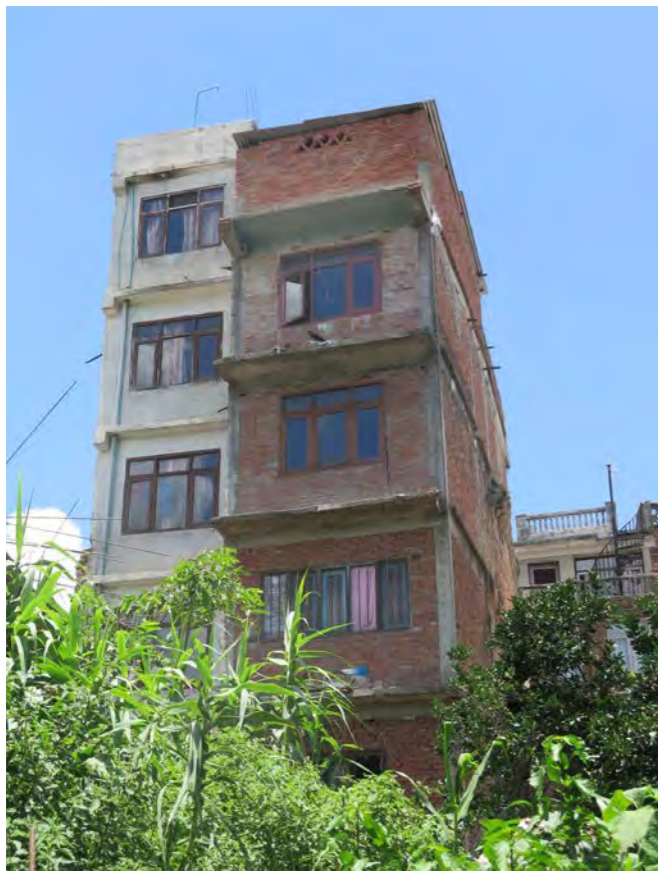
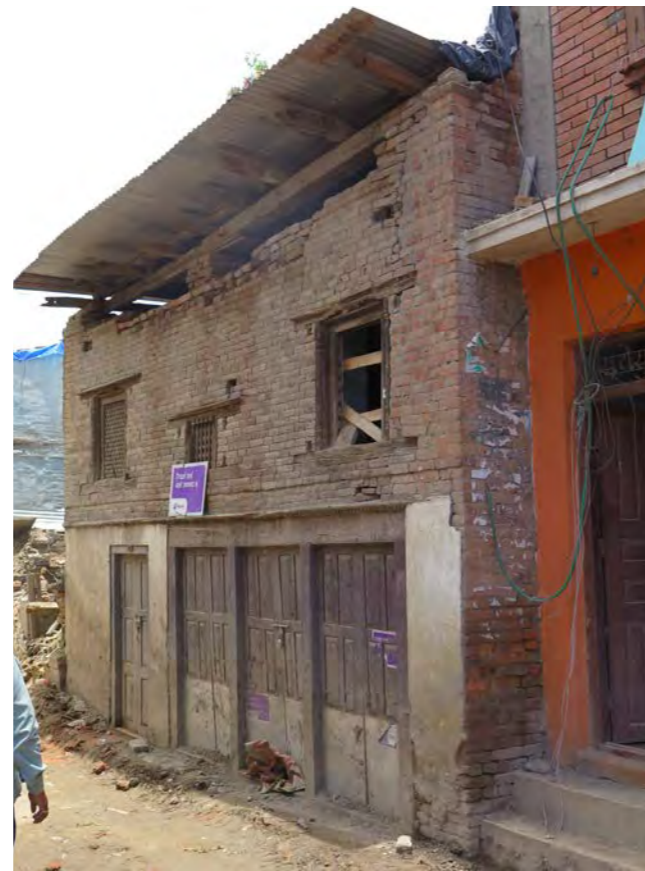
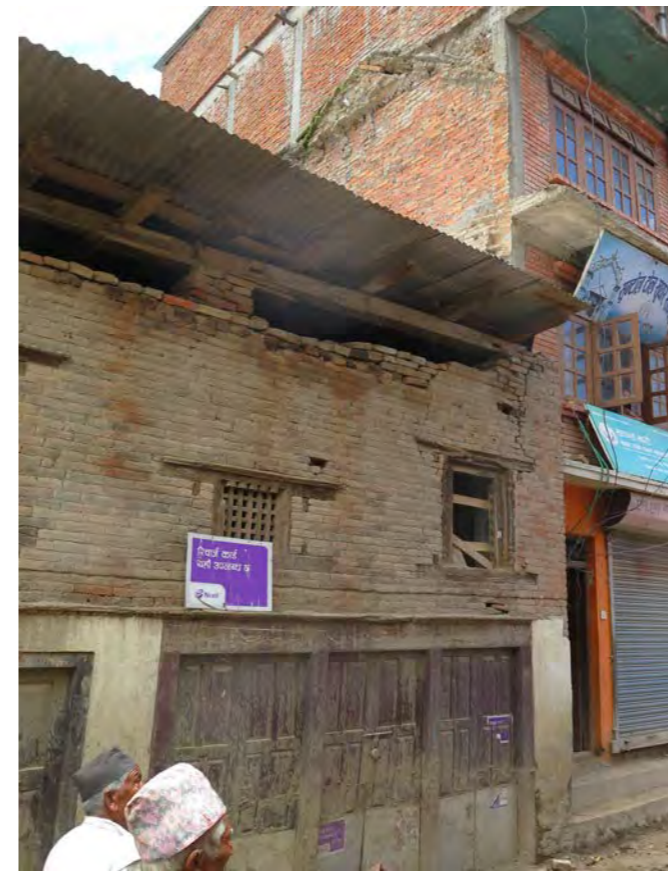
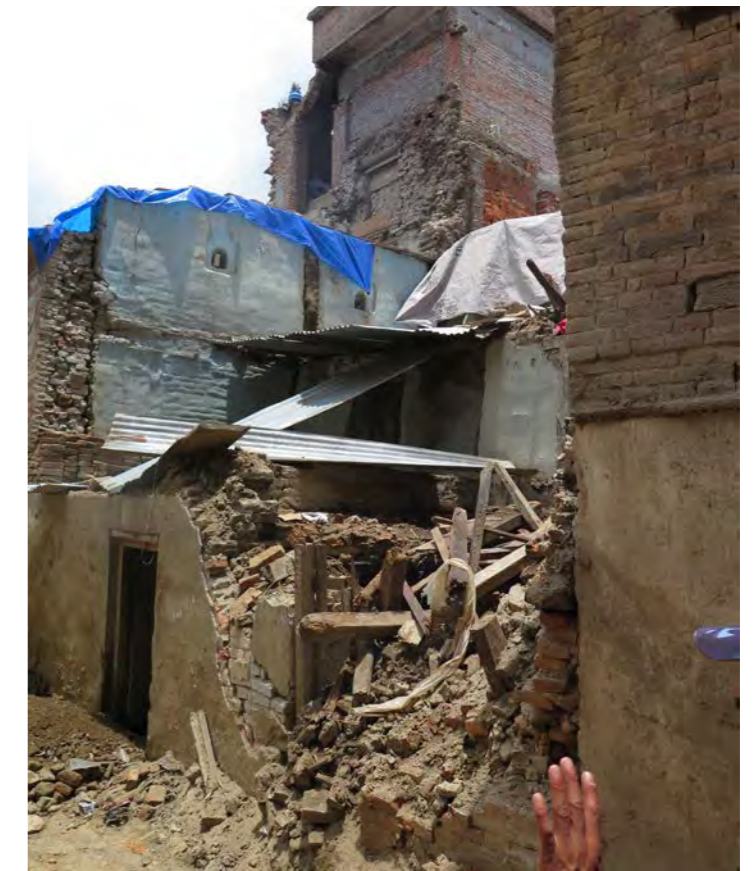
I46, I47, I48

NUMBER	CONTACT	STOREY NO. RELATIVE POSITION	STRUCTURAL SYSTEM	PROBLEMS DESCRIPTION	DANGER	CONDITION	
I46	Madan Shrestha	G+3	B	Collapsed upto second floor	1/2	+	
I47/ I48	Sagar Shrestha/ Pancha Maya Shrestha	G+2/ G+3	B	Collapsed upto ground floor		+

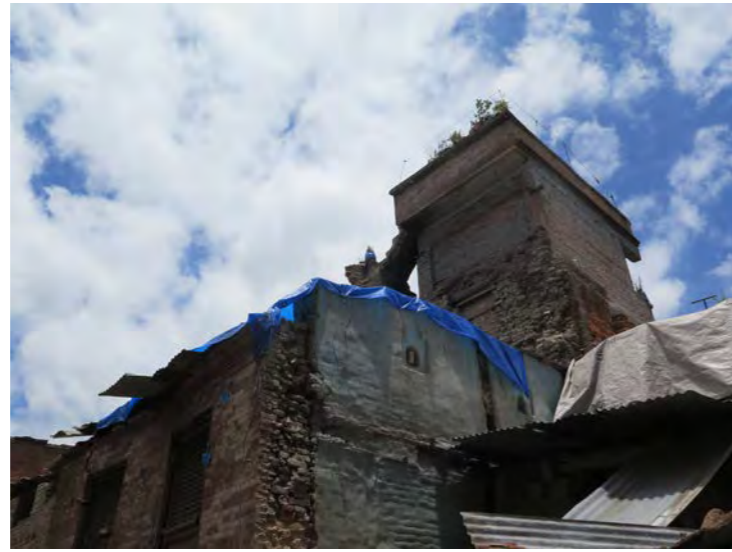
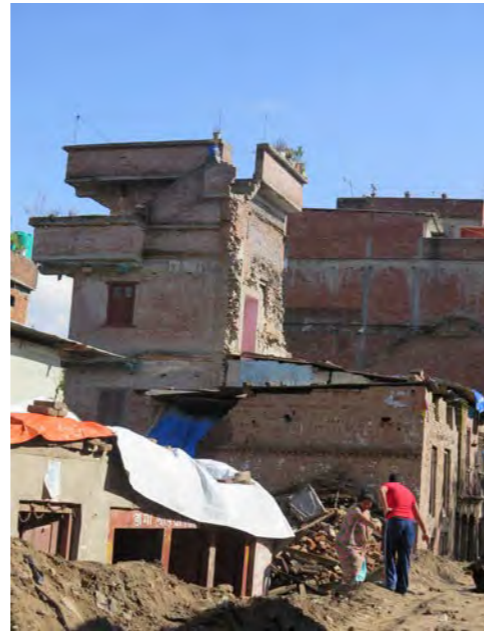
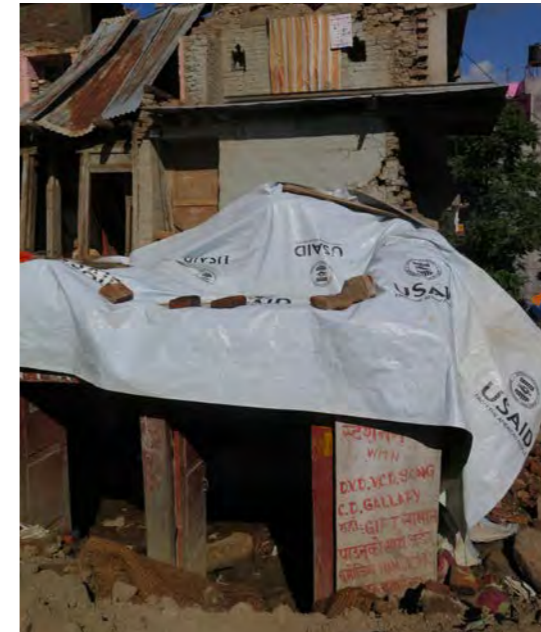
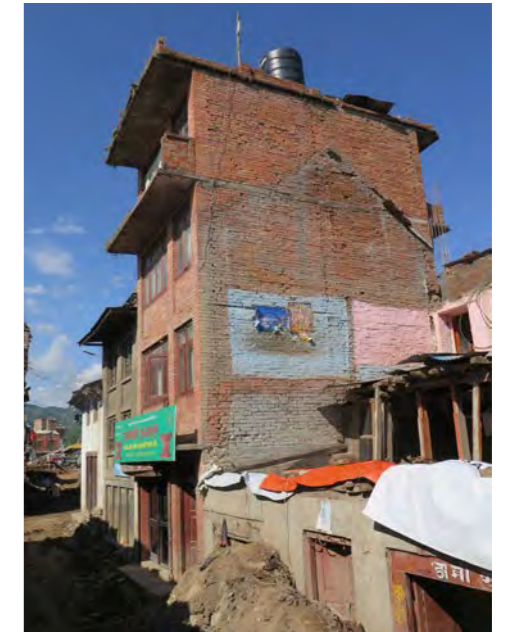
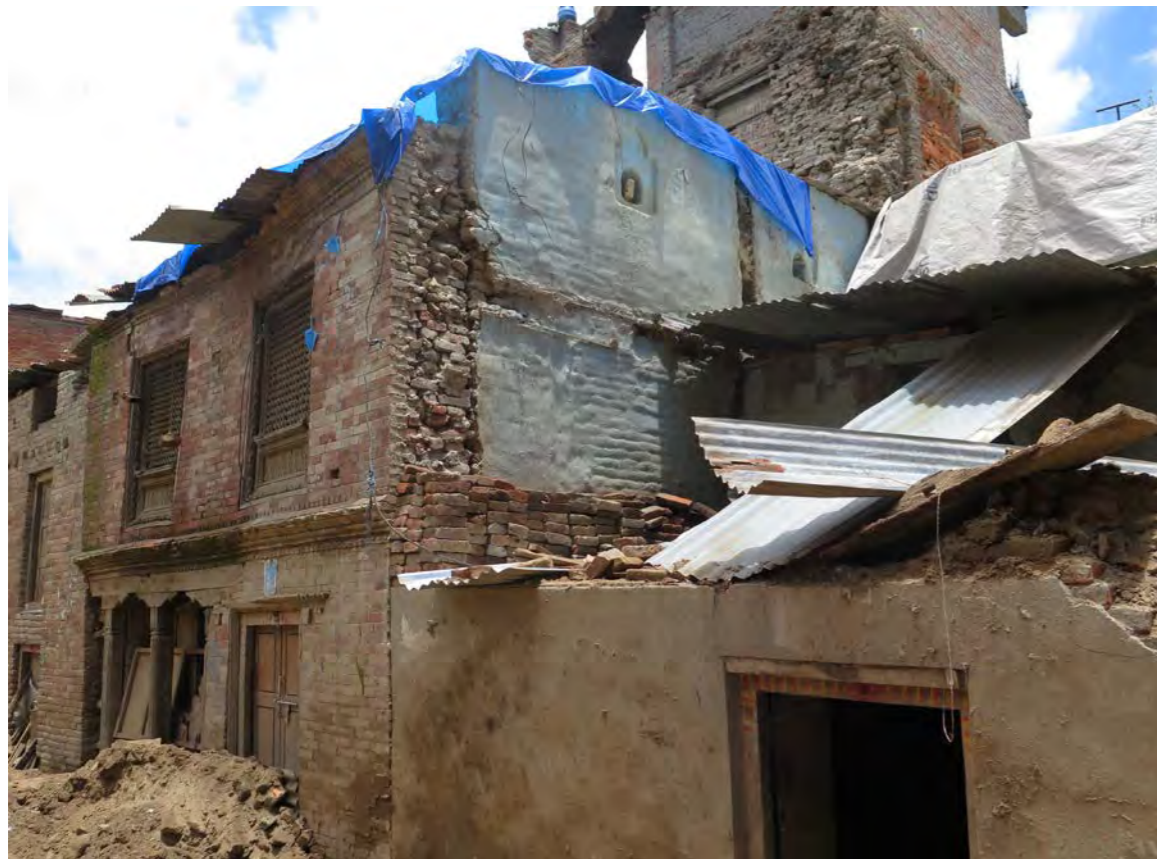
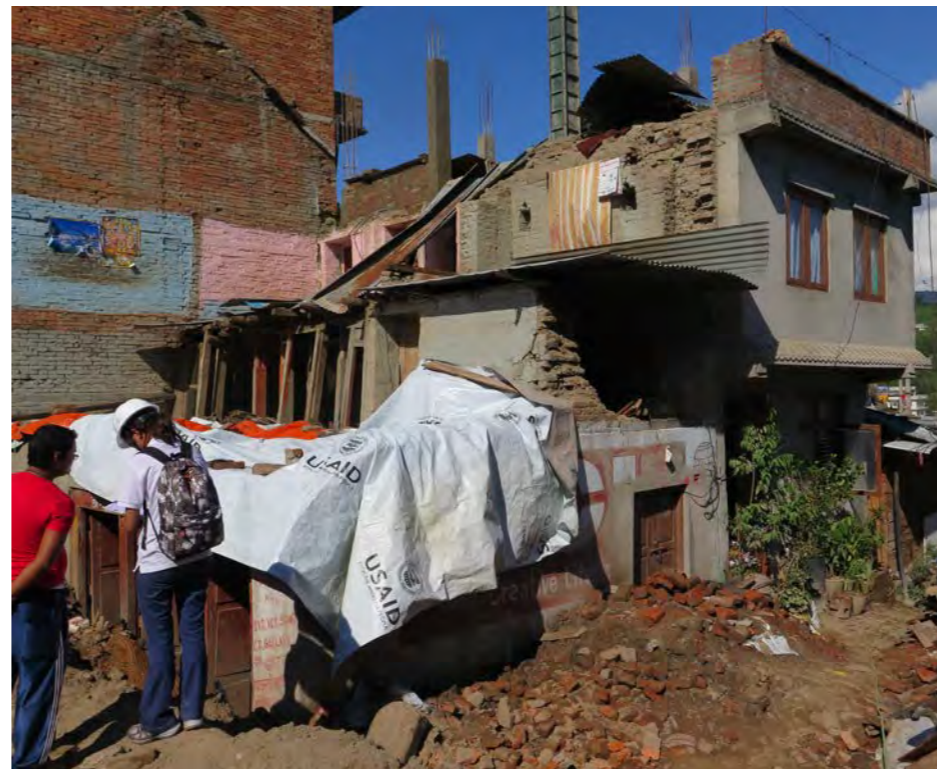
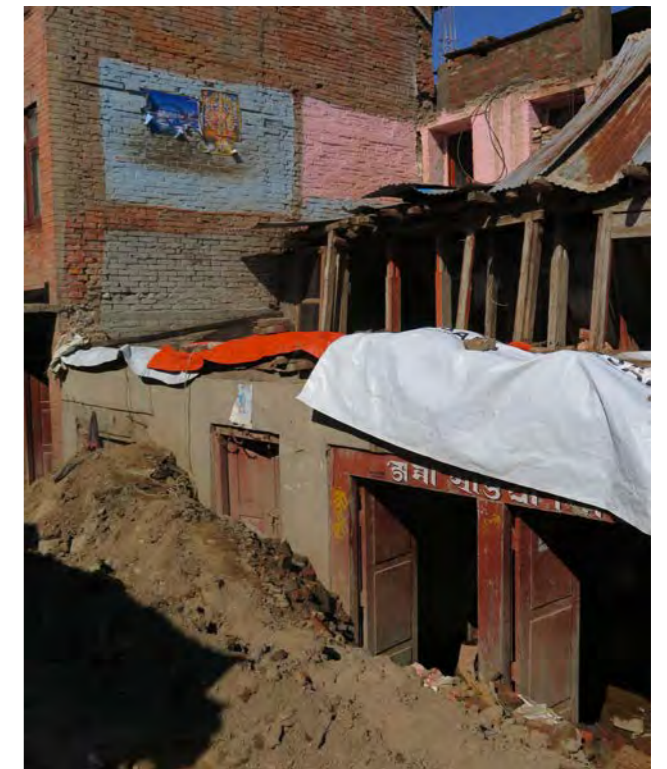
149, 159, 160

NUMBER	CONTACT	STOREY NO. RELATIVE POSITION	STRUCTURAL SYSTEM	PROBLEMS DESCRIPTION	DANGER	CONDITION	
149	Kiran Bahadur Napit	G+3	B	Collapsed till second floor. Western face bulding inside.	1/2	+	
159/ 160	Nir Bahadur Joshi (9841859350)/ Min Bahadur Joshi	G+2	B	Western wall collapsed upto ground floor	3/4	+

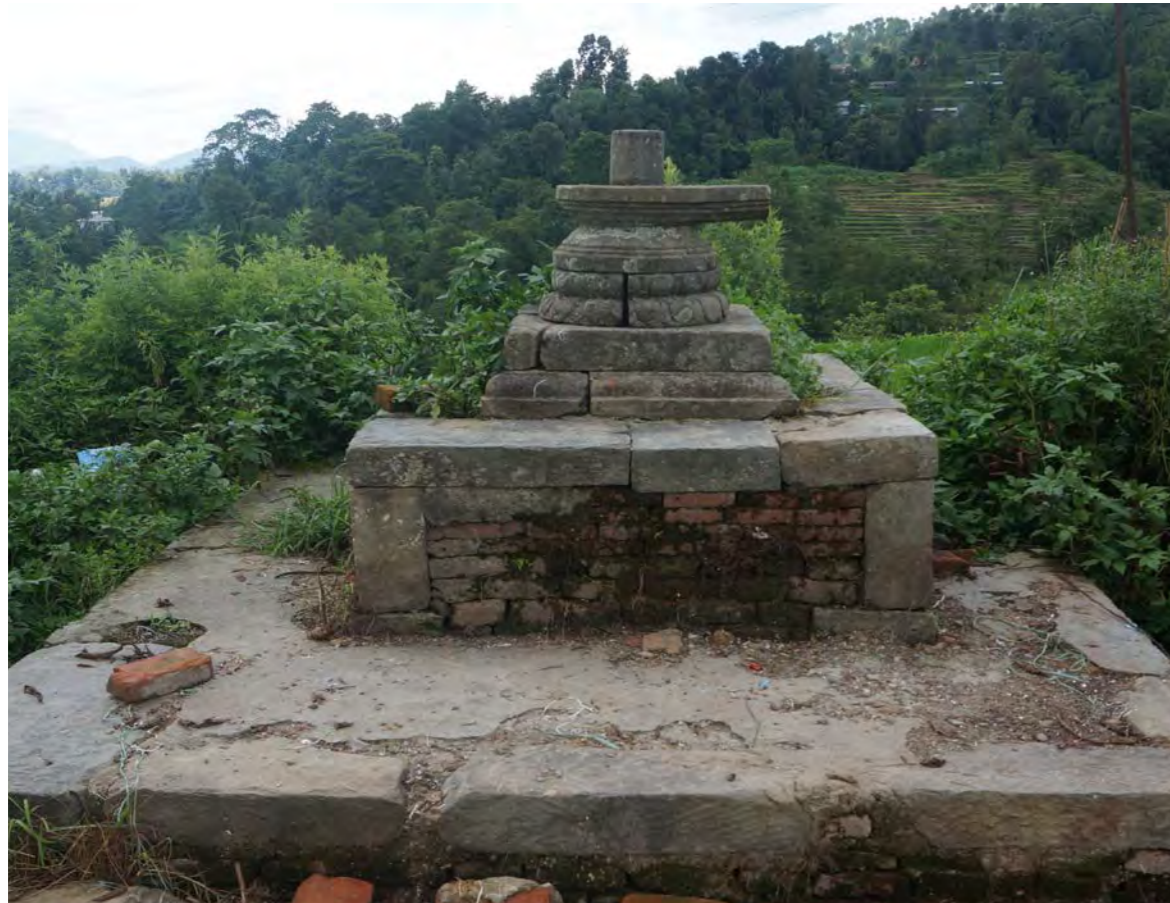
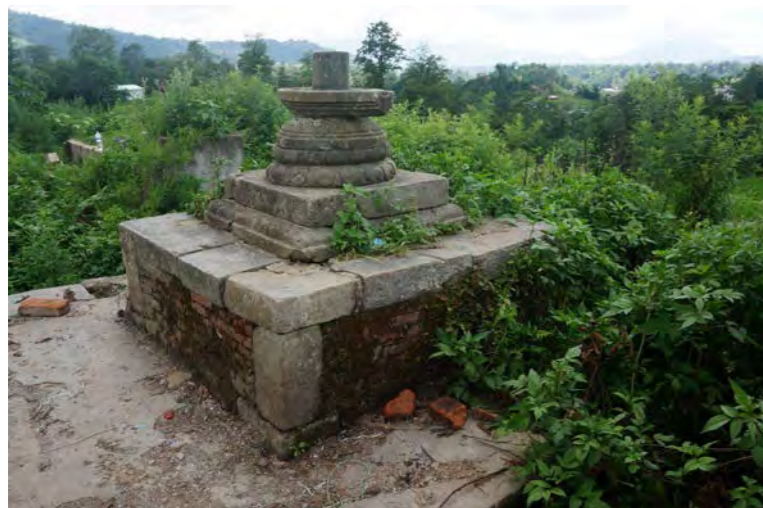
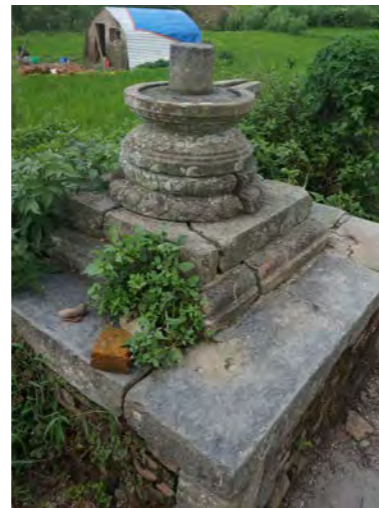
01a SHIVA LINGA

NUMBER	NAME	ESTABLISHED DATE (A.D.)	TYPOLOGY	GENERAL DESCRIPTION	PROBLEMS DESCRIPTION	DANGER/ DESTROY	
01a			Shivalinga	slightly dilapidated over the time	Slightly dislocated, Vegetation growth		
01b	Bishnu shrine		Open shrine	Jalhari used as the base of the shrine	Tilted towards south, Vegetation growth

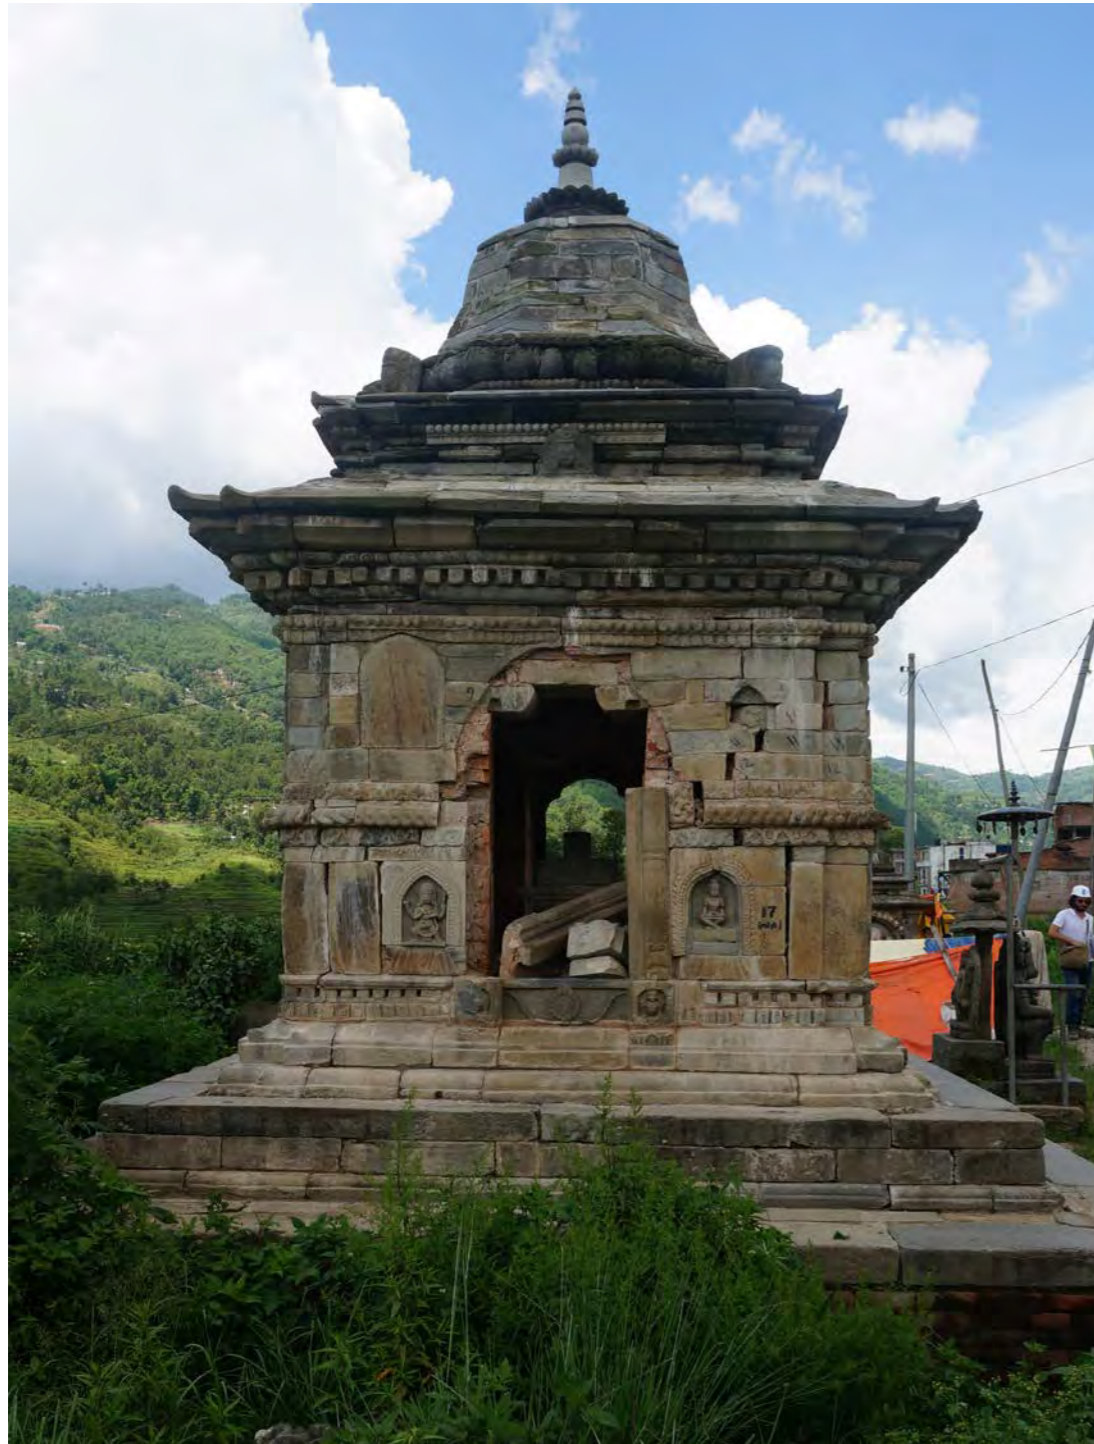
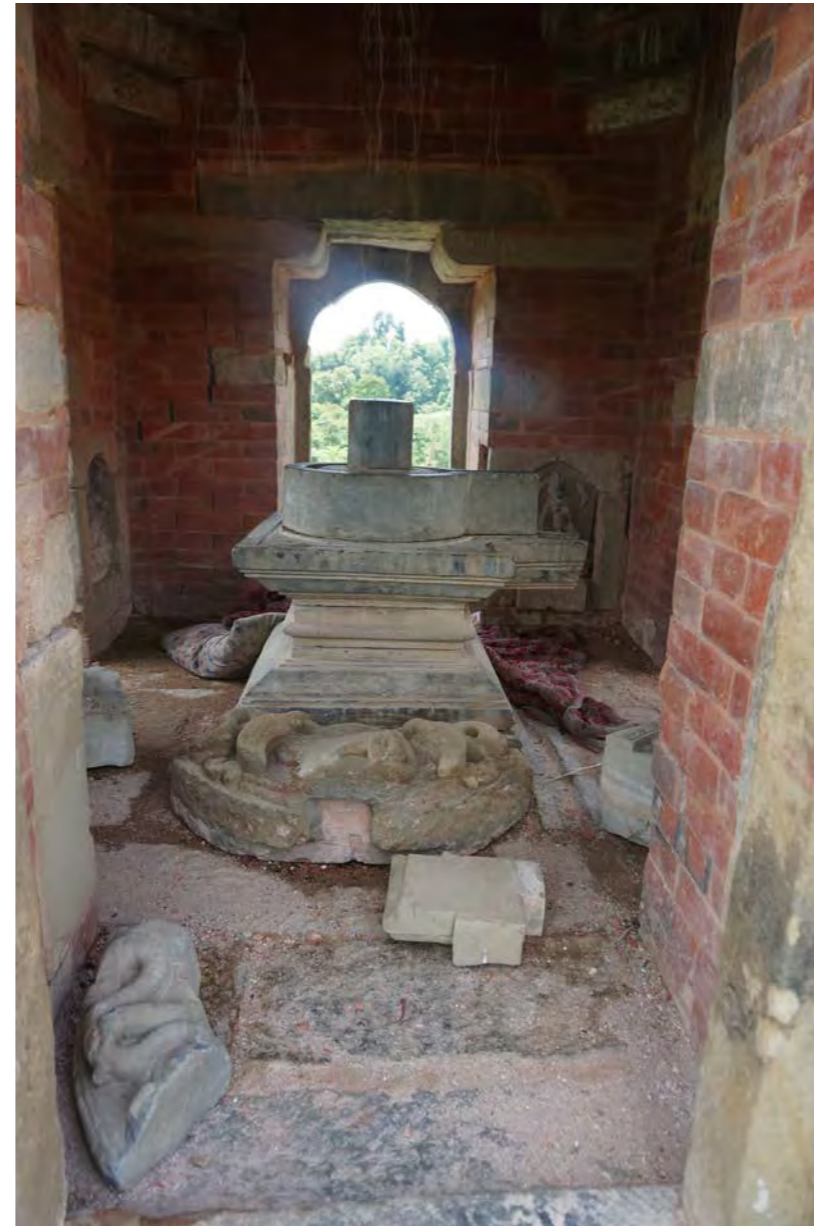
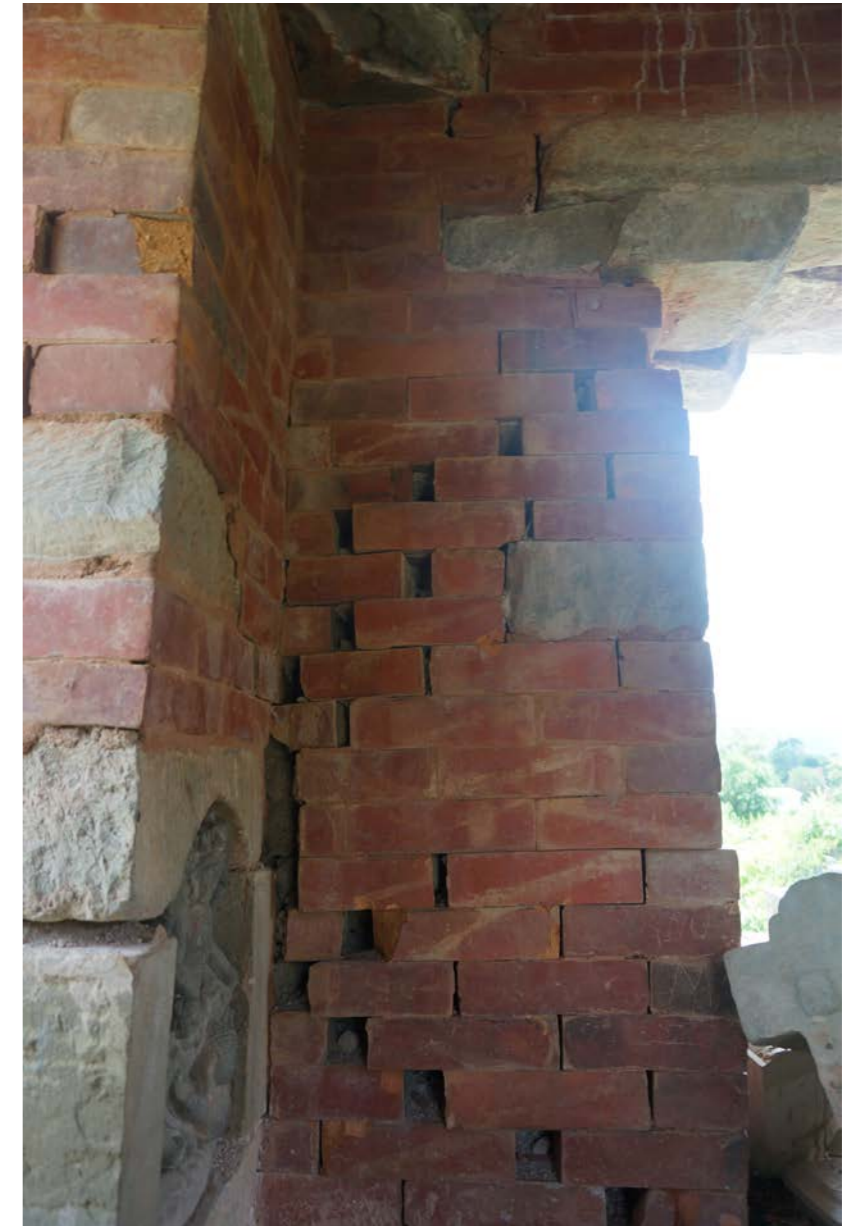
01c ENCLOSED SHRINE

NUMBER	NAME	DATE A.D.	TYPOLOGY	GENERAL DESCRIPTION	PROBLEMS DESCRIPTION	DANGER/ DESTROY	
01c			Enclosed shrine	Stone Shrine with shiva linga.	East facade is dislocating. Lintel is broken. North and south corners are heavily cracked, around 4cm. South wall is bulging. South east corner is dislocated, threatning the strength of the shrine. west wall has a big crack, around 2cm. North wall dislocating. north east corner with a big stone falling down about 10 cm.

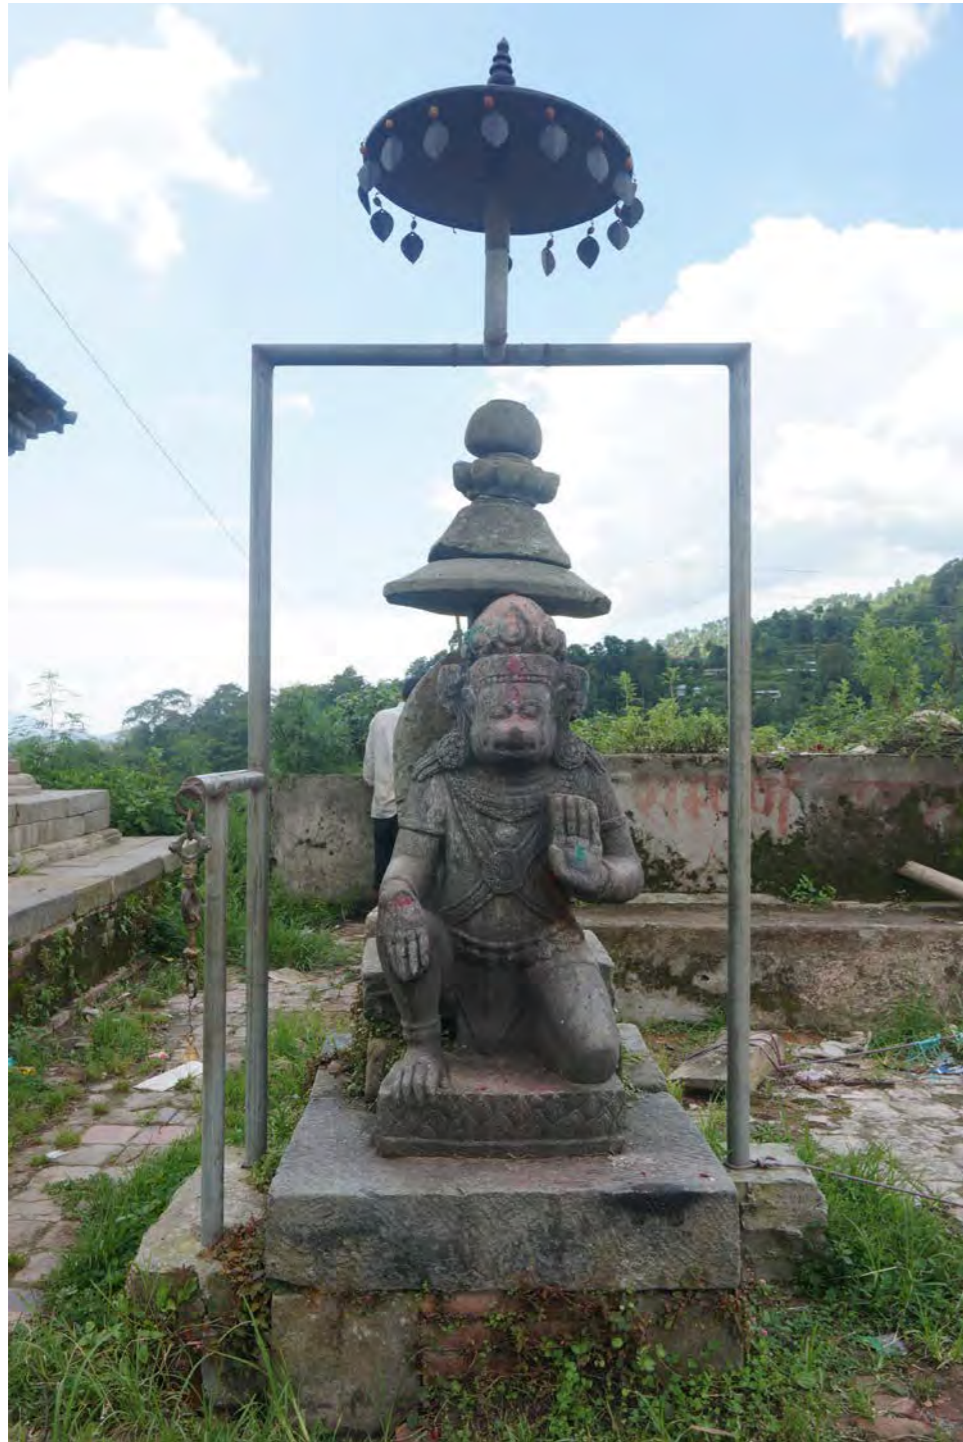
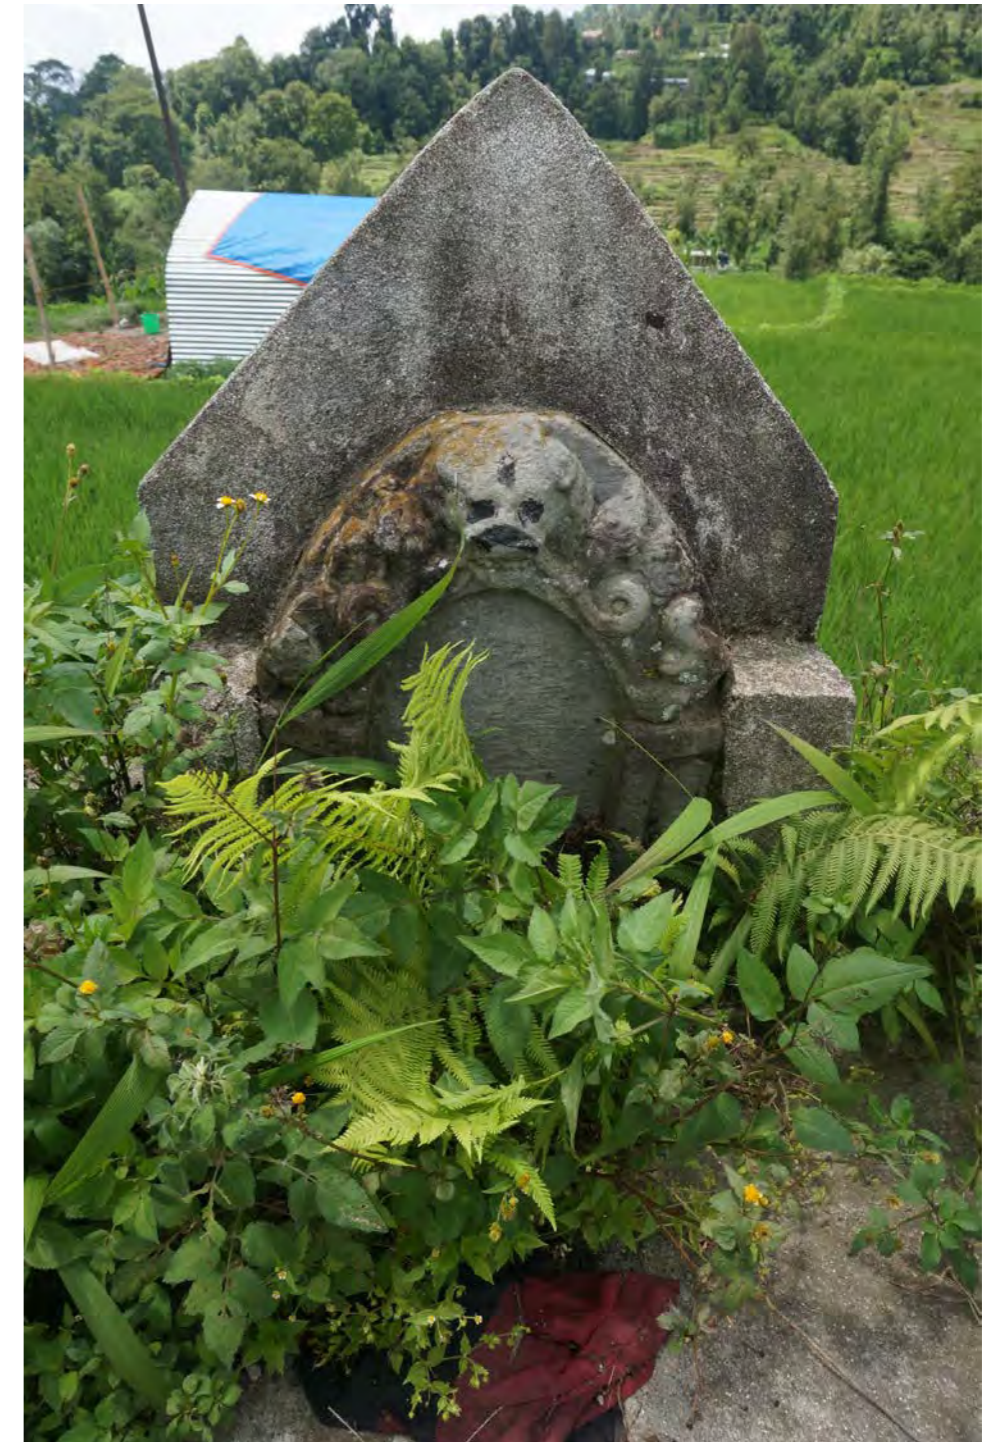
NUMBER	NAME	ESTABLISHED DATE (A.D.)	TYPOLOGY	GENERAL DESCRIPTION	PROBLEMS DESCRIPTION	DANGER/ DESTROY	
01d	Hanuman statue		Open shrine	Carved stone of Gorud with metal structure for supporting umbrella	Upper part of the structure is dislocated and slightly tilted.		
01e			Open shrine	Carved toran	Vegetation growth
