2015 Earthquake Damage Mapping

Sankhu

October 2015

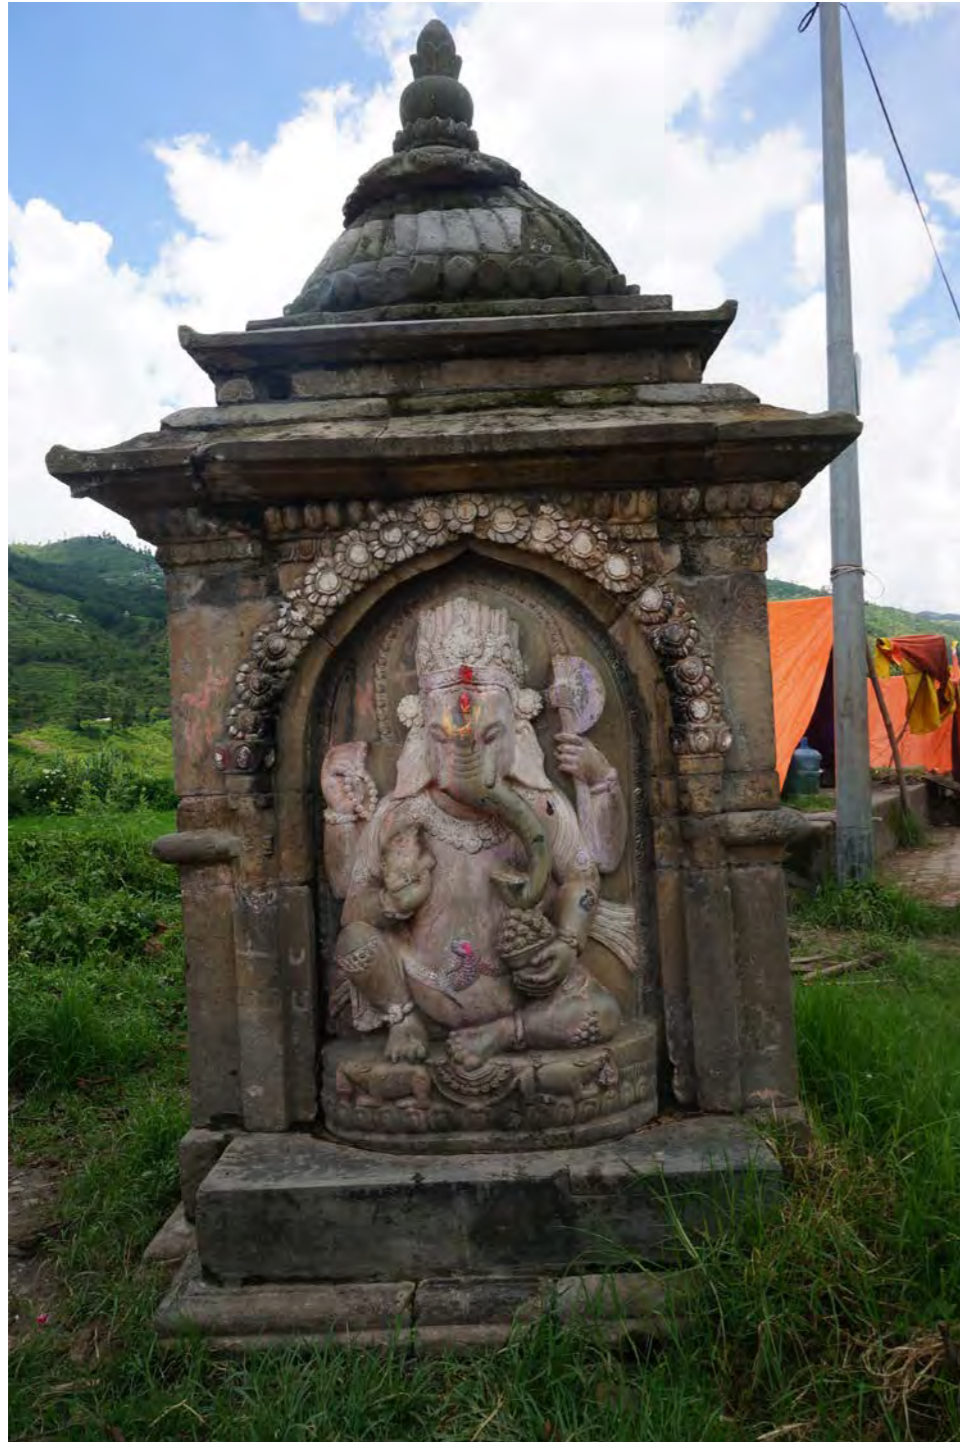
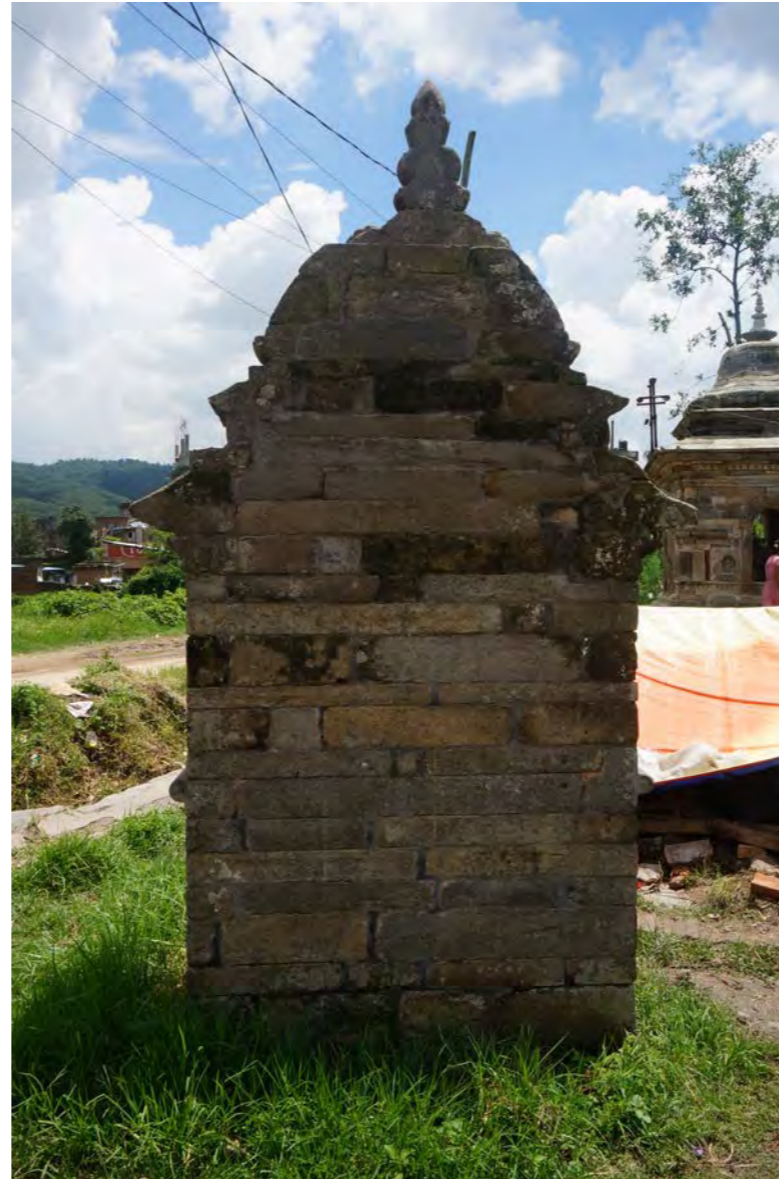
01f GANESH TEMPLE

NUMBER	NAME	DATE A.D.	TYPOLGY	GENERAL DESCRIPTION	PROBLEMS DESCRIPTION	DANGER/ DESTROY	
01f	Ganesh temple		Open shrine	Carved stone of Ganesh	No visible damage in statue but the top of the shrine is dislocated.		
01g			Open shrine	Carved toran	Vegetation growth

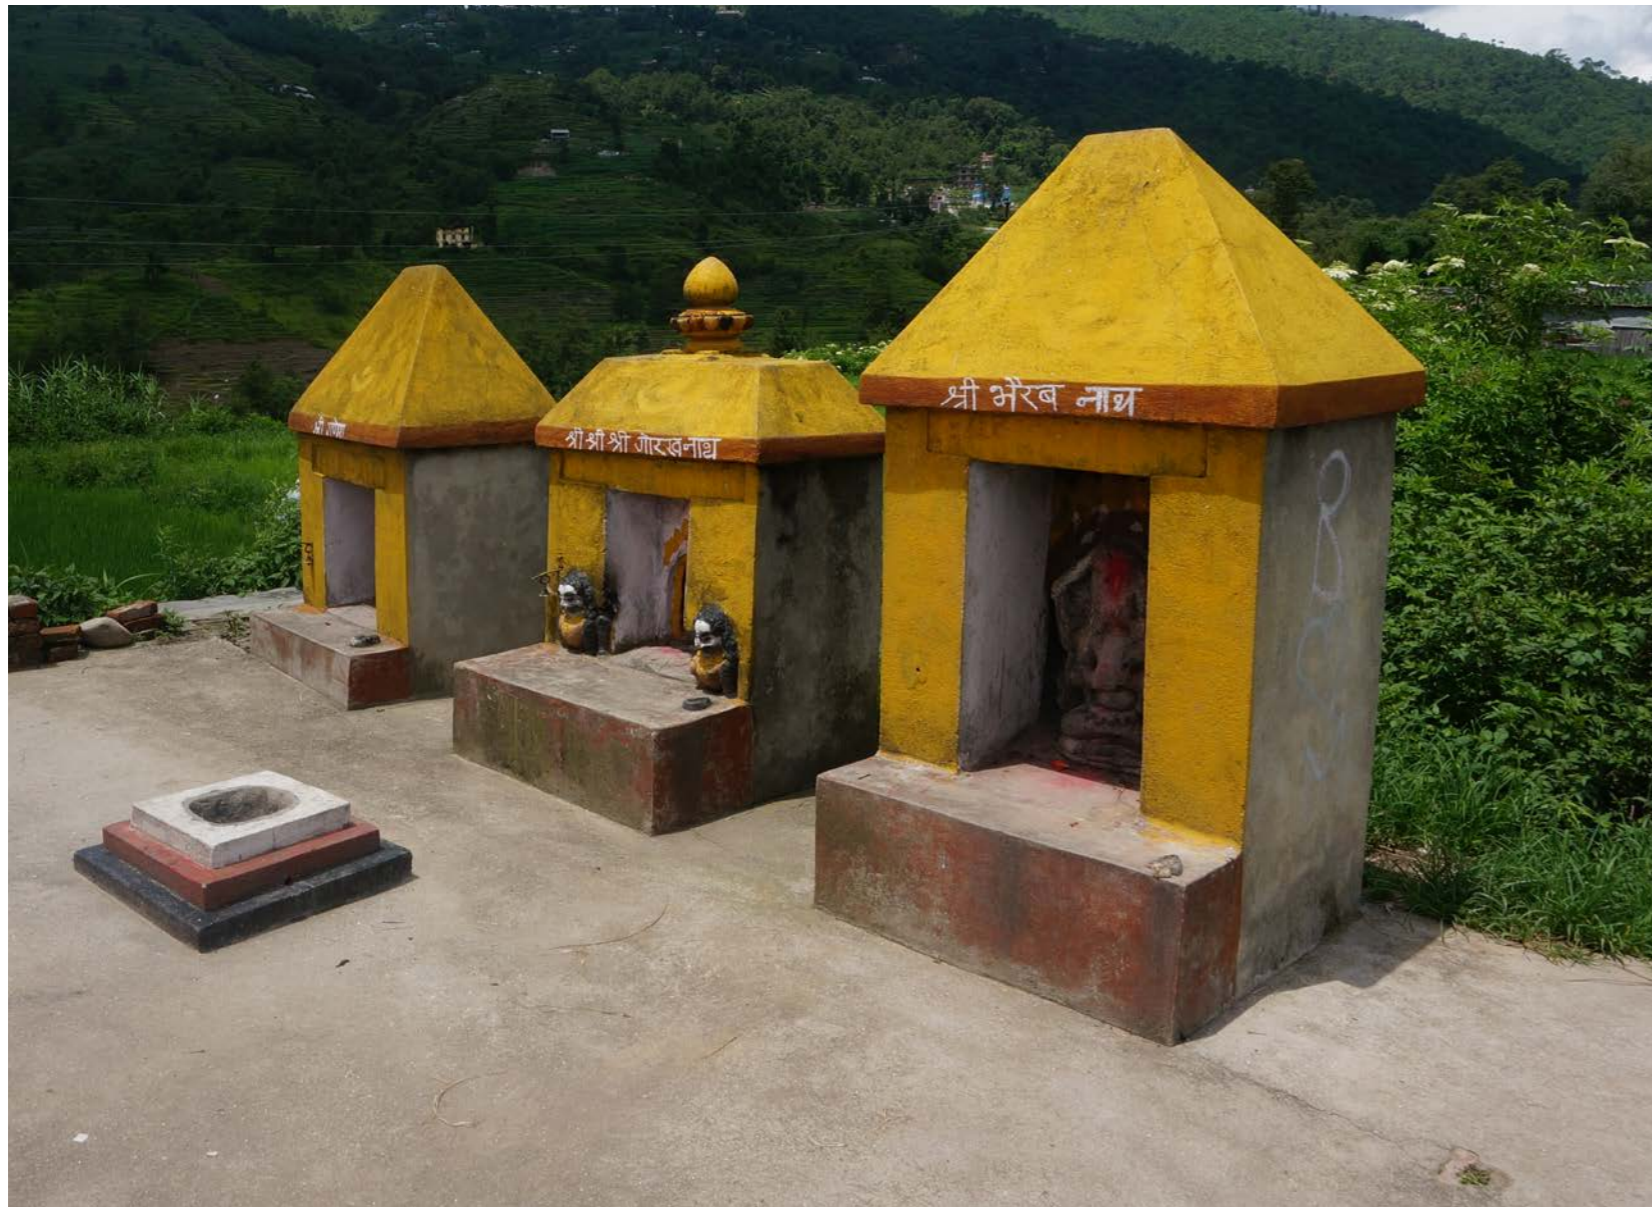
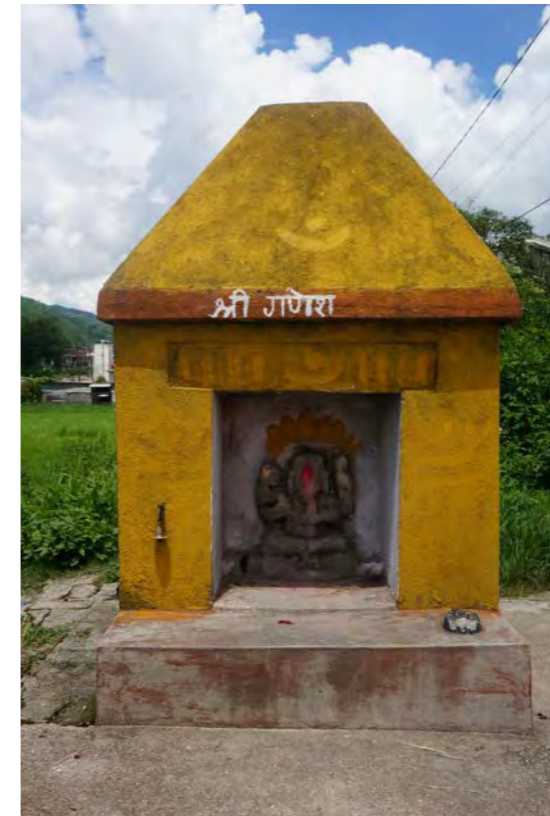
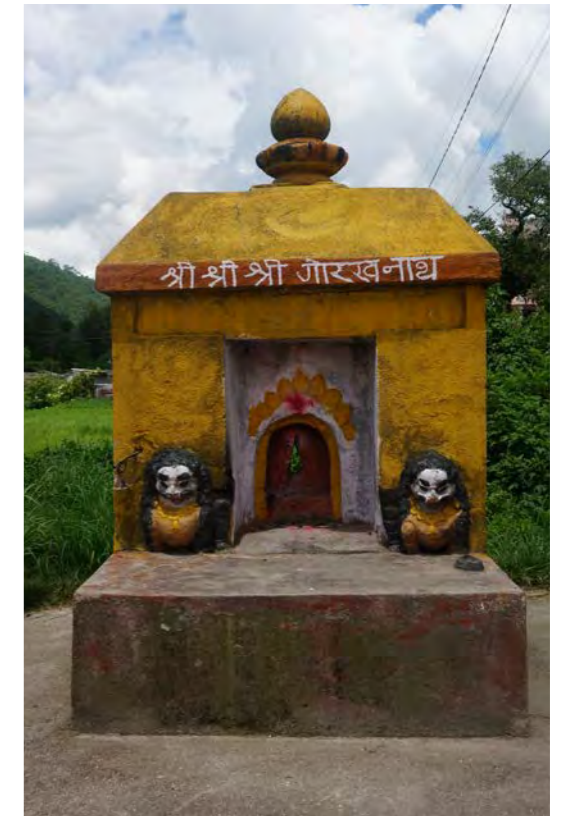
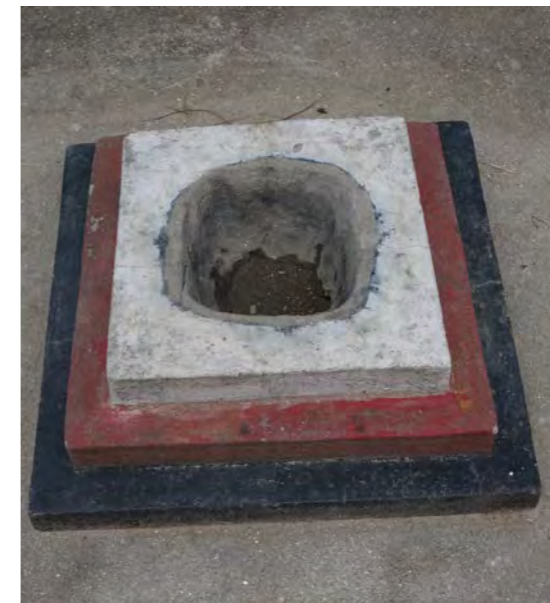
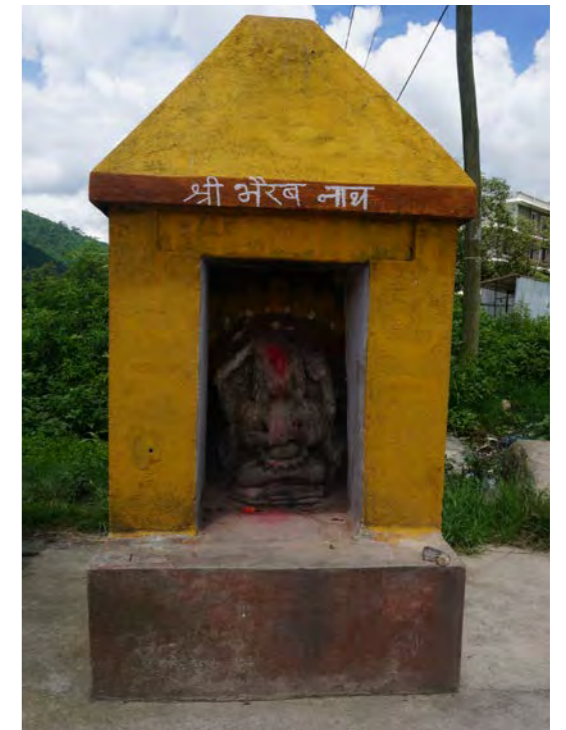
01h,01i,01j,01k OPEN SHRINE

NUMBER	NAME	ESTABLISHED DATE (A.D.)	TYOLOGY	GENERAL DESCRIPTION	PROBLEMS DESCRIPTION	DANGER/ DESTROY
01h	Ganesh		Open shrine	Carved stone of Ganesh.	No visible damage in statue	
01i	Gorakhnath		Open shrine	Carved stone of Gorakhnath.	No visible damage in statue	
01j	Bhairabhath		Open shrine	Carved stone of Bhiarav.	No visible damage in statue	
01k	Yagya			3 stepped Painted concrete structure	No visible damage in statue

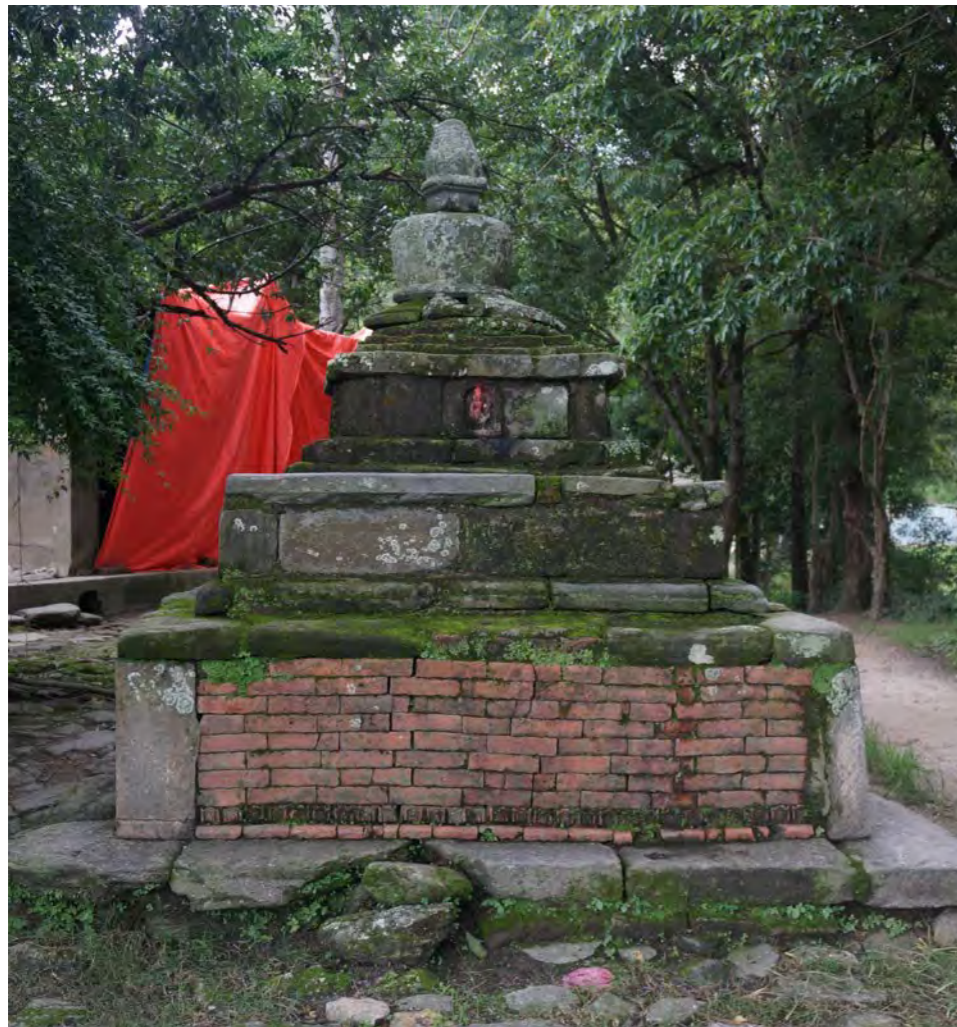
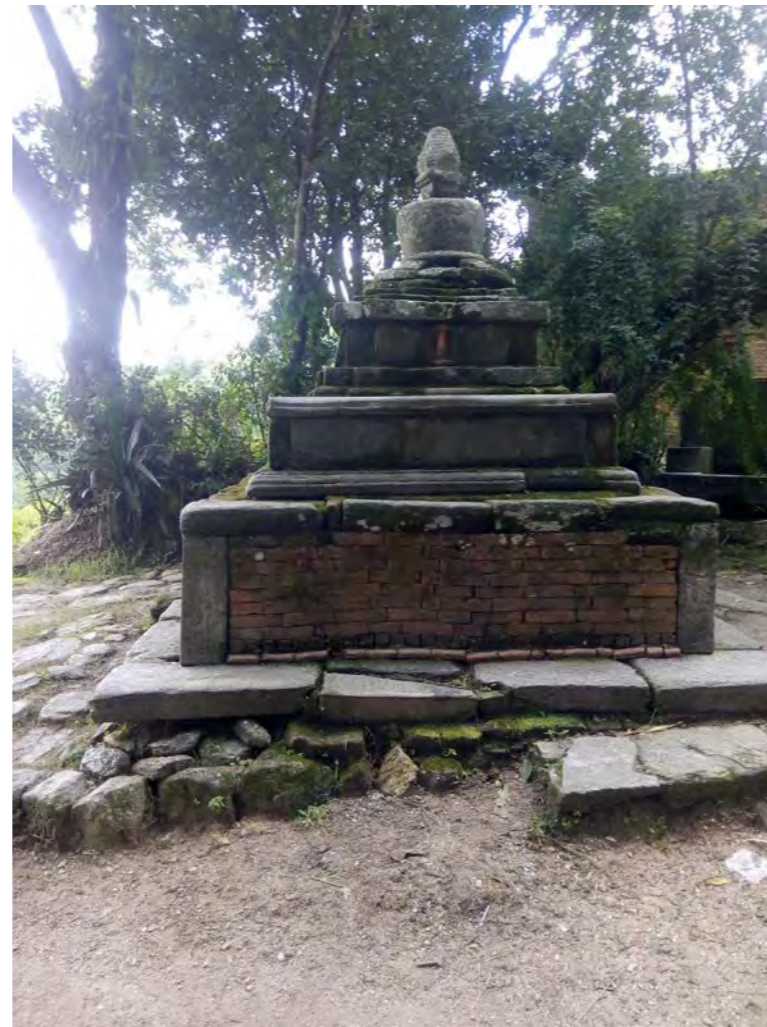
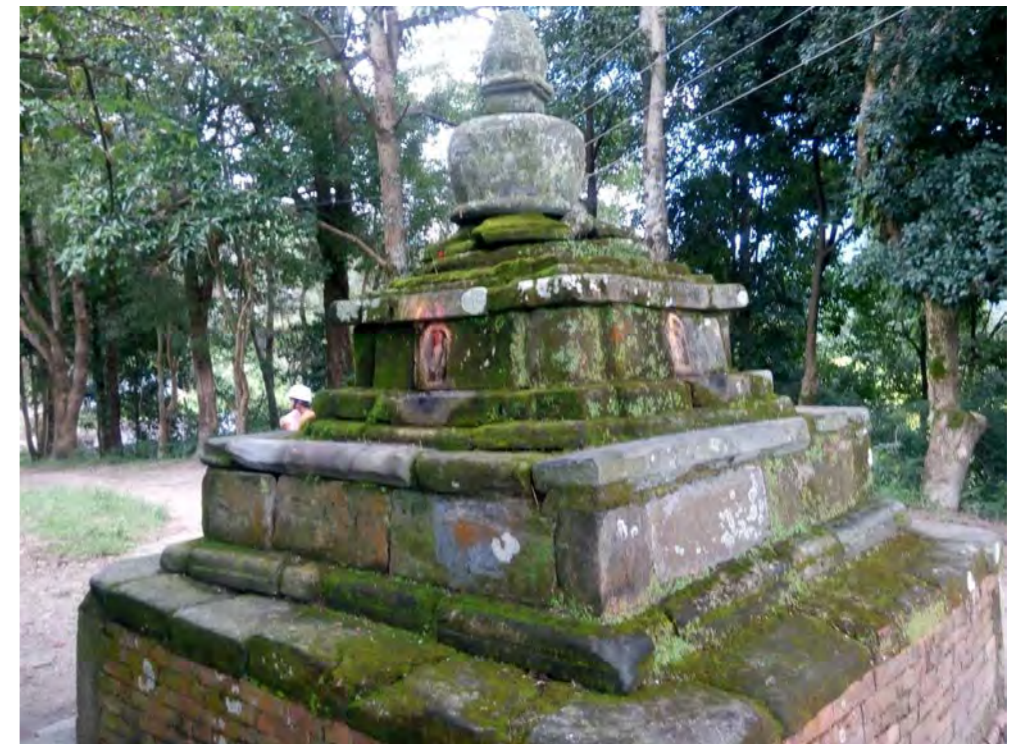
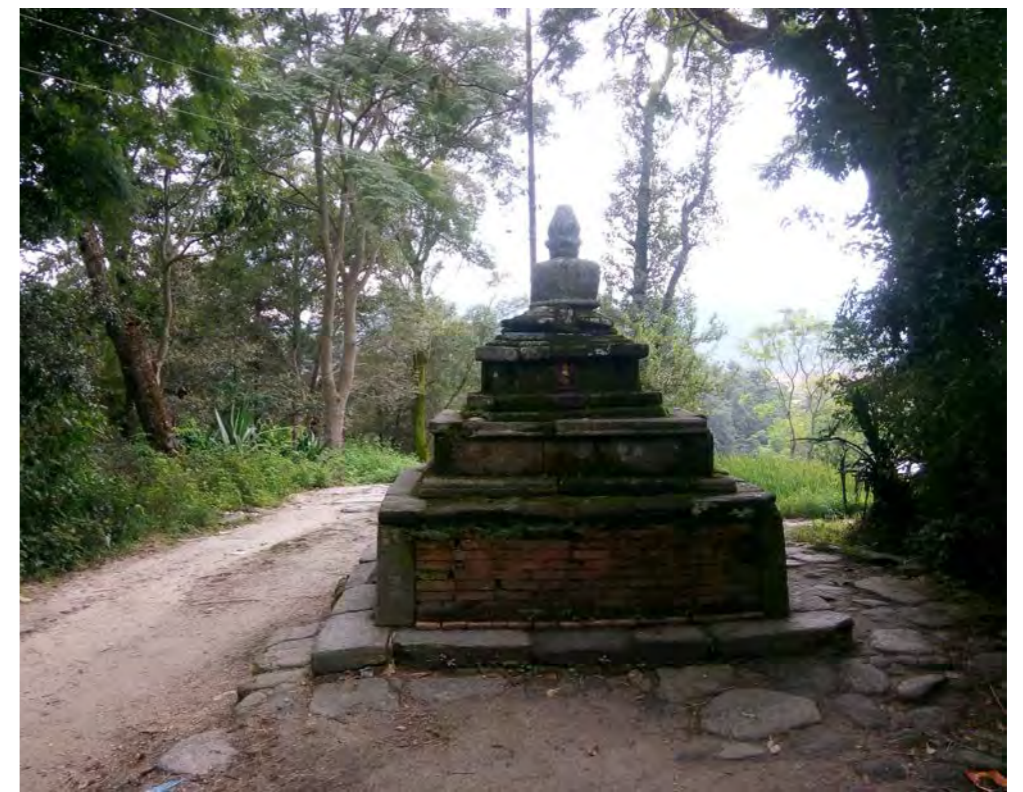
02 CHAITYA

NUMBER	NAME	DATE A.D.	TPOLOGY	GENERAL DESCRIPTION	PROBLEMS DESCRIPTION	DANGER/ DESTROY	
02	Chaitya		Open shrine		Stones are missing at the base and at the middle

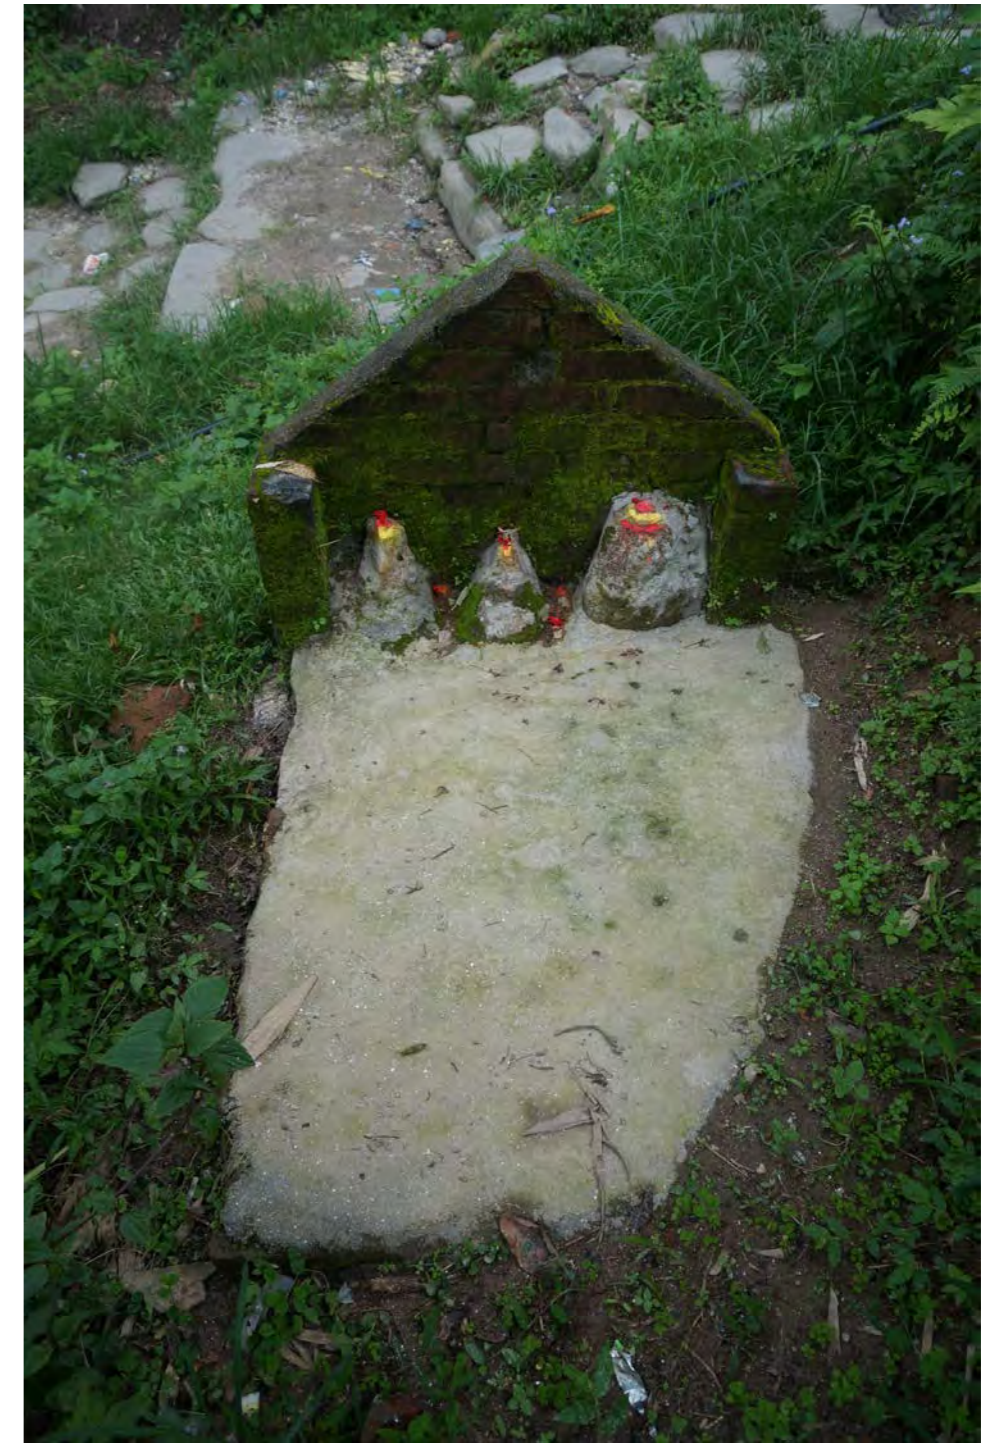
03B

NUMBER	NAME	ESTABLISHED DATE (A.D.)	TYPOLOGY	GENERAL DESCRIPTION	PROBLEMS DESCRIPTION	DANGER/ DESTROY	
03a			Stone idol	Stone surrounded by brick structure			
03b			Stone idol	Stone surrounded by cemented structure

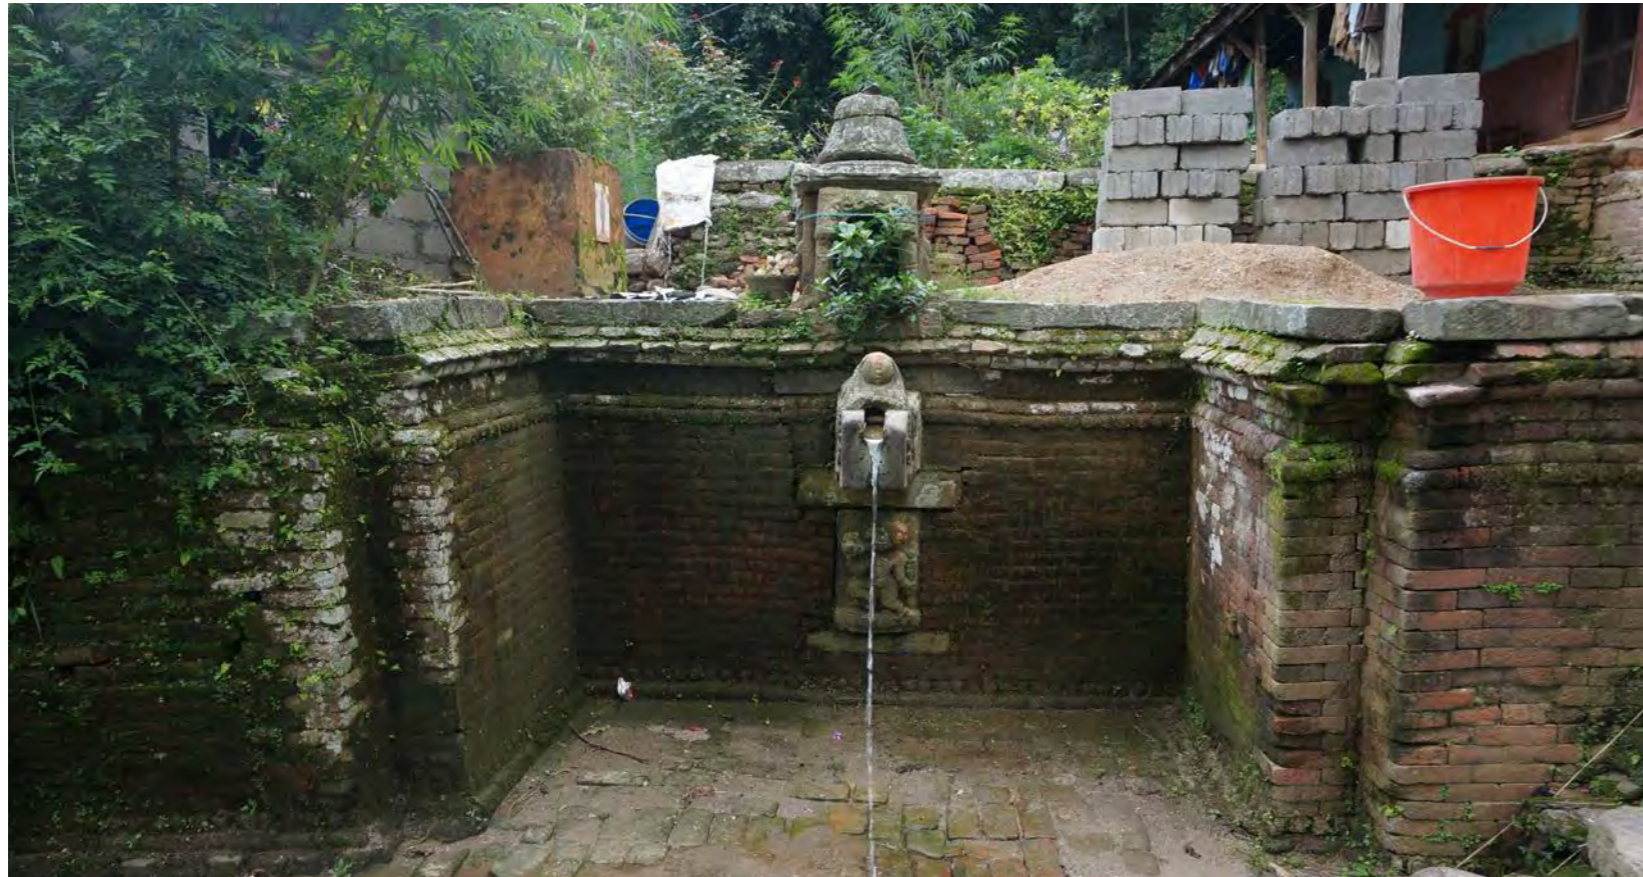
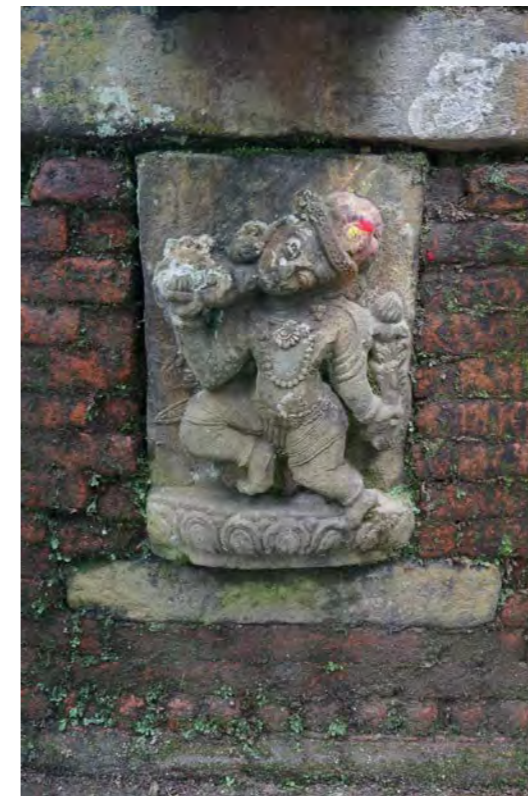
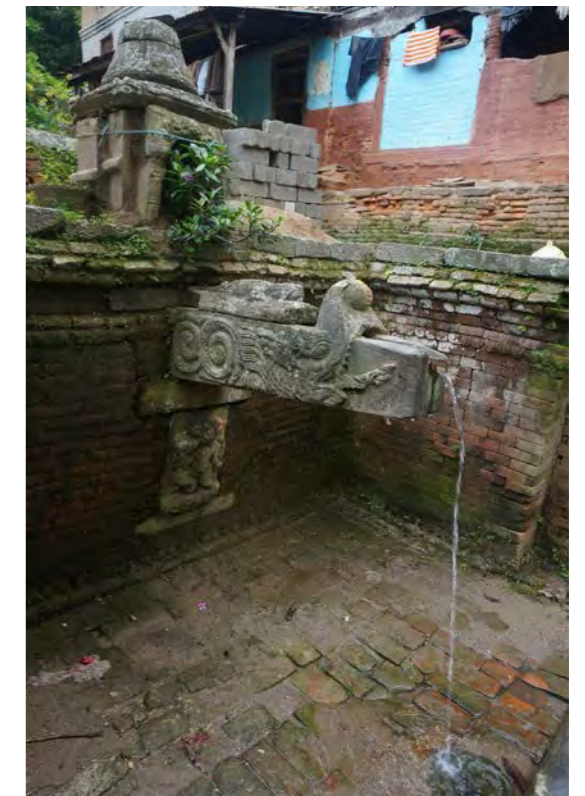
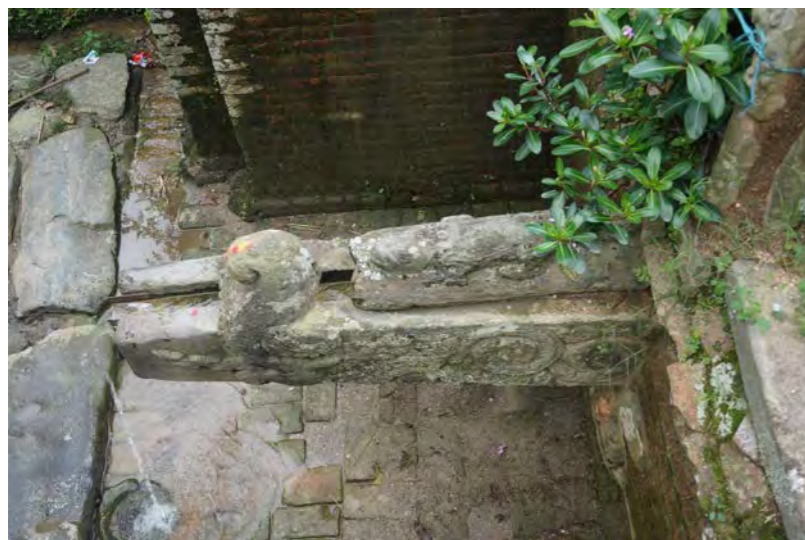
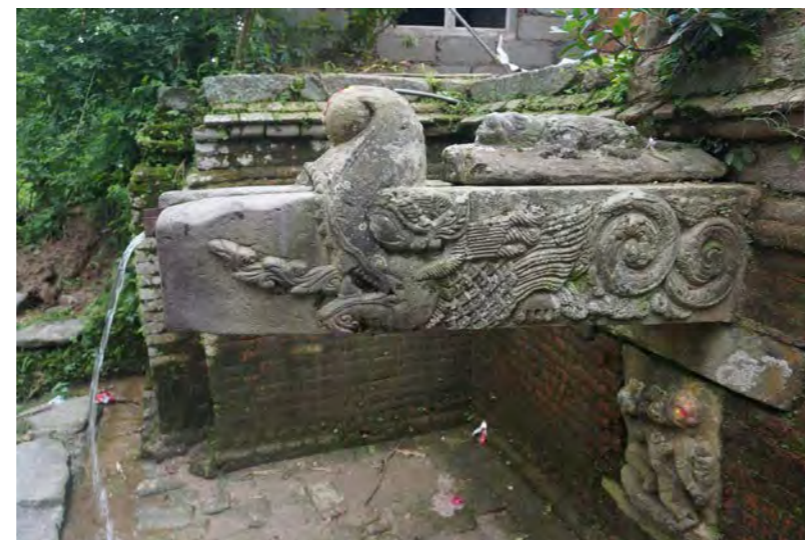
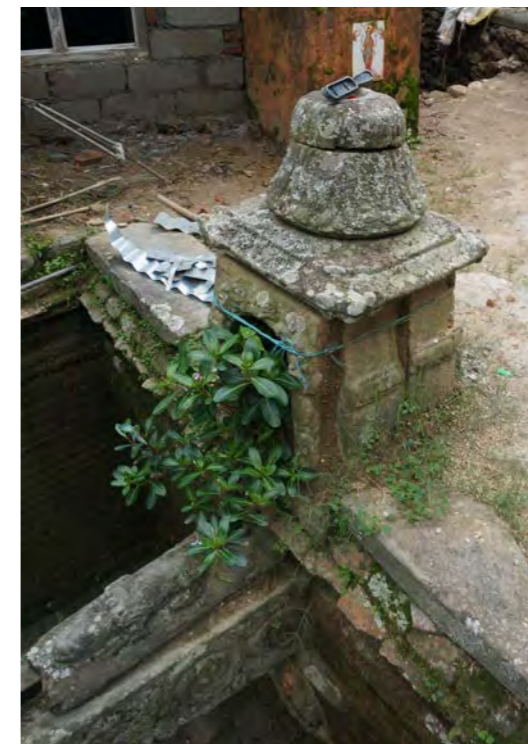
04 DHUNGEDHARA

NUMBER	NAME	DATE A.D.	TYPOLOGY	GENERAL DESCRIPTION	PROBLEMS DESCRIPTION	DANGER/ DESTROY
04			Waterspout		West wall is bulging out with a crack of 2cm. Top part is dislocated. South east side is bulging out with cracks.

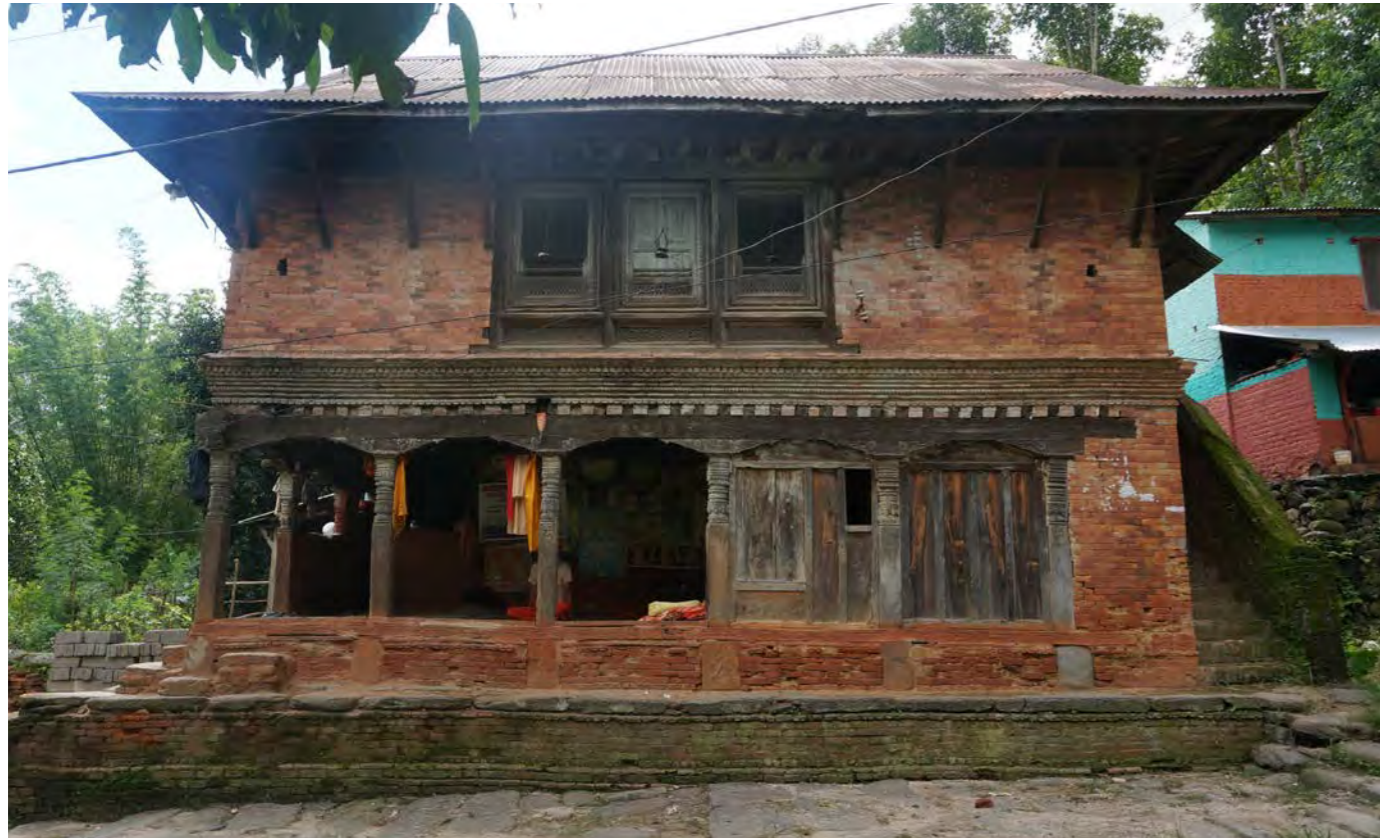
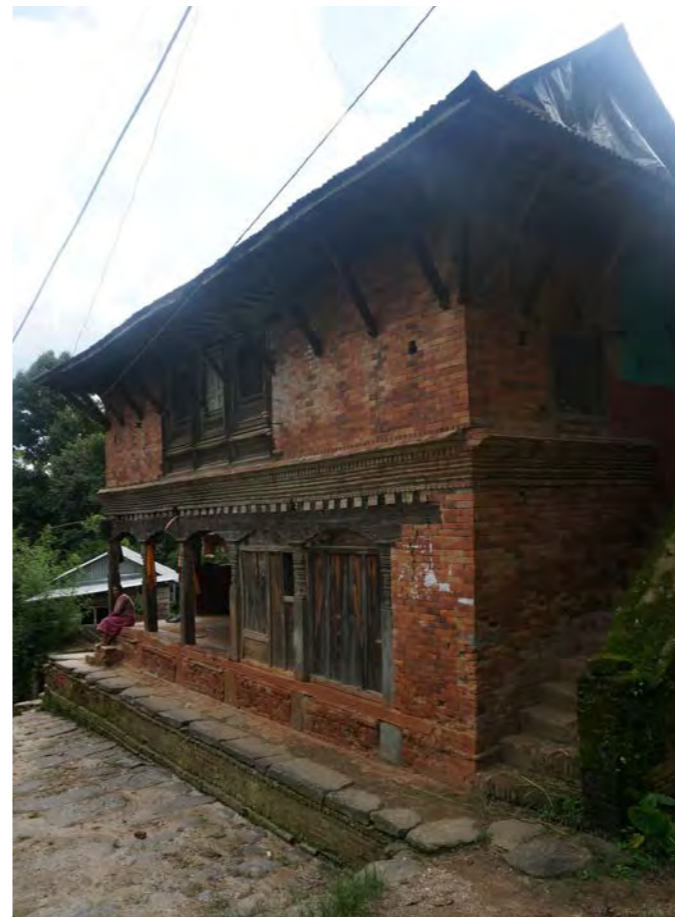
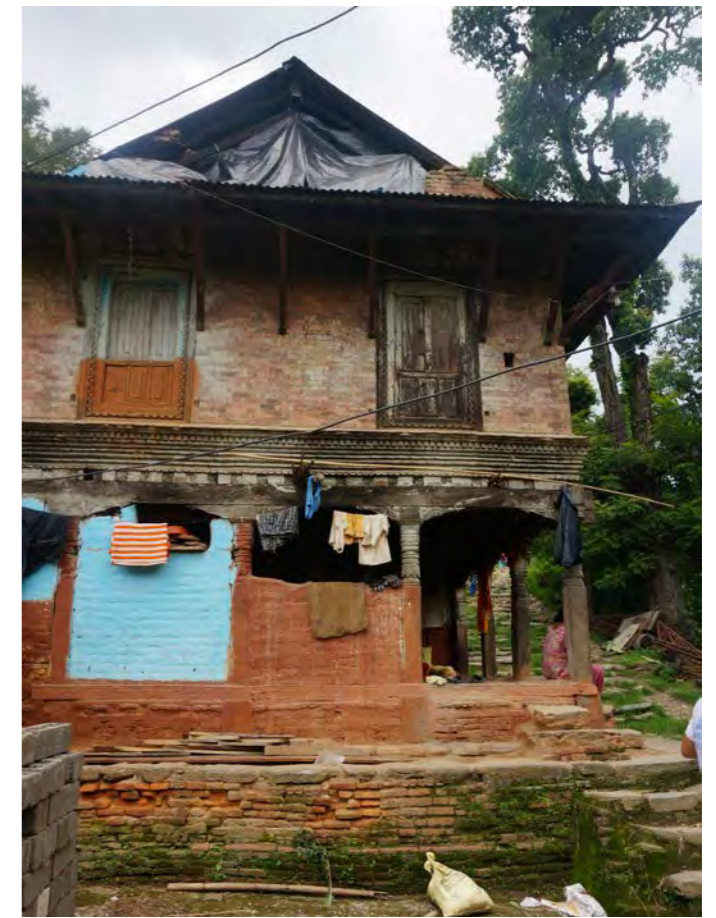
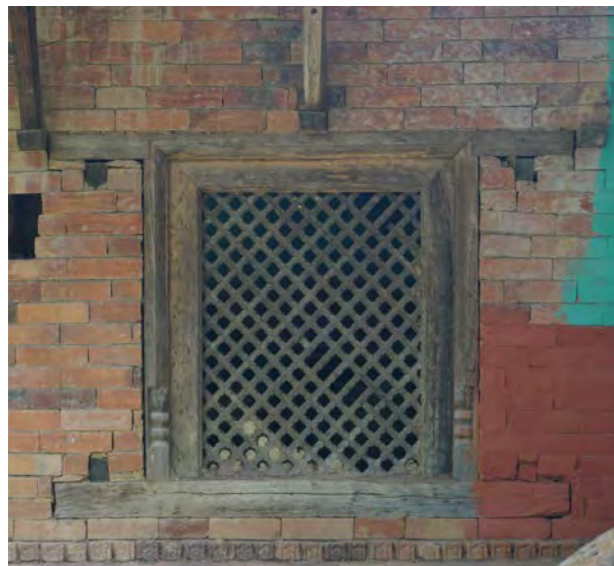
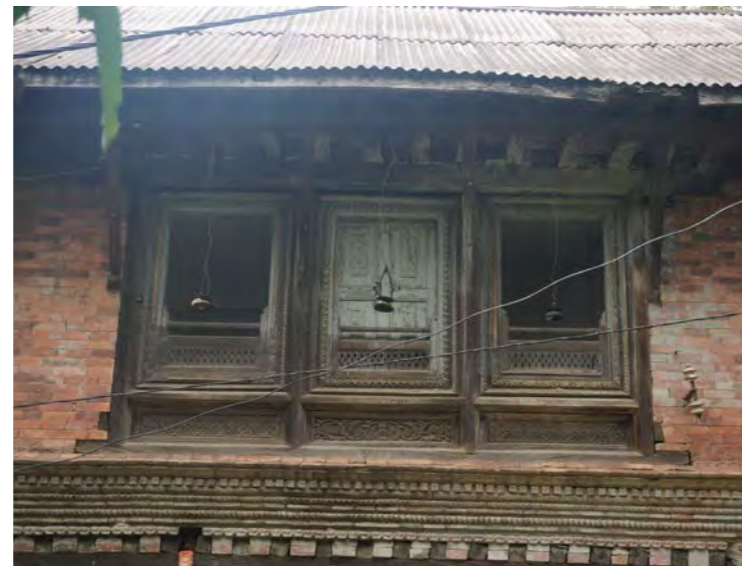
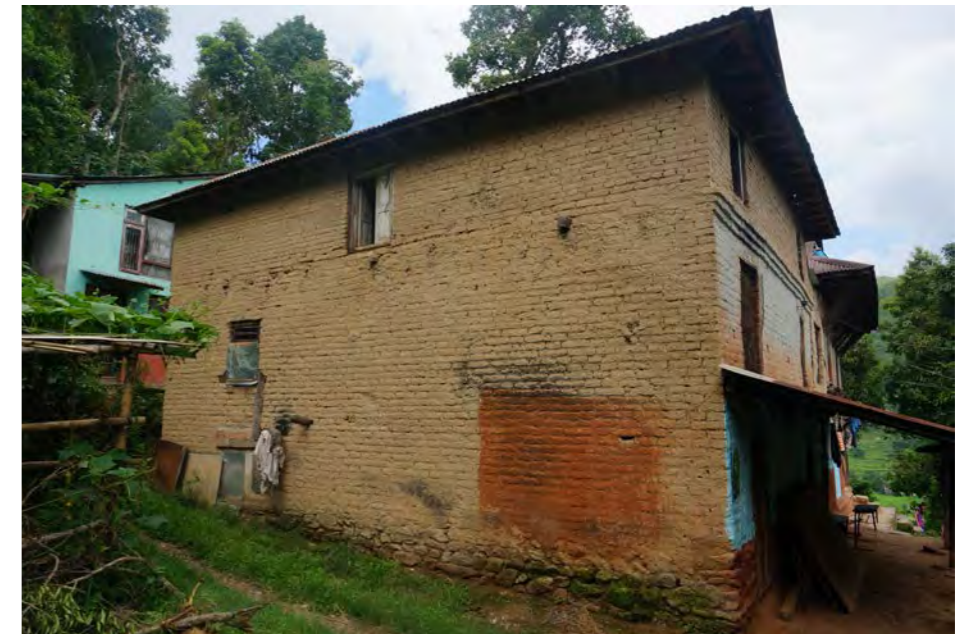
05 SATTAL

NUMBER	NAME	ESTABLISHED DATE (A.D.)	TYPOLOGY	GENERAL DESCRIPTION	PROBLEMS DESCRIPTION	DANGER/ DESTROY
05	Sattal			Brick walled. G+2, ground floor is semi open collonaded space.	North East corner has cracks of about 2cm. North gable wall has collapsed in the top floor.

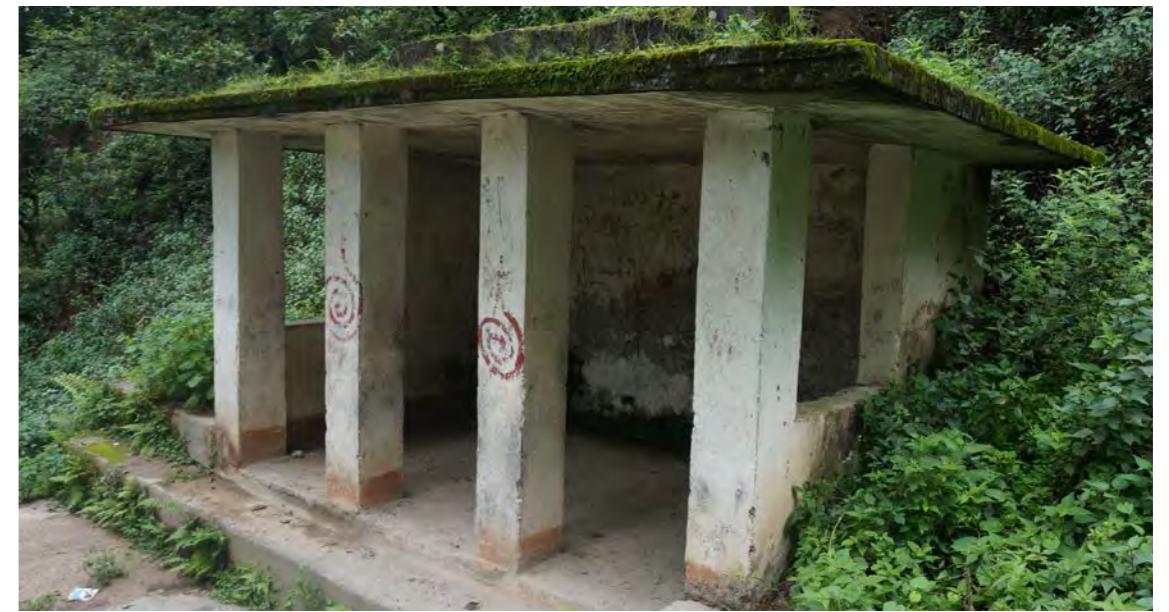
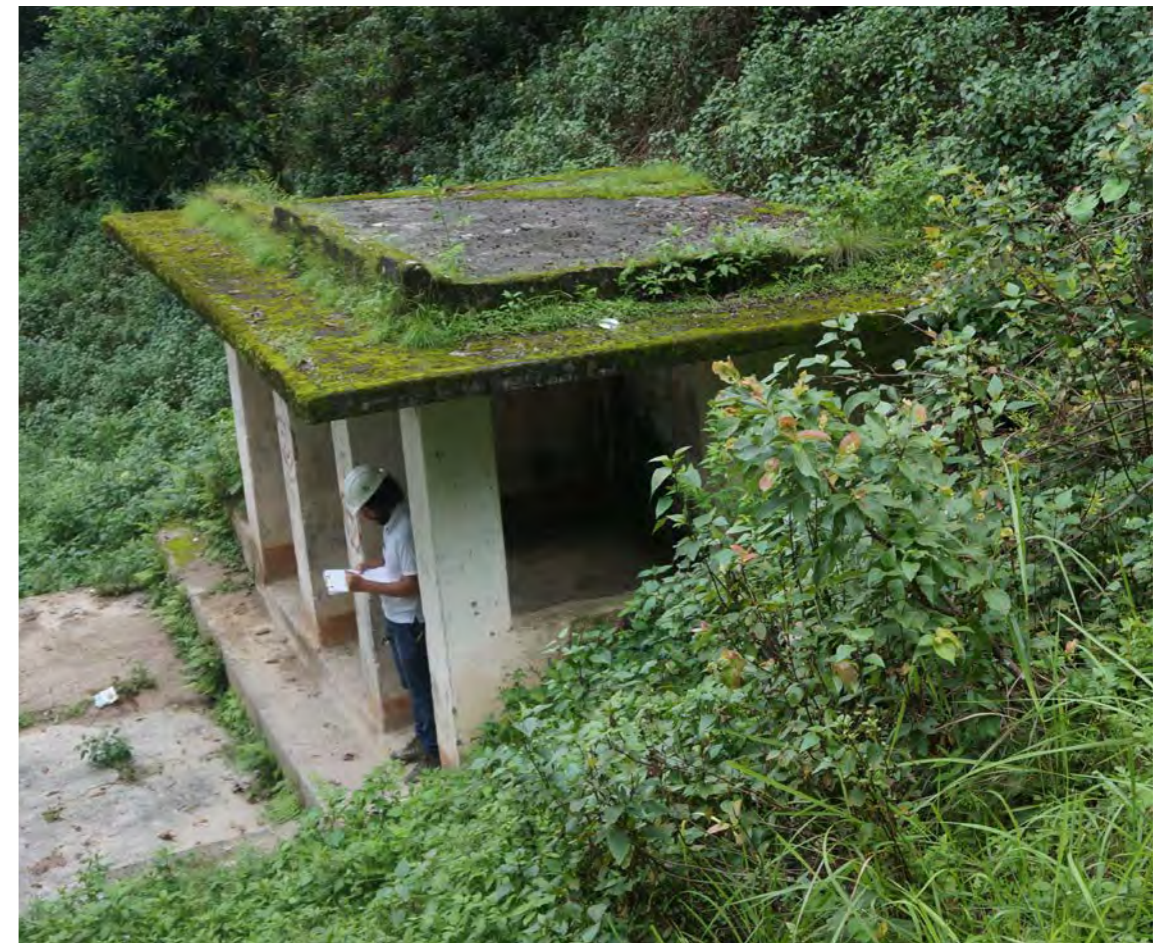
06 PATI

NUMBER	NAME	DATE A.D.	TPOLOGY	GENERAL DESCRIPTION	PROBLEMS DESCRIPTION	DANGER/ DESTROY	
06	Pati			Concrete structure. G.	Dampness at the west wall

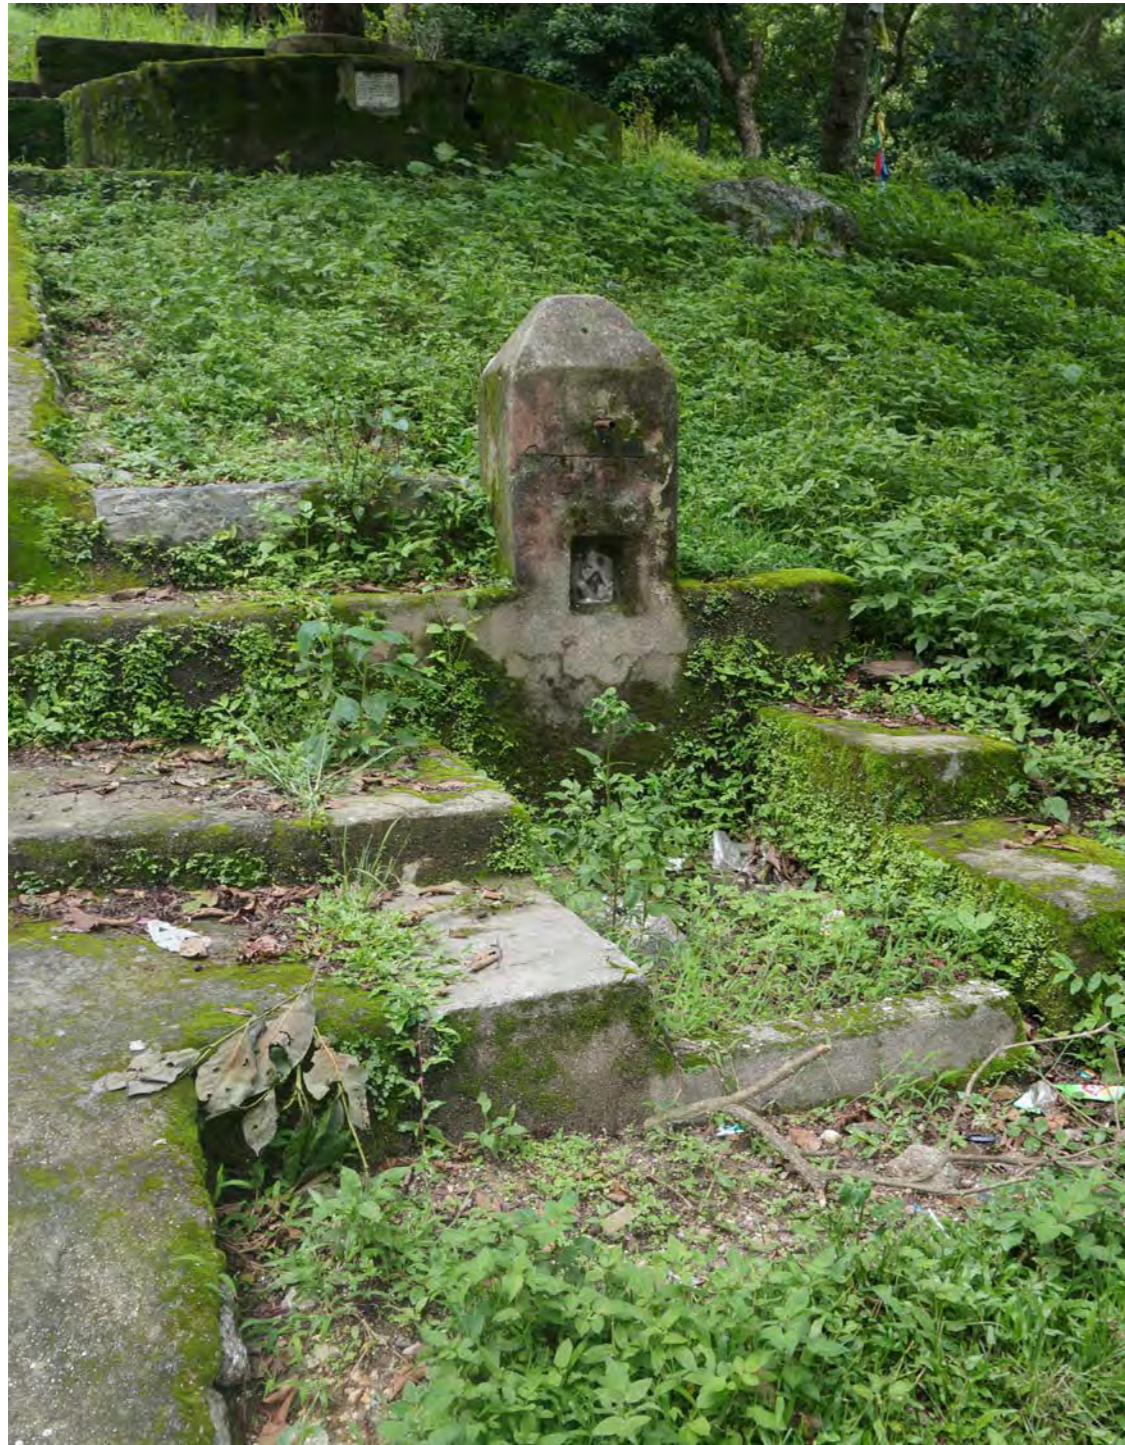
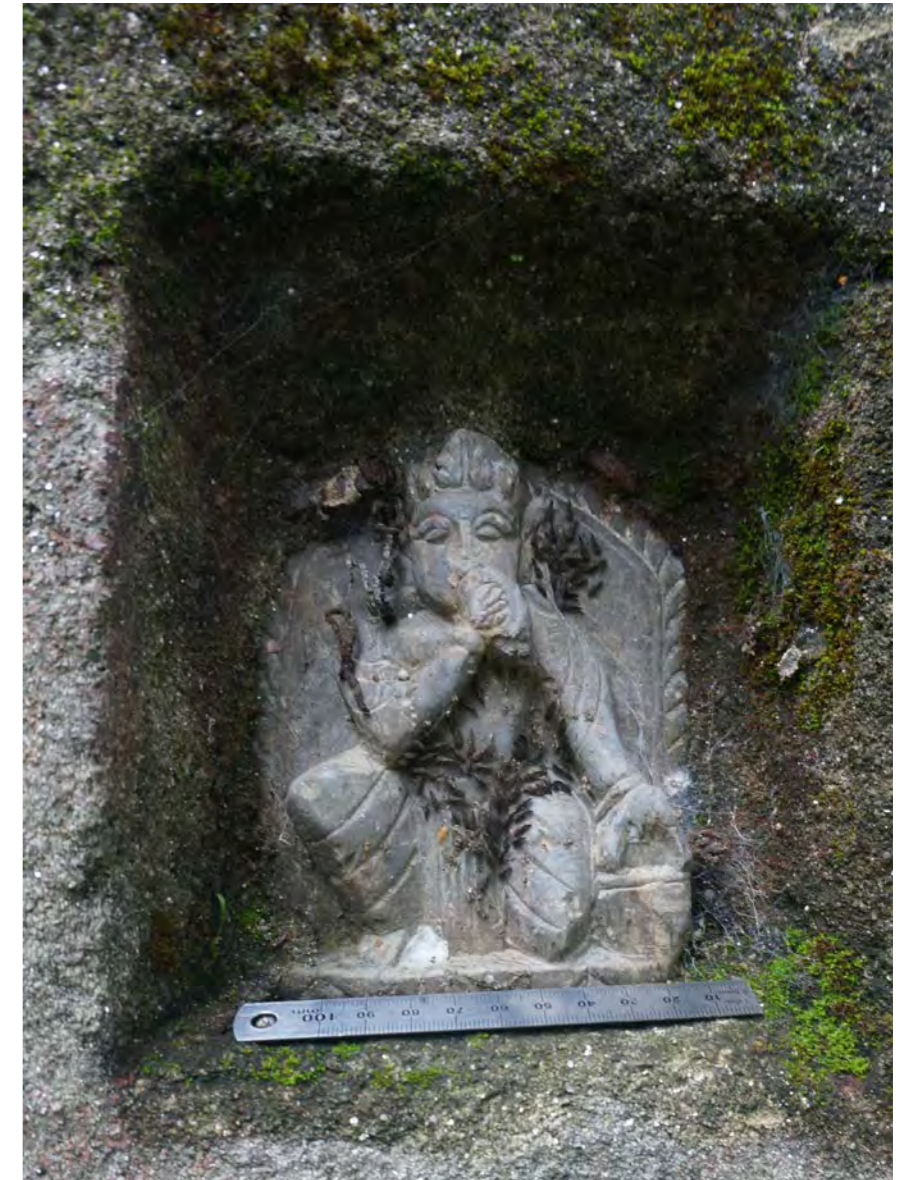
07 WATER TAP

NUMBER	NAME	ESTABLISHED DATE (A.D.)	TYPOLOGY	GENERAL DESCRIPTION	PROBLEMS DESCRIPTION	DANGER/ DESTROY	
07	Water tap			Cemented structure with a carved stone structure	Vegetation growth
