2015 Earthquake Damage Mapping

Sankhu

October 2015

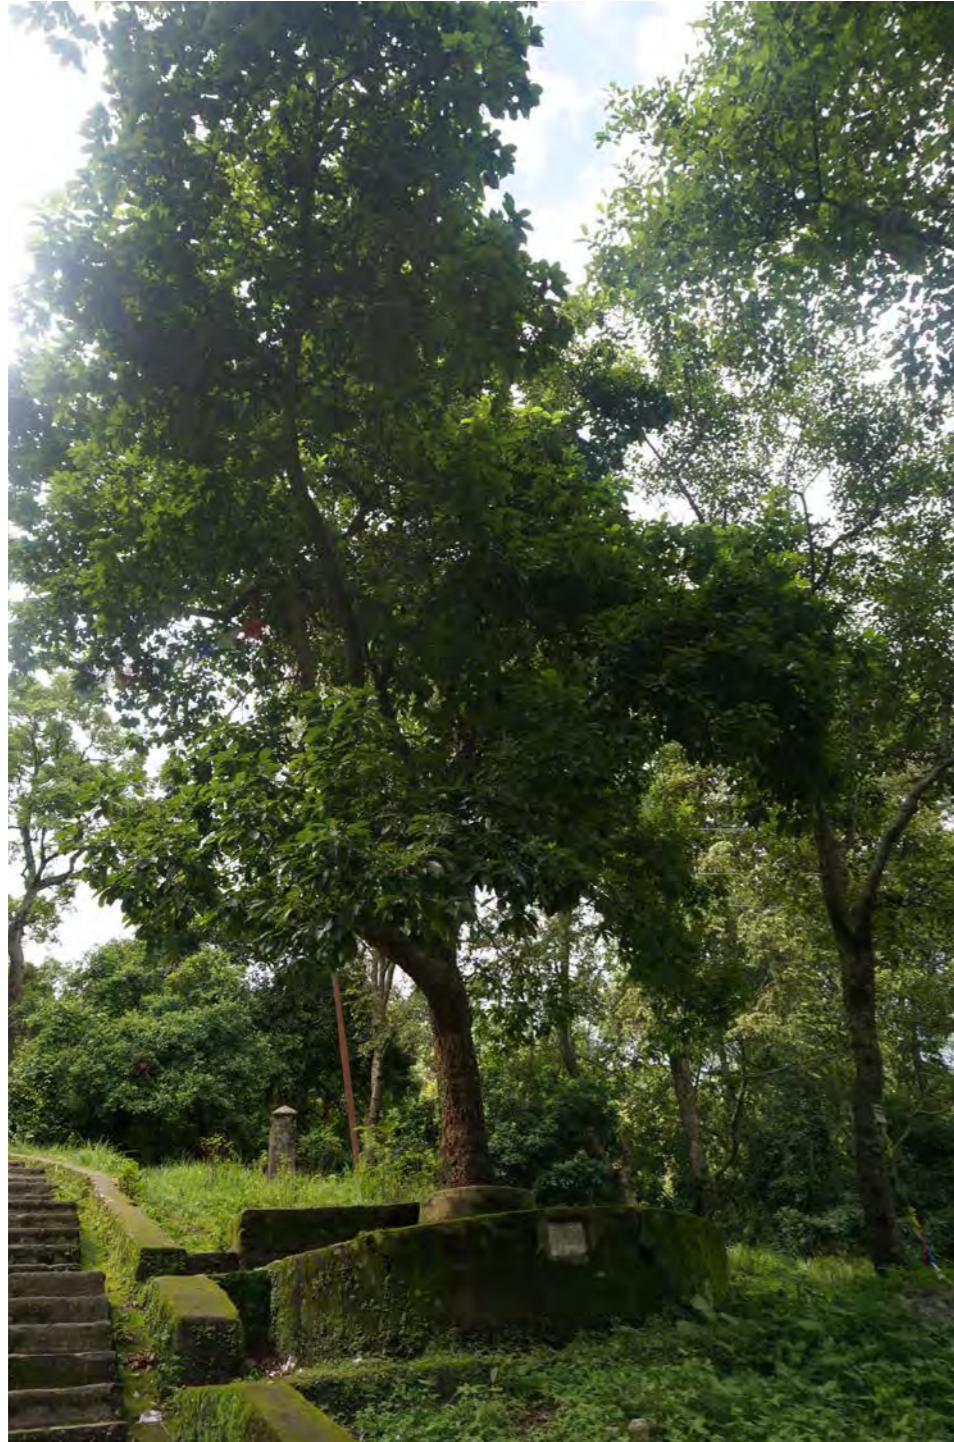
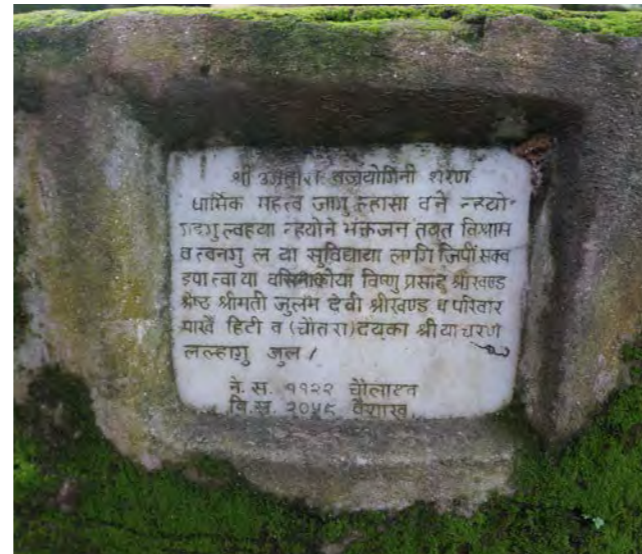
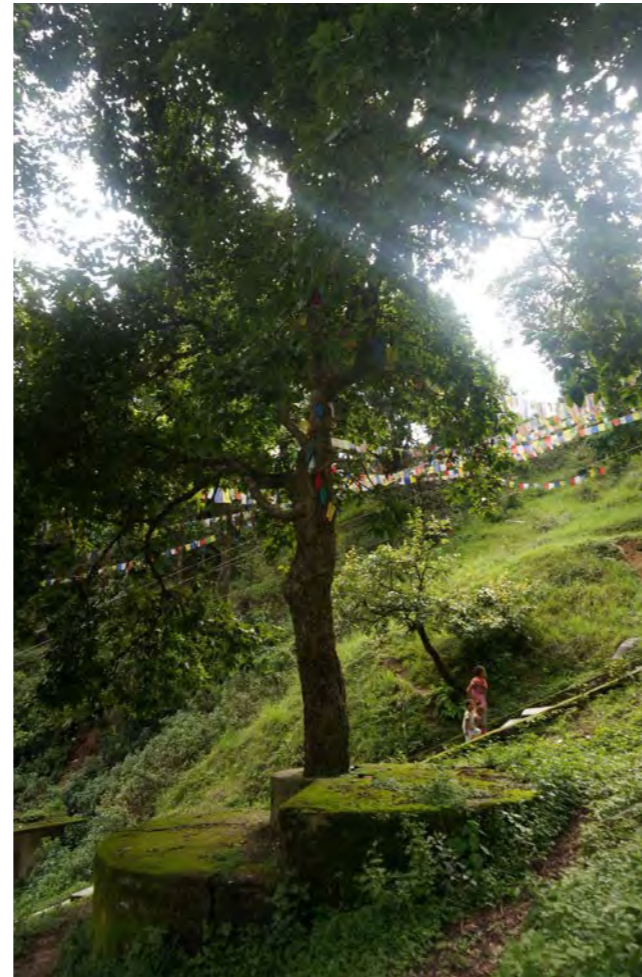
08 CHAUTARA

NUMBER	NAME	DATE A.D.	TYPOLOGY	GENERAL DESCRIPTION	PROBLEMS DESCRIPTION	DANGER/ DESTROY	
08	Chautara			Tree with a cemented base.	Craks on the base		
09	Name plate			Cemented structure with details written	A corner of metal plate is tore out of the wall

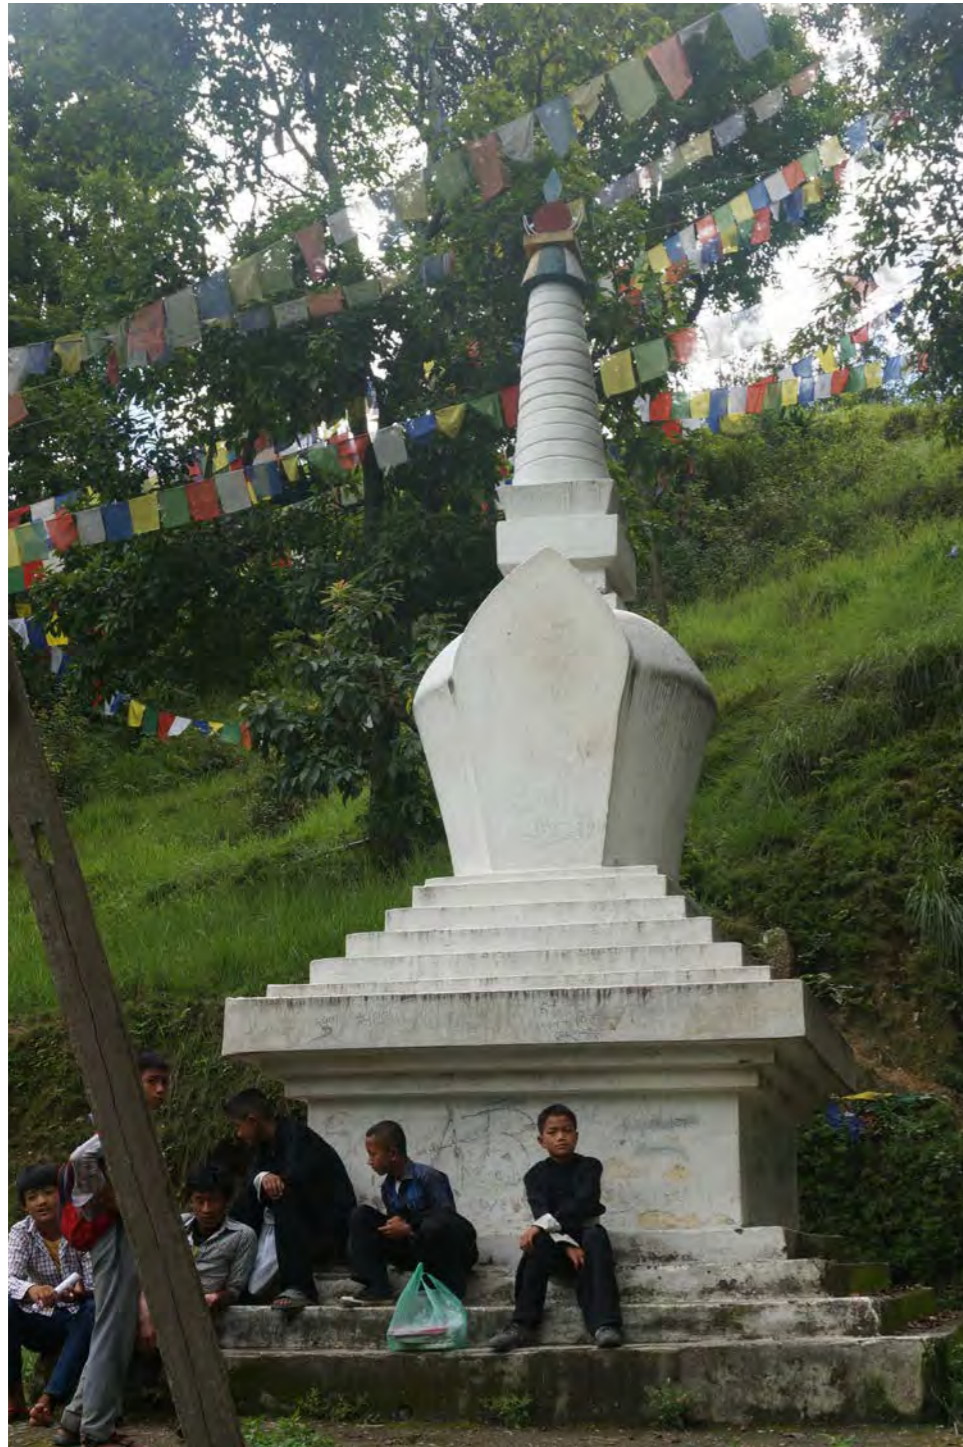
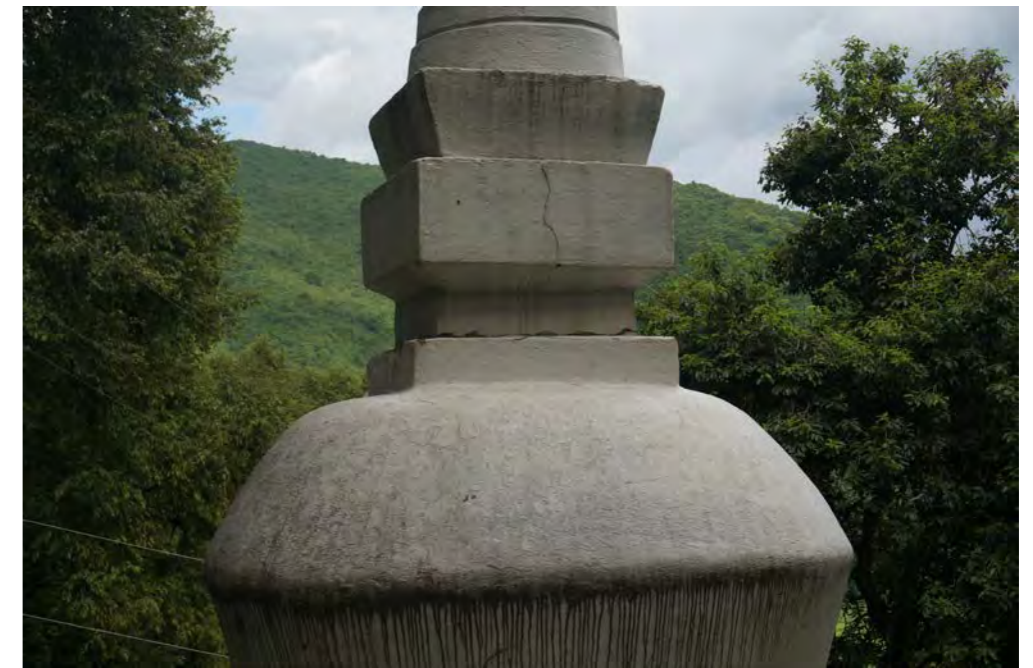
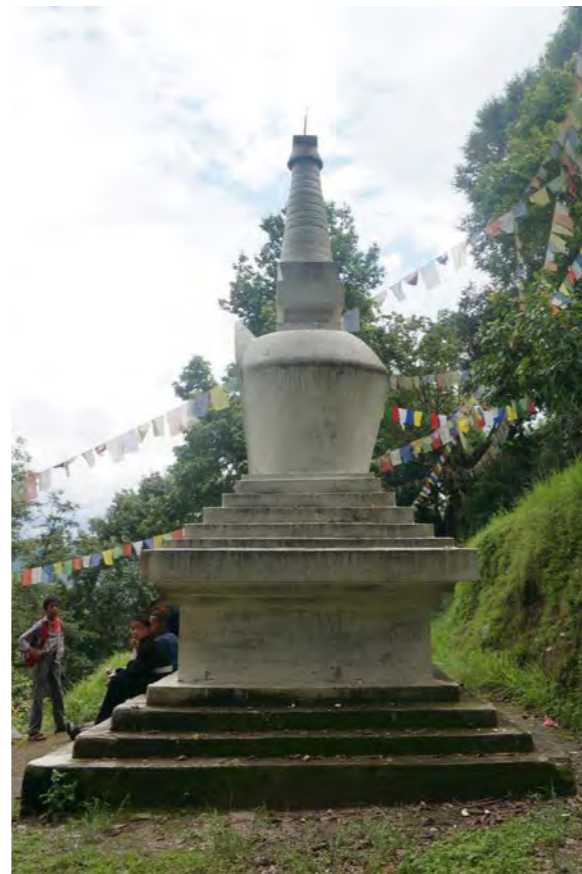
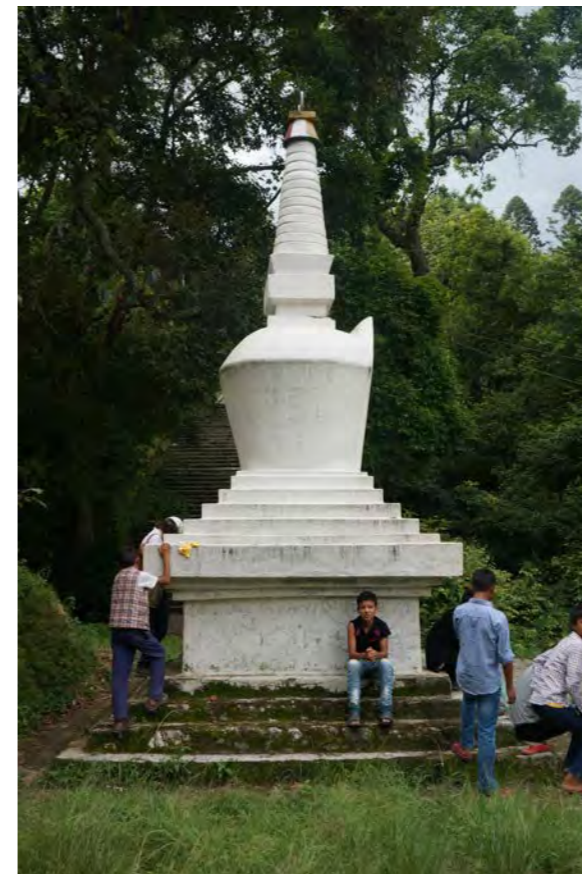
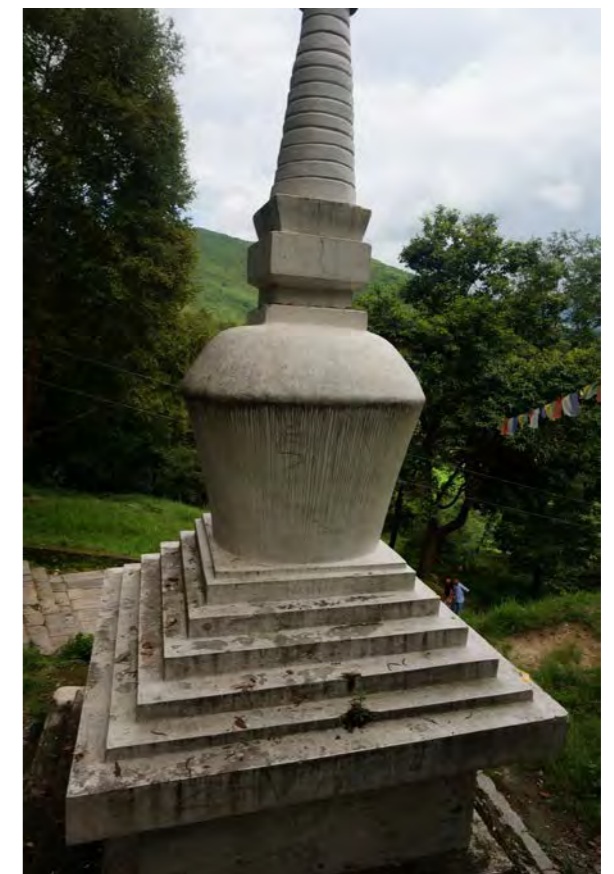
10 CHAITYA

NUMBER	NAME	ESTABLISHED DATE (A.D.)	TYPOLOGY	GENERAL DESCRIPTION	PROBLEMS DESCRIPTION	DANGER/ DESTROY	
10	Chaitya			Cement plasterd white structure	Minor hairline cracks

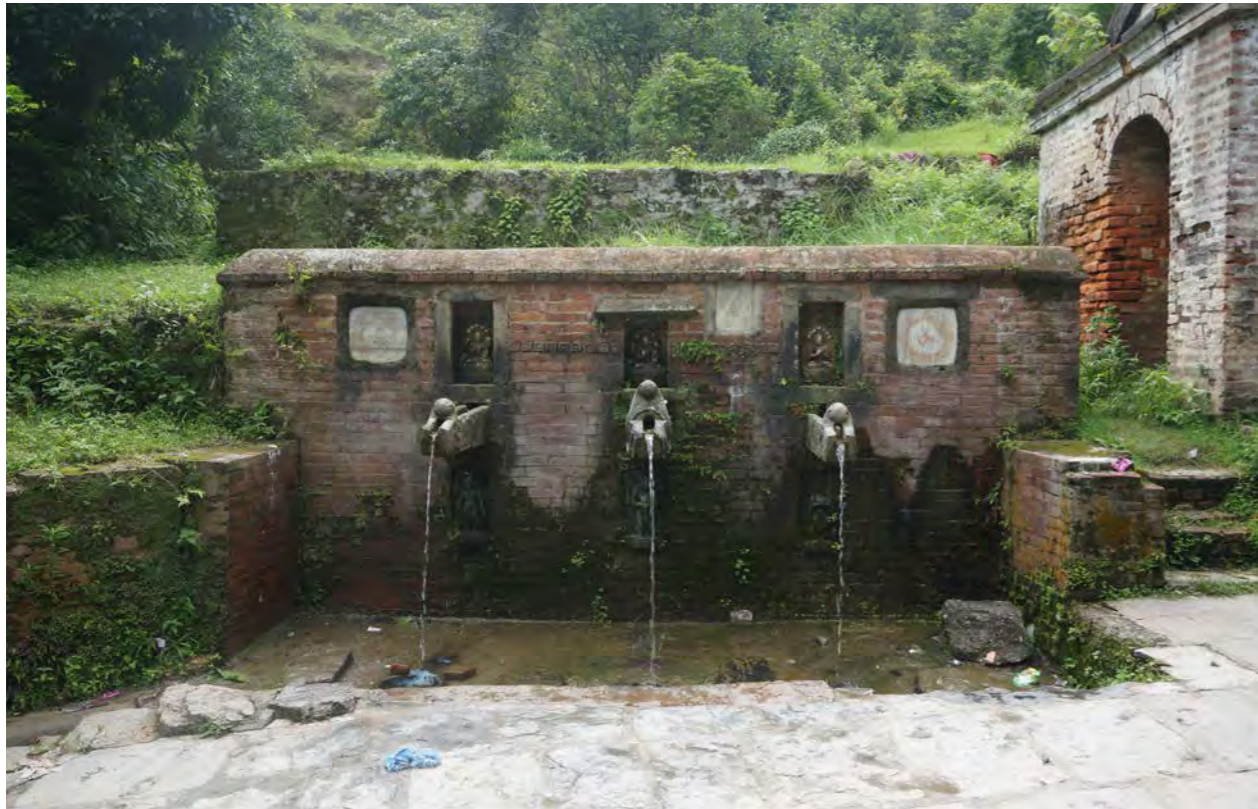
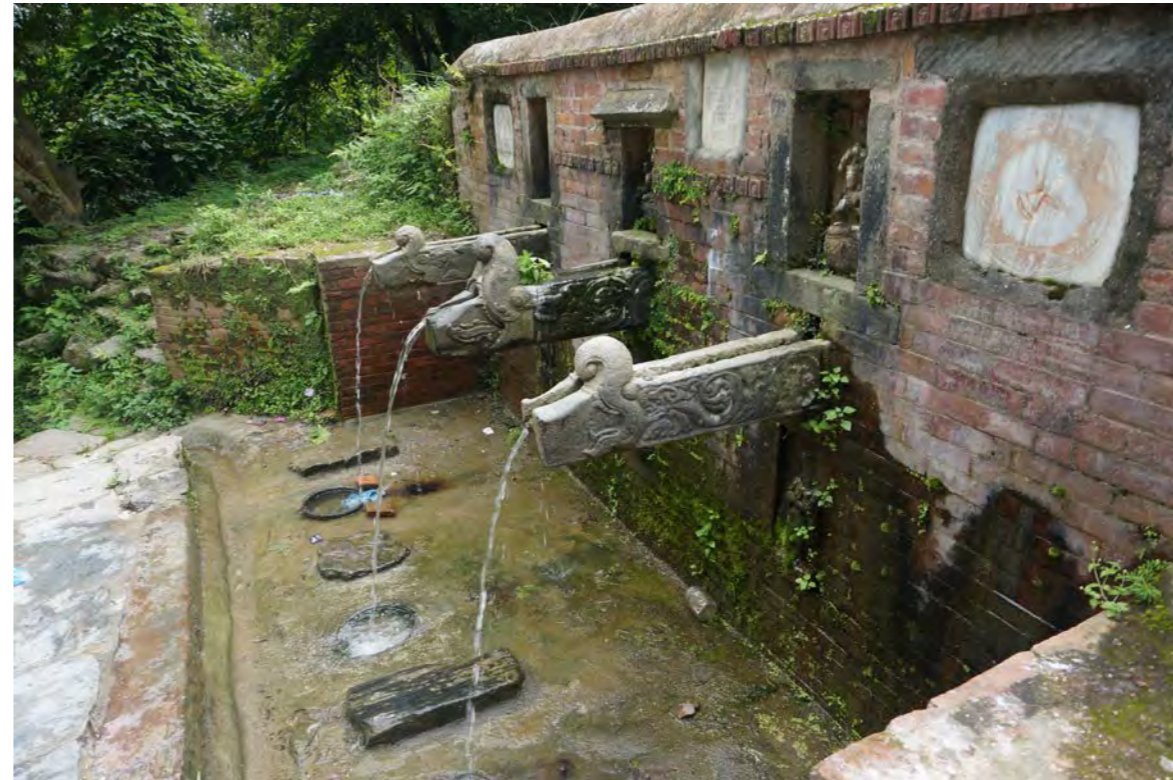
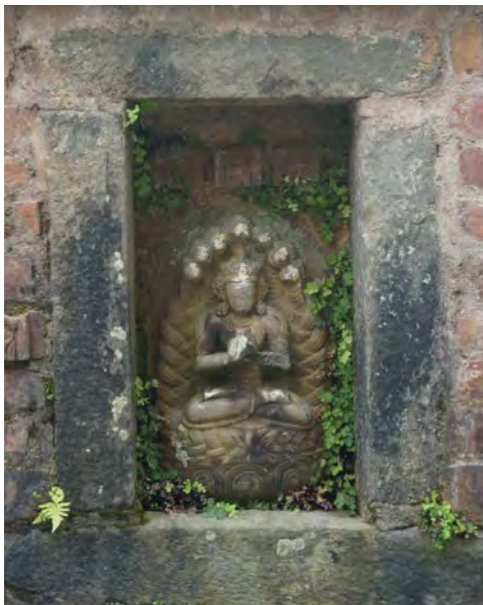
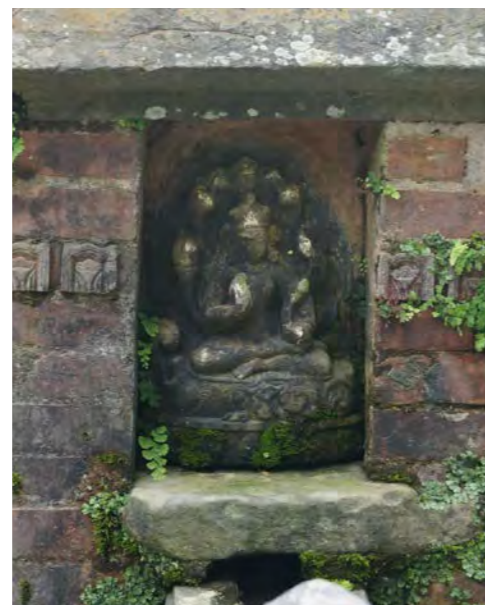
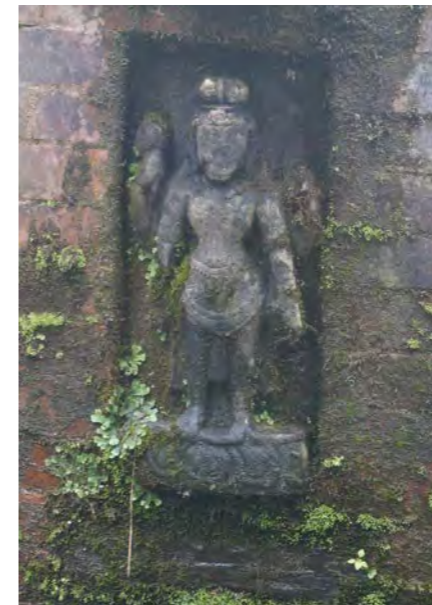
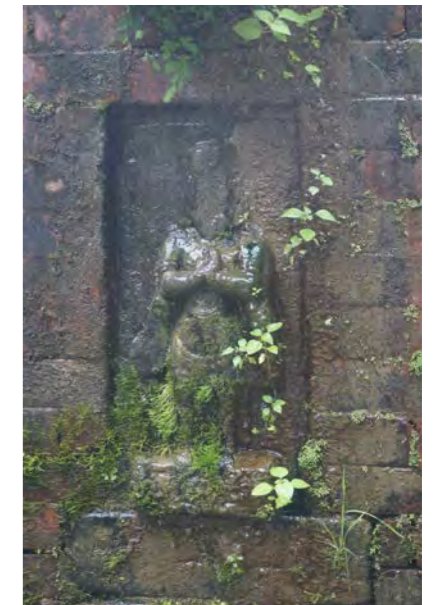
11 DHUNGEDHARA

NUMBER	NAME	DATE A.D.	TYPOLOGY	GENERAL DESCRIPTION	PROBLEMS DESCRIPTION	DANGER/ DESTROY	
11			Hiti	6 stone carved stone idols are placed above and below the tap.	Vegetation growth all around

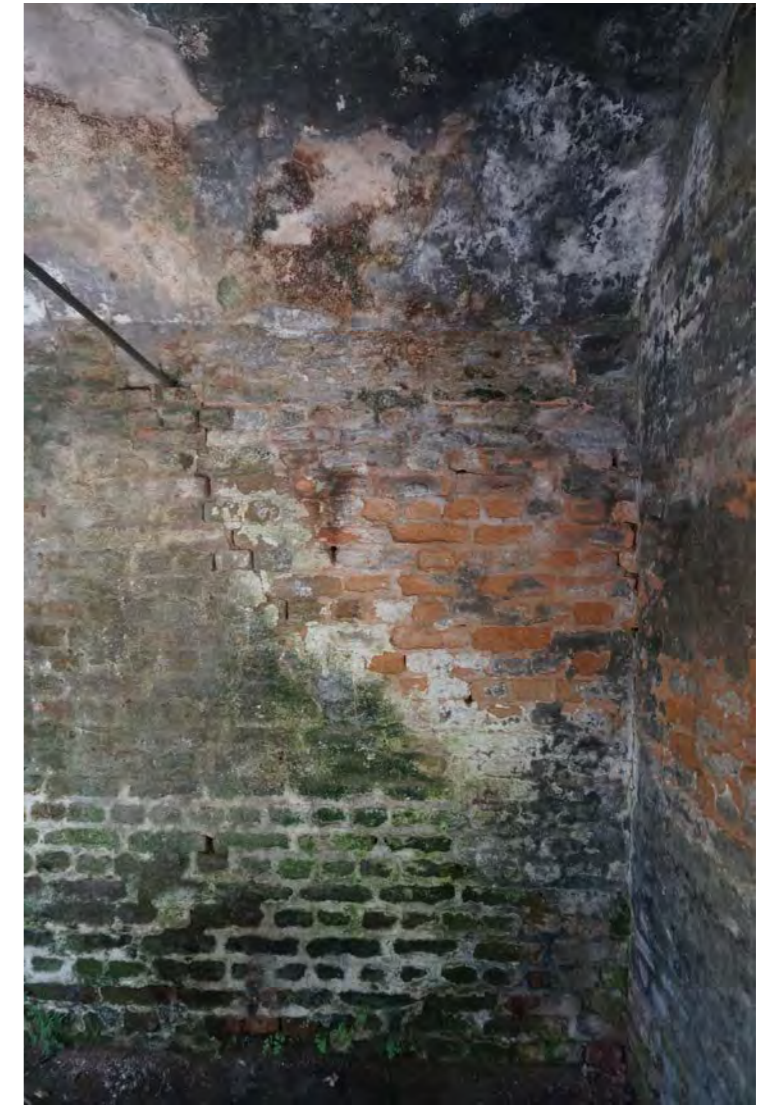
12 PATI

NUMBER	NAME	ESTABLISHED DATE (A.D.)	TYPOLOGY	GENERAL DESCRIPTION	PROBLEMS DESCRIPTION	DANGER/ DESTROY	
12			Pati	Cemenetd roof of arcade space	Cracked south wall and dampness. West wall has diagonal crack. The living space has problem of dampness.		A site plan diagram showing the location of structure 12. The structure is highlighted in yellow and labeled with the number 12. It is situated near a road and other structures.

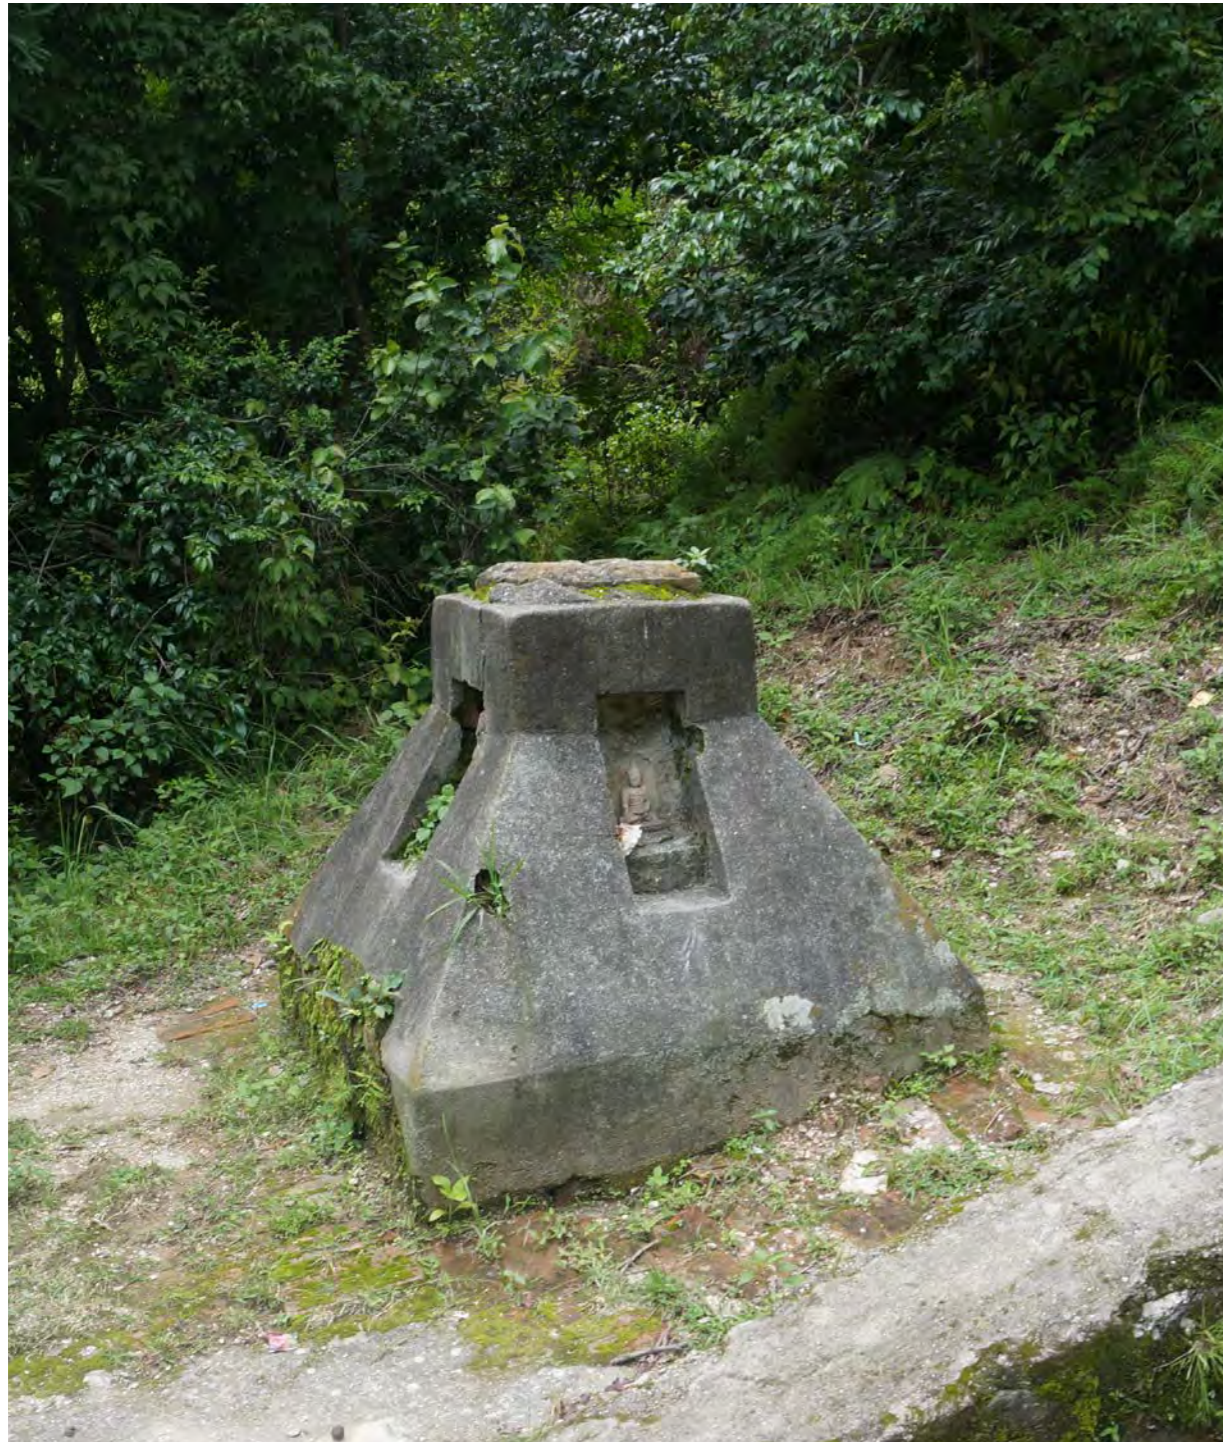
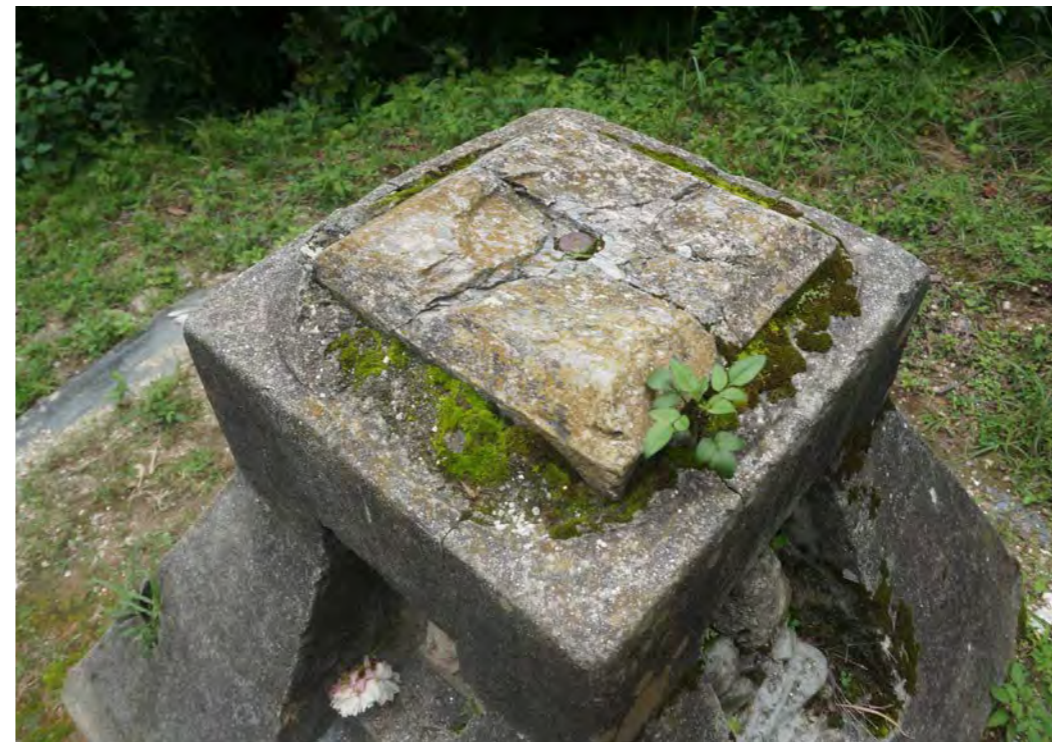
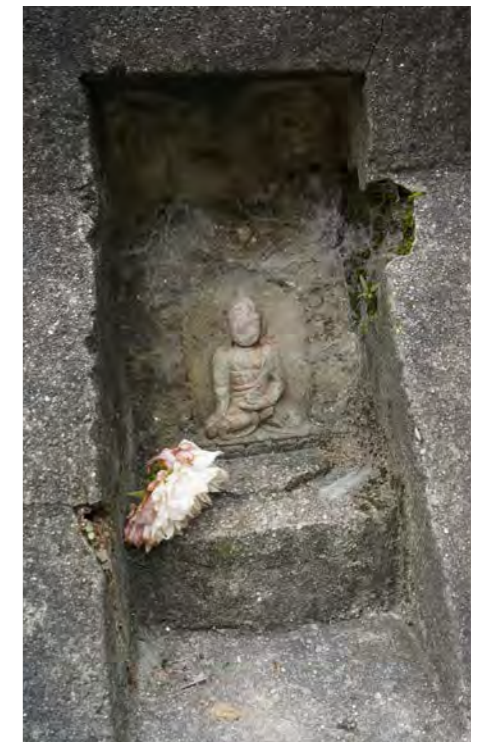
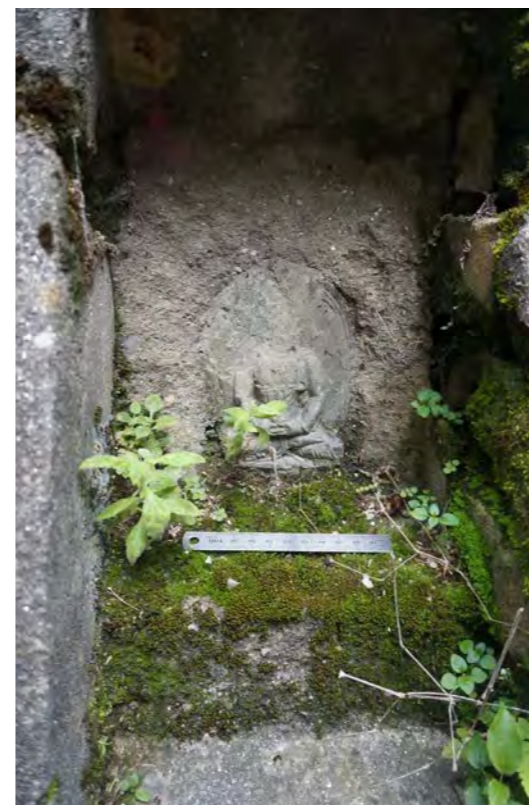
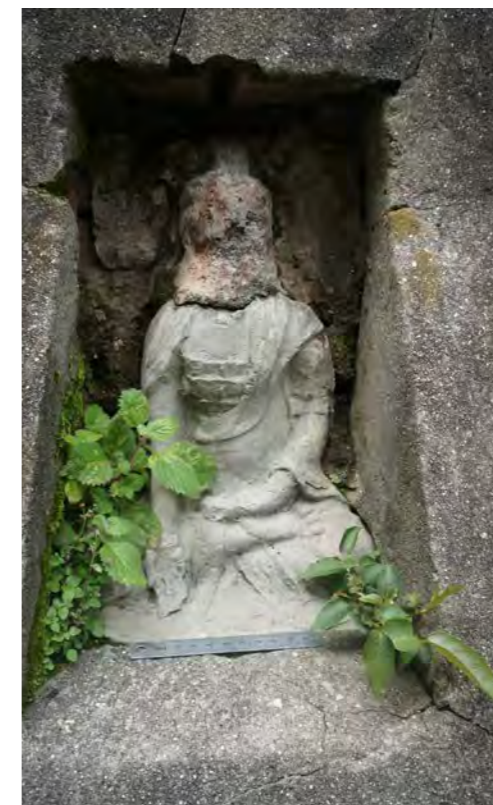
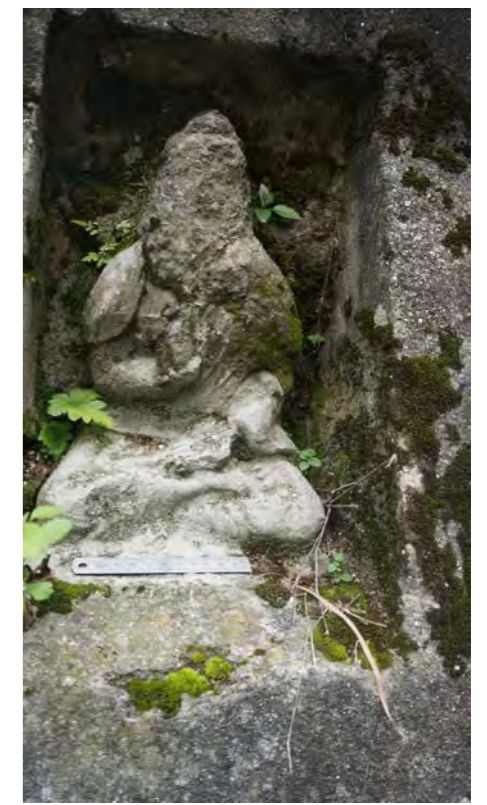
13 OPEN SHRINE

NUMBER	NAME	DATE A.D.	TPOLOGY	GENERAL DESCRIPTION	PROBLEMS DESCRIPTION	DANGER/ DESTROY	
13			Open Shrine	Cemented stone structure with four idols at four directions	Part of the stucture is missing. Vegetation growth

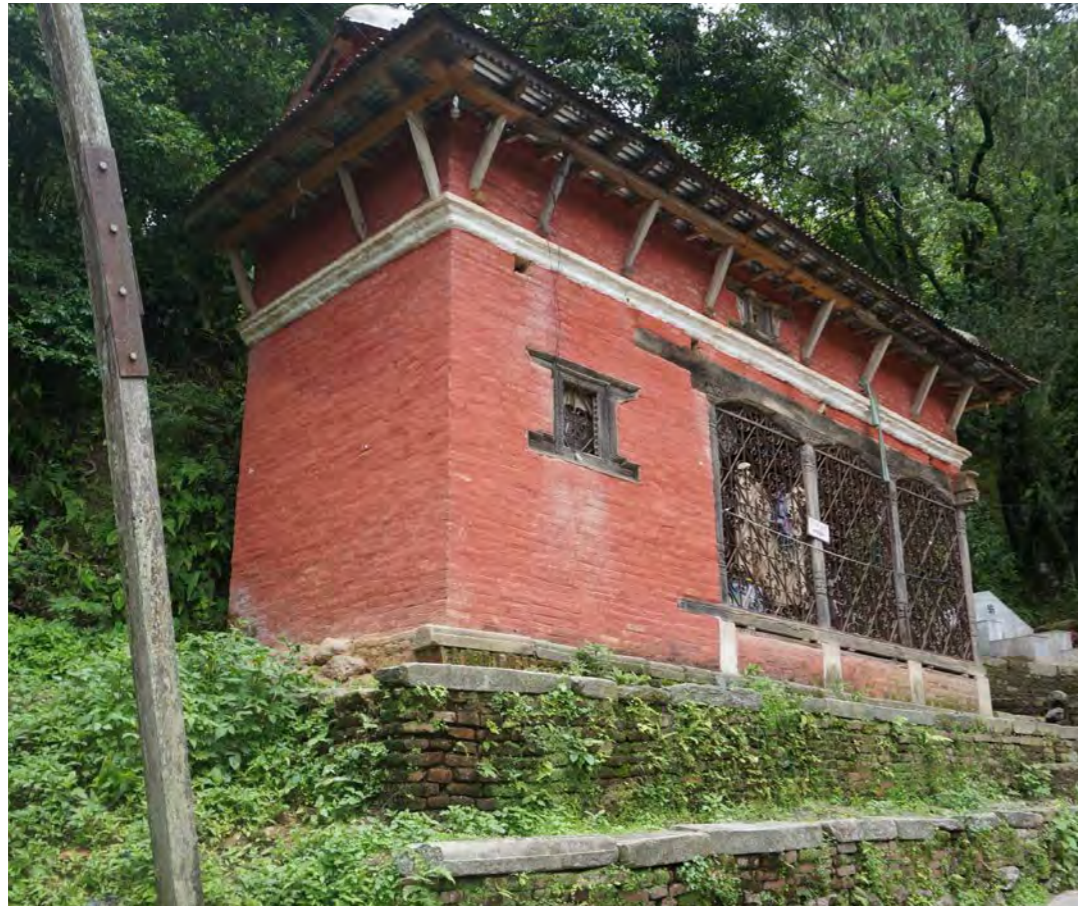
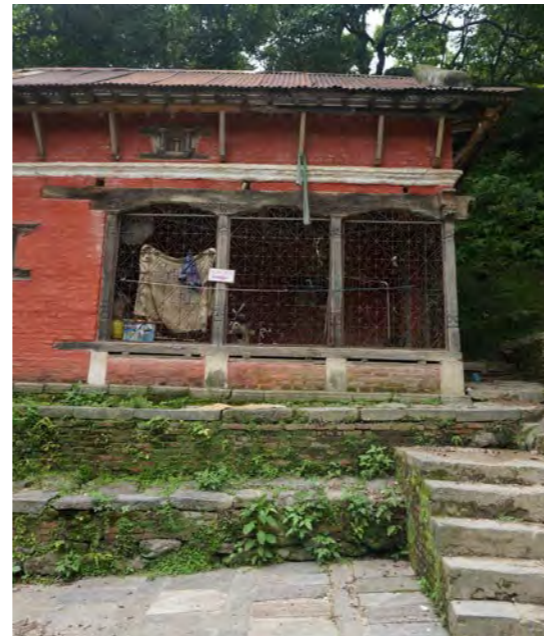
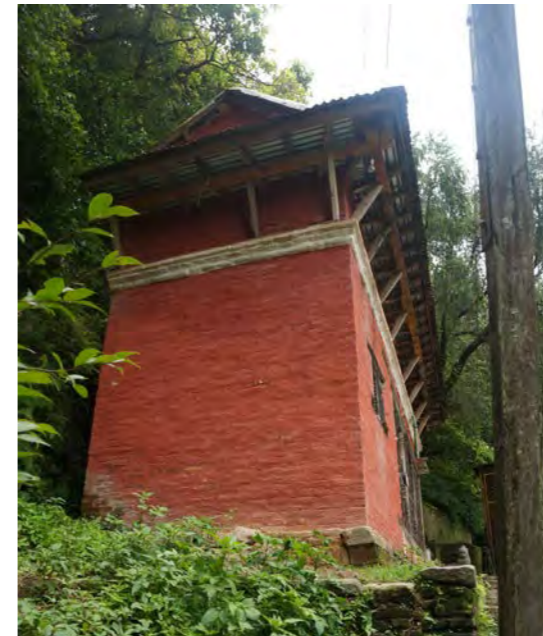
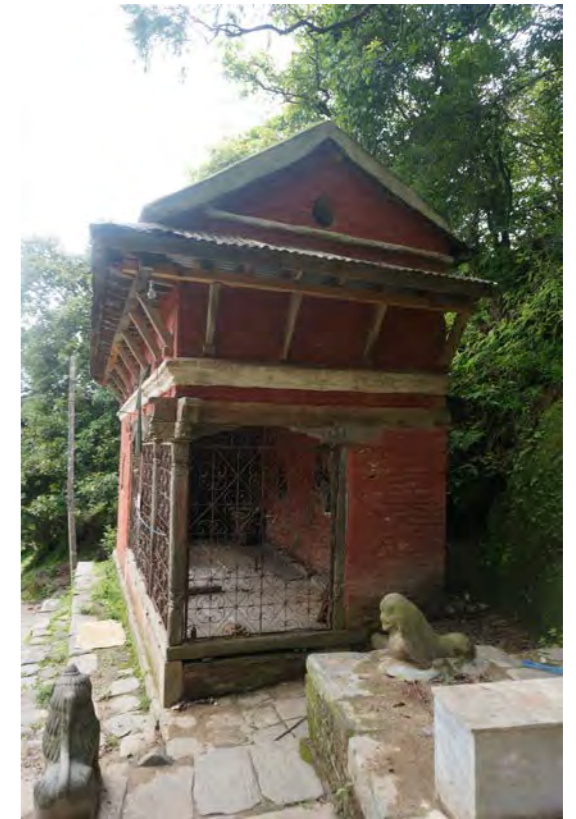
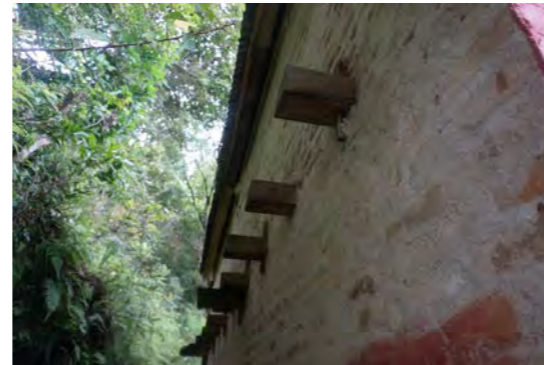
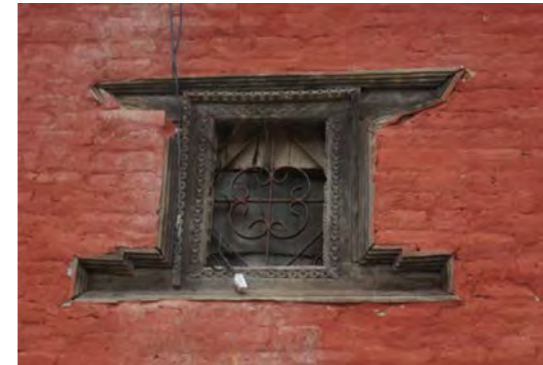
14 PATI

NUMBER	NAME	ESTABLISHED DATE (A.D.)	TYPOLOGY	GENERAL DESCRIPTION	PROBLEMS DESCRIPTION	DANGER/ DESTROY
14			Pati	2 floors brick structure. restored few years back.	North wall craked about 5cm. And bulging slightly. Dampness in seen in the living space.

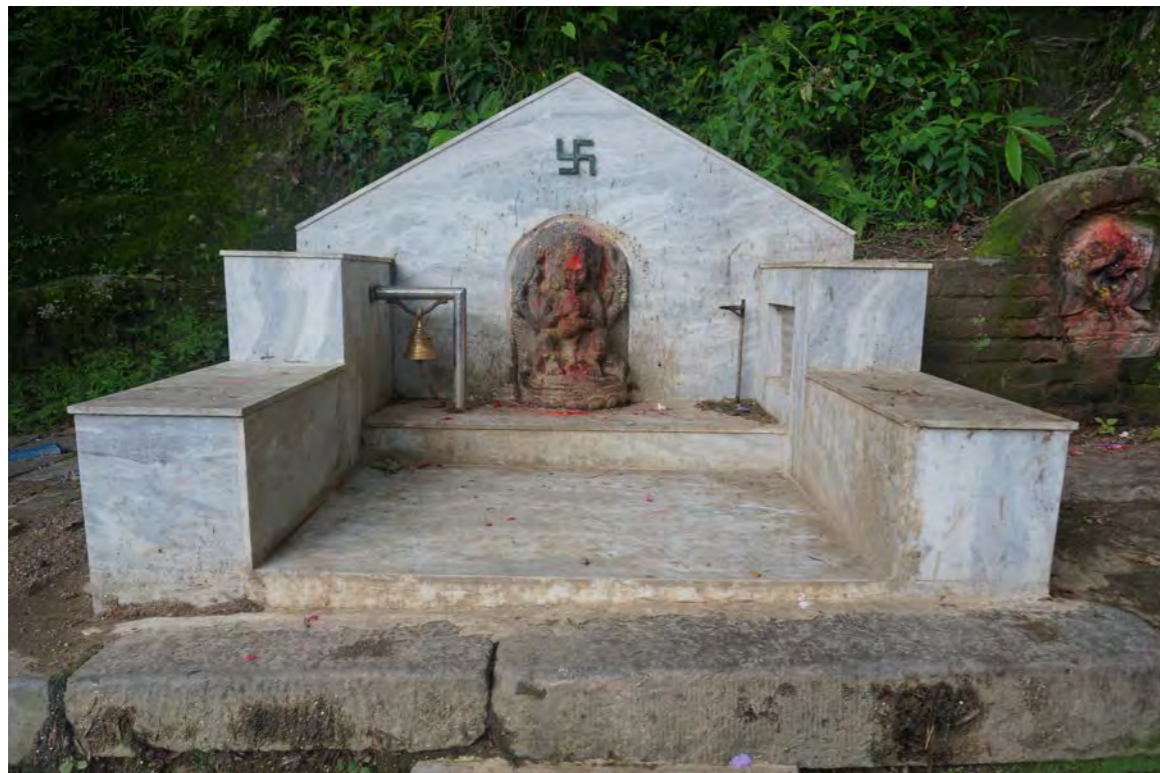
15b OPEN SHRINE

NUMBER	NAME	DATE A.D.	TPOLOGY	GENERAL DESCRIPTION	PROBLEMS DESCRIPTION	DANGER/ DESTROY
15a	Guardian lions			Two stone lions in either side of the stair.		
15b			Open shrine	Stone idol surrounded by marble clad structure. A bell is hung on a metal support.	Use of modern material in the shrine.	
15c			Open shrine	Stone idol embedded on the wall		
15d	Ganesh temple		Open shrine		No visible damage

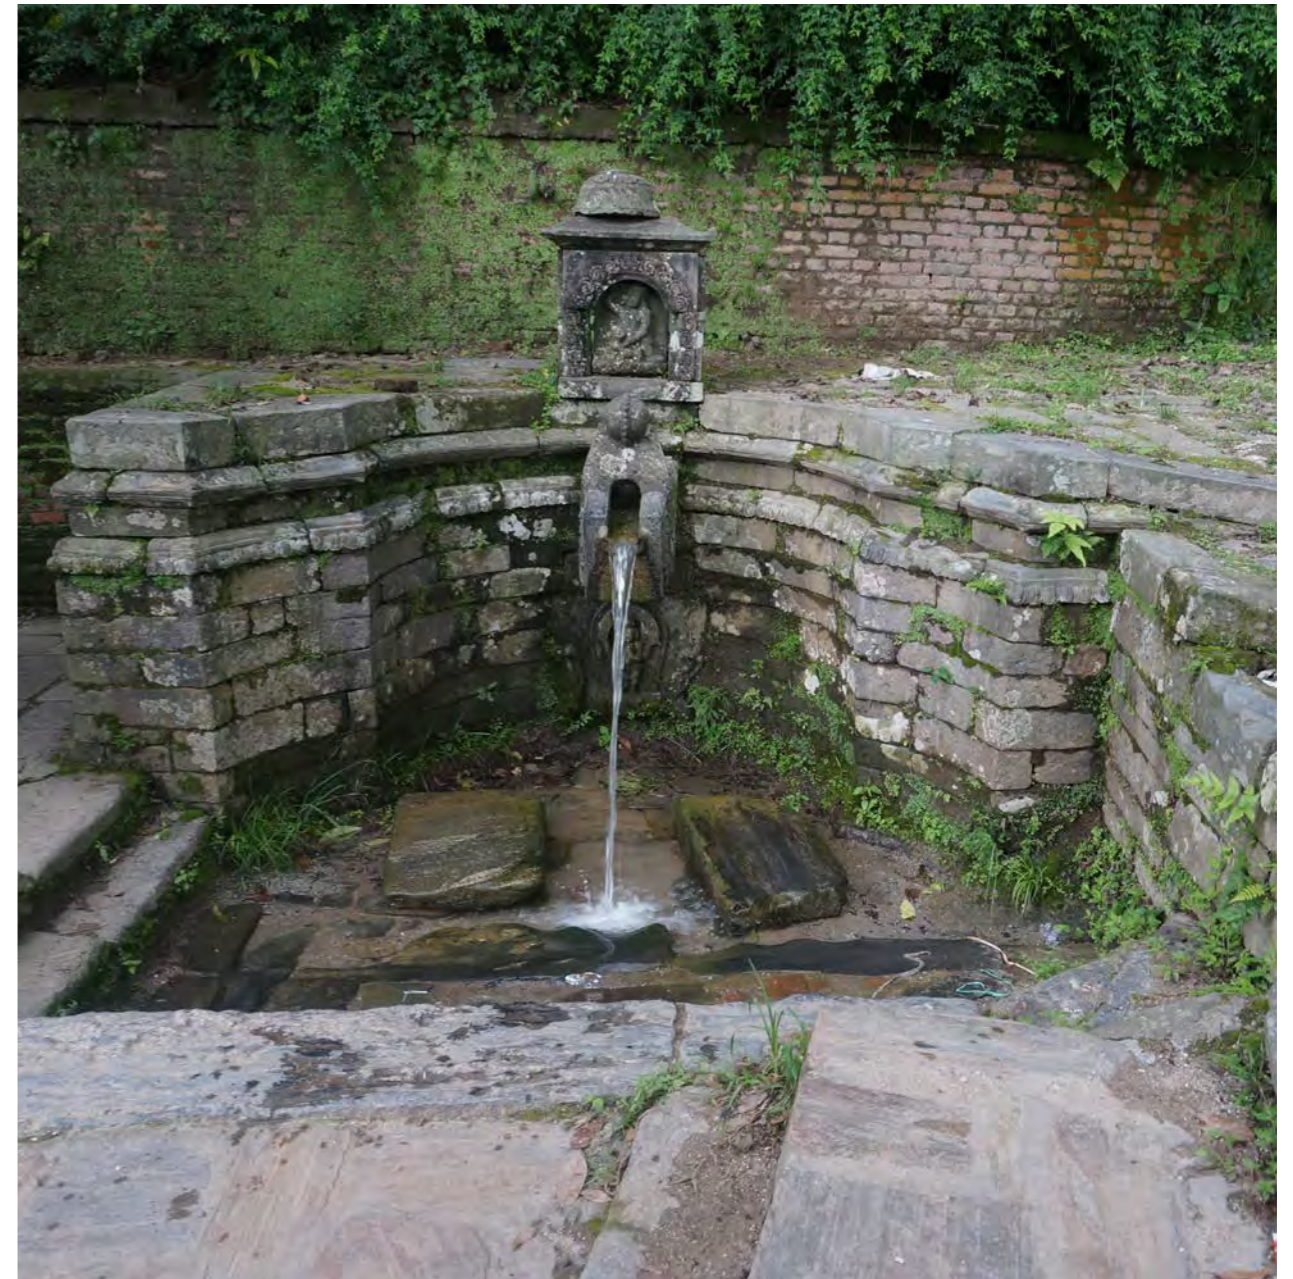
NUMBER	NAME	ESTABLISHED DATE (A.D.)	TYPOLOGY	GENERAL DESCRIPTION	PROBLEMS DESCRIPTION	DANGER/ DESTROY	
15e				Carved stone with inscriptions in it	No visible damage		
15g	Dhunge dhara			Stone structure	Carved struture above the tap is dislocated. Vegetation growth.

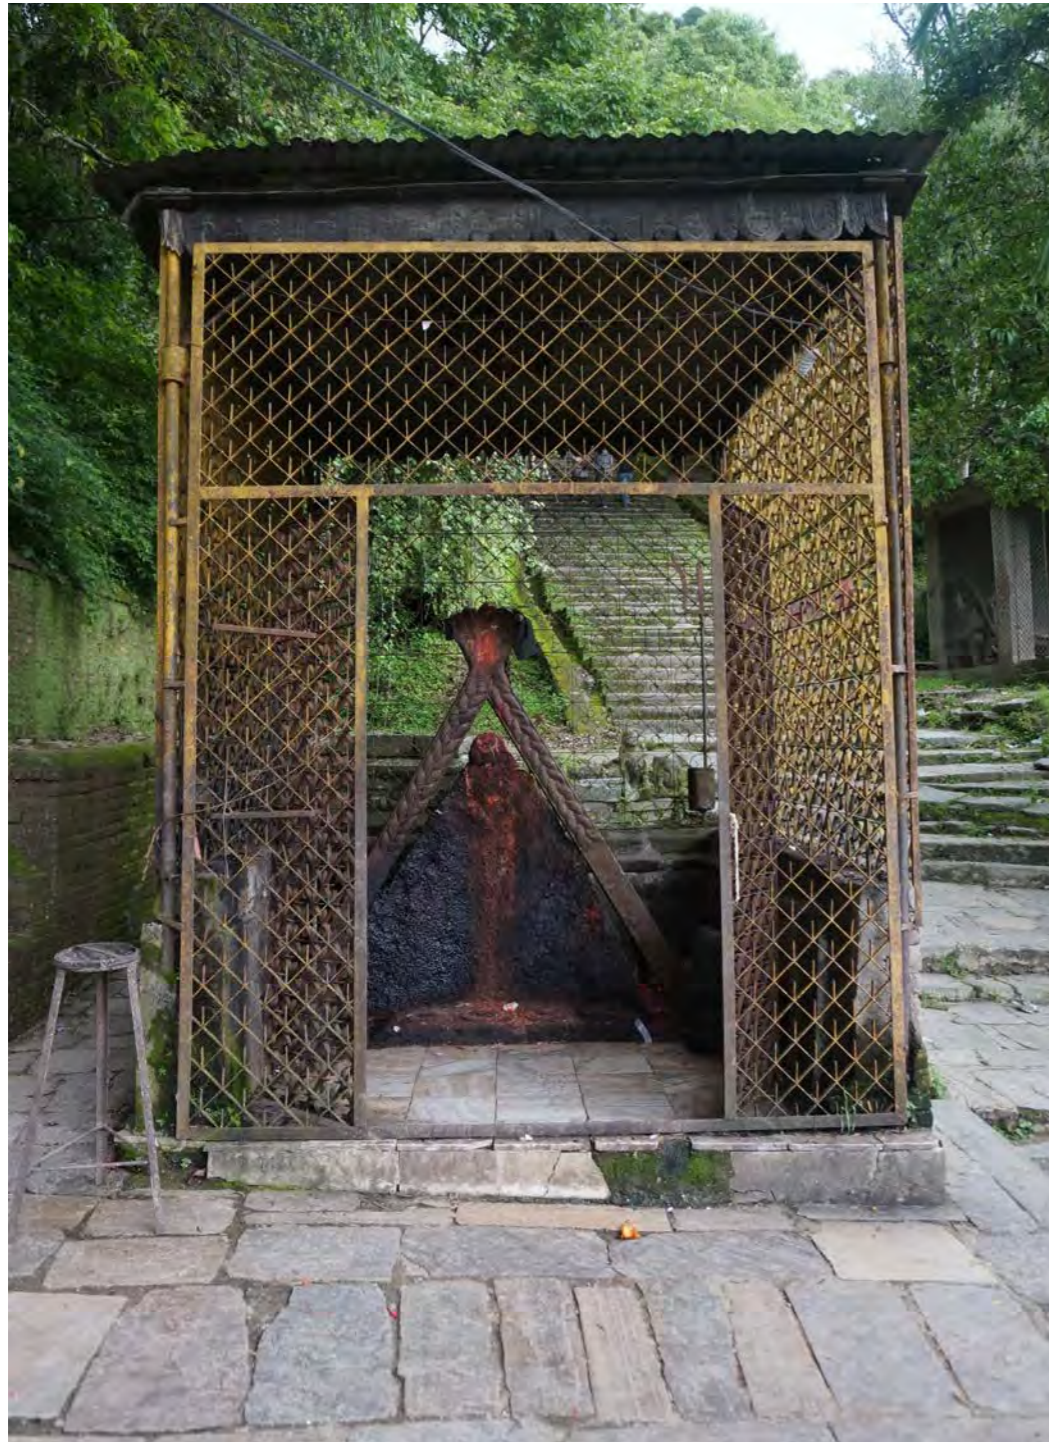
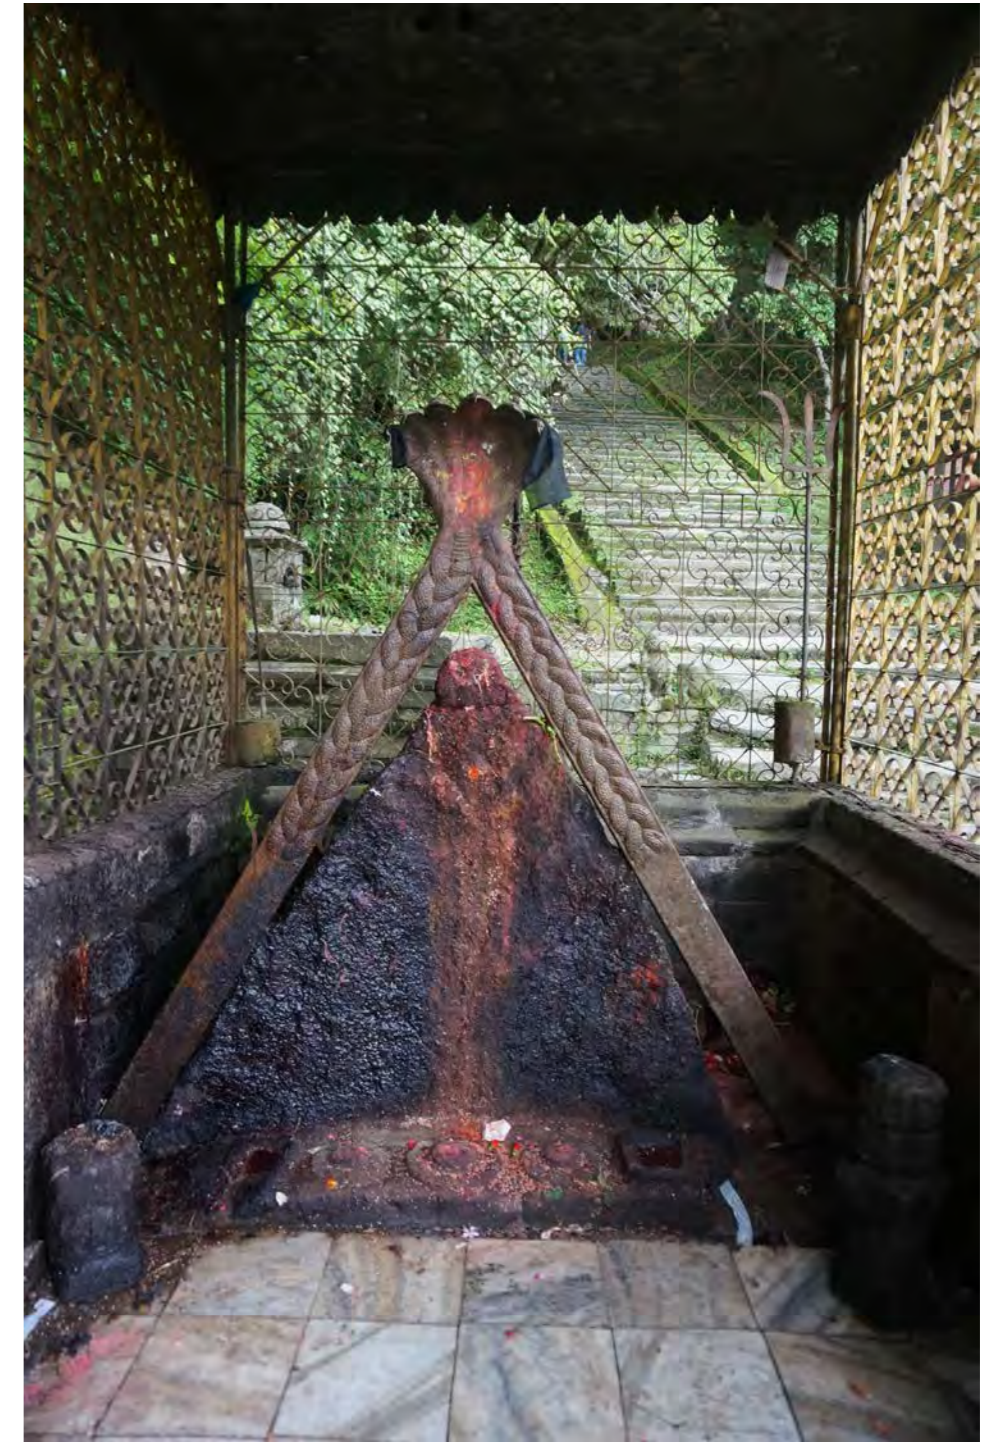
NUMBER	NAME	DATE A.D.	TPOLOGY	GENERAL DESCRIPTION	PROBLEMS DESCRIPTION	DANGER/ DESTROY	
15f				Small temple for sacrifices surrounded by metal fences.	East wall bulging out.
