2015 Earthquake Damage Mapping

Sankhu

October 2015

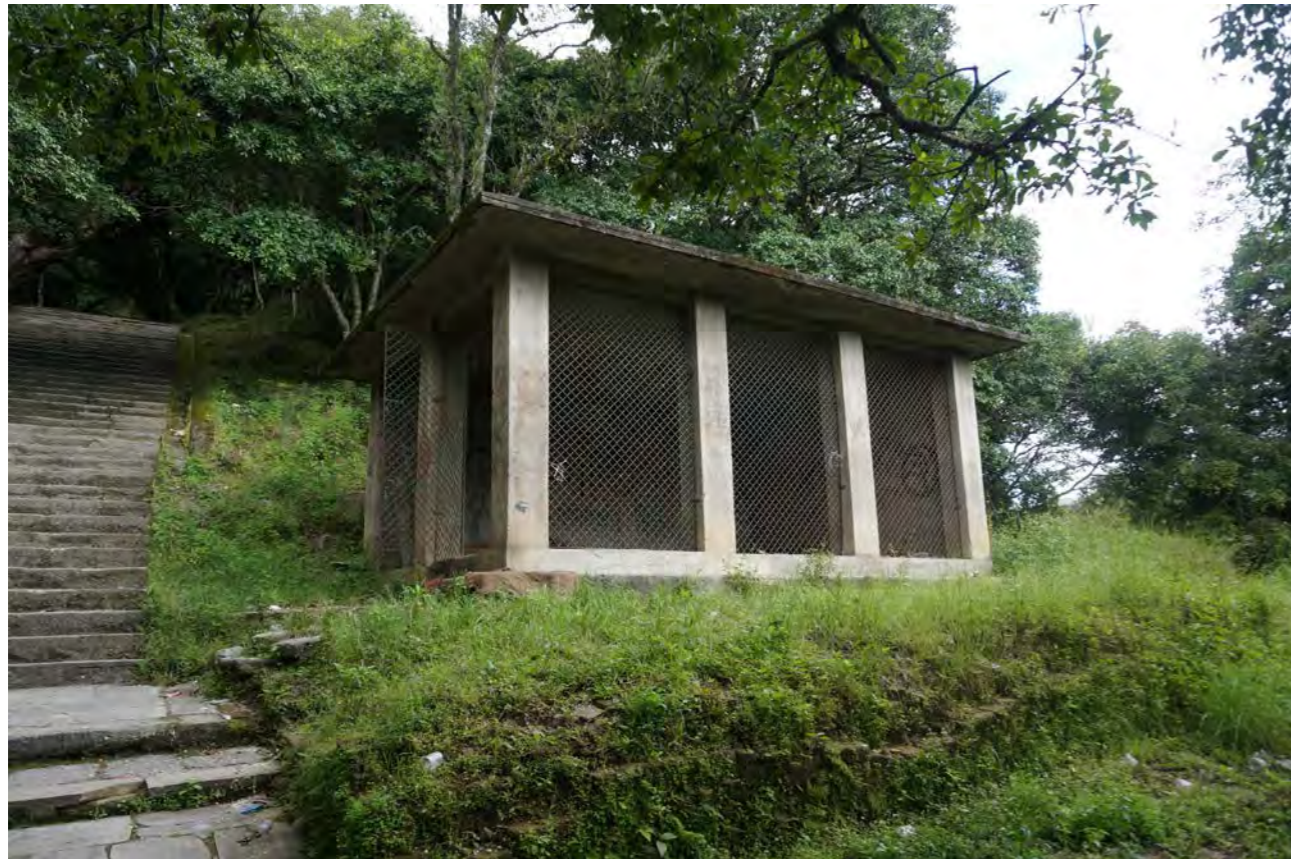
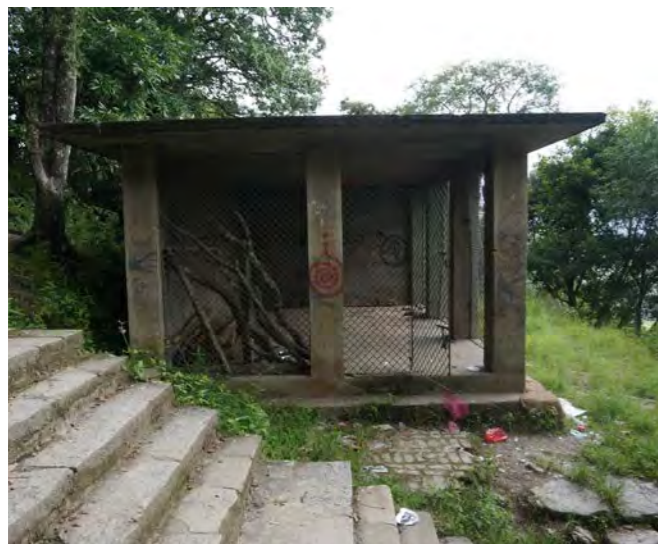
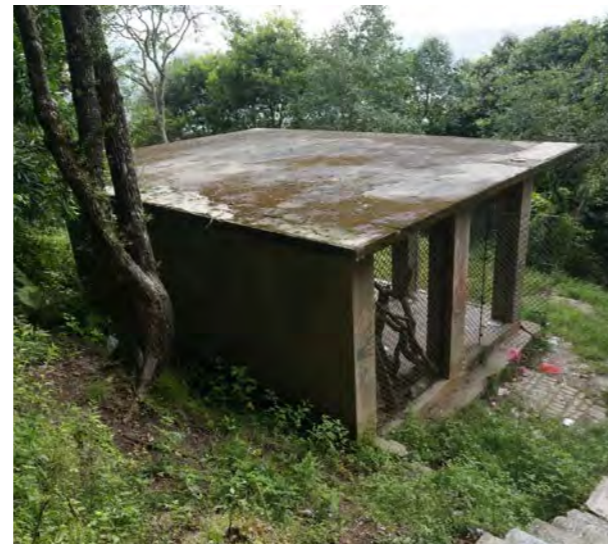
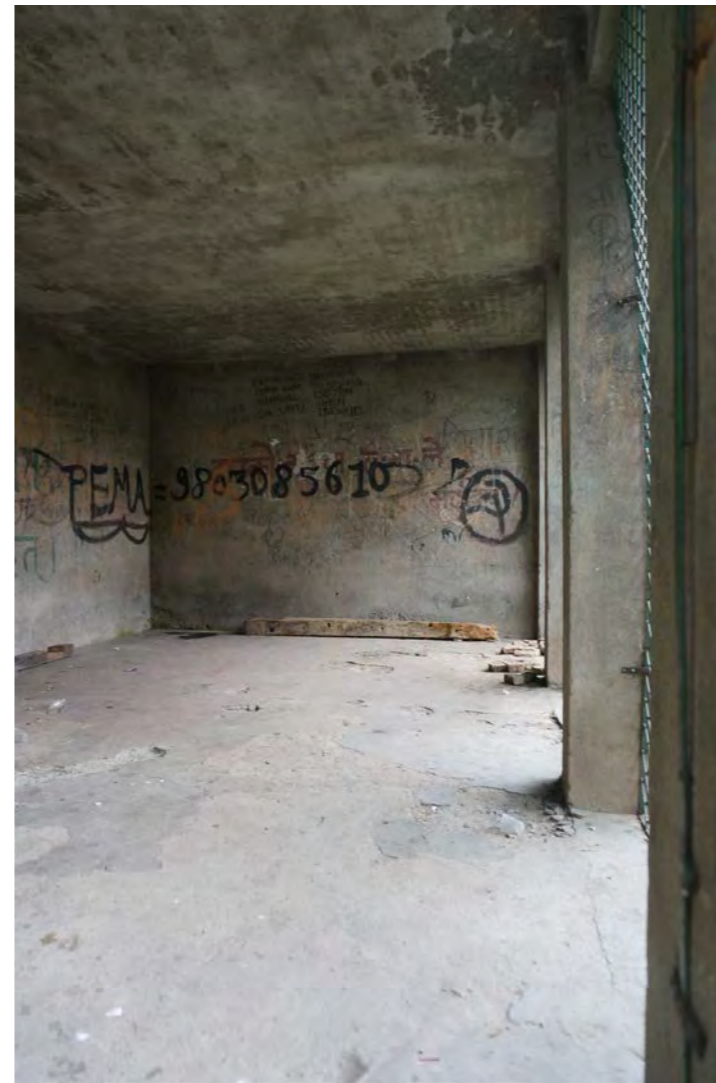
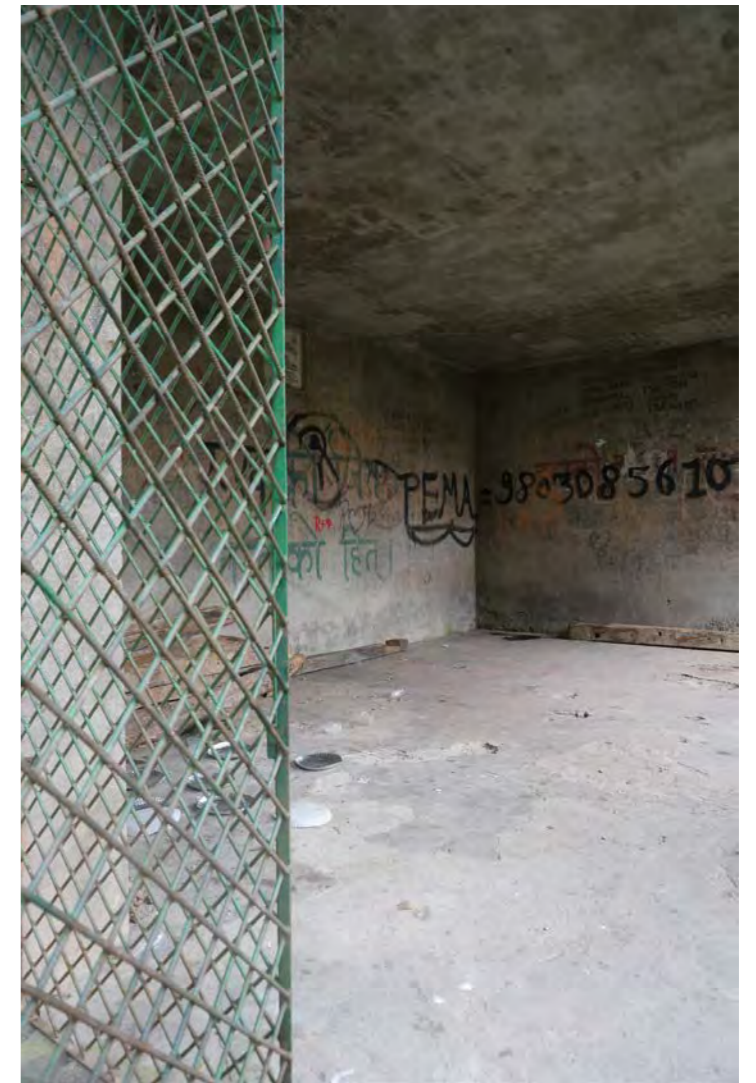
16 PATI

NUMBER	NAME	ESTABLISHED DATE (A.D.)	TYPOLOGY	GENERAL DESCRIPTION	PROBLEMS DESCRIPTION	DANGER/ DESTROY	
16			Pati	Small temple for sacrifices surrounded by metal fences.	East wall bulging out.

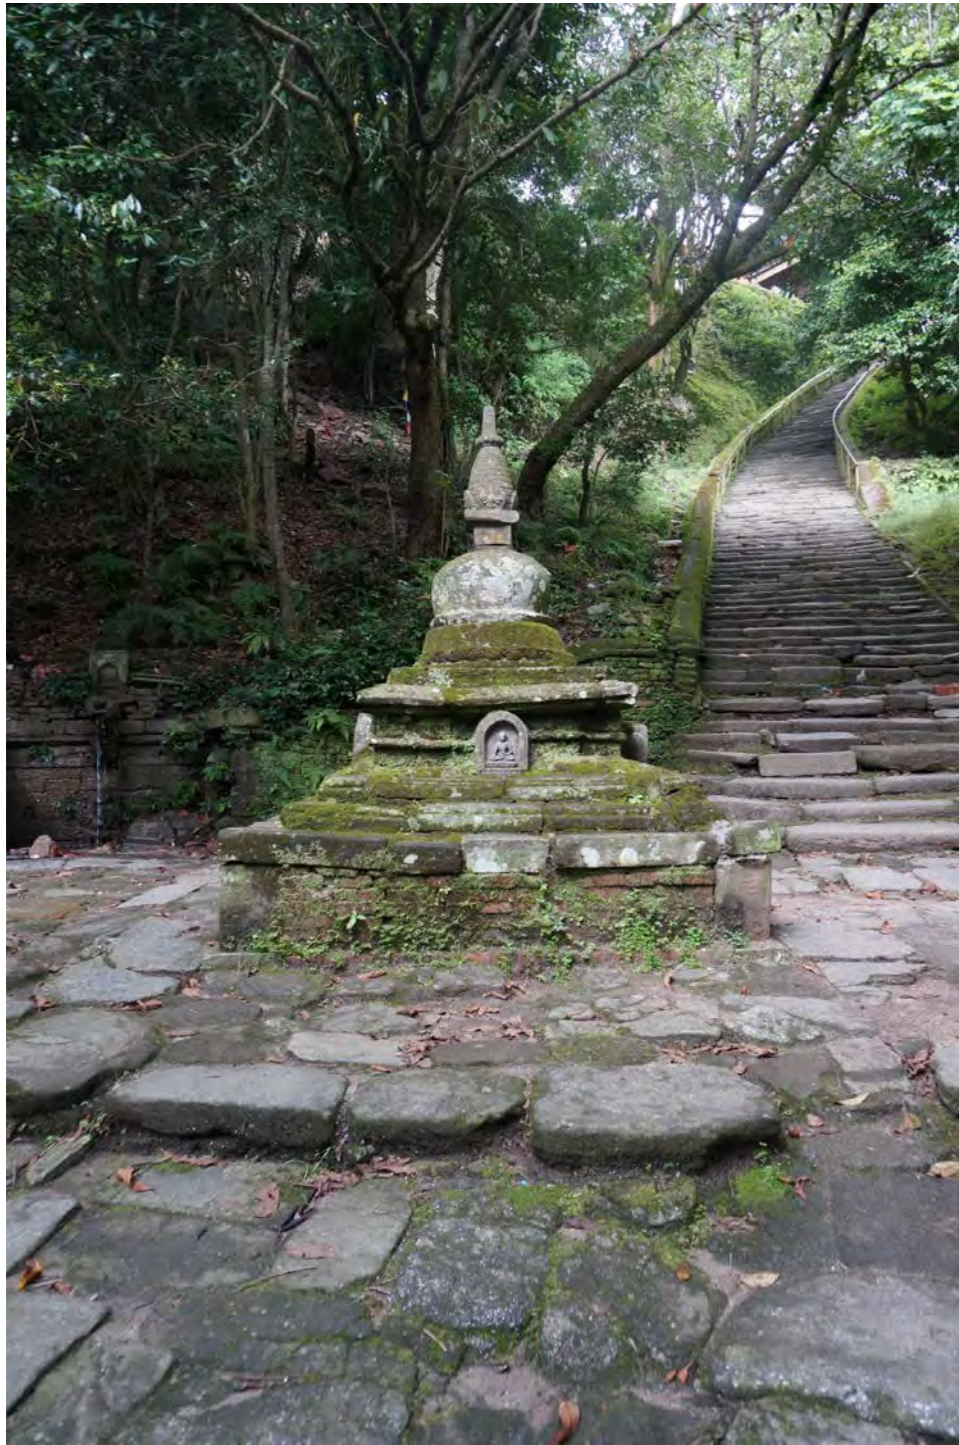
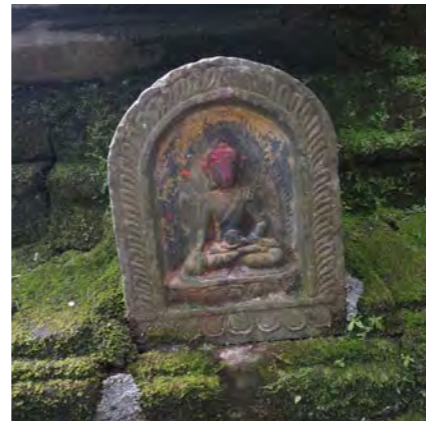
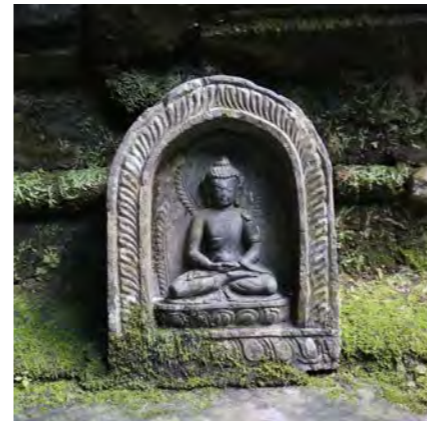
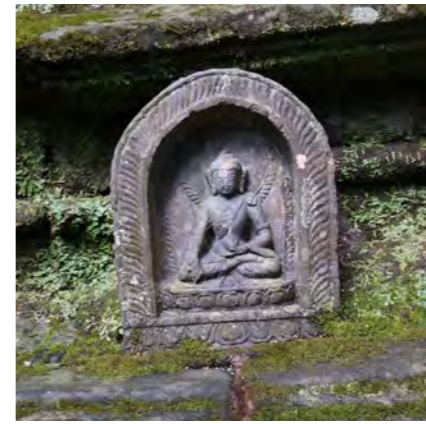
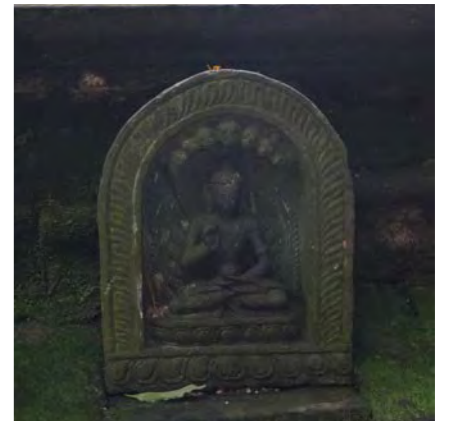
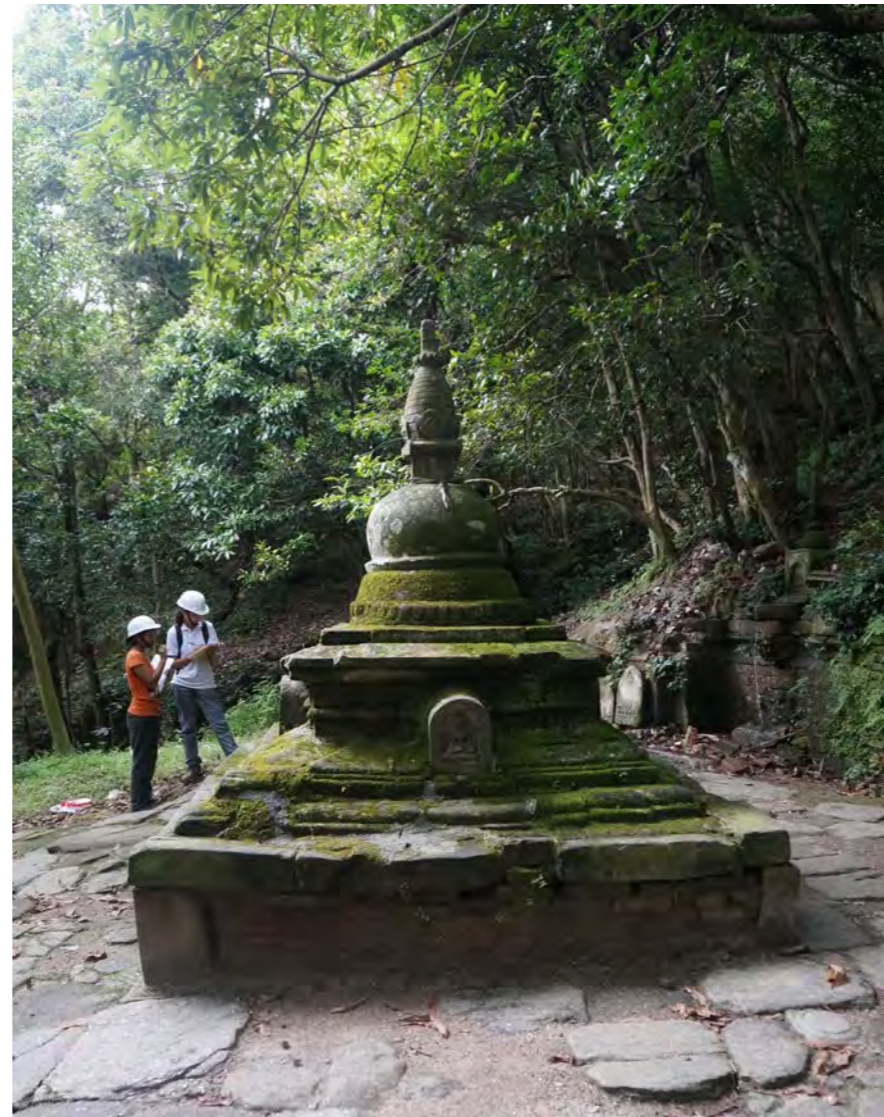
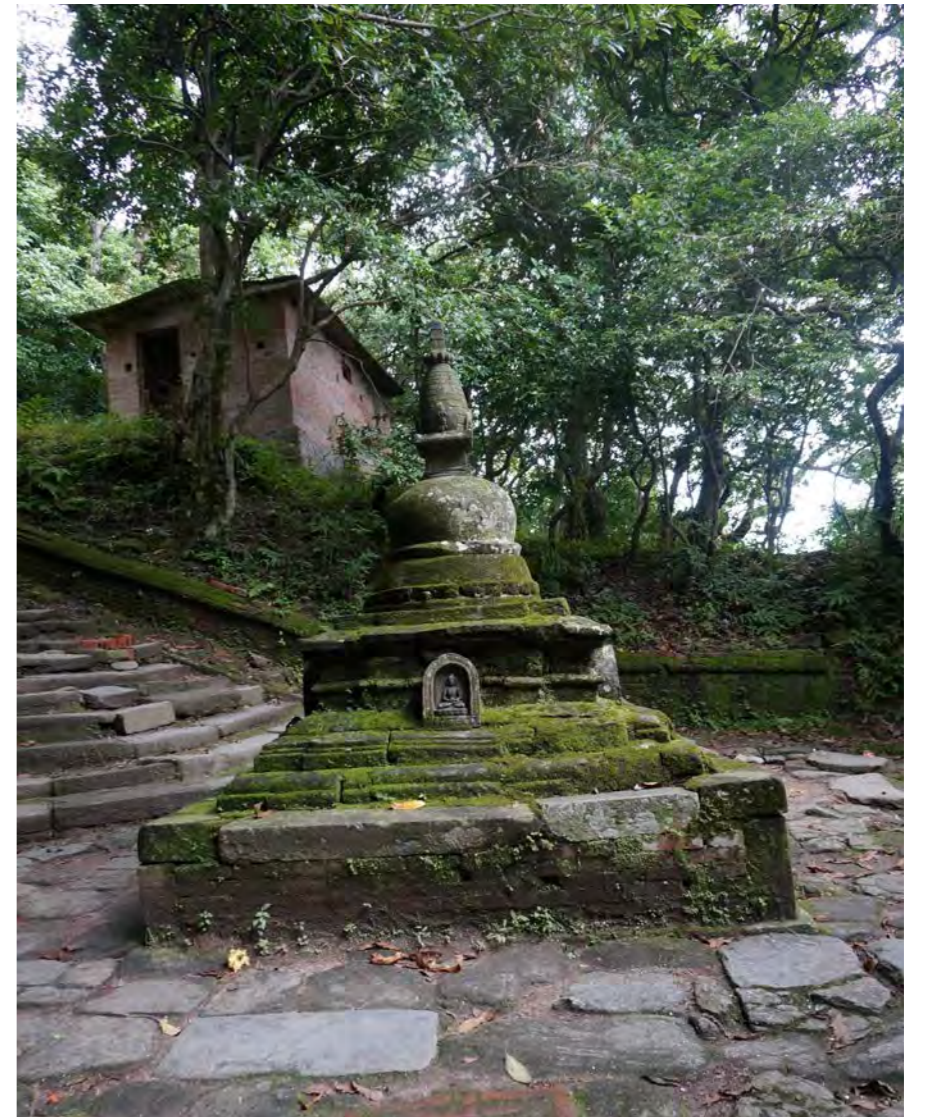
18 CHAITYA

NUMBER	NAME	DATE A.D.	TPOLOGY	GENERAL DESCRIPTION	PROBLEMS DESCRIPTION	DANGER/ DESTROY	
18			Chaitya	Small temple for sacrifices surrounded by metal fences.	Vegetation growth all around.

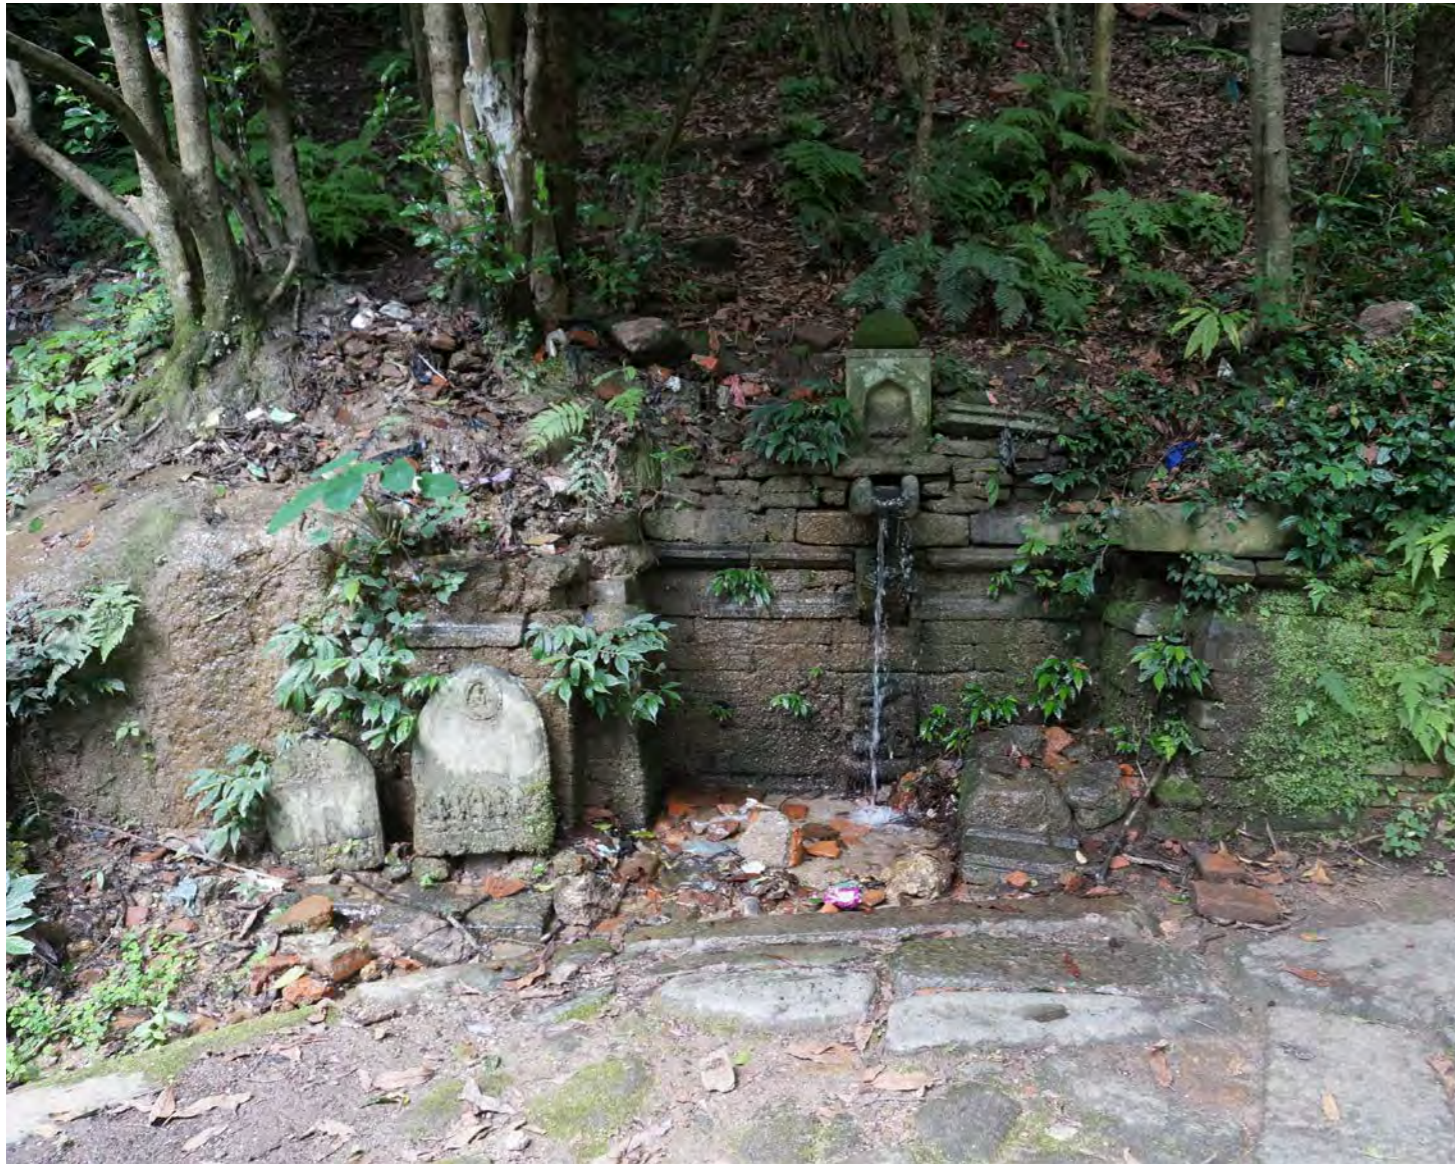
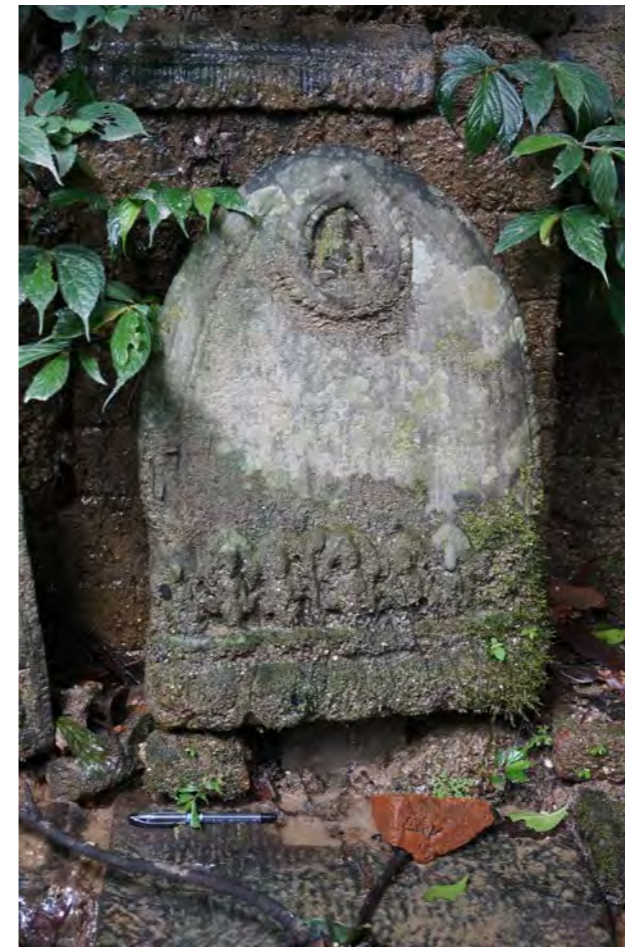
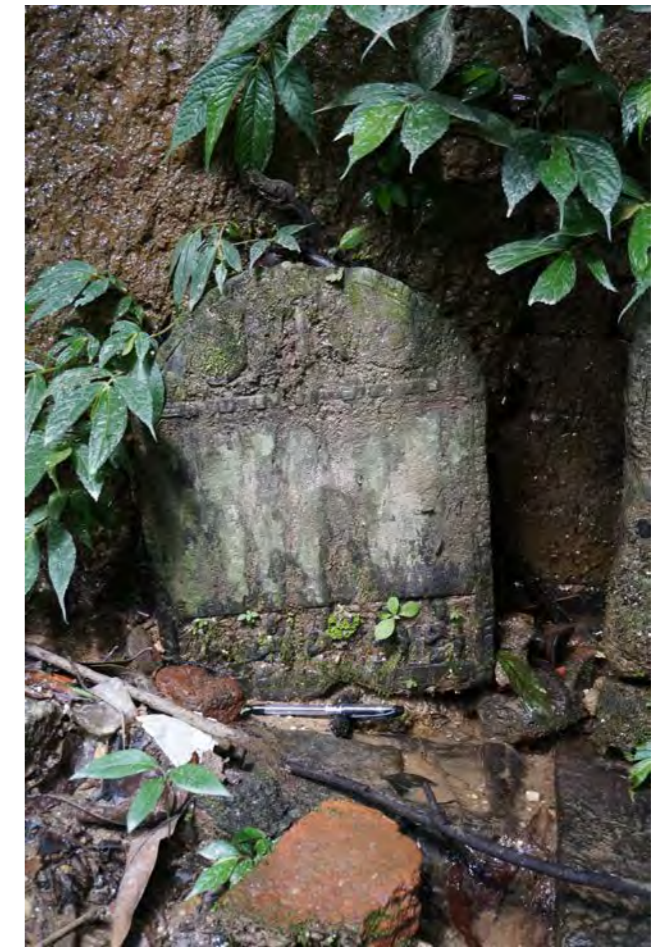
19 HITI

Vegetation growth all around.

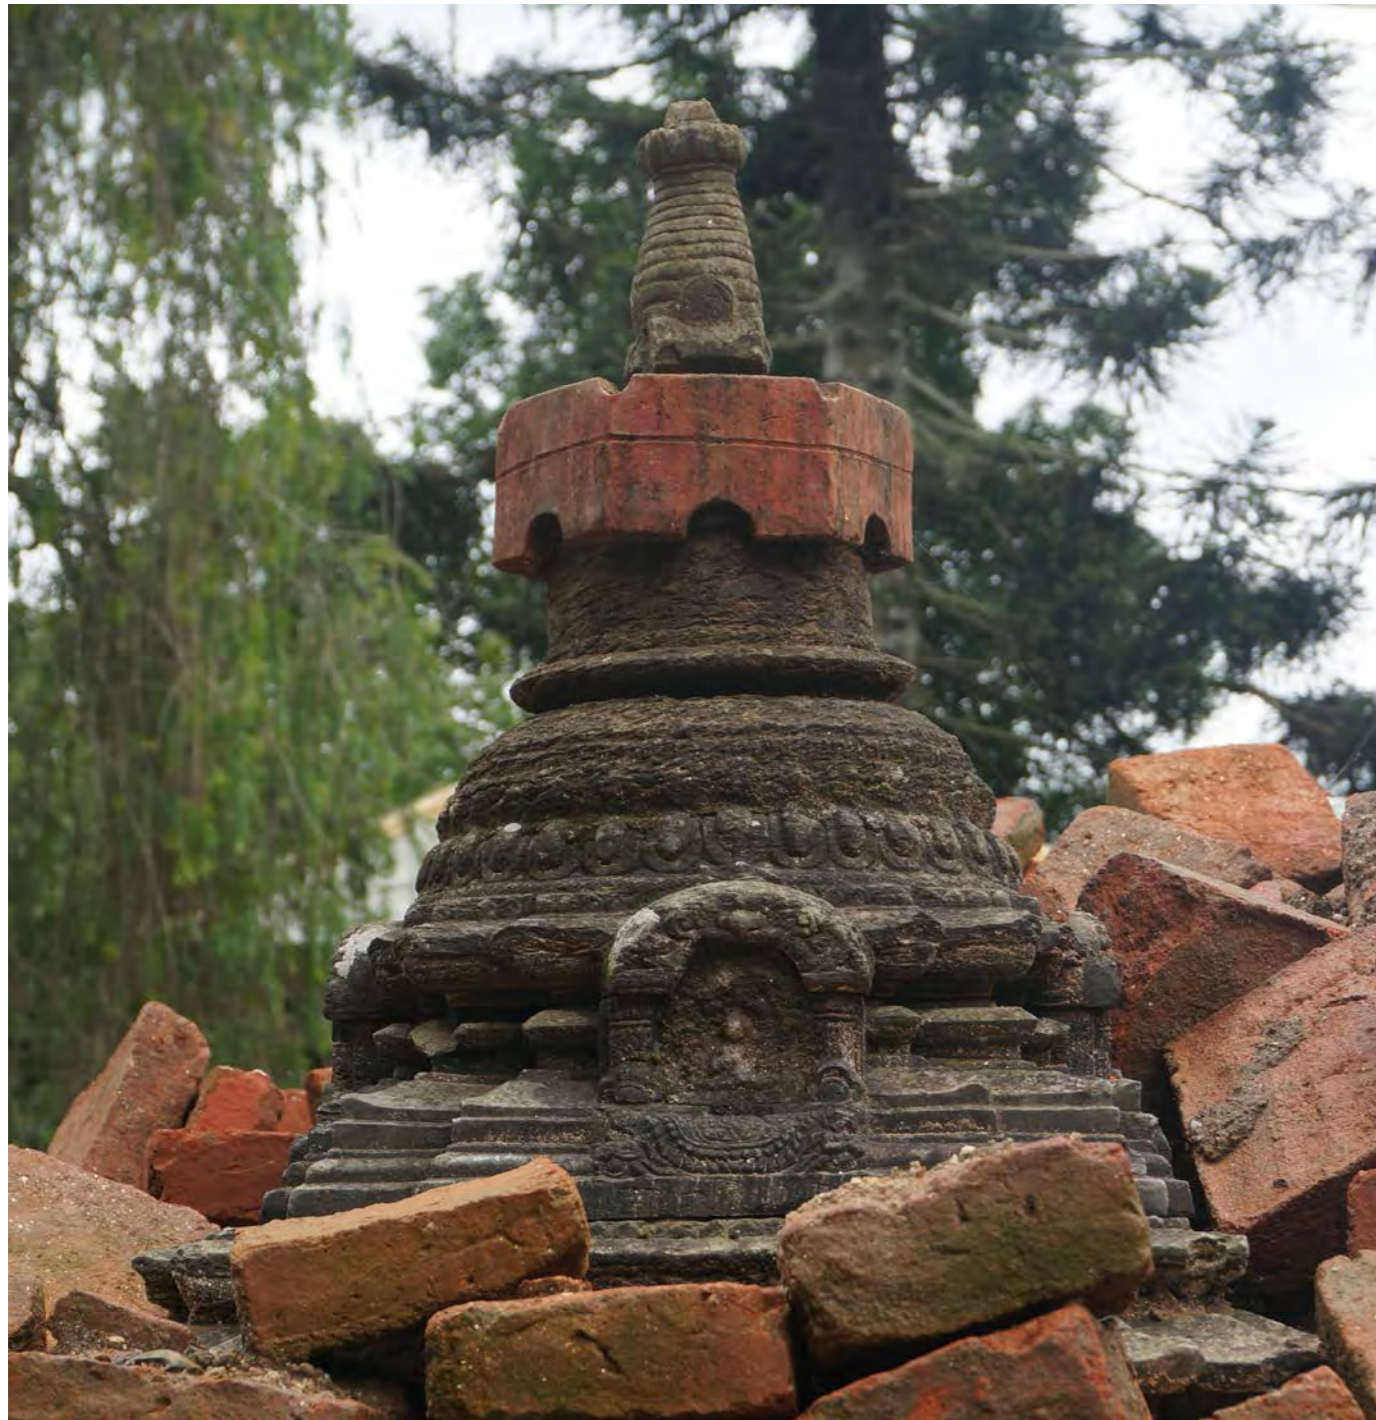
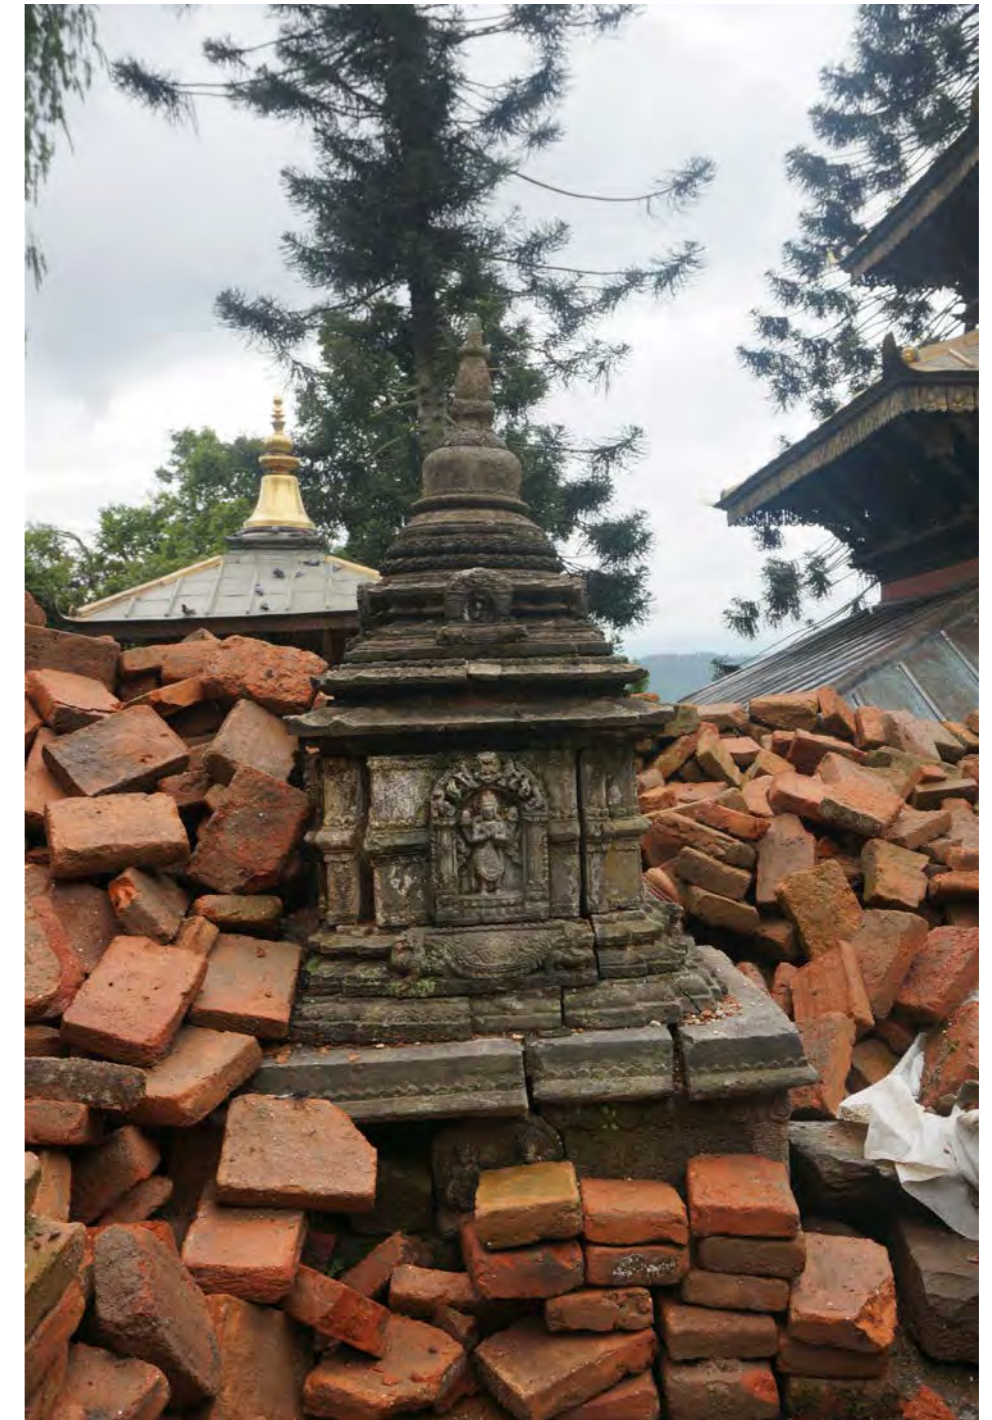
01,02 LICHCHHAVI CHAITYA

NUMBER	NAME	ESTABLISHED DATE (A.D.)	TYPOLOGY	GENERAL DESCRIPTION	PROBLEMS DESCRIPTION	DANGER/ DESTROY
01, 02	Lichchhavi Chaitya		Chaitya		Covered by brick debris of nearby buildings Vegetation growth on plinth Disoriented Stone

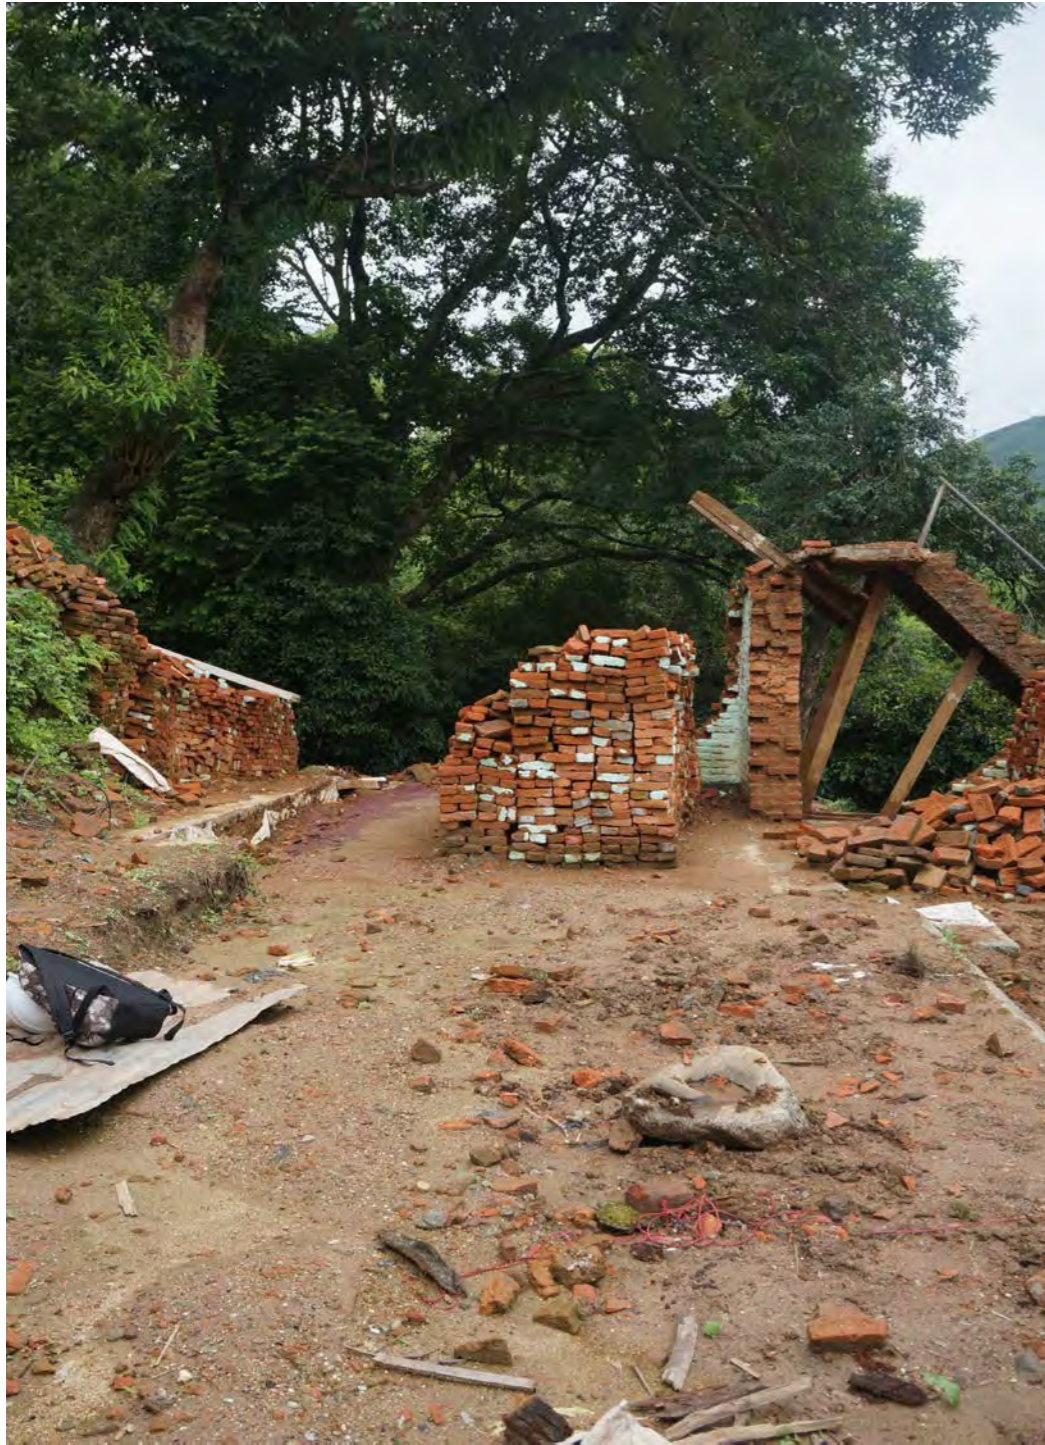
03 MONASTRY, 04 ARMY HOUSE

NUMBER	NAME	DATE A.D.	TYOLOGY	GENERAL DESCRIPTION	PROBLEMS DESCRIPTION	DANGER/ DESTROY
03			Monastery	Renovated 5-6 years ago.	Totally collapsed	
04			Army House		Totally collapsed Only staircase remaining	
05			Idol	Ganesh idol on wall of stairs	Rising damp in adjacent wall Saved by metal grill

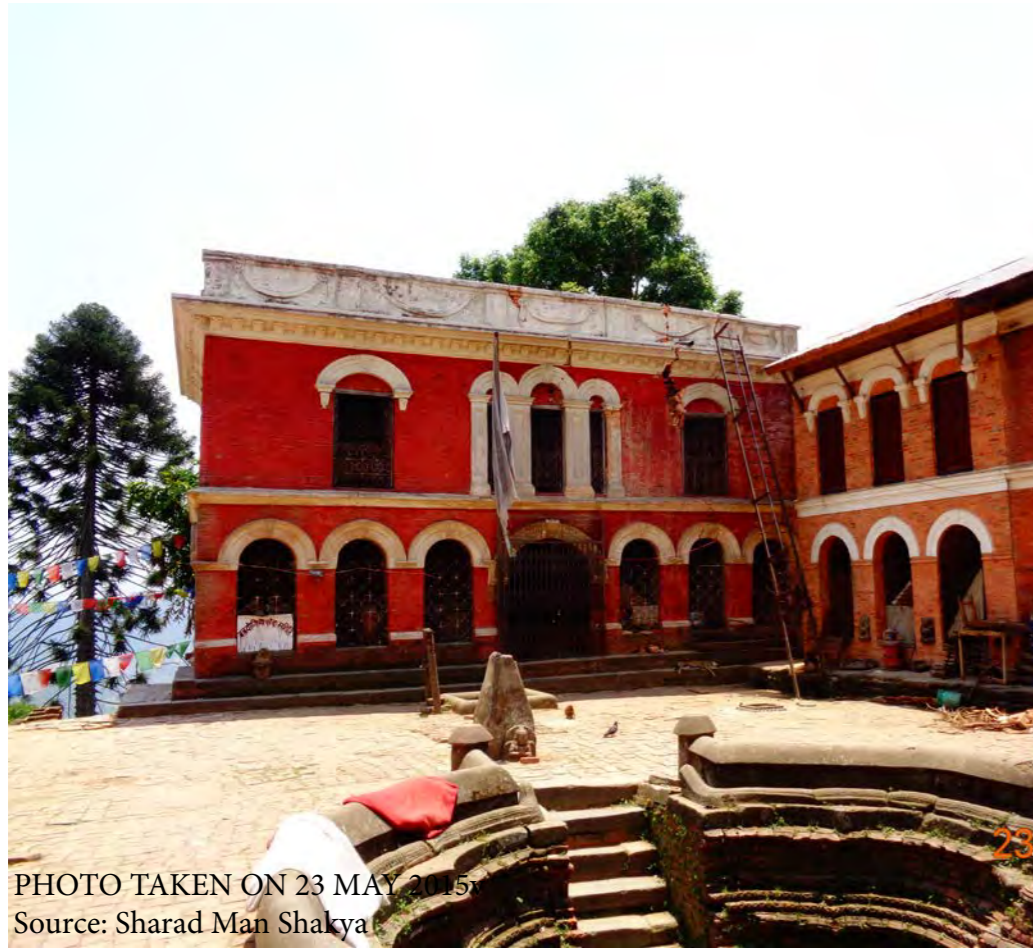
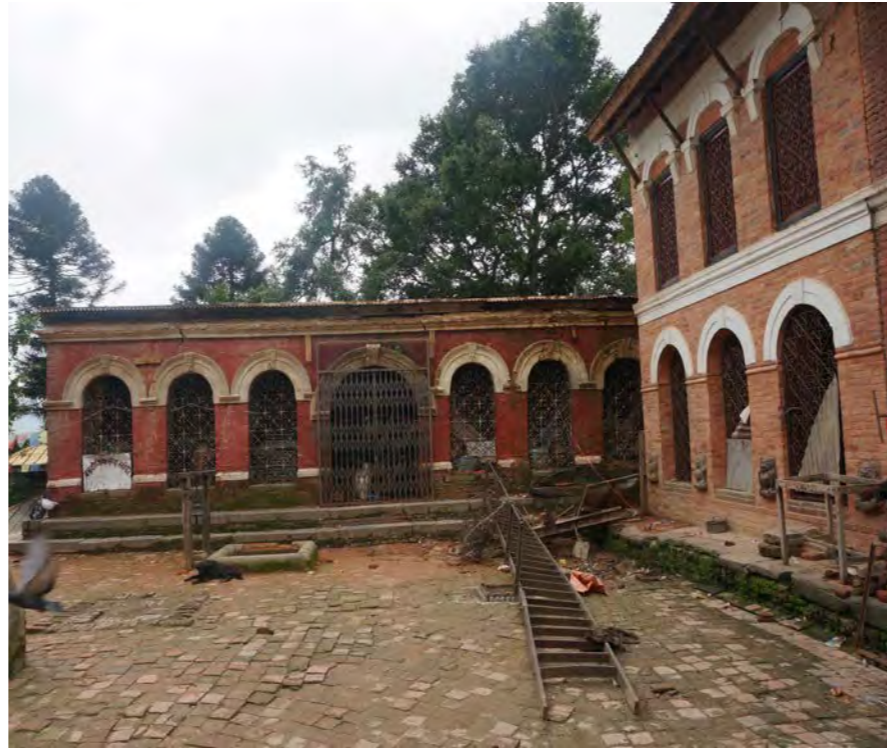
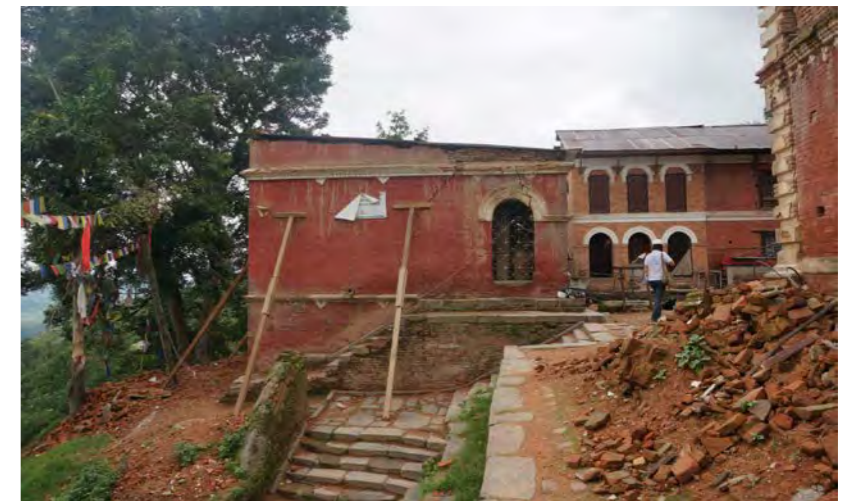
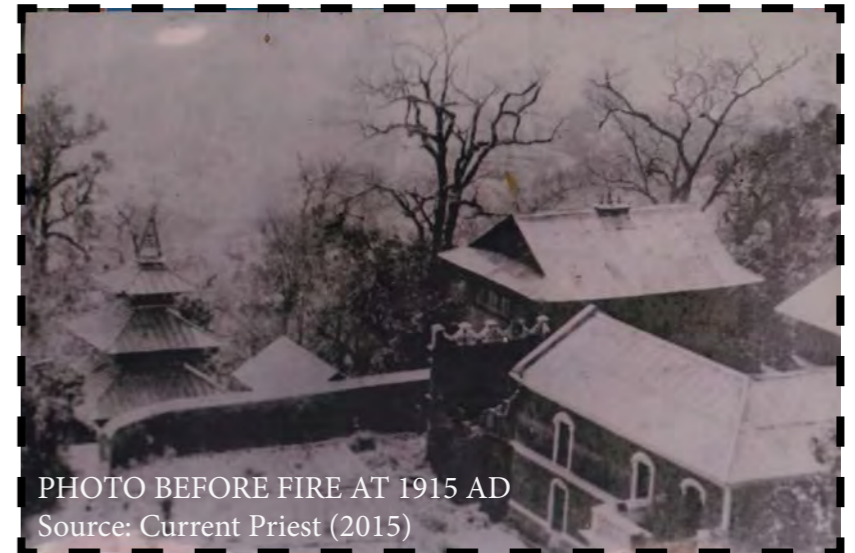
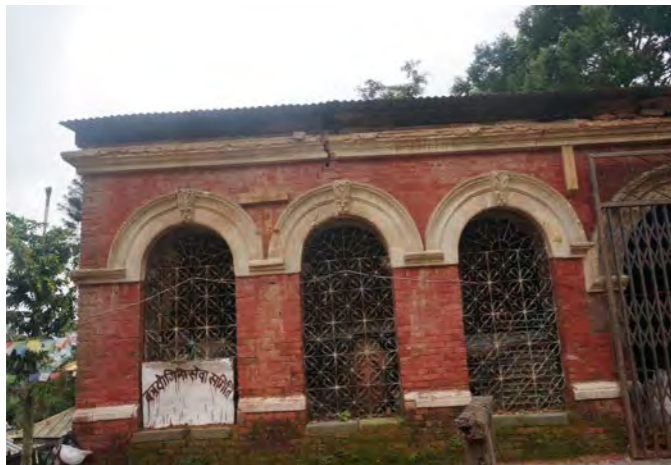
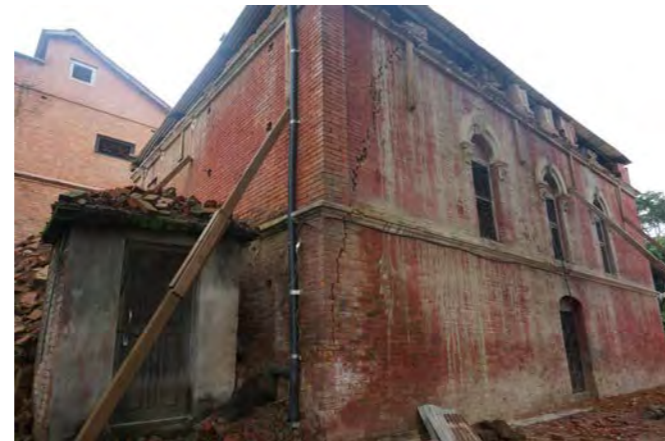
06 MHASUKHWA MAJU

NUMBER	NAME	ESTABLISHED DATE (A.D.)	TYPOLOGY	GENERAL DESCRIPTION	PROBLEMS DESCRIPTION	DANGER/ DESTROY
06	Mhasukhwa Maju		Temple	Brick structure G+1+basement Damaged by 1915 A.D. (1975 B.S.) fire and reconstructed in 1916 A.D.	Upper floor demolished Major vertical cracks on N-wall Rising Damp W-side filled with rubbles

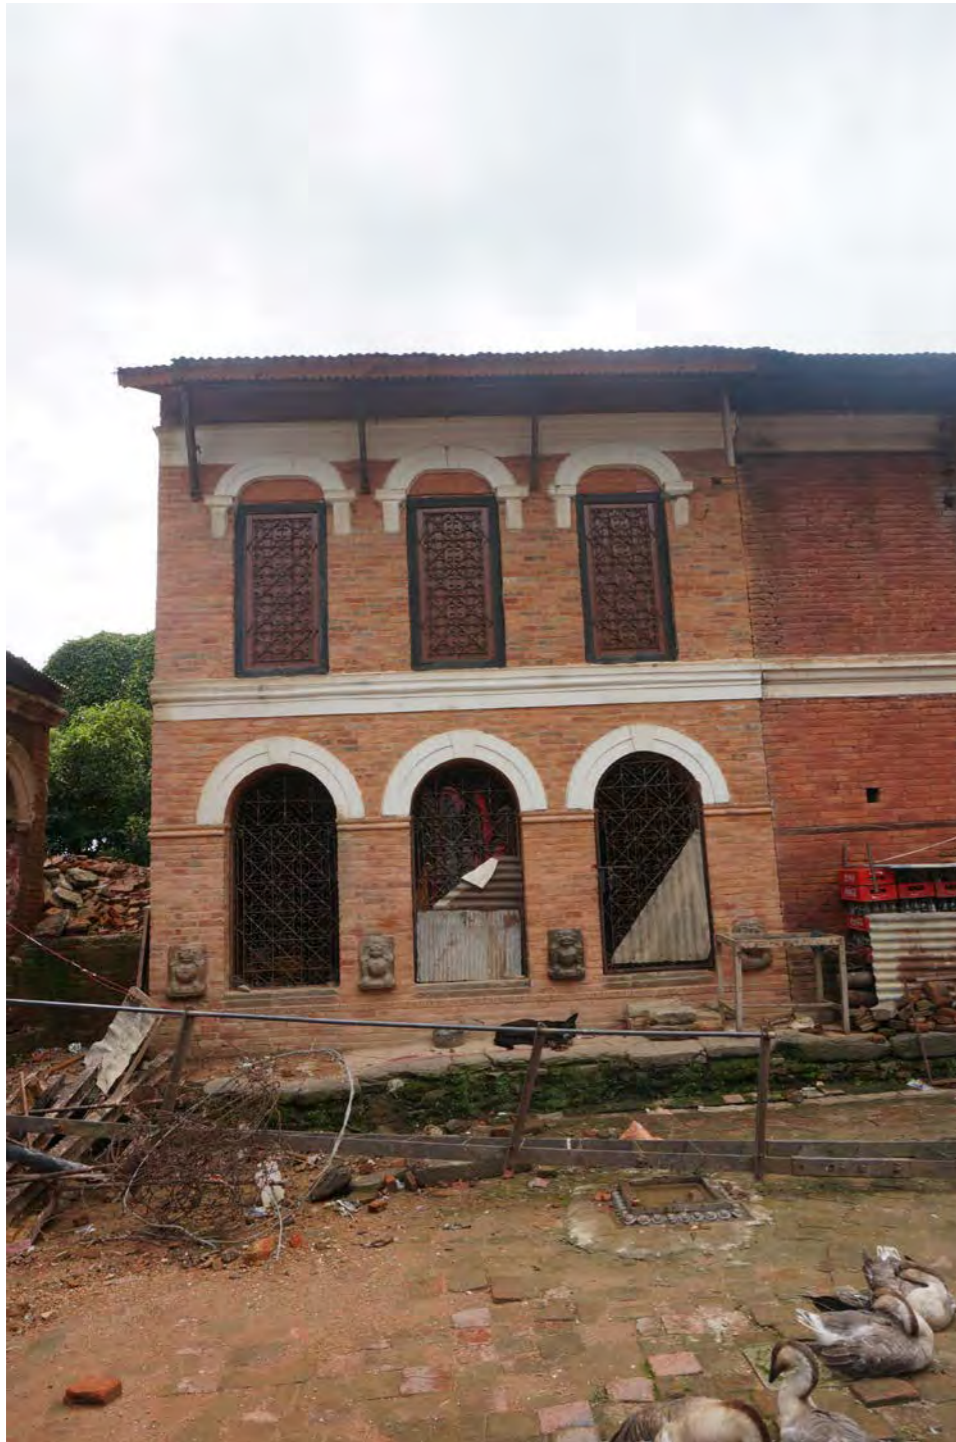
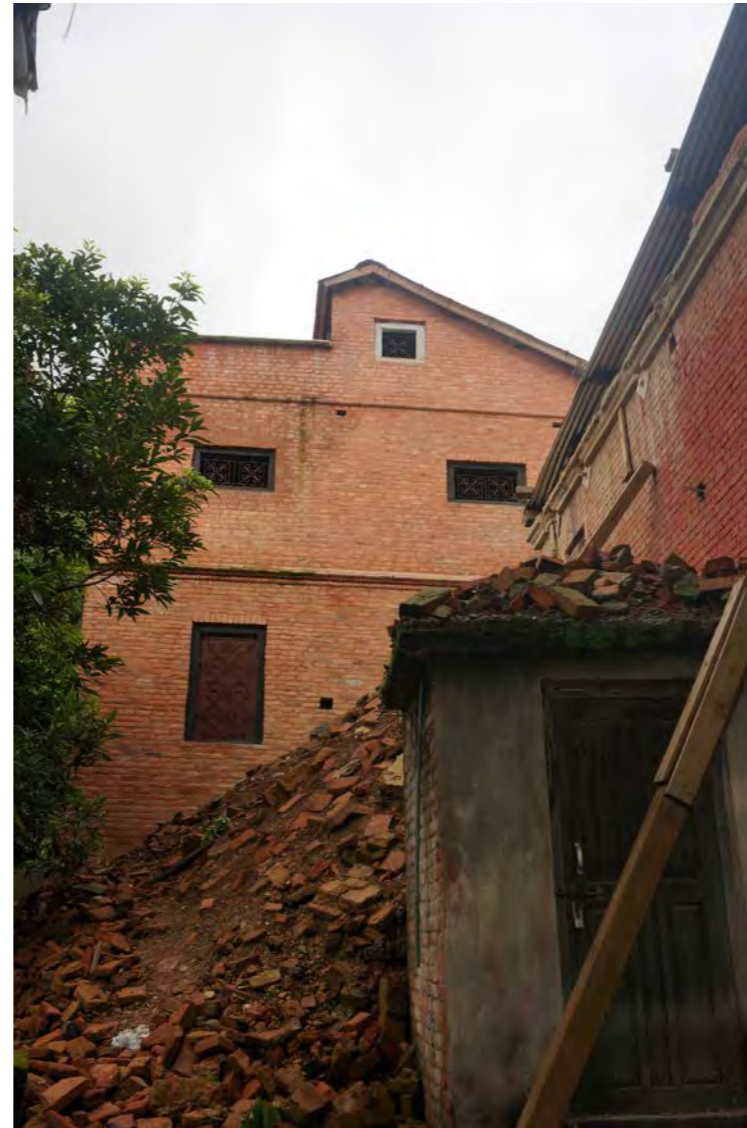
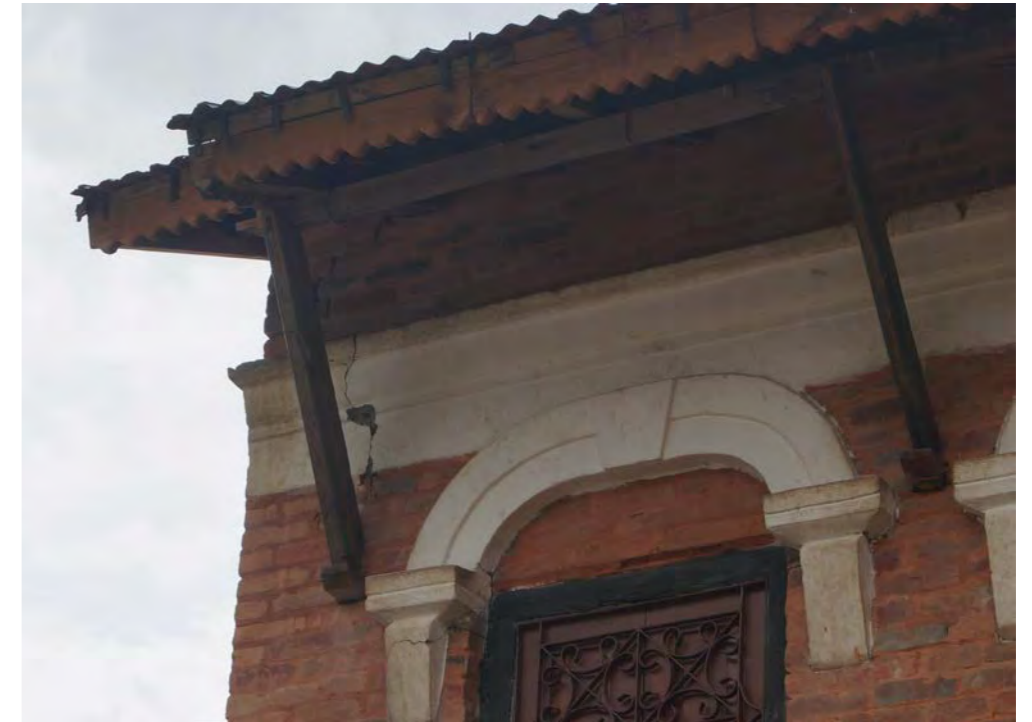
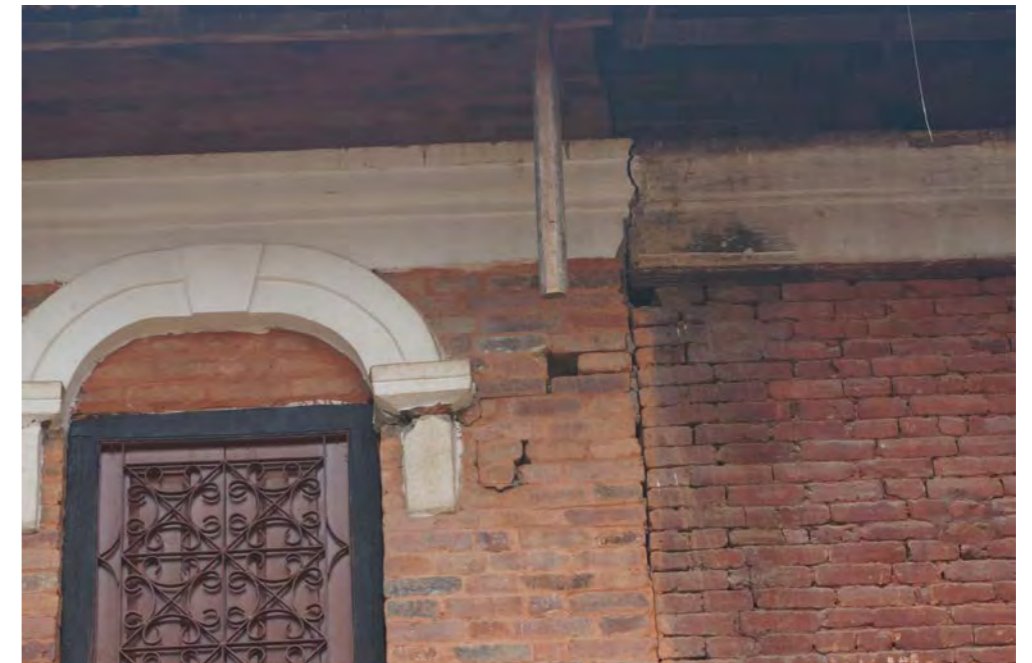
07 BHWAY CHEN

NUMBER	NAME	DATE A.D.	TYPOLOGY	GENERAL DESCRIPTION	PROBLEMS DESCRIPTION	DANGER/ DESTROY	
07	Bhway Chen		Sattal	G+1.5	Rising damp on E-side Top floor Northern and Southern walls collapsed Vertical cracks all over on 1st floor S-side broken down
