2015 Earthquake Damage Mapping

Sankhu

October 2015

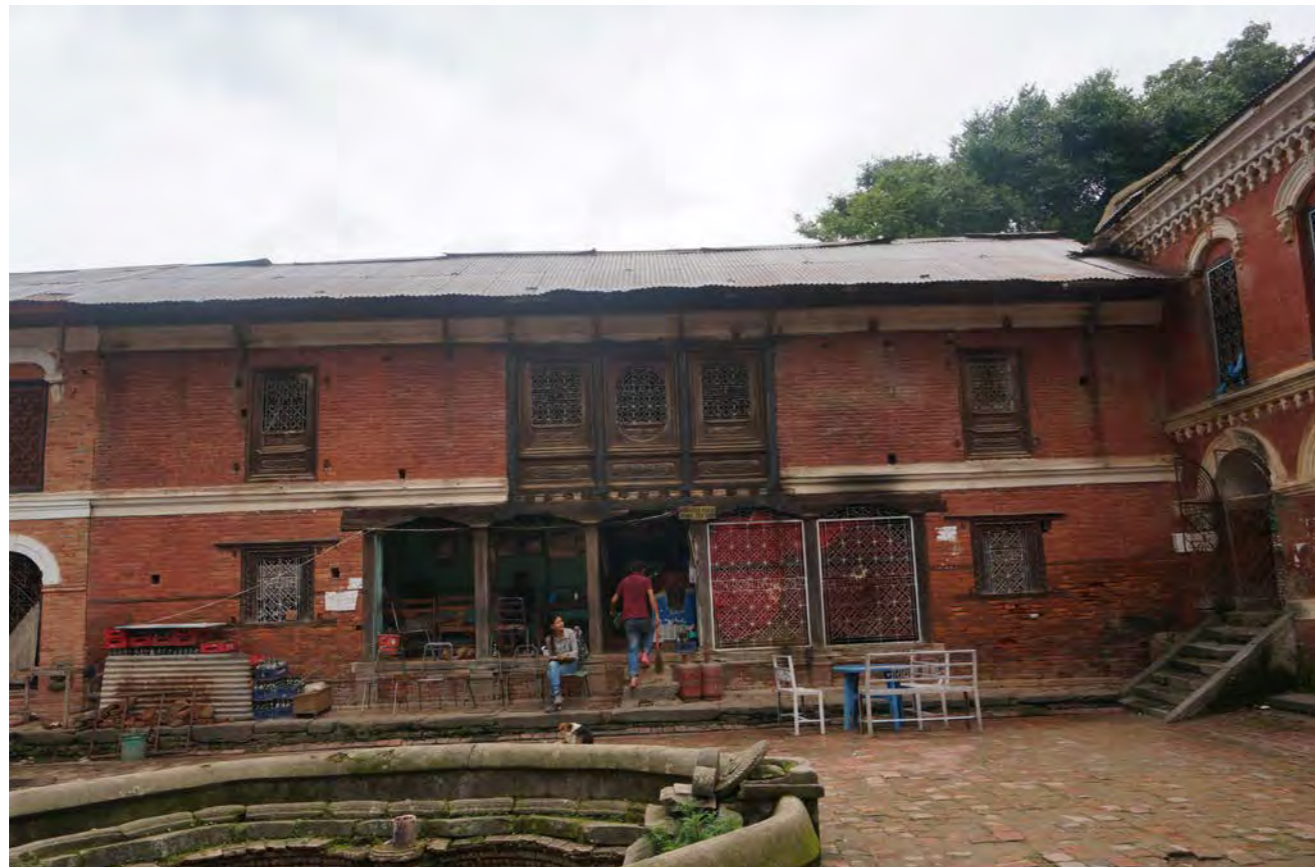
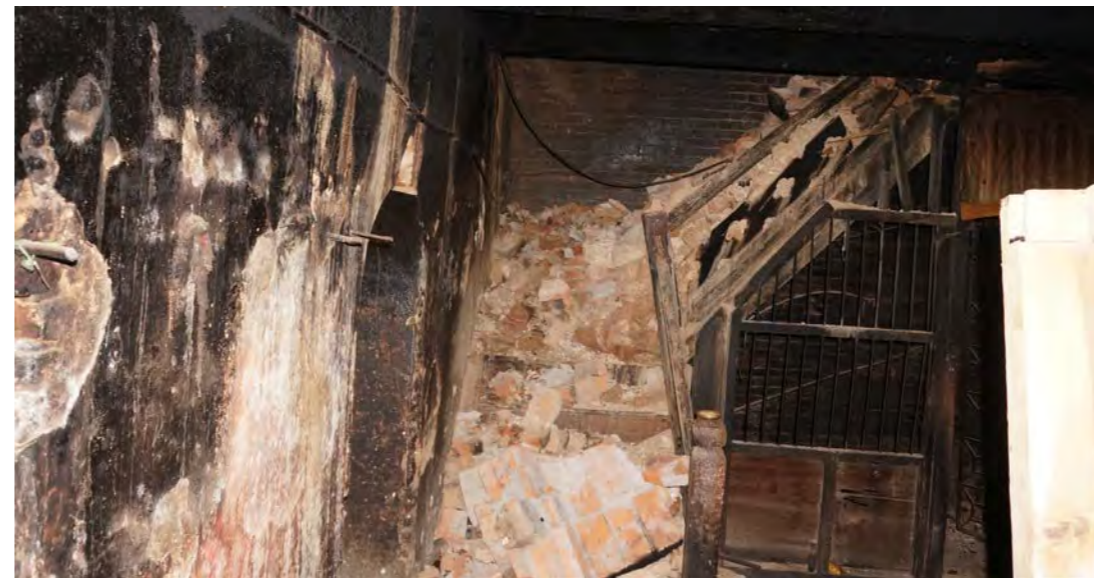
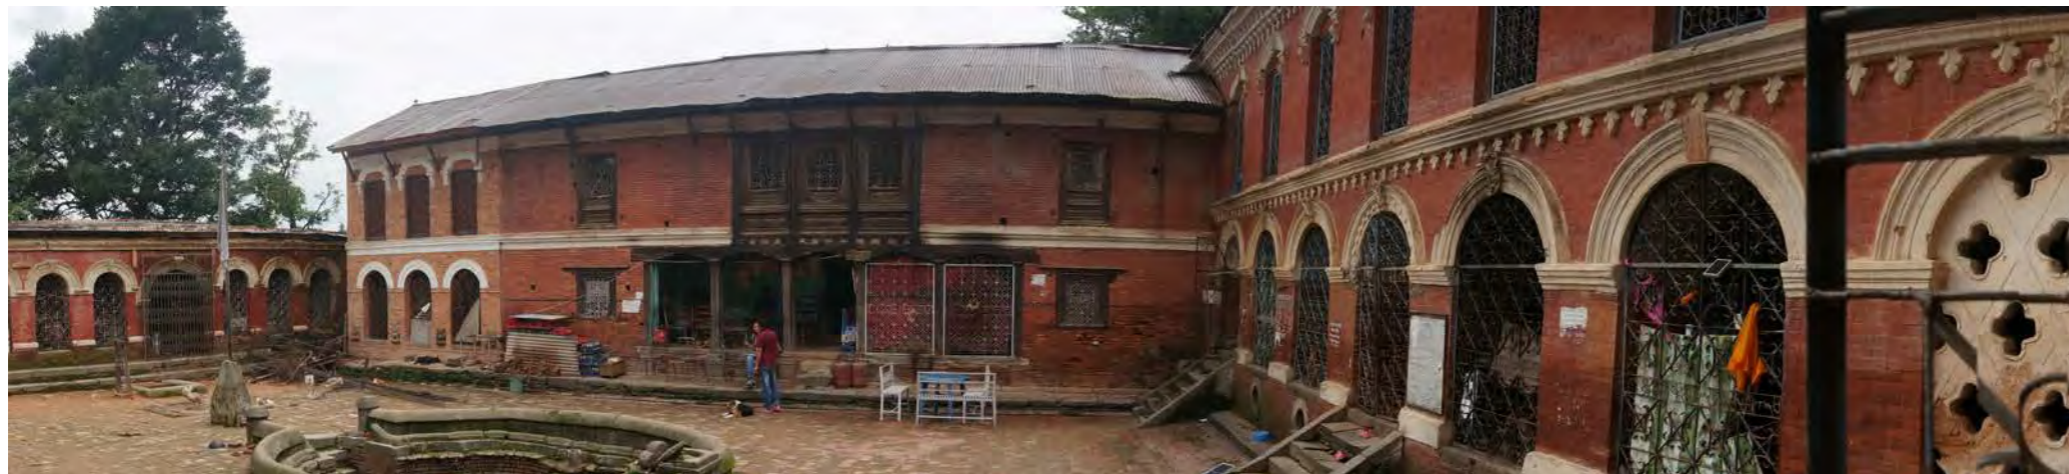
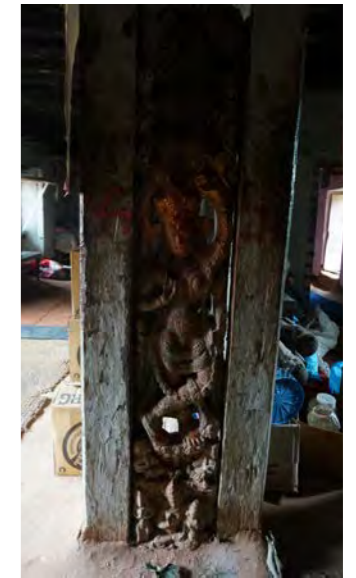
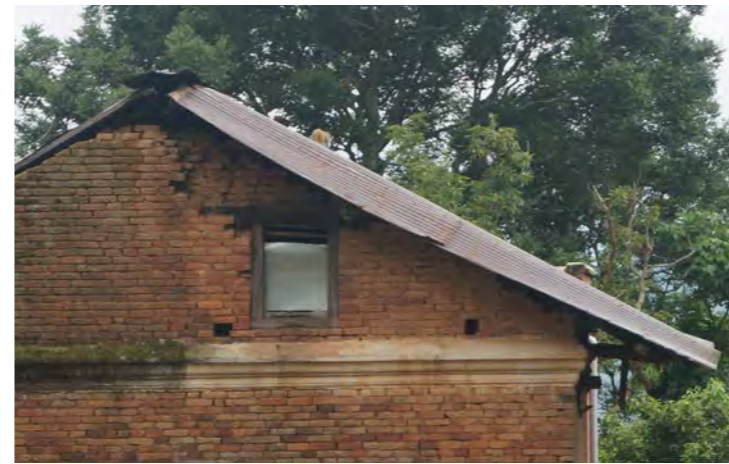
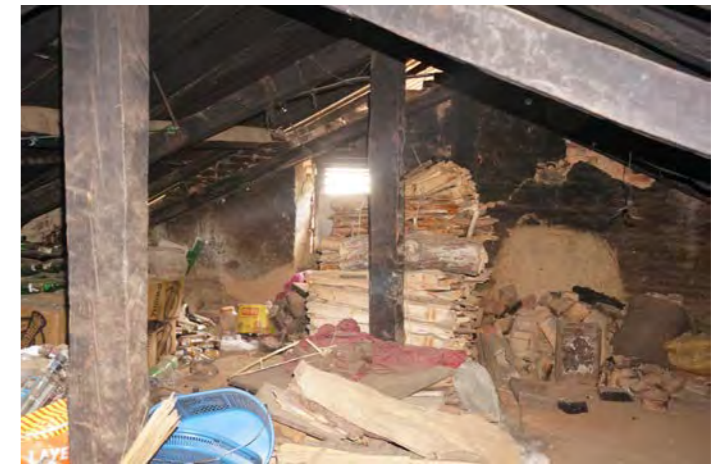
08 BHWAY CHEN

NUMBER	NAME	ESTABLISHED DATE (A.D.)	TYPOLOGY	GENERAL DESCRIPTION	PROBLEMS DESCRIPTION	DANGER/ DESTROY	
08	Kaptan Sata		Sattal	G+1.5 Built by Narayan Prashad Nuchhe Pradhan	Rising damp on E-side Top floor Northern and Southern walls collapsed Vertical cracks all over on 1st floor S-side broken down

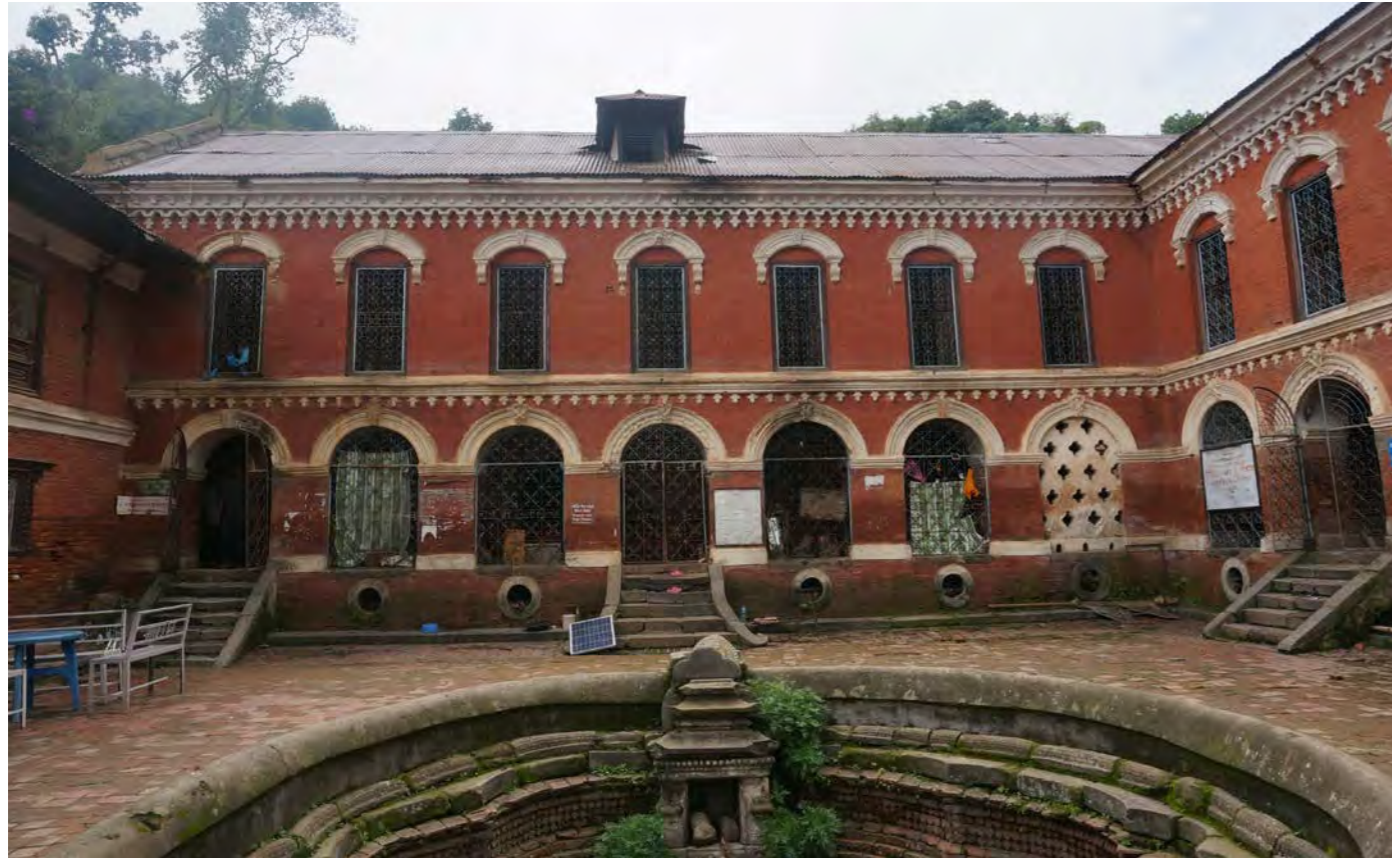
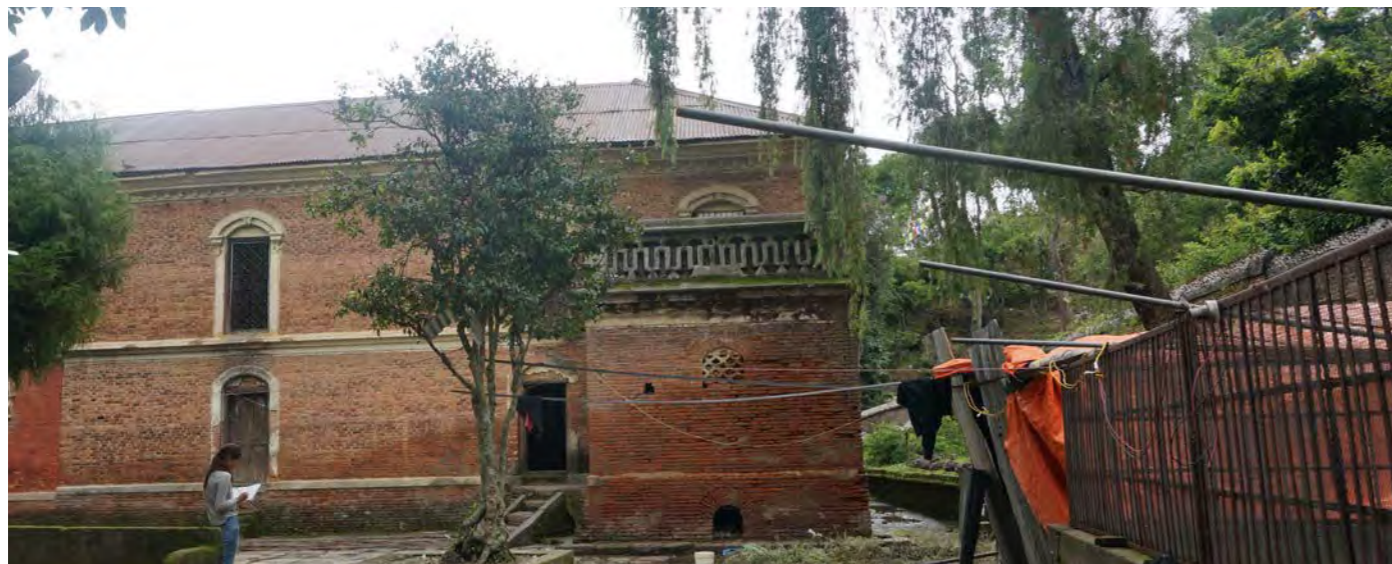
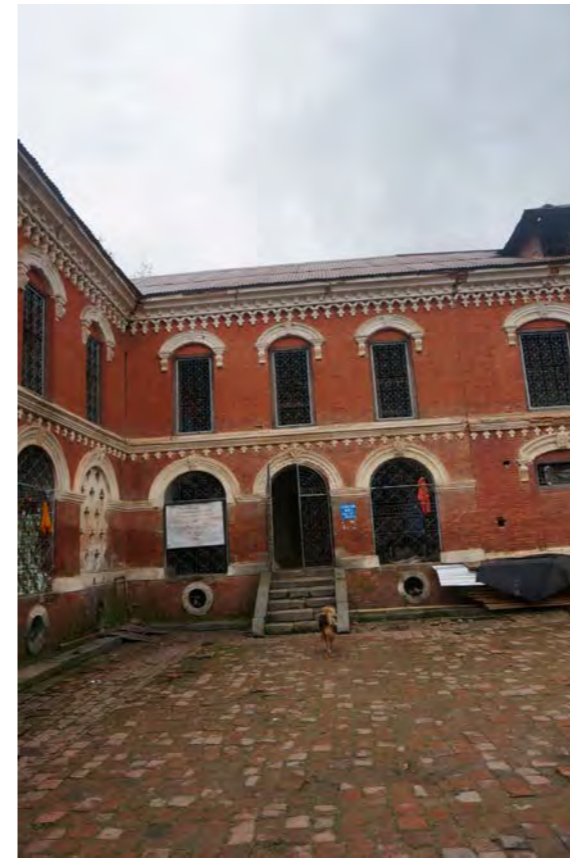
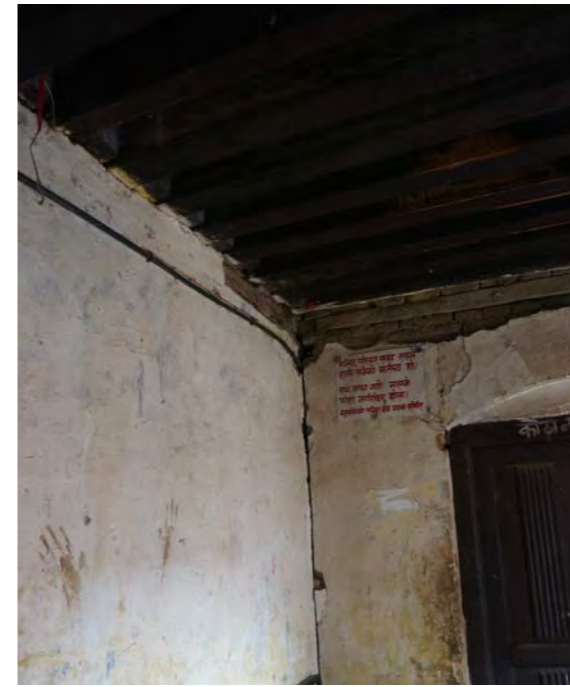
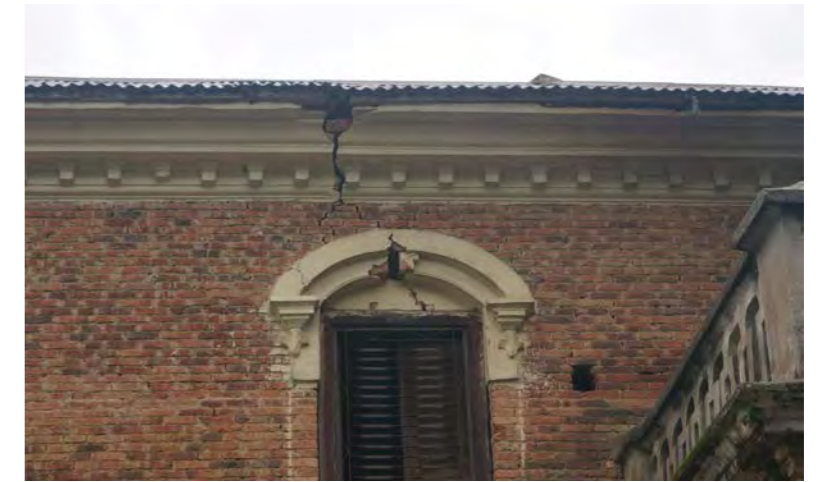
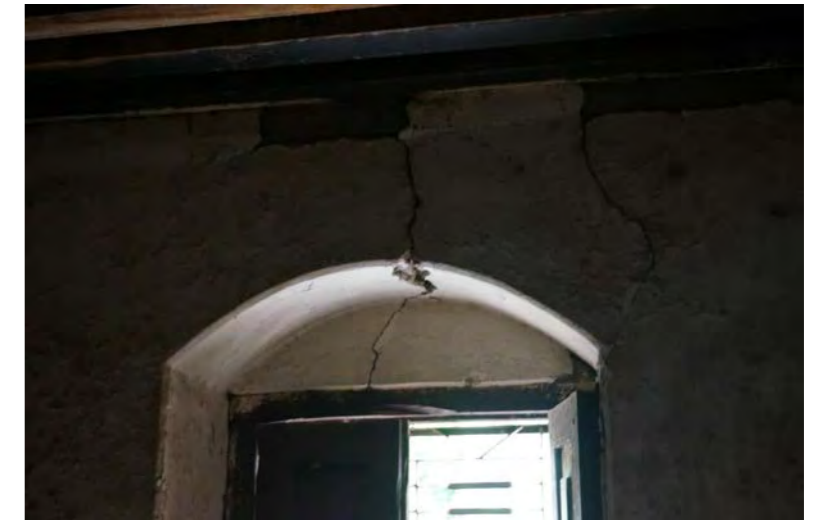
09 BHWAY CHEN

NUMBER	NAME	DATE A.D.	TYPOLOGY	GENERAL DESCRIPTION	PROBLEMS DESCRIPTION	DANGER/ DESTROY	
09	Bhway Chen		Sattal	G+1.5 Currently idols of Mhasukhwamaju is placed here. Built by Chandra Shumsher	Rising damp on S-wall. Diagonal cracks above lintels on 1st floor. Internal walls separating at corners. Upper floor dangerous. External end walls seperating. Vertical cracks extending till floor. Heavy rising damp on E-part on projected portio. Major cracks above lintels on E-window

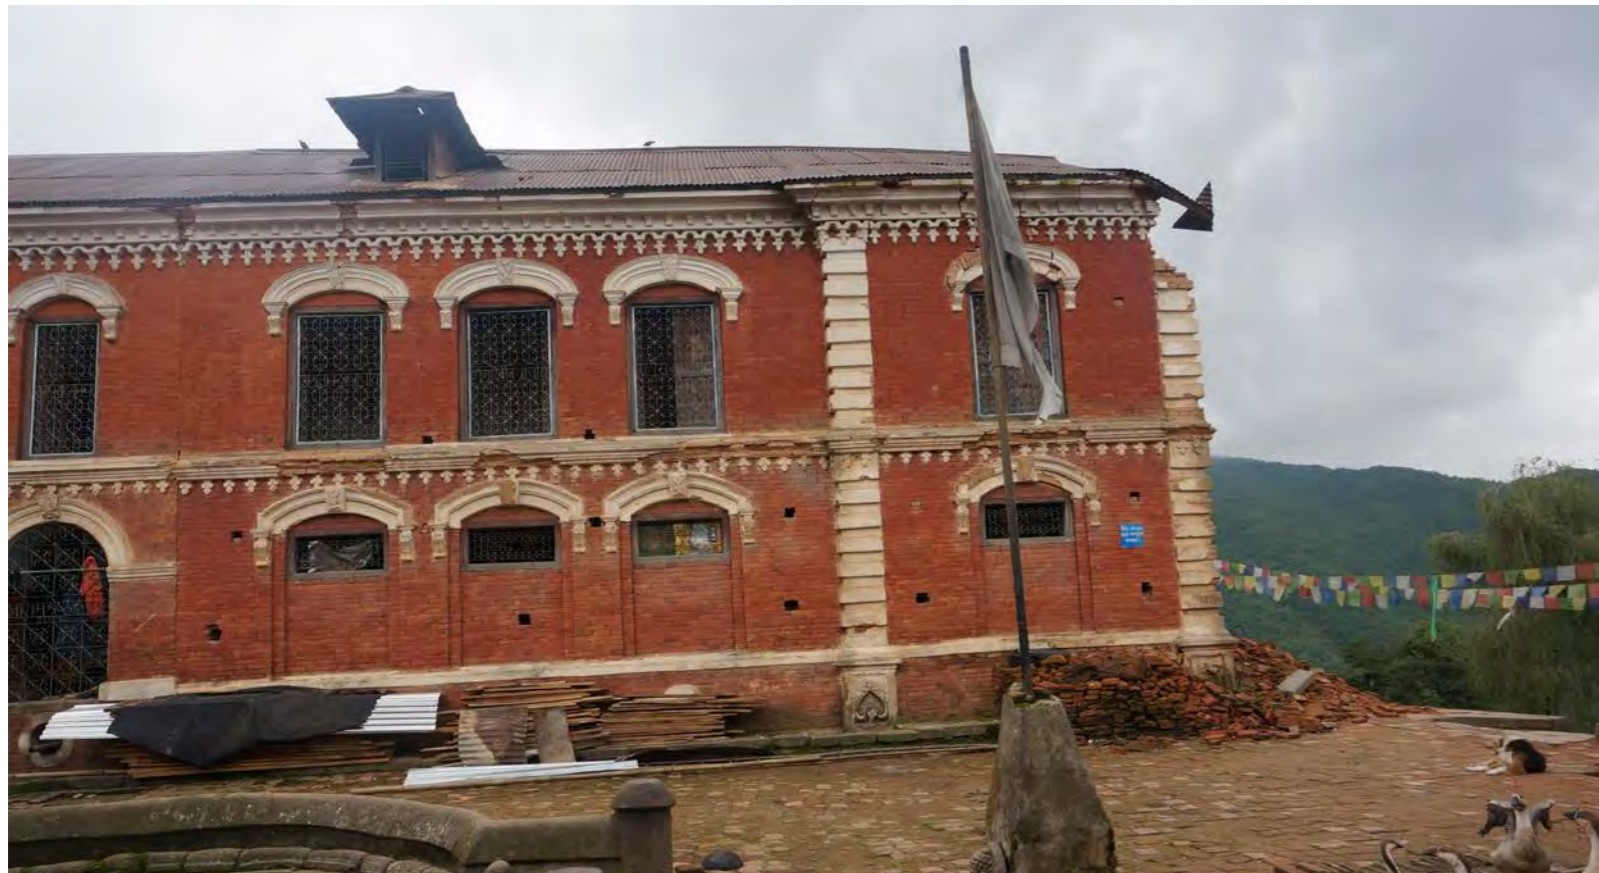
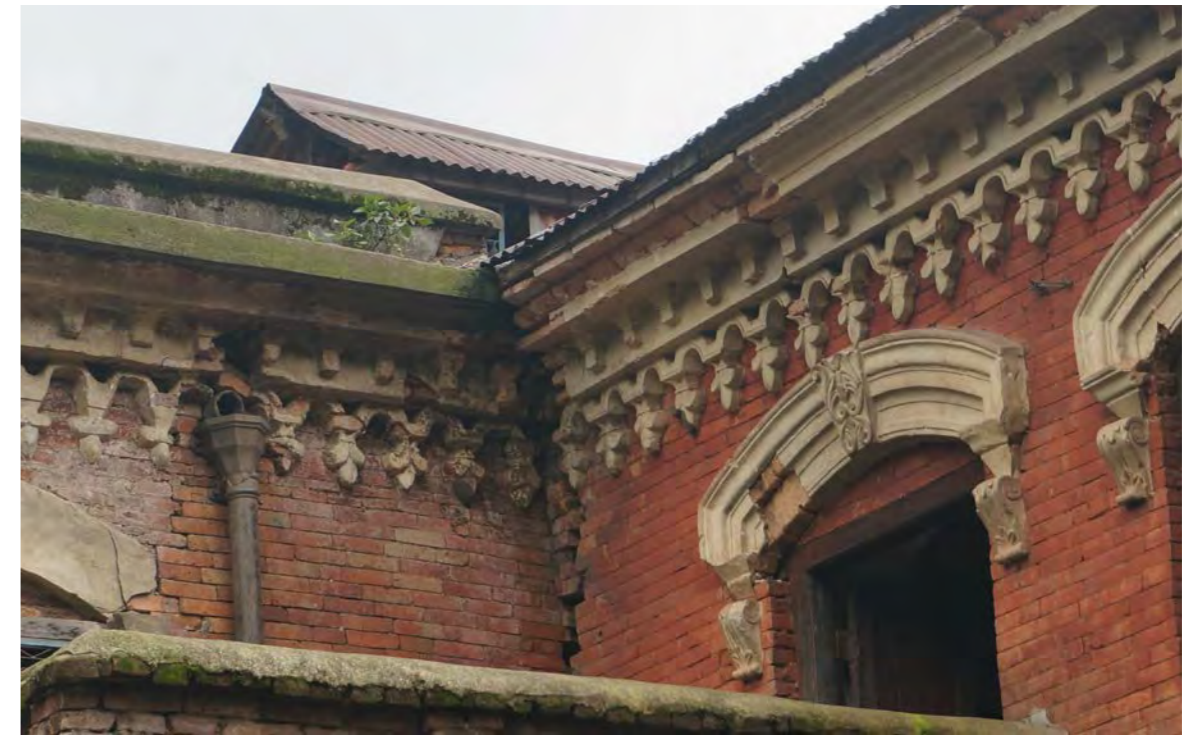
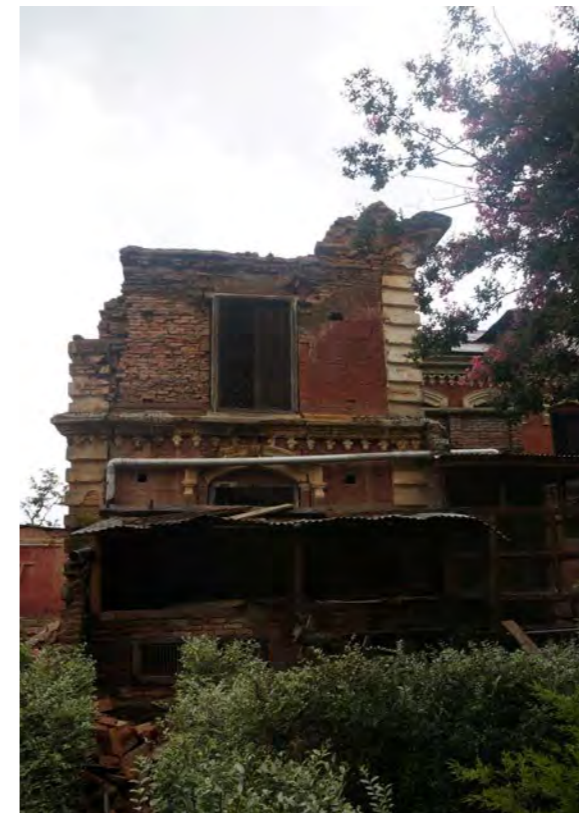
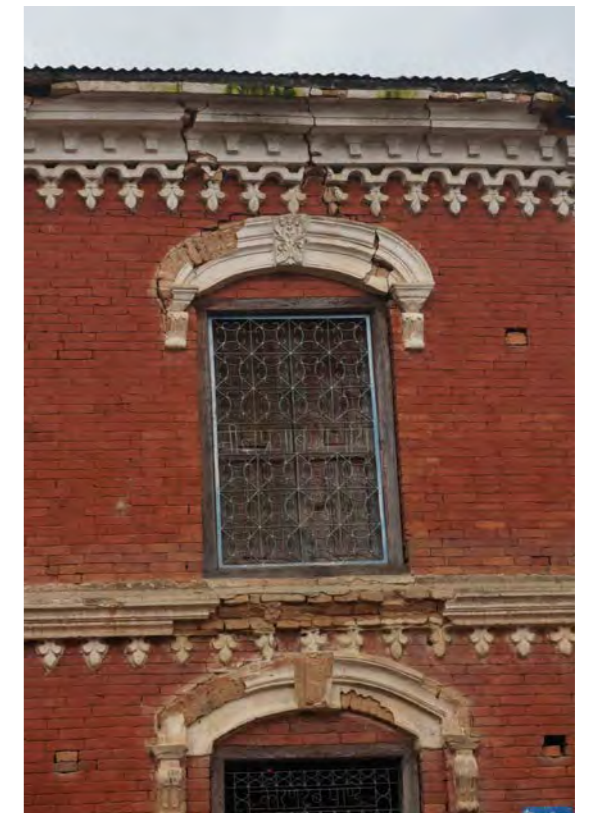
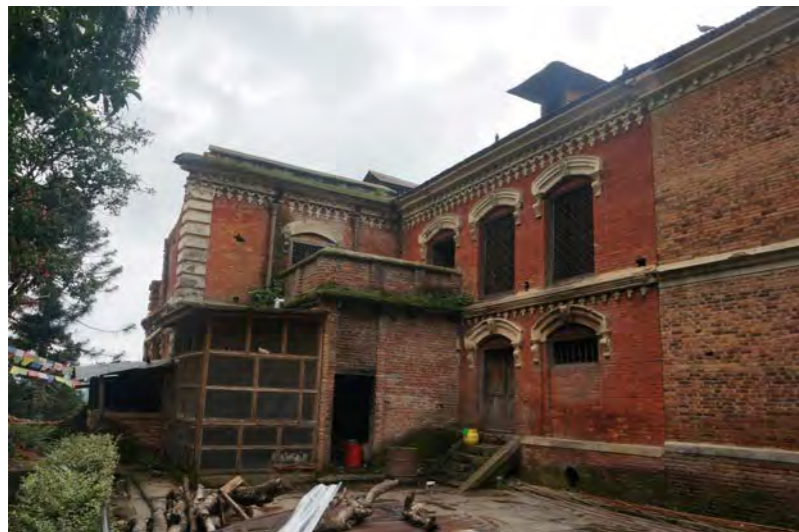
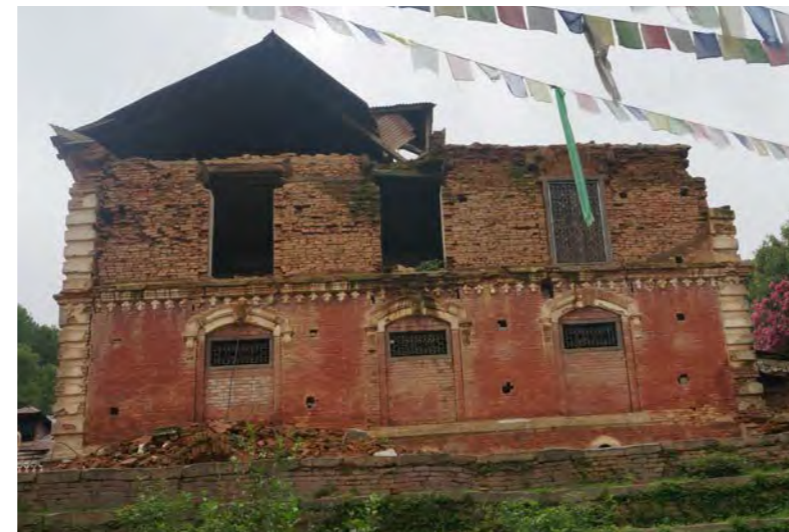
10 BHWAY CHEN

NUMBER	NAME	ESTABLISHED DATE (A.D.)	TYPOLOGY	GENERAL DESCRIPTION	PROBLEMS DESCRIPTION	DANGER/ DESTROY
10			Sattal	G+1.5	<p>E-wall collapsed upto 1st floor</p> <p>Vegetation growth on roof</p> <p>Corner cracks and bricks falling</p> <p>S-wall 1st floor collapsed</p> <p>S-W corner with vertical cracks from plinth to FI</p> <p>Major cracks on Western wall S-corner</p>

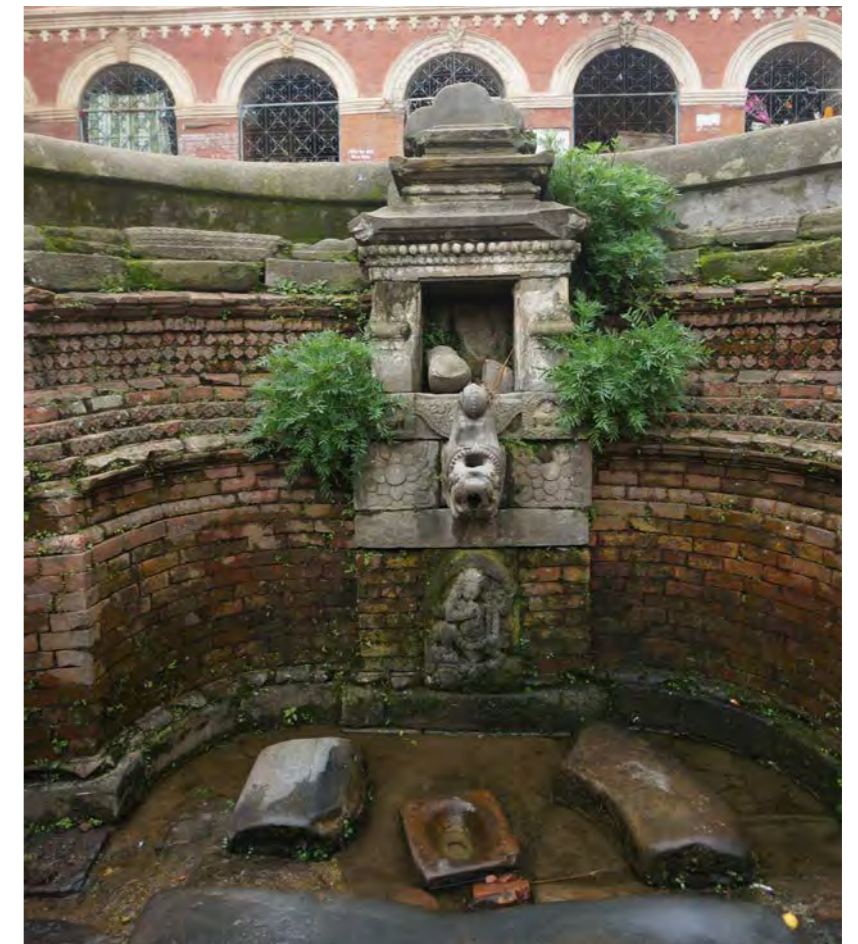
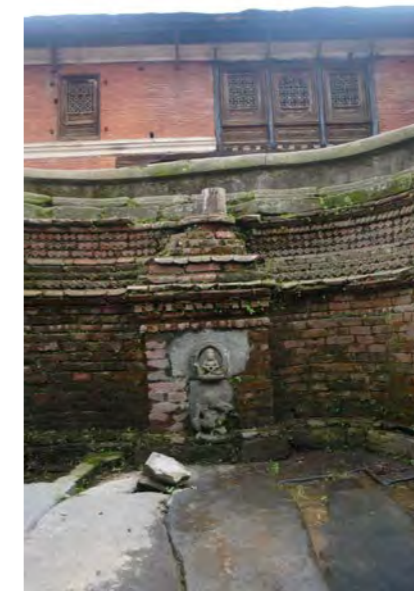
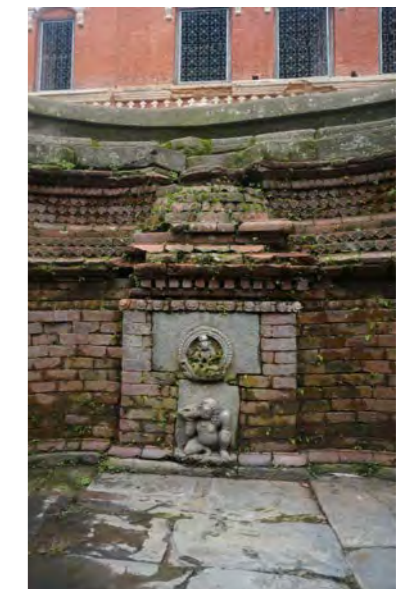
11 HITI

NUMBER	NAME	DATE A.D.	TYOLOGY	GENERAL DESCRIPTION	PROBLEMS DESCRIPTION	DANGER/ DESTROY	
11			Hiti	Stone Water spout	Growing vegetation on wall Some bricks out of plane

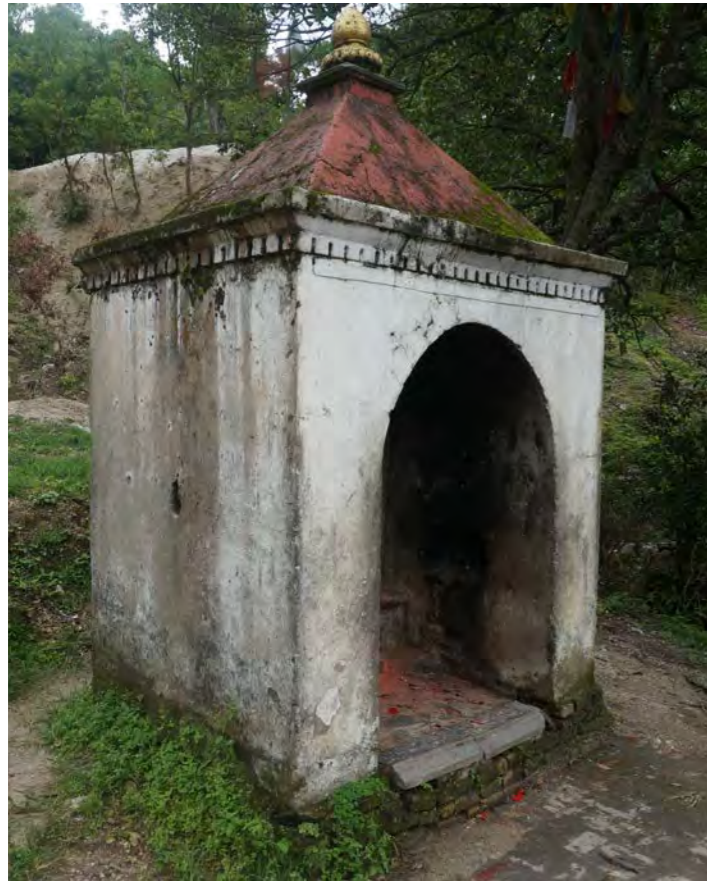
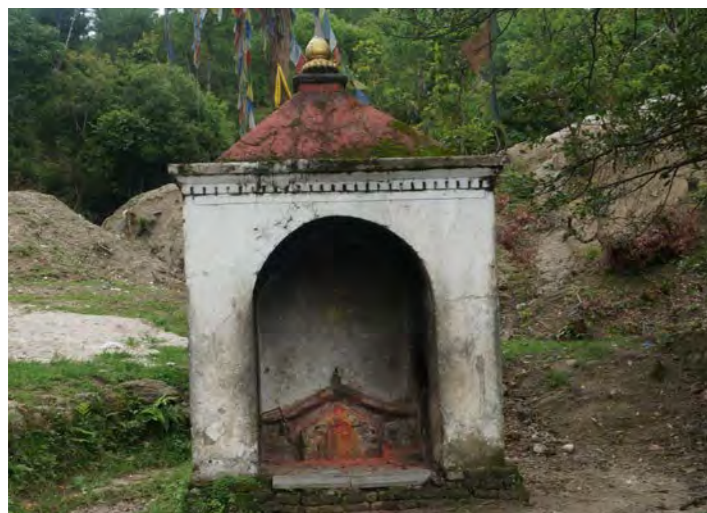
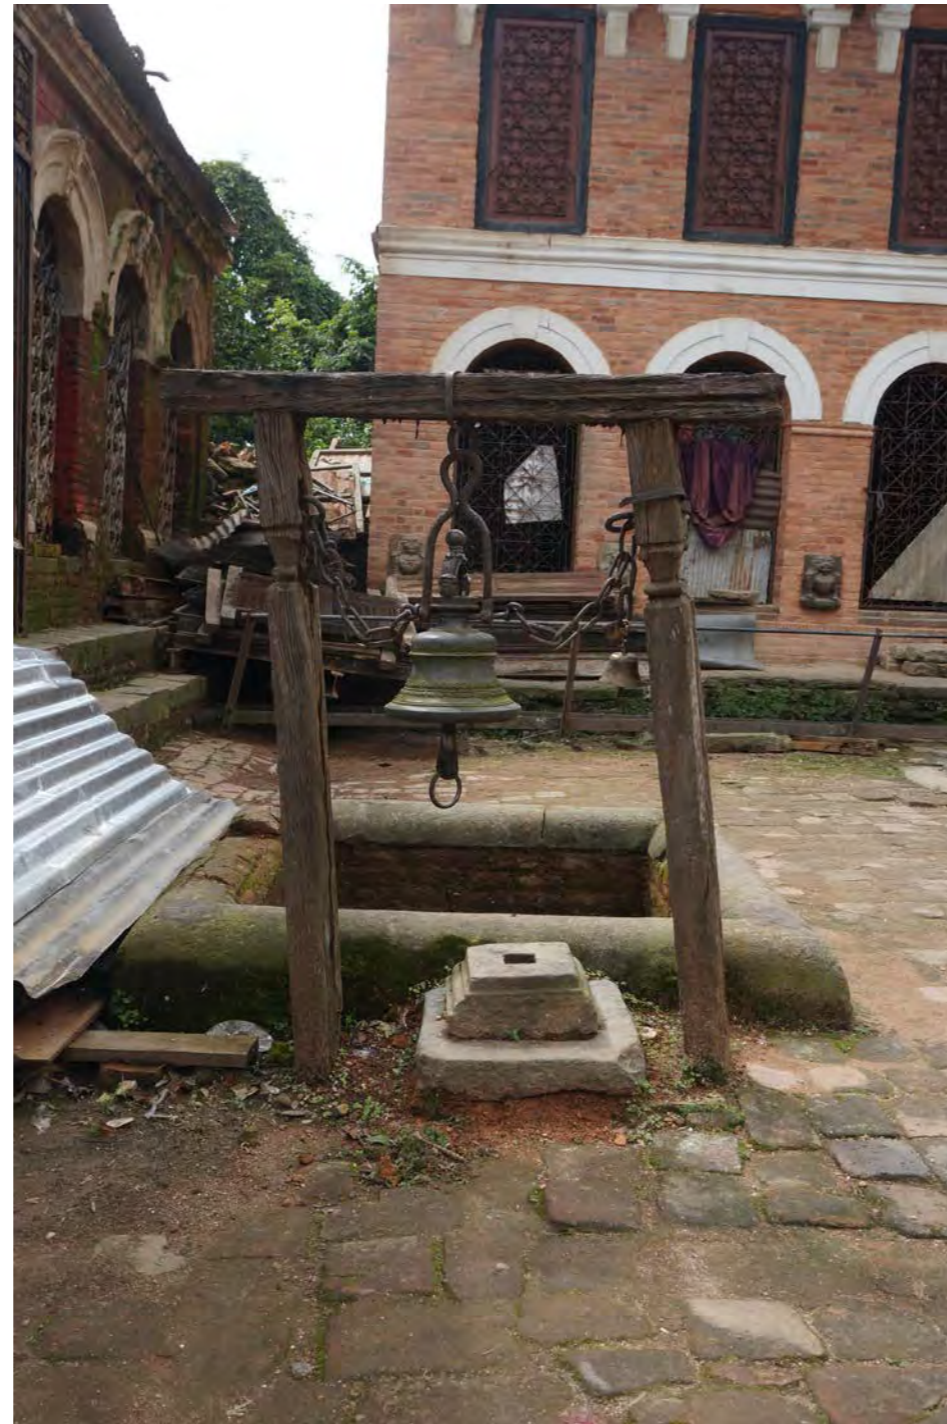
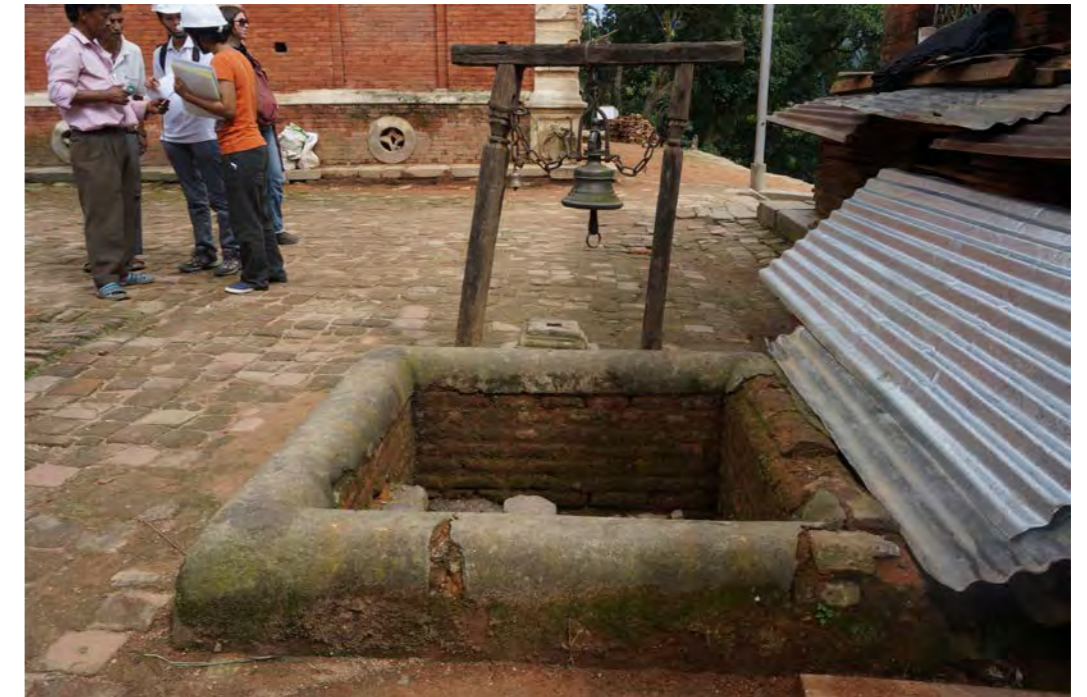
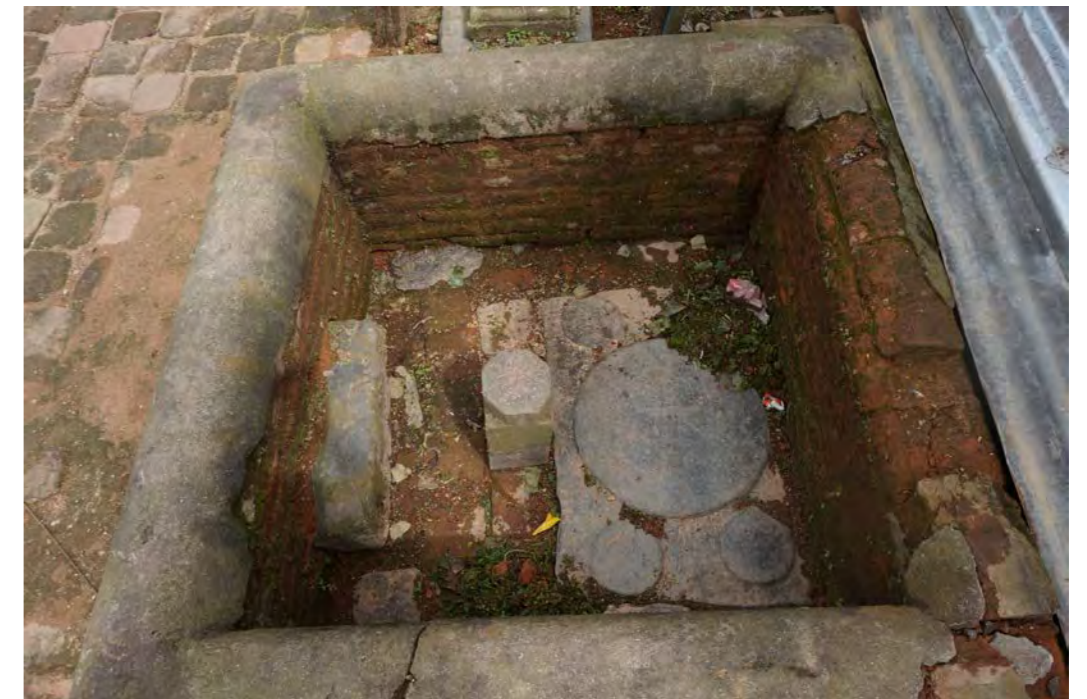
12 GUM GANESH

NUMBER	NAME	ESTABLISHED DATE (A.D.)	TYPOLOGY	GENERAL DESCRIPTION	PROBLEMS DESCRIPTION	DANGER/ DESTROY
12	Gum Ganesh		Enclosed Shrine		Vegetation growth due to rising damp. Plaster cracks	
13	Bau Gaa		Open Shrine		No visible damage

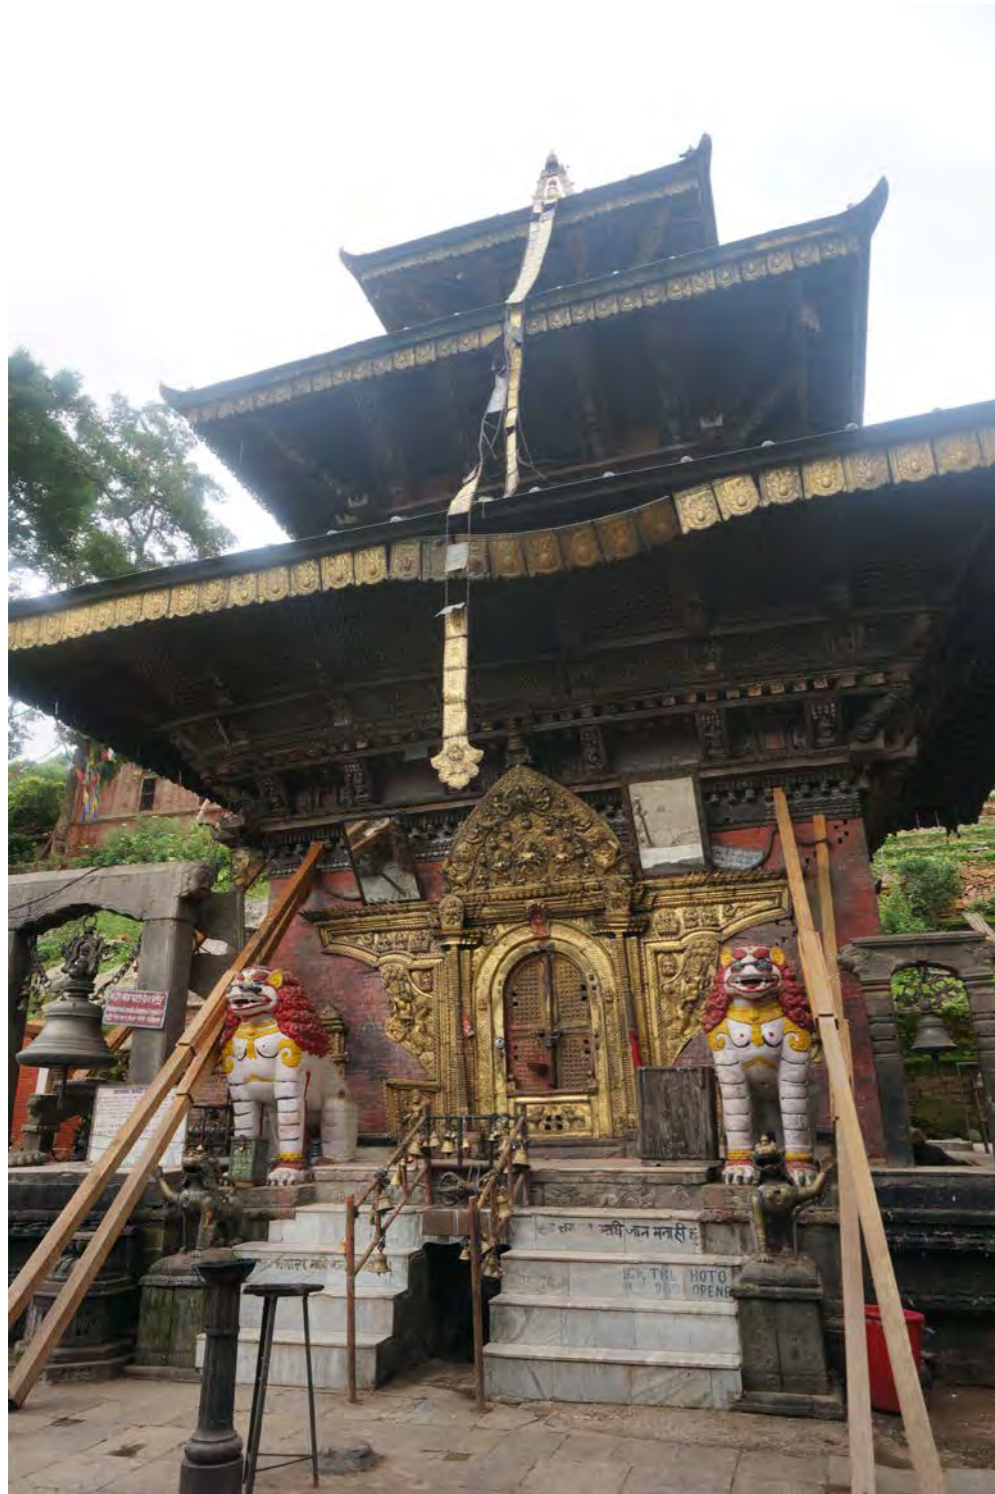
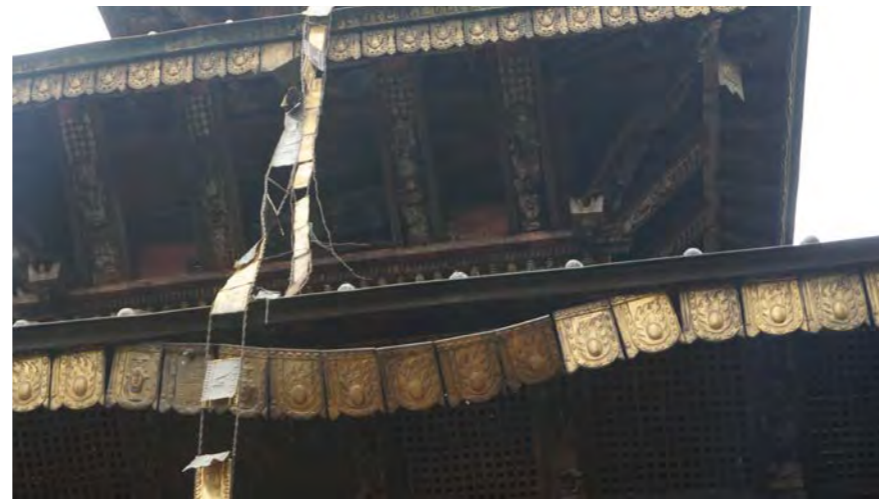
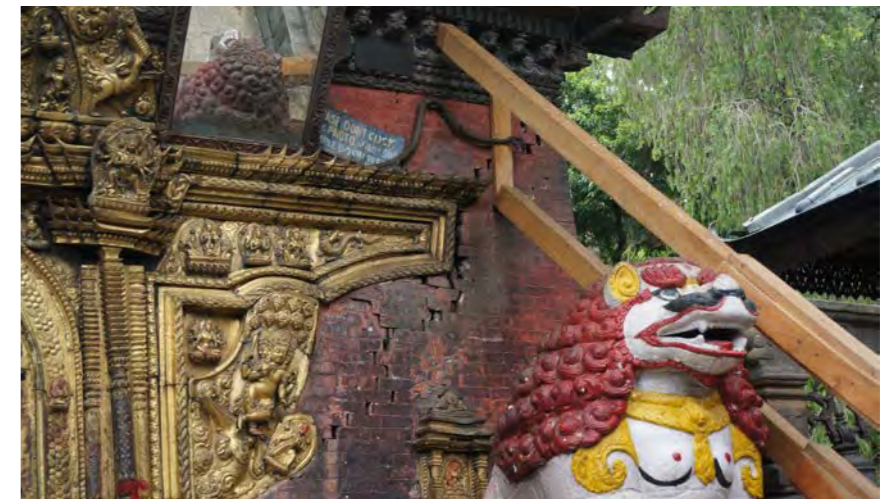
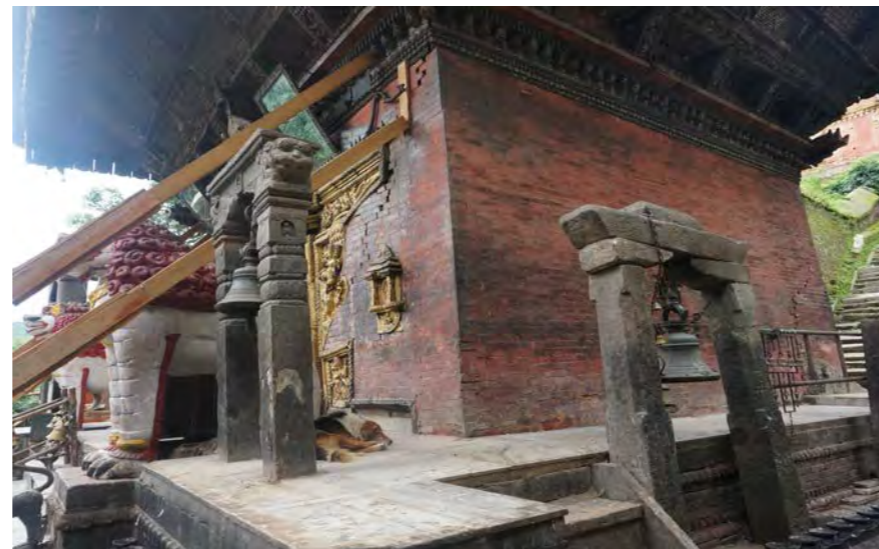
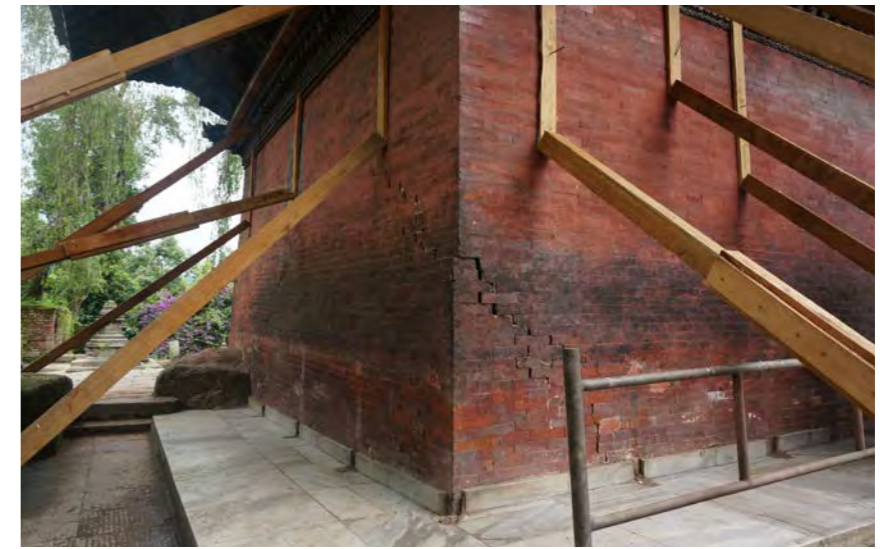
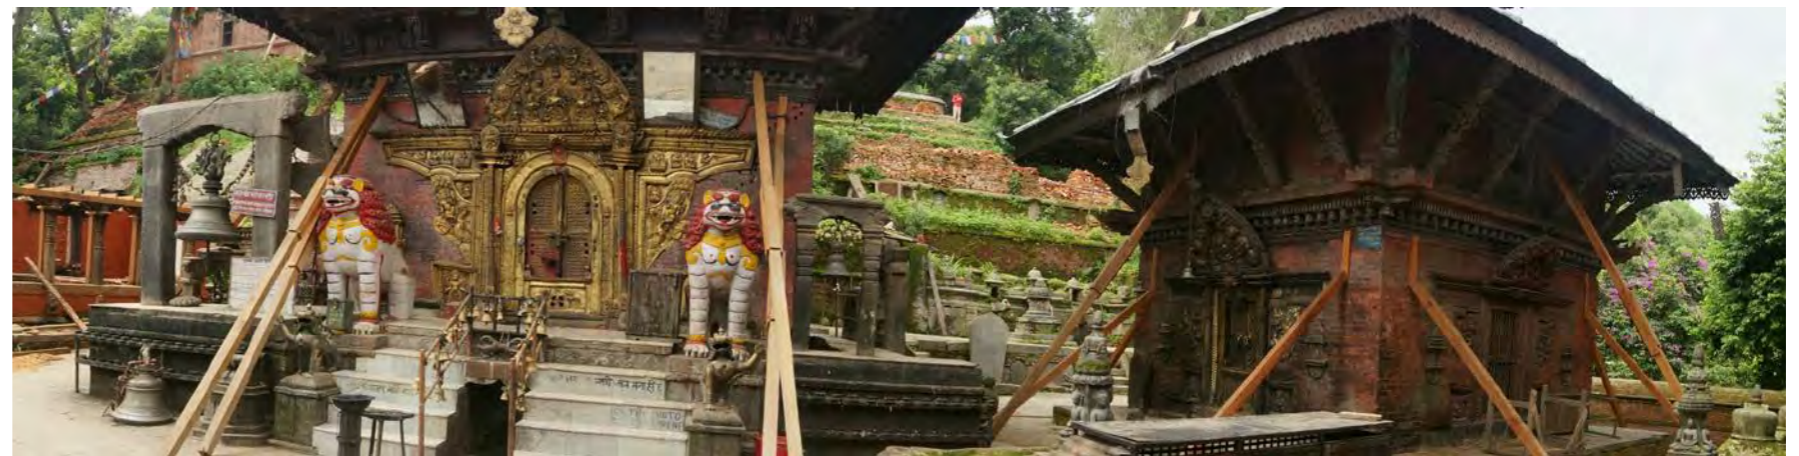
16-a HYAUKHWA MAJU

NUMBER	NAME	DATE A.D.	TYPOLOGY	GENERAL DESCRIPTION	PROBLEMS DESCRIPTION	DANGER/ DESTROY
16-a	Hyaukhwa Maju				S-E corner separating N-W and N-E base corner separating out Diagonal cracks on Northern wall

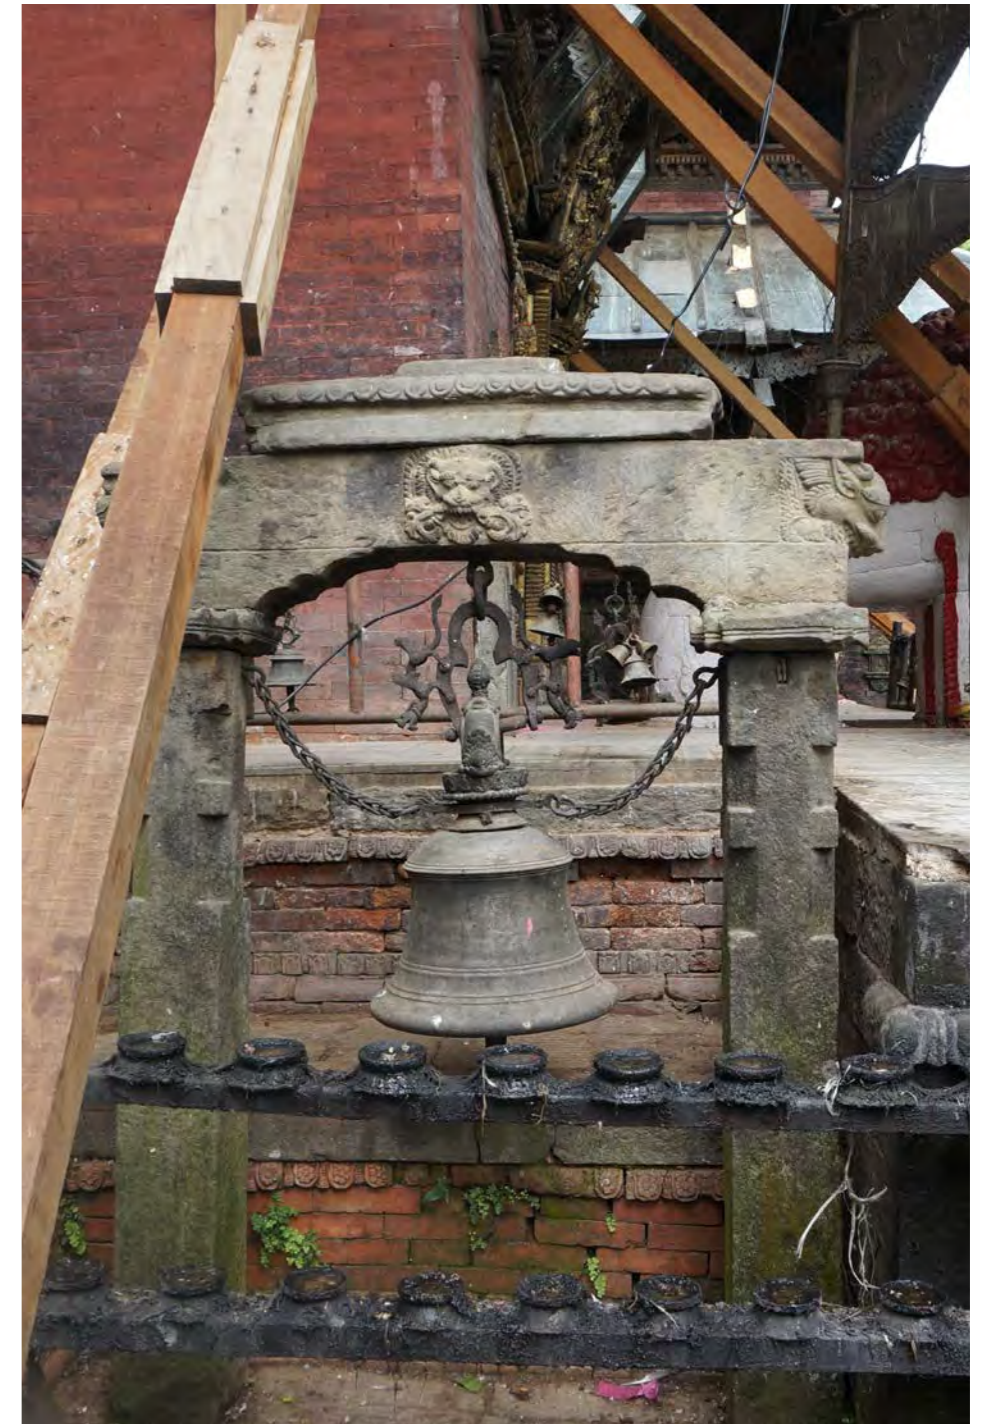
NUMBER	NAME	ESTABLISHED DATE (A.D.)	TYPOLOGY	GENERAL DESCRIPTION	PROBLEMS DESCRIPTION	DANGER/ DESTROY
16-b			Mandala	Stone Mandala	No Visible Damages	
16-c			Big Bell		No Visible Damages	
16-d			Bell		Tilted and stone parts separating
