2015 Earthquake Damage Mapping

Sankhu

October 2015

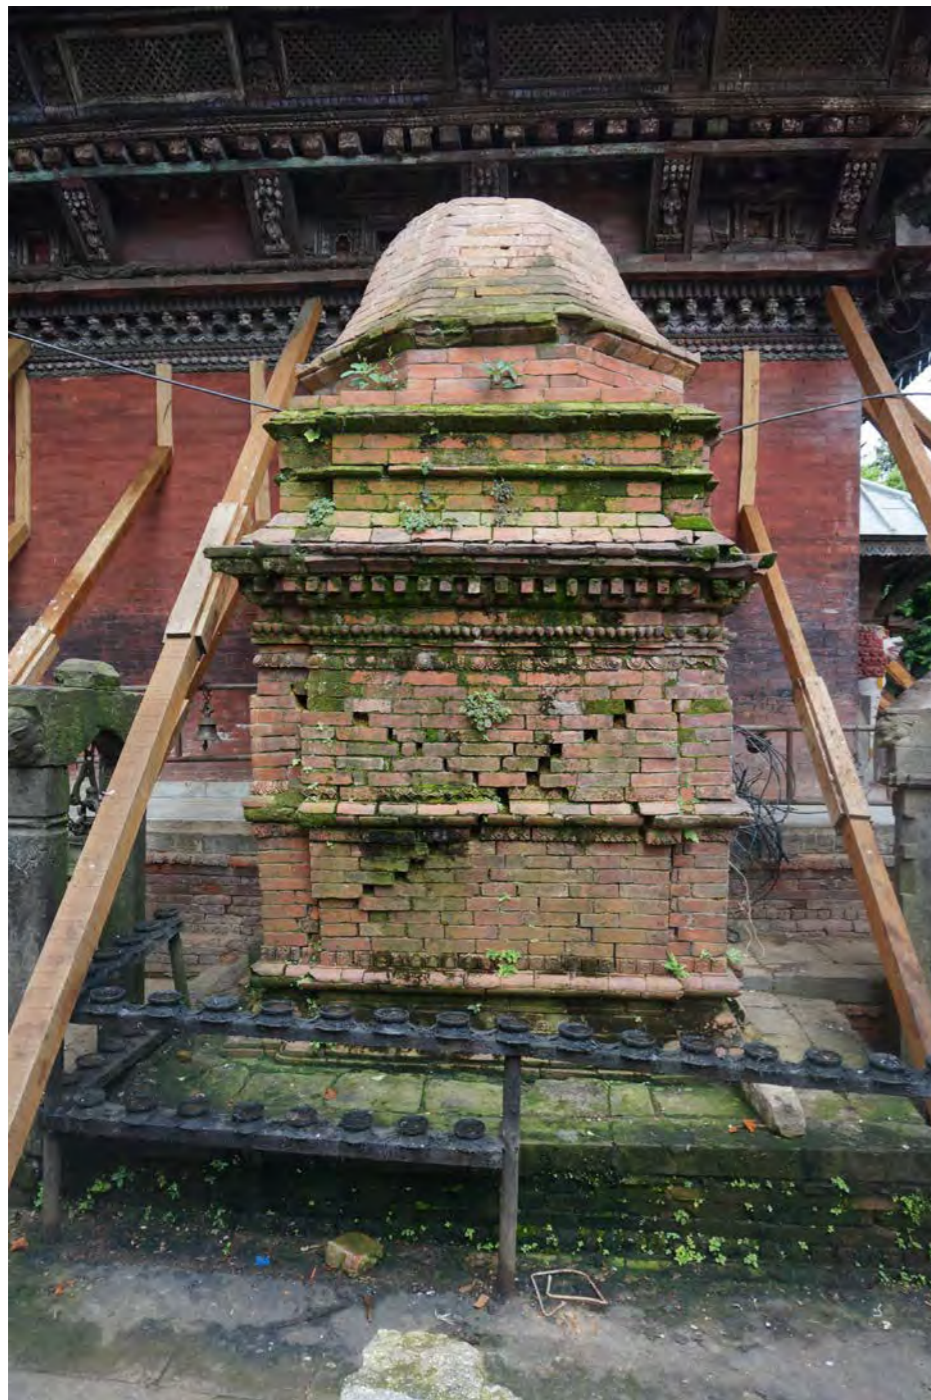
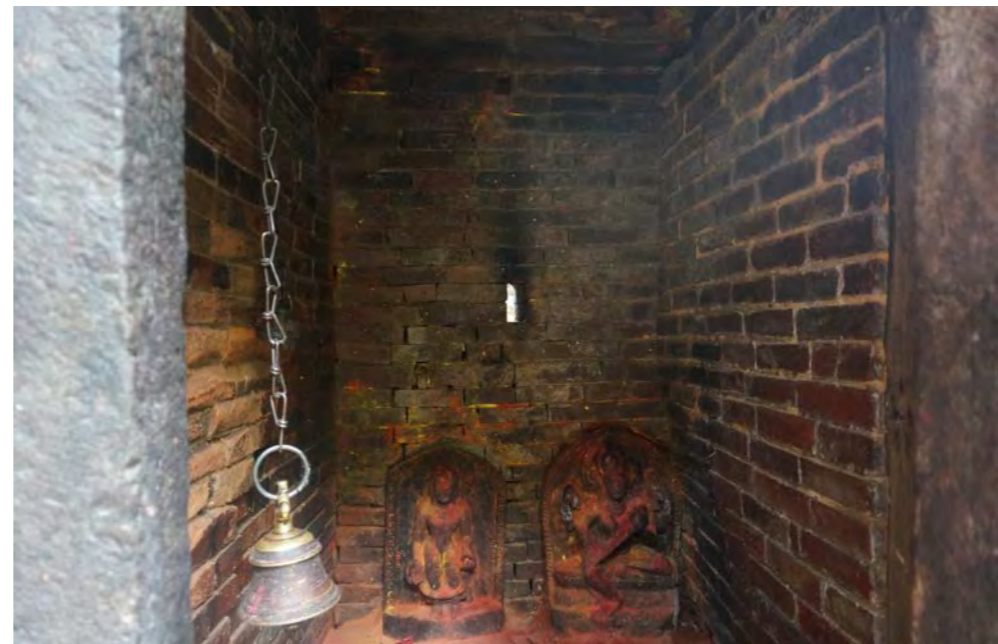
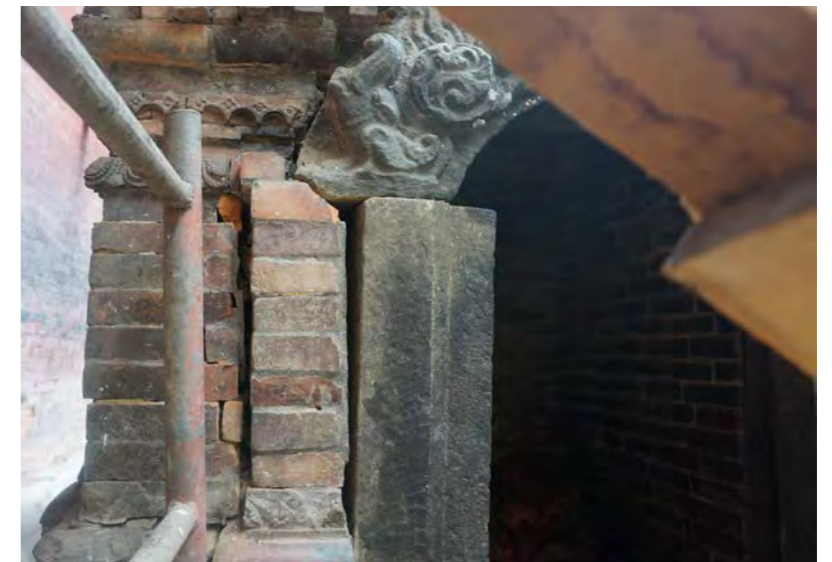
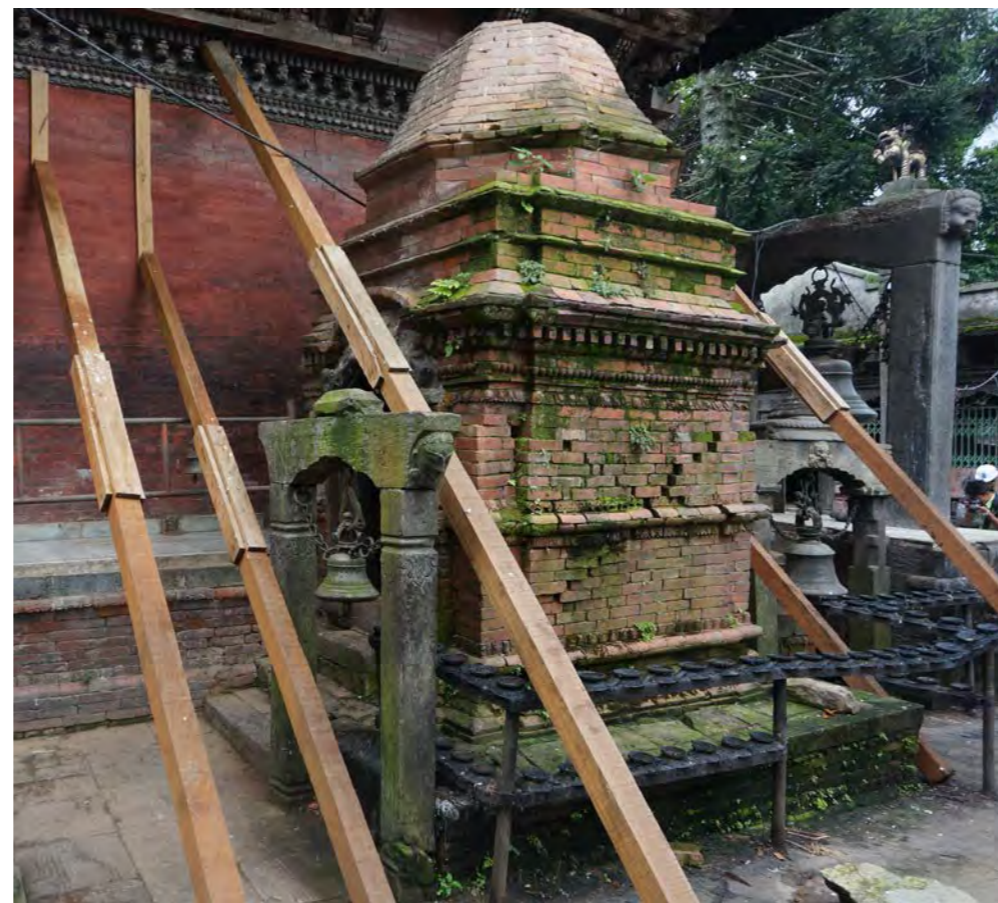
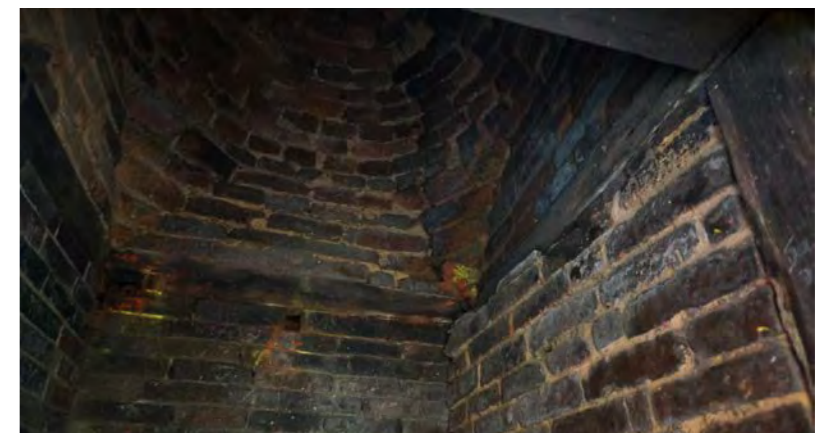
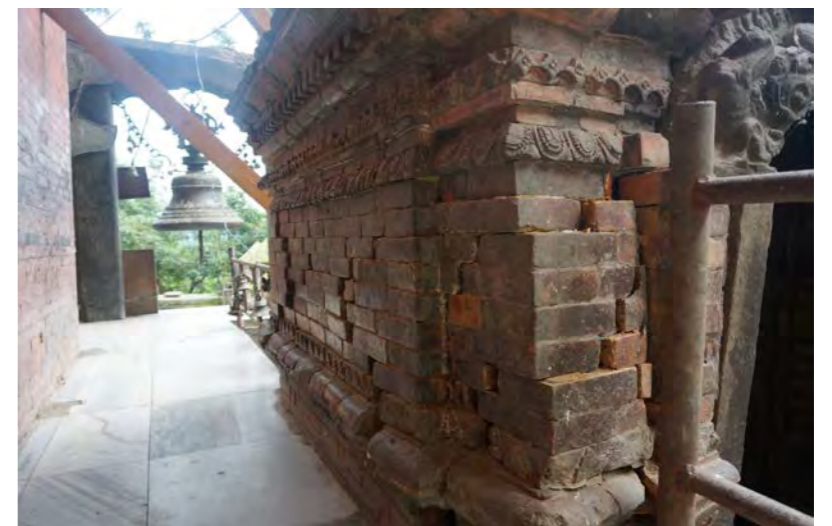
16-e MANJUSHRI

NUMBER	NAME	DATE A.D.	TYOLOGY	GENERAL DESCRIPTION	PROBLEMS DESCRIPTION	DANGER/ DESTROY
16-e	Manjushri		Shrine	Shikhara Style brick shrine	Vertical cracks on S-W corner Diagonal cracks on W-wall Rising Damp and vegetation all over N-E corner separating Brick dislocation on E-side

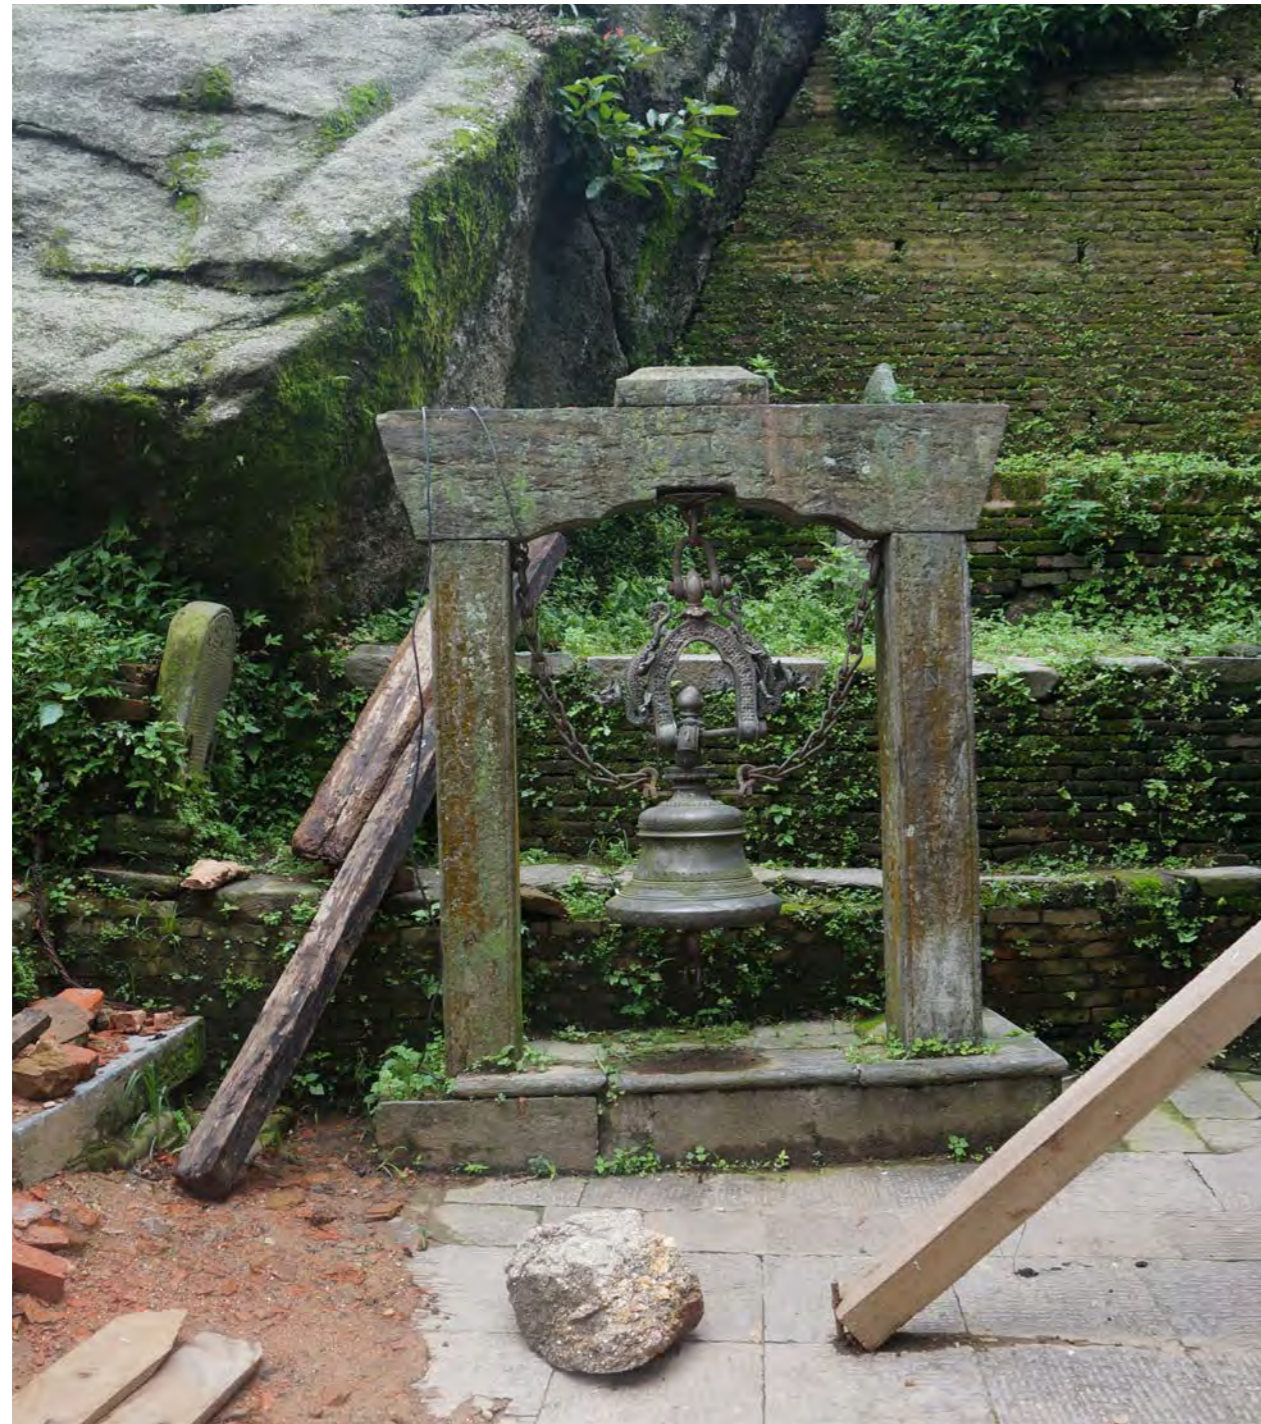
16-f BELL

NUMBER	NAME	ESTABLISHED DATE (A.D.)	TYPOLOGY	GENERAL DESCRIPTION	PROBLEMS DESCRIPTION	DANGER/ DESTROY	
16-f			Bell		N-W base out of place		
16-h			Bell	Bell on brick with plastered support	No Visible Damages

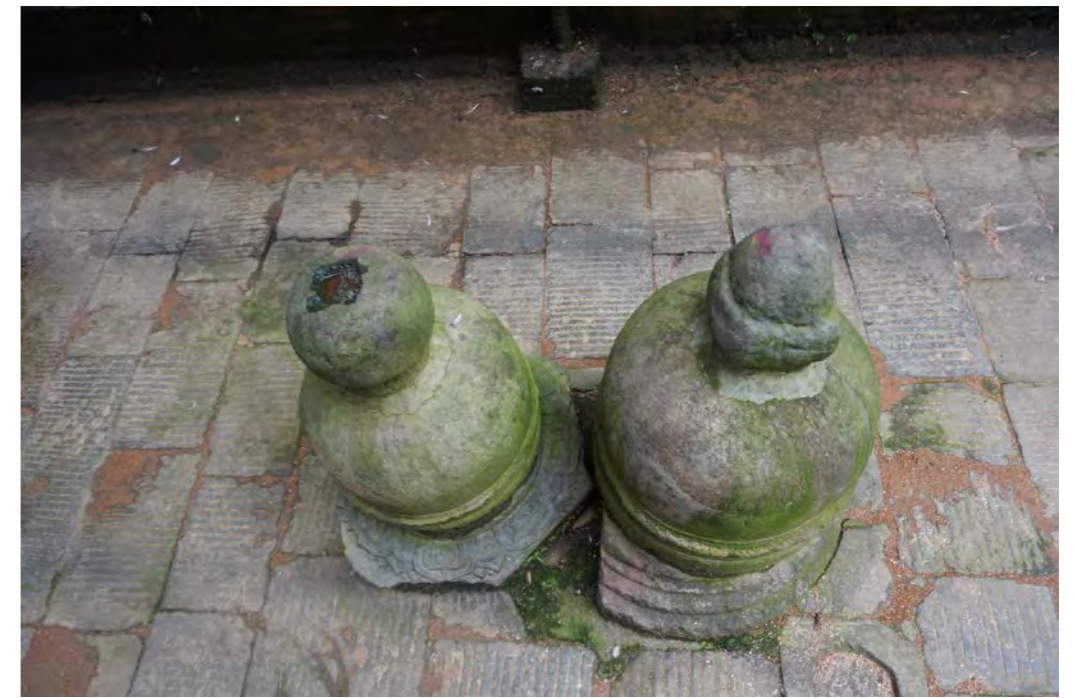
16- i & j ASHOKA CHAITYA

NUMBER	NAME	ESTABLISHED DATE (A.D.)	TYPOLOGY	GENERAL DESCRIPTION	PROBLEMS DESCRIPTION	DANGER/ DESTROY
16-i, j	Ashoka Chaitya		Chaitya	Stone Structure	Stone deteriorated

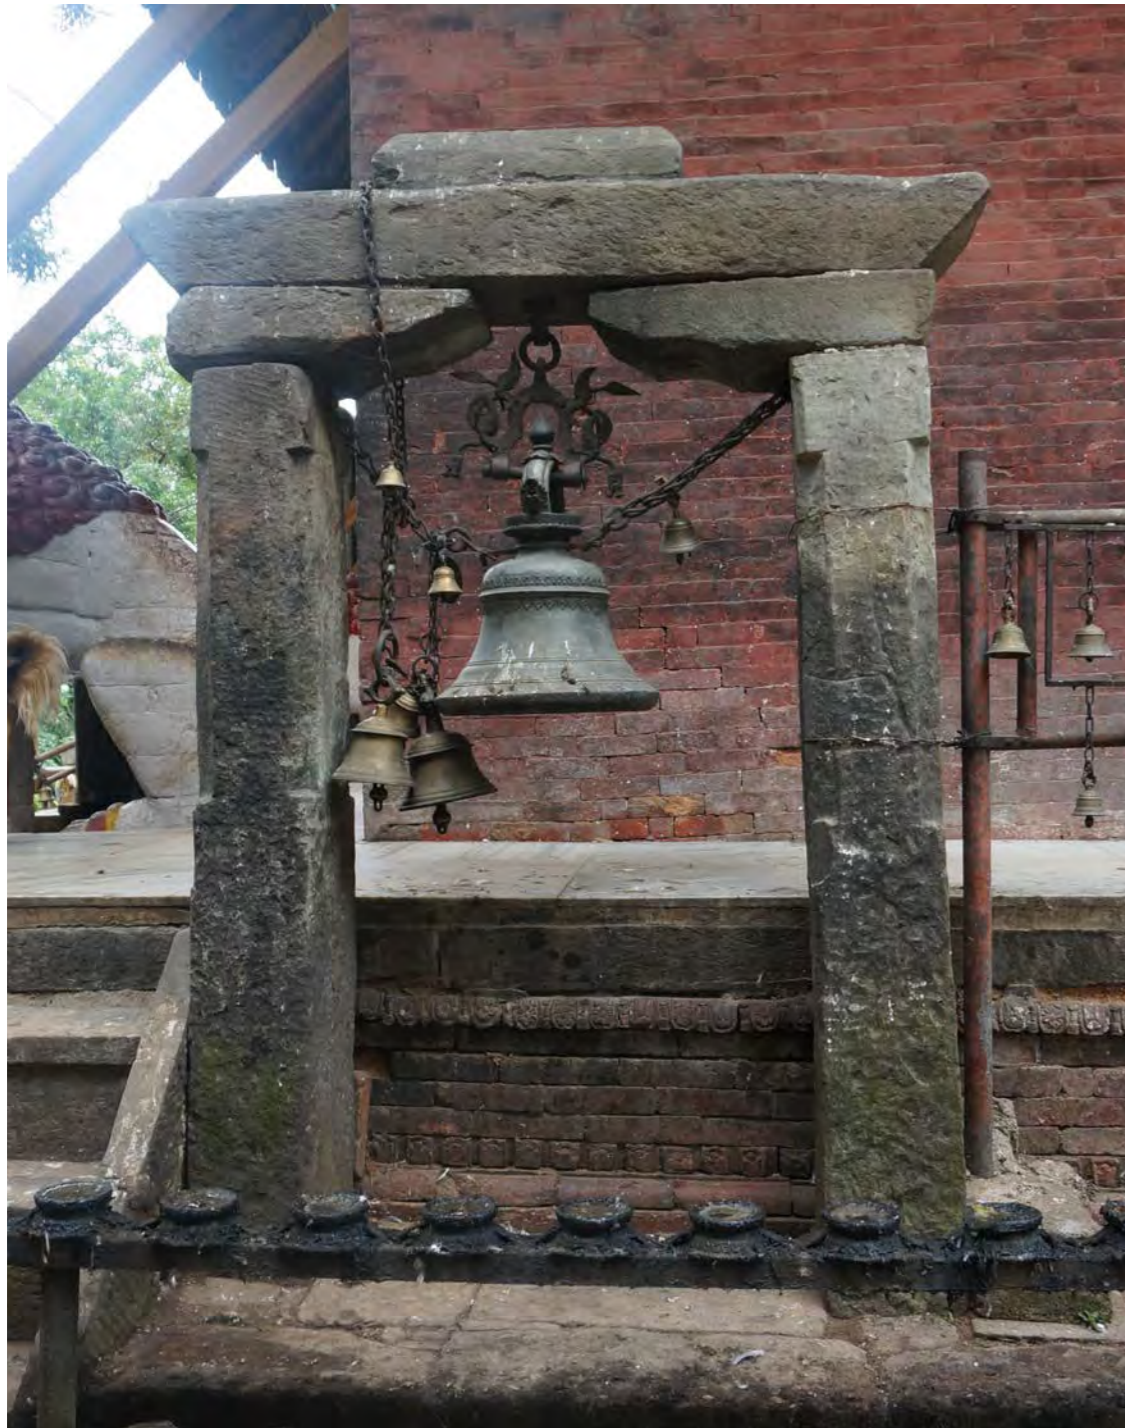
NUMBER	NAME	DATE A.D.	TPOLOGY	GENERAL DESCRIPTION	PROBLEMS DESCRIPTION	DANGER/ DESTROY
16-k 16-m			Bell Bell	Bell on Stone Support	Some Stone support out of place No Visible Damages

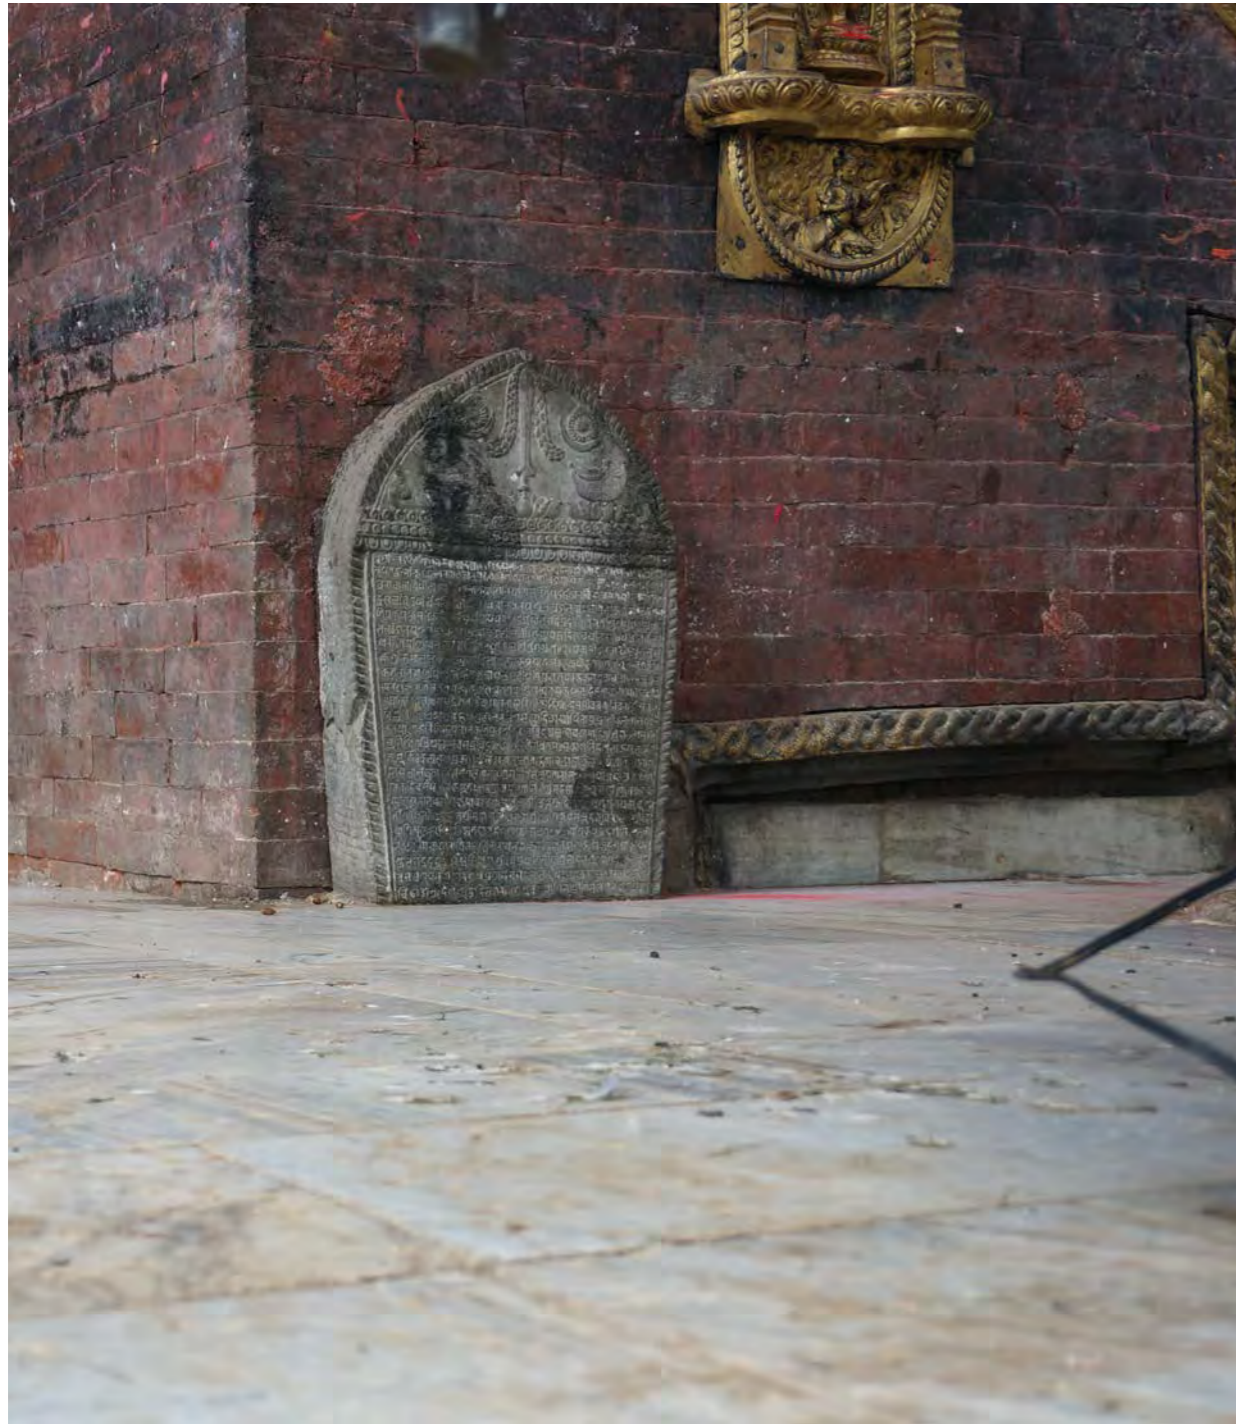
16-I INSCRIPTION

NUMBER	NAME	ESTABLISHED DATE (A.D.)	TYPOLOGY	GENERAL DESCRIPTION	PROBLEMS DESCRIPTION	DANGER/ DESTROY
16-I			Inscription	Stone tablet	No Visible Damages	
17	Vasuki Naga		Temple		Some Vegetation growth on wall Dampness problem

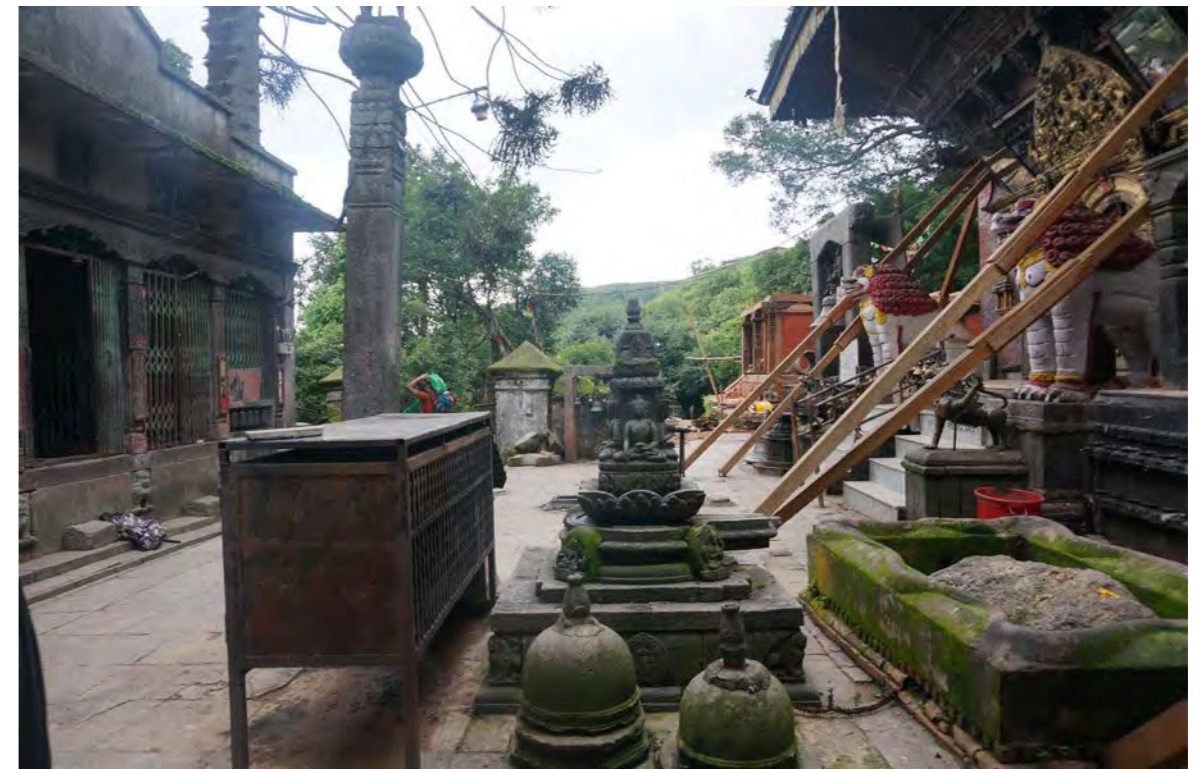
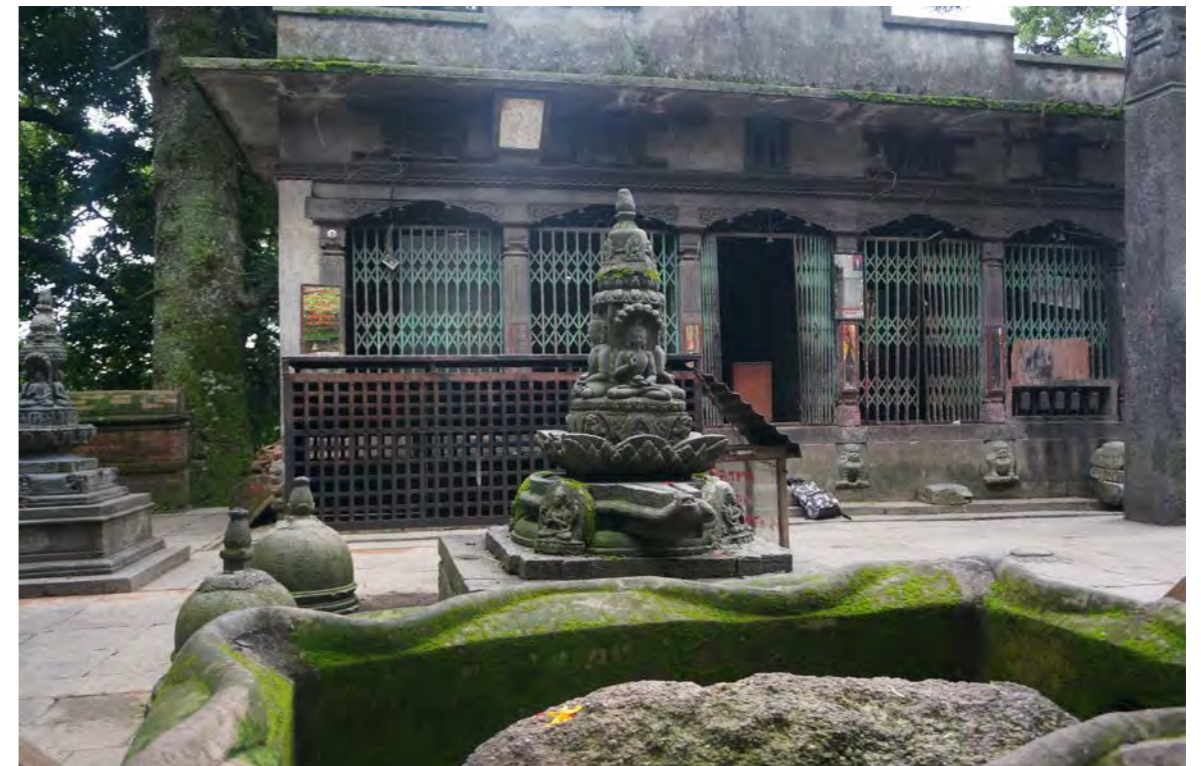
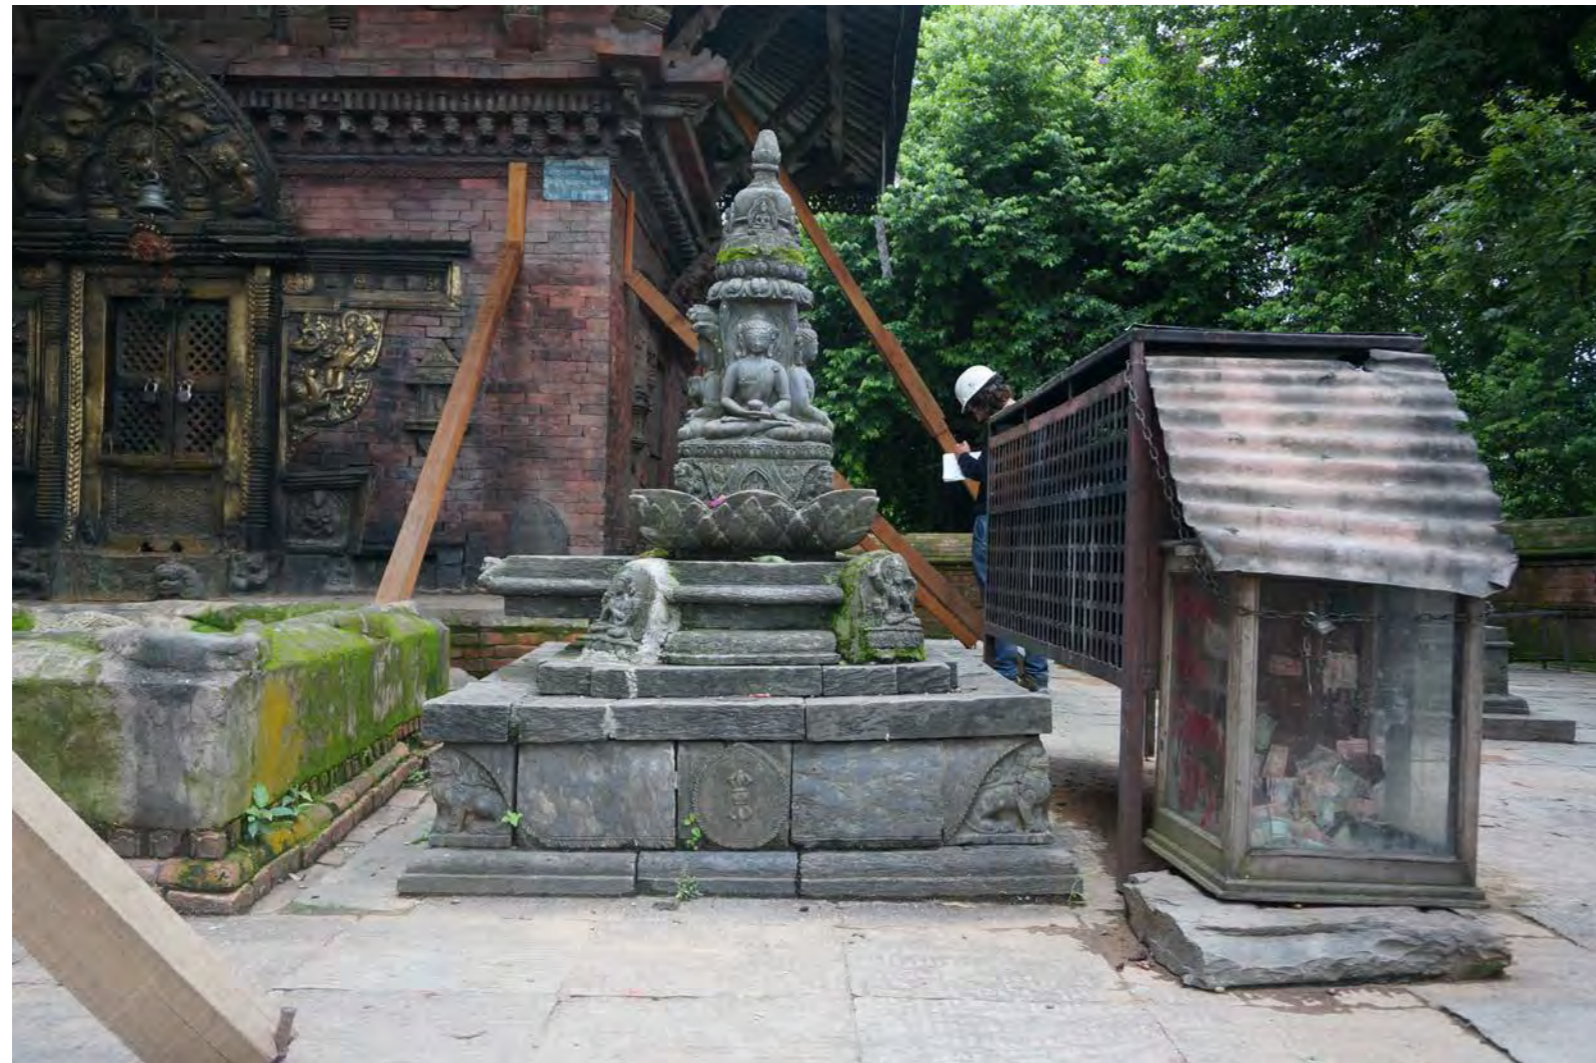
18 CHAITYA

NUMBER	NAME	DATE A.D.	TPOLOGY	GENERAL DESCRIPTION	PROBLEMS DESCRIPTION	DANGER/ DESTROY
18			Chaitya		Some Vegetation growth

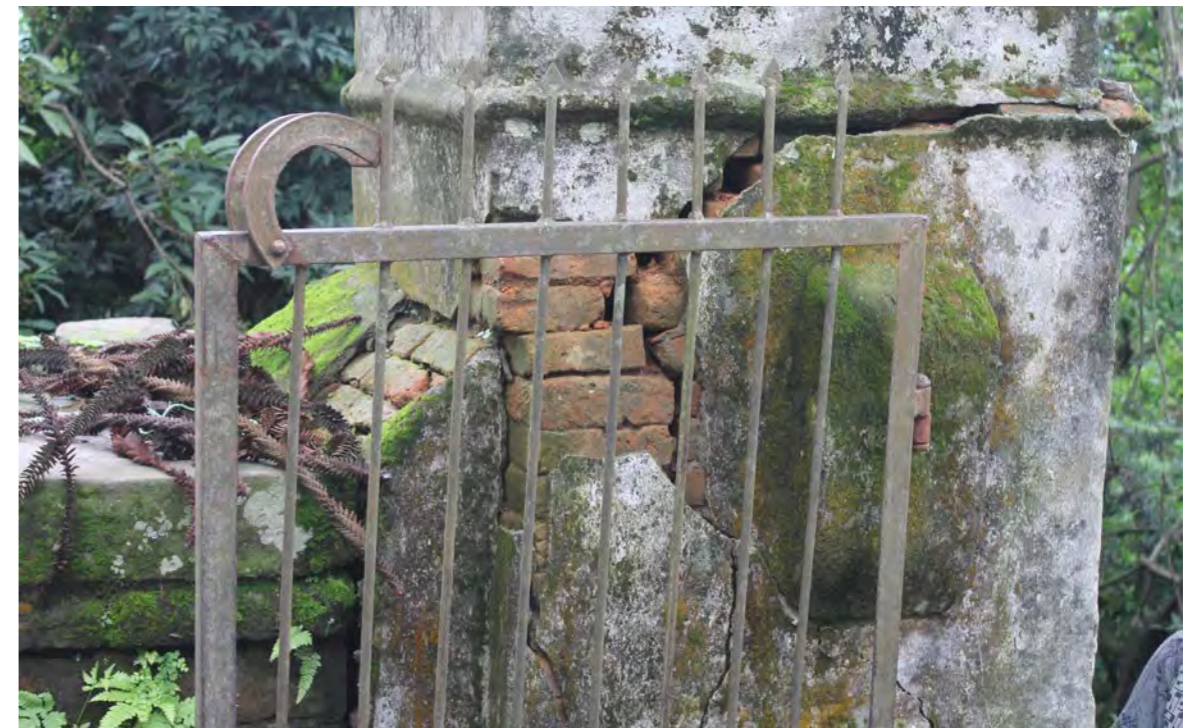
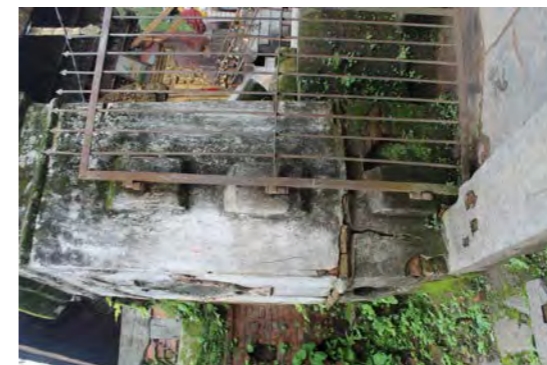
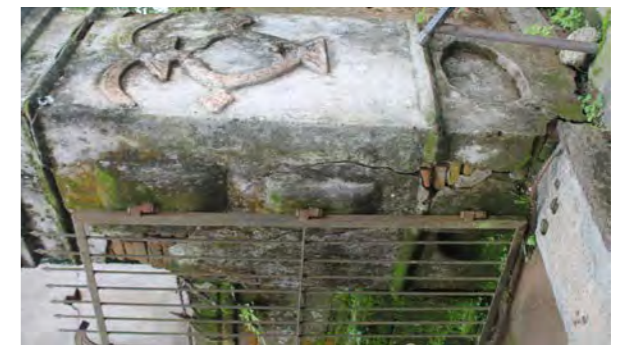
21 ENTRANCE GATE

NUMBER	NAME	DATE A.D.	TYPOLOGY	GENERAL DESCRIPTION	PROBLEMS DESCRIPTION	DANGER/ DESTROY
21			Entrance gate	Metal bar Doors with two big sized supporting brick pillars	Both pillars with major cracks and offsets Two stone lion statues are missing, probably damaged

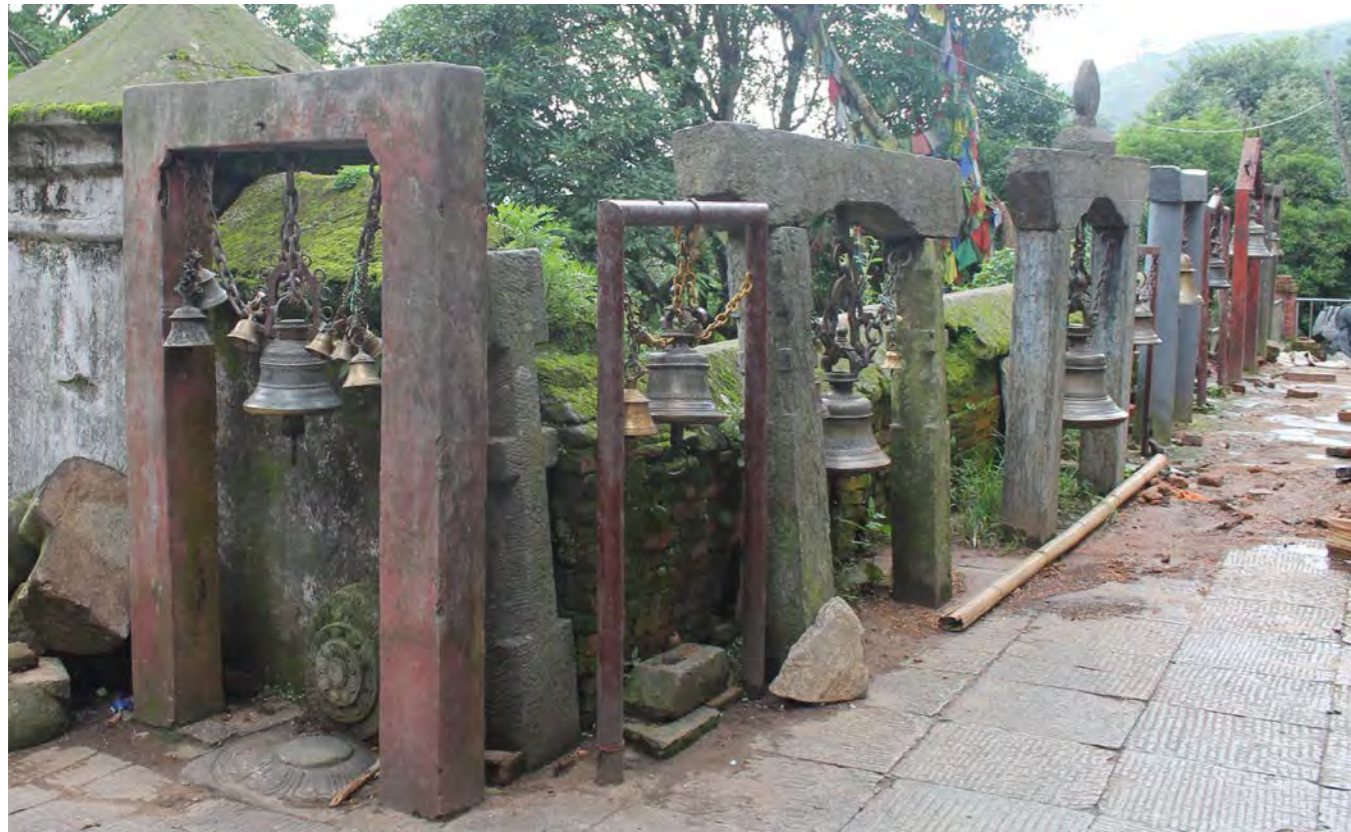
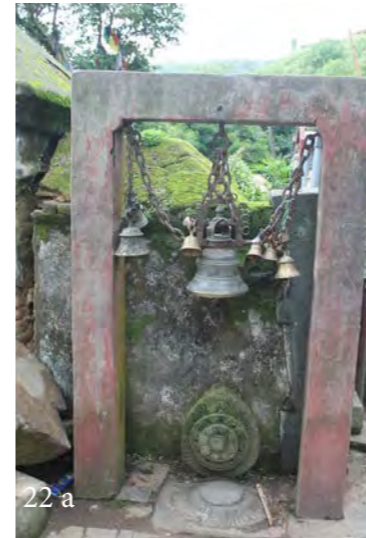
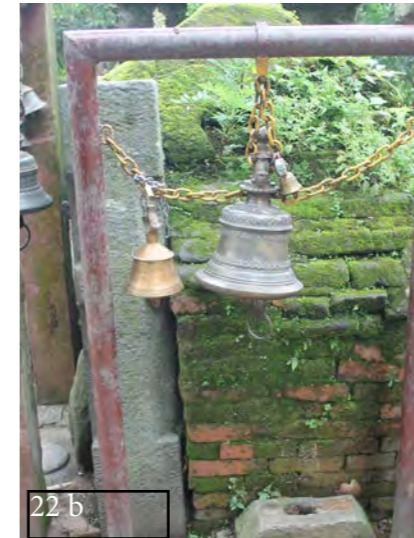
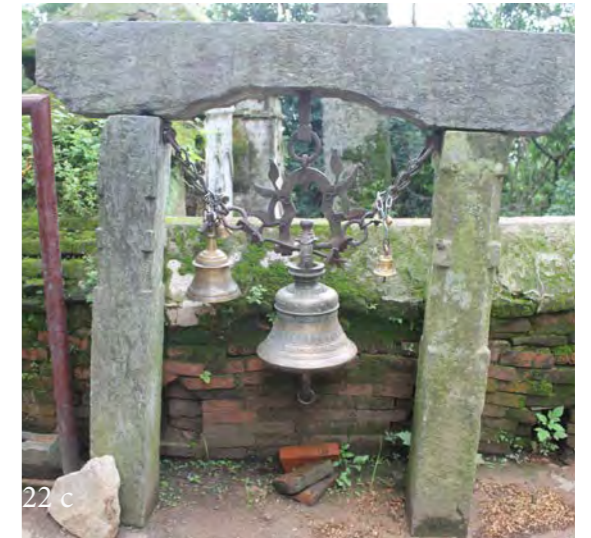
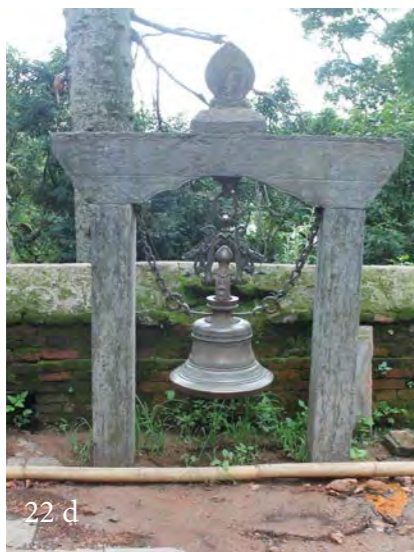
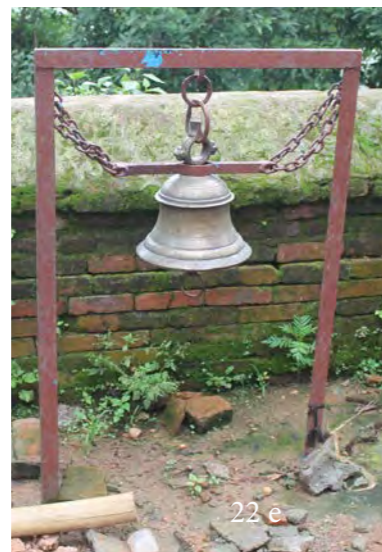
22 BELLS

NUMBER	NAME	ESTABLISHED DATE (A.D.)	TYPOLOGY	GENERAL DESCRIPTION	PROBLEMS DESCRIPTION	DANGER/ DESTROY
22			Bell	Stone and metal framed bells	a. Needs minor repair b - i. In good condition

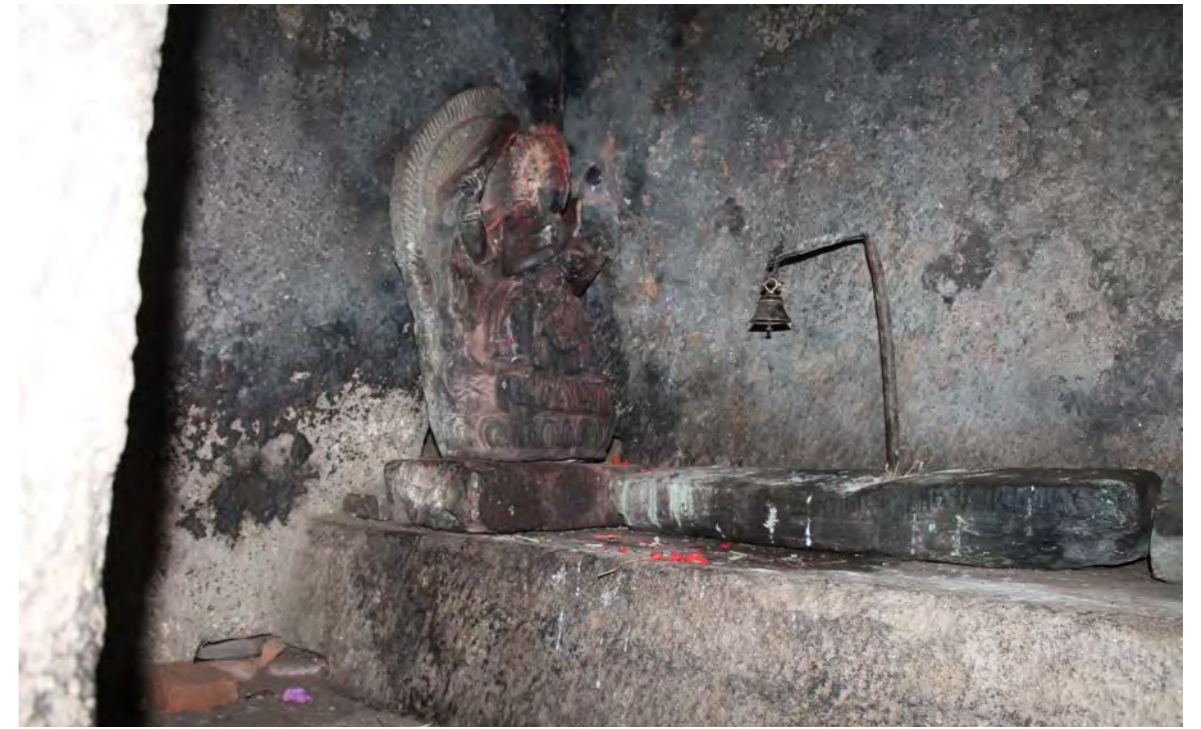
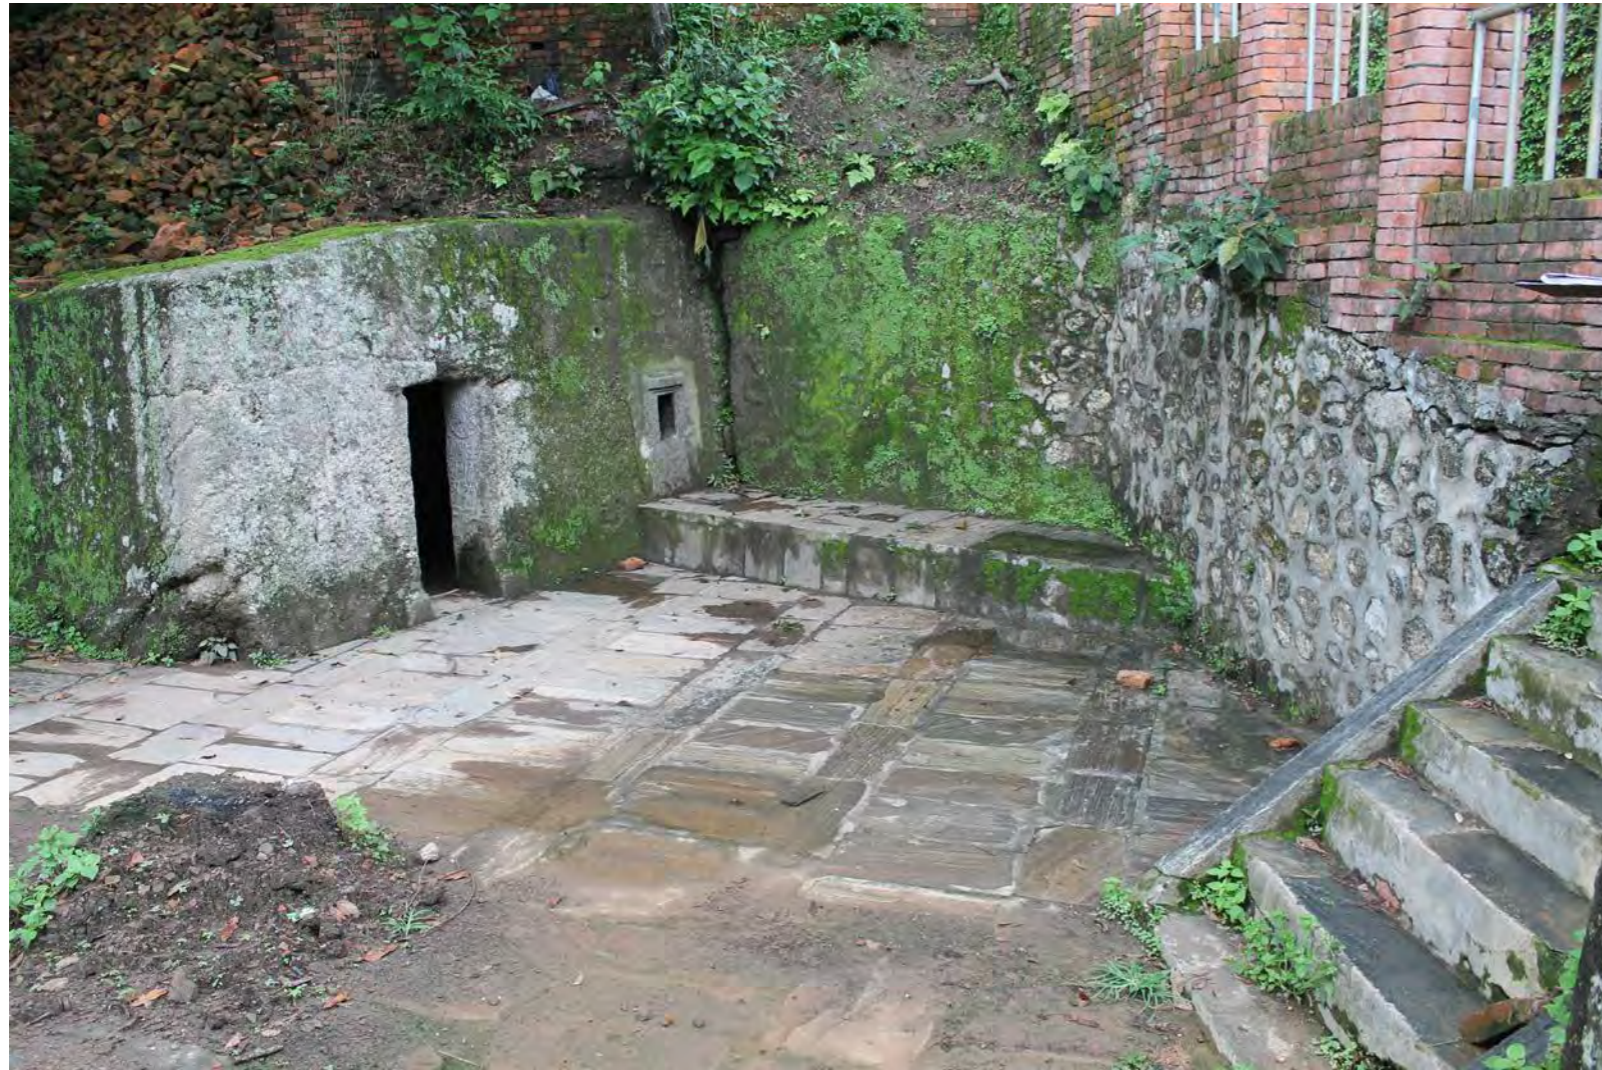
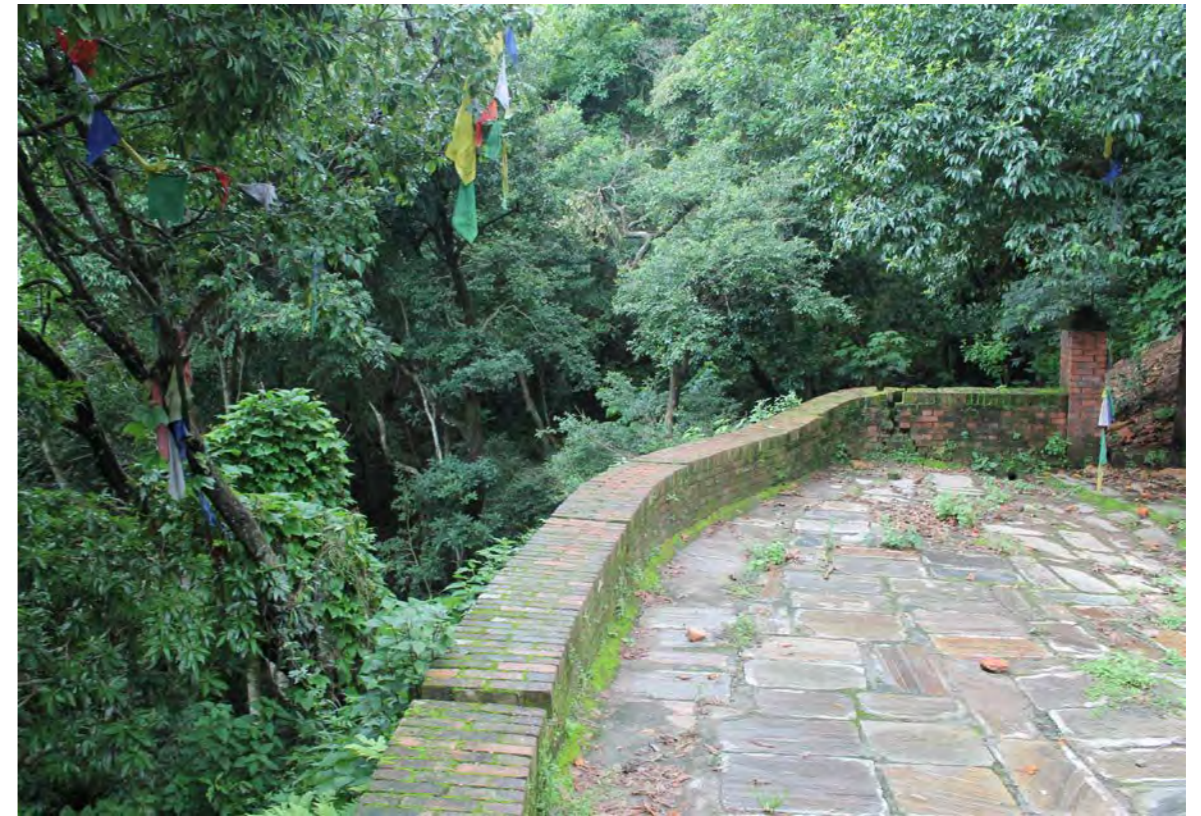
23 CAVE

NUMBER	NAME	DATE A.D.	TPOLOGY	GENERAL DESCRIPTION	PROBLEMS DESCRIPTION	DANGER/ DESTROY
23			Holy Cave	Stone Cave used for some occasions and ceremony	Needs maintainance
