2015 Earthquake Damage Mapping

Sankhu

October 2015

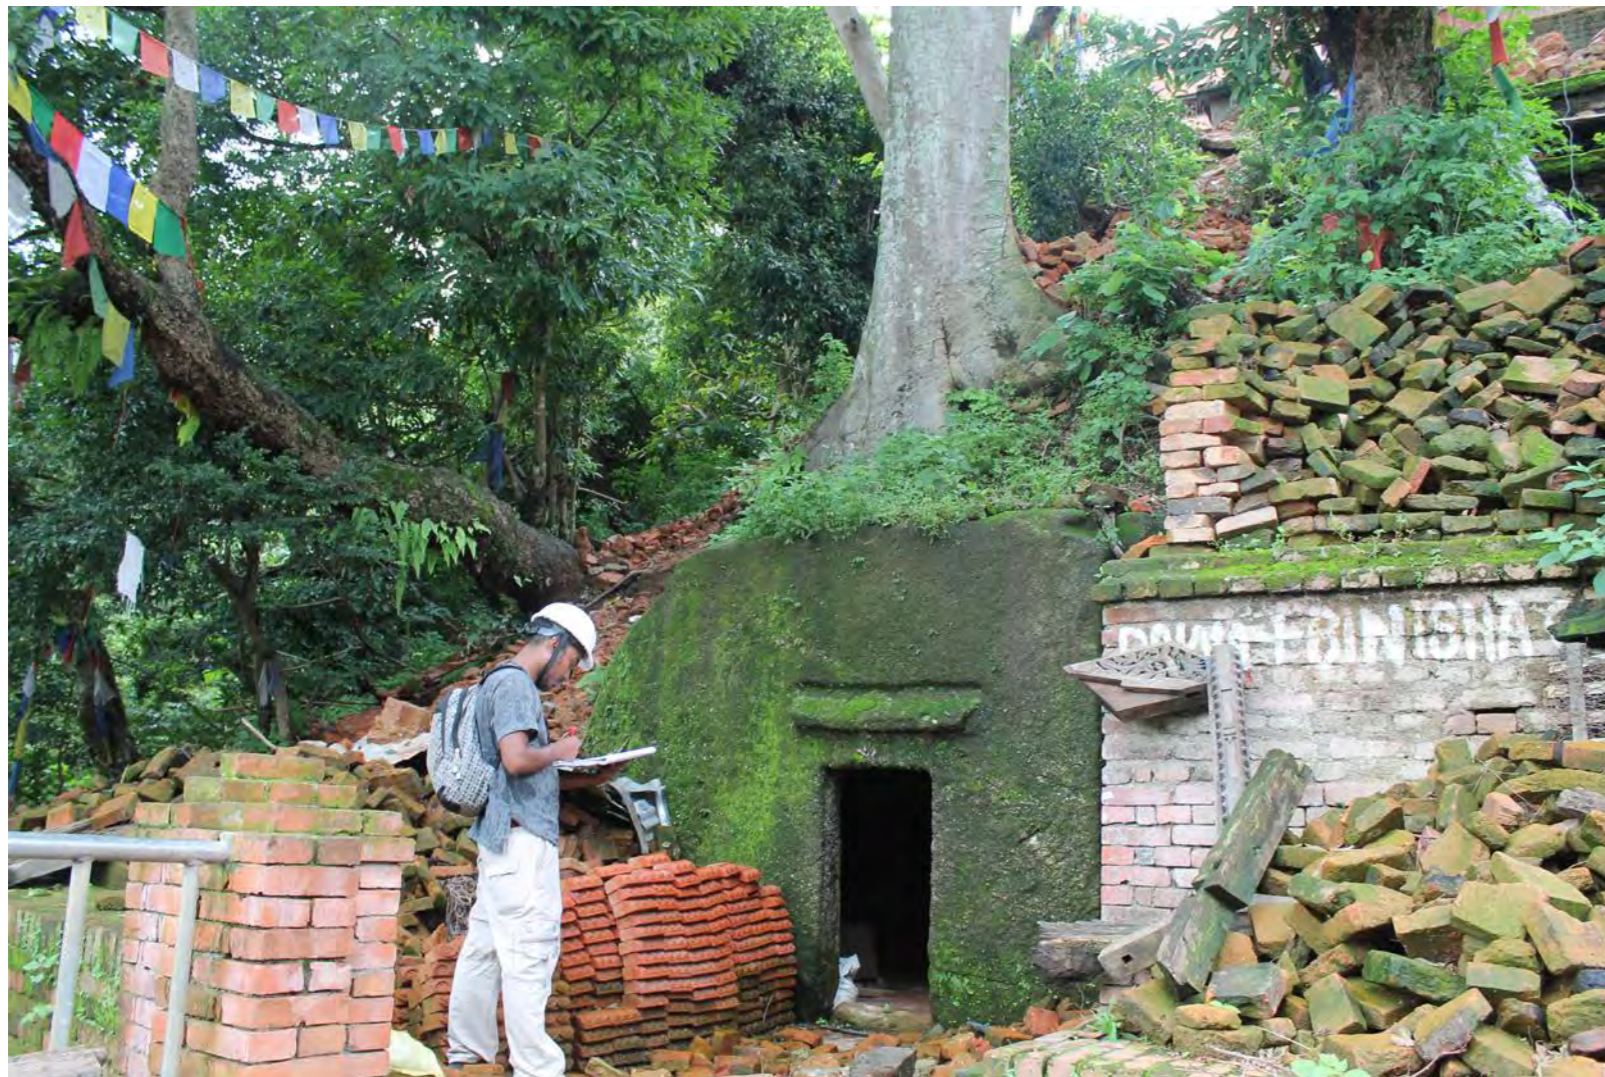
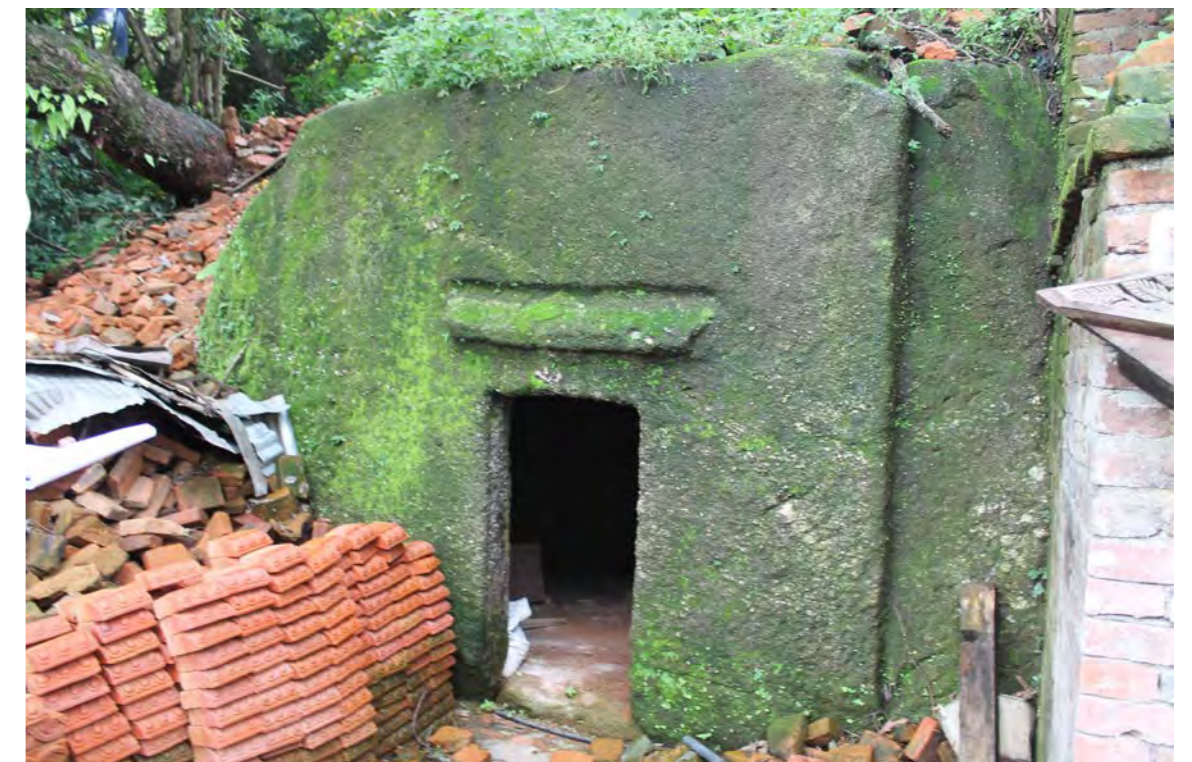
NUMBER	NAME	ESTABLISHED DATE (A.D.)	TYPOLOGY	GENERAL DESCRIPTION	PROBLEMS DESCRIPTION	DANGER/ DESTROY
24			Holy Cave	Stone Cave Used for some occasions and ceremony	Needs maintainance

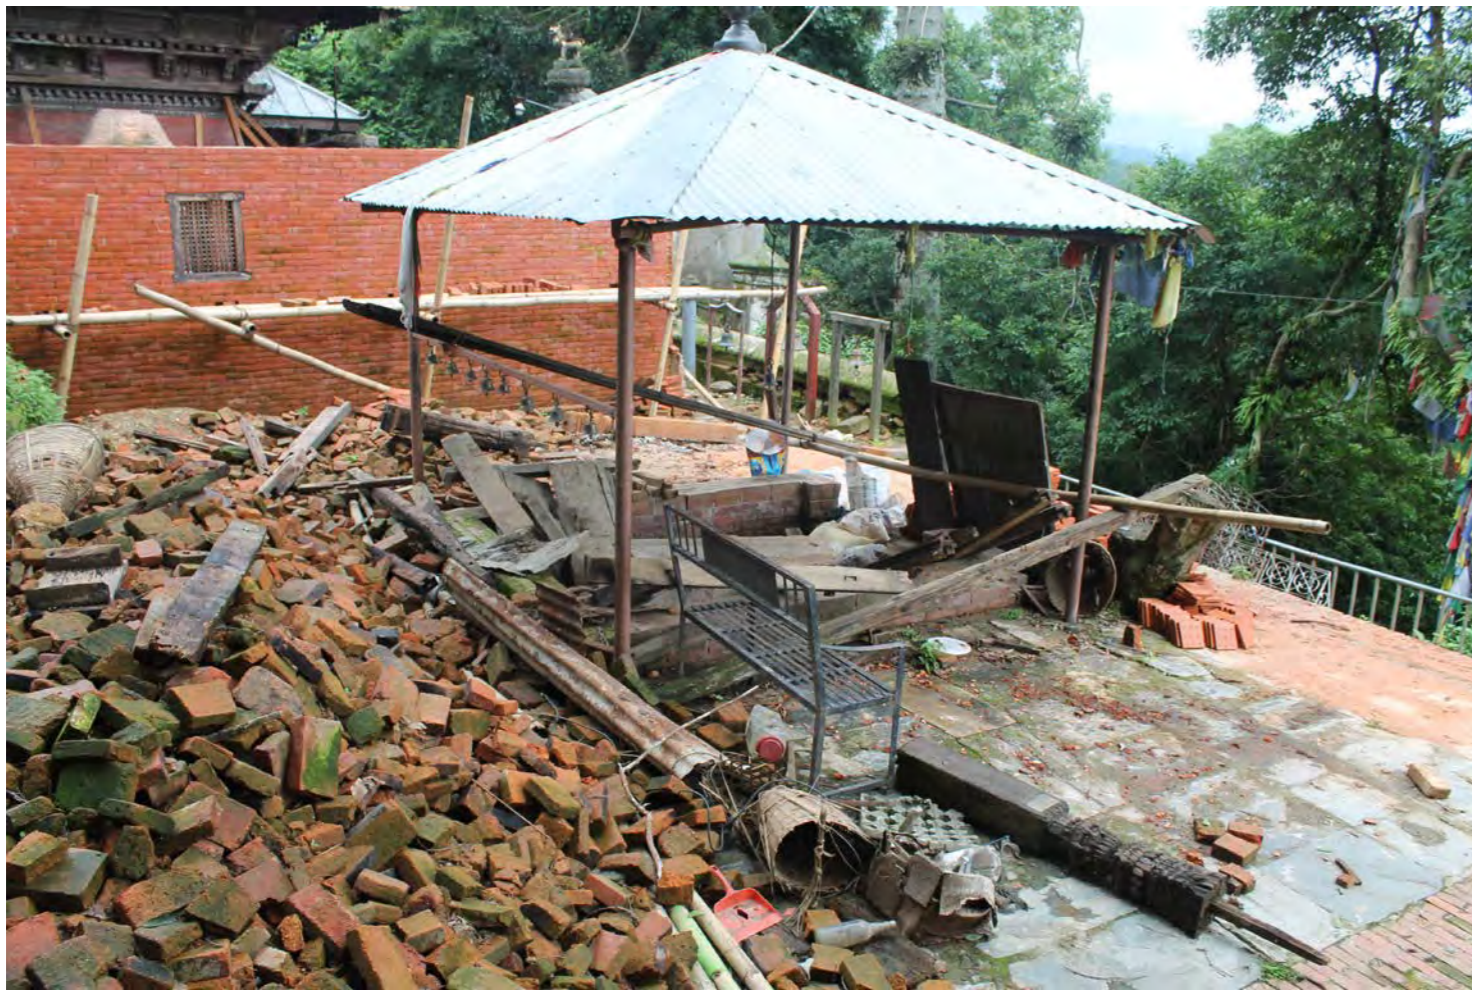
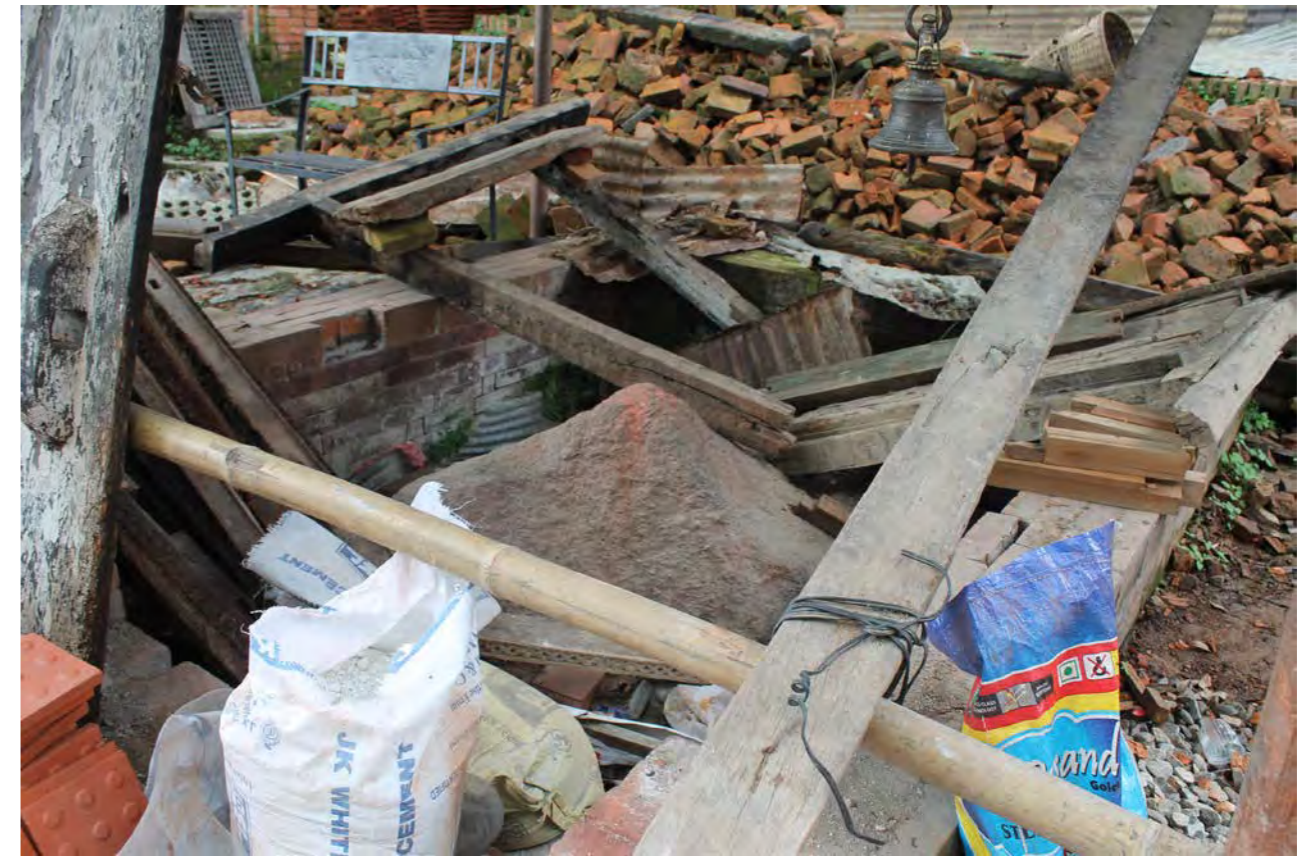
NUMBER	NAME	DATE A.D.	TPOLOGY	GENERAL DESCRIPTION	PROBLEMS DESCRIPTION	DANGER/ DESTROY	
25			Temple	Metal frame and CGI sheet under construction temple with stone statues at the middle	Needs proper care and attention Stones and wooden pieces piled near and around it

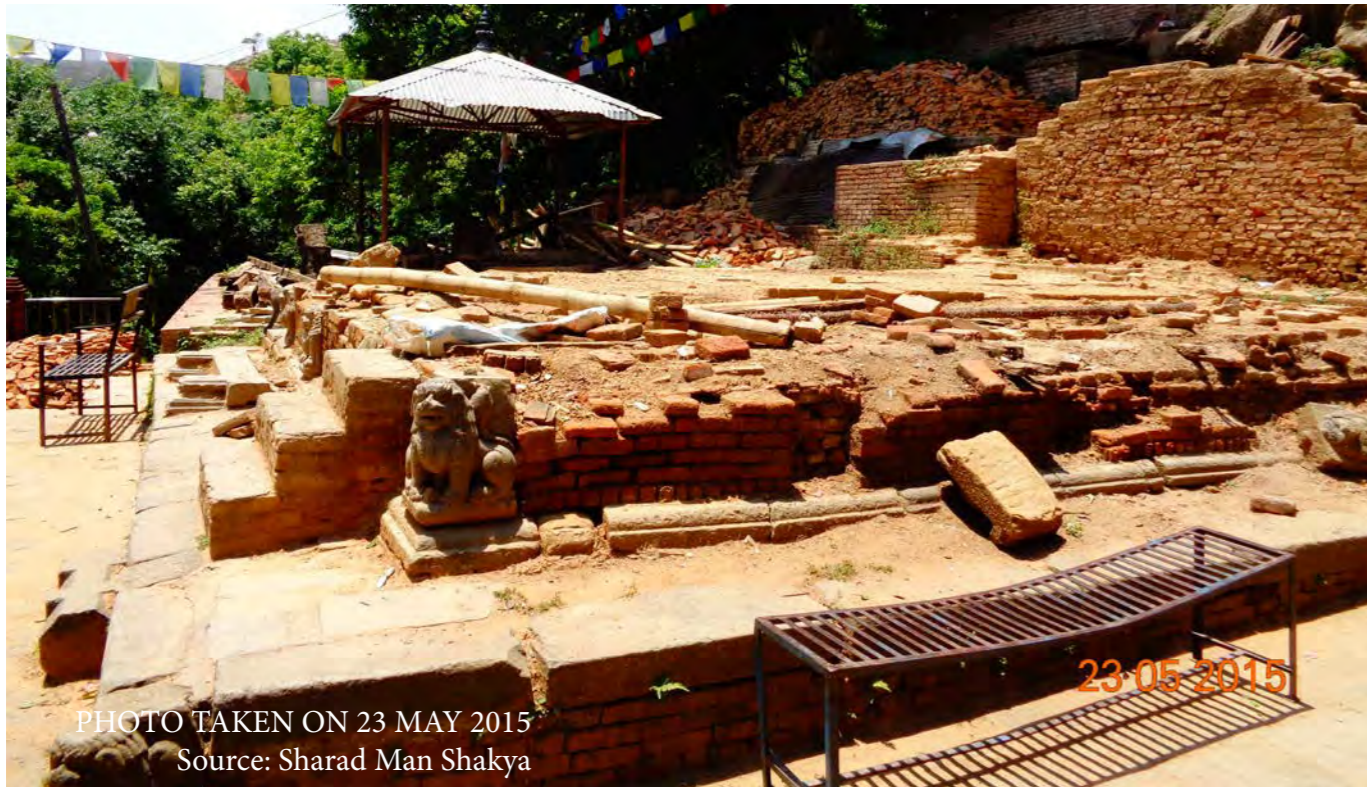
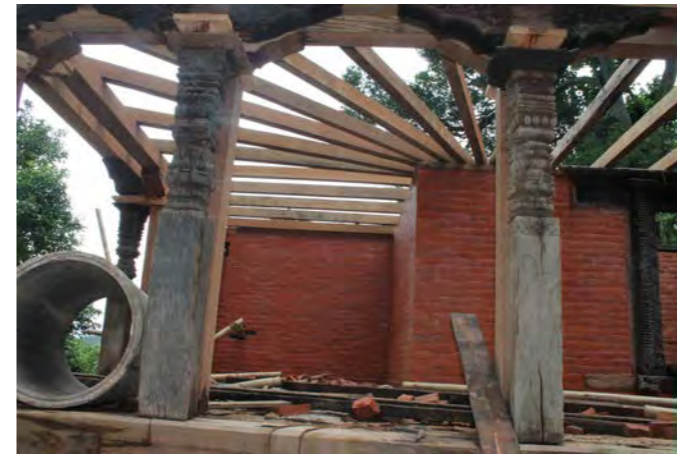
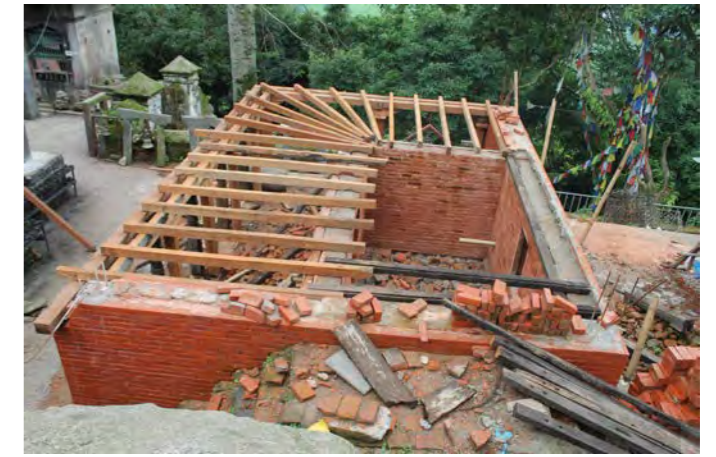
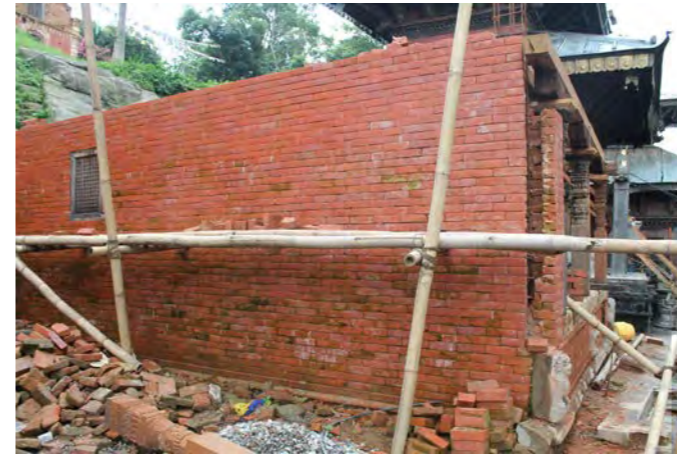
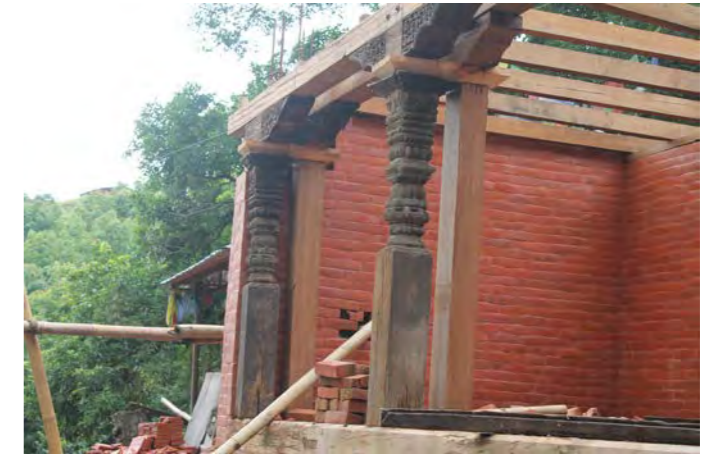
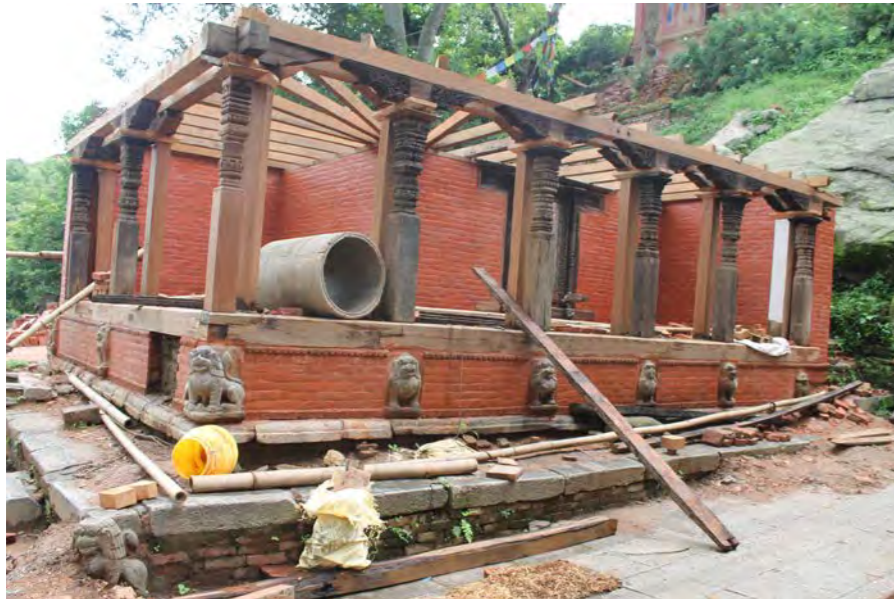
26- PATI

NUMBER	NAME	ESTABLISHED DATE (A.D.)	TYPOLOGY	GENERAL DESCRIPTION	PROBLEMS DESCRIPTION	DANGER/ DESTROY
26			Pati	Newly underconstruction brick structure with wooden columns and joists (both old and new wooden pieces are being used)	Totally collapsed. Now being reconstructed.

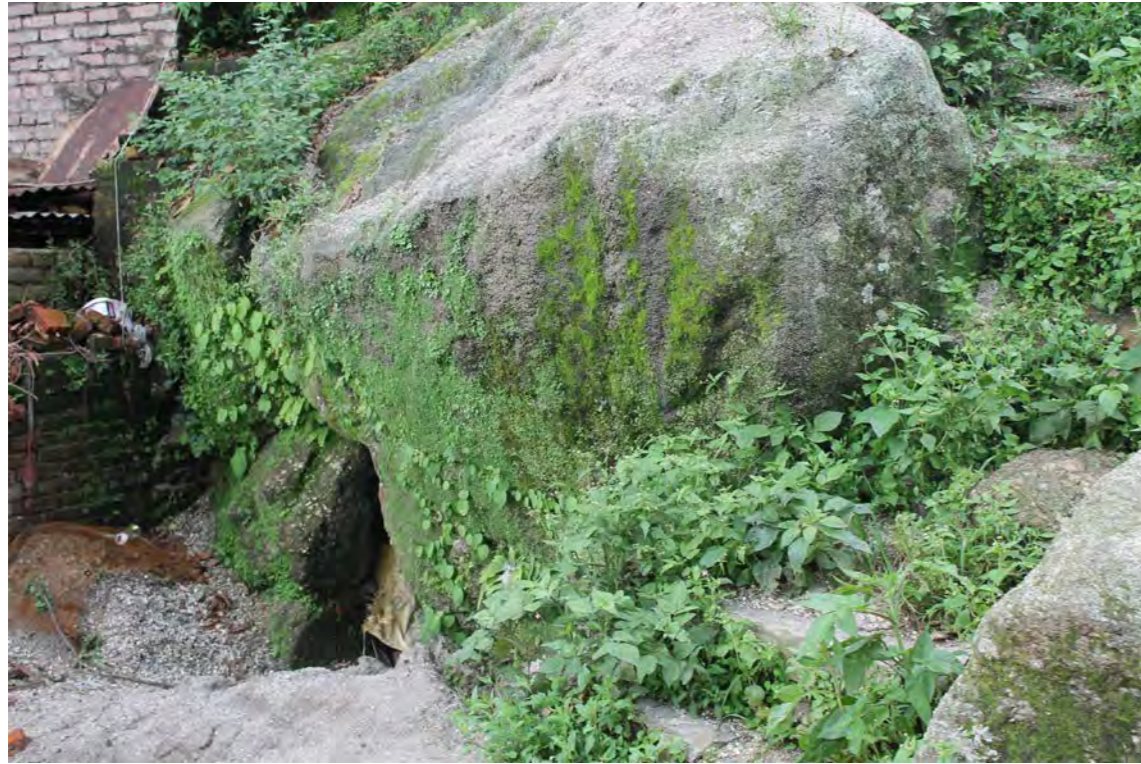
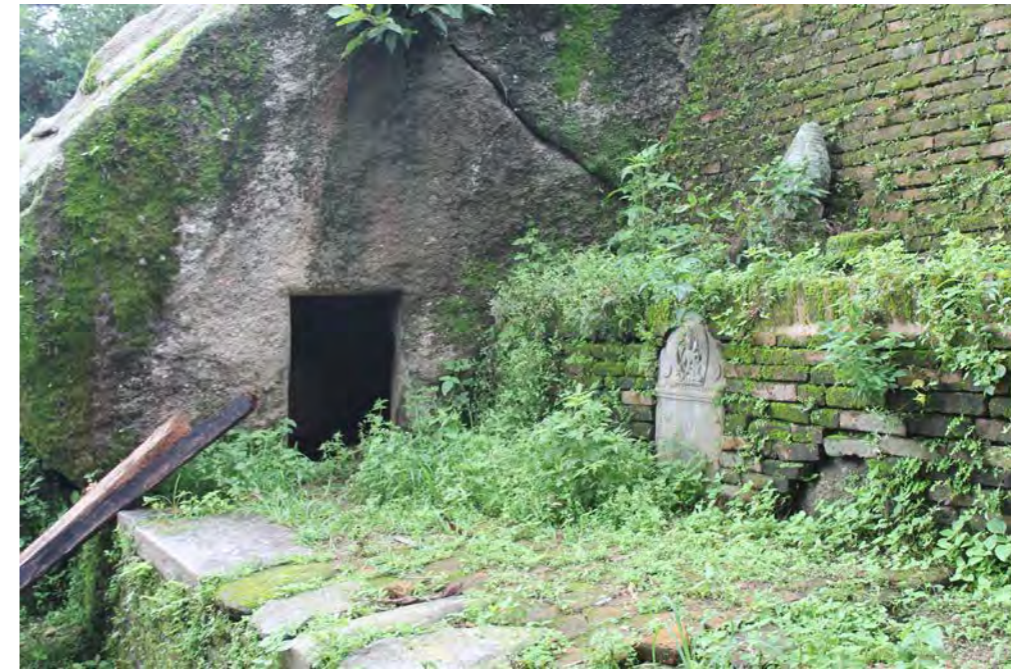
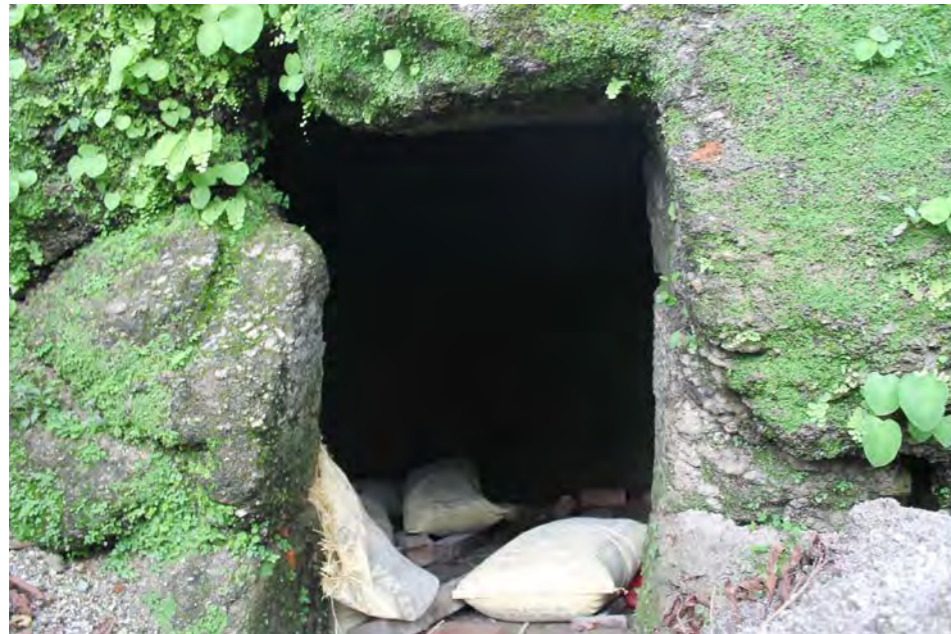
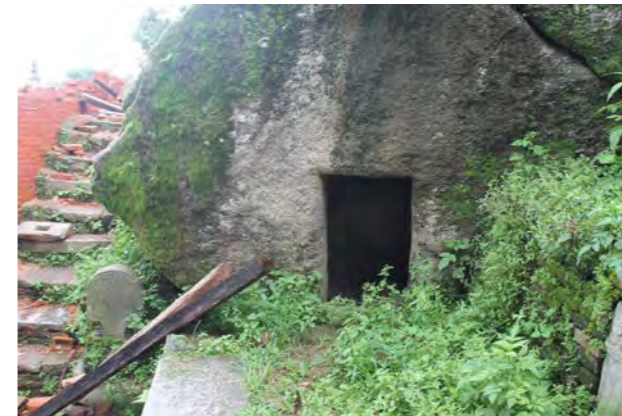
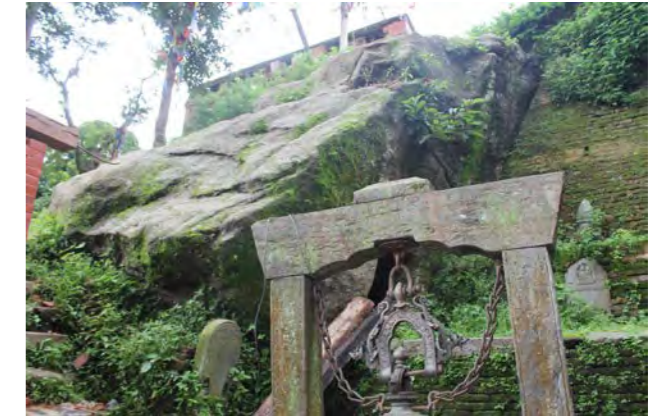
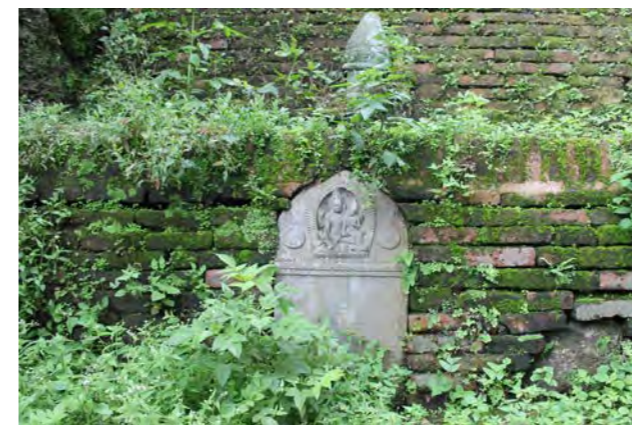
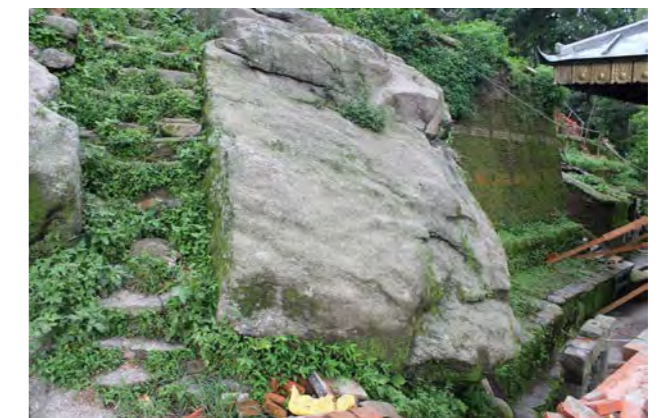
27, 28 CAVE

NUMBER	NAME	DATE A.D.	TPOLOGY	GENERAL DESCRIPTION	PROBLEMS DESCRIPTION	DANGER/ DESTROY	
27, 28			Holy Cave	Stone cave used by devotees	Needs repair

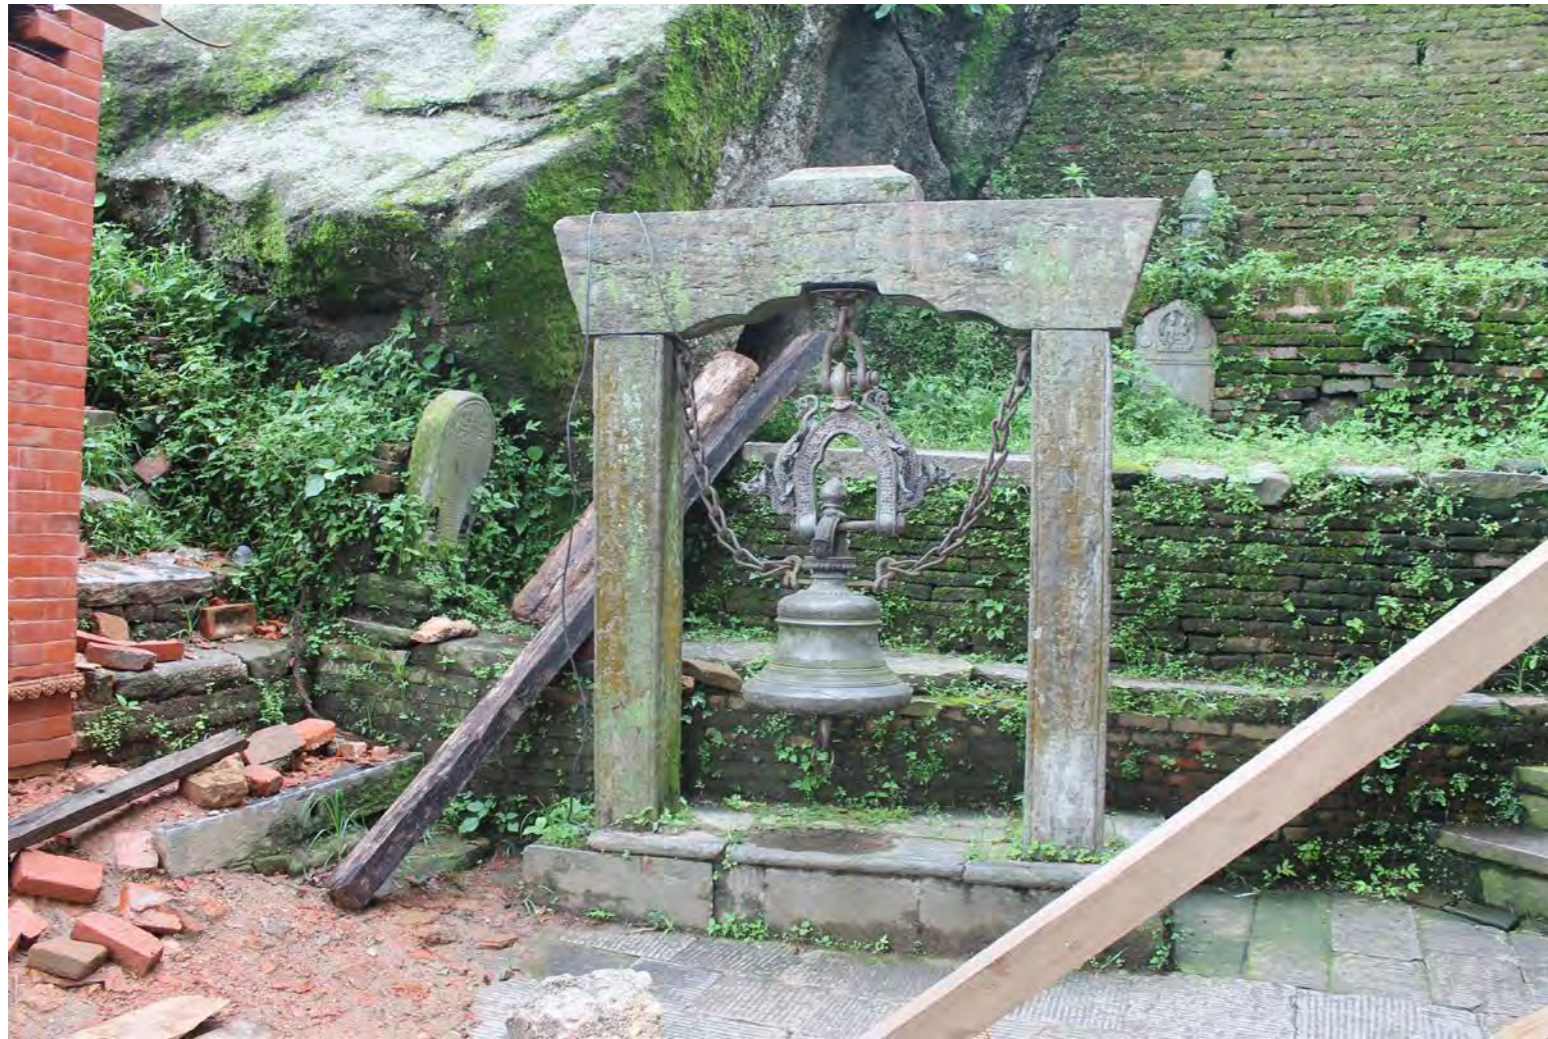
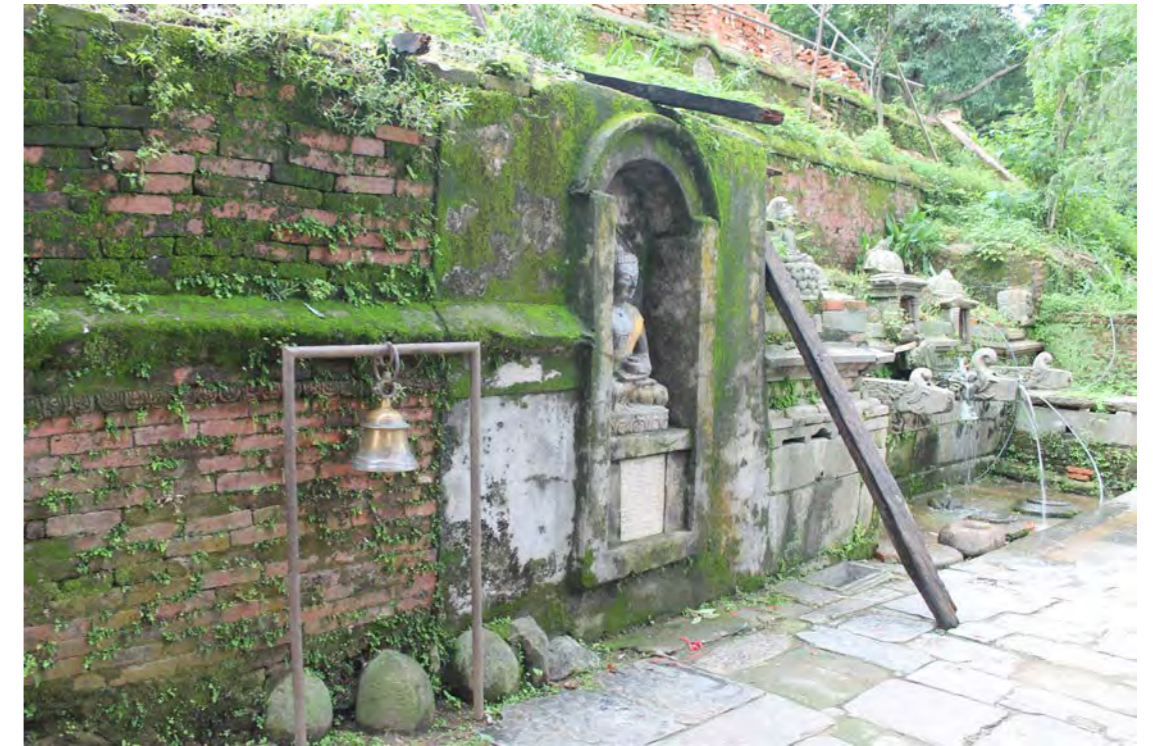
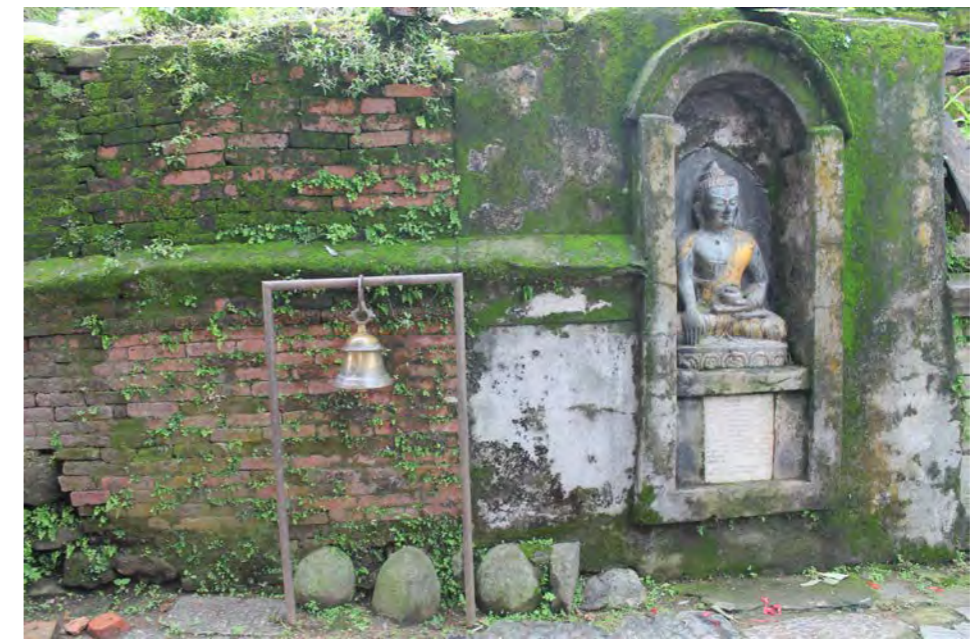
29 BELL

NUMBER	NAME	ESTABLISHED DATE (A.D.)	TYPOLOGY	GENERAL DESCRIPTION	PROBLEMS DESCRIPTION	DANGER/ DESTROY	
29			Bell	Stone framed bell	Good Condition		
30	Buddha Statue		Open Shrine	Stone statue of Buddha on brick framed shrine	Needs maintainance

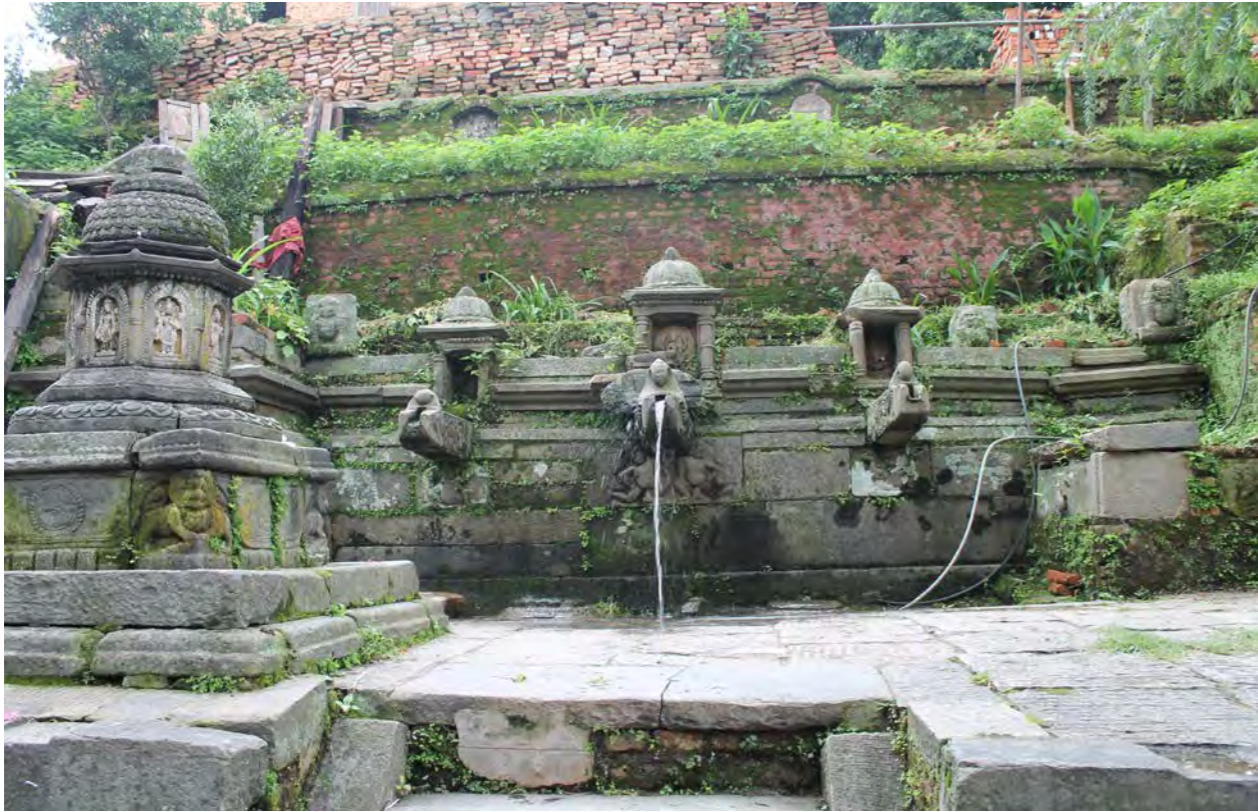
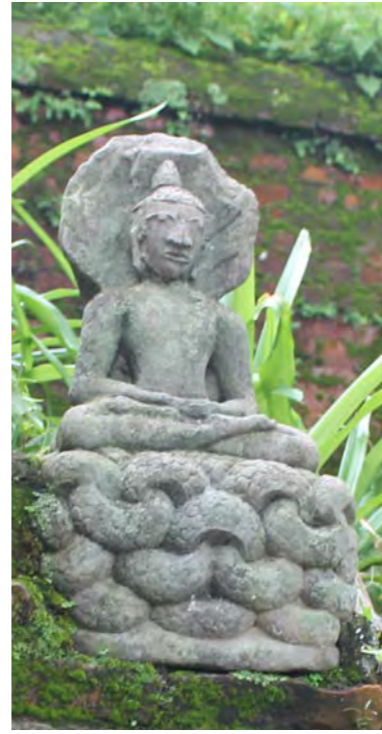
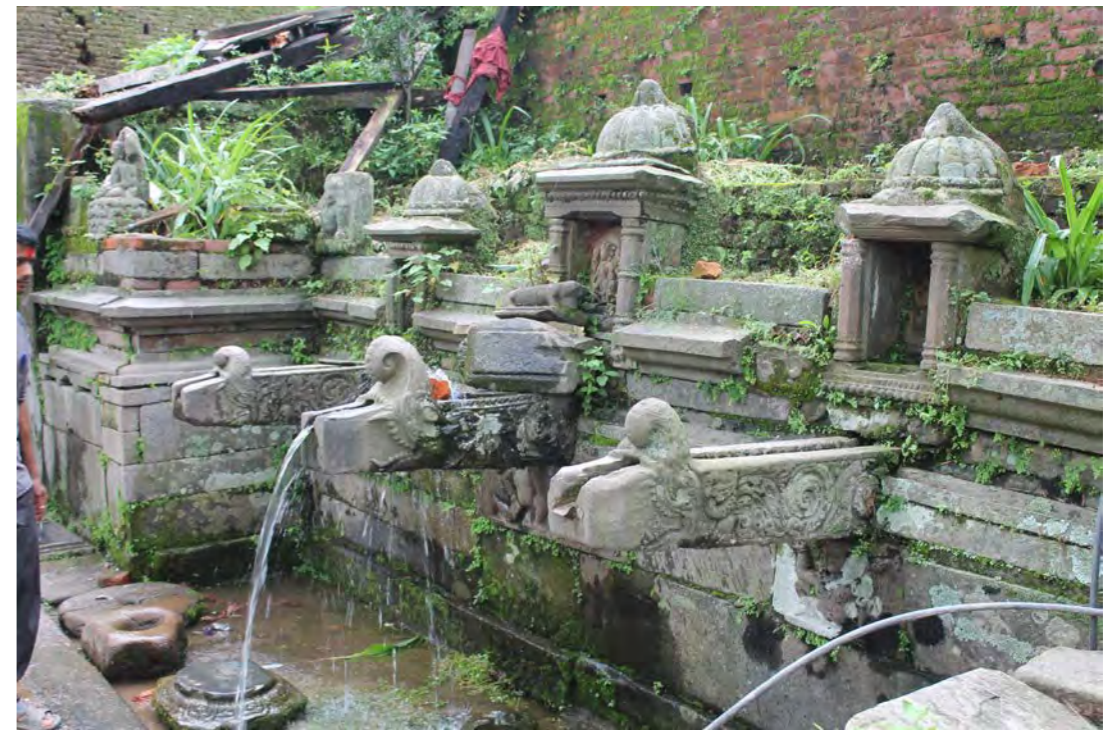
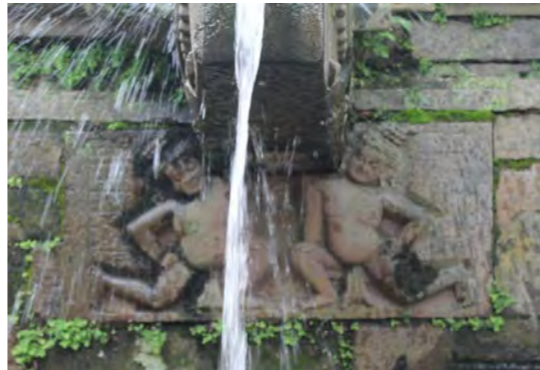
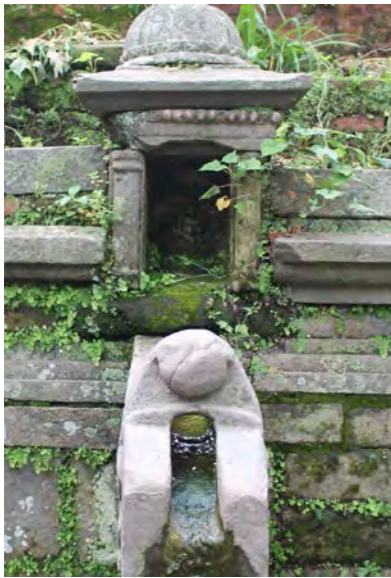
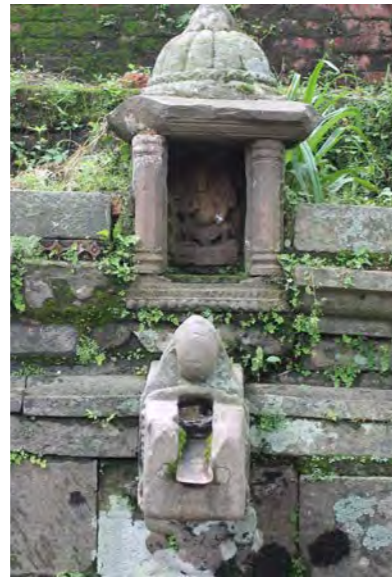
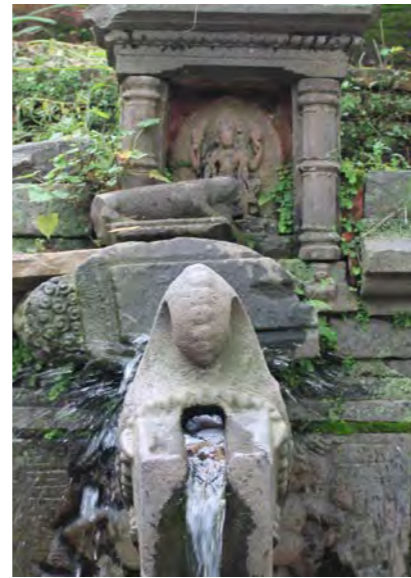
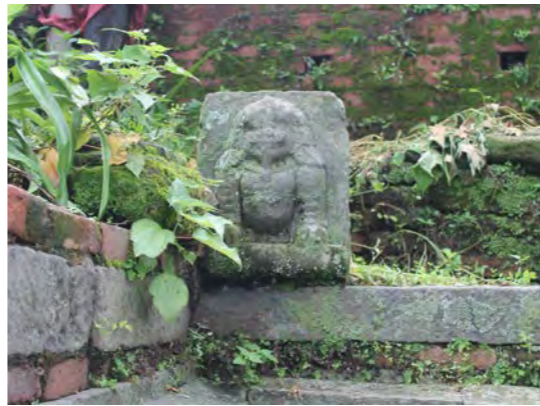
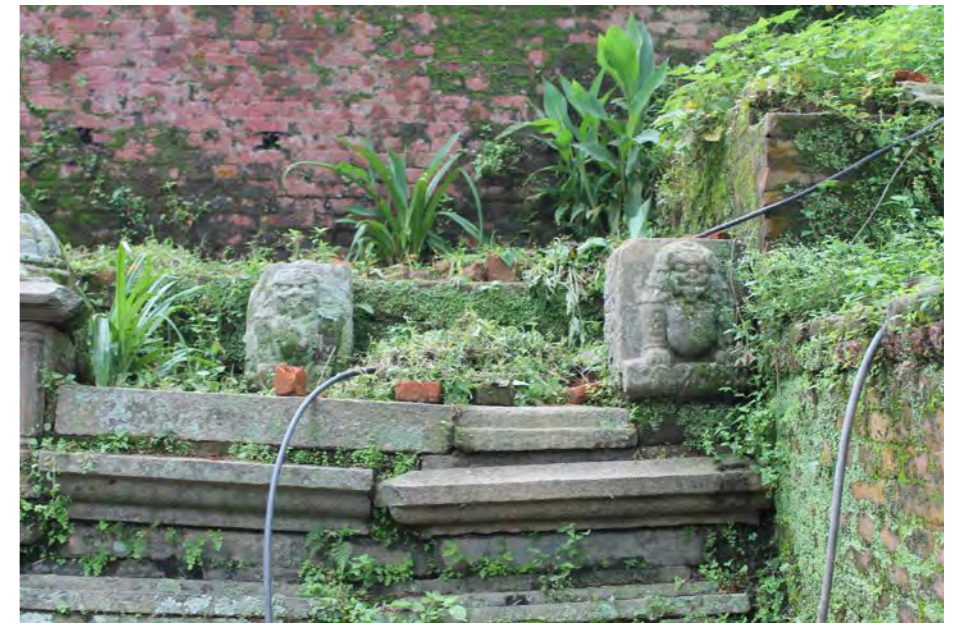
NUMBER	NAME	DATE A.D.	TYOLOGY	GENERAL DESCRIPTION	PROBLEMS DESCRIPTION	DANGER/ DESTROY
31			Hiti	Stone water spouts	Full of vegetation Needs maintainance

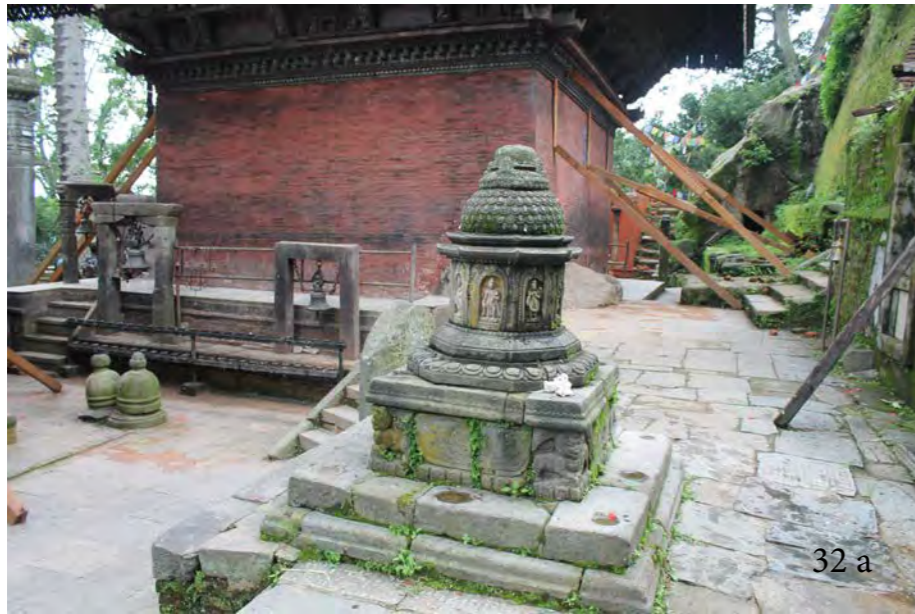
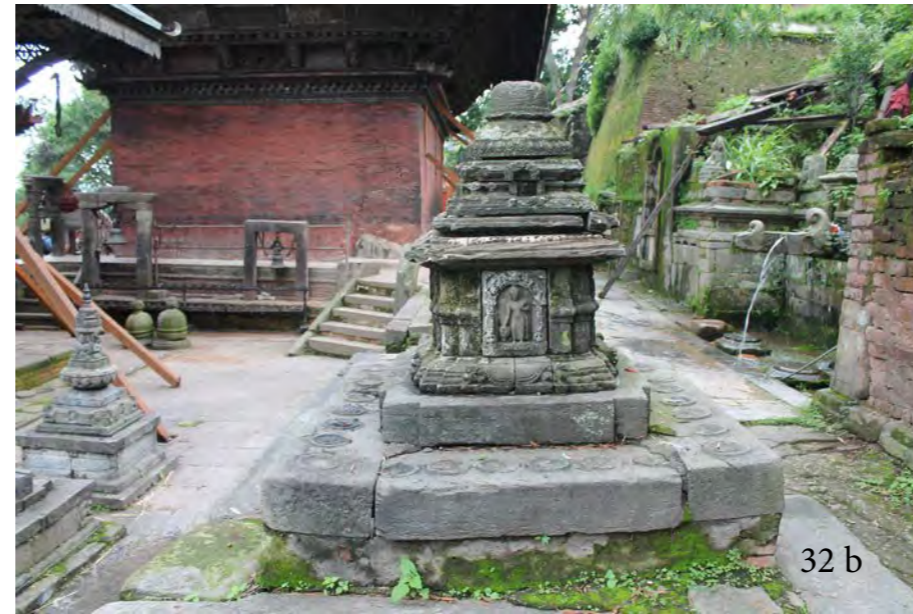
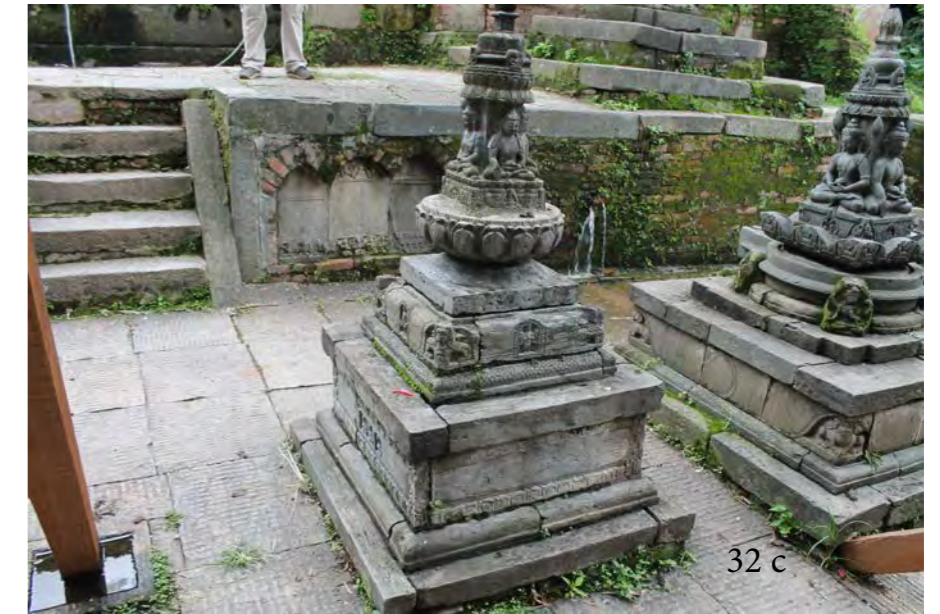
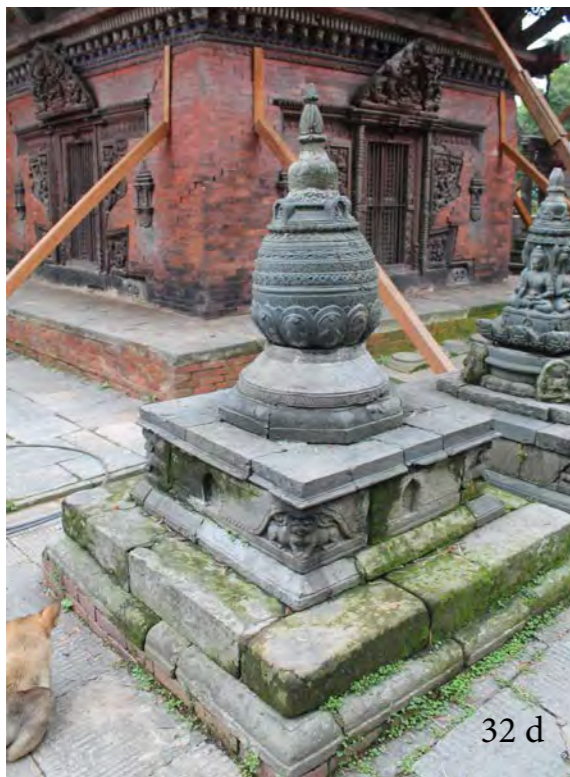
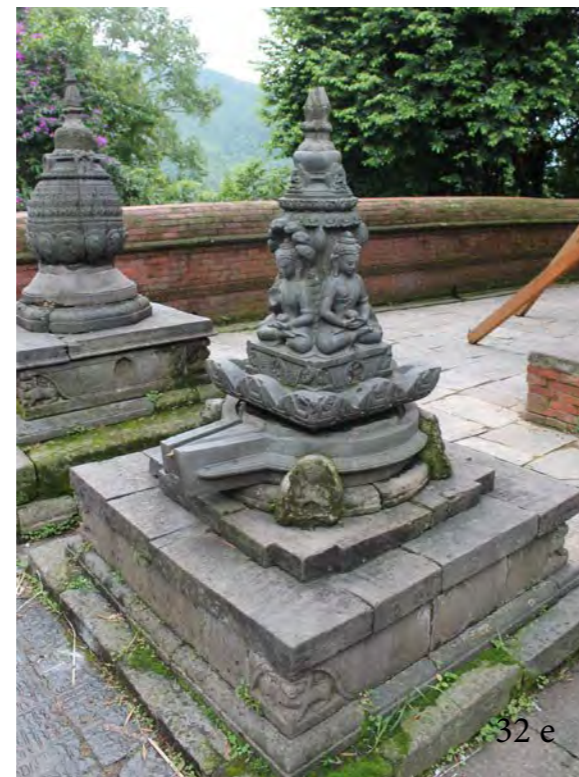
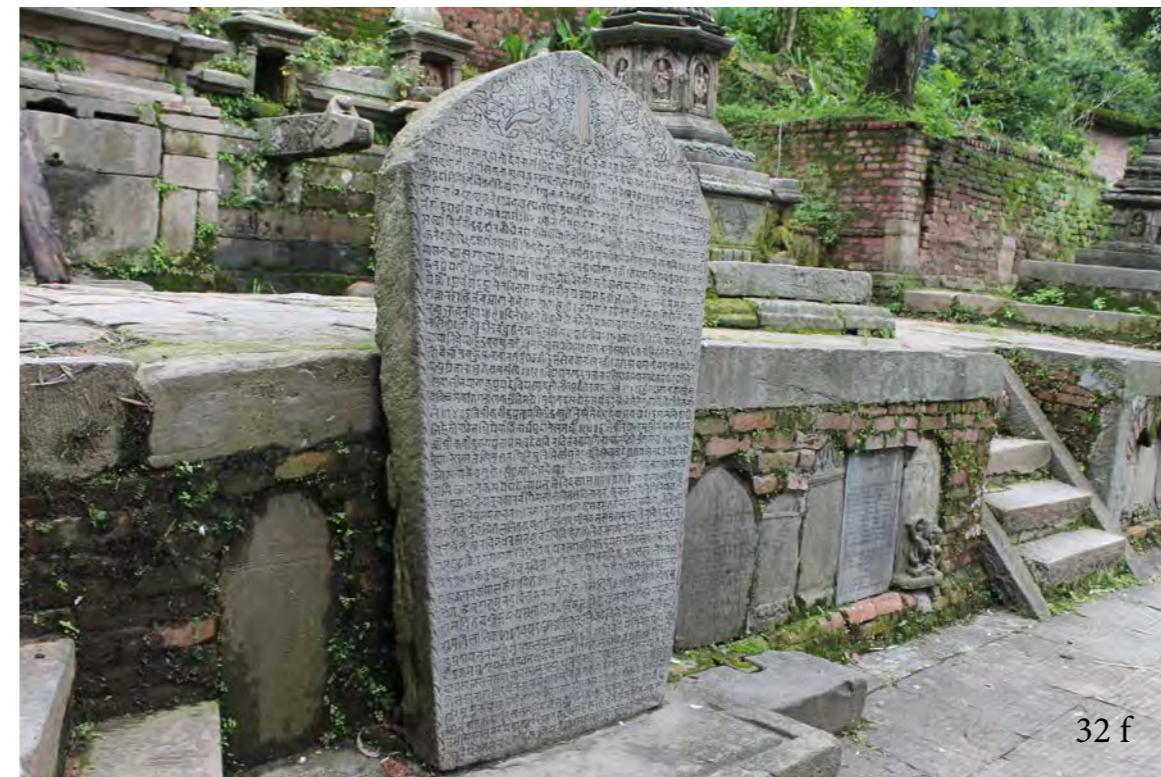
32 a-e CHAITYA, 32f INSCRIPTION

NUMBER	NAME	ESTABLISHED DATE (A.D.)	TYPOLOGY	GENERAL DESCRIPTION	PROBLEMS DESCRIPTION	DANGER/ DESTROY
32 a-e			Chaityas	Stone structure	Needs repair and maintainance	
32 f			Inscription	Stone inscription	Good condition
