2015 Earthquake Damage Mapping

Sankhu

October 2015

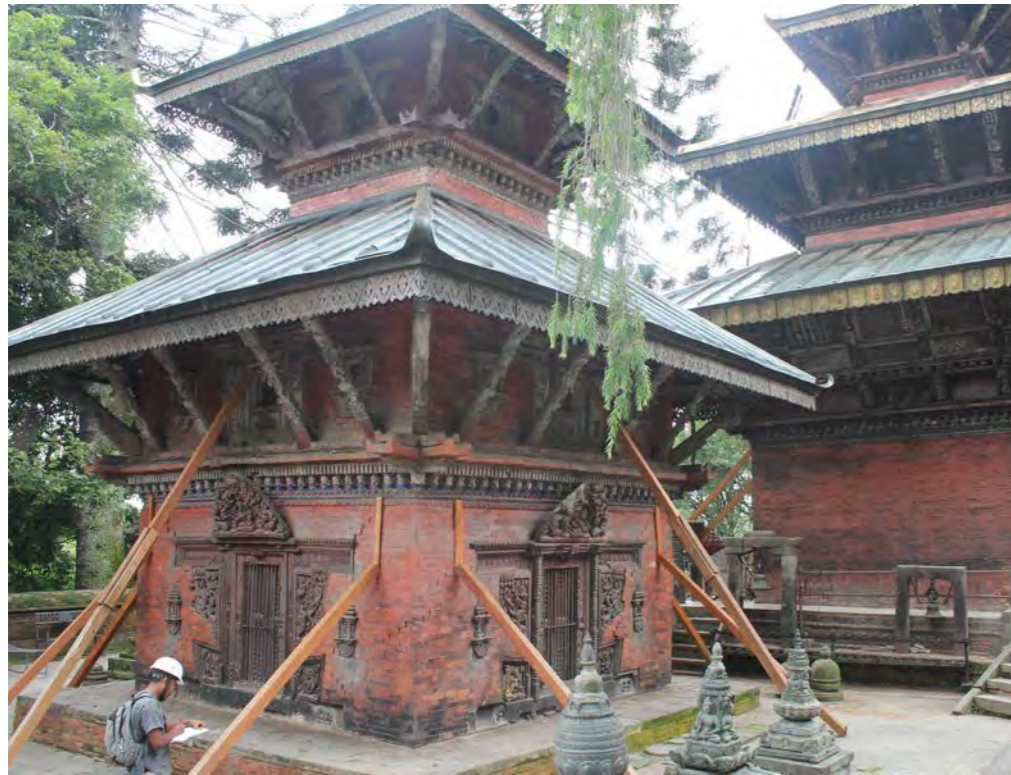
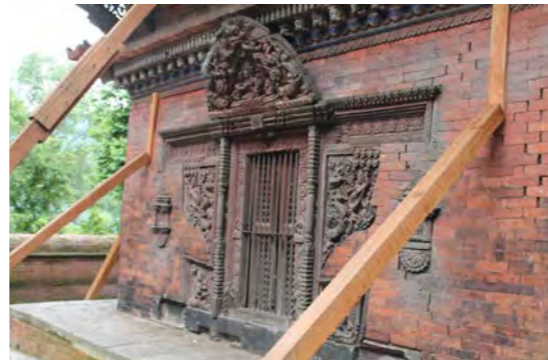
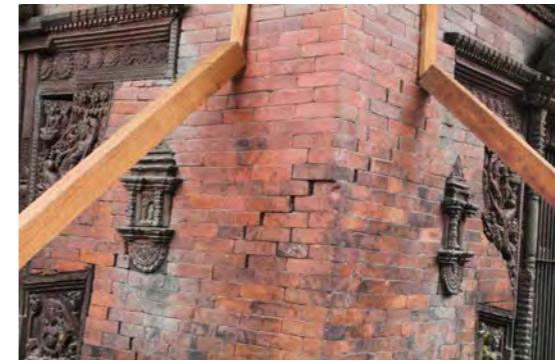
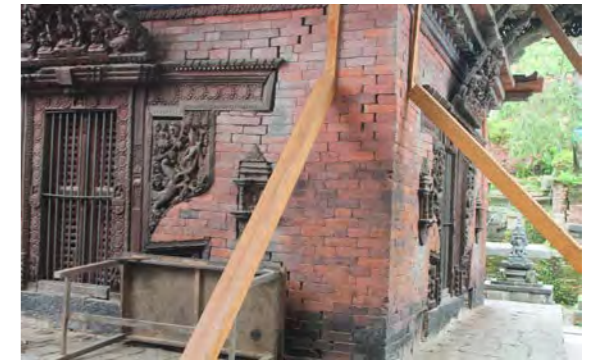
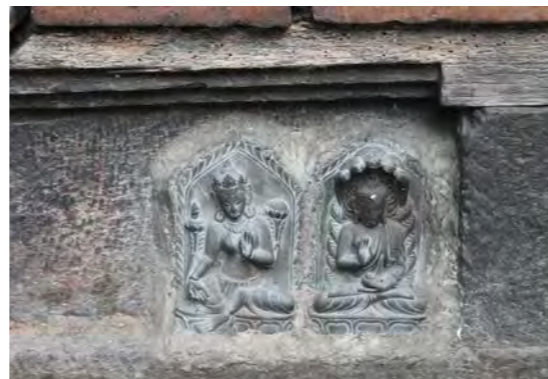
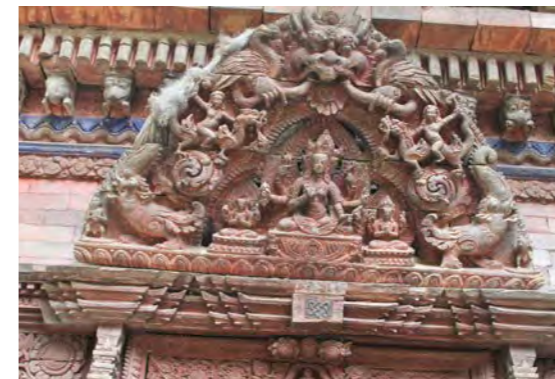
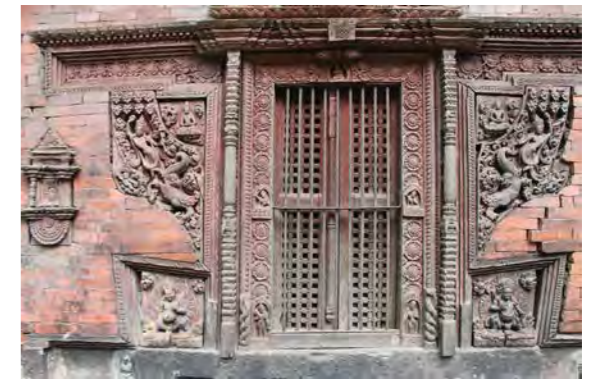
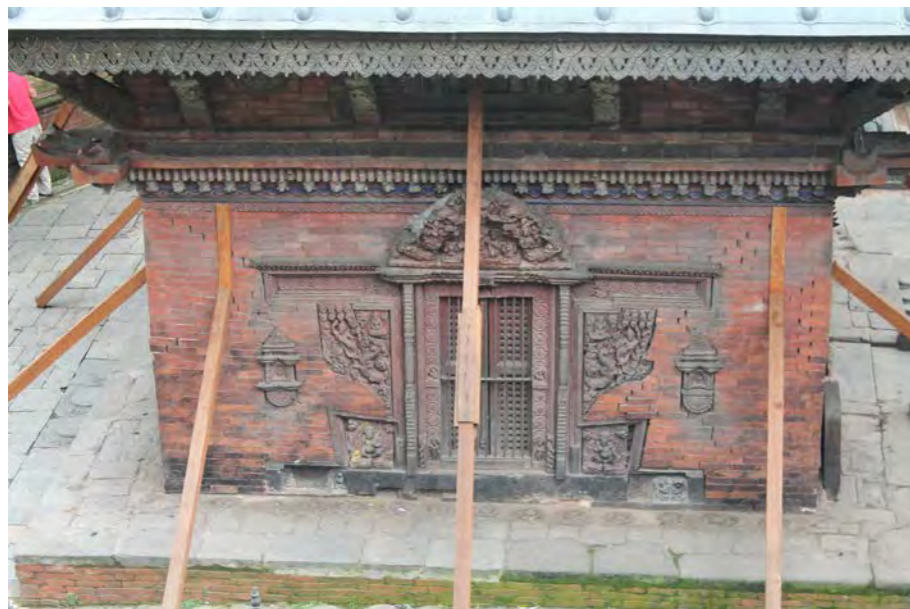
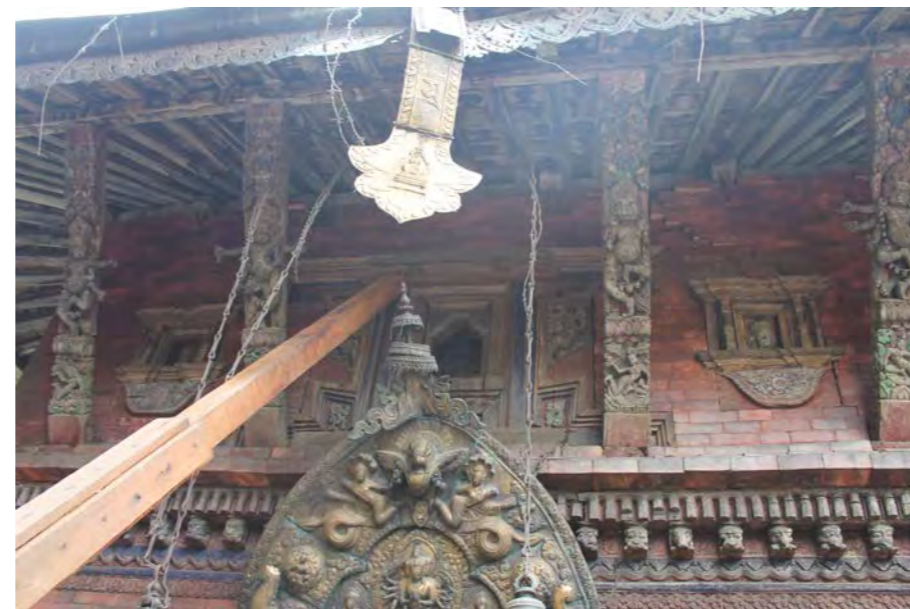
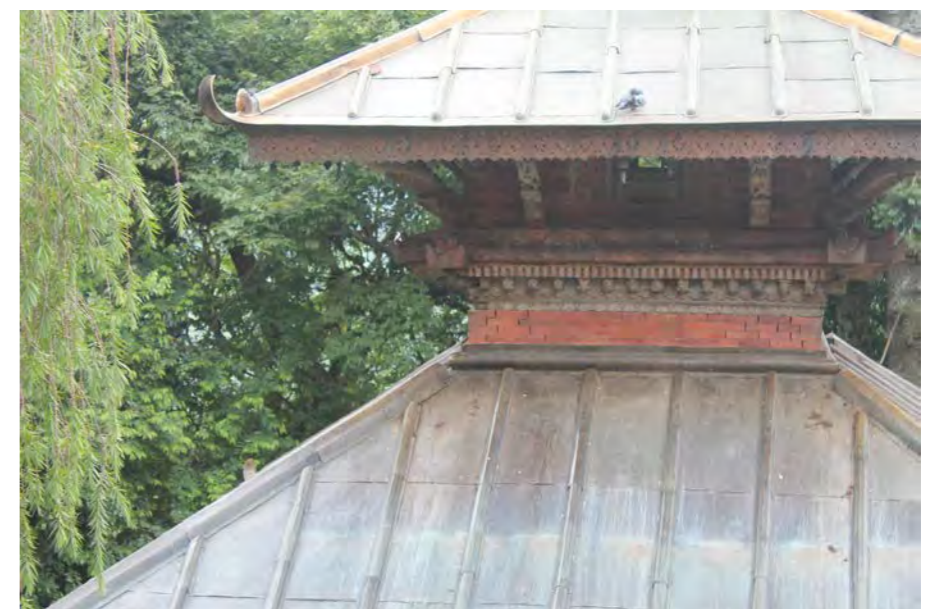
33 MULTI TIRED TEMPLE

NUMBER	NAME	DATE A.D.	TYPOLOGY	GENERAL DESCRIPTION	PROBLEMS DESCRIPTION	DANGER/ DESTROY
33			Multi tired temple	Two-tiered pagoda temple with Chibaha inside Brick structure with gilded metal roof	All façade corners cracking out E-façade with major stepped cracks and bulging out Temporary wooden shoring is done Wall cracks seen on upper levels too Roof damaged on W-part and S-part

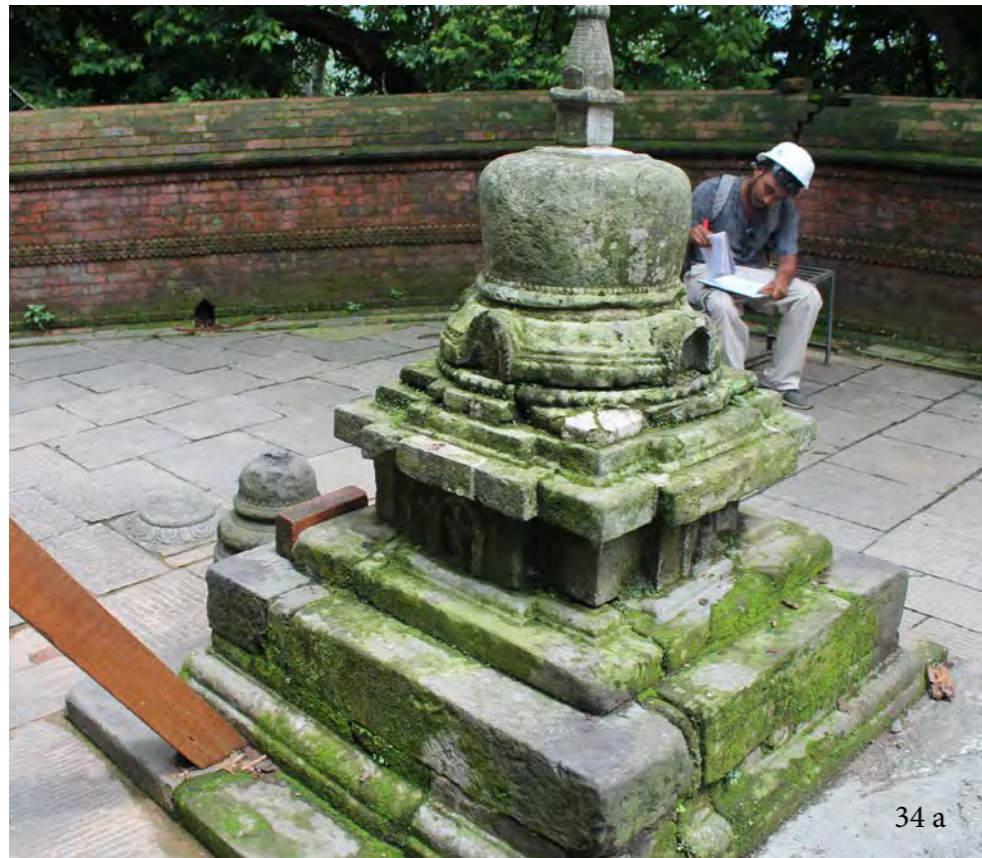
34 a

NUMBER	NAME	ESTABLISHED DATE (A.D.)	TYPOLOGY	GENERAL DESCRIPTION	PROBLEMS DESCRIPTION	DANGER/ DESTROY
34 a-c			Chaityas	Stone structure	Needs repair and maintainance Some parts damaged and missing

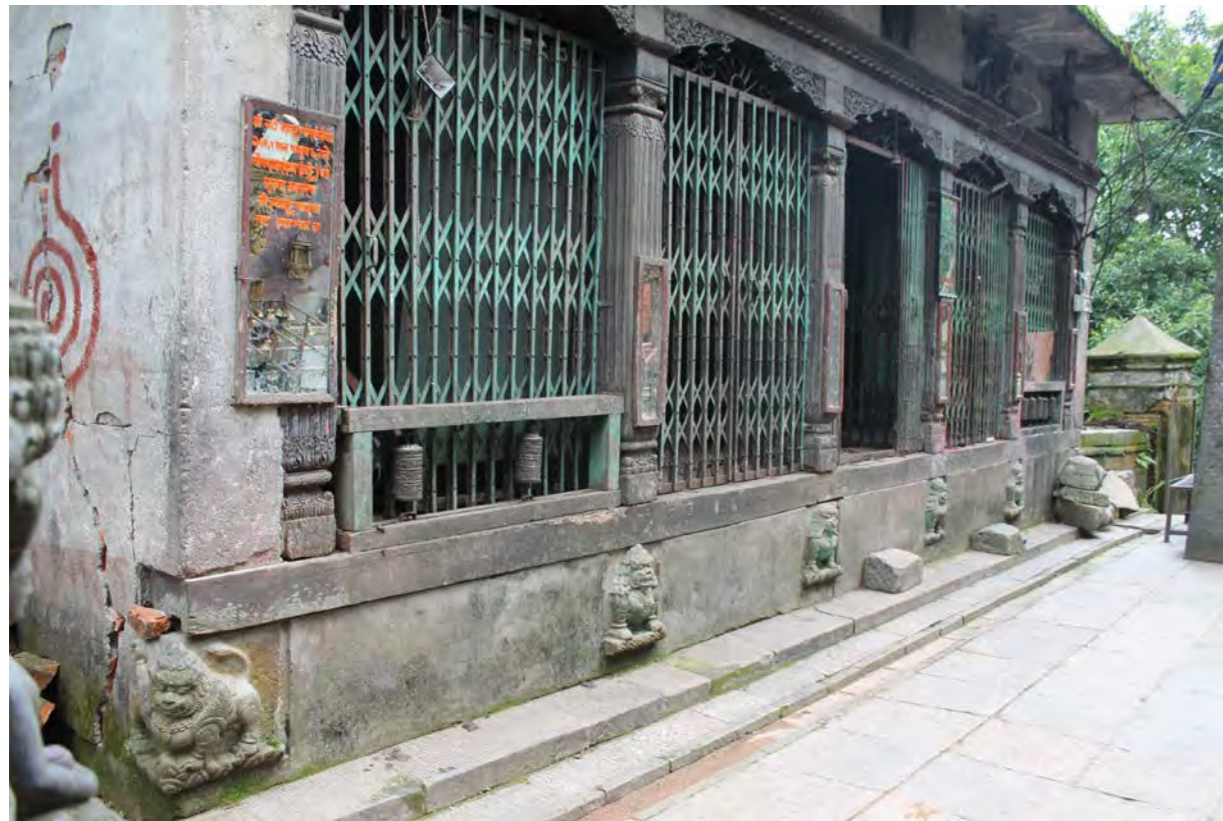
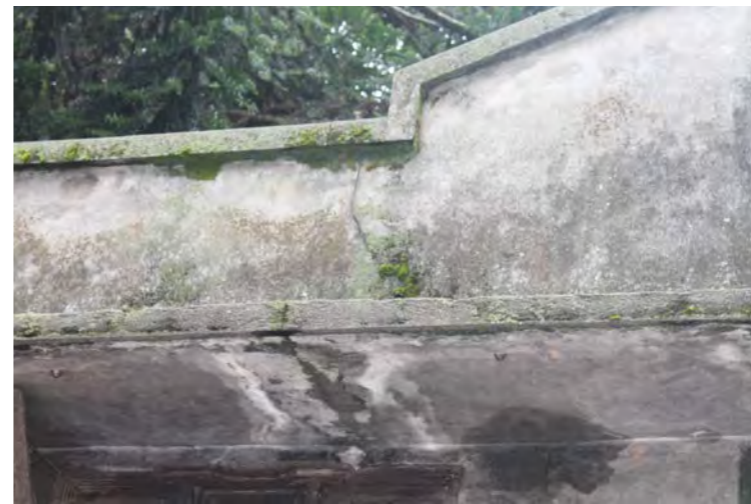
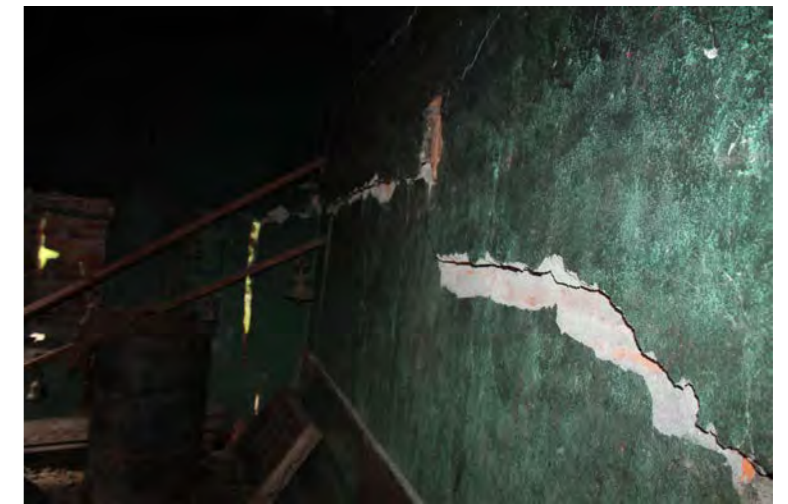
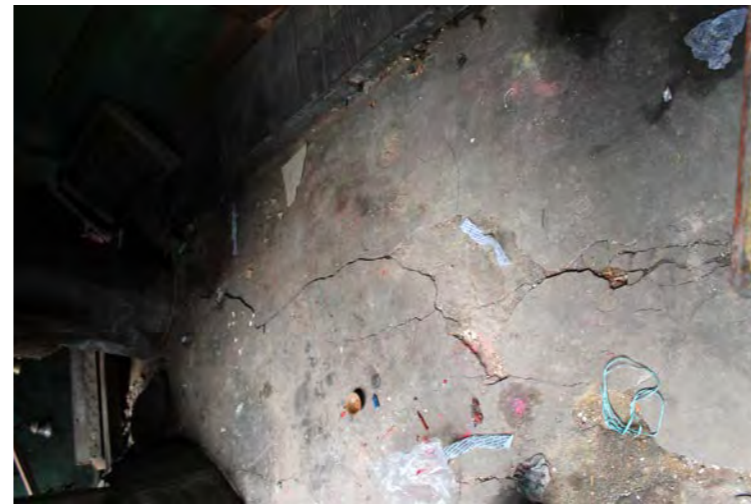
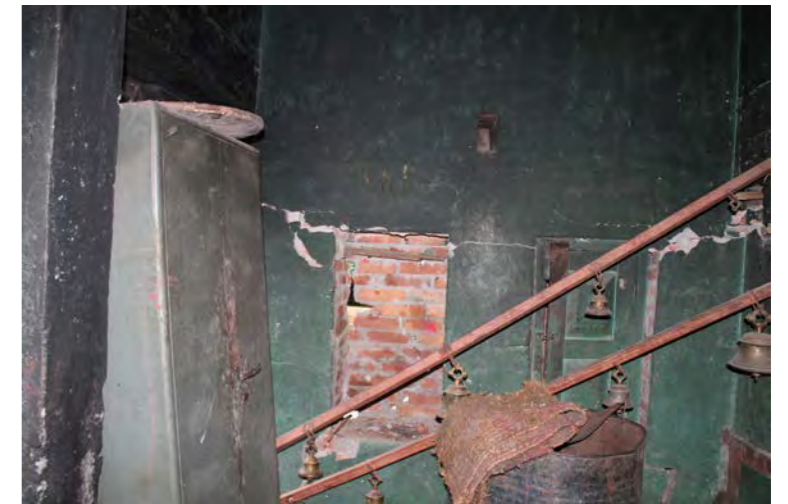
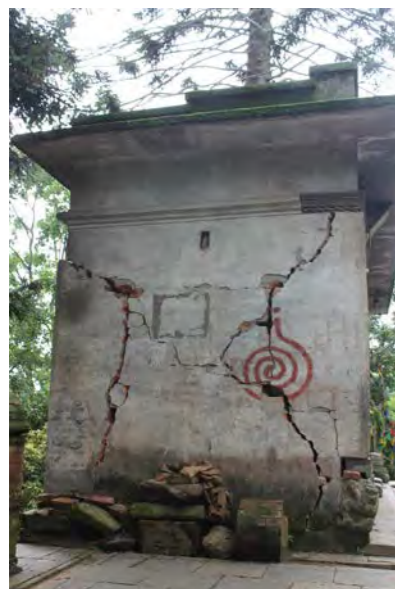
35 PATI

NUMBER	NAME	DATE A.D.	TYPOLOGY	GENERAL DESCRIPTION	PROBLEMS DESCRIPTION	DANGER/ DESTROY
35	Bajrayogini Bhajan Pati		Pati	Brick masonry structure with concrete slab combined with wooden pillars and joists Plastered with cement	E-wall severely damaged and major cracks of about 4-5 cms Floor cracked and subsidence of floor portion S-wall with offset cracks due to sunsidence of floor W-wall with major diagonal cracks Inner S-wall with horizontal cracks

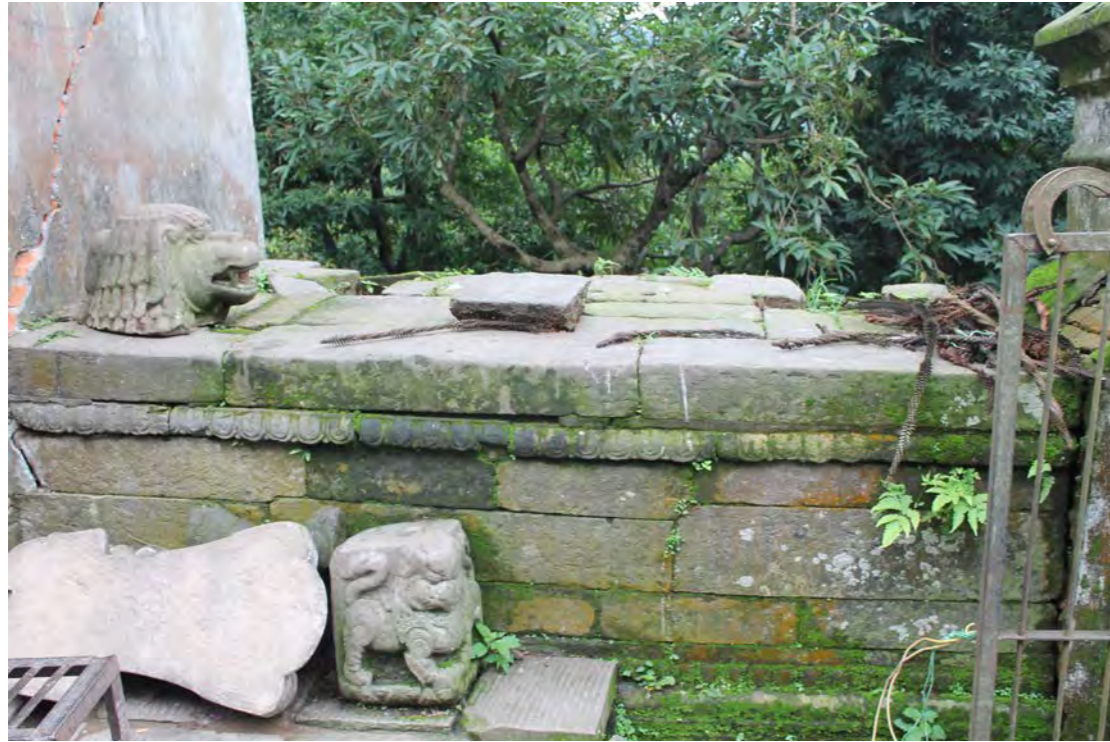
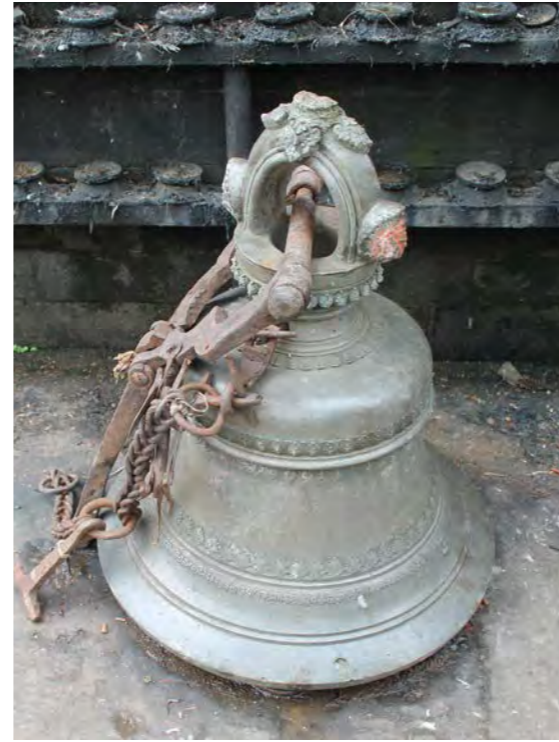
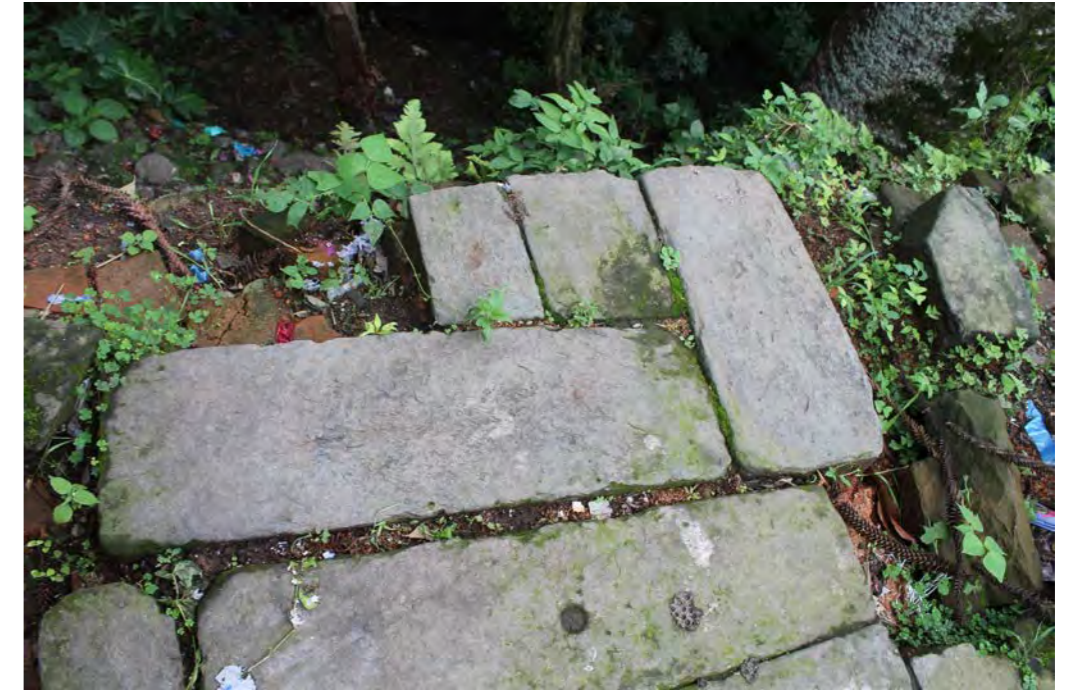
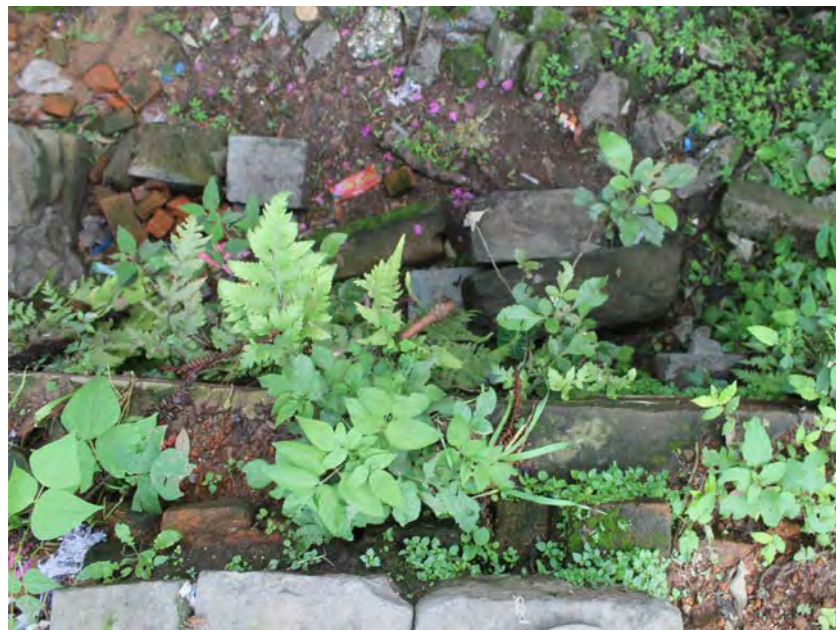
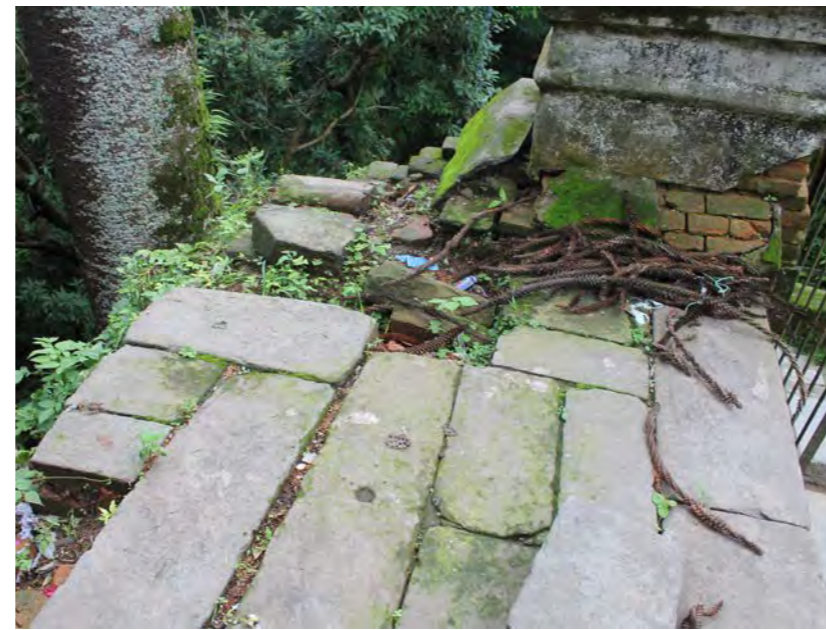
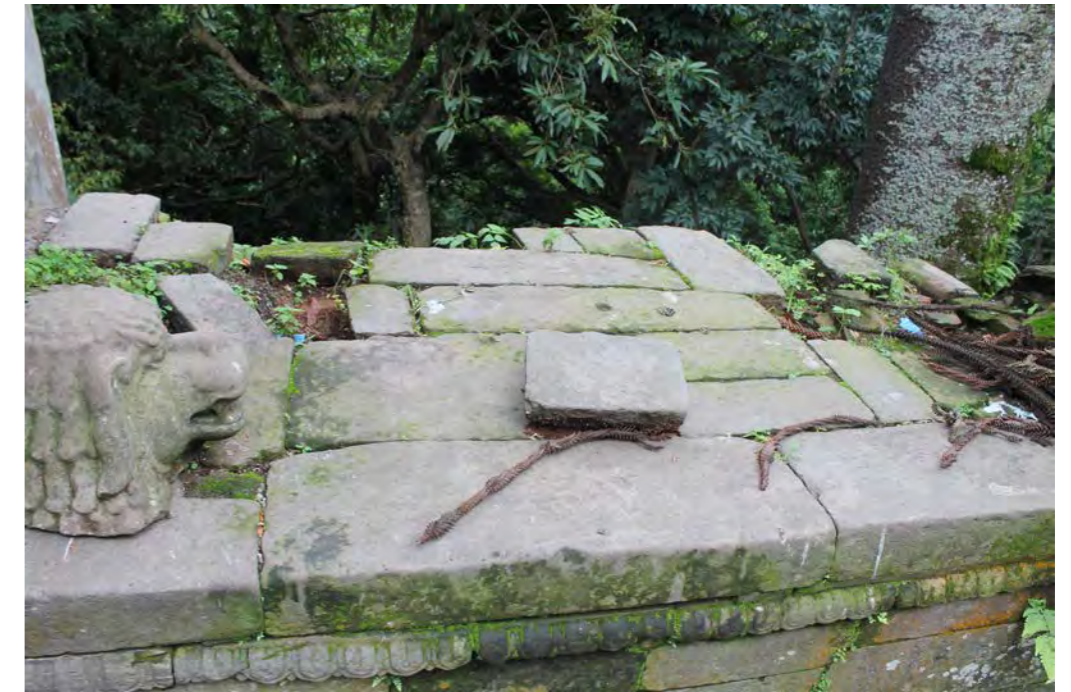
36 BELL

NUMBER	NAME	ESTABLISHED DATE (A.D.)	TYPOLOGY	GENERAL DESCRIPTION	PROBLEMS DESCRIPTION	DANGER/ DESTROY
36			Bell	Stone bell	Totally collapsed Main bell is retrieved but other stone pillars and other parts not retrieved from hills

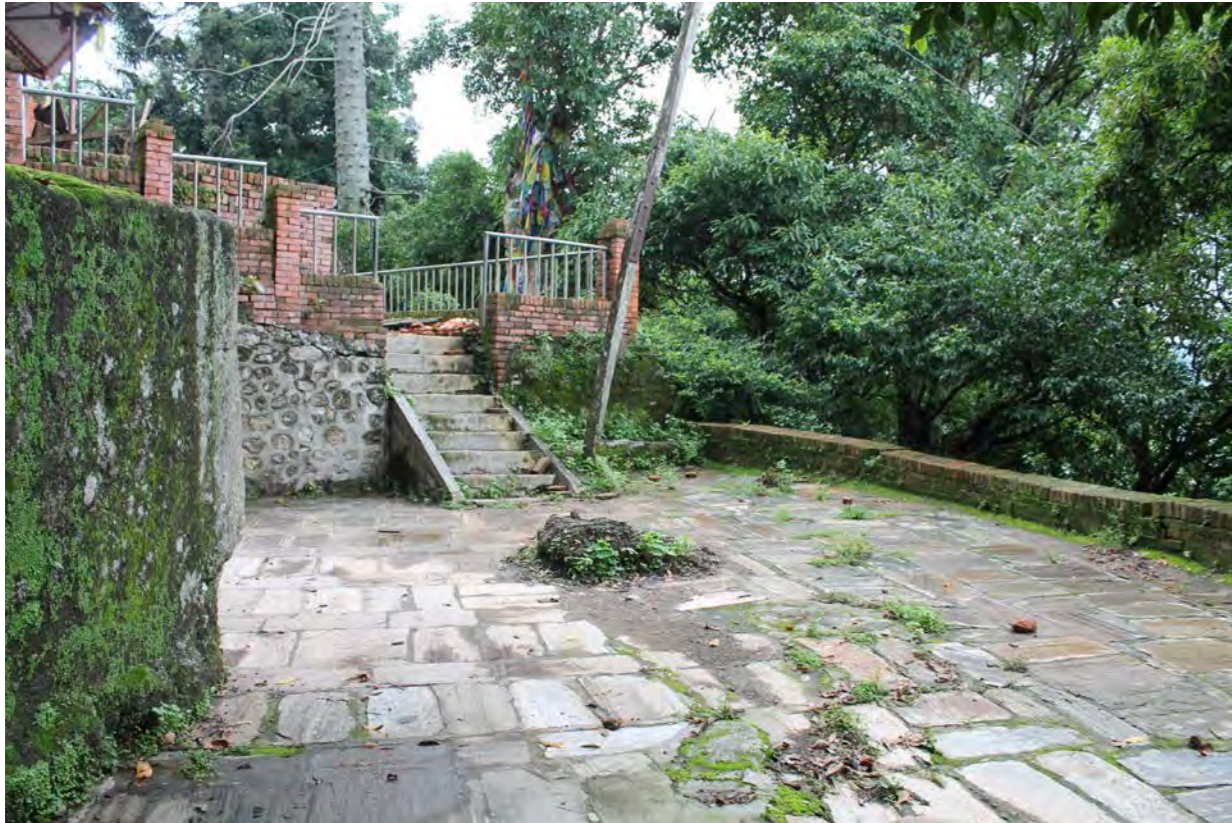
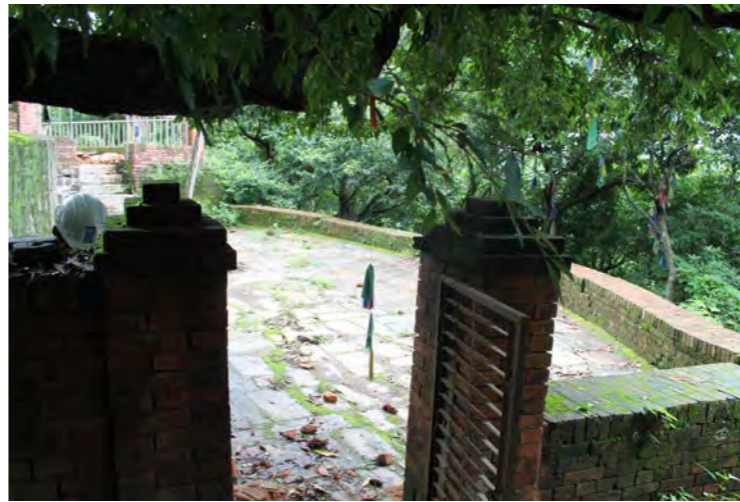
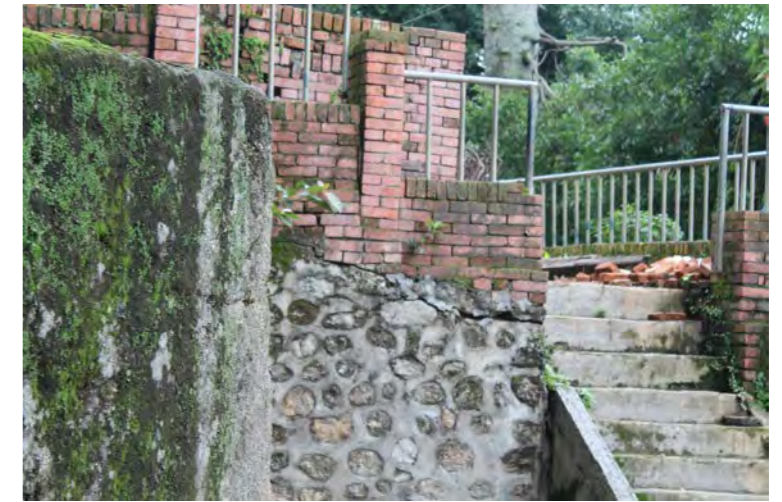
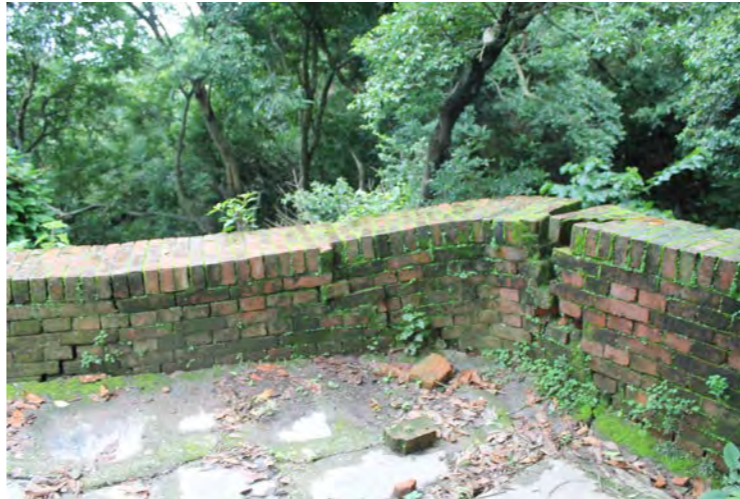
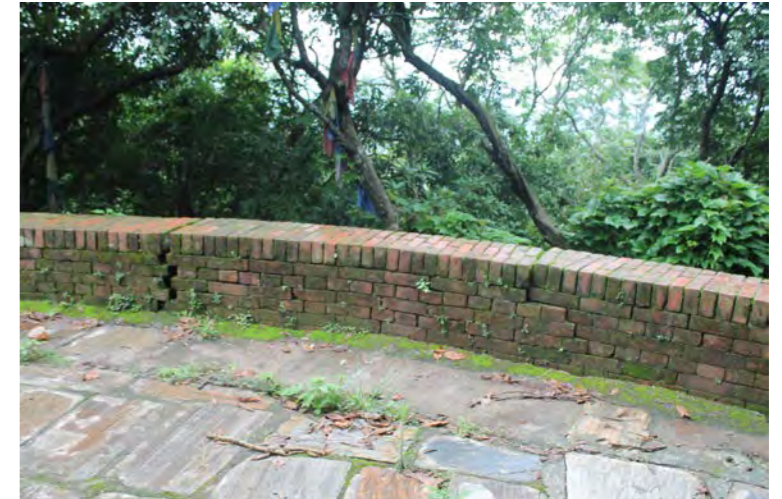
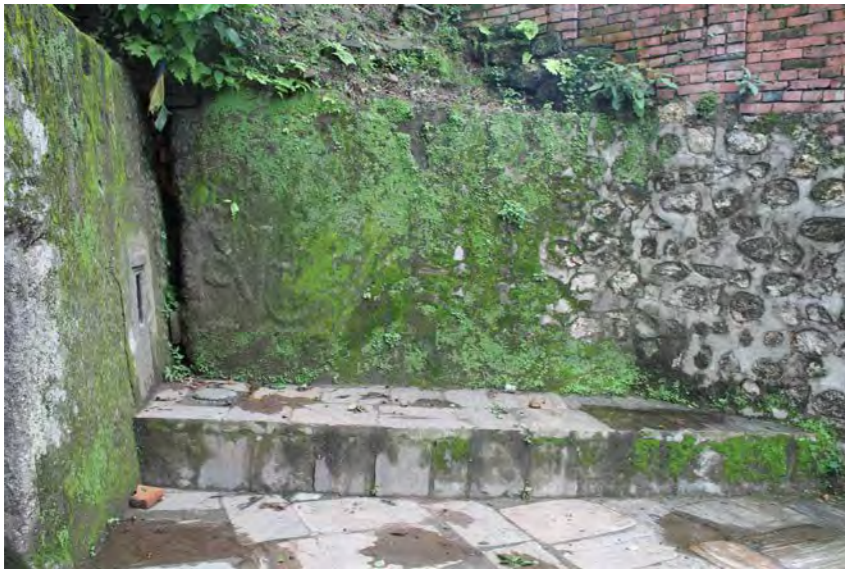
37 PLATFORM

NUMBER	NAME	DATE A.D.	TPOLOGY	GENERAL DESCRIPTION	PROBLEMS DESCRIPTION	DANGER/ DESTROY
37			Platform	Stone laid platform with brick wall boundary	Boundary wall with stepped cracks and slight displacement Platform Subsidence towards S-side Vertical cracks near starcase Platform longitudinal cracks

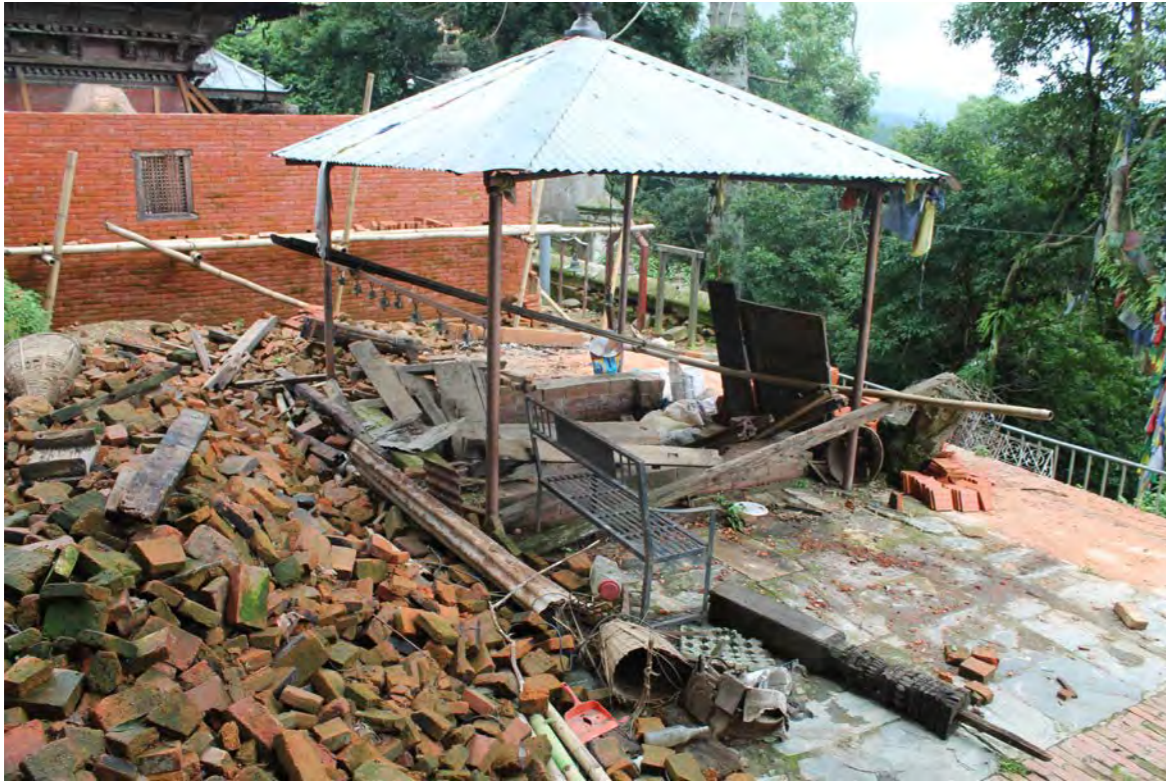
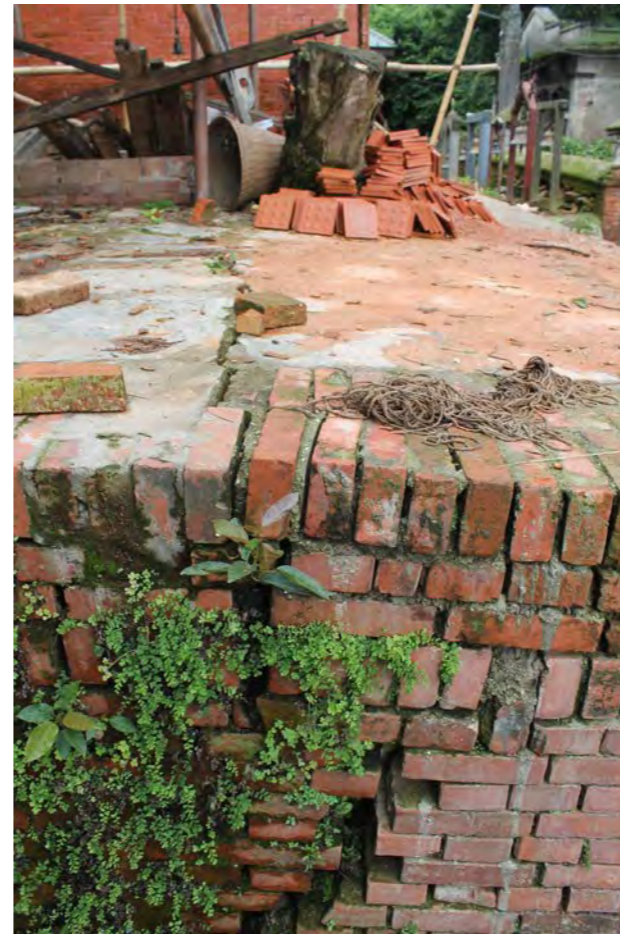
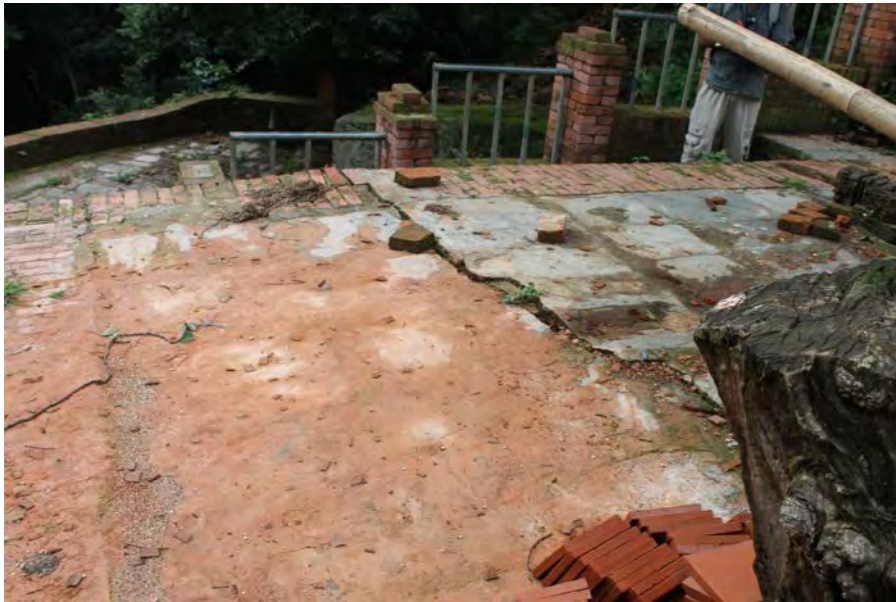
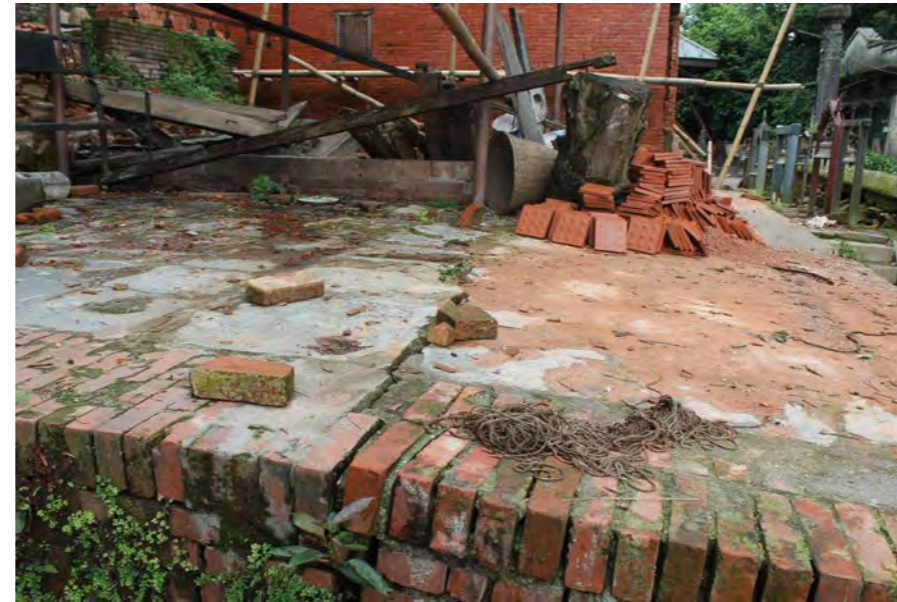
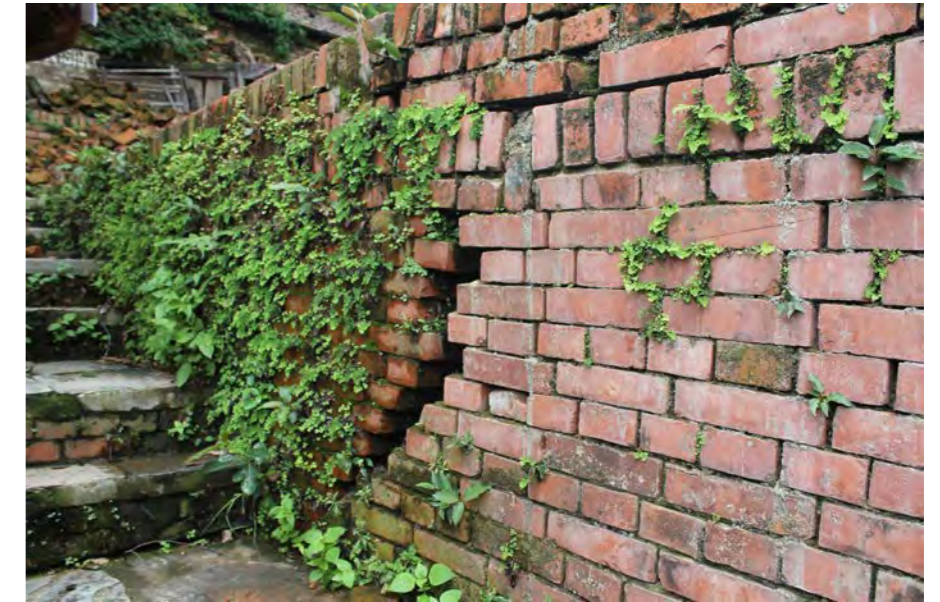
38 PLATFORM

NUMBER	NAME	ESTABLISHED DATE (A.D.)	TYPOLOGY	GENERAL DESCRIPTION	PROBLEMS DESCRIPTION	DANGER/ DESTROY	
38			Platform	Stone laid platform around temple no. 5	Severe platform ground cracks due to subsidence towards South Needs reconstruction

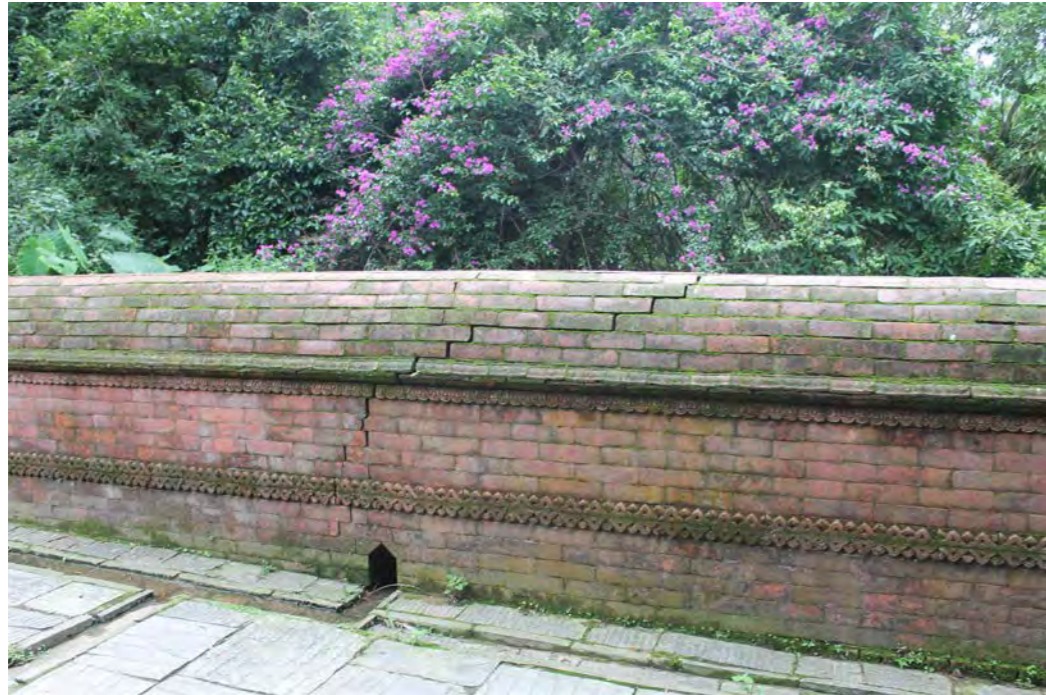
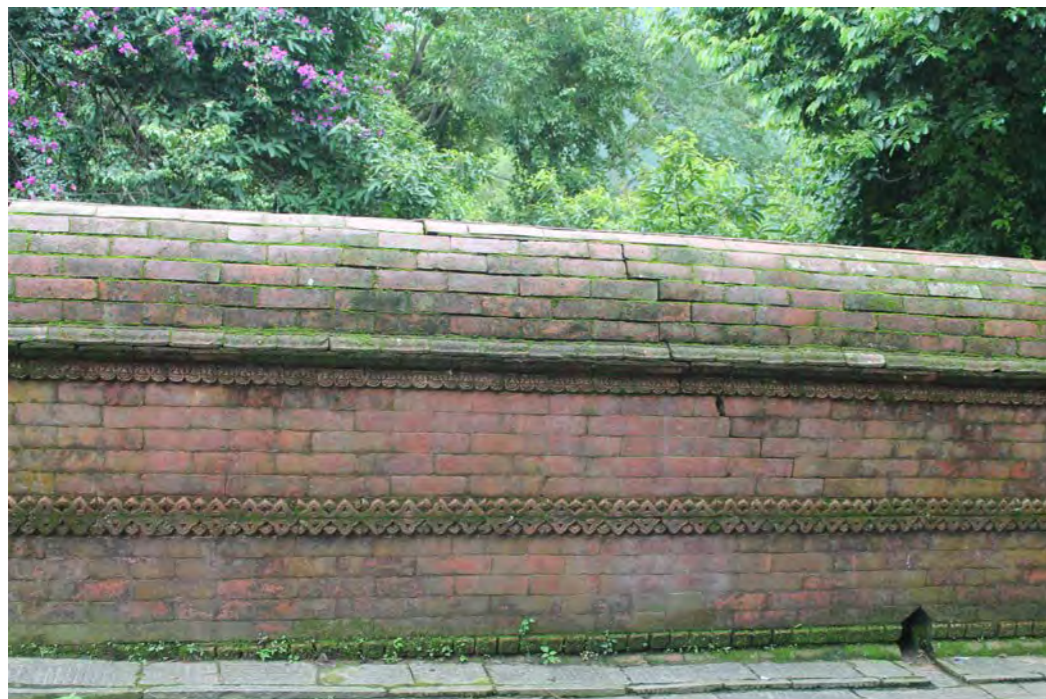
39 WALL

NUMBER	NAME	DATE A.D.	TYOLOGY	GENERAL DESCRIPTION	PROBLEMS DESCRIPTION	DANGER/ DESTROY
39, 40			Wall cracks	About 1m thick brick masonry boundary wall around temple area	Major vertical and stepped cracks

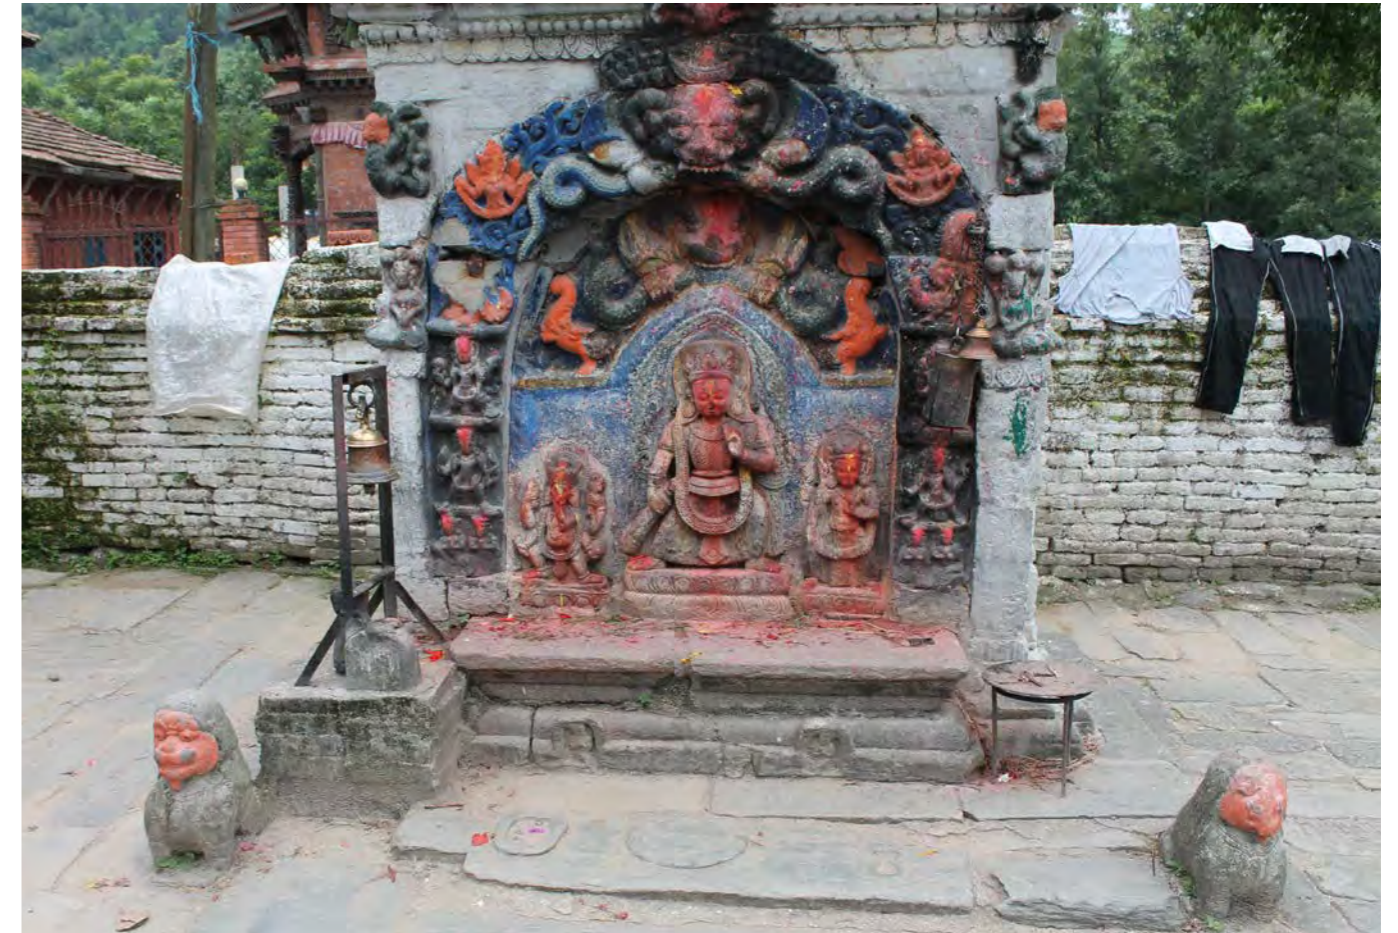
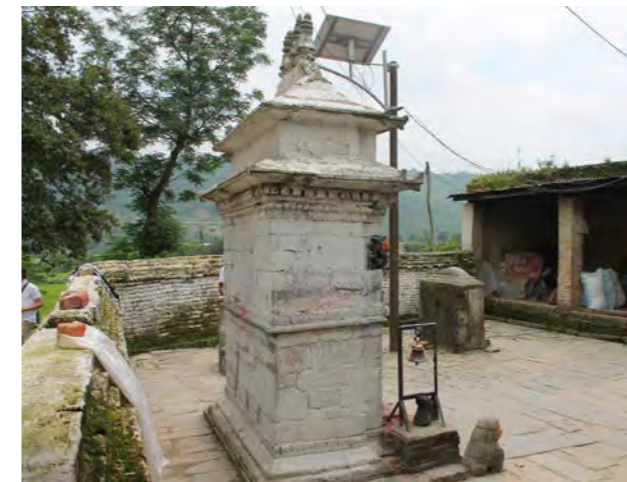
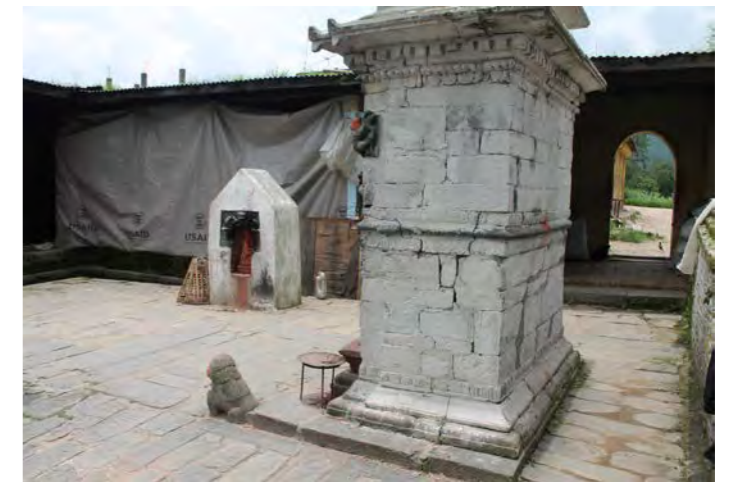
01 BHIMSEN

NUMBER	NAME	ESTABLISHED DATE (A.D.)	TYPOLOGY	GENERAL DESCRIPTION	PROBLEMS DESCRIPTION	DANGER/ DESTROY	
01	Bhindya (Bhimsen temple)		Open Shrine	Brick and Stone Structure	S-part with stepped cracks Needs proper repair and maintainance
