2015 Earthquake Damage Mapping

Sankhu

October 2015

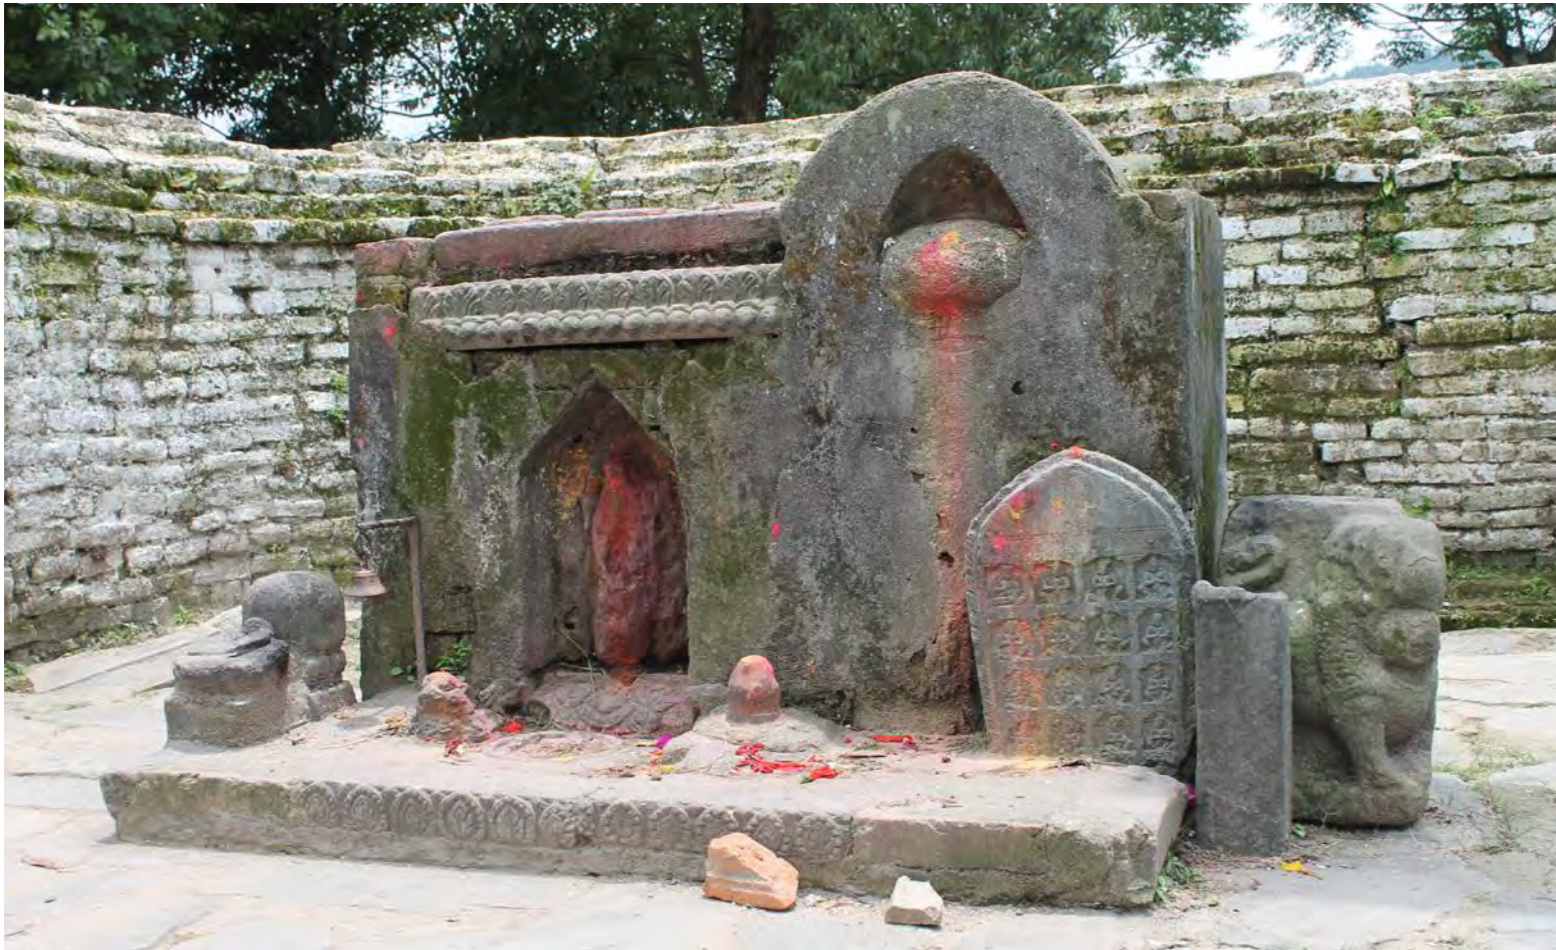
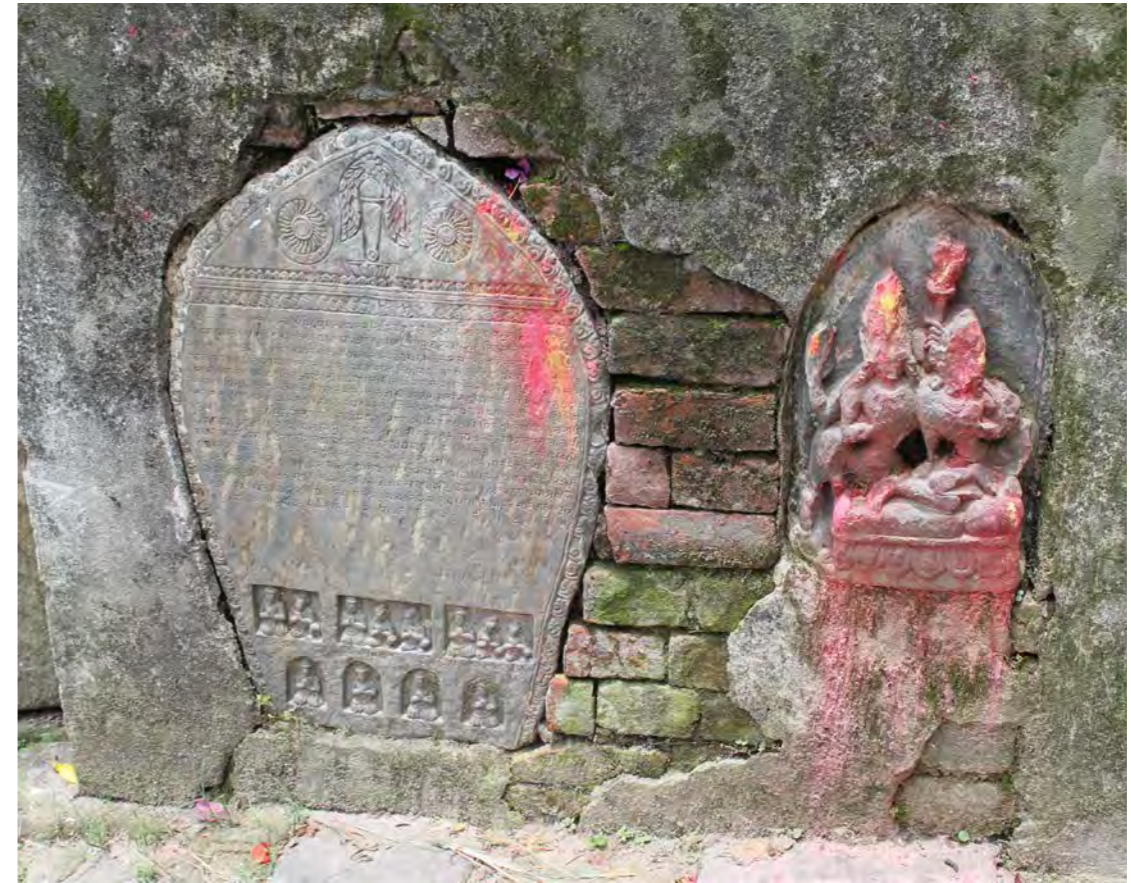
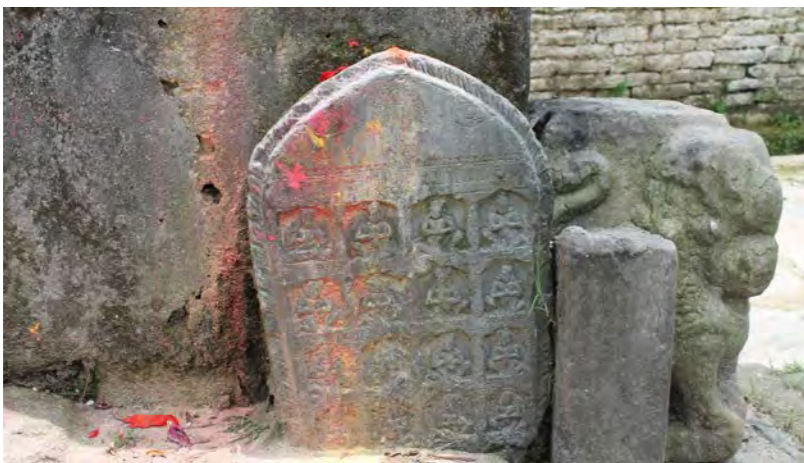
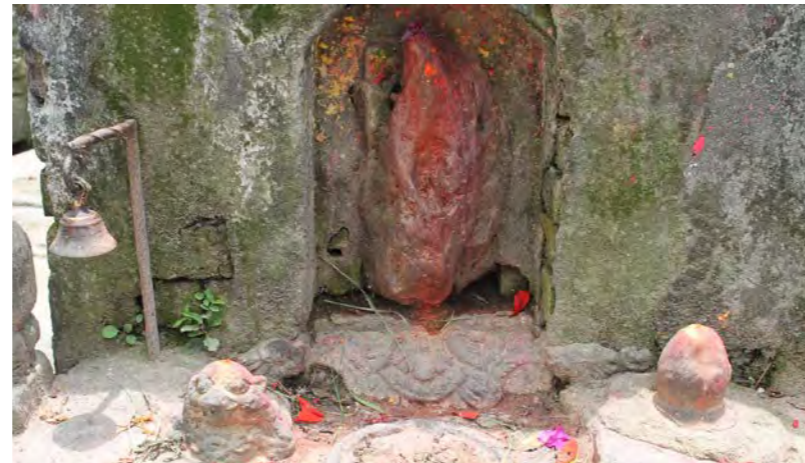
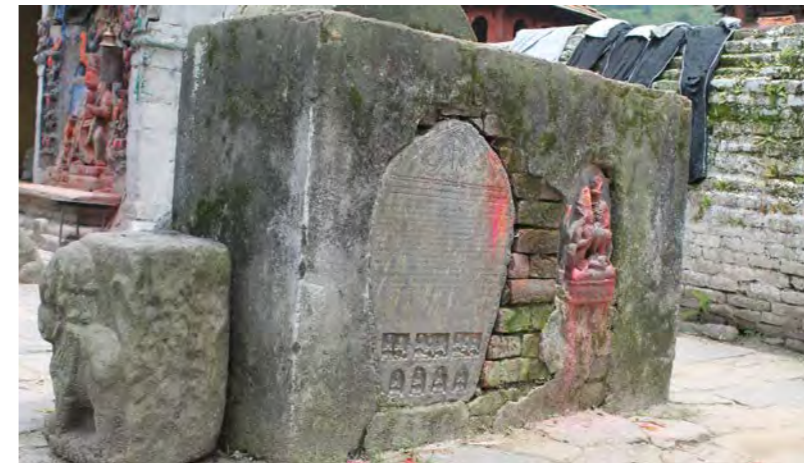
02 WANDYA TEMPLE

NUMBER	NAME	DATE A.D.	TPOLOGY	GENERAL DESCRIPTION	PROBLEMS DESCRIPTION	DANGER/ DESTROY	
02	Wandya temple		Open Shrine	Stone statues and inscription Plastered with bricks	Good Condition

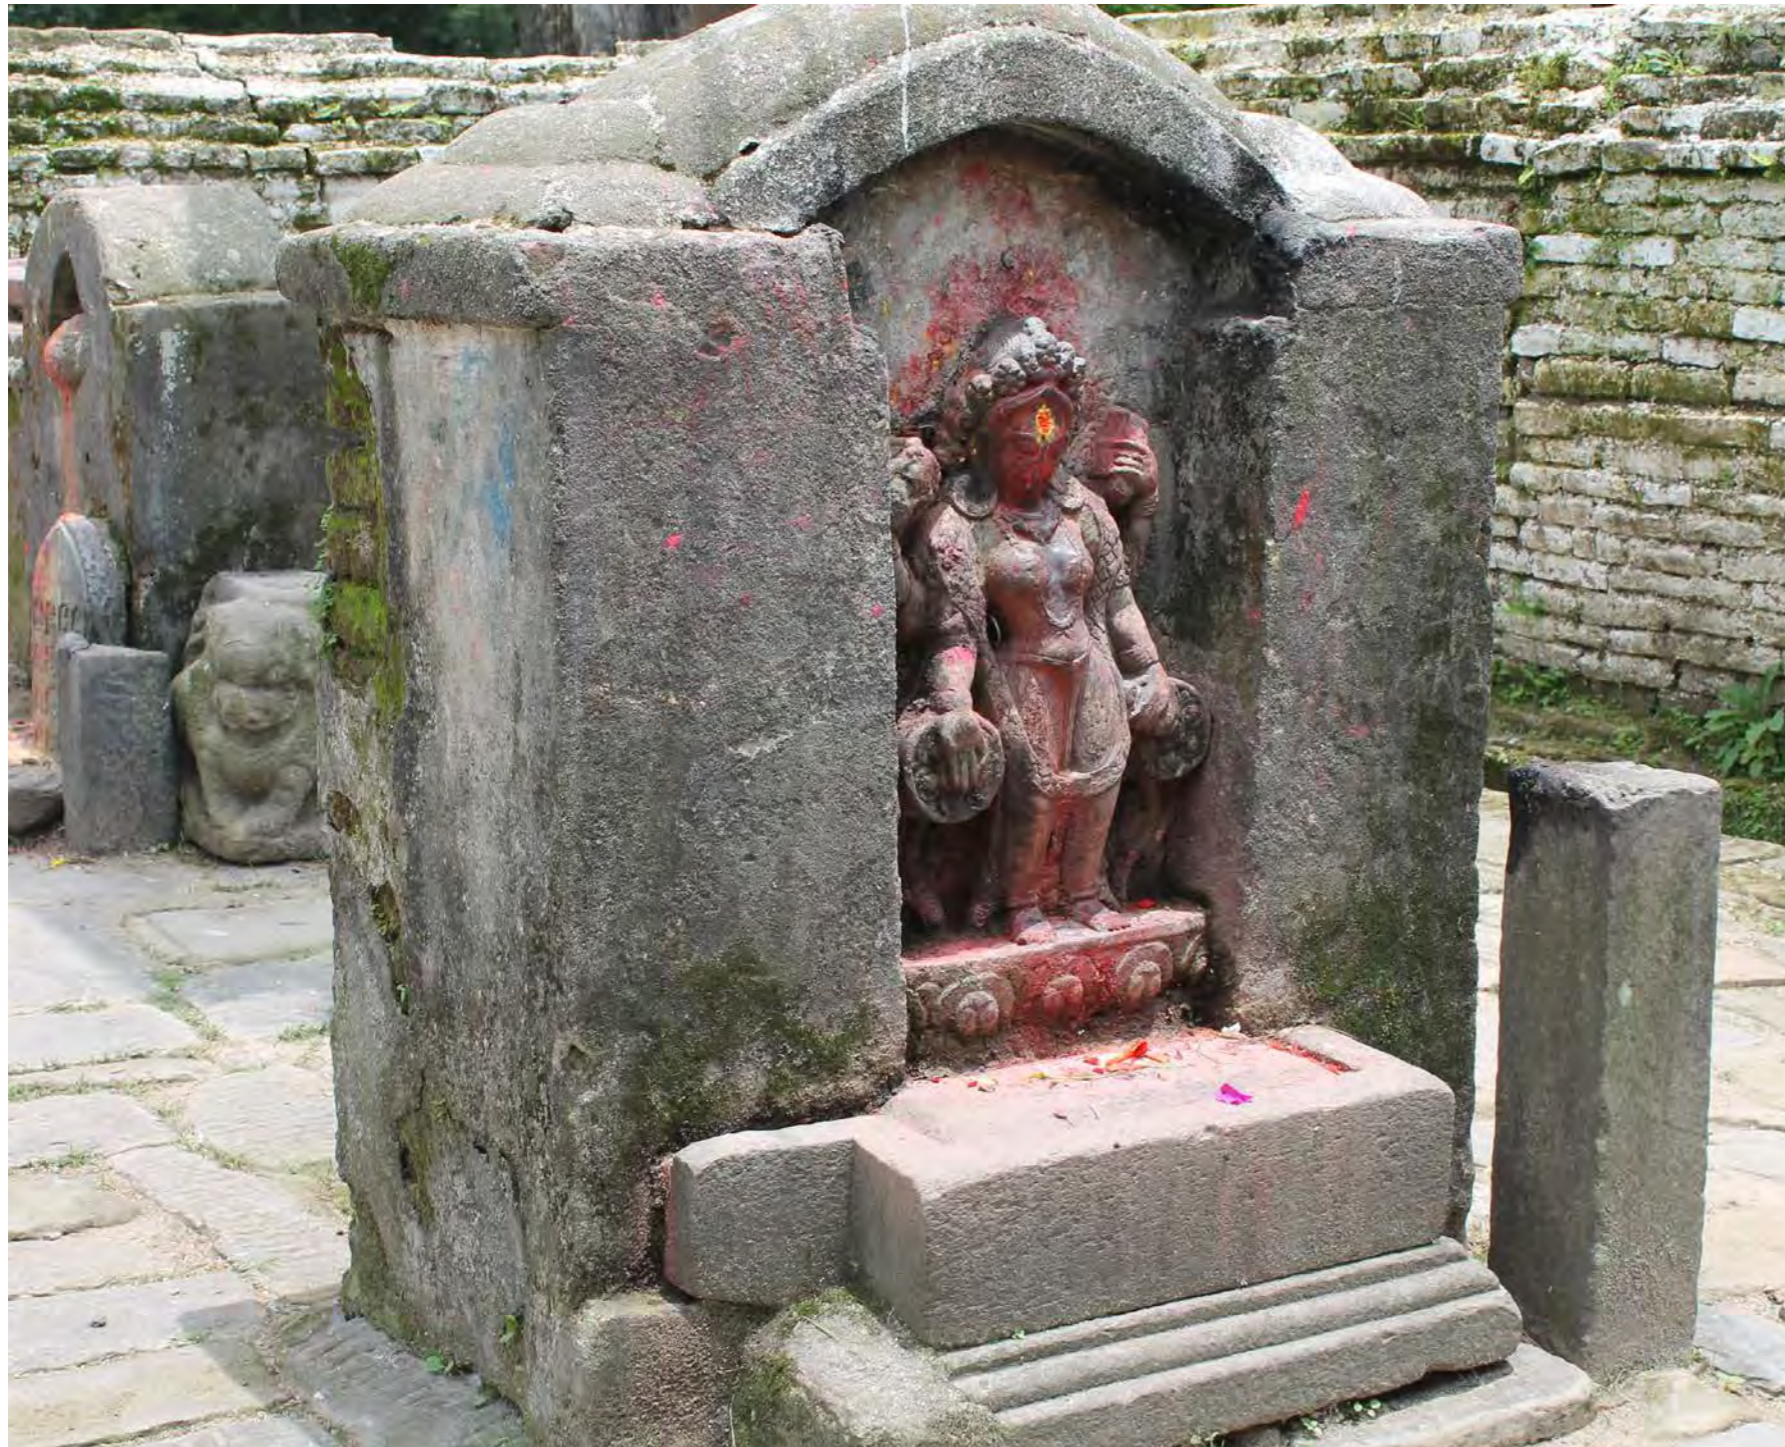
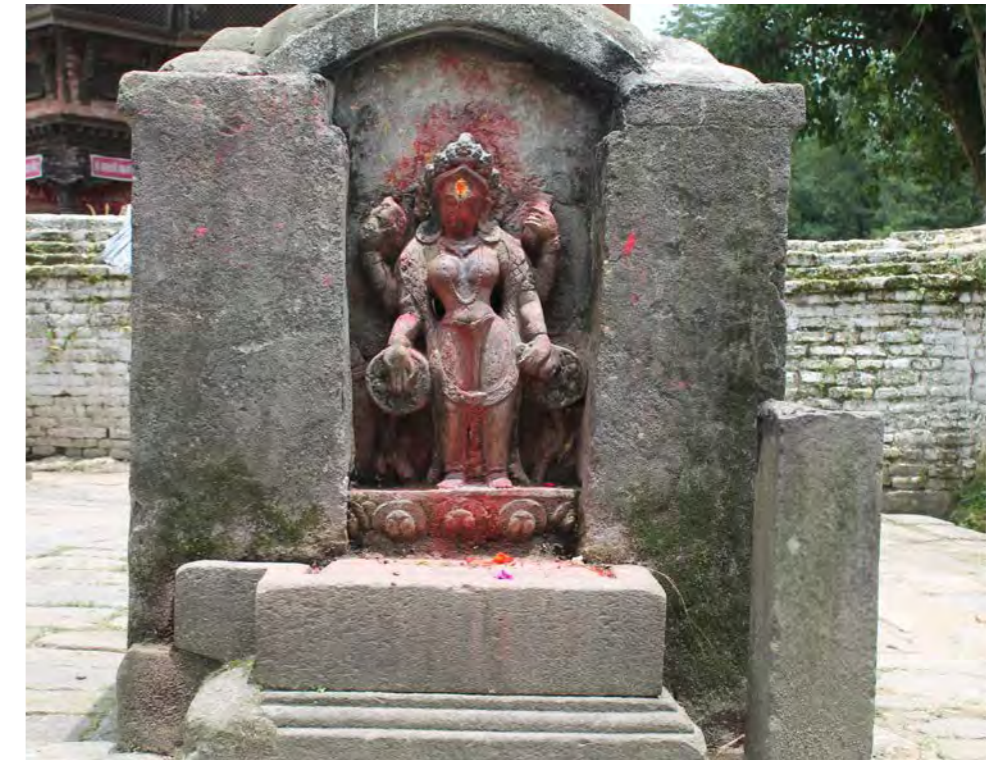
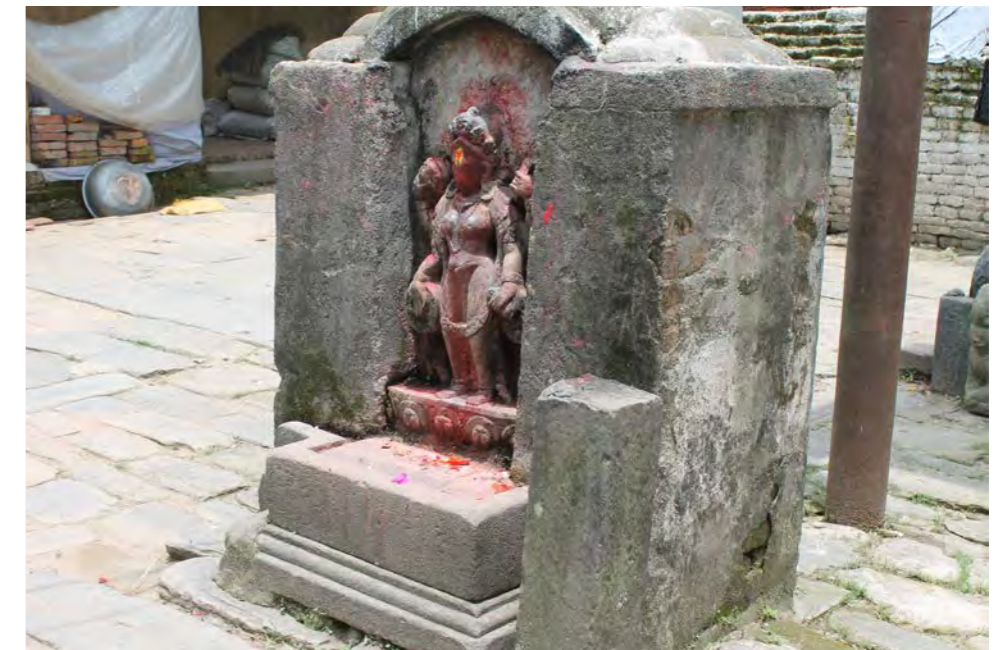
03 SARASWATI

NUMBER	NAME	ESTABLISHED DATE (A.D.)	TYPOLOGY	GENERAL DESCRIPTION	PROBLEMS DESCRIPTION	DANGER/ DESTROY	
03	Saraswati		Open Shrine	Bricks with plastered layer and stone statues	Good Condition

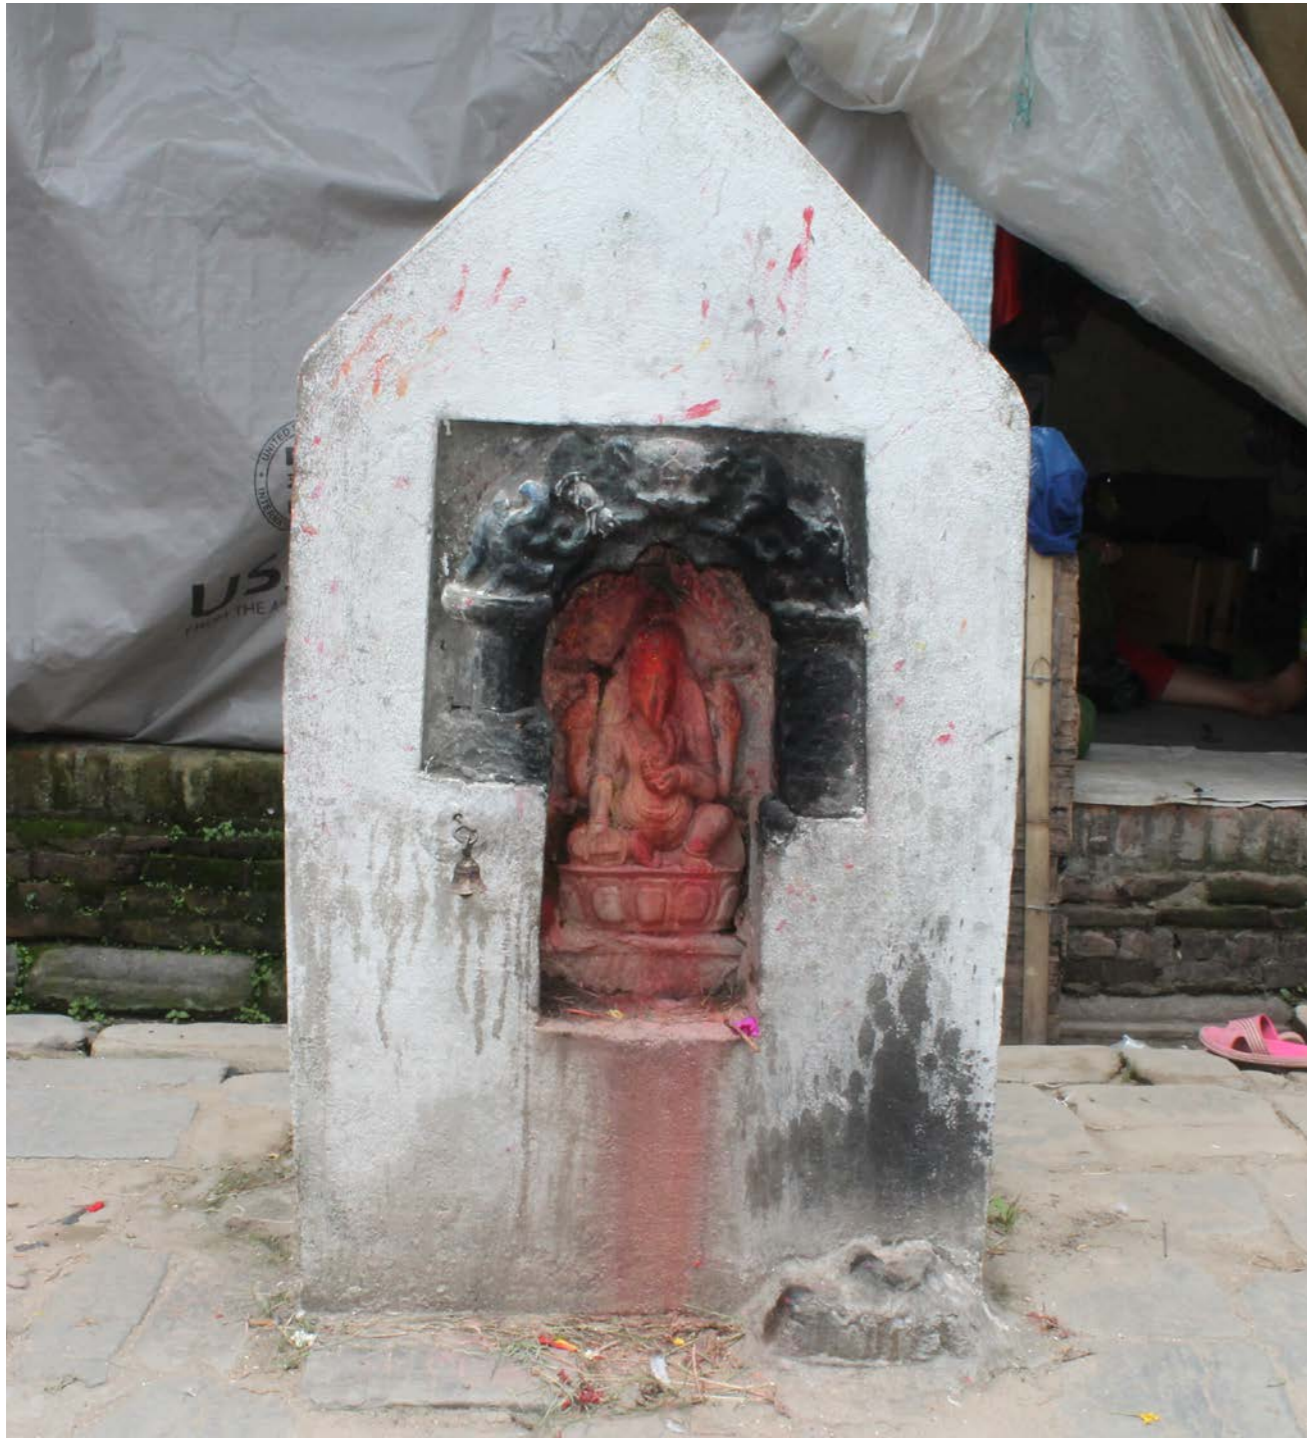
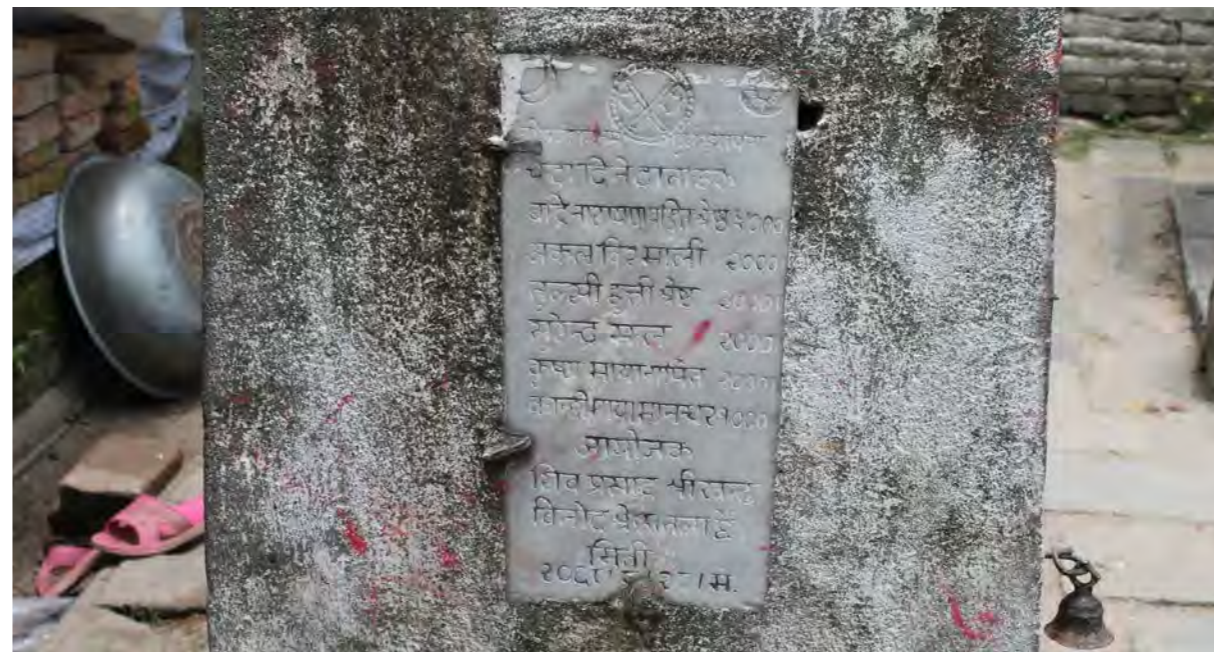
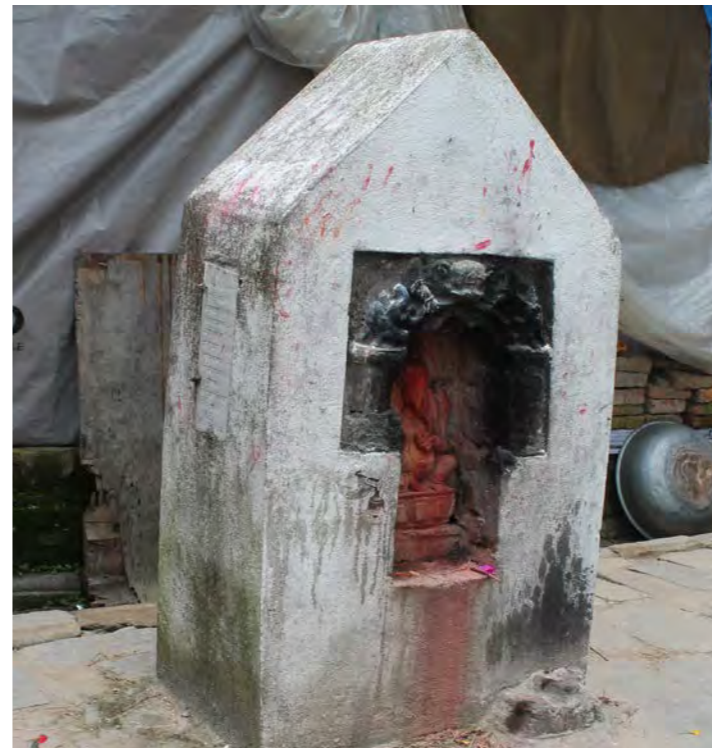
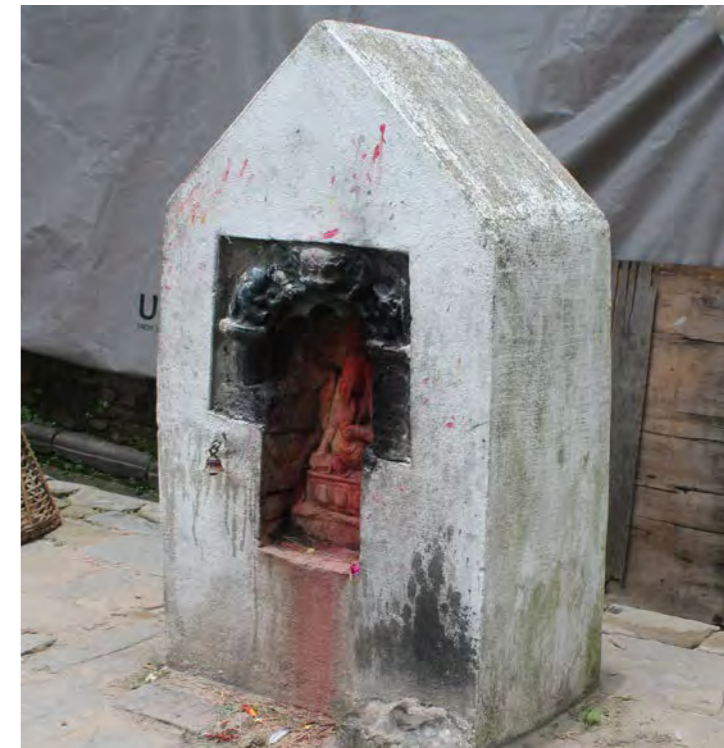
04 GANESH

NUMBER	NAME	DATE A.D.	TPOLOGY	GENERAL DESCRIPTION	PROBLEMS DESCRIPTION	DANGER/ DESTROY	
04	Ganesh		Open Shrine	Bricks with plastered layer and stone statues	Good Condition

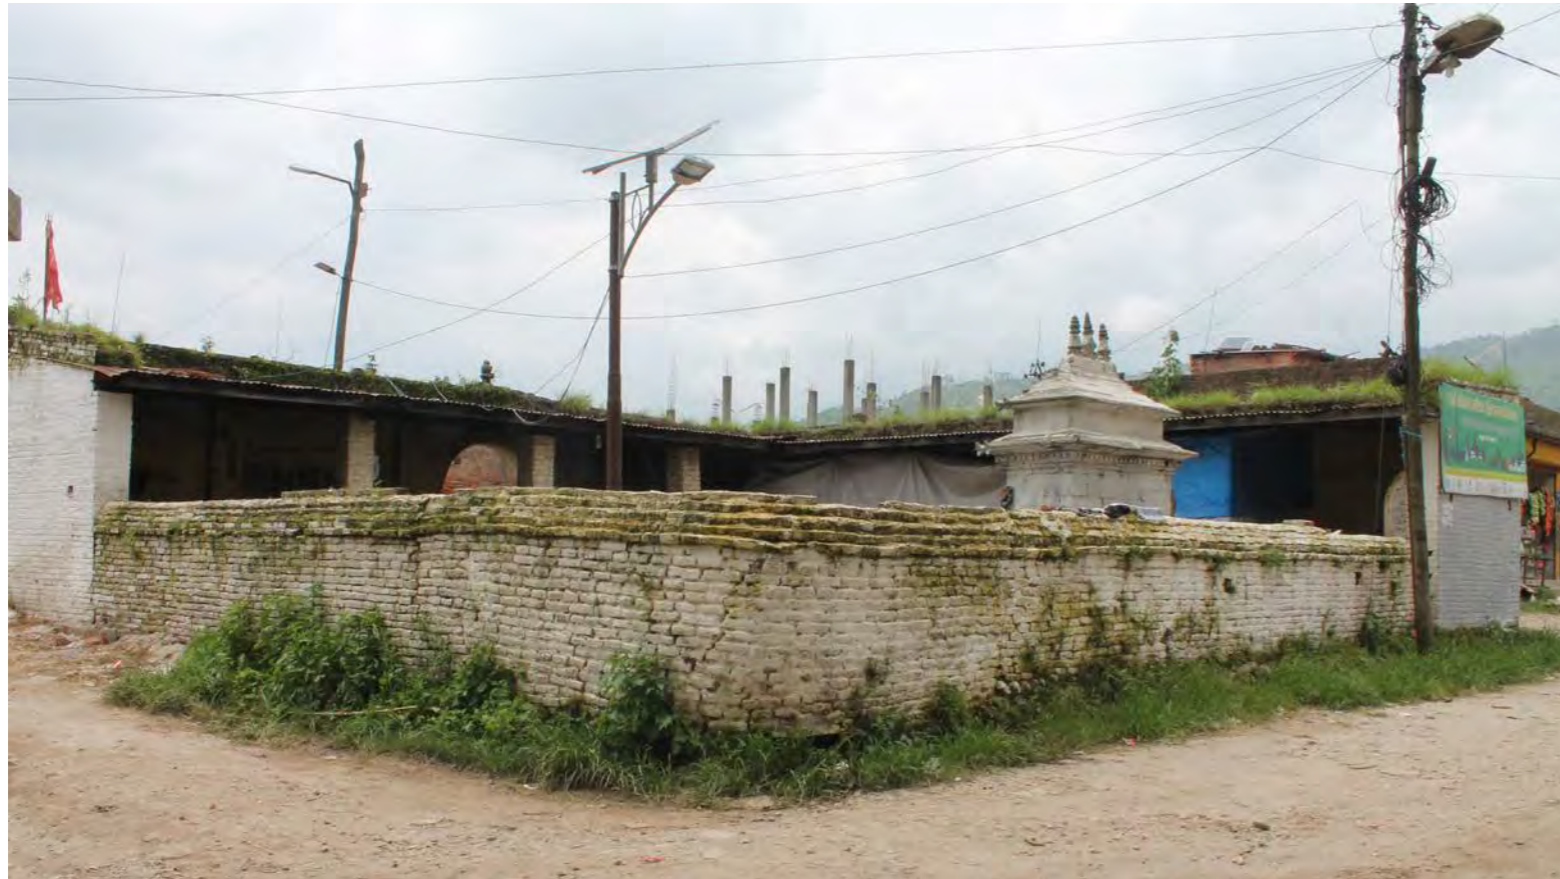
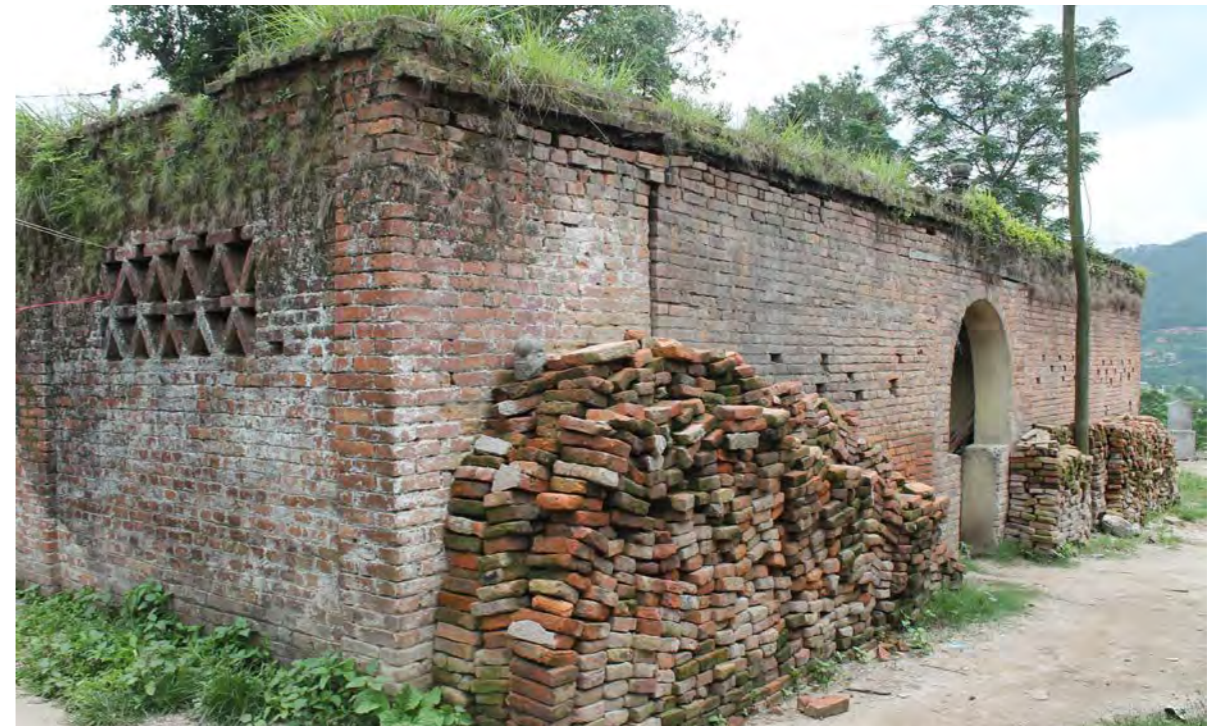
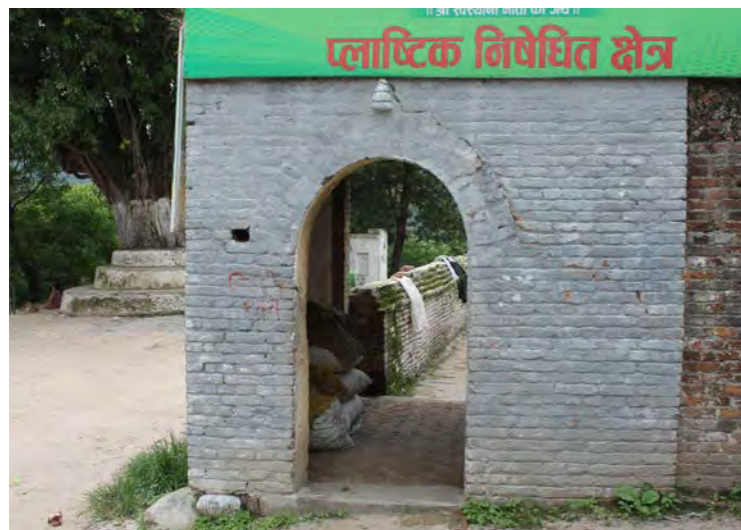
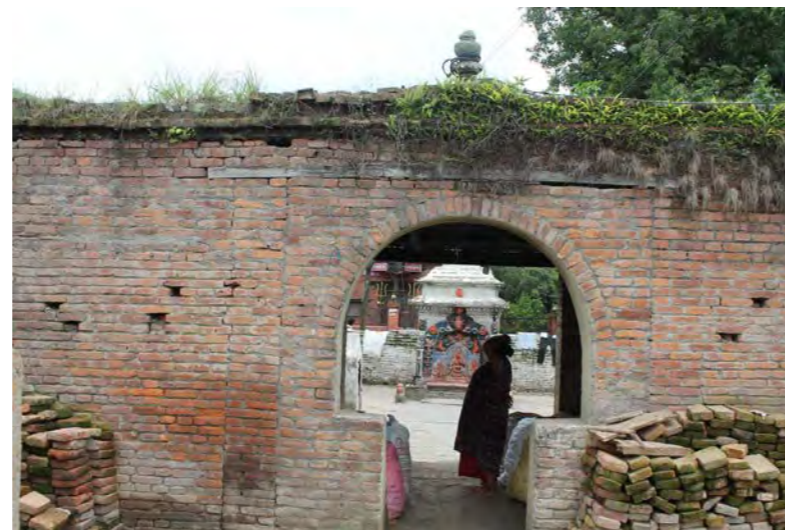
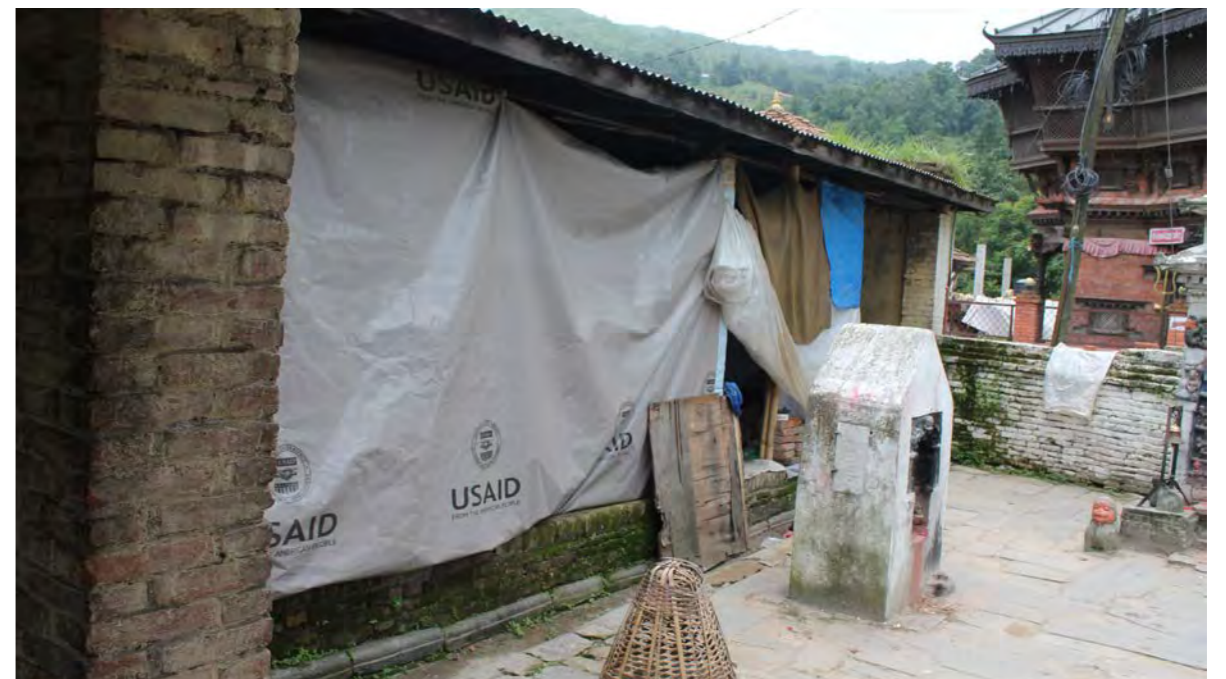
05 BHINDYA SATTAL

NUMBER	NAME	ESTABLISHED DATE (A.D.)	TYPOLOGY	GENERAL DESCRIPTION	PROBLEMS DESCRIPTION	DANGER/ DESTROY	
05	Bhindya Satta		Sattal	Brick structure with wooden joist and CGI sheet roofing Single storey sattal 9 number of Brick pillars supporting the whole structure”	Vegetation and grass on roof Not well maintained Cracks on N-façade inner side Some wooden joist broken Plaster cracks Through wall cracks near and above arch shaped entrance openings

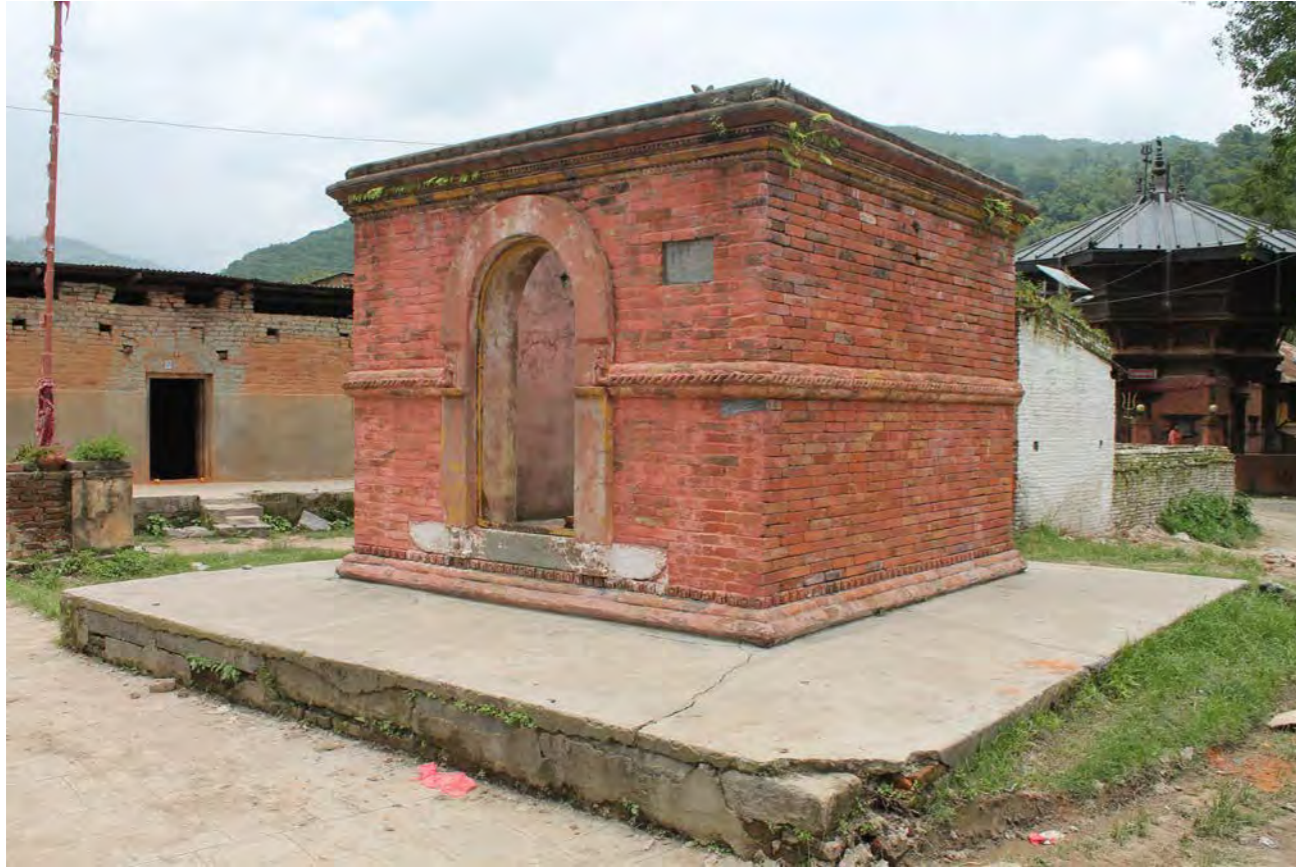
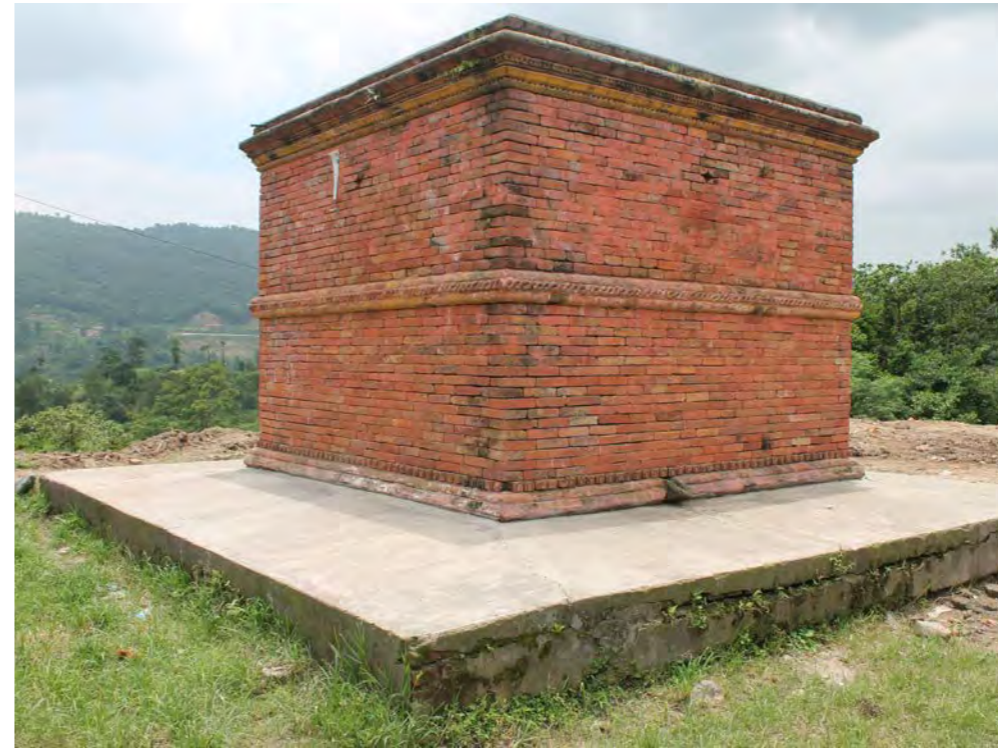
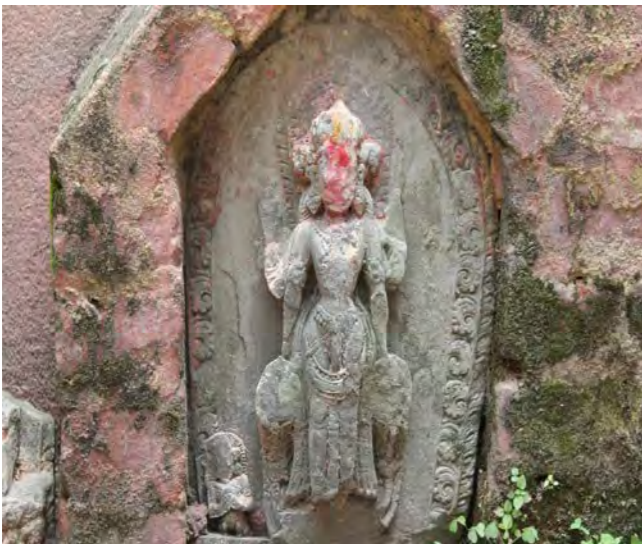
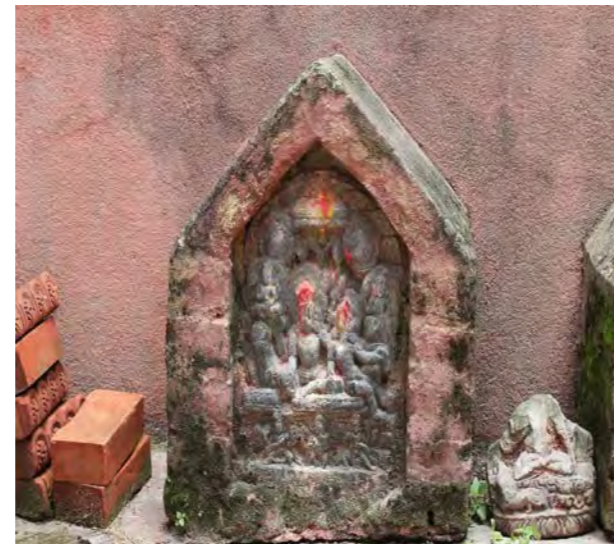
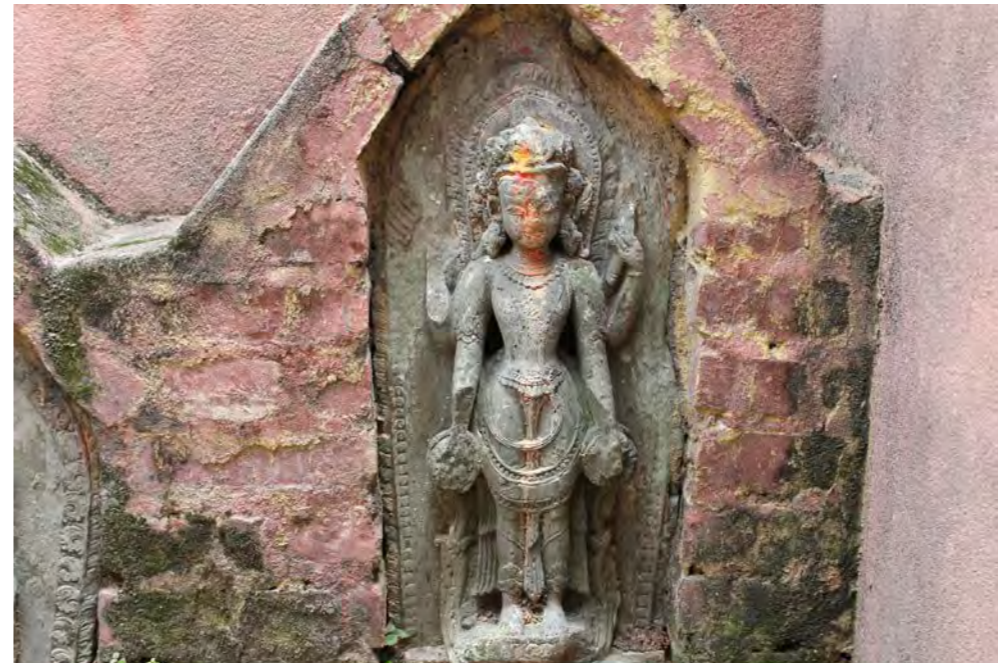
06 MAHADEV NARAYAN

NUMBER	NAME	DATE A.D.	TYPOLGY	GENERAL DESCRIPTION	PROBLEMS DESCRIPTION	DANGER/ DESTROY
06	Mahadev Narayan		Enclosed Shrine	Brick structure with about 2' of plastered plinth level above ground	Plastered plint with multiple longitudinal cracks Dilapidated Needs repair

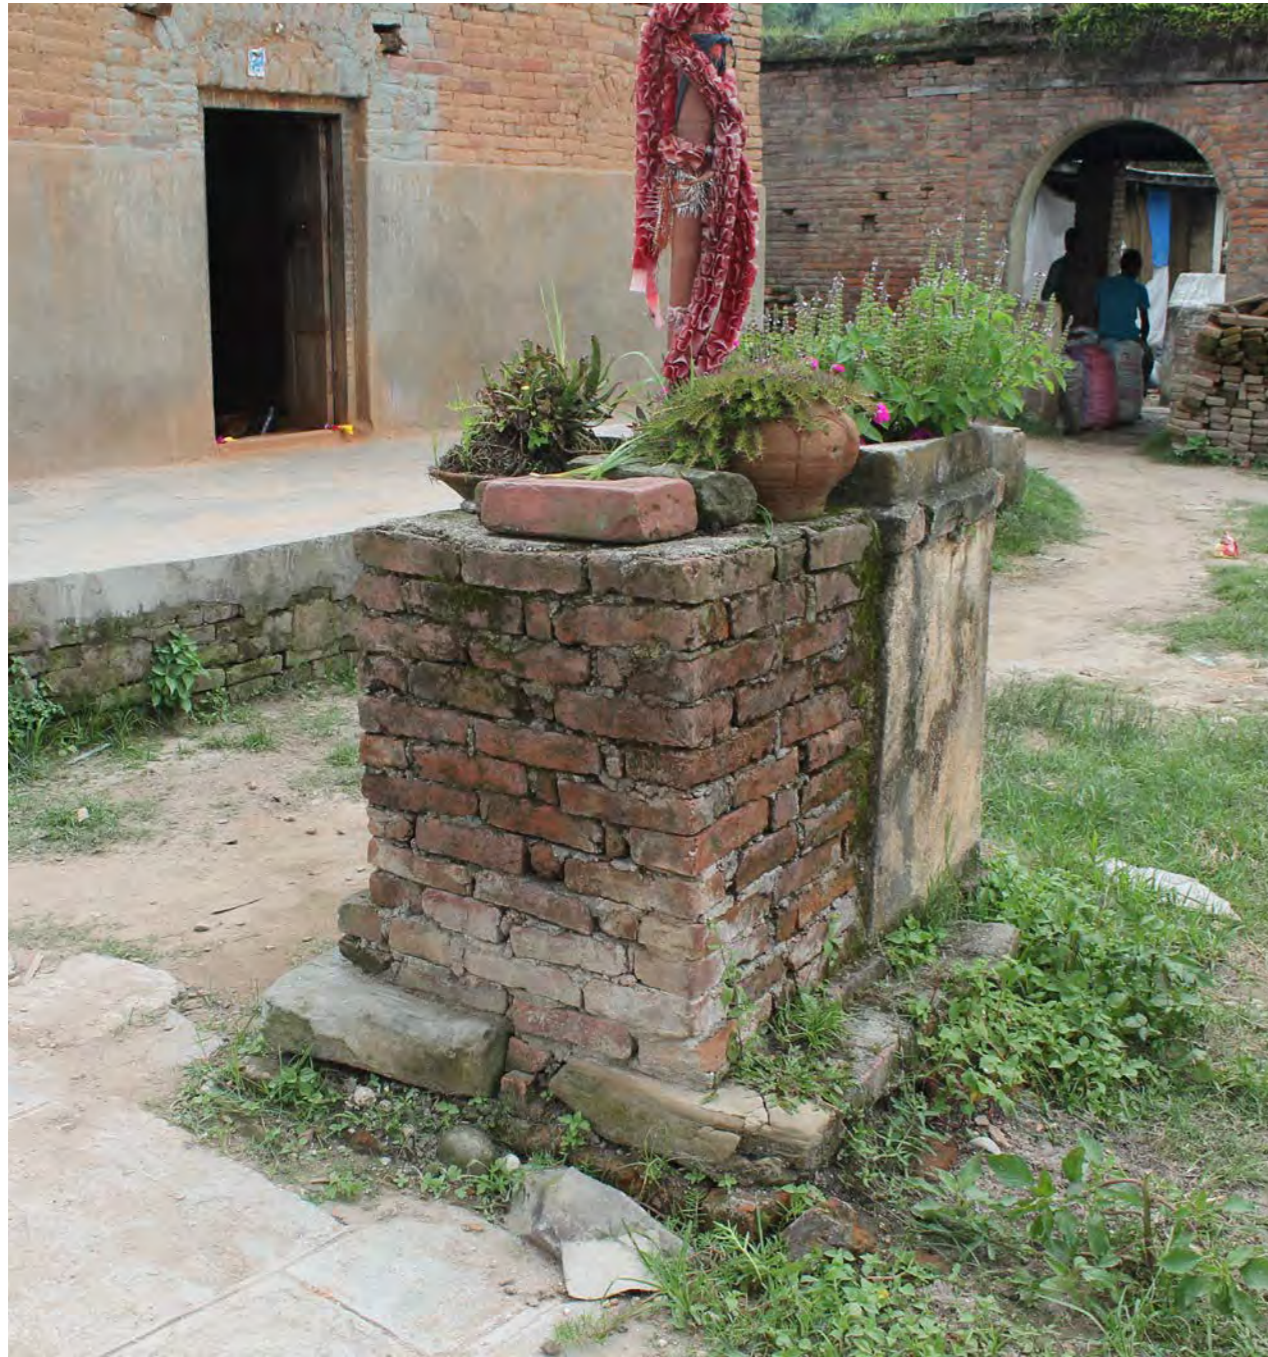
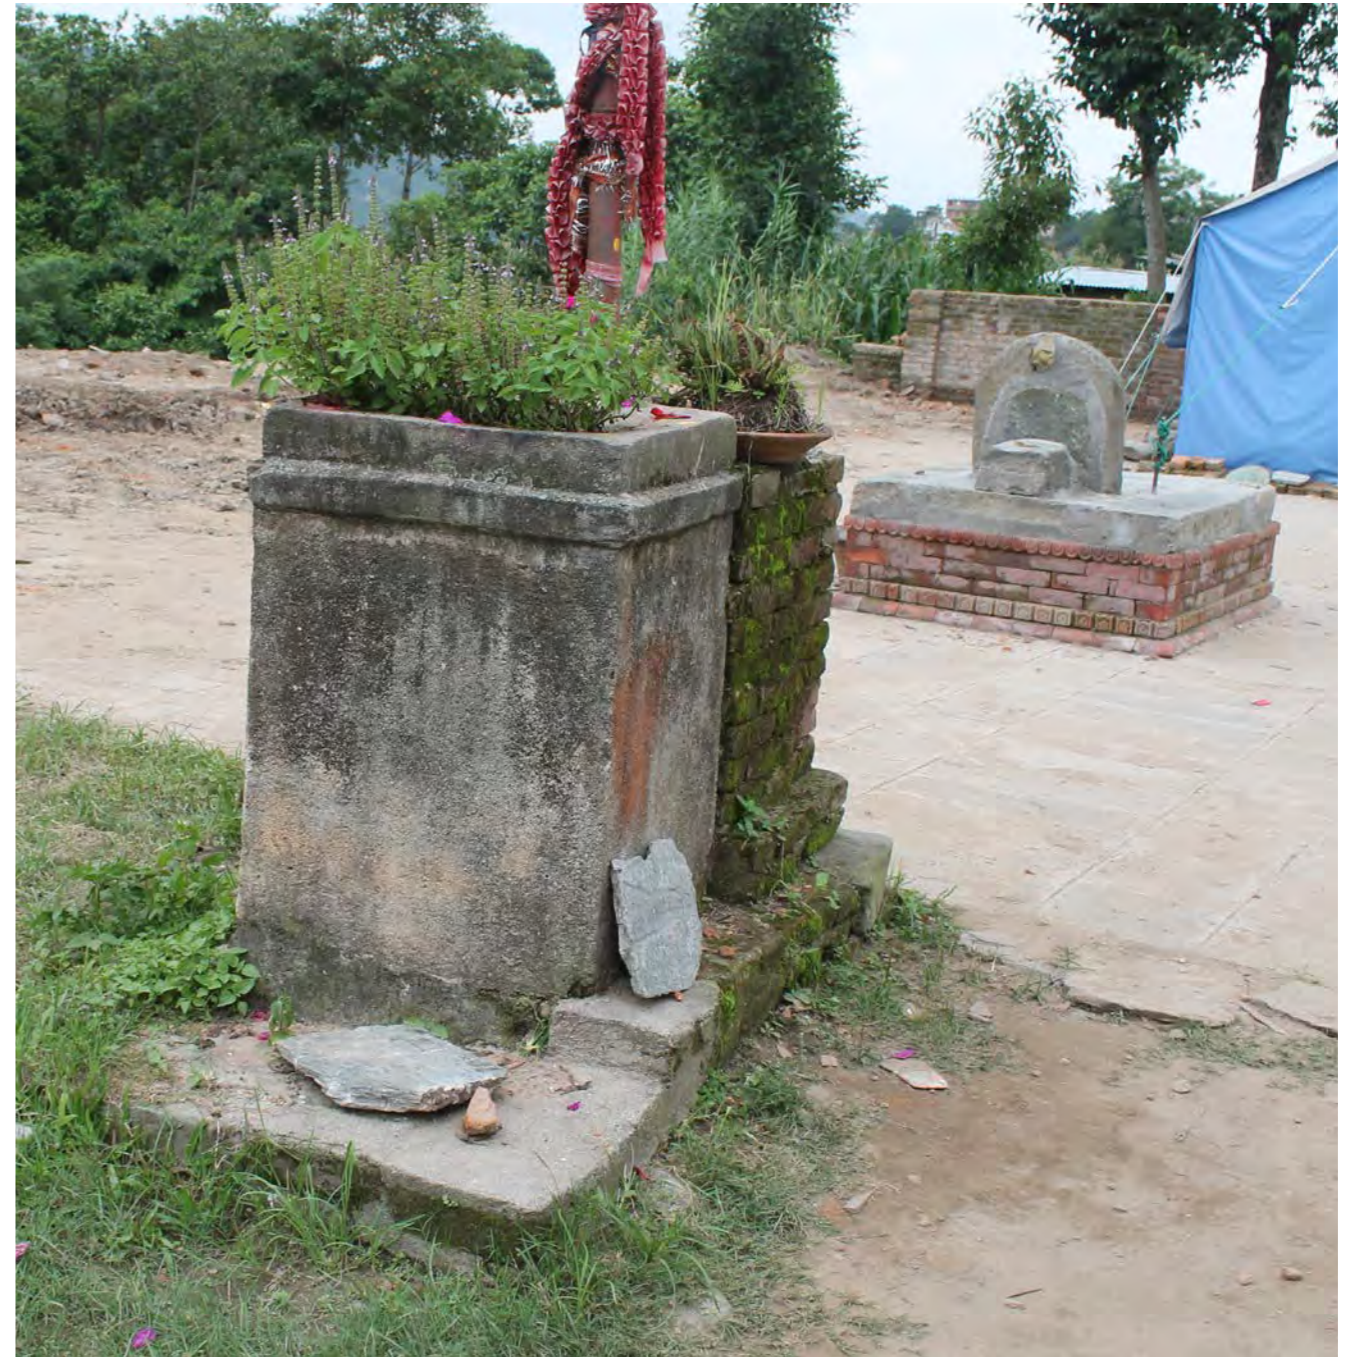
NUMBER	NAME	ESTABLISHED DATE (A.D.)	TPOLOGY	GENERAL DESCRIPTION	PROBLEMS DESCRIPTION	DANGER/ DESTROY	
07			Brick base	Brick structure with stones staues used as basement to install Narayan on special occasions	No major visible damages Needs proper maintainance		<p>BHIMSENSTHAN</p>
