2015 Earthquake Damage Mapping

Sankhu

October 2015

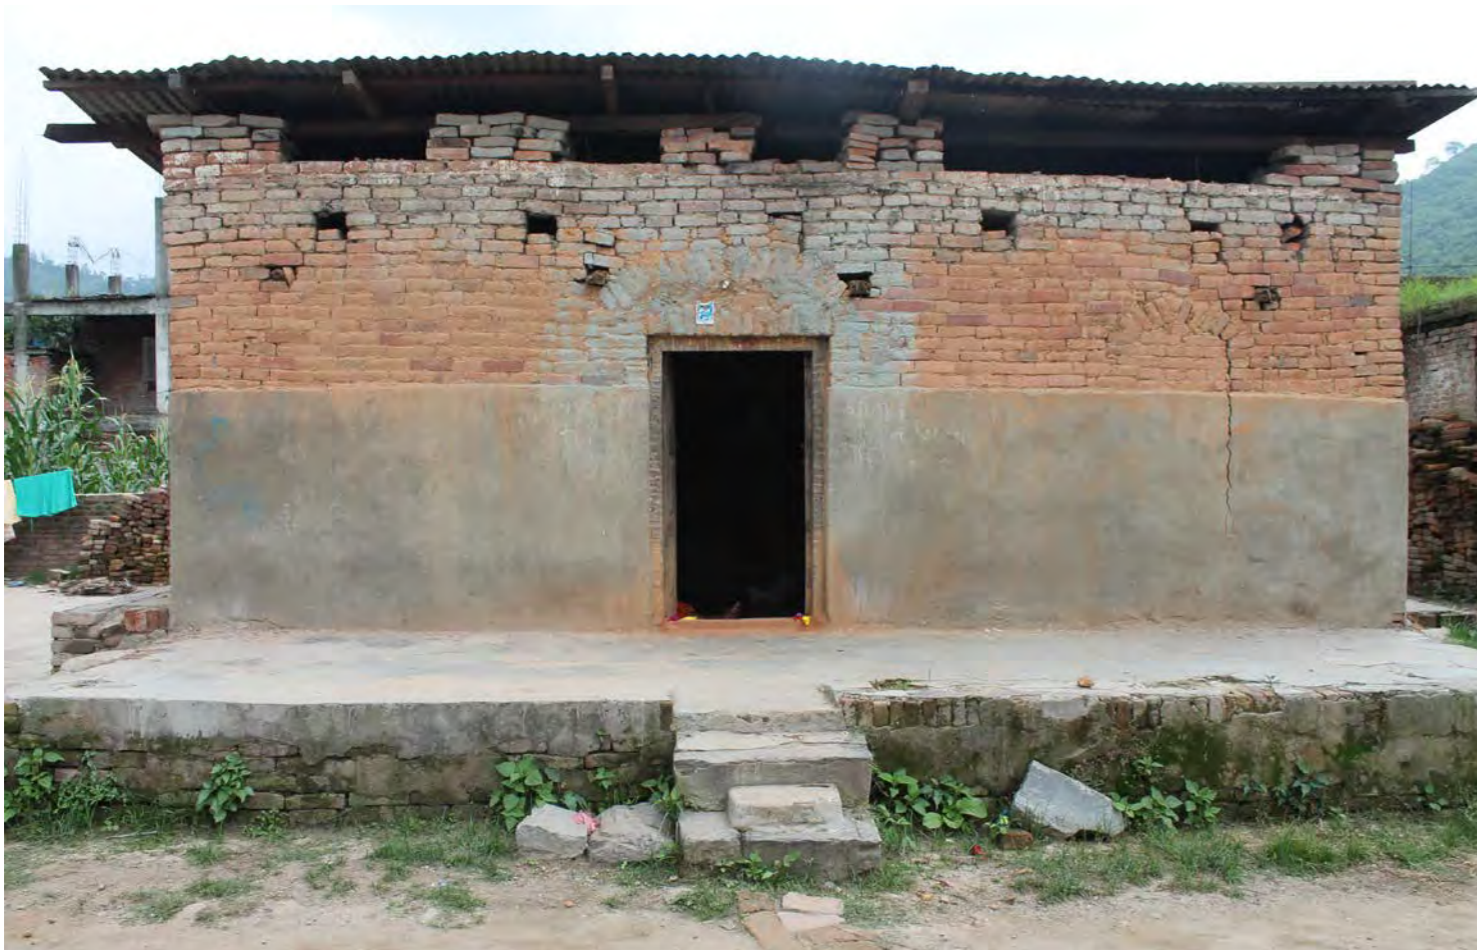
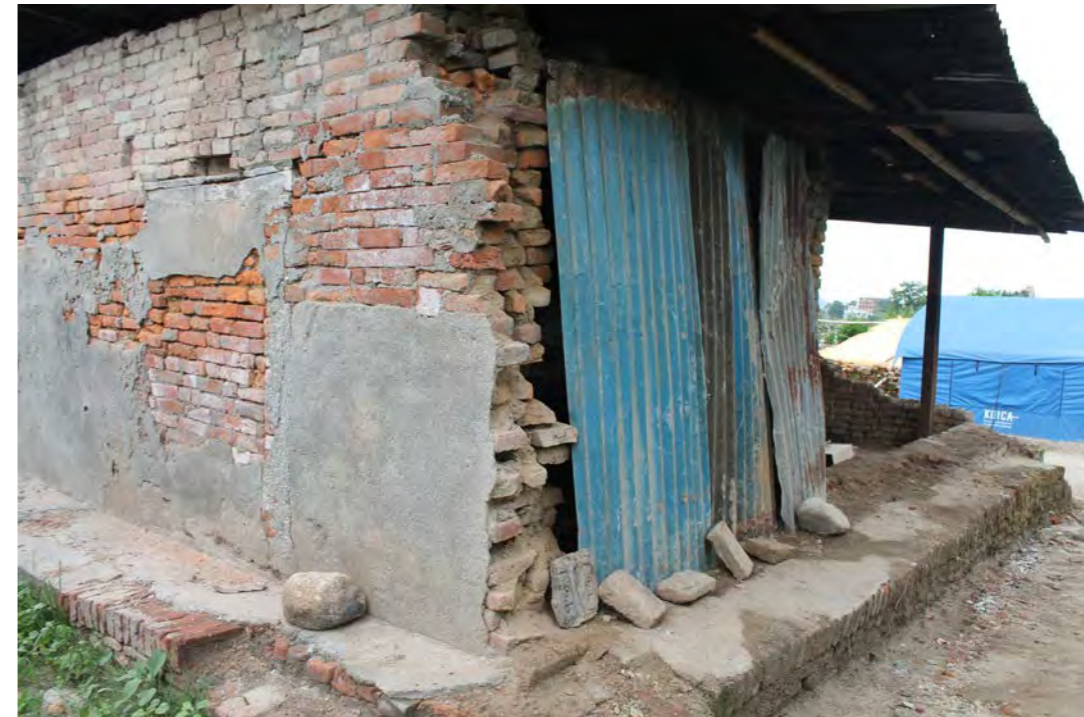
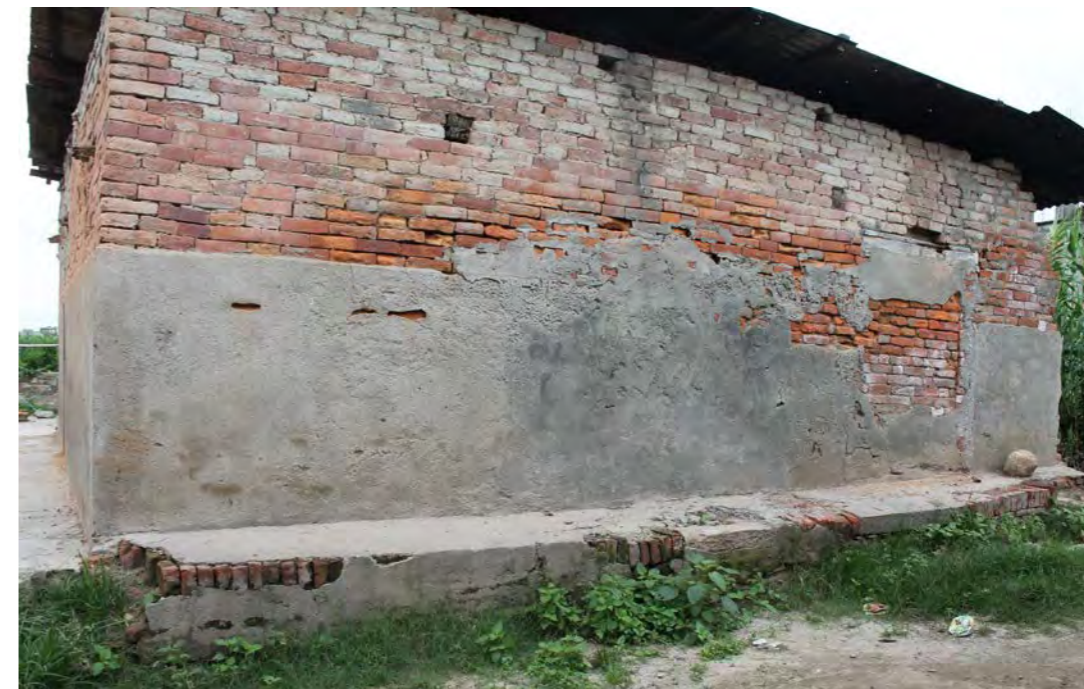
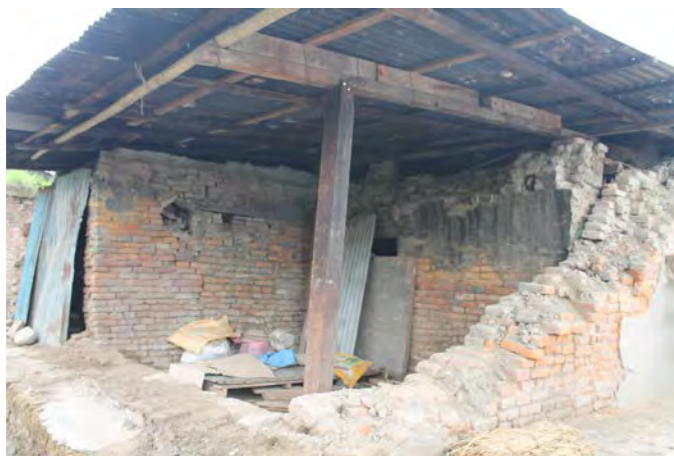
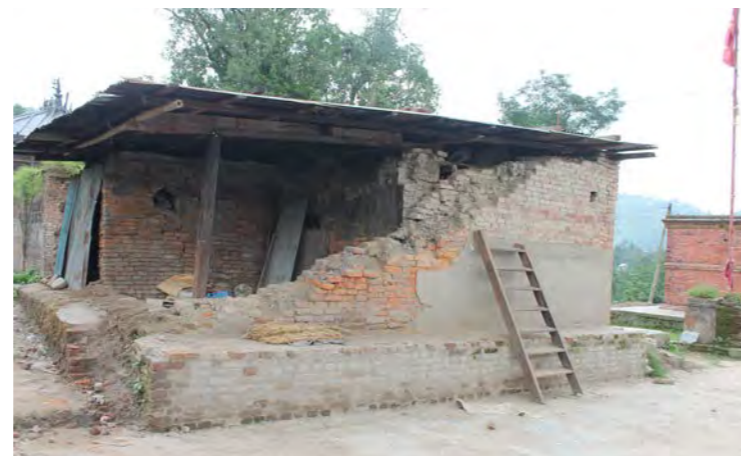
08 RELIGIOUS HOUSE

NUMBER	NAME	DATE A.D.	TYPOLOGY	GENERAL DESCRIPTION	PROBLEMS DESCRIPTION	DANGER/ DESTROY	
08	Guthi Ghar		Religious House dwelling by Yogi	G+2 house with cooked and uncooked brick with mud mortar	Upper two storey collapsed Lower remaining ground floor severely damaged Needs total reconstruction

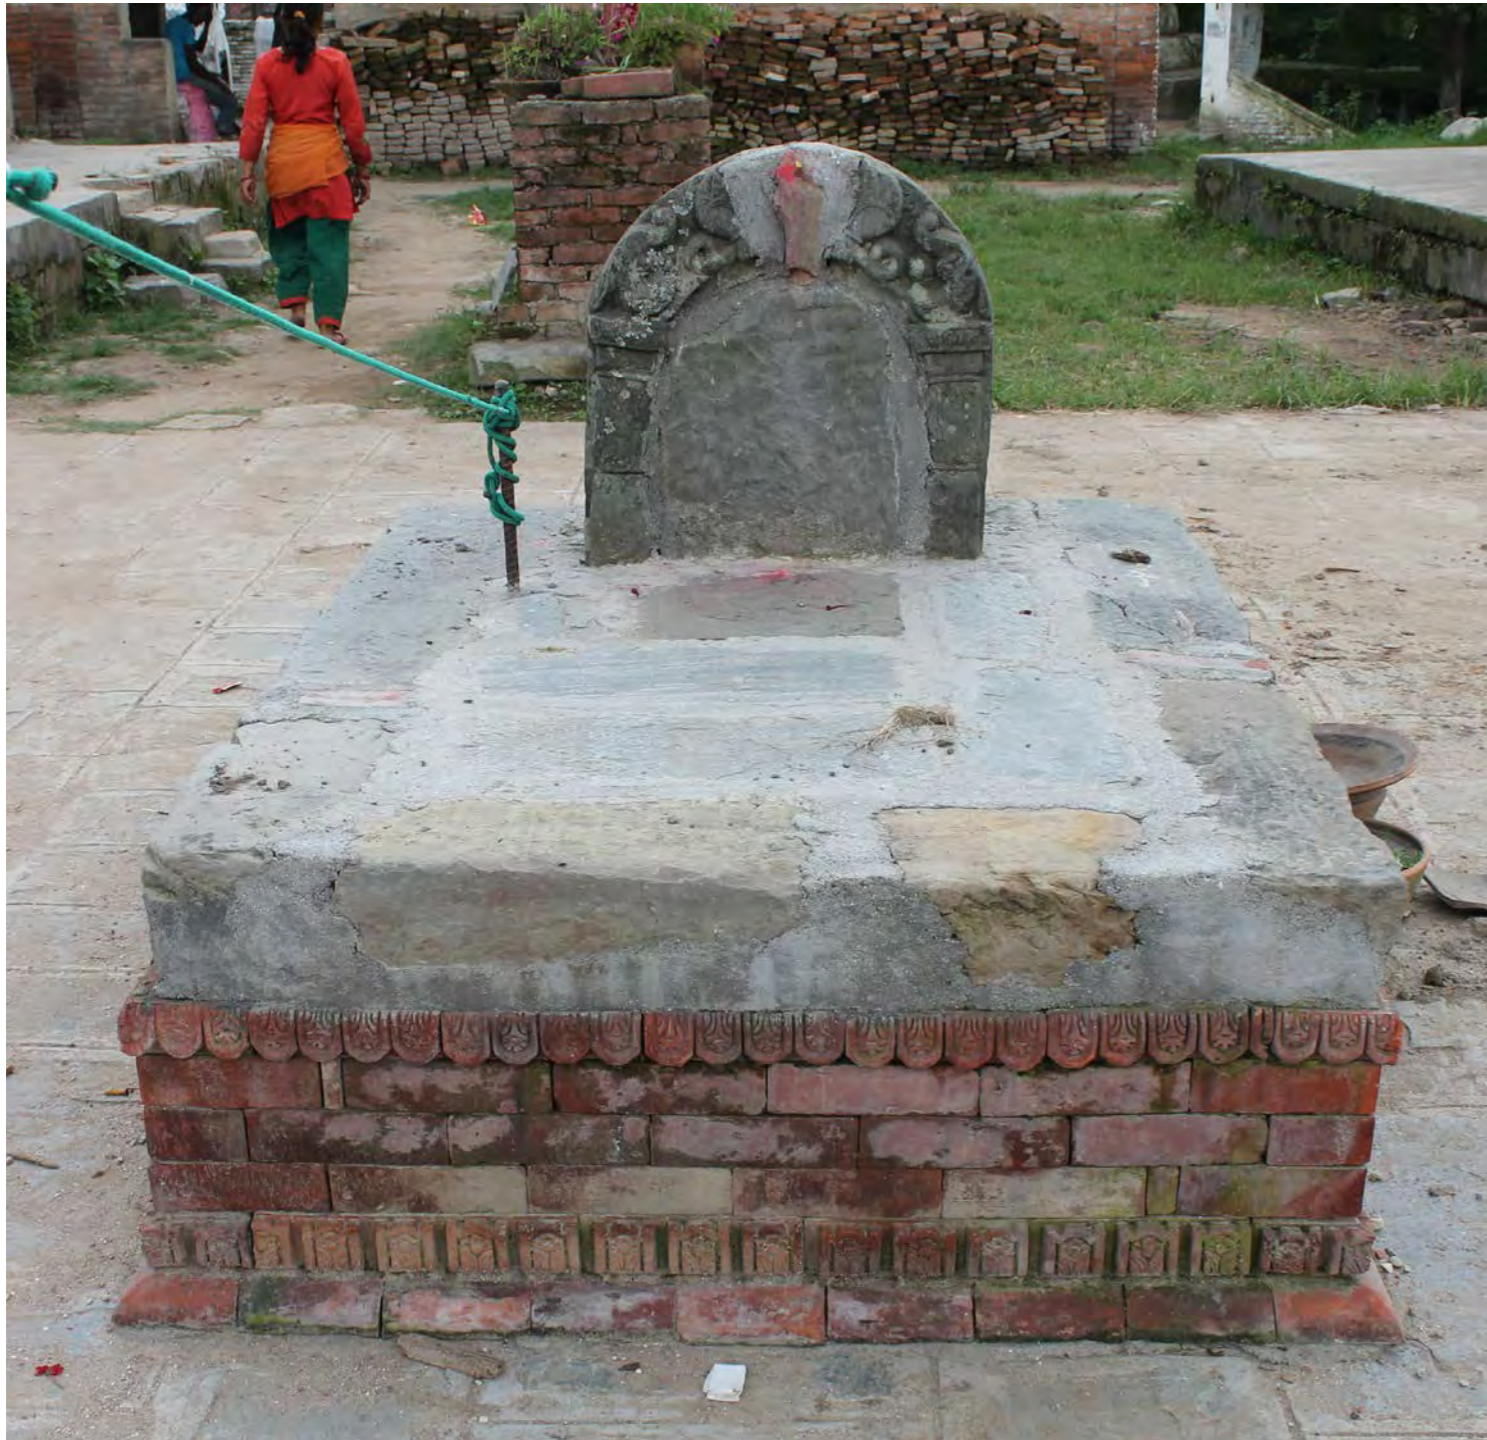
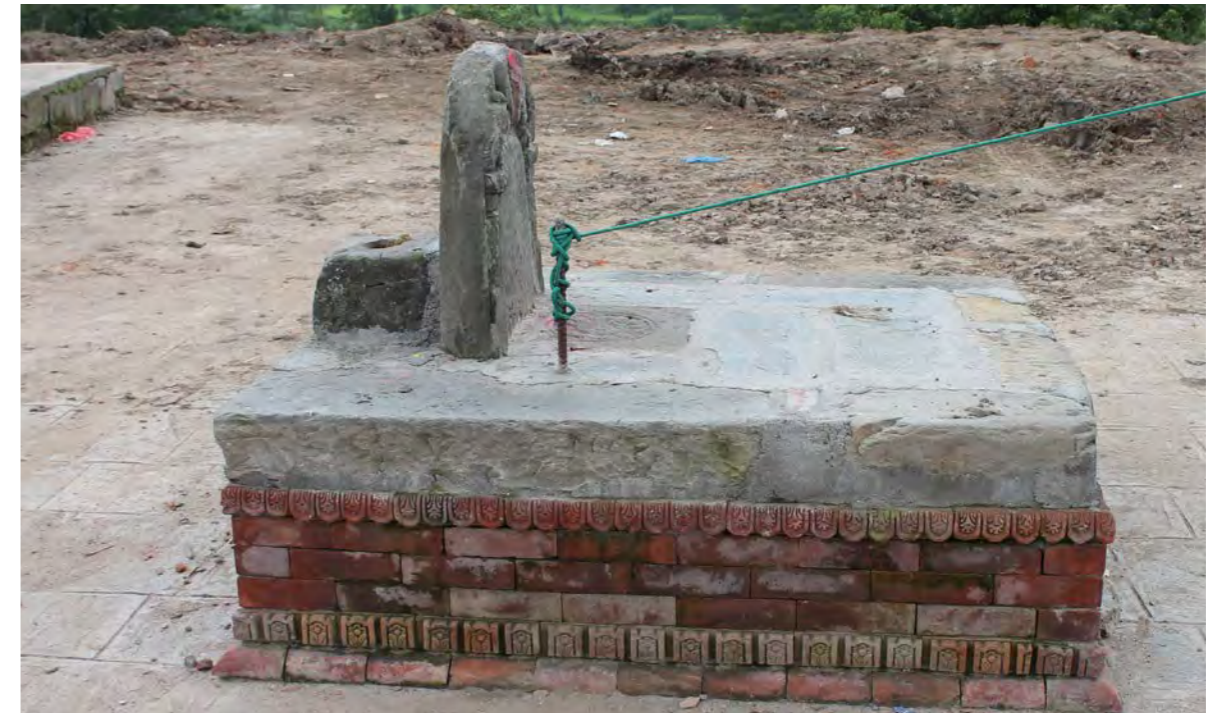
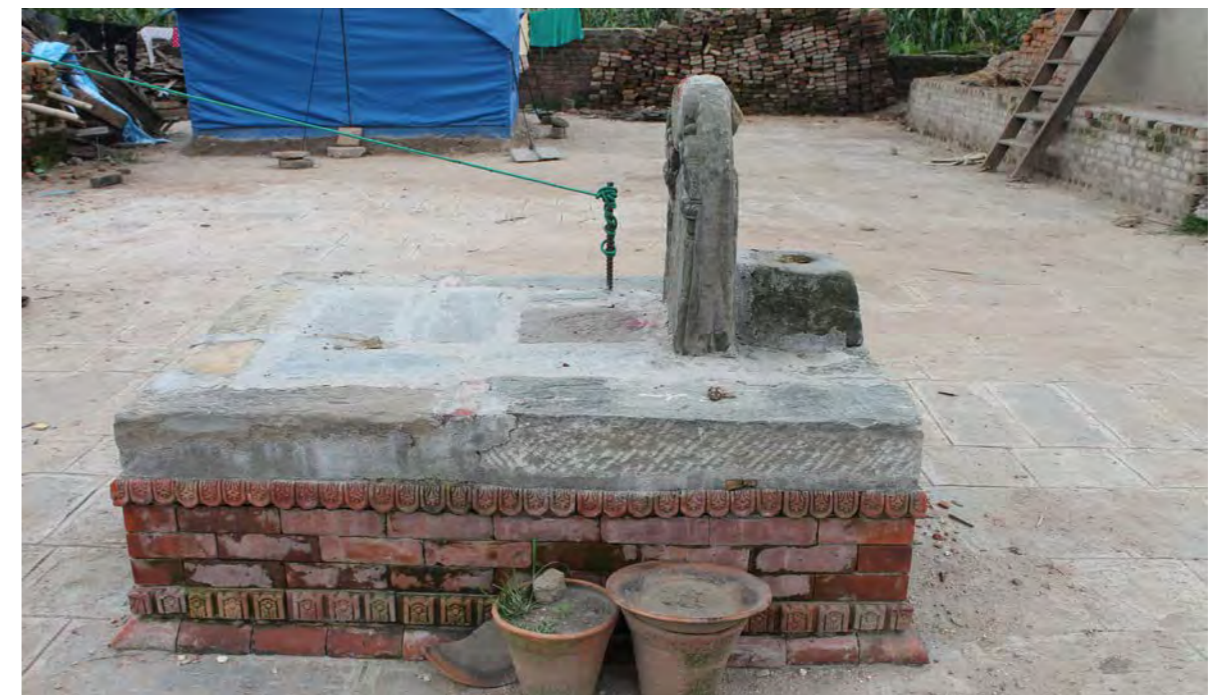
NUMBER	NAME	ESTABLISHED DATE (A.D.)	TYPOLOGY	GENERAL DESCRIPTION	PROBLEMS DESCRIPTION	DANGER/ DESTROY	
09			Small Stone Platform	Stone made platform for establishment of Narayan during Melas and special occasions	Good Condition

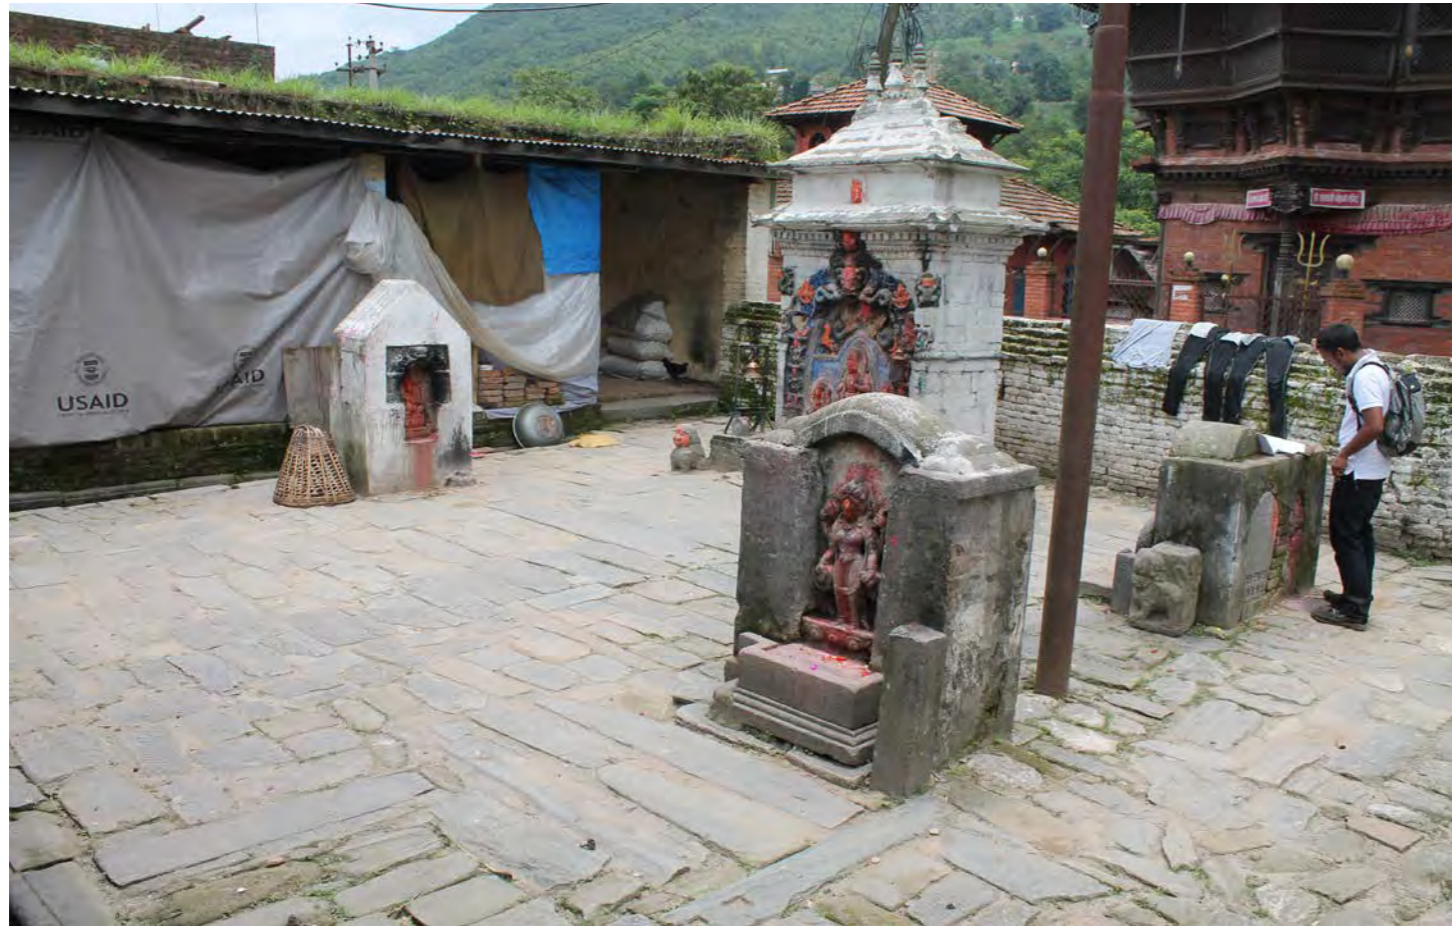
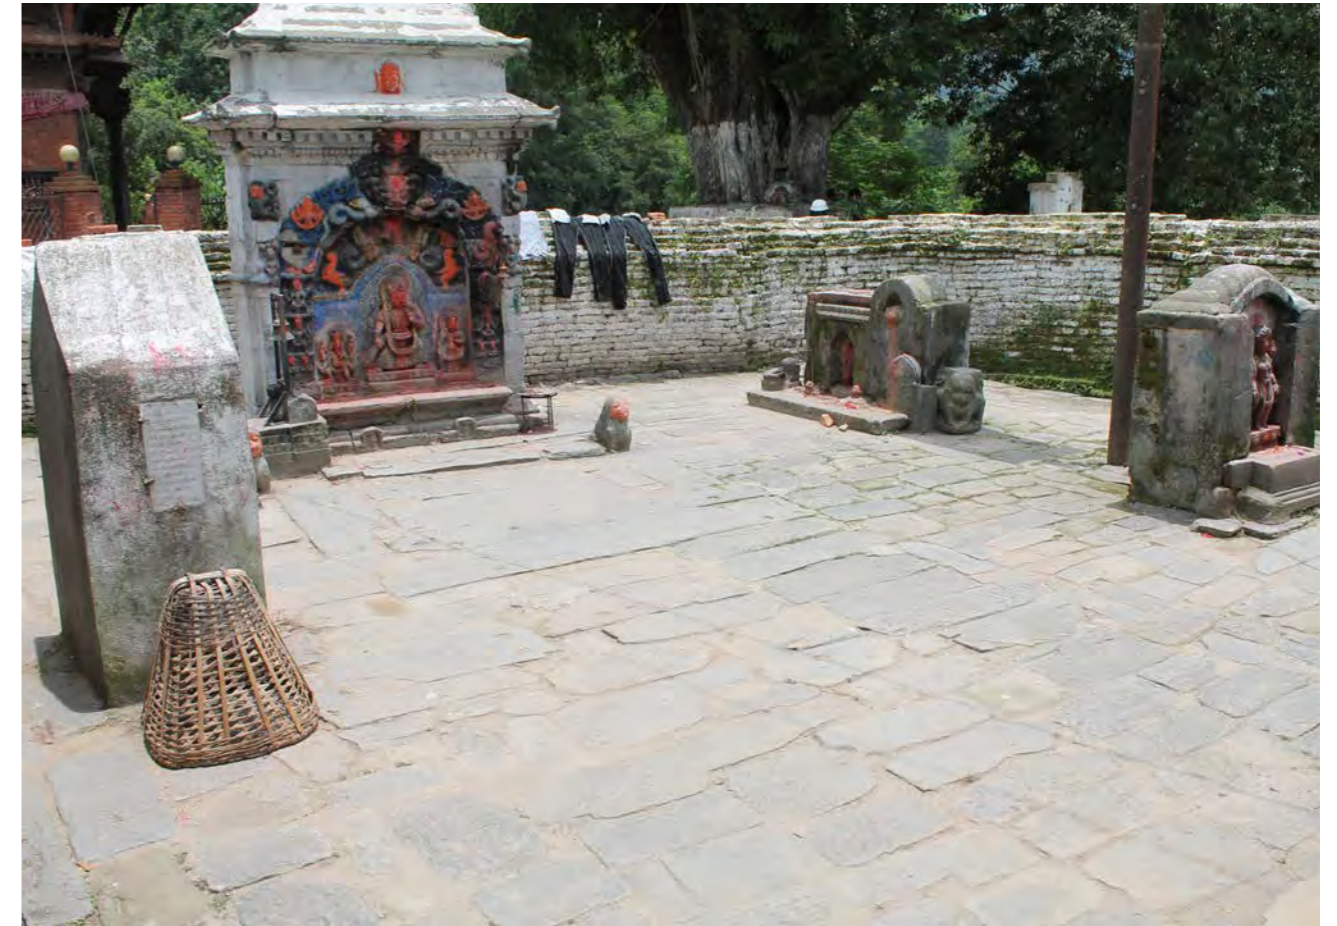
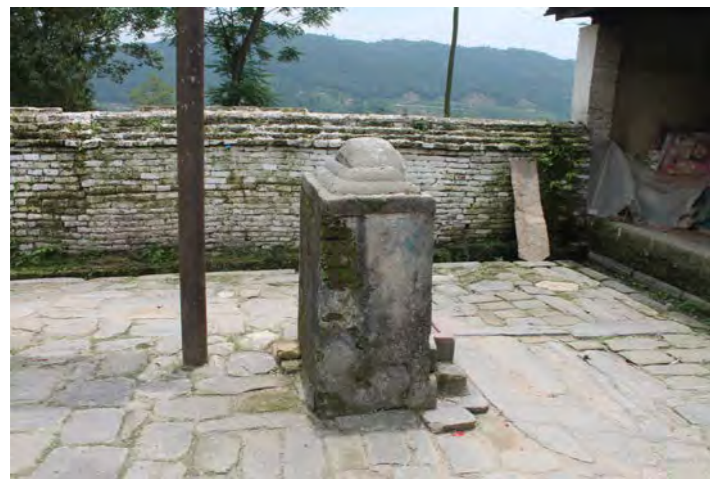
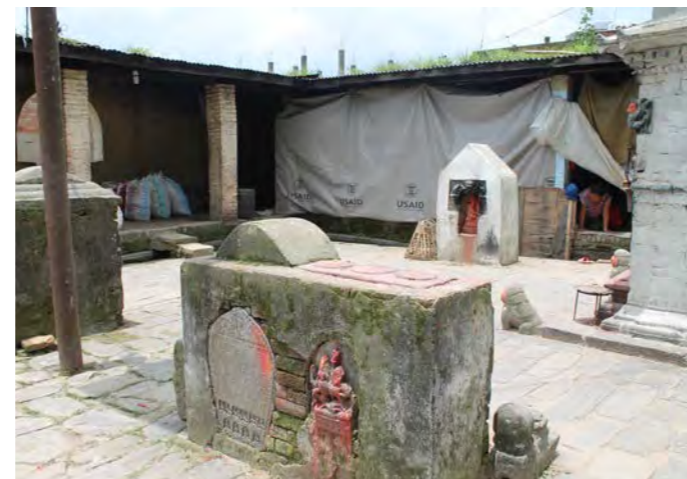
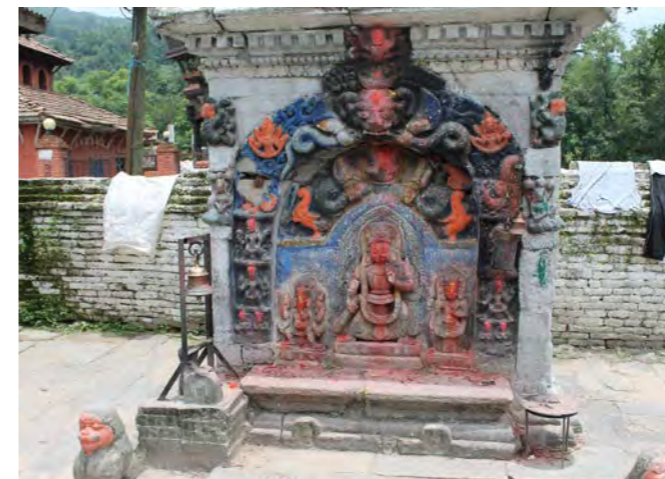
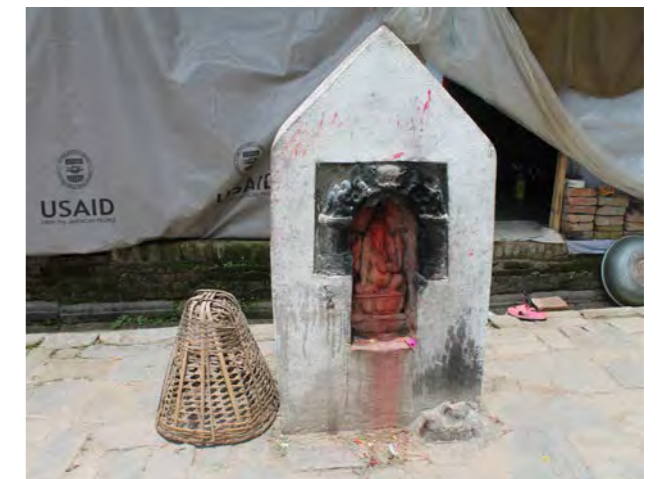
COURTYARD A

NUMBER	NAME	ESTABLISHED DATE (A.D.)	TYPOLOGY	GENERAL DESCRIPTION	PROBLEMS DESCRIPTION	DANGER/ DESTROY	
Courtyard A	Bhimsen temple Courtyard		Courtyard	Stone paved with small drainage around the circumference	Surrounded by Bhimsen Sattal which needs proper reconstruction		<p>BHIMSENSTHAN</p>

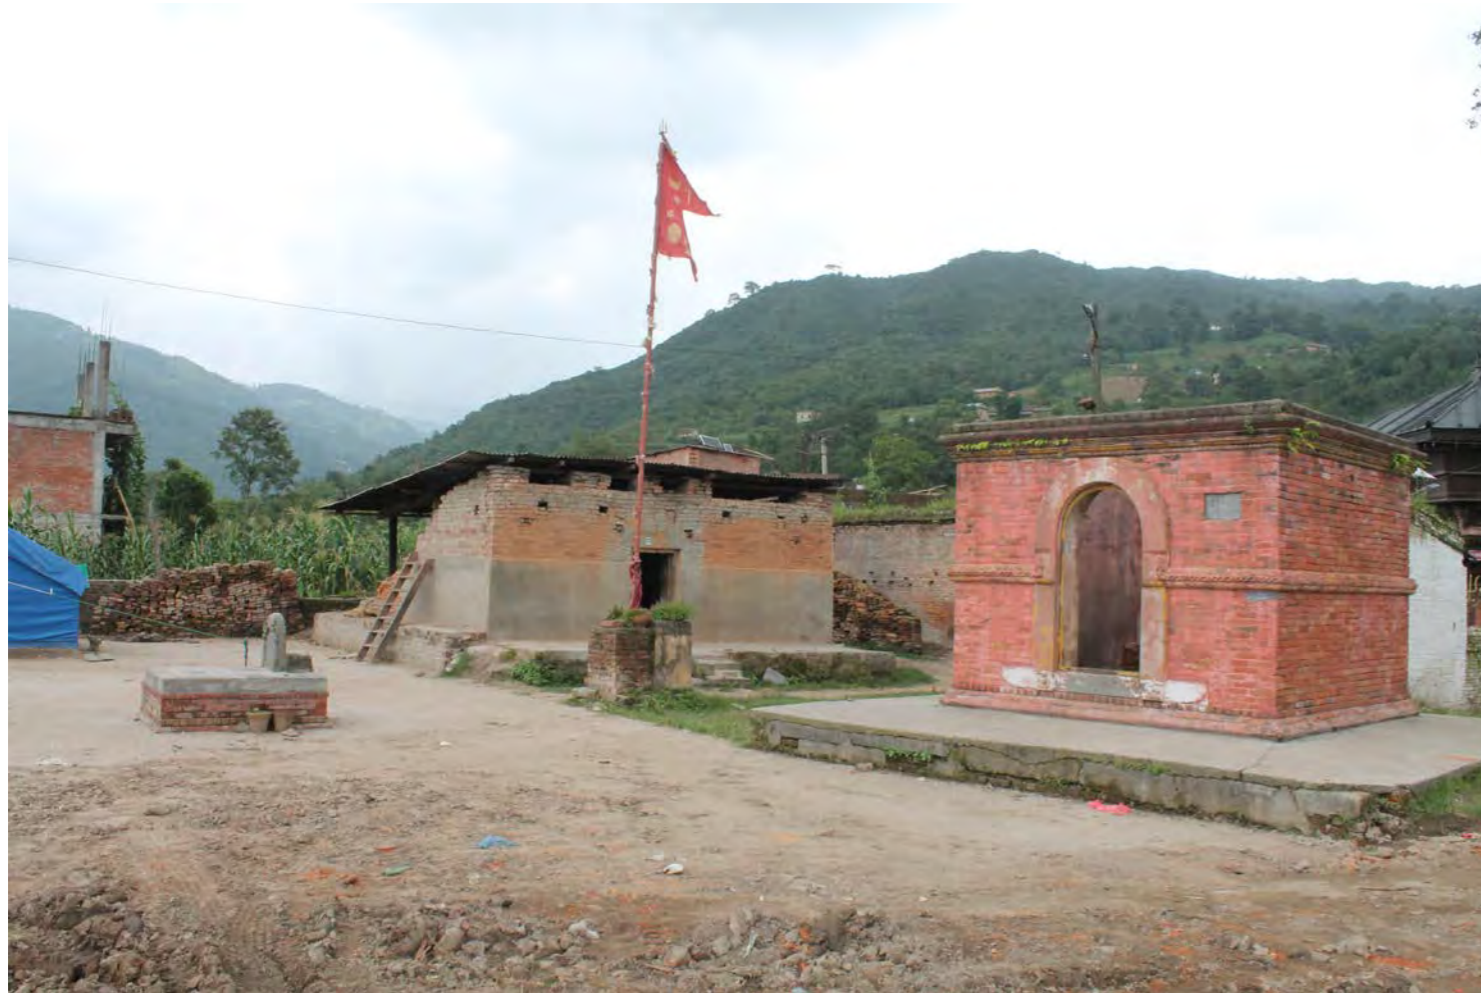
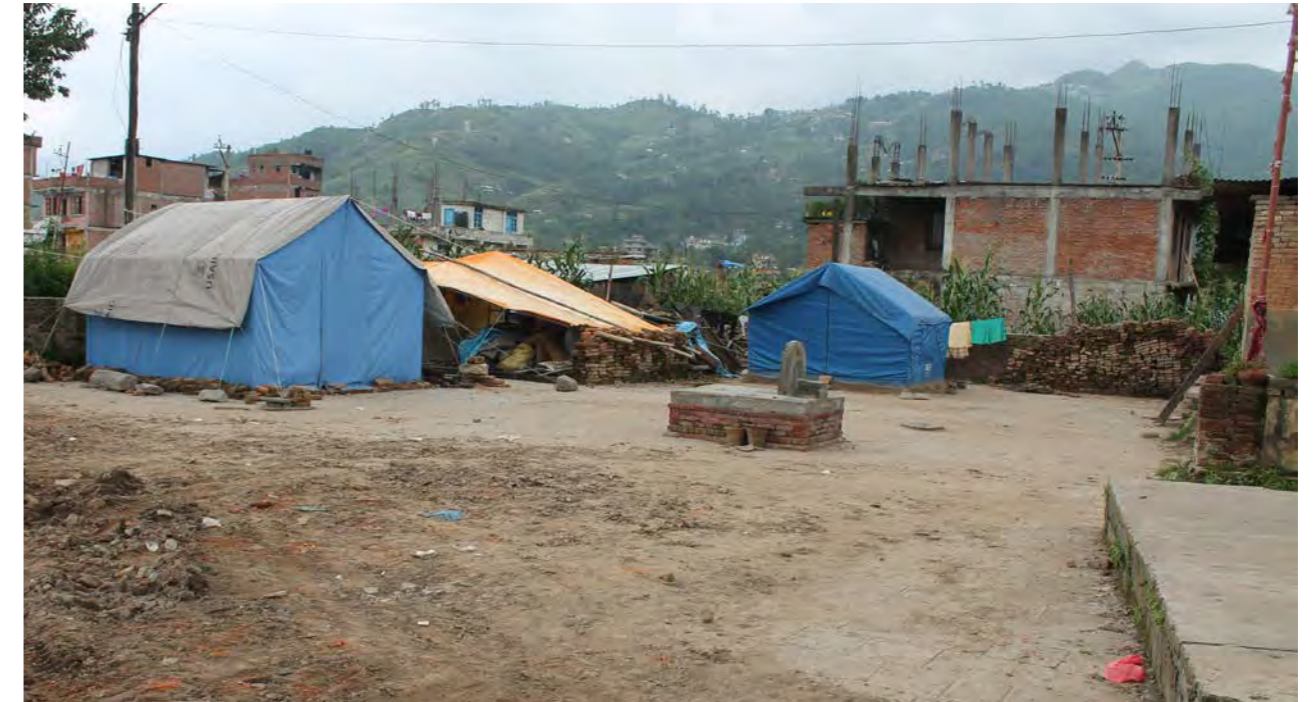
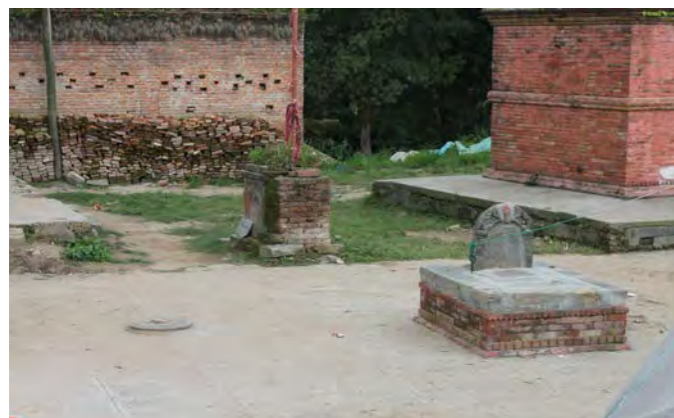
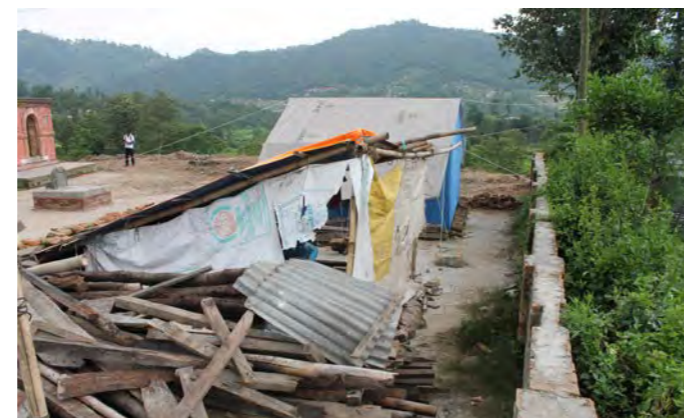
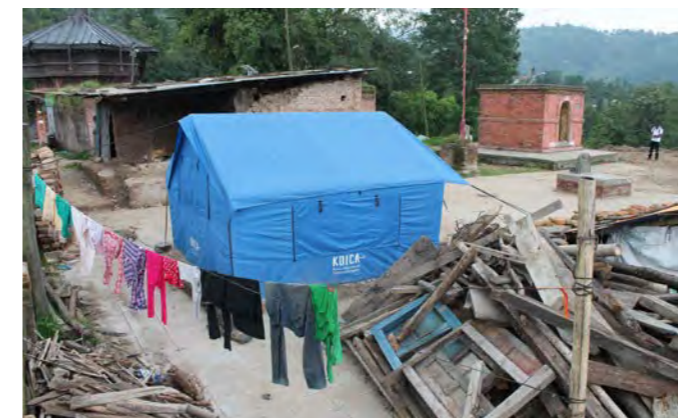
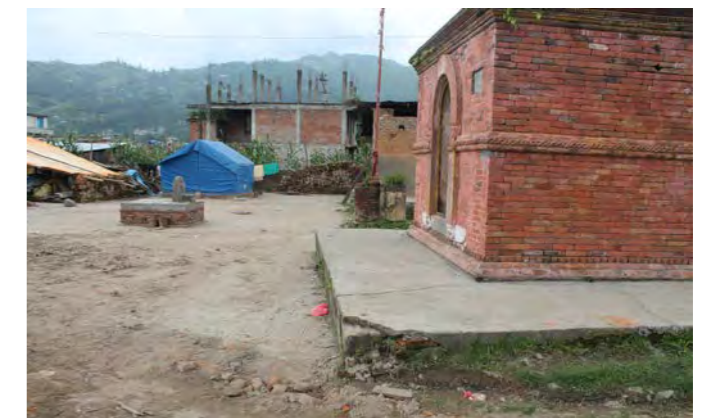
COURTYARD B

NUMBER	NAME	DATE A.D.	TYOLOGY	GENERAL DESCRIPTION	PROBLEMS DESCRIPTION	DANGER/ DESTROY	
Courtyard B			Stone platform	Large open stone paved platform for religious ceremony and festivals Surrounded by brick wall boundary of about 1.5 m height	Used as space for temporary shelters Needs proper construction and protection

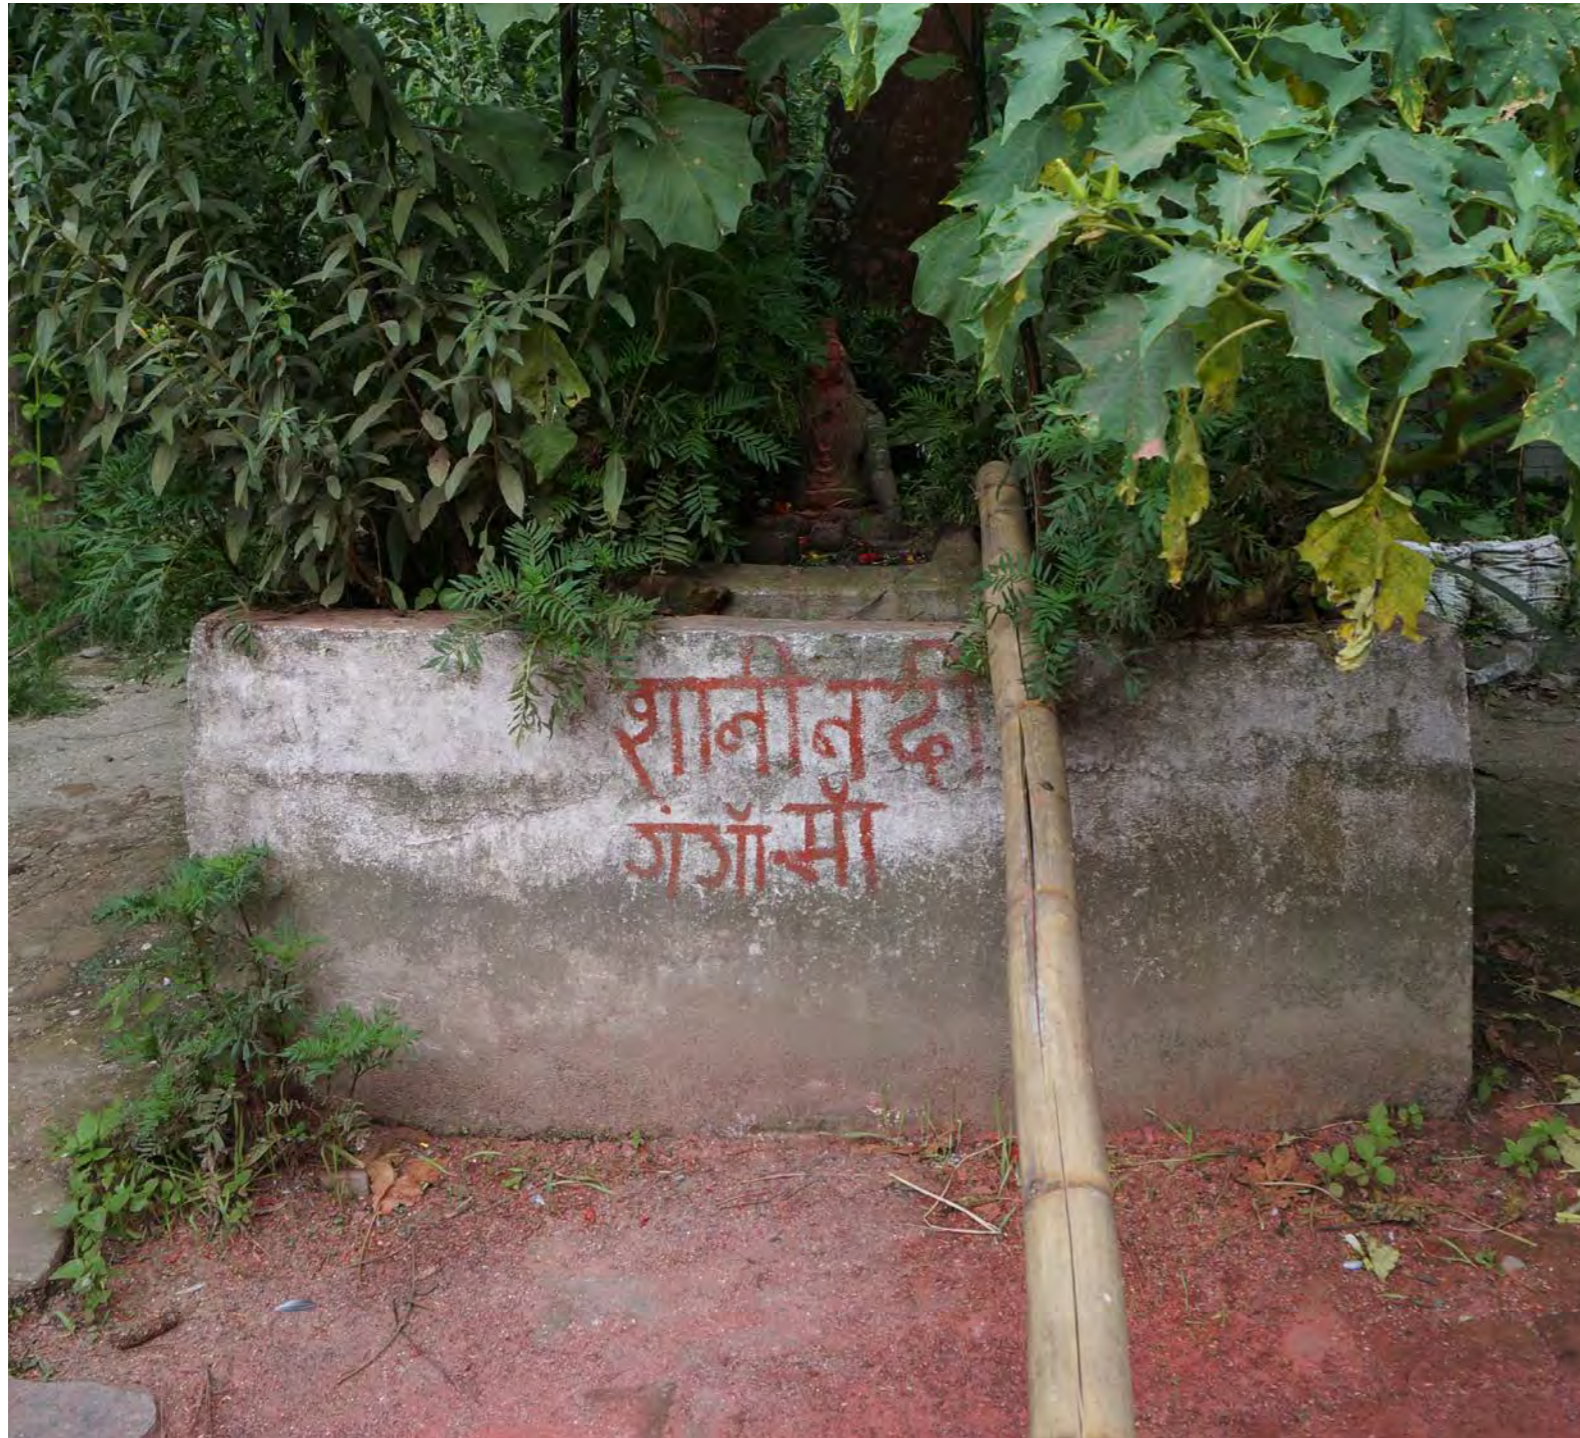
NUMBER	NAME	ESTABLISHED DATE (A.D.)	TPOLOGY	GENERAL DESCRIPTION	PROBLEMS DESCRIPTION	DANGER/ DESTROY	
01			Tree with brick base		No visible damage

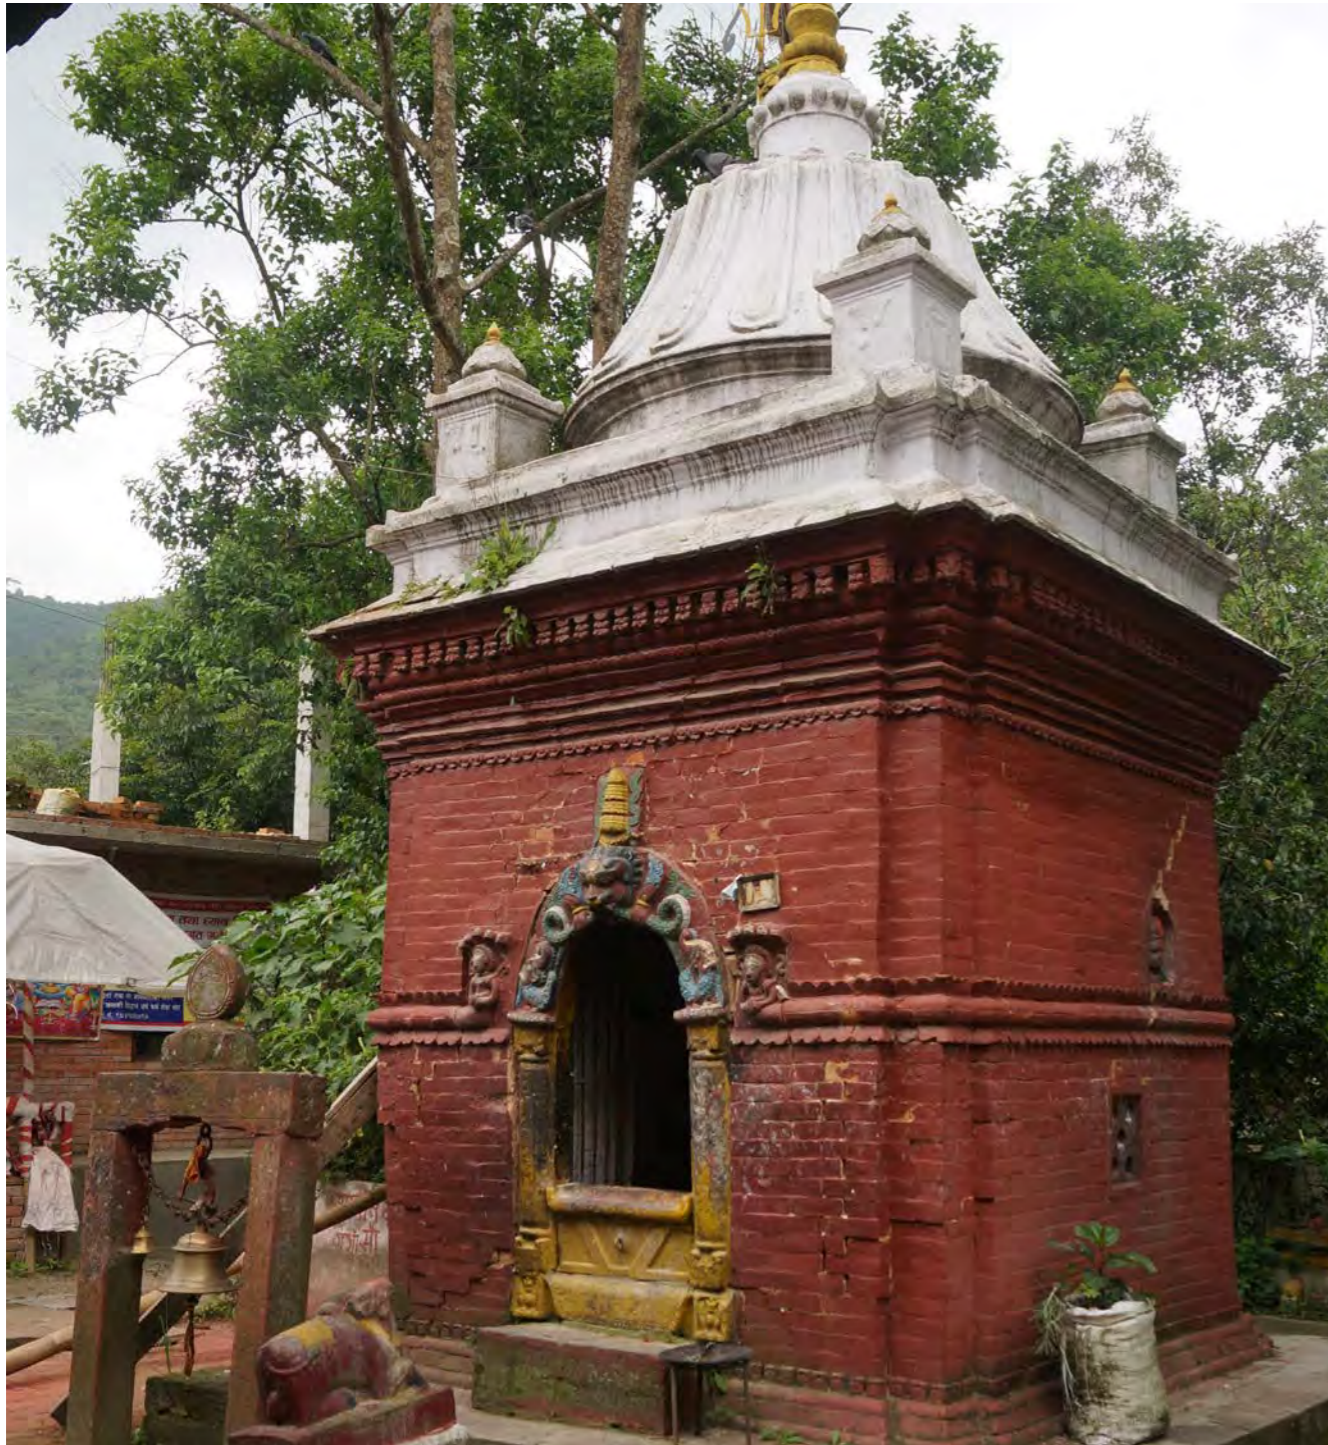
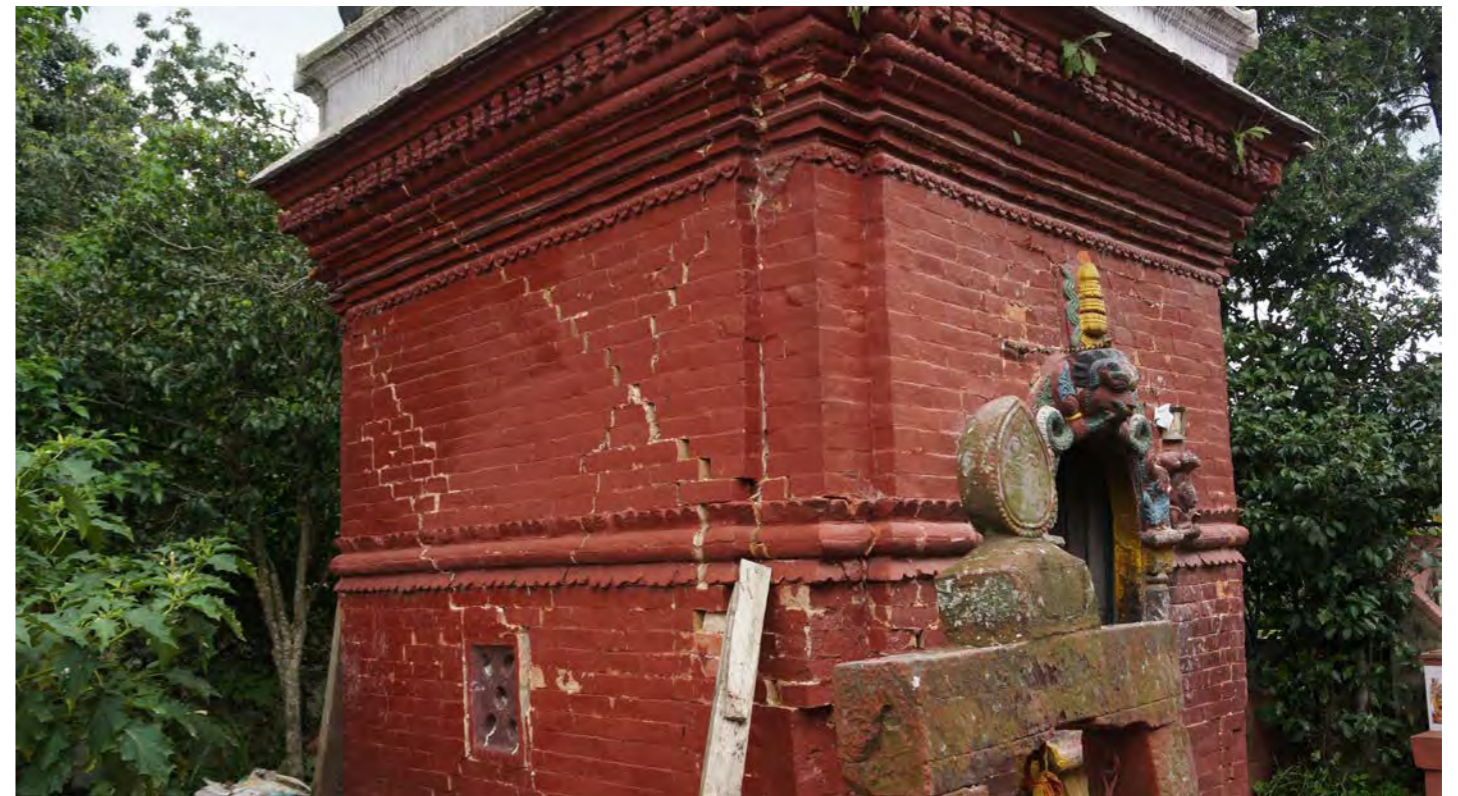
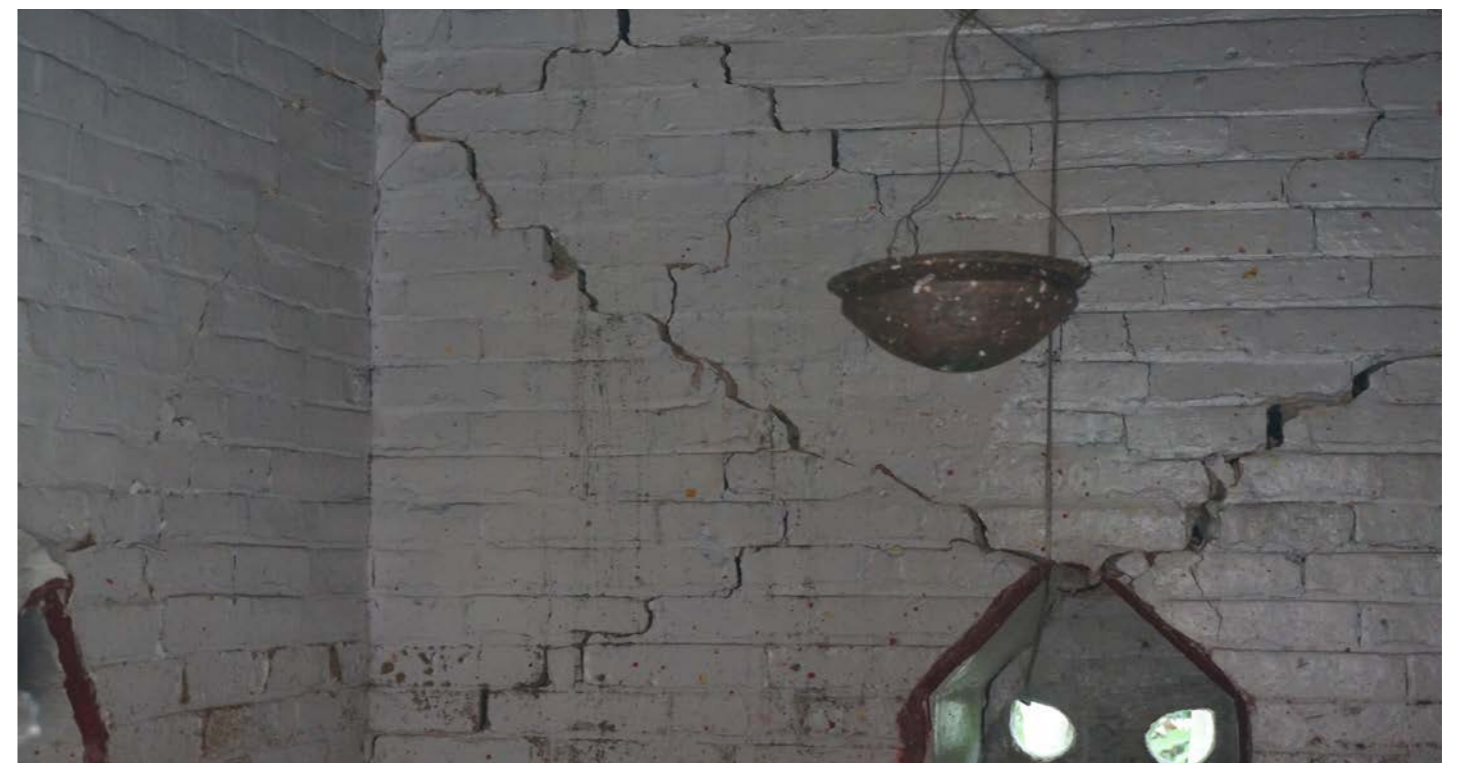
02 SHIVA TEMPLE

NUMBER	NAME	DATE A.D.	TPOLOGY	GENERAL DESCRIPTION	PROBLEMS DESCRIPTION	DANGER/ DESTROY	
2	Shiva Temple		Shikhara Temple		Vertical and diagonal cracks all over Vegetation growth on E side

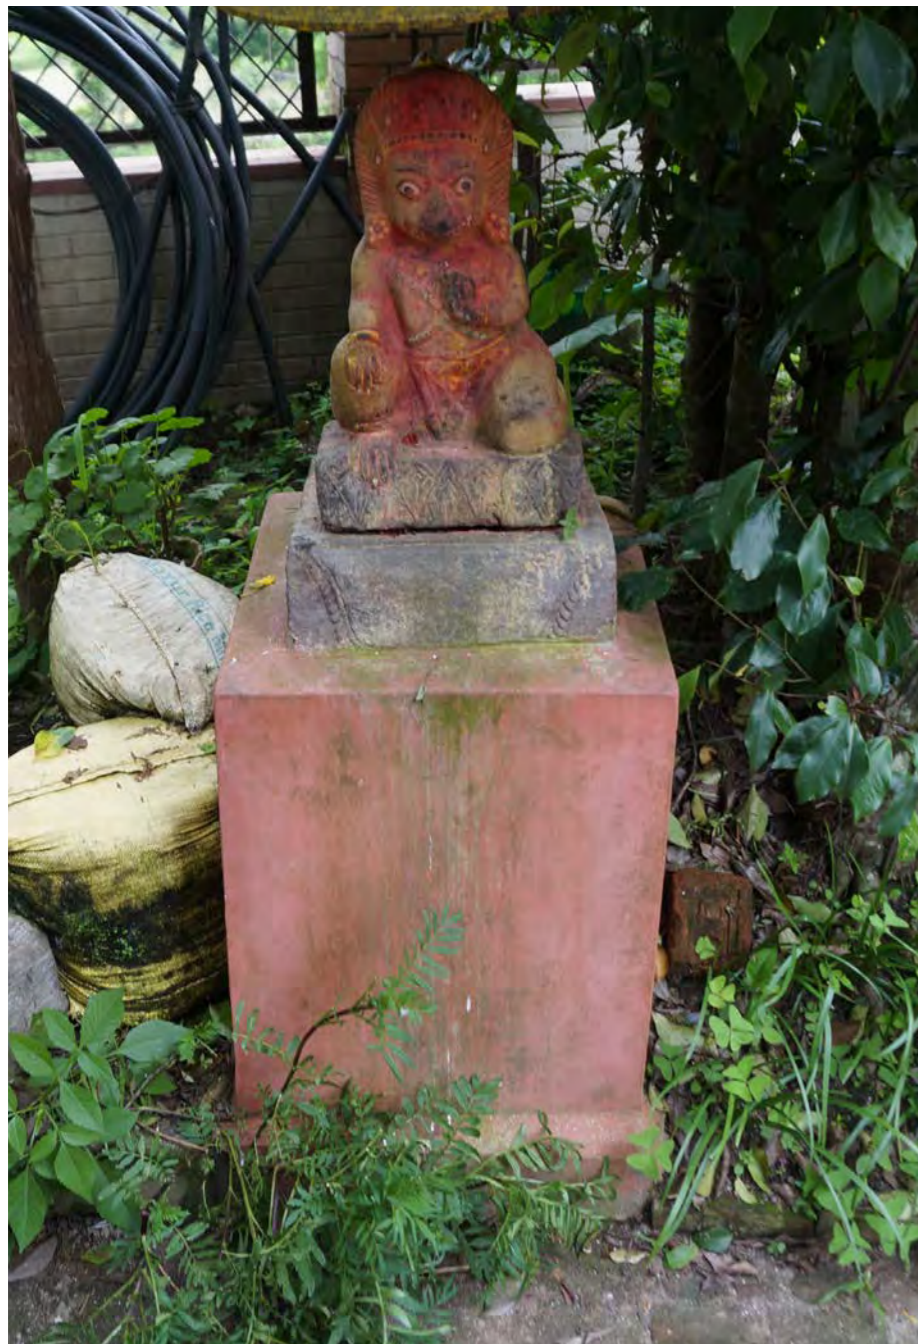
03 HANUMAN

NUMBER	NAME	ESTABLISHED DATE (A.D.)	TYPOLOGY	GENERAL DESCRIPTION	PROBLEMS DESCRIPTION	DANGER/ DESTROY	
03	Hanuman		Open Shrine		No Visible Damages		
04			Tulsi Plant				
05			Shiva Linga		Rising Damp and vegetation growth. Other Shiva linga and ganesh idol nearby.
