2015 Earthquake Damage Mapping

Sankhu

October 2015

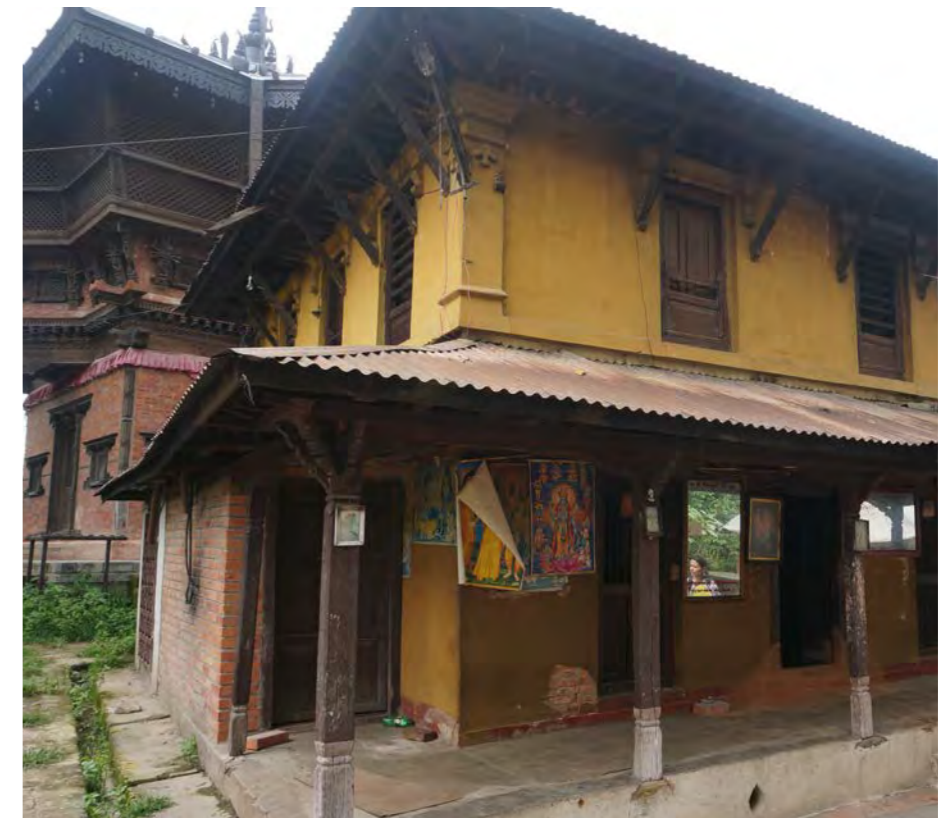
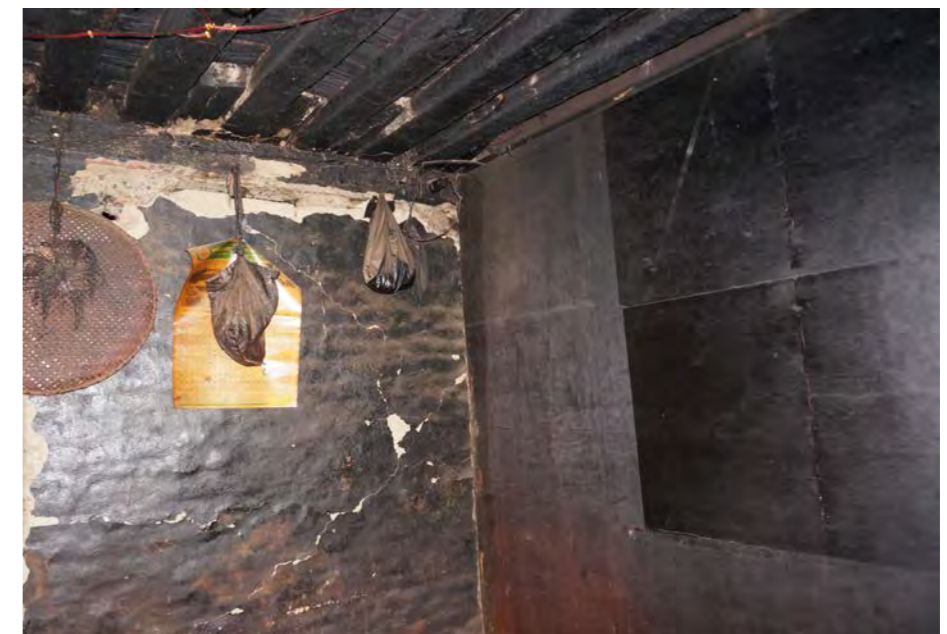
06 NARBADESHWOR KUTI

NUMBER	NAME	DATE A.D.	TYPOLOGY	GENERAL DESCRIPTION	PROBLEMS DESCRIPTION	DANGER/ DESTROY	
06	Narbadeshwor Kuti		Kuti	Two storey building	Plaster falling off at base of North Partition wall cracked Shiva Linga at W-wall and other idols at centre.

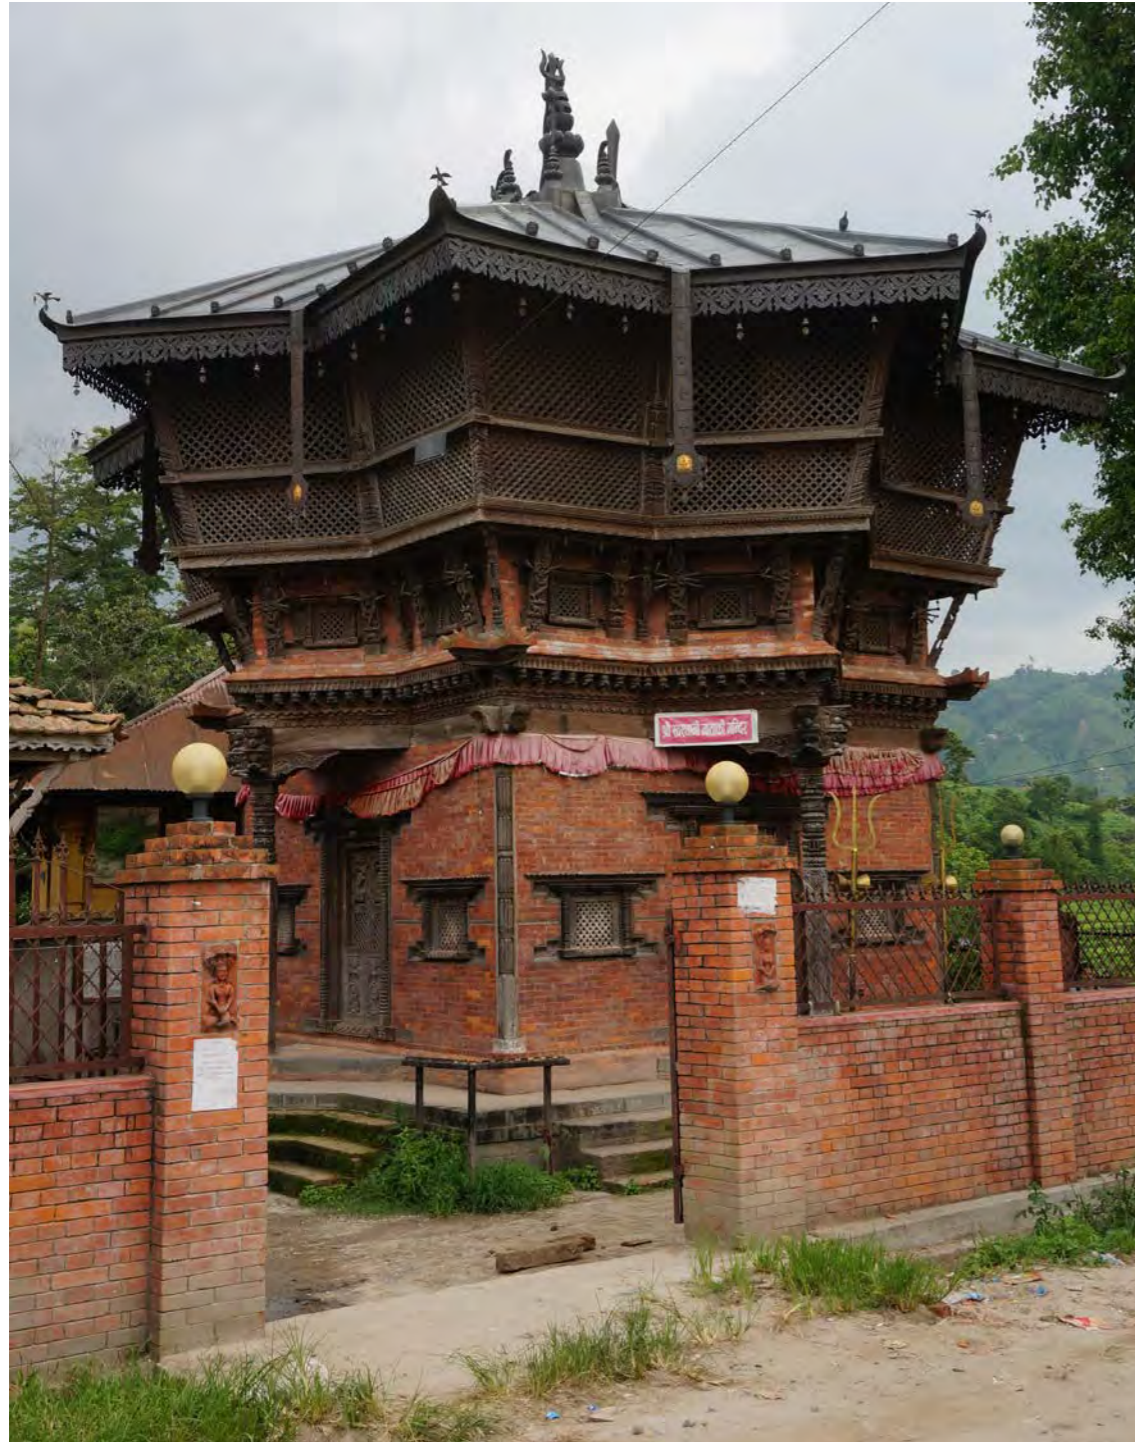
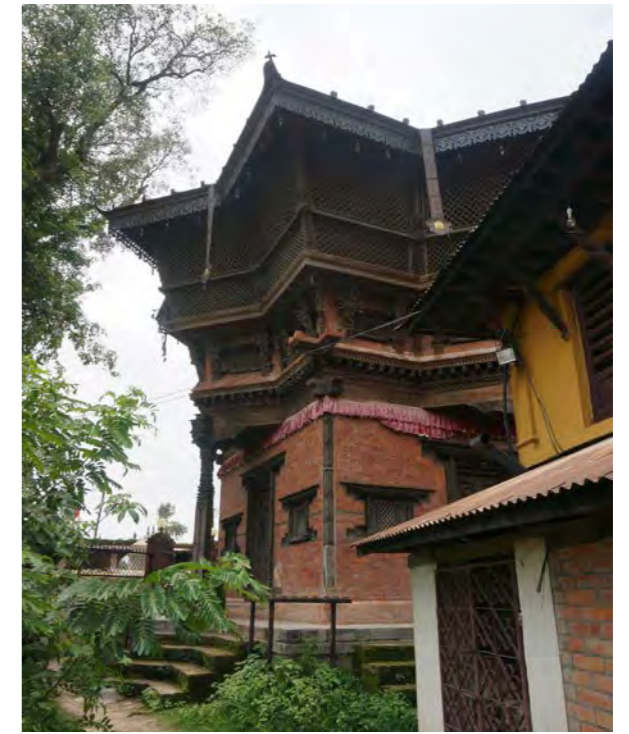
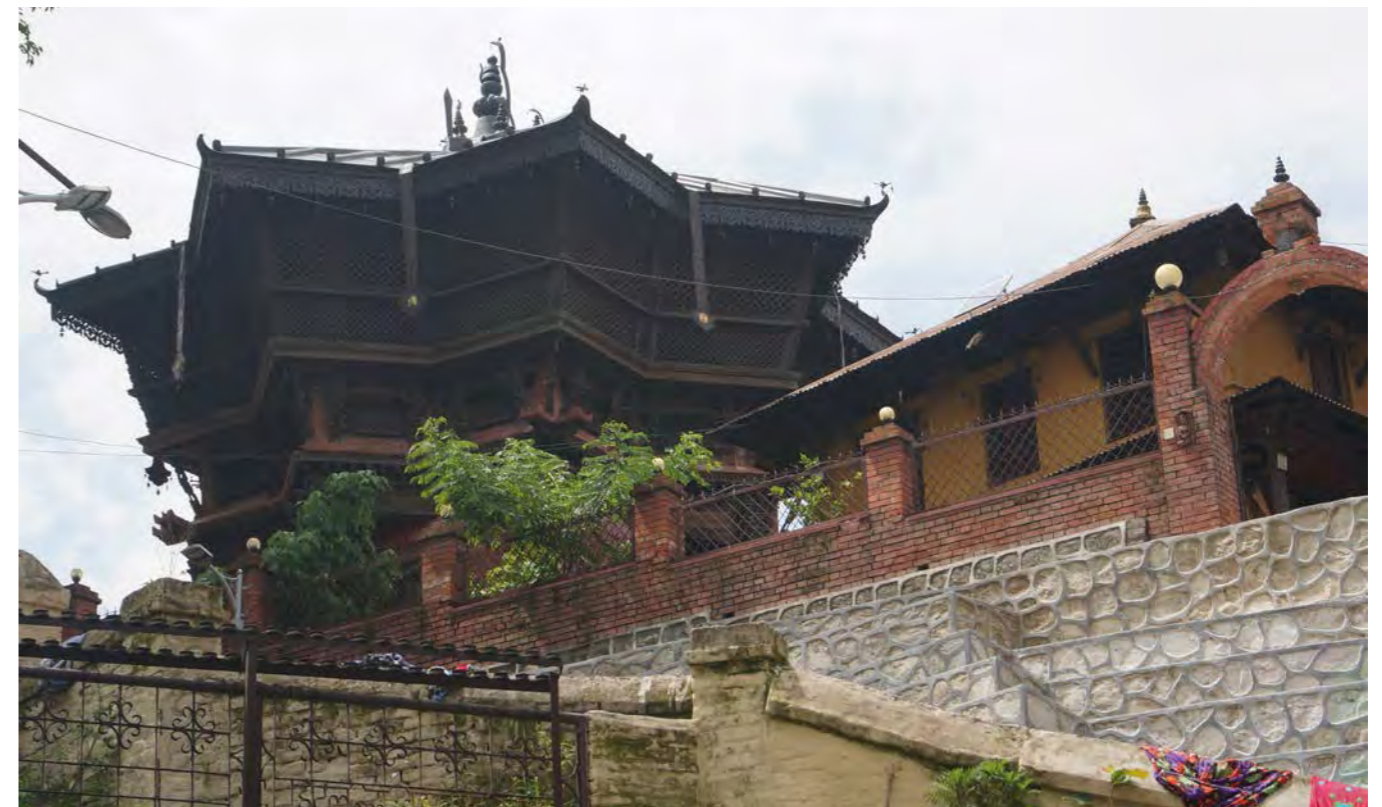
07 SWOSTHANI MANDIR

NUMBER	NAME	ESTABLISHED DATE (A.D.)	TYPOLOGY	GENERAL DESCRIPTION	PROBLEMS DESCRIPTION	DANGER/ DESTROY
07	Swasthani Mandir		Temple	Two storey temple with heavily carved wooden members	Rising Damp and vegetation growth on steps Major cracks in all walls Upper floor walls bea...

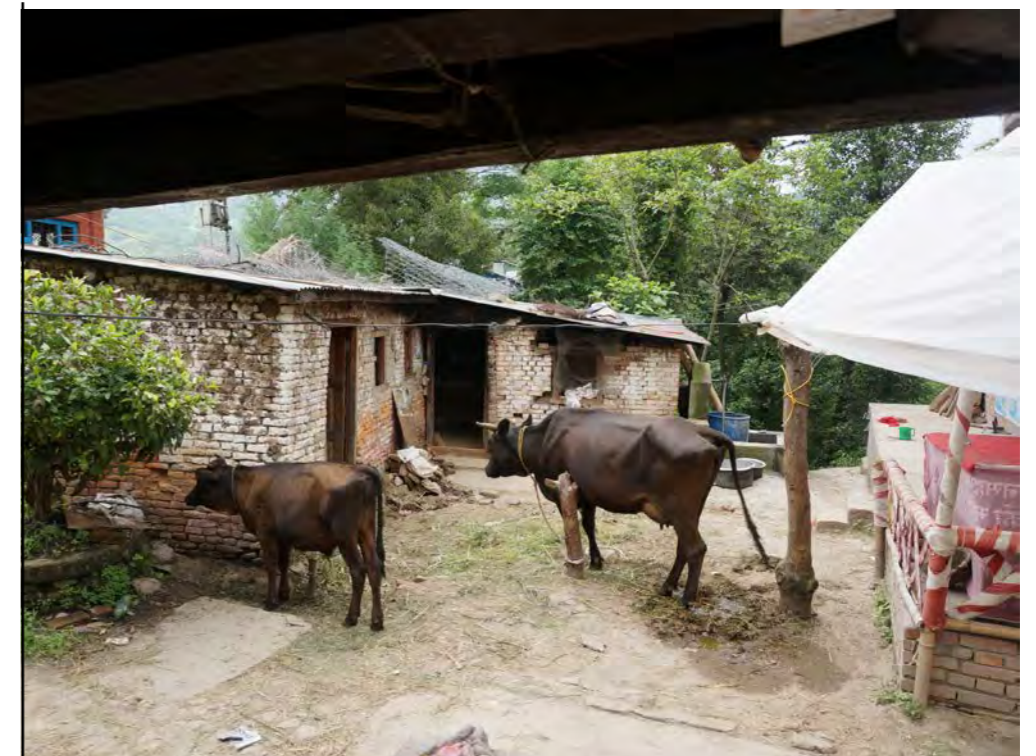
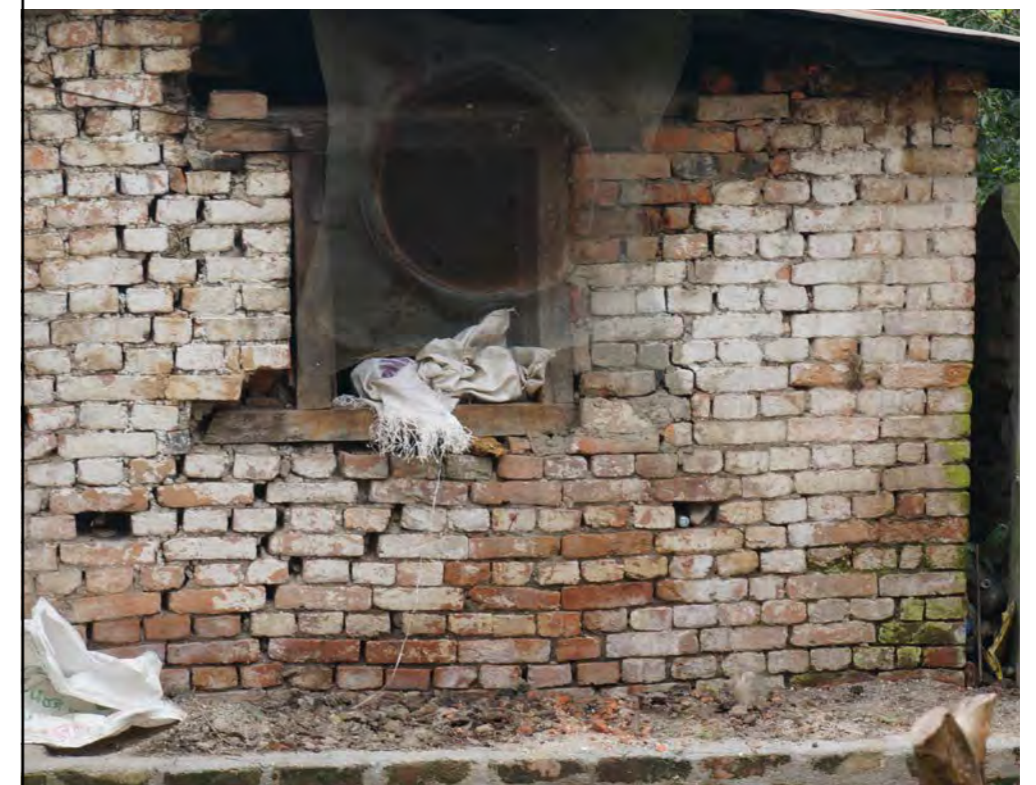
NUMBER	NAME	ESTABLISHED DATE (A.D.)	TYPOLOGY	GENERAL DESCRIPTION	PROBLEMS DESCRIPTION	DANGER/ DESTROY
09			Cow Shed		Brick deterioration due to rising damp. Vertical cracks on S-wall S-wall top bricks falling. E-wall bricks above lintel falling.

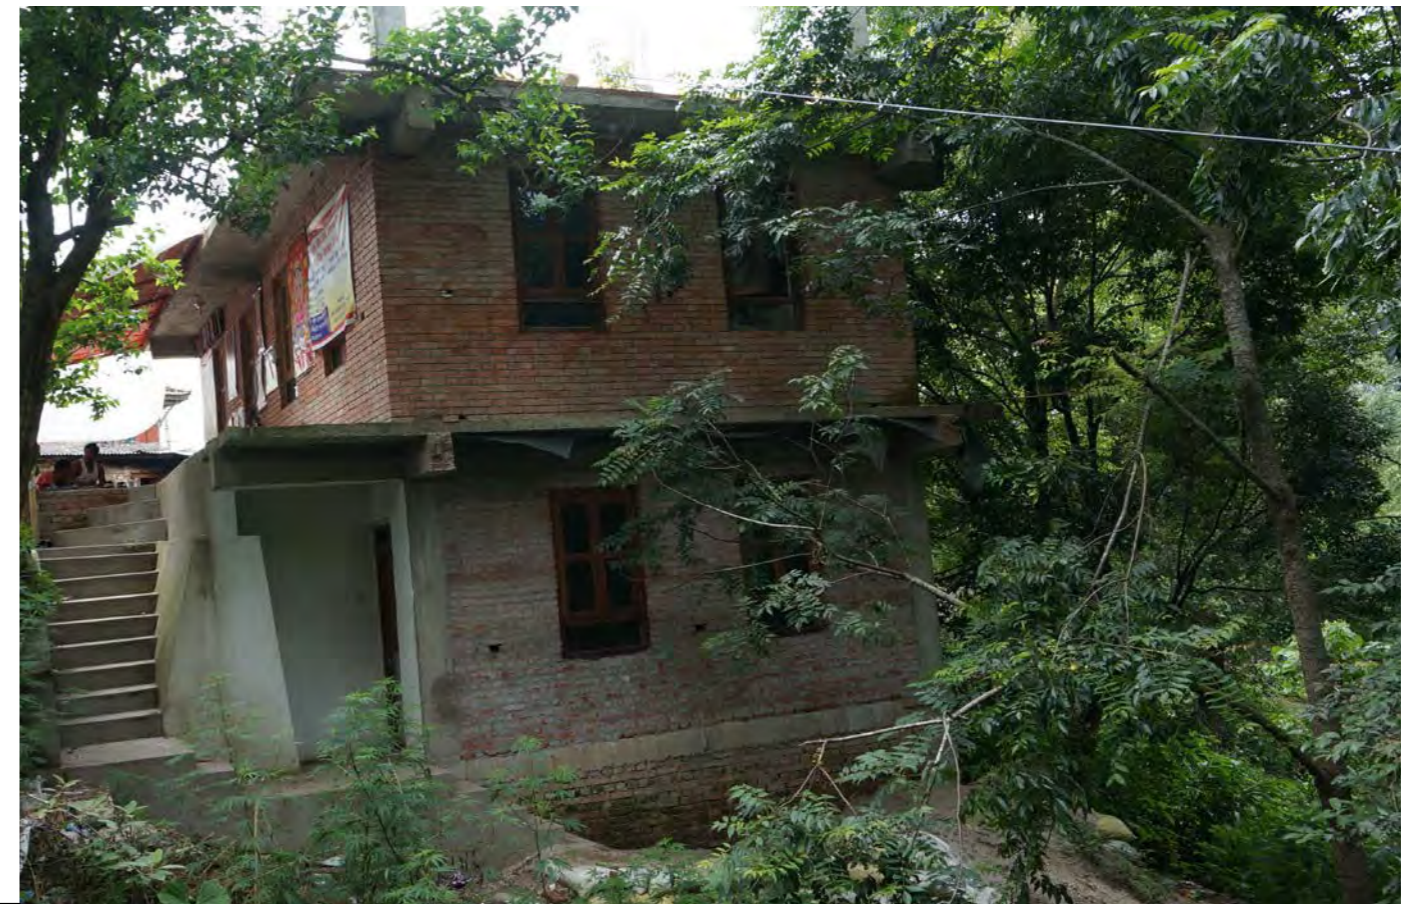
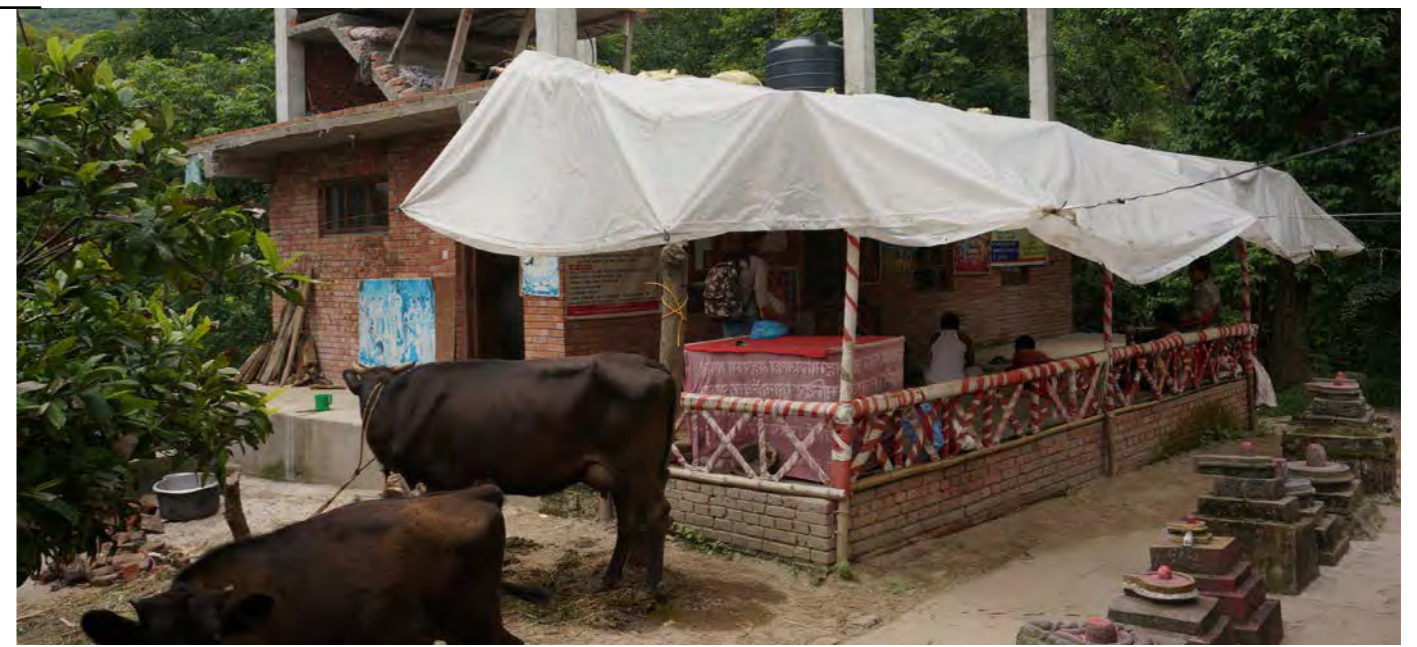
NUMBER	NAME	DATE A.D.	TPOLOGY	GENERAL DESCRIPTION	PROBLEMS DESCRIPTION	DANGER/ DESTROY	
11			Ashram	G + Basement Concrete structure.	Rising Damp on S-wall. No Visible Damages Minor Plinth Cracks

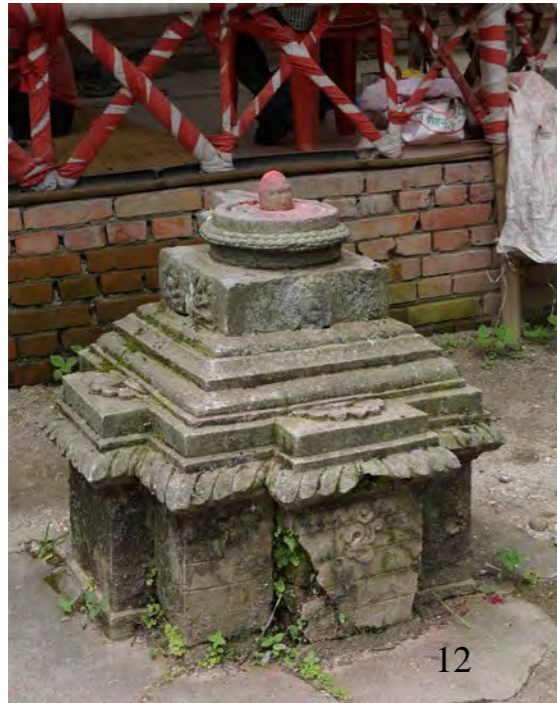
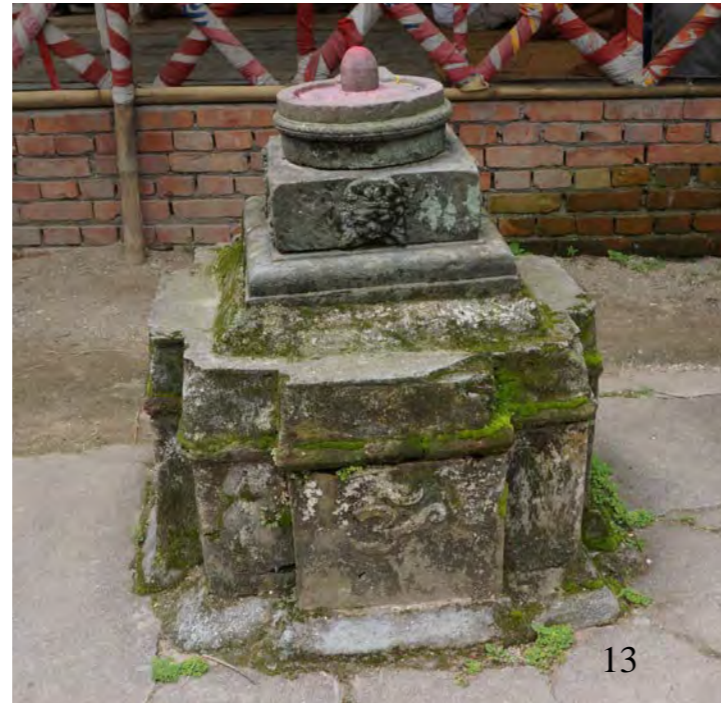
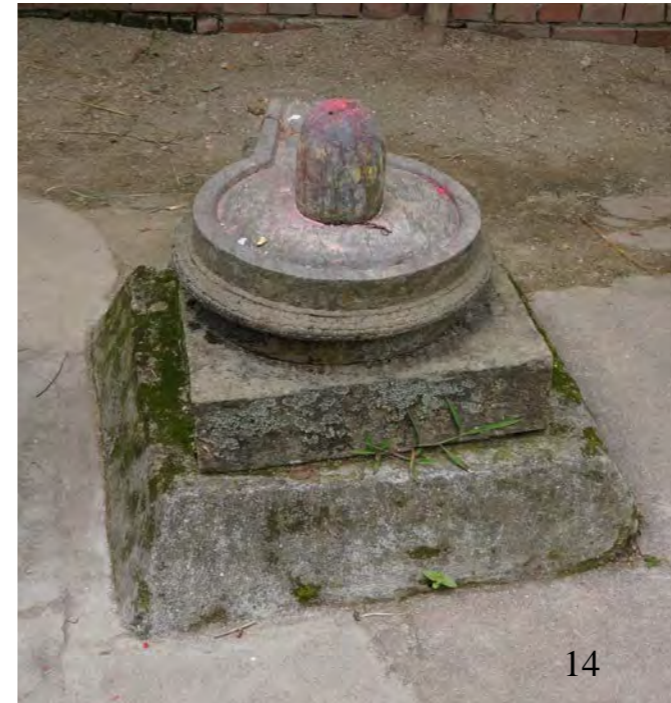
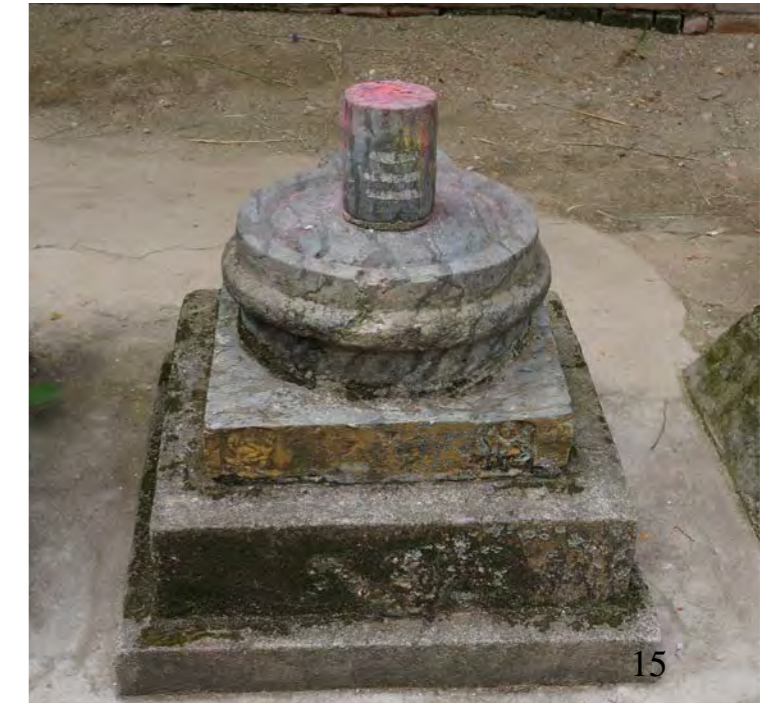
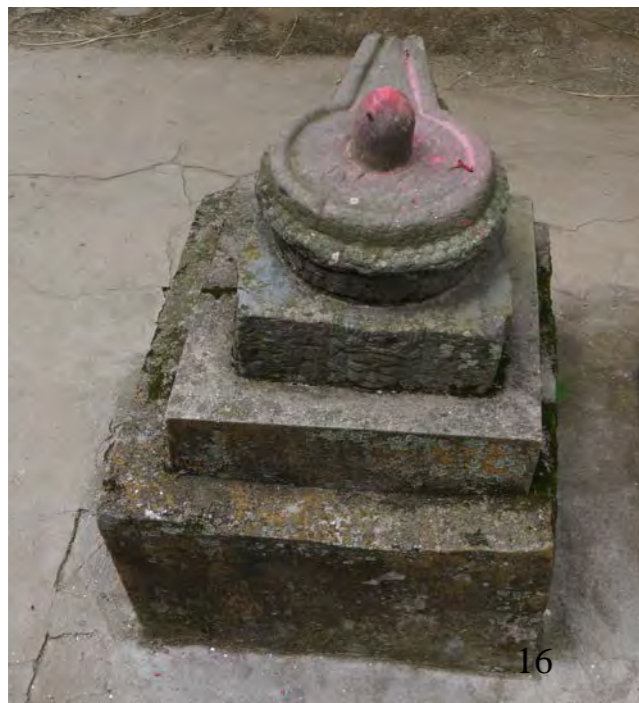
12,13,14,15,16,17,18,19

NUMBER	NAME	ESTABLISHED DATE (A.D.)	TYPOLOGY	GENERAL DESCRIPTION	PROBLEMS DESCRIPTION	DANGER/ DESTROY
12 - 16			Shiva Linga		Vegetation growth Minor plaster cracks.	
17 - 19			Shiva Linga		No Visible damage

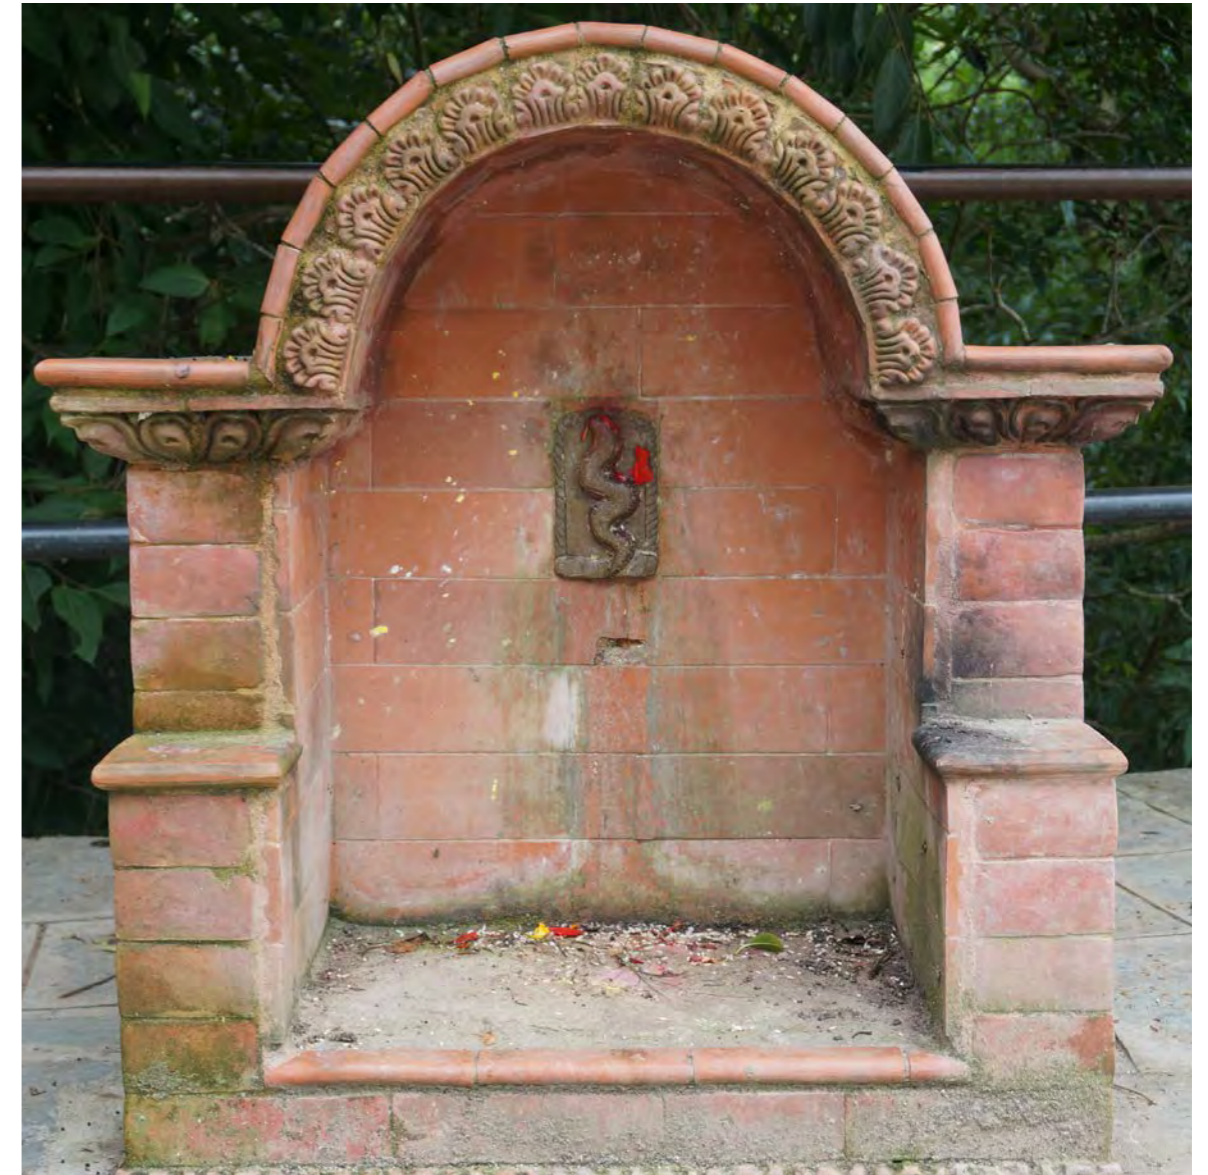
21 NAG MANDIR

NUMBER	NAME	DATE A.D.	TYPOLOGY	GENERAL DESCRIPTION	PROBLEMS DESCRIPTION	DANGER/ DESTROY
20	Mijan Chen (Dyo Chhen)		God House	One storey shelter with CGI Roof.	No Visible Damages	
21	Nag Mandir		Shrine		No Visible Damages.Minor rising damp and vegetation growth.

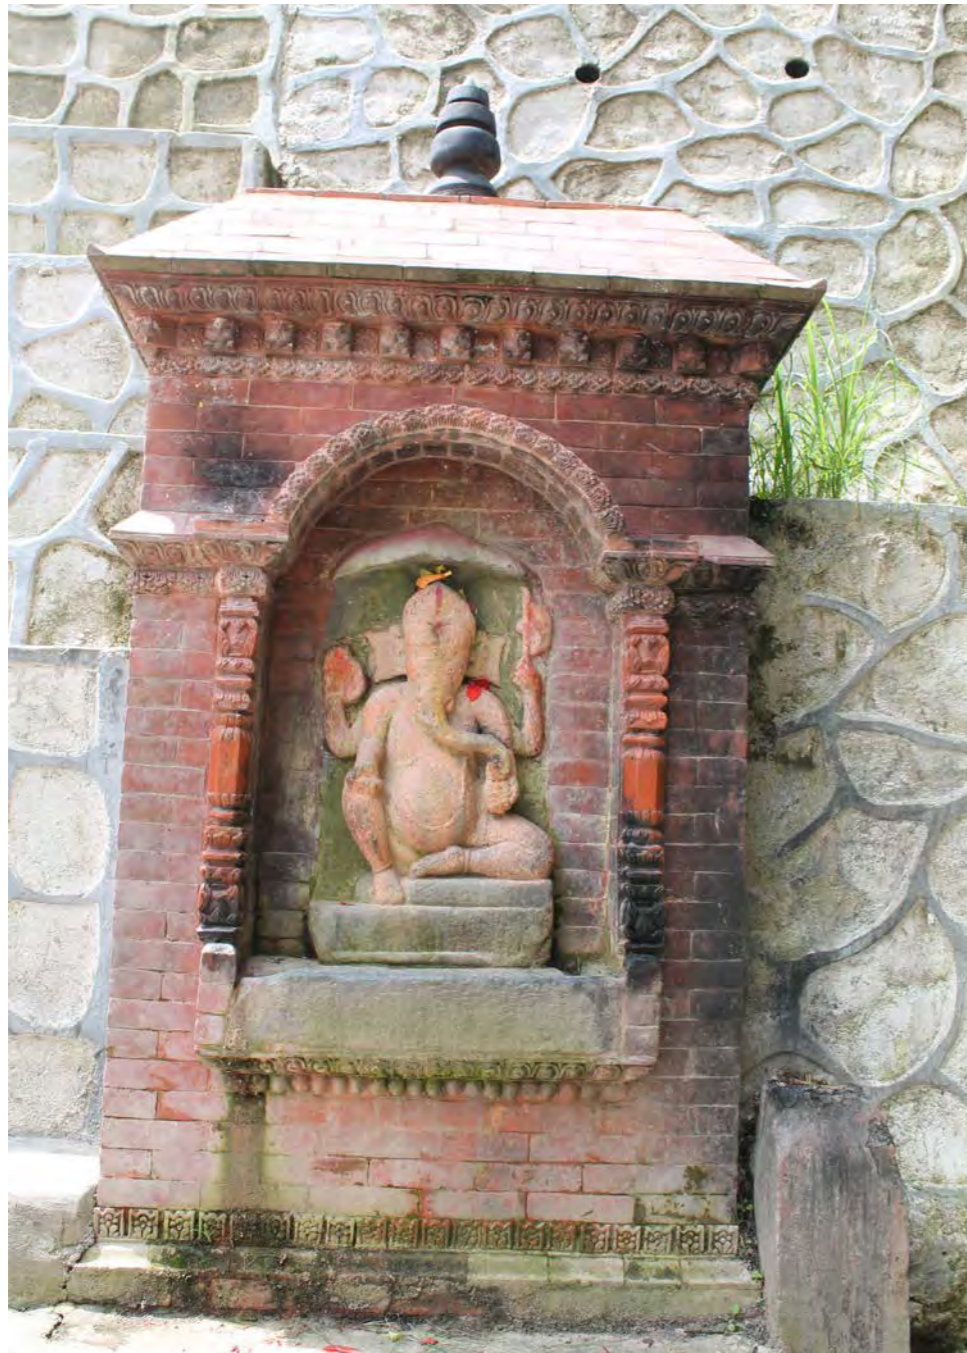
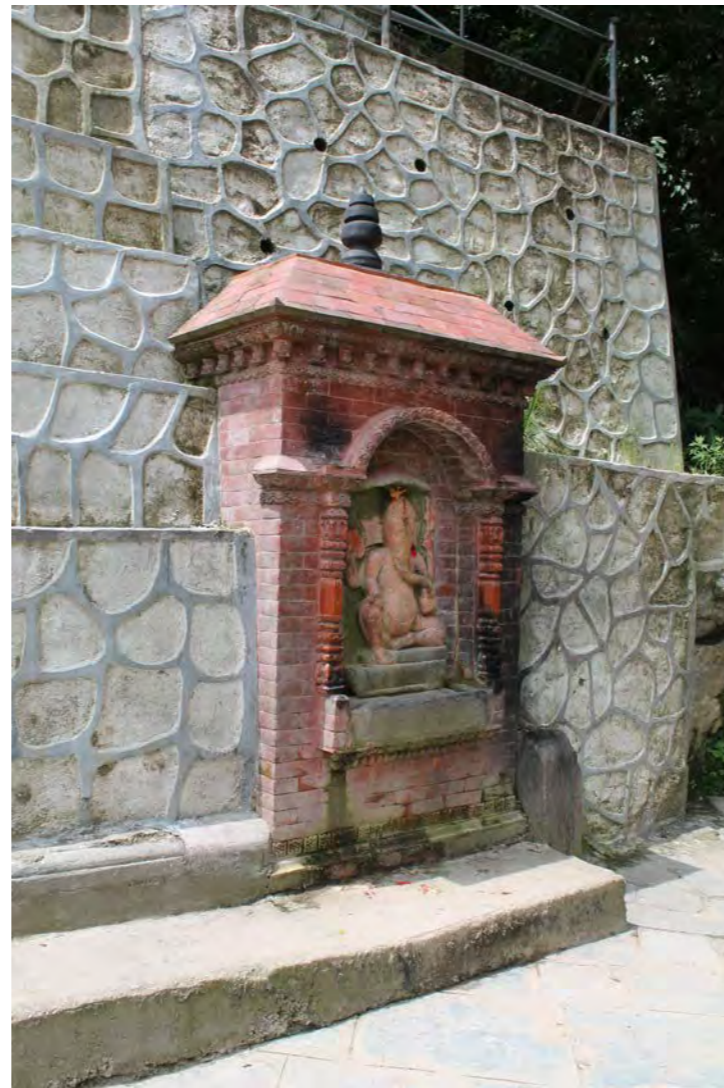
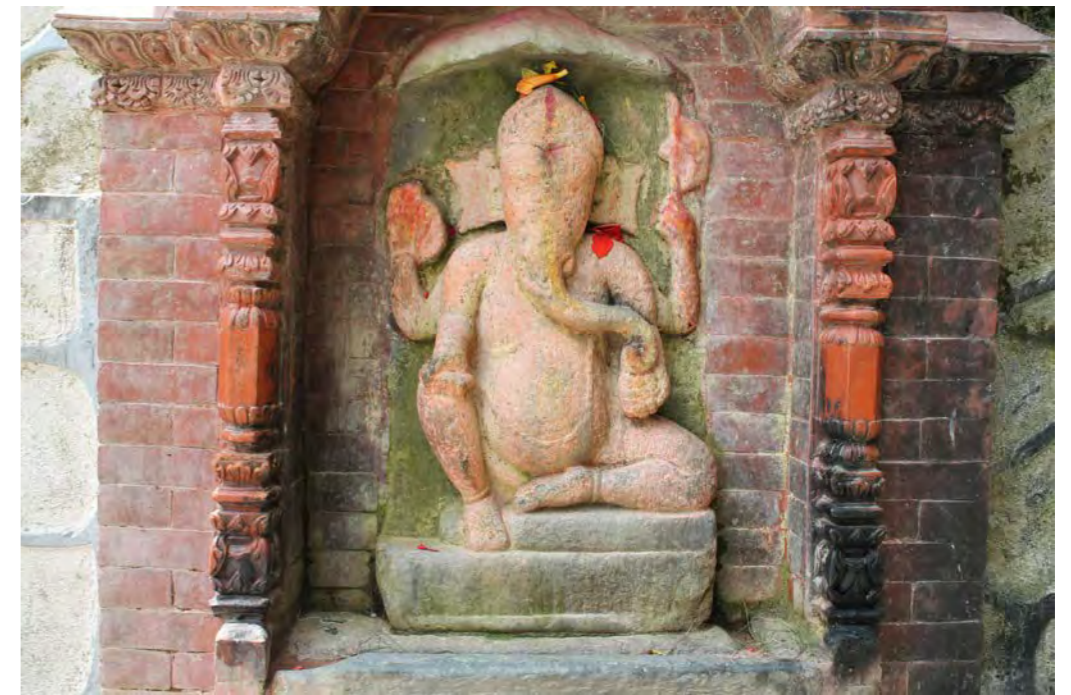
01 OPEN SHRINE - GANESH

NUMBER	NAME	ESTABLISHED DATE (A.D.)	TYPOLOGY	GENERAL DESCRIPTION	PROBLEMS DESCRIPTION	DANGER/ DESTROY
01	Ganesha		Open Shrine	Brick structure flushed at the retaining wall near river	Good Condition

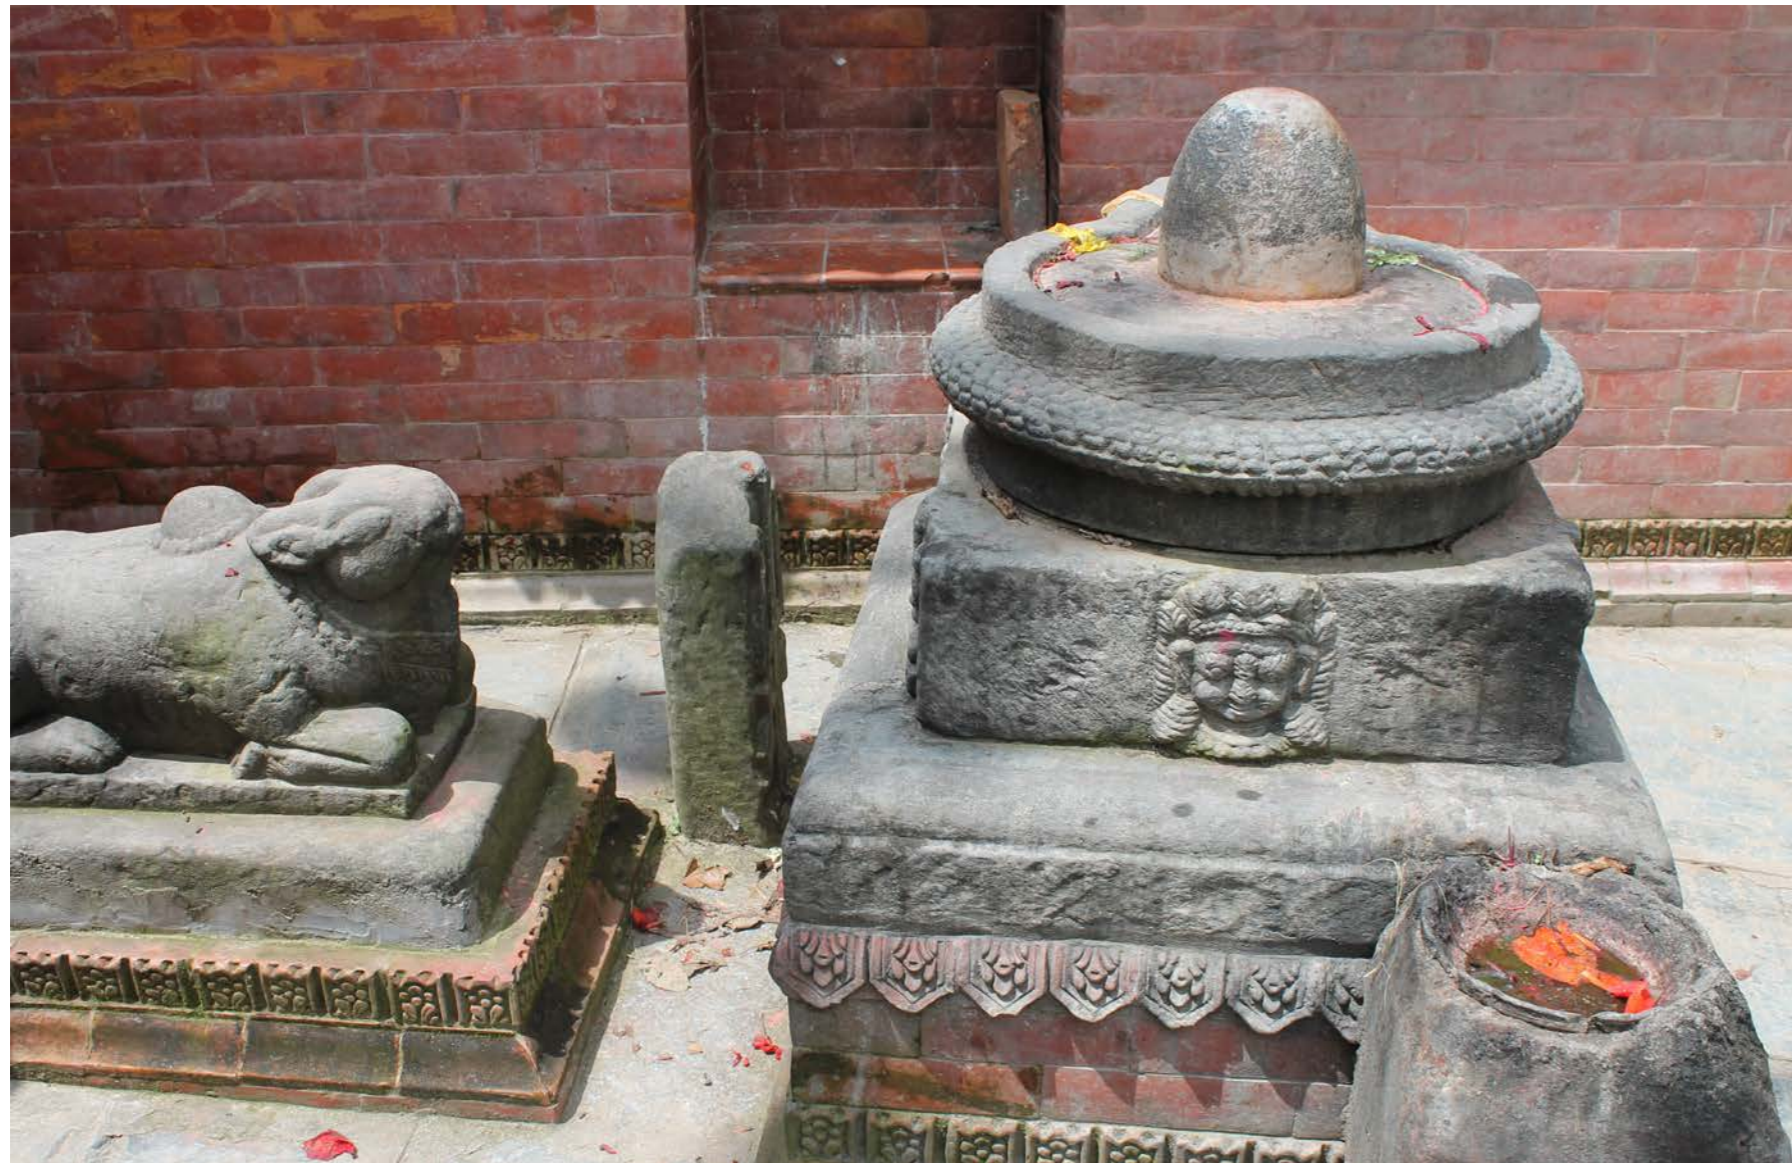
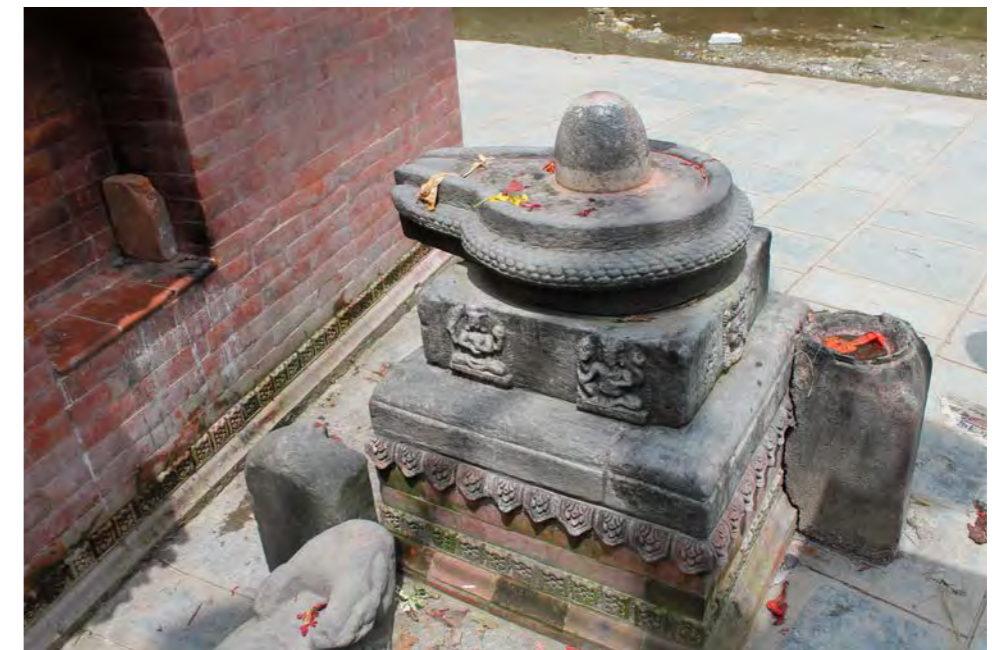
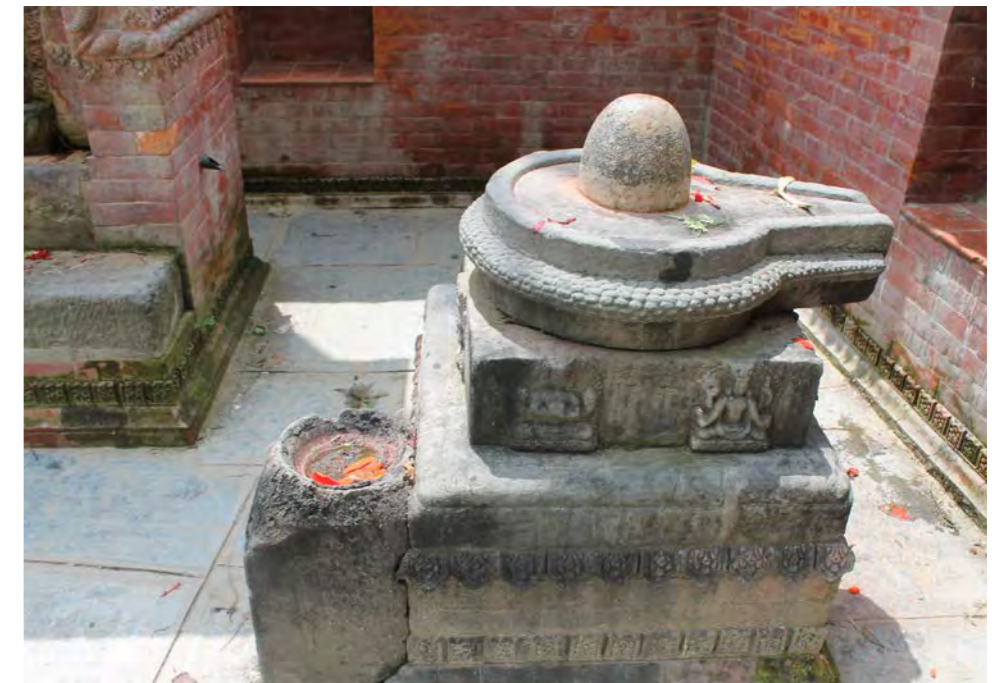
02 SHIVA LINGA

NUMBER	NAME	DATE A.D.	TPOLOGY	GENERAL DESCRIPTION	PROBLEMS DESCRIPTION	DANGER/ DESTROY	
02			Shiva linga	Stone Monument	Good Condition

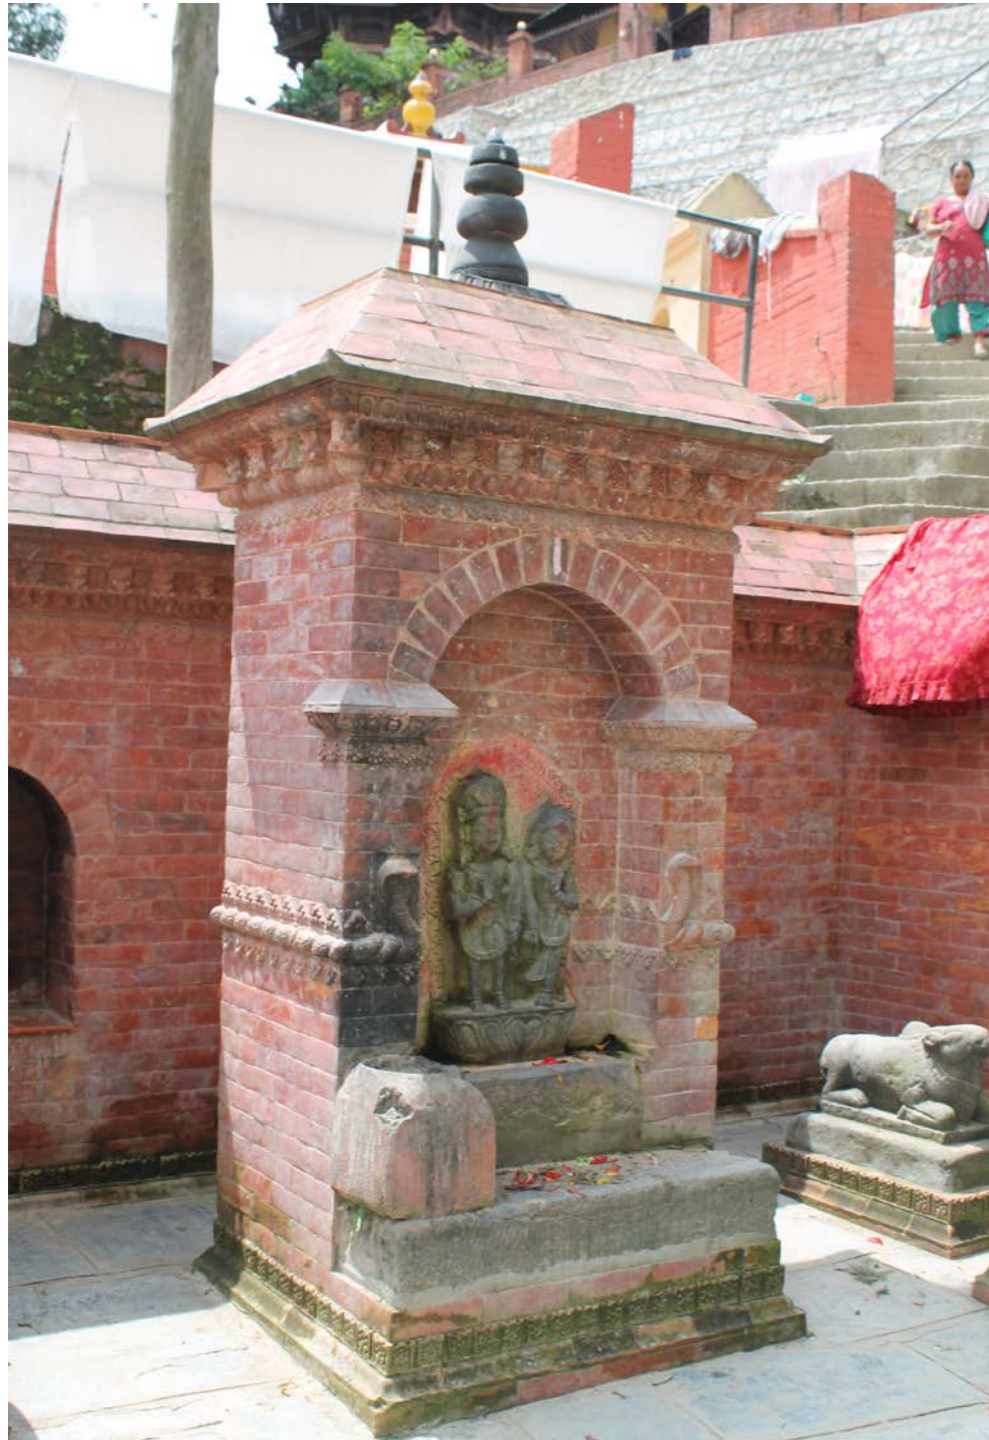
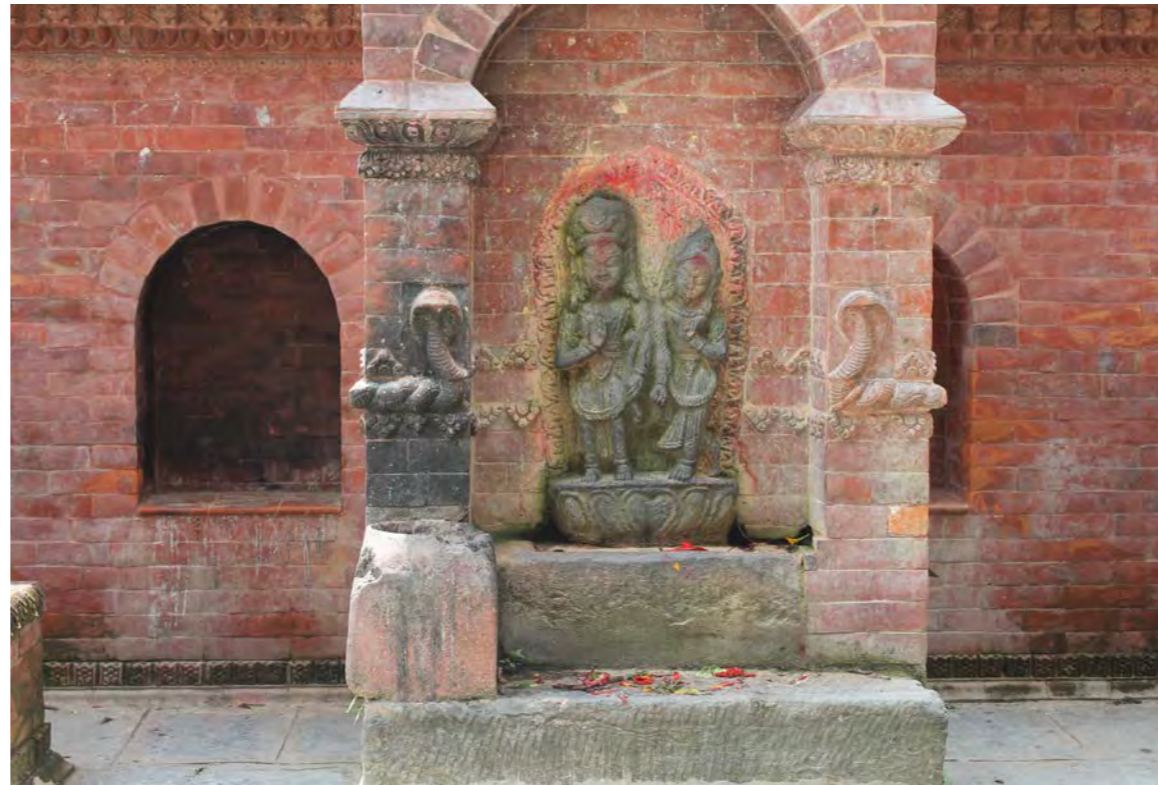
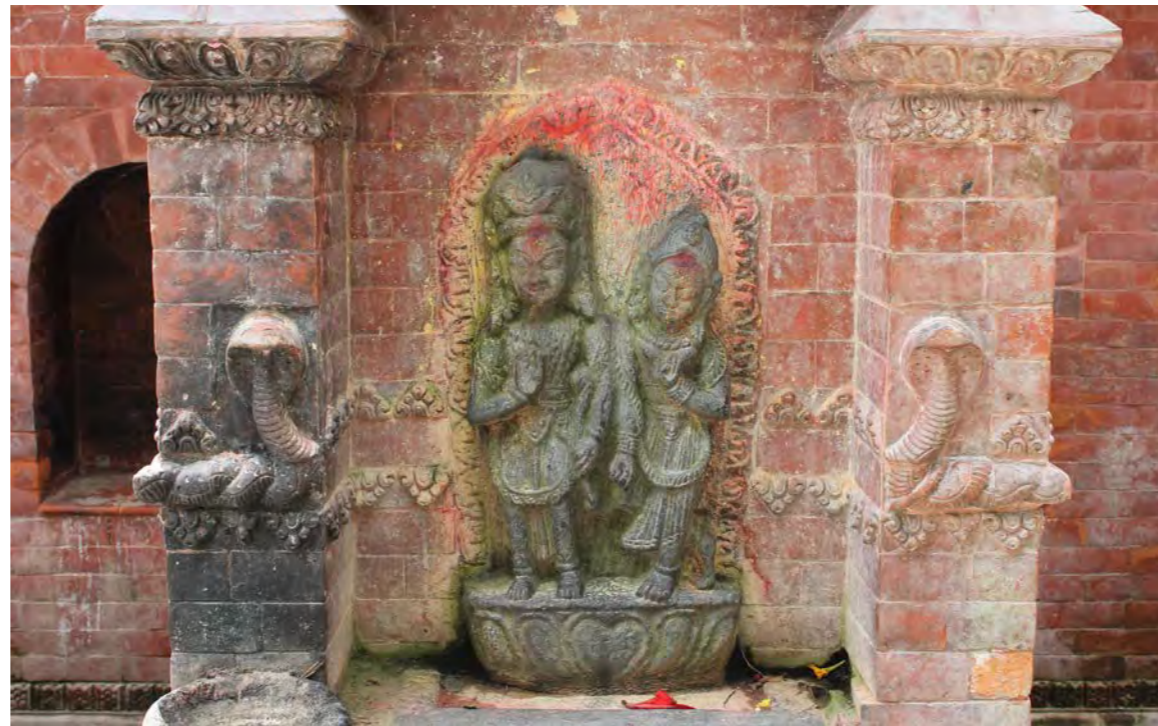
03 OPEN SHRINE - NARAYAN

NUMBER	NAME	ESTABLISHED DATE (A.D.)	TYPOLOGY	GENERAL DESCRIPTION	PROBLEMS DESCRIPTION	DANGER/ DESTROY	
03	Narayan		Open Shrine	Brick structure with stone statue of Narayan(Hindu God Bishnu)	Good Condition
