2015 Earthquake Damage Mapping

Sankhu

October 2015

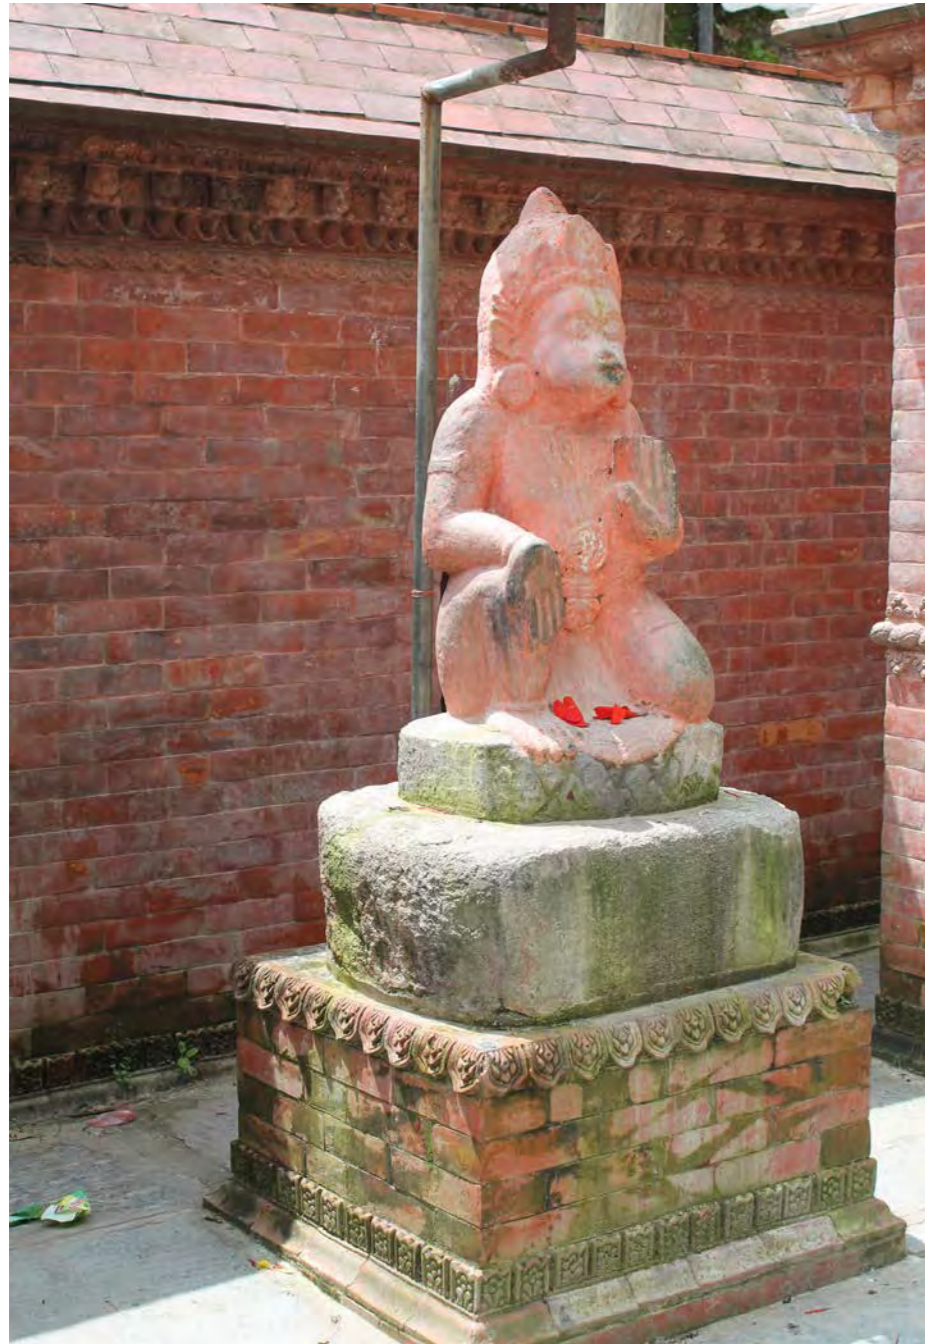
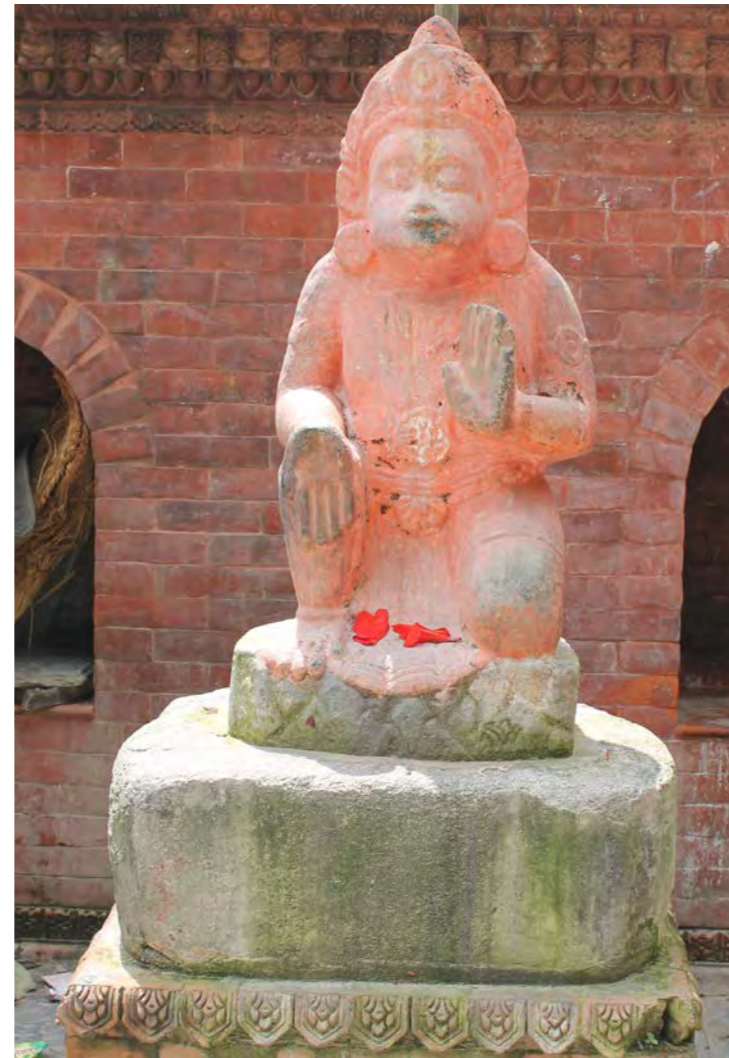
04 STONE STATUE - HANUMAN

NUMBER	NAME	DATE A.D.	TPOLOGY	GENERAL DESCRIPTION	PROBLEMS DESCRIPTION	DANGER/ DESTROY	
04	Hanuman		Stone Statue	Stone made monument of Hunuman(Monkey god)	Good Condition

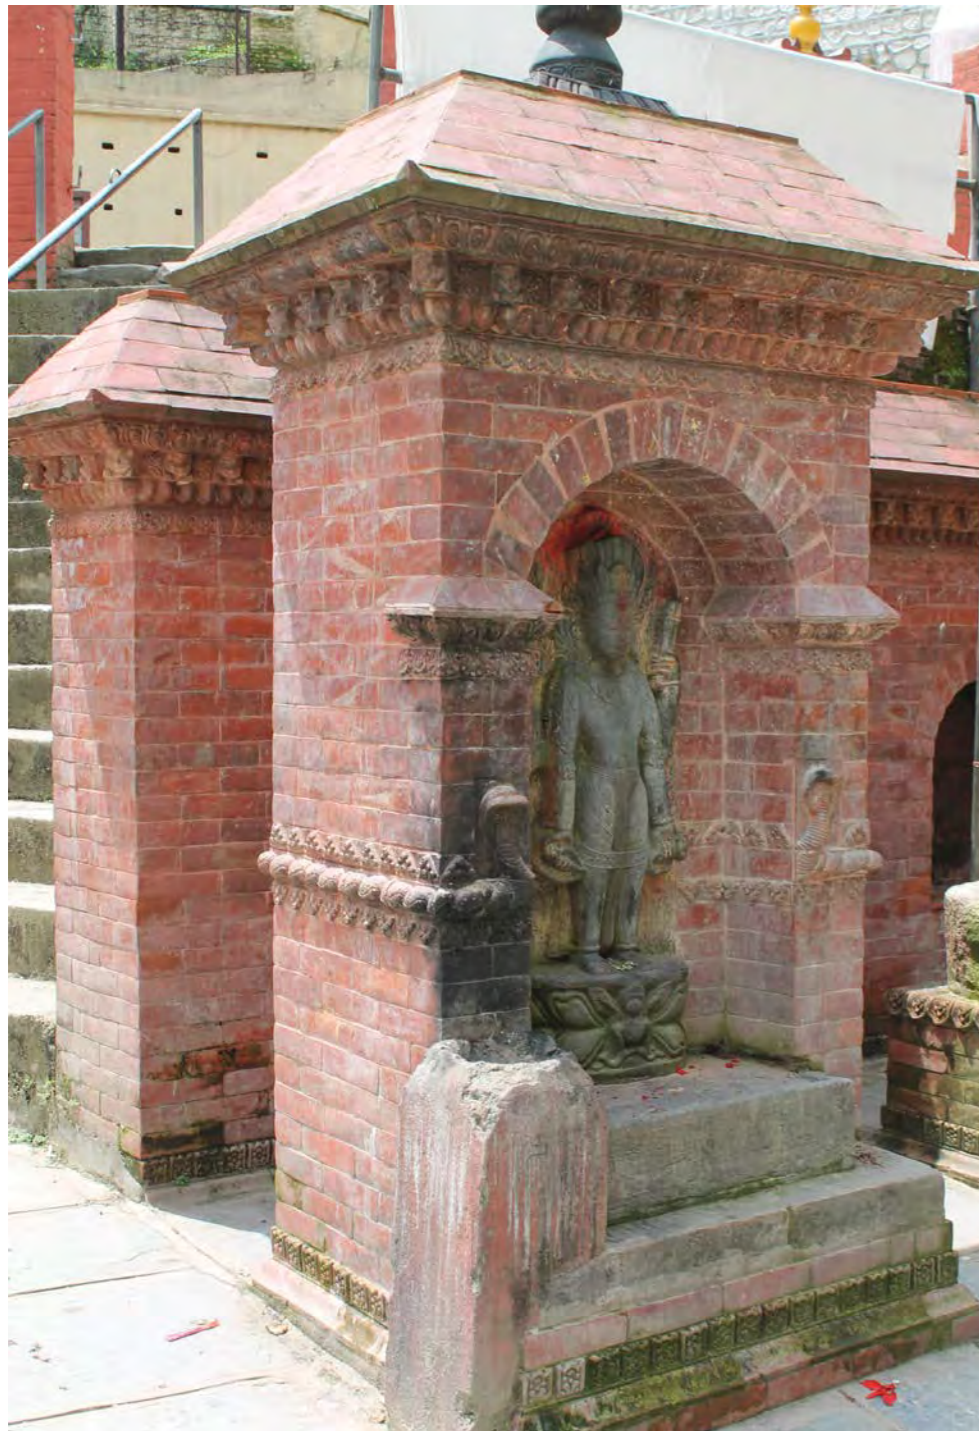
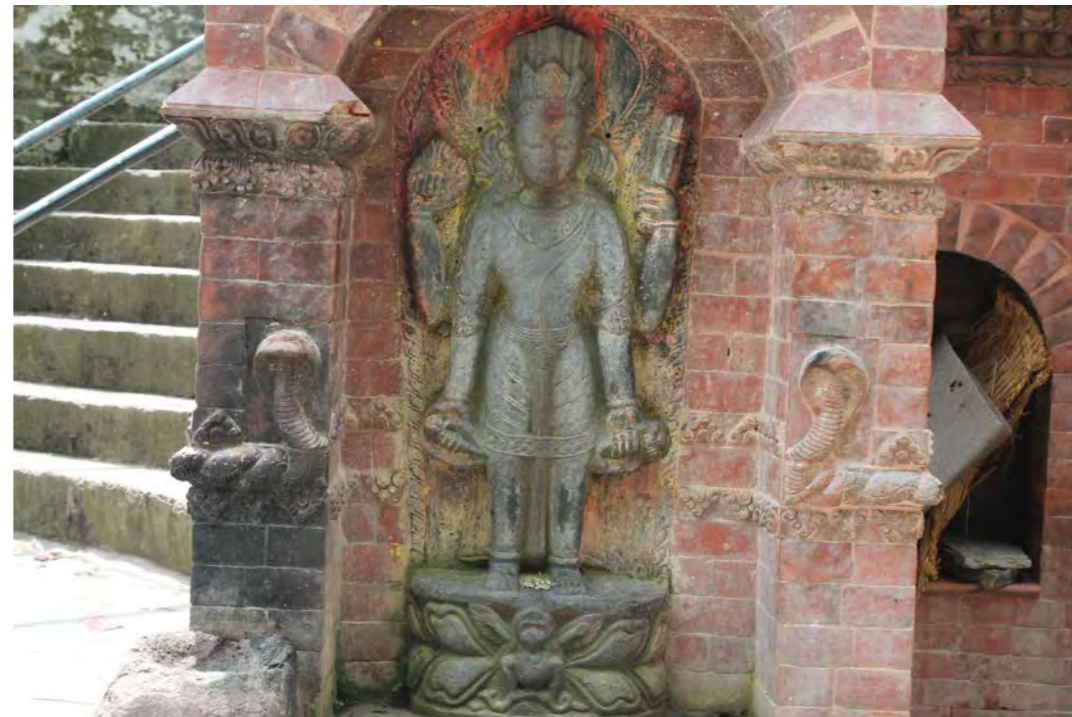
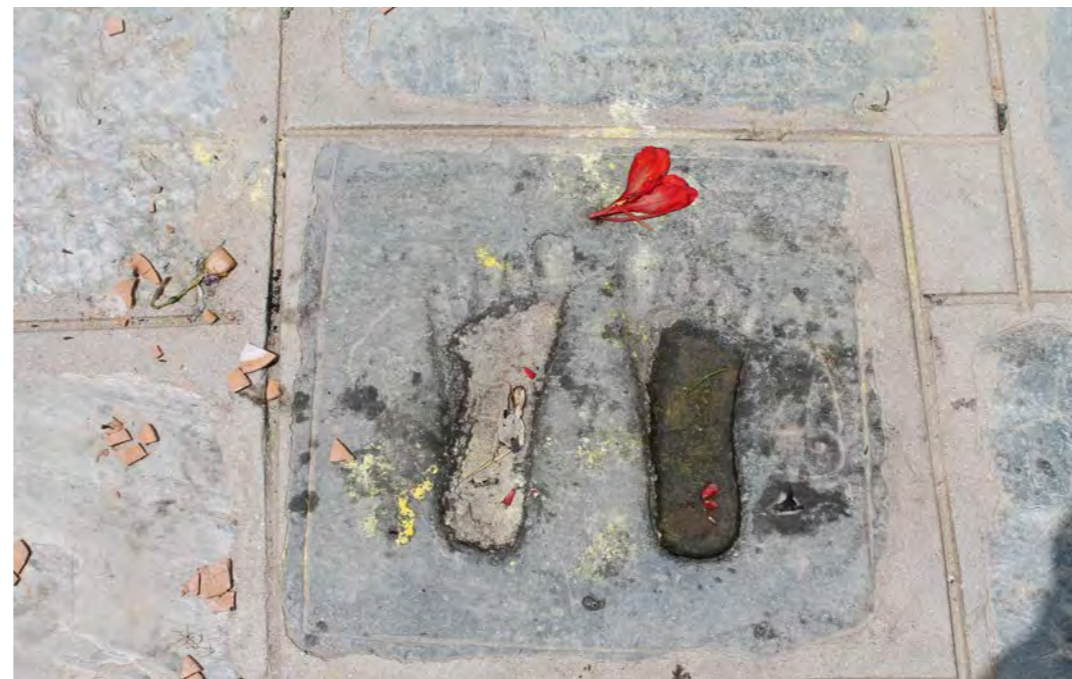
05 OPEN SHRINE

NUMBER	NAME	ESTABLISHED DATE (A.D.)	TYPOLOGY	GENERAL DESCRIPTION	PROBLEMS DESCRIPTION	DANGER/ DESTROY	
05			Open Shrine	Brick structure with stone statue of Standing Narayan	Good Condition

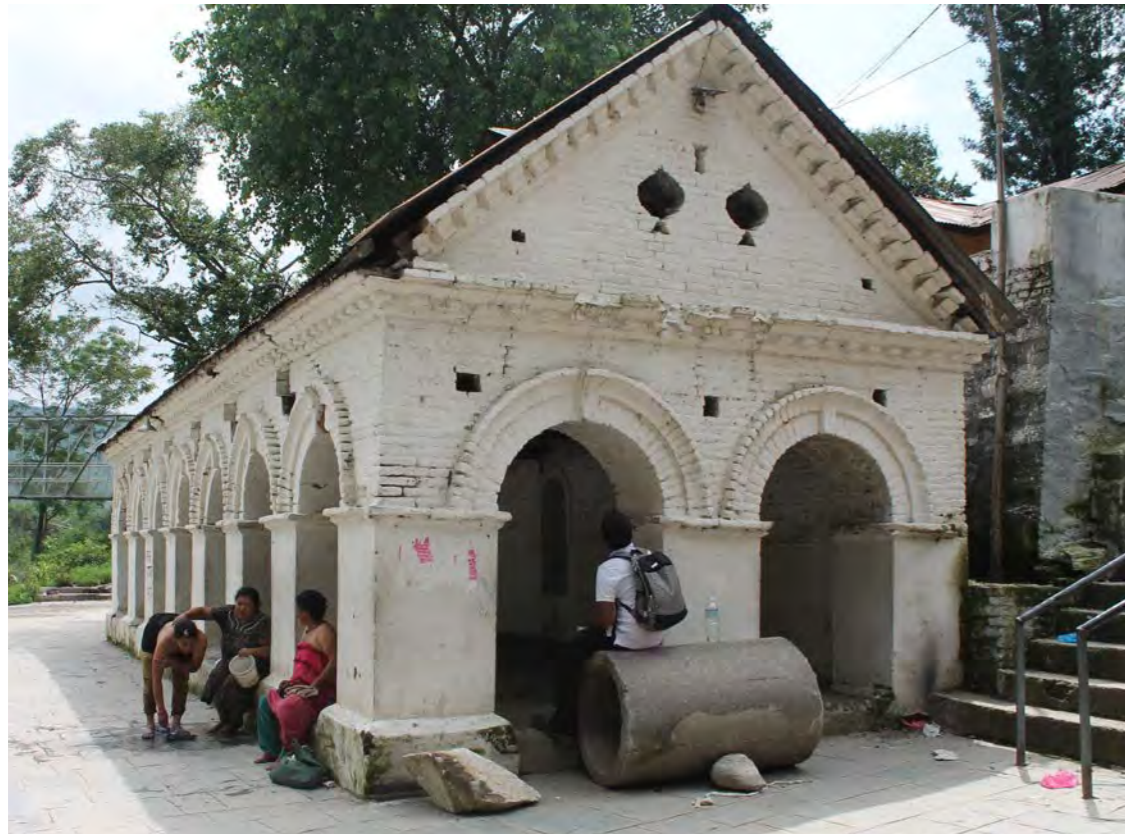
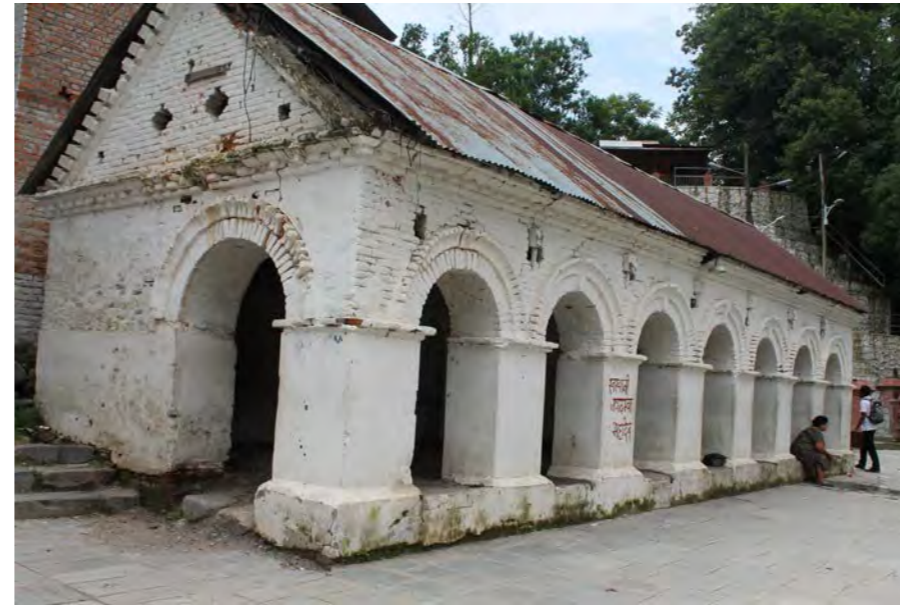
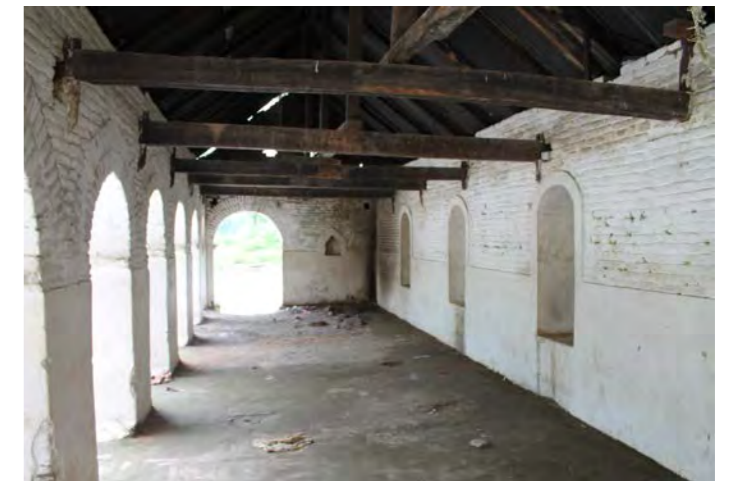
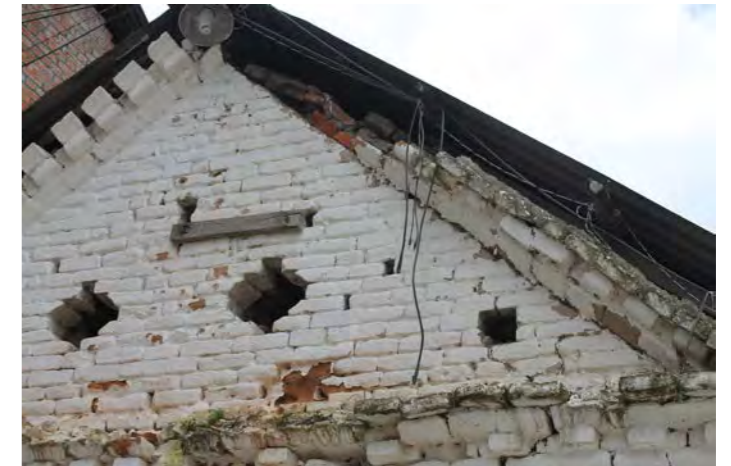
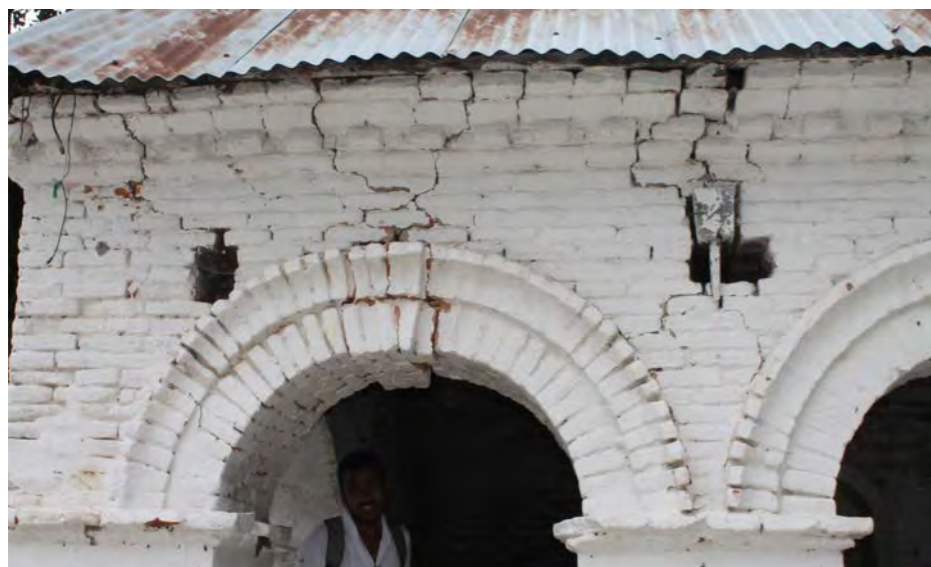
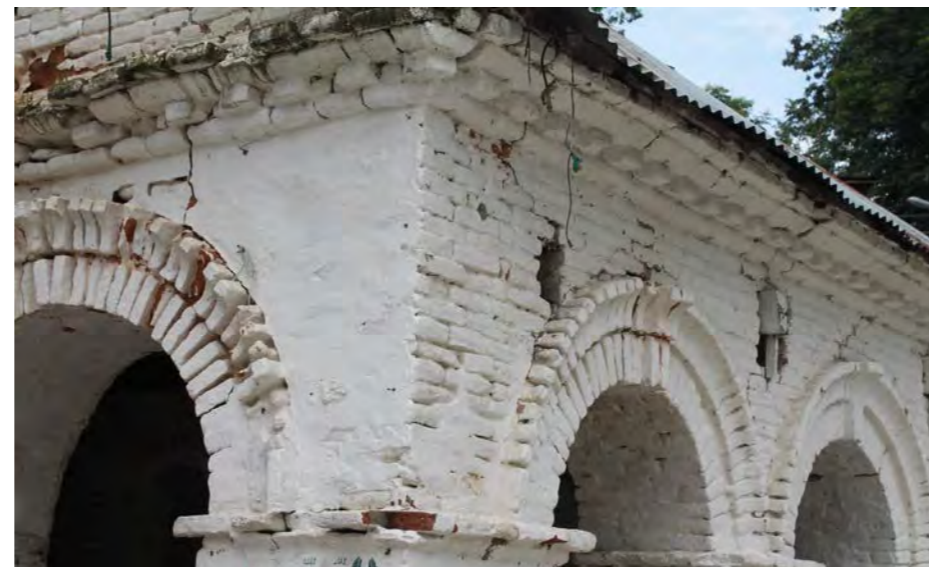
06 PATI- SALINADI PATI

NUMBER	NAME	DATE A.D.	TPOLOGY	GENERAL DESCRIPTION	PROBLEMS DESCRIPTION	DANGER/ DESTROY	
06	Salinadi pati		Pati	“Single storey long pati with wooden joist and CGI roofing Brick made structure with lime plastered and many arch openings”	“W-façade corner cracked Mostly multiple cracks seen at arch openings Through wall cracks at E-façade S-façade partially collapsed with vertical cracks”

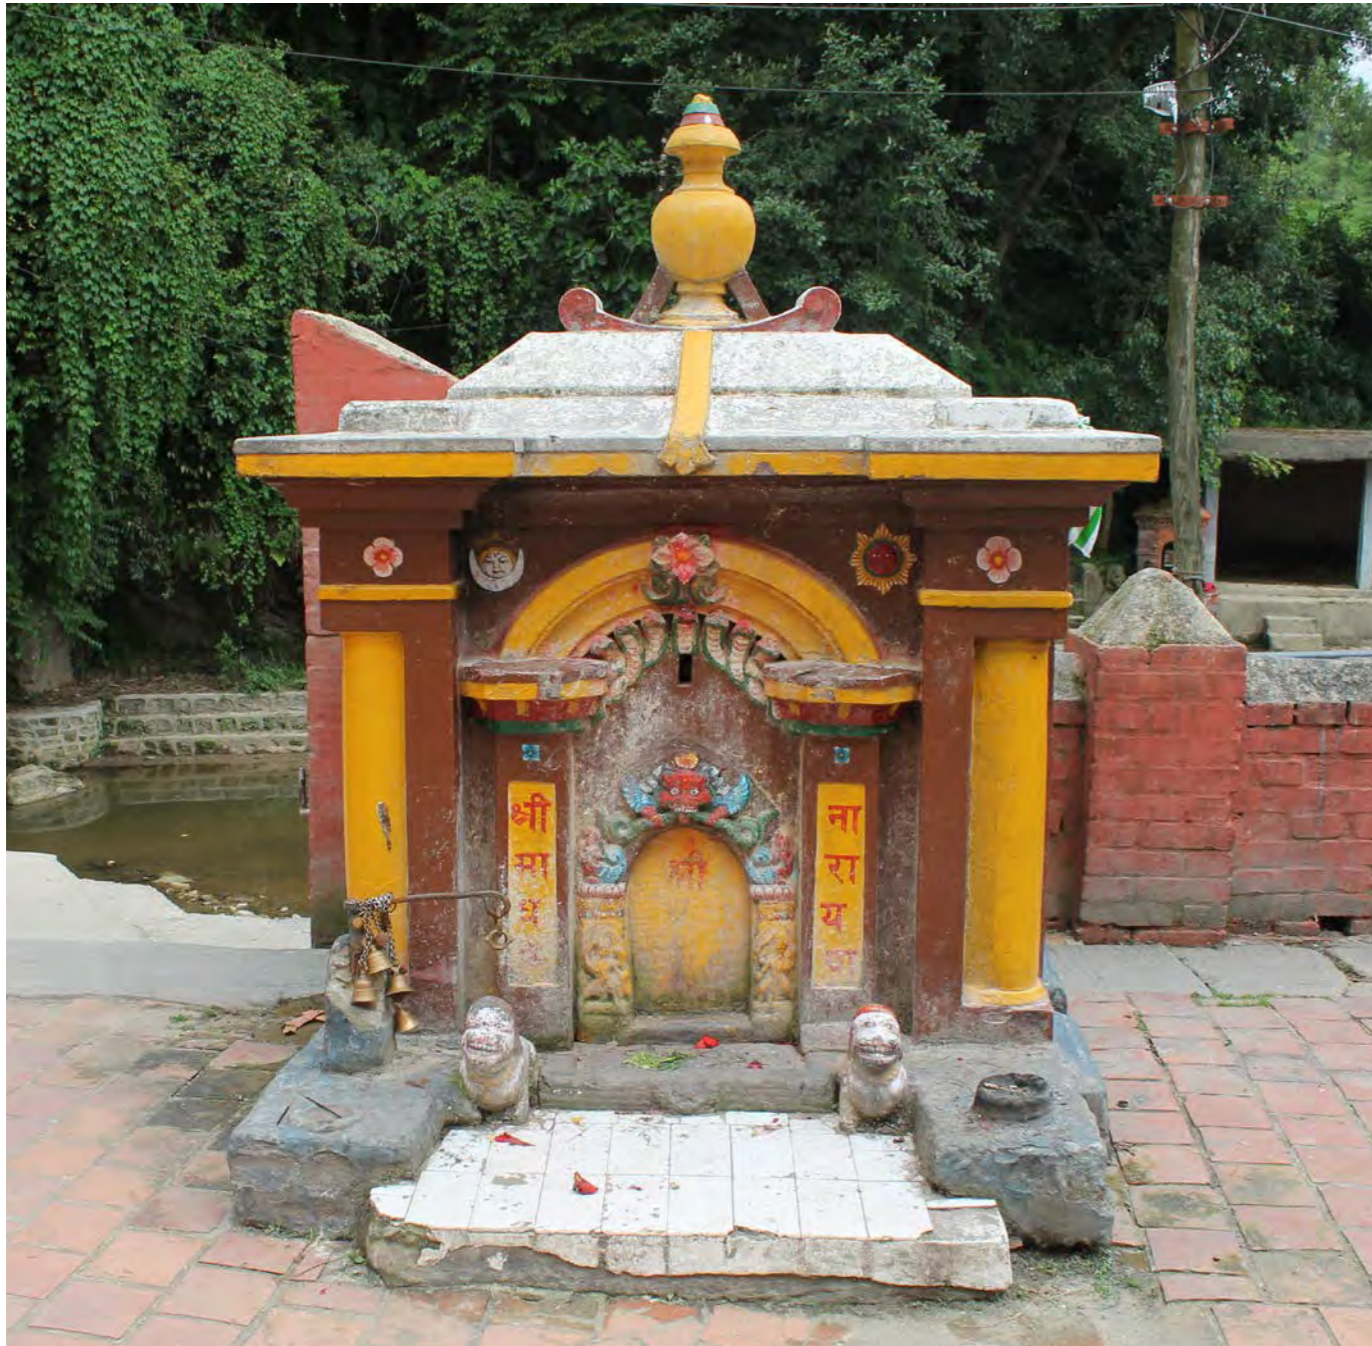
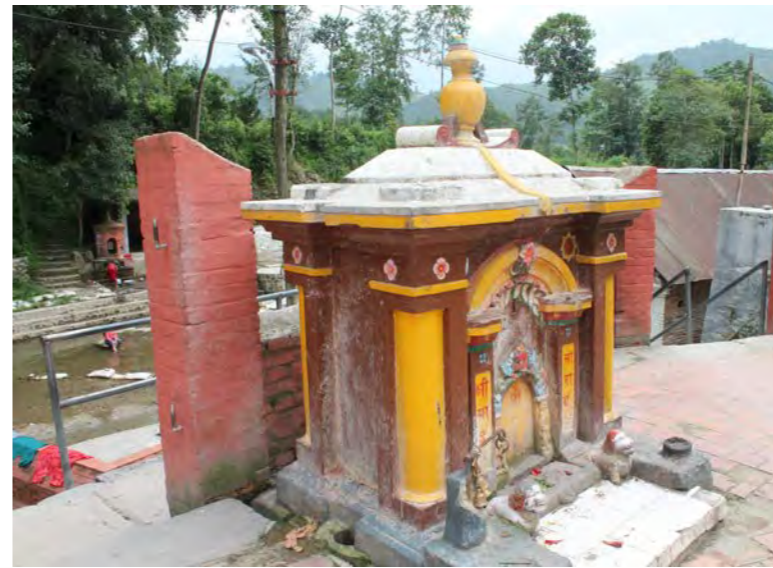
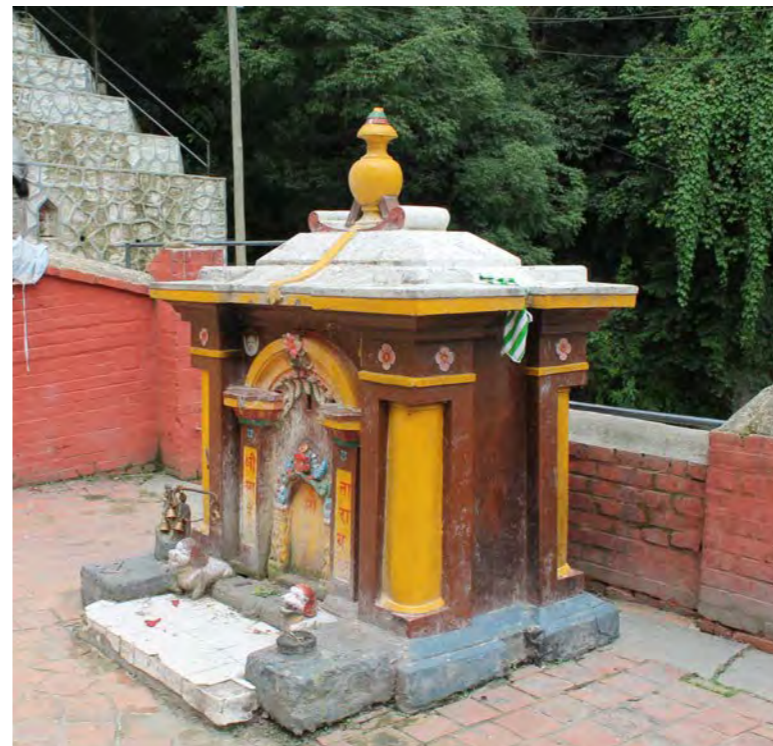
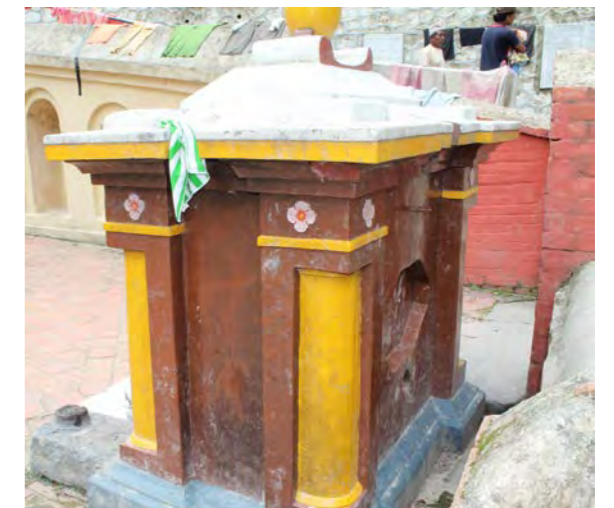
07 SHRI MAHADEV NARAYAN

NUMBER	NAME	ESTABLISHED DATE (A.D.)	TYPOLOGY	GENERAL DESCRIPTION	PROBLEMS DESCRIPTION	DANGER/ DESTROY	
07	Shri Madhav Narayan		Open Shrine	Brick structure with cement plastered	Good Condition

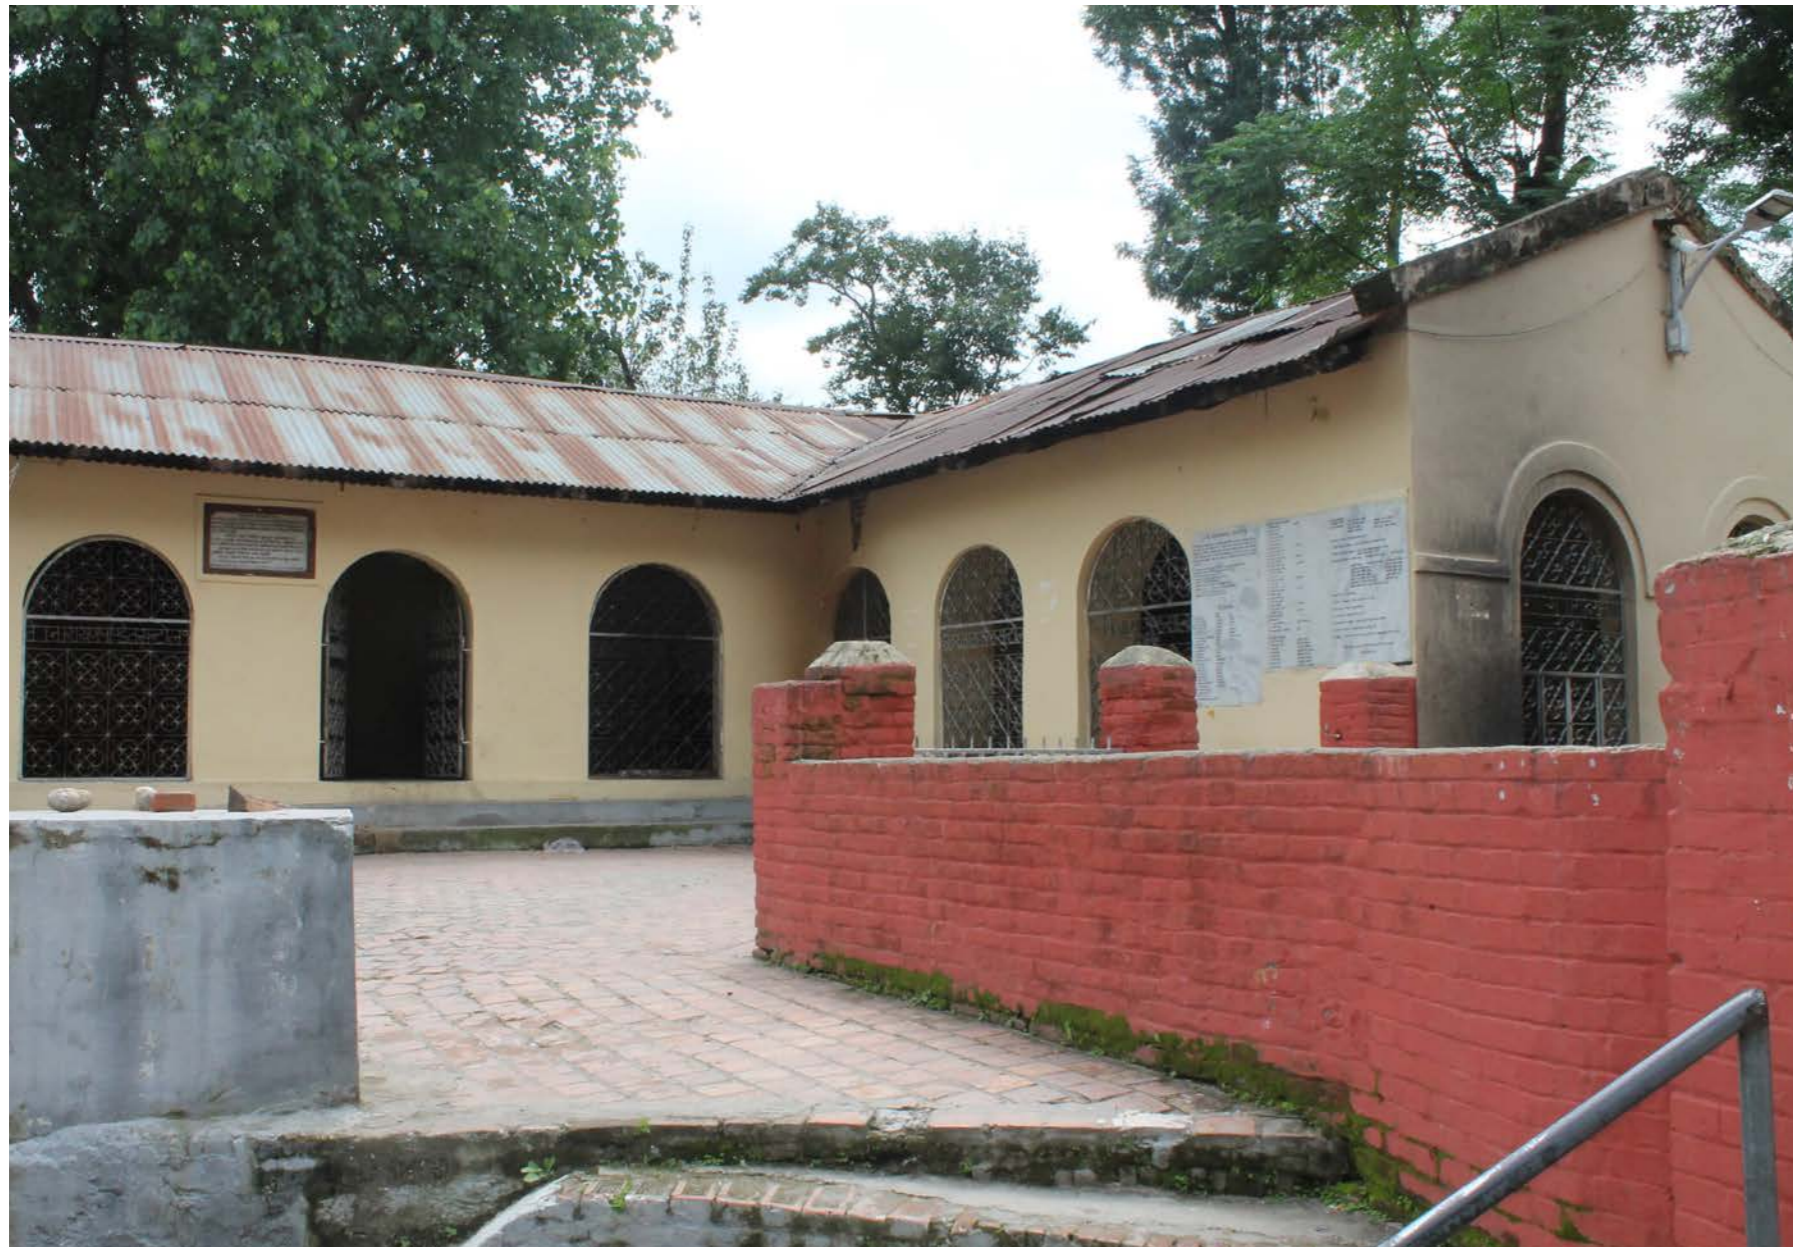
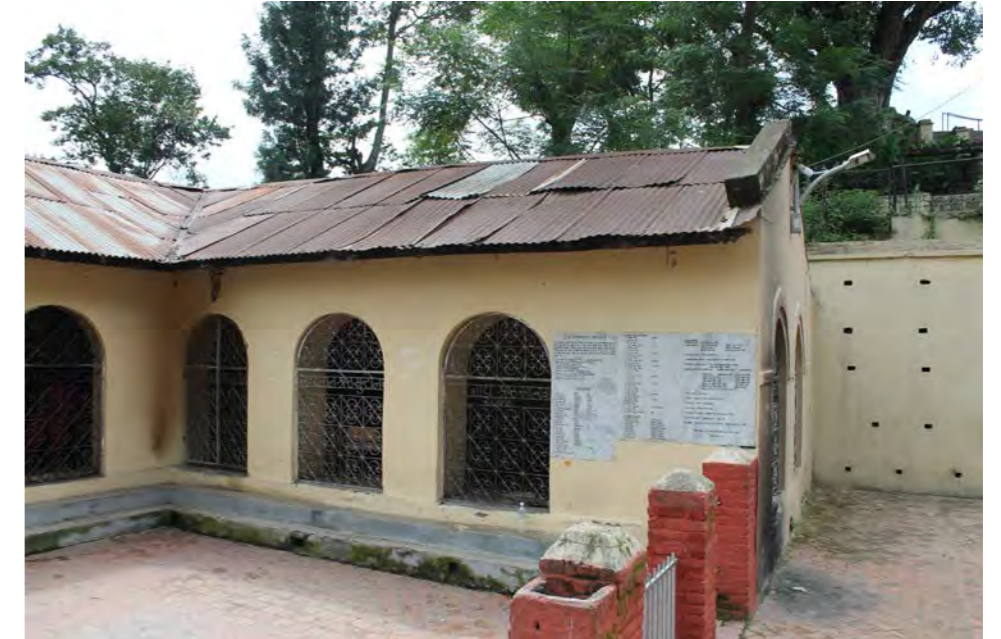
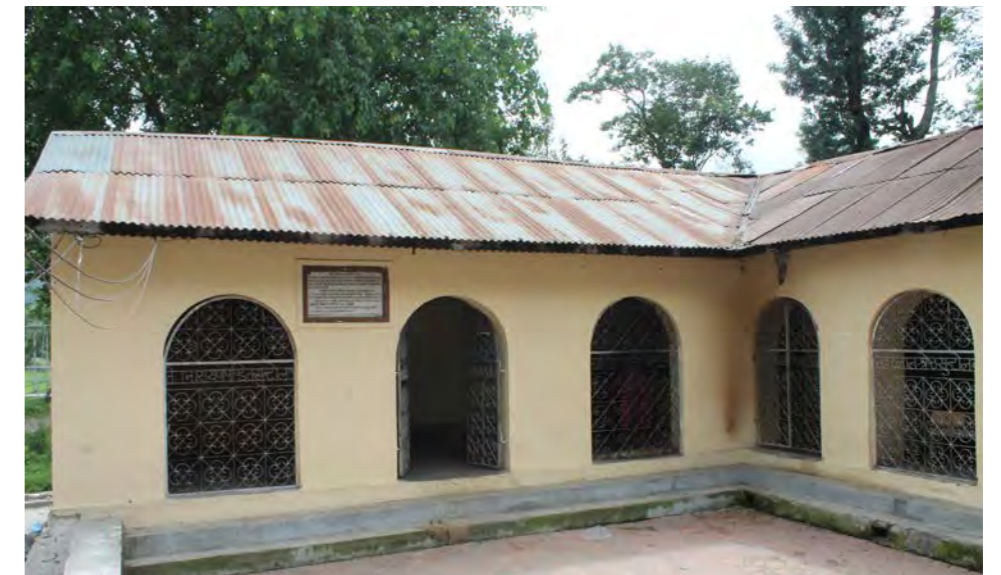
08 PUBLIC HOUSE

NUMBER	NAME	DATE A.D.	TPOLOGY	GENERAL DESCRIPTION	PROBLEMS DESCRIPTION	DANGER/ DESTROY	
08			Public house	“Single storey brick wall structure with cement plastered Public house used by different special castes’ people for ceremonial events”	No Visible Damages

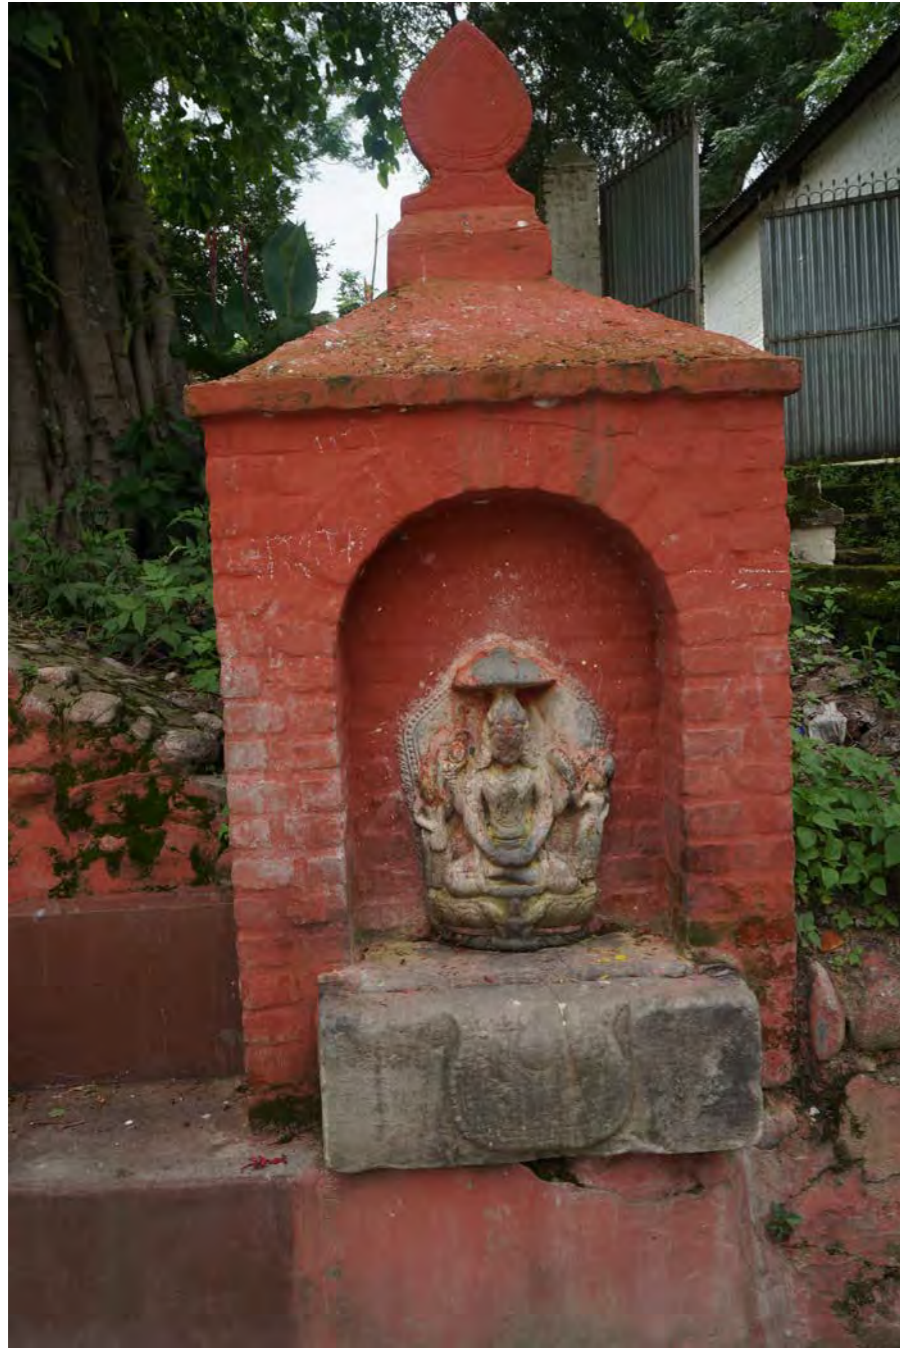
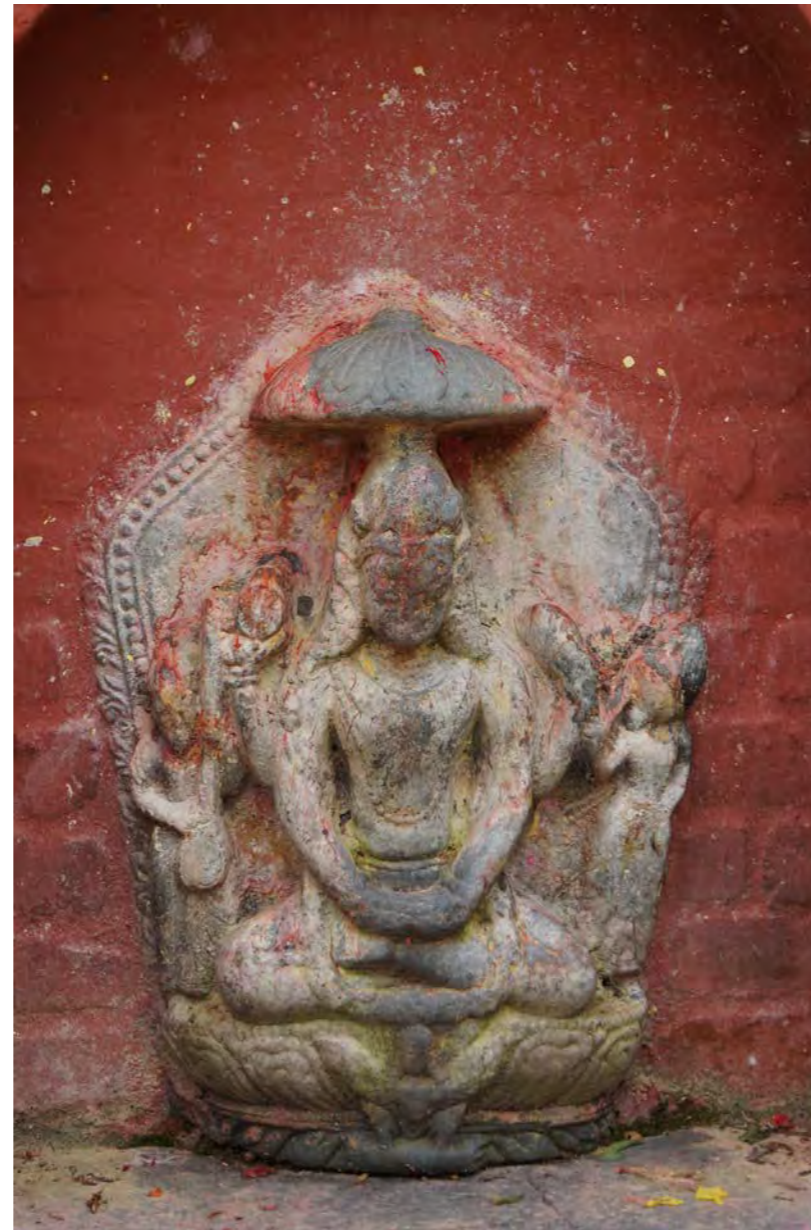
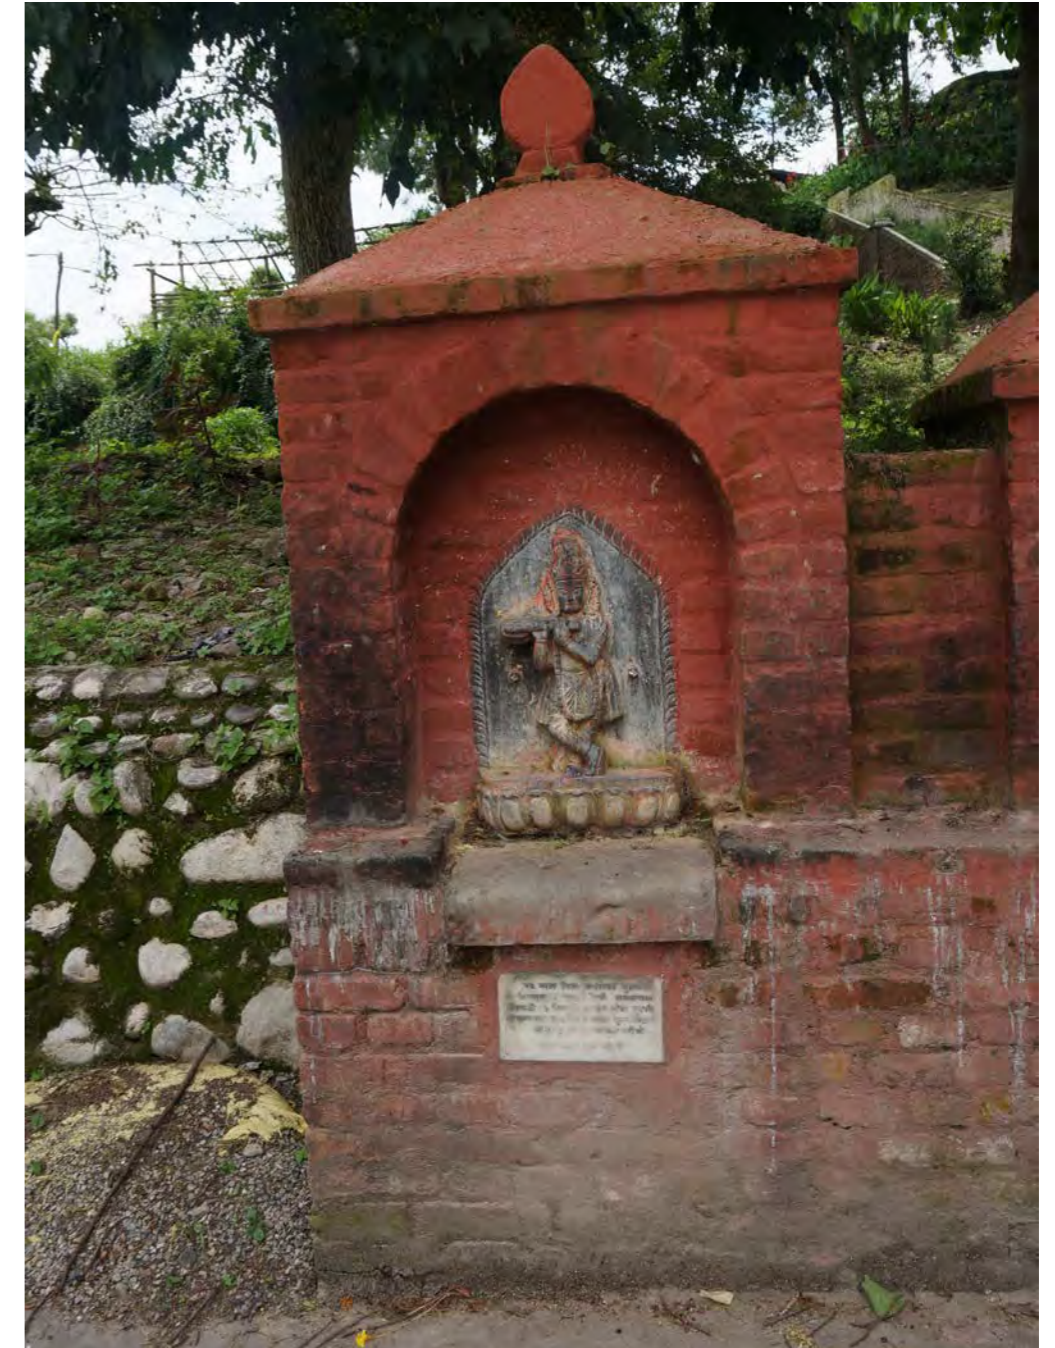
09, 10 PURUSHOTTAM NARAYAN/ KRISHNA

NUMBER	NAME	ESTABLISHED DATE (A.D.)	TYPOLOGY	GENERAL DESCRIPTION	PROBLEMS DESCRIPTION	DANGER/ DESTROY	
09	Purushottam Narayan		Open Shrine	Brick Shrine with Stone idol	No Visible Damages		
10	Krishna		Open Shrine		“Rising Damp Vegetation growth”

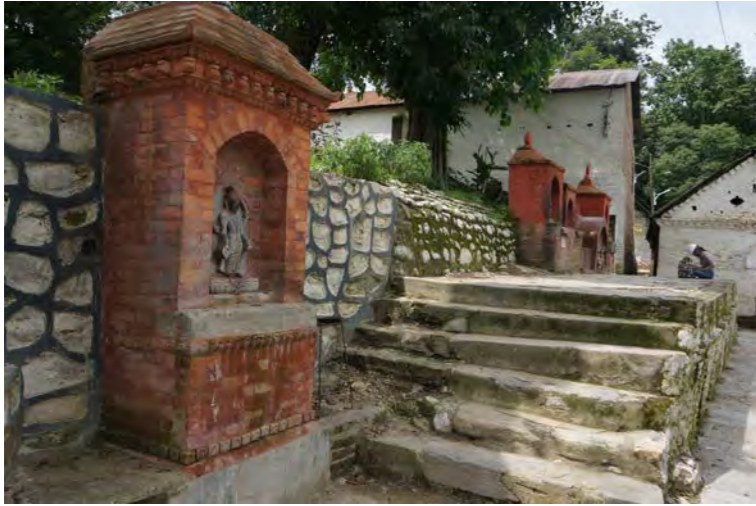
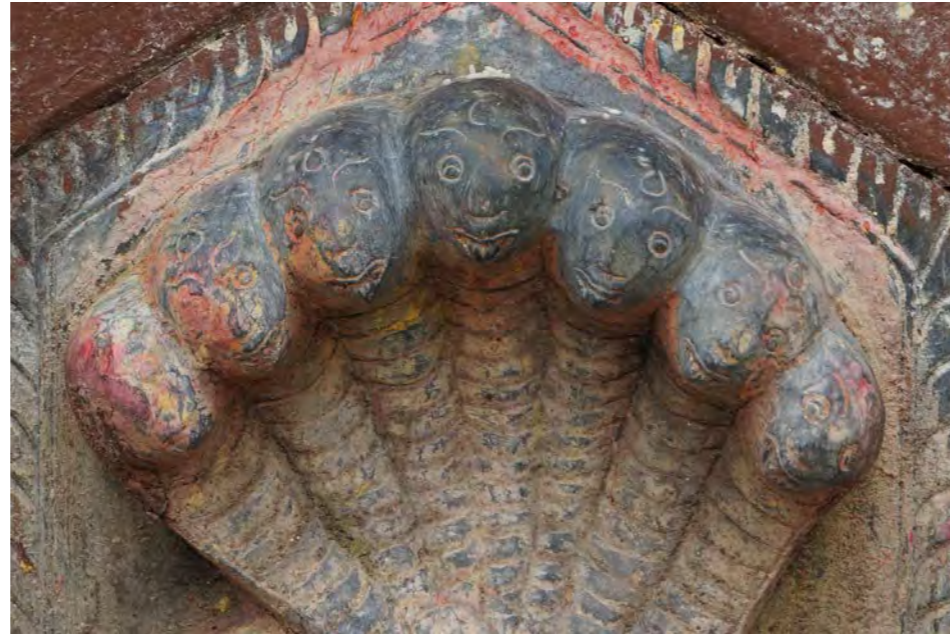
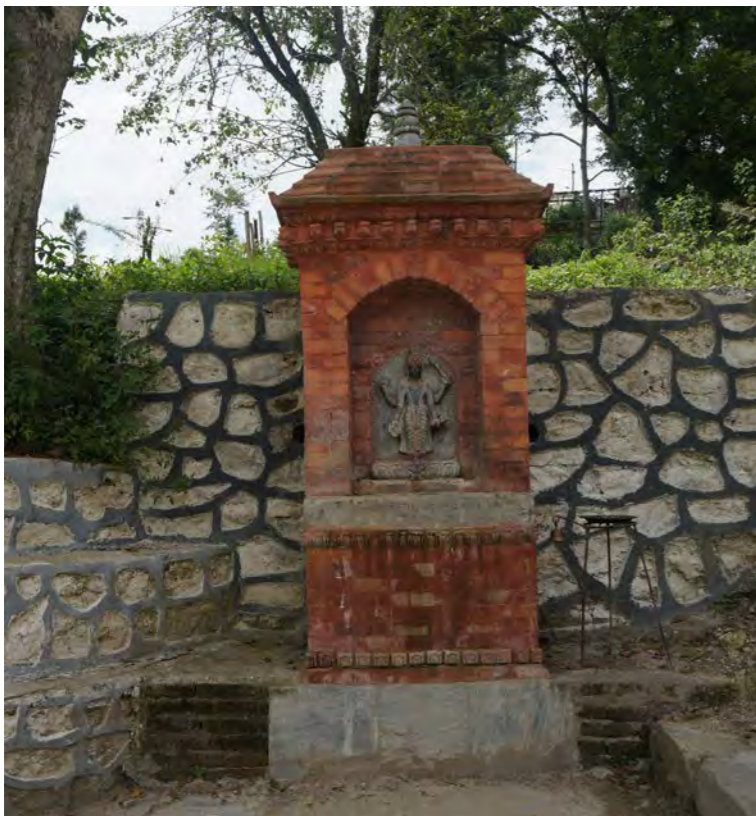
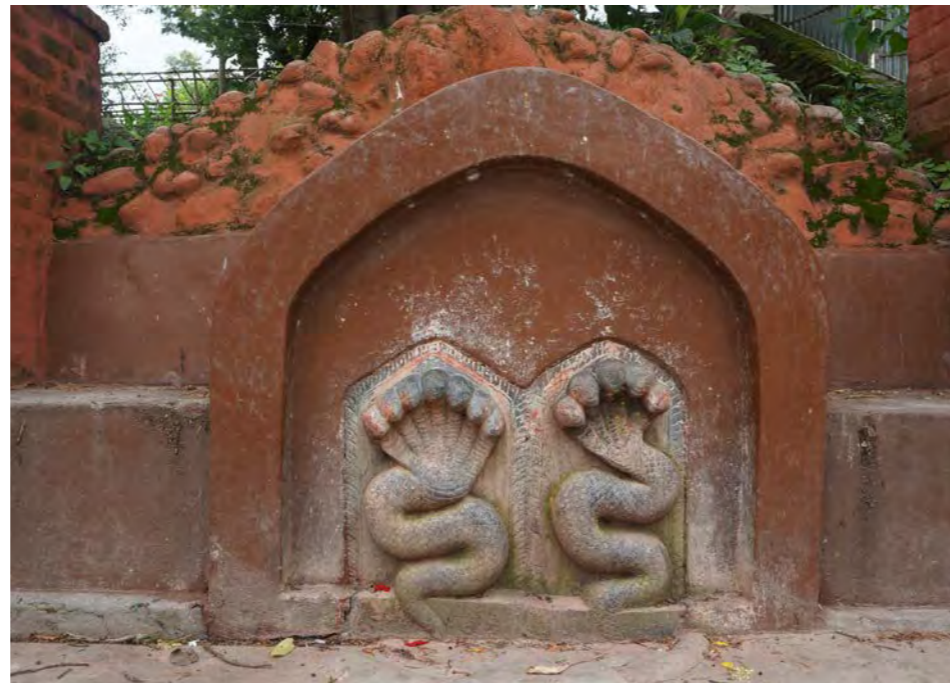
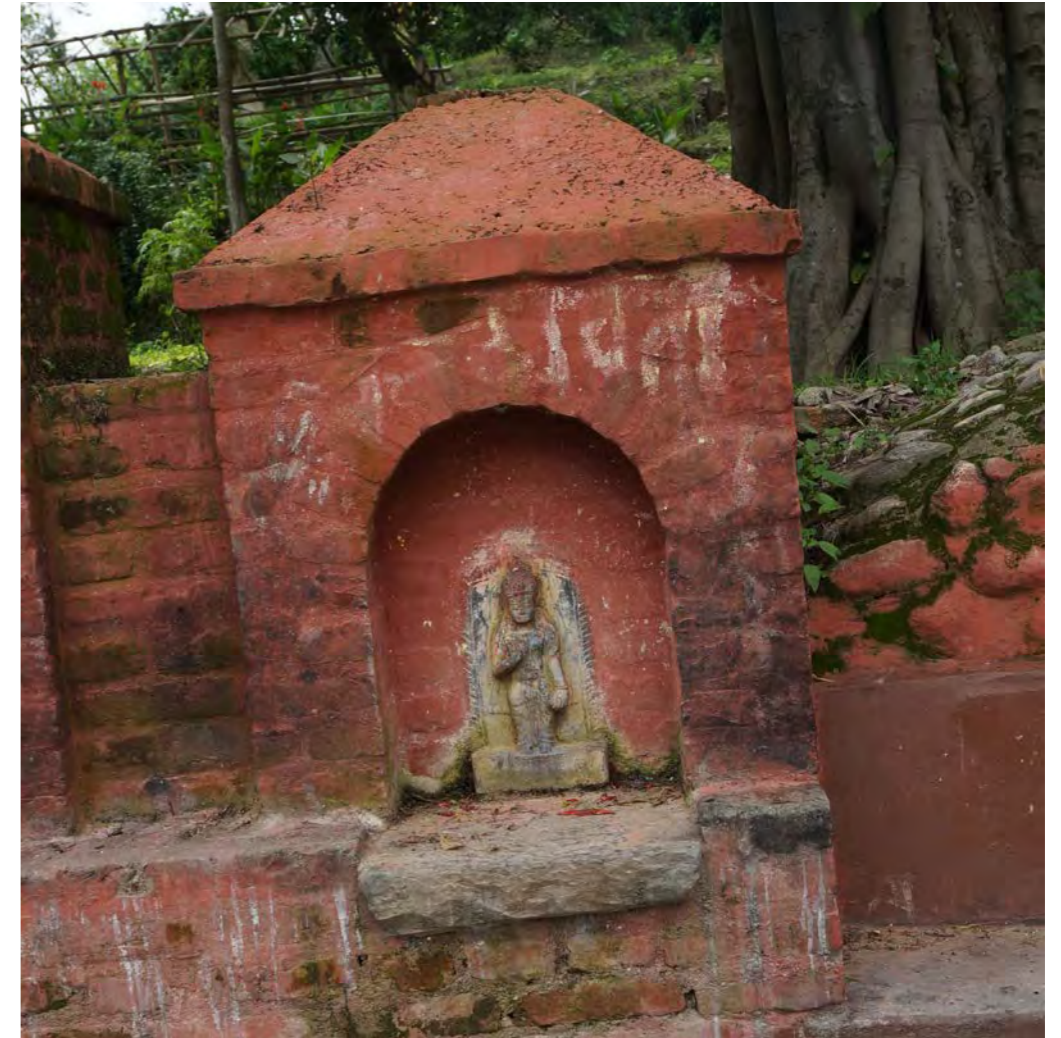
11, 12, 13

NUMBER	NAME	DATE A.D.	TYOLOGY	GENERAL DESCRIPTION	PROBLEMS DESCRIPTION	DANGER/ DESTROY	
11			Open Shrine	Shrine of Standing Godess	Rising Damp/Vegetation growth		
12			Statue	Image of Nag-Nagini	No Visible Damages		
13	Badri Narayan		Shrine		No Visible Damages
