2015 Earthquake Damage Mapping

Sankhu

October 2015

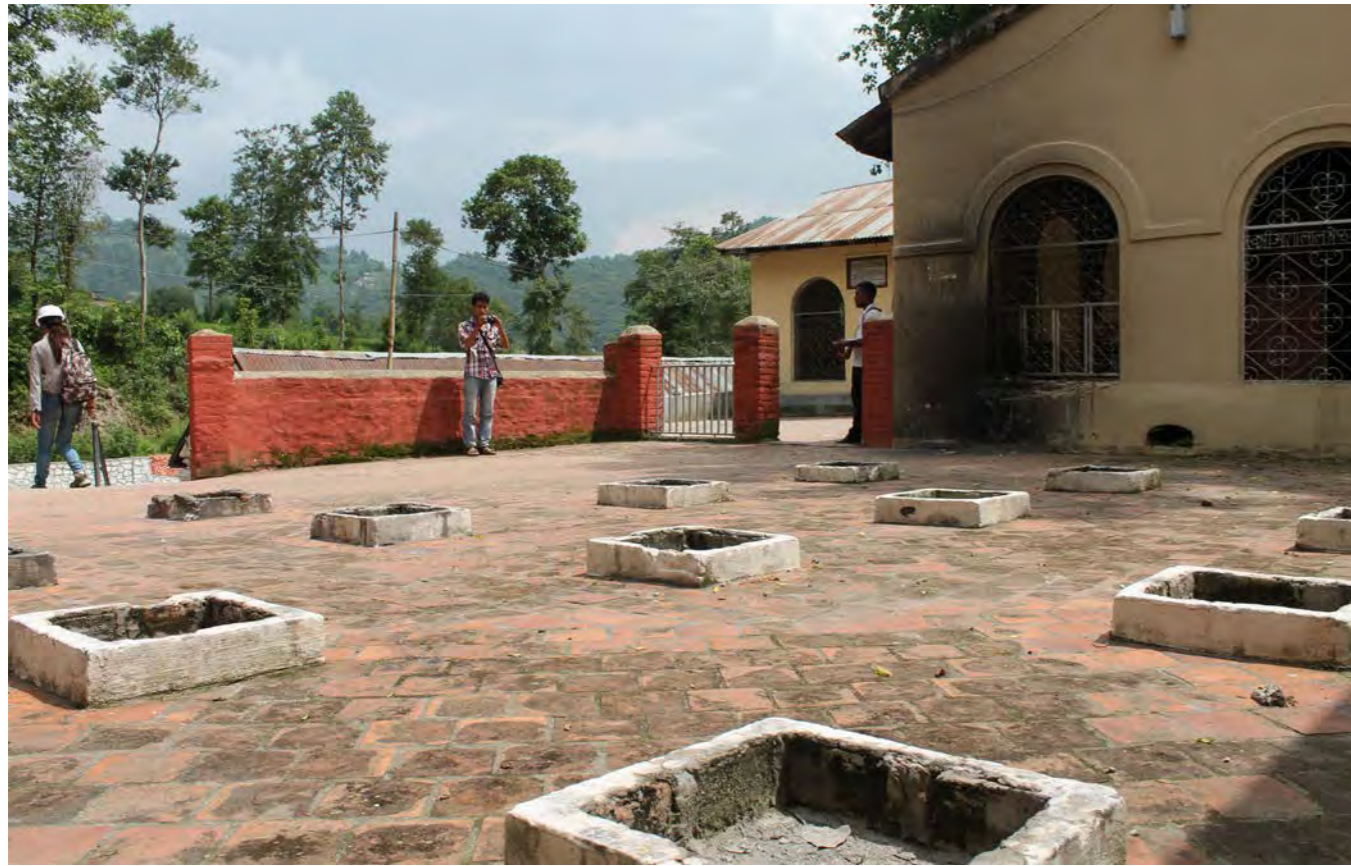
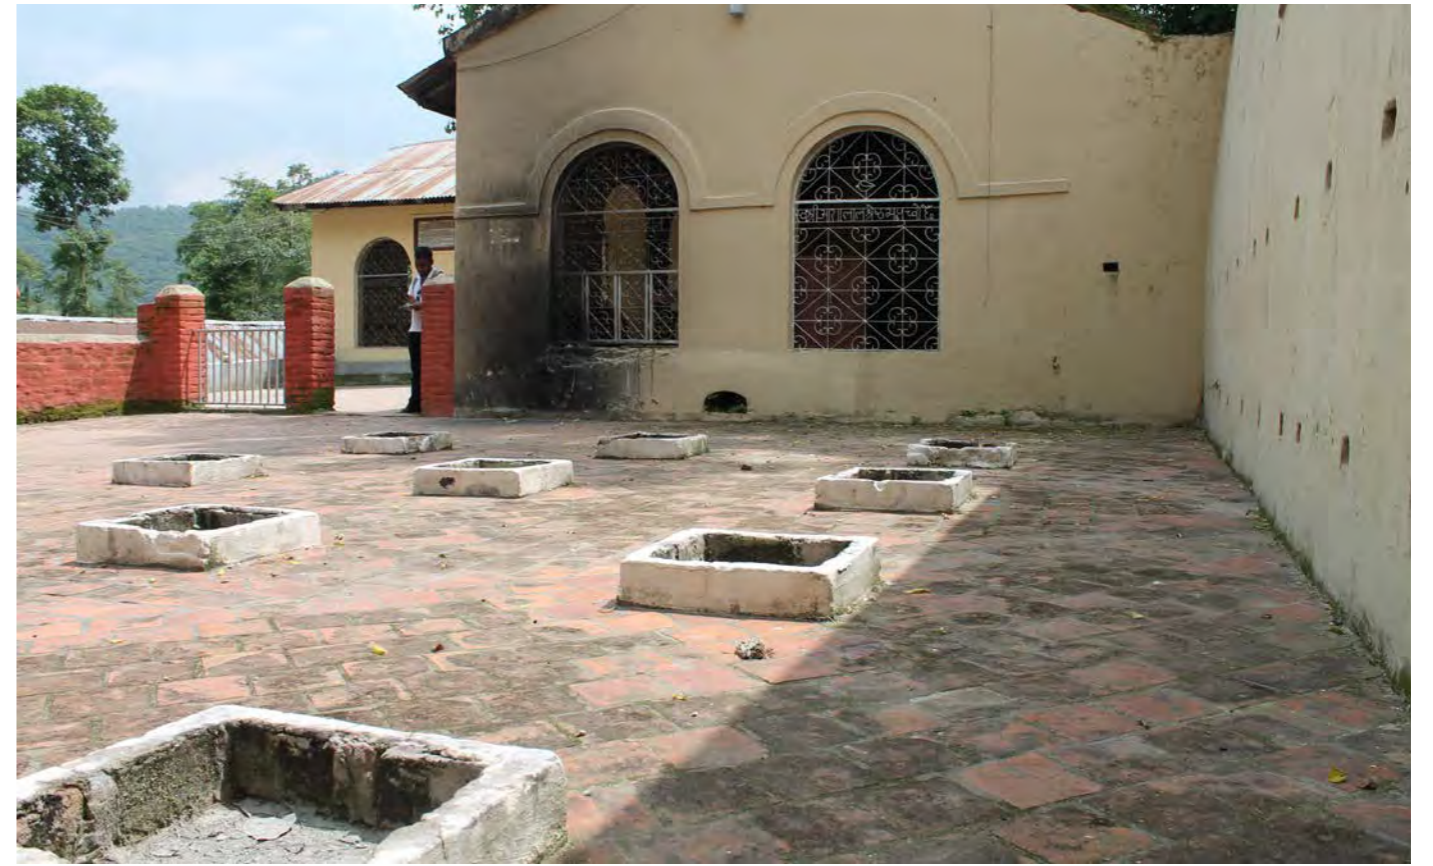
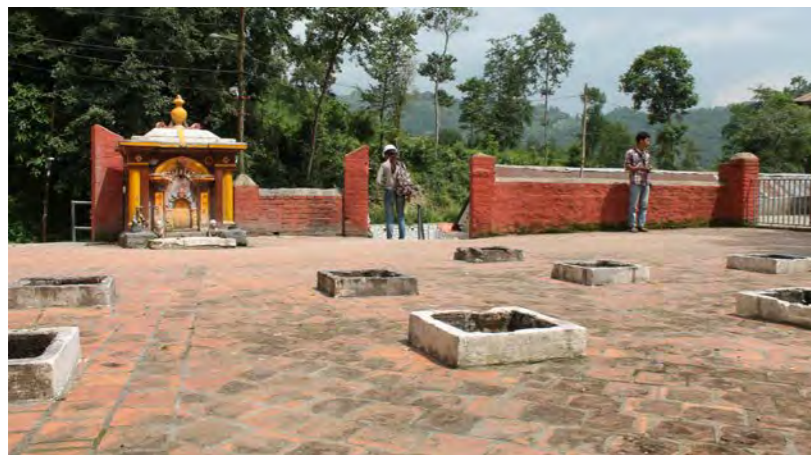
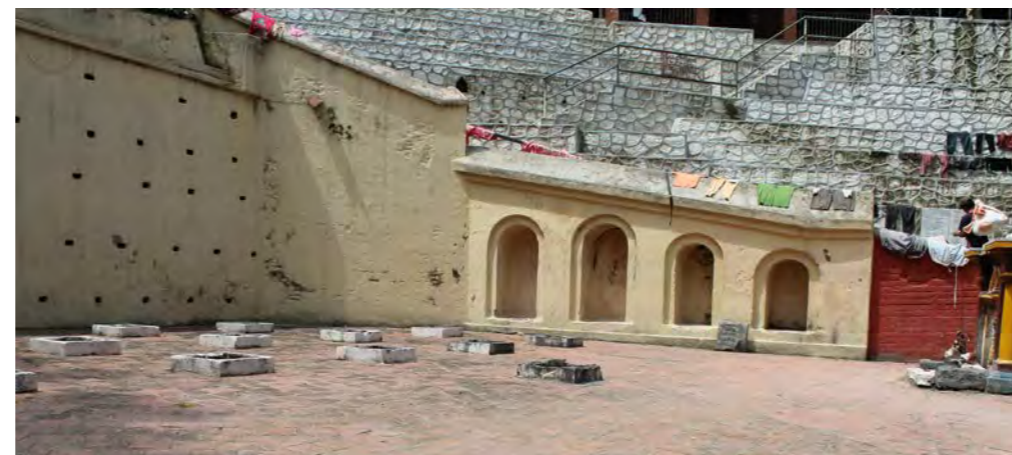
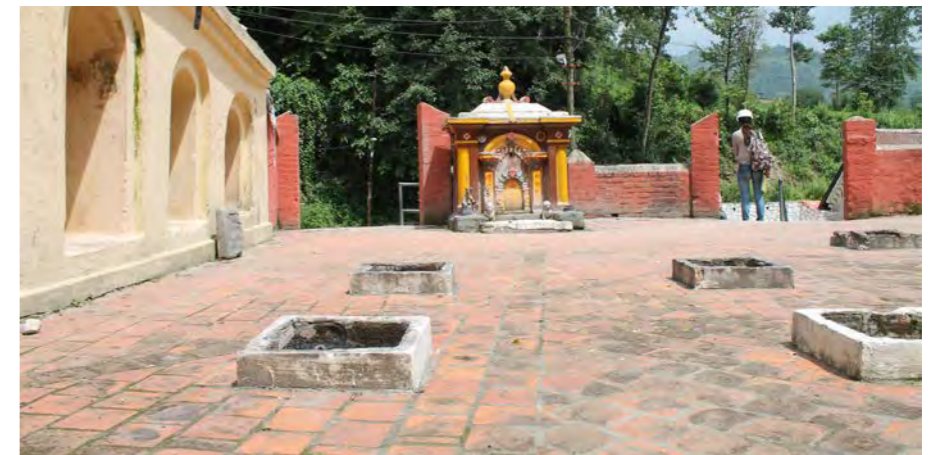
COURTYARD A

NUMBER	NAME	ESTABLISHED DATE (A.D.)	TYPOLOGY	GENERAL DESCRIPTION	PROBLEMS DESCRIPTION	DANGER/ DESTROY	
Courtyar A			Courtyard	Brick paved with thick wall boundary	Good Condition

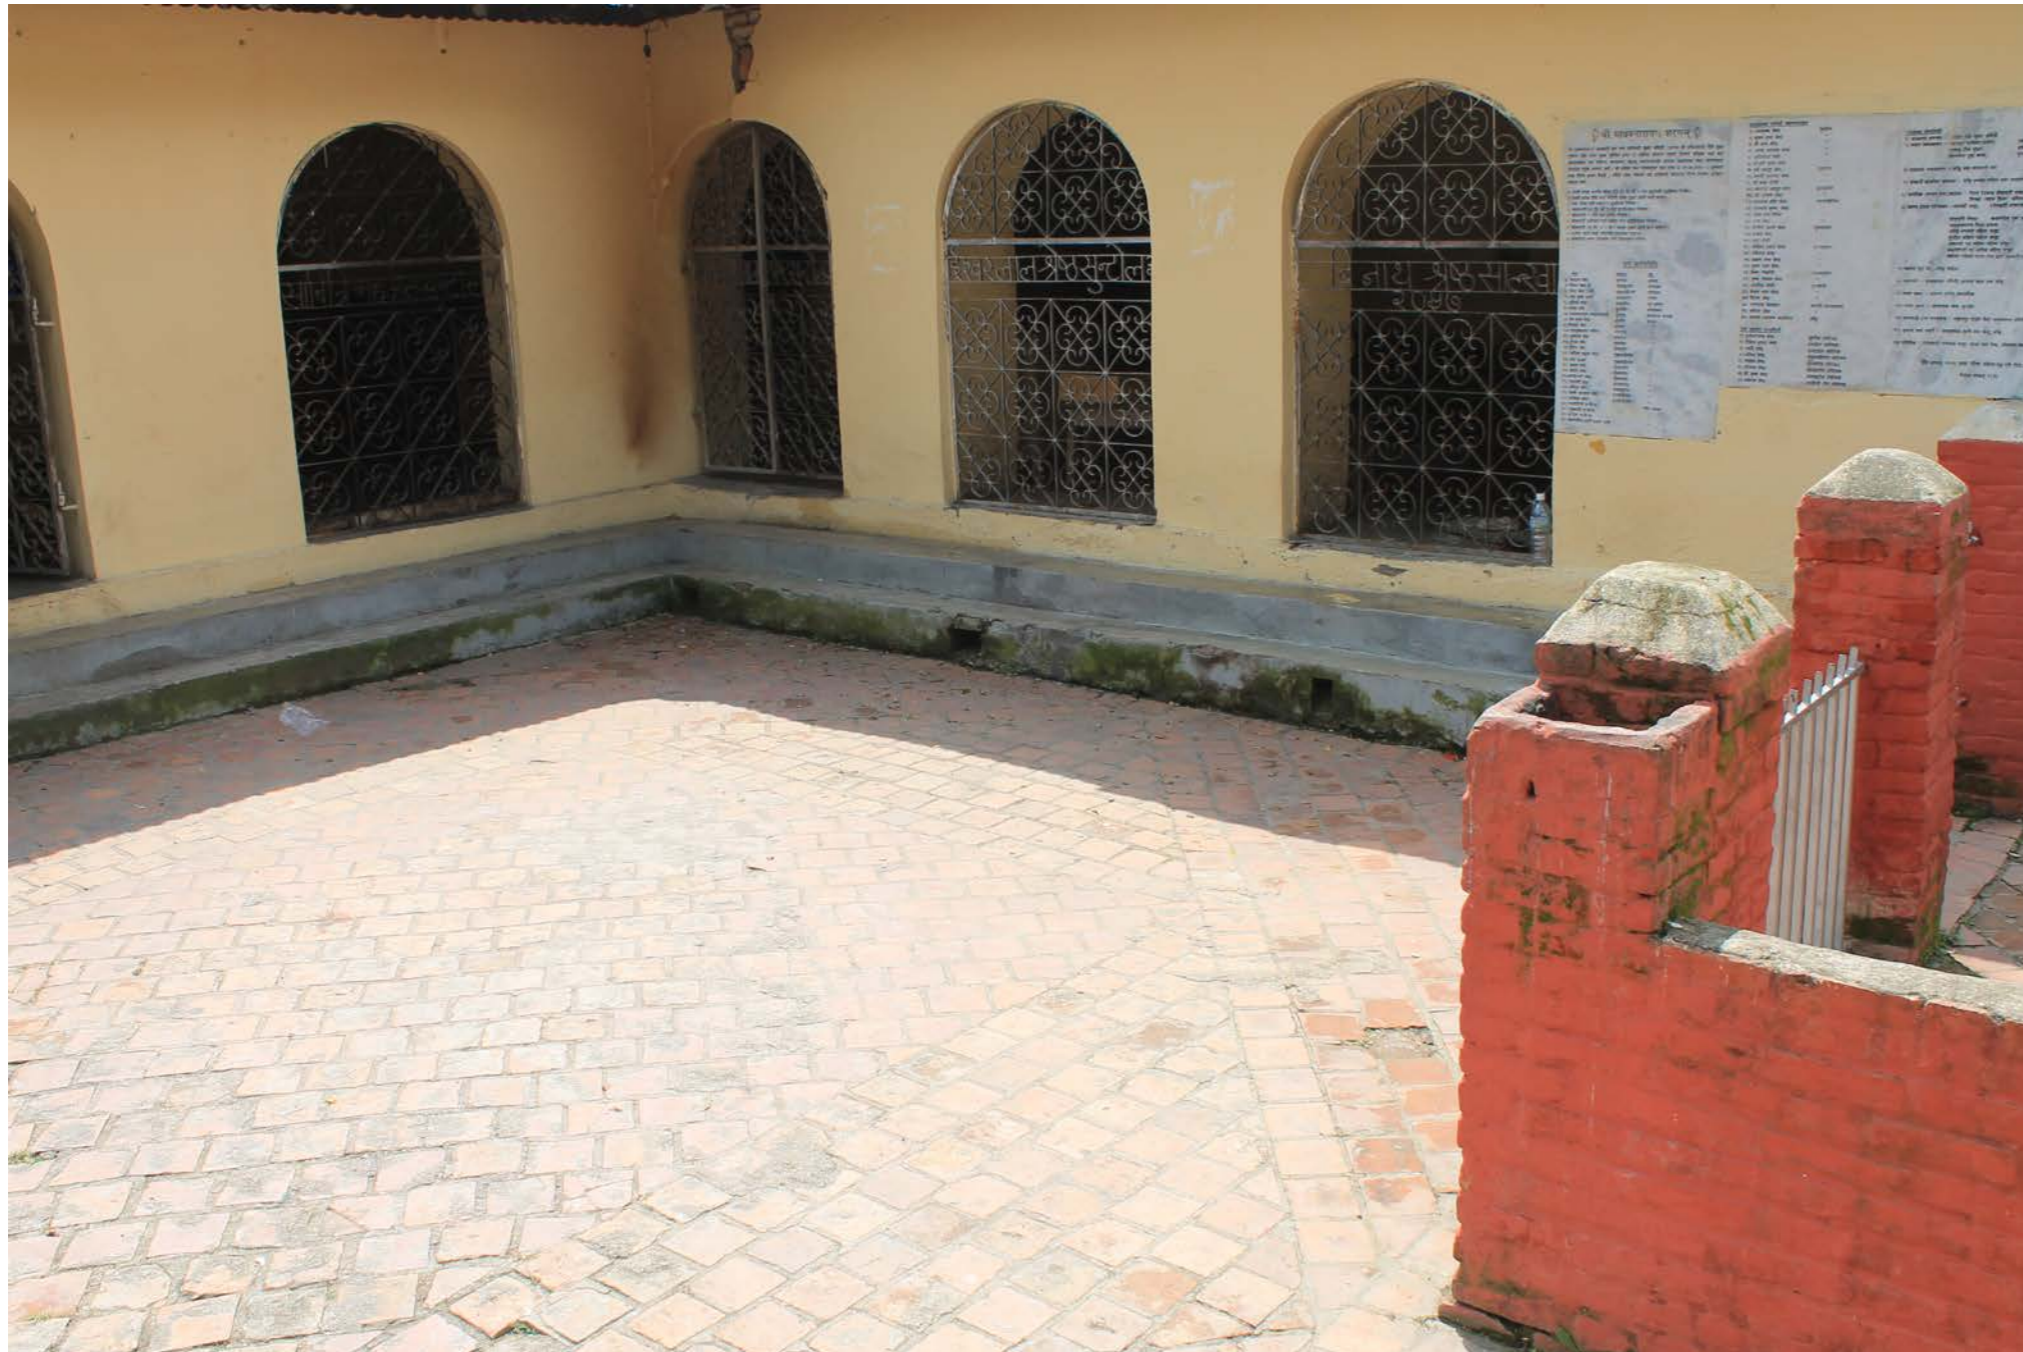
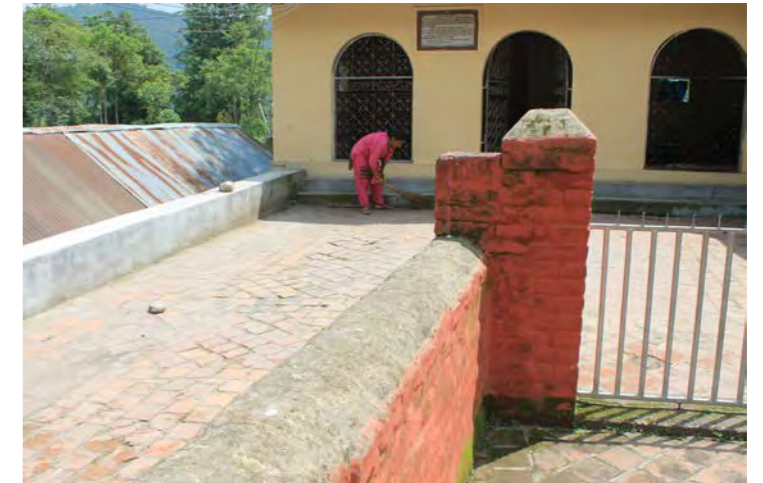
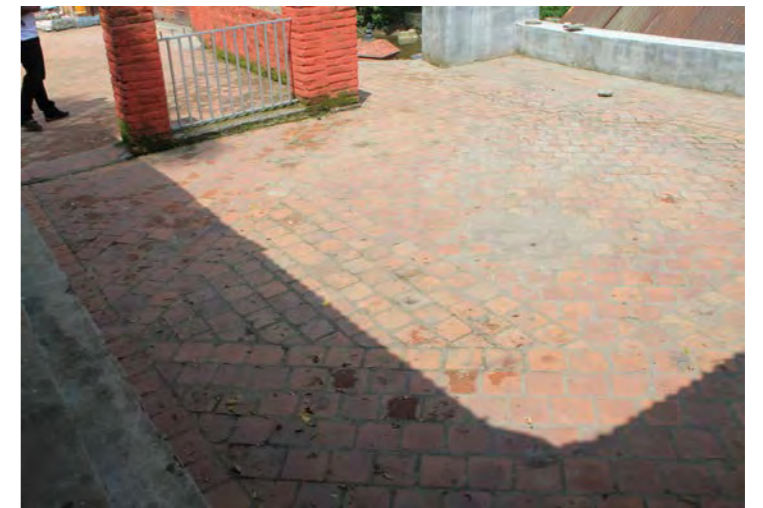
COURTYARD B

NUMBER	NAME	DATE A.D.	TYOLOGY	GENERAL DESCRIPTION	PROBLEMS DESCRIPTION	DANGER/ DESTROY	
Courtyar B			Courtyard	Small corurtyard infront of public house no. 8 Brick paved	Good Condition
