# **SURVEYS AND ACTIVITIES ON POST-EARTHQUAKE DISASTER**

**UNESCO-IPRED-RIHS INTERNATIONAL WORKSHOP  
PADANG, INDONESIA, 6-8 JULY 2010**

Research Institute for Human Settlements  
Agency for R&D – Ministry of Public Works of Indonesia  
Provincial Government of West Sumatra  
Padang, Indonesia

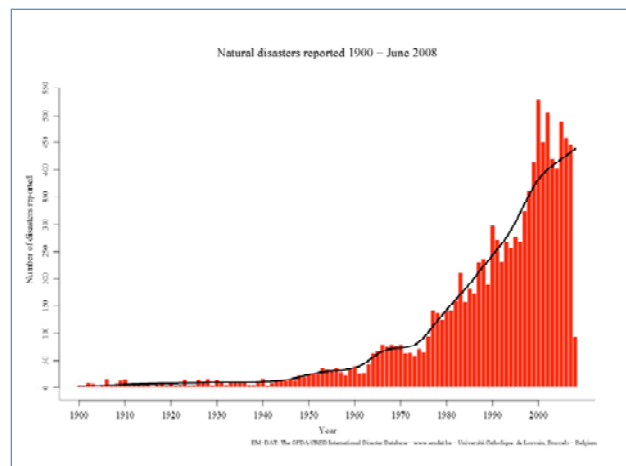
Figure 1 Reported natural disasters (EM-DAT)

Over the past months and years images of death and destruction caused by various natural disasters worldwide have haunted us. The tragedy caused by the earthquakes in Wenchuan, China (May 2008), Haiti (January 2010) and Chile (February 2010) are dramatic reminders (The Great East Japan earthquake and tsunami occurred in March 2011 while this paper was being prepared, after the author had returned to Tokyo.) Recently, we have also witnessed how fires and floods can disrupt a nation like Australia. According to EM-DAT, the number of natural disasters has increased dramatically since the beginning of the last century. Since 1950, and in particular over the last 20 years, the rate of disasters has accelerated (Figure 1).

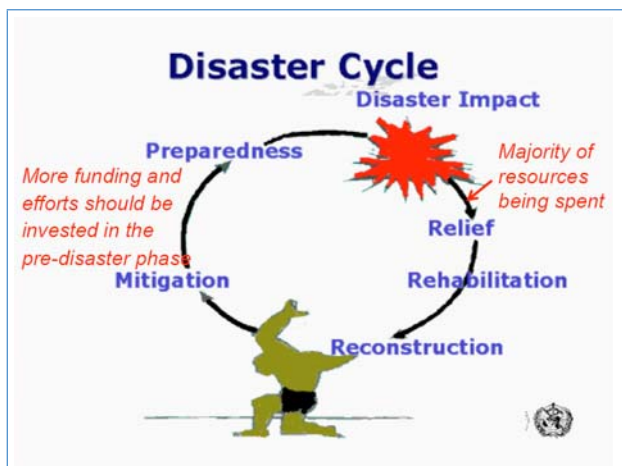
**Figure 7** Disaster cycle

Unfortunately, the disaster cycle reveals that most resources for disaster-related activities are spent when disasters occur, in emergency-response and relief operations (Figure 7). Much less funding and efforts are invested in the other phases of the cycle, namely mitigation, disaster preparedness and the pre-disaster phase in general. This trend must be reversed in order to reduce losses.

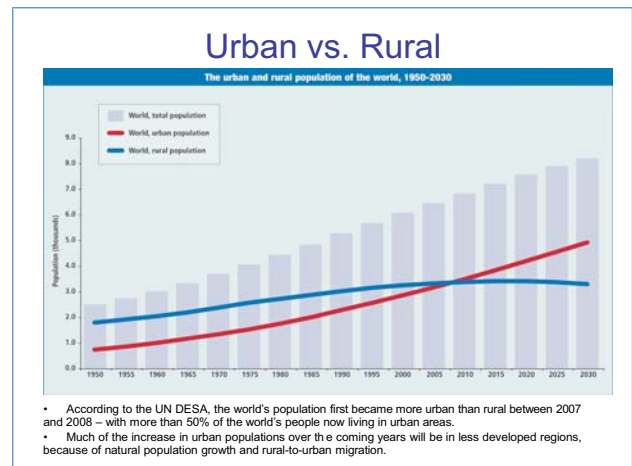
**Figure 10** Global urban and rural population (1950–2030)

urbanization and economic development (Figure 10). Unsafe, poorly built housing, schools, hospitals and lifeline infrastructure all contribute to physical vulnerability.

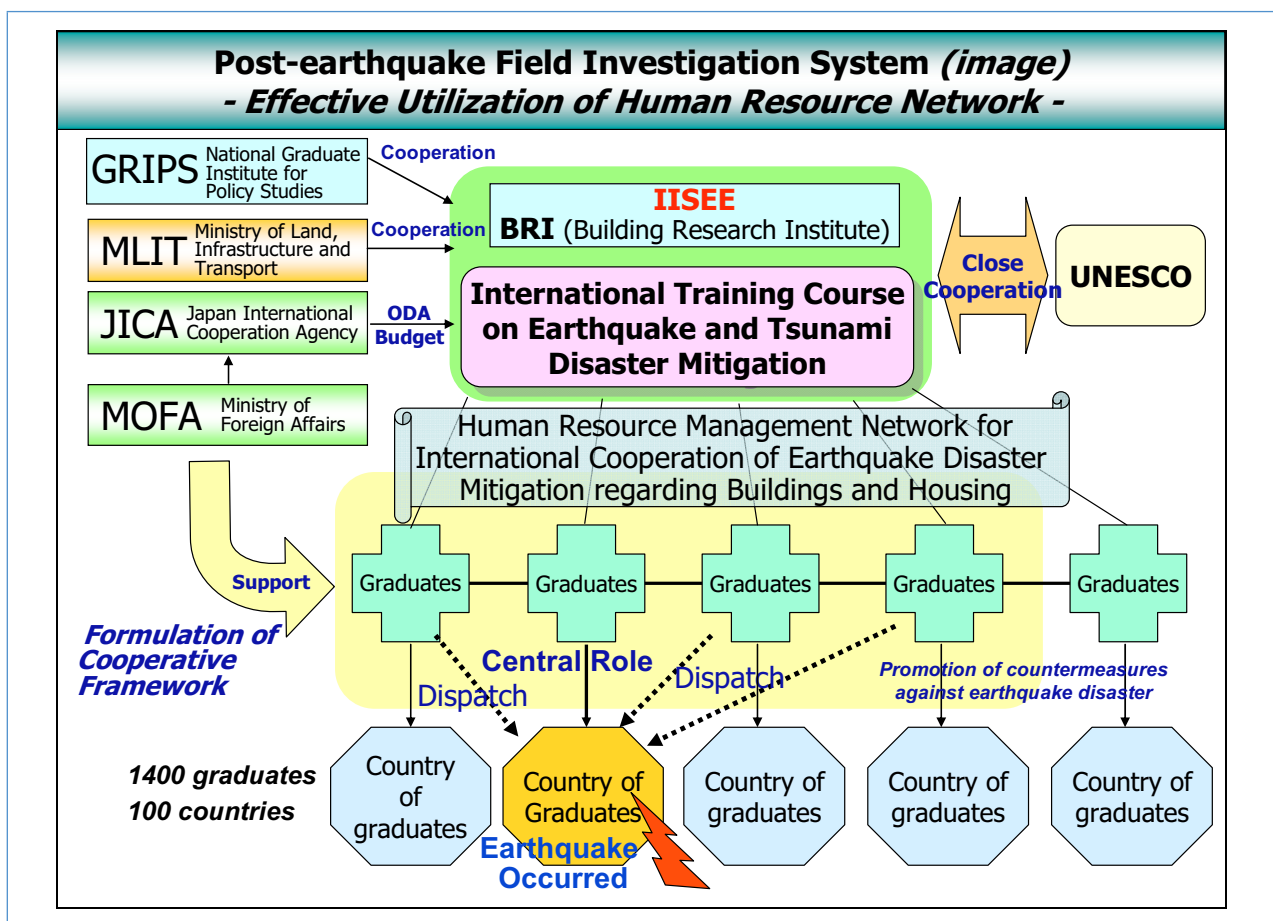
Figure 18 IPRED's post-earthquake field investigation system

One of IPRED's most important objectives is to establish a system for post-earthquake field investigation. It is recommended that, before major earthquakes occur, UNESCO and IISEE as the IPRED Centre of Excellence prepare a register of names and email addresses of members who may be able to cooperate with and/or participate in post-earthquake field investigations. Initially, it would be a good idea to use the global network of IISEE international training alumni (Figure 18).

When a major earthquake occurs, UNESCO and IISEE should gather information on its magnitude and damage, and dispatch the information to registered members by Internet and/or emails. If a post-earthquake field investigation is deemed necessary, UNESCO and IISEE will promptly establish a field investigation team in cooperation with registered members.

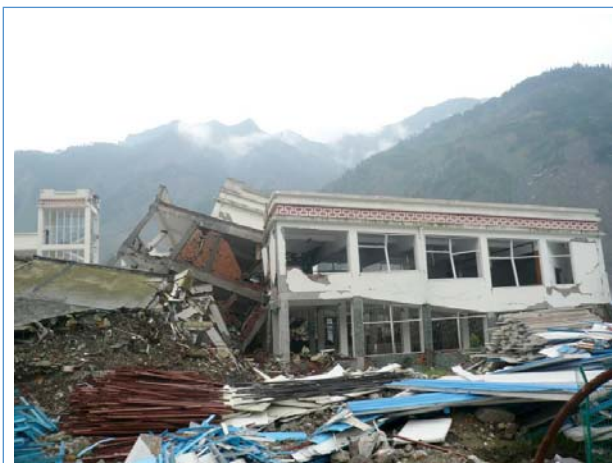
**Figure 22** Collapsed junior high school buildings in Yingxiu (© 2008 T. Imamura)

The dramatic increase in human and economic losses from disasters in recent years is alarming (Figures 22–25). In particular, natural disasters often hit hardest some of the world's poorest communities, which are the most poorly placed to protect themselves or recover afterwards. While natural hazards are not a new phenomenon, sadly they tend to attract attention only when they become disasters. Reducing and mitigating disaster risk is still low on many governments' agendas despite the ample available body of knowledge and know-how on assessing natural hazards and reducing their impact.

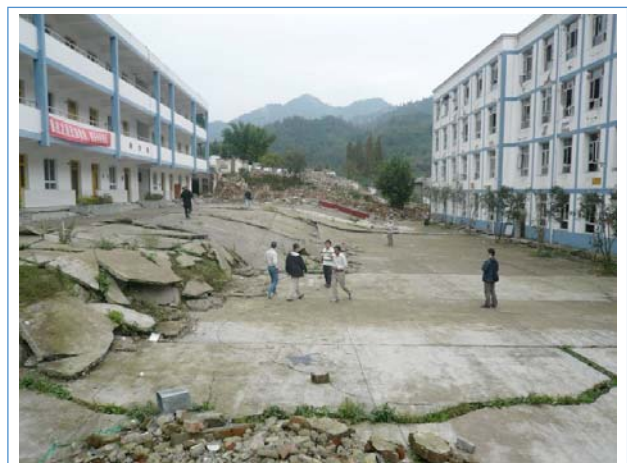
**Figure 23** School building (left) raised 2 m by the fault in Bailu (© 2008 T. Imamura)

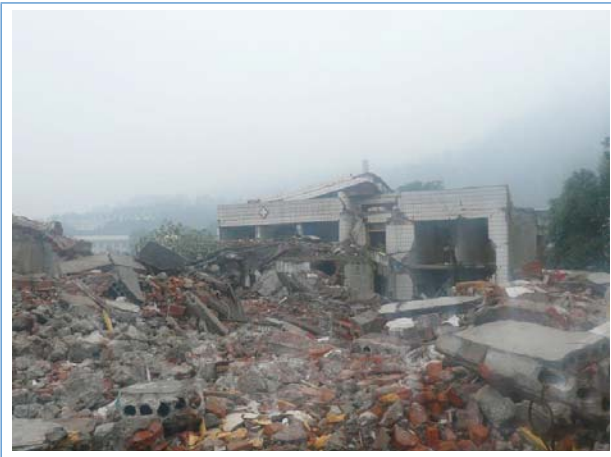
**Figure 24** Heavily damaged hospital surrounded by debris in Hanwang (© 2008 T. Imamura)

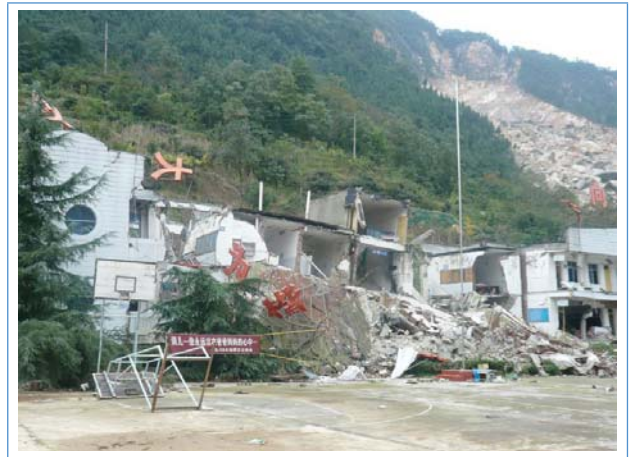
**Figure 25** Collapsed elementary school buildings in Beichuan (© 2008 T. Imamura)

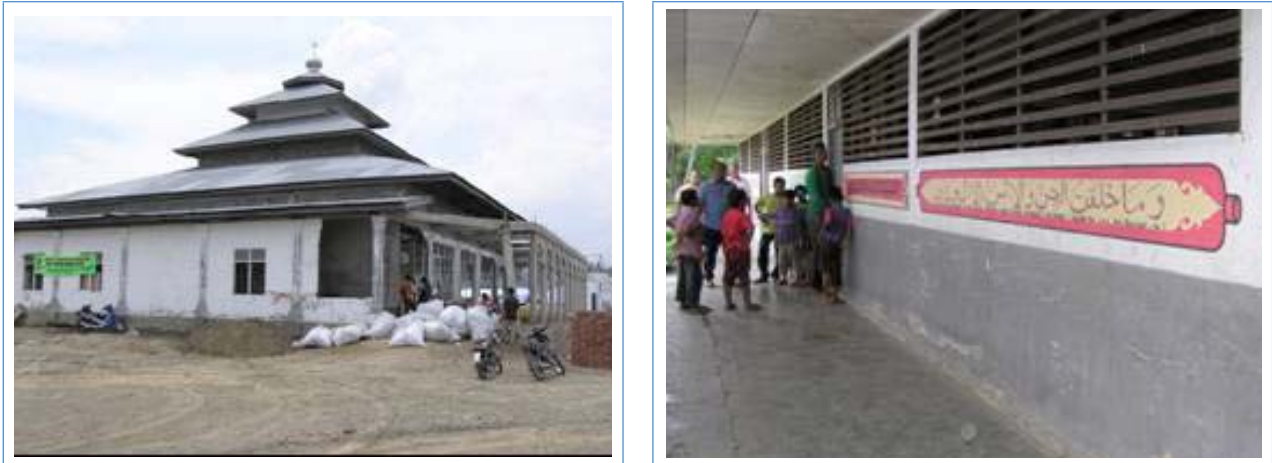
In general, most buildings in Aceh are masonry structures, most commonly one- and two-storey houses, which first caught on in the 1970s and continue to be the most popular choice. The existing buildings can survive earthquakes with little or no damage, provided that they were built properly using good-quality materials and good workmanship (Figure 1). It is interesting to note that masonry structures built in the 1970s or 1980s performed better than those built in the 1990s. The changes may be attributed to new building codes that allow an inelastic response of the structure assuming that it can develop adequate ductility, thus requiring specific detailing. Almost all damaged structures from the 1990s were designed incorrectly, failing to meet the stipulated seismic standards.

**Figure 1** Examples of surviving masonry structures

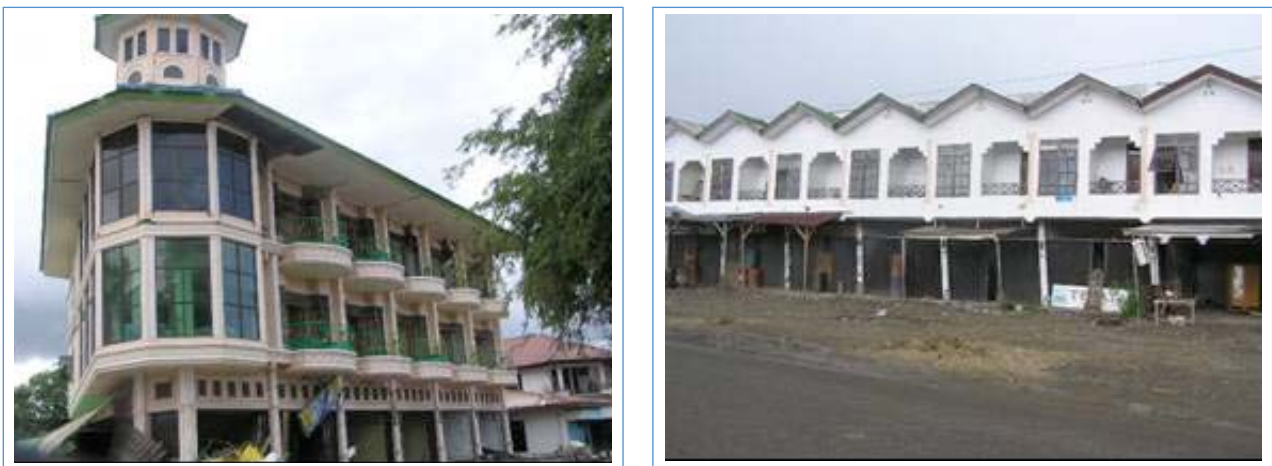
The survey showed that the new trend for buildings in NAD is a “Ruko” (“house and shop”), a two-storey building with several units like townhouses (Figure 2). Each unit is two-storeys high and can be used as an office or a shop on the first floor, with an apartment on the second floor. The new trend in NAD also reveals a growing trend for steel structures, especially in Ruko buildings.

**Figure 2** Ruko buildings, increasingly popular in Aceh

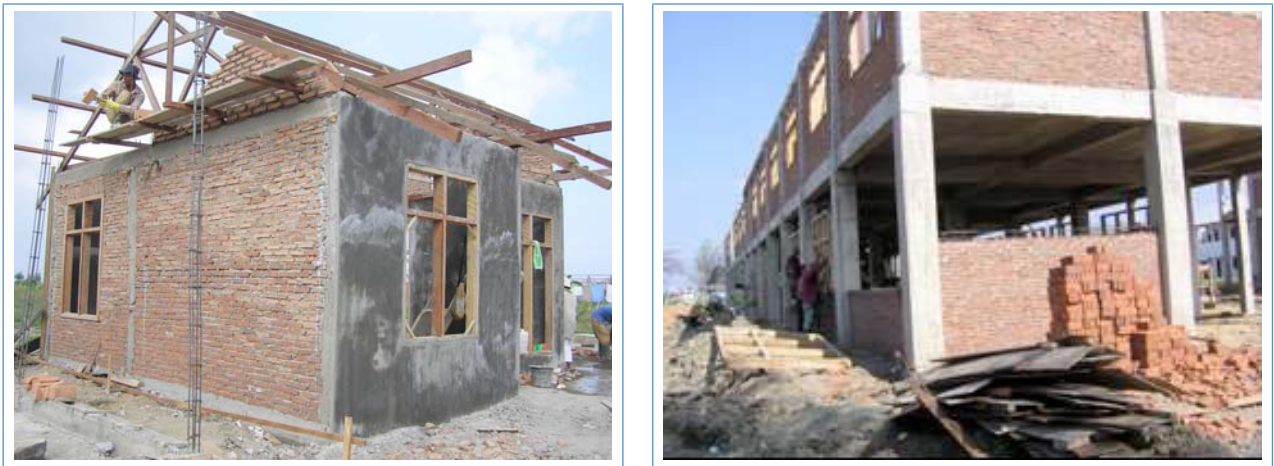
In the study, houses and school buildings were permanent structures using typical materials (burnt brick confined masonry with sand and Portland cement mortar) and confinements made of reinforced concrete columns and beams (Figure 3). A typical flat footing is usually used for the column foundation of two-storey buildings, while a spread footing is commonly used for one-storey buildings. The roof is also typical, with a metal roof deck being the most popular choice due to its cost, workability and durability.

**Figure 3** Type 36 house (left) and school building (right)

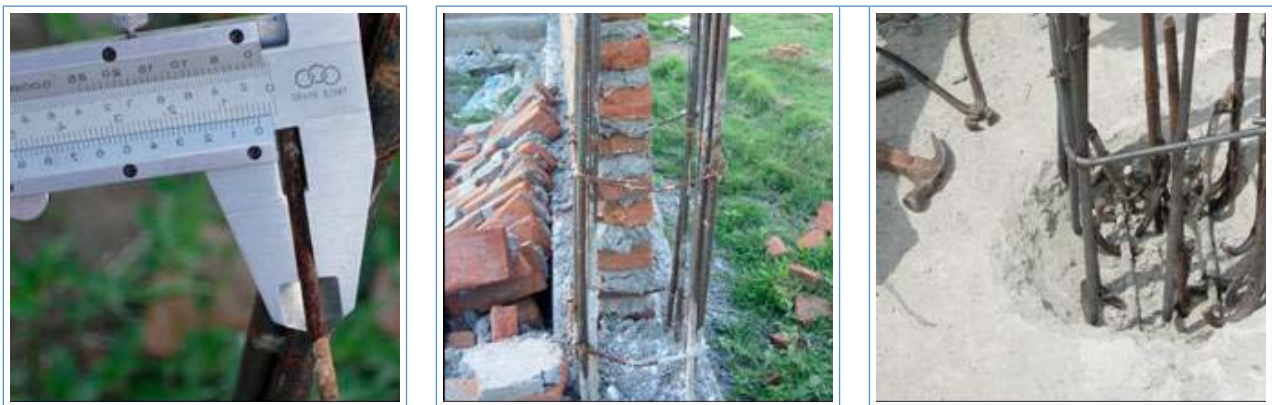
The reinforcements typically used in the buildings are at most 10 mm diameter for longitudinal plain rebars and 6 mm diameter for stirrups. (8 mm and 4 mm diameters were found in some buildings, as shown in Figure 7.) The Indonesian seismic code stipulates minimum diameters of 12 mm for deformed bars used as column longitudinal reinforcements, 10 mm for deformed bars used as beam longitudinal reinforcements, and 8 mm for plain bars used as stirrups in earthquake resistant buildings. Therefore, most of the reinforcements found in the field survey violated the building codes (Figure 7). Even worse, reinforcements that claimed to meet seismic demands did not in reality.

**Figure 5** The use of a 4 mm stirrup (left), large spacing of stirrups (centre) and no seismic hook (right)

The required seismic hook, provided by a 135° bend in stirrups, was found in only a small number of projects. Stirrup spacing also posed a problem, measuring an average of 200–250 mm, compared with the maximum spacing of 150 mm required by the code. Laboratory tests confirmed the sub-standard strength of materials (Table 2). All these facts indicate that the bending and shear strength of structural elements could be much lower than expected.

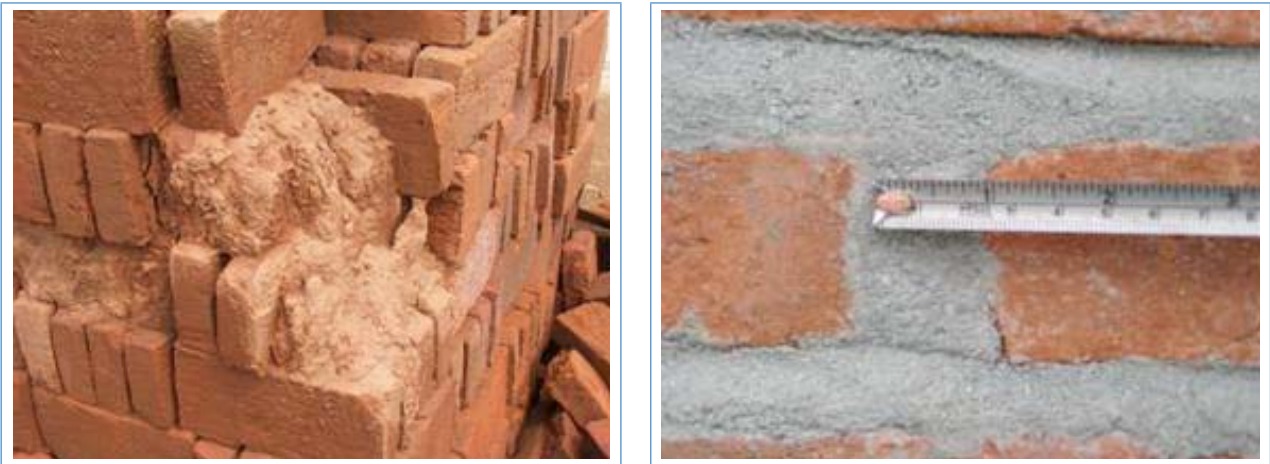
**Figure 6** Melting bricks (left) and large brick spacing (right)

With the exception of a few projects, the quality of bricks used in the region is very low (Figure 8). The minimum quality stipulated by the Indonesian code is Class III, which relates to a minimum brick strength of 25 kg/cm<sup>2</sup>. Most bricks fall below this level and could not be tested for strength as they disintegrate when soaked with water. Mortar quality is also questionable, in terms of average strength (most only reaching K-60 or fc' of 4.8 MPa), and the wide variations observed. No standard appears to have been followed to mix mortar, leaving the matter up to workers' judgment. Brick laying is also a major problem, with excessive amounts of mortar being applied between bricks (with a spacing of more than 15 mm) and bricks not being installed in a straight line, due to minimum leveling (Figure 6).

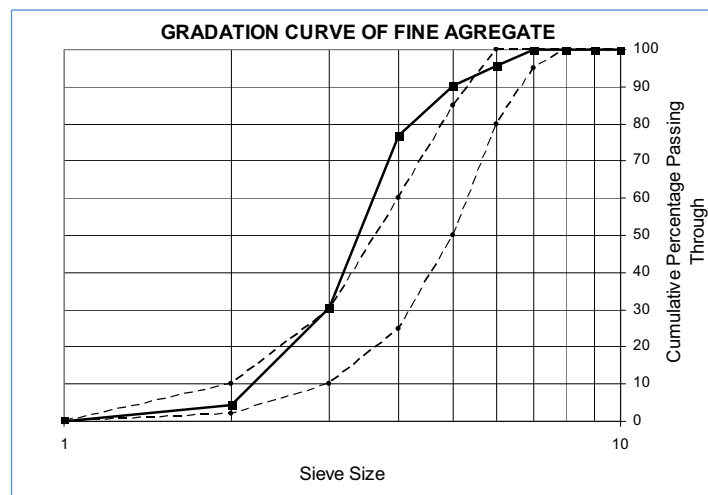
The poor gradation of sand used (Figure 7) is much coarser than required, leading to poor brick spacing. The common mortar mixture found in the area was 1 bag of cement for 3 carts of sand, or a 1:5.5 volume ratio, compared to the recommended 1:3 ratio. Altogether, these factors contribute to poor-quality walls and partitions, reducing building strength.

**Figure 7** Sieve analysis for sand

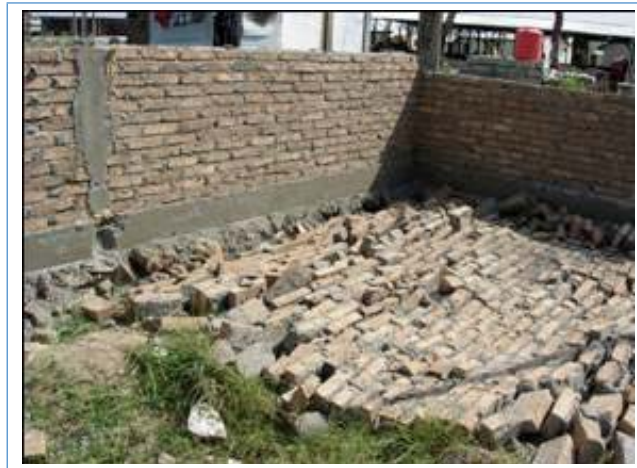
Buildings are also lacking in structural integrity, due to insufficient connections between each structural component. For example, in one of the projects surveyed, beam-column connections did not comply with the requirements laid out in the codes, and no wall anchorage was provided to the columns and ring beams, leading walls to collapse during construction in one of the project surveyed (Figure 8).

**Figure 8** Wall collapse before completion

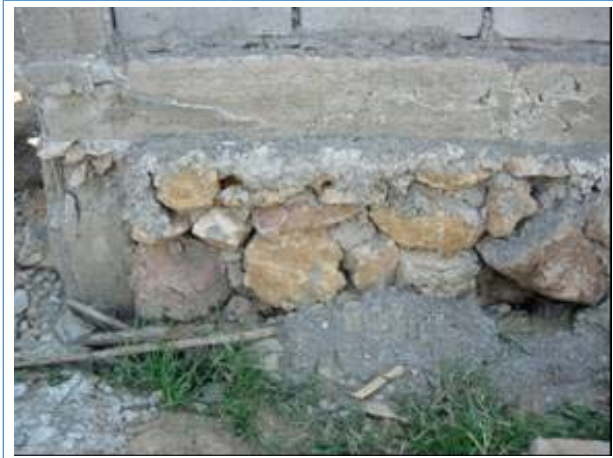
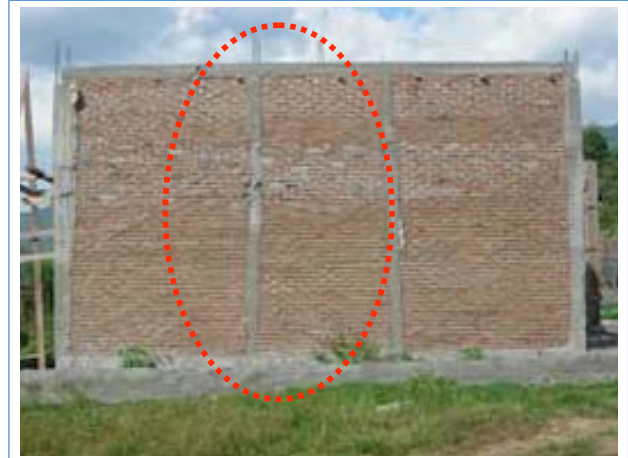
While poor quality materials produce poor structural quality, poor quality workmanship amplifies the problems found in reconstruction problems. Given the amount of building work being carried out, trained and qualified workers are scarce in the region. Most projects demonstrated that workers were inadequately trained for the job, given, for example the lack of a sieving process for concrete ingredients, seismic hooks for stirrups, curing for concrete, and soaking of bricks before laying, while the water content of concrete mixture was high to facilitate pouring (Figure 19). All these problems arose from the absence of awareness of building quality issues. Workers simply did what seemed easiest with no concern for quality because they were not equipped with knowledge of proper construction methods or basic concepts of building quality.

**Figure 9** Poor workmanship (left) and a tilted column resulting from poor workmanship (right)

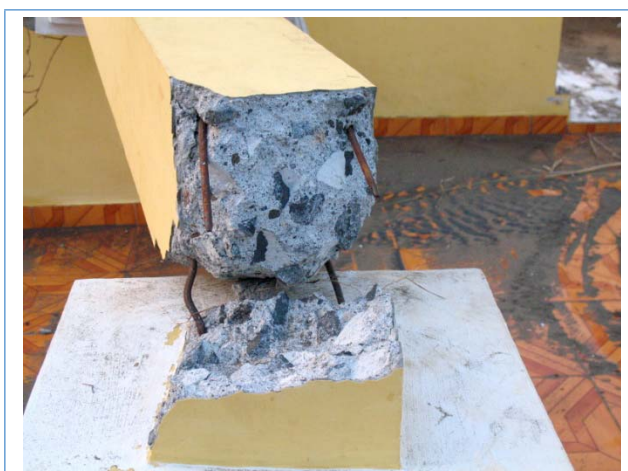
**Reinforcement bars:** The use of reinforcement bar, especially as the main reinforcement, was still using small-diameter (10 mm) steel, which does not meet standards, meaning that the building is unable to bear the load of its capacity (Figure 1), making a buckled column and beam damage unavoidable.

**Figure 1** Column component after collapsing during the aftershock

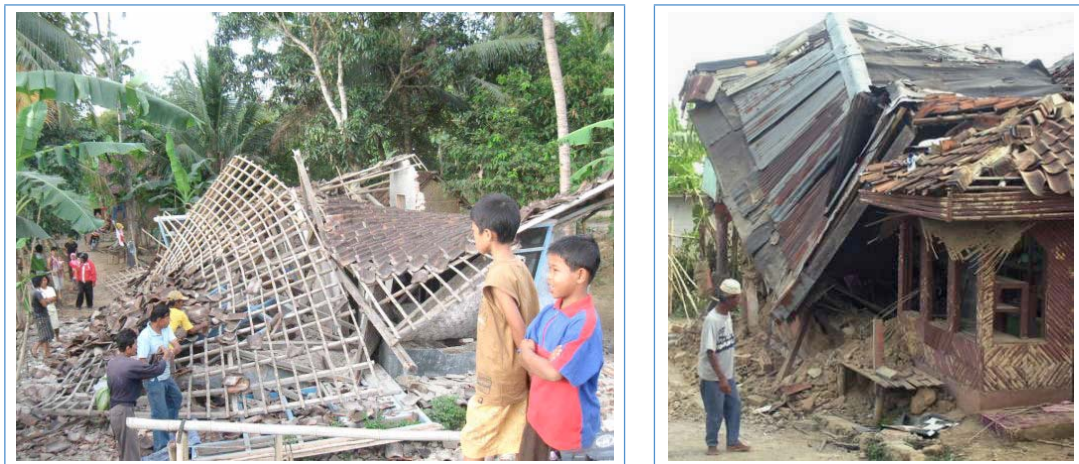
**Figure 2** Houses collapsed after the Jogjakarta earthquake

- (a) The heavy weight of brick walls, which causes sudden collapse (Figure 2)
- (b) Heavy Joglo roofing made of clay tiles, which increases the moment of inertia to lateral seismic force (Figure 3)
- (c) No serration connection between wall joints, at neither the corner nor the middle of walls
- (d) No anchorage between the roof and walls
- (e) No anchorage between walls and foundations
- (f) Joglo wooden roofing being too heavy for the building
- (g) Weak sand mortar for the brick masonry
- (h) No wall bracing in the confined masonry system

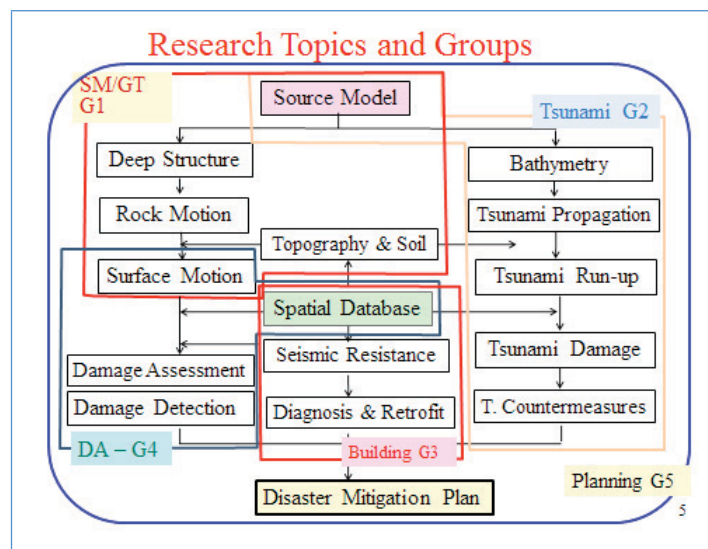
Figure 3 Research topics and project items

The joint research is focusing on five main research topics (Figure 3): 1) strong-motion prediction and development of seismic microzonation, 2) the development of tsunami countermeasures based on numerical simulations, 3) enhancing the seismic resistance of buildings based on structural experiments and field investigations, 4) the development of a spatial information database using remote sensing technology and earthquake damage assessment for scenario earthquakes, and 5) the development of an earthquake and tsunami disaster mitigation plan and its implementation in society.

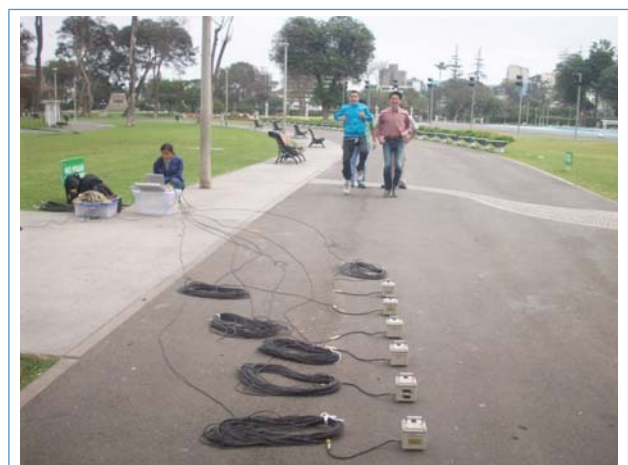
**Figure 6** A linear arrangement setting a distance between sensors of 0.5–2.0 m in Reserva Park, Lima

1. G1: Seismology and geotechnical engineering (source and soil response)
  - A training course was developed on evaluation technologies for seismology (G1) and tsunamis (G2) (IGP-DHN-UNMSM-UNI), and knowledge was exchanged on the evaluation of seismic sources, seismic hazards and tsunami evaluation (Figure 5).
  - Equipment was received (CV 374AV2 sensor network, GEODAS-15 HS equipment and a Network Seismocorder CV-575). A linear arrangement was performed in Puente Piedra, La Molina, Villa El Salvador, San Martin de Porres, and the Callao districts of Lima City. In addition, generation waves and signal acquisition were performed (Figure 6).

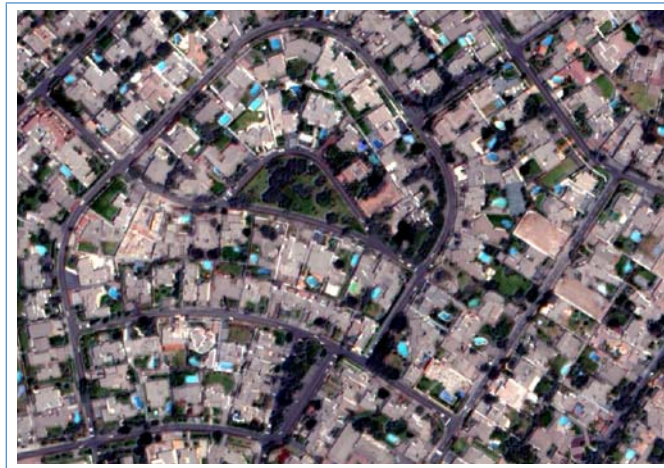
**Figure 10** Different types of land use, La Molina district, Lima (2010) – measuring the social vulnerability of residents from satellite images used to infer the quality of housing

- Development of a building inventory and a geo-spatial database
- Damage simulations (earthquakes and tsunamis)
- Seismic risk assessment for earthquake scenarios
- Damage assessment methodologies and web-based system for data dissemination (Figure 10)

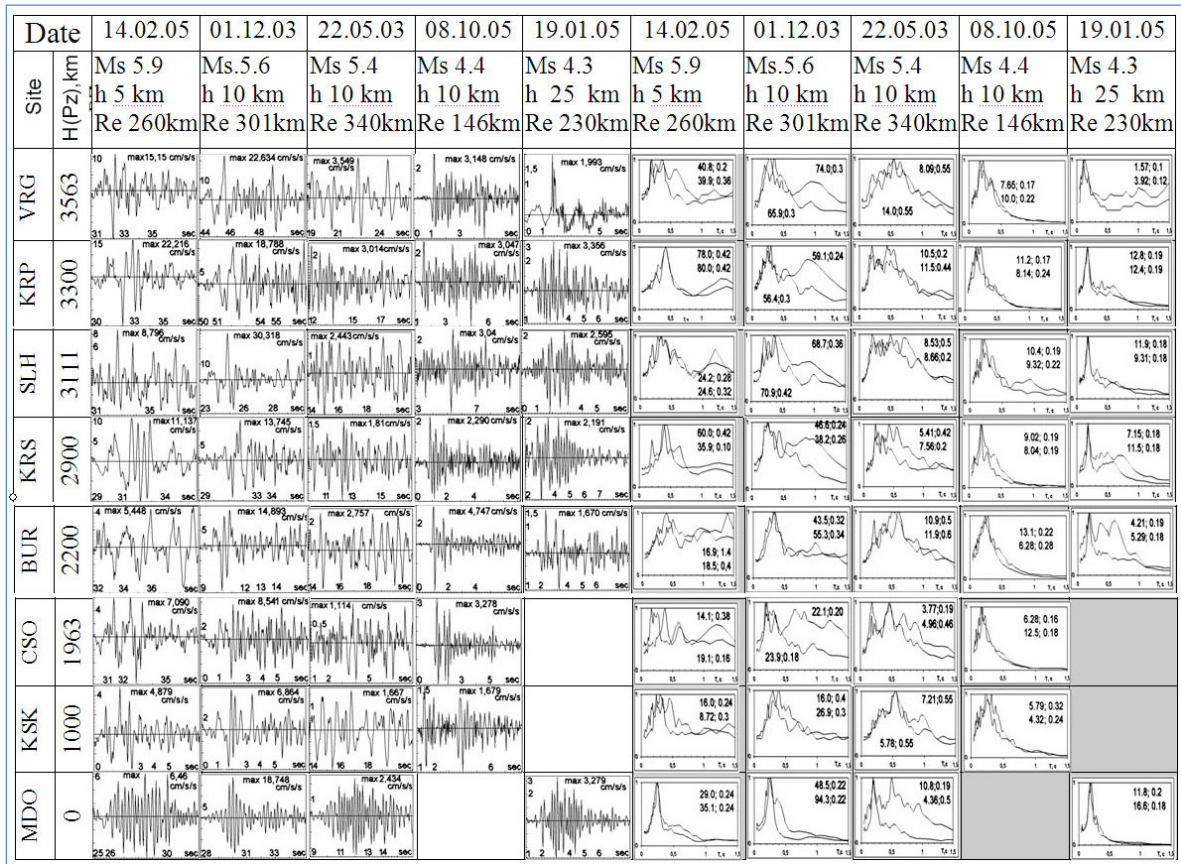
Figure 3a Acceleration waveforms recorded by different stations of the city's strong motion network, and corresponding normalized response spectra

The lefthand side of Table 2 contains accelerograms (horizontal components) for five events recorded by the stations located in different engineering-geological conditions. In each case, the component with the highest peak acceleration is chosen. The earthquakes are listed from left to right in order of magnitude. Although the 1 December 2003 earthquake in Narynkol was of a smaller magnitude than the 14 May 2005 earthquake (Ms 5.7 vs 5.9) with an epicentre located further from the observation sites, the accelerations recorded in Almaty during this event were on average 2.2 times higher than those recorded during the second earthquake (Table 2). Table 2 shows the depth of the Paleozoic basement (sedimentary cover thickness) at the observation sites in descending order and the waveform differences caused by features of earthquakes and site conditions. The influence of the sedimentary layer and its dynamic characteristics is one of the most important factors determining seismic effects. Usually waveforms obtained in different site conditions differ even within the scope of an event (e.g. Nakamura, 2000) and each site displays typical waveforms during different events.

In this research, the territory is rather local and peculiarities bound with different events are more expressed. Even here, however, waveforms of the only station located on rock (MDO) are similar for different events, but differ from other station waveforms. Close events have much higher frequency waveforms than stronger, more remote earthquakes. Changing dynamics of acceleration predominant periods can be traced on response spectra placed on the righthand side of Table 2. It includes response spectra ( $\xi=5$  per cent) for horizontal accelerations normalized to their maximal values. The spectra of the earthquake on 14 May 2005 (5.9 Ms; Rep $\approx$ 260km) with maximal Ms have maximal predominant periods. The spectra of the Narynkolskoye earthquake on 1 December 2003 (5.6 Ms; Rep $\approx$ 301km) are characterized by significantly higher acceleration levels and shorter predominant periods than the spectra of the Lugovskoe earthquake on 22 May 2003 (5.4 Ms; Rep $\approx$ 340km). In general, the lower the magnitude, the narrower and higher the frequency of the spectra. In the case of remote events, the wave varies in spectral content when going through an absorbing

Figure 3a shows predominant periods of Fourier spectra plotted compared with magnitude and distance for the data obtained by the network. A scattering of values is observed within separate events due to differences in site conditions and in separate events, with different source spectra and wave routes. However, the maximum differences are due probably to the influence of basin peculiarities in Almaty. Even for magnitude 4 (3.6–4.5) the predominant peaks in some cases correspond to surface waves with much larger periods than body waves. For magnitude 5 the number of peaks due to surface waves considerably increases and becomes dominant for magnitude 6. At this magnitude, both surface waves produced by the basin geometry and numerous faults inside the basin, and surface waves coming to the basin from outside are observed, supported by considerable amplification of vertical components as well as by H/V spectral ratio analysis for the MDO station and the new TNS station located on rock. In all magnitude groups, the periods increase with magnitude and distance. It is early, however, to speak about predictive relations that take into account all the complication factors, when the maximum periods may refer to different wave types. The distribution of predominant periods over the city territory shows longer periods in the areas with thicker sedimentary cover.

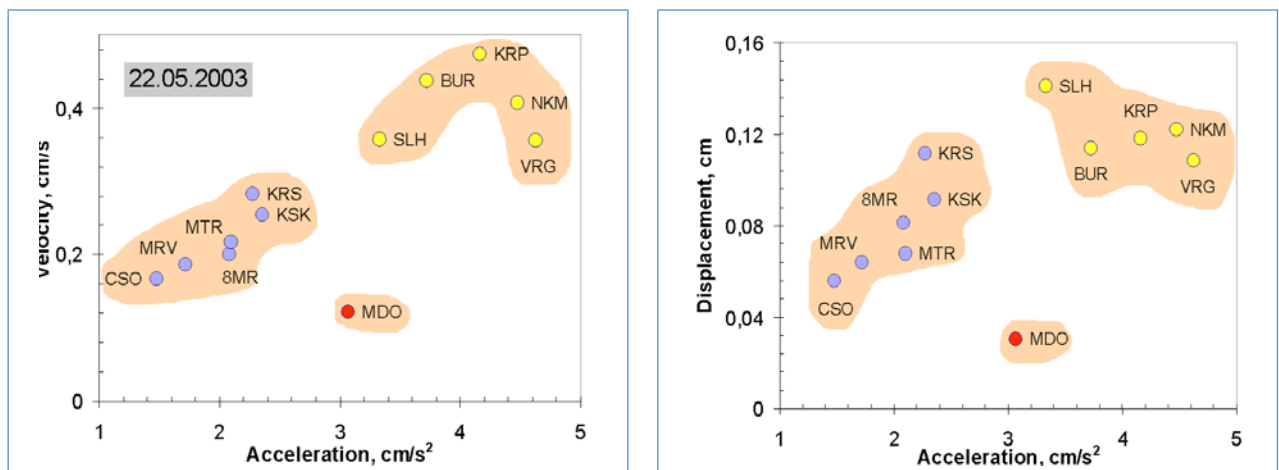
**Figure 5** Relation between maximal spectral accelerations, velocities and displacements for the 22 February 2003 Lugovskoe earthquake

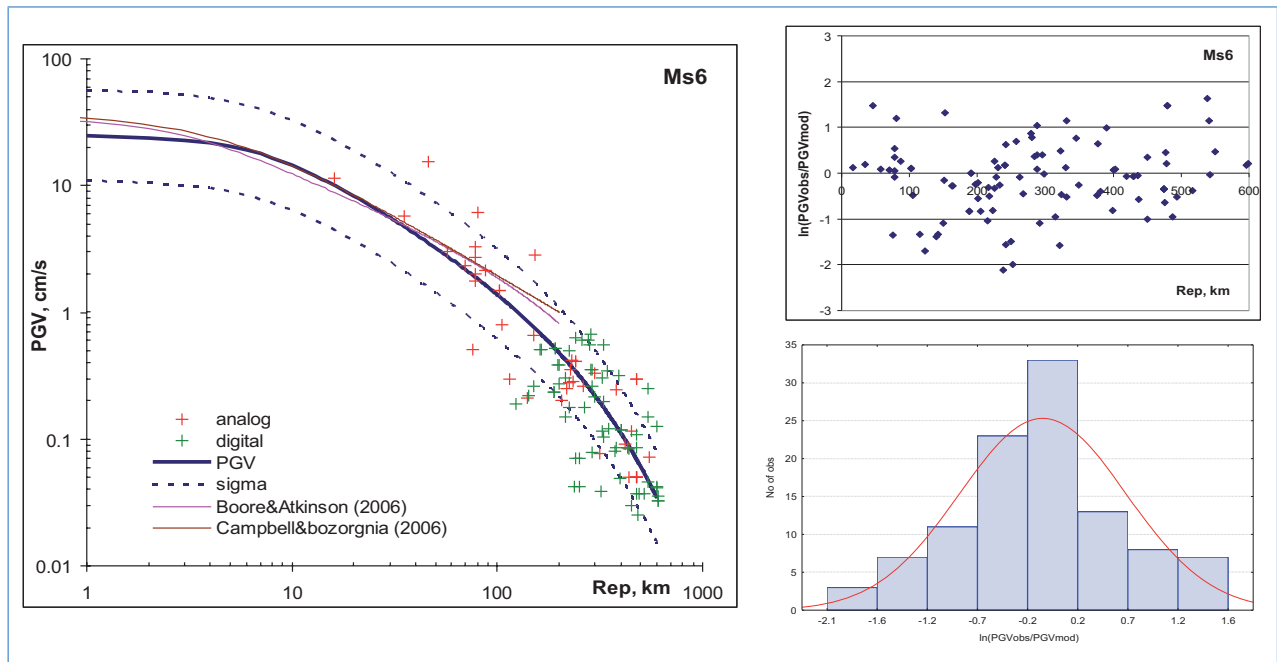
**Figure 8** PGV attenuation model for 6 Ms and corresponding residual distribution and histogram

To obtain our own regional relations, an attempt was made to use strong-motion data together with data from other seismological networks in Kazakhstan (records of earlier local and regional analogue networks and records of regional network of digital velocigraphs). Such an approach enables PGA and peak ground velocity (PGV) attenuation relations to be obtained in southeastern Kazakhstan for prediction ground motions in seismic hazard assessment and microzonation. As an example, Figure 8 shows the PGV attenuation model for Category II soil, based on complex data for the 6 Ms group, together with observed peak velocities, a corresponding residual distribution and a histogram.

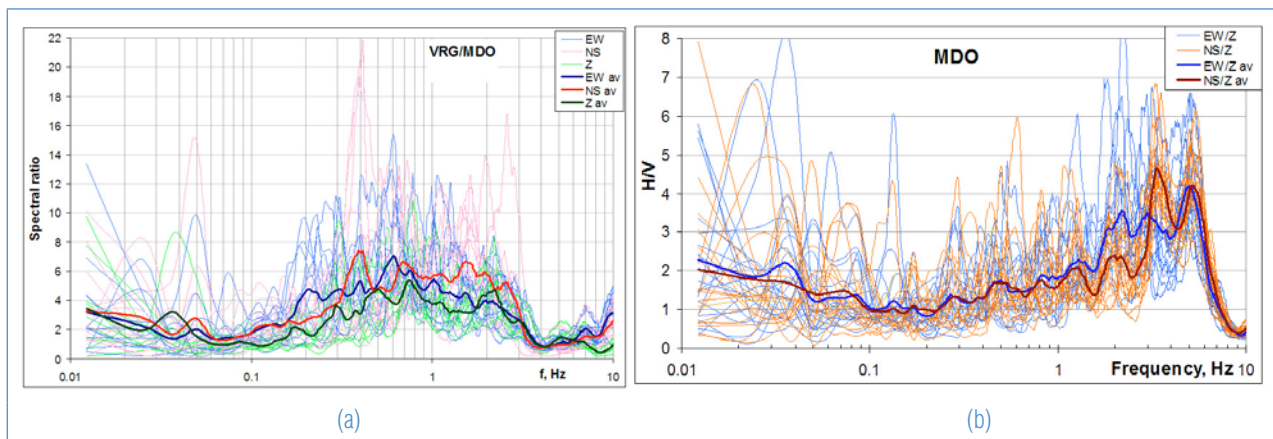
**Figure 10** Spectral ratios (a) standard for the VRG station with respect to the MDO station, (b) H/V for the MDO station

Spectral analysis of network records enables empirical transfer functions to be obtained in the area of strong motion stations, and the city territory to be zoned with respect to the spectral characteristics of soils. For each station, the average spectral ratios of the Fourier spectra horizontal component over vertical are calculated and the average standard spectral ratios are obtained with relation to the reference MDO station located on the bedrock outcrop within the city. As an example, Figure 10a shows plots for the VRG station. The need to use both techniques is due to the imperfection of MDO as a reference station and the peculiarities of the basin in which Almaty is located (in the centre). From one side, the H/V ratio for MDO, averaged over all available events, shows amplification at frequencies of about 2–6 Hz (Figure 10b), probably due to topographic conditions or weathering of the upper rock layers. From the other site, in major cases both horizontal and vertical components of records are also amplified, changing the pattern of local amplification given by the H/V method. For all cases, there are complicated spectral ratios with amplification within the range of 0.2–3 Hz. The general level of amplification increases at the stations located on debris cones compared to the stations over the deepest part of the basin. A complicated form of empirical transfer functions and considerable amplification of vertical components may indicate the existence of 2D–3D effects in the Almaty area.

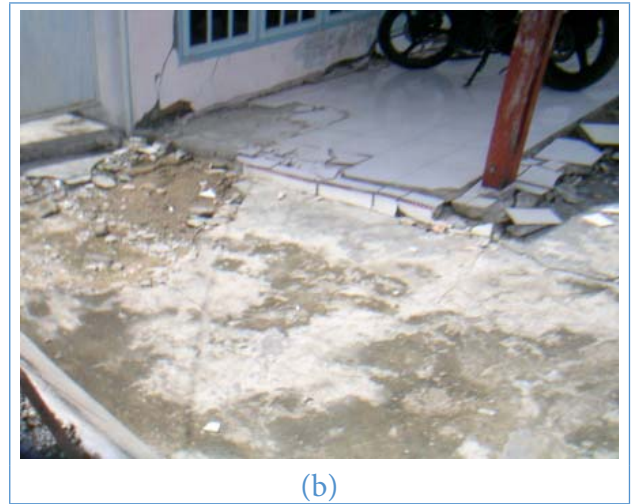
**Figure 1** Liquefaction: (a) soil settlement at Jl. Gereja, and (b) sand ejected from the fissure floor in the residential complex at the National University of Padang

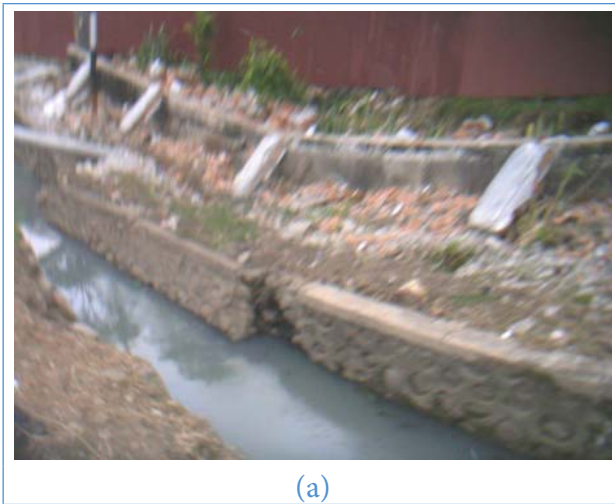
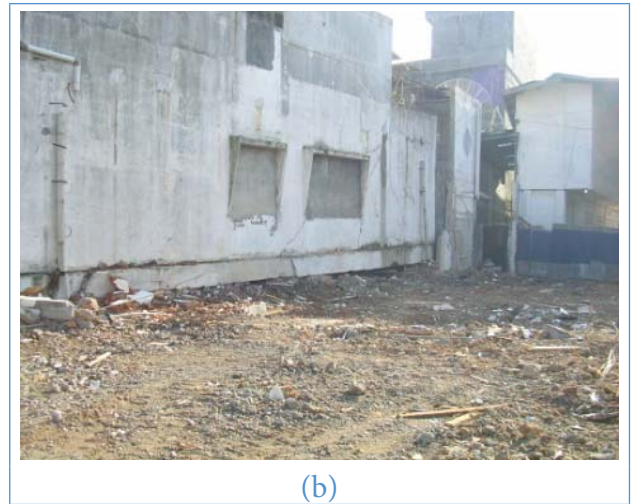
**Figure 2** Liquefaction: (a) deformation of the soil layer due to the river wall breaking, Jl. Gereja, and (b) differential settlement of subgrade foundations

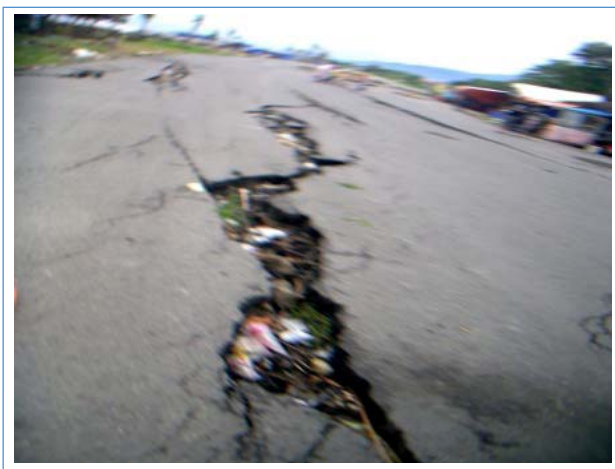
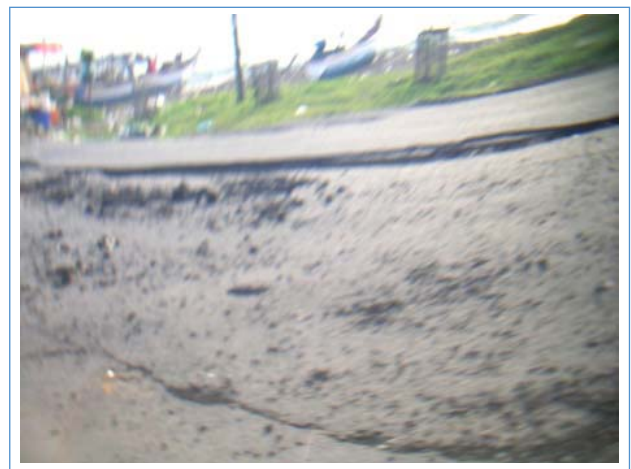
**Figure 3** Liquefaction: (a) lateral movement causing a road to crack, Jl. Samudera, and (b) sand from the bottom of a road experiencing landslides, Jl. Samudera

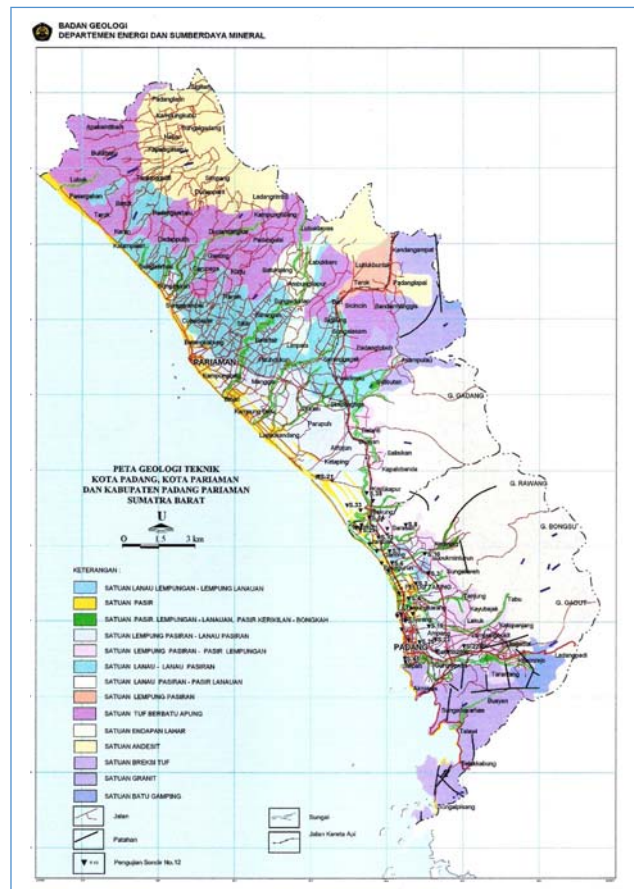
Figure 4 Geotechnical map of Padang

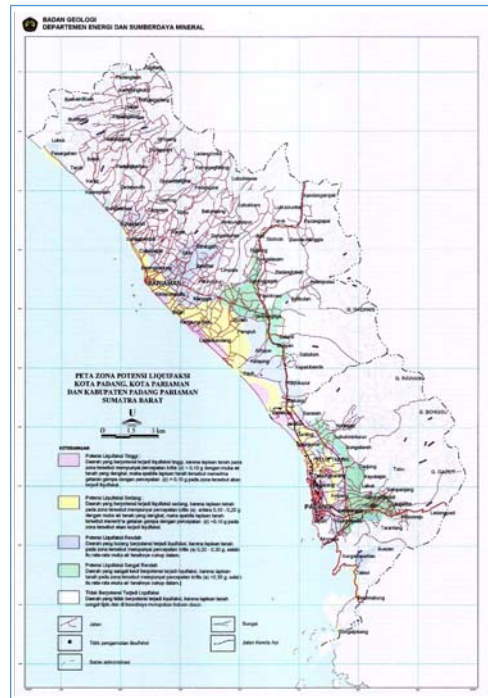
Figure 6 Liquefaction hazard map

After the 30 September earthquake, the Geological Agency conducted soil tests and made a zoning map of liquefaction potential in the vicinity of the city and along the west coast of Padang Pariaman. The mapping results indicate that some areas of Padang City and its region that have a high potential for liquefaction, such as Ulak Karang. Tabing and Ganting showed moderate results, while Kubu is among the very low potential areas (Figure 6). These results were very close to the mapping that existed before the earthquake in 1997. For example, the previous map shows Padang and Ulak Karang as having high liquefaction potential, Ganting moderate potential, and Kubu very low potential.

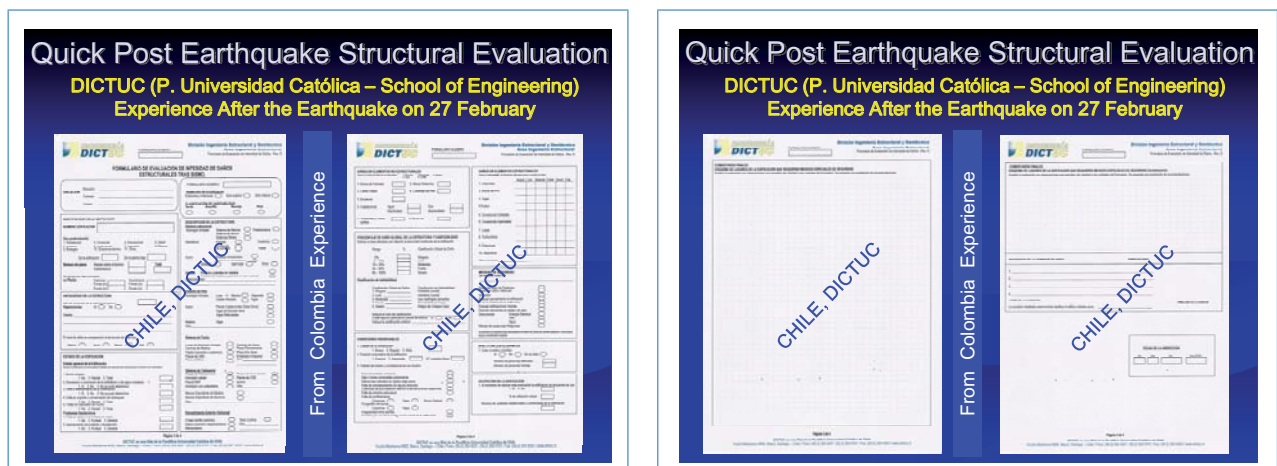
Figure 9 Evaluation sheet created by DICTUC, using the Colombian evaluation sheet as a model

The evaluation sheet prepared by DICTUC (Figure 9) consisted of two pages of forms to fill out, explaining general and specific features of the building, the most common types of damage and the building security status. In addition, two pages were included for notes that could be helpful to a future report.

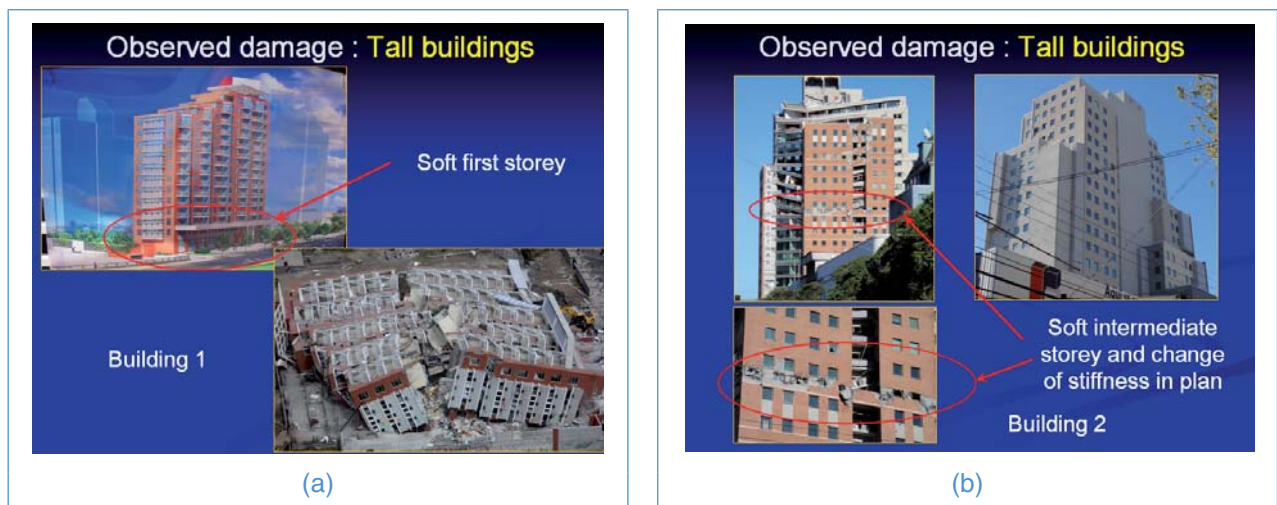
**Figure 13** (a) Collapsed building with soft first storey, and (b) building with partially collapsed soft intermediate storey

Figure 13a shows the only tall structure experiencing total collapse due to earthquake. This building had a double height soft first storey, which is very common in Chilean construction. Figure 13b shows an intermediate soft storey collapse, without total collapse of the building. Both buildings are in Concepción City.
