# **SURVEYS AND ACTIVITIES ON POST-EARTHQUAKE DISASTER**

**UNESCO-IPRED-RIHS INTERNATIONAL WORKSHOP  
PADANG, INDONESIA, 6-8 JULY 2010**

Research Institute for Human Settlements  
Agency for R&D – Ministry of Public Works of Indonesia  
Provincial Government of West Sumatra  
Padang, Indonesia

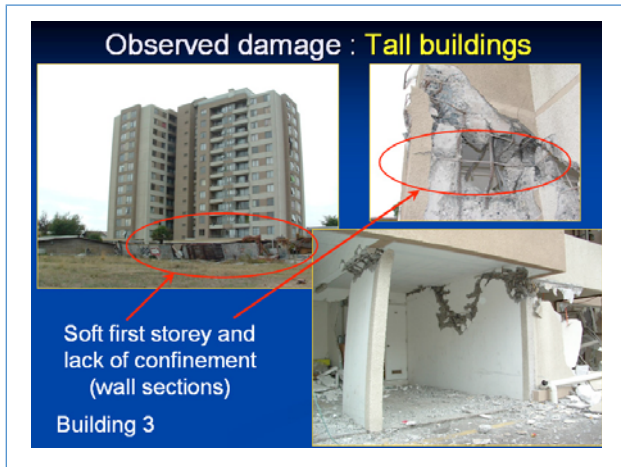
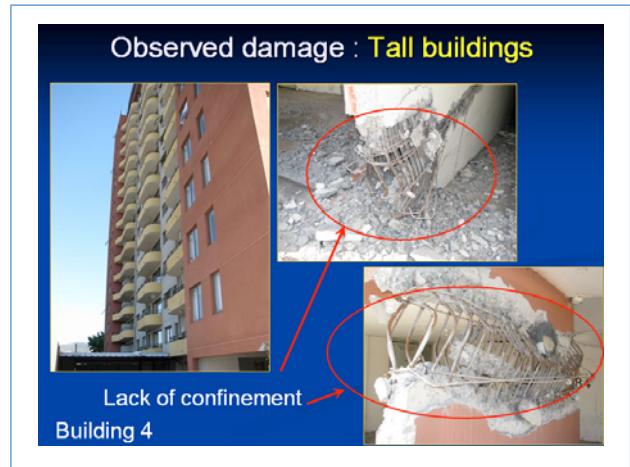
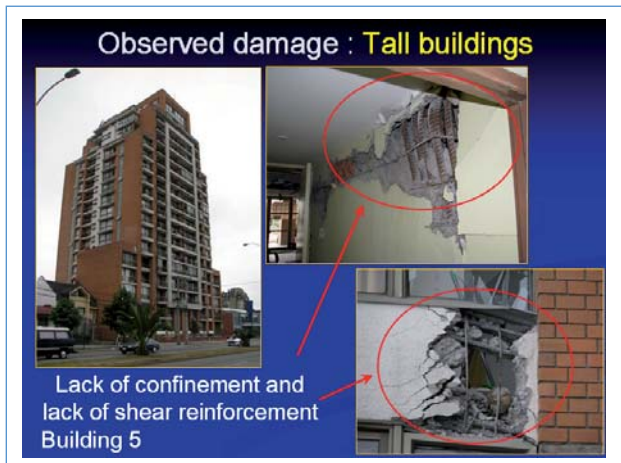
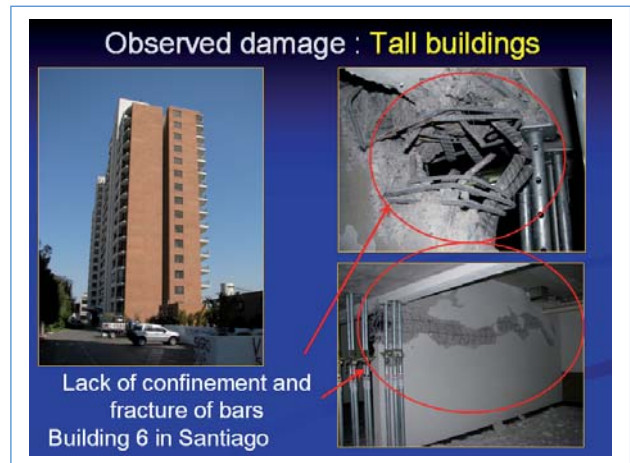
**Figure 14** Typical failure due to lack of confinement in compressed wall heads

Together with soft first storeys, because of lax requirements in the Chilean building Code until 2008 (before NCh430.2008), there is commonly a low confinement in compressed wall heads, resulting in concrete fractures and loosening, and buckling of compressed bars.

the earthquake, the large-diameter reinforcing bars did not have enough material to develop their strength (Figures 14–15).

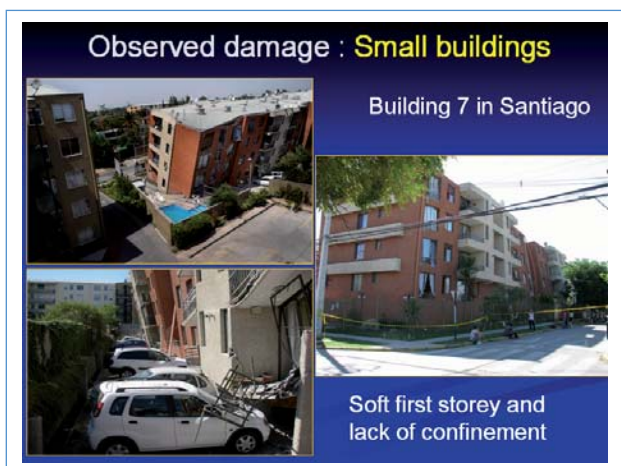
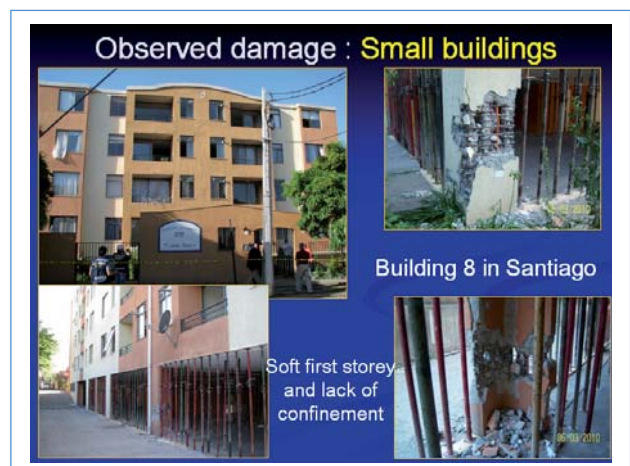
**Figure 15** Typical failures due to lack of confinement in compressed wall heads and thin walls

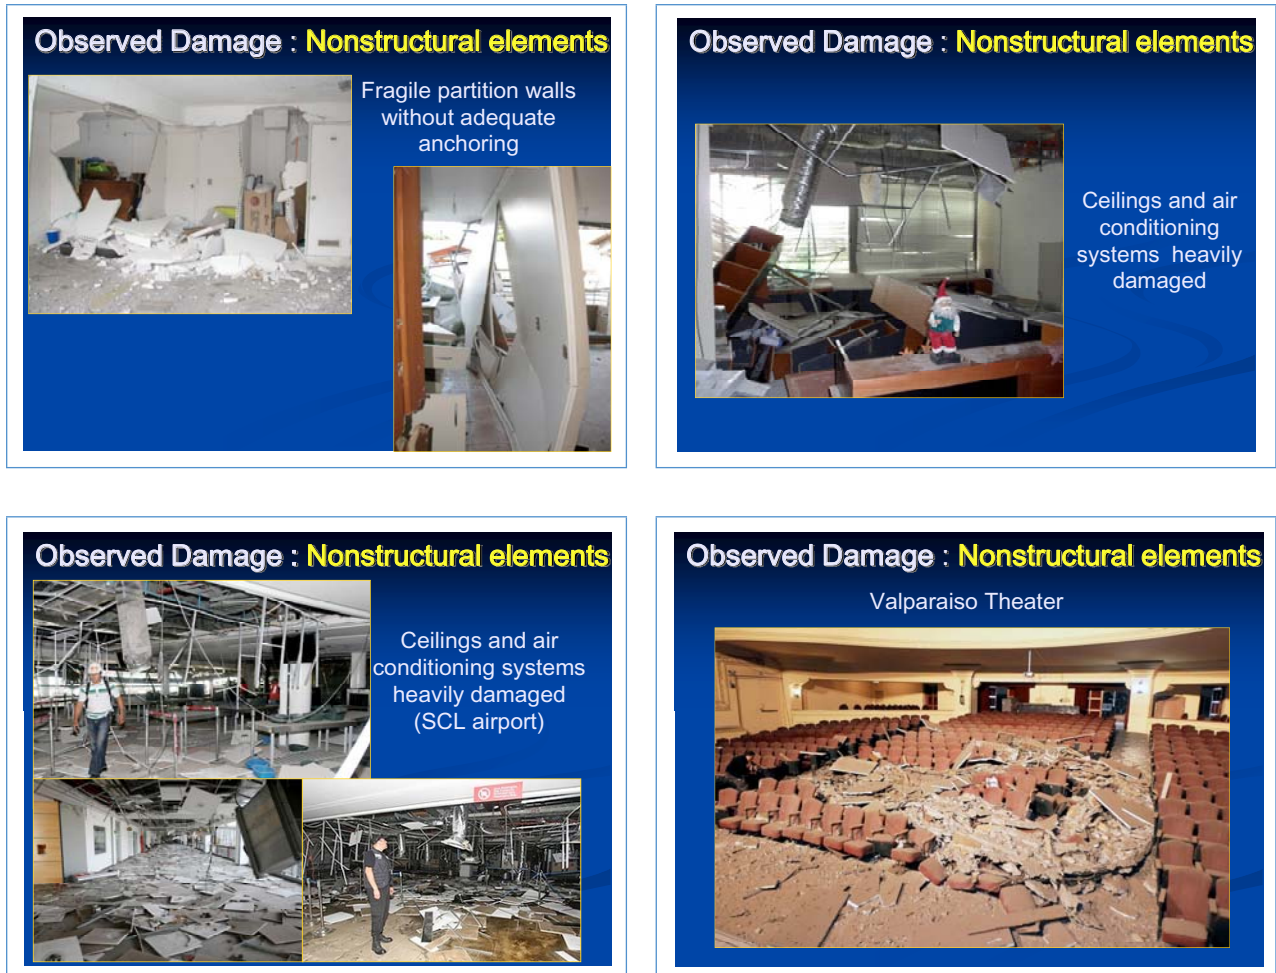
**Figure 16** Typical damage to non-structural elements

The most common damage observed in almost all buildings in the affected areas was to non-structural elements. Many buildings had fragile partition walls, mainly consisting of plasterboard without adequate anchoring and isolation from structural walls and slabs.

In addition, ceilings and air conditioning with poor anchorage suffered severe damage with parts falling off, even injuring people passing the affected areas (Figure 16).

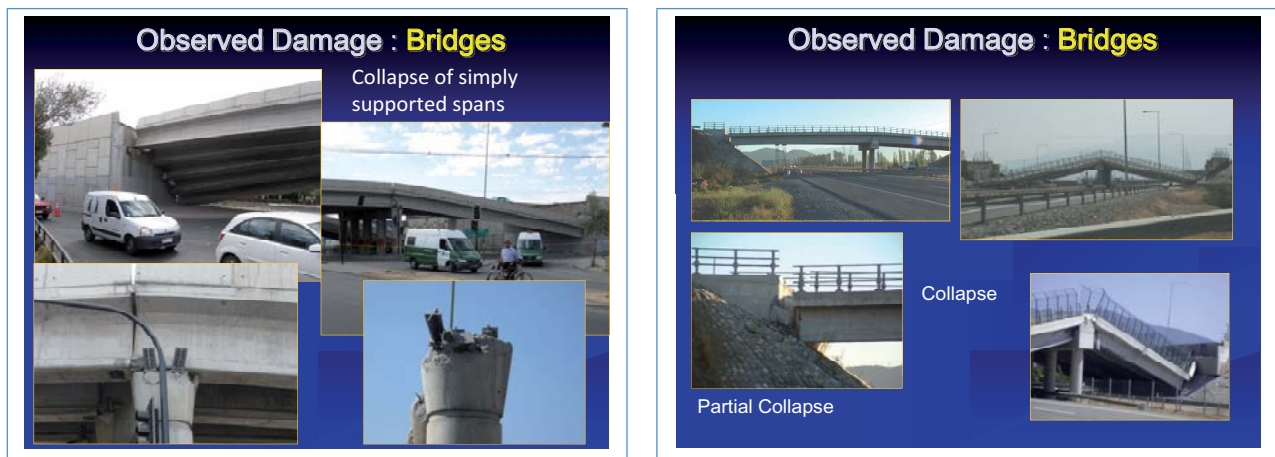
**Figure 18** Bridge failure due to weak anchoring and lack of lateral support

Poor anchoring systems make up a simply supported slab. If the supports are displaced, the bridge deck may fall almost freely (Figure 18).

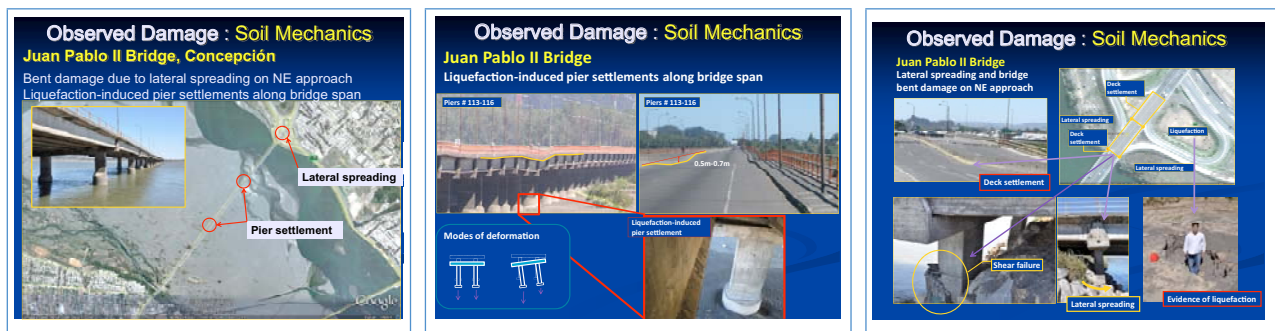
**Figure 19** Bridge failure due to liquefaction and settling

Near Concepción City, damage was observed to river bridges due to soil foundation failure. At Juan Pablo II bridge, the longest in Chile, soil failure occurred under its piles by liquefaction and settlements, as well as problems with bridge access embankments, where liquefaction also occurred (Figures 17–18).

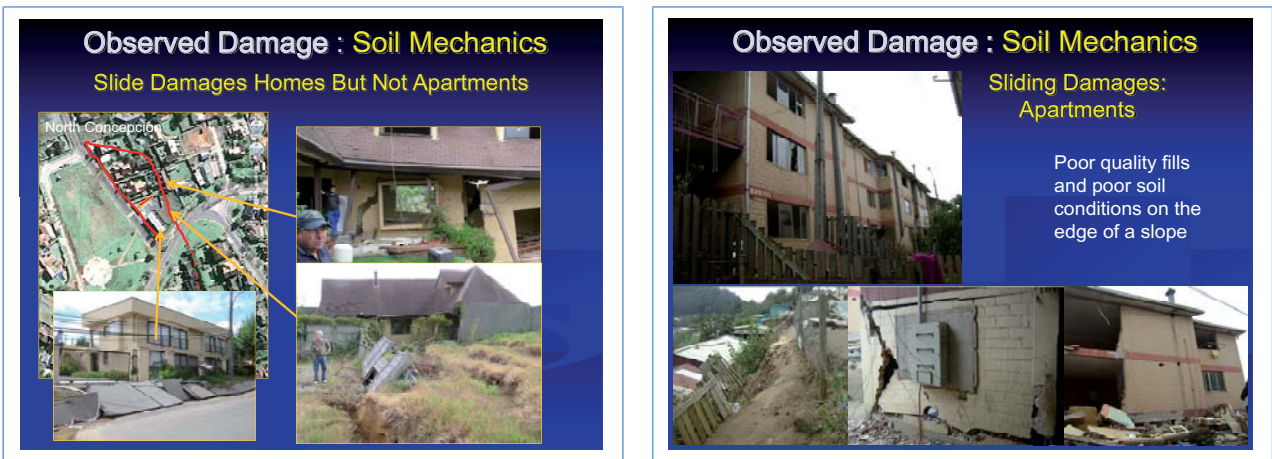
**Figure 20** Failure of houses and small buildings due to landslides and poor soil conditions

Landslides and poor-quality soil fills caused damage to houses and small social buildings, especially in landfills on the edge of slopes (Figure 20).

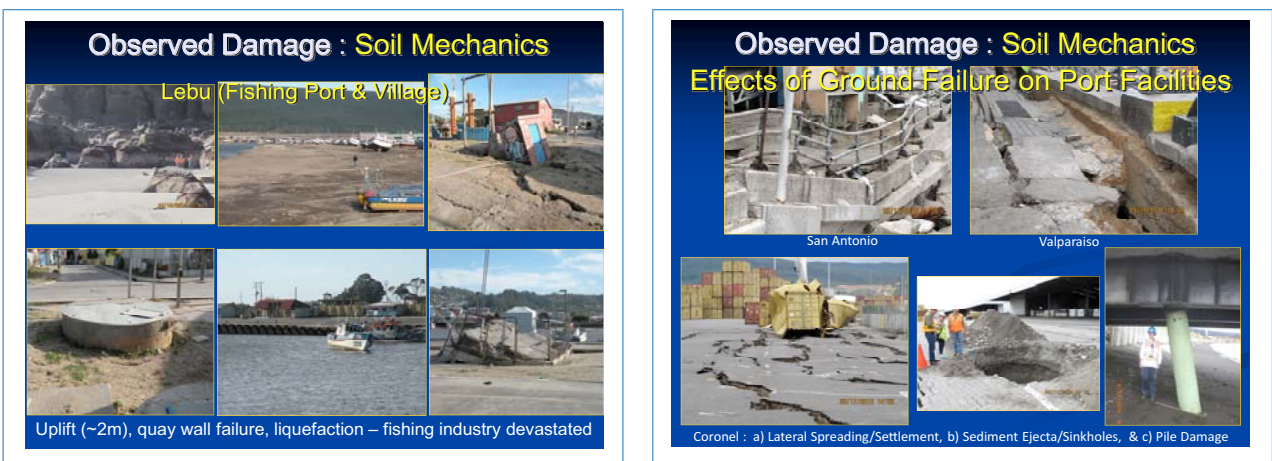
**Figure 21** Soil failures in port facilities.

Both fishing and industrial ports experienced coastal soil disturbance, as well as liquefaction and landslides due to poor compaction of embankments and dock walls.

Figure 21 shows soil disturbance and damage to boarding embankments at a small fishing port near the earthquake epicentre, and similar damage to a large port facility near Santiago.

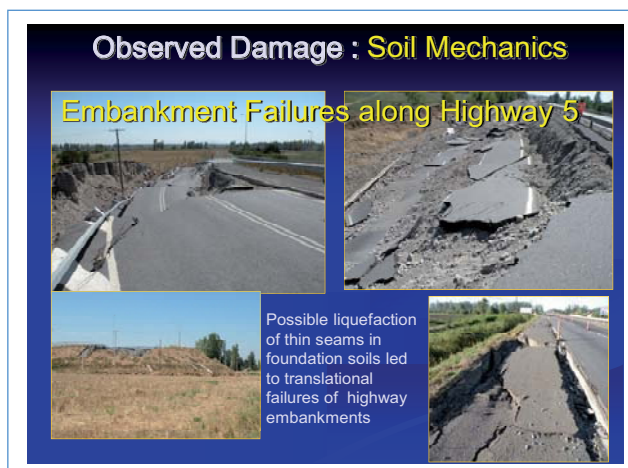
**Figure 22** Soil failure and landslides on the embankment of Highway 5

Similar damage occurred as a result of landslides and poor compaction of the embankment along Highway 5, which connects most of the country (Figure 22).

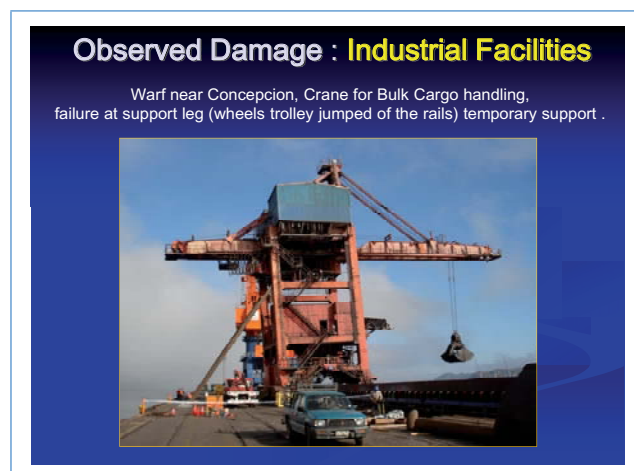
**Figure 24** Crane on a wharf near Concepción with failure of the support leg

Figure 24 shows a crane for bulk cargo handling on a wharf near Concepción, with failure of the support leg and a large angle of inclination.

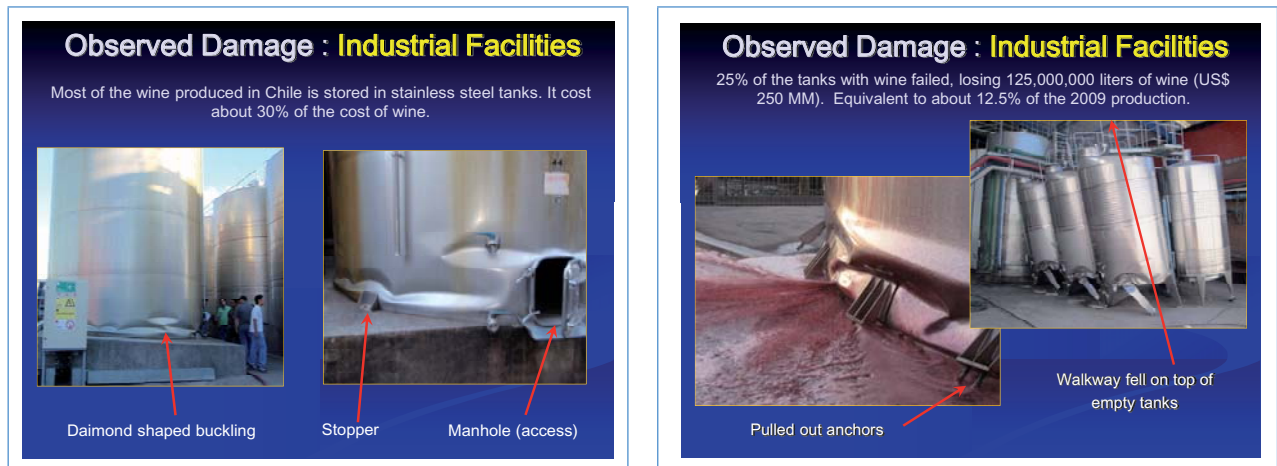
Figure 25 Failed stainless steel tanks and loss of wine

Most of the wine produced in Chile is stored in stainless steel tanks. The earthquake revealed problems with tank anchorage, supports and shell strength (Figure 25), which caused the failure of 25 per cent of wine tanks and the loss of 125 million litres of wine, equivalent to US\$250 million or about 12.5 per cent of the 2009 production (El Mercurio, 2010).

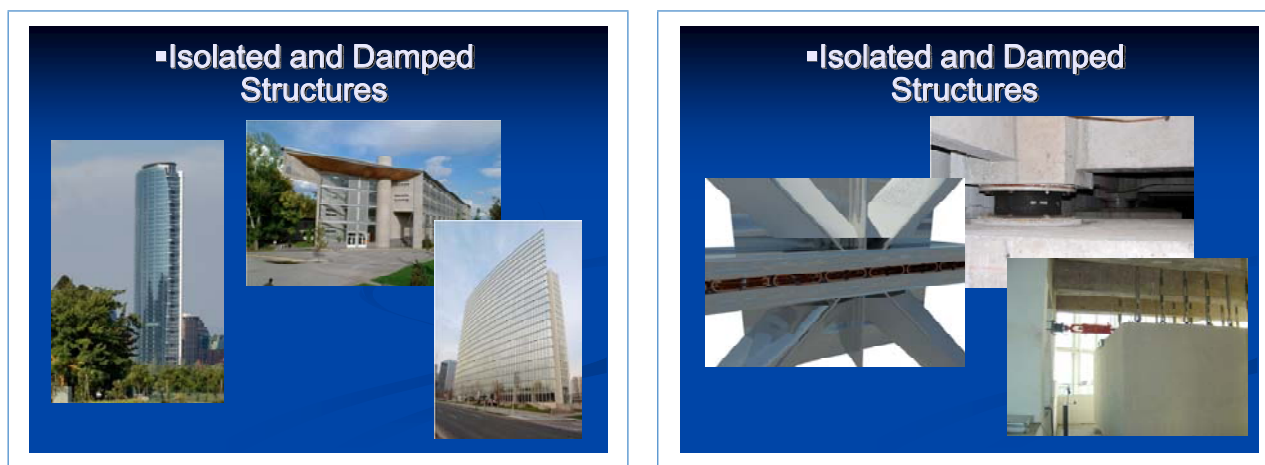
**Figure 28** Buildings equipped with seismic protection systems (Sirve, 2011)

At the time of the earthquake, many buildings with seismic isolation or dissipation systems had an excellent performance, registering no structural damage or problems with their seismic protection systems.

Figure 28 shows some buildings equipped with seismic protection systems, including elastomeric isolators, metallic dampers and tuned mass systems.

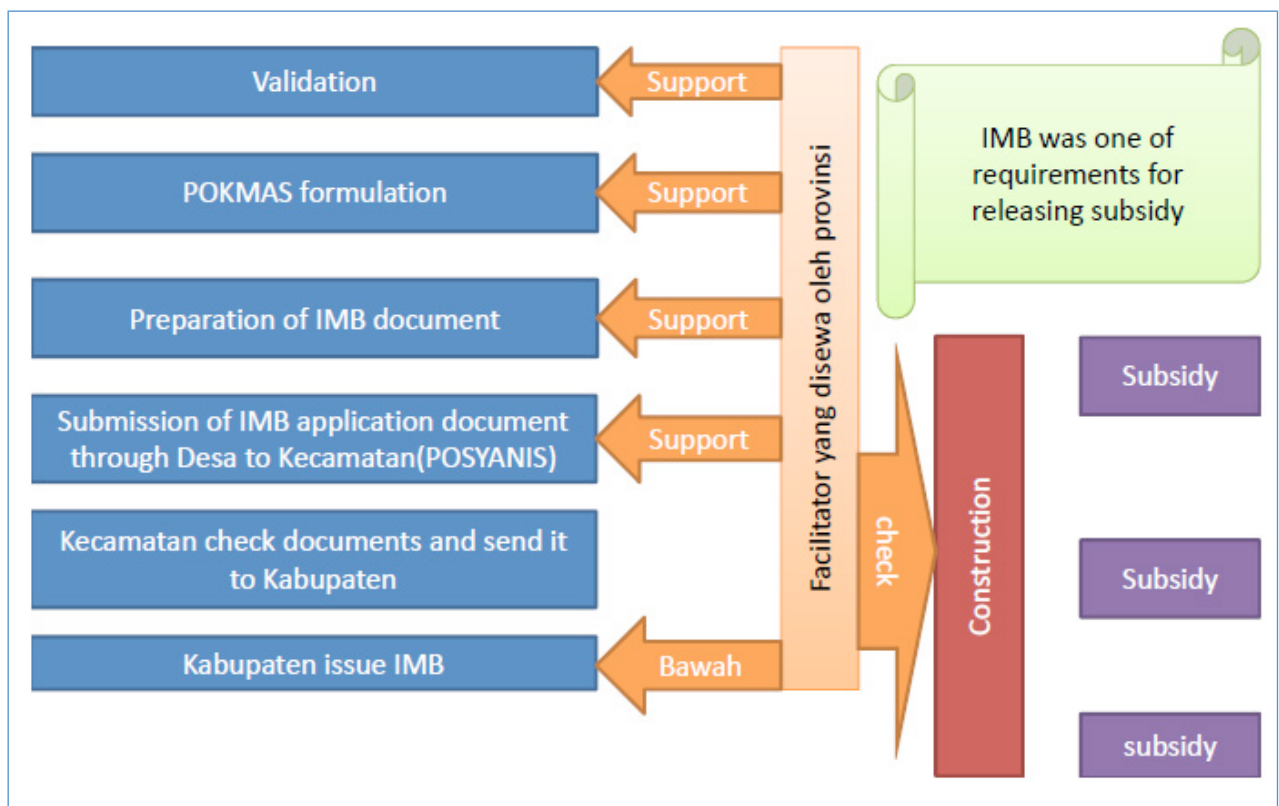
**Figure 1** Mechanism of the reconstruction project with the building permit system

This research reviewed the mechanism used in the reconstruction project after the central Java earthquake (Figure 1).

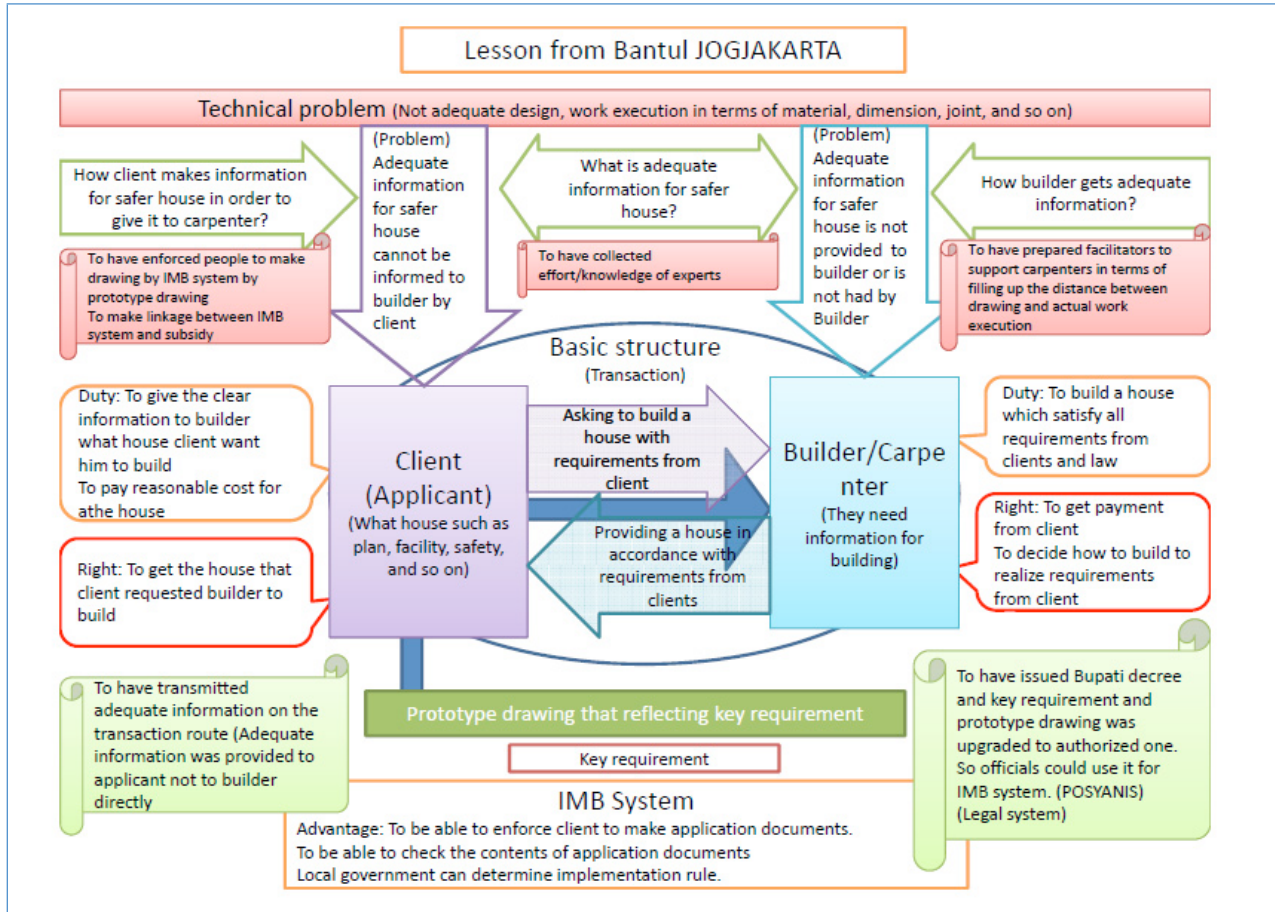
Figure 2 Influence of building permit system on construction work

The study also aims to show the effectiveness of the building permit system in that it forces people to prepare drawings with adequate information to construct their houses, compared to no drawings at all or drawings with insufficient information. The IMB (building permit) influencing mechanism is shown in Figure 2. As underlined in this chart, an important aim of the building permit system is to force construction clients to provide adequate drawings in line with legal requirements. Given that the future owners of simple houses often do not have enough money to ask engineers to make technically adequate drawings, there is a need to find solutions that the government can implement.

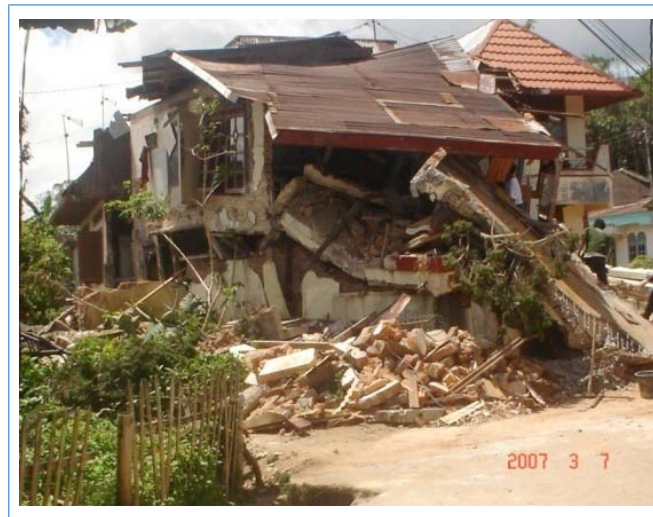
**Figure 1** One of the collapsed houses in the research

Many buildings including hotels, offices and homes collapsed after the West Sumatra earthquake on 30 September 2011 (Figure 1). Most of the collapsed buildings were made of brick. Therefore the Department of Civil Engineering, Faculty of Engineering at the State University of Padang (UNP) and Japan International Corporation Agency (JICA) decided to conduct research into the quality and characteristics of bricks used by the West Sumatra community. Brick samples were taken from brick factories (in burning stoves) and collapsed buildings in the Padang–Pariaman area. Tests were conducted in the Material Testing Laboratory Department of the Civil Engineering Faculty of Engineering at the State University of Padang.

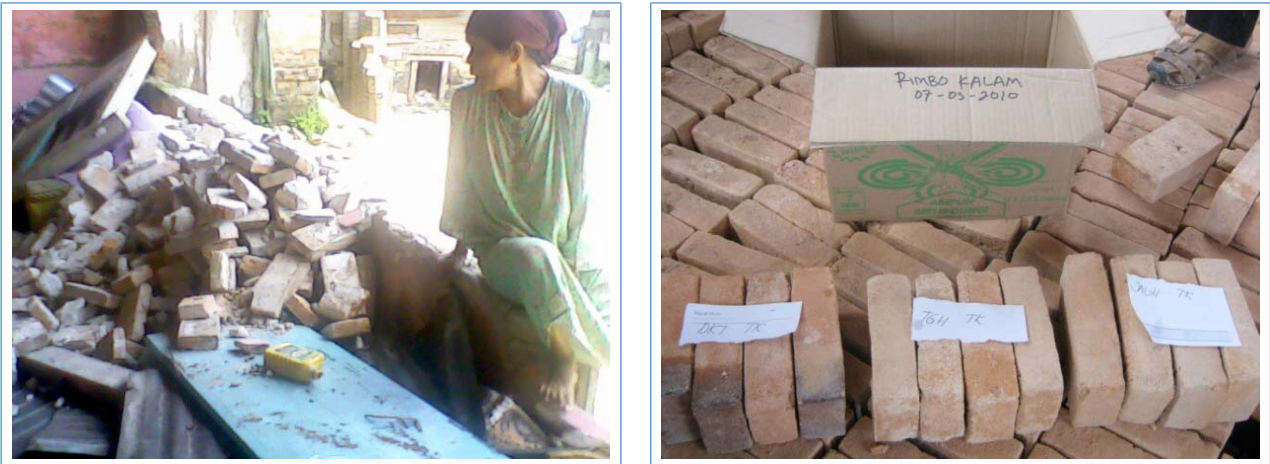
**Figure 2** Brick samples from collapsed houses

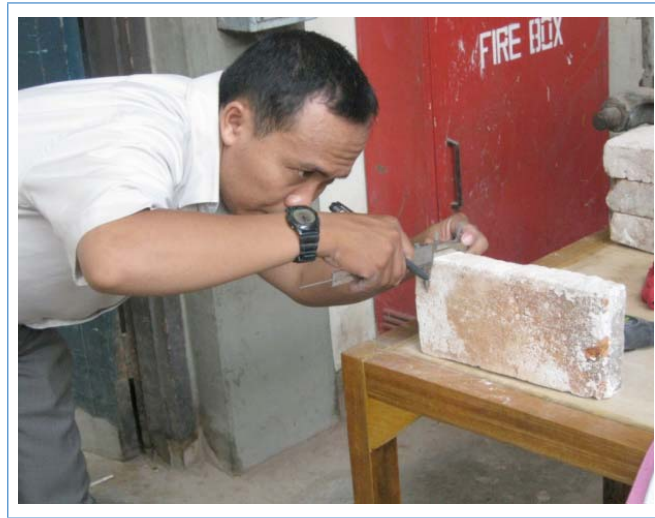
A sample must be measured by ruler to ensure squared sides (Figure 4).

**Figure 4** Measuring a brick sample

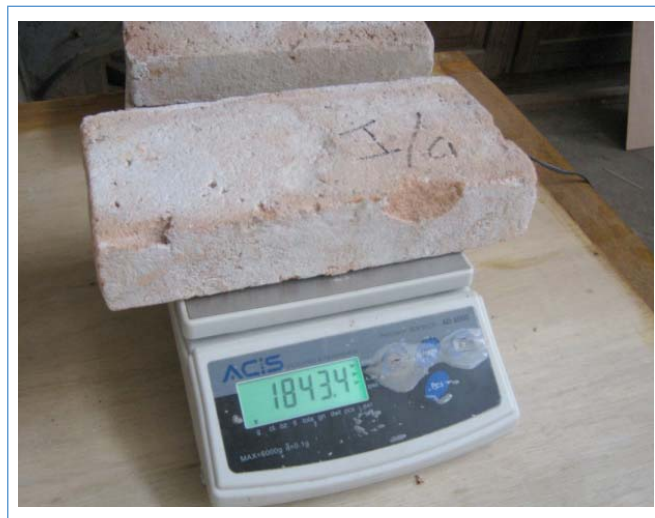
A sample must be weighed digitally in the Material Testing Laboratory Department of Civil Engineering, Faculty of Engineering at the State University of Padang (Figure 5).

**Figure 5** UNP Research Team Weighing Brick Sample

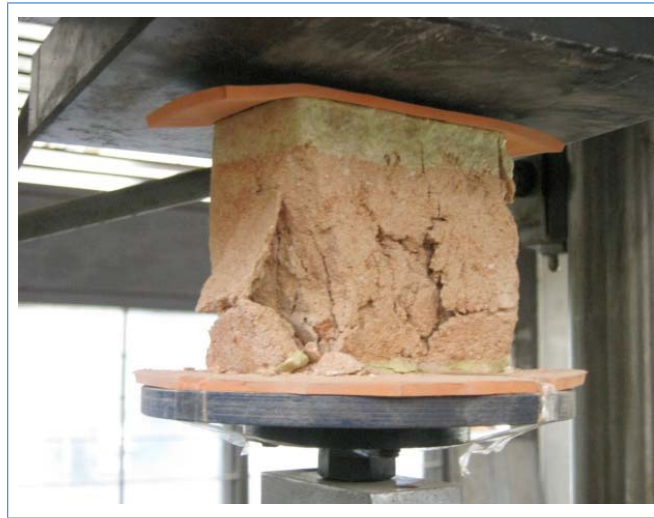
Compressive Strength should be tested using the Universal Testing Machine (UTM) and the 2kg/cm<sup>2</sup>/s speed test (Figure 6).

**Figure 6** Compressive strength test

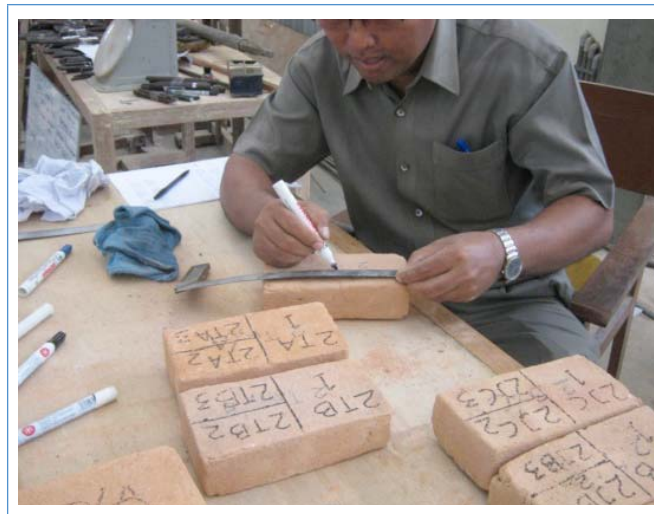
The brick sample should be cut into two pieces, with one piece cut again into two to produce three pieces. The total sample should comprise 144 pieces. The compressive strength is force divided by the sample area (Figure 7).

**Figure 7** Factory brick sample

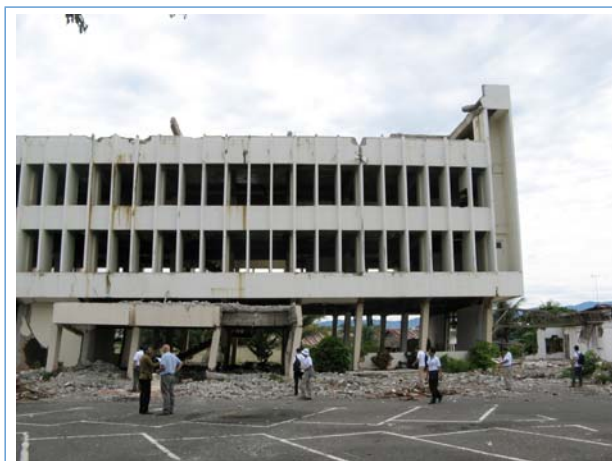
(a) Soft-storey failure exacerbated by liquefaction (Provincial Public Works Office)

**Figure 1** Typical public sector building failures

Many public buildings collapsed through the soft-storey syndrome, exacerbated by poor reinforcement detailing, especially at the joints, and poor quality concrete (Figure 1).

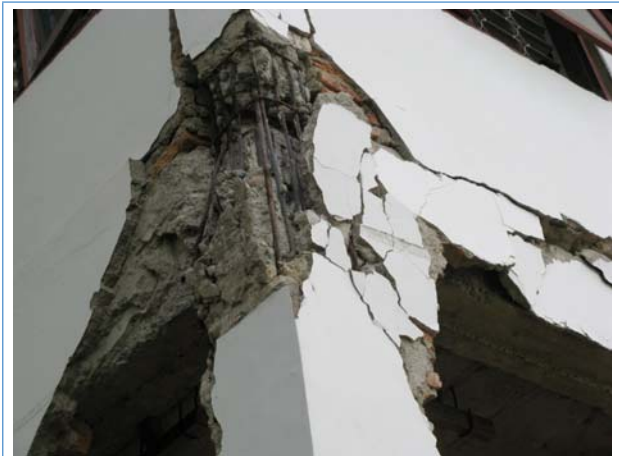
(b) Strong beam/weak column failure exacerbated by poor detail and quality (Food Security Agency Building)

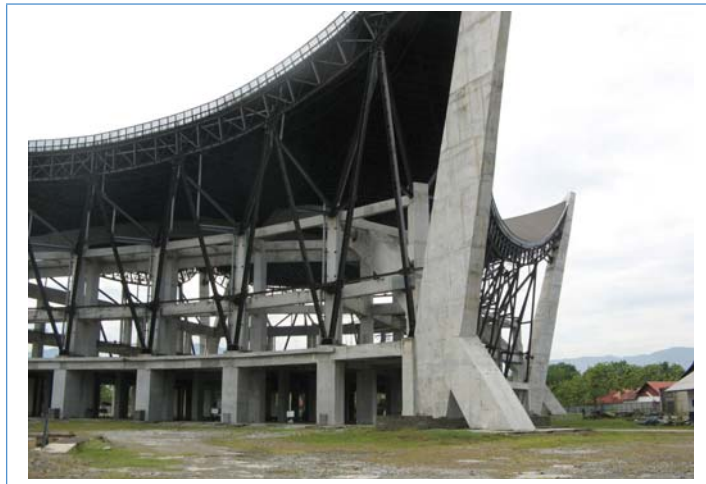
**Figure 2** Mosque under construction, surviving intact

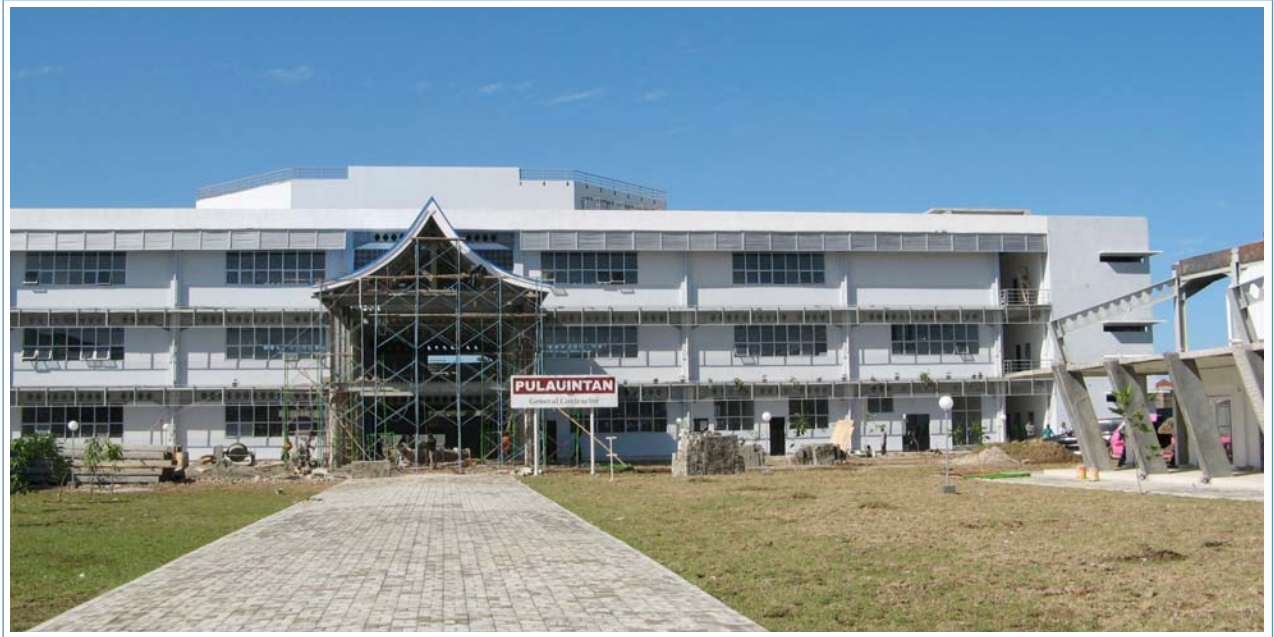
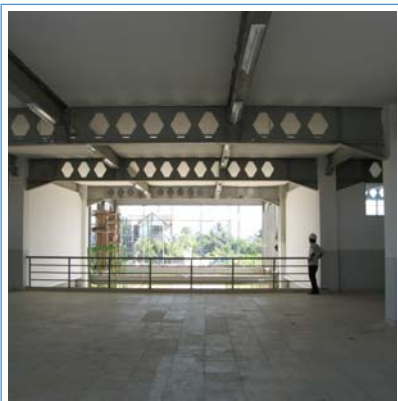
(a) Castellated beams in a bolted steel frame and concrete encased columns

**Figure 3** Regional school with post-disaster function

It is unlikely that the standard of disaster resilience built into this building could have been achieved using familiar local construction methods for reinforced concrete. It takes at least a decade of reform and a change in cultural perceptions to eliminate detrimental practices. This is illustrated by the quality of the reinforced concrete stairways in this building that reflects standard local practices in concrete construction: the reinforcement is not properly supported on bar chairs and the concrete is not correctly compacted.

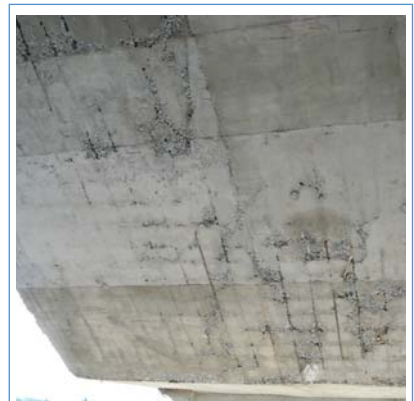
(b) A cast in situ stairway

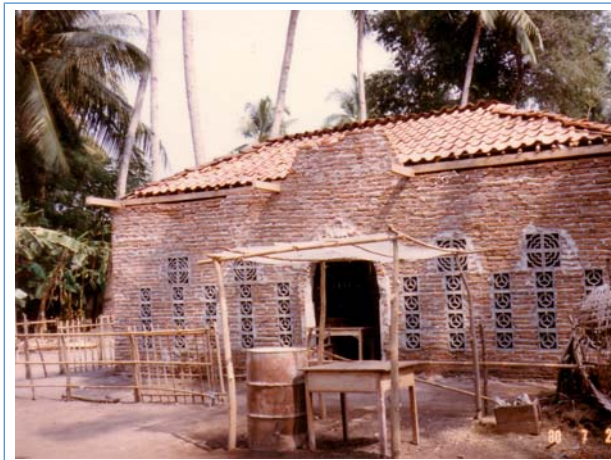
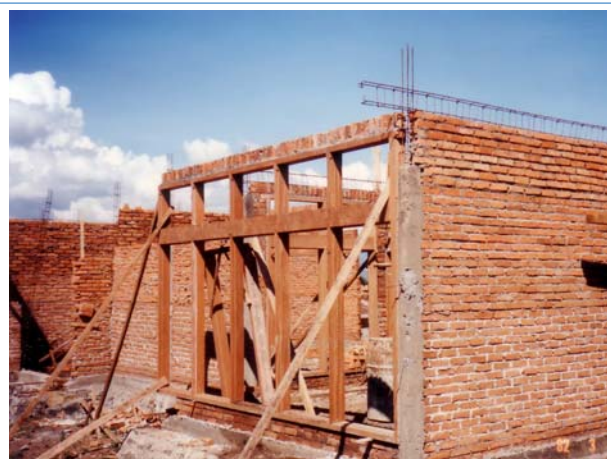
(a) Unreinforced brick masonry (Indonesia)

(b) Confined masonry under construction (Indonesia)

**Figure 1** Typical non-engineered construction (1)

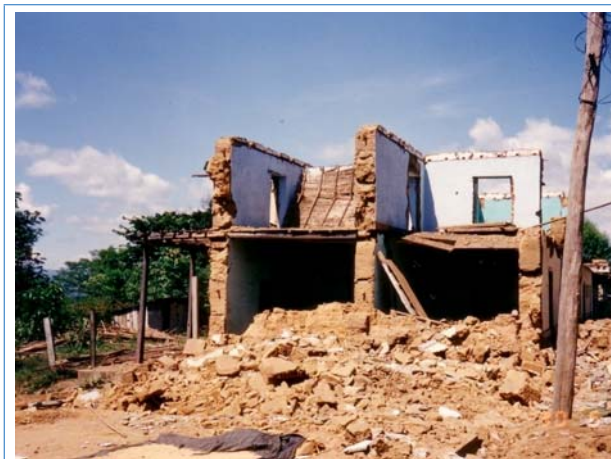
(a) Damaged tapial house (Peru)

(b) Tapial under construction (Peru)

**Figure 2** Typical non-engineered construction (2)

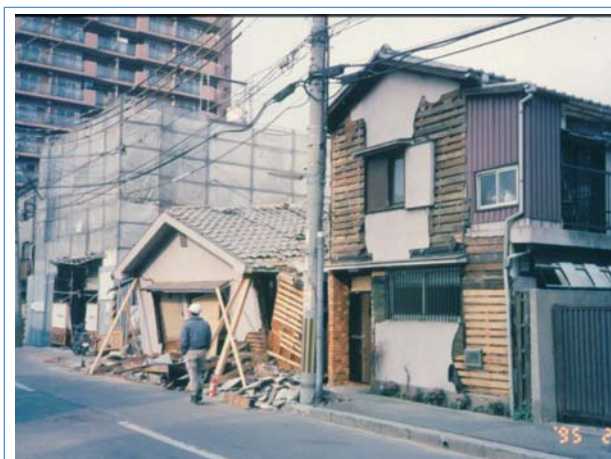
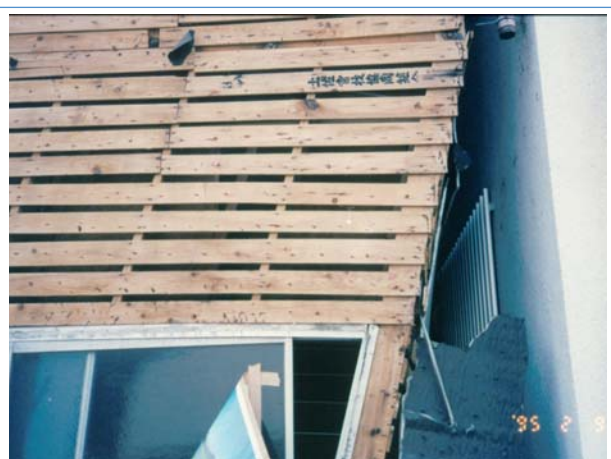
(a) Damaged wooden house (Japan)

(b) Detail of damaged wooden house (Japan)

**Figure 3** Typical non-engineered construction (3)

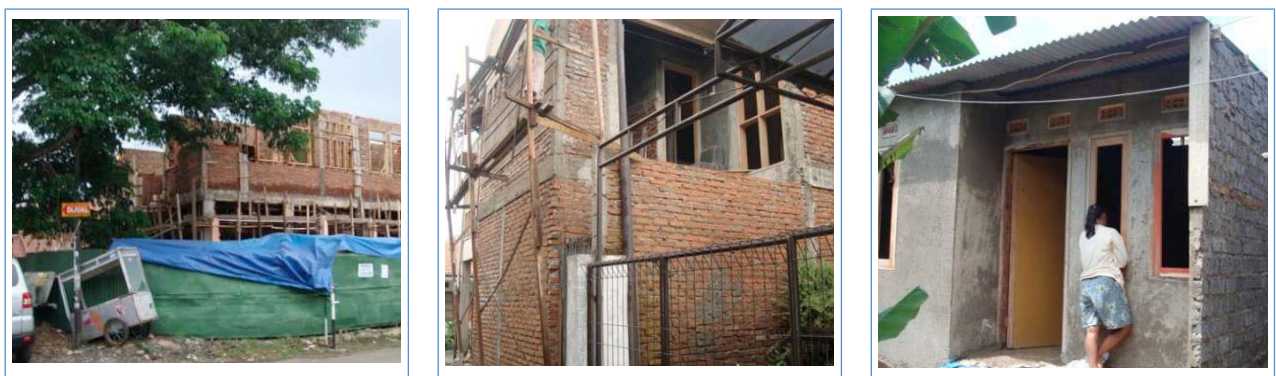
**Figure 7** Typical non-engineered buildings in Indonesia (Photos by CDM ITB, Indonesia)

In general, three non-engineered constructions are most commonly found in Indonesia: confined masonry, reinforced concrete with infill masonry and unconfined brick or concrete block masonry.

Confined masonry buildings rely on masonry walls as the main load bearing structural elements. The confinement will also help to maintain the integrity of the wall when loads are applied. In this type of structure, the confinement can be developed from various systems such as practical column/beams and steel wire mesh. Most of the confined masonry structures in Bandung are confined by reinforced concrete practical column/beams.

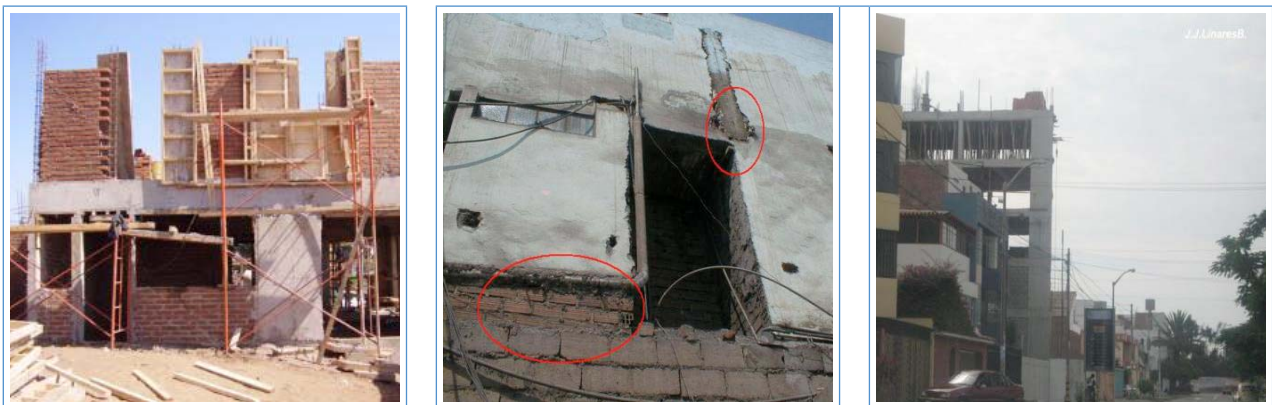
**Figure 9** Typical non-engineered buildings in Peru (Photos by CISMID-UNI Peru)

In Peru, there are three types of non-engineered buildings: confined masonry building with horizontal and vertical confinements that support the bricks walls, unconfined masonry wall buildings without a reinforced collar beam and reinforced confined elements, and a concrete moment resistant frame with concrete shear walls or infill masonry.

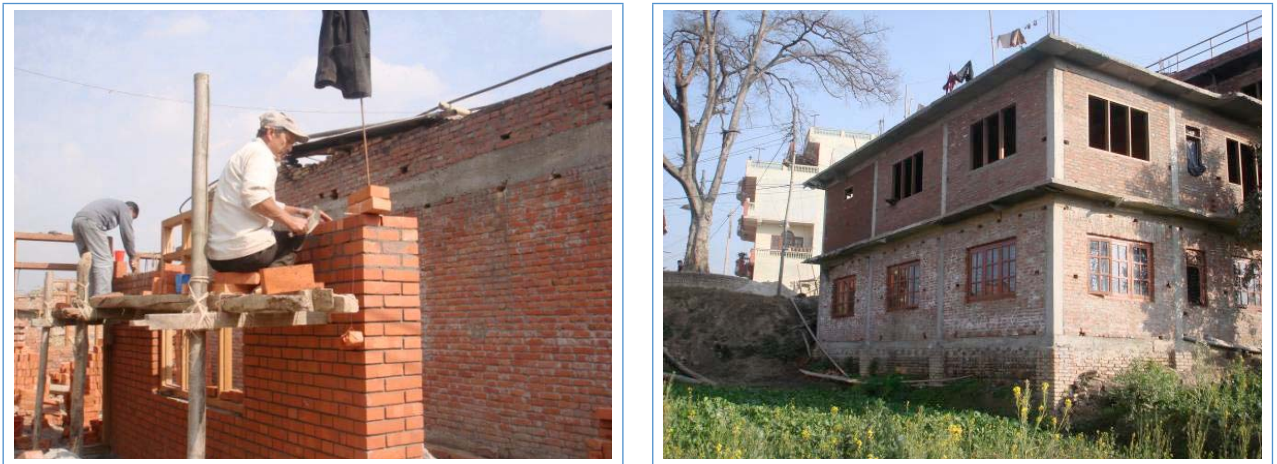
**Figure 11** Typical non-engineered buildings in Nepal (Photos by NSET, Nepal)

In Nepal, there are two types of non-engineered brick masonry buildings: unconfined brick masonry buildings and reinforced concrete buildings with brick masonry infill.

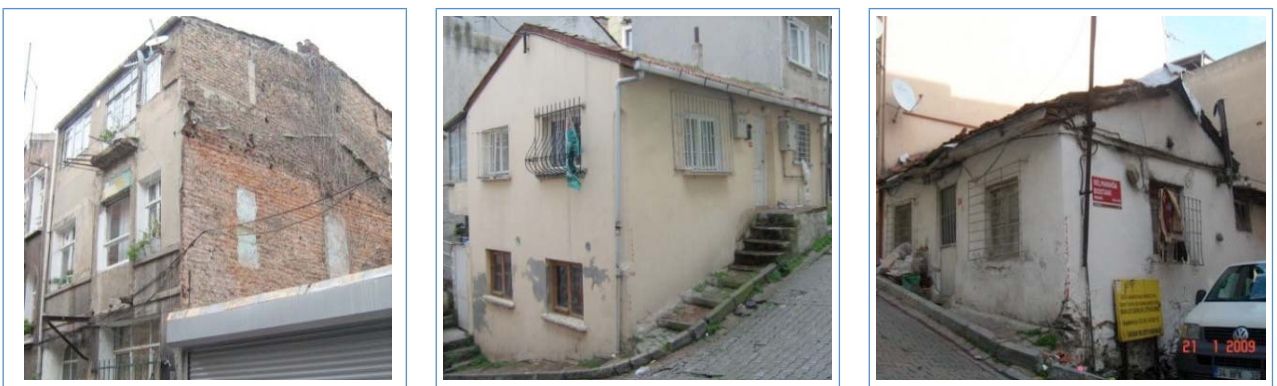
**Figure 12** Typical non-engineered buildings in Turkey (Photos by Istanbul Culture University-Istanbul Technical University, Turkey)

There are three types of non-engineered buildings in Turkey: reinforced concrete frame with clay hollow brick infill walls, unreinforced brick masonry, and wooden structures.

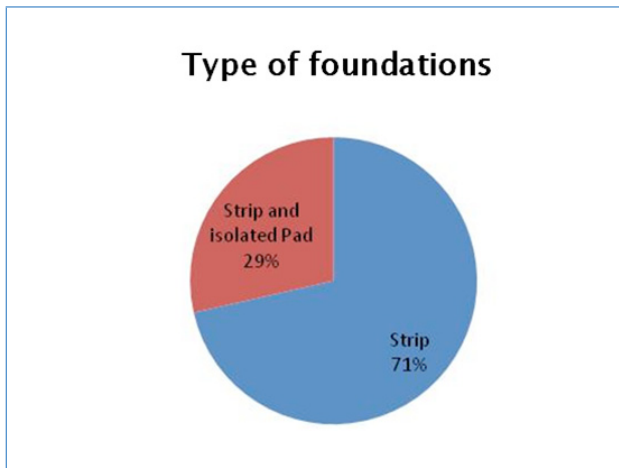
Figure 17 Type of foundations

- Most of the non-engineered constructions are used as homes and small commercial buildings, while some are also used as school buildings.
- Strip and isolated pad (the simplest foundation system) is used in non-engineered constructions. Various materials, such as stone and reinforced concrete, are used to build foundations.

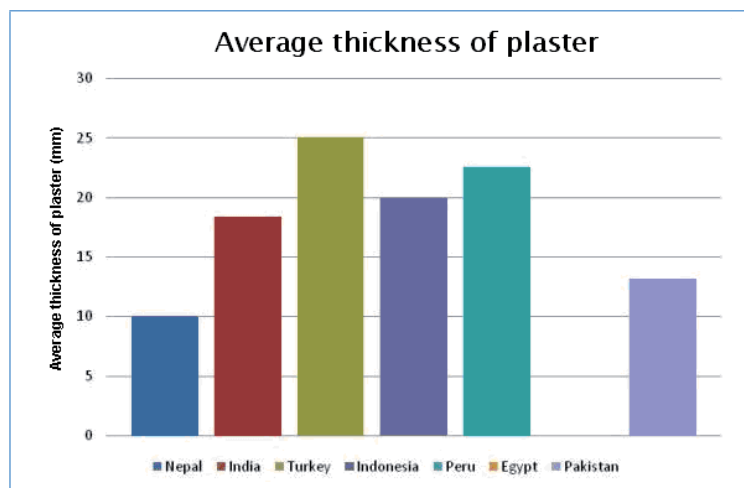
Figure 28 Average thickness of plaster

- The common plaster composition is either 1:6 or 1:4, except in Peru where the composition is 1:1.
- Turkey has the thickest layer of plaster (20–30 mm), while Nepal has the thinnest (10 mm).

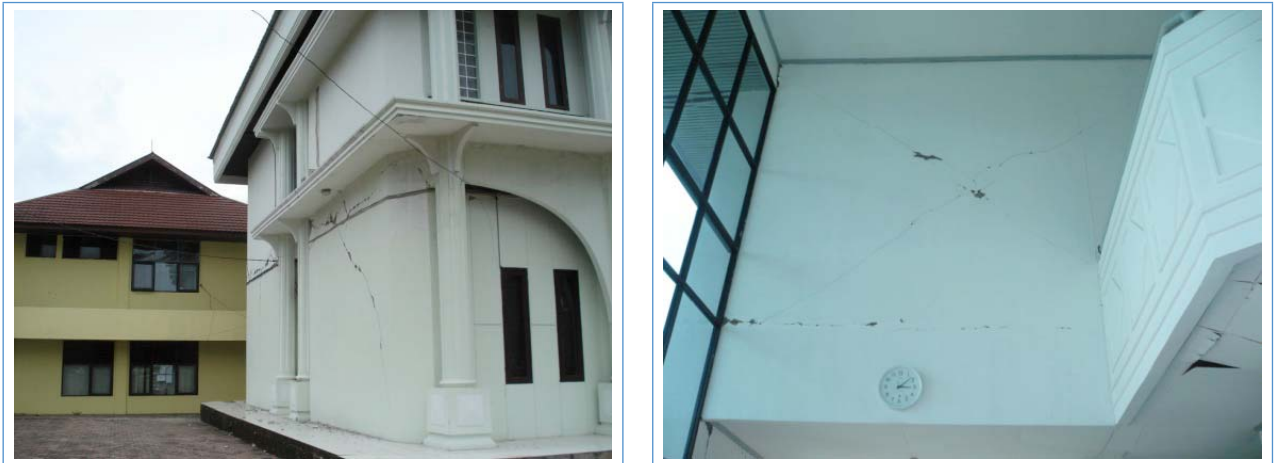
**Figure 1** Damage to partition walls

Wall damage occurred in the form of cracks in wall connections with columns or beams and shear cracks in the diagonal direction due to in-plane and out-of-plane force. Figure 1 shows damage to partition walls.

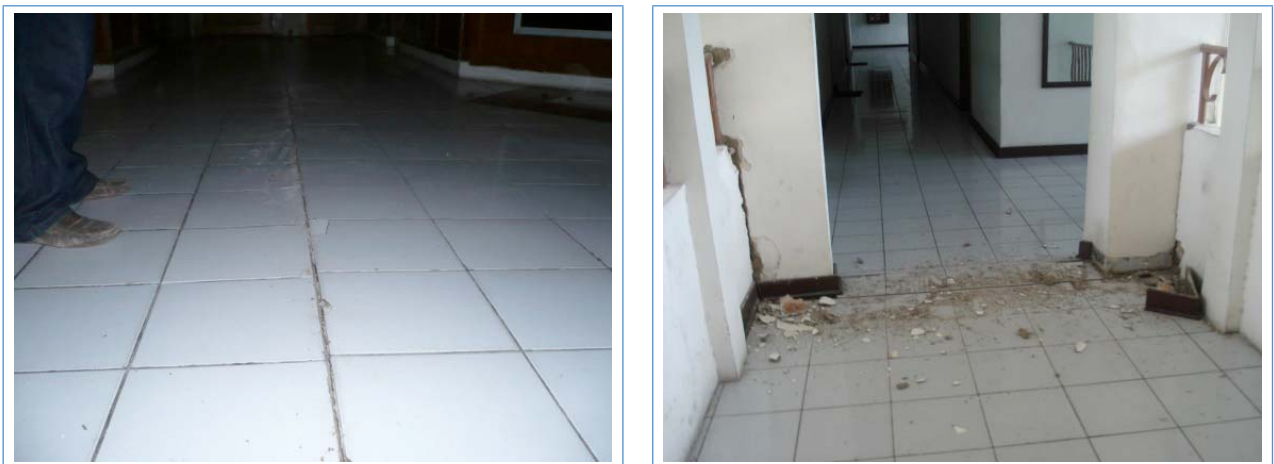
**Figure 2** Damage to floors

Floor damage occurred to ceramic floor coverings. Damage is usually at the dilatation covered with ceramic. Figure 2 shows damage to floors.

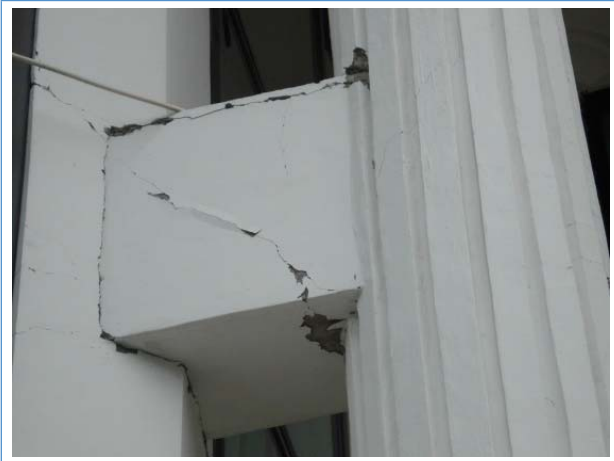
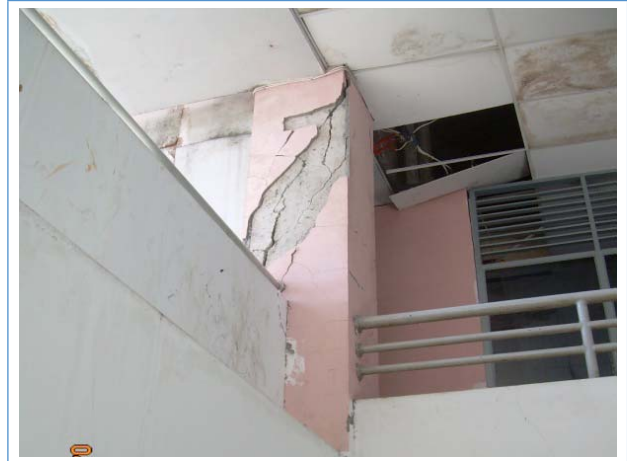
**Figure 3** Structural damage to beams and columns

Damage occurred in the form of cracks in structural components or spalling of the concrete cover. Figure 3 shows this condition.

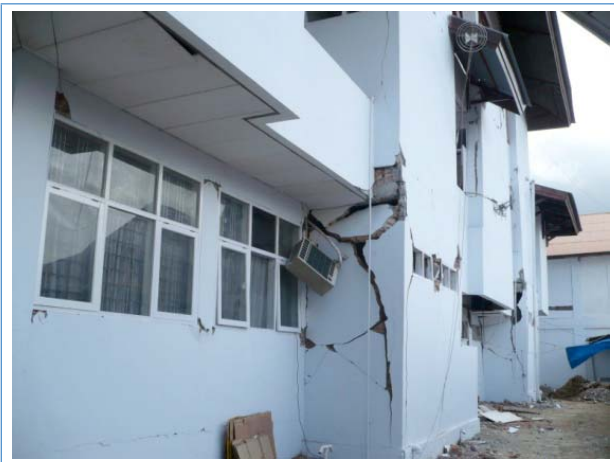
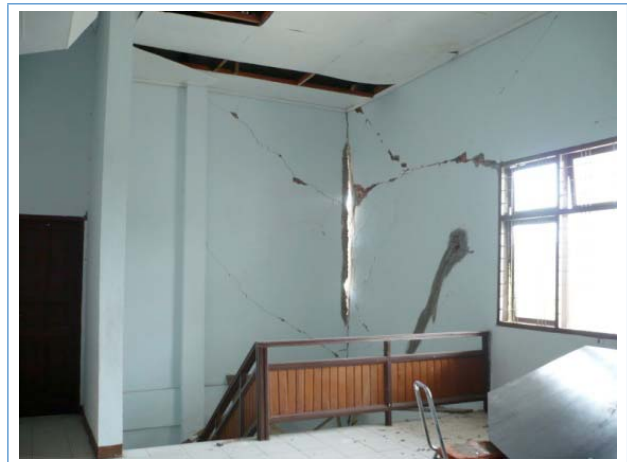
**Figure 4** Damage to partition walls

Partition walls showed a fairly high level of damage in both out-of-plane and in-plane directions. Examples of this damage are shown in Figure 4.
