# **SURVEYS AND ACTIVITIES ON POST-EARTHQUAKE DISASTER**

**UNESCO-IPRED-RIHS INTERNATIONAL WORKSHOP  
PADANG, INDONESIA, 6-8 JULY 2010**

Research Institute for Human Settlements  
Agency for R&D – Ministry of Public Works of Indonesia  
Provincial Government of West Sumatra  
Padang, Indonesia

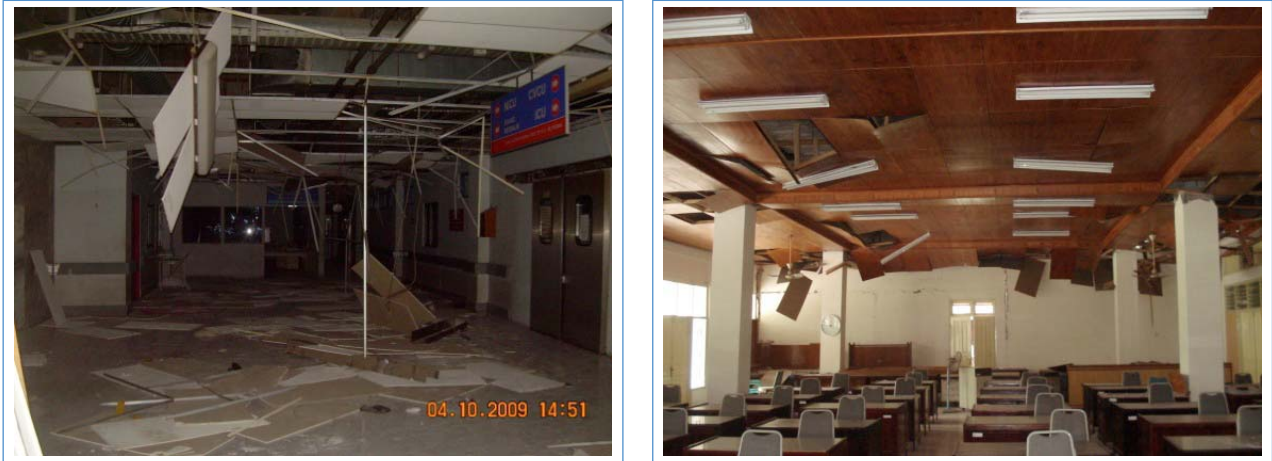
**Figure 5** Damage to ceilings

Damage to ceilings included the release of the cover of the ceilings due to the use of insufficiently strong lack bolts or nails at the time of installation. This damage occurred in ceilings with wood or light steel frames. In the case of light steel framed ceilings, failure did not only occur at the cover of the ceiling but also in the the connection frame or in the hanger frame of the floor plate. Figure 5 shows damage to ceilings.

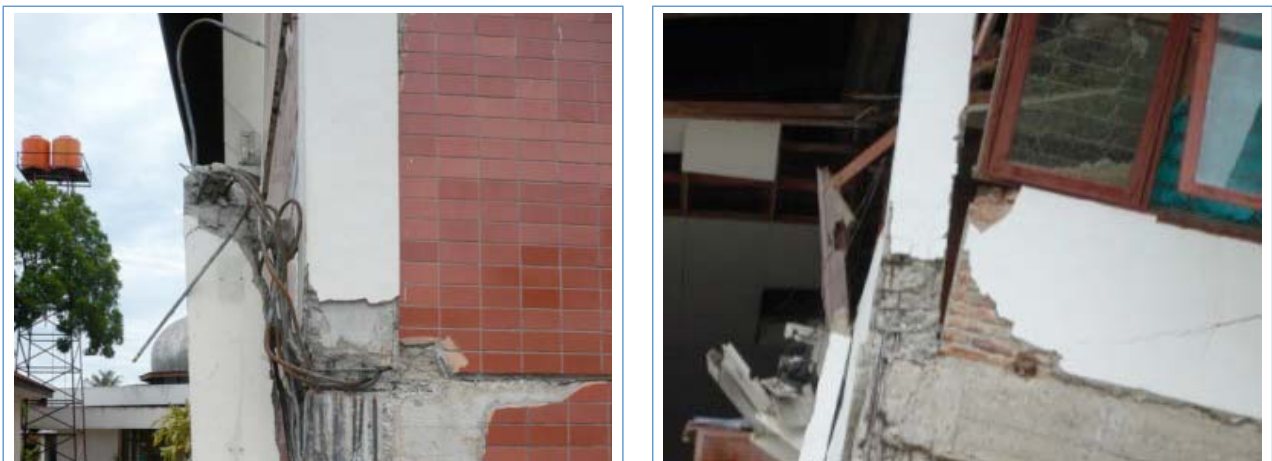
**Figure 6** “Strong beam, weak column”

The “strong column, weak beam” principle must be respected in the design of earthquake-resistant structures, but the structural failure of many buildings in Padang after the 2009 Pariaman earthquake showed that this principle was ignored. Instead, the common situation found was “strong beam, weak column”, where capacity and stiffness is greater for the beam than the column. In this case, buildings usually experienced quite severe damage to the column although the beam was still in one piece or only slightly damaged. Figure 6 shows examples of this condition.

In this case, plastic hinges should be placed on the beam, as well as a switch to column components, especially in areas close to the beam column connections. The column shown in Figure 6 suffered a stress concentration high enough to cause severe damage to the fracture, which later led to the building's collapse.

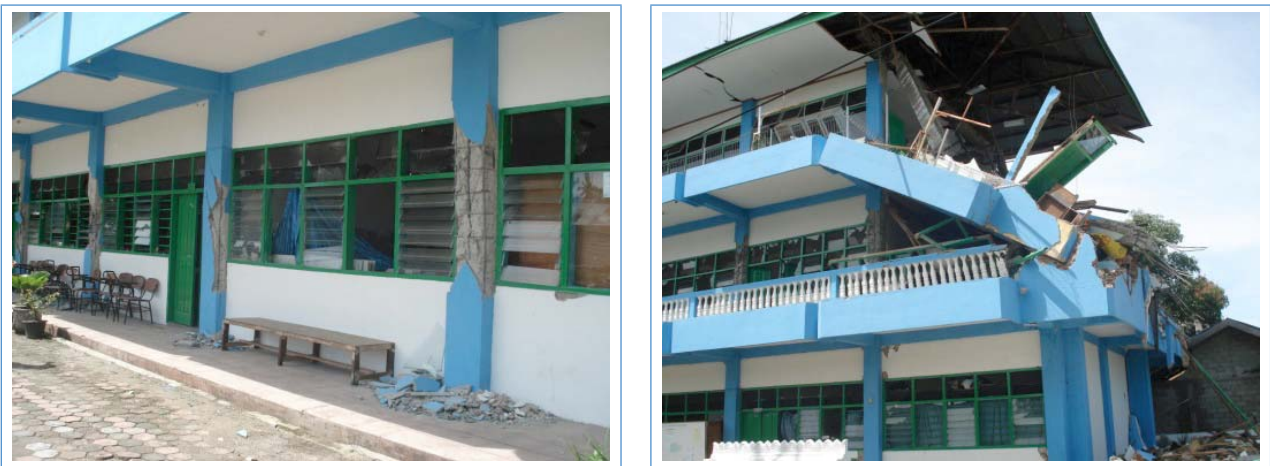
**Figure 7** Short column effect

The short column mechanism was one of the common causes of damage occurring after the Pariaman earthquake. This mechanism most often occurs in columns adjacent to windows or door openings. The column's effective length is shortened to just the open height of the window adjacent to the column, while the part adjacent to the wall has added stiffness. The column, which is expected to encounter a large shear in the pedestal region, experiences a change in position of shear stress concentration towards the centre (area of opening windows) due to the reduced effective column length. Yet planned capacity at this position is generally lower shear. The high shear stress causes damage to the concrete cover columns to the point of destroying the concrete core. The location of the damaged column then becomes a weak point that can lead to the total destruction of buildings. Figure 7 shows examples of short column mechanisms that led to building collapse.

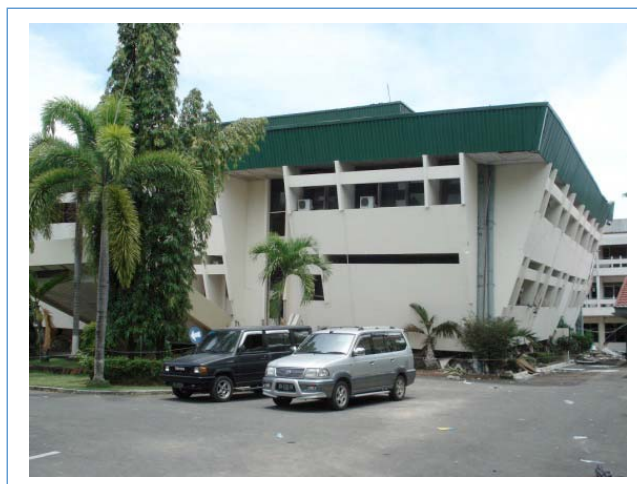
**Figure 8** Poor distribution of mass

Mass distribution between storeys can affect the stiffness of a floor. Extreme differences in mass between storeys will lead to one having less stiffness than the others so that soft storey mechanisms may occur during the earthquake. Figure 8 shows an example of this. The mass of the third floor is much larger than the first floor, which led to the building collapsing on the first floor after the earthquake.

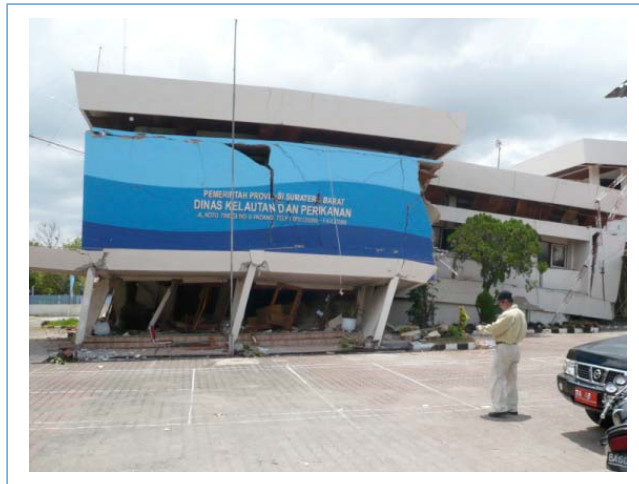
**Figure 9** Damage to buildings due to the soft-storey mechanism

A rigid partition on a floor may also affect differences in stiffness of a floor. The large difference can also cause the soft-storey mechanism, which is one cause of severe damage or collapse in the 2009 Pariaman earthquake. Figure 9 shows examples of buildings that collapsed due to the soft-storey mechanism.

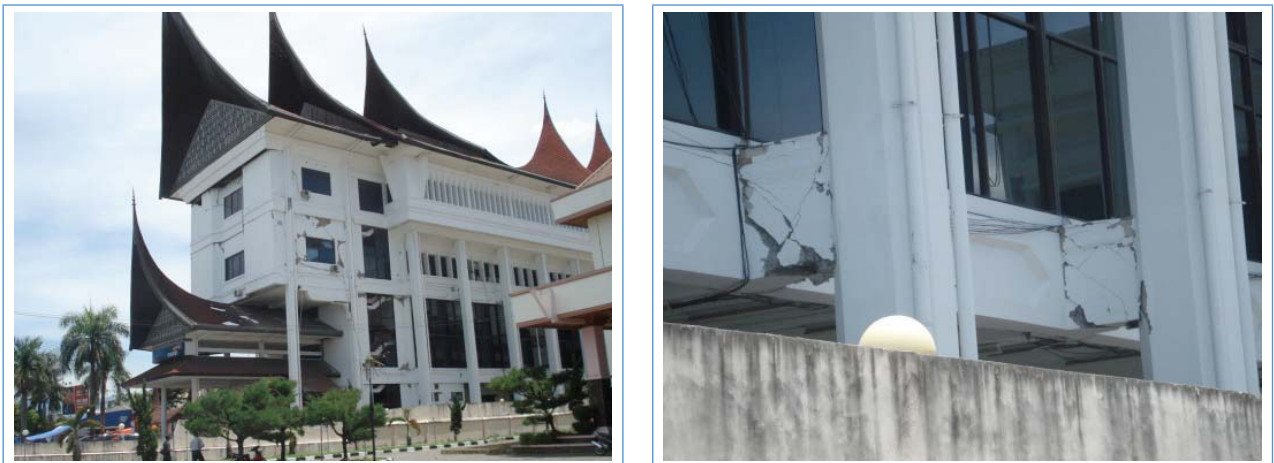
**Figure 10** Damage to beams

Adoption of Minangkabau traditional house architecture in modern high-rise buildings in West Sumatra creates new problems, particularly eccentricity of the main beam-to-column connections. This condition is prone to failure in shear and torsion if poorly planned. This problem is evident with considerable damage found in buildings that use traditional architecture after the 2009 Pariaman earthquake. Beams with eccentric main columns experience shear and torsion failure that may reduce the reliability of the building. Figure 10 shows examples of buildings that were damaged in this way.

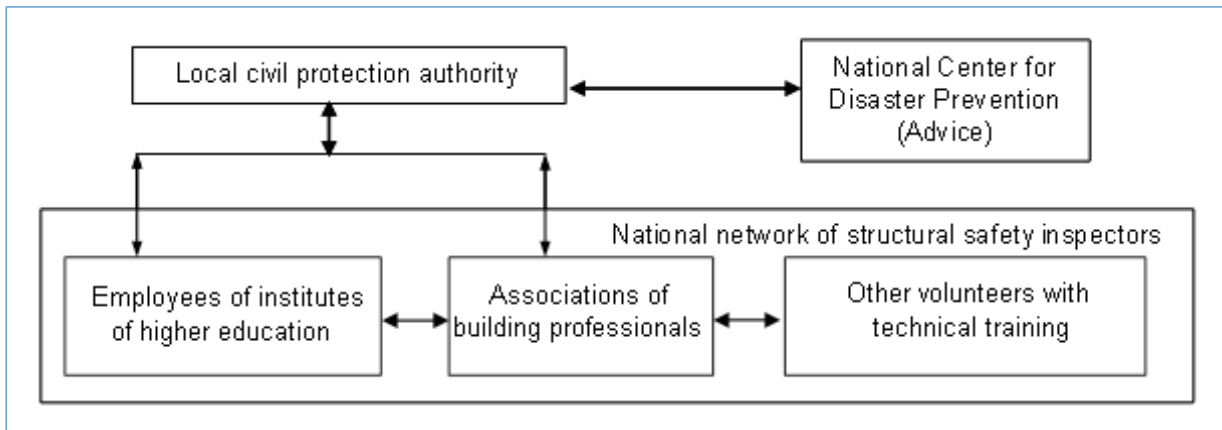
**Figure 3** Scheme of the protocol of response for RENE

1. The General Coordination of Civil Protection, through a letter of invitation sent to local universities and professional associations (engineers and architects), in conjunction with the local Management of Civil Protection, has asked professionals to join the National Network of Structural Safety Inspectors (RENE), in accordance with the requirements for the different levels of assessment.
2. Once the RENE participants have been identified, CENAPRED staff will conduct a training course. At the end of the course the participants will replicate the training for other localities and municipalities within the state.
3. A response protocol has been proposed to identify the level of structural safety of existing buildings, as well as their structural stability following a disruptive event causing damage and requiring an assessment of urban infrastructure. This protocol is shown in Figure 3.

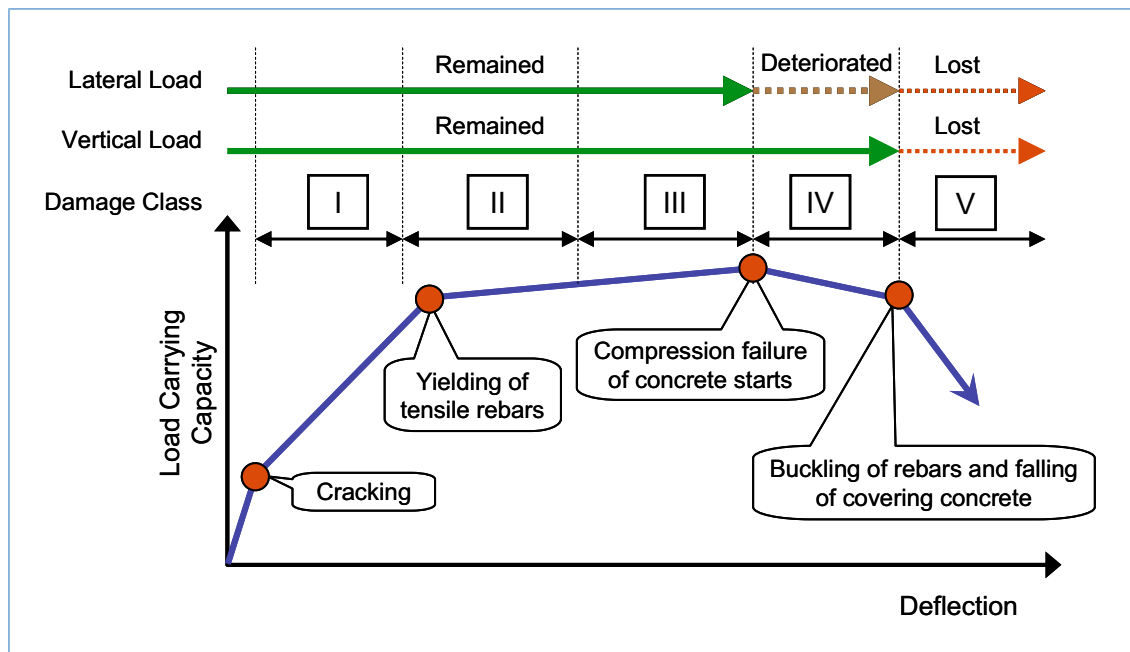
**Figure 5** Relationship between observable damage and remaining strength

Based on the information and concepts above, criteria and benchmarks are established, as indicated in Figure 5. This information is necessary to define the remaining strength and therefore the structural safety of buildings.

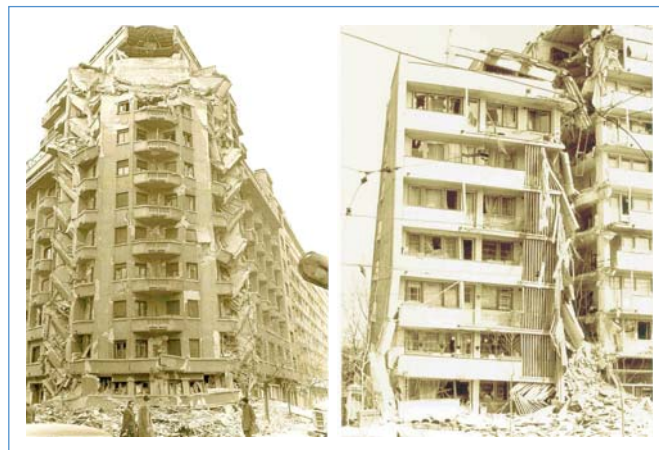
**Figure 7** Soft-storey collapse of the building at ground level

(i) The Wilson building, built in the 1930s      (ii) The Lizeanu building, built in the 1960s

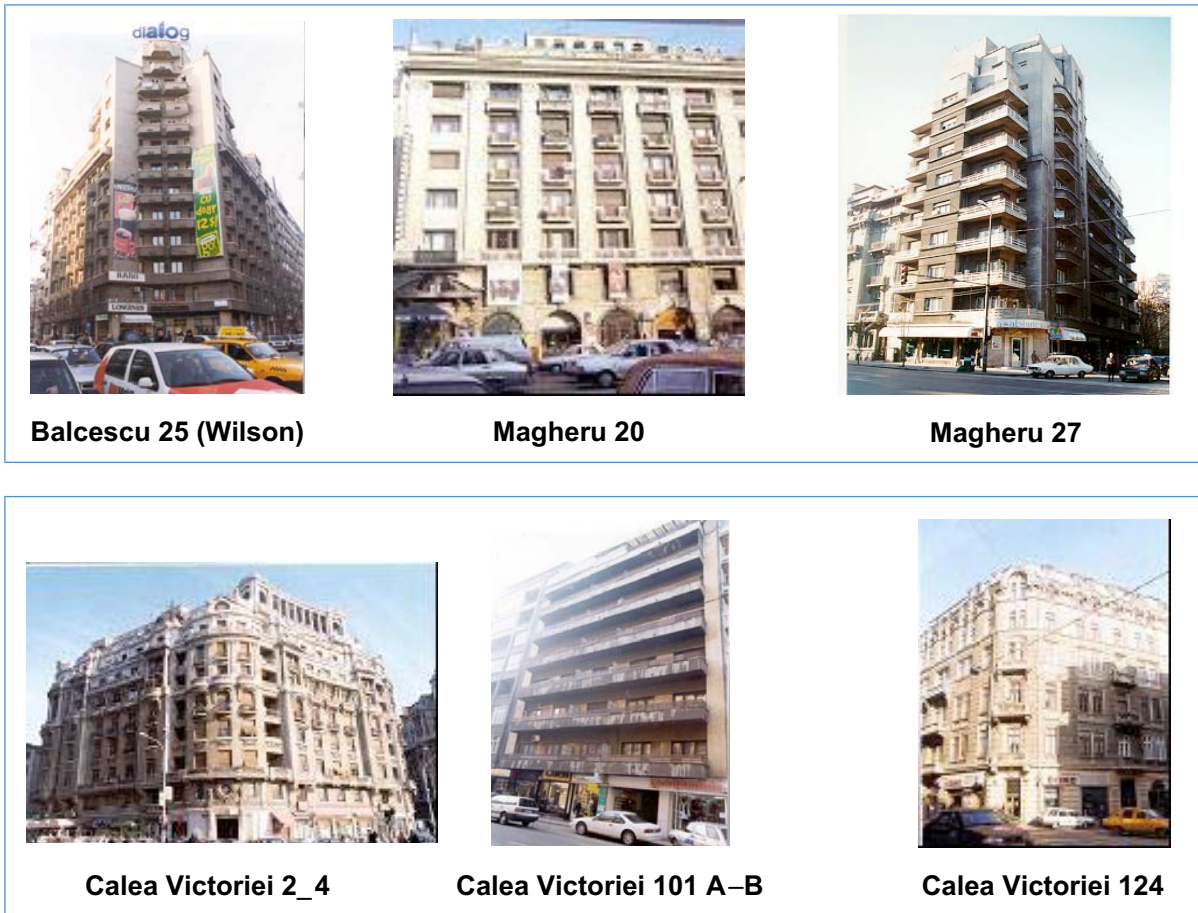
**Figure 10** Architectural heritage buildings in central Bucharest: examples of tall RC buildings built before 1940 in the city centre

Ten years after the creation of the consolidation programme for Class 1 seismic risk buildings, 19 of the initial 127 entries on the list (buildings over four storeys) are located on the Calea Victoriei and Magheru and Bălcescu boulevards (Figure 10). Most of them are considered part of the city’s architectural heritage:

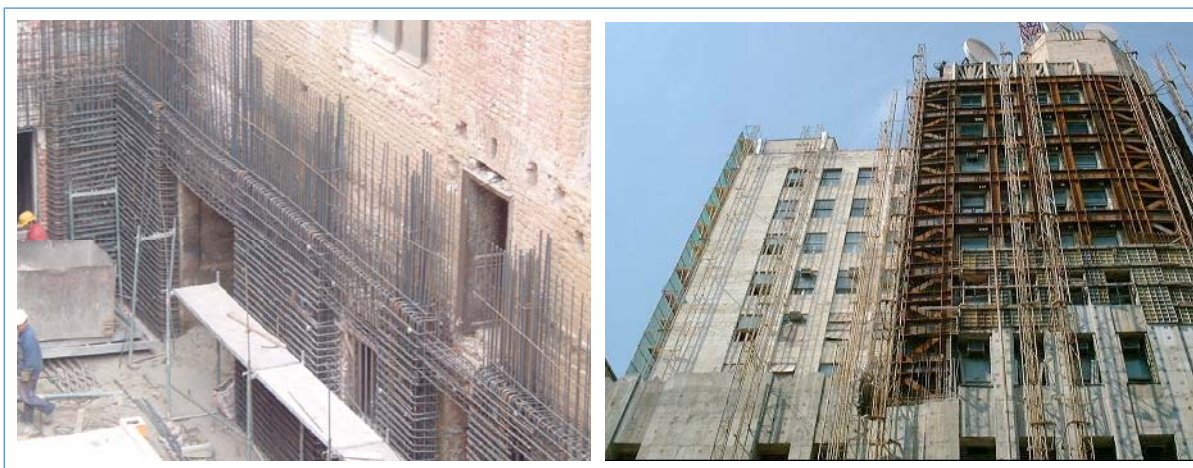
**Figure 12** Retrofitting of (a) the Justice Palace, 2006, and (b) the Telephone Palace, 2002

The Historical Monuments List (prepared by the National Institute for Historical Monuments – INMI, 2004), contains 26 cultural heritage palaces in Bucharest. Among these, the following Seismic Risk Class 1 palaces might be considered for priority strengthening: (1) Multistorey steel structures: the Ministry of Transport, Construction and Tourism, (2) Multistorey reinforced-concrete structures: Romanian Government Palace and City Hall of Sector 1, Bucharest, (3) Masonry and reinforced concrete buildings: the Royal Palace or National Museum of Art of Romania (central building), etc. Only the Justice Palace and Telephone Palace are now fully retrofitted (Figure 12).

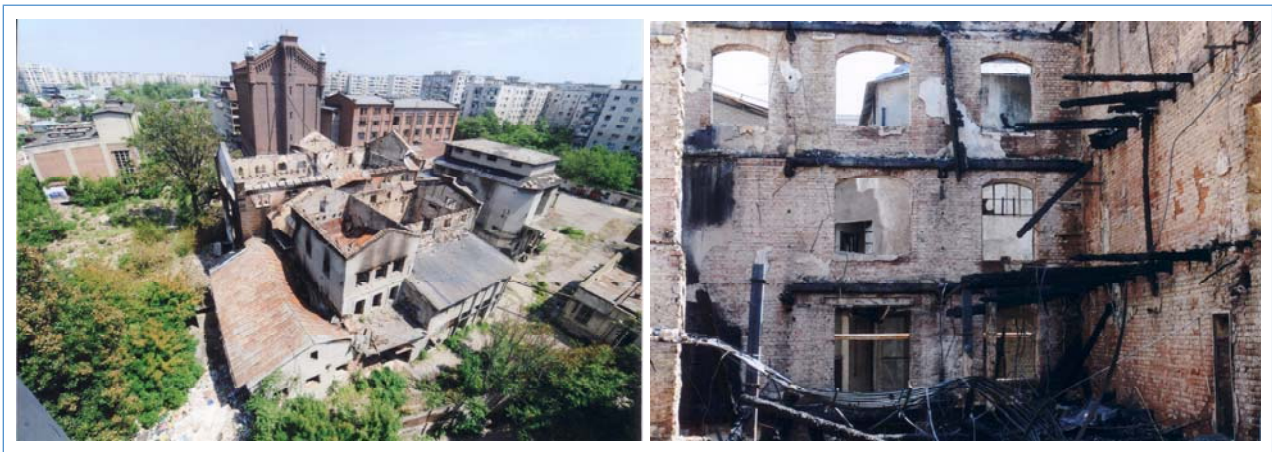
Asan Mill, built in 1853, is the first steam mill in Romania. It is an industrial architectural monument in category A, the 2004 List of Historic Monuments, code B-II-m-A-19692. The building is made of bearing walls with wooden boards. The mill was lewd on 14 May 2008 for a thorough and rapid extermination of the wooden boards and roof ridge. The walls show signs of vandalization of bearing walls (Figure 17).

**Figure 17.** Arson and vandalism precipitated the self-collapse of the Asan Mill, industrial heritage, Bucharest, 1853

Figures 14–18, which show typical examples of vandalism to Bucharest's heritage buildings, call for an urgent amendment of the protection legislation and the real-estate policy of demolishing historic monuments or buildings located in "protected areas". Beautiful historic buildings have been lost for good, either with approval from the Department for Culture, Religious Affairs and National Cultural Heritage in Bucharest, (e.g. the building on Str. G. Clemenceau 8-10), or the National Commission of Historic Monuments (e.g. the building on Str. Visarion 8, on the corner of L. Catargiu Boulevard).

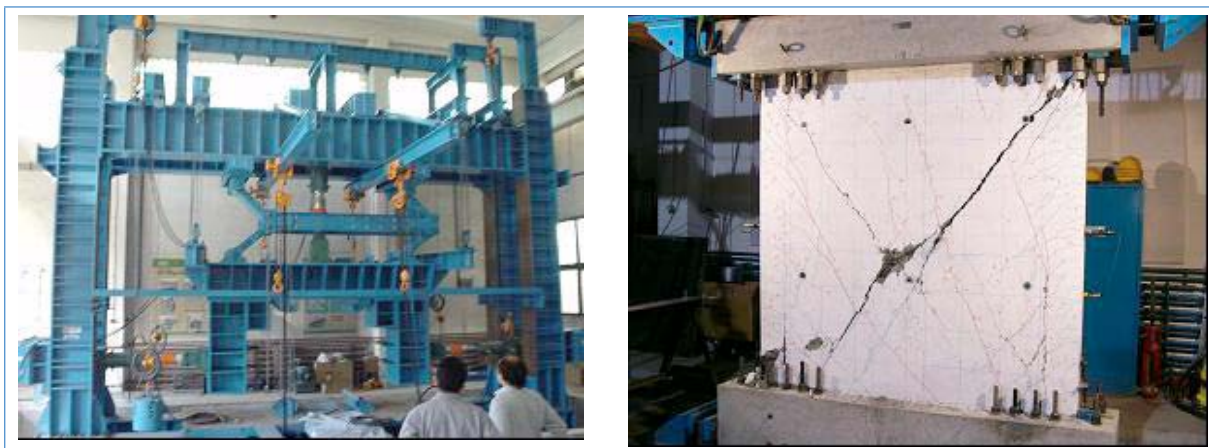
**Figure 19.** (a) Reaction frame donated by JICA, and (b) CNRRS tests on RC shear wall

The activities were carried out by NCSRR in partnership with the Technical University of Civil Engineering (UTCB) and the National Institute for Building Research (INCERC) in Bucharest. During the project period, 29 young Romanian engineers were trained in Japan, while Japanese experts worked in Romania (7 experts for a long-term period and 37 for a short-term period). Equipment for seismic instrumentation, and dynamic characterization of soil and structural testing required approximately ¥260 million (US\$2.17 million), donated by JICA to the NCSRR. The total cost of the project was roughly US\$7 million.

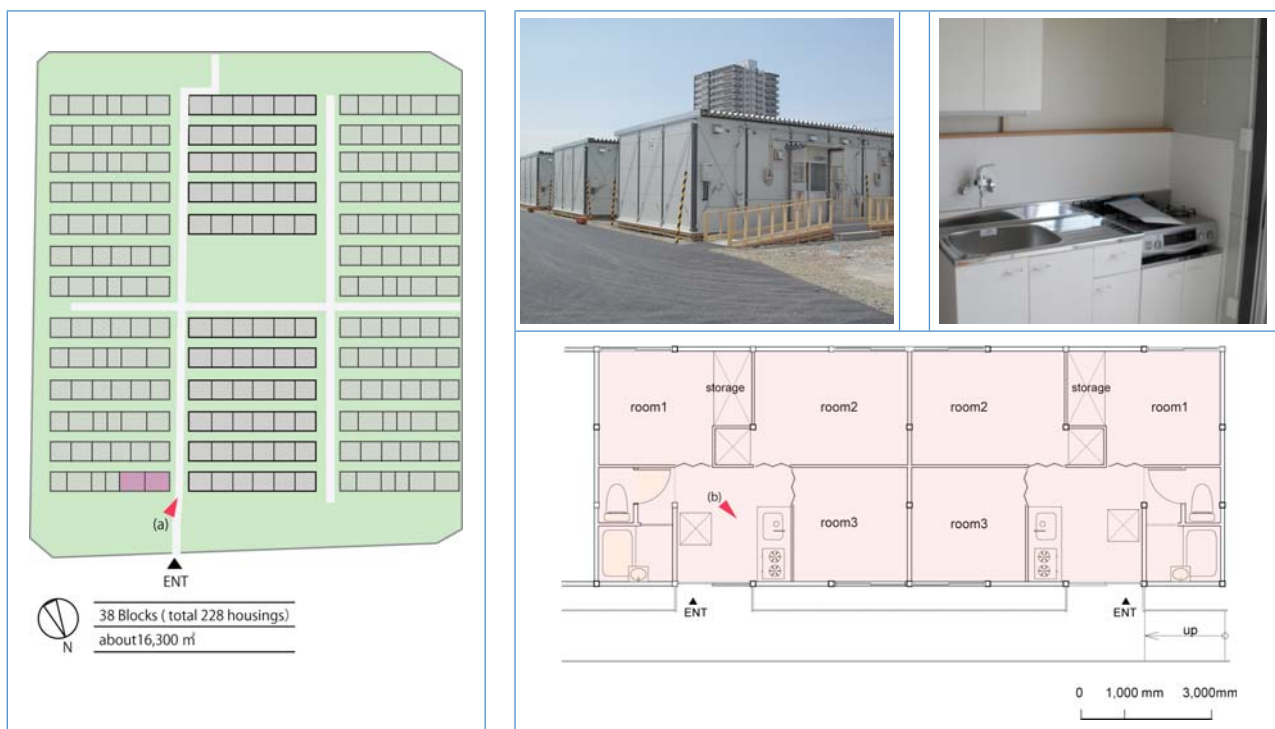
On 20 May, 30,647 affected people were accommodated in 404 refugee units. Temporary houses were built across 16,300m<sup>2</sup> in Sendai City (Asuto Nagamachi), consisting of 38 blocks (one block for six housing units), with the standard housing type consisting of 3K with a bath and toilet (two rooms to sleep six and one to sleep eight). Here, the temporary houses are quite industrial and not particularly personal.

Figure 2 Temporary housing (Asuto Nagamachi), Sendai (9 May 2011)

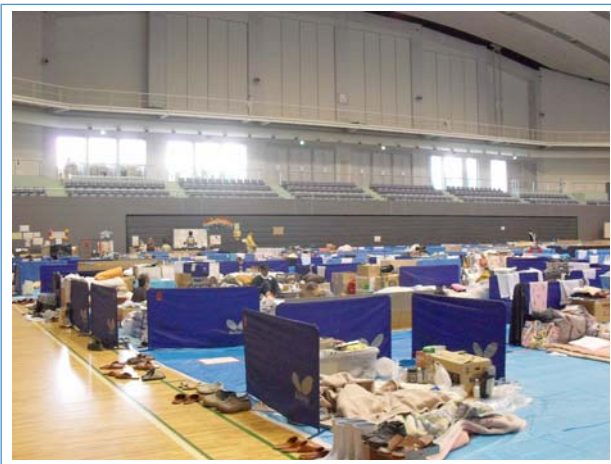
In these facilities, the refugees construct living spaces using cardboard boxes. The children use bus services to go to school. Some of the elderly people forced to live in such unhealthy environment have suffered from illness and died.

**Figure 3** Kesenuma gym (10 May, 2011)
