World Heritage Scanned Nomination

SITE NAME: **Chhatrapati Shivaji Terminus (formerly Victoria Terminus)**

DATE OF INSCRIPTION: 7th July 2004

STATE PARTY: INDIA

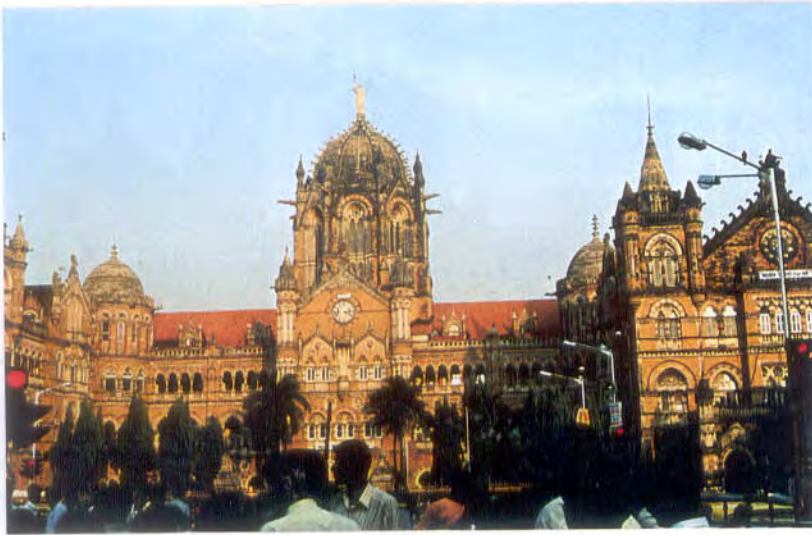
1. The dome is placed on a high drum having two levels of very good quality stained glass panels on its eight sides with an allegorical statue of Progress symbolizing the railways and the city.

29. A prominent dome is the crowning feature of this building²⁹. A prominent dome is the crowning feature of this building
30. The Statue of Progress which is 16 feet 6 inches high
31. The dome is placed on a high drum having two levels of very good quality stained glass panels on its eight sides with an allegorical statue of Progress symbolizing the railways and the Mumbai city

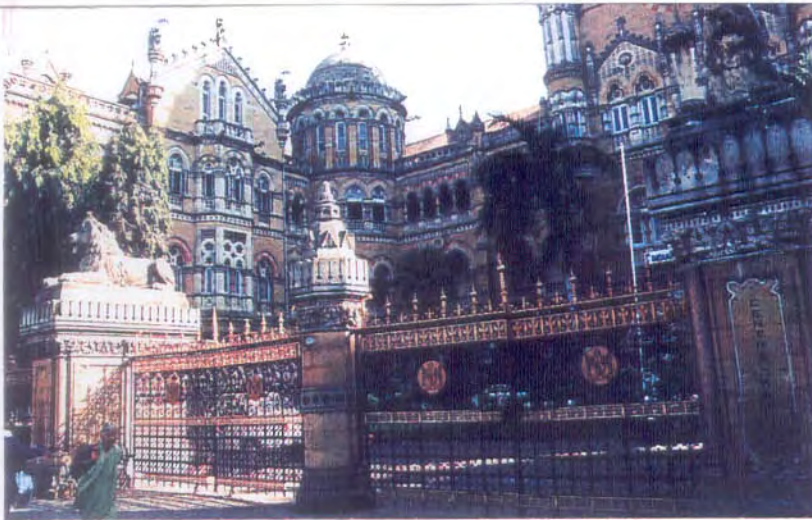
2. The building has very ornate WI railing with gate which houses a befitting landscape garden within. The gateways are flanked with life size statues of Lion and Tiger.

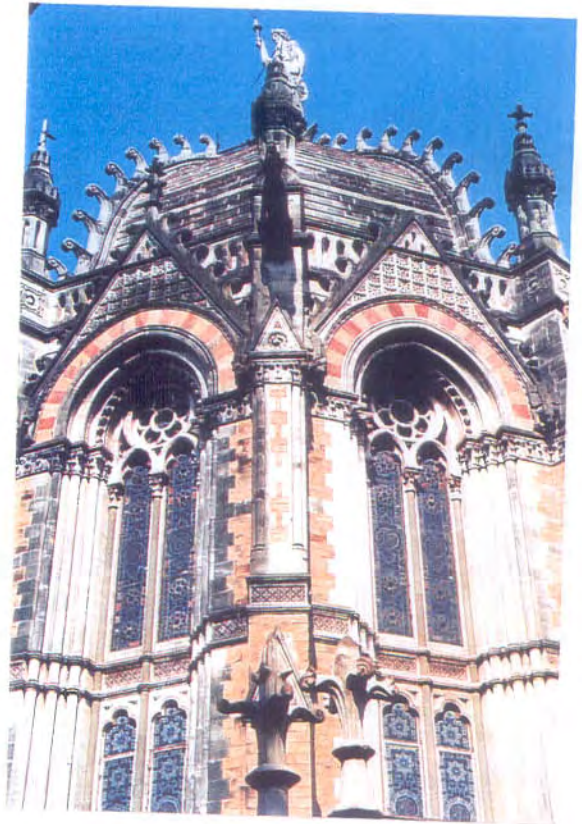
3. Series of different types of arches at each floor with highly decorated stone carving makes it one of the most splendid buildings of Mumbai

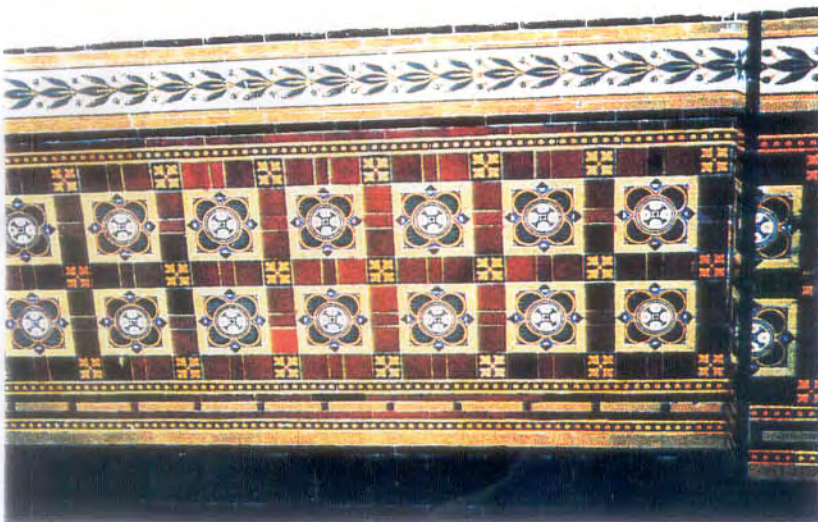
33 Encaustic tile dado in banqueting hall

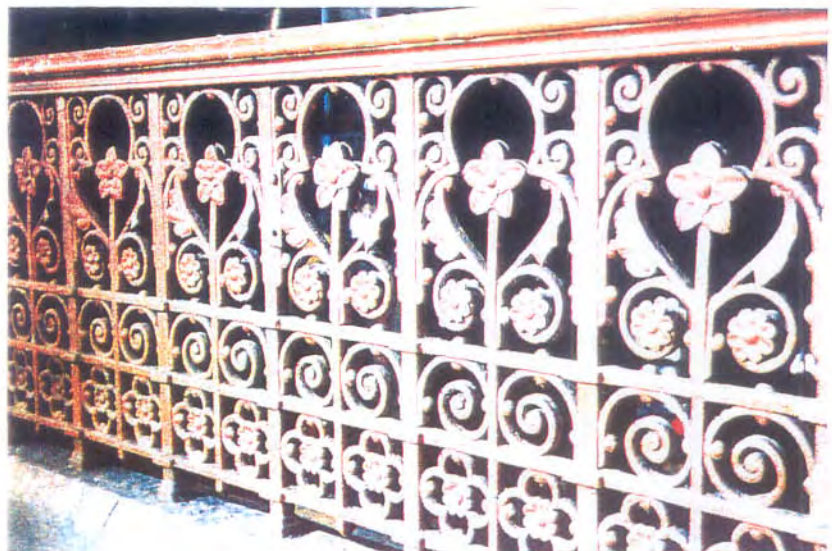
34. highly decorated and originally richly coloured and gilded WI railing was one of the highlights of 2007

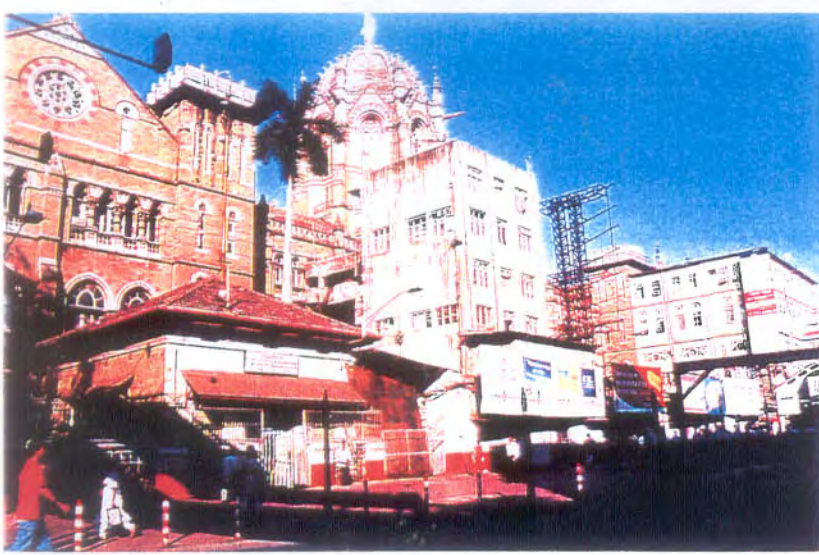
35.

View of rear East facing elevation. This is the only façade that has been altered subsequently by additions, encroachments and hoarding.

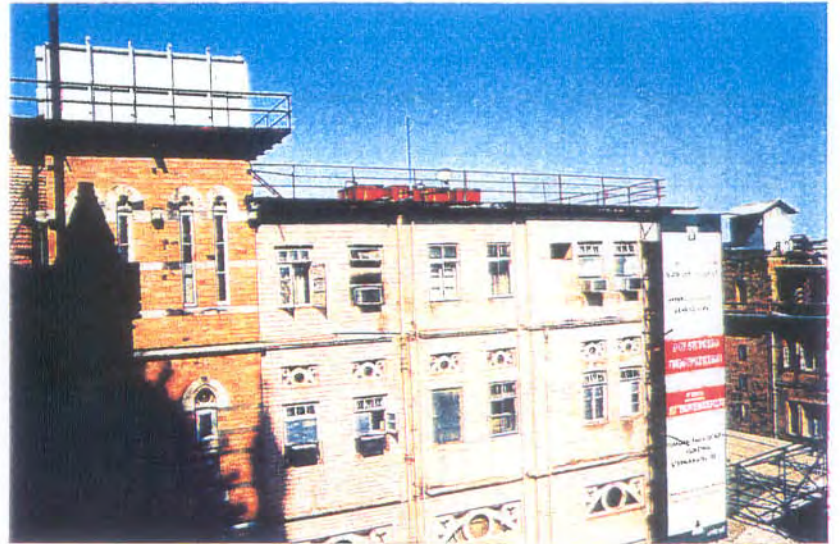
36. Insensitive extension done in 1980's to meet the growing need of space.

An increase in the users correspondingly required an increase in the services for the building. Hence several toilet and wash areas have been added, as well as new overhead water tanks for the same. Electrical services also have increased, most notably air conditioning plants, and most of these service facilities have been added in the rear of the building, where open space was available. (this part of the building was originally a kitchen and canteen for staff, and was also landscaped.)

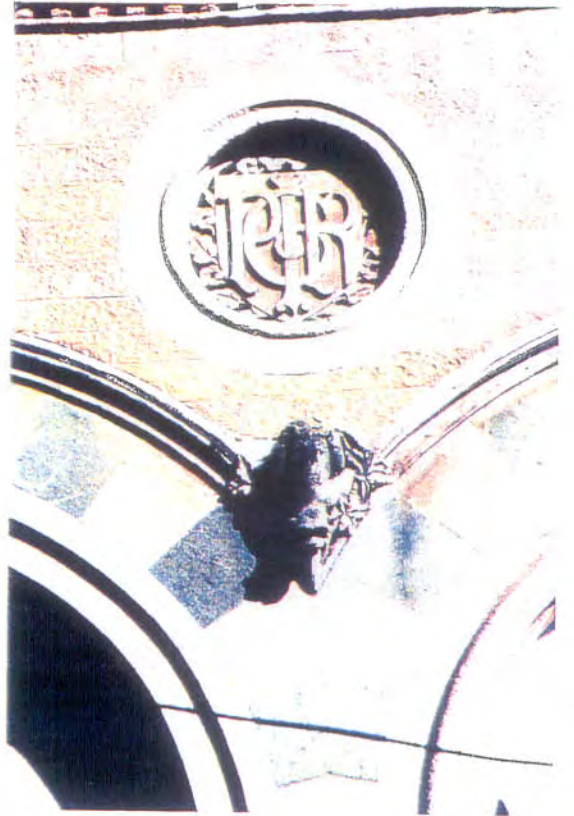
8. Use of polychrome masonry , animal motifs and coats of arms decorates this building everywhere.

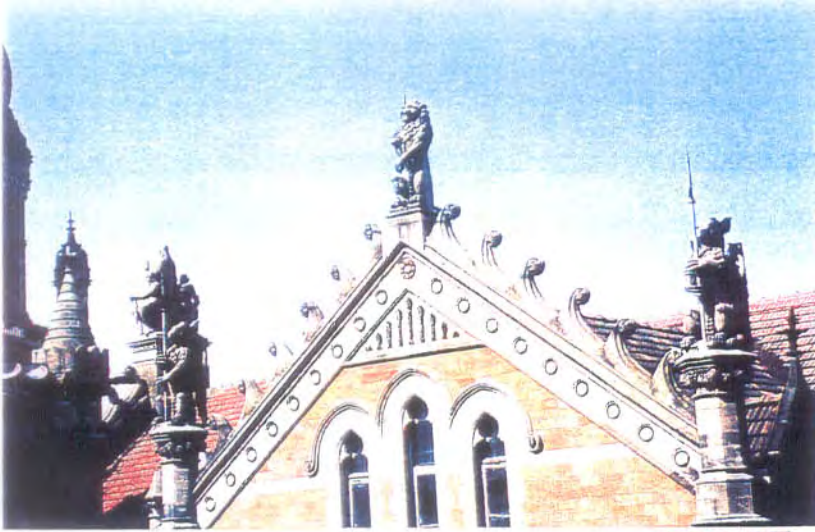
10.

The ornamentation of this building creates an interesting skyline which epitomizes the Gothic Revival architecture.

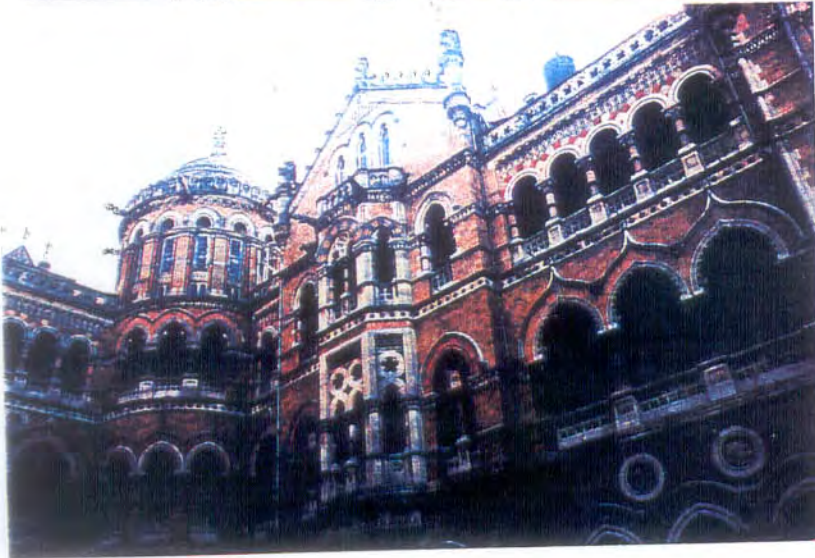
11.

Distinctly noticeable features are the Ogee shape arches on the first floor.

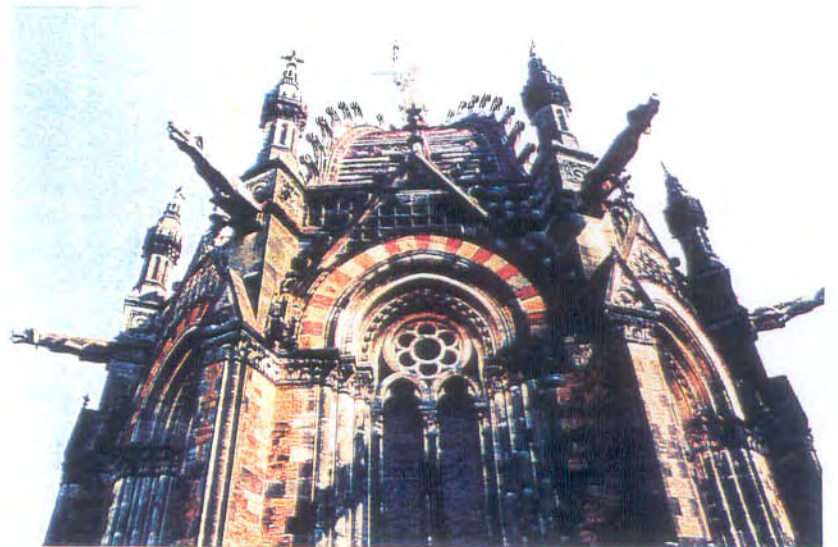
12. The crowning feature of CST is its dome, one of the first public buildings in Mumbai to have one, more for a dramatic purpose rather than a function.

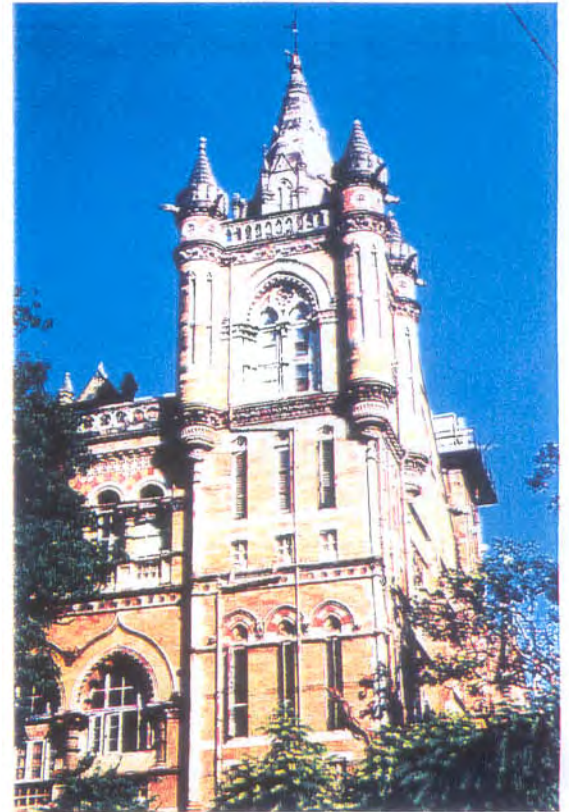
14. Corner turret details is reflection of the inspiration from St Pancras Station in London.

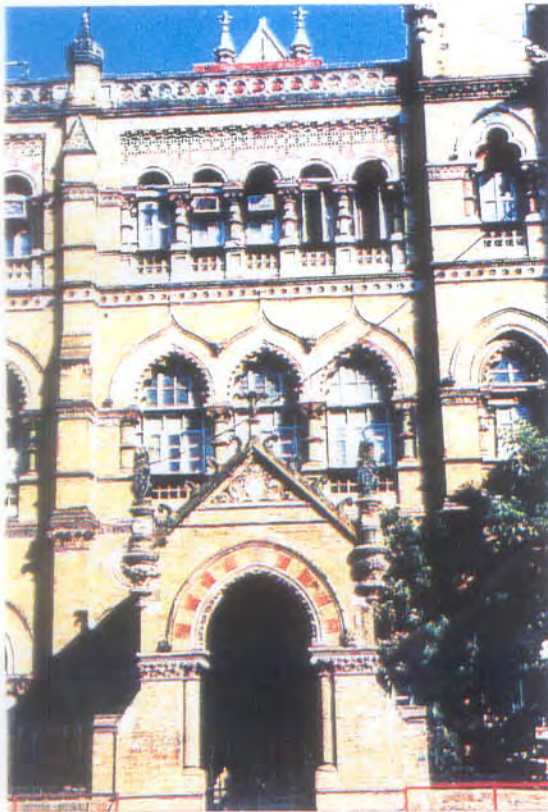
15. Many of the openings have unfortunately been sealed, the proposed restoration project aims in opening these up in future.

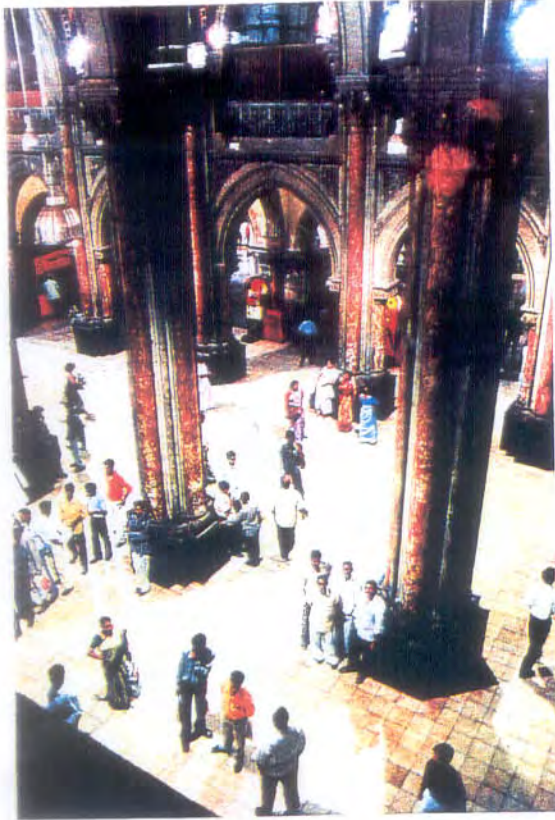
16. Gothic Revival interiors- ribbed vaulting with gilt work still intact.

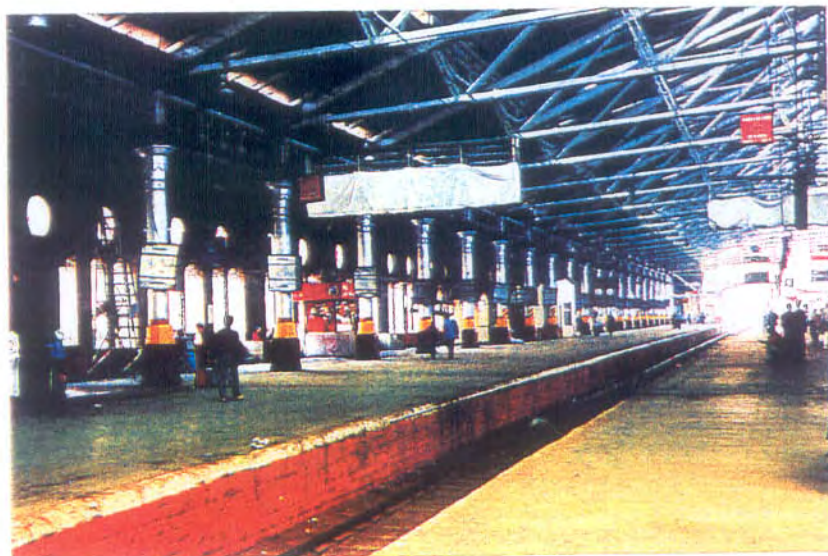
19 Decoration to steel work – a very conspicuous Gothic Revival detail,

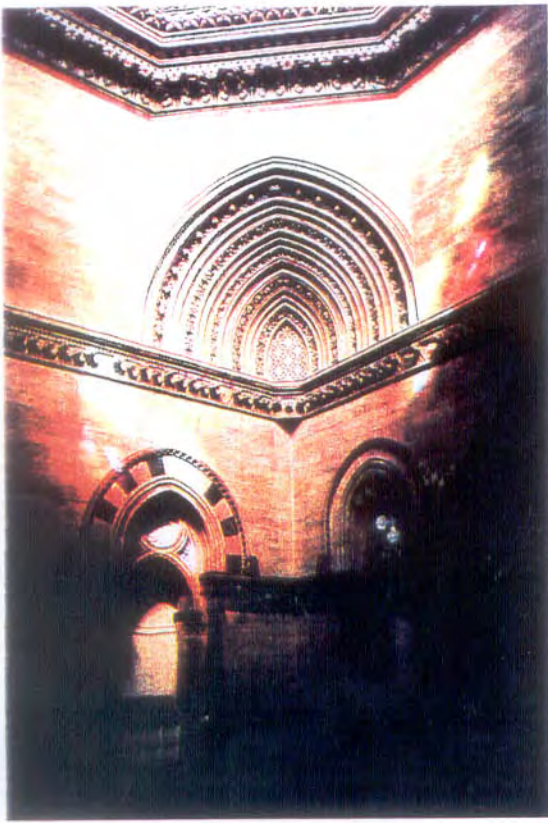
24. Decorative squinches/pendentives in the staircase area to make the square plan an octagon.

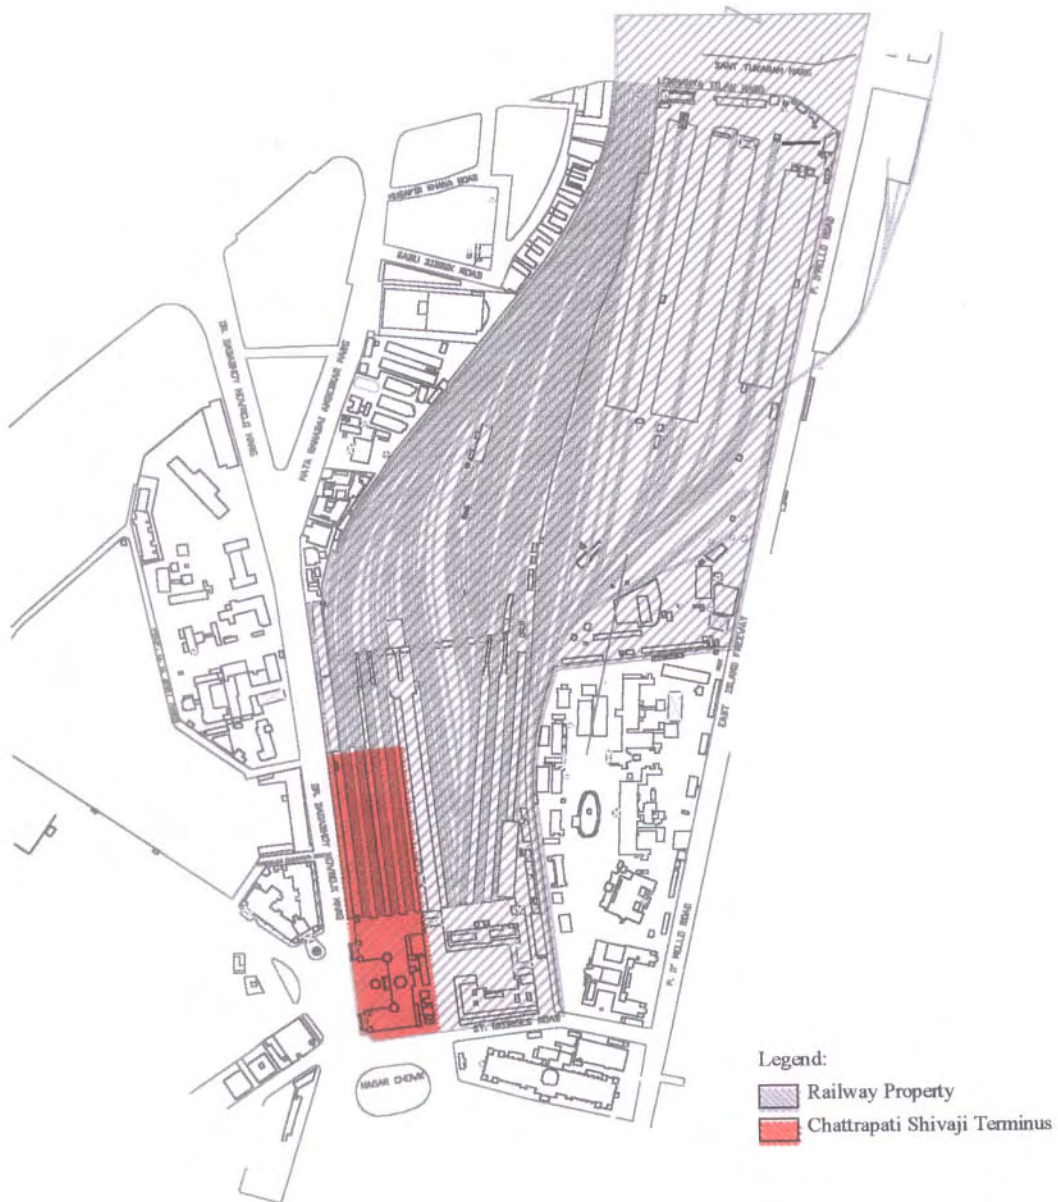
SITE PLAN WITH BOUNDARY

Note: The plan shows the site of the Chhatrapati Shivaji Terminus Bldg Administrative Office as well as concourse marked within its boundaries. This part that has been delineated is the original building and concourse designed by architect F.W.Stevens

- Fig 13 Vantage location of CST (source: Vikas Dilawari)
- Fig 14 The Fort Precinct-A Conservation Zone (source: complied by Intach)
- Fig 15 Site Plan with its Boundary (source: complied by Intach)

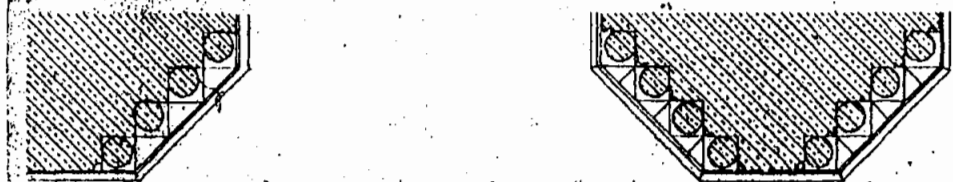
Plan of Arches of Hall of Grand Staircase under Principal Dome.

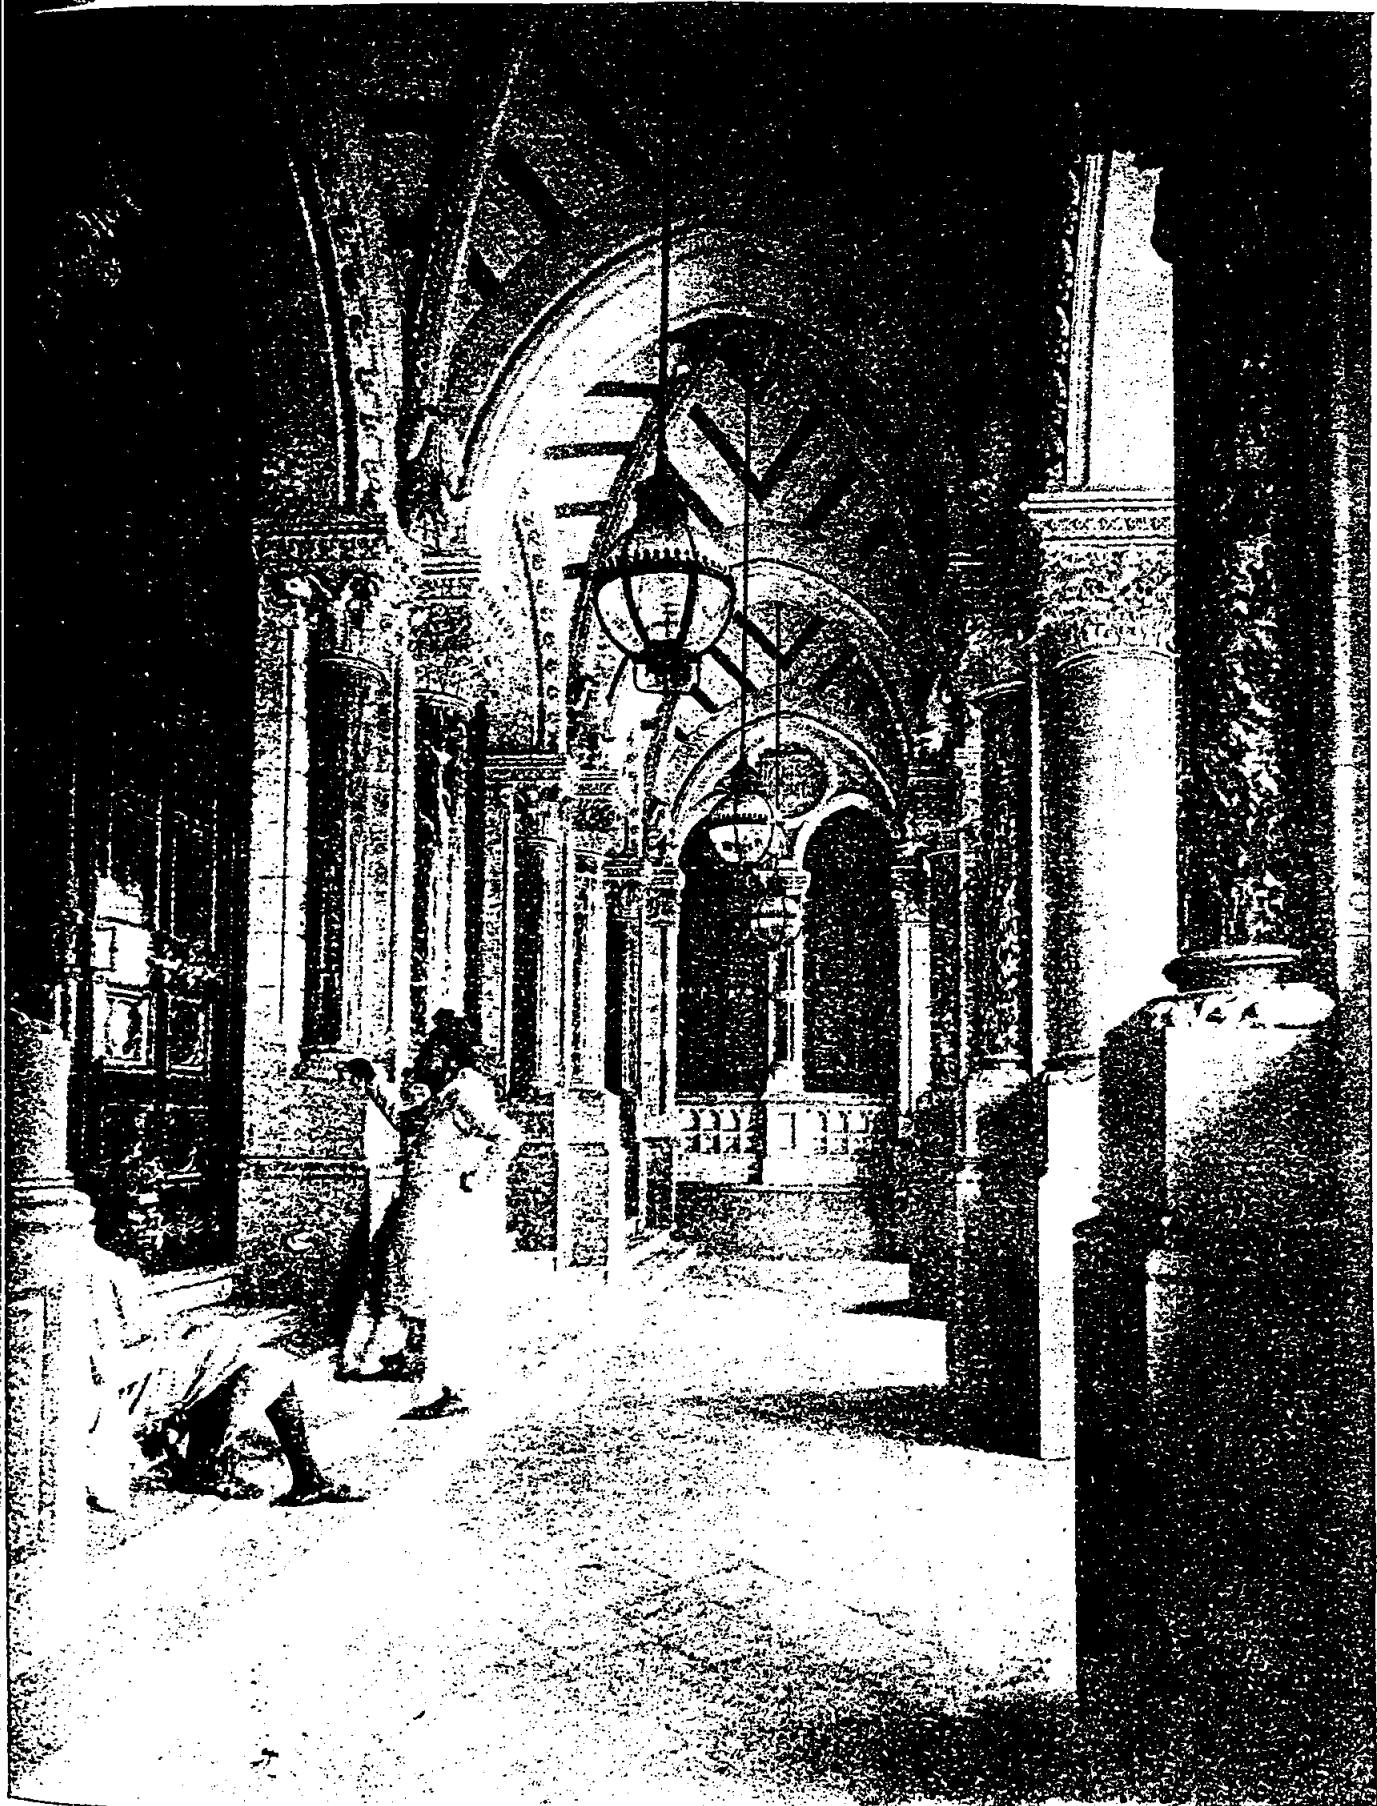
ENTRANCE CORRIDOR TO THE WAITING HALL, GREAT INDIAN PENINSULAR RAILWAY TERMINUS BOMBAY.

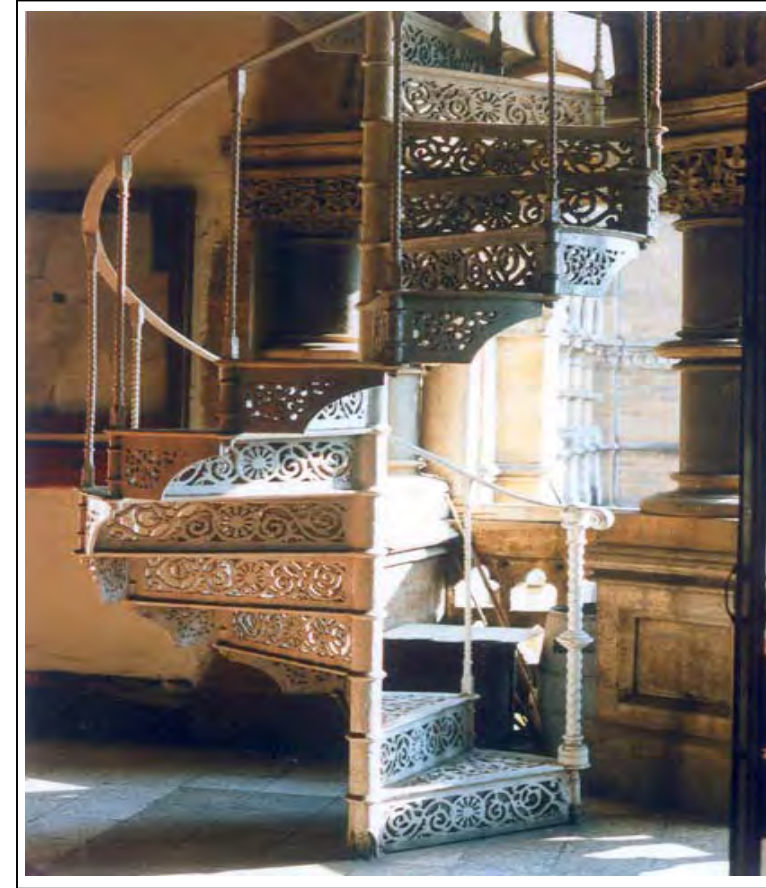
Spiral staircase

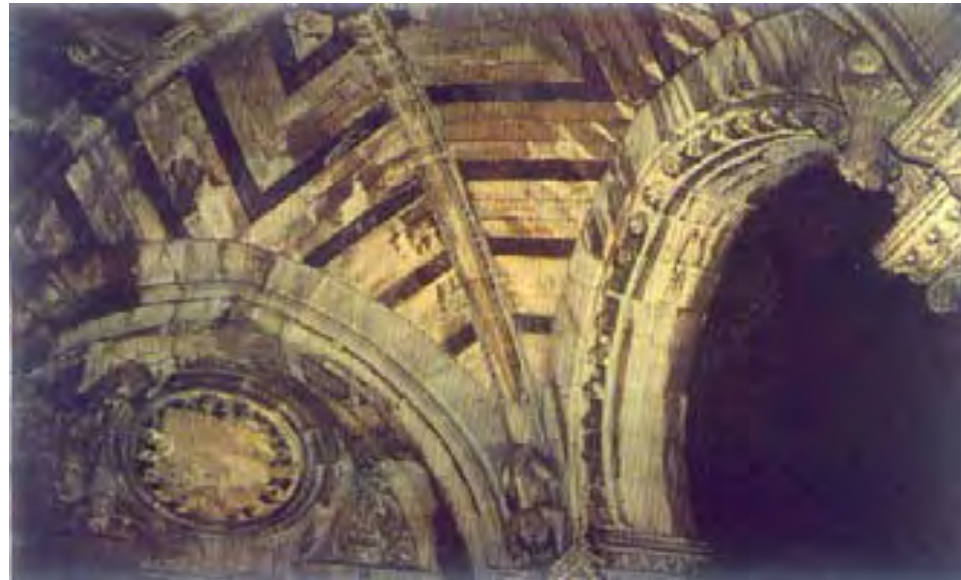
Salts absorbed by poutice

SEEPAGE DUE TO FAILURE OF WATER PROOFING

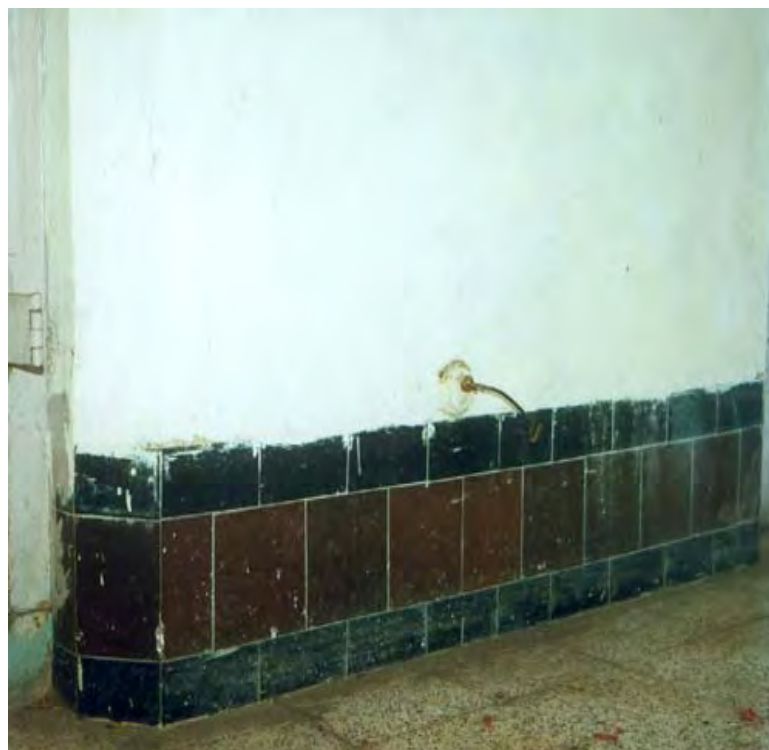
Mosaic Tiles laid later on

The floors are made of a topping course on lime concrete of about 15-20 cm thick placed over wooden plankings and beams. The flooring does not show excessive signs of deflection and other distress. Many of the original building materials would have been replaced by a variety of modern materials such as mosaic, ceramic graded tiles, linoleum, IPS etc

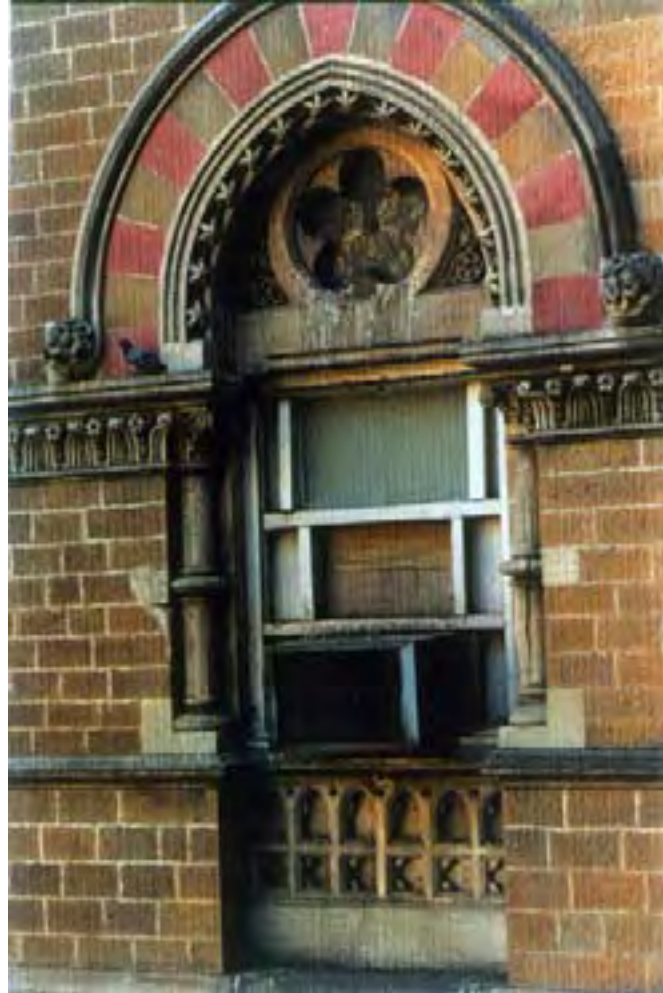
ARCH OPENINGS FILLED UP
IN DIFFERENT MANNERS
EVERWHERE

- CONSIDERING THE HISTORICAL AND ARCHITECTURAL IMPORTANCE OF THE STRUCTURE, ALTERATIONS AND ADDITIONS SHOULD BE VERY SENSITIVELY DONE.
- DUE REGARD SHOULD BE GIVEN TO THE EXISTING CHARACTER WHILE ADDING FOLLOWING FEATURES
 1. Filling of arches
 2. Windows frames
 3. Grills
 4. Partitions
 5. Flooring
 6. Cladding
 7. Signage

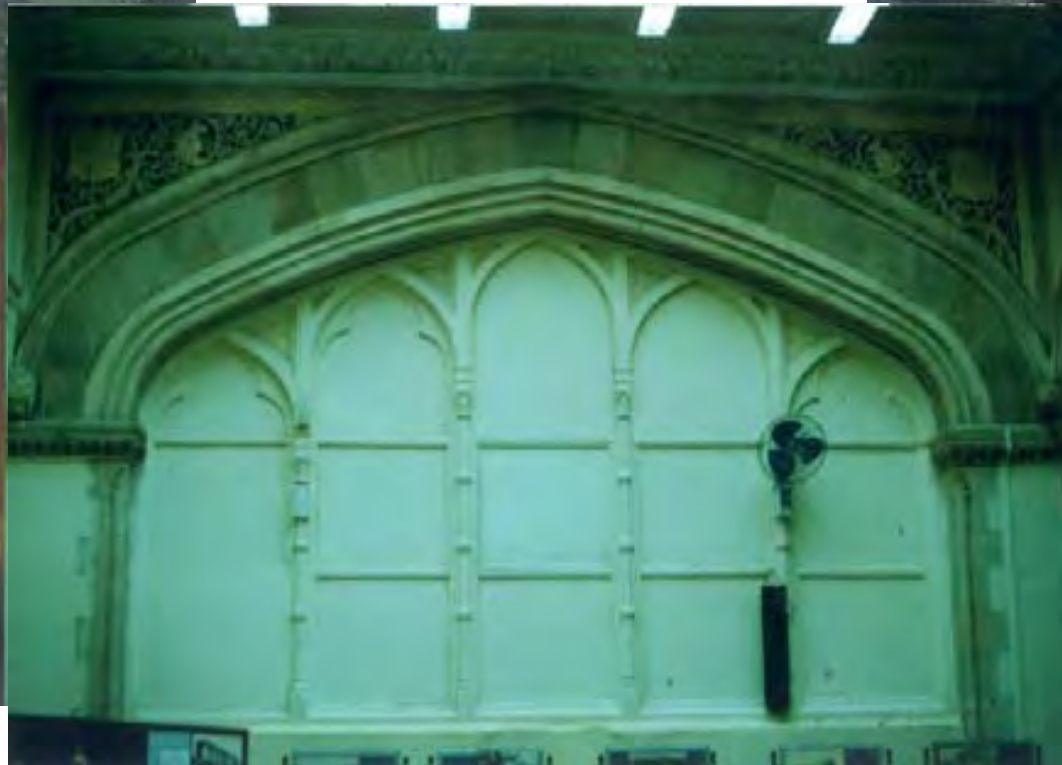
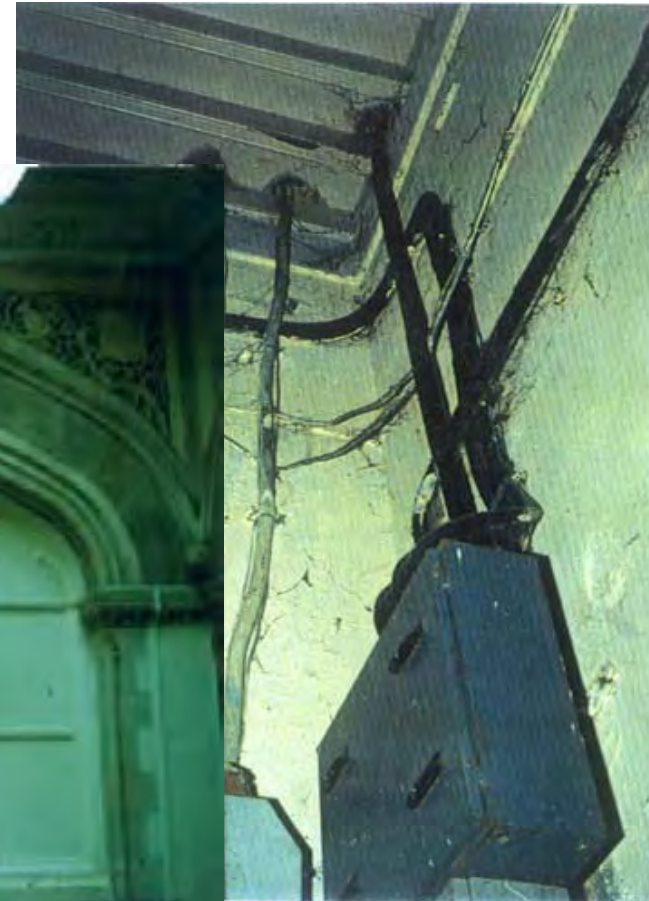
PARTITIONS

WIRING :-
CABLES RUNNING ON THE WALL

2 Mains cables are hanging loose across the walls and along corridors. (Refer to the photographs).

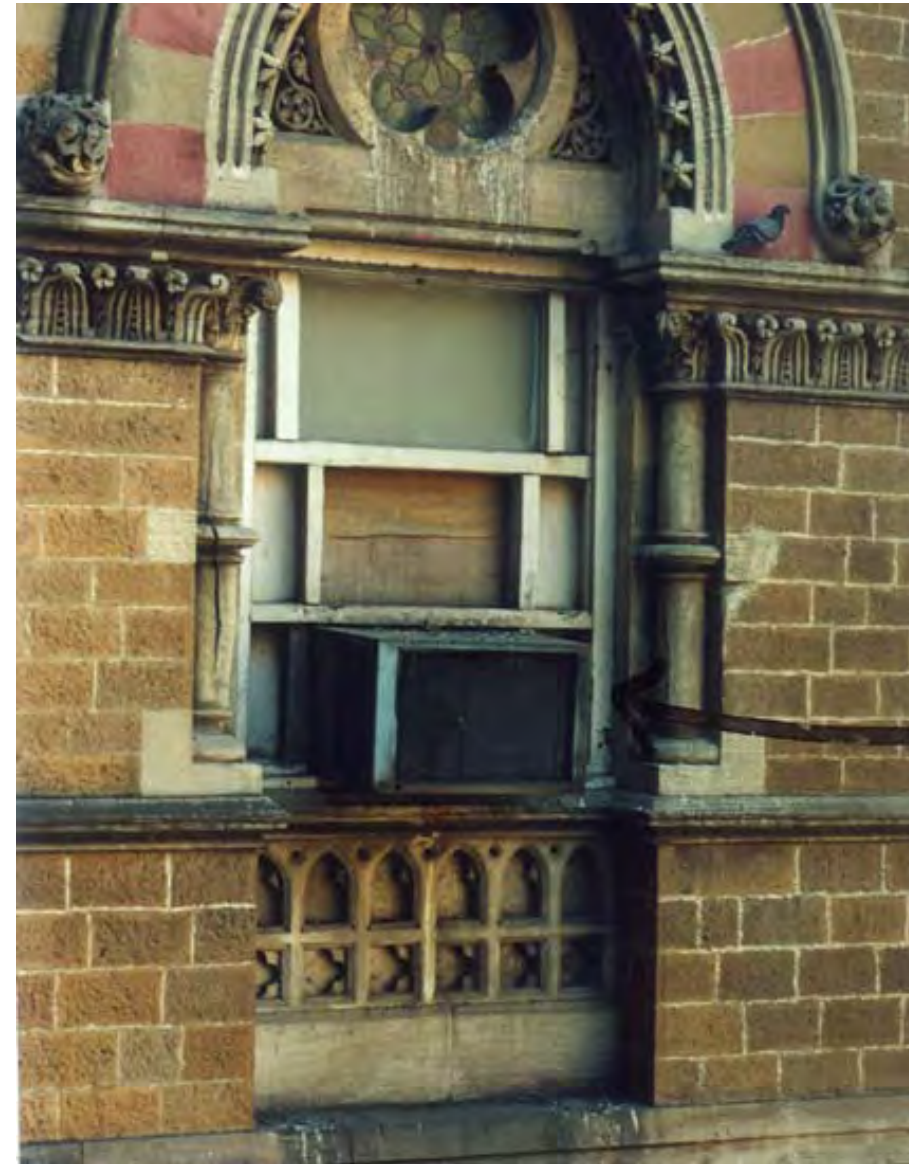
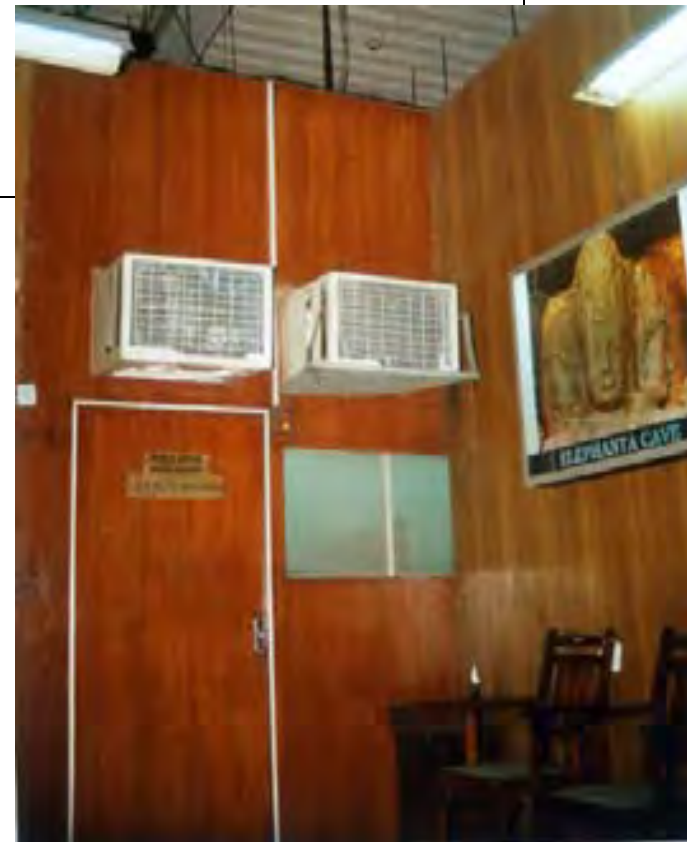
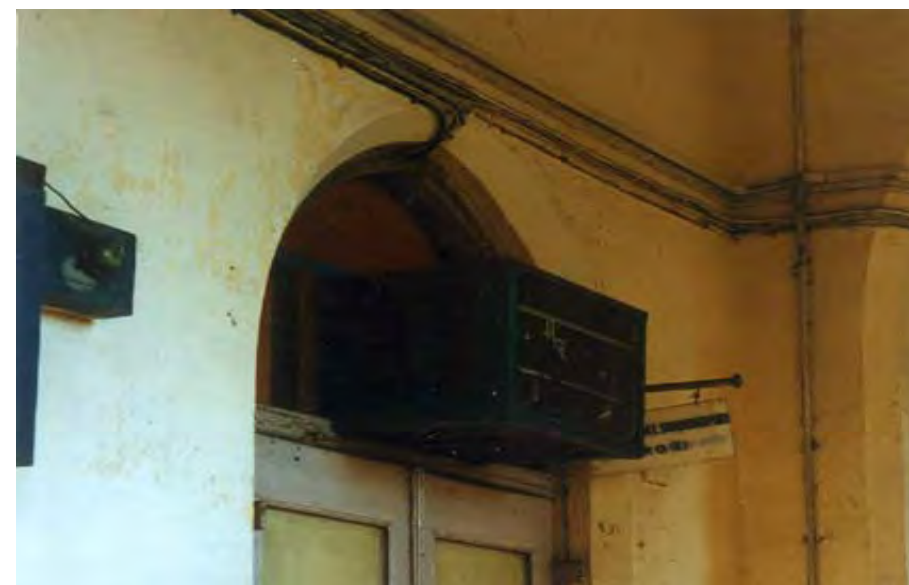
Existing air-conditioning system

A.C. Window units shall be replaced by split A.C. units in the long run

6 The combined switch-plug units for window A.C. units result in loose connecting cables hanging out which is not safe and aesthetic. (Refer to photographs)

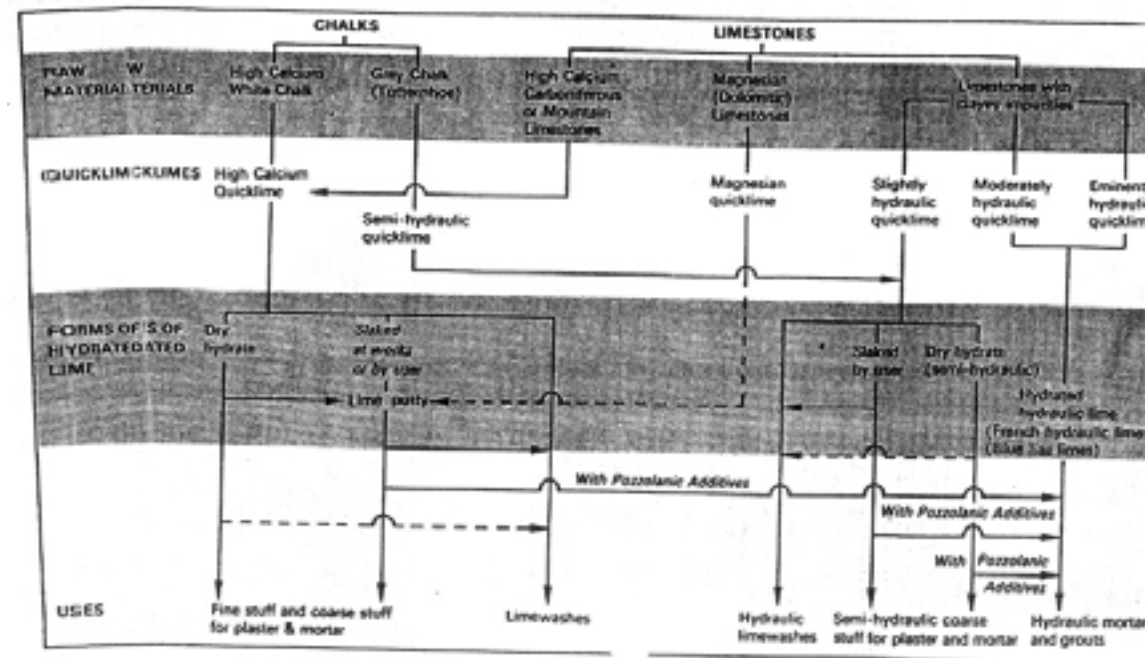
RELATIONSHIPS AND USES OF DIFFERENT TYPES OF LIME. (Chart after Cooper, BRE Special Report No 9; the chart is intended only to give a general idea of the way in which the different broad types of lime are best adapted and should not be interpreted too literally).

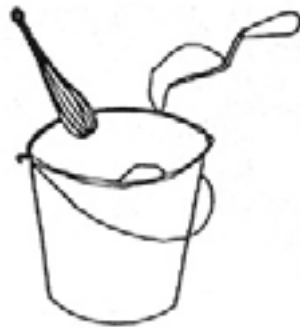
6.

(If home-staked lime is runny, then go straight on to stage 7.) Place about 3 trowelfuls of lime putty into a bucket with a few inches of water and work to a smooth paste with the whisk. Add more water until the mixture is like thin cream.

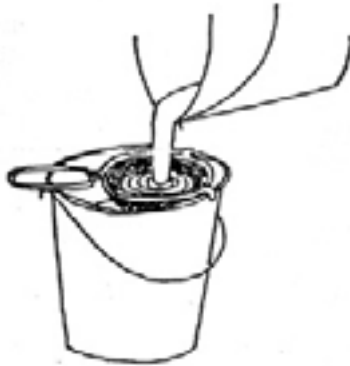
7.

Pour through sieve into second bucket, working through any lumps, but leaving any grit in the sieve.

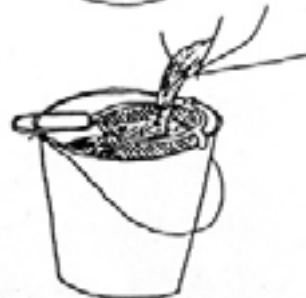
9.

Dilute the mixture until it is the consistency of milk and sieve again into the first bucket. This limewash is now ready to use.

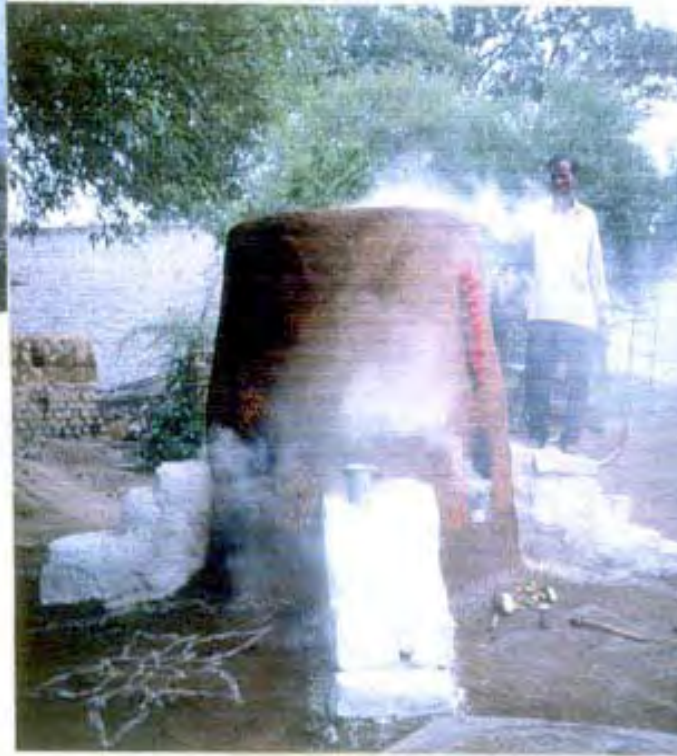
TRADITIONAL LIME KILN

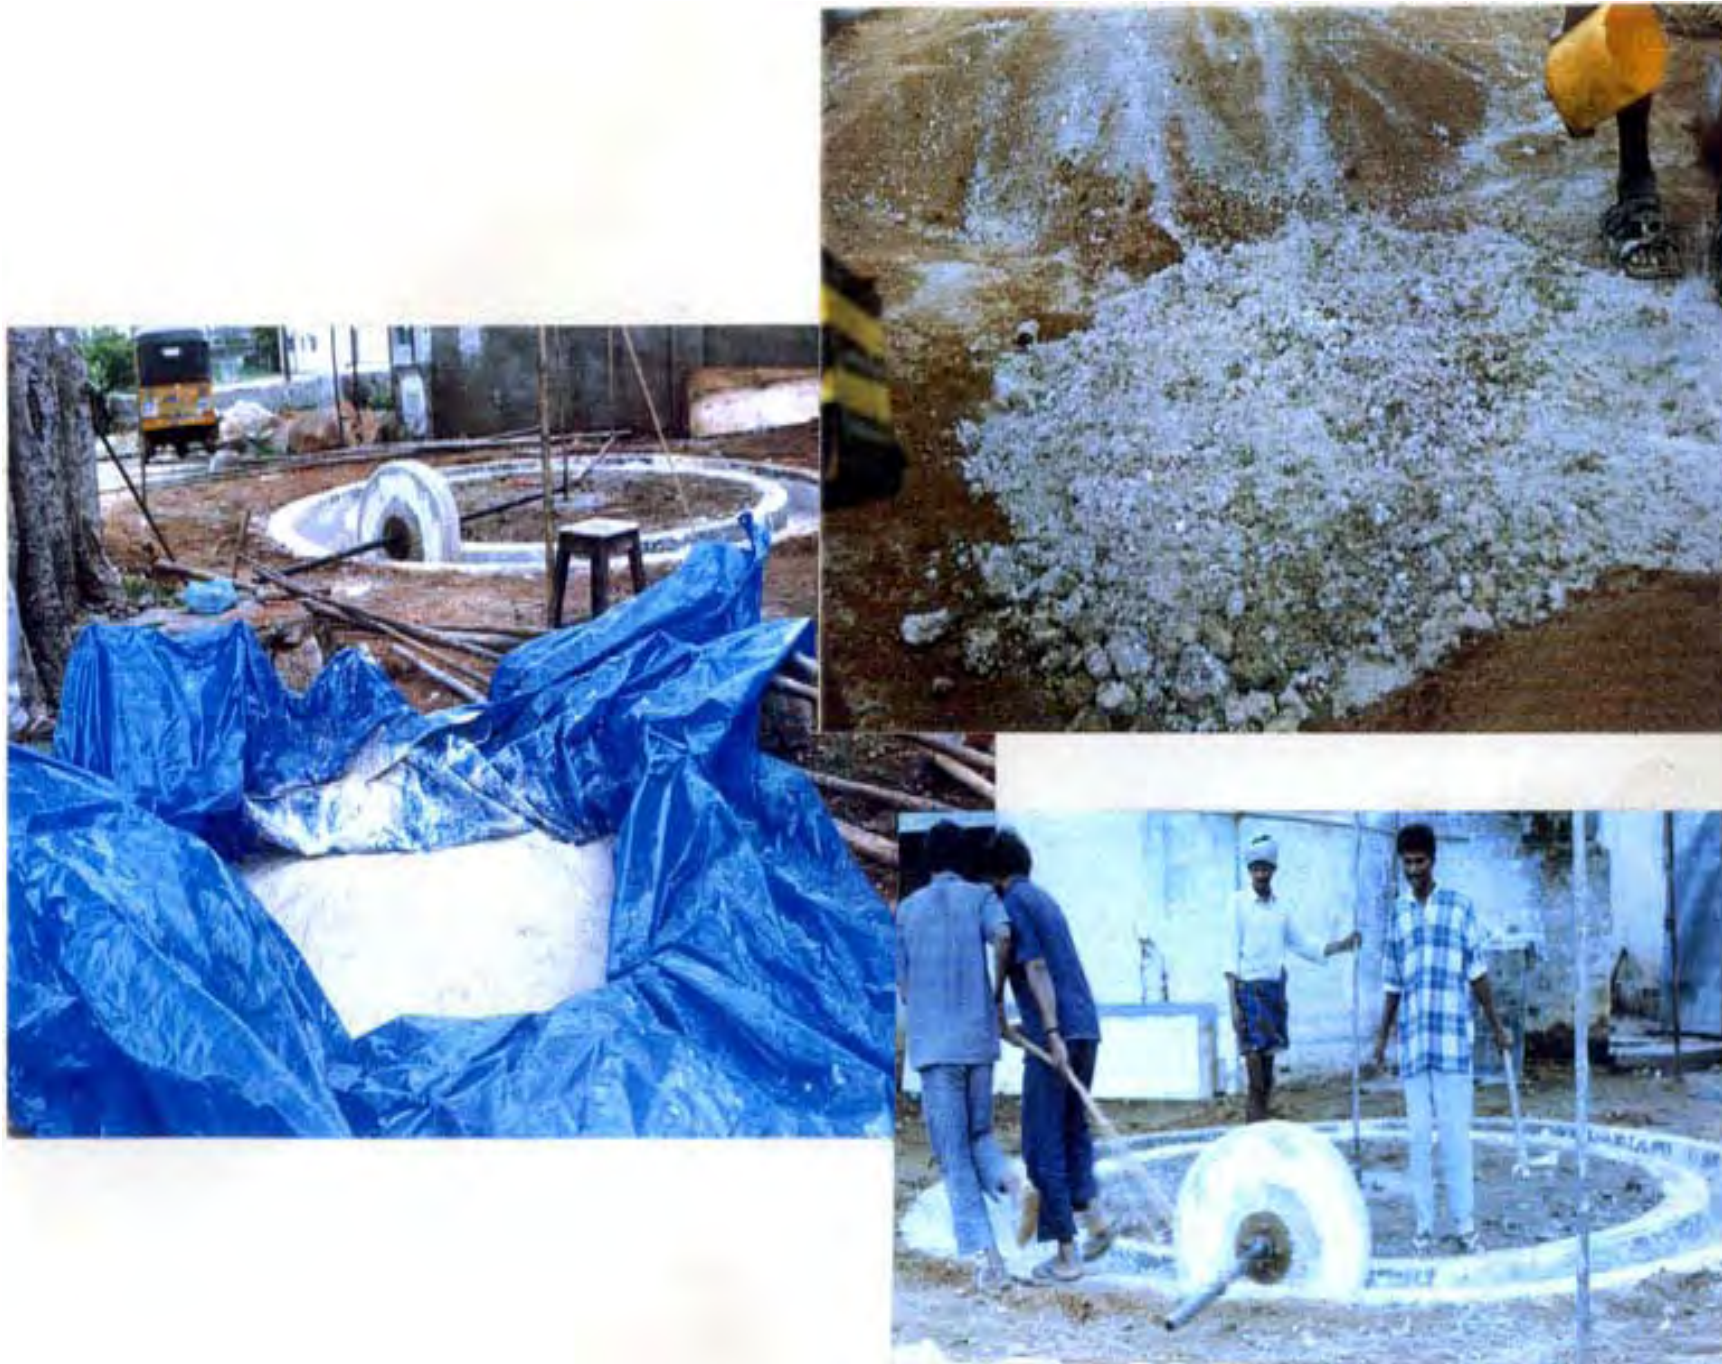
USE OF TRADITIONAL MATERIALS & TRADITIONAL LIME MORTAR TECHNOLOGY FOR AUTHENTICITY OF THE WORK
