Inventory of **earthen** architecture

2012
WHEAP

WORLD HERITAGE EARTHEN ARCHITECTURE PROGRAMME

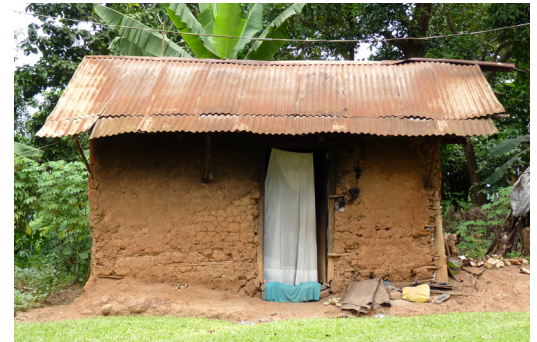
House of one of the traditional guardians who watches over the spirits of deceased kings. This is the last earthen house within the property, as all the others have been replaced by burnt brick structures.
 © Sébastien Moriset, CRAterre

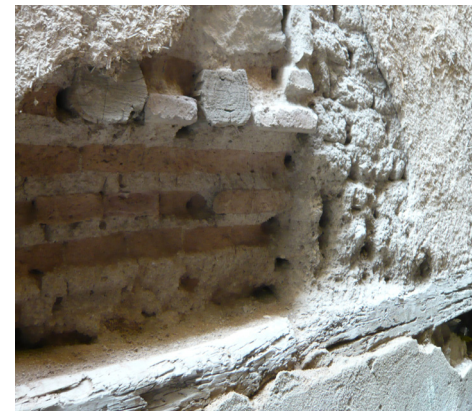
Detail of degraded plaster and of the earth bricks showing underneath

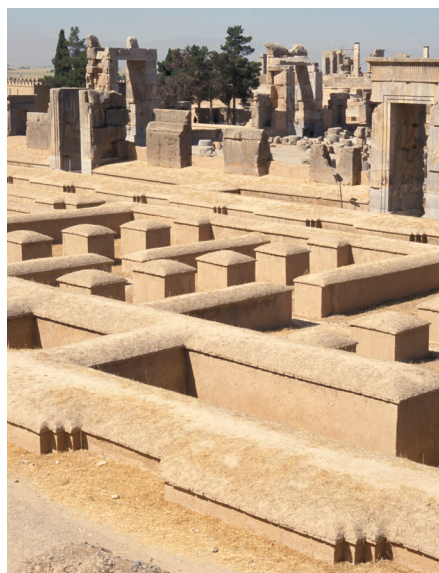
Detail, restored earth walls
© David Gandreau, CRAterre

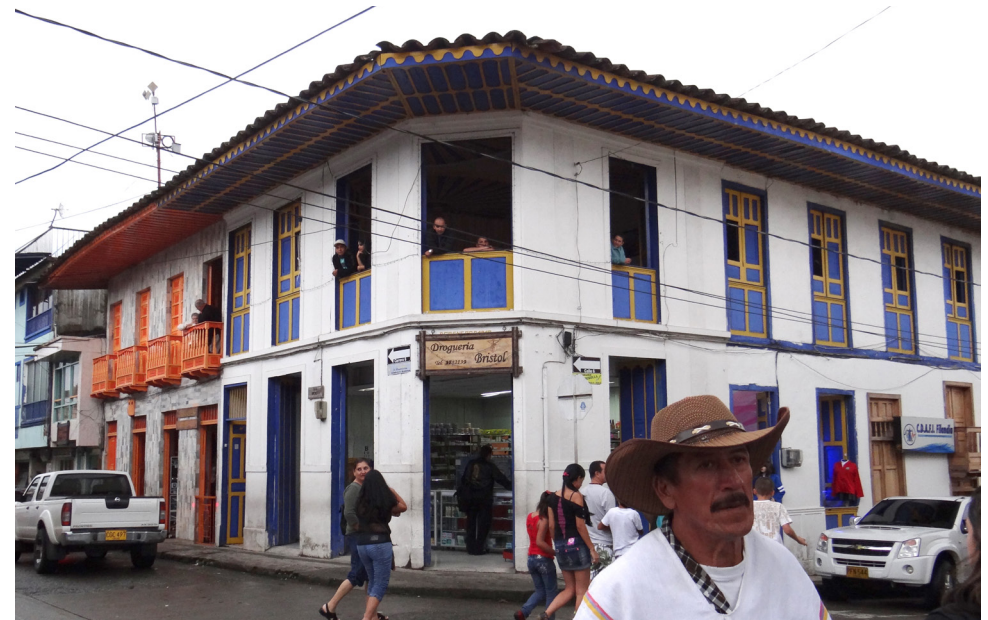
Earth constructions, rammed earth and wattle and daub (bahareque)
