# CentralAsianEarth

## Ayaz Kala

Practical training workshop on conservation of earthen structures in Central Asia  
and Afghanistan

Preventive conservation work

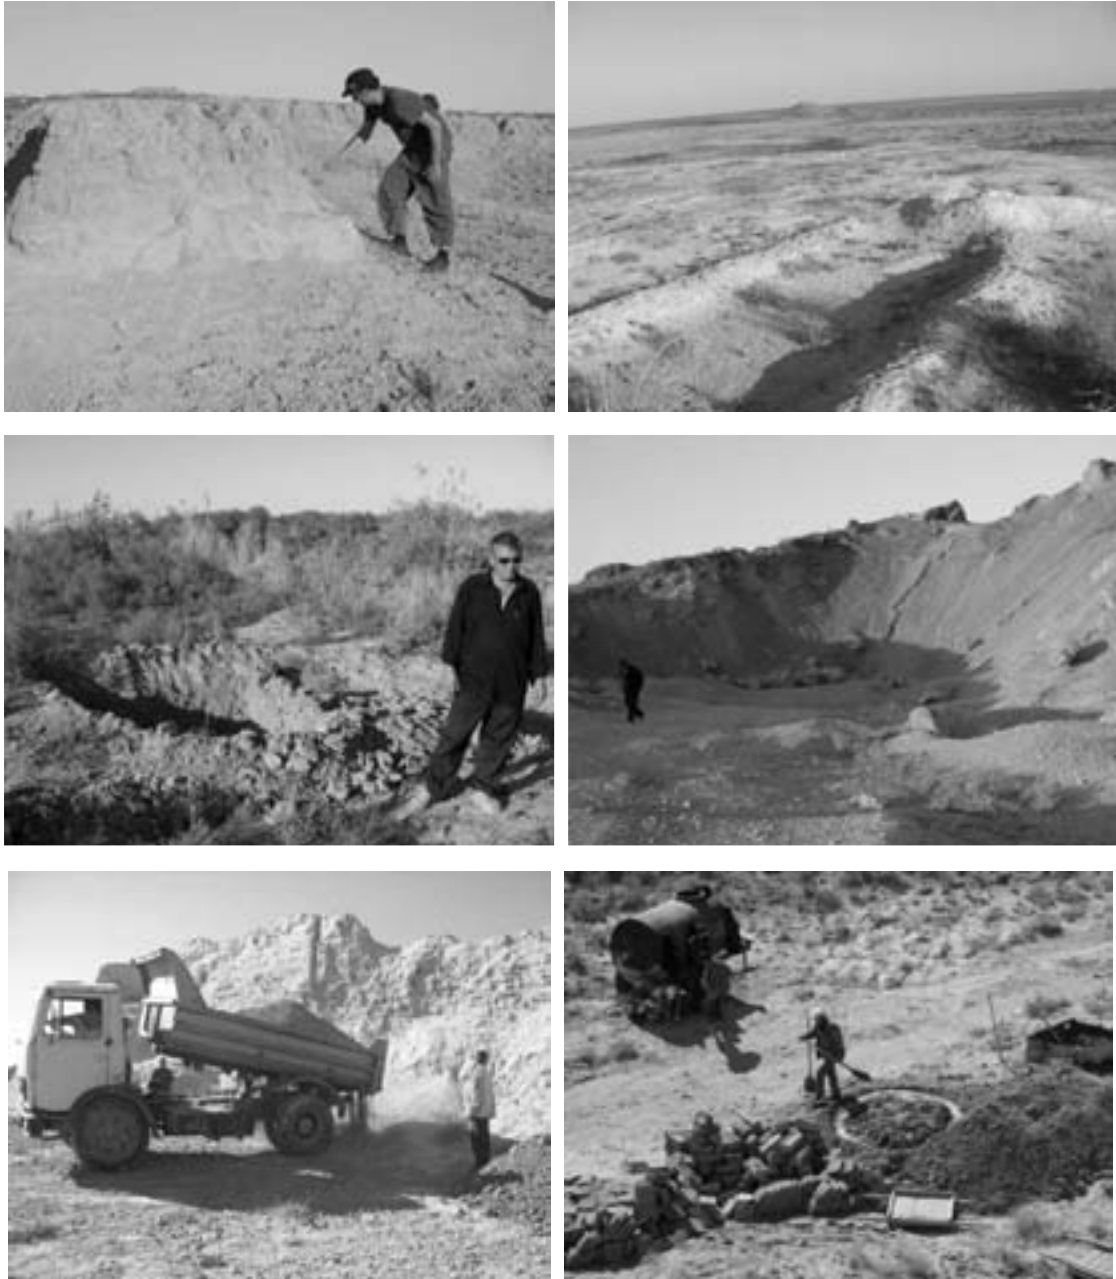
*31 trucks of soil have been delivered to repair the access road and allow the circulation to the main gate of Ayaz Kala 1. 6 trucks of brown soil and 6 others of green soil, 10 water tanks, about 2000 mud-bricks of different sizes, gravel, straw and all the equipment and tools were then brought directly the conservation site.*

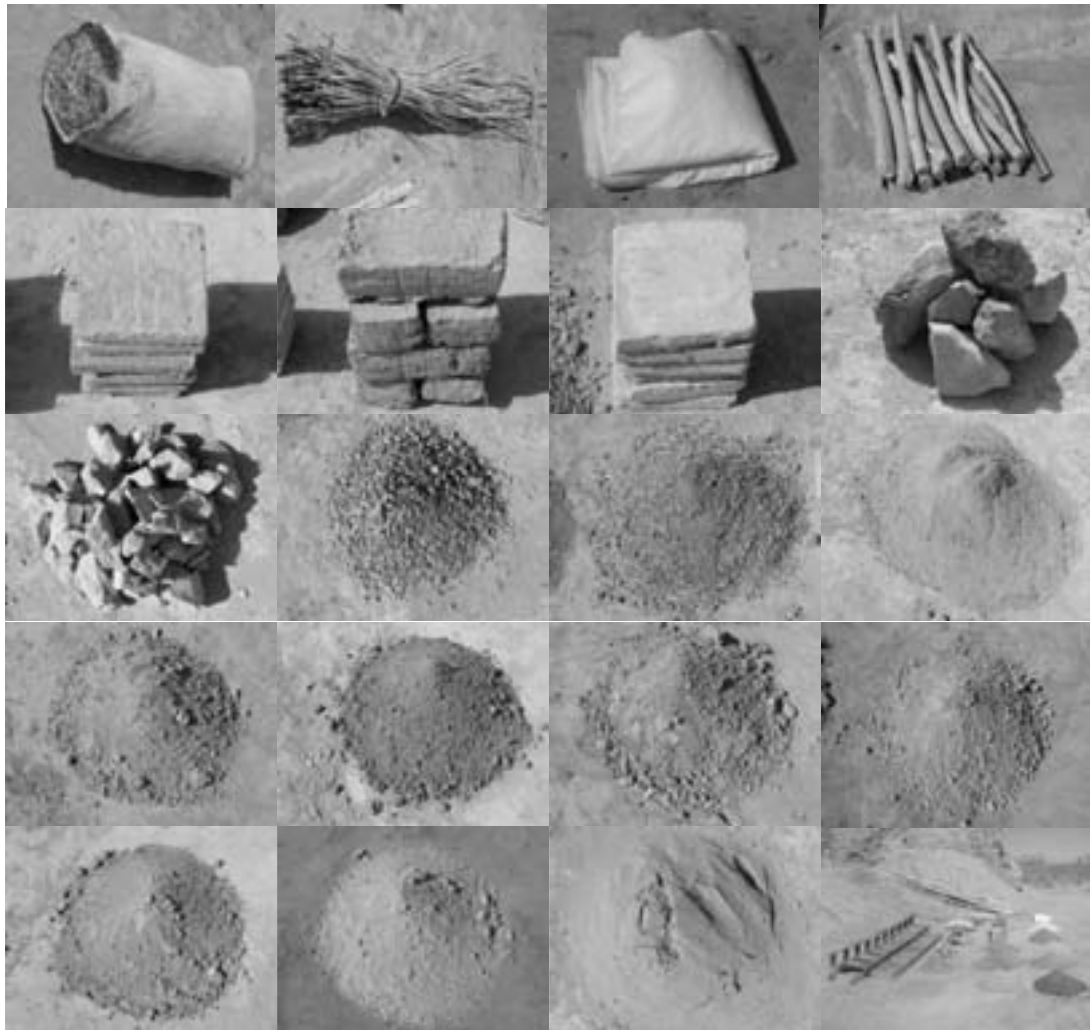
*Samples of soils and material exhibited at Ayaz Kala to show to the local workers, the national authorities and the participants of the workshop the variety of resources available in the close surrounding of Ayaz Kala*

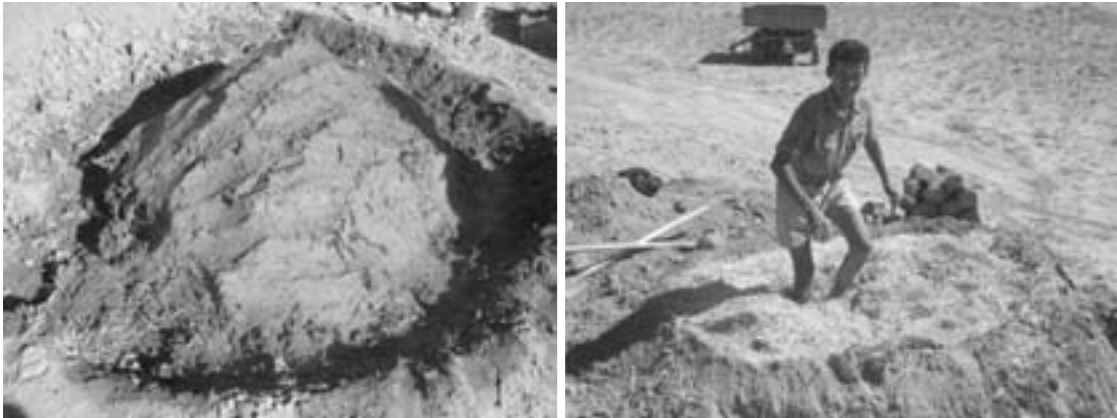
Cob: first experiments showed lot of cracks and problems of adherence with the support. This has been improved by adding sand (1 for 8 in volume) and more straw in the mud mixture.

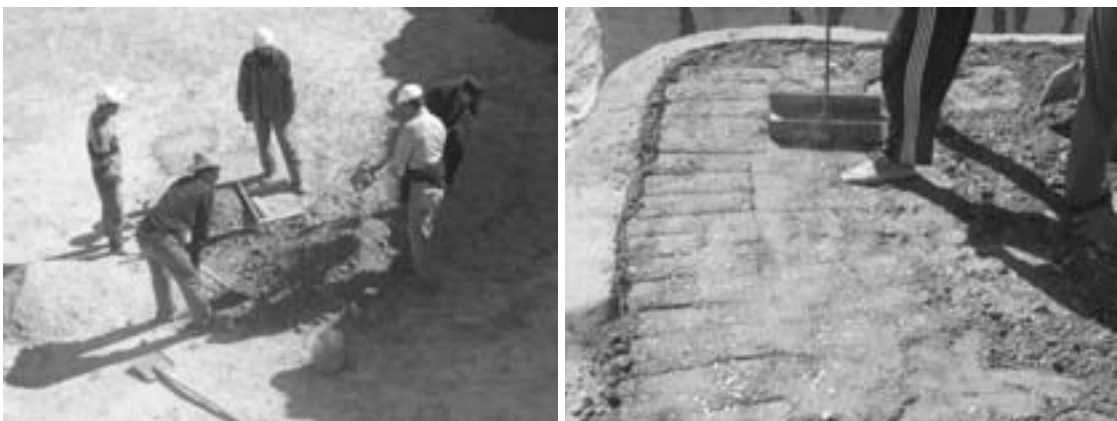
Rammed earth: Tests have been developed with a soil green in colour found 3 km at the east of Ayaz Kala which appeared to be gravelly. The results are quite efficient after ramming. Gravels have been added on the surface to reduce the speed of erosion due to rain waters.

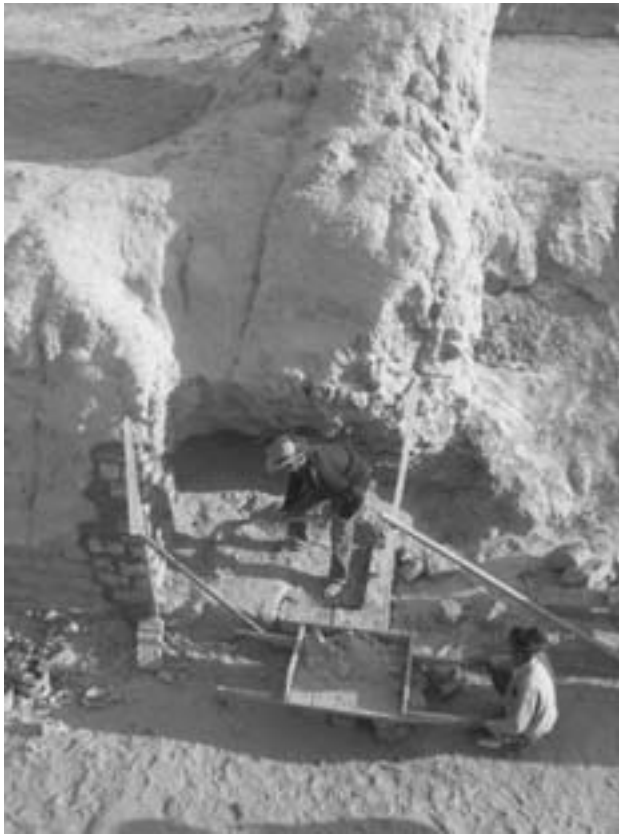
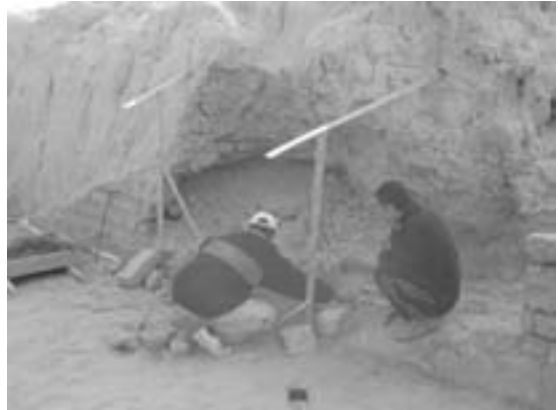
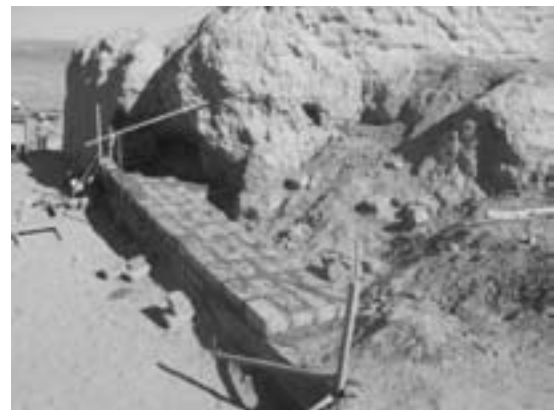
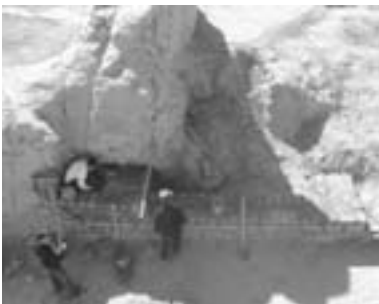
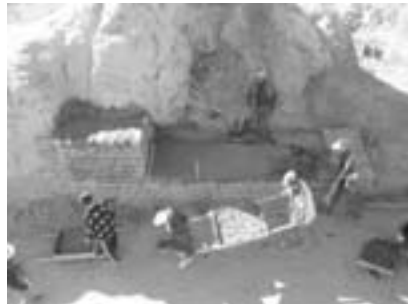
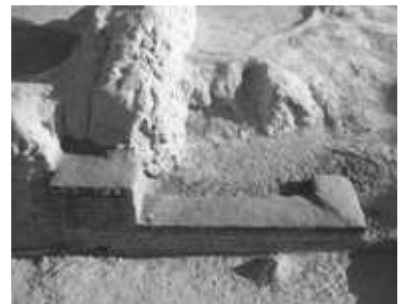
*Restoration and partial restitution of the south western wall of the main gate, heavily affected by erosion. The new masonry will avoid further degradation of the original wall by channelling the water flows away from it*

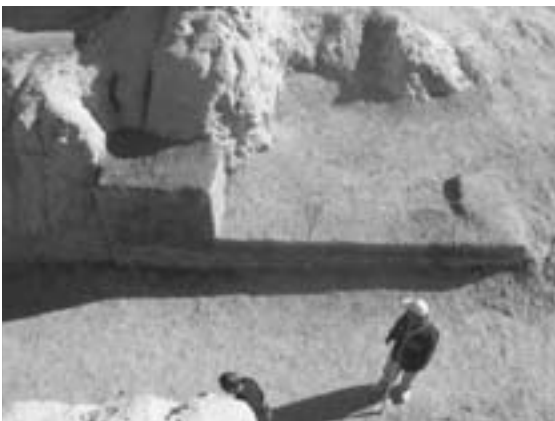
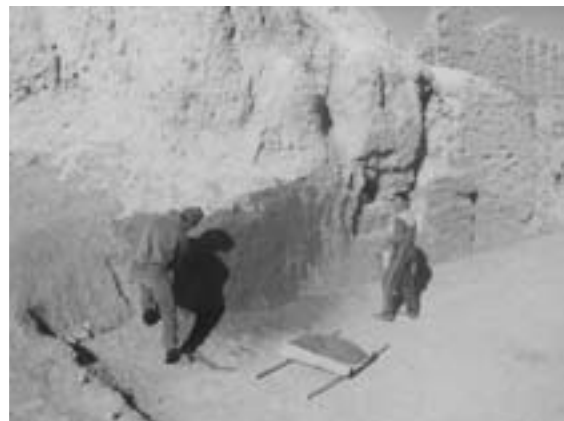
*Protective plastering of the walls on both sides of the main gate*

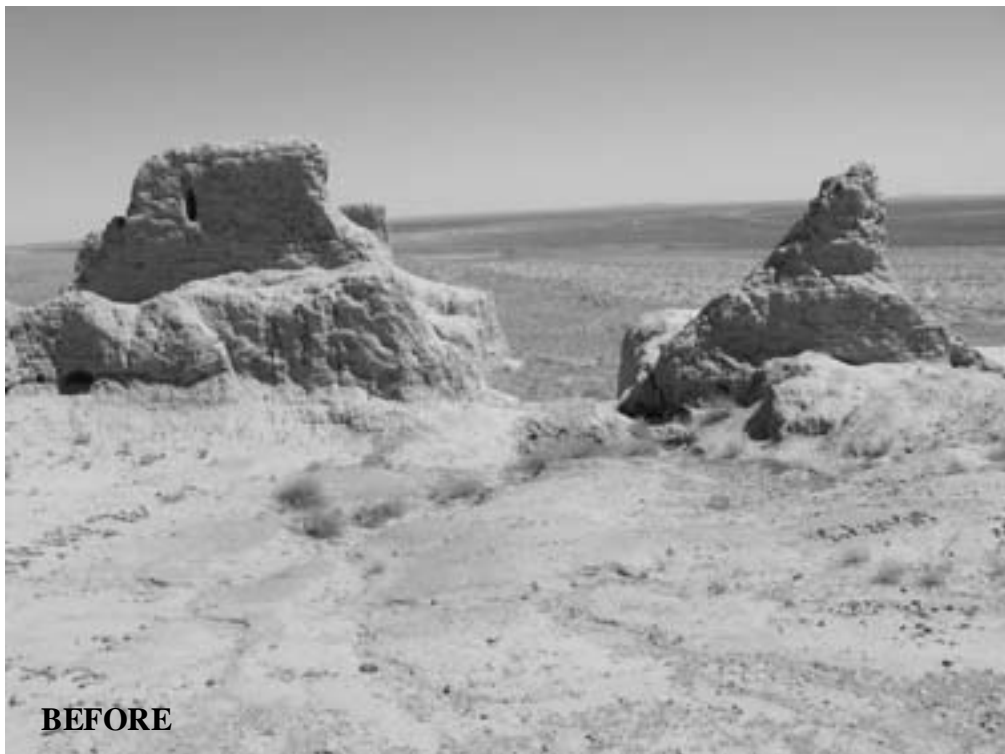
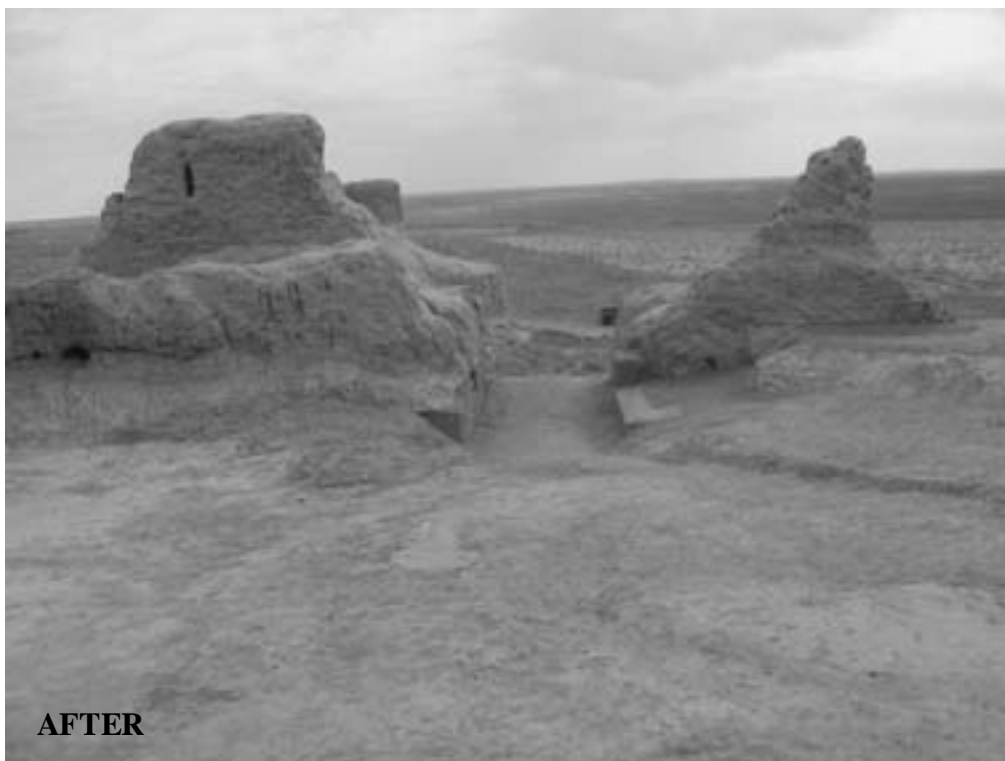
*Views of the gateway at Ayaz Kala 1,  
Before / after archaeological cleaning and preventive conservation interventions*

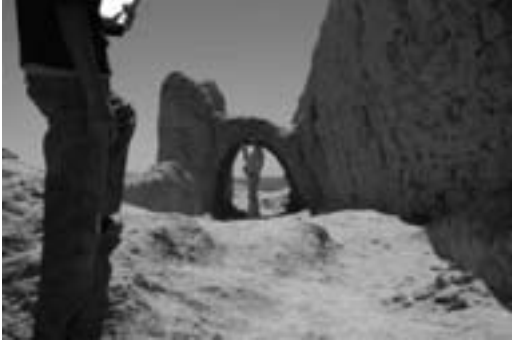
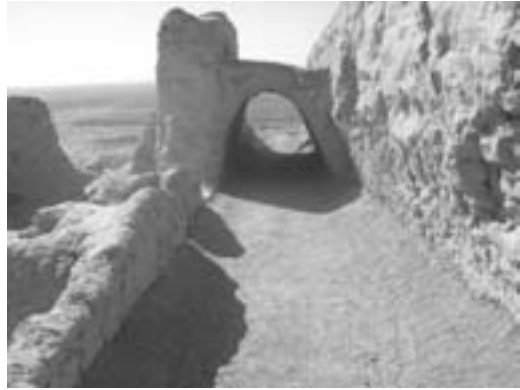
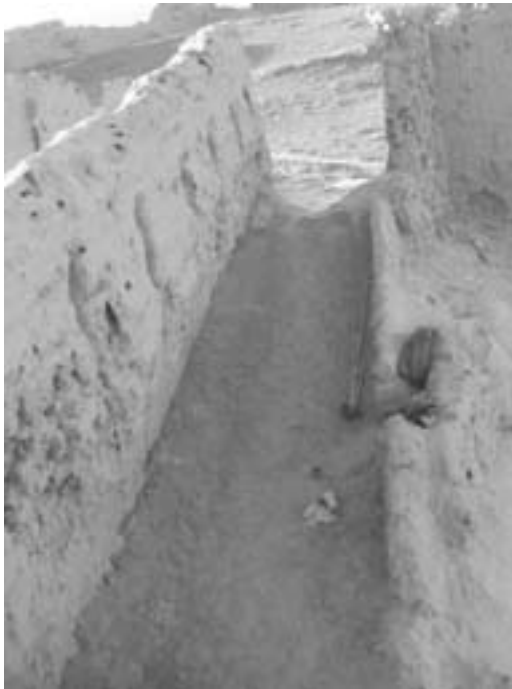
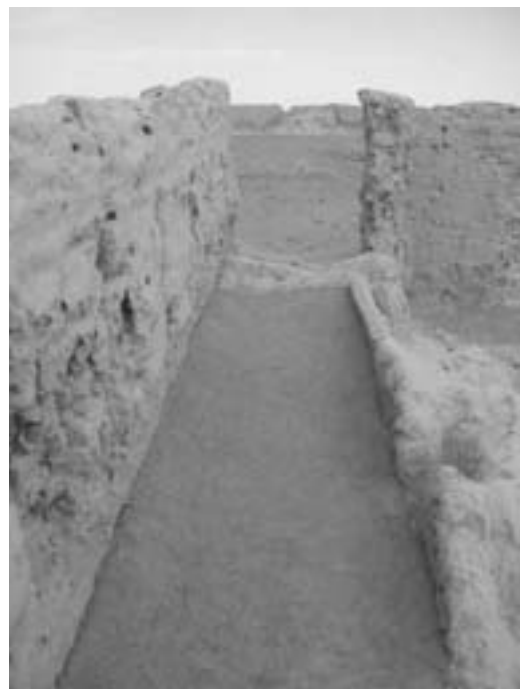
The majority of the vaulted corridors which surround Ayaz Kala have collapsed, but some remain and they must be conserved in priority as they are the last visible evidences of this particular system. The work accomplished on the vault situated on the western side of the main gate consisted on repairing part of it (filling the void which was the starting point of punctual erosion) and to ensure a proper drainage on top of it.

*Drainage of the corridor*
