# TOWARDS RESILIENT NON-ENGINEERED CONSTRUCTION

GUIDE FOR  
RISK-INFORMED POLICY MAKING

Published by the United Nations Educational, Scientific and Cultural Organization (UNESCO),  
7, place de Fontenoy, 75352 Paris 07 SP, France,

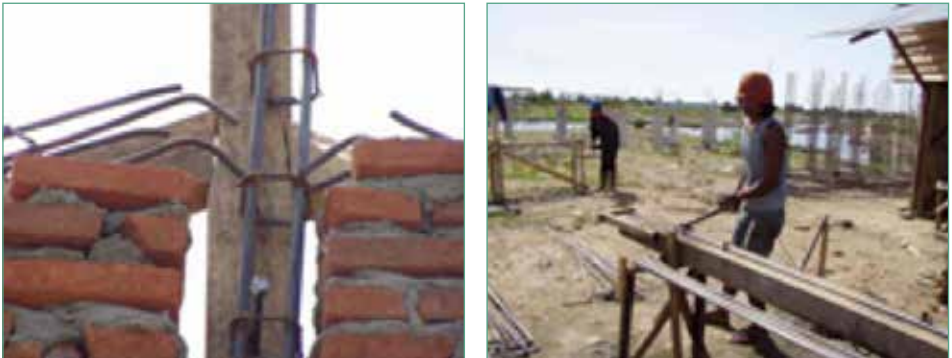
Figure 1.1.5 Inadequate detailing of rebar connections (left), and bending of rebar on site with simple tools (right), in Banda Aceh, Indonesia

equipment and machines, and the supply of well-designed components. For example, the bending of rebar is one of the most crucial issues in the construction of reinforced concrete members (columns, beams, etc.), and we often find inadequate detailing at the connections of beams and columns on construction sites (Figure 1.1.5). This is not only because of the poor workmanship of the workers, but also because of detailing of the overlapping of rebar, as required by the drawing, (Figure 1.1.6) cannot be accomplished with the simple tools available on the site (Figure 1.1.5). Easier detailing and construction methods, or more effective tools and facilities are typical improvements that approach would favor.

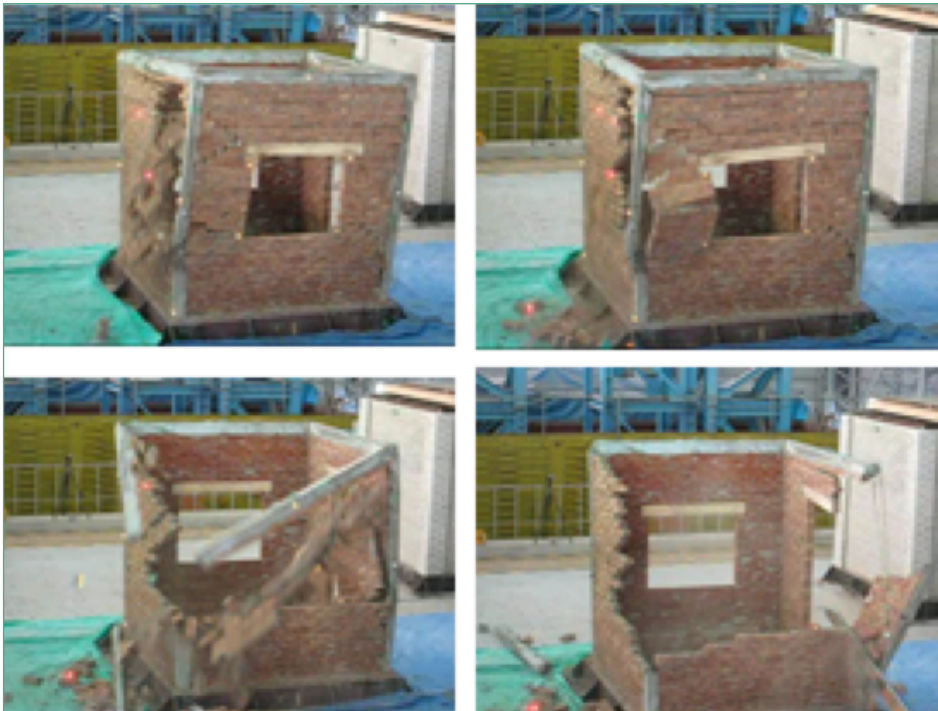
**Figure 1.1.11** Shaking table experiment with a confined masonry structure which is popular in Indonesia, July 2008, at the National Research Institute for Earth Science and Disaster Reduction (NIED) in Tsukuba, Japan, organized by NIED and Mie University, in cooperation with BRI

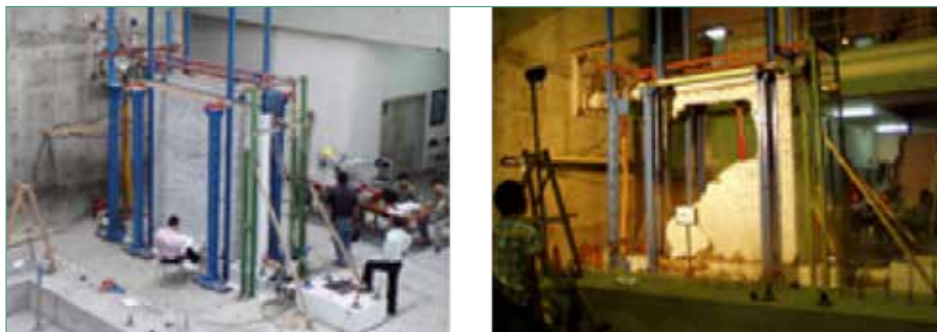
**Figure 1.1.12** Cyclic loading experiments of confined masonry walls (9 specimens), February and March 2009, at the Research Institute for Human Settlements, Department of Public Works (RIHS/DPU), Bandung, Indonesia, organized by Bandung Institute of Technology (ITB) and BRI. Setting up of specimen- and measurement equipment (left), and final stage of cyclic loading (right)

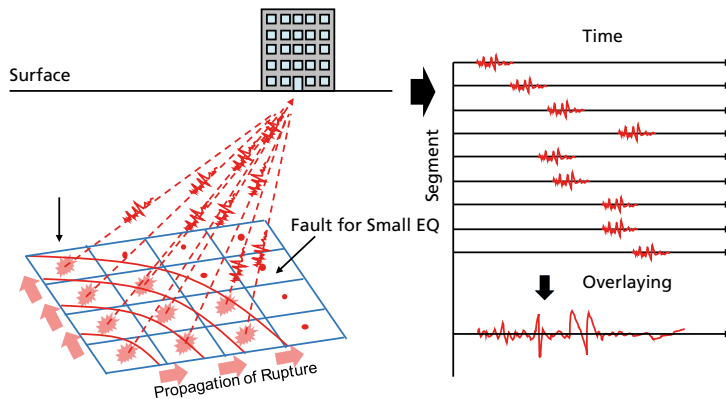
Figure. 2.1.10 Concept of the semi-empirical method

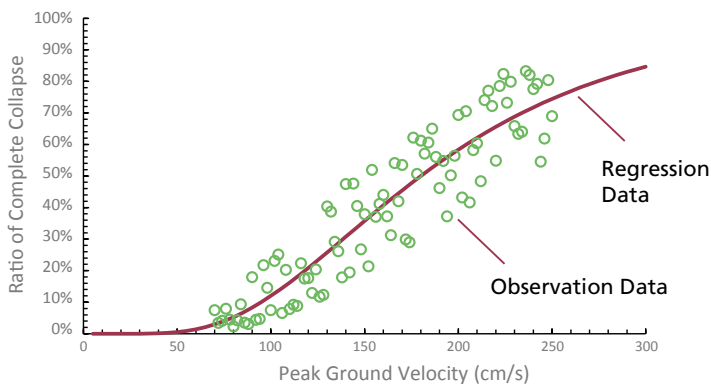
Figure. 2.1.11 Examples of vulnerability functions

It must be noted that the vulnerability function by the empirical method is earthquake dependent. Therefore, it is important to use ground motion intensity that is insensitive to seismic-source type, such as inter-plate earthquakes, intra-plate earthquakes and crustal earthquakes.

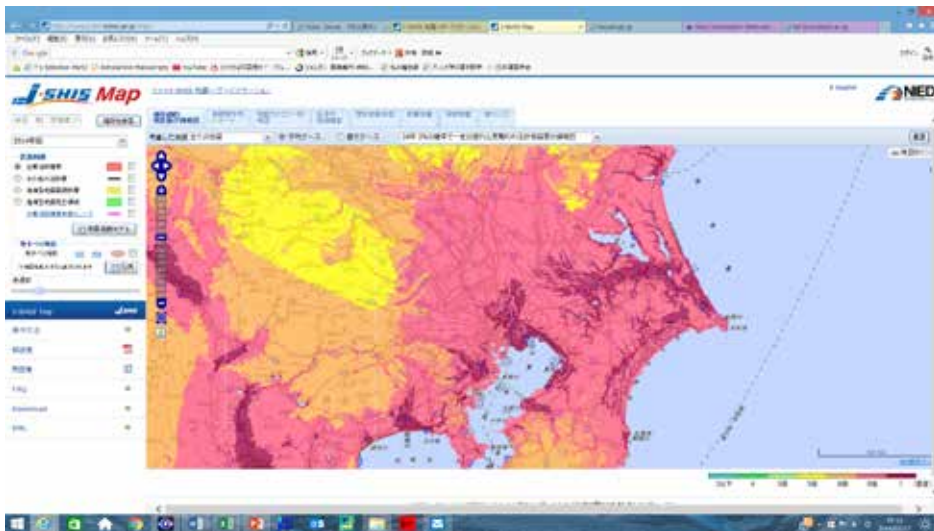
Figure. 2.1.13 Example of seismic hazard map by NIED  
(National Research Institute for Earthquake and Disaster Prevention, Japan)

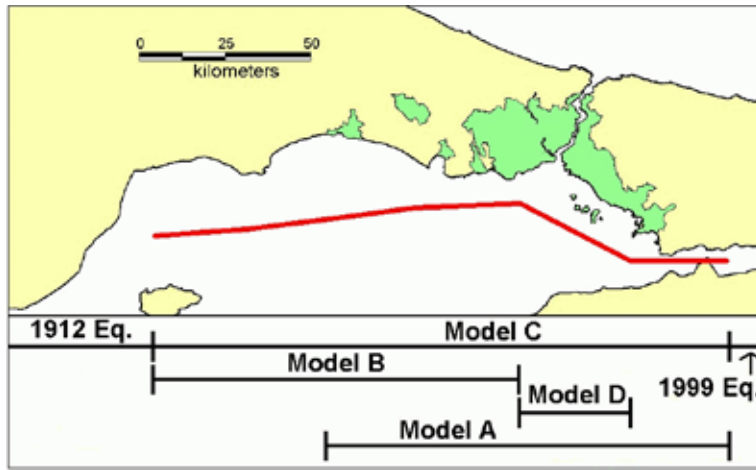
Figure. 2.2.2 Fault Models of Scenario Earthquakes

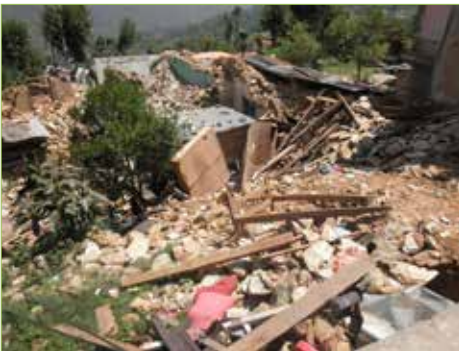
**Figure 3.1.3. Damages of houses (Sindhupalchowk Districts)**

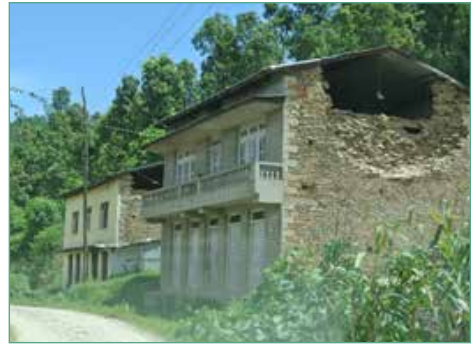
**Figure 3.1.5. Out-of-plane failure in masonry walls**

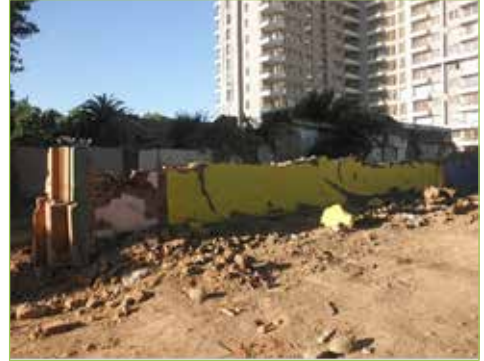
**Figure 3.1.10. Damaged adobe construction located next to undamaged high-rise building in Talca**

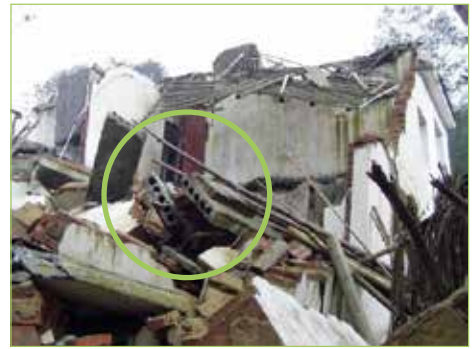
**Figure 3.1.15. The same building as in Figure 3.1.14. (Hollow core slabs were observed)**

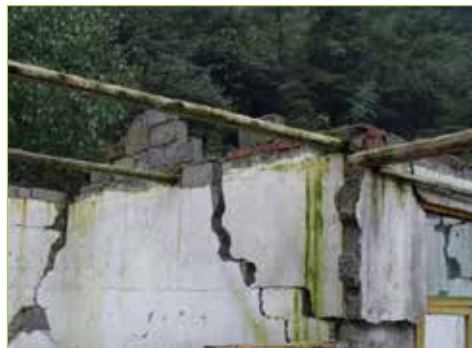
**Figure 3.1.17. Damaged concrete block house**

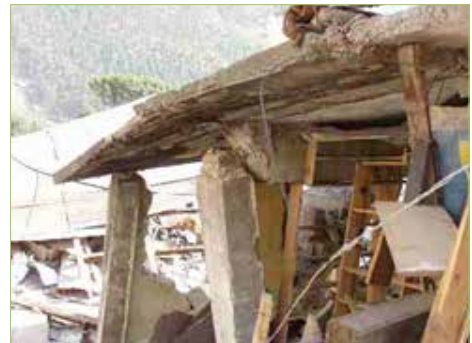
Figure 3.1.21. Connection failure

The quality of materials and labor work were often found poor. Also it was often found that concrete with honeycomb and steel bars had been deeply eaten up with rust.

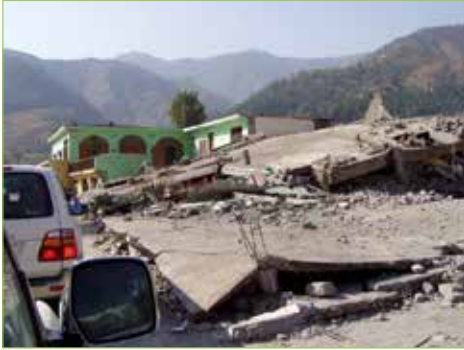
Figure 3.2.3. Collapsed buildings by the Northern Pakistan

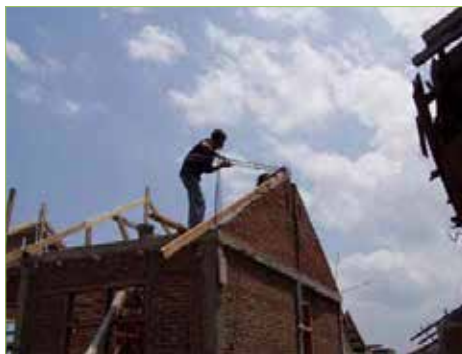
Figure 3.2.8. Placing the assembled rebar of a roof beam fabricated on ground

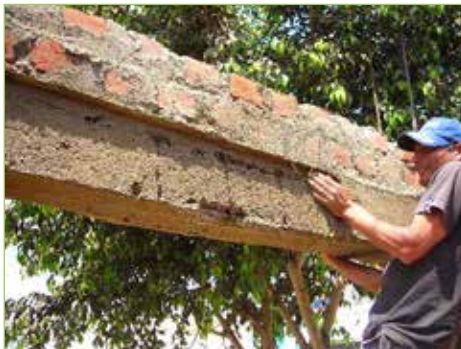
Figure 3.2.14. Honey comb in beam Some of rebar is exposed to air observed

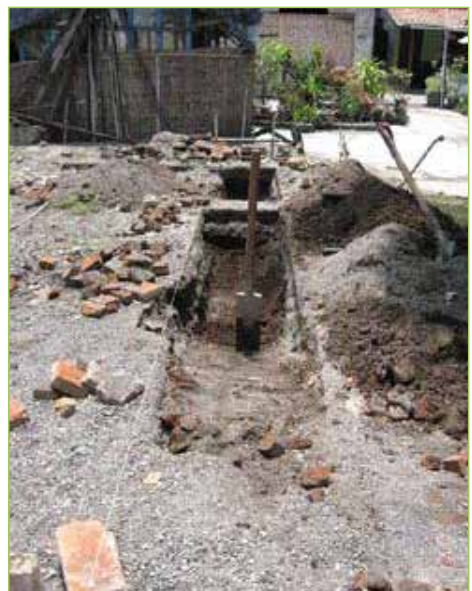
**Figure 3.2.16. Excavation works for foundation**

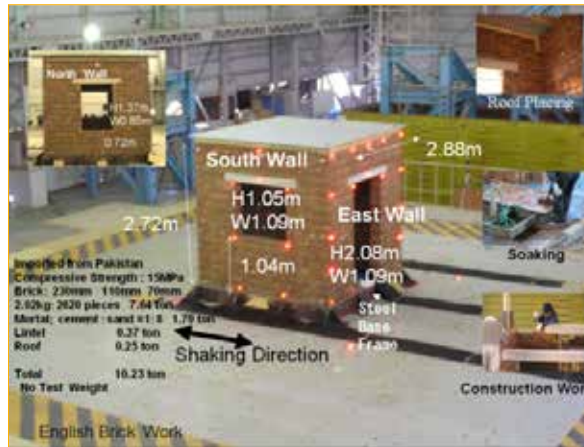
Figure 4.1.2. Shaking table and model structure

Openings are located in the east, north and south walls, but not in the west wall. The bricks of walls were laid in English bond brickwork 230mm thick. Bricks with dimensions of 230 mm x 110 mm x 70 mm weighing 2.92 kg were imported from Pakistan. The bricks were soaked in water before laying. The mixture ratio

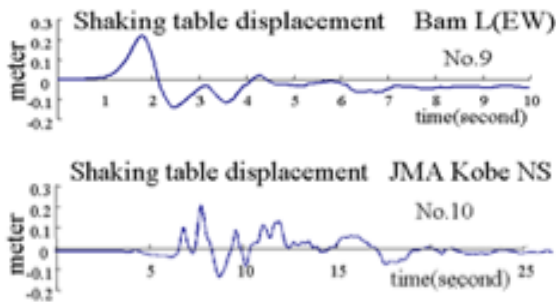
Figure 4.1.3. Time-reduced Bam L(EW) wave and JIMA Kobe NS wave (response wave)

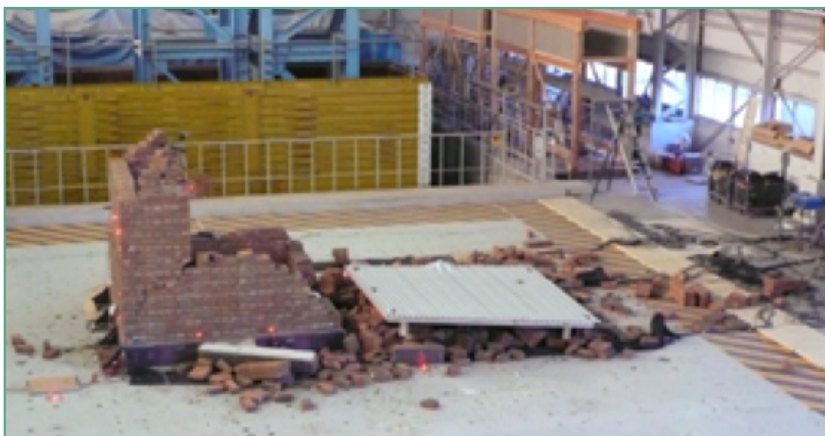
Figure 4.1.5. Model structure after shaking

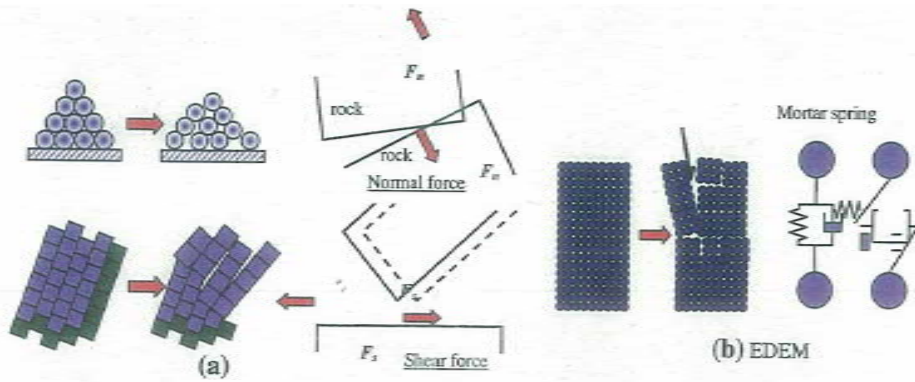
Figure 4.1.6. Illustration of DEM and Extended DEM

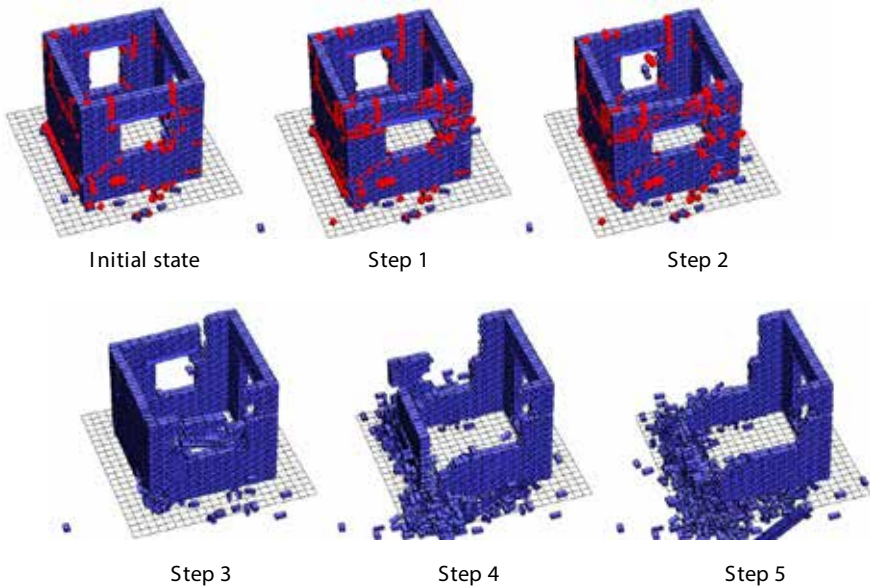
Figure 4.1.8. Simulated process of collapse by the Bam earthquake wave (No. 9)

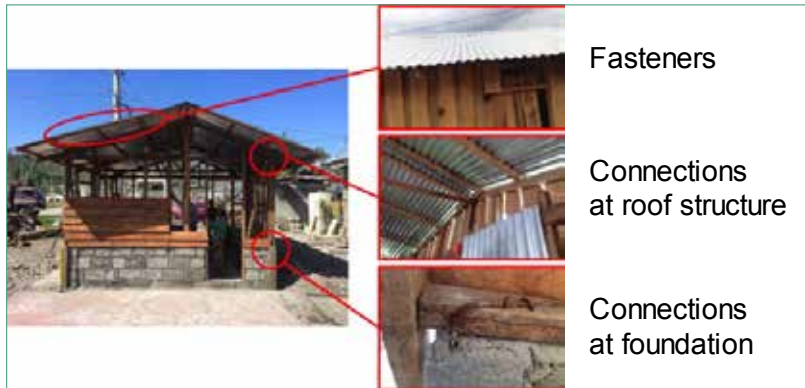
Figure 1. A non-engineered construction (left) and identified weak points by field survey (right).

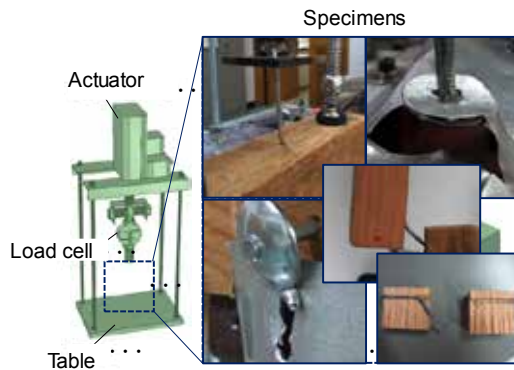
The photos in Figure 2 shows material test set-up as well as typical failure modes of the connections.

Figure 2. Material test set-up and typical failure modes of the connections

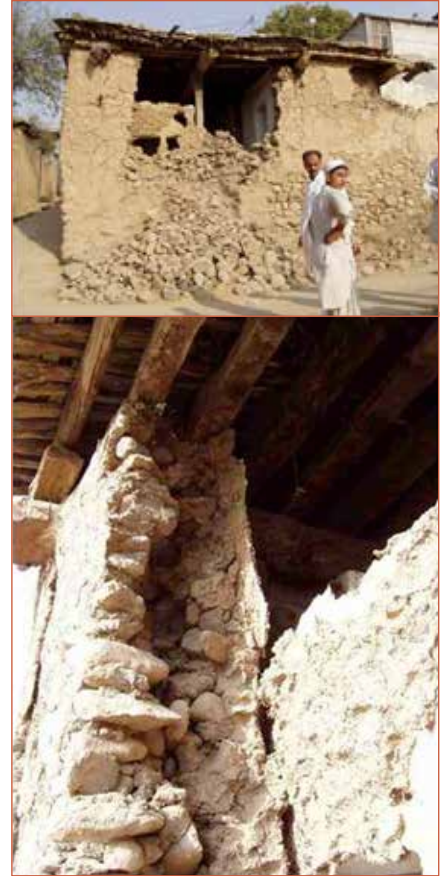
Figure 5.2.3 Typical damage to houses of undressed stone masonry with mud mortar, as shown in the Guideline (2005 Northern Pakistan Earthquake (Kashmir Earthquake)) Much typical damage to various types of structures are addressed

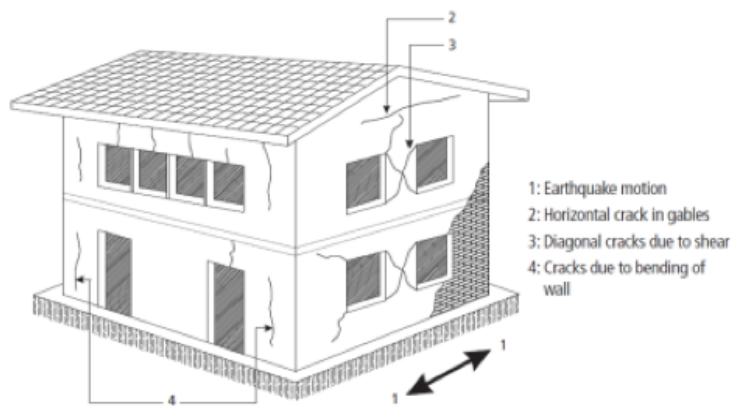
Figure 5.2.5 An illustration showing several types of damage in masonry buildings

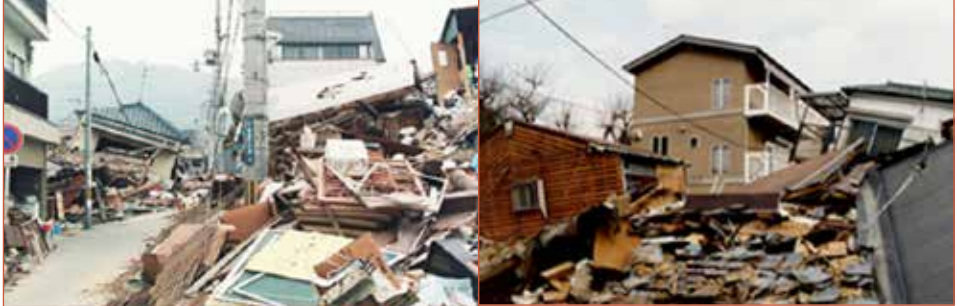
Figure 5.4.3 Many wooden houses collapsed in the Kobe Earthquake 1995 (left), but new houses, following the revised code in 1981, suffered little damage, even in otherwise heavily damaged areas (right)

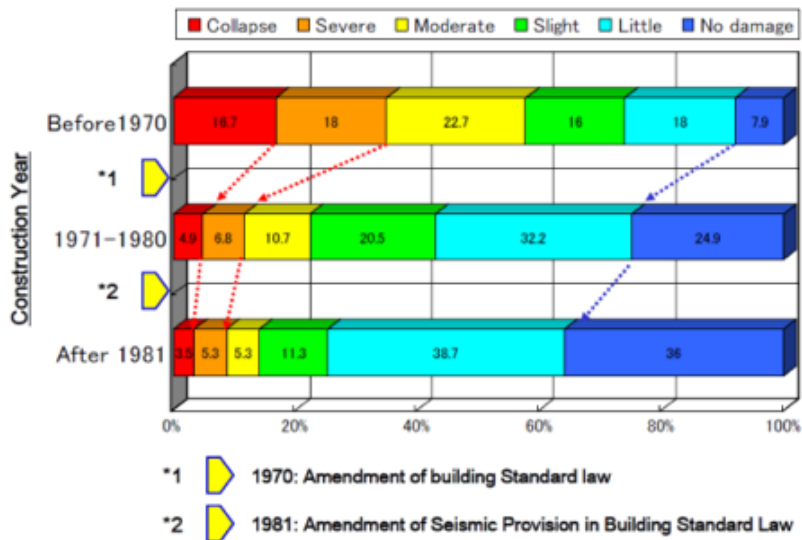
Figure 5.4.4 Break down of collapsed buildings by Kobe Earthquake in years of construction

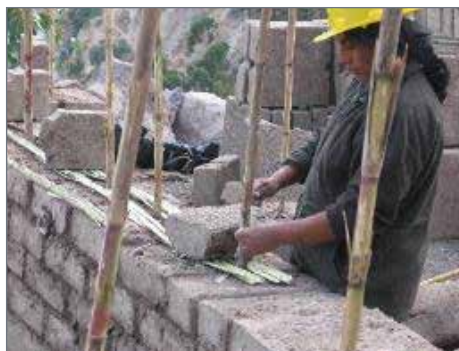
Fig. A.2.4 Installation of horizontal reinforcement from crushed cane

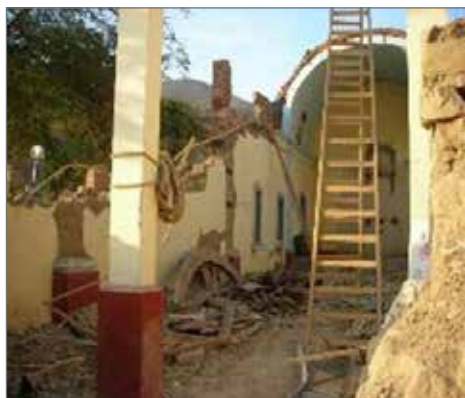
Figure A.2.5 Heavily damaged church (Adobe wall, vaulted roof made from quincha), Zuniga, Lima state

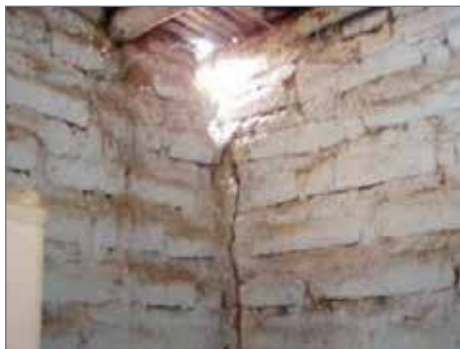
Figure A.2.10 maged Heavy cracks in House B

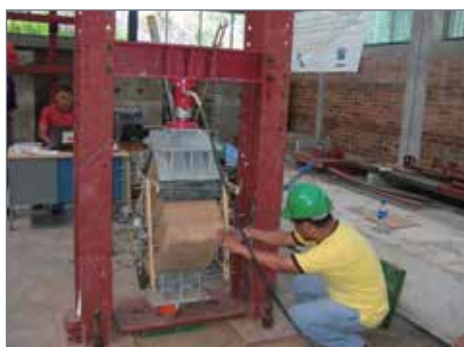
A.2.14 Seismic capacity experiment of a commonly used brick
