Wise practices for coping with

BEACH EROSION

Montserrat

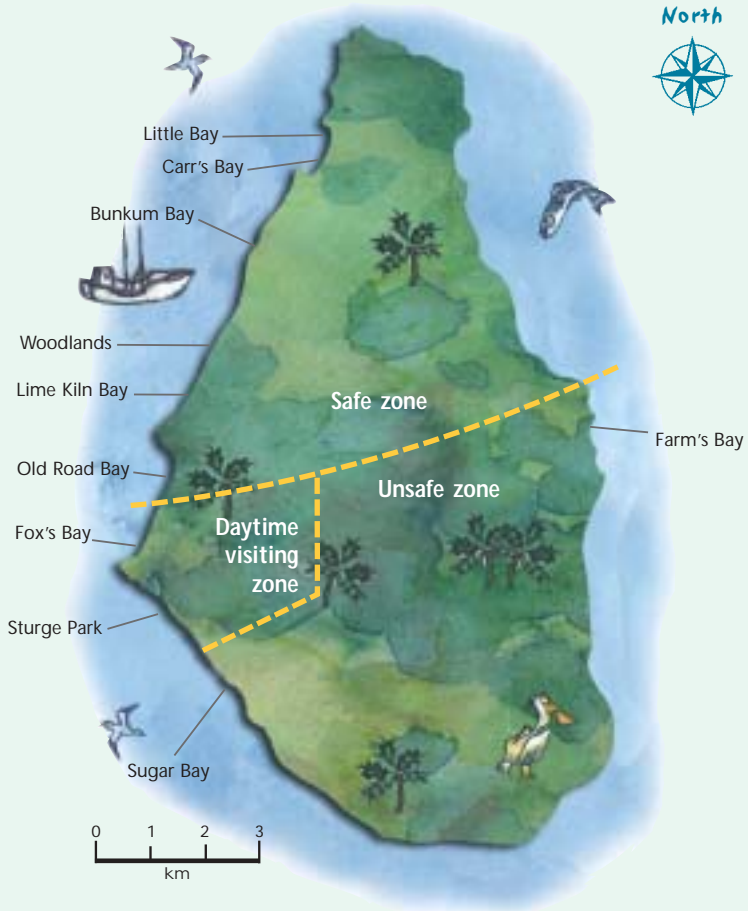
Location of
monitored
beaches
in Montserrat

In order to manage these changes, Montserrat's beaches have been monitored since 1990 by the Ministry of Agriculture, Land, Housing and the Environment, and more recently by the Fisheries Division. They measure the beach slope and width every three months at several sites around the islands. During the volcanic emergency, 1995-1998, monitoring was interrupted, but recommenced in 1999.

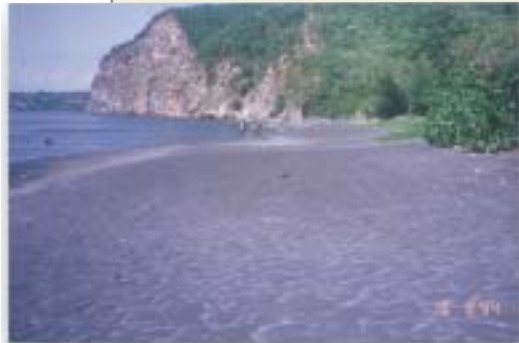
Fox's Bay, 1994,
before Hurricane Luis

When Hurricane Luis struck in 1995, much of the beach was lost at Fox's Bay on the west coast and at other beaches. In the months and years after the hurricane, the beaches recovered to some extent, but were further impacted by Hurricane Georges in 1998, and Hurricane Lenny in 1999.

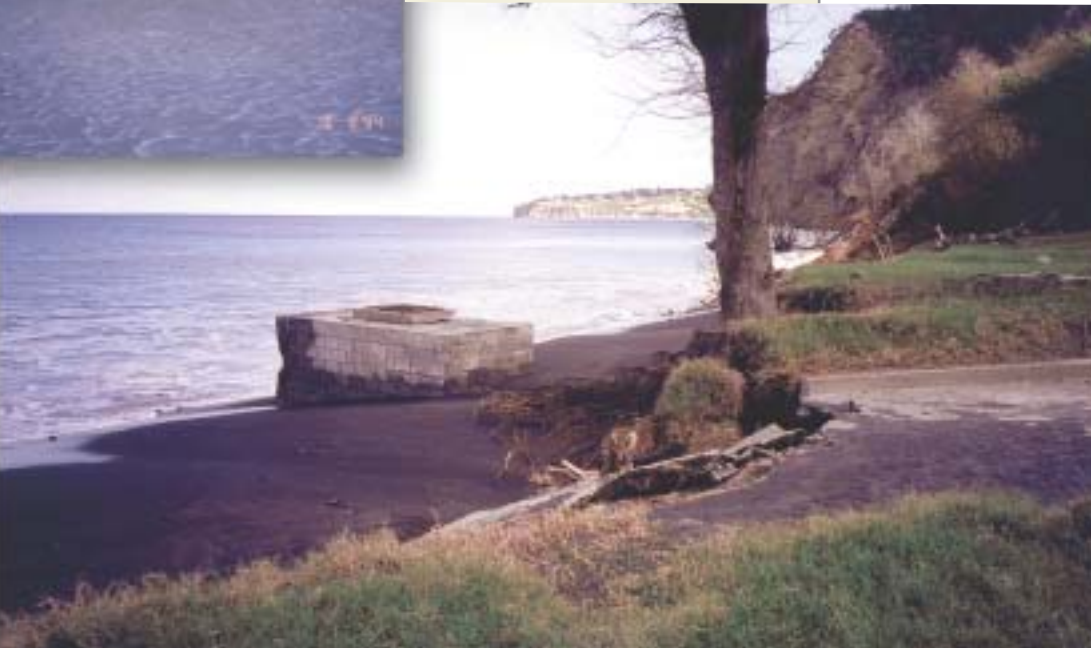
Fox's Bay, 1999,
after the impact of
Hurricanes Luis, 1995,
Georges, 1998,
and Lenny, 1999

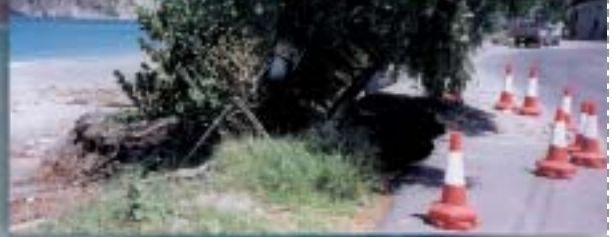
Road damage at Carr's Bay after Hurricane Georges, 1998

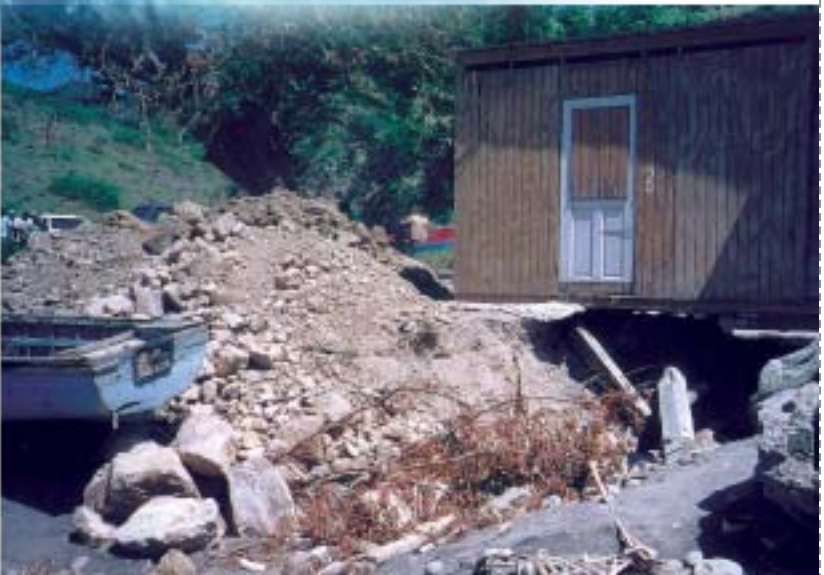
The foundations of this house at Carr's Bay were washed out during Hurricane Georges, 1998

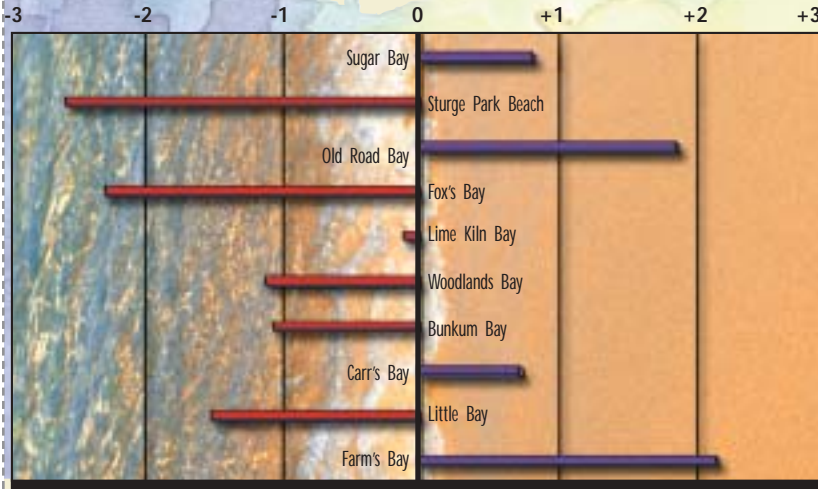
Beach change rates in Montserrat (metres per year)

A negative rate of change (—) indicates erosion and retreat of the shoreline, a positive rate of change (—) indicates accretion or advancement of the shoreline towards the sea.

The table shows generalized rates of change at the measured beaches in Montserrat between 1990 and 1996. During this period most of the beaches showed erosion, a result, at least in part, of the impact of several severe hurricanes. However, most beaches in Montserrat show erosion along one part of the beach and accretion (or build-up) at adjacent sections, thus these figures must be treated as average trends.

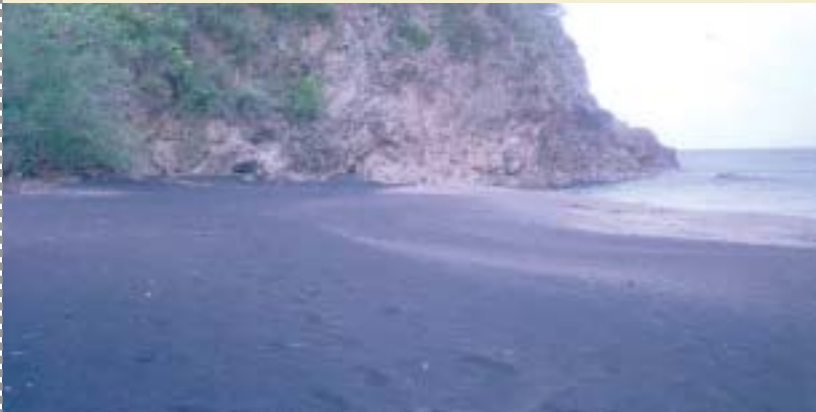
(top) Measuring the sand loss at Bunkum Bay in 1990 after Hurricane Hugo

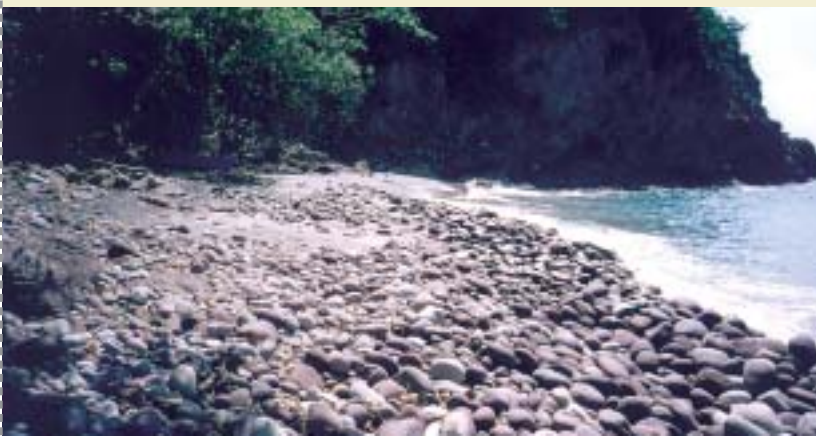
Many of Montserrat's west coast beaches are sandy in the summer months but covered with stones in the winter months, as seen here at Bunkum Bay, 1995

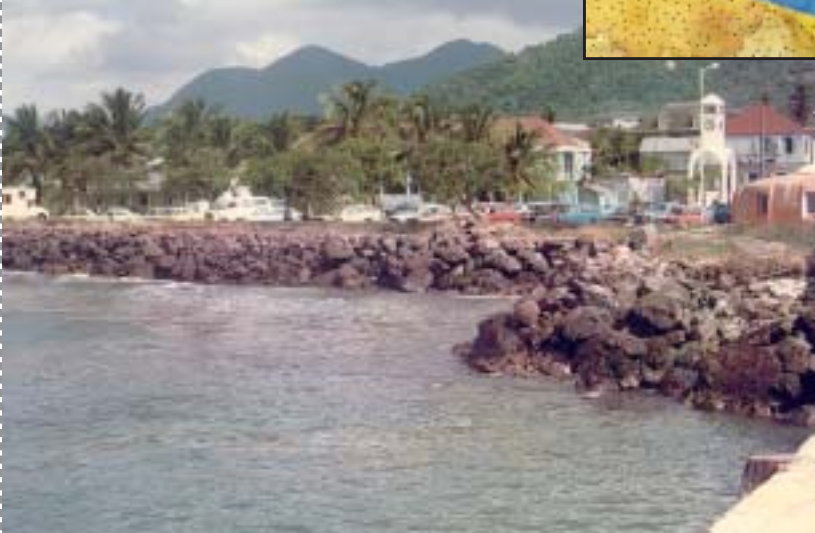
(below) Groynes, such as seen here at Sugar Bay in 1989, result in sand build-up on one side, but erosion on the other side
