# Satellite-Based Damage Assessment of Cultural Heritage Sites

2015 Summary Report of  
Iraq, Nepal, Syria & Yemen

June 2016

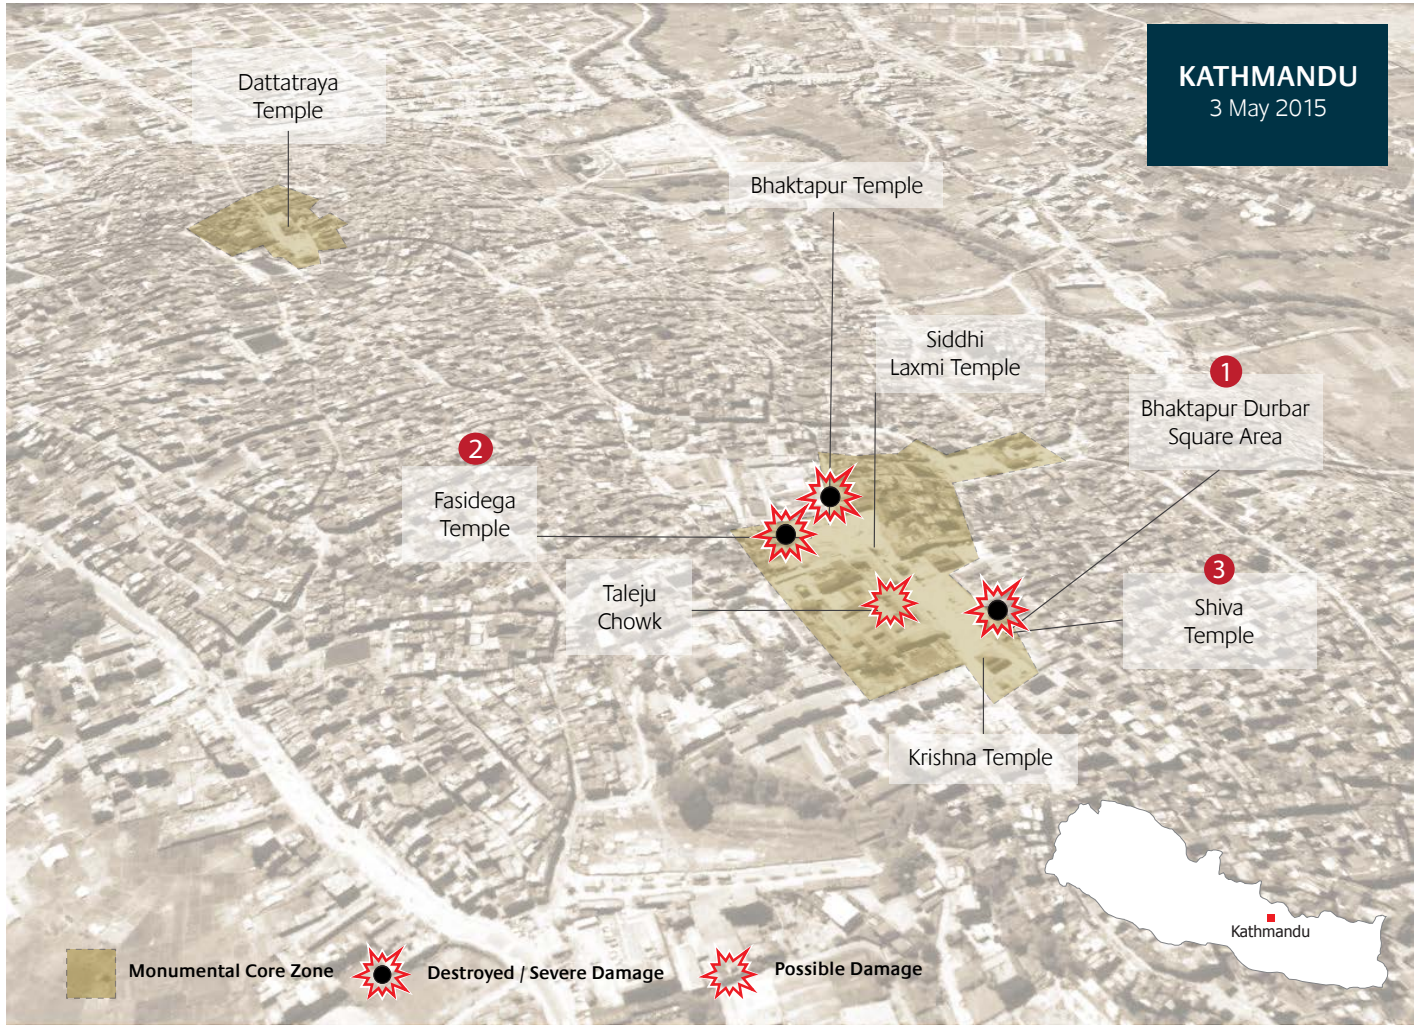
Boudhanath was the only monument zone which did not suffer visible damage that could be observed in satellite imagery. Regarding the other six monumental zones, a total of 175 structures (monuments and buildings) located in the core and buffer zones were affected: 43 structures have been destroyed, 53 structures show severe damage and 79 have been moderately damaged. Satellite image analysis of Bhaktapur Durbar Square Monumental Zone from 3 May 2015 shows severe damage to Fasidega Temple and Vatsala Durga Temple and moderate damage to Taleju Chowk and Siddhi Lazmi Temple as seen in the UN-ASIGN\* pictures on page 8. Inside the perimeter of the monumental zone, a total of 45 structures were identified in satellite imagery as affected by the earthquake.

Source: Digital Globe WorldView 2 ©2016, 3 May 2015. Satellite imagery analysis by UNITAR-UNOSAT.

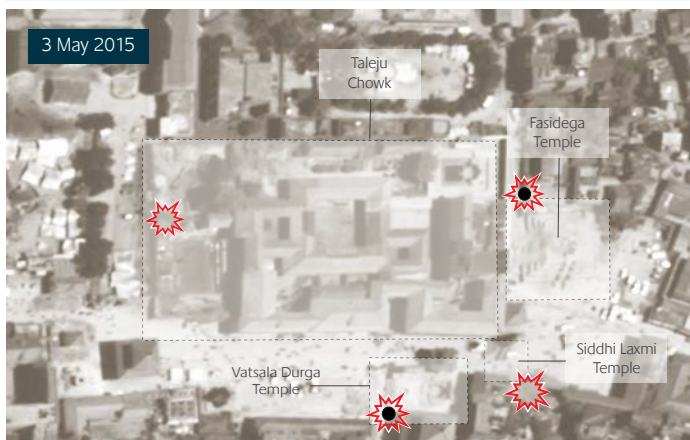
Bhaktapur Durbar Square Monument Zone shows severely damage to the Fasidega Temple and Vatsala Durga Temple and moderate damage to the Taleju Chowk and Siddhi Lazmi Temples. Inside the perimeter of the monument zone a total of 45 structures were affected by the earthquake.

Source: Digital Globe WorldView 2 ©2016, 3 May 2015. Satellite imagery analysis by UNITAR-UNOSAT.

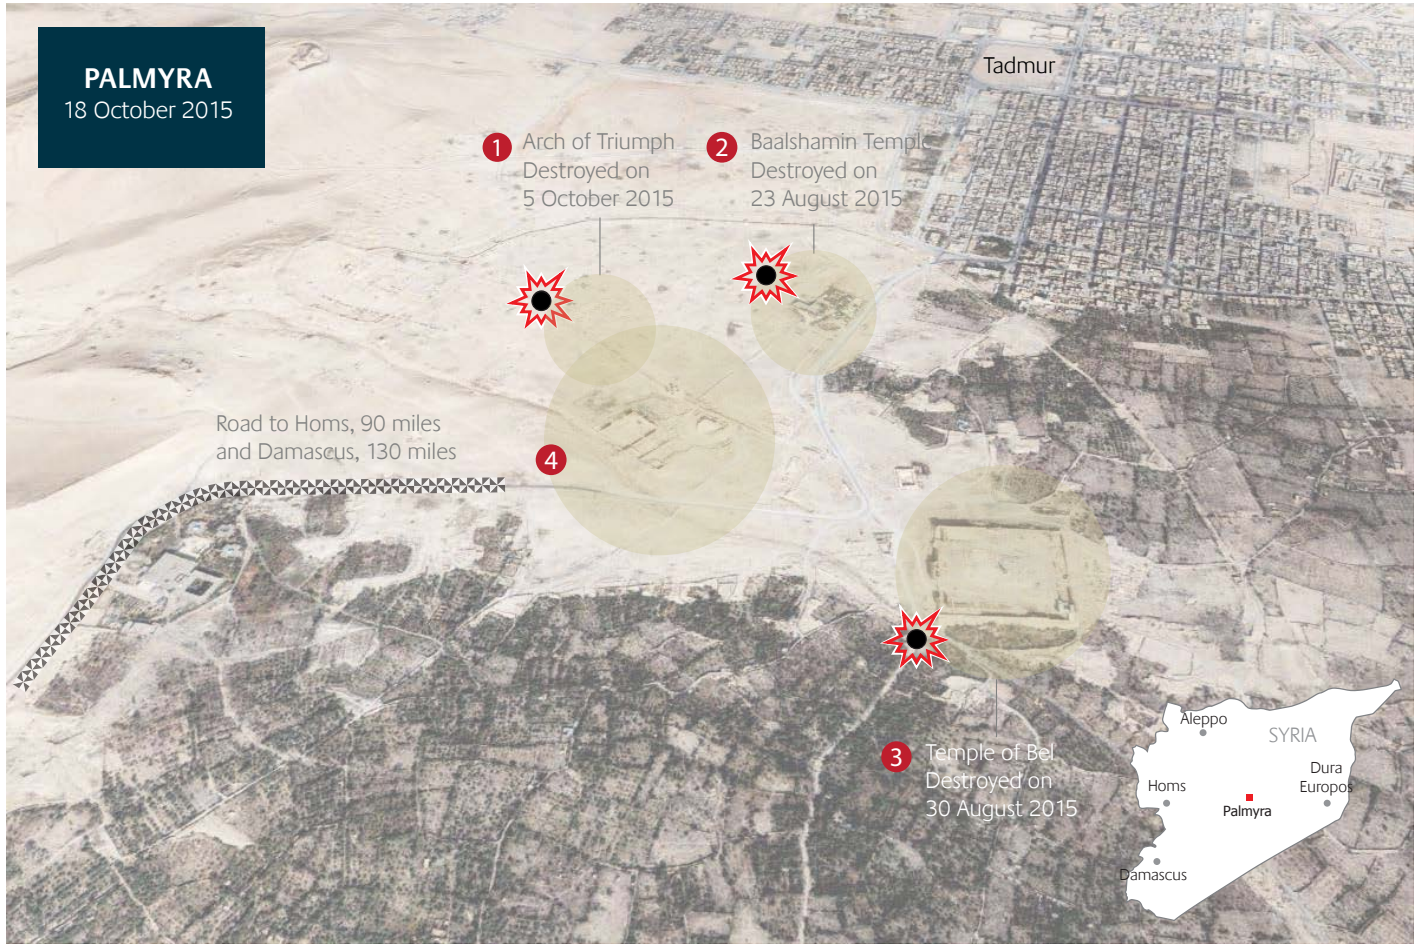
Damaged Locations in Palmyra - Between 23 August 2015 and 5 October 2015 (43 days) ISIL/Daesh destroyed a total of three Cultural Heritage Sites in Palmyra, Syria. (Source: Airbus Defense and Space Pléiades Imagery ©2016. Satellite imagery analysis by UNITAR-UNOSAT.)
