# Satellite-Based Damage Assessment of Cultural Heritage Sites

2015 Summary Report of  
Iraq, Nepal, Syria & Yemen

June 2016

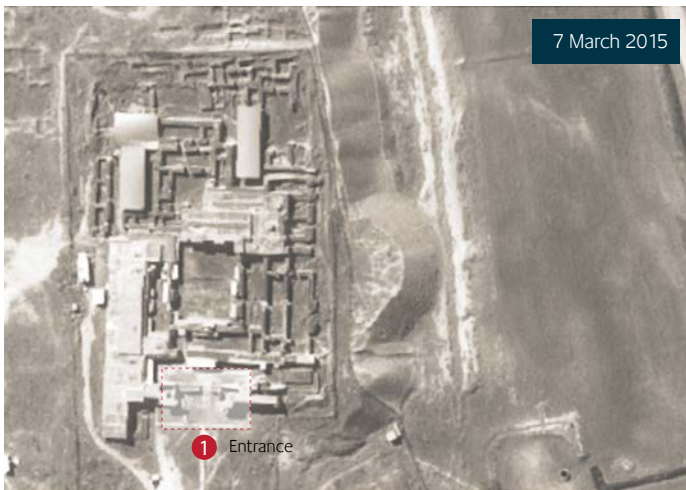
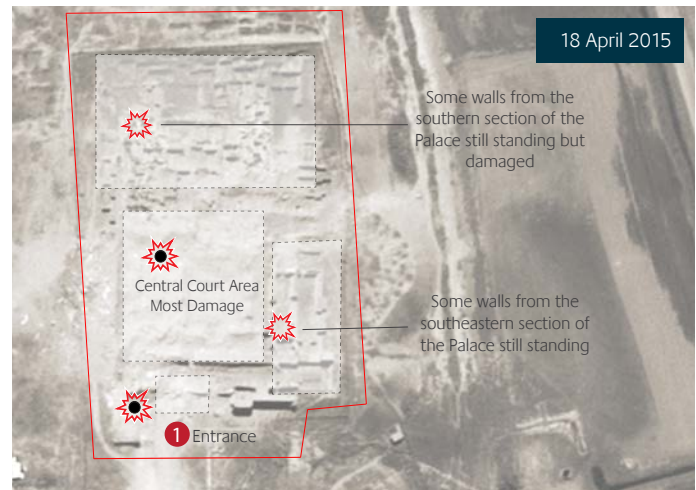
**PALACE OF ASHURNASIRPAL II** - UNOSAT confirmed the destruction and extent of the damage using satellite imagery from 18 April, 2015 compared to imagery collected on 7 March 2015 (see before and after images). The satellite derived damage assessment showed extensive damage over the Ashurnasirpal II Palace, inside the Nimrud Citadel. The main court area inside the palace and the surrounding building structures, including the entrance, appeared to be completely destroyed. Some of the surrounding corridors walls appeared to be intact, but most likely damaged. (Source: Before image (left) - Airbus Defense & Space Pléiades Imagery ©2016, 7 March 2015. After image (right) - Airbus Defense & Space Pléiades Imagery ©2016, 18 April 2015. Satellite imagery analysis by UNITAR-UNOSAT.)

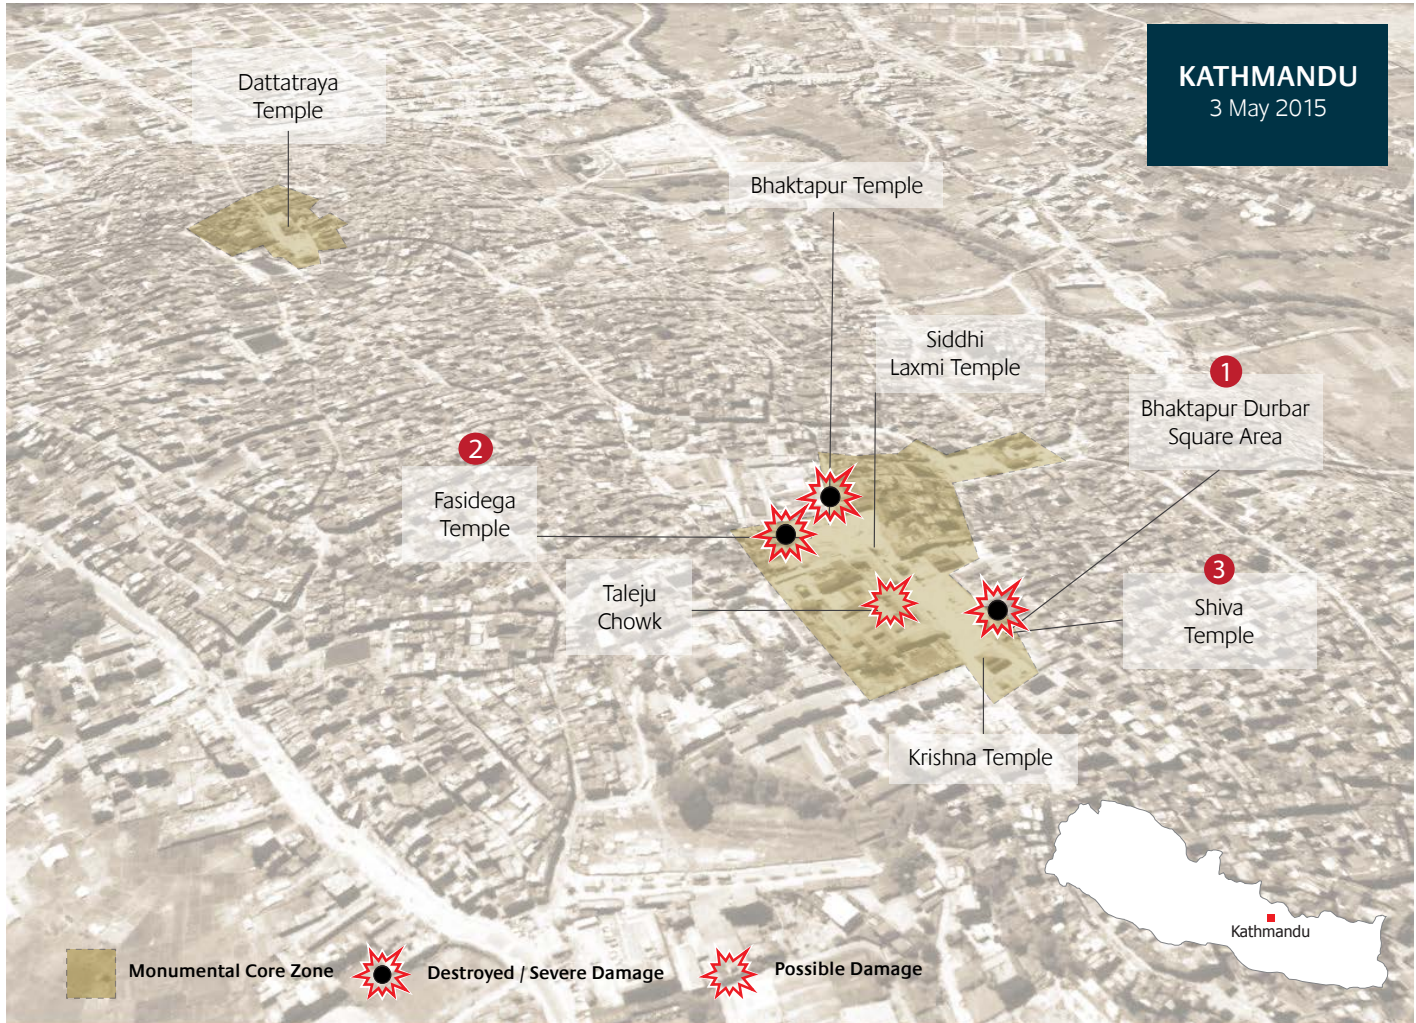
Source: Digital Globe WorldView 2 ©2016, 3 May 2015. Satellite imagery analysis by UNITAR-UNOSAT.

Boudhanath was the only monument zone which did not suffer visible damage that could be observed in satellite imagery. Regarding the other six monumental zones, a total of 175 structures (monuments and buildings) located in the core and buffer zones were affected: 43 structures have been destroyed, 53 structures show severe damage and 79 have been moderately damaged. Satellite image analysis of Bhaktapur Durbar Square Monumental Zone from 3 May 2015 shows severe damage to Fasidega Temple and Vatsala Durga Temple and moderate damage to Taleju Chowk and Siddhi Lazmi Temple as seen in the UN-ASIGN\* pictures on page 8. Inside the perimeter of the monumental zone, a total of 45 structures were identified in satellite imagery as affected by the earthquake.

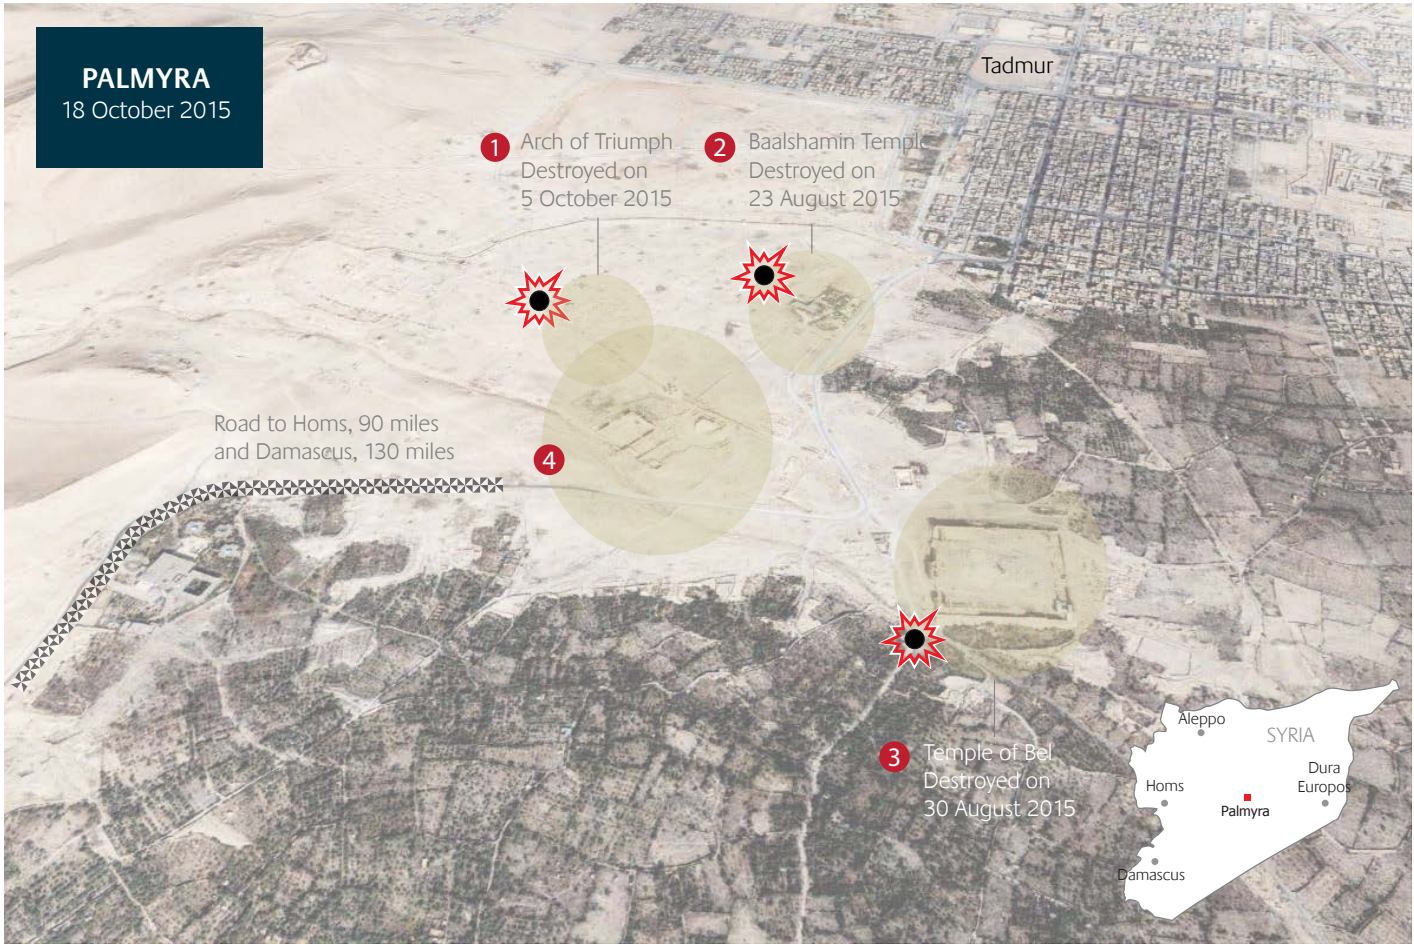
Damaged Locations in Palmyra - Between 23 August 2015 and 5 October 2015 (43 days) ISIL/Daesh destroyed a total of three Cultural Heritage Sites in Palmyra, Syria. (Source: Airbus Defense and Space Pléiades Imagery ©2016. Satellite imagery analysis by UNITAR-UNOSAT.)

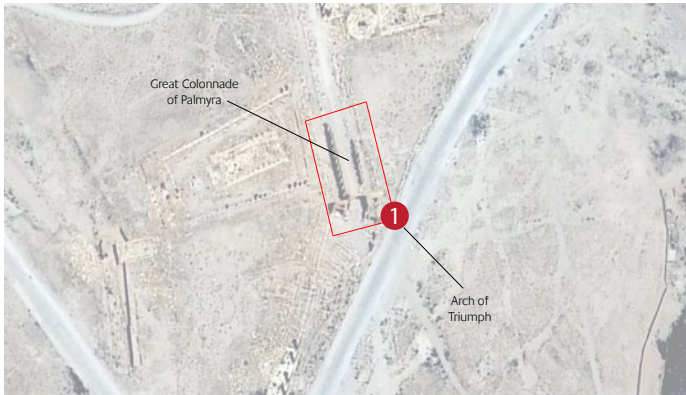
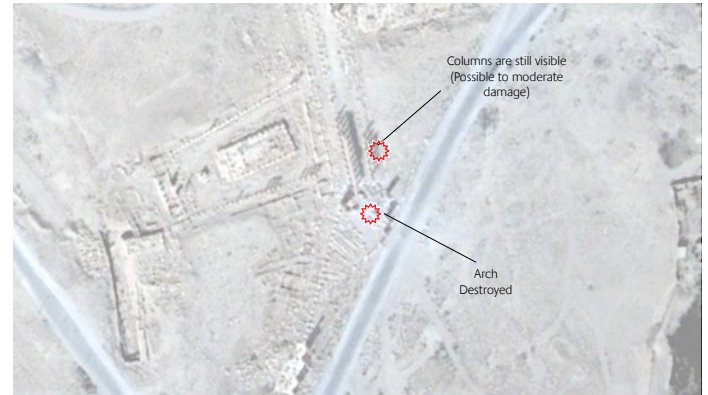
**Arch of Triumph** - The damage caused by the alleged explosive devices placed at the Arch of Triumph in Palmyra, Syria, destroyed the arch and most likely damaged many of the adjacent columns of the colonnade. (Source: Before image (left) - Airbus Defense & Space Pléiades Imagery ©2016, 26 June 2016. After imagery (right) - Airbus Defense & Space Pléiades Imagery ©2016, 18 October 2016. Satellite imagery analysis by UNITAR-UNOSAT.)

On 5 October 2015 ISIL/Daesh destroyed the Arch of Triumph at the entrance of the Great Colonnade of Palmyra. Using a satellite image collected on 18 October 2015 and comparing it to a 14 February 2014 satellite image, UNOSAT assessed the extent of the damage and reported the complete destruction of the Arch (see page 11).

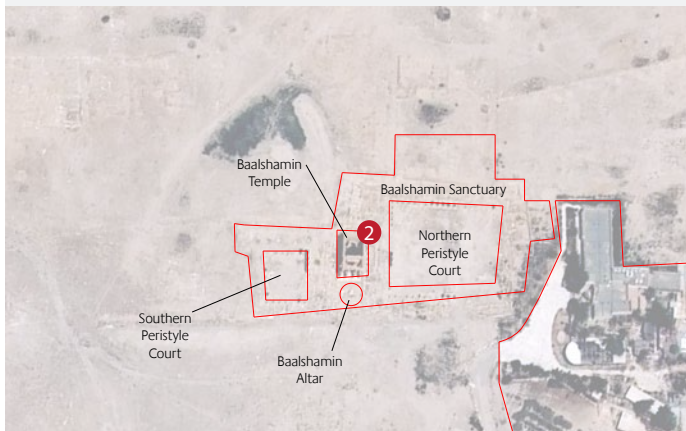
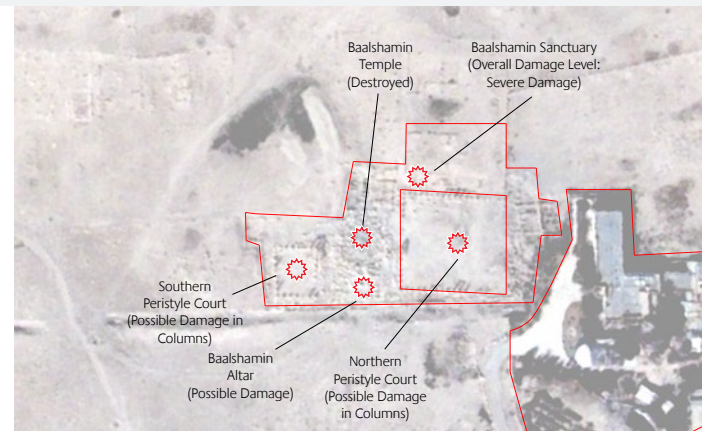
**Baalshamin Temple** - The damage caused by the detonation of a large quantity of explosives placed inside the Baalshamin Temple destroyed the temple and the Baalshamin Altar inside the sanctuary grounds. The expansive explosion possibly damaged all the other surrounding columns and structures that are within the sanctuary. (Source: Before image (left) - Airbus Defense & Space Pléiades Imagery ©2016, 26 June 2015. After image (right) - Airbus Defense & Space Pléiades Imagery ©2016, 18 October 2016. Satellite imagery analysis by UNITAR-UNOSAT.)

On 13 May 2015, ISIL/Daesh launched an attack on the modern town of Tadmur, sparking fears that the group would destroy some of the many heritage sites in the adjacent ancient site of Palmyra (see QR Code). On 23 August 2015 ISIL/Daesh militants reportedly detonated a large quantity of explosives inside the Baalshamin Temple. Using a 25 August 2015 satellite collected image compared to a 26 June 2015 satellite image, UNOSAT assessed the extent of the damage and reported the complete destruction of the temple, which is estimated to have occurred between the 25 and 27 August 2015 (see page 11).

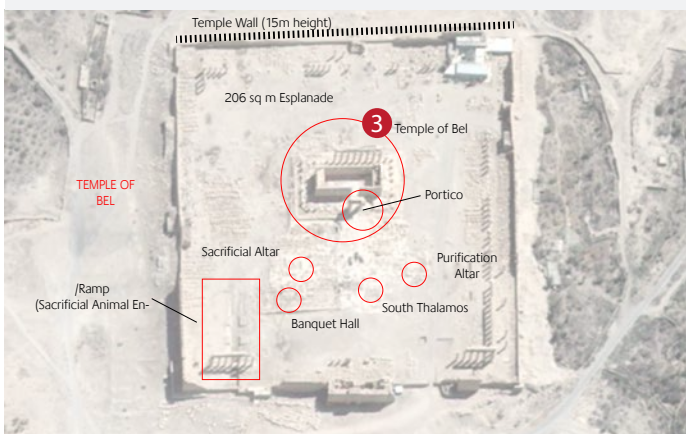
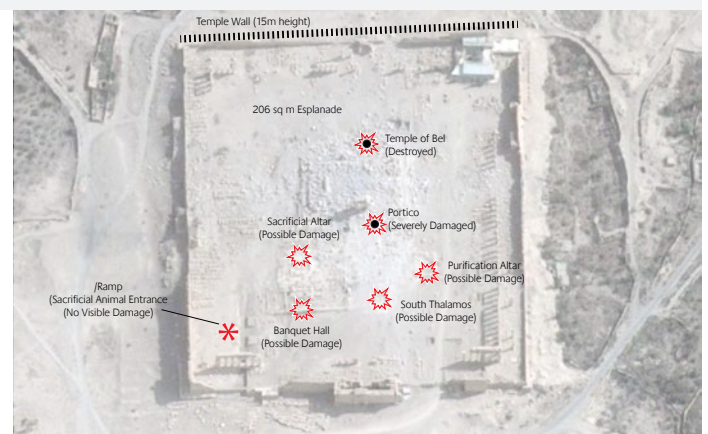
**Temple of Ba'al** - The damage caused by the alleged explosive devices placed inside the Temple of Ba'al in Palmyra, Syria, destroyed the Temple of Ba'al at the centre of the esplanade, severely damaged the portico and possibly damaged all the other surrounding structures that are within the temple walls. (Source: Before image (left) - Airbus Defense & Space Pléiades Imagery ©2016, 27 August 2015. After image (right) - Airbus Defense & Space Pléiades Imagery ©2016, 18 October 2016. Satellite imagery analysis by UNITAR-UNOSAT.)

Shortly after, on 30 August 2015, ISIL/Daesh reportedly destroyed the Temple of Ba'al. Using a satellite image collected on 31 August 2014 compared with a satellite image collected on 27 August 2015, UNOSAT confirmed the destruction of the main temple inside the temple grounds.

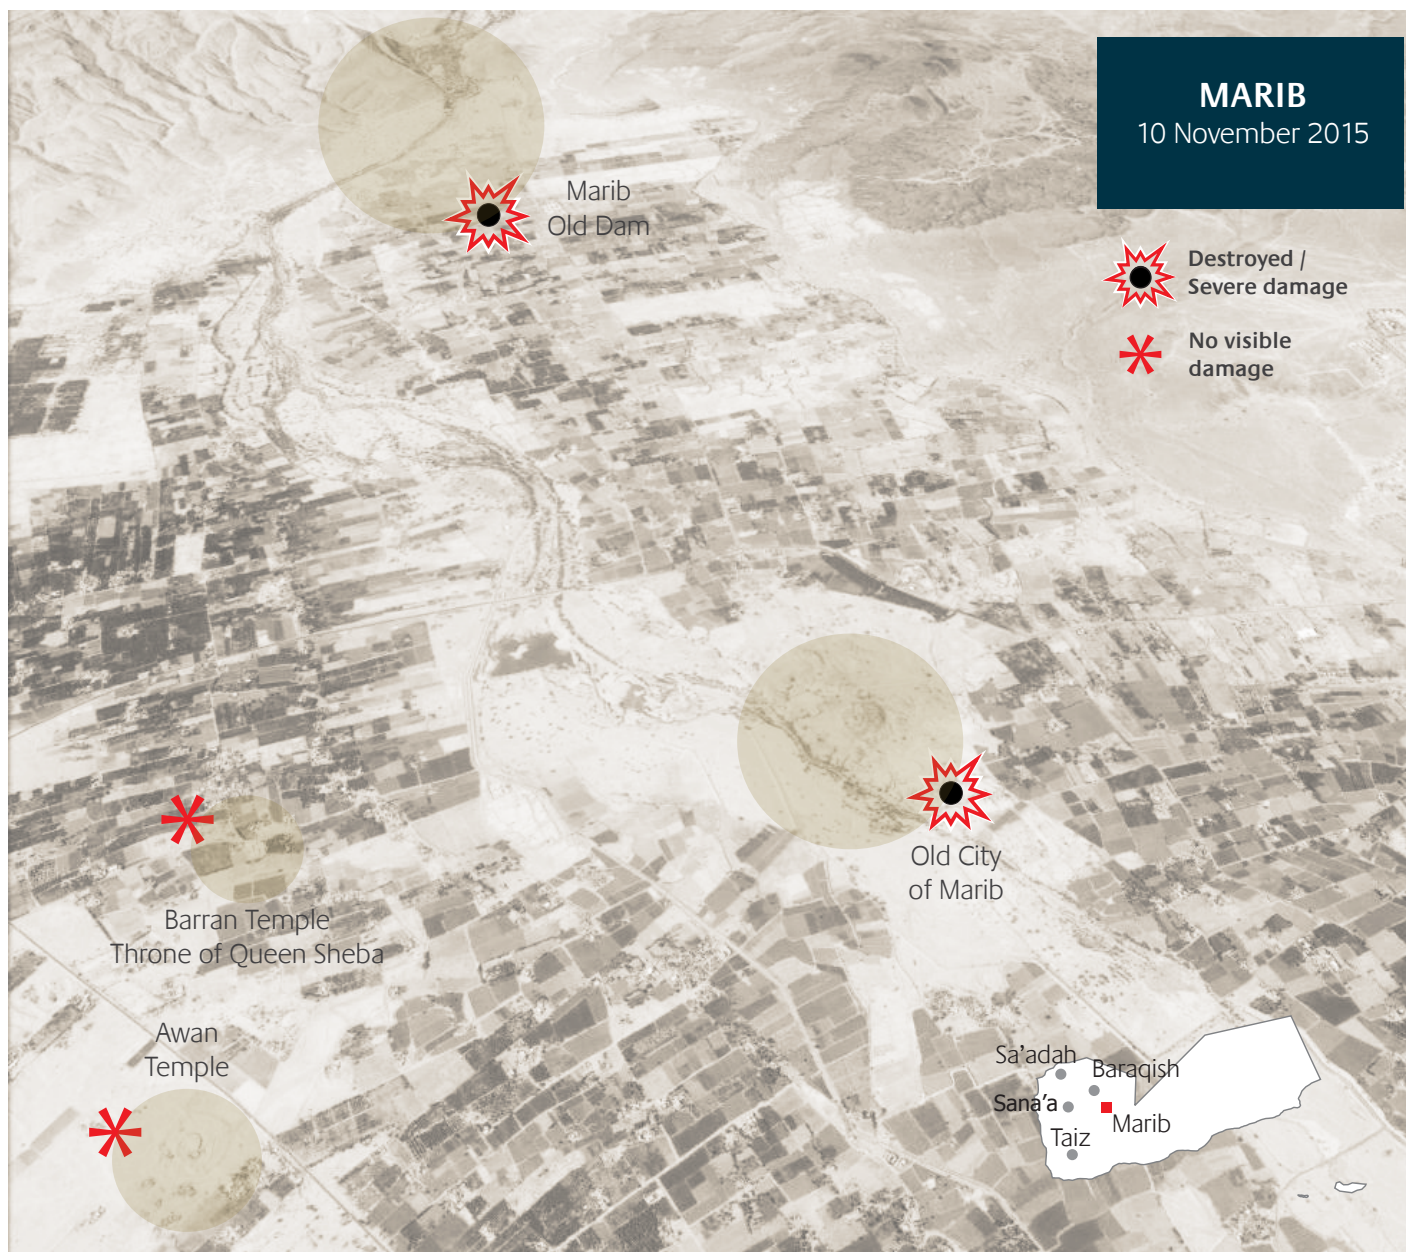
Source: Marib, Yemen, 10 November 2015. © US Department of State, Humanitarian Information Unit, NextView license. Satellite imagery analysis by UNITAR-UNOSAT.

With an expanse of 98 hectares, the Sabaean capital **Marib** was the largest ancient city in Southern Arabia and is considered one of the most significant historic sites in the Arabian Peninsula. Despite climatically unfavourable conditions, at the end of the 2nd millennium BC, a complex society emerged there, whose economy relied on a highly developed irrigation system. Thanks to its economic prosperity and geographic location, Marib became the most important trading station along the Incense Route. Marib hosts several important cultural sites such as the Bar'an Temple, the Awam Temple with its necropolis, the Wadi Ghufaina settlement and al-Mabna dam, and the Great Dam of Marib, which is considered to be a wonder of technical engineering and also appears in a verse of the Qur'an. Both the Great Dam of Marib as well as the Ancient City, part of the Archaeological site of Marib listed on Yemen's Tentative List of World Heritage since 2002, have been bombed and looted on several occasions over the course of the current conflict, severely damaging the site's historic structures. The Dam of Marib, twice as long as the Hoover Dam, sustained the largest city in ancient southern Arabia for more than a thousand years. Satellite imagery collected on 29 October 2015 confirmed the severe damage sustained by the two remaining sluices in the ancient dam system (see before and after images on page 14). Satellite imagery collected on 29 October 2015 also showed extensive damage to the ruins of the Ancient City of Marib and increased looting activities within the citadel, as well as new construction activities in the immediate vicinity of the area.

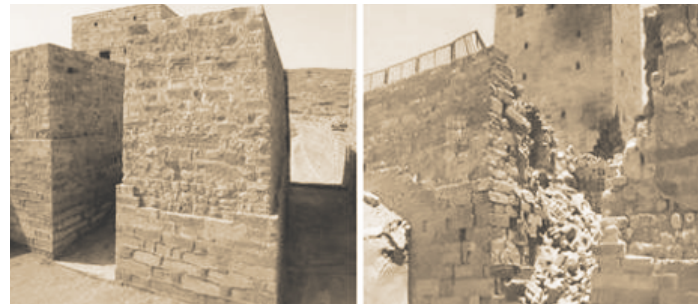
Marid Old Dam before and after image. Photo credit: Hussain Bukhaiti. Satellite imagery collected on 29 October 2015 shows one of the retention towers severely damaged with visible debris in the middle section of the Southern Dam sluice.

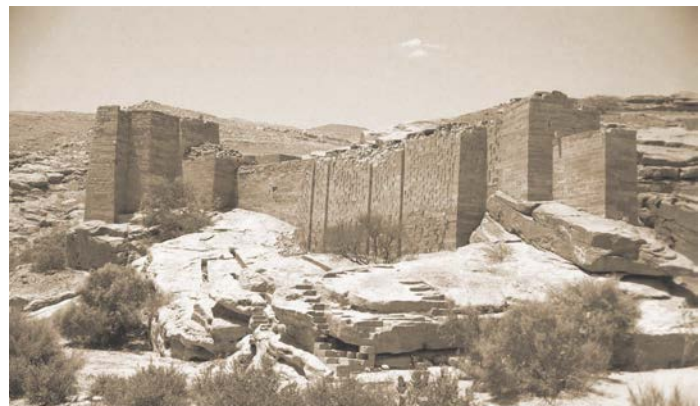
Marib Old Dam before destruction. Photo credit: Jordi Zaragoza Anglès, Mikaku planet, 1995 (www.mikakuplanet.com).
