SITE NAME: The Old Bridge area of the Old City of Mostar

Nomination Dossier
“The Old City of Mostar”

January 2005

**Parts of Studies and Designs prepared
for the facsimile reconstruction of the
Old Bridge in Mostar during period
1999 - 2004**

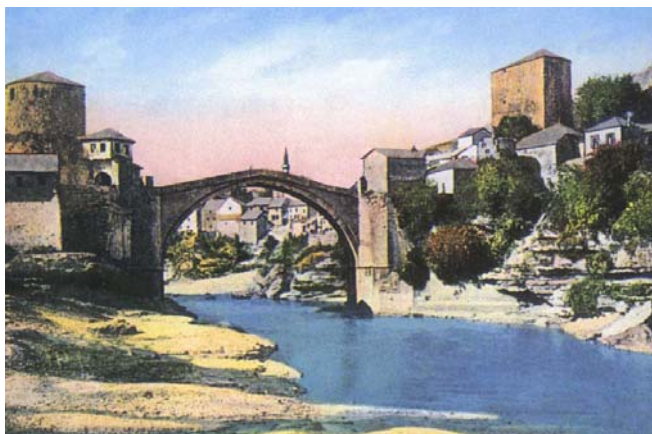
The bridge constitutes one stone arch with a span of 28.70 meters. The supporting vault is 90 cm thick, four meters wide, and its height in summer when the water is low is about 20 m. Three ribs rest on its vault, a middle one and two at equal distances on either side of it, to support the roadway. The entire construction is thus considerably lightened.

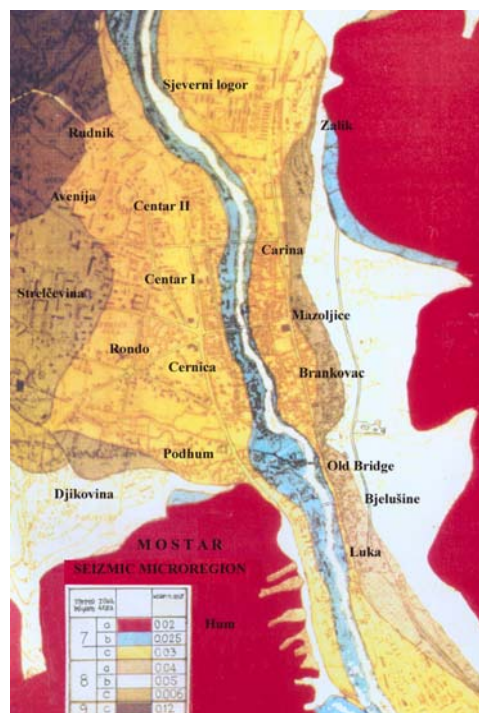
Mostar seismic microregion

Seismic micro-regions as a basic pre-condition for planning and construction in the city were defined and under permanent observations by the special unit of the local Planning institute. It is important to emphasize that a sizeable part of the territory of Mostar has bed seismic characteristics of soil, especially in the north-west part of the central urban valley.

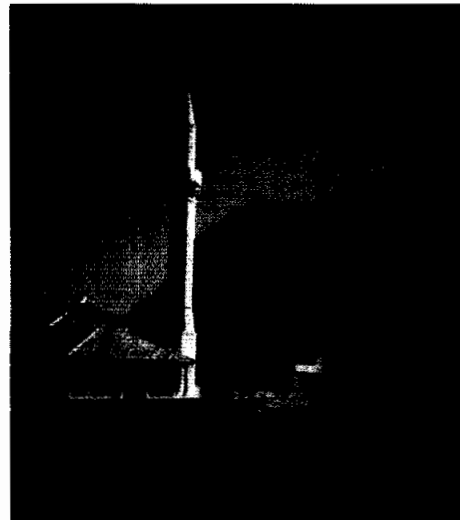
Neziraga Mosque Complex before and after restoration

- Restoration of this complex was foreseen in the Master plan from 1989.

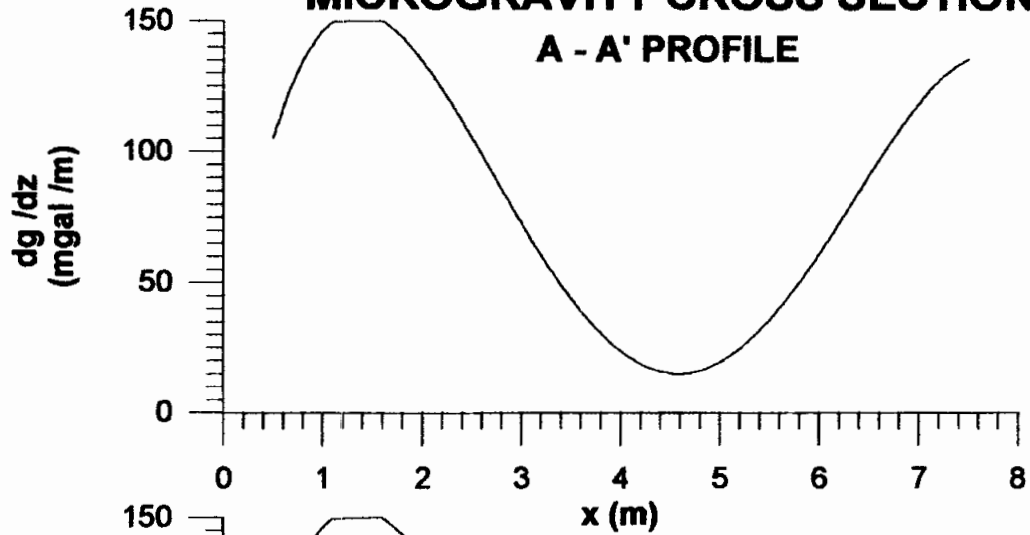
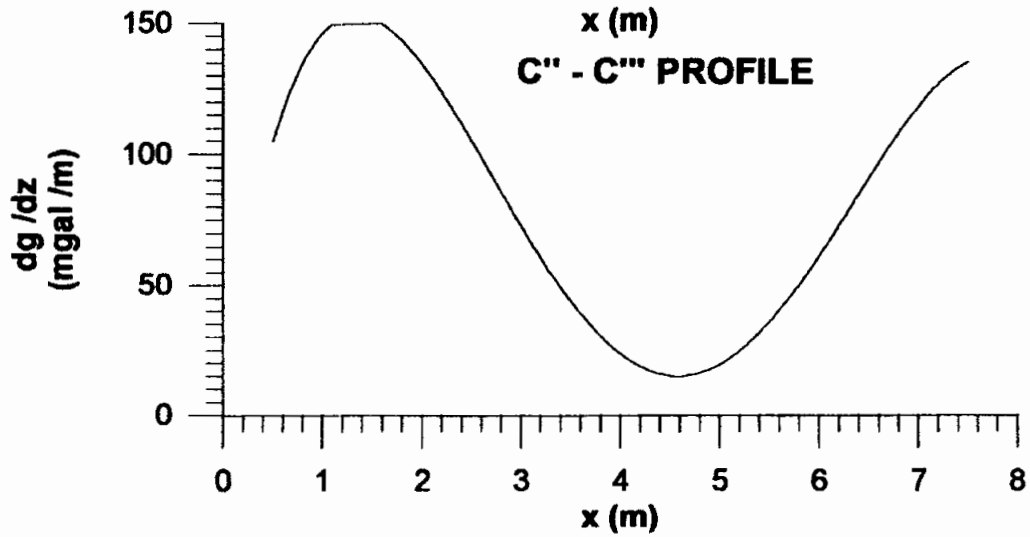
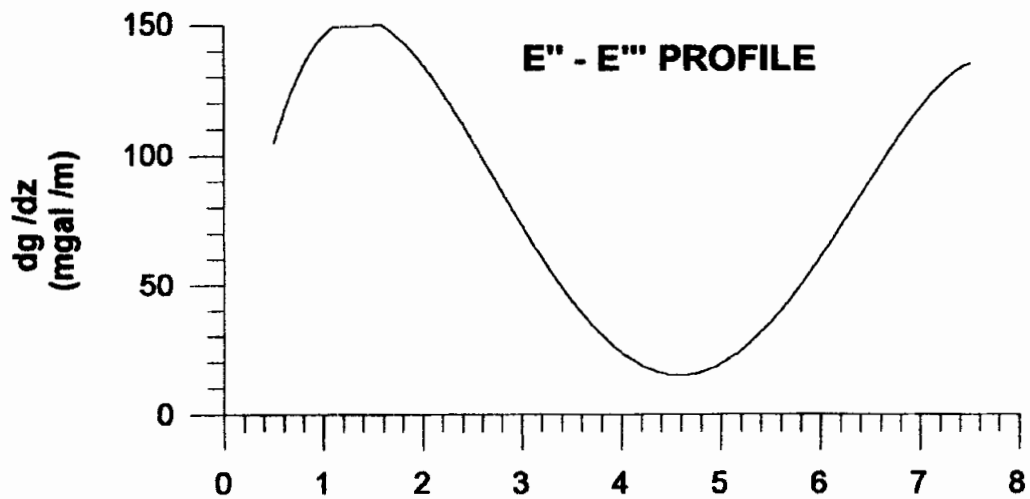
MICROGRAVITY CROSS SECTION

Discontinuity Location	Station Interval	Surface Projection of Anomaly	Depth to Center h-meter	Entrance Depth (Top)	Exit Depth (Bottom)
West Bank	W6 – W8	0.5 meter Northwest of W6	1.69	1.16	2.22
West Bank	W6 – W8	0.5 meter North of W6	2.61	2.14	3.08
West Bank	W19 – W20	0.25 meter North of W20	0.65	0.37	0.93
West Bank	W110 – W49	0.5 meter Northeast of W49	2.87	2.12	3.62
East Bank	E12 – E13	0.75 meter East of E12	2.74	2.01	3.51
East Bank	E12 – E13	0.4 meter South of E13	2.59	1.89	3.29

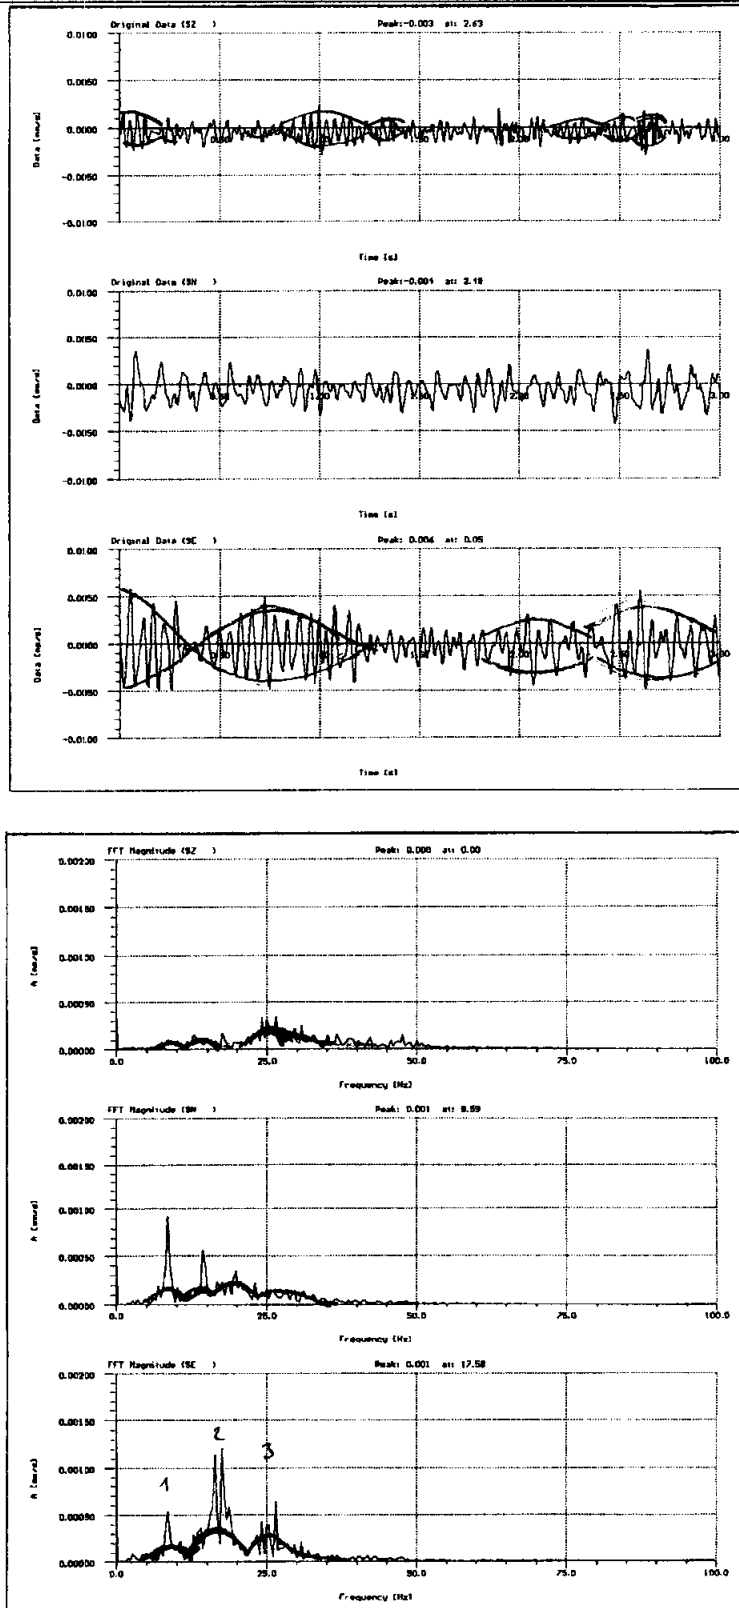
Sample three component (Vertical (z), NS, EW) microtremor recordings (upper section) and their spectrums and first, second and third spectral harmonics, by floating point average in frequency domain (lower). In upper part on observes typical Rayleigh wave train.

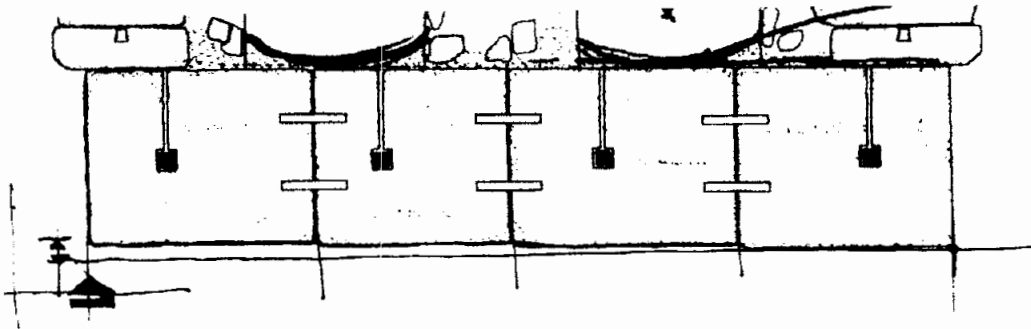
fig.3 - variation of height of a single row in the bridge thickness

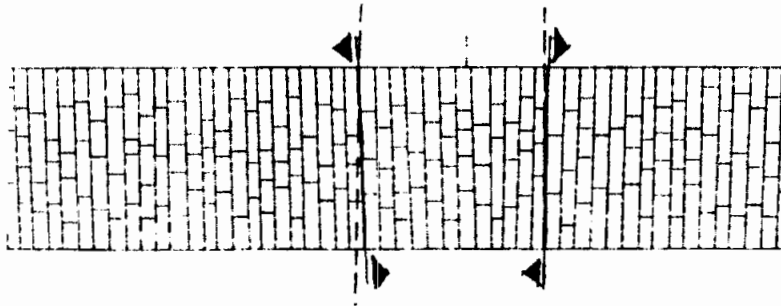
fig.4 - different raising of the arch voussoirs rows on north and south elevation (plan view of the arch extrados)

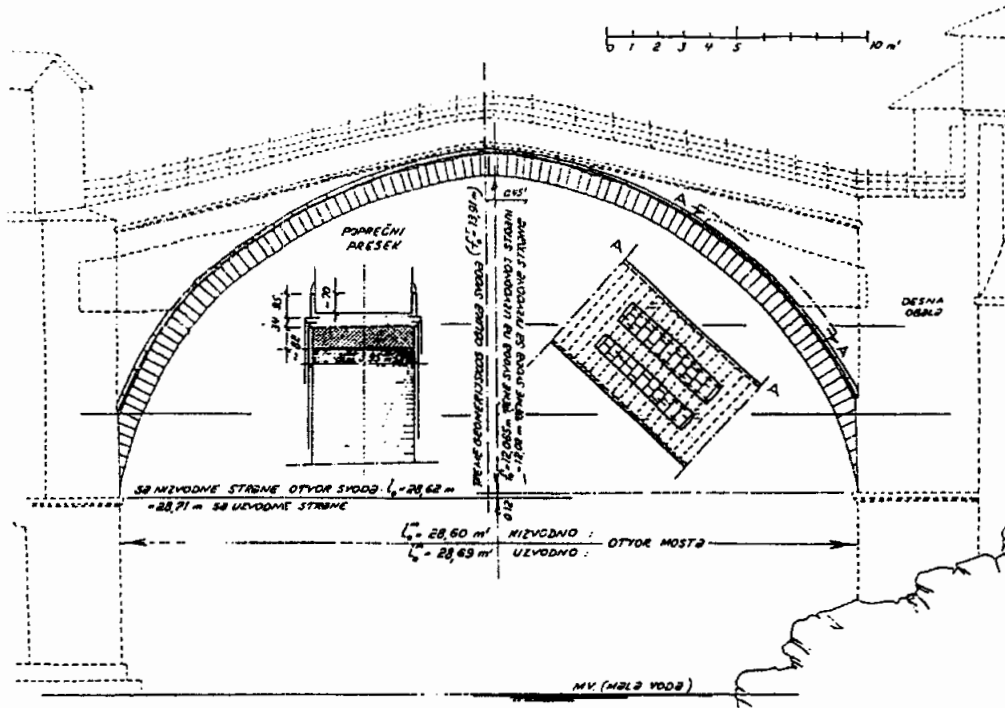
fig. 8 - Section of arch. Notice the collapse of the abutment

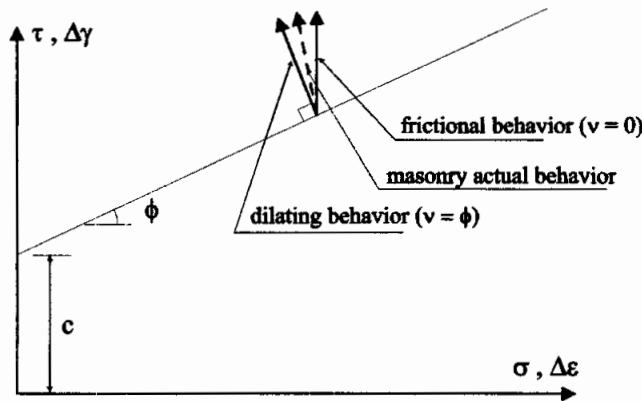
fig. A - Frictional and dilating behaviour: flow rule for masonry material

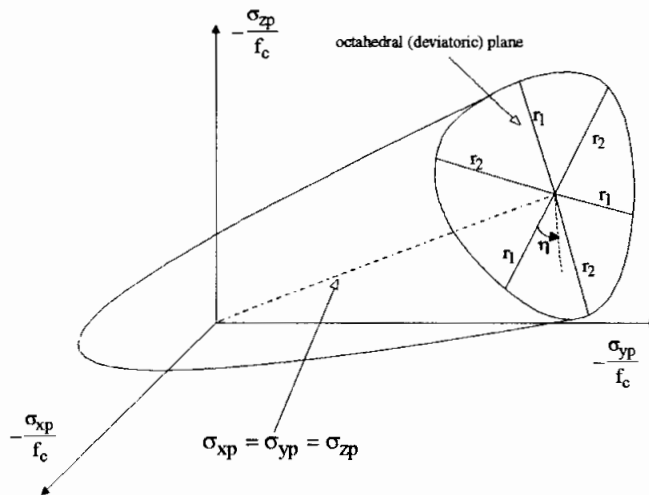
fig. B - Failure surface

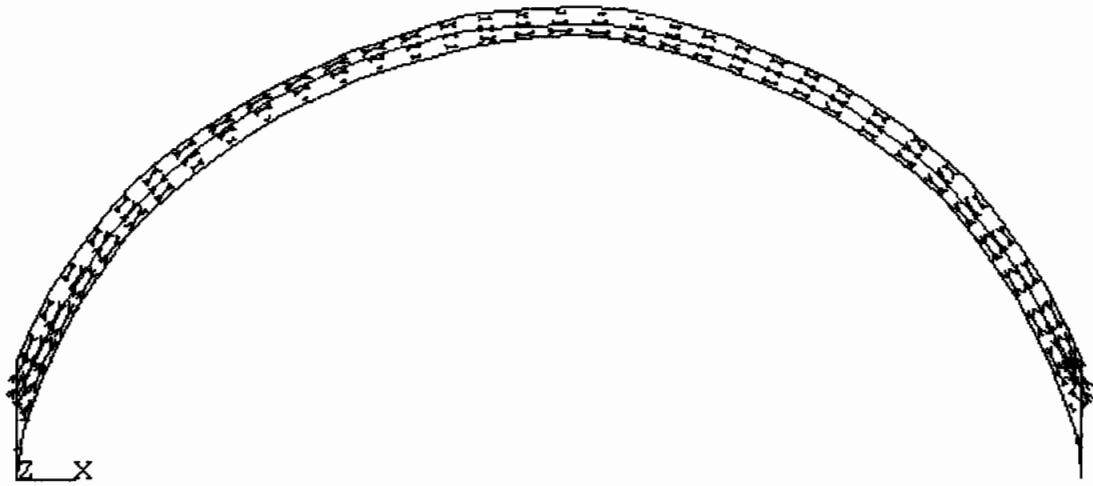
fig. 14 - Thrust line in the arch (extracted from the F.E. of the whole bridge)
