กรณีศึกษาโครงการอนุรักษ์ ของสำนักงานทรัพย์สินส่วนพระมหากษัตริย์

Rehabilitation of Na Phra Lan Shop-houses

กรณีศึกษา โครงการตึกแถวถนนหน้าพระลาน

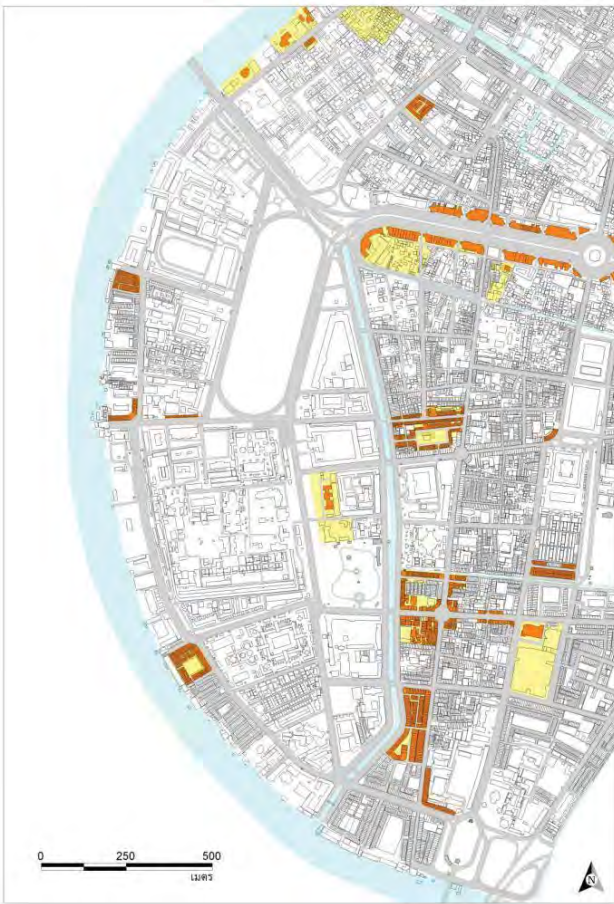
- In 2001, the shop-house row was on national register under the Monument Act of 1961
- According to the law, the registered property must maintain its cultural value and integrity
- In 2008, the shop-houses were found in bad condition without proper care
- A site evaluation notice from Fine Arts Department sent to CPB on lack of proper maintenance

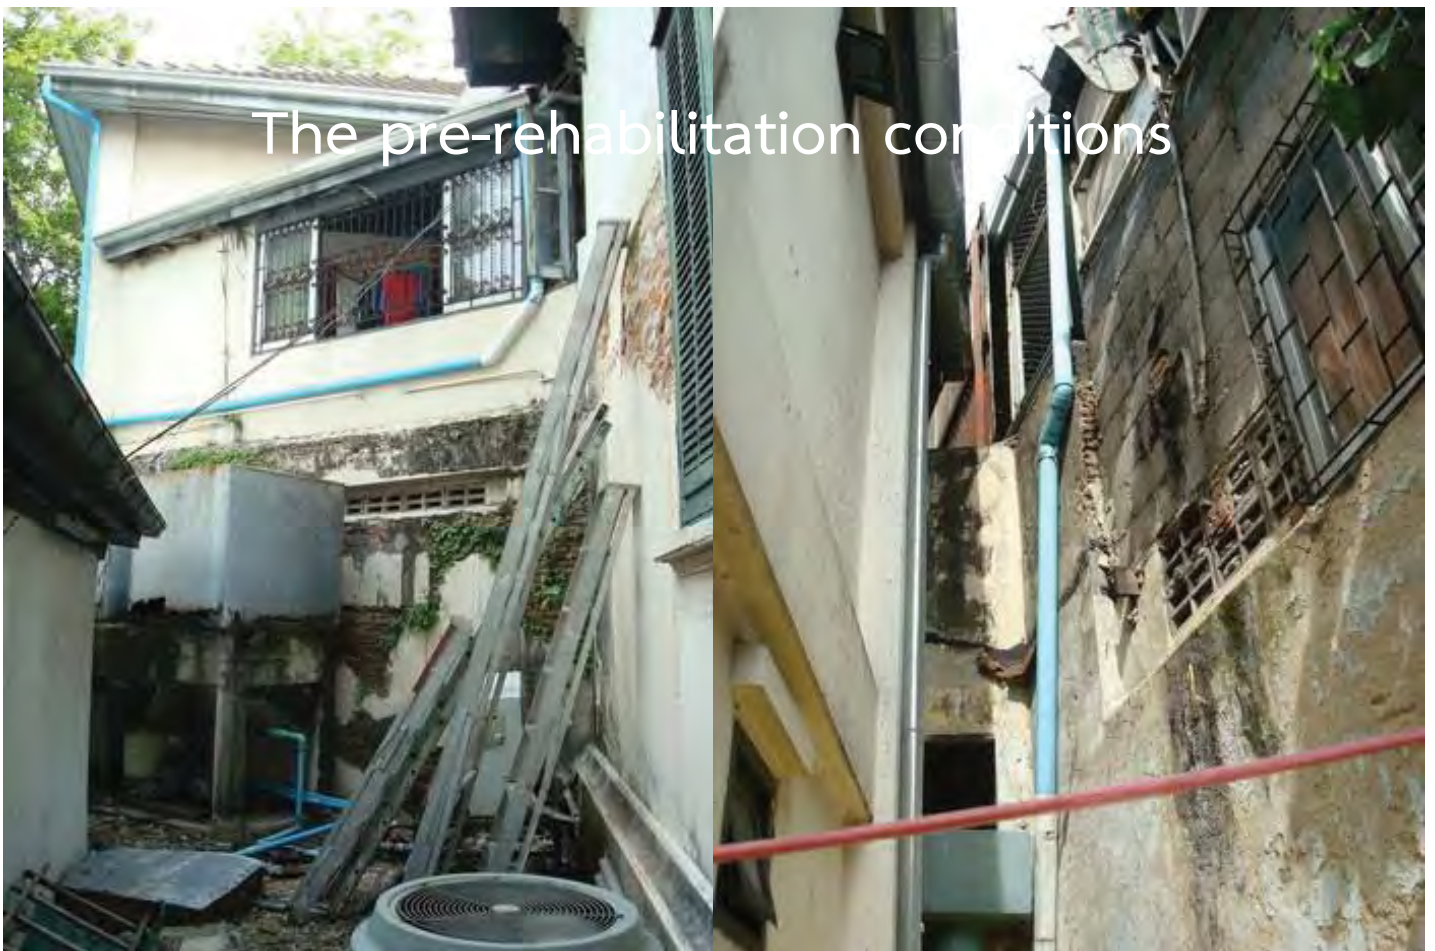
Physical problems

- Original material damage and deterioration
- Building modifications/ alterations
- Installation of wires and facilities

Causes of damage

- Lack of periodic investigation from the CPB
- Negligence of the tenants
- Lack of maintenance

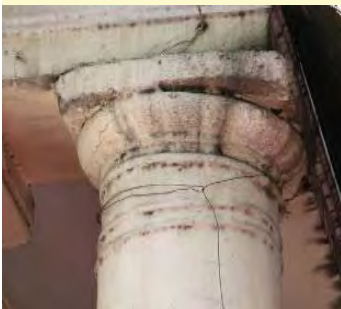
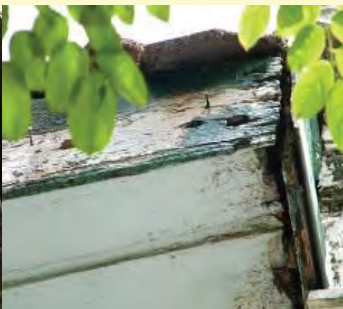
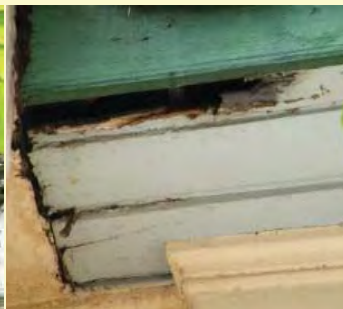
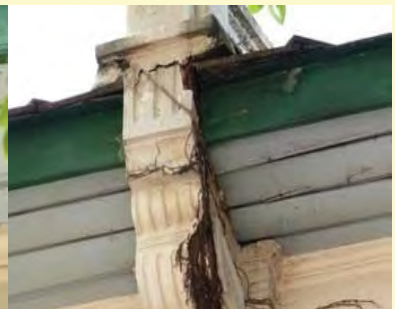
Exterior damages due to lack of maintenance

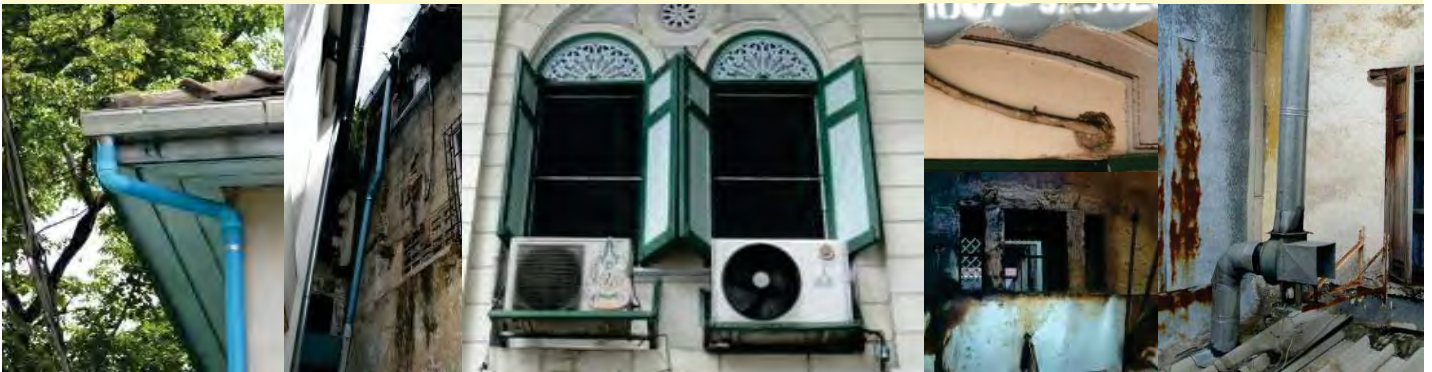
Inappropriate installment of facilities and wires

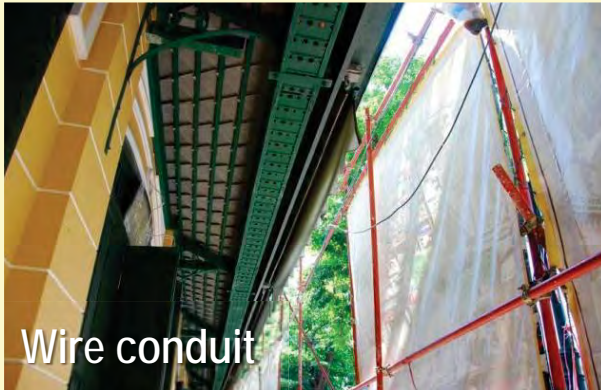
Wire conduit

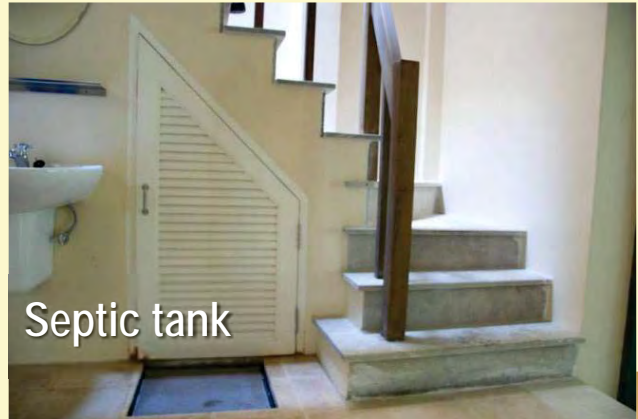
Septic tank

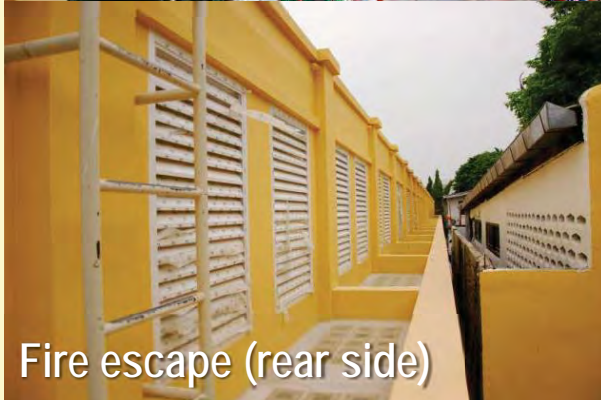
Fire escape (rear side)

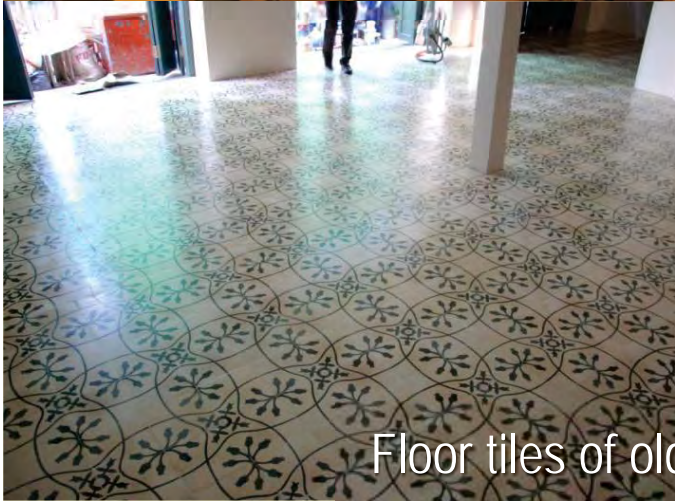
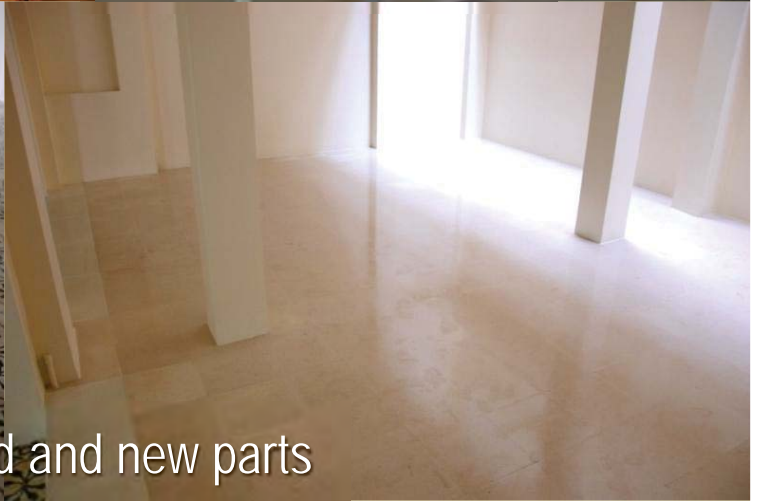
Repair of original ceiling

Replacement of steel beam with original timber beam
